**QUALITY ASSURANCE  
MONTHLY SITE  
ASSESSMENT REPORT**

Airfield Modernization Program  
Runway 5L-23R Reconstruction  
Project 2 / Project 3

## QUALITY ASSURANCE SITE ASSESSMENT

## **AIRFIELD MODERNIZATION PROGRAM RUNWAY 5L-23R RECONSTRUCTION**

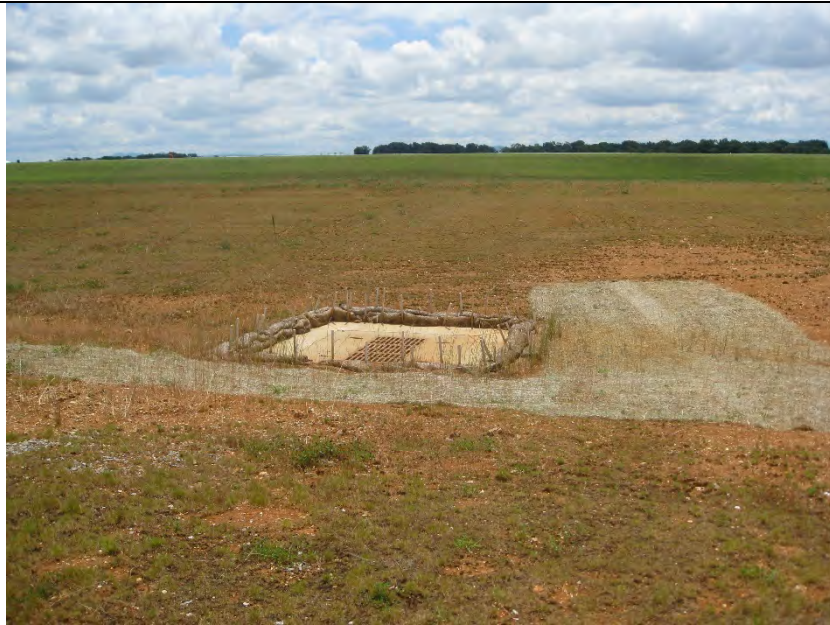
Photo 67  
Sta. 296+83 RT  
(RW 5L-23R)  
Structure 220  
Project 2

Structure 220.  
Recommend stabilizing remaining bare areas.

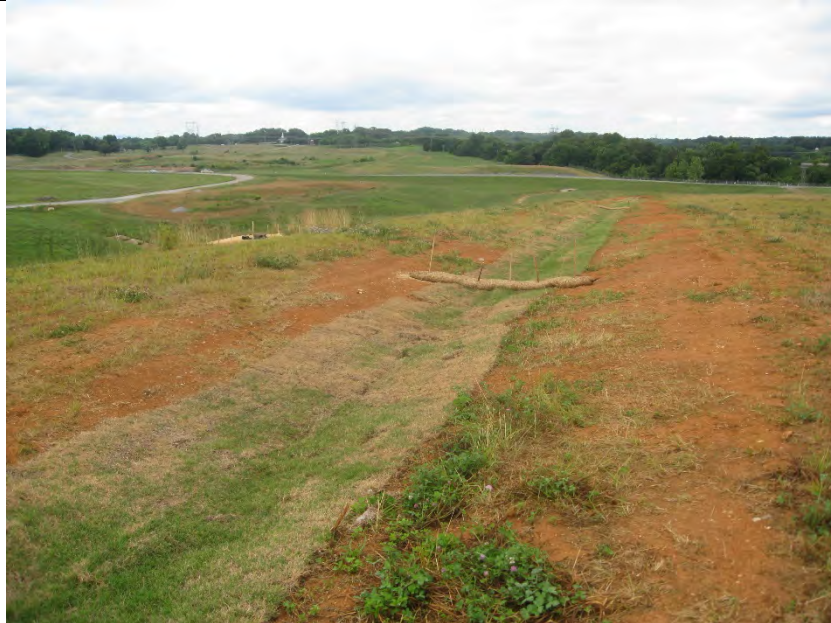
Photo 69  
Sta. 290+26 RT  
(RW 5L-23R)  
Structure 600 Ditch  
Project 2

Structure 600 Ditch.  
Ditch recently regraded and sod applied.  
Recommend stabilizing remaining bare areas.

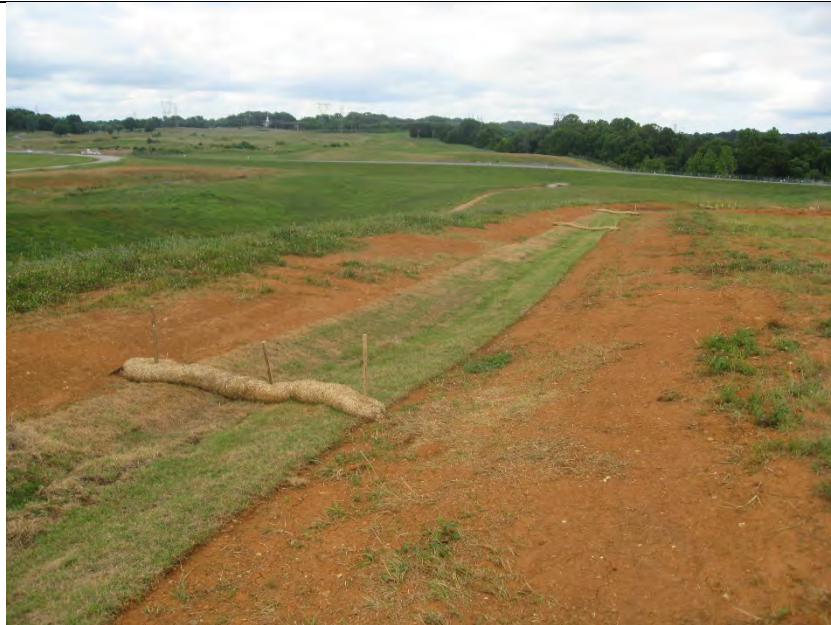
Photo 71  
Sta. 290+26 RT  
(RW 5L-23R)  
Structure 600 Ditch  
Project 2

Structure 600 ditch.  
Ditch recently regraded and sod applied.  
Recommend stabilizing remaining bare areas.

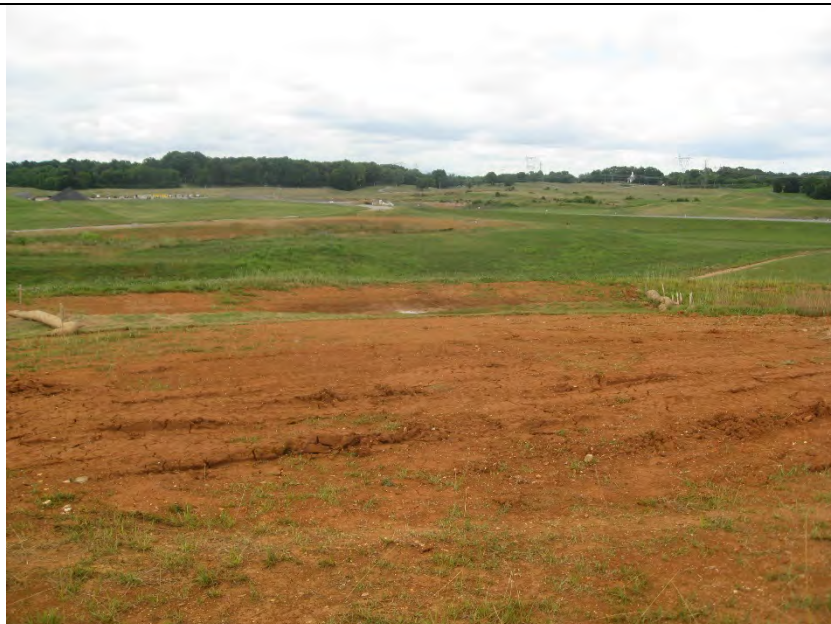
Photo 72  
Sta. 290+26 RT  
(RW 5L-23R)  
Structure 600 Ditch  
Project 2

Structure 600 ditch.  
Recommend stabilizing bare areas.

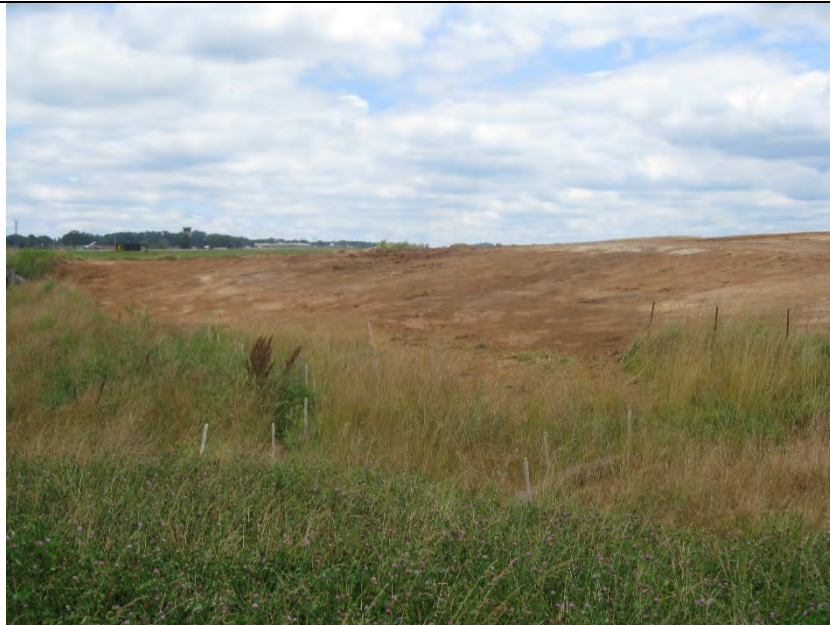
Photo 77  
(RW 5L-23R)  
Project 3

Grading operations recently taken place at existing crushing operations area.  
Recommend adding silt fence on contour and stabilizing bare areas.

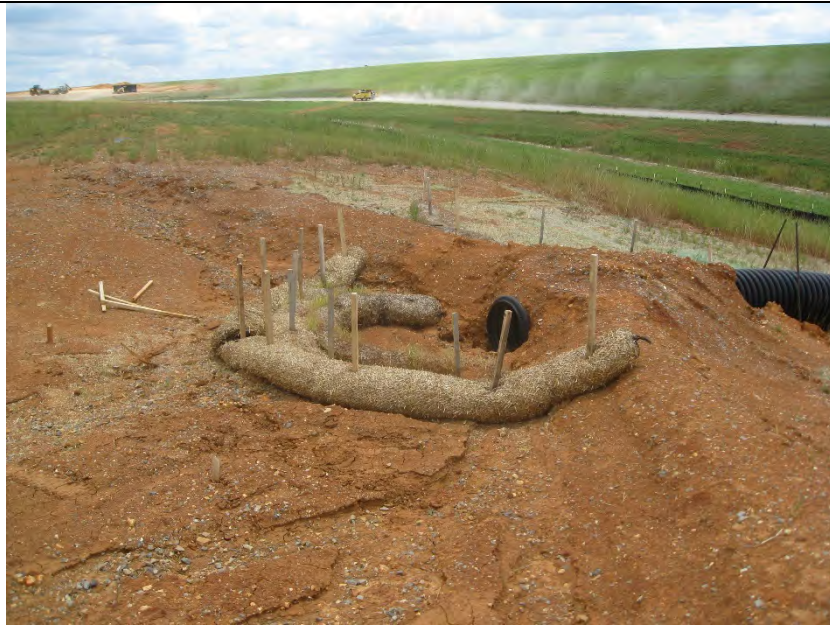
Photo 83  
Sta. 302+54  
(RW 5L-23R)  
Project 2

Soil stockpile area next to haul road at Taxiway B.  
Additional sediment tubes recently installed.  
Recommend stabilizing bare areas.

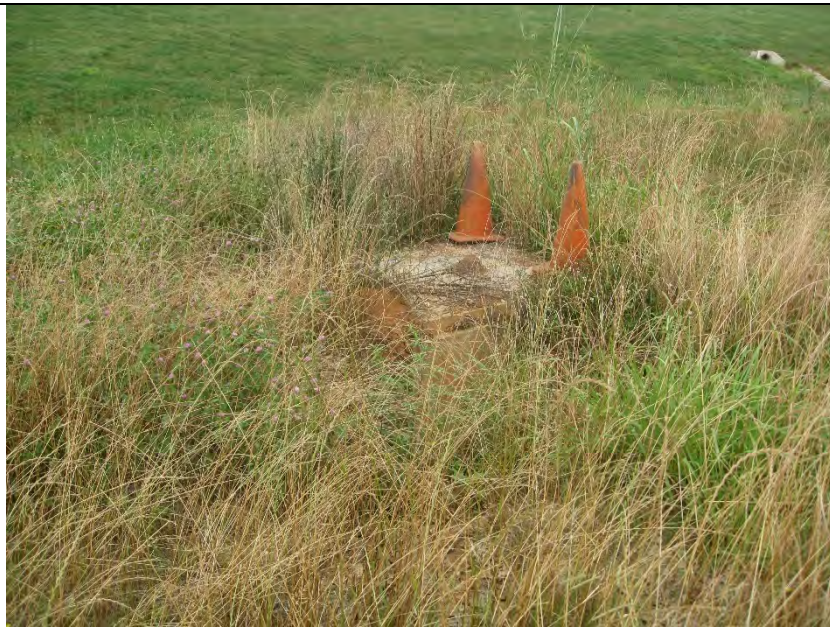
Photo 95  
Sta. 284+00 LT  
(RW 5L-23R)  
Project 2

Existing vault at old Liberty street.  
Construction fallout present. Recommend coordinating with CHA on remediation.

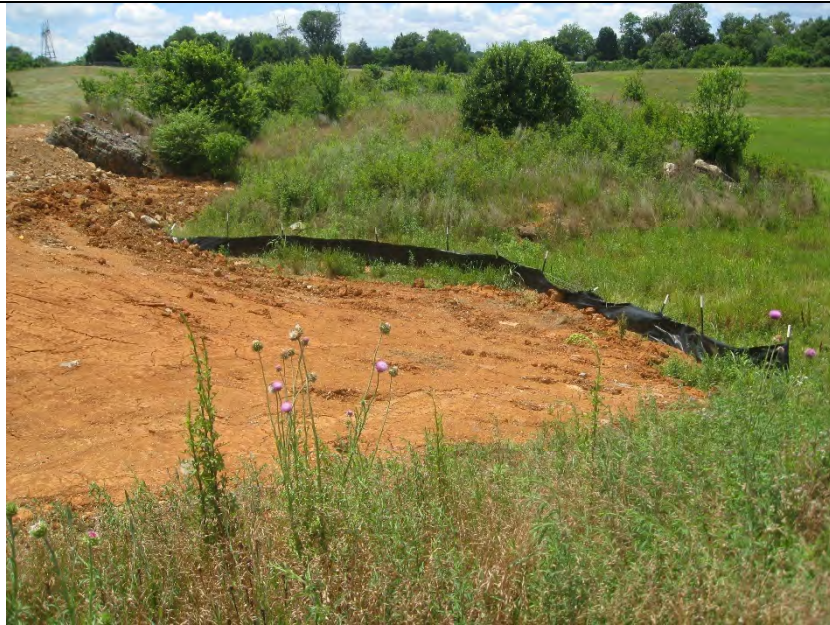
Photo 97  
(Repair TWY Lighting)

Fill area adjacent to Liberty Street from Taxiway shoulder removal.

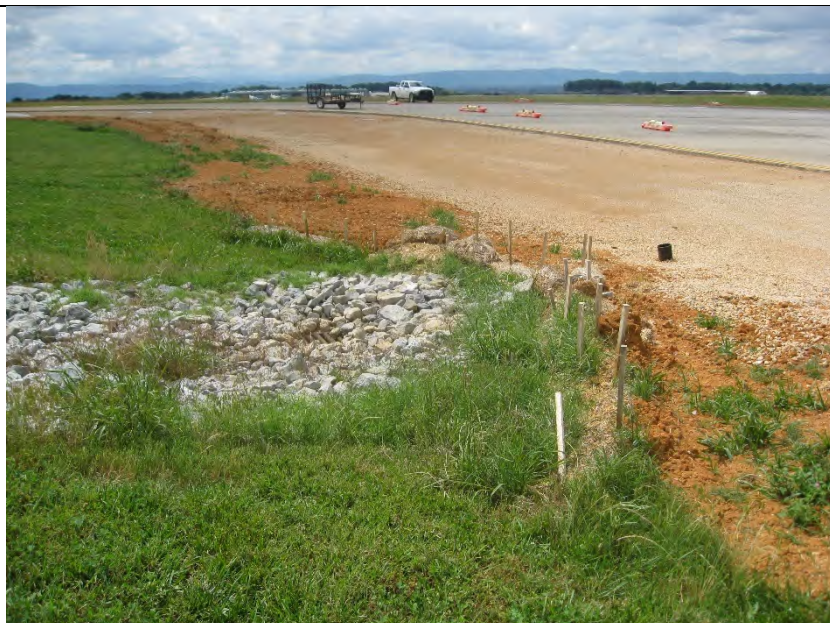
Photo 98  
(Repair TWY Lighting)  
Sheet EC2.1.7

Existing structure at Upper Apron.  
Base stone recently installed. Area appears to be stable.  
Recommend continuing to monitor for possible sediment migration and/or color contrasted water entering apron storm structures.

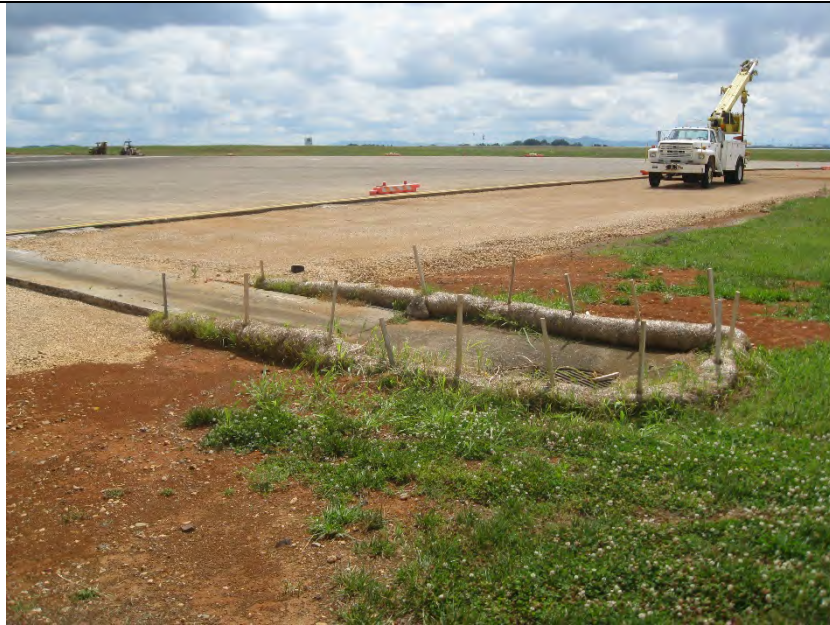
Photo 101  
(Repair TWY Lighting)  
Sheet EC2.1.5

Existing structure at Upper Apron.  
Newly installed underdrain recently backfilled and sediment tubes reinstalled.
