**QUALITY ASSURANCE
MONTHLY SITE
ASSESSMENT REPORT**

Airfield Modernization Program
Runway 5L-23R Reconstruction
Project 2 / Project 3

NPDES TN0081868 (Individual)
NPDES TNR134734 (General)

AIRFIELD MODERNIZATION PROGRAM RUNWAY 5L-23R RECONSTRUCTION

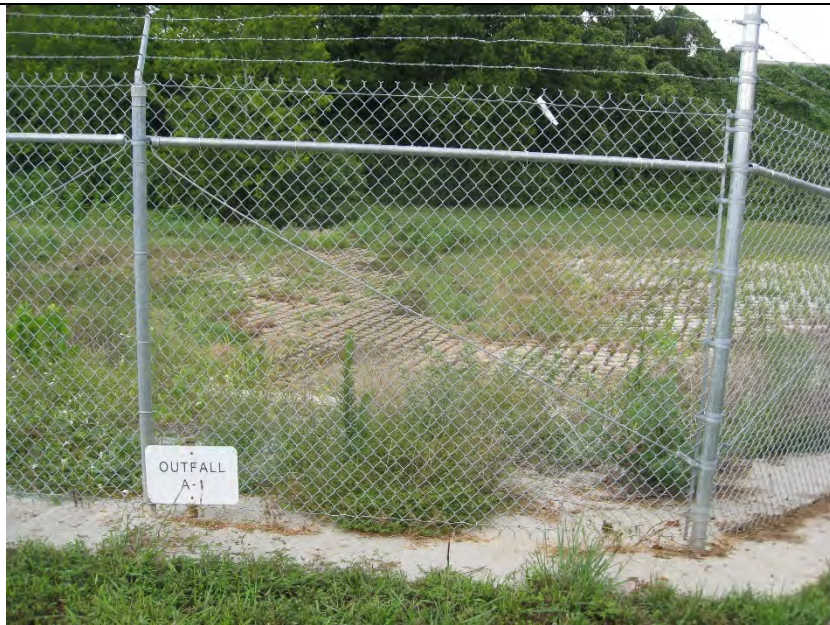
Photo 2
Sta. 111+56 RT
(Line LB)
NLET 01
Project 2

North Lateral End Treatment 01 (Outfall A).
Clear flow observed.

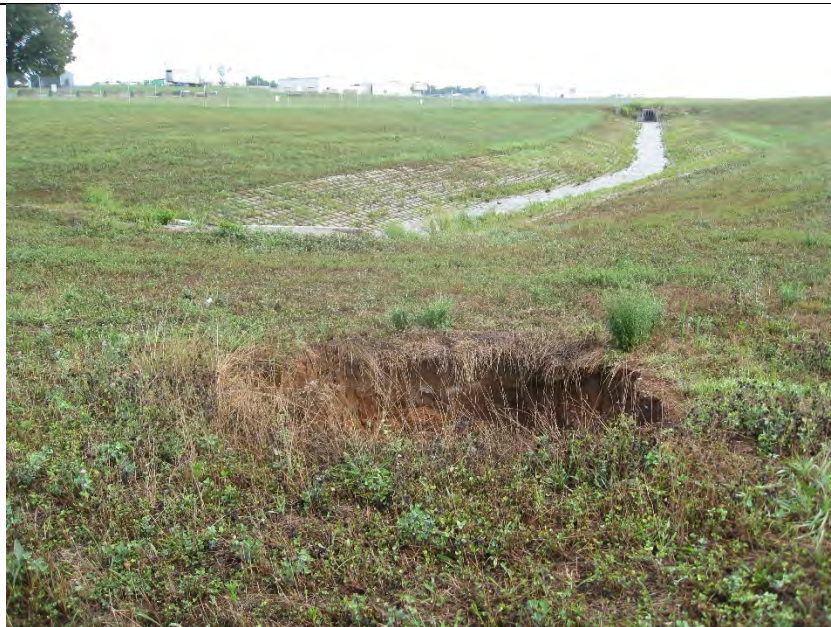
Photo 6
Sta. 117+00
(Line LB)
Project 2

Guard Lateral Ditch (Outfall B).
Clear flow observed.

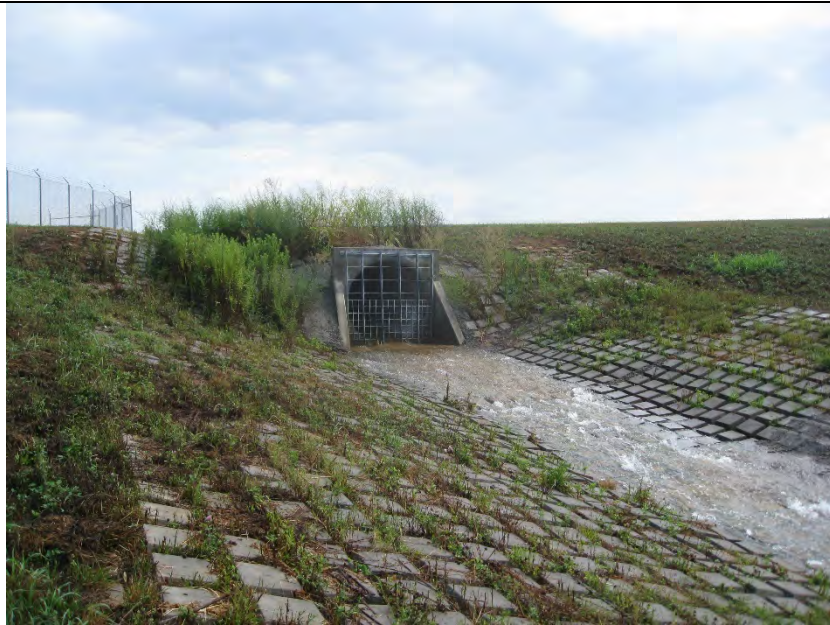
Photo 8
Sta. 117+00
(Line LB)
Project 2

Guard Lateral Ditch (Outfall B).
Clear flow observed.

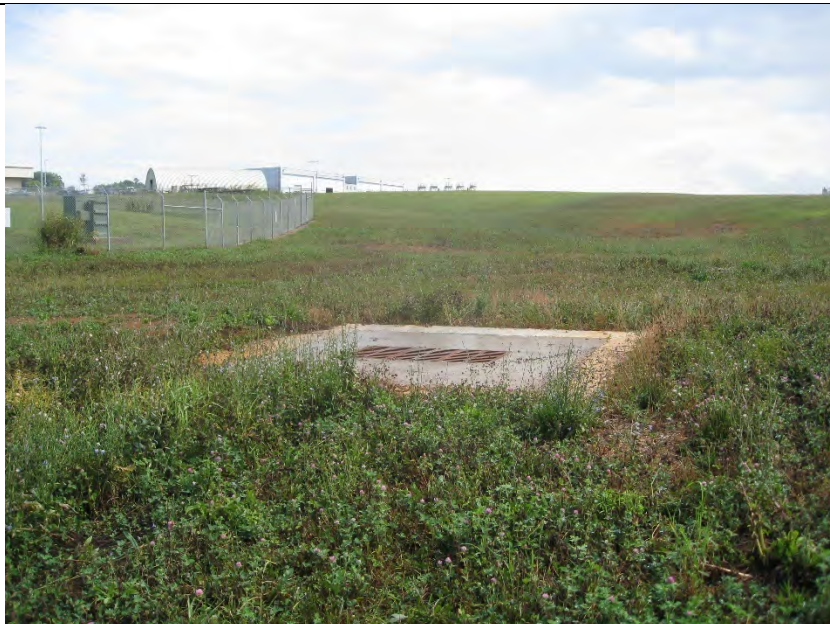
Photo 9
Sta. 117+00 (RT)
Project 2

78" culvert in the Guard Lateral Ditch.
Clear flow observed.

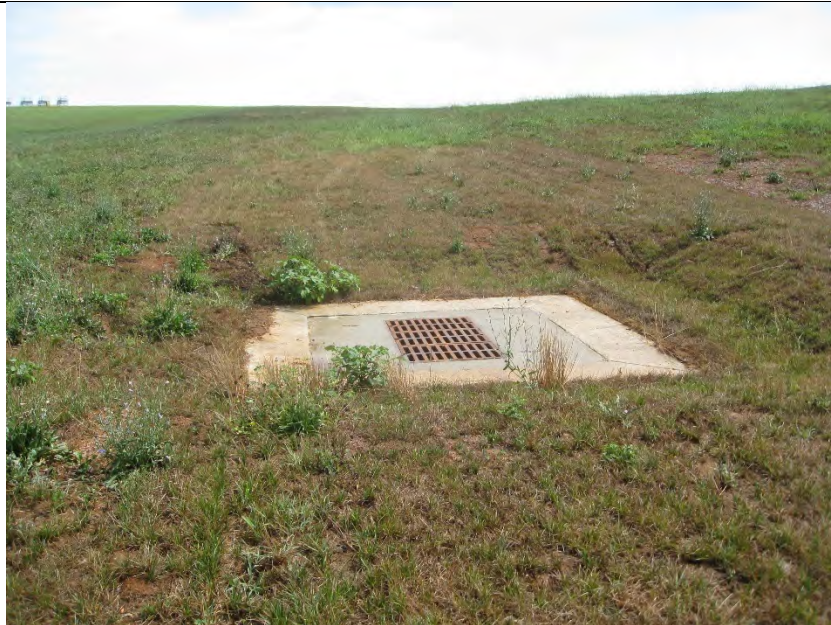
Photo 10
Sta. 287+21 LT
(RW 5L-23R)
Structure 124
Project 3

Structure 124.

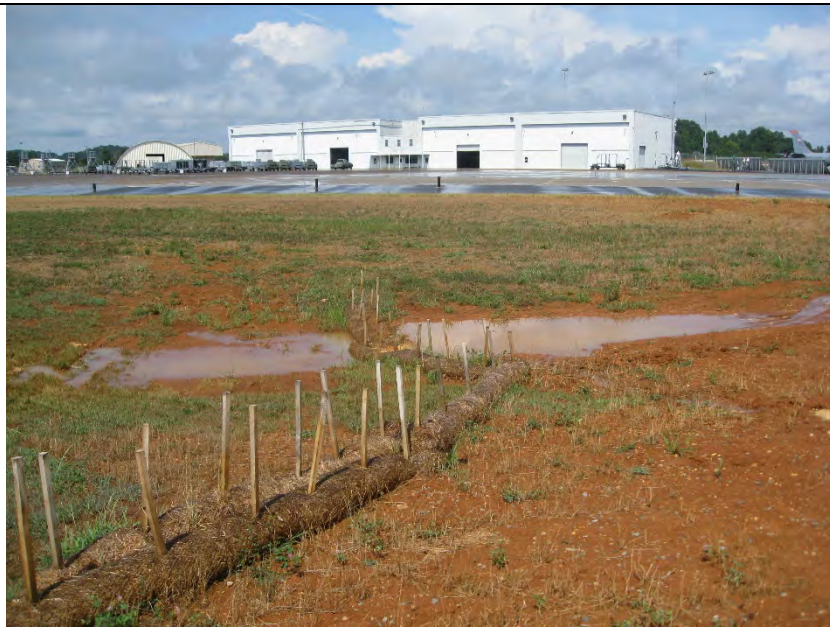
Photo 14
Sta. 298+71 LT
(RW 5L-23R)
Structure 116
Project 3

Structure 116.
Recommend stabilizing bare areas and repairing rills (see photos #15 and #16 below).

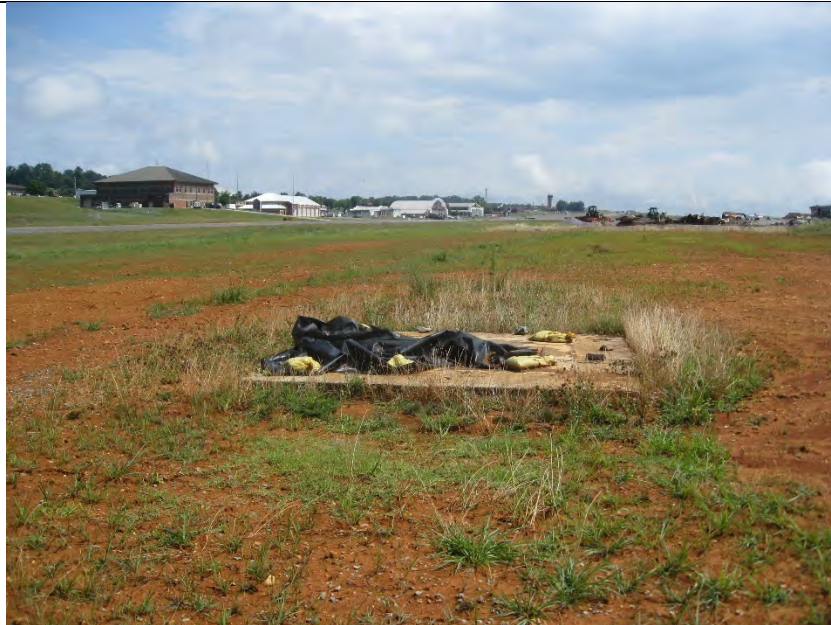
Photo 16
Sta. 298+71 LT
(RW 5L-23R)
Structure 116
Project 3

Above Structure 116 on Taxiway G2.
Recommend repairing rills and stabilizing bare areas.

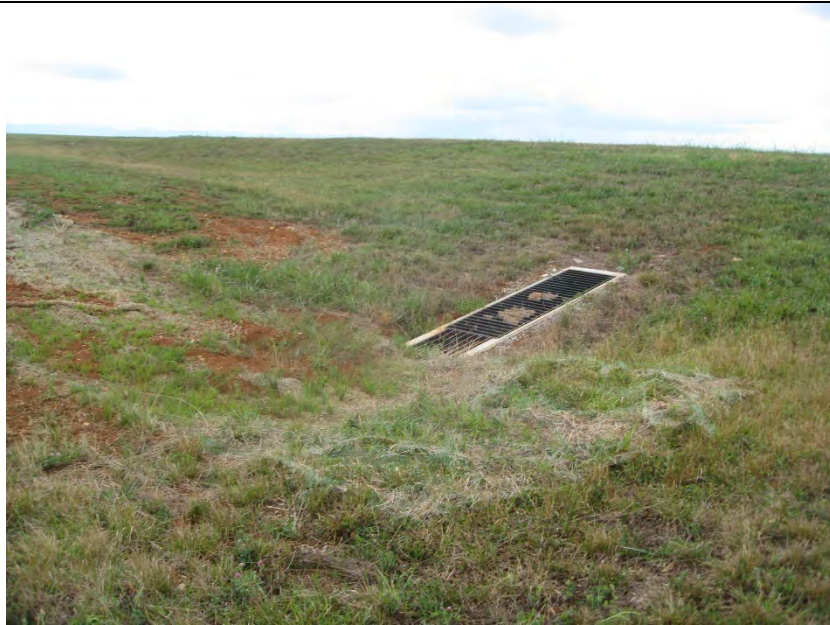
Photo 32
Sta. 341+50 LT
(RW 5L-23R)
Between ES Endwall 104 and 102
Project 3

Sixth construction fallout on Storm Line 1 between ES Endwall 104 and 102.
Coordinate remediation with CHA.

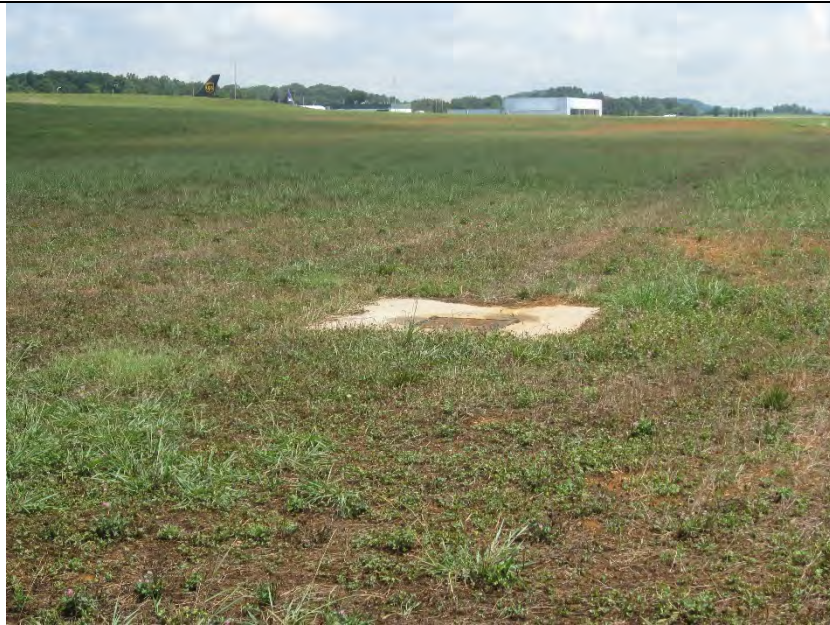
Photo 38
Sta. 361+39 LT
(RW 5L-23R)
Structure 100
Project 3

Structure 100.
Recommend stabilizing remaining bare areas.

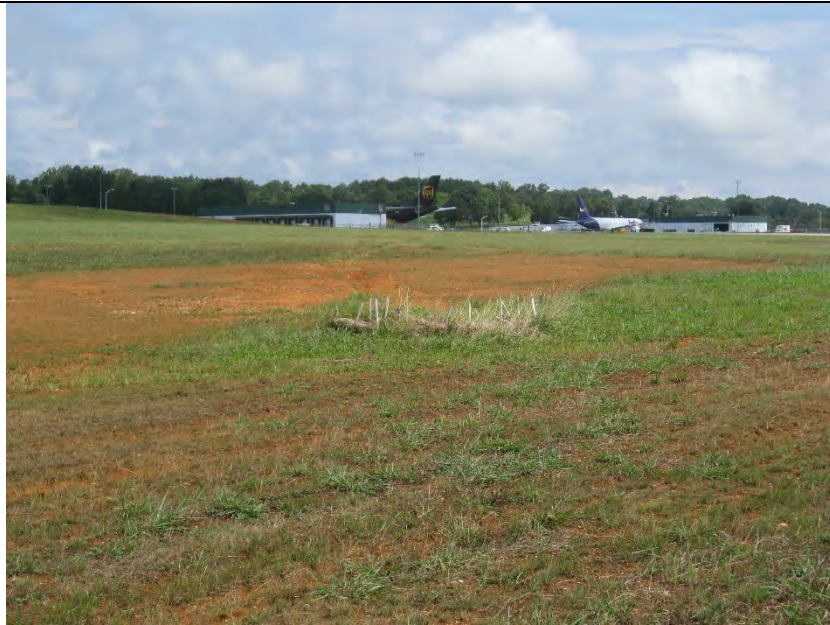
Photo 40
Sta. 366+25 LT
(RW 5L-23R)
Existing Structure
Project 2

Existing Structure.
Recommend stabilizing bare areas.

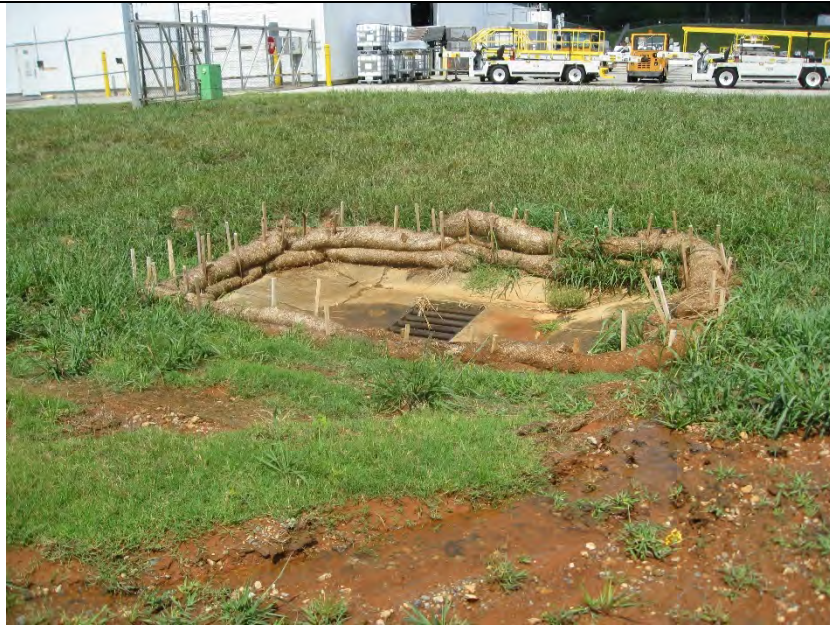
Photo 42
Sta. 677+00 RT
(RW 5L-23R)
Existing Structure
Project 4

Structure south of Taxiway "G".
Slopes started to rill after previous storm events. Sediment has migrated to structure.
Recommend repairing rills, removing accumulated sediment, and replacing sediment tubes.
Recommend stabilizing bare areas.

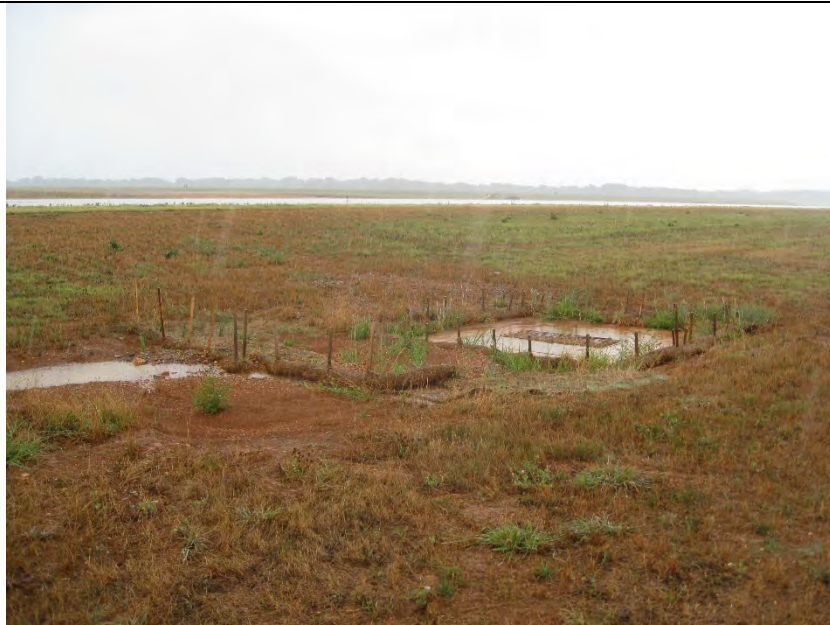
Structure 210.
Bare areas recently stabilized.

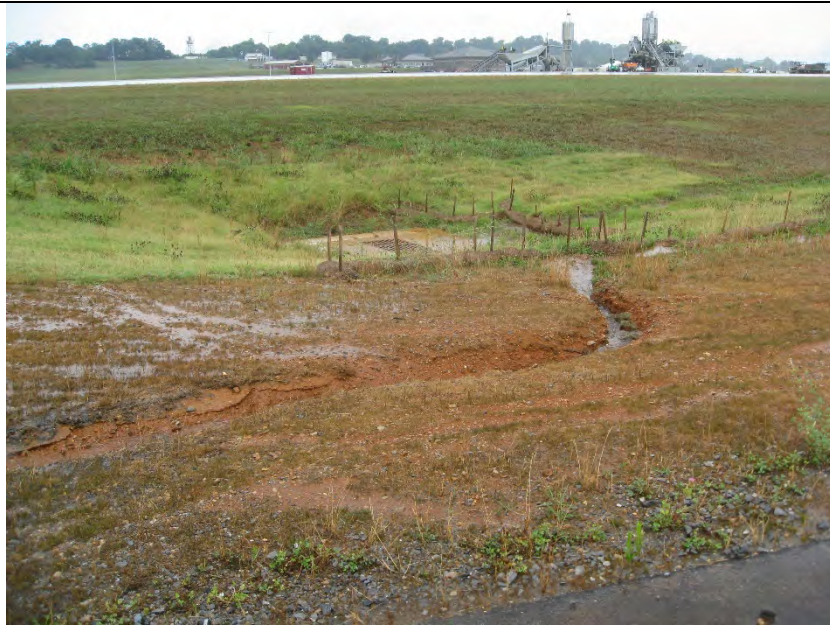
Recommend stabilizing bare areas and repairing rill above structure (see photo below).

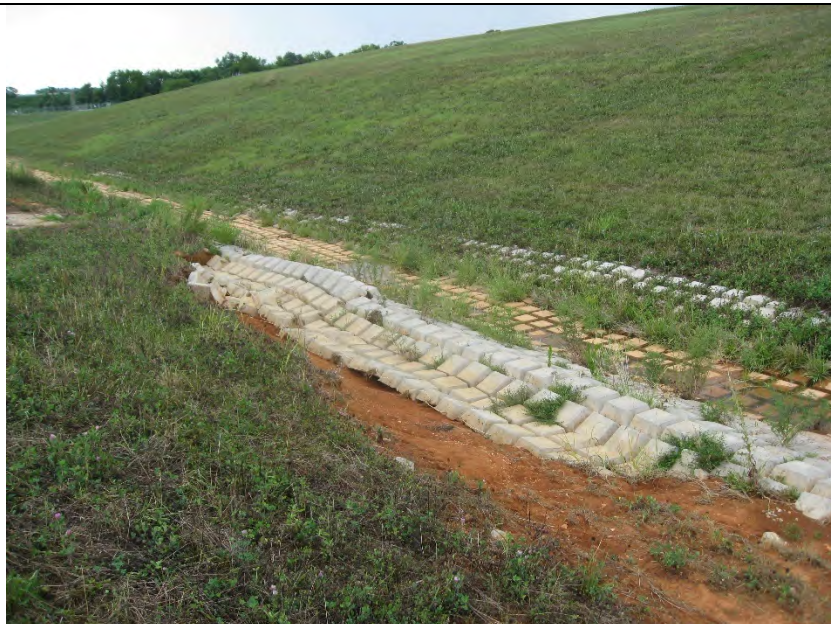
Photo 69
Sta. 288+26
(RW 5L-23R)
Structure 224
Project 2

Structure 224.

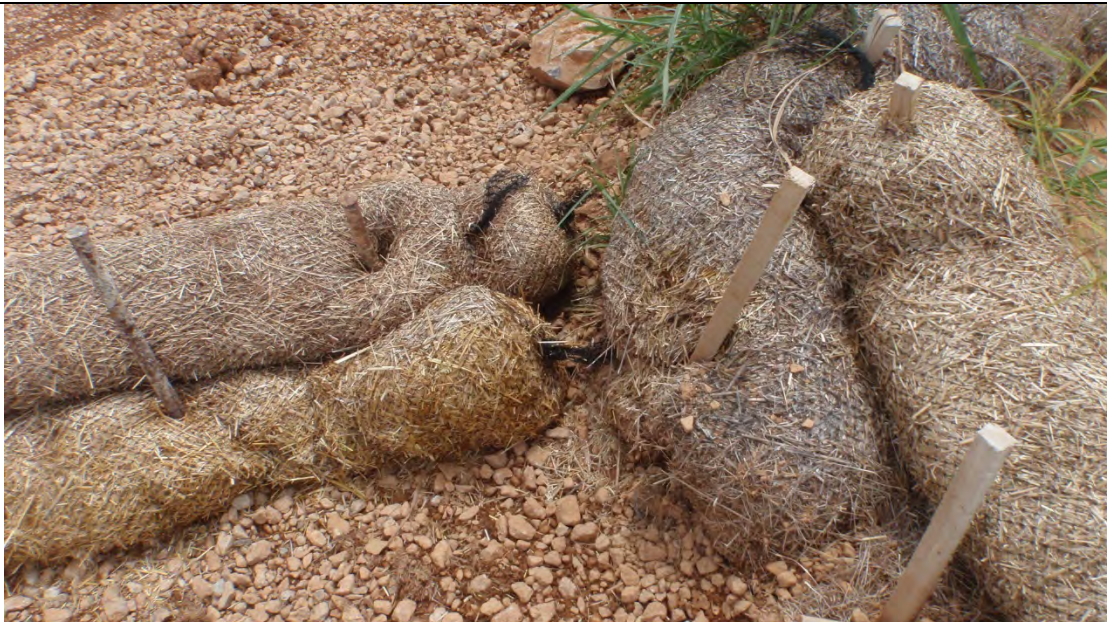
Photo 75
(RW 5L-23R)
Project 3

Area above Haul Road Culvert Inlet (stone stockpile area).
Sediment tubes recently installed to divert runoff into existing storm structure.

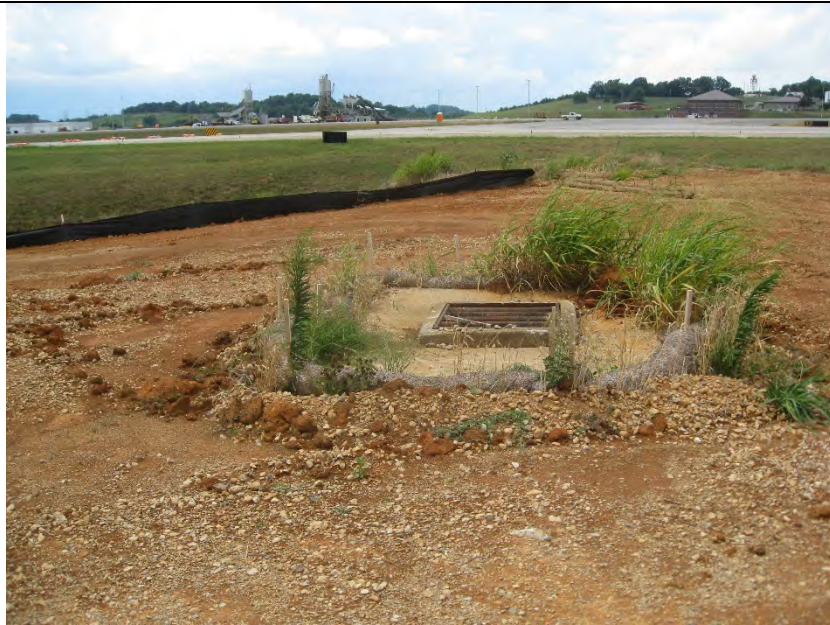
Photo 76
(RW 5L-23R)
Project 3

Area above Haul Road Culvert Inlet (stone stockpile area).
A gap exists between existing sediment tubes and newly installed sediment tubes (see previous photo) which will allow water to bypass structure. Recommend additional sediment tubes be installed to ensure runoff is treated or diverted to storm structure.

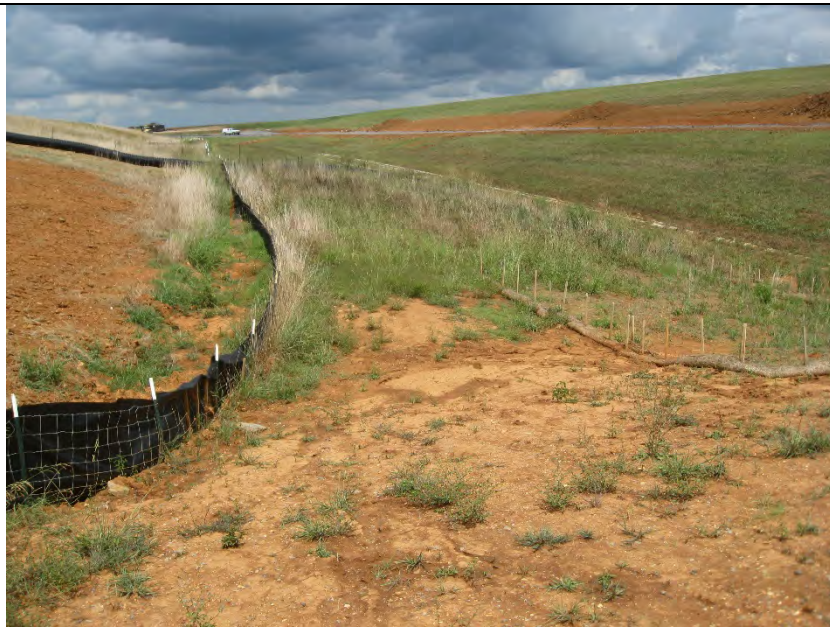
North Lateral Fill Area
Rills have formed and sediment has migrated to silt fence.
Recommend removing accumulated sediment.
Recommend coordinating with CHA on remediating rills.

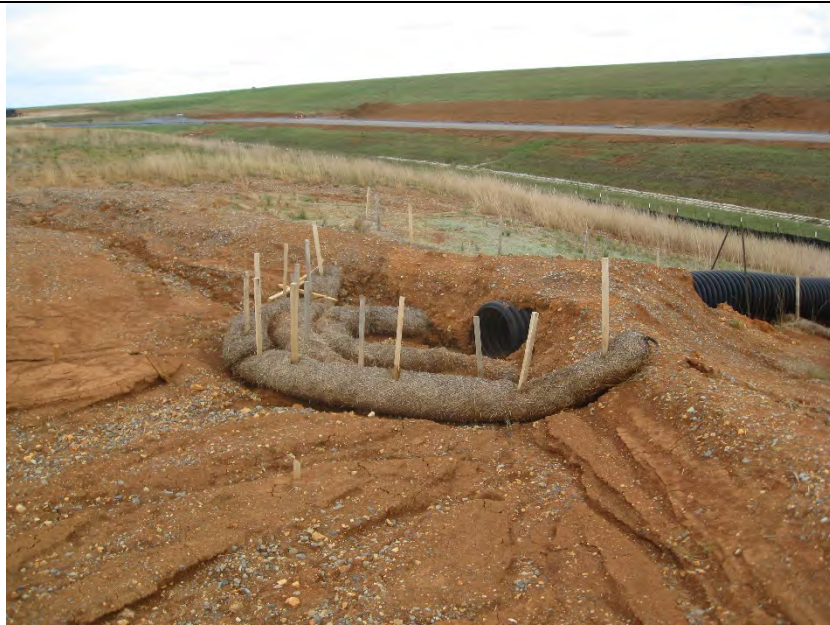
Above North Lateral Endwall 100.
Recommend stabilizing bare areas.

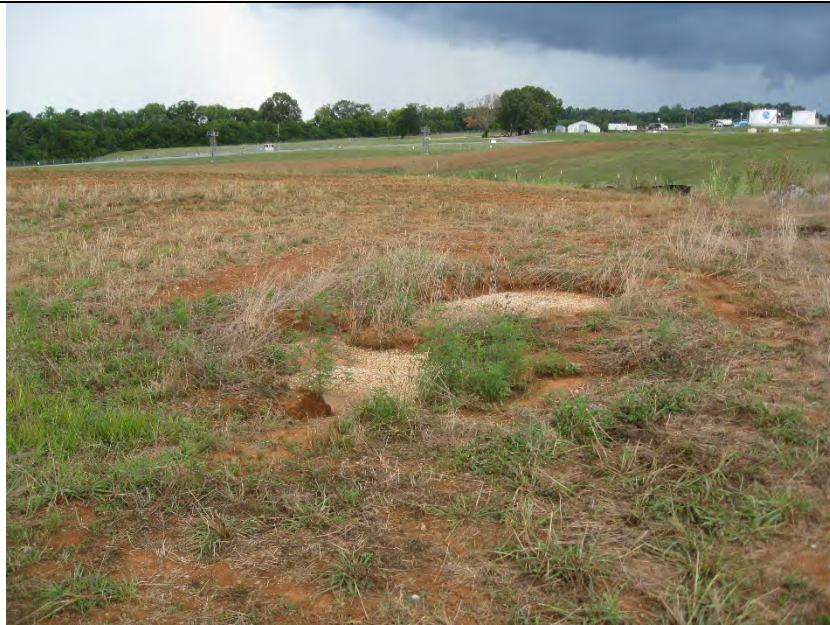
Existing vault at old Liberty street.
Construction fallout present. Recommend coordinating with CHA on remediation.

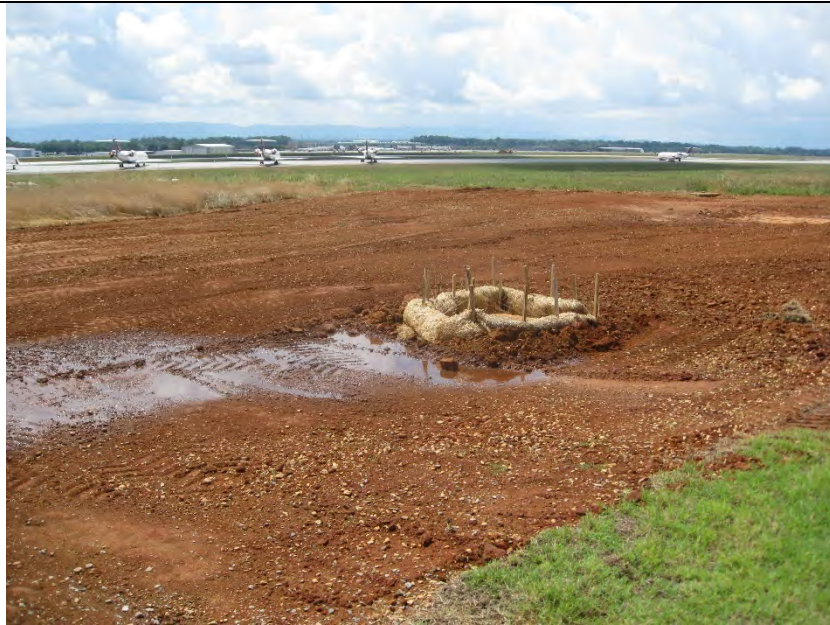
Photo 102
(Repair TWY Lighting)

Fill area adjacent to Liberty Street from Taxiway shoulder removal.
Sediment has migrated to silt fence. Recommend removing accumulated sediment.

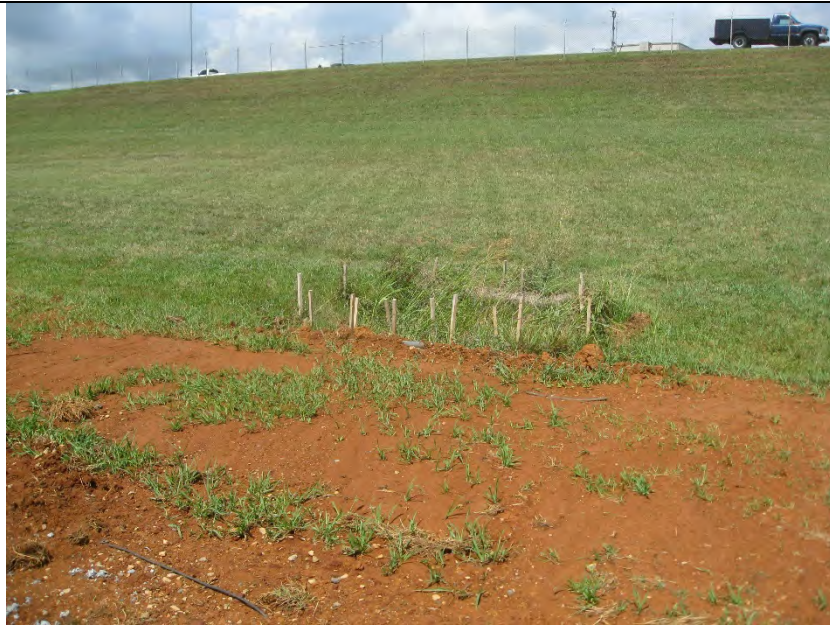
Photo 104
(Repair TWY Lighting)
Existing Structure

Existing structure south of Taxiway G.
Area recently graded and appears to be at finished grade.
Recommend stabilizing bare areas.

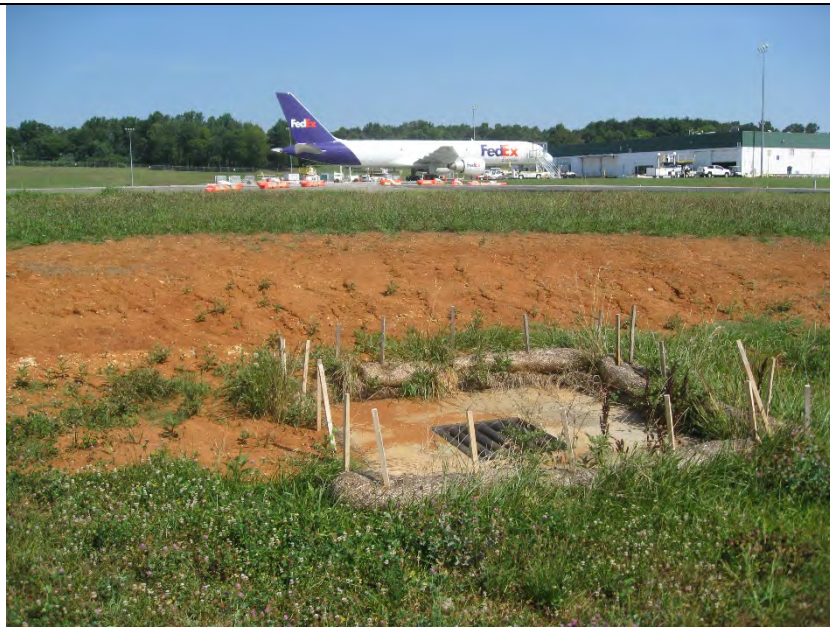
Photo 39
Sta. 677+00 RT
(RW 5L-23R)
Existing Structure
Project 4

Structure south of Taxiway "G".
Slopes started to rill after recent storm event. Sediment has migrated to structure.
Recommend repairing rills and removing accumulated sediment.
Recommend stabilizing bare areas.

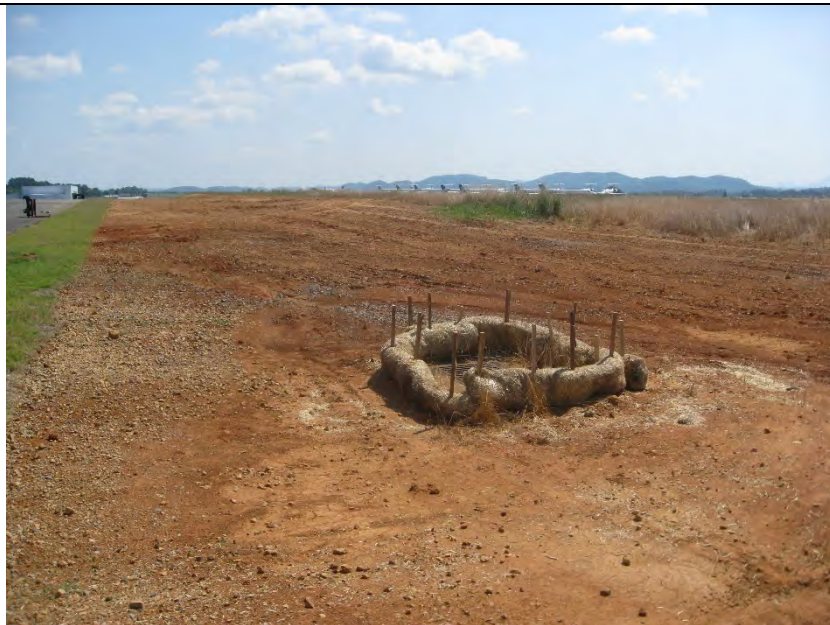
Photo 43
(RW 5L-23R)
Existing Structure
Project 4

Existing structure south of Taxiway G
Sediment tubes recently replaced.
Recommend stabilizing bare areas.

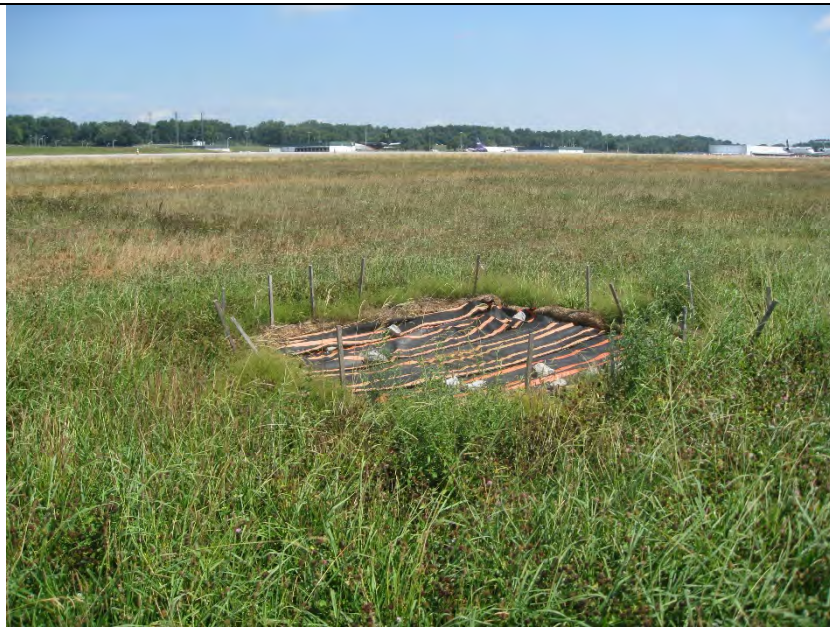
Photo 47
Sta. 366+89 RT
(RW 5L-23R)
Outfall C
Project 4

Recommend removing filter fabric from this structure to allow sampling for DMR.
(Outfall C).

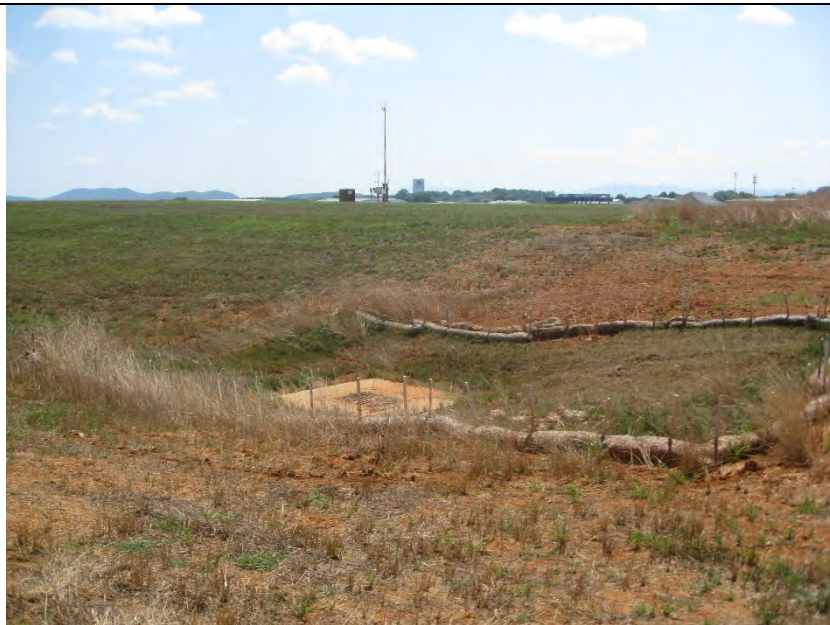
Photo 53
Sta. 347+26 RT
(RW 5L-23R)
Structure 22
Project 4

Structure 22.
Sediment tubes recently relocated to edge of sod. Recommend stabilizing bare areas.

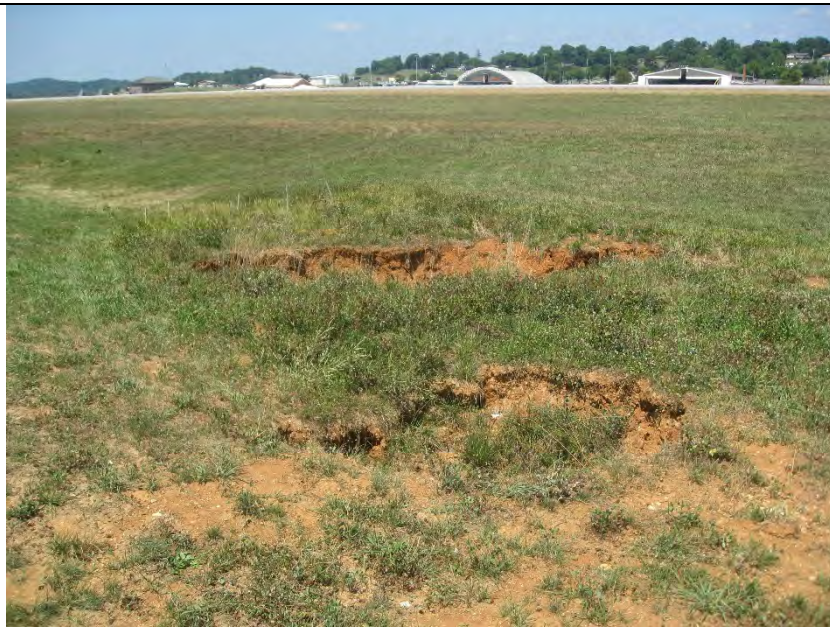
Photo 57
Sta. 341+86 RT
(RW 5L-23R)
Project 4

Construction fallout on Storm Line 2 between structures 204 and 206.
Recommend coordinating remediation with CHA.

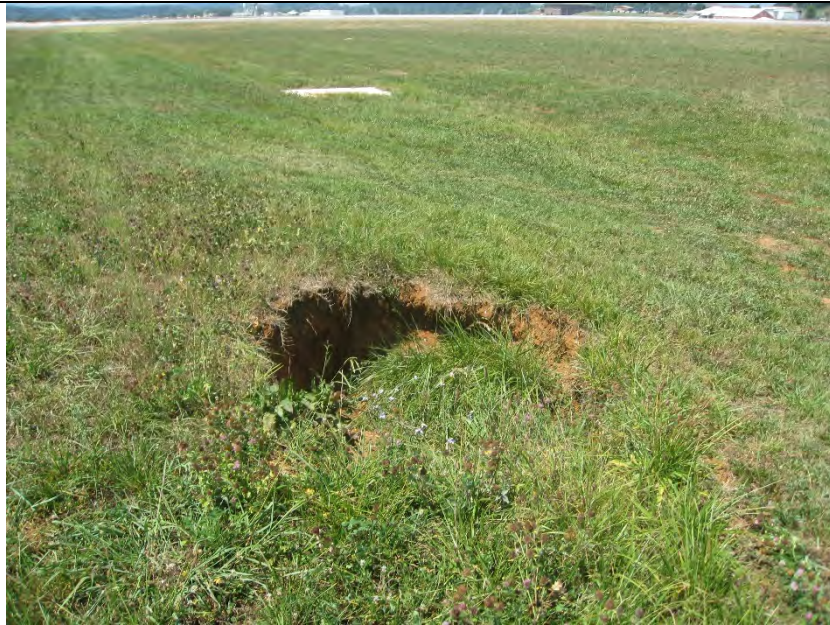
Photo 59
(RW 5L-23R)
Project 4

Construction fallout on Storm Line 2 between structures 206 and 208.
Recommend coordinating remediation with CHA.

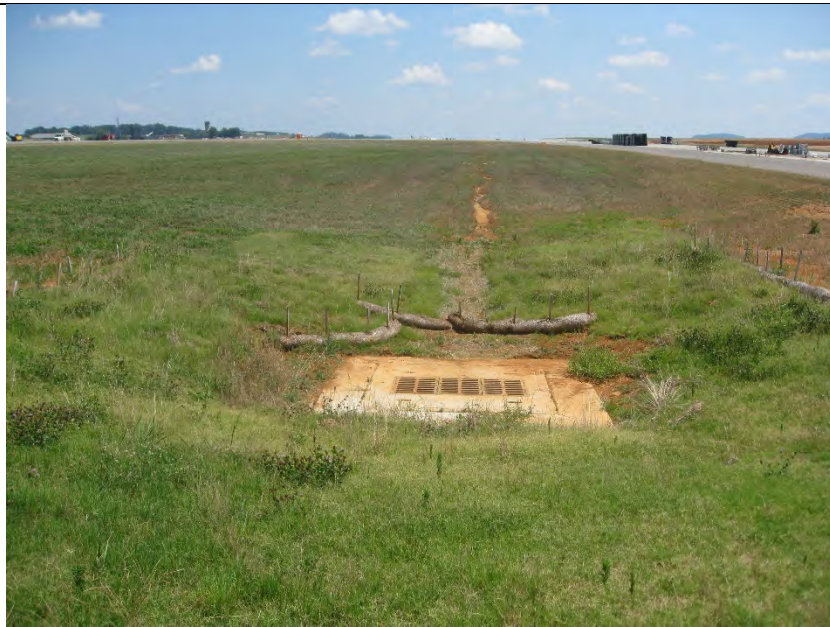
Photo 65
Sta. 301+87 RT
(RW 5L-23R)
Structure 218
Project 3

Structure 218.
Recommend stabilizing bare areas.

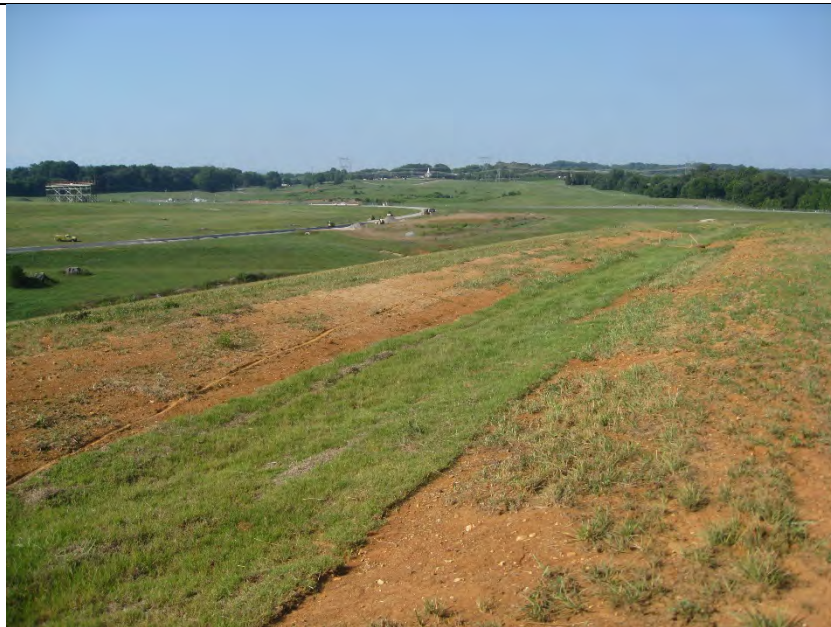
Photo 69
Sta. 290+26 RT
(RW 5L-23R)
Structure 600 Ditch
Project 2

Structure 600 Ditch.
Ditch recently regraded and sod applied.
Recommend stabilizing remaining bare areas.

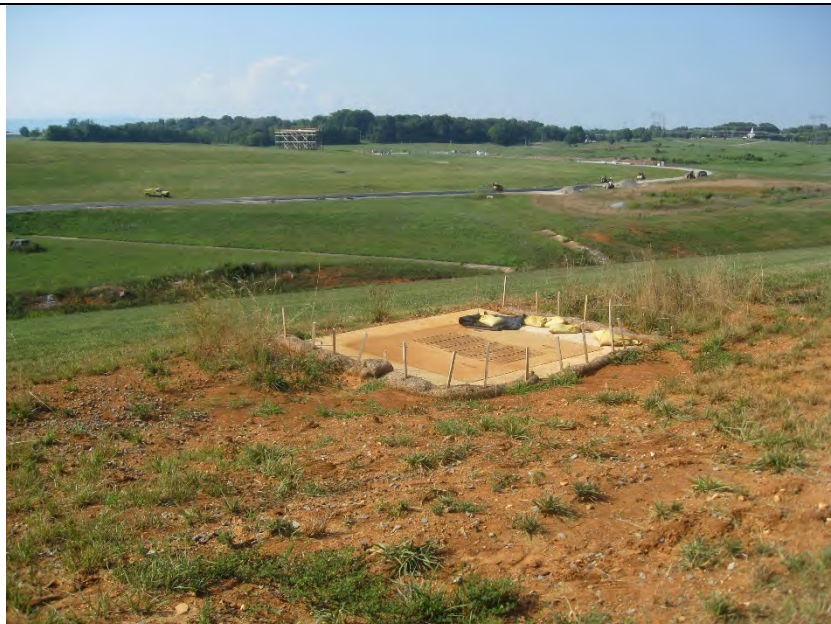
Photo 70
Sta. 290+26 RT
(RW 5L-23R)
Structure 222
Project 2

Structure 222.
Recommend removing inlet protection.
Recommend stabilizing bare areas.

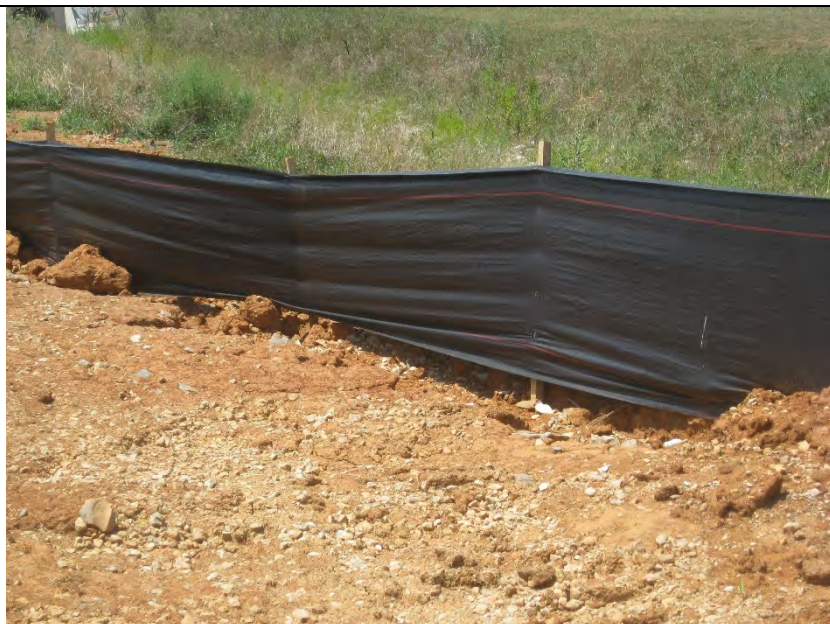
Photo 74
(RW 5L-23R)
Project 3

Recently installed silt fence has been undermined from recent storm events.
Recommend removing silt fence in this area and installing sediment tubes per the attached exhibit.

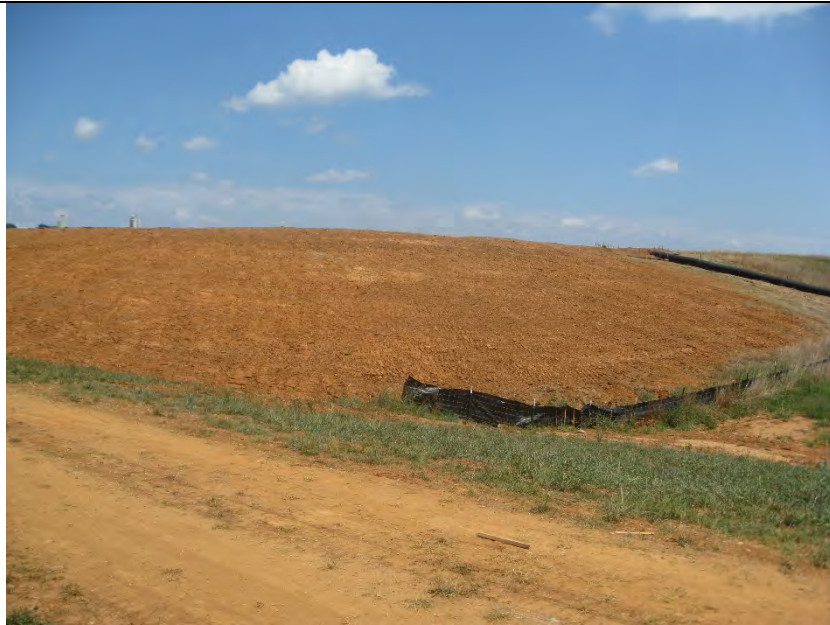
Photo 81
Sta. 302+54
(RW 5L-23R)
Project 2

Above North Lateral Endwall 100.
Slope recently regraded.
Recommend stabilizing bare areas.

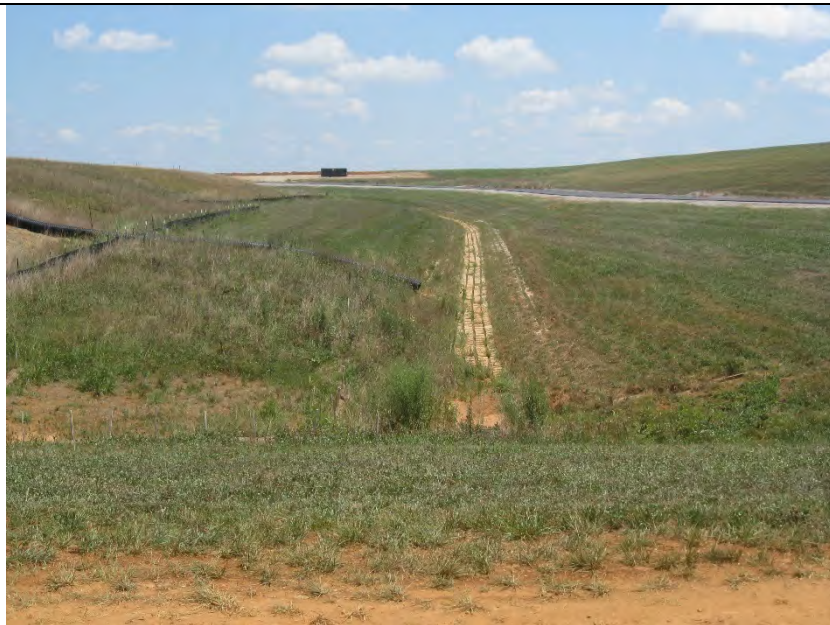
Photo 83
Sta. 302+54 to Sta. 313+50
(RW 5L-23R)
Project 2

North Lateral Endwall 100.
Recommend stabilizing bare areas.
