**QUALITY ASSURANCE
MONTHLY SITE
ASSESSMENT REPORT**

Airfield Modernization Program
Runway 5L-23R Reconstruction
Project 2 / Project 3
Project 4 / Repair TWY Lighting
Project 5 / Project 6

QUALITY ASSURANCE SITE ASSESSMENT

AIRFIELD MODERNIZATION PROGRAM RUNWAY 5L-23R RECONSTRUCTION

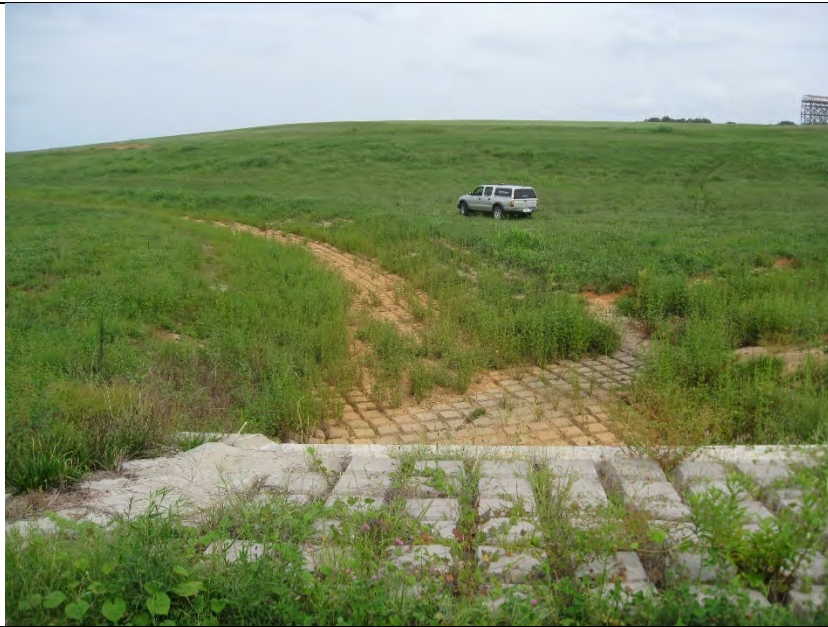
Photo 1
Sta. 111+56 RT
(Line LB)
NLET 01
Project 2

North Lateral End Treatment 01 (Outfall A).
No flow observed.

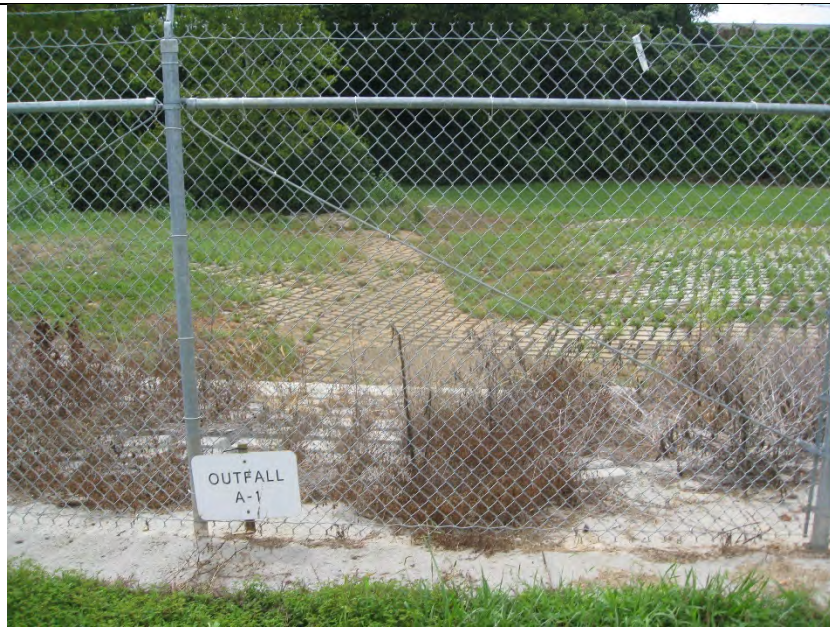
Photo 3
Sta. 111+82 LT
(Line LB)
NLET 02
Project 2

Main outfall to Lackey Creek. This section of the site was inaccessible at time of inspection.

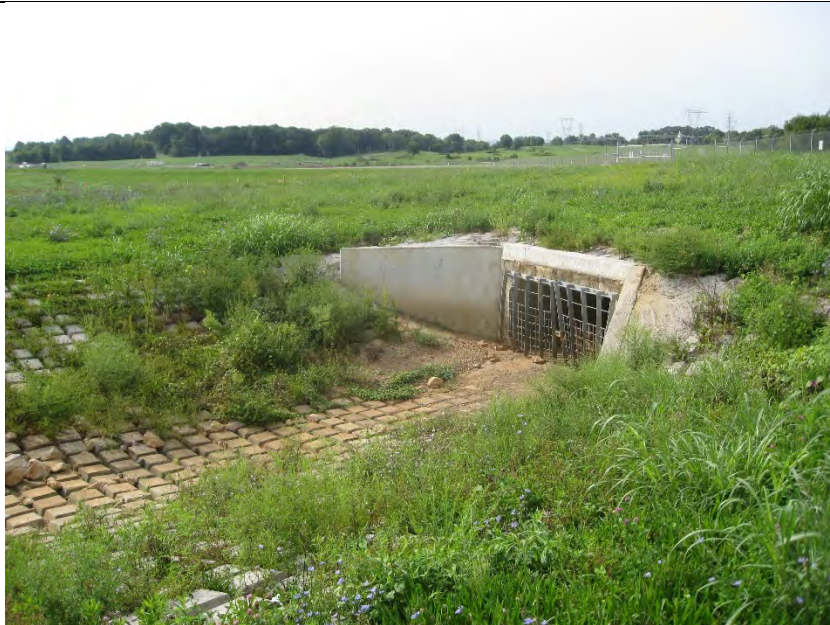
Photo 5
Sta. 117+00
(Line LB)
Project 2

Guard Lateral Ditch (Outfall B).
No flow observed.

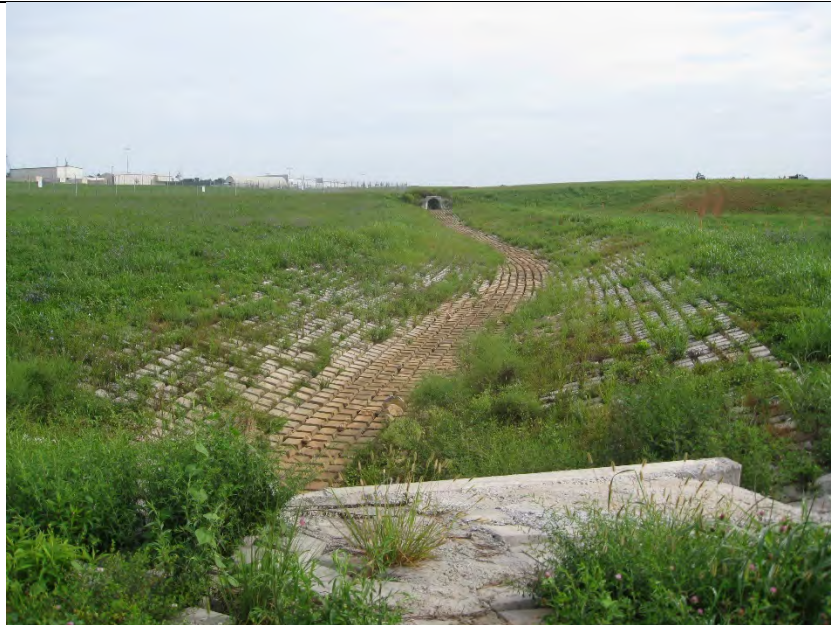
Photo 7
Sta. 117+00
(Line LB)
Project 2

Guard Lateral Ditch (Outfall B).

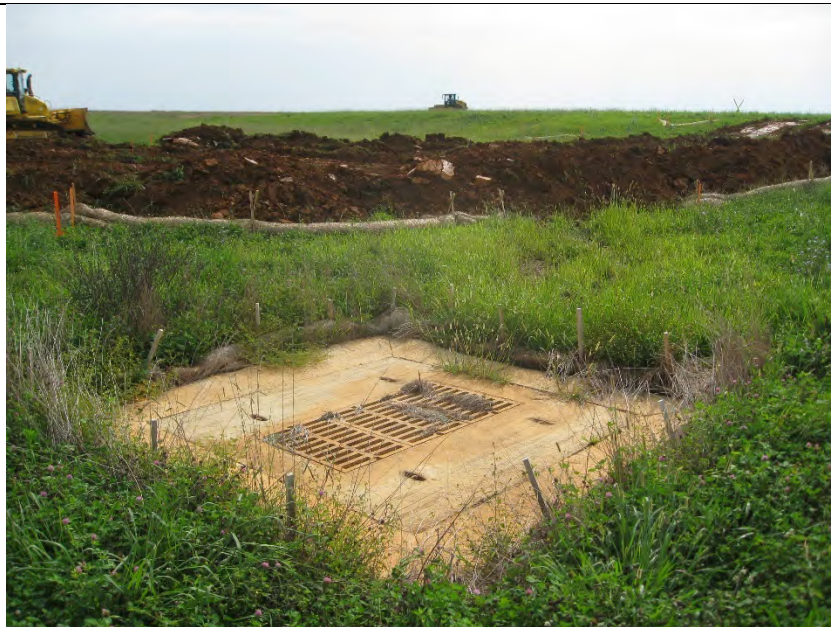
Photo 11
Sta. 291+51 LT
(RW 5L-23R)
Structure 120
Project 3

Structure 120. See Project 5/6 for additional information.

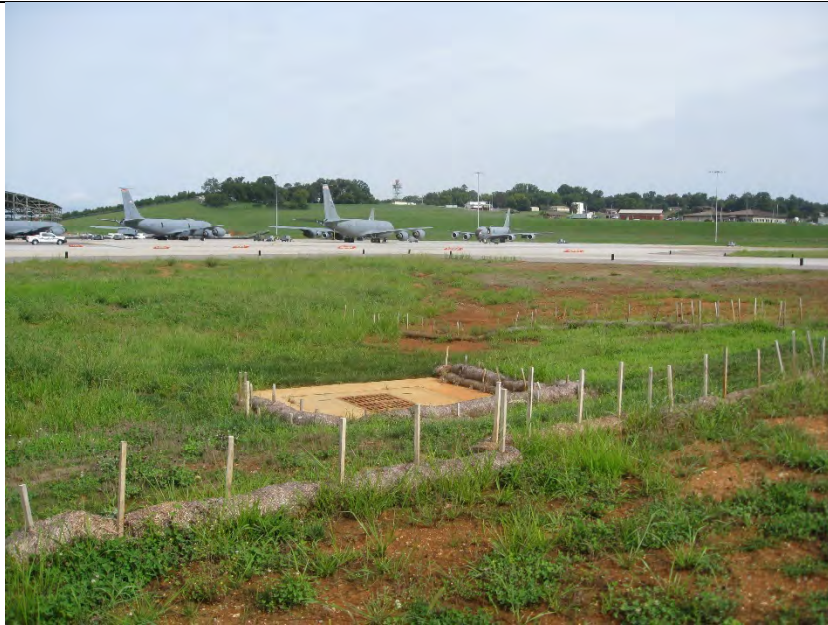
Photo 13
Sta. 298+71 LT
(RW 5L-23R)
Structure 116
Project 3

Structure 116.
Recommend stabilizing bare areas and repairing rills (see photos #15 and #16 below).

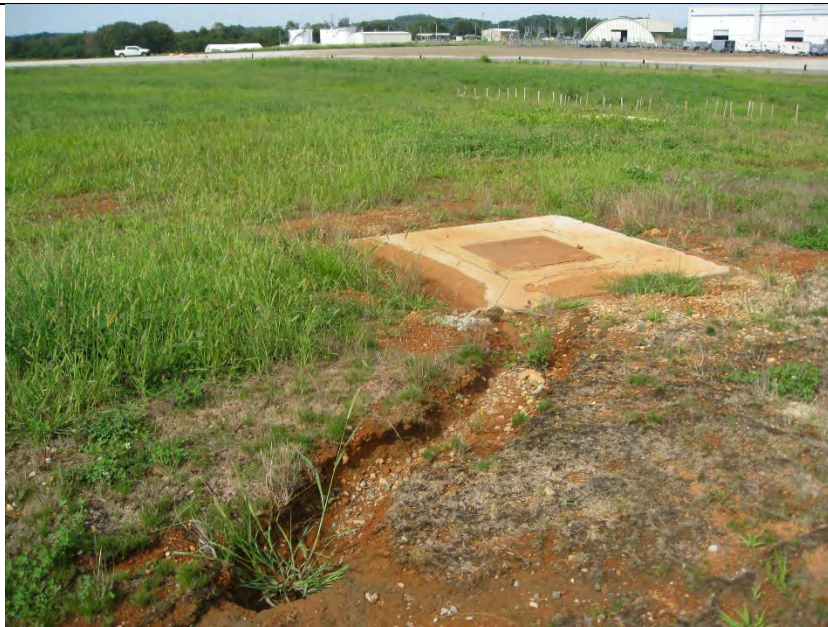
Photo 15
Sta. 298+71 LT
(RW 5L-23R)
Structure 116
Project 3

Above Structure 116 on Taxiway G2.
Recommend repairing rills and stabilizing bare areas.

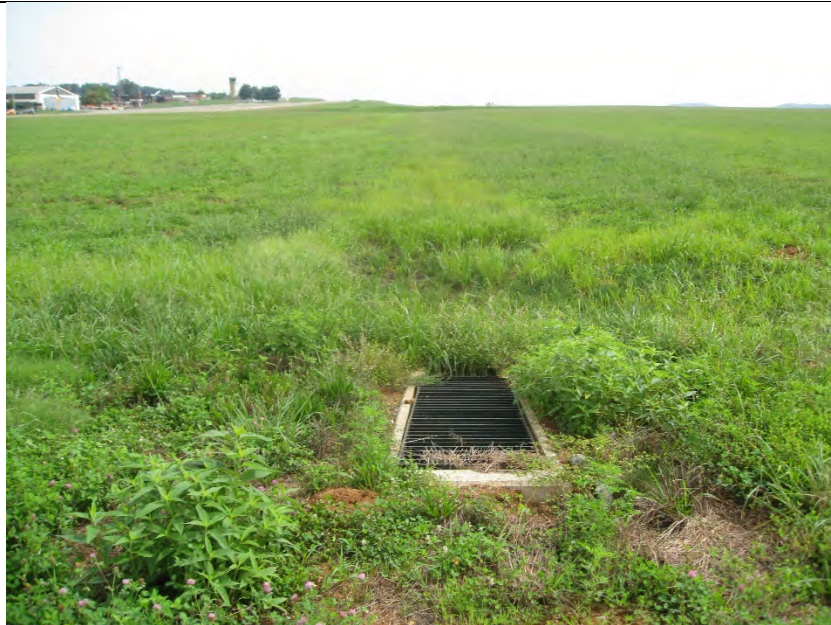
Photo 21
Sta. 314+48 LT
(RW 5L-23R)
ES Endwall 108
Project 3

Enhanced Swale Endwall 108.
Recommend repairing rills above endwall.

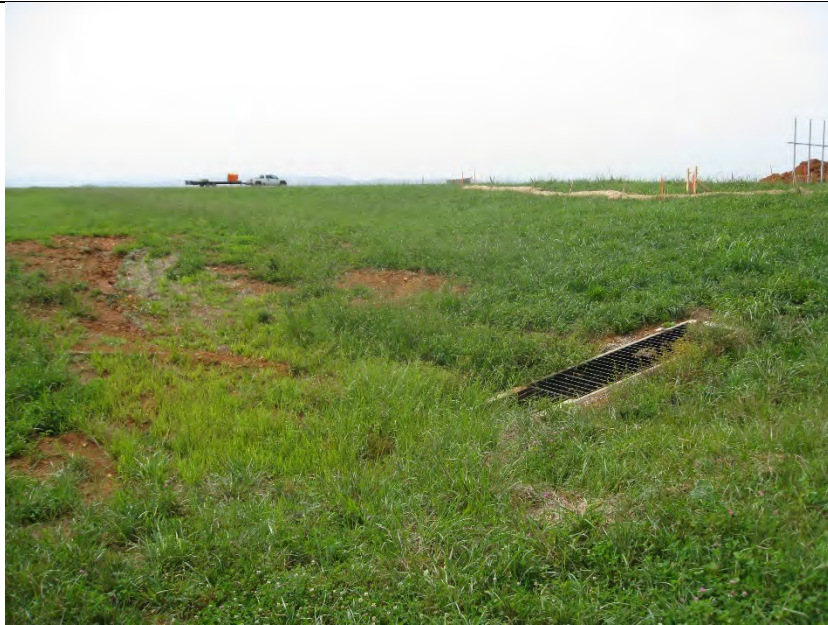
Photo 33
Sta. 347+31 LT
(RW 5L-23R)
ES Endwall 102
Project 3

Enhanced Swale Endwall 102.
Recommend stabilizing remaining bare areas.

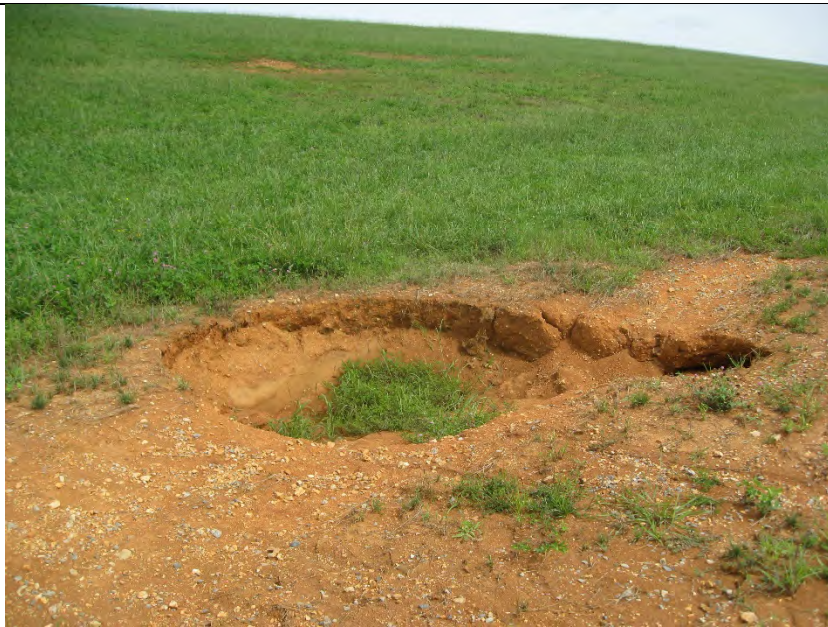
Photo 35
Sta. 341+50 LT
(RW 5L-23R)
ES Endwall 102
Project 3

Eighth construction fallout on Storm Line 1 between ES Endwall 102 and 100.
Coordinate remediation with CHA.

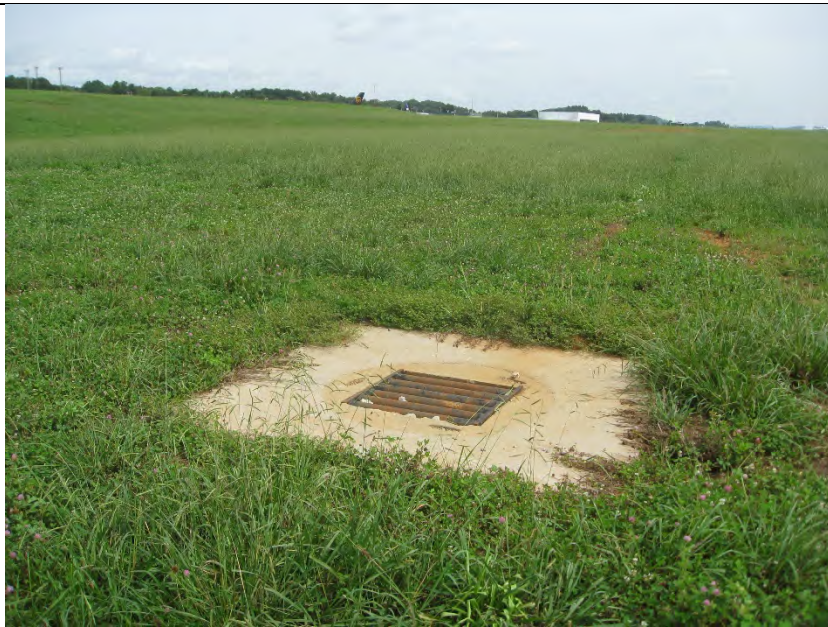
Photo 39
Sta. 363+35 LT
(RW 5L-23R)
Existing Structure
Project 2

Existing Structure.

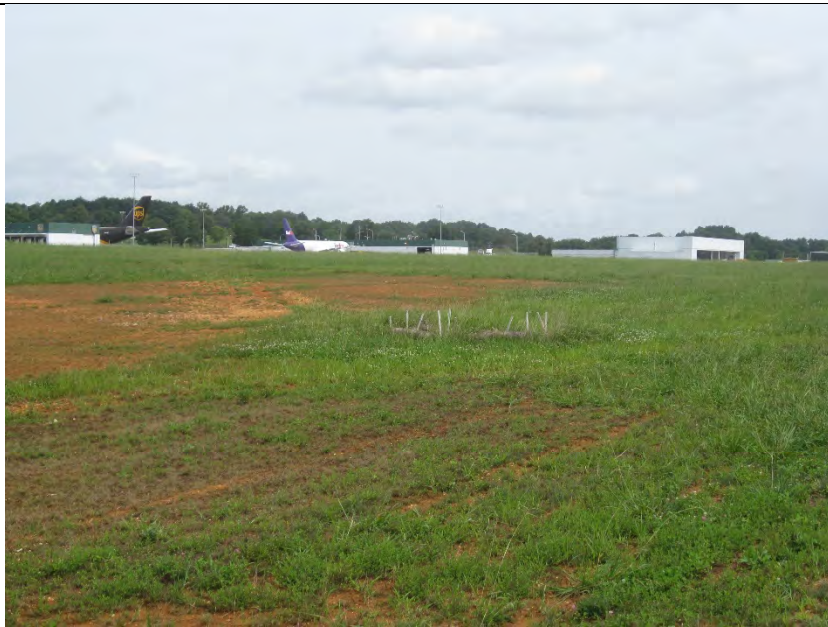
Photo 41
Sta. 369+11 LT
(RW 5L-23R)
Existing Structure
Project 2

Existing Structure.
Recommend stabilizing bare areas.

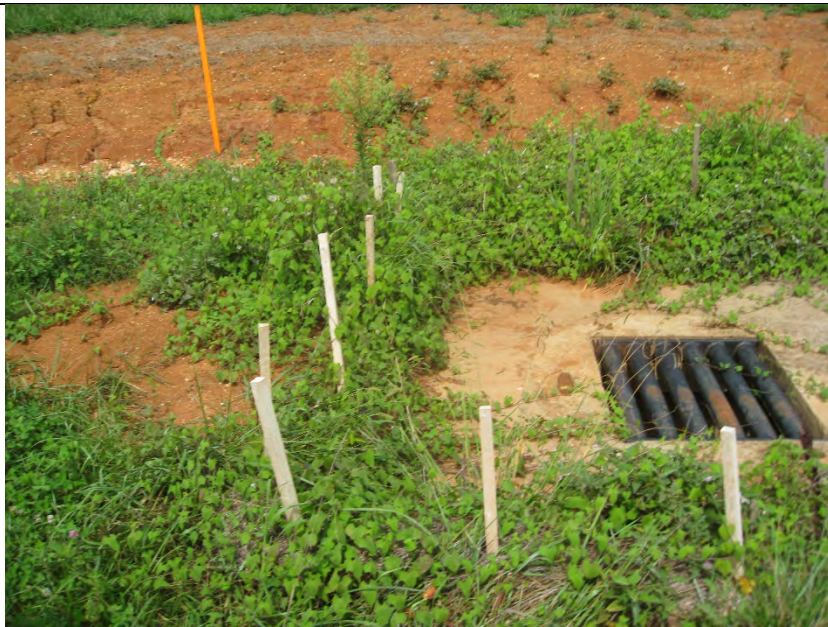
Photo 43
Sta. 677+00 RT
(RW 5L-23R)
Existing Structure
Project 4

Structure south of Taxiway "G".
Slopes continue to rill and deposit sediment at the structure.
Recommend repairing rills and replacing sediment tubes.
Recommend stabilizing bare areas.

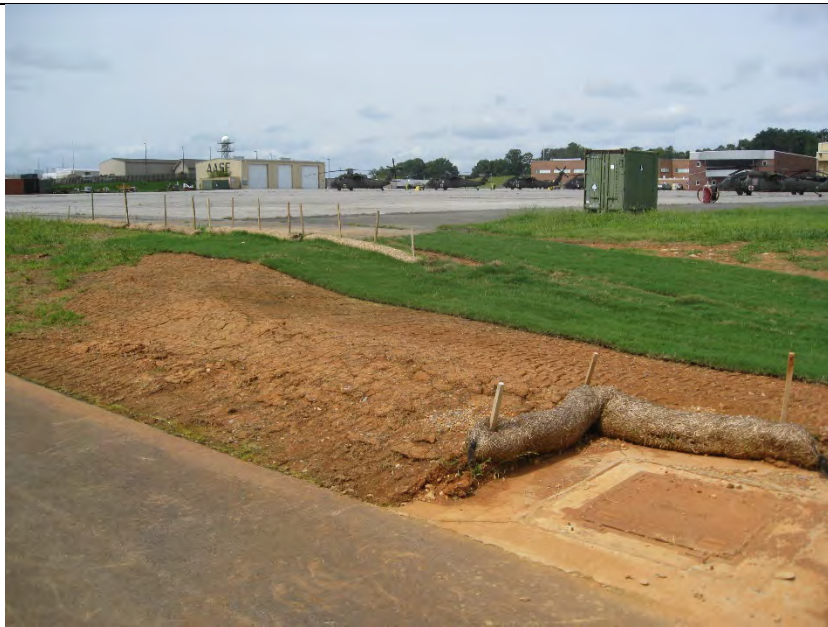
Photo 47
New structure
Project 4

New storm structure located north of Taxiway G.
Area recently regraded to capture runoff from the helipad apron. Sod recently installed.
Recommend stabilizing remaining bare areas.

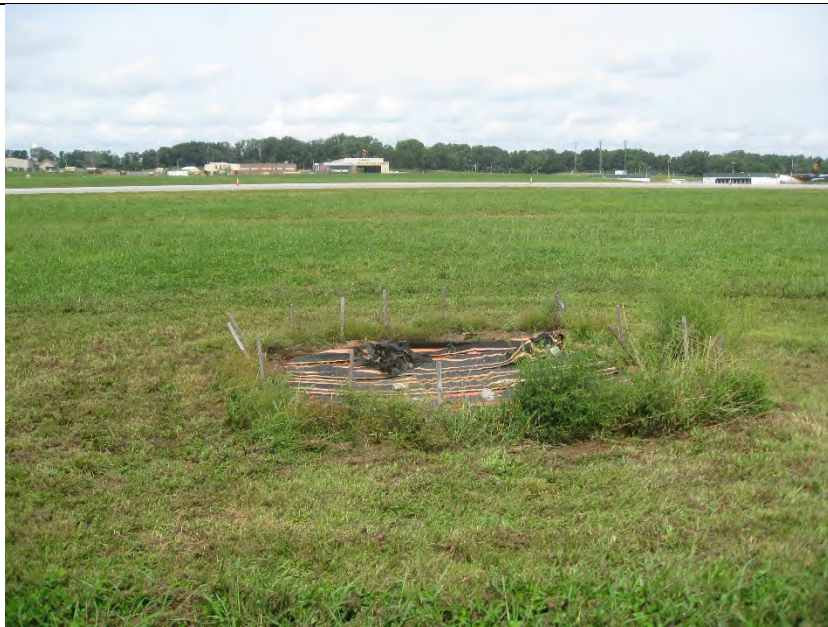
Photo 49
Sta. 366+89 RT
(RW 5L-23R)
Outfall C
Project 4

Recommend removing filter fabric from this structure.
(Outfall C).

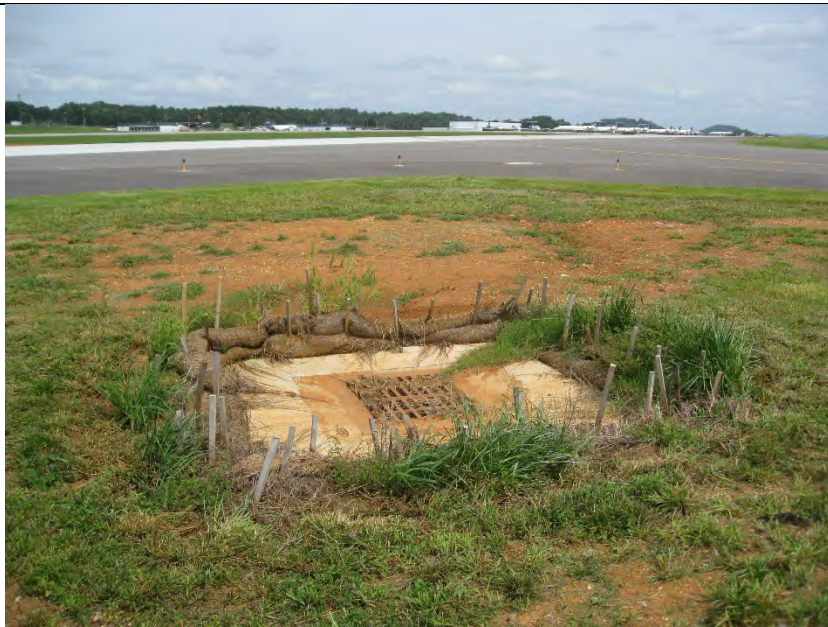
Photo 53
Sta. 362+02 LT
(RW 5L-23R)
Structure 400
Project 4

Structure 400.
Recommend stabilizing remaining bare areas.

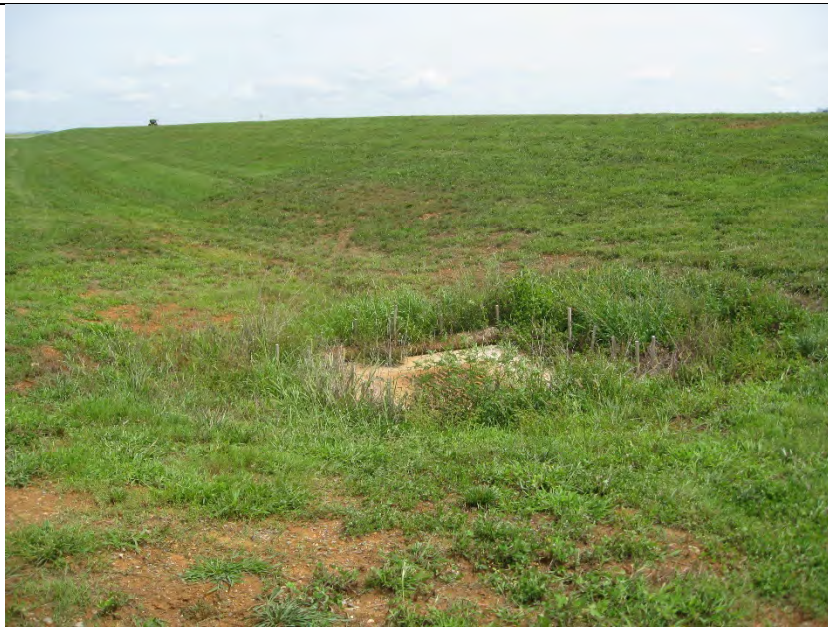
Photo 55
Sta. 353+56 RT
(RW 5L-23R)
Structure 20
Project 4

Structure 20.
Area appears stable.
Recommend removing inlet protection.

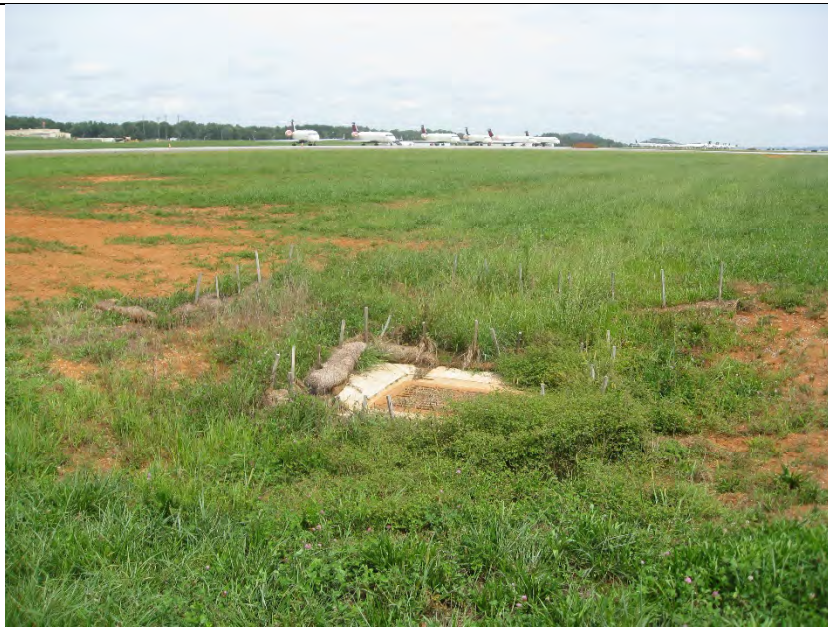
Photo 57
Sta. 353+56 RT
(RW 5L-23R)
Structure 200
Project 4

Structure 200.
Recommend stabilizing bare areas.

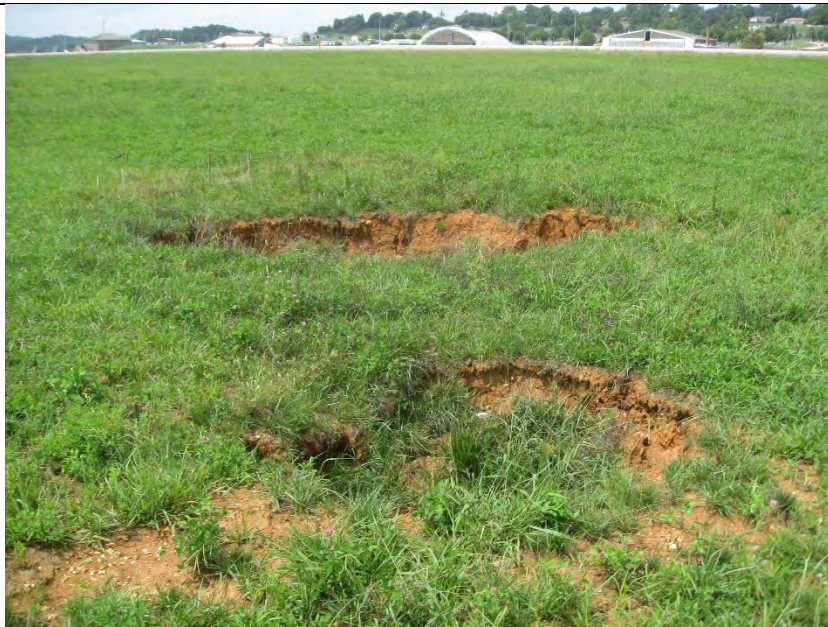
Photo 61
Sta. 341+86 RT
(RW 5L-23R)
Project 4

Construction fallout on Storm Line 2 between structures 204 and 206.
Recommend coordinating remediation with CHA.

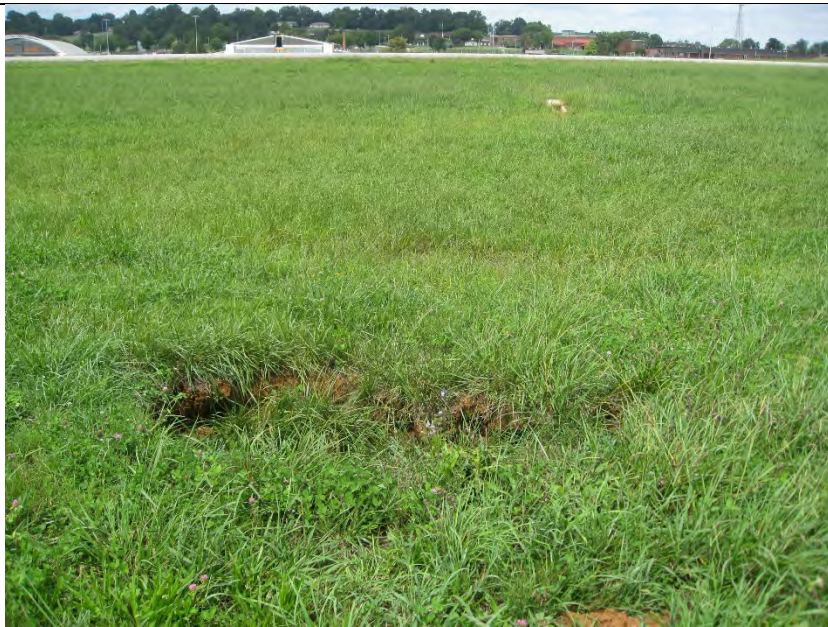
Photo 63
(RW 5L-23R)
Project 4

Construction fallout on Storm Line 2 between structures 206 and 208.
Recommend coordinating remediation with CHA.

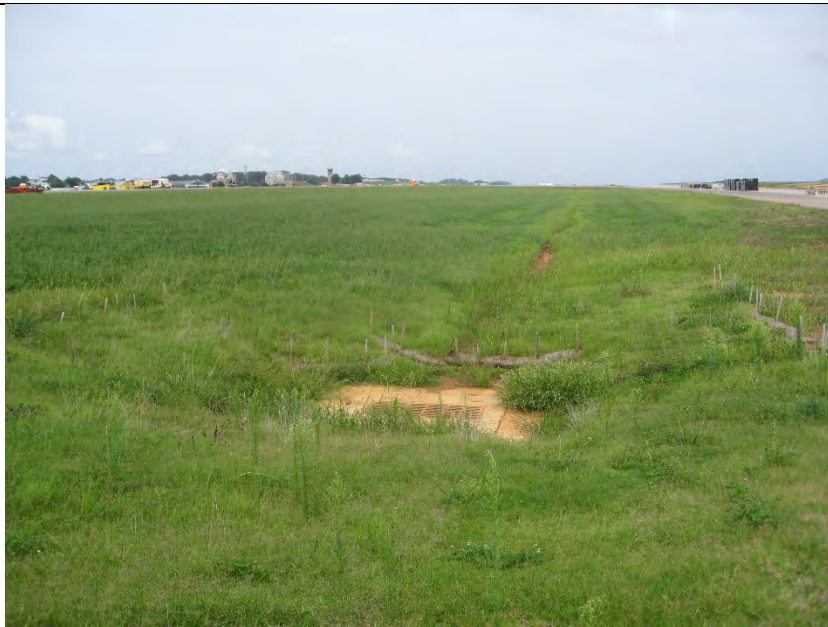
Photo 69
Sta. 301+87 RT
(RW 5L-23R)
Structure 218
Project 3

Structure 218.
Recommend stabilizing remaining bare areas and repairing rill above structure (see photo below).

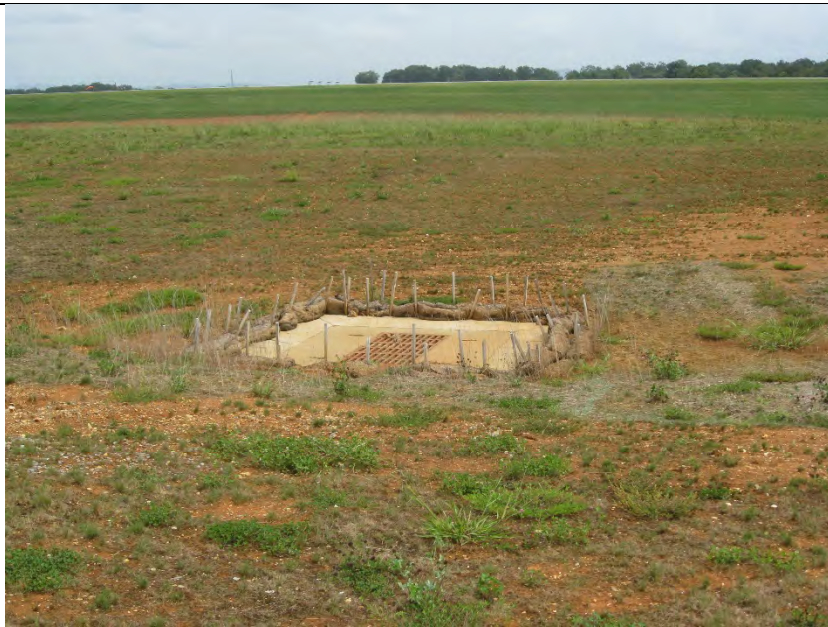
Photo 71
Sta. 296+83 RT
(RW 5L-23R)
Structure 220
Project 2

Structure 220.
Recommend stabilizing remaining bare areas.

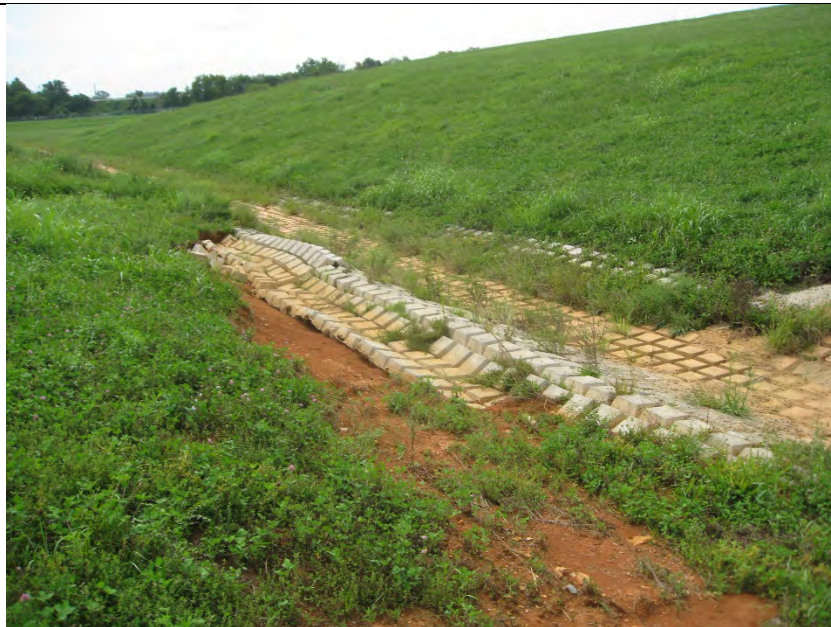
Photo 73
Sta. 288+26
(RW 5L-23R)
Structure 224
Project 2

Below structure 224.
Side slope has eroded causing damage to the articulated concrete block.
CHA, Harper and KMAA were already aware of the issue as discussed in a progress meeting dated 07/16/2020.

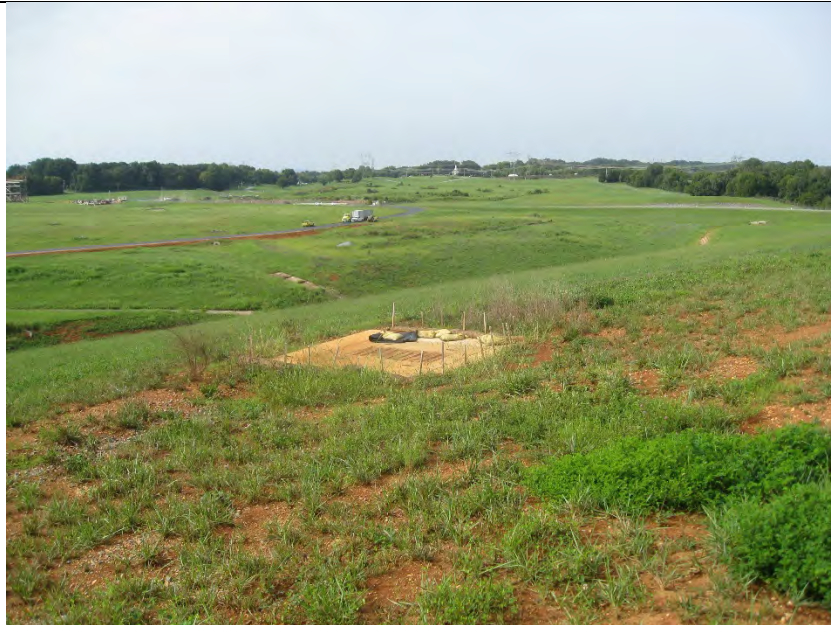
Photo 75
Sta. 290+26 RT
(RW 5L-23R)
Structure 222
Project 2

Structure 222.
Recommend removing inlet protection.
Recommend stabilizing bare areas.

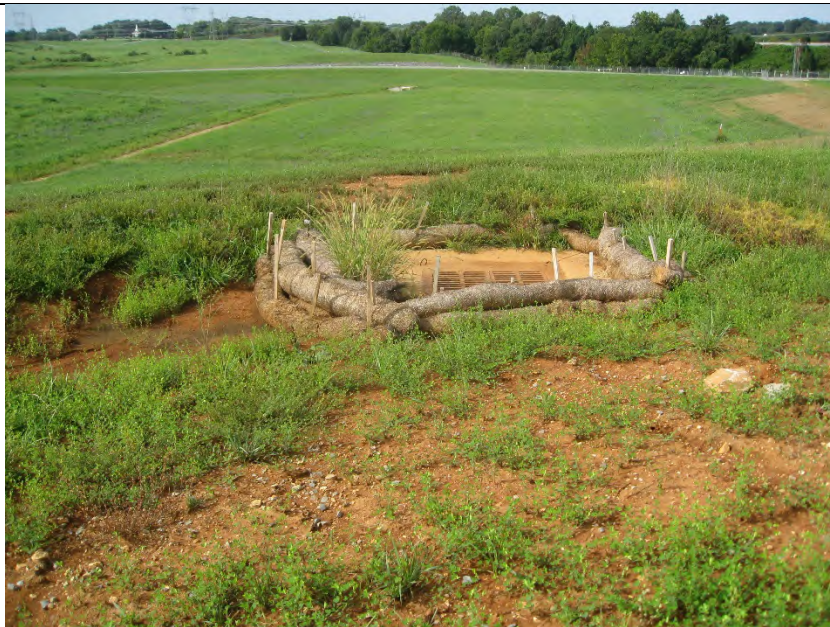
Photo 77
Sta. 284+59
(RW 5L-23R)
Structure 600
Project 3

Structure 600.
Sediment recently removed and sediment tubes repaired.

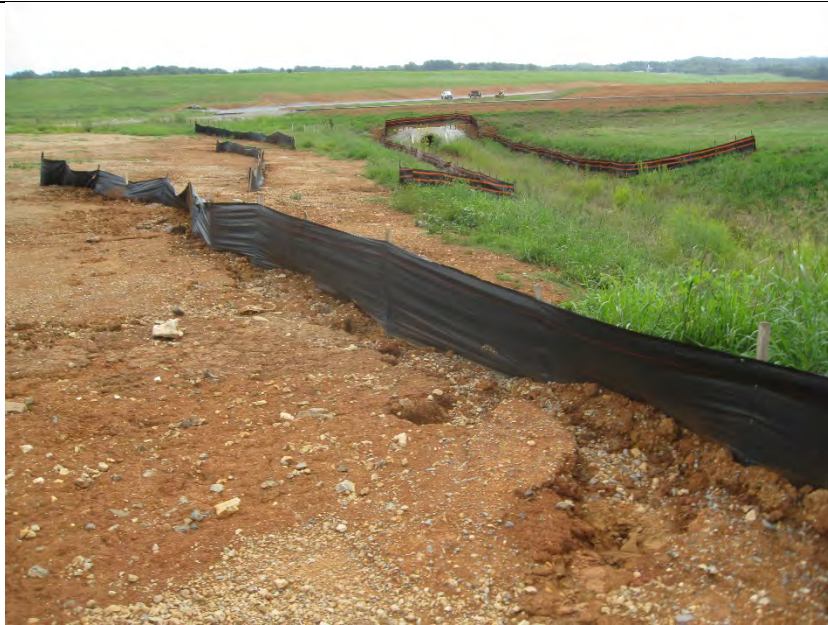
Photo 81
(RW 5L-23R)
Project 3

Silt fence above North Lateral Ditch at stone stockpile area.
Silt fence continues to erode during storm events.
Recommend repairing silt fence.

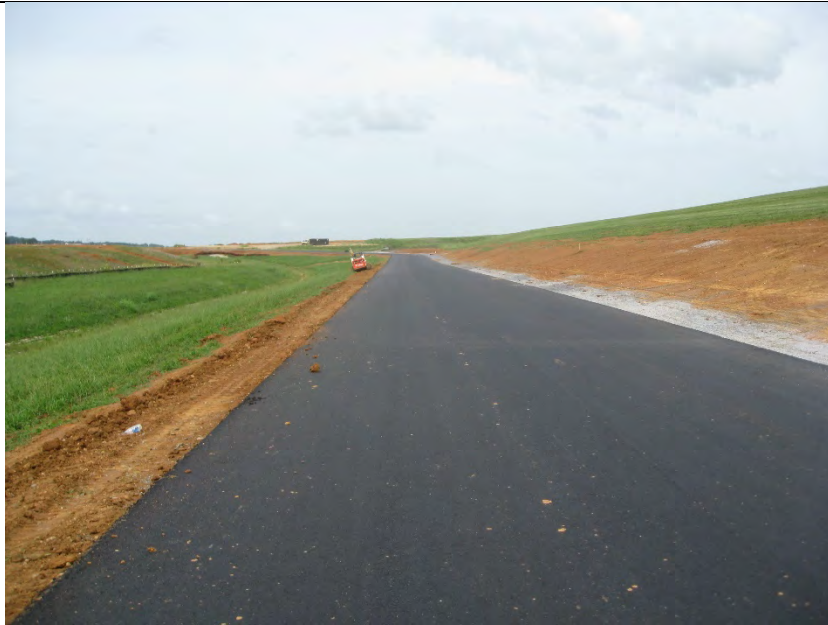
Photo 87
Sta. 32+50 RT
Proposed Haul Route
Project 3

Haul Route recently paved.
Recommend stabilizing slope as soon as practical.

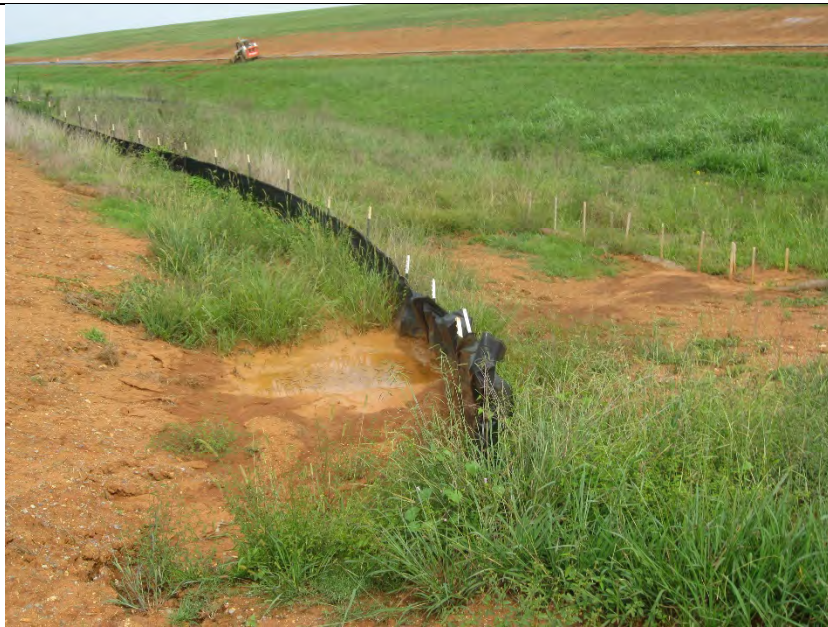
Photo 89
Sta. 302+54
(RW 5L-23R)
Project 2

Above North Lateral Endwall 100.
Sediment recently removed.
Recommend stabilizing bare areas.

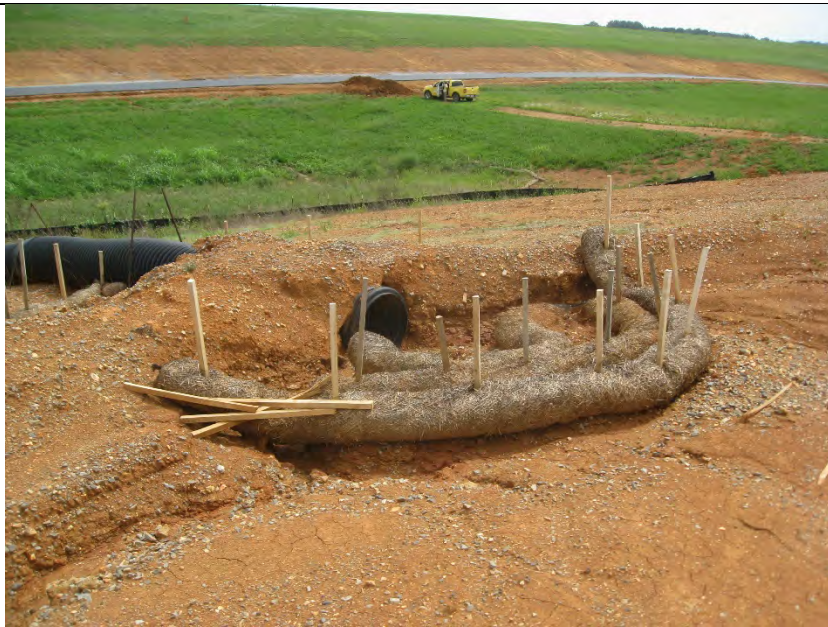
Photo 91
Sta. 302+54
(RW 5L-23R)
Project 2

Soil stockpile area next to haul road at Taxiway B.
Sediment tubes at slope drain have been undermined. Recommend repairing or adding tubes to prevent runoff under the sediment tubes.
Recommend stabilizing all bare areas.

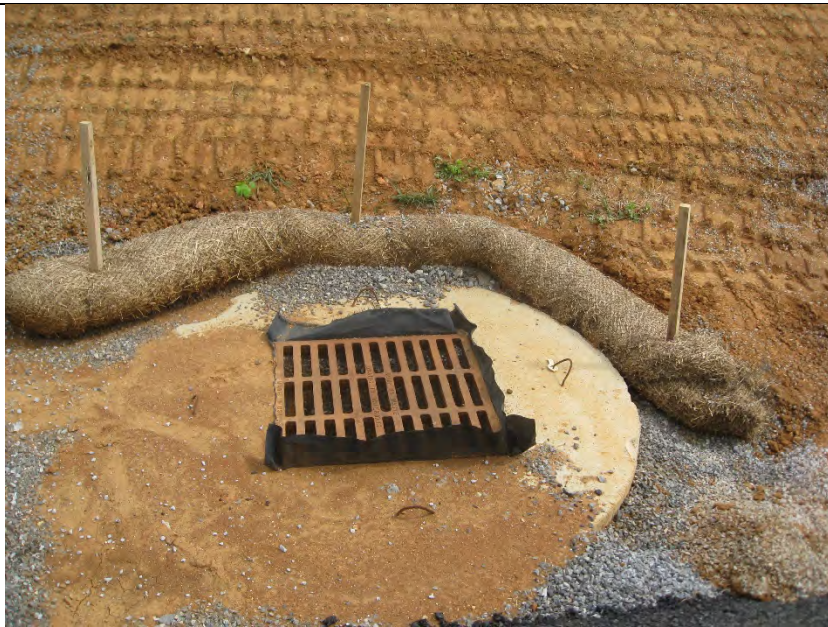
Photo 95
Sta. 25+50 RT
Proposed Haul Route
Project 3

Inlet structure along haul road.
Underdrain/French drain recently installed and slope regraded.
Recommend stabilizing slope as soon as practical.

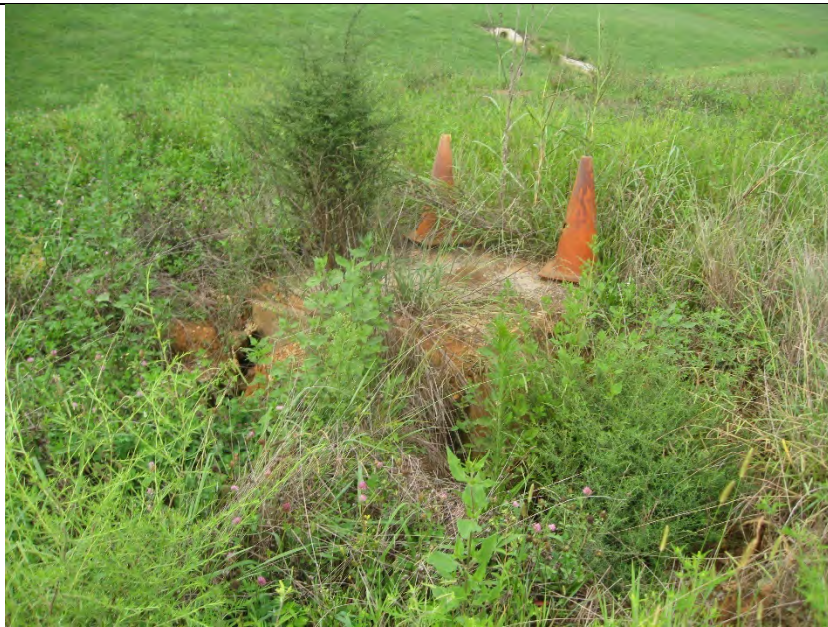
Photo 103
Sta. 284+00 LT
(RW 5L-23R)
Project 2

Existing vault at old Liberty street.
Construction fallout present. Recommend coordinating with CHA on remediation.

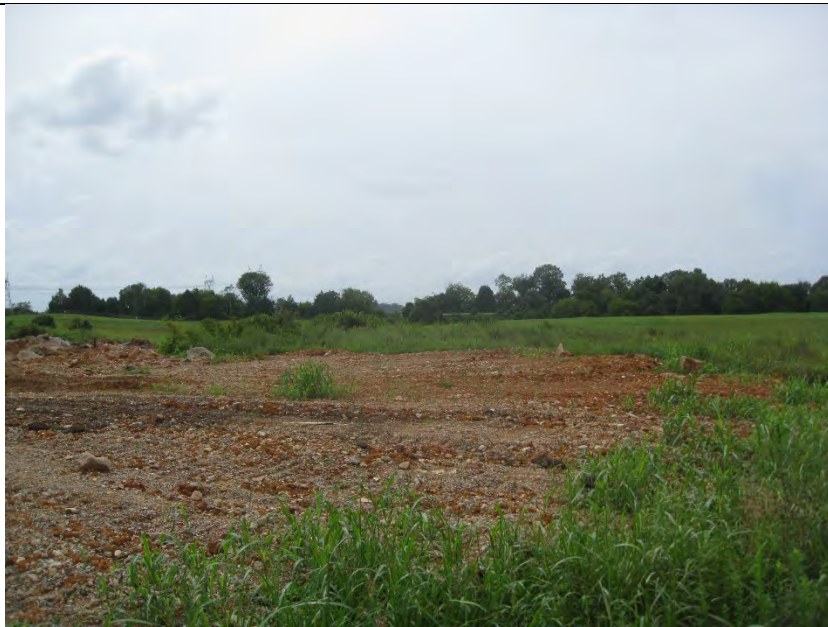
Photo 105
(Repair TWY Lighting)

Fill area adjacent to Liberty Street.
Grading operations have moved towards ditch line.
Recommend monitoring for sediment movement.

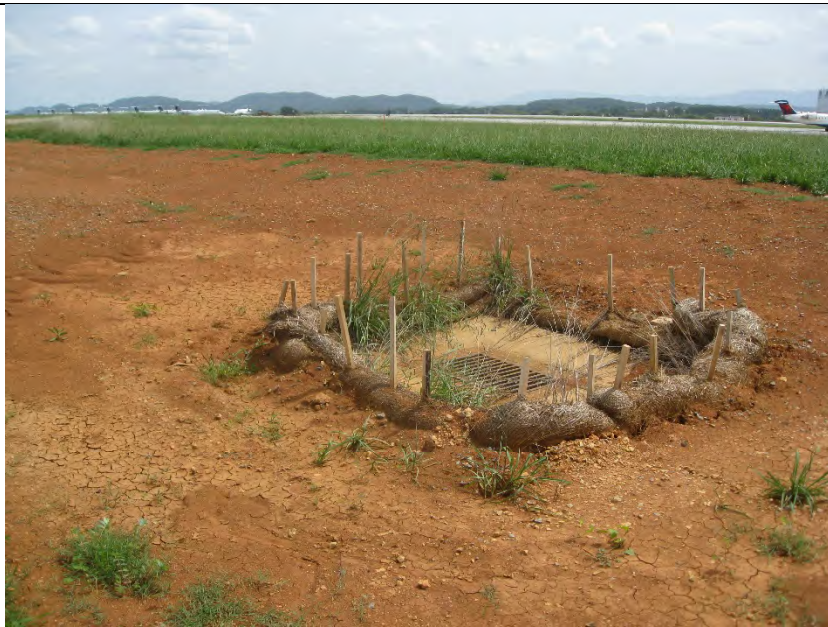
Photo 107
(Repair TWY Lighting)
Existing Structure

Existing structure south of Taxiway G.
Recommend stabilizing bare areas.

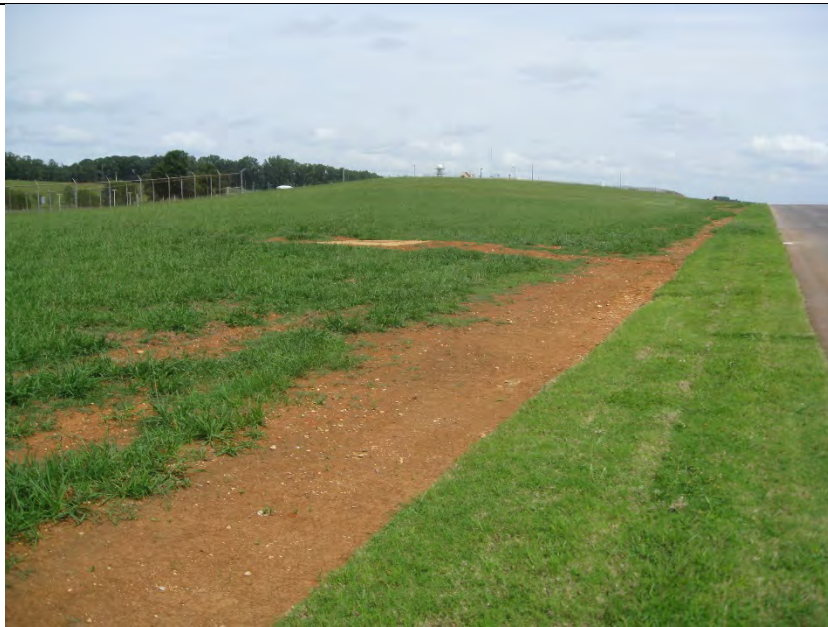
Photo 109
(Repair TWY Lighting)

Sod establishing along Taxiway G.
Recommend stabilizing remaining bare areas.

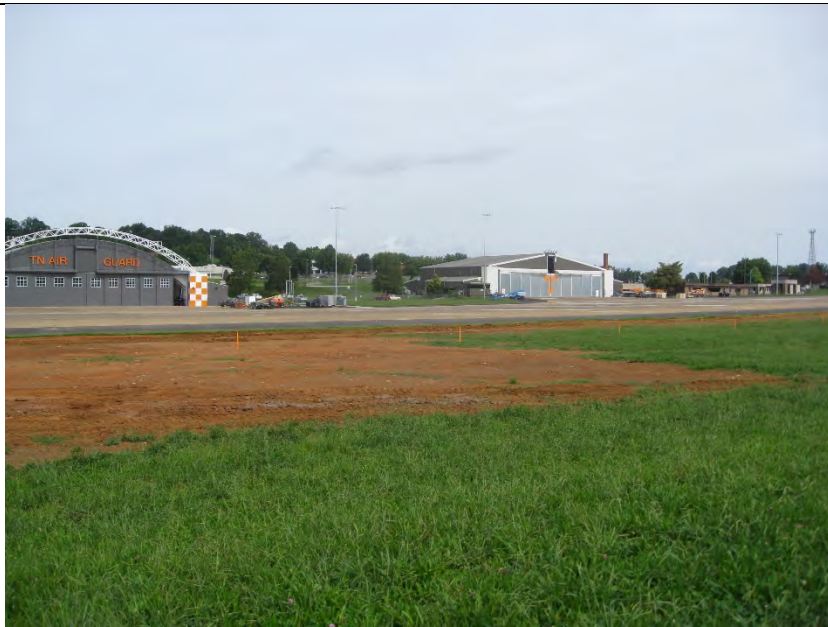
Photo 111
(Repair TWY Lighting)

Demolished old Taxiway G4 and shoulder.
Recommend stabilizing bare areas.

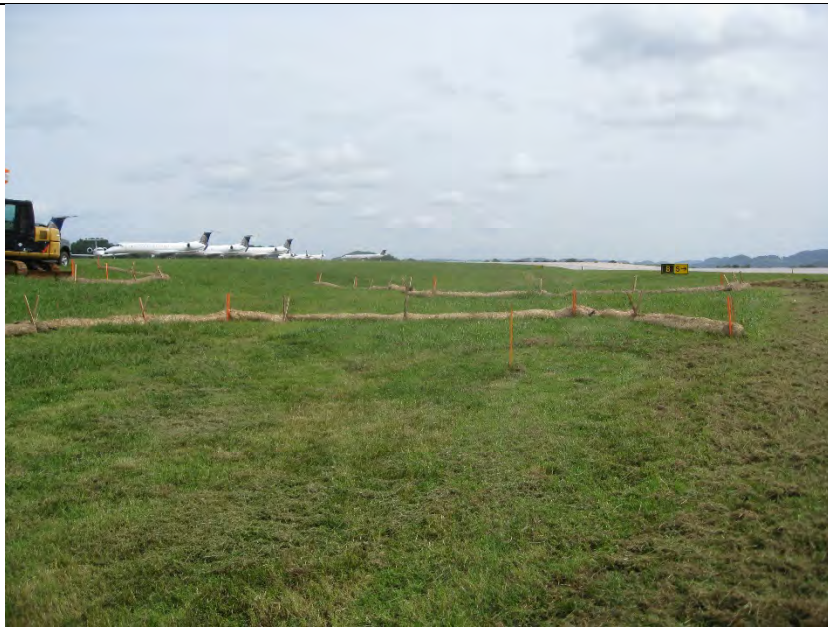
Photo 119
(Project 5/6)

Sediment tubes recently installed. Spacing of stakes appeared to be too far apart (typical throughout project). Recommend adding stakes.

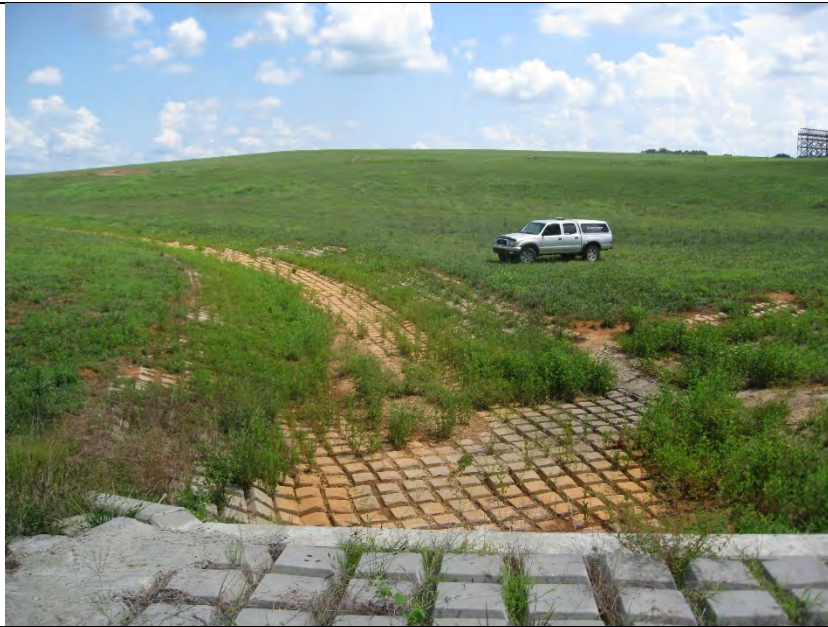
Photo 1
Sta. 111+56 RT
(Line LB)
NLET 01
Project 2

North Lateral End Treatment 01 (Outfall A).
No flow observed.

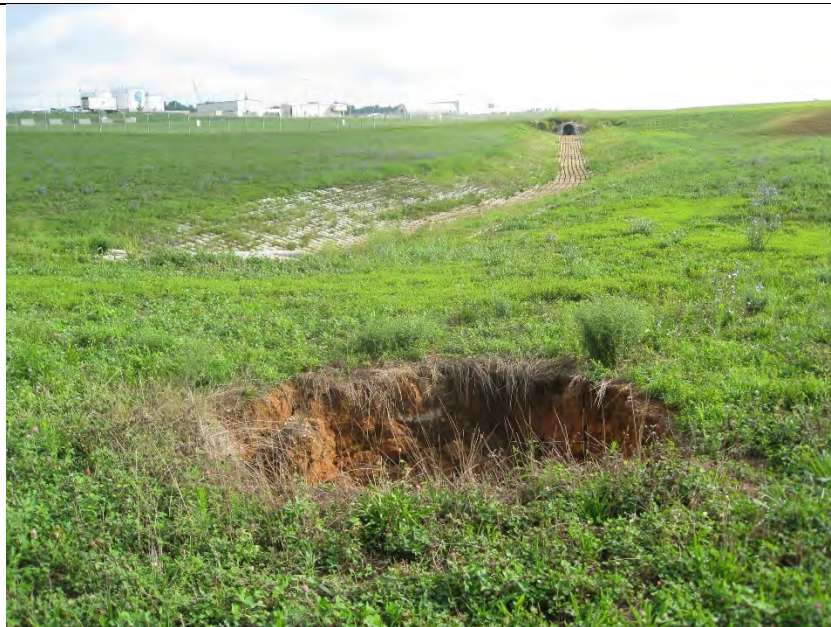
Photo 7
Sta. 117+00
(Line LB)
Project 2

Above the Guard Lateral Ditch (Outfall B).
Construction fall out present. Recommend coordinating remediation with CHA.

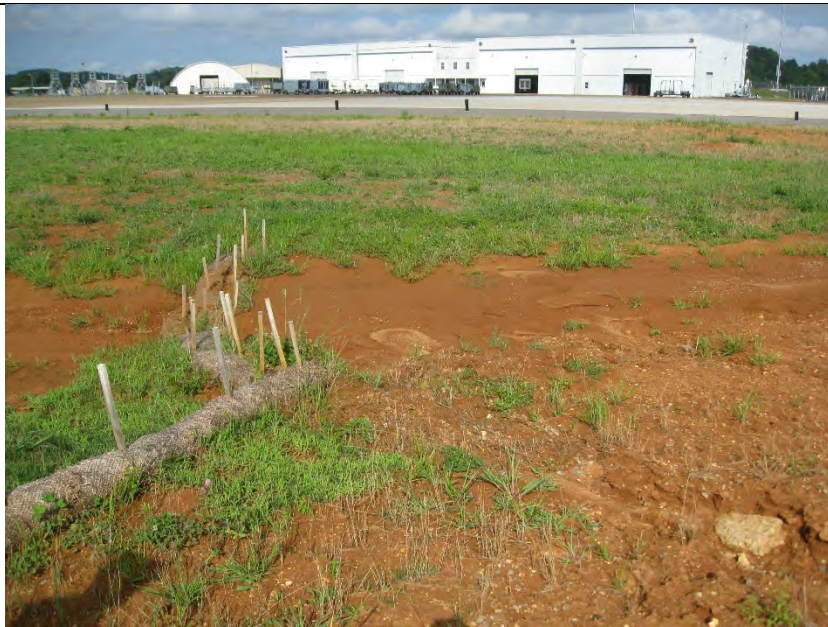
Photo 15
Sta. 298+71 LT
(RW 5L-23R)
Structure 116
Project 3

Above Structure 116.
Due to recent storm events, rills have started to form and sediment has accumulated in ditch line.
Recommend removing accumulated sediment. Recommend stabilizing remaining bare areas.

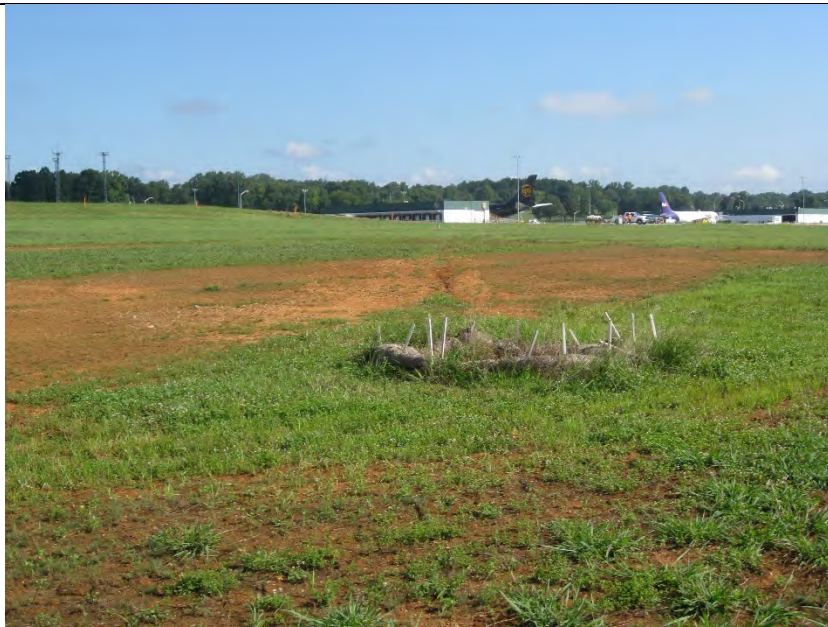
Photo 39
Sta. 369+11 LT
(RW 5L-23R)
Existing Structure
Project 2

Existing Structure.
Recommend stabilizing bare areas.

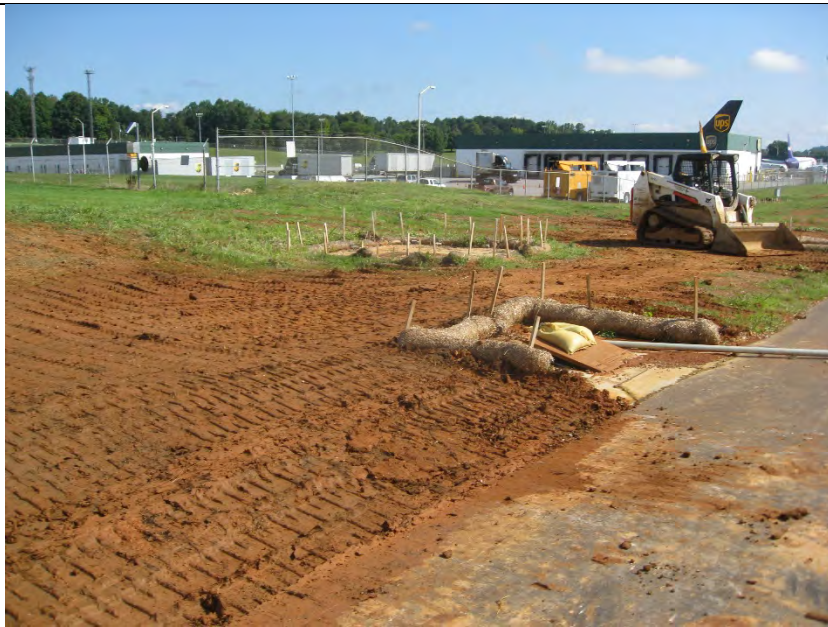
Photo 43
New structure
Project 4

New storm structure located north of Taxiway G.
Area recently regraded to capture runoff from the helipad apron.
Recommend stabilizing bare areas once grading is complete.
