**QUALITY ASSURANCE
MONTHLY SITE
ASSESSMENT REPORT**

Airfield Modernization Program
Runway 5L-23R Reconstruction
Project 2 / Project 3
Project 4 / Repair TWY Lighting
Project 5 / Project 6

QUALITY ASSURANCE SITE ASSESSMENT

AIRFIELD MODERNIZATION PROGRAM RUNWAY 5L-23R RECONSTRUCTION

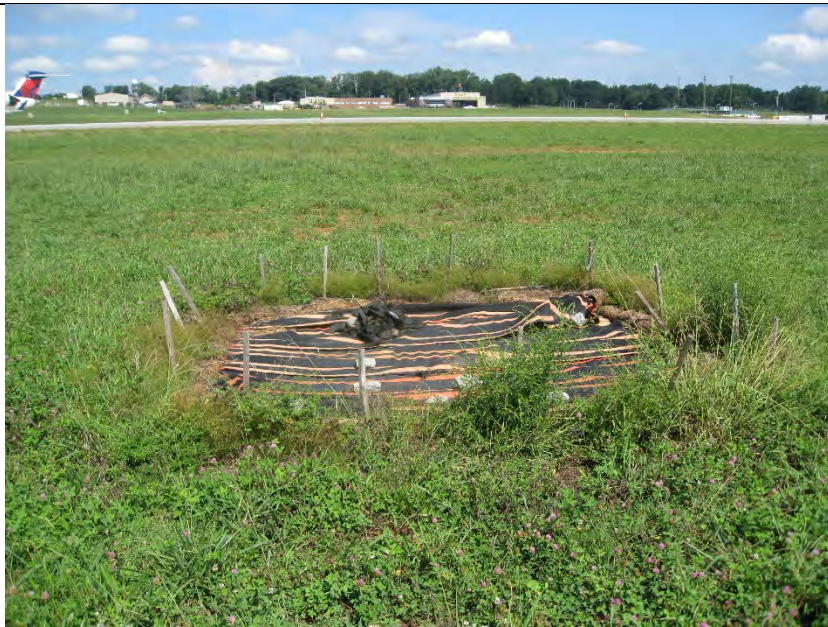
Photo 45
Sta. 366+89 RT
(RW 5L-23R)
Outfall C
Project 4

Recommend removing filter fabric from this structure.
(Outfall C).

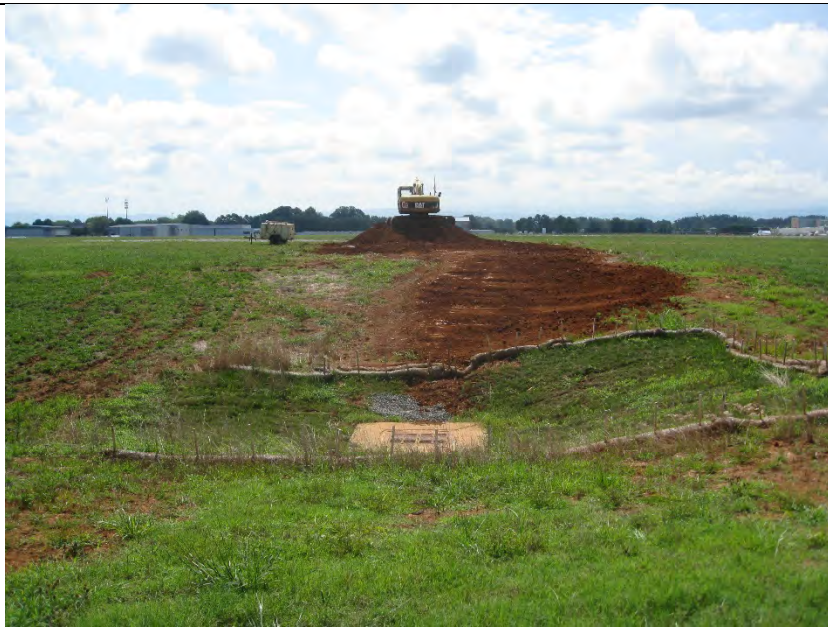
Photo 51
Sta. 347+26 RT
(RW 5L-23R)
Structure 22
Project 4

Structure 22.
Construction activities taking place at time of inspection.
Recommend stabilizing bare areas once operations are complete.

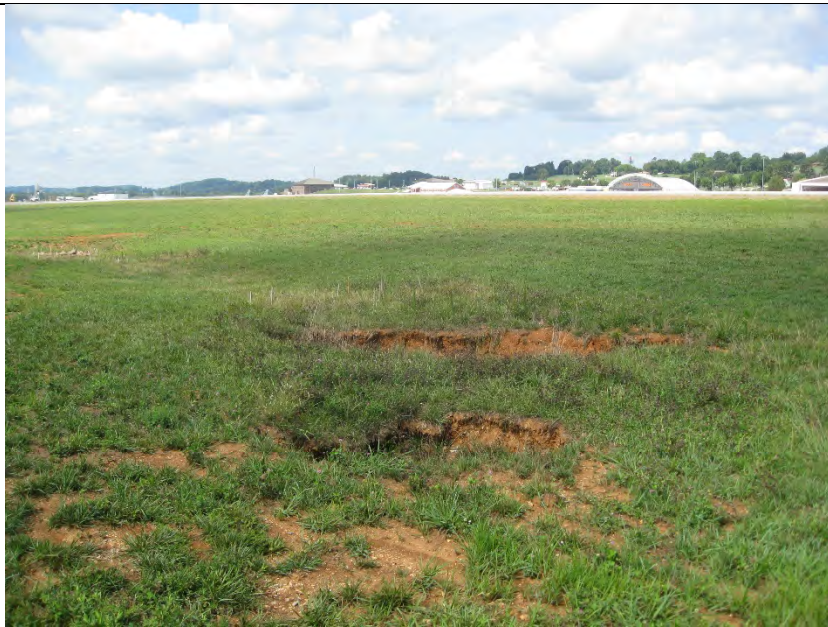
Photo 55
Sta. 341+86 RT
(RW 5L-23R)
Project 4

Construction fallout on Storm Line 2 between structures 204 and 206.
Recommend coordinating remediation with CHA.

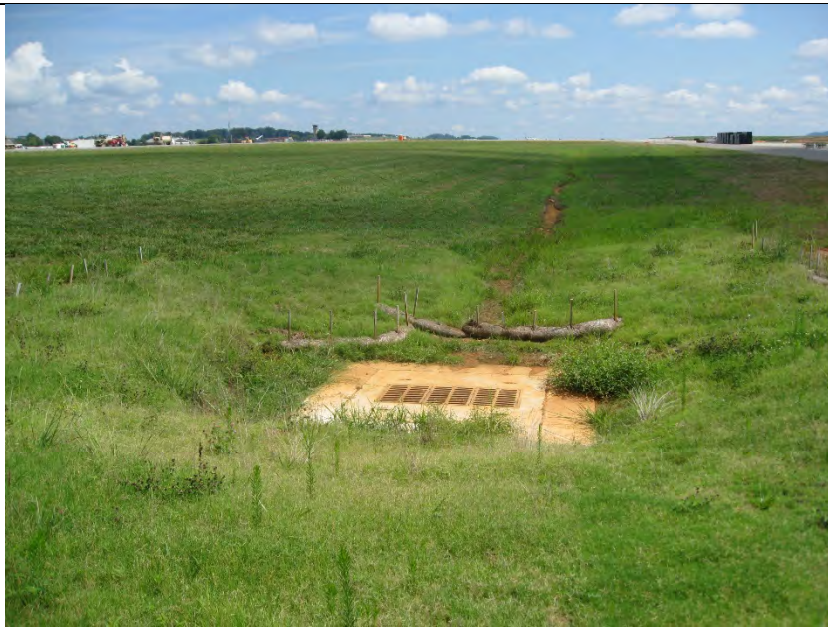
Photo 63
Sta. 301+87 RT
(RW 5L-23R)
Structure 218
Project 3

Structure 218.
Recommend stabilizing bare areas and repairing rill above structure (see photo below).

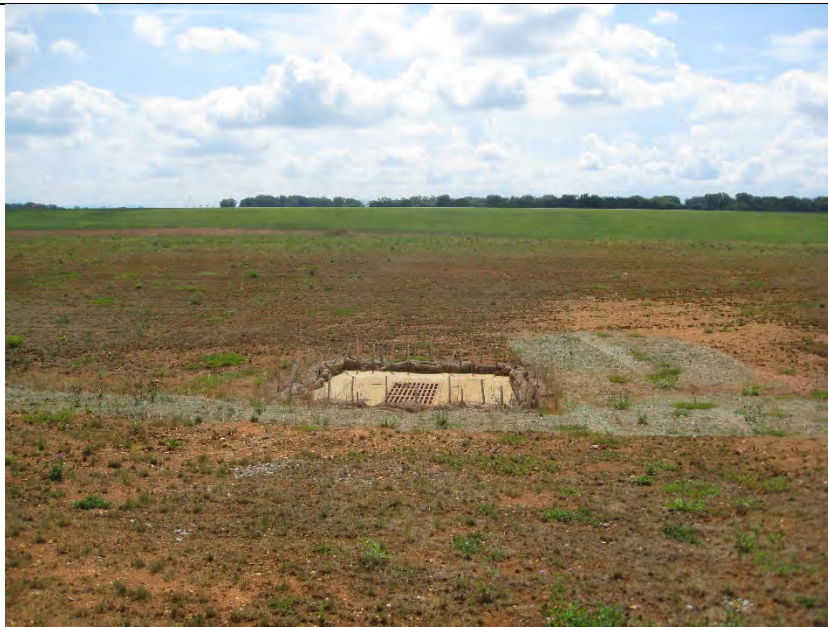
Photo 65
Sta. 296+83 RT
(RW 5L-23R)
Structure 220
Project 2

Structure 220.
Recommend stabilizing remaining bare areas.

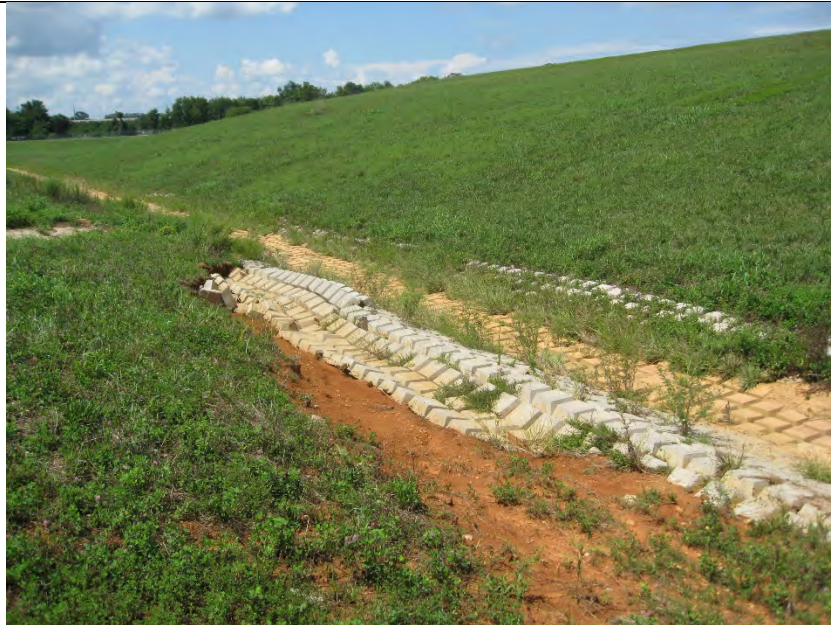
Photo 67
Sta. 288+26
(RW 5L-23R)
Structure 224
Project 2

Below structure 224.
Side slope has eroded causing damage to the articulated concrete block.
CHA, Harper and KMAA were already aware of the issue as discussed in a progress meeting dated 07/16/2020.

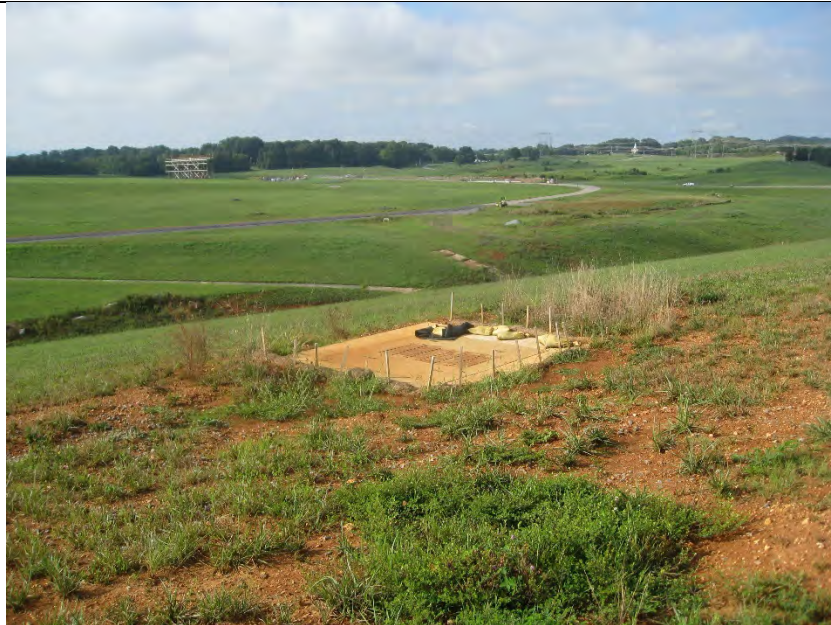
Photo 69
Sta. 290+26 RT
(RW 5L-23R)
Structure 222
Project 2

Structure 222.
Recommend removing inlet protection.
Recommend stabilizing bare areas.

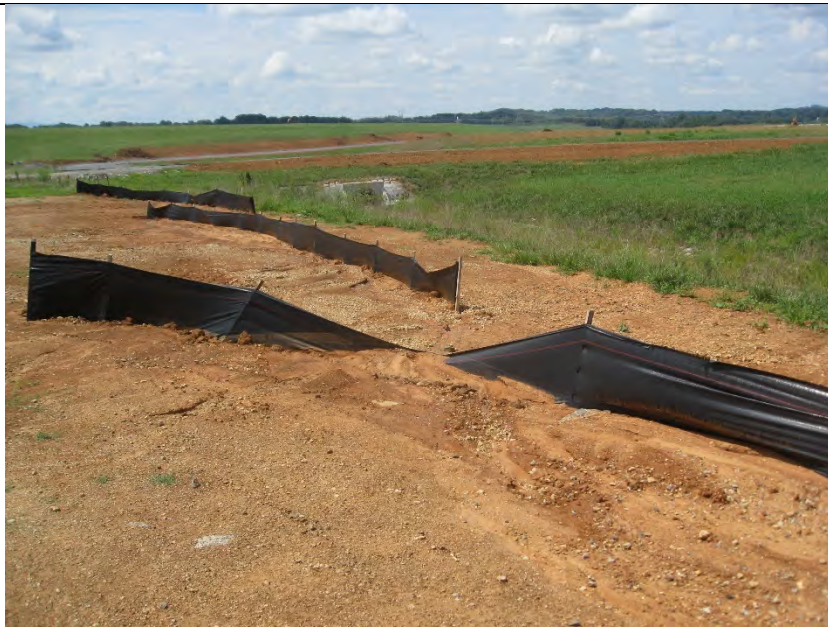
Photo 75
(RW 5L-23R)
Project 3

Silt fence above North Lateral Ditch at stone stockpile area.
Silt fence toppled from recent storm events.
Recommend repairing silt fence.

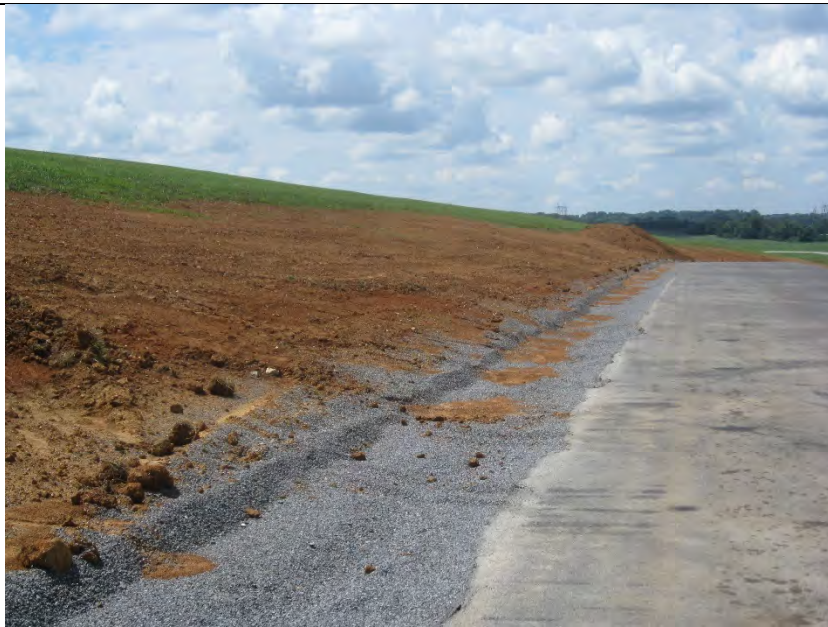
Photo 81
Sta. 32+50 RT
Proposed Haul Route
Project 3

Haul Route.
Underdrain/French drain recently installed and slope regraded. Recommend tracking slope perpendicular to prevent creation of rills.
Recommend stabilizing slope as soon as practical.

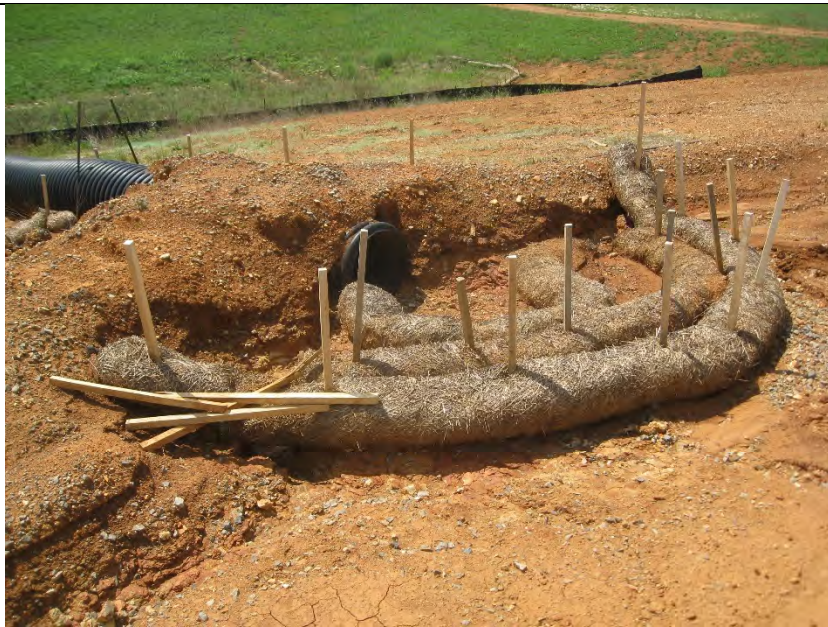
Photo 85
Sta. 302+54
(RW 5L-23R)
Project 2

Soil stockpile area next to haul road at Taxiway B.
Sediment tubes at slope drain have been undermined. Recommend repairing or adding tubes to prevent runoff under the sediment tubes.
Recommend stabilizing all bare areas.

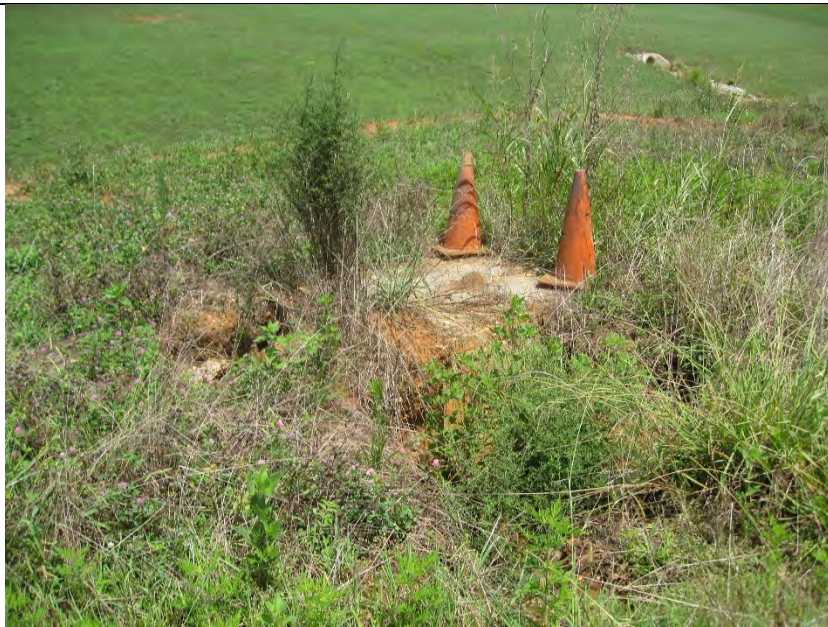
Photo 97
Sta. 284+00 LT
(RW 5L-23R)
Project 2

Existing vault at old Liberty street.
Construction fallout present. Recommend coordinating with CHA on remediation.

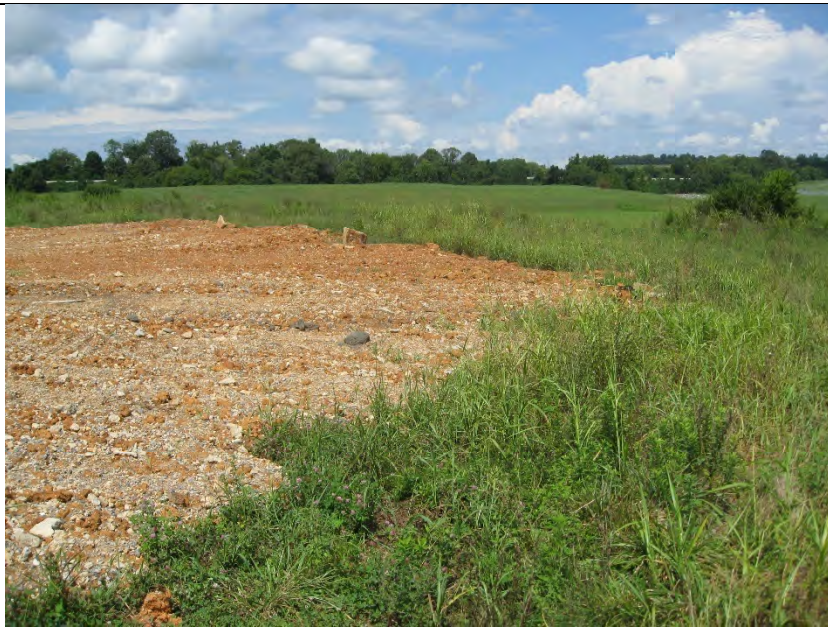
Photo 99
(Repair TWY Lighting)

Fill area adjacent to Liberty Street from Taxiway shoulder removal.
Sediment has migrated to silt fence. Recommend removing accumulated sediment.

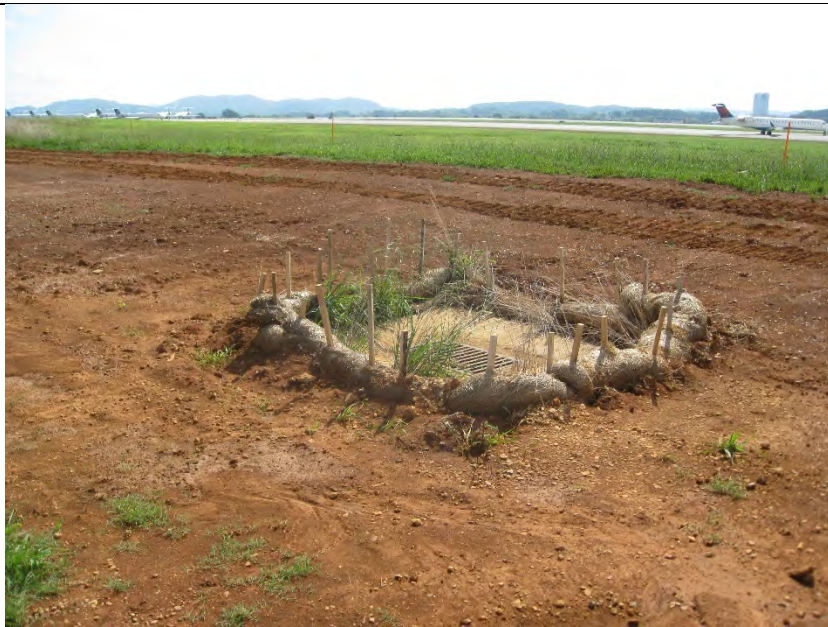
Photo 101
(Repair TWY Lighting)
Existing Structure

Existing structure south of Taxiway G.
Recommend stabilizing bare areas.

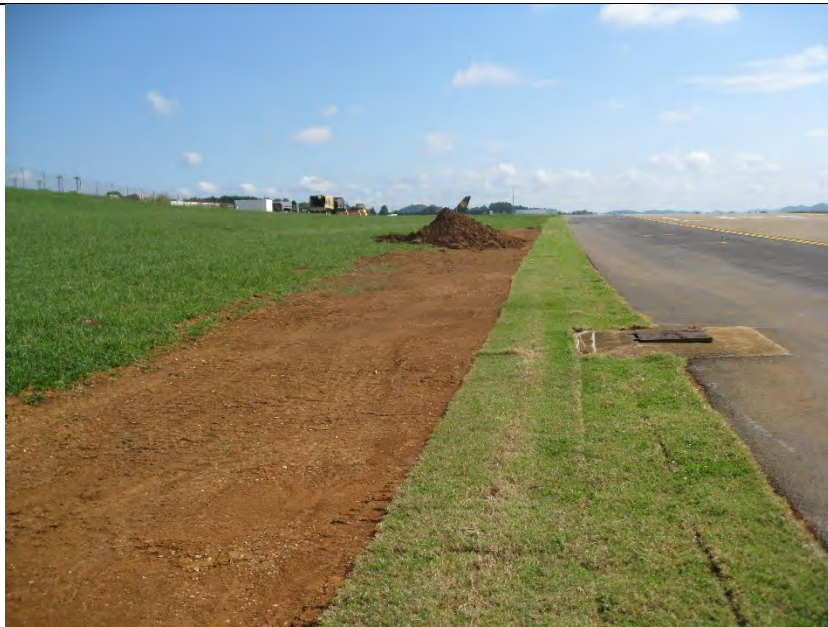
Photo 103
(Repair TWY Lighting)

Sod establishing along Taxiway G.
Recommend stabilizing remaining bare areas.

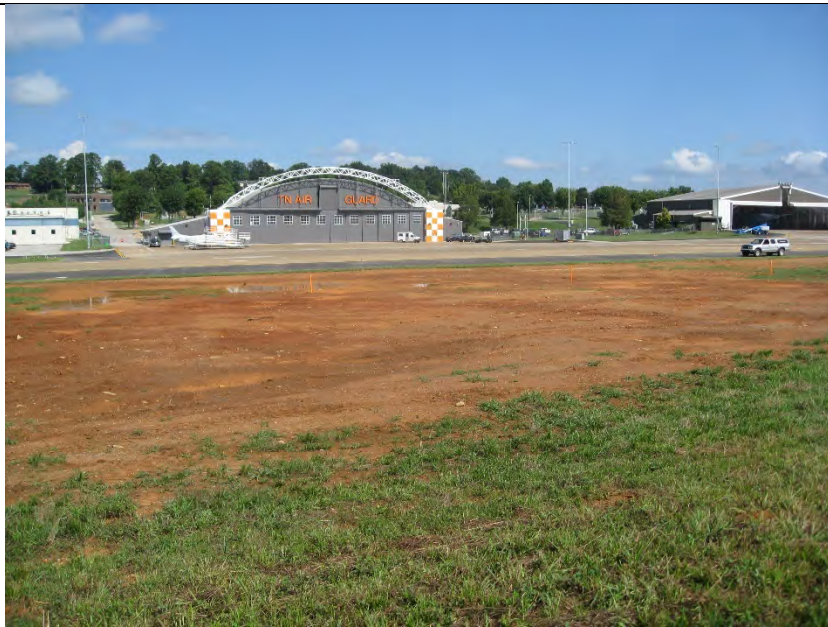
Photo 105
(Repair TWY Lighting)

Demolished old Taxiway G4 and shoulder recently graded.
Recommend stabilizing bare areas.
