QUALITY ASSURANCE MONTHLY SITE ASSESSMENT REPORT

Airfield Modernization Program
Runway 5L-23R Reconstruction
Project 2 / Project 3
Project 4 / Repair TWY Lighting
Project 5 / Project 6

QUALITY ASSURANCE SITE ASSESSMENT

10/29/2020

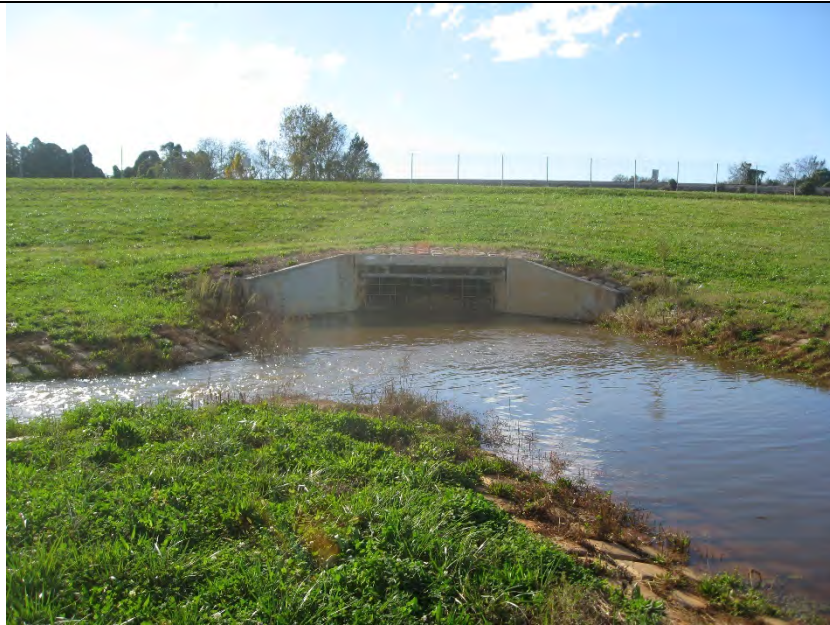
Photo 1
Sta. 111+56 RT
(Line LB)
NLET 01
Project 2

North Lateral End Treatment 01 (Outfall A).
Clear flow observed.

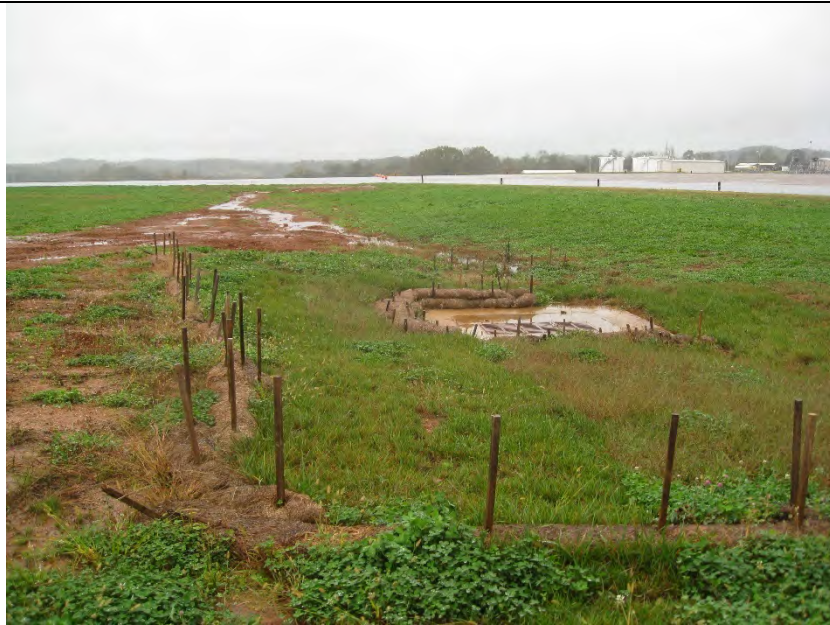
Photo 9
Sta. 298+71 LT
(RW 5L-23R)
Structure 116
Project 3

Structure 116.
Recommend removing accumulated sediment and immediately stabilizing bare areas to reduce the probability of future erosion issues (see photos #10 and #111 below).

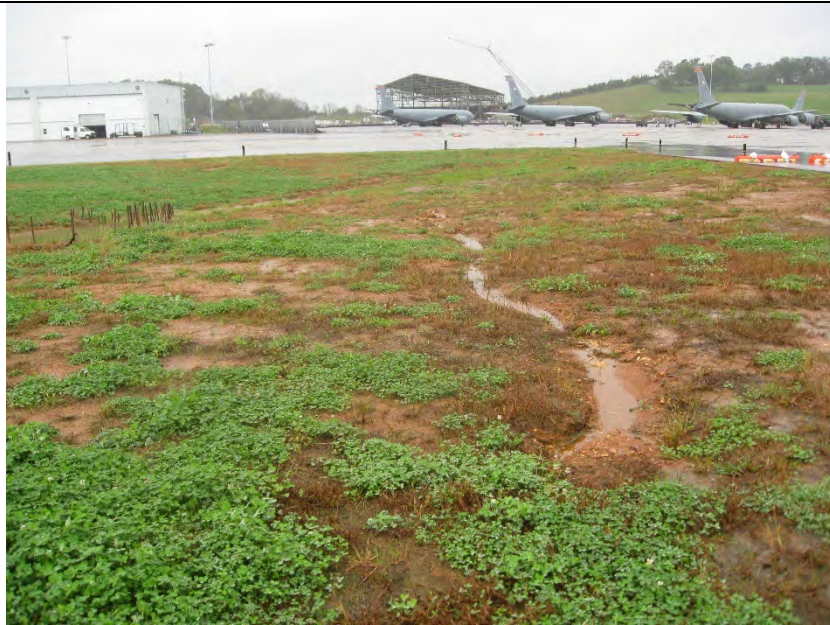
Photo 11
Sta. 298+71 LT
(RW 5L-23R)
Structure 116
Project 3

Above Structure 116 on Taxiway G2.
Recommend repairing rills and stabilizing bare areas.

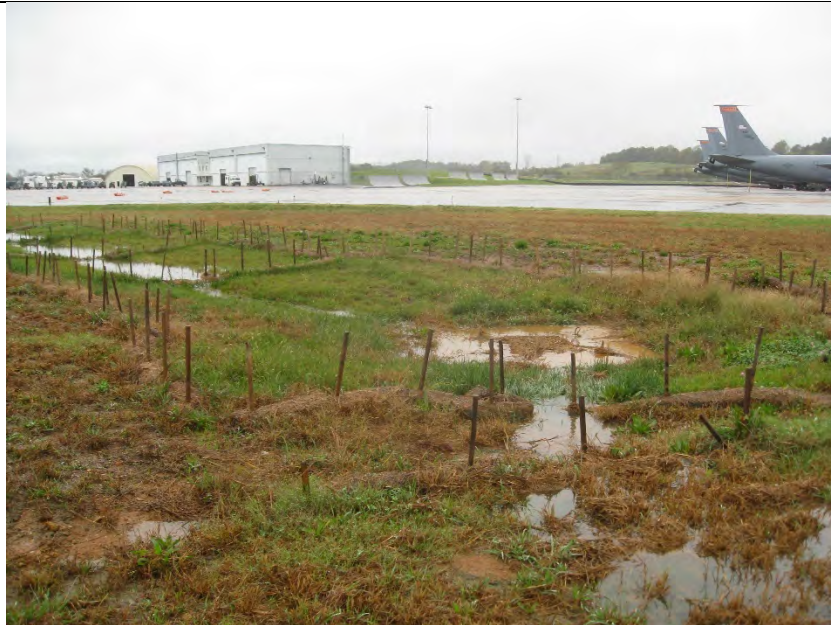
Photo 13
Sta. 303+36 LT
(RW 5L-23R)
Structure 12
Project 3

Structure 12.
Recommend removing sediment tubes.

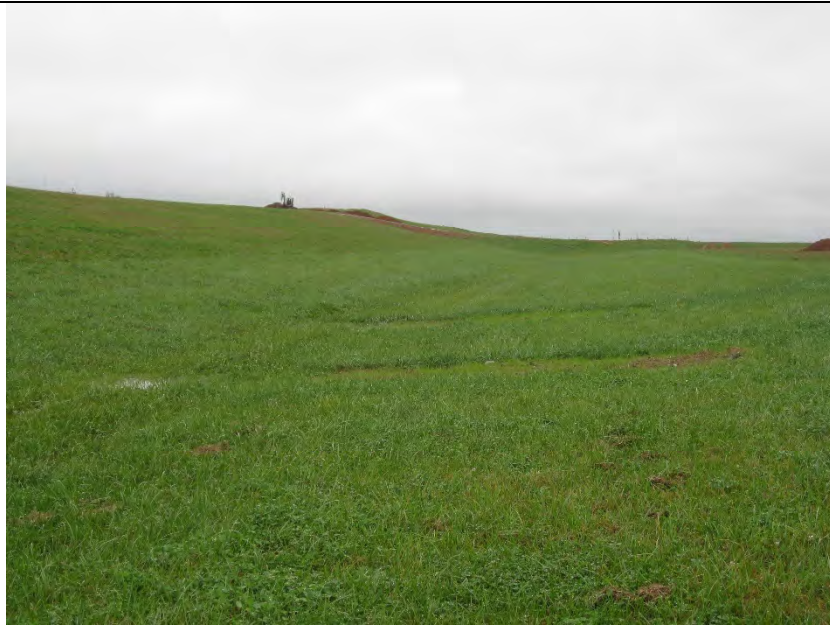
Photo 23
Sta. 341+50 LT
(RW 5L-23R)
Between ES Endwall 104 and 102
Project 3

Repaired construction fallouts recently stabilized.

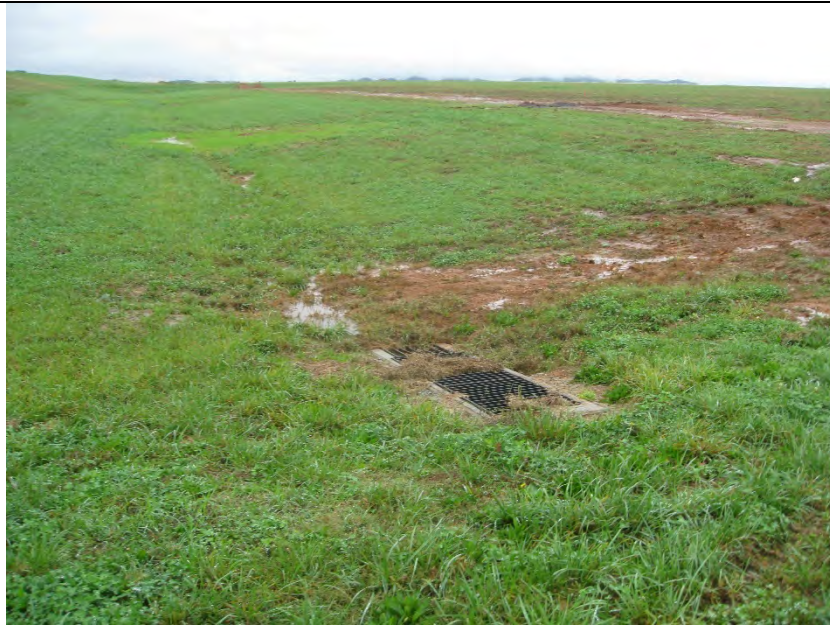
Photo 25
Sta. 347+31 LT
(RW 5L-23R)
ES Endwall 102
Project 3

Enhanced Swale Endwall 102
Recommend repairing long-standing rills.
Recommend coordinating with CHA on possible use of matting to help stabilization.
Recommend stabilizing all remaining bare areas.
Construction activities are per Project 6 (EUTAW).

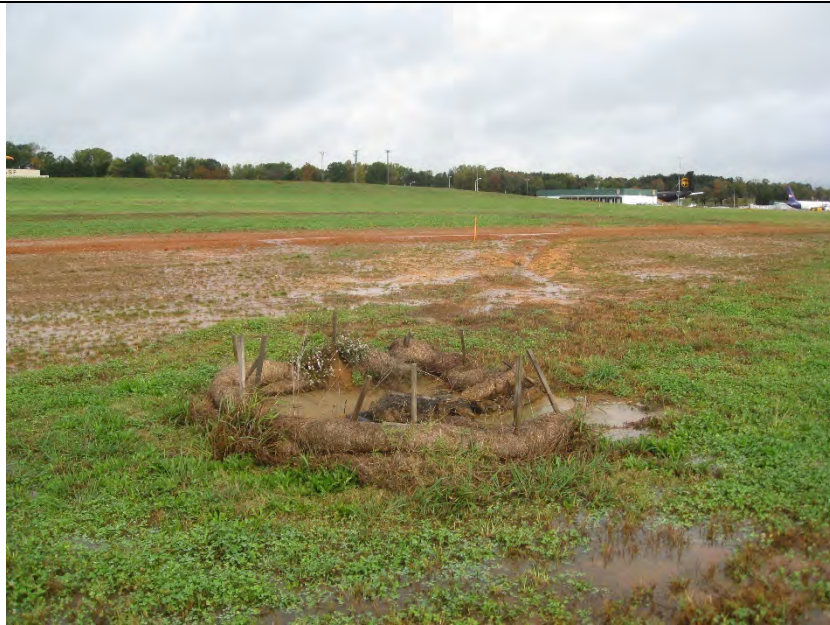
Photo 31
Sta. 369+11 LT
(RW 5L-23R)
Existing Structure
Project 2

Existing Structure.
Recommend stabilizing long-standing bare areas.
Recommend repairing damaged sediment tubes.
Construction activities are per Project 6 (EUTAW)

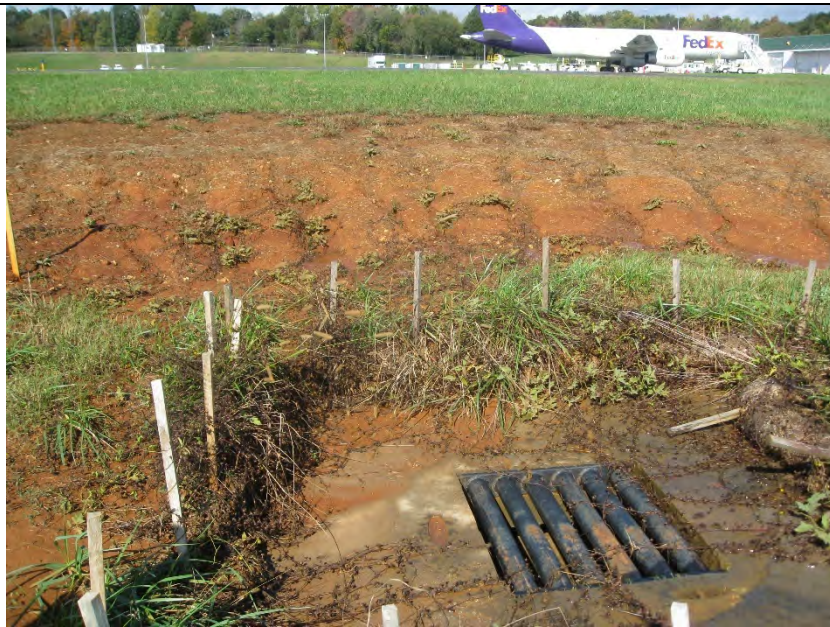
Photo 33
Sta. 677+00 RT
(RW 5L-23R)
Existing Structure
Project 4

Existing structure south of Taxiway "G" (see previous photo).
Recommend removing long-standing sediment from behind sediment tubes and on top of structure. Recommend replacing sediment tubes.

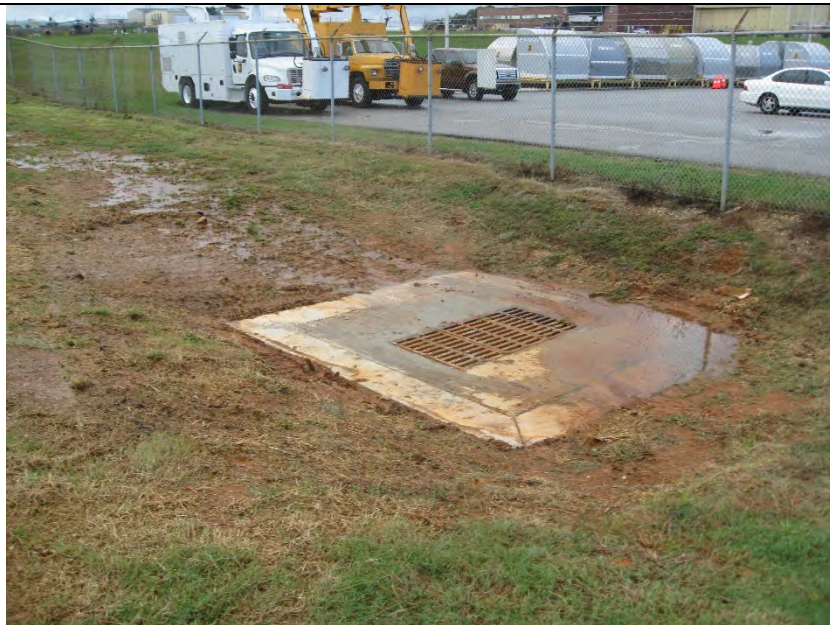
Photo 35
Sta. 676+00 RT
(RW 5L-23R)
Project 4

Structure adjacent to UPS.
Sediment tubes recently removed and not replaced. Area not stable.
Recommend reseeding bare areas.

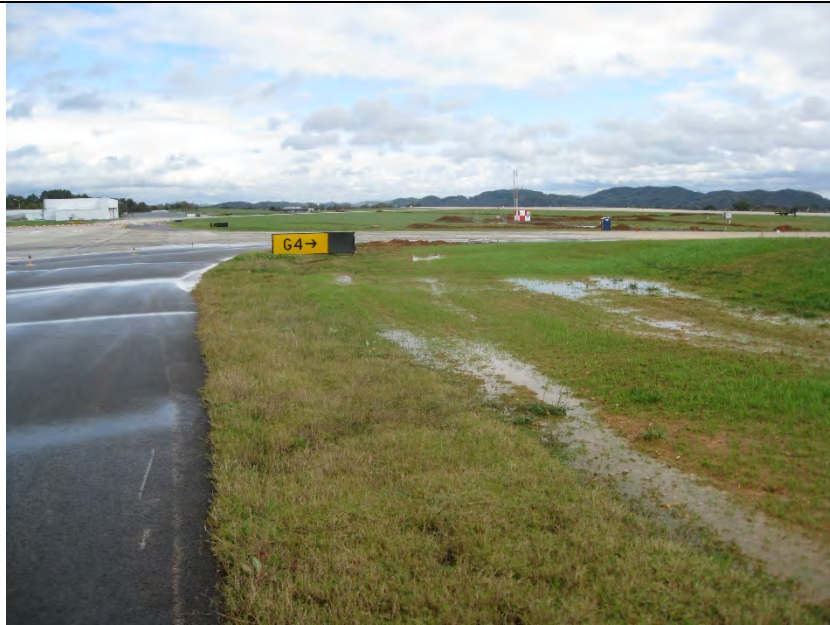
Photo 37
New structure
Project 4

Bare areas recently stabilized.

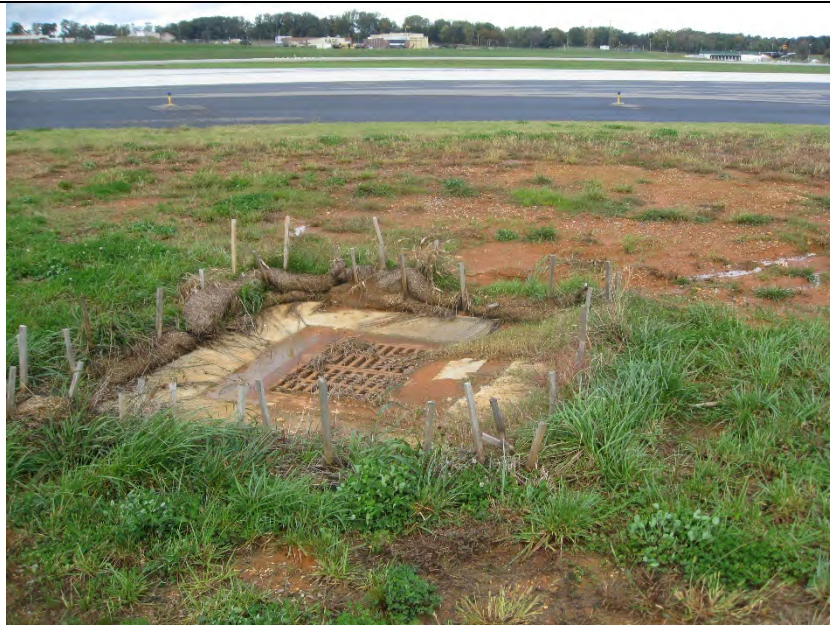
Photo 43
Sta. 362+02 LT
(RW 5L-23R)
Structure 400
Project 4

Structure 400.
Bare areas never stabilized and continue to push sediment onto existing structure.
Recommend stabilizing long-standing bare areas after removing accumulated sediment.

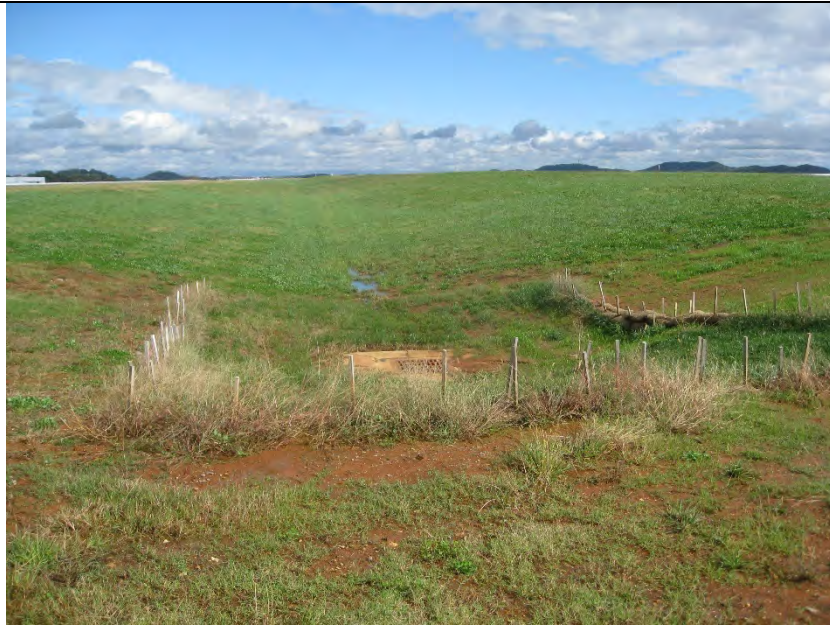
Photo 45
Sta. 347+26 RT
(RW 5L-23R)
Structure 22
Project 4

Structure 22.
Sediment never removed from top of structure.
Recommend removing long-standing sediment from top of structure.

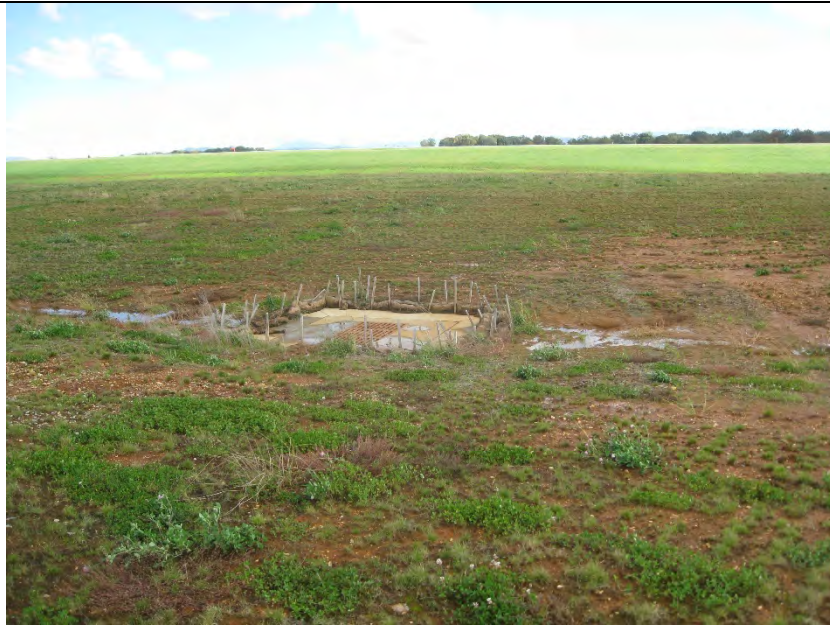
Photo 57
Sta. 296+83 RT
(RW 5L-23R)
Structure 220
Project 2

Structure 220.
Recommend stabilizing remaining bare areas.

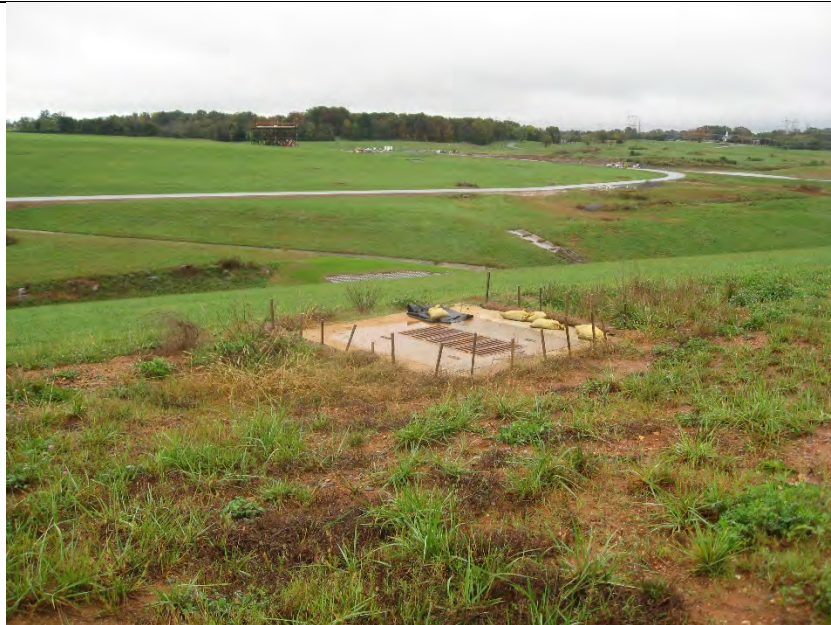
Photo 61
Sta. 290+26 RT
(RW 5L-23R)
Structure 222
Project 2

Structure 222.
Recommend removing inlet protection.
Recommend stabilizing bare areas.

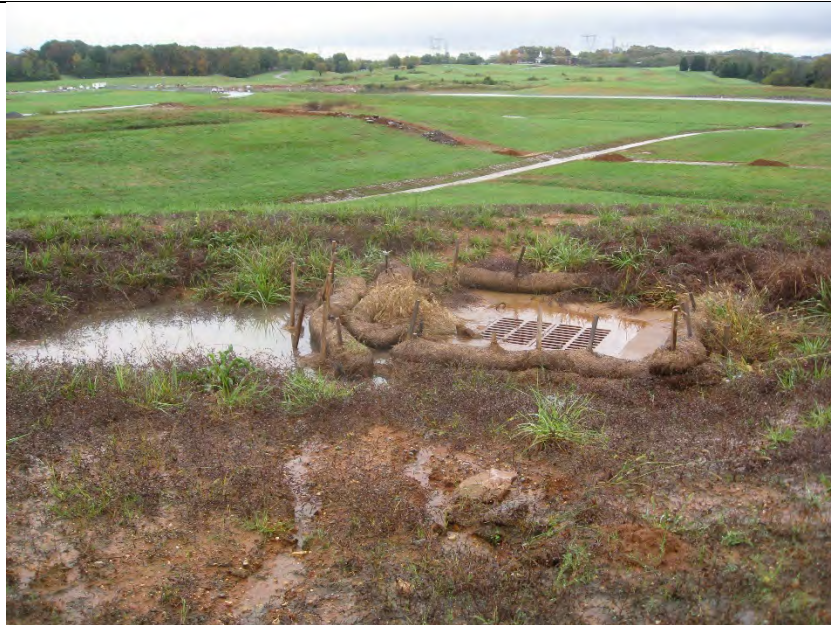
Photo 63
Sta. 284+59
(RW 5L-23R)
Structure 600
Project 3

Structure 600.
Recommend removing inlet protection and stabilizing bare areas.

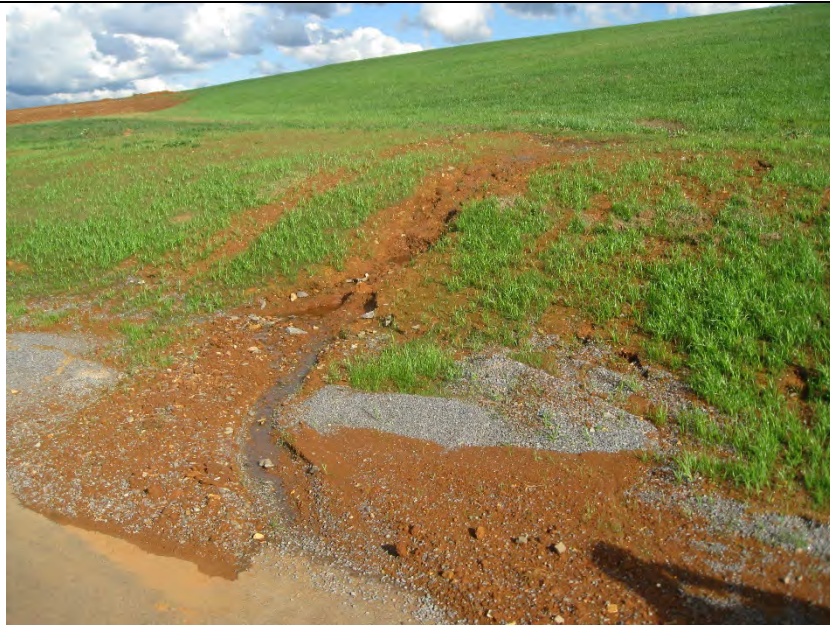
Photo 65
Sta. 37+25 RT
Proposed Haul Route
Project 3

Haul Road.
Due to recent storm events, Rills have formed.
Recommend coordinating with CHA on remediation of rills.

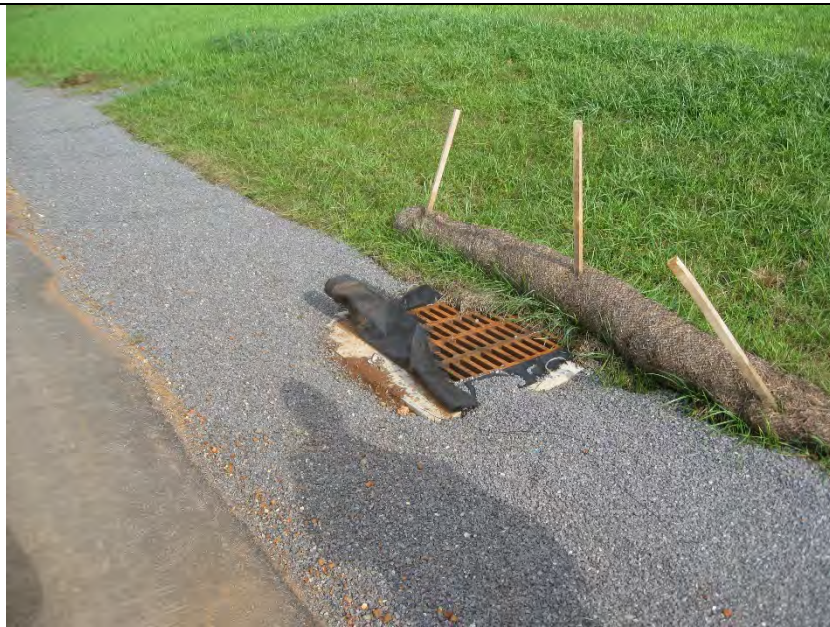
Photo 67
Sta. 37+25 RT
Proposed Haul Route
Project 3

Haul Road.
Recommend removing filter fabric and sediment tubes.

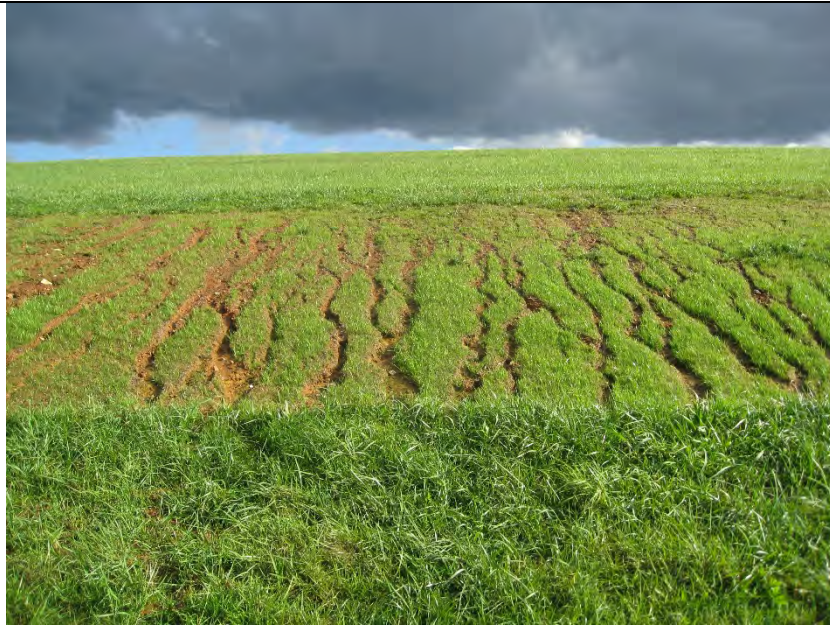
Photo 69
Sta. 32+50 RT
Proposed Haul Route
Project 3

Haul Road.
Recommend repairing rills (including any not pictured) and stabilizing resulting bare areas. Once rills are repaired and slope stabilized, recommend removing filter fabric and sediment tubes from storm structures along Haul Road.

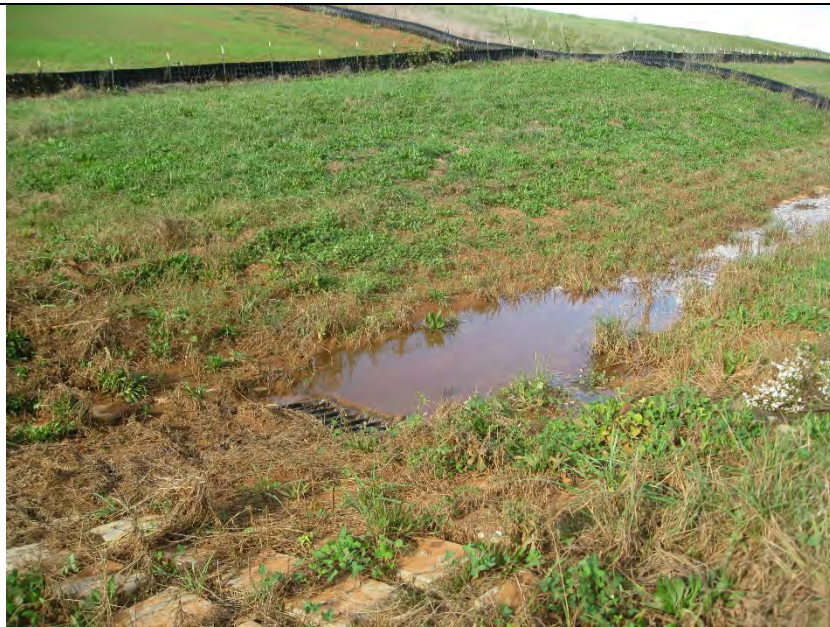
Photo 73
Sta. 302+54
(RW 5L-23R)
Project 3

Above North Lateral Endwall 100.
Sediment has settled in the North lateral ditch.
Recommend removing sediment.
See previous photo.

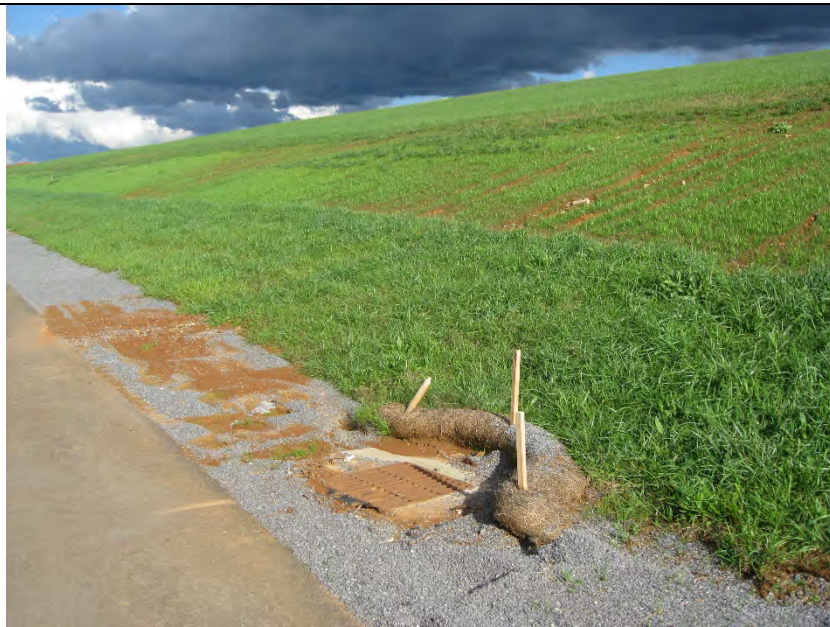
Photo 77
Sta. 29+00 RT
Proposed Haul Route
Project 3

Inlet structure along haul road.
Sod recently installed.
Recommend stabilizing remaining bare areas as soon as practical.

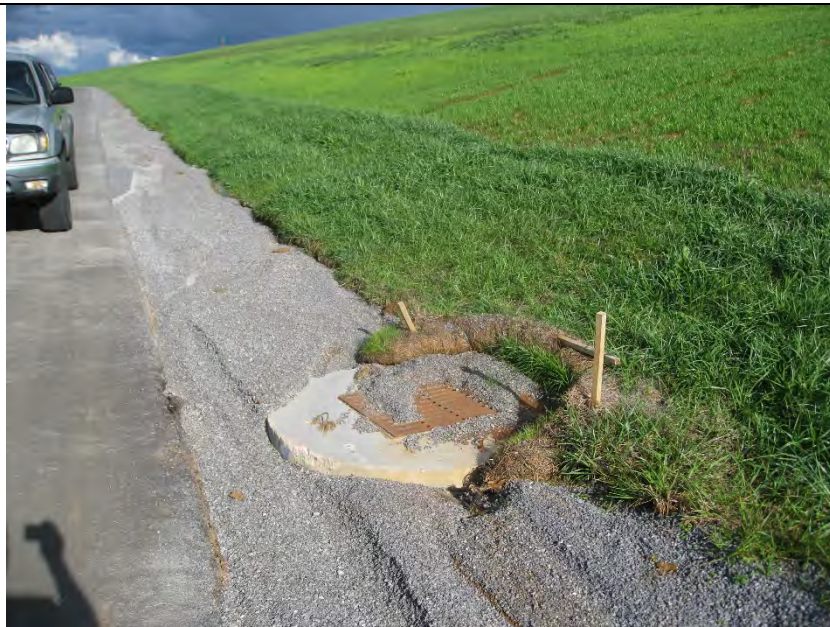
Photo 79
Sta. 22+00 RT
Proposed Haul Route
Project 3

Inlet structure along haul road.
Area drain is full of stone and sediment.
Recommend removing sediment from area drain and insuring that french drain is unclogged.
Recommend removing any filter fabric as well as sediment tubes.

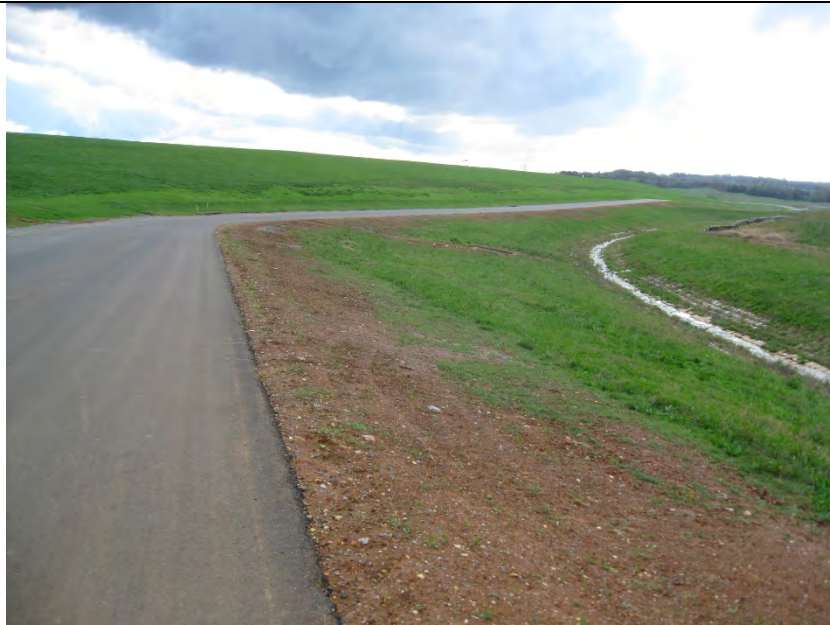
Photo 85
Sta. 15+50 RT
Proposed Haul Route
Project 3

Recommend stabilizing bare areas along haul route as soon as practical.

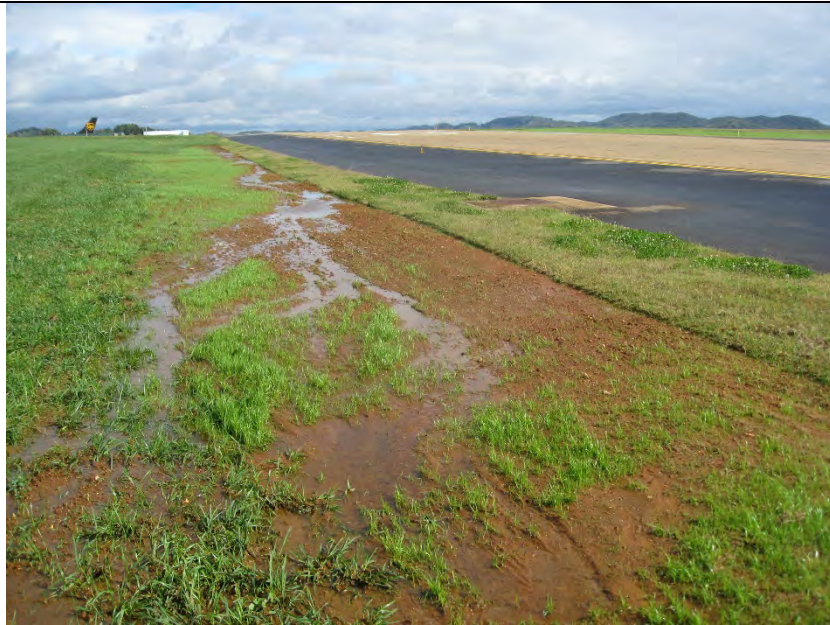
Photo 91
(Repair TWY Lighting)

Shoulder of Taxiway G (Looking back towards cargo apron)
Bare areas recently stabilized.
Recent storm events have moved the seed downstream.
Recommend restabilizing resulting bare areas.

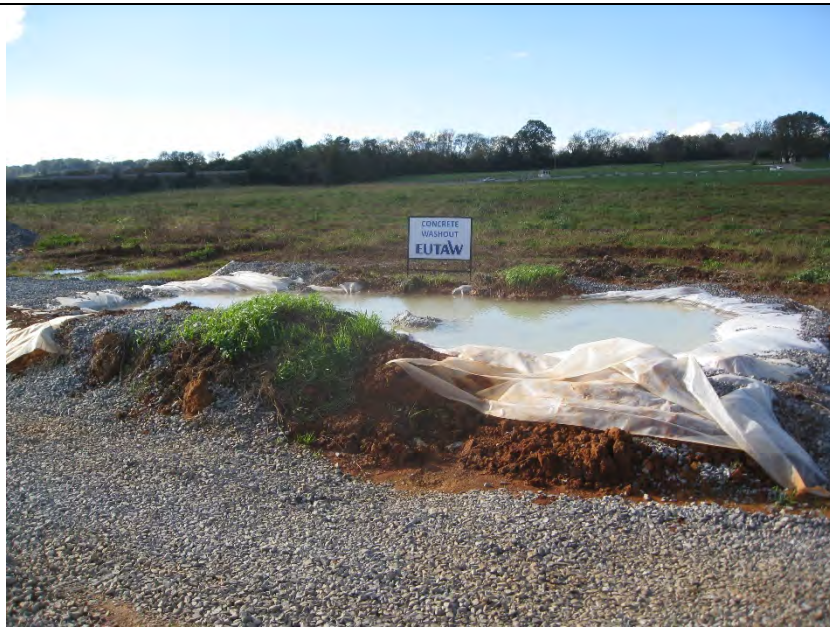
Photo 95
(Project 5/6)

Area adjacent to haul road.
Signage recently added. Concrete washout facility is at capacity.
Recommend dewatering washout with approved methods or adding second facility.

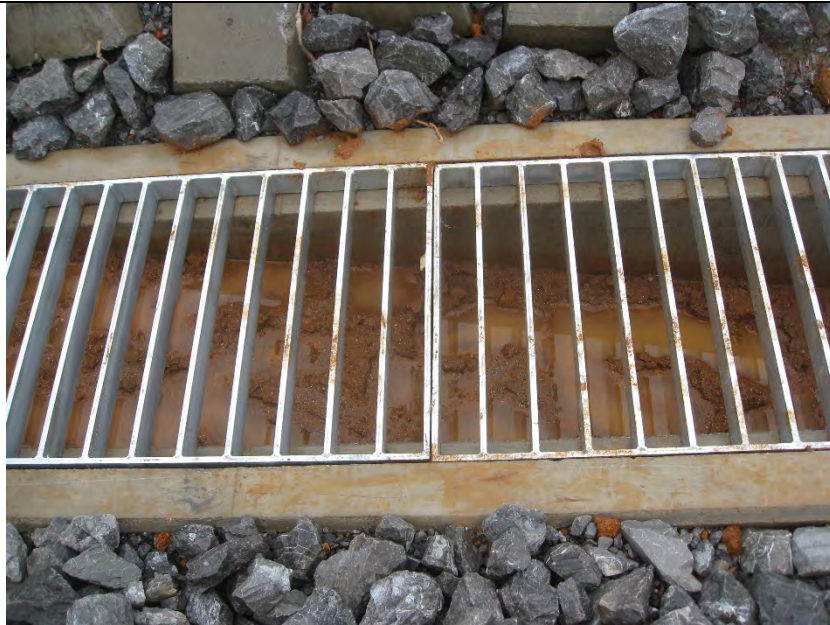
Photo 99
(Project 5/6)

Proposed MALSR access road.
Sediment shown in pipe from previous report has exited the endwall and entered the Guard Lateral ditch. Recommend removing sediment.

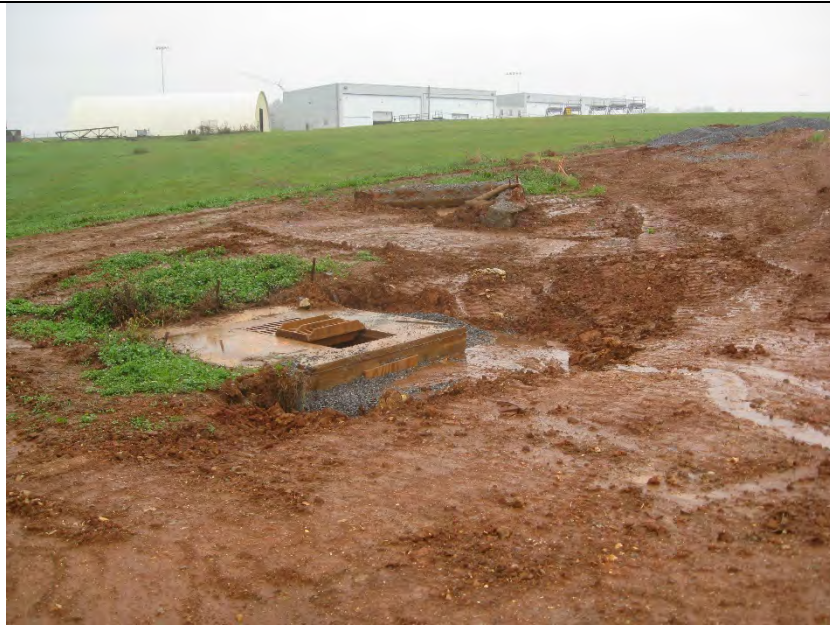
Photo 101
(Project 5/6)

Existing structure #120 adjacent to proposed MALSR access road.
Once area is to grade and structure receives run-off, recommend adding inlet protection per the plans. Recommend monitoring back side of structure that is already at grade for sediment migration.

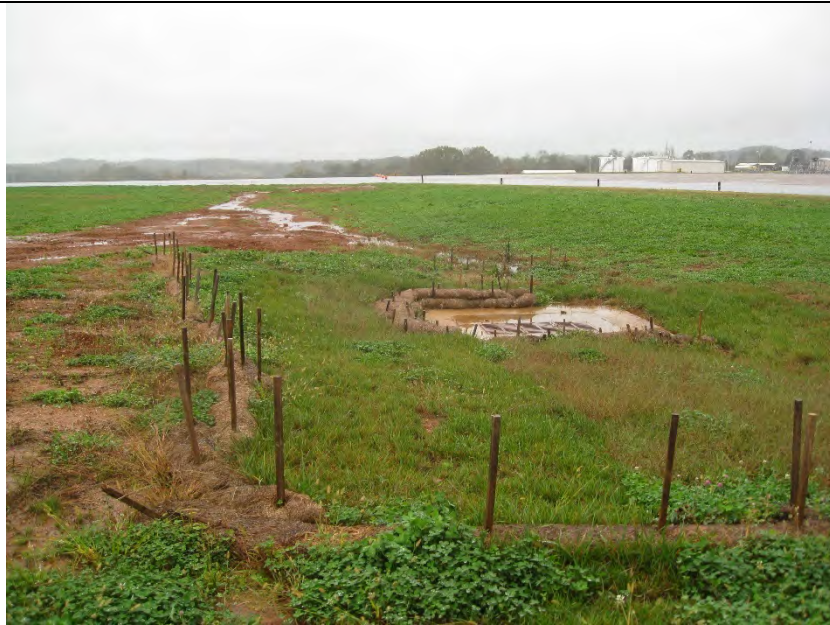
Photo 105
(Project 5/6)

Structure 116.
Recommend stabilizing all bare areas above structure from duct bank installation.

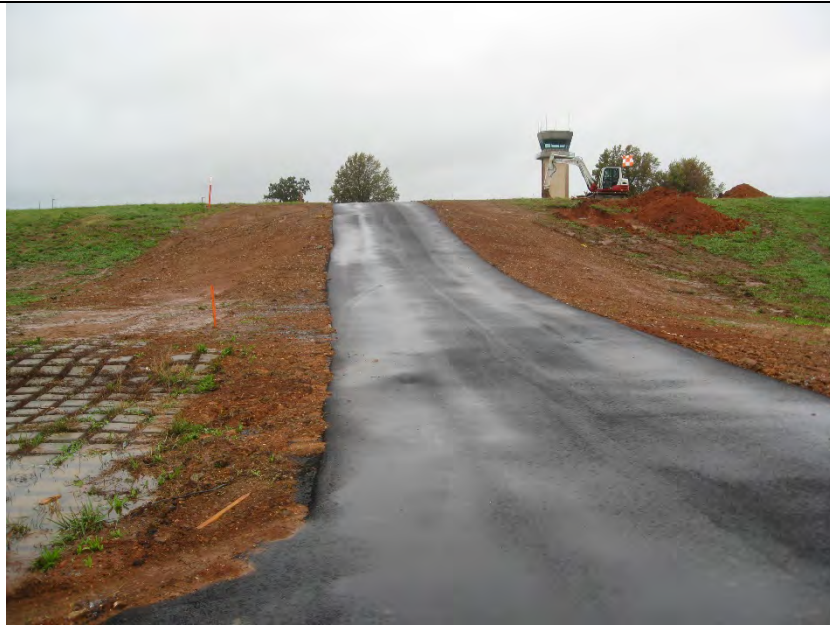
Photo 107
(Project 5/6)

23R Midpoint RVR
Side slopes appear to be at grade.
Recommend adding sediment tubes per the plans.
Recommend stabilizing bare areas.

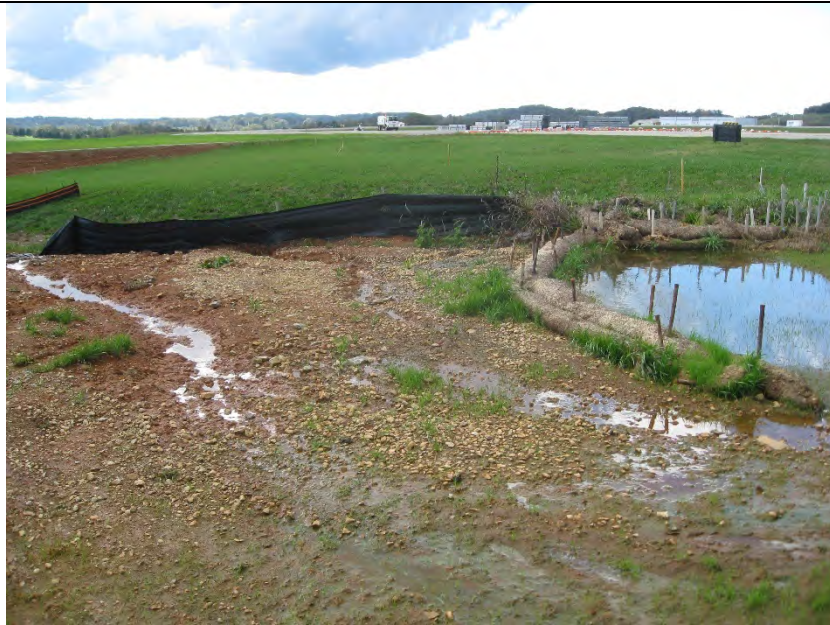
Photo 113
(Project 5/6)

Airfield Lighting Vault
Storm events continue to cause rills and erosion issues while depositing sediment in the North Lateral Ditch. Recommend on site coordination with CCI and CHA on possible shaping of area to direct runoff into existing structure. See next photo.

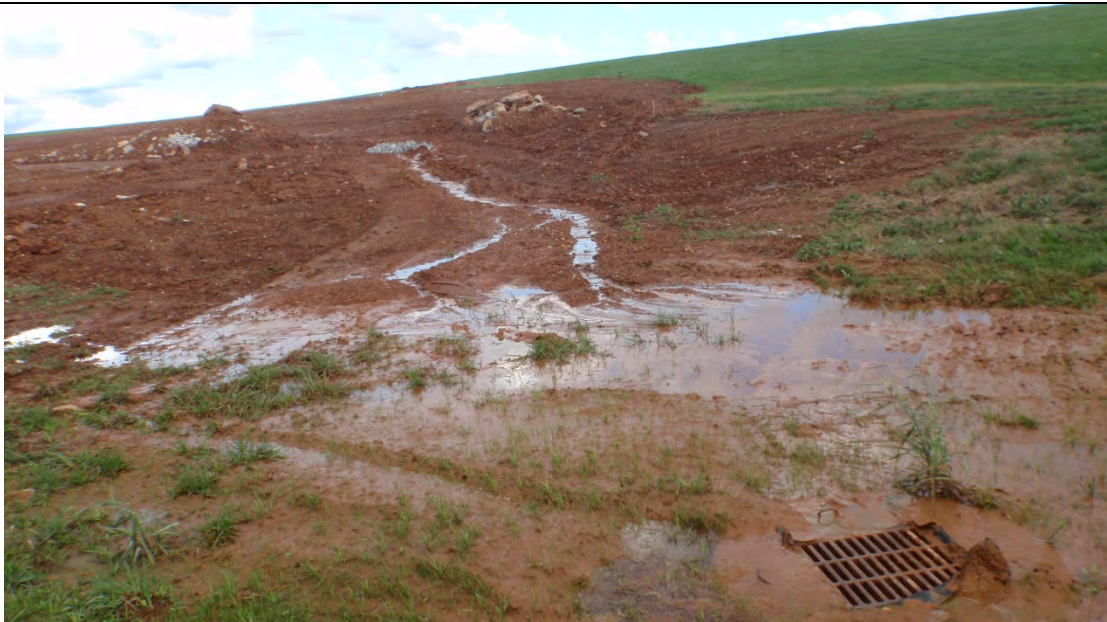
Photo 118
(Project 5/6)

Airfield Lighting Vault
Recommend installing inlet protection and sediment tube check dams in ditch line per the plans
(sheet EC102)

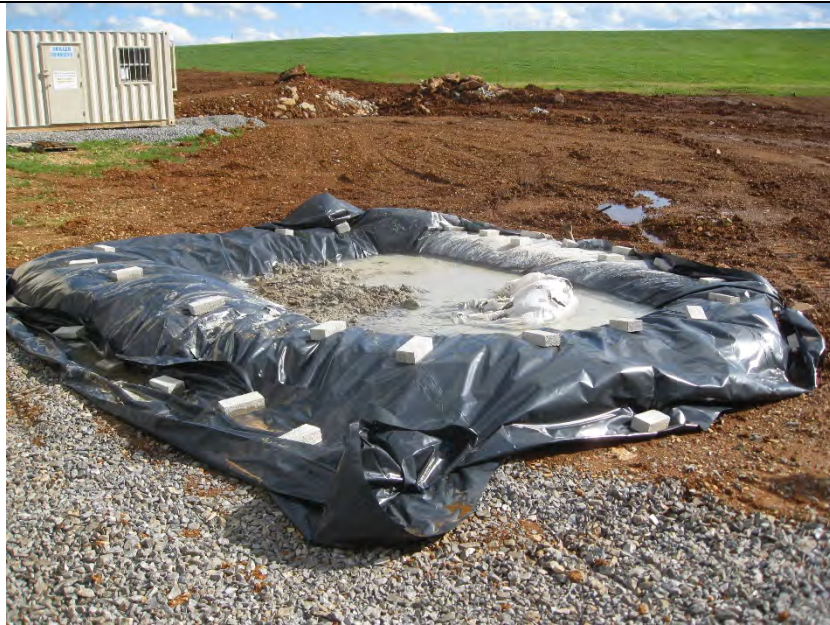
Photo 119
(Project 5/6)

Airfield Lighting Vault
Concrete washout facility.
Recommend adding signage per detail #6 on sheet EC201.

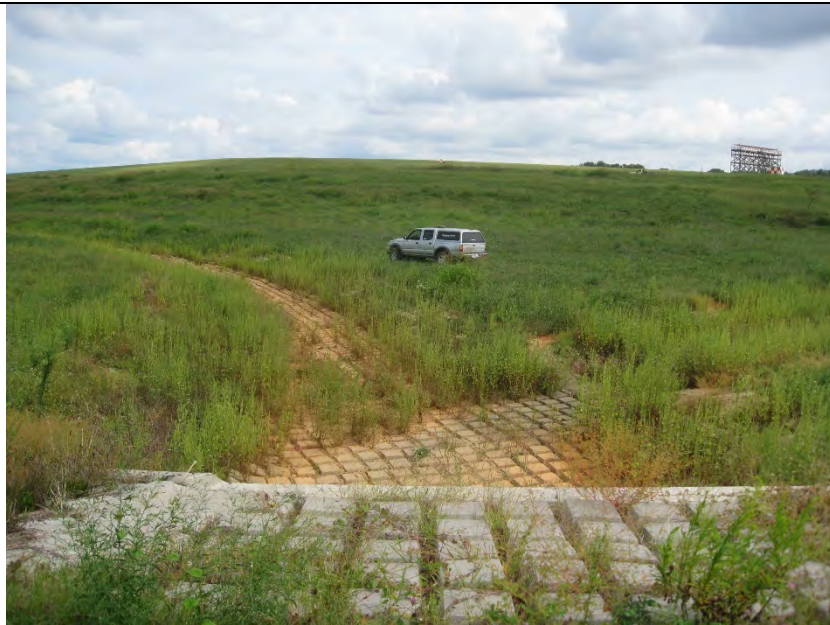
Photo 1
Sta. 111+56 RT
(Line LB)
NLET 01
Project 2

North Lateral End Treatment 01 (Outfall A).
No flow observed.

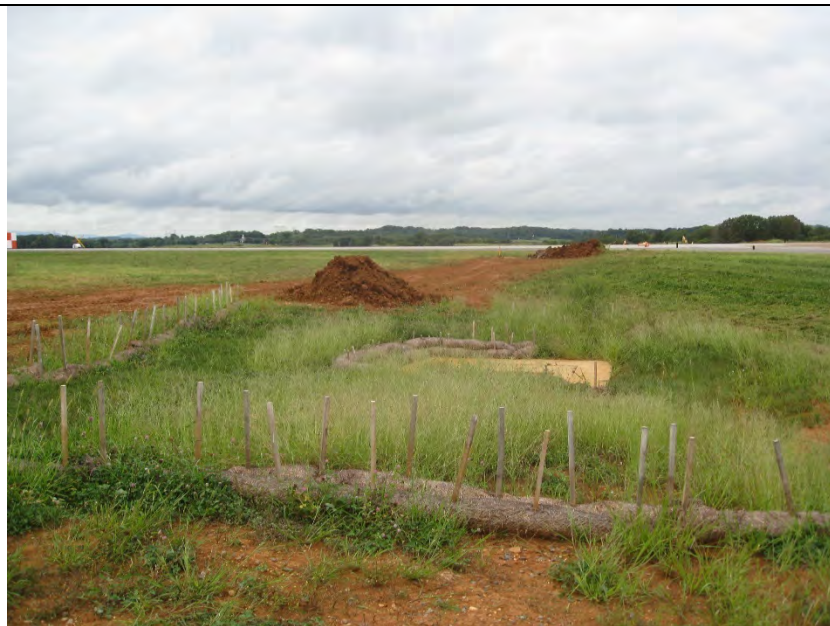
Photo 10
Sta. 298+71 LT
(RW 5L-23R)
Structure 116
Project 3

Structure 116.
Recommend stabilizing bare areas and repairing rills (see photos #11 and #12 below).

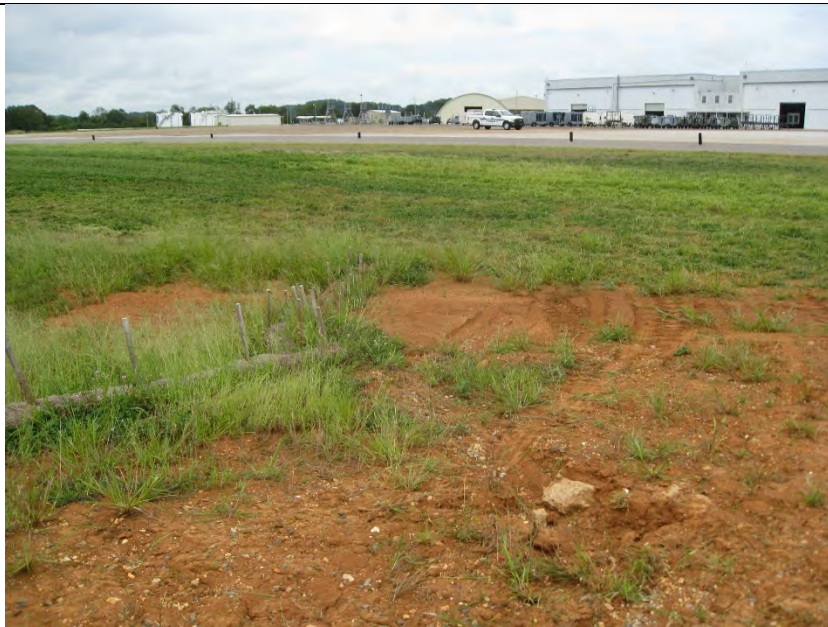
Photo 11
Sta. 298+71 LT
(RW 5L-23R)
Structure 116
Project 3

Above Structure 116.
Due to recent storm events, rills have started to form and sediment has accumulated in ditch line.
Recommend removing accumulated sediment. Recommend stabilizing remaining bare areas.

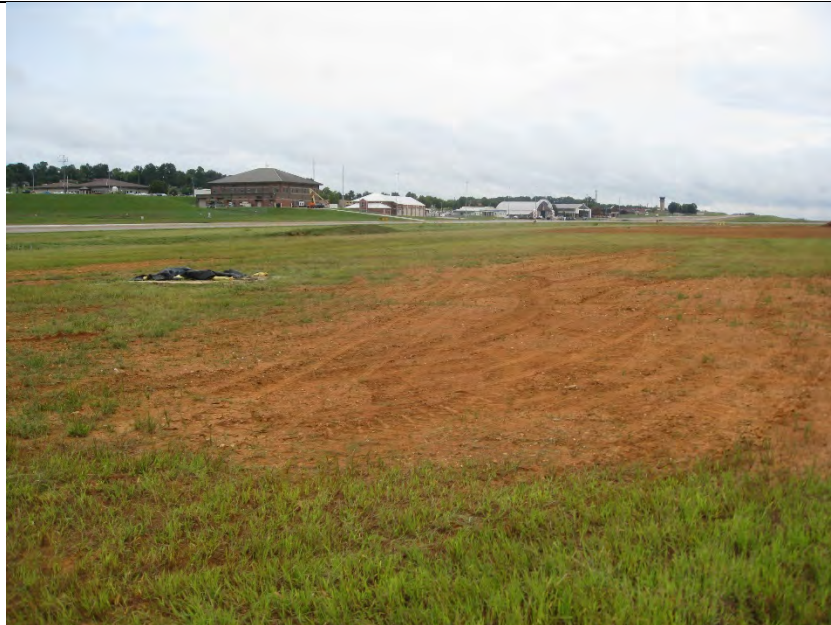
Photo 13
Sta. 302+54 LT
(RW 5L-23R)
Structure 114
Project 3

Structure 114.
Recommend stabilizing remaining bare areas.

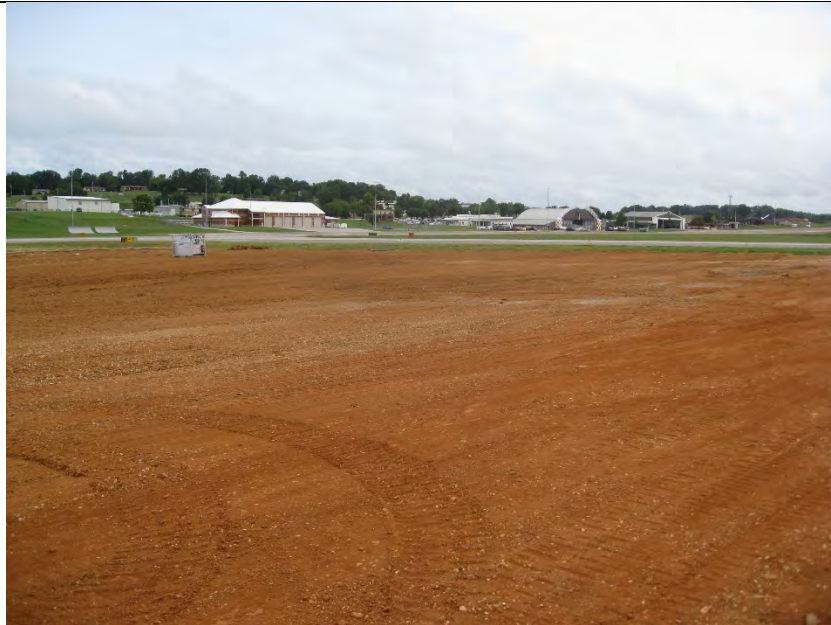
Photo 17
Sta. 310+00 LT
(RW 5L-23R)
Project 3

Batch plant stone area being removed. Recommend stabilizing bare areas as soon as possible.

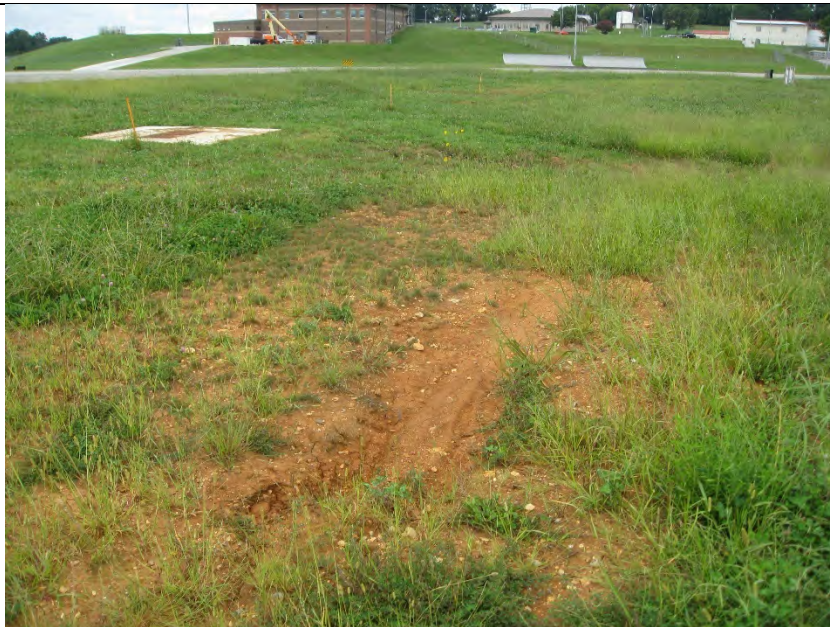
Photo 19
Sta. 314+48 LT
(RW 5L-23R)
ES Endwall 108
Project 3

Enhanced Swale Endwall 108.
Recommend repairing rills above endwall.

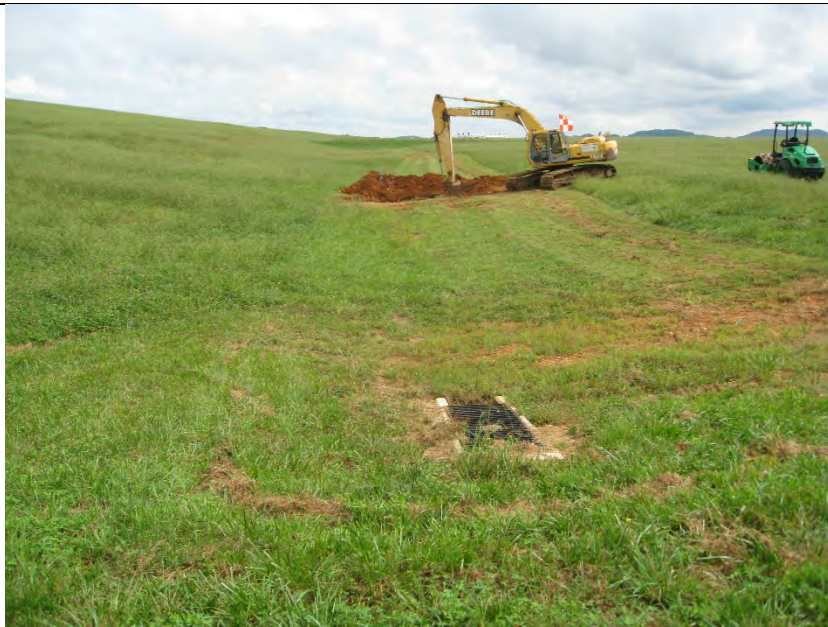
Photo 33
Sta. 347+31 LT
(RW 5L-23R)
ES Endwall 102
Project 3

Enhanced Swale Endwall 102.
Rills have started to form.
Recommend repairing rills and stabilizing all remaining bare areas.

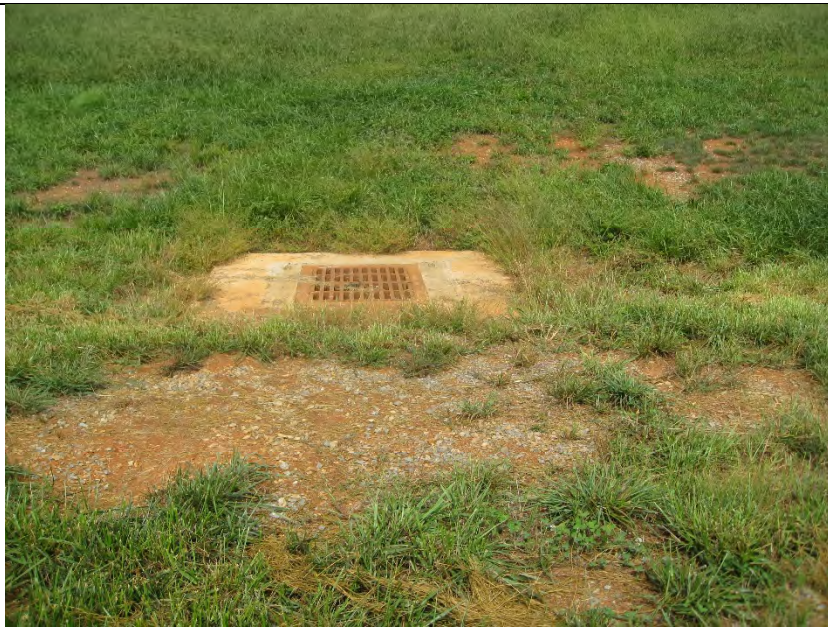
Photo 37
Sta. 361+39 LT
(RW 5L-23R)
Structure 100
Project 3

Structure 100.
Recommend stabilizing remaining bare areas.

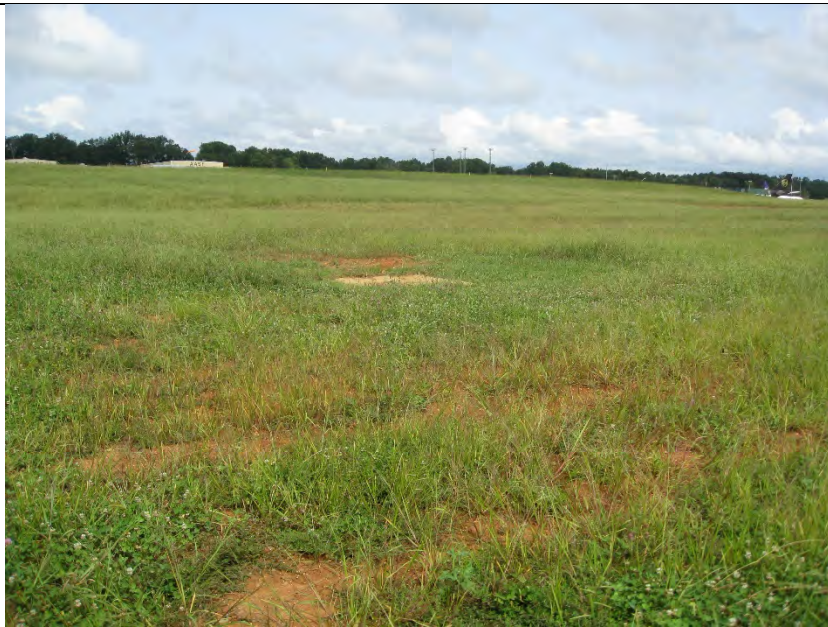
Photo 39
Sta. 366+25 LT
(RW 5L-23R)
Existing Structure
Project 2

Existing Structure.
Recommend stabilizing bare areas.
