QUALITY ASSURANCE MONTHLY SITE ASSESSMENT REPORT

Airfield Modernization Program
Runway 5L-23R Reconstruction
Project 2 / Project 3
Project 4 / Repair TWY Lighting
Project 5 / Project 6

QUALITY ASSURANCE SITE ASSESSMENT

10/29/2020

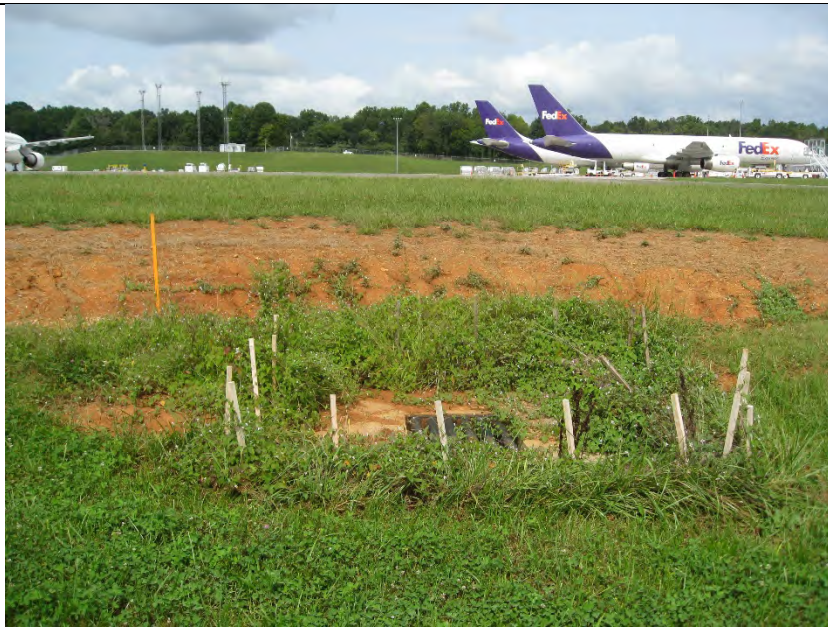
Photo 41
Sta. 677+00 RT
(RW 5L-23R)
Existing Structure
Project 4

Structure south of Taxiway "G".
Erosion and rills continue to occur along the graded slope.
Recommend repairing eroded areas, removing accumulated sediment, and immediately stabilizing slope to reduce the probability of future erosion issues.
See photo below.

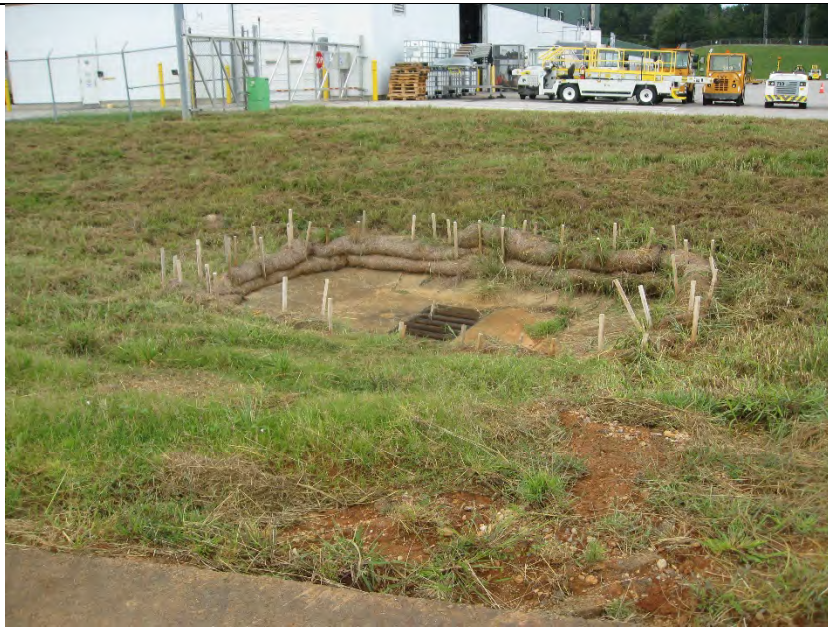
Photo 43
Sta. 677+00 RT
(RW 5L-23R)
Project 4

Structure between taxiway and UPS.
Recommend repairing rills as needed and stabilizing remaining bare areas.

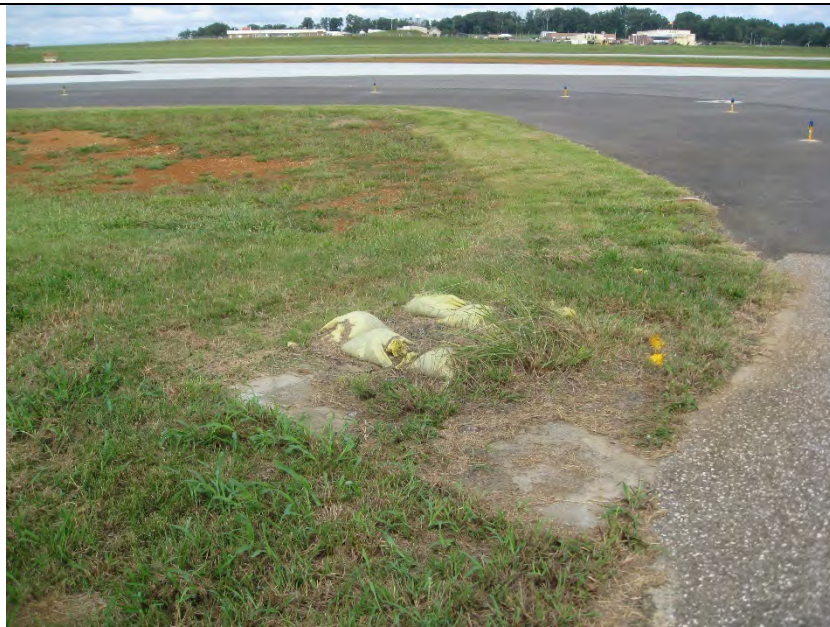
Photo 49
(RW 5L-23R)
TWY Y Tie-in
Project 4

Existing structure south of Taxiway Y.
Recommend removing inlet protection.

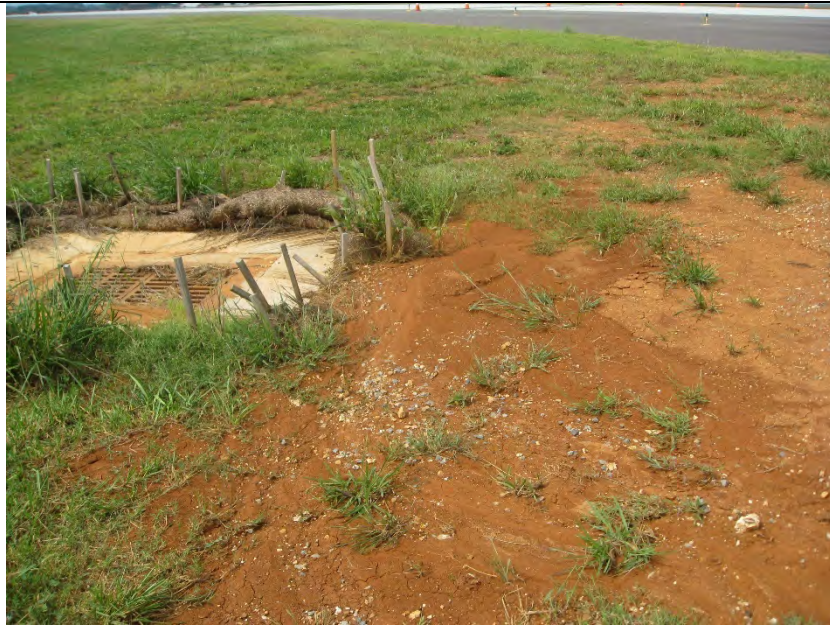
Photo 51
Sta. 362+02 LT
(RW 5L-23R)
Structure 400
Project 4

Structure 400.
Recommend removing accumulated sediment, regrading area as needed, and immediately stabilizing remaining bare areas to reduce the probability of future erosion issues.

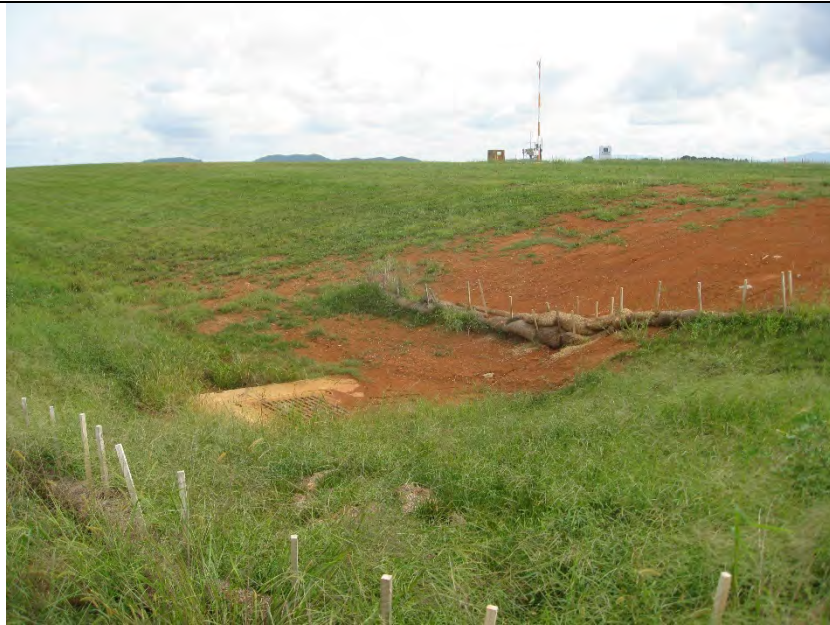
Photo 53
Sta. 347+26 RT
(RW 5L-23R)
Structure 22
Project 4

Structure 22.
Recommend removing sediment from top of structure.
Recommend adding sediment tubes.
Recommend stabilizing bare areas.

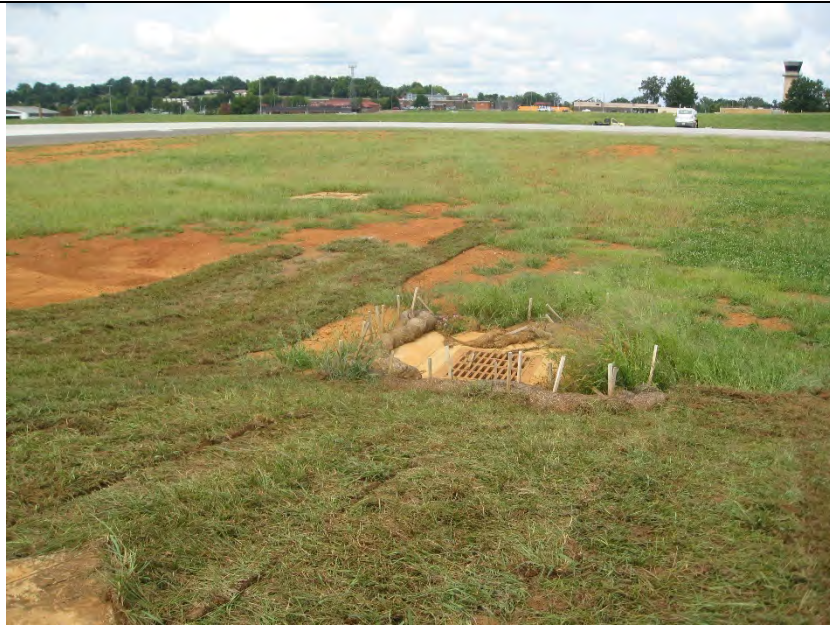
Photo 55
Sta. 347+26 RT
(RW 5L-23R)
Structure 202
Project 4

Structure 202.
Sod recently installed.
Recommend stabilizing remaining bare areas and then removing inlet protection.

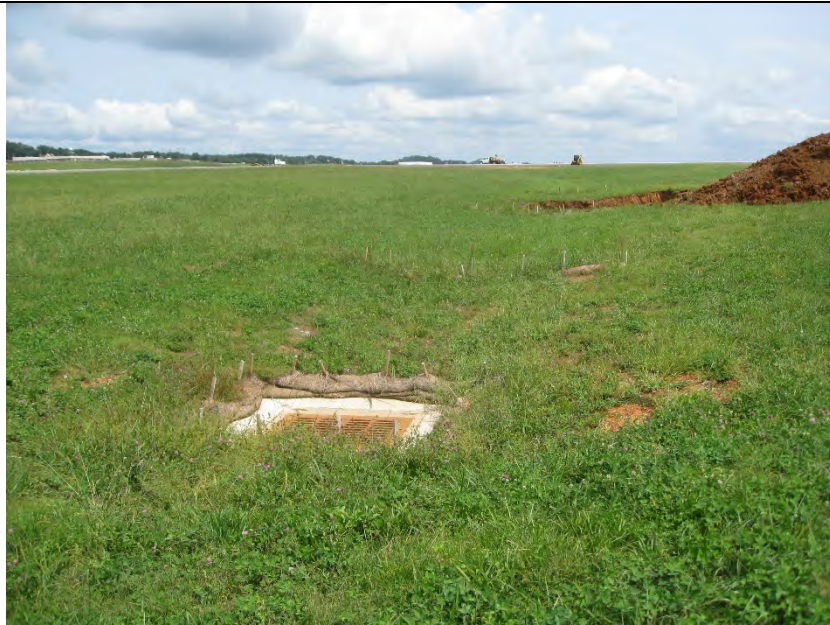
Photo 59
Sta. 338+02 RT
(RW 5L-23R)
Structure 206
Project 4

Structure 206.
Recommend removing inlet protection.
