## QUALITY ASSURANCE MONTHLY SITE ASSESSMENT REPORT

Airfield Modernization Program  
Runway 5L-23R Reconstruction  
Project 2 / Project 3  
Project 4 / Repair TWY Lighting  
Project 5 / Project 6

**QUALITY ASSURANCE  
SITE ASSESSMENT  
EPSC WEEKLY  
INSPECTION**

Airfield Modernization Program  
Runway 5L-23R Reconstruction  
Project 2 / Project 3 /  
PSXE820001-Repair Taxiway  
Lighting

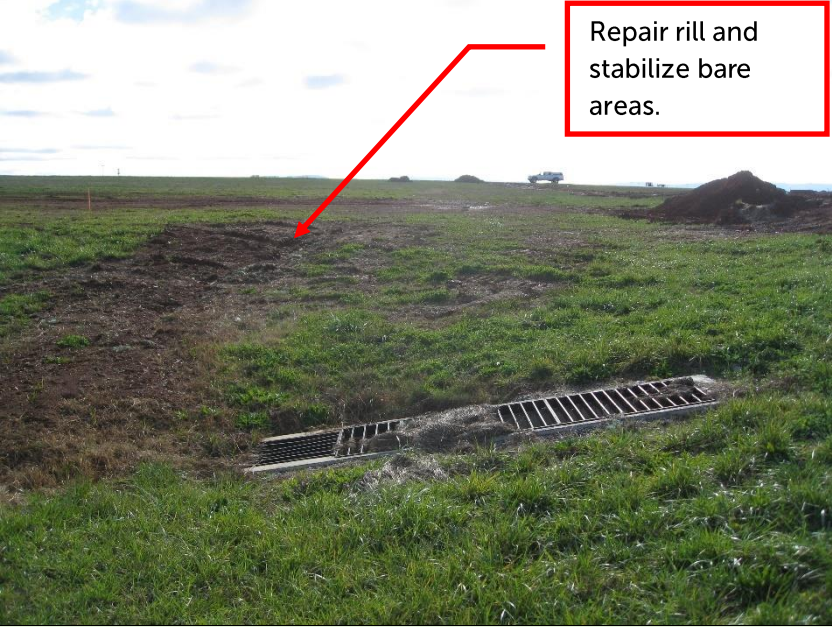
<p>Photo 15 Sta. 347+31 LT (RW 5L-23R) Structure 104 Enhanced Swale Endwall 102 Project 3</p>

<p>Entry Code: RCA/ RCA Action Code: R/TS or PS</p>	<p>Enhanced Swale Endwall 102 Recommend repairing rills (as noted on previous reports). Recommend coordinating with CHA on possible use of matting to help stabilization. Recommend stabilizing all remaining bare areas.</p>

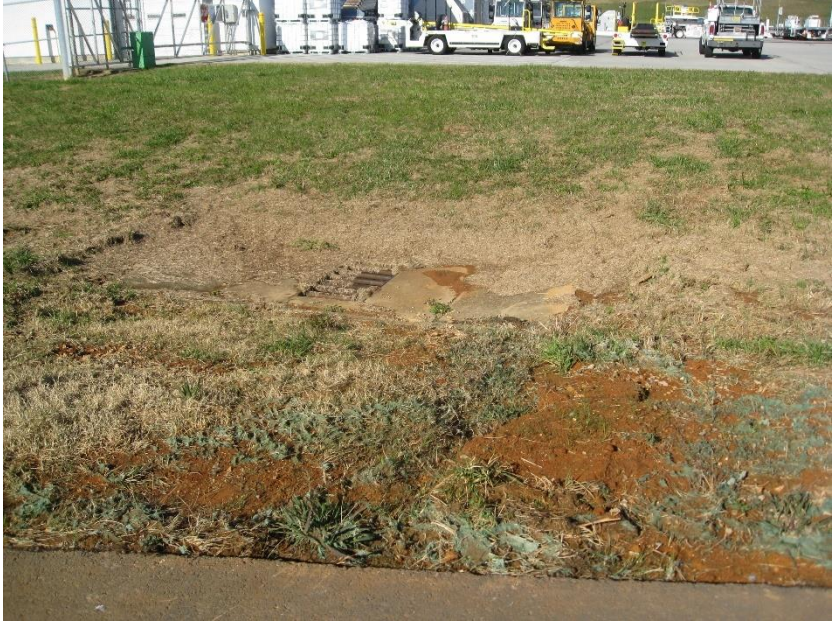
<p>Photo 23 STA 677+00 RT (RW 5L-23R) Existing Structure Project 4</p>

<p>Entry Code: RCA/RCA Action Code: R/TS or PS</p>	<p>Structure between taxiway and UPS. Recommend repairing rills (as noted on previous reports). Recommend immediately stabilizing slope to reduce the probability of future erosion issues.</p>

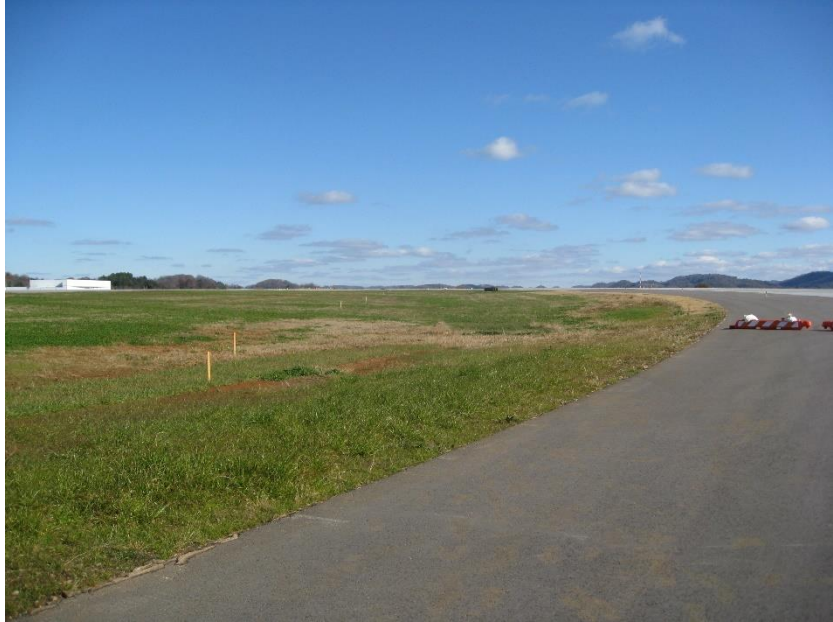
<p>Photo 24 Sta. 365+69 RT (RW 5L-23R) Structure 300 Project 4</p>

<p>Entry Code: S Action Code:</p>	<p>Structure 300 and Outfall C Portions of the site are now unavailable for inspection due to Taxiway "Y" being open to traffic.</p>

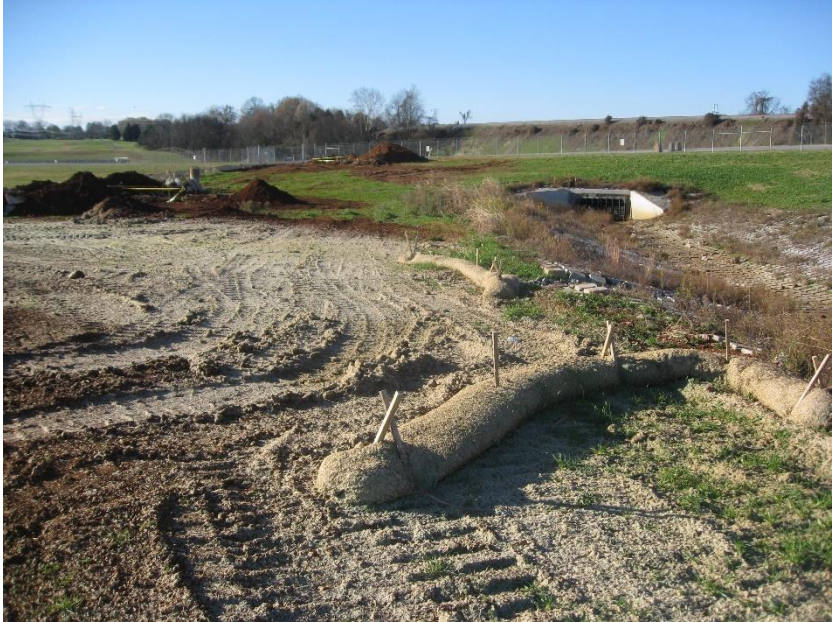
<p>Photo 64 (RW 5L-23R) Sheet EC1.1.1 Project 6</p>

<p>Entry Code: S Action Code:</p>	<p>Proposed Malsr access road. Bare areas outside of active construction zones recently stabilized.</p>

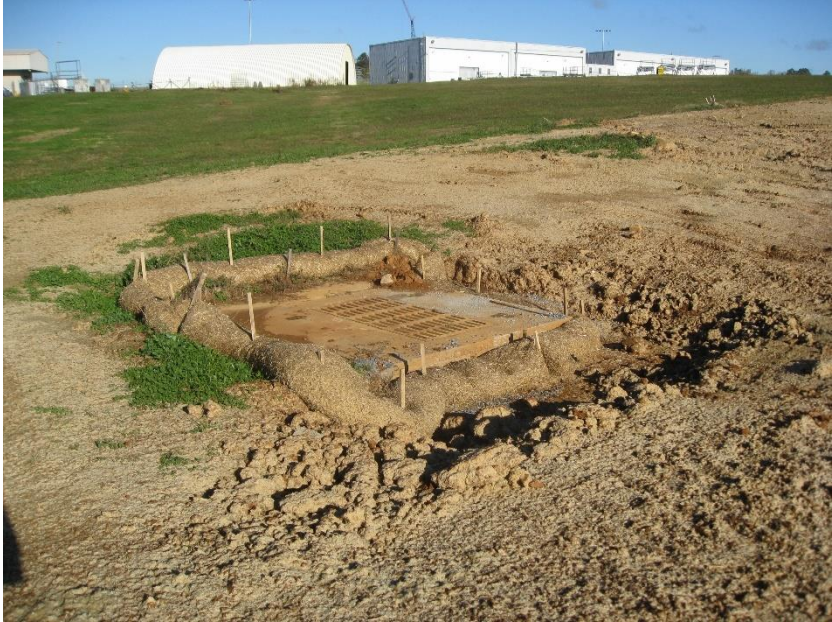
<p>Photo 66 (RW 5L-23R) Sheet EC1.1.3 Project 6</p>

<p>Entry Code: S Action Code:</p>	<p>Existing structure #120 adjacent to proposed Malsr access road. Inlet protection recently added and bare areas stabilized.</p>

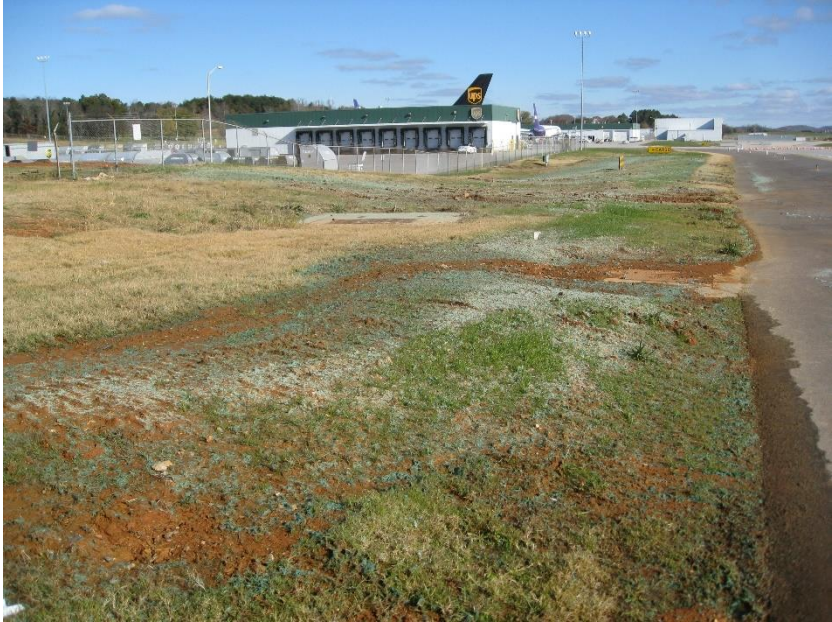
<p>Photo 76 STA 372+00 LT (RW 5L-23R) Project 6</p>

<p>Entry Code: S Action Code:</p>	<p>New structure north of Taxiway G Bare areas recently stabilized.</p>

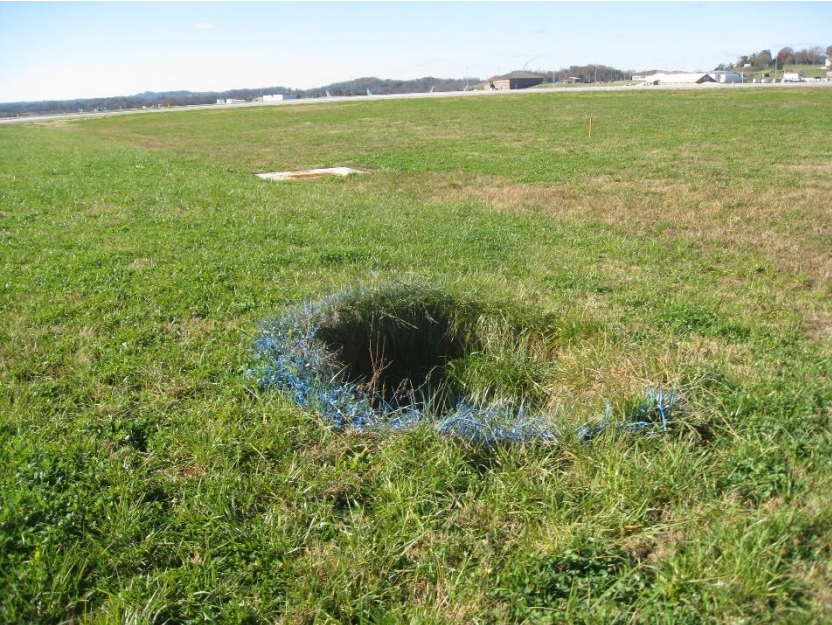
<p>Photo 80 Sta. 334+52 RT (RW 5L-23R) Structure 208 Project 3</p>

<p>Entry Code: Action Code:</p>	<p>Above structure 208. Construction fallout present. Recommend coordinating with CHA on remediation.</p>

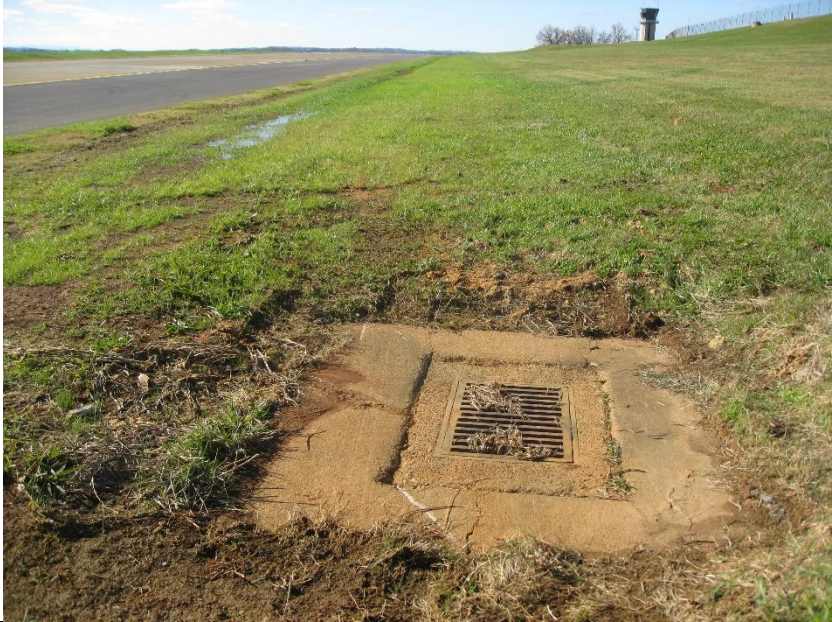
<p>Photo 97 (RW 5L-23R) Existing Structure Sheet EC2.1.9 PSXE82001 Repair Taxiway Lighting</p>

<p>Entry Code: S Action Code:</p>	<p>Existing structure north of Taxiway G</p>

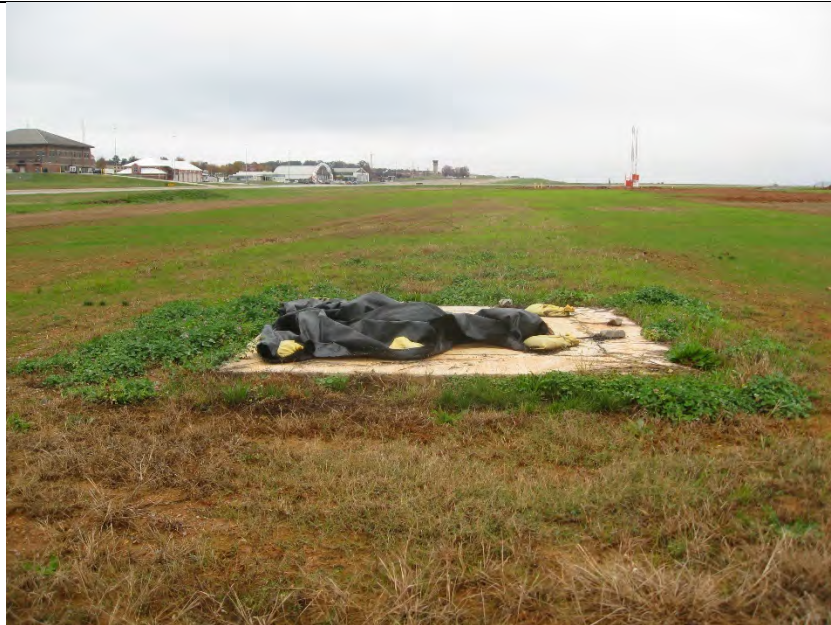
Photo 11  
Sta. 302+54 LT  
(RW 5L-23R)  
Structure 114  
Project 3

Structure 114.  
Recommend removing inlet protection.

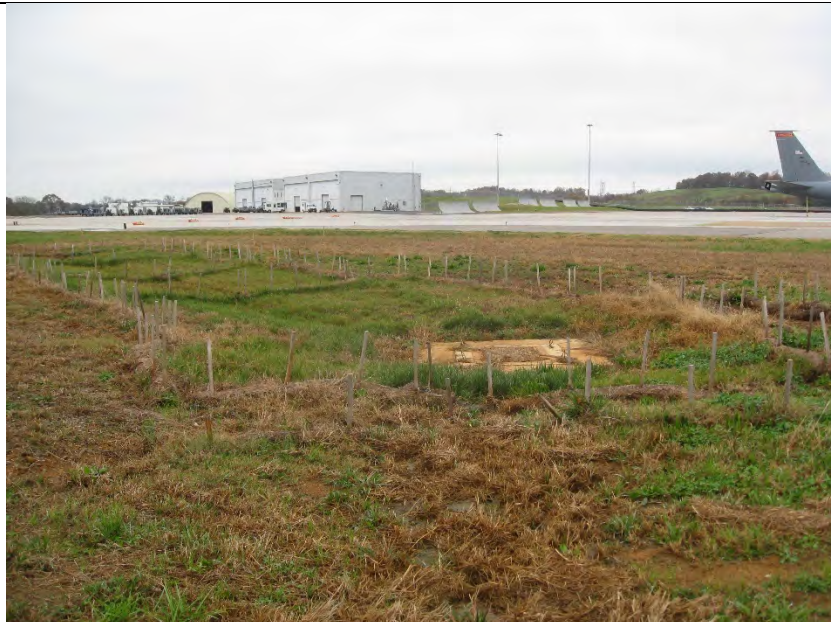
Photo 12  
Sta. 303+36 LT  
(RW 5L-23R)  
Structure 12  
Project 3

Structure 12.  
Recommend removing sediment tubes.

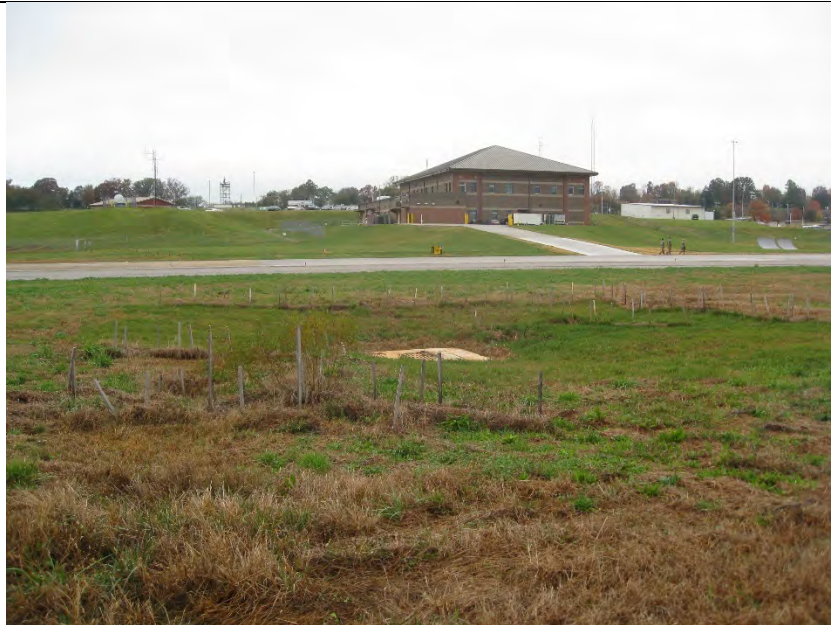
Photo 13  
Sta. 310+04 LT  
(RW 5L-23R)  
Structure 10  
Project 3

Structure 10.  
Bare areas above structure have been stabilized, recommend removing all sediment tubes.

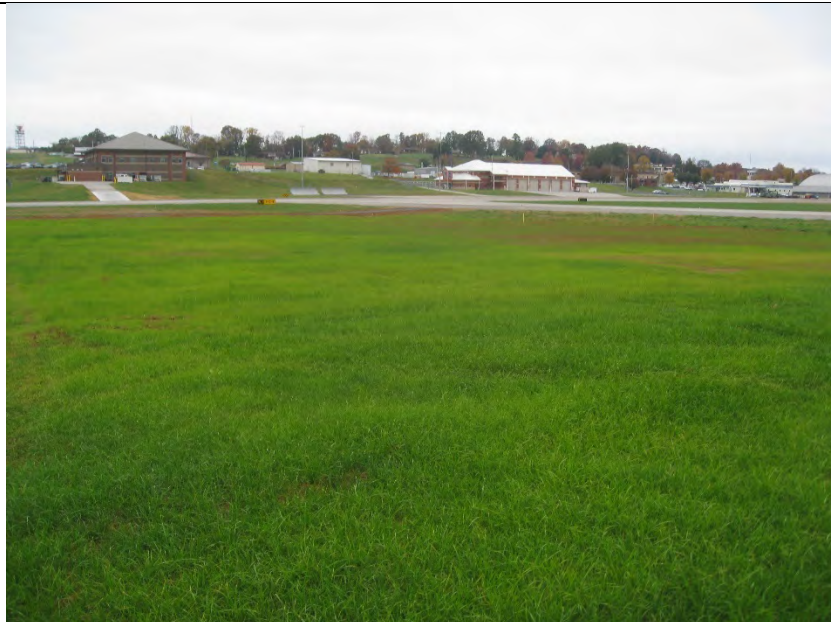
Photo 14  
Sta. 310+00 LT  
(RW 5L-23R)  
Project 3

Site of recently demolished concrete batch plant.  
Grass established.

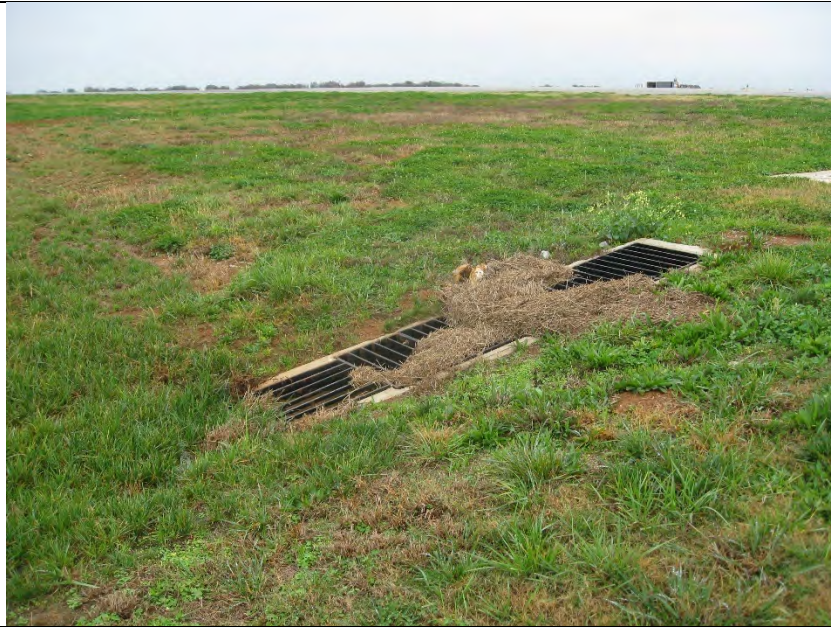
Photo 15  
Sta. 314+48 LT  
(RW 5L-23R)  
ES Endwall 108  
Project 3

Enhanced Swale Endwall 108.  
Recommend repairing rills (as noted on previous reports) and immediately stabilizing bare areas.

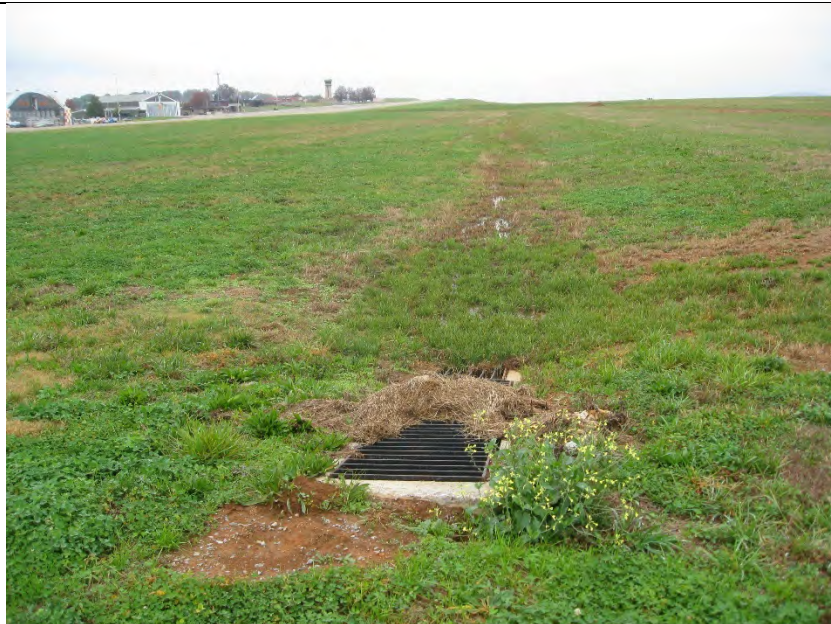
Photo 16  
Sta. 314+48 LT  
(RW 5L-23R)  
ES Endwall 108  
Project 3

Enhanced Swale Endwall 108.  
Recommend repairing rills (as noted on previous reports) and immediately stabilizing bare areas.

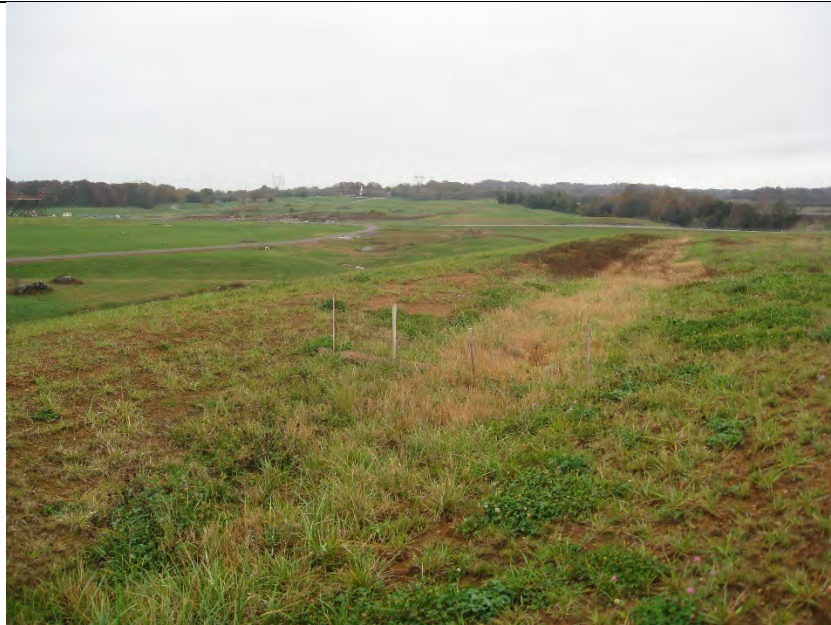
Photo 55  
Sta. 290+26 RT  
(RW 5L-23R)  
Structure 600 Ditch  
Project 2

Structure 600 Ditch.  
Recommend removing sediment tubes from entire 600 ditch and stabilizing bare areas.

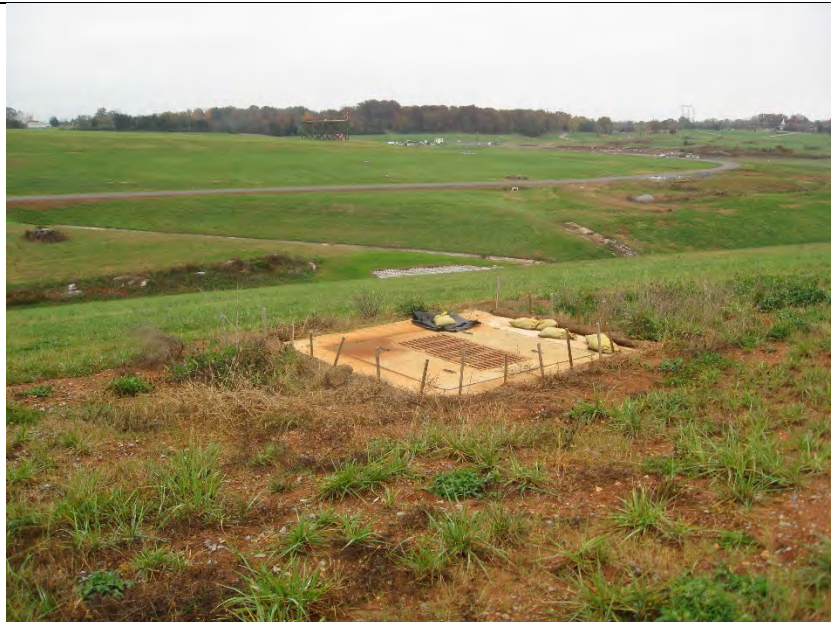
Photo 56  
Sta. 290+26 RT  
(RW 5L-23R)  
Structure 222  
Project 2

Structure 222.  
Recommend removing inlet protection.  
Recommend stabilizing bare areas.

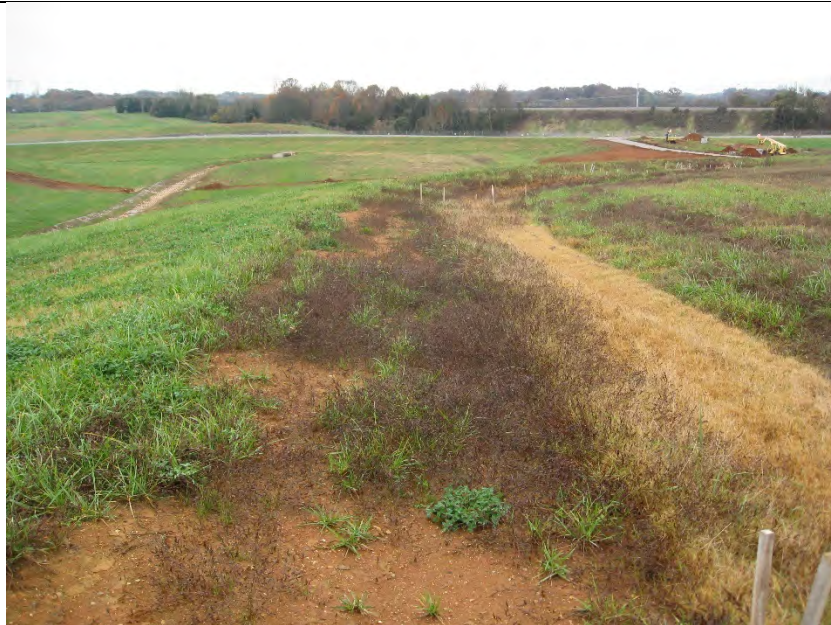
Photo 57  
Sta. 290+26 RT  
(RW 5L-23R)  
Structure 600 Ditch  
Project 2

Structure 600 ditch.  
Recommend removing sediment tubes from entire 600 ditch and stabilizing bare areas.

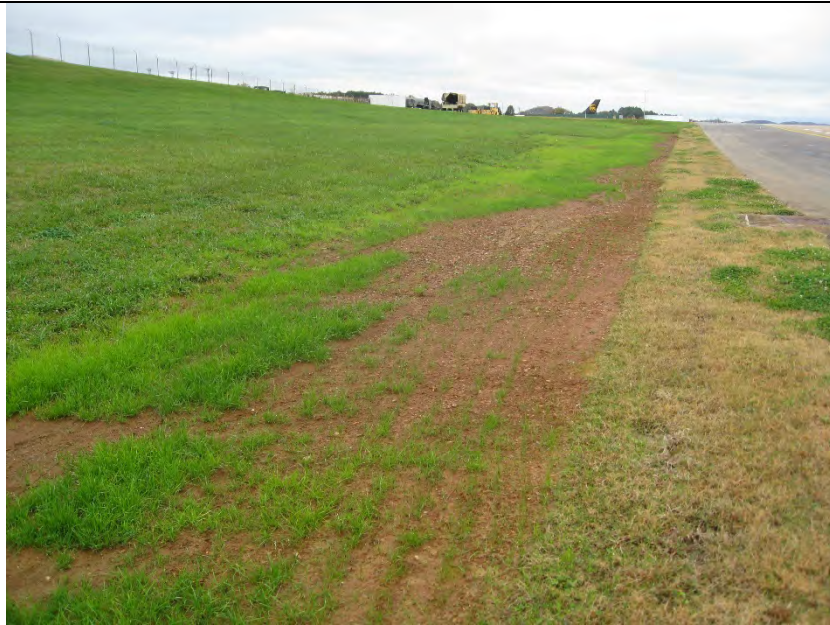
Photo 87  
(Repair TWY Lighting)

Shoulder of Taxiway G (Looking back towards cargo apron)  
Bare areas recently stabilized.  
Recent storm events have moved the seed downstream.  
Recommend restabilizing resulting bare areas.

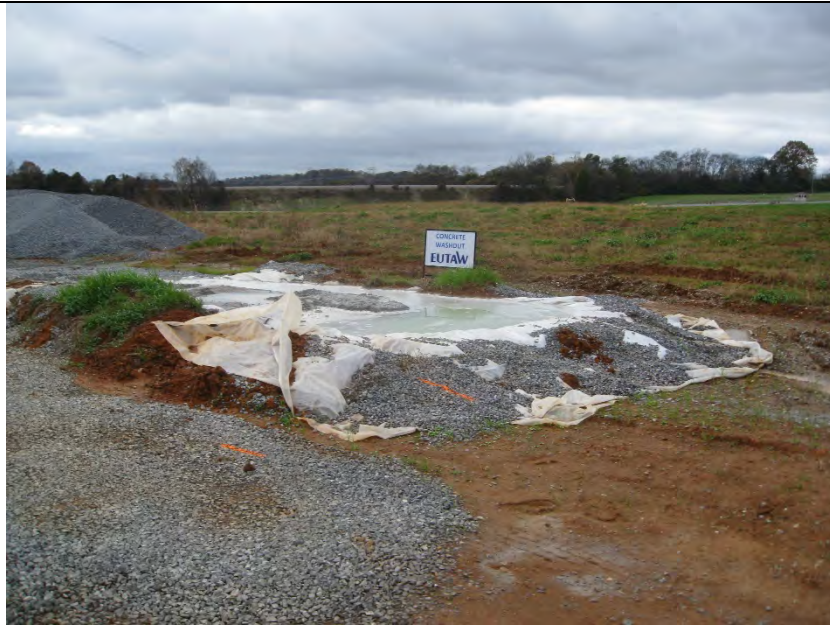
Photo 91  
(Project 5/6)

Area adjacent to haul road.  
Signage recently added. Concrete washout facility is at capacity.  
Recommend dewatering washout with approved methods or adding second facility.

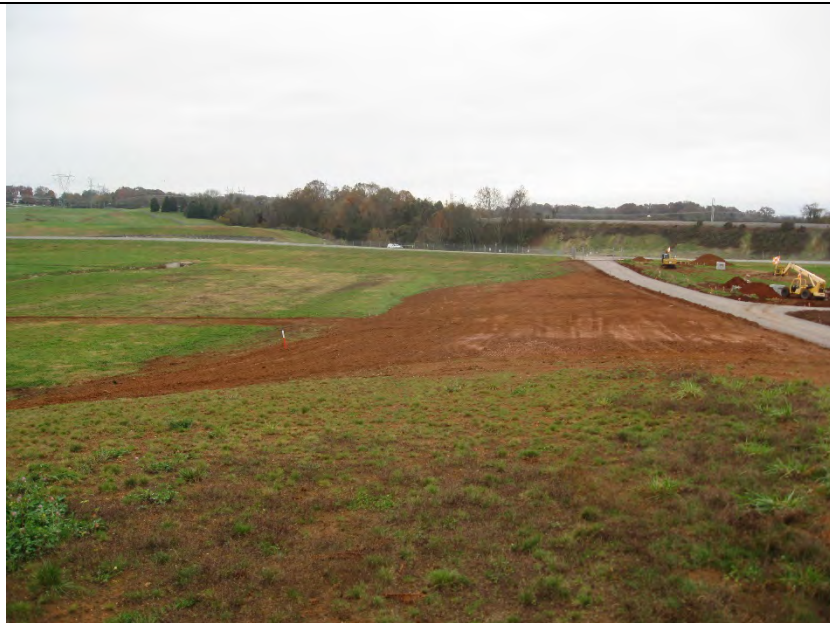
Photo 92  
(Project 5/6)

Proposed MALSR access road.  
Rills appear to have been recently remediated and slopes regraded.  
Recommend stabilizing side slopes outside of active roadway construction area.

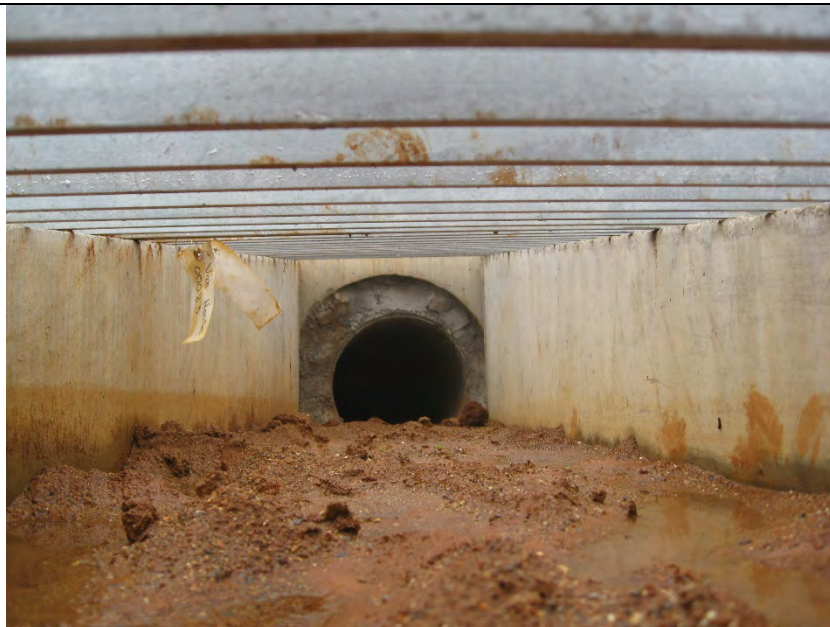
Photo 95  
(Project 5/6)

Proposed MALSR access road.  
Sediment remains on endwall.  
Recommend removing sediment.

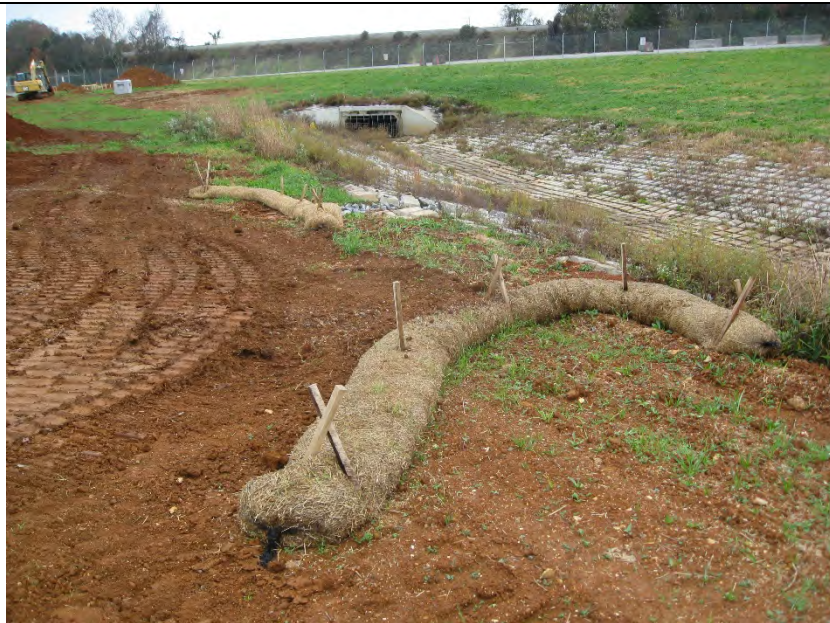
Photo 96  
(Project 5/6)

Proposed MALSR access road.  
Area recently regraded.  
Sediment tubes recently added.  
Recommend stabilizing any bare areas that are to grade and outside of active construction areas.

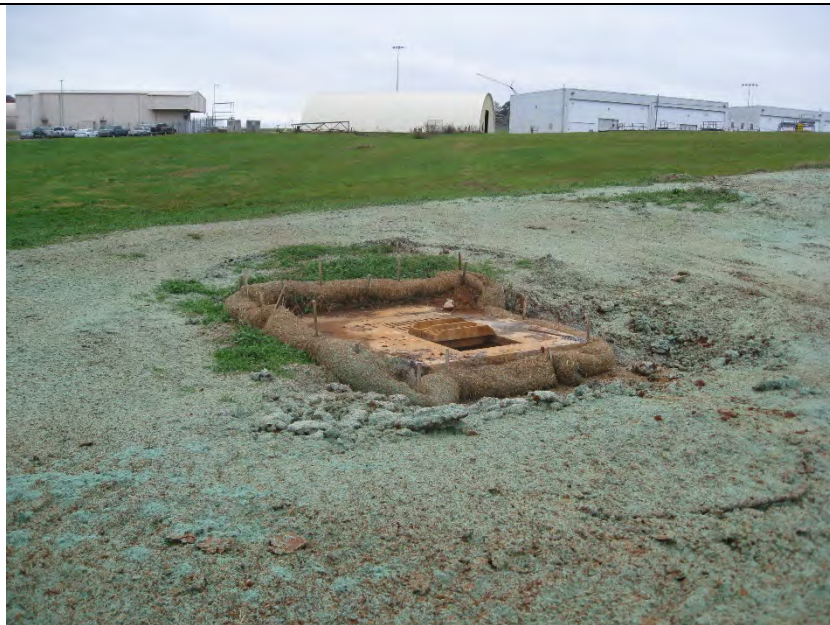
Photo 97  
(Project 5/6)

Existing structure #120 adjacent to proposed MALSR access road.  
Inlet protection recently added and bare areas stabilized.

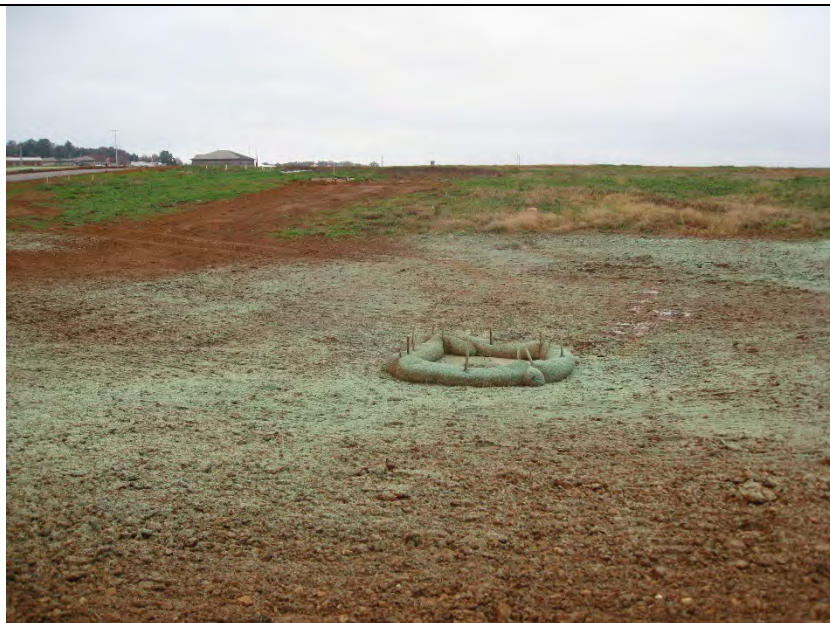
Photo 98  
(Project 5/6)

Above existing structure #120.  
Inlet protection recently added and some bare areas stabilized.  
Recommend stabilizing remaining bare areas.

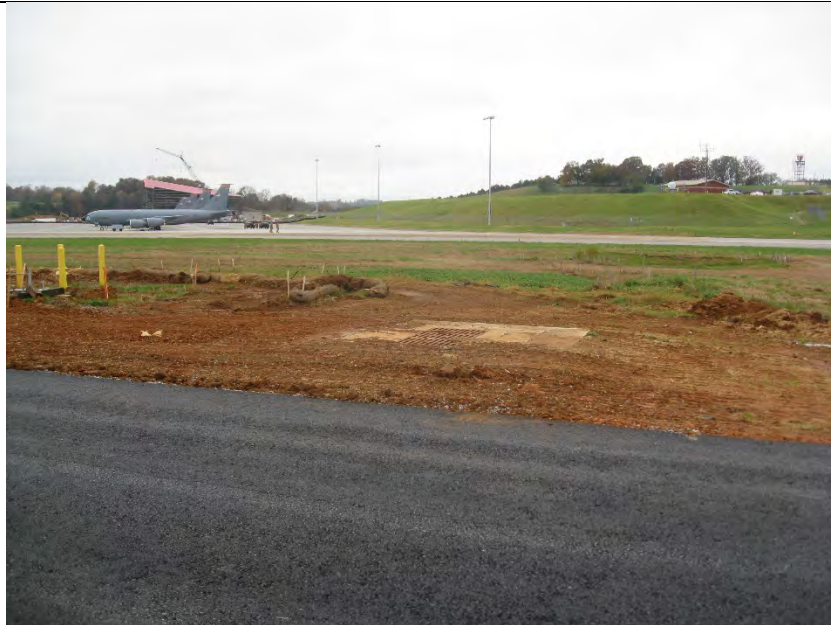
Photo 103  
(Project 5/6)

5L PAPI  
Access road completed and backfilled.  
Recommend stabilizing bare areas.  
Recommend removing sediment from top of structure and installing inlet protection per the plans.

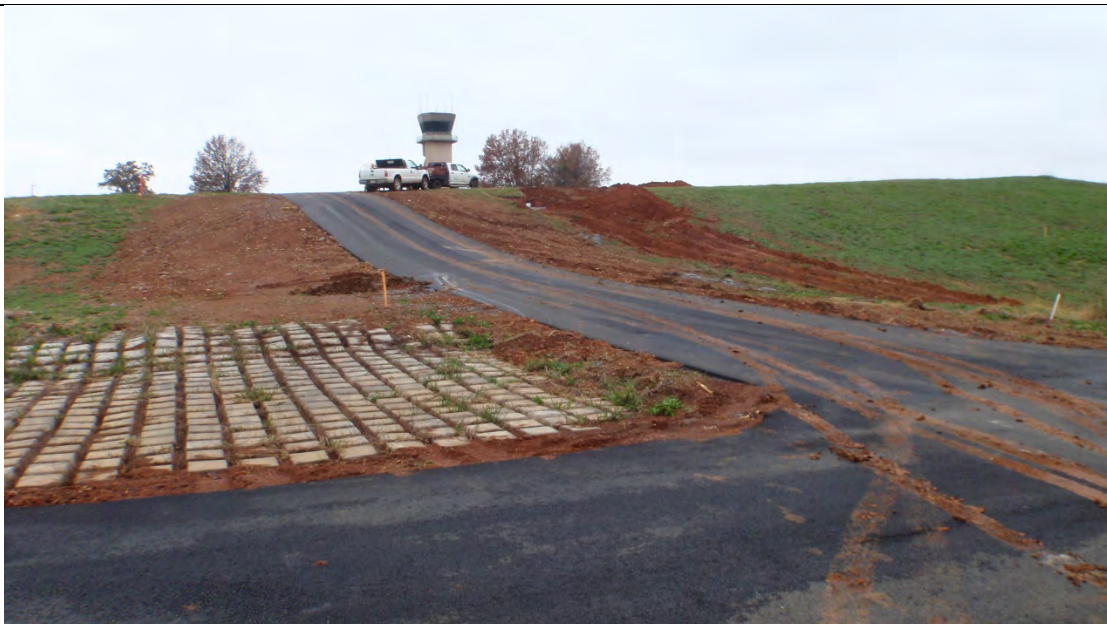
Photo 104  
(Project 5/6)

23R Midpoint RVR  
Side slopes appear to be at grade.  
Recommend adding sediment tubes per the plans.  
Recommend stabilizing bare areas.

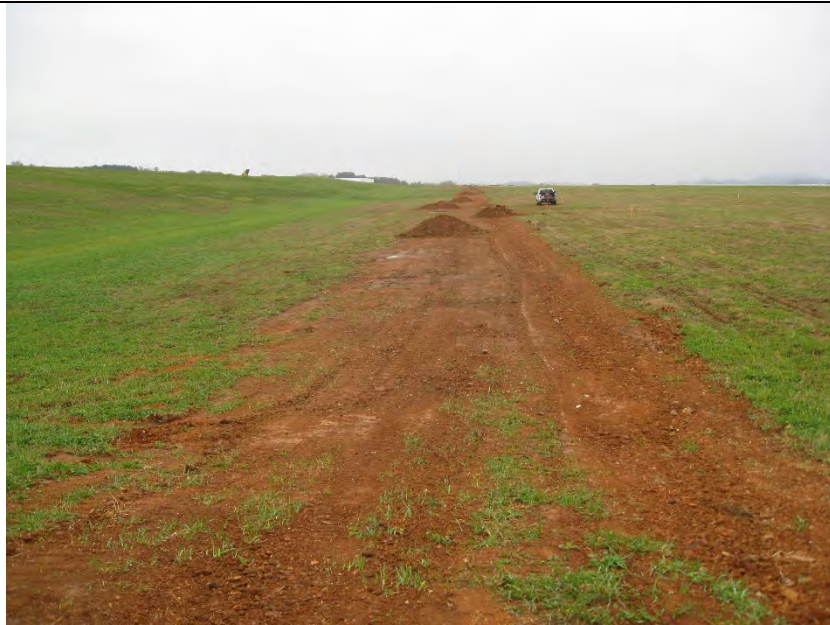
Photo 105  
(Project 5/6)

23R Midpoint RVR  
Recommend stabilizing or removing any remaining spoil piles.  
Recommend stabilizing bare areas.

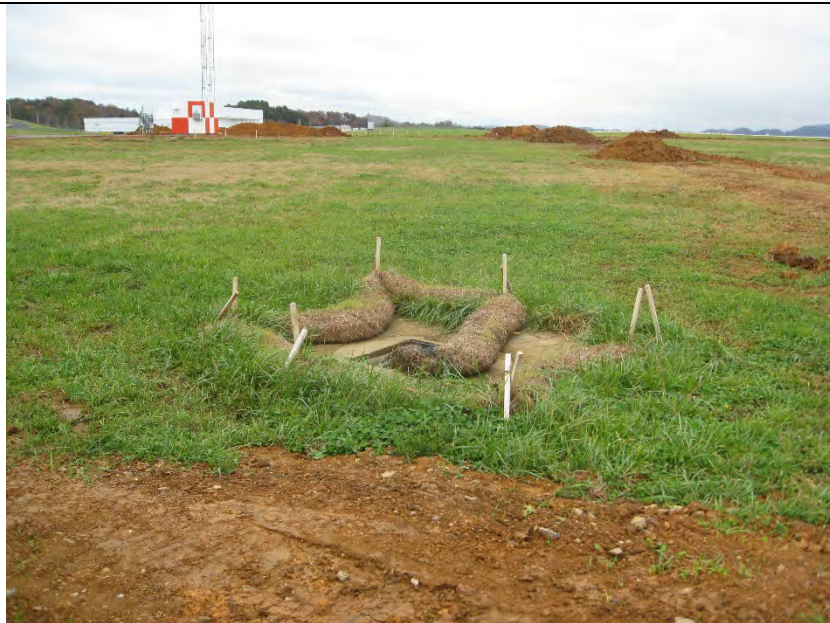
Photo 106  
(Project 5/6)

23R Glide Slope and Touchdown RVR  
Recommend repairing/replacing damaged sediment tubes.

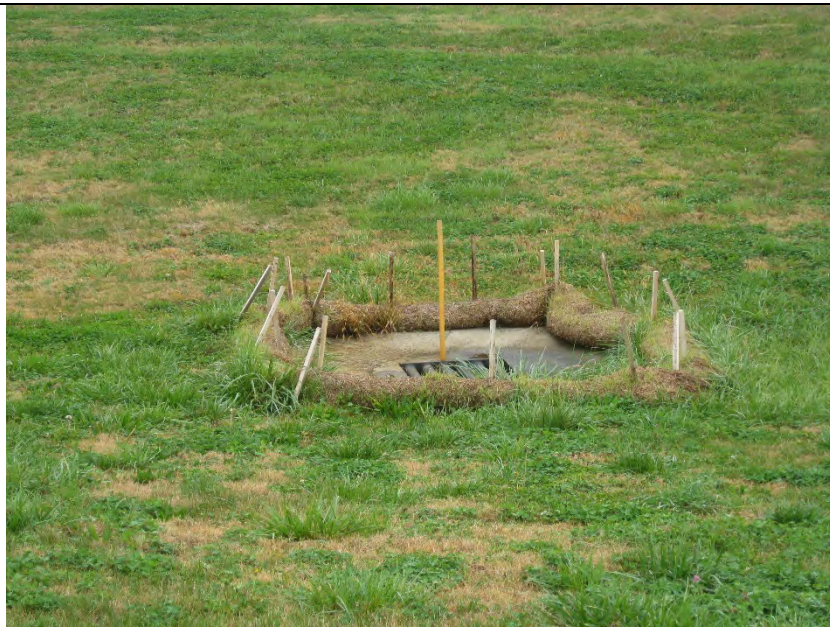
Photo 107  
(Project 5/6)

Inlet protection in place near TWY A.

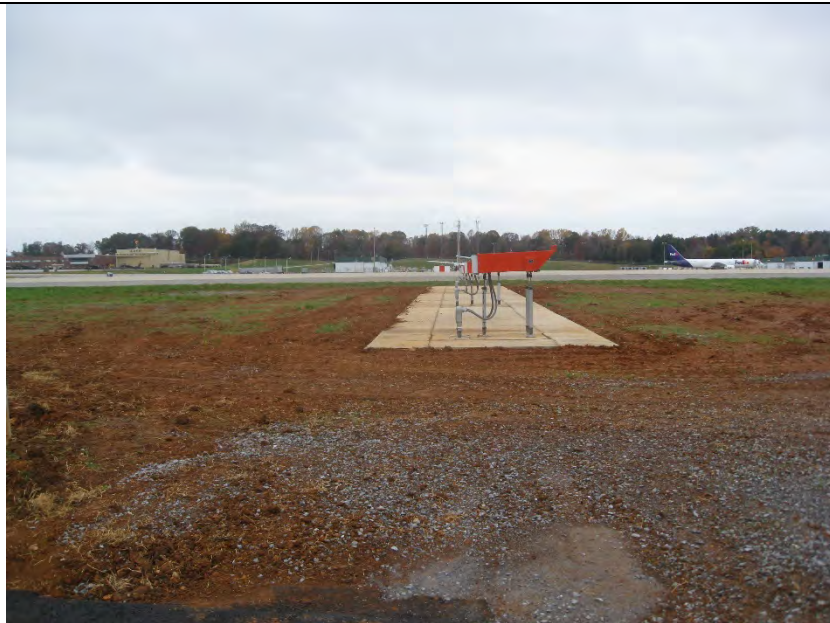
Photo 108  
(Project 5/6)

23R PAPI  
Area recently backfilled.  
Recommend stabilizing bare areas.

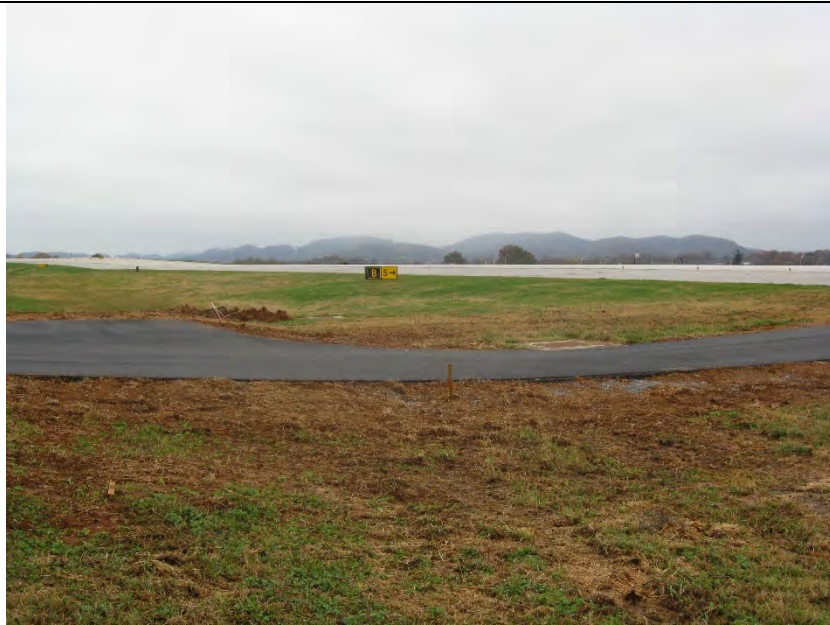
Photo 109  
(Project 5/6)

23R PAPI access road.  
Access road installed and shoulders recently backfilled.  
Recommend stabilizing bare areas.

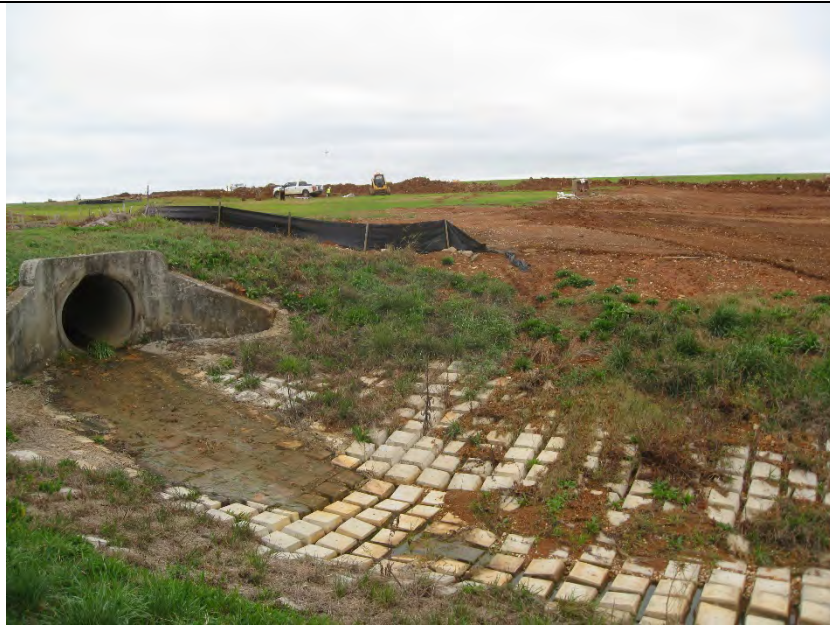
Photo 113  
(Project 5/6)

Airfield Lighting Vault  
Rills have formed on side slope.  
Recommend repairing rills.  
See previous photo.
