## QUALITY ASSURANCE MONTHLY SITE ASSESSMENT REPORT

Airfield Modernization Program  
Runway 5L-23R Reconstruction  
Project 2 / Project 3  
Project 4 / Repair TWY Lighting  
Project 5 / Project 6

**QUALITY ASSURANCE  
SITE ASSESSMENT  
EPSC WEEKLY  
INSPECTION**

## **AIRFIELD MODERNIZATION PROGRAM RUNWAY 5L-23R RECONSTRUCTION**

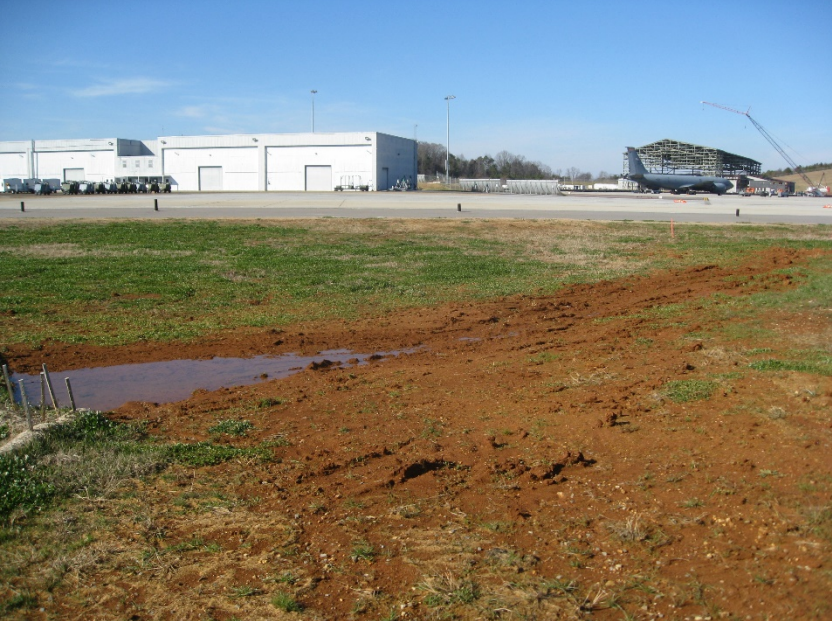
| <p>Photo 5<br/>Sta. 298+71 LT<br/>(RW 5L-23R)<br/>Structure 116<br/>Between Taxiway<br/>"G1" and "G2"<br/>Project 3</p> | |

| <p>Entry Code:<br/>CA<br/>Action Code: TS or<br/>PS</p> | <p>Above structure 116.<br/>Recommend stabilizing bare areas.</p> |

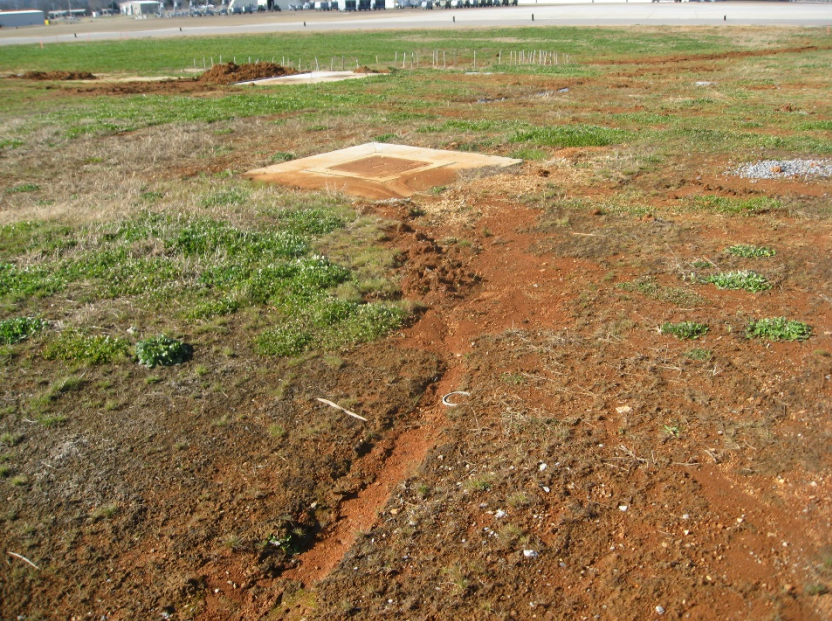
| <p>Photo 7<br/>Sta. 298+71 LT<br/>(RW 5L-23R)<br/>Structure 116<br/>Between Taxiway<br/>"G1" and "G2"<br/>Project 3</p> | |

| <p>Entry Code:<br/>CA, CA<br/>Action Code: R, TS or<br/>PS</p> | <p>Above structure 116.<br/>Recommend repairing rills and immediately stabilizing bare areas to reduce the probability of future erosion issues.</p> |

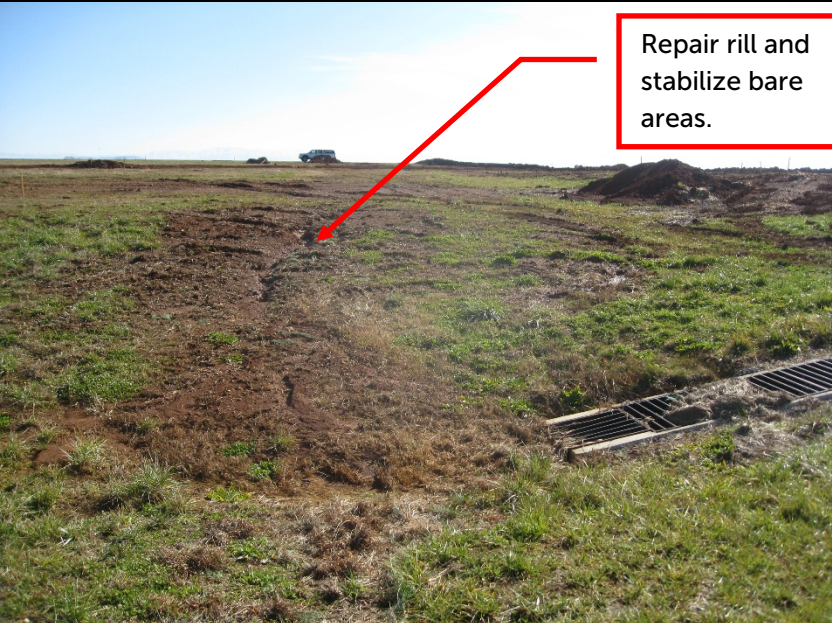
| <p>Photo 14<br/>Sta. 347+31 LT<br/>(RW 5L-23R)<br/>Structure 104<br/>Enhanced Swale<br/>Endwall 102<br/>Project 3</p> | |

| <p>Entry Code: CA/ CA<br/>Action Code: R/TS or<br/>PS</p> | <p>Enhanced Swale Endwall 102<br/>Recommend repairing rills.<br/>Recommend stabilizing all remaining bare areas.<br/>See next photo.</p> |

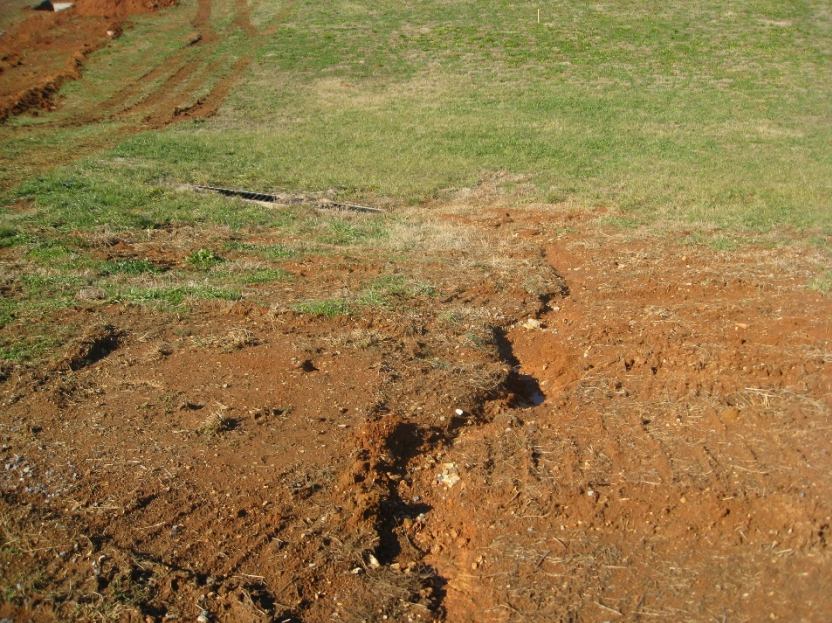
| <p>Photo 15<br/> Sta. 347+31 LT<br/> (RW 5L-23R)<br/> Structure 104<br/> Enhanced Swale<br/> Endwall 102<br/> Project 3</p> | |

| <p>Entry Code:<br/> Action Code:</p> | <p>Enhanced Swale Endwall 102<br/> Rills have formed.<br/> See previous photo for recommendations.</p> |

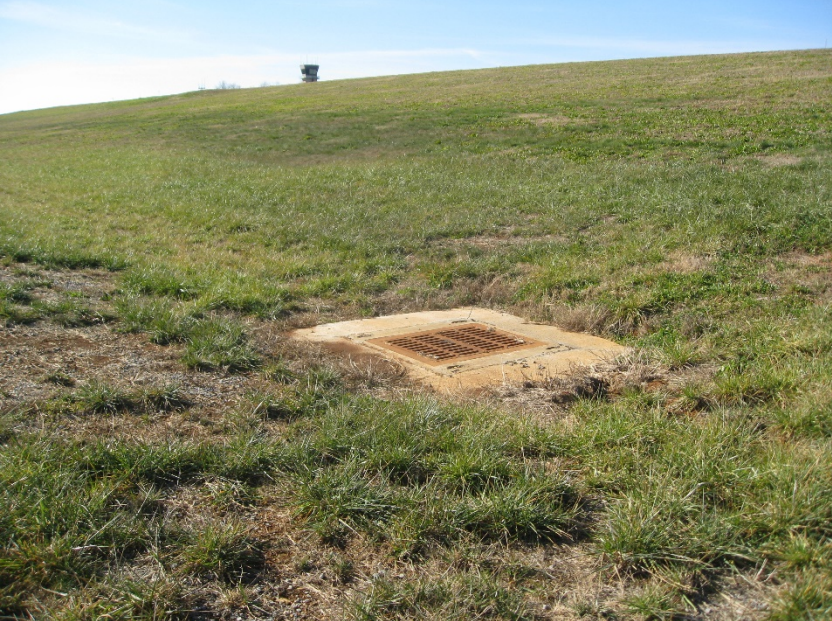
| <p>Photo 17<br/>Sta. 361+39 LT<br/>(RW 5L-23R)<br/>Structure 100<br/>Project 3</p> | |

| <p>Entry Code: S<br/>Action Code:</p> | <p>Structure 100.</p> |

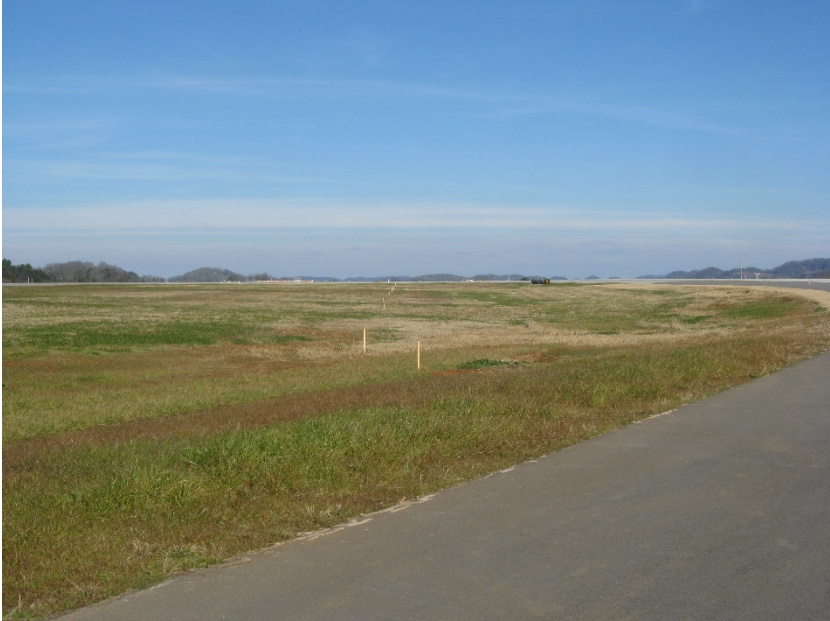
| <p>Photo 23<br/> Sta. 365+69 RT<br/> (RW 5L-23R)<br/> Structure 300<br/> Project 4</p> | |

| <p>Entry Code: S<br/> Action Code:</p> | <p>Structure 300 and Outfall C<br/> Portions of the site are now unavailable for inspection due to Taxiway "Y" being open to traffic.</p> |

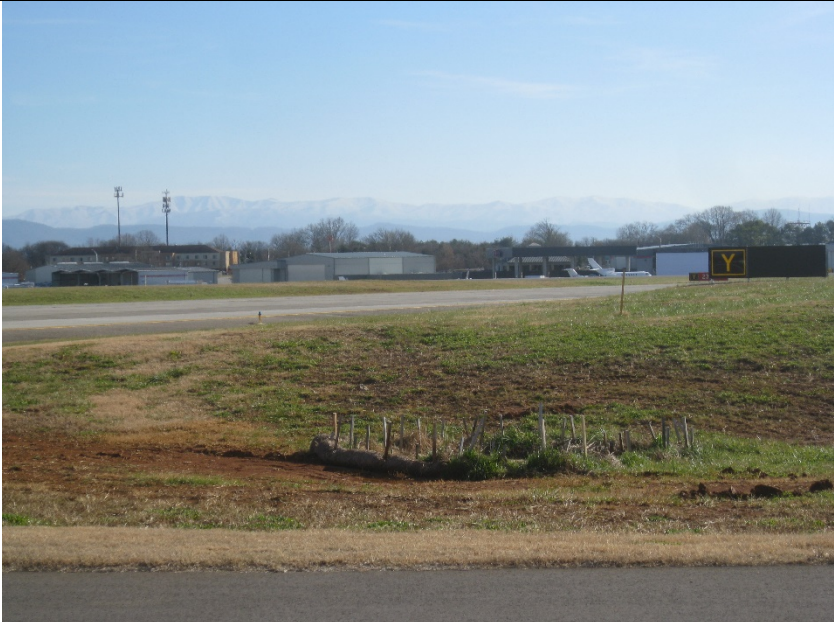
| <p>Photo 24<br/> Sta. 362+02 RT<br/> (RW 5L-23R)<br/> Structure 400<br/> Project 4</p> | |

| <p>Entry Code: CA<br/> Action Code: TS or<br/> PS</p> | <p>Structure 400.<br/> Recommend stabilizing bare areas.</p> |

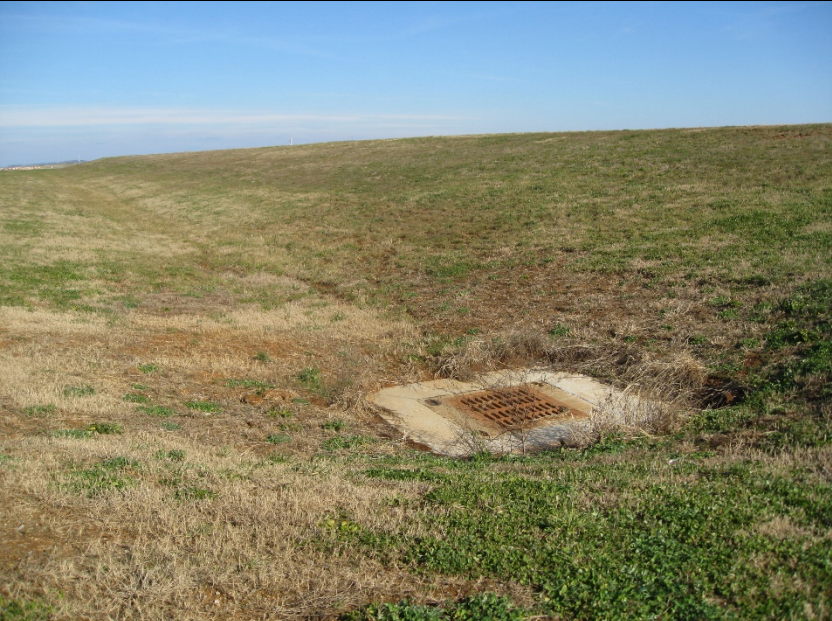
| <p>Photo 26<br/>Sta. 353+56 RT<br/>(RW 5L-23R)<br/>Structure 20<br/>Project 4</p> | |

| <p>Entry Code: S<br/>Action Code:</p> | <p>Structure 20.</p> |

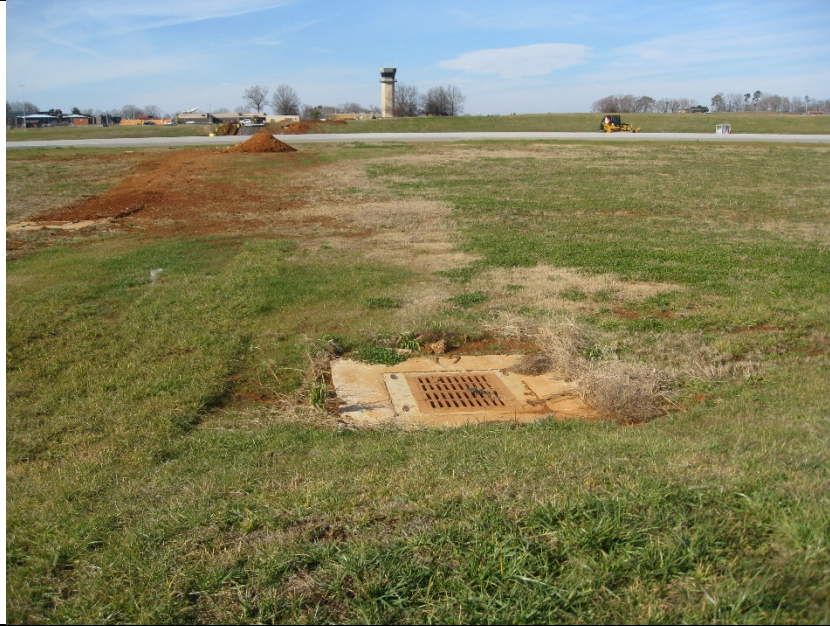
Photo 27  
Sta. 347+26 RT  
(RW 5L-23R)  
Structure 202  
Project 4

Structure 202.

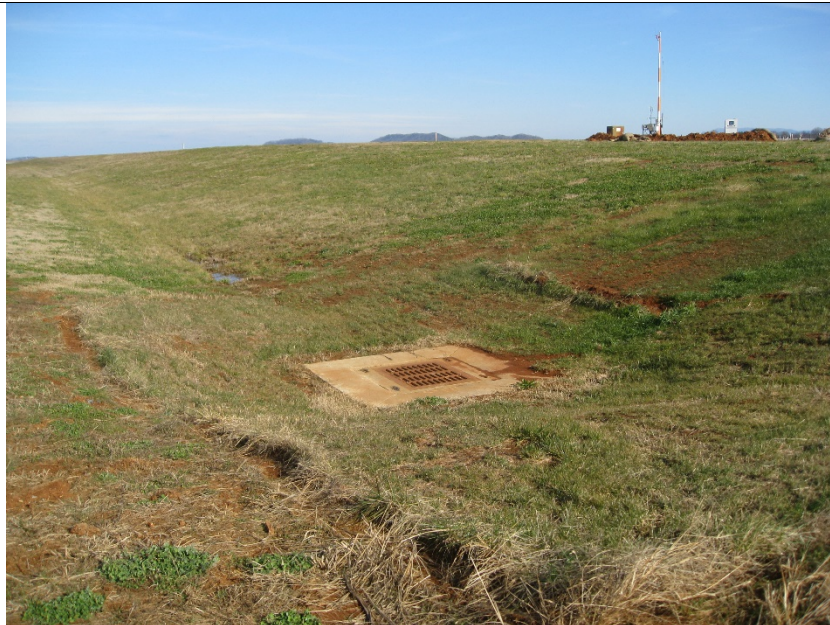
Photo 28  
Sta. 347+26 RT  
(RW 5L-23R)  
Structure 22  
Project 4

Structure 22

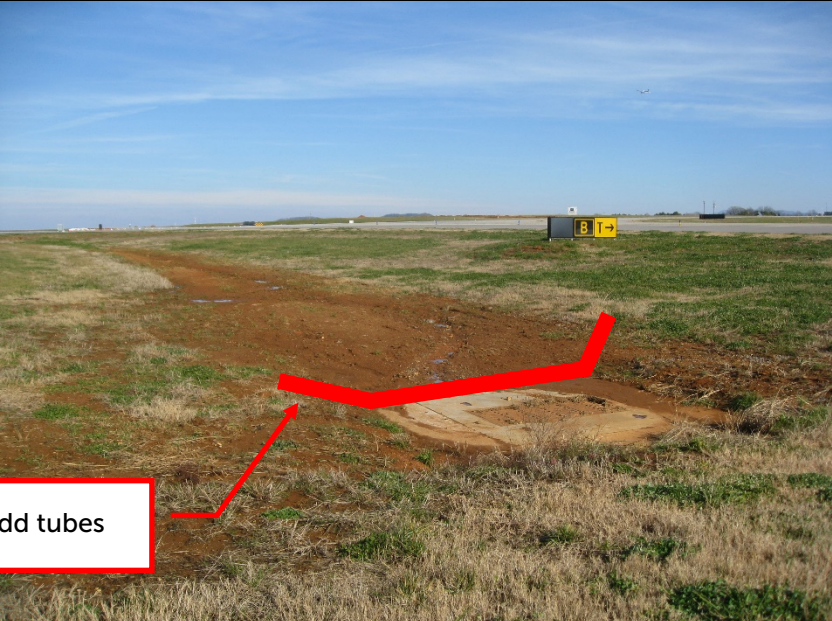
| <p>Photo 32<br/>Sta. 321+73 RT<br/>(RW 5L-23R)<br/>Structure 212<br/>Adjacent to<br/>Taxiway "B"<br/>Project 3</p> | |

| <p>Entry Code: CA, CA<br/>Action Code: I, TS or<br/>PS</p> | <p>Structure 212.<br/>Recommend adding sediment tubes.<br/>Recommend stabilizing bare areas.</p> |

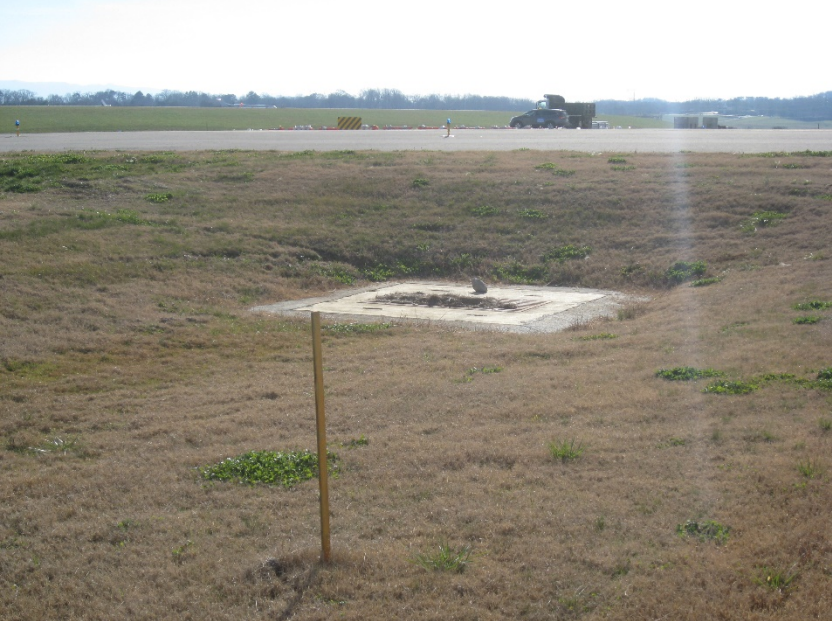
| <p>Photo 33<br/> Sta. 314+32 RT<br/> (RW 5L-23R)<br/> Structure 214<br/> Adjacent to<br/> Taxiway "B"<br/> Project 3</p> | |

| <p>Entry Code: S<br/> Action Code:</p> | <p>Structure 214.</p> |

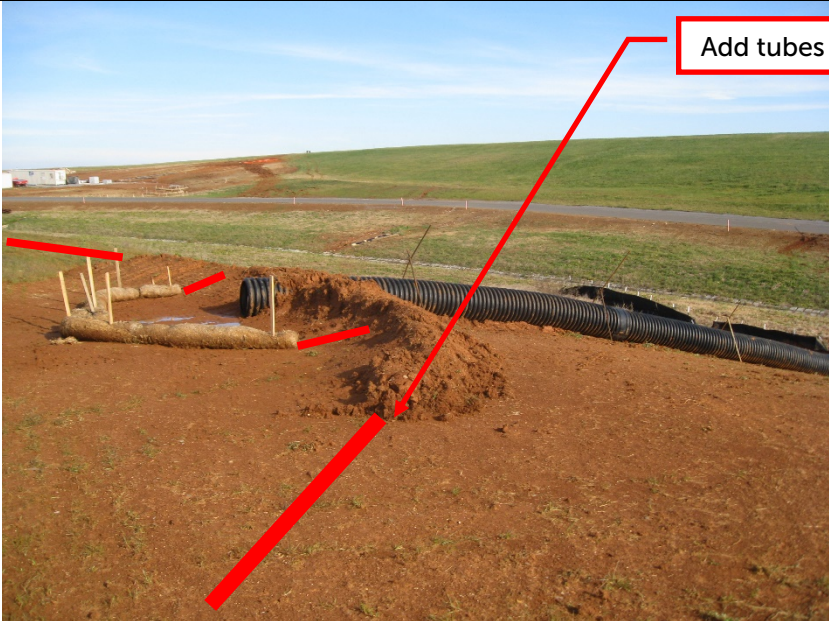
| <p>Photo 38<br/>North Lateral Fill Area<br/>Project 3</p> | |

| <p>Entry Code: CA/CA<br/>Action Code: I/TS or<br/>PS</p> | <p>North Lateral Fill Area.<br/>Slope drain recently installed.<br/>Recommend additional sediment tubes to protect inlet and capture more run-off.<br/>Recommend stabilizing bare areas.</p> |

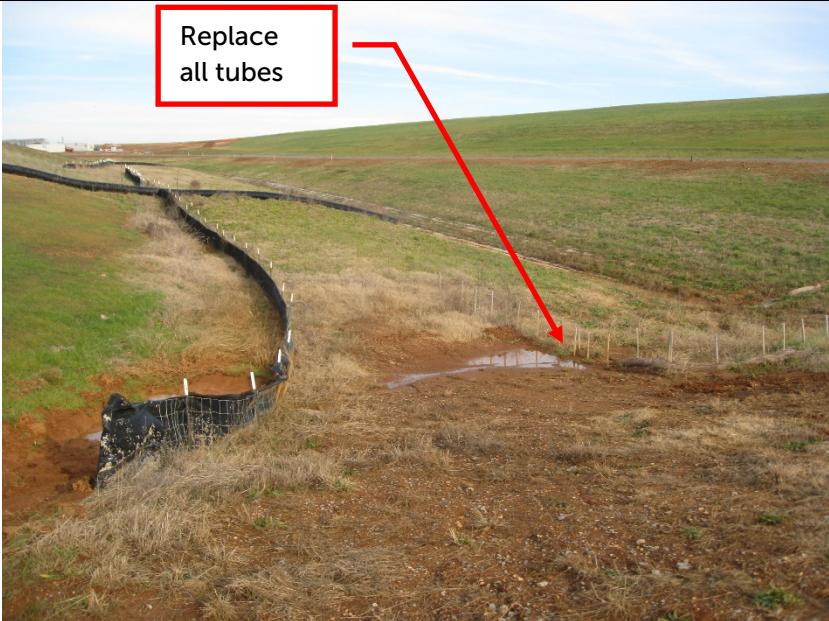
| <p>Photo 40<br/>Sta. 302+54 RT<br/>(RW 5L-23R)<br/>North Lateral Ditch<br/>Endwall 100<br/>Project 2</p> | |

| <p>Entry Code: CA, CA<br/>Action Code: I, TS or<br/>PS</p> | <p>North Lateral Endwall 100.<br/>Recommend replacing sediment tubes and stabilizing bare areas.</p> |

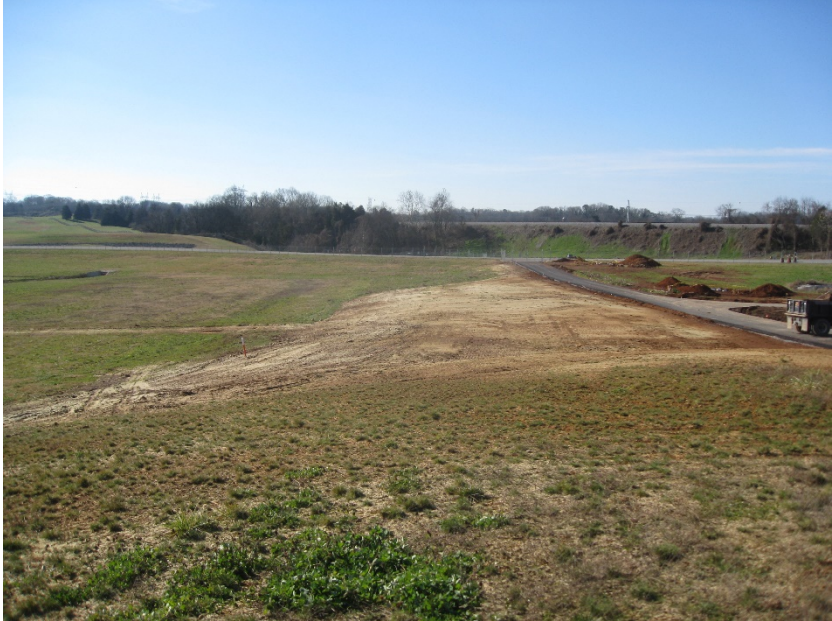
| <p>Photo 51<br/>(RW 5L-23R)<br/>Sheet EC1.1.1<br/>Project 6</p> | |

| <p>Entry Code: S<br/>Action Code:</p> | <p>Proposed Malsr access road</p> |

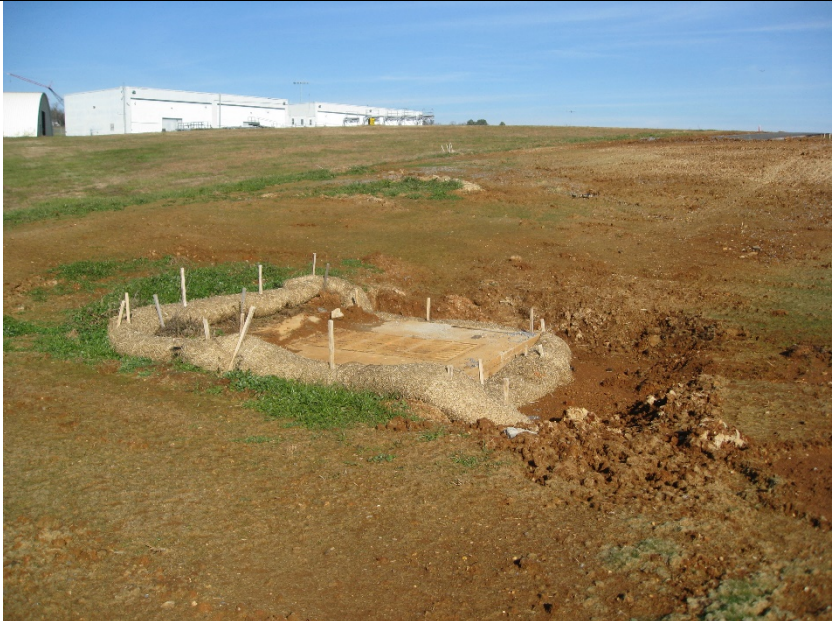
| <p>Photo 56<br/>(RW 5L-23R)<br/>Sheet EC1.1.3<br/>Project 6</p> | |

| <p>Entry Code: S<br/>Action Code:</p> | <p>Existing structure #120 adjacent to proposed Malsr access road.</p> |

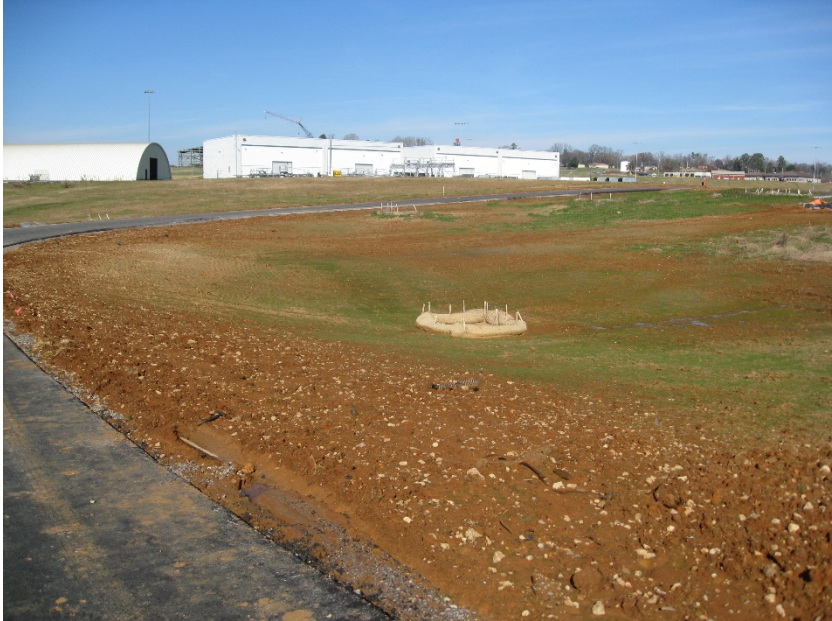
| <p>Photo 57<br/>(RW 5L-23R)<br/>Sheet EC1.1.3<br/>Project 6</p> | |

| <p>Entry Code: S<br/>Action Code:</p> | <p>Above existing structure #120.<br/>Edge of pavement recently saw cut in preparation for backfill operations.</p> |

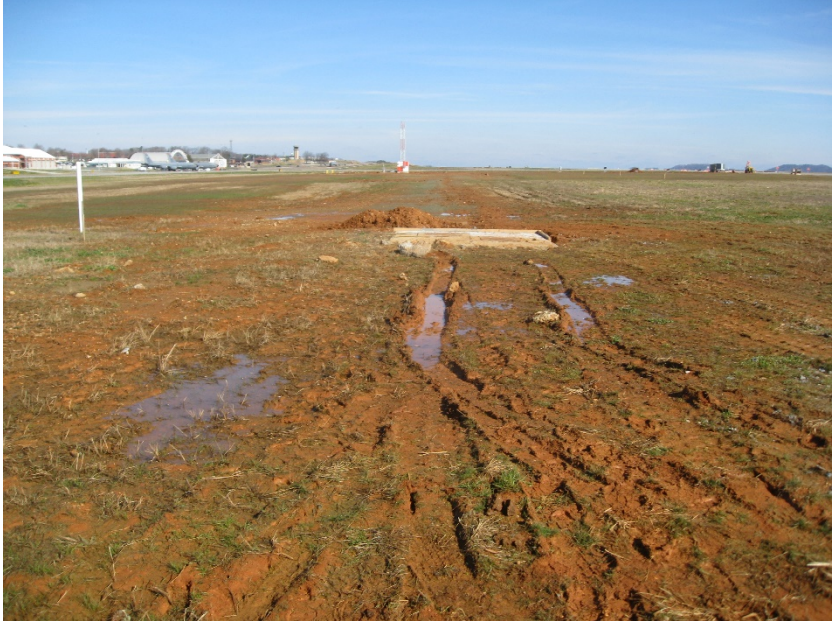
| <p>Photo 59<br/>Project 6</p> | |

| <p>Entry Code: S<br/>Action Code:</p> | <p>Bare areas recently stabilized.</p> |

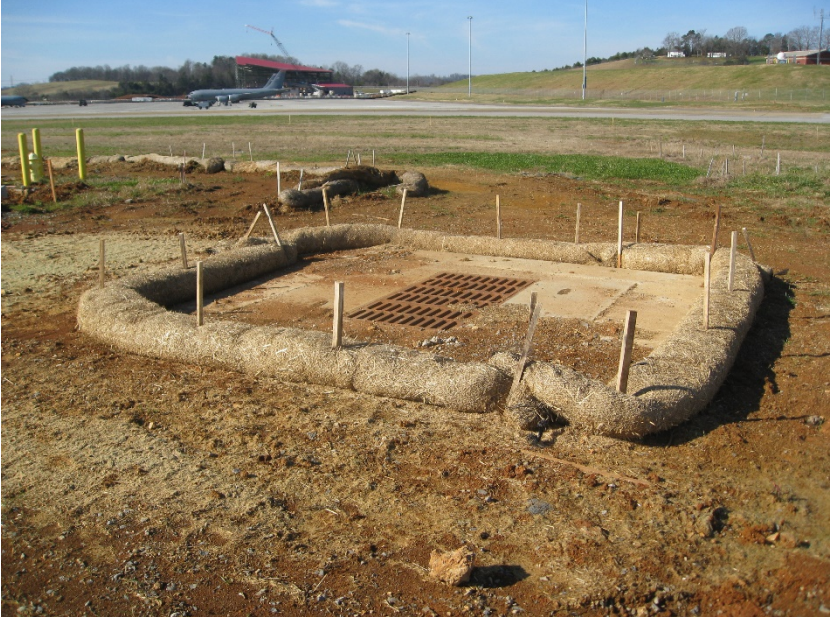
| <p>Photo 61<br/>Project 6</p> | |

| <p>Entry Code: FM<br/>Action Code: TS or PS</p> | <p>5L PAPI<br/>Inlet protection recently installed.<br/>Recommend stabilizing remaining bare areas.</p> |

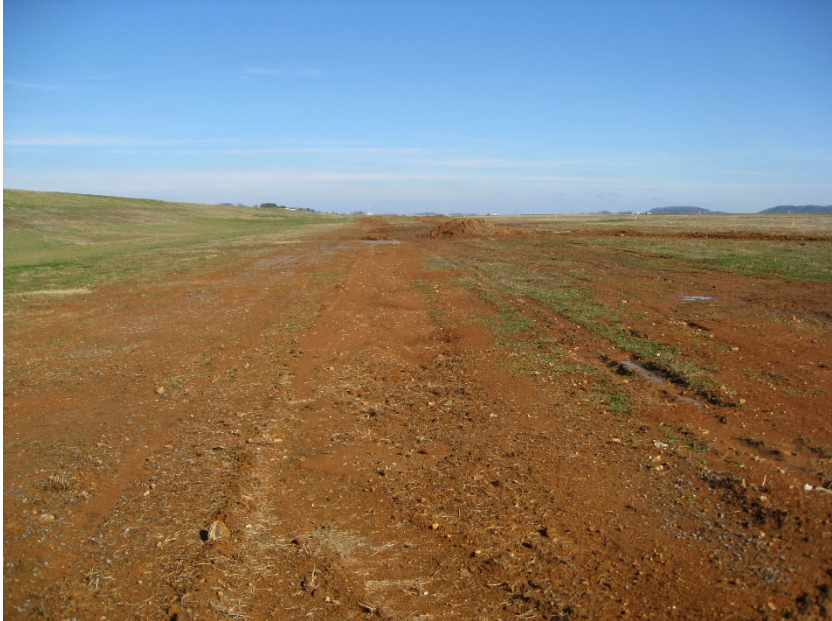
| <p>Photo 63<br/> (RW 5L-23R)<br/> Sheet EC1.1.5<br/> Project 6</p> | |

| <p>Entry Code: RCA<br/> Action Code: TS or<br/> PS</p> | <p>Installed Duct bank<br/> Recommend stabilizing or removing any remaining spoil piles.<br/> Recommend stabilizing bare areas.</p> |

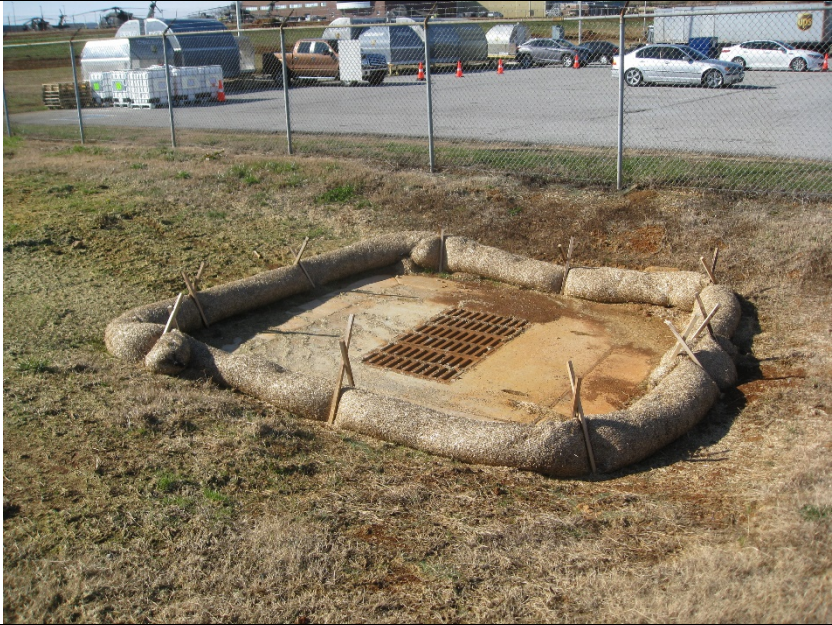
| <p>Photo 64<br/> STA 378+00 LT<br/> (RW 5L-23R)<br/> Project 6</p> | |

| <p>Entry Code: S<br/> Action Code:</p> | <p>Structure adjacent to UPS.</p> |

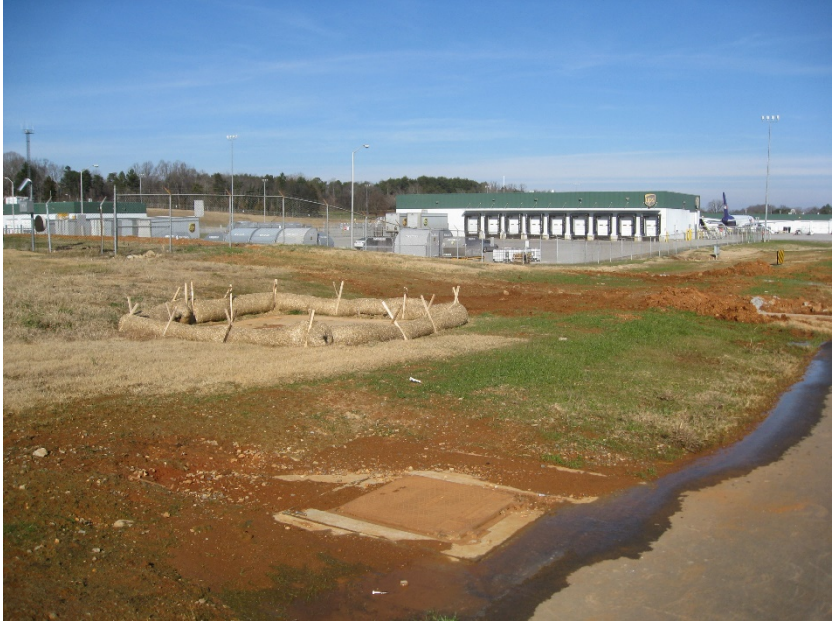
| <p>Photo 65<br/> STA 372+00 LT<br/> (RW 5L-23R)<br/> Project 6</p> | |

| <p>Entry Code: S<br/> Action Code:</p> | <p>New structure north of Taxiway G</p> |

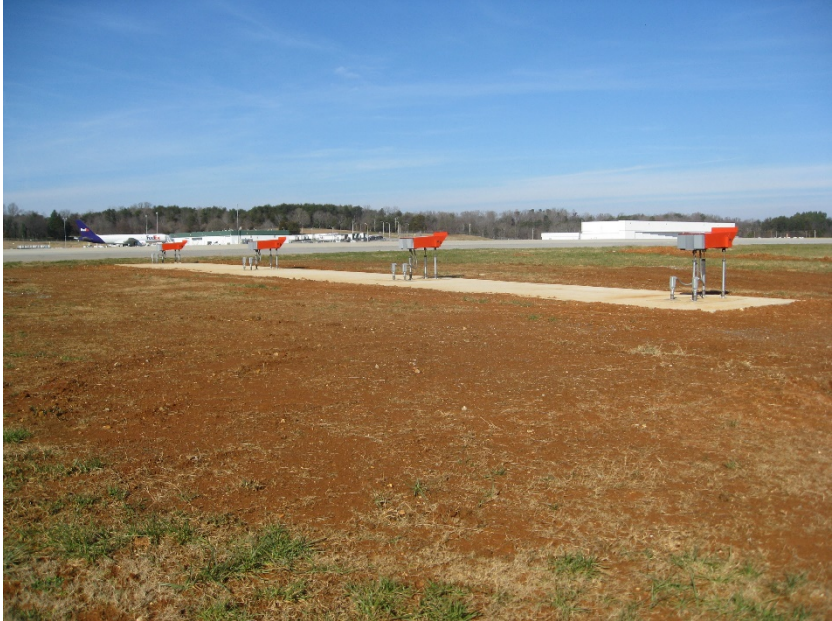
| <p>Photo 67<br/> (RW 5L-23R)<br/> Sheet EC1.1.5<br/> Project 6</p> | |

| <p>Entry Code: RCA<br/> Action Code: TS or<br/> PS</p> | <p>23R PAPI</p> <p>Per the permit, any recently disturbed areas are required to be stabilized once grading of area is complete or within 14 days of construction activities ceasing.<br/> Recommend stabilizing bare areas.</p> |

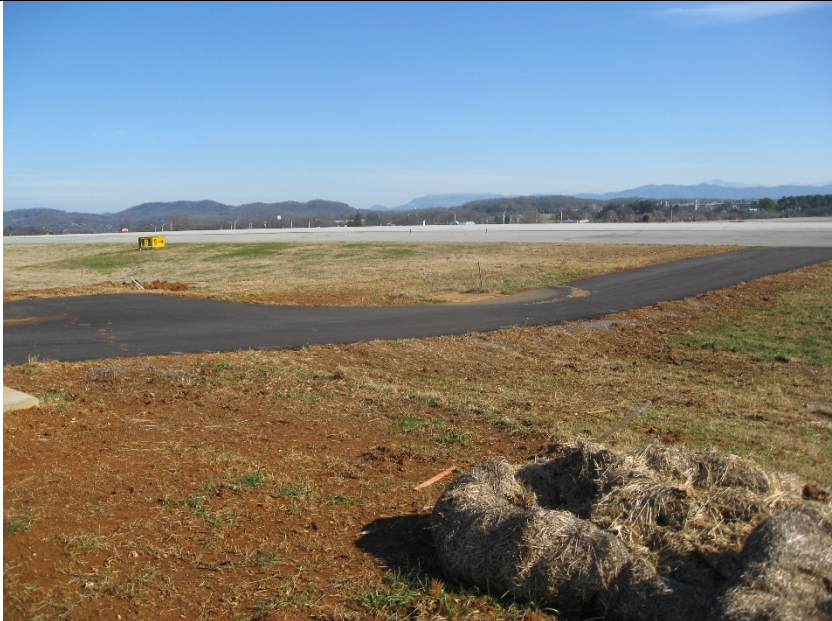
| <p>Photo 68<br/> (RW 5L-23R)<br/> Sheet EC1.1.5<br/> Project 6</p> | |

| <p>Entry Code: RCA<br/> Action Code: TS or<br/> PS</p> | <p>23R PAPI access road.</p> <p>Access road installed and shoulders backfilled.</p> <p>Per the permit, any recently disturbed areas are required to be stabilized once grading of area is complete or within 14 days of construction activities ceasing.<br/> Recommend stabilizing bare areas.</p> |

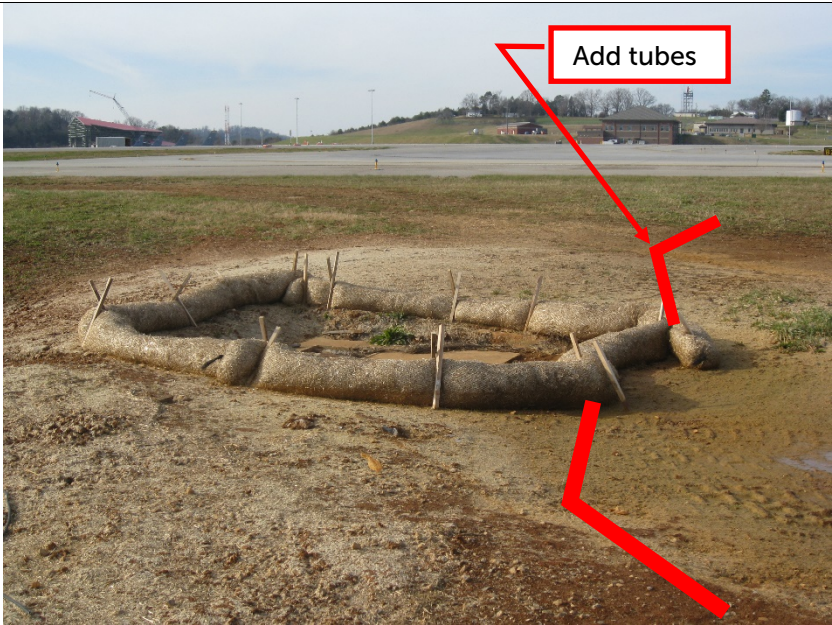
| <p>Photo 70<br/>Sheet EC102<br/>Project 5</p> | |

| <p>Entry Code: CA<br/>Action Code: I</p> | <p>Airfield Lighting Vault<br/>Recommend adding sediment tubes to capture run-off that is bypassing structure and starting to fill the side slope.</p> |

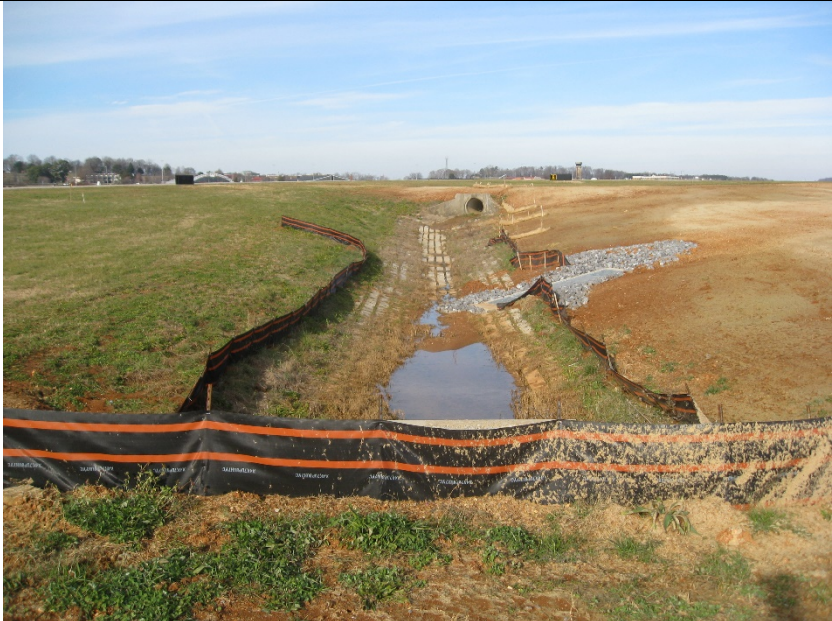
| <p>Photo 72<br/>Sheet EC102<br/>Project 5</p> | |

| <p>Entry Code: S<br/>Action Code:</p> | <p>North lateral ditch at the airfield lighting vault</p> |

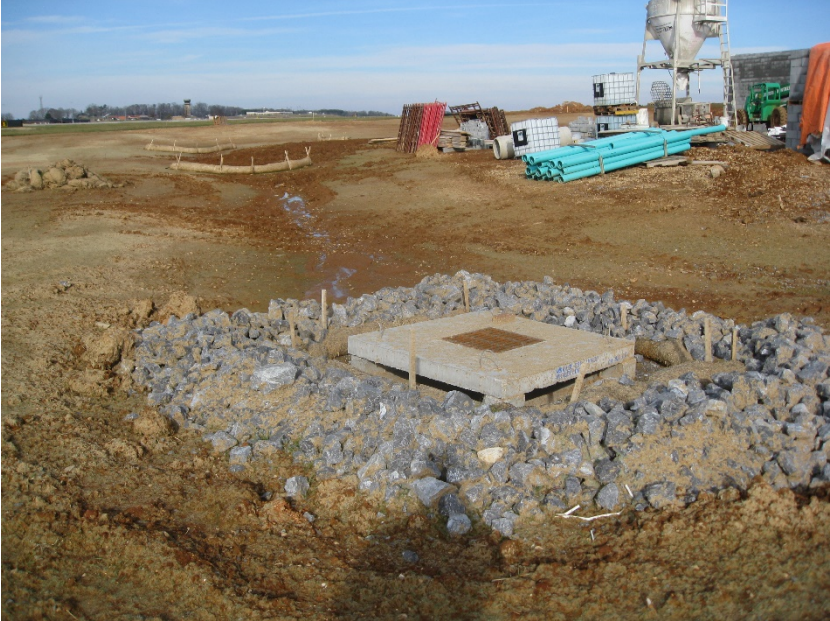
| <p>Photo 73<br/>Sheet EC102<br/>Project 5</p> | |

| <p>Entry Code: S<br/>Action Code:</p> | <p>Airfield Lighting Vault</p> |

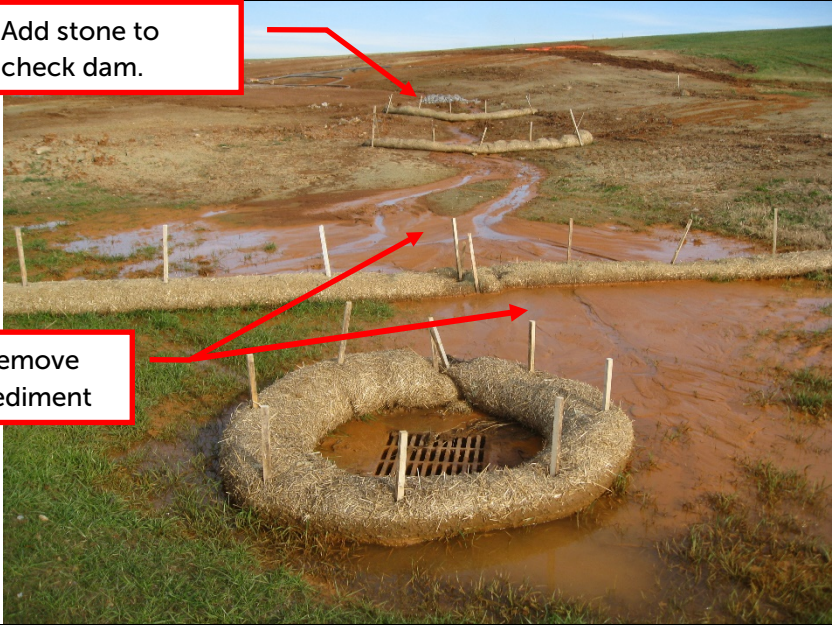
| <p>Photo 76<br/>Sheet EC102<br/>Project 5</p> | |

| <p>Entry Code: CA/CA<br/>Action Code: R/C</p> | <p>Airfield Lighting Vault<br/>Due to recent storm events sediment has migrated to inlet of structure.<br/>Recommend removing all sediment. Recommend adding stone to sides of rock check dam (runoff appears to be by passing check dam).<br/>See next photo for recommendations on installation of additional stakes.</p> |

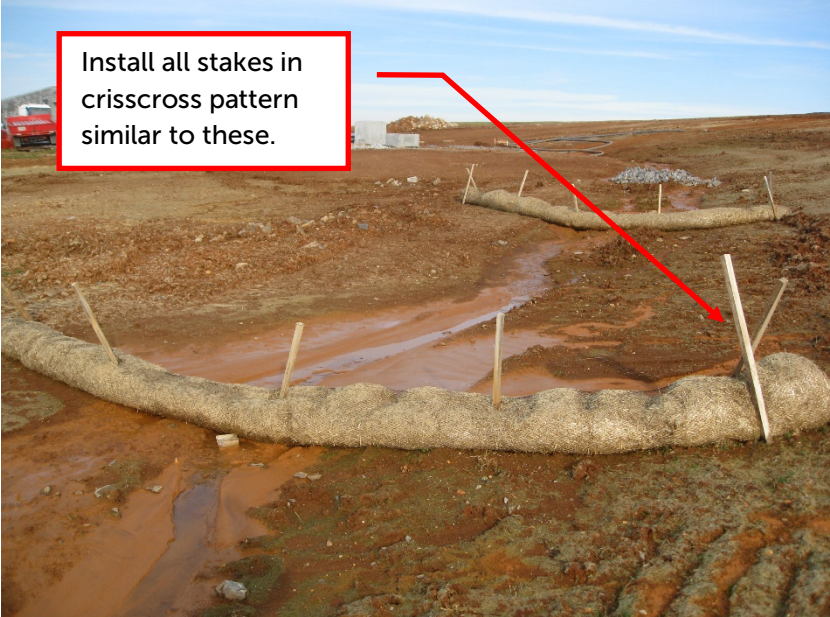
| <p>Photo 77<br/>Sheet EC102<br/>Project 5</p> | |

| <p>Entry Code: CA<br/>Action Code: I</p> | <p>Airfield Lighting Vault<br/>Sediment appears to be passing underneath sediment tubes.<br/>Recommend installing all stakes per the plans to help maintain ground contact and to minimize the possibility of tubes "floating" during storm events.<br/>See previous photo.</p> |

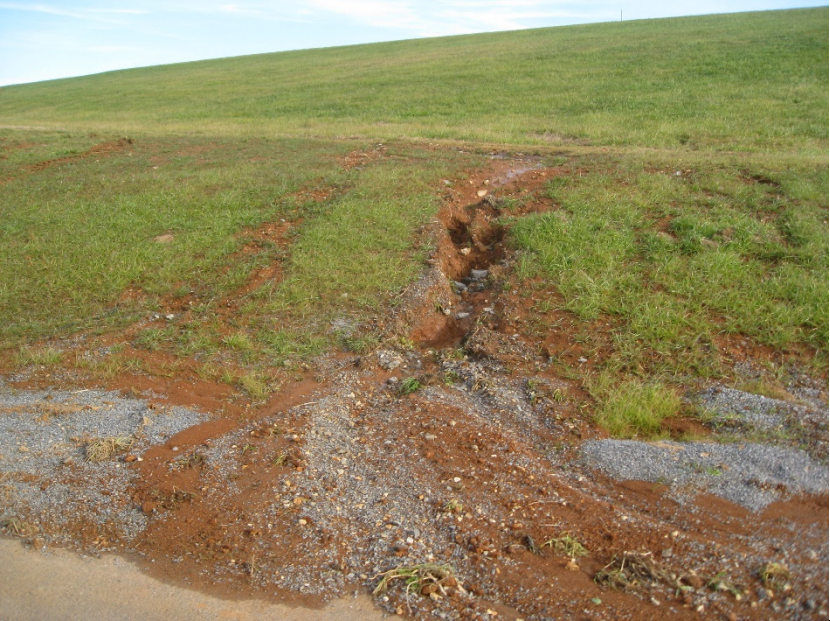
| <p>Photo 78<br/>Haul Rd<br/>Project 3</p> | |

| <p>Entry Code: CA<br/>Action Code: R</p> | <p>Haul Road.<br/>Due to recent storm events, Rills have formed.<br/>Recommend coordinating with CHA on remediation of rills.</p> |

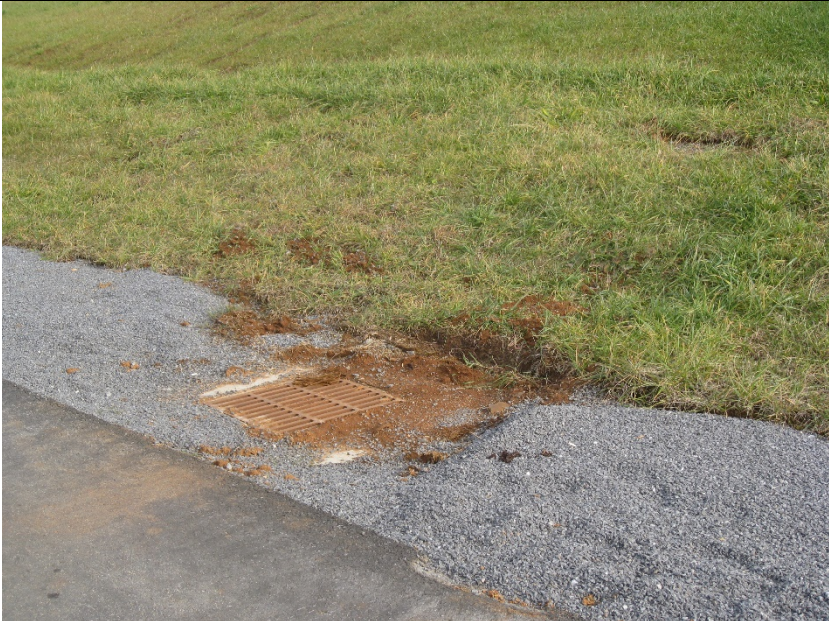
| <p>Photo 80<br/>Haul Rd<br/>Project 3</p> | |

| <p>Entry Code: S<br/>Action Code:</p> | <p>Haul Road.<br/>Recommend removing sediment tubes.</p> |

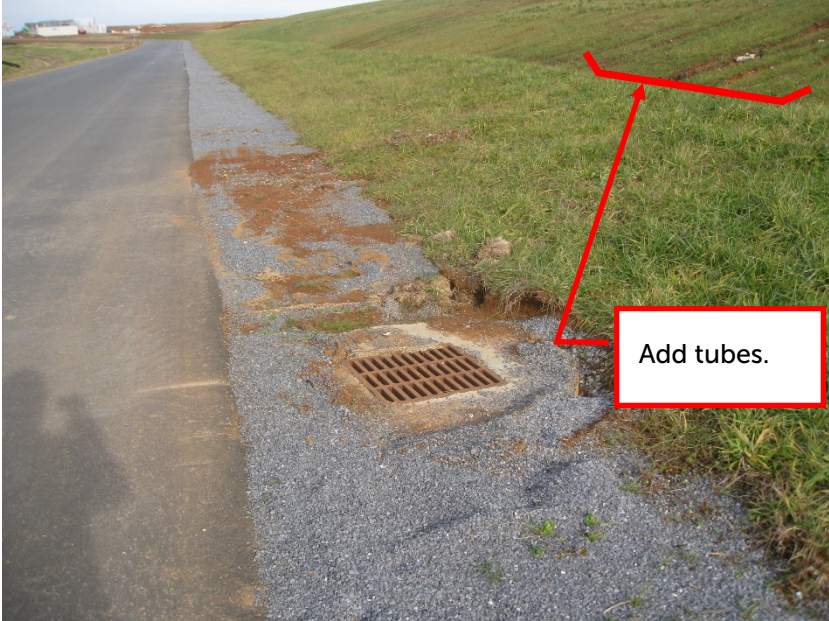
| <p>Photo 81<br/>Haul Rd<br/>Project 3</p> | |

| <p>Entry Code: CA<br/>Action Code: I</p> | <p>Haul Road inlet.<br/>Area appears to continuing to rill.<br/>Recommend installing sediment tubes.</p> |
