## QUALITY ASSURANCE MONTHLY SITE ASSESSMENT REPORT

Airfield Modernization Program  
Runway 5L-23R Reconstruction  
Project 2 / Project 3  
Project 4 / Repair TWY Lighting  
Project 5 / Project 6

## **AIRFIELD MODERNIZATION PROGRAM RUNWAY 5L-23R RECONSTRUCTION**

**QUALITY ASSURANCE SITE  
ASSESSMENT  
& EPSC INSPECTION**  
Review Date: 01/11/2021  
Inspector: Jason Hunt

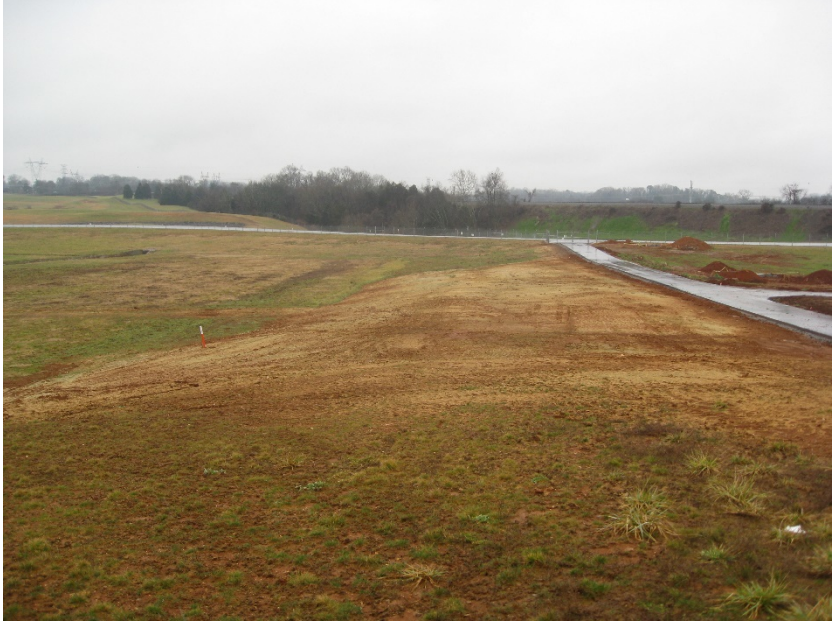
<p>Photo 3 (RW 5L-23R) Sheet EC1.1.1 Project 6</p>

<p>Entry Code: S Action Code:</p>	<p>Proposed Malsr access road</p>

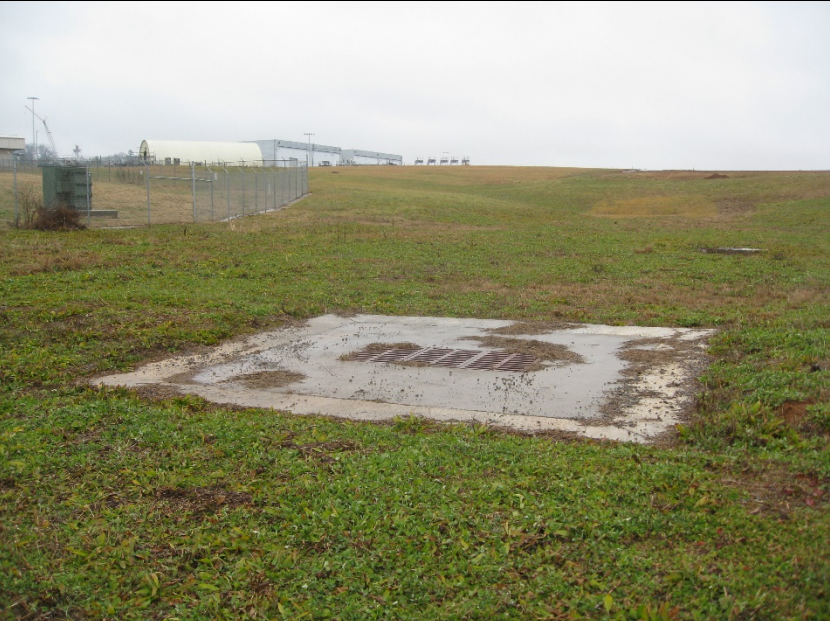
<p>Photo 6 Sta. 287+21 (RW 5L-23R) Structure 124 Project 3</p>

<p>Entry Code: S Action Code:</p>	<p>Storm structure 124 adjacent to proposed Malsr access road.</p>

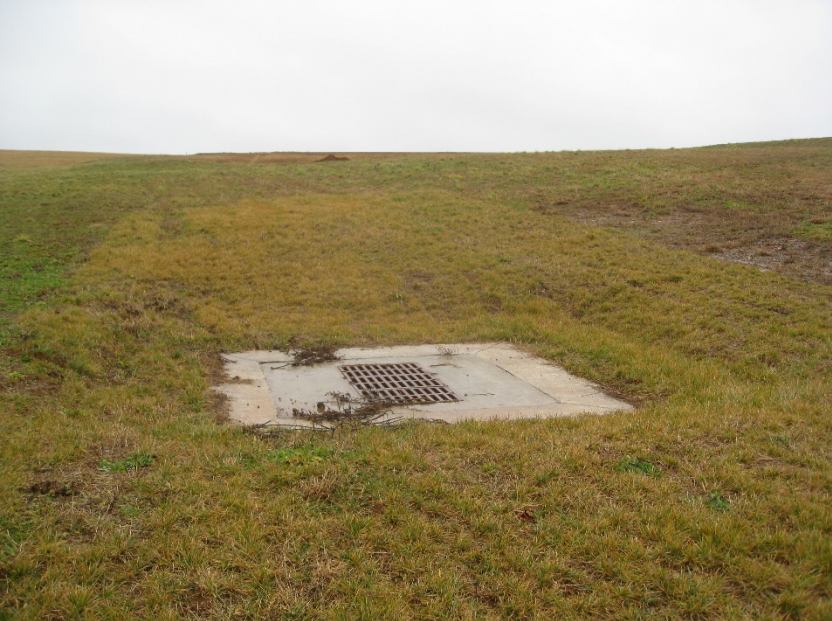
<p>Photo 7 Sta.289+13 LT (RW 5L-23R) Structure 122 Project 3</p>

<p>Entry Code: S Action Code:</p>	<p>Storm structure 122. adjacent to proposed Malsr access road.</p>

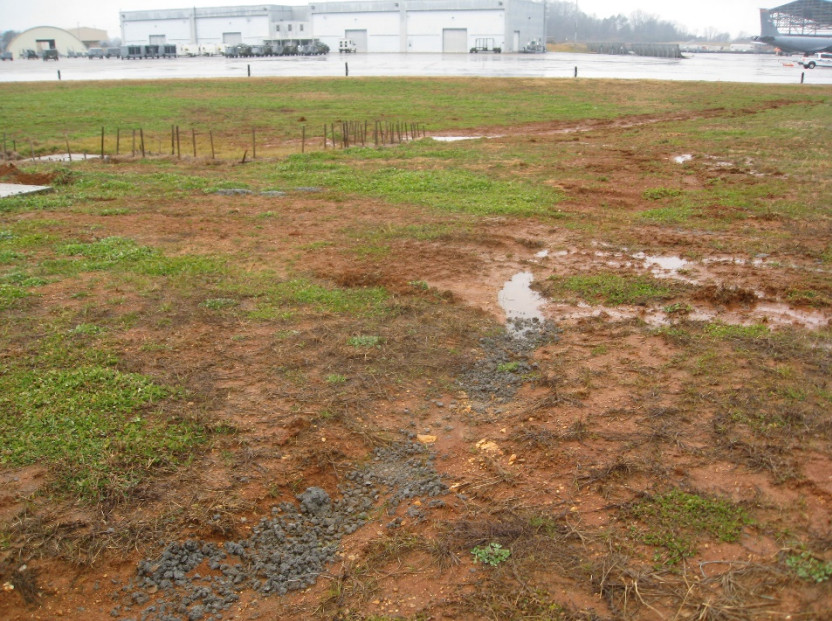
<p>Photo 13 Sta. 298+71 LT (RW 5L-23R) Structure 116 Between Taxiway "G1" and "G2" Project 3</p>

<p>Entry Code: FM, FM Action Code: R, TS or PS</p>	<p>Above storm structure 116. Recommend repairing rills and immediately stabilizing any resulting bare areas.</p>

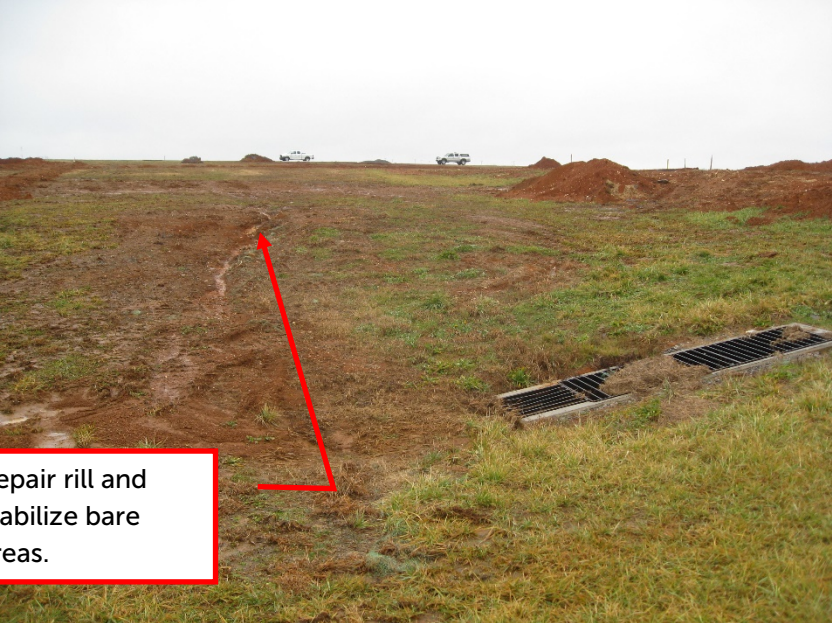
<p>Photo 27 Sta. 347+31 LT (RW 5L-23R) Structure 104 Enhanced Swale Endwall 102 Project 3</p>

<p>Entry Code: CA/ CA Action Code: R/TS or PS</p>	<p>Enhanced Swale Endwall 102 adjacent to 23R Midpoint-RVR Recommend repairing rills. Recommend stabilizing all remaining bare areas.</p>

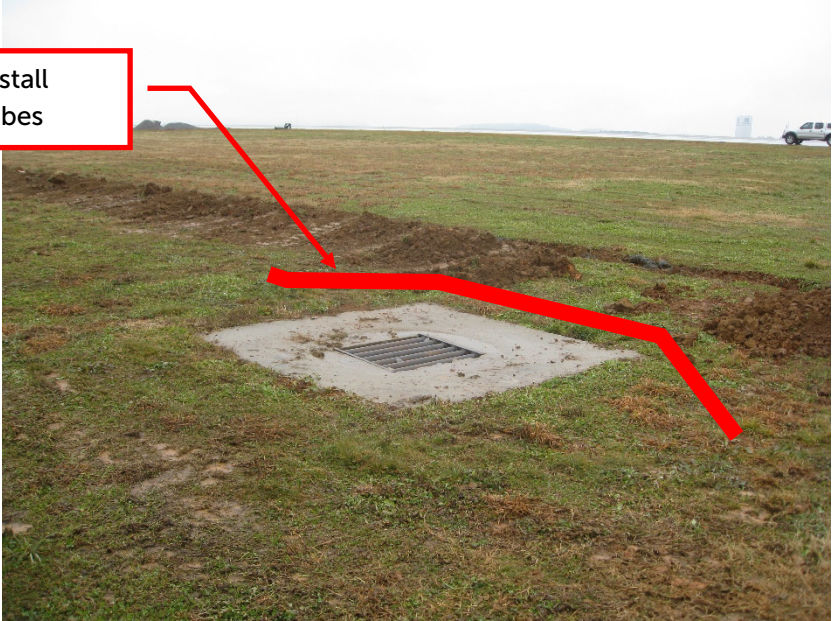
<p>Photo 31 Sta. 363+50 LT (RW 5L-23R) Existing Structure Project 2</p>

<p>Entry Code: CA Action Code: I</p>	<p>Existing Storm structure. Duct bank being installed at time of inspection. Recommend installing sediment tubes to protect structure.</p>

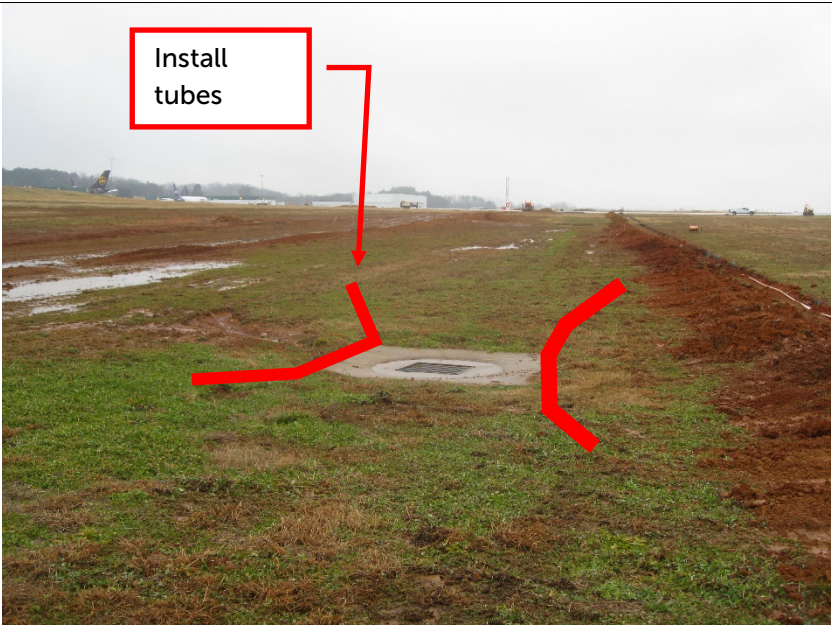
<p>Photo 32 Sta. 366+25 LT (RW 5L-23R) Existing Structure Project 2</p>

<p>Entry Code: CA Action Code: I</p>	<p>Existing Storm structure. Duct bank being installed at time of inspection. Recommend installing sediment tubes to protect structure.</p>

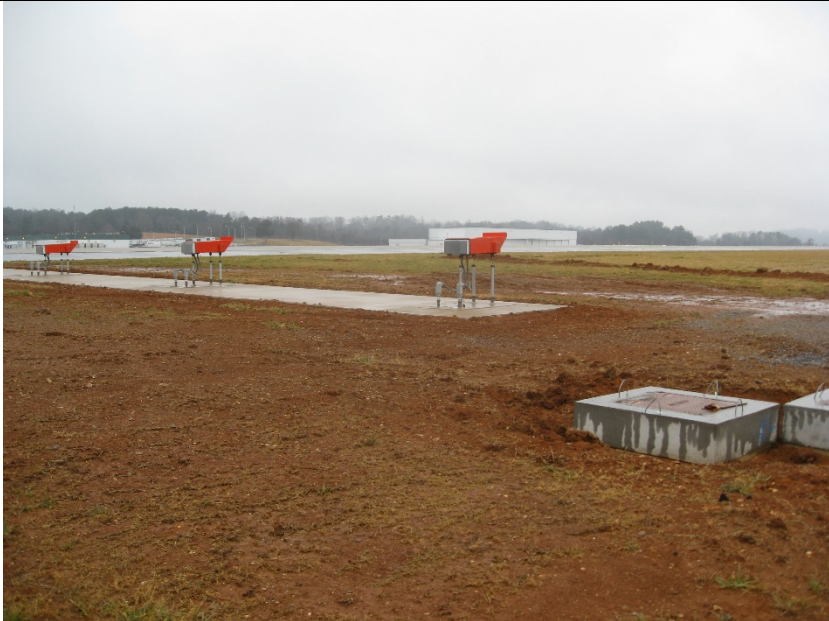
<p>Photo 34          (RW 5L-23R)          Sheet EC1.1.5          Project 6</p>

<p>Entry Code: RCA          Action Code: TS or          PS</p>	<p>23R PAPI          Per the permit, any recently disturbed areas are required to be stabilized once grading of area is complete or within 14 days of construction activities ceasing.          Recommend stabilizing bare areas.</p>

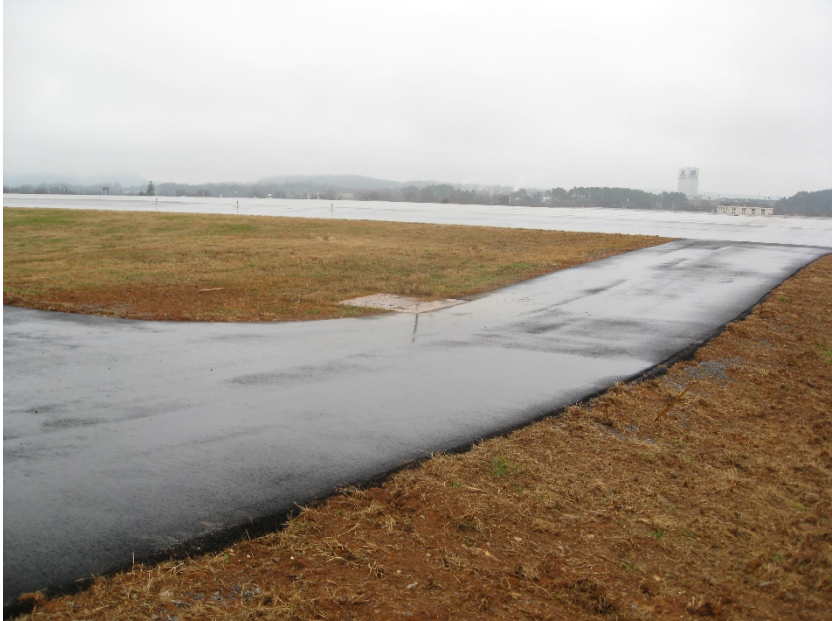
<p>Photo 35 (RW 5L-23R) Sheet EC1.1.5 Project 6</p>

<p>Entry Code: RCA Action Code: TS or PS</p>	<p>23R PAPI access road. Access road installed and shoulders backfilled. Per the permit, any recently disturbed areas are required to be stabilized once grading of area is complete or within 14 days of construction activities ceasing. Recommend stabilizing bare areas.</p>

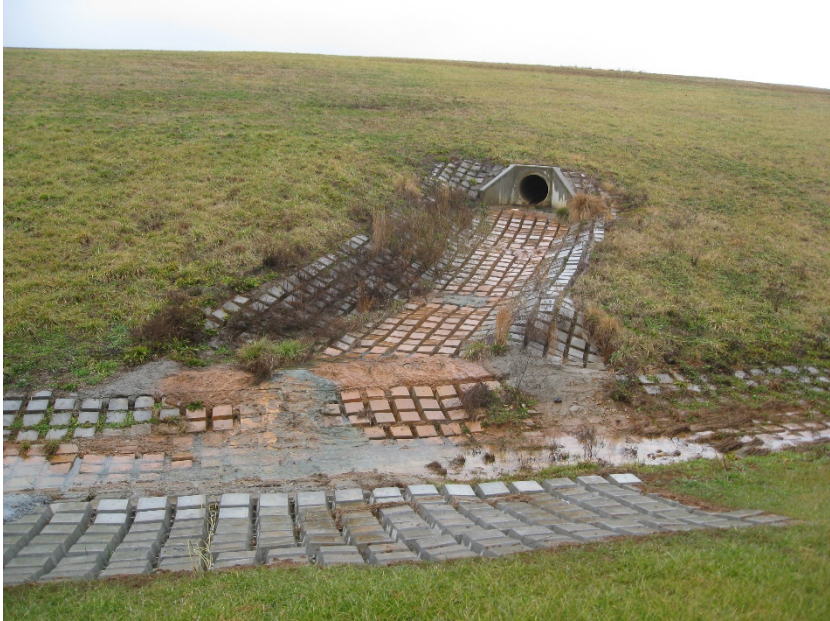
<p>Photo 38 Sta. 288+26 RT (RW 5L-23R) Structure 224 Project 2</p>

<p>Entry Code: S Action Code:</p>	<p>Structure 224.</p>

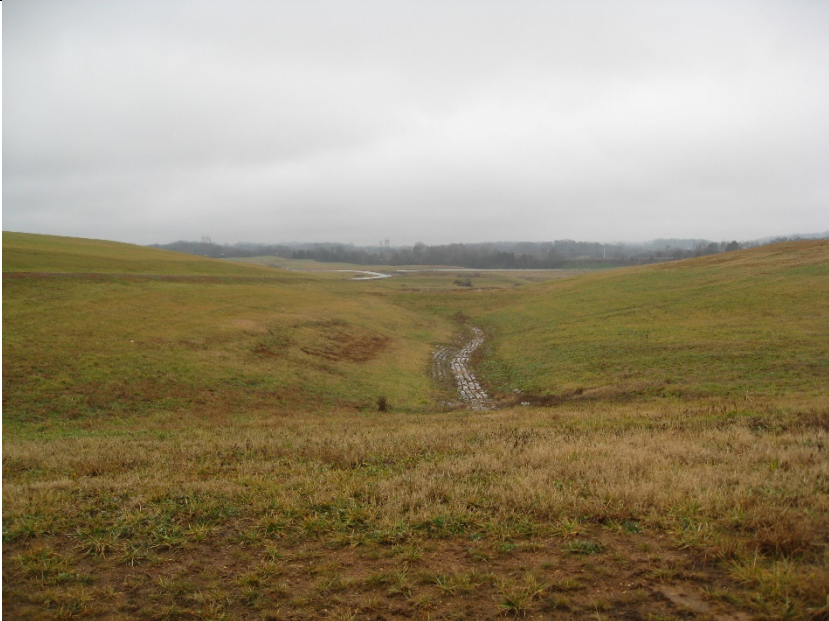
<p>Photo 43          Sta. 300+60 RT          (RW 5L-23R)          North Lateral Ditch          Endwall 102          Project 2</p>

<p>Entry Code: S          Action Code:</p>	<p>North Lateral Endwall 102.</p>

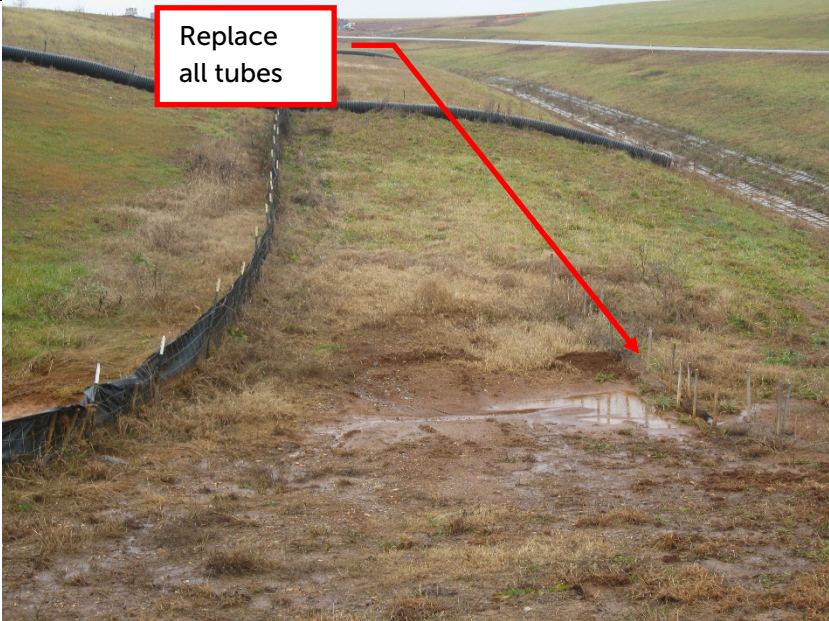
<p>Photo 45 Sta. 302+54 RT (RW 5L-23R) North Lateral Ditch Endwall 100 Project 2</p>

<p>Entry Code: CA, CA Action Code: I, TS or PS</p>	<p>North Lateral Endwall 100. Recommend replacing sediment tubes and stabilizing bare areas.</p>

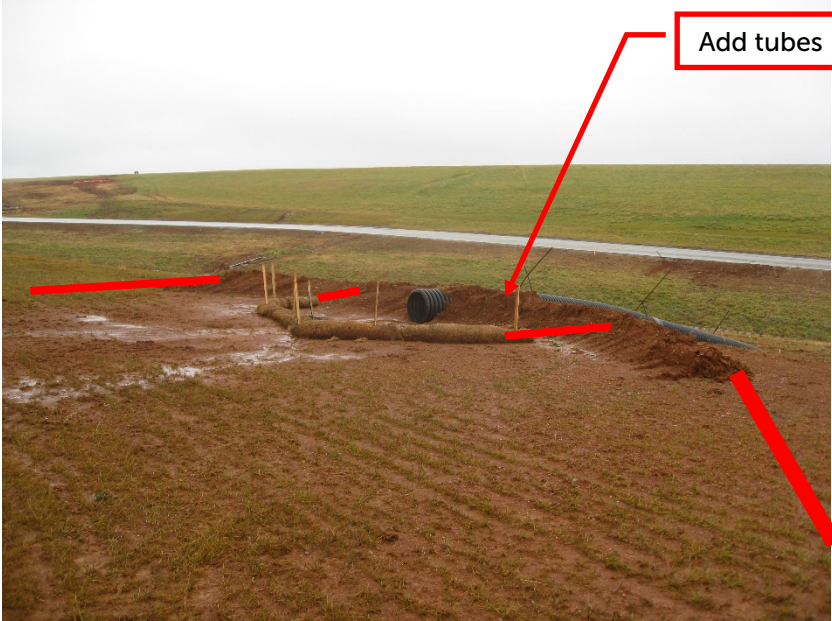
<p>Photo 46 North Lateral Fill Area Project 3</p>

<p>Entry Code: CA/CA Action Code: I/TS or PS</p>	<p>North Lateral Fill Area. Recommend additional sediment tubes to protect inlet and capture more run-off. Recommend stabilizing bare areas.</p>

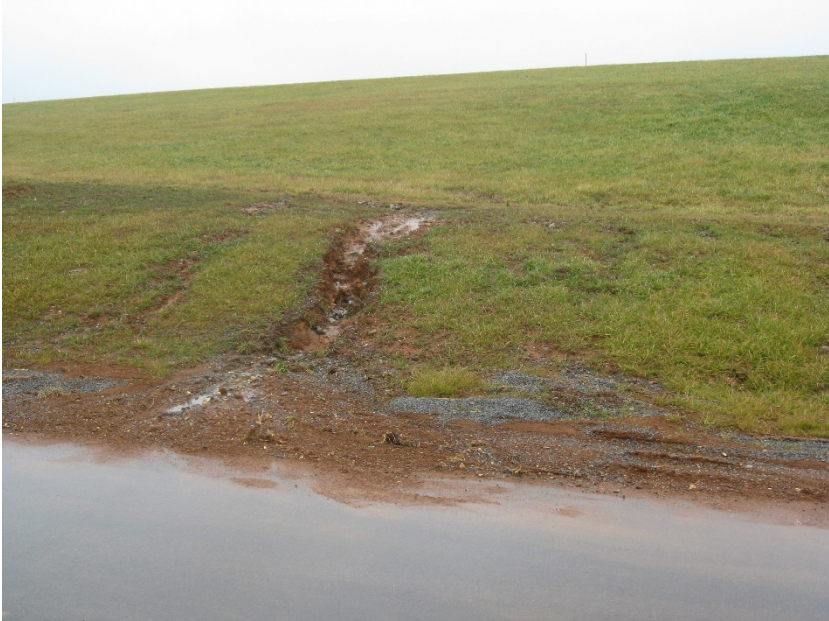
<p>Photo 48 Haul Rd Project 3</p>

<p>Entry Code: CA Action Code: R</p>	<p>Haul Road. Recommend coordinating with CHA on remediation of rills.</p>

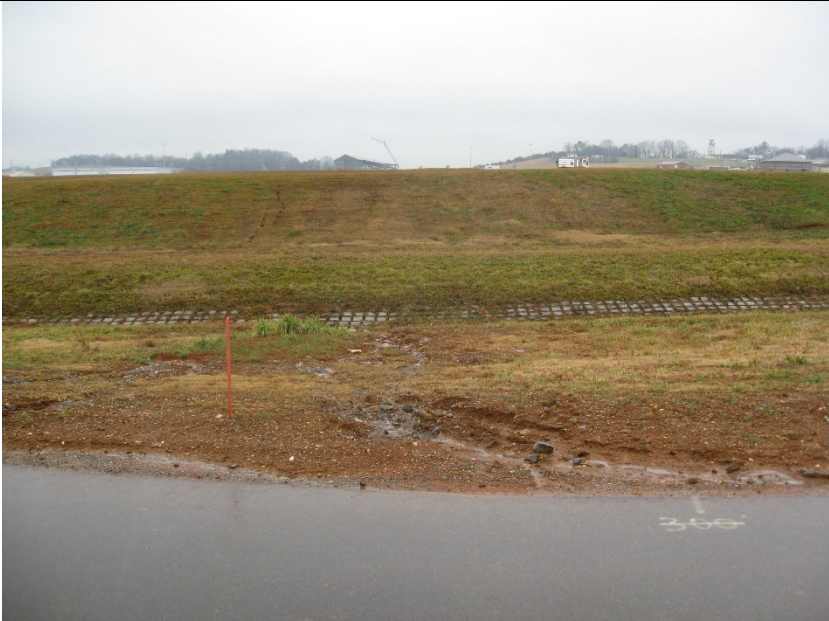
<p>Photo 49 Haul Rd</p>

<p>Entry Code: RCA, RCA Action Code: R, TS or PS</p>	<p>Haul Road. Recommend coordinating with CHA on remediation of rills. Recommend stabilizing all bare areas along shoulder of haul road.</p>

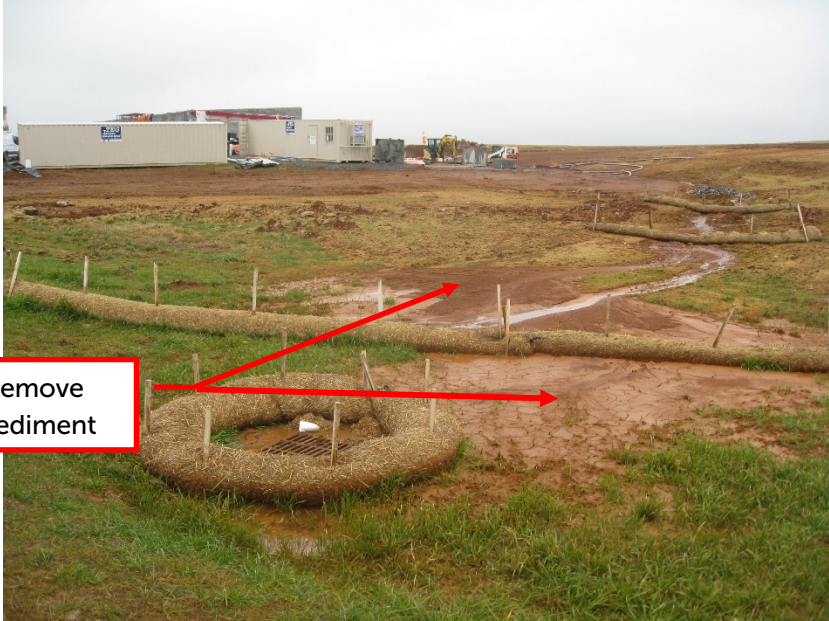
<p>Photo 50 Sheet EC102 Project 5</p>

<p>Entry Code: RCA Action Code: C</p>	<p>Airfield Lighting Vault Due to past storm events sediment has migrated to inlet of structure. Recommend removing all sediment. See next photo for recommendations on installation of additional stakes.</p>

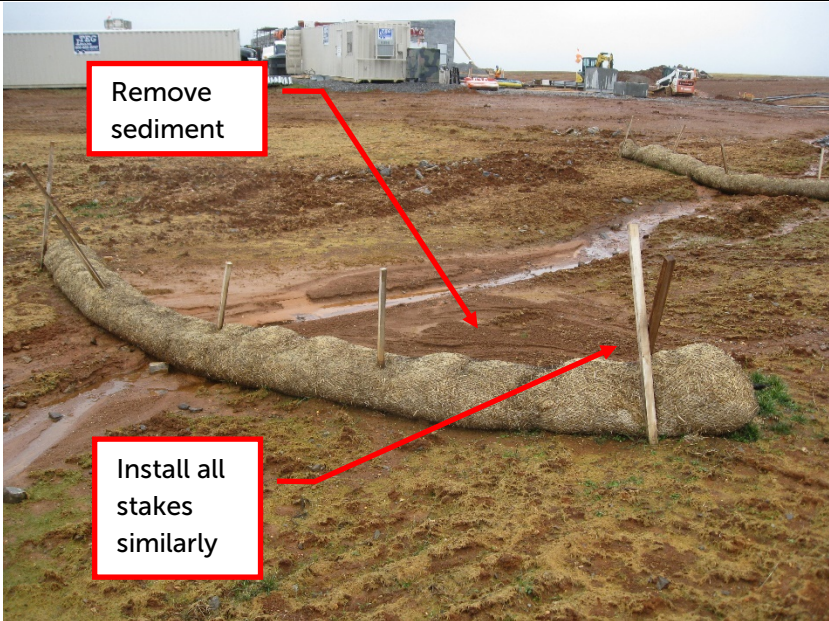
<p>Photo 51 Sheet EC102 Project 5</p>

<p>Entry Code: RCA/RCA Action Code: C/I</p>	<p>Airfield Lighting Vault Sediment appears to be passing underneath sediment tubes. Recommend removing sediment. Recommend installing all stakes per the plans to help maintain ground contact and to minimize the possibility of tubes "floating" during storm events. See previous photo.</p>

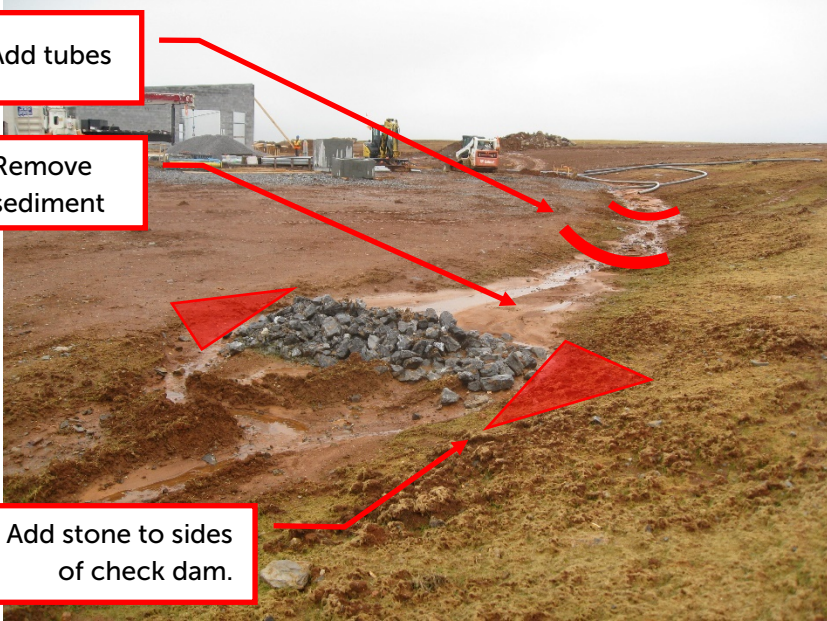
<p>Photo 52 Sheet EC102 Project 5</p>

<p>Add tubes</p> <p>Remove sediment</p> <p>Add stone to sides of check dam.</p>
<p>Entry Code: RCA/RCA/RCA Action Code: C/R/I</p>	<p>Airfield Lighting Vault</p> <p>Recommend removing all sediment. Run-off appears to be bypassing check dam instead of running over the top of it.</p> <p>Recommend adding stone to sides of rock check dam.</p> <p>Recommend adding more sediment tubes above check dam.</p>

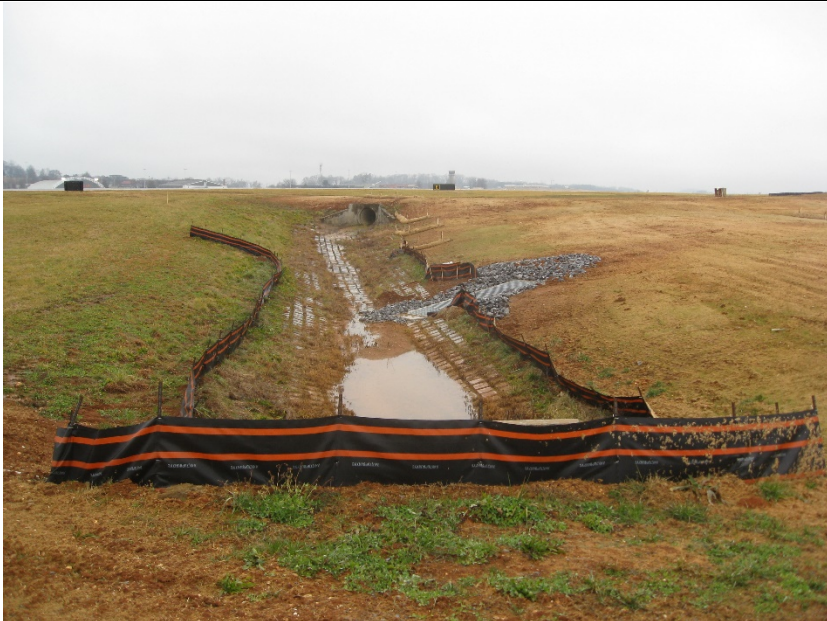
<p>Photo 53 Sheet EC102 Project 5</p>

<p>Entry Code: S Action Code:</p>	<p>North lateral ditch at the airfield lighting vault</p>

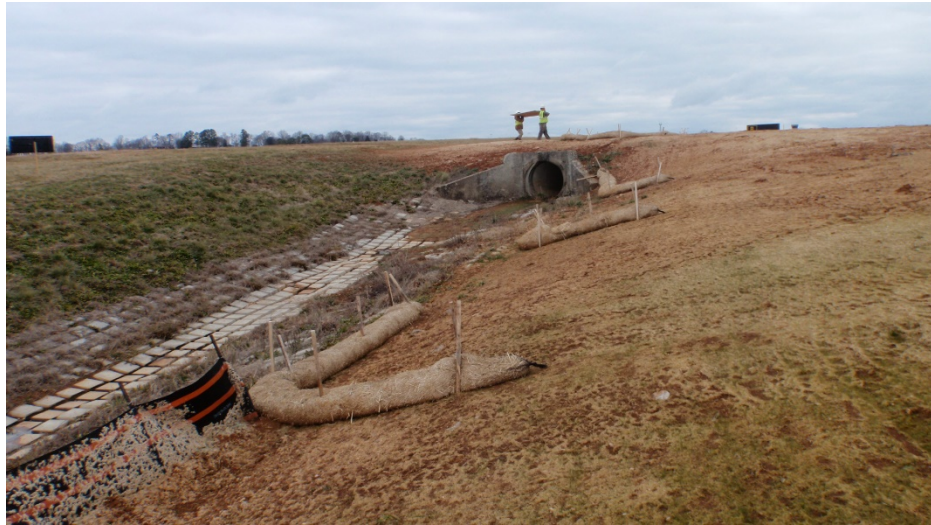
Photo 54  
Sheet EC102  
Project 5

Entry Code: S  
Action Code:

Airfield Lighting Vault

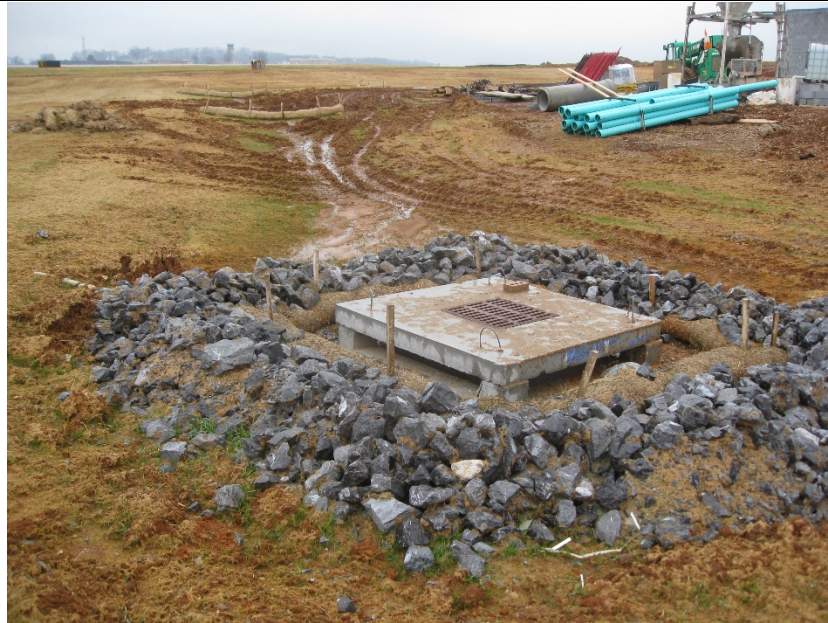
Photo 55  
Sheet EC102  
Project 5

Entry Code: S  
Action Code:

New structure at the Airfield Lighting Vault

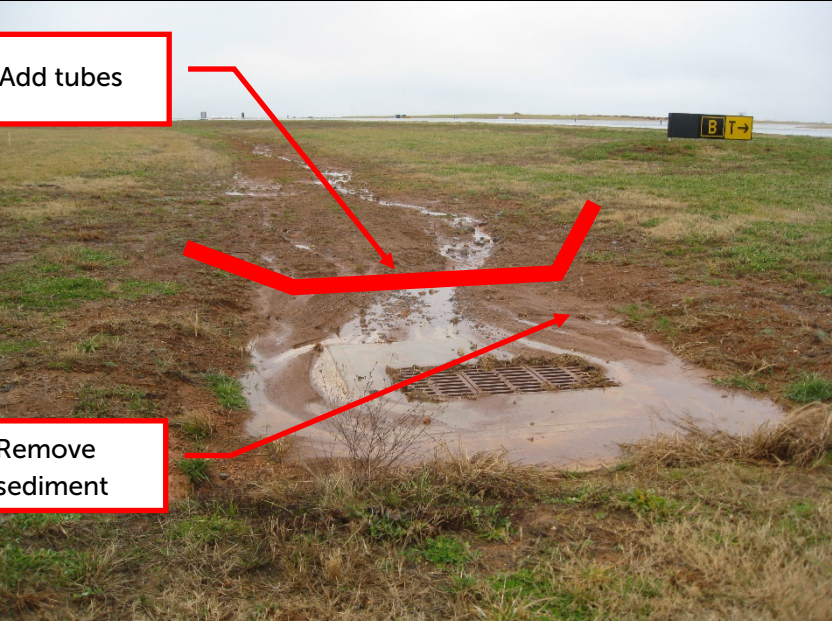
<p>Photo 63 Sta. 321+73 RT (RW 5L-23R) Structure 212 Adjacent to Taxiway "B" Project 3</p>

<p>Entry Code: CA, CA, CA Action Code: I, C, TS or PS</p>	<p>Storm structure 212. Recommend adding sediment tubes. Recommend removing sediment from top of structure. Recommend stabilizing bare areas.</p>

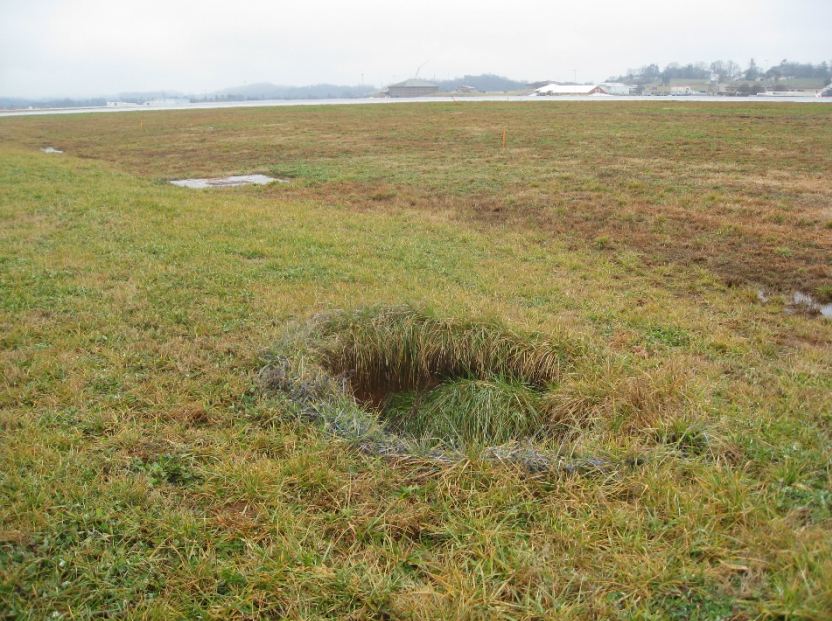
<p>Photo 66 Sta. 334+52 RT (RW 5L-23R) Structure 208 Project 3</p>

<p>Entry Code: Action Code:</p>	<p>Above structure 208. Construction fallout present. Recommend coordinating with CHA on remediation.</p>

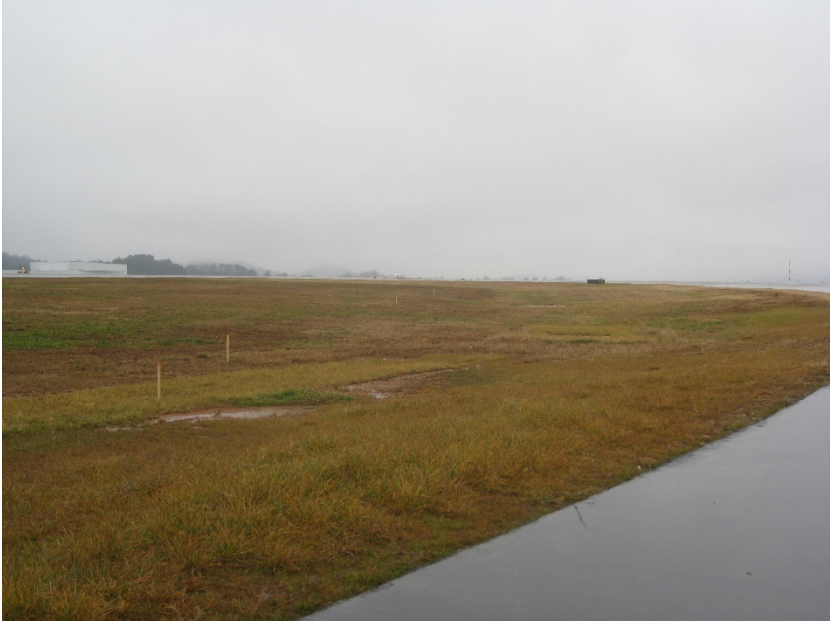
<p>Photo 74          Sta. 365+69 RT          (RW 5L-23R)          Structure 300          Project 4</p>

<p>Entry Code: S          Action Code:</p>	<p>Structure 300 and Outfall C          Portions of the site are now unavailable for inspection due to Taxiway "Y" being open to traffic.</p>
