**To:** Greg Young  
**From:** Joellyn Brazile  
**Date:** 2/15/2024  
**Subject:** Compliance Assistance Ford Motor Company TN0082368

Included under this Memo is documentation regarding the Compliance Assistance site visit of the Ford Motor Company Blue Oval City Memphis Regional Megasite covered under Individual Construction Permit TN0082368 conducted on January 9, 2024.

Compliance Assistance Date: January 9, 2024

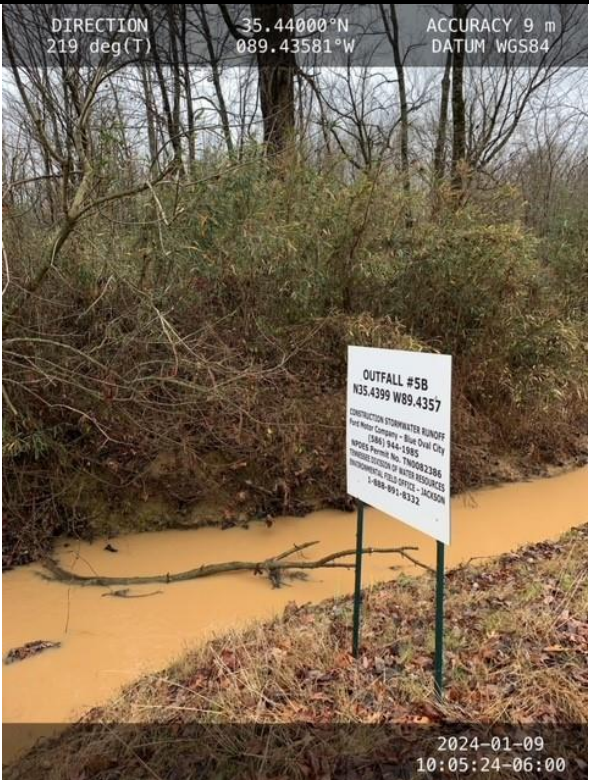
## **SW5B (Photo 1))**

- Discharge very sediment-laden. Drainage area contributing to SW5B is construction activity east of Fredonia Road, including MAG area.

Project:		Site Location:	Permit No.:
Memphis Regional Megasite-Blue Oval City		S. of Keeling Road, W. of Hwy 222	TN0082368
Photo No.	Date		
1	1-9-24		
<b>Description</b> Outfall <b>SW5B</b> -Sediment-laden water observed. Drainage area contributing to <b>SW5B</b> is construction activity east of Fredonia Road, including MAG area.		<div> <div> DIRECTION 219 deg(T) </div> <div> 35.44000°N 089.43581°W </div> <div> ACCURACY 9 m DATUM WGS84 </div> </div>

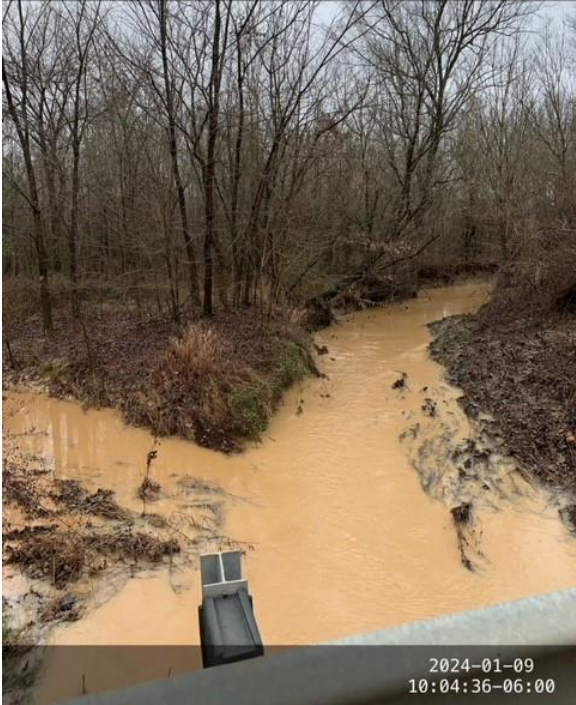
## **Little Muddy at Keeling Road (Photo 2)**

- Water in Little Muddy very sediment-laden. Drainage area contributing to SW5B is construction activity east of Fredonia Road, including MAG area. Drainage area contributing to Little Muddy Creek, includes area associated with SW6, SW11, SW7 and SW12.

Project:		Site Location:		Permit No.:
Memphis Regional Megasite-Blue Oval City		S. of Keeling Road, W. of Hwy 222		TN0082368
Photo No.	Date			
2	1-9-24			
<b>Description</b> Confluence of discharge from outfall <b>SW5B</b> and <b>Little Muddy Creek</b> . Water was sediment-laden. Drainage area contributing to <b>SW5B</b> is construction activity east of Fredonia Road, including MAG area. Drainage area contributing to Little Muddy Creek, includes area associated with <b>SW6</b> , <b>SW11</b> , <b>SW7</b> and <b>SW12</b> .		<div> <div> DIRECTION 185 deg(T) </div> <div> 35.43998°N 089.43630°W </div> <div> ACCURACY 8 m DATUM WGS84 </div> </div>

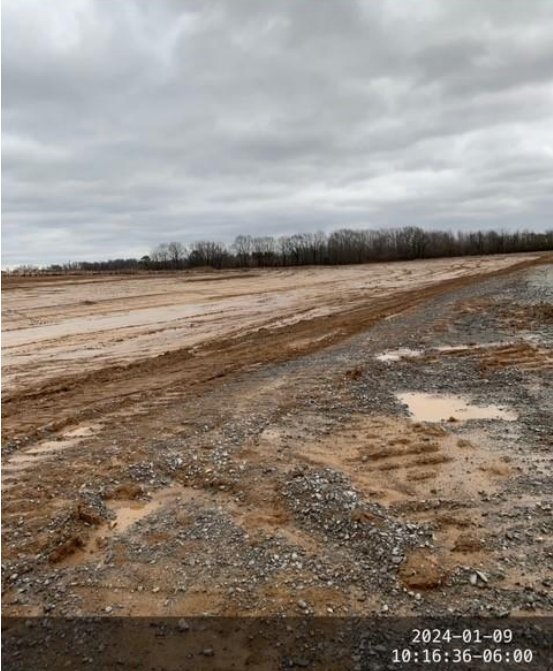
- ❖ **S03MAG**-not at grade, no internal components, no discharge pipe, still need to cut 5-6ft. Currently draining/discharging towards western end towards Fredonia Rd. Area surrounding basin was not stabilized. *Recommended during site discussion earthen berm be installed at downgradient end and to use cells within basin to help provide treatment (use pumps to move water around).* (Photos 3 and 4)
- ❖ **S05MAG**-no internal components, but holding water, no discharge pipe installed. Area surrounding basin was not stabilized. (Photo 5)
- ❖ **S02MAG**-no internal components, but holding water, no discharge pipe installed. Area surrounding basin was not stabilized. (Photo 6)

Project:		Site Location:		Permit No.:
Memphis Regional Megasite-Blue Oval City		S. of Keeling Road, W. of Hwy 222		TN0082368
Photo No.	Date		DIRECTION 35.43701°N 64 deg(T) 089.43300°W ACCURACY 8 m DATUM WGS84	
3	1-9-24			
<b>Description</b> View of eastern portion of <b>S03MAG</b> . Sediment basin was not at grade, no internal components, no discharge pipe, still need to cut 5-6ft. Currently draining/discharging towards western end towards Fredonia Rd (see photo 4). <i>Recommended during site discussion earthen berm be installed at downgradient end and to use cells within basin to help provide treatment (use pumps to move water around).</i>

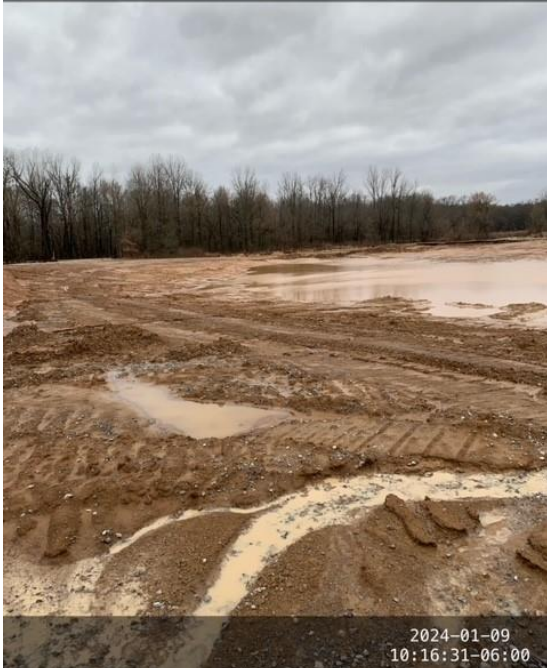
Project:		Site Location:		Permit No.:	
Memphis Regional Megasite-Blue Oval City		S. of Keeling Road, W. of Hwy 222		TN0082368	
Photo No.	Date		DIRECTION 306 deg(T)		
4	1-9-24		35.43702°N 089.43300°W		
<b>Description</b> View of western portion of S03MAG. Sediment basin was not at grade, no internal components, no discharge pipe, still need to cut 5-6ft. Discharge from basin directed towards Fredonia Road. Area surrounding basin was not stabilized. <i>Recommended during site discussion earthen berm be installed at downgradient end and to use cells within basin to help provide treatment (use pumps to move water around).</i>			ACCURACY 10 m DATUM WGS84

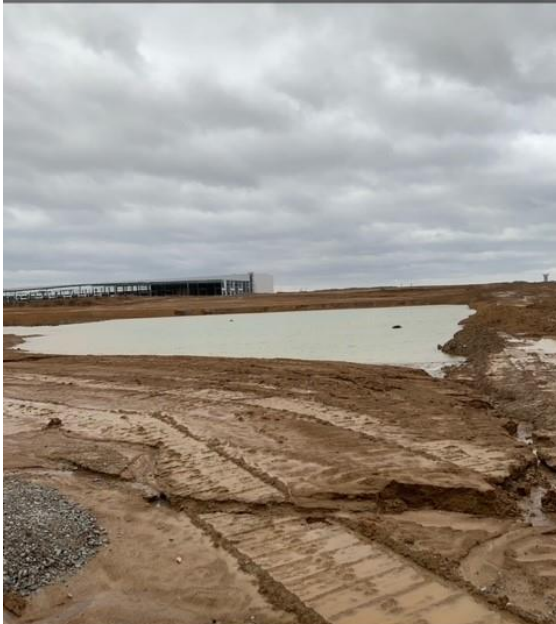
Project:		Site Location:		Permit No.:	
Memphis Regional Megasite-Blue Oval City		S. of Keeling Road, W. of Hwy 222		TN0082368	
Photo No.	Date		<div><div>DIRECTION 161 deg(T)</div><div>35.43624°N 089.43296°W</div><div>ACCURACY 9 m DATUM WGS84</div></div>		
5	1-9-24				
<b>Description</b> View of <b>S05MAG</b> . No internal components or discharge pipe had been installed. Area surrounding basin was not stabilized.		<div>

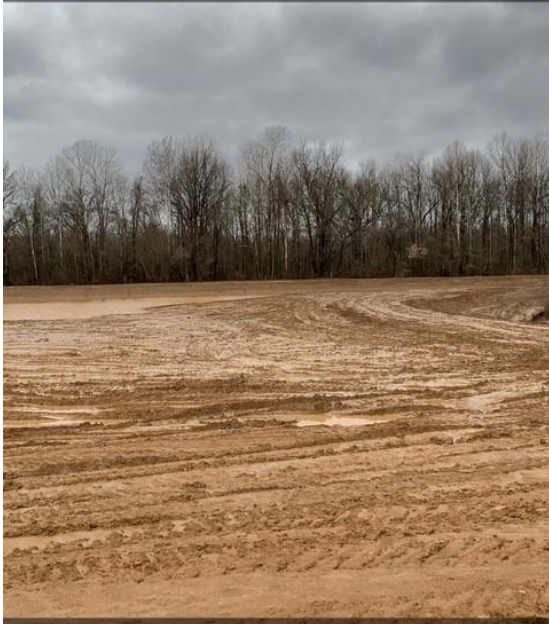
<b>Description</b> View of <b>S02MAG</b> . No internal components or discharge pipe had been installed. Area surrounding basin was not stabilized.					
			2024-01-09 10:29:38-06:00

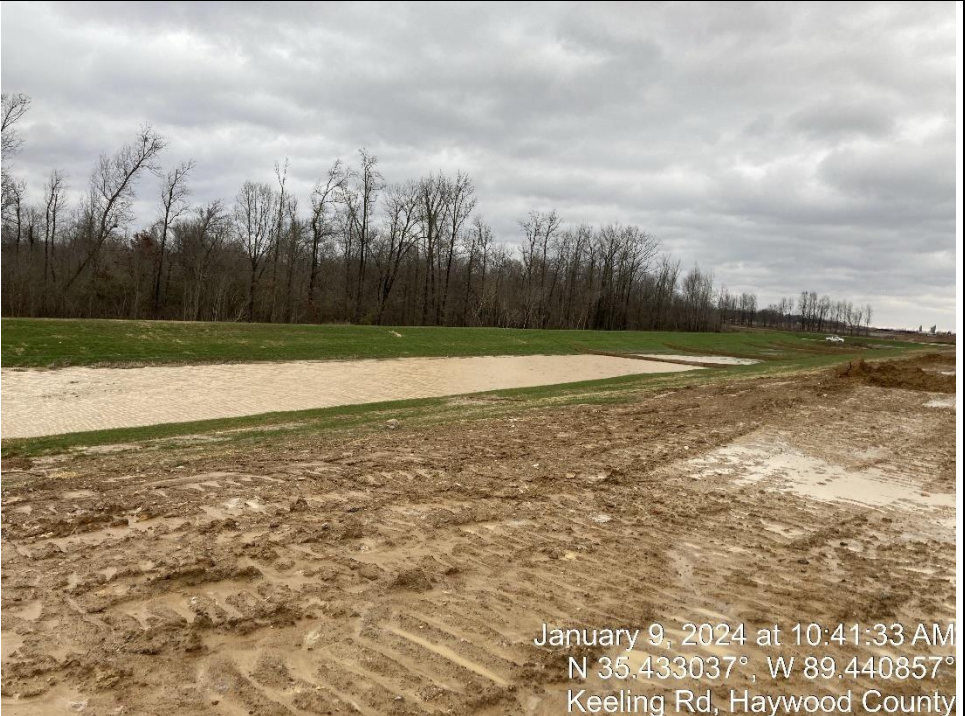
- Sediment-laden discharge from S06A was entering Stream 1-B at SW6. (Photo 10)
  - ❖ **S06A**-Porous baffles had been installed, but no skimmer outlet structure installed. Only riprap check dam installed at outlet end of basin. Basin segregated. Fredonia Road acting as earthen berm. Grass establishing on internal slopes of sediment basin. (Photo 8 and 9)

8	1-9-24		
<b>Description</b> View of <b>S06A</b> sediment basin. Porous baffles were installed and grass was establishing on internal banks of basin. No skimmer installed (see photo 9).		January 9, 2024 at 10:41:33 AM N 35.433037°, W 89.440857° Keeling Rd, Haywood County

**SW6/S06A Sediment Basin** *During site discussion, discussed need for skimmer outlet control structures to be installed.*

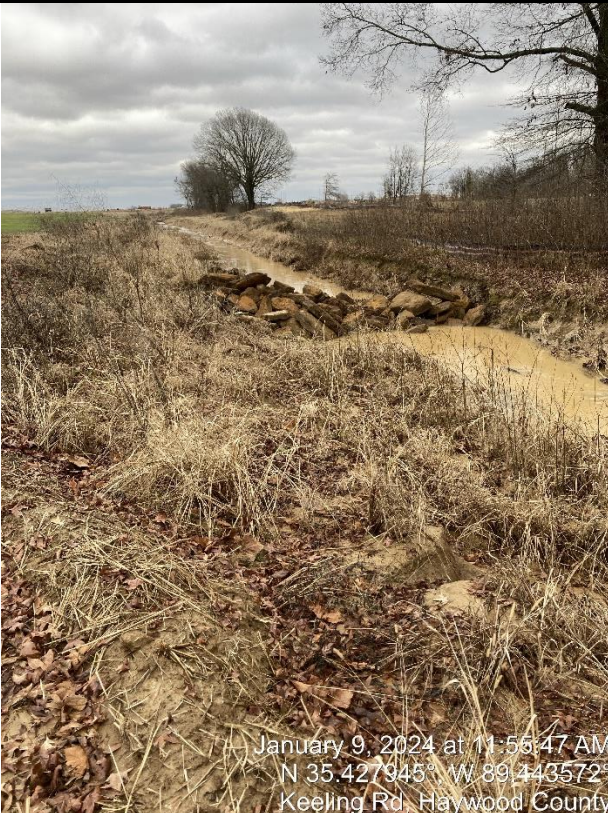
Project:		Site Location:	Permit No.:
Memphis Regional Megasite-Blue Oval City		S. of Keeling Road, W. of Hwy 222	TN0082368
Photo No.	Date		
12	1-9-24		
<b>Description</b> Sandstone rock was placed in <b>Stream 2</b> . <i>Recommended during site discussion rock be removed because instream treatment structures are not allowed in-stream.</i>

- Sandstone rock check dam had been placed across western end of stream channel. (Photo 12)  
*Recommended during site discussion rock be removed because instream treatment structures are not allowed in-stream.*

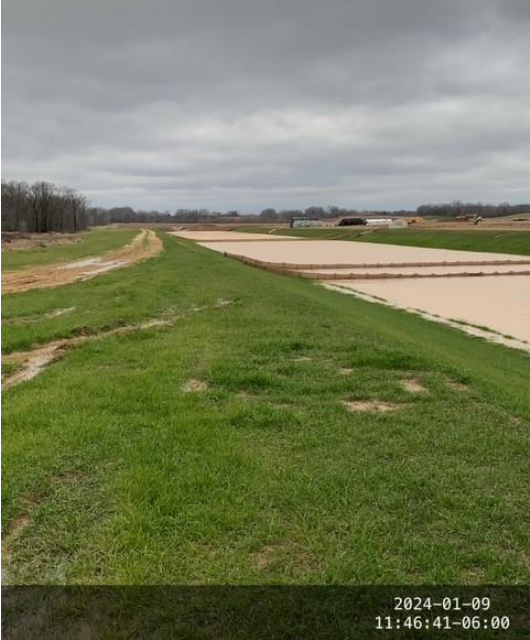
- ❖ **S07B**-Porous baffles were installed and grass was establishing on internal banks of basin and external slopes of the sediment basin. Nonporous baffles were not installed or skimmer. Basin was discharging a considerable amount of sediment-laden water into confluence of Stream 1-A and Stream 2 which flows north into Stream 9. (Photos 13-17)

Project:		Site Location:	Permit No.:
Memphis Regional Megasite-Blue Oval City		S. of Keeling Road, W. of Hwy 222	TN0082368
Photo No.	Date		
14	1-9-24		
<b>Description</b> Another view of <b>S07B</b> sediment basin. Porous baffles were installed and grass was establishing on internal banks and external slopes of basin. No non-porous baffles or skimmer outlet structure installed. <b>S07B</b> was discharging into confluence of <b>Stream 1-A</b> and <b>Stream 2</b> (see photos 16-17).		<div> <div> DIRECTION 273 deg(T) </div> <div> 35.42783°N 089.43822°W </div> <div> ACCURACY 14 m DATUM WGS84 </div> </div>

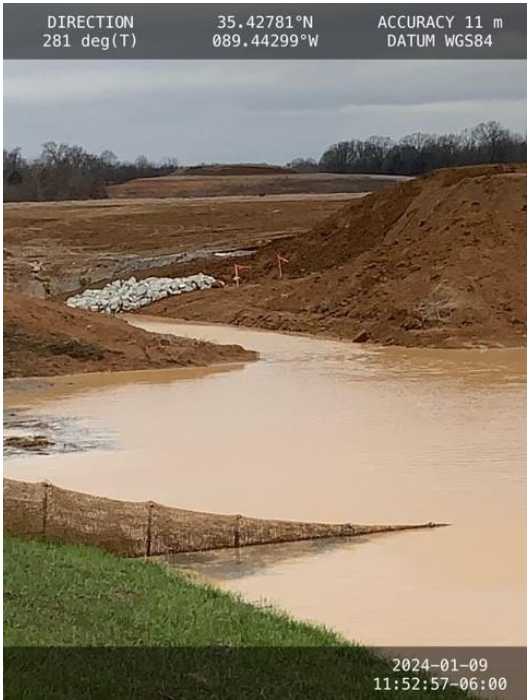
<div> 2024-01-09 11:52:57-06:00 </div>	
15	1-9-24		
<b>Description</b> View of discharge point of <b>S07B</b> sediment basin. Sediment-laden discharge entering confluence of <b>Stream 1-A</b> and <b>Stream 2</b> (see photos 16-17). No skimmer outlet control structure installed. <i>Recommended during site discussion, all internal components of sediment basin, including but not limited to the skimmer be installed immediately.</i>

- Considerable amount of sediment-laden discharge entering confluence of Stream 1-A, Stream 2 and Stream 9. *Recommended during site discussion, all internal components of sediment basin, including but not limited to the skimmer be installed immediately. Recommended during the site discussion to stabilize all slopes.*
  - ❖ **S07A**-Couldn't access because of muddy conditions

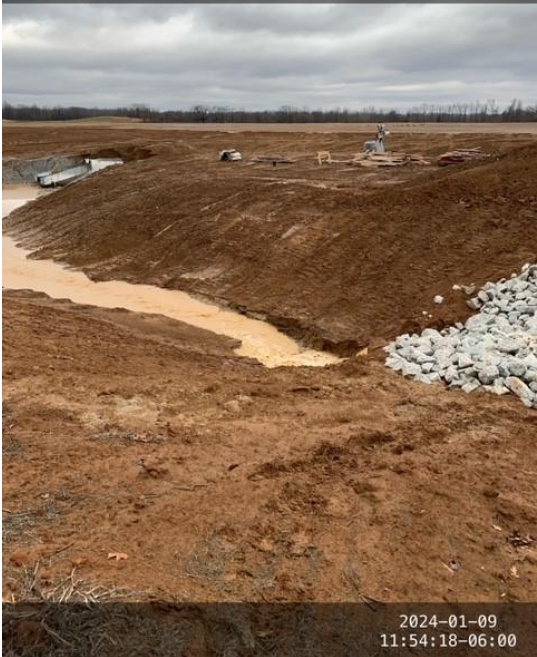
Project:		Site Location:		Permit No.:
Memphis Regional Megasite-Blue Oval City		S. of Keeling Road, W. of Hwy 222		TN0082368
Photo No.	Date			
16	1-9-24			
<b>Description</b> Another view of discharge point of <b>S07B</b> sediment basin at <b>SW7</b> . Sediment-laden discharge entering confluence of <b>Stream 1-A</b> and <b>Stream 2</b> . Slopes surrounding this area were not stabilized. <i>Recommended during the site discussion to stabilize all slopes.</i>		<div> <div> DIRECTION 330 deg(T) </div> <div> 35.42794°N 089.44360°W </div> <div> ACCURACY 11 m DATUM WGS84 </div> </div>

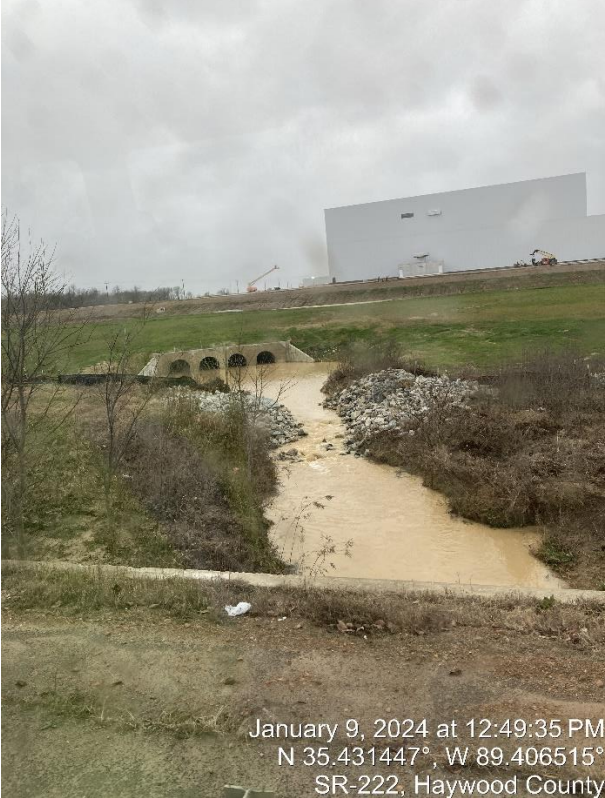
Project:		Site Location:	Permit No.:
Memphis Regional Megasite-Blue Oval City		S. of Keeling Road, W. of Hwy 222	TN0082368
Photo No.	Date		
19	1-9-24		
<b>Description</b> View of sediment-laden discharge from <b>S01A</b> and <b>S01B</b> via <b>SW1</b> entering <b>Stream 4-A</b> . Site representatives stated that culvert road crossing east of Hwy 222 at times constricts flow in stream channel and discharge from site.
