STATE OF TENNESSEE
DEPARTMENT OF ENVIRONMENT AND CONSERVATION
DIVISION OF WATER RESOURCES

August 29, 2023

RE: Follow-up Site Inspection
 Blue Oval City – Ford Motor Company
 NPDES Permit Number TN0082368
 Haywood County, Tennessee

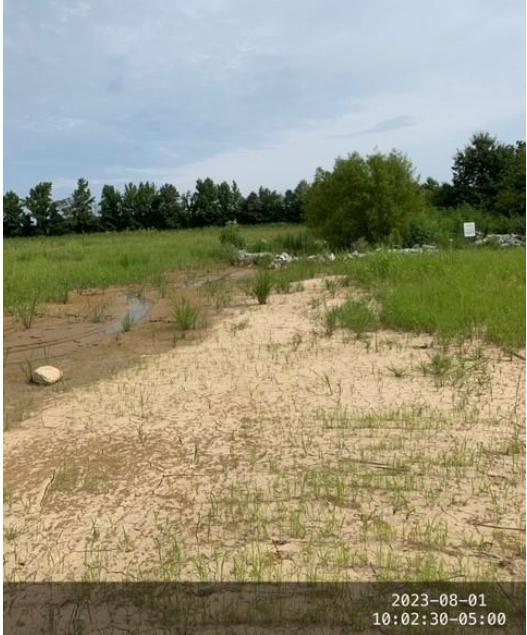
- **Outfall #2/Sediment Basin S02A** (*Photos 1-3*)-The sediment basin outlet structure was installed, including the skimmer device. However, other internal components of the basin had not been fully completed per the submitted EPSC Plans as required such as the forebay, baffles, etc. The inner slopes and surrounding area of the sediment basin had been seeded and covered with hay. Vegetative establishment was observed; however, some areas were sparsely stabilized. Hydroseed was reported to be used on the inner slopes along the water edge within the sediment basin. A rock check dam was

Project:		Site Location:	Permit No.:
Blue Oval City – Ford Motor Company		Stanton, Haywood County	TN0082368
Photo No.	Date		
1	8/1/23		
Description Photo is the area downgradient of Sediment Basin S02A, upgradient of Outfall #2. Area was stabilized with vegetation in some areas, but had sparse vegetative cover in other areas as well. Water was observed discharging at Outfall #2, but was clear.		<div> <div> DIRECTION 354 deg(T) </div> <div> 35.43810°N 089.40661°W </div> <div> ACCURACY 9 m DATUM WGS84 </div> </div>

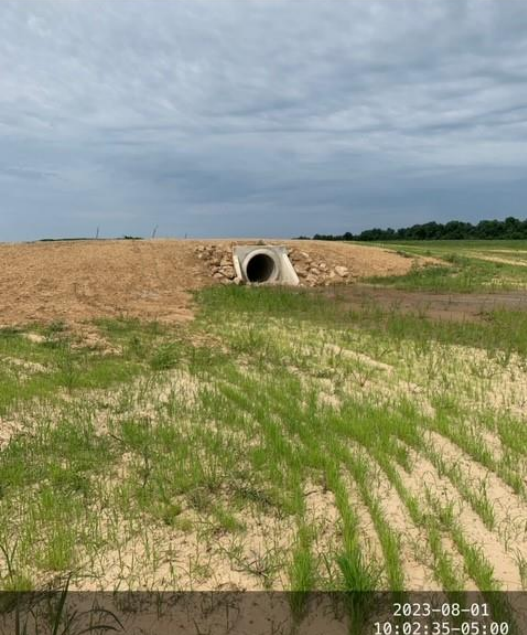
<div> 2023-08-01 10:02:30-05:00 </div>	
Photo No.	Date		
2	8/1/23		
Description View of the outfall pipe of Sediment Basin S02A, which discharges towards the area shown in photo 1 and Outfall #2. Vegetation was establishing in areas, but outside slope of basin was not stabilized.		<div> <div> DIRECTION 251 deg(T) </div> <div> 35.43810°N 089.40664°W </div> <div> ACCURACY 8 m DATUM WGS84 </div> </div>

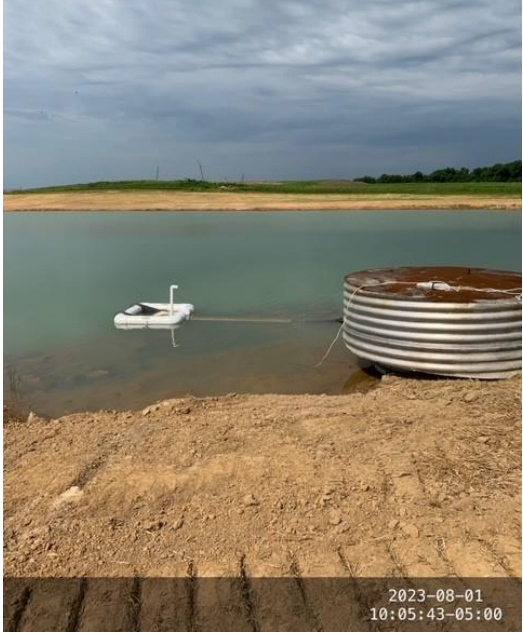
installed at Outfall #2. Clear water was observed within the sediment basin and discharging to Outfall #2.

Project:		Site Location:	Permit No.:
Blue Oval City – Ford Motor Company		Stanton, Haywood County	TN0082368
Photo No.	Date		
3	8/1/23		
Description View of Sediment Basin S02A principal spillway, including the skimmer device. Water in the basin appeared clear and was discharging at Outfall #2. Portions of the sediment basin banks were covered with seed/hay. The area along the water's edge will be hydroseeded. Other areas were not stabilized.		<div style="display: flex; justify-content: space-between; font-size: 0.8em;"> DIRECTION 248 deg(T) 35.43697°N 089.40780°W ACCURACY 65 m DATUM WGS84 </div>

- 1) On or before **September 15, 2023**, submit a written response providing information regarding why sediment basins have not been installed as shown on submitted EPSC plans (i.e. skimmer, porous and non-porous baffles, forebay, etc). If a sediment basin cannot be or will not be implemented per the EPSC plan design including all internal components, then a justification as to why the plans have not been or will not be followed should be submitted explaining the equivalent control measure that is being substituted.

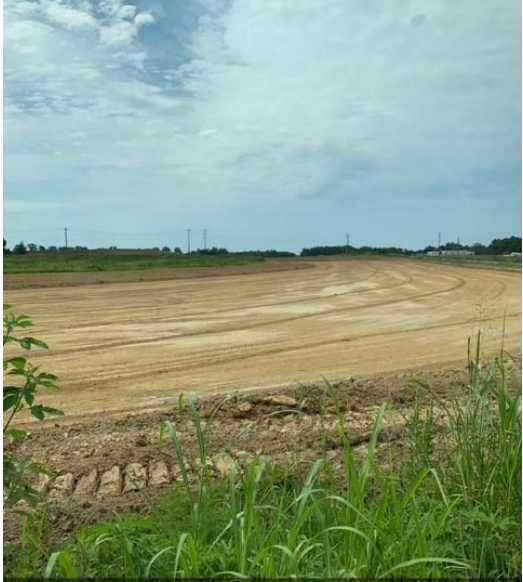
- **Outfall #17A**-The upgradient area associated with Outfall #17A (*Photo 5*) recently started construction and was being graded. Please ensure EPSC associated with this area are installed and functional.

Project:		Site Location:	Permit No.:
Blue Oval City – Ford Motor Company		Stanton, Haywood County	TN0082368
Photo No.	Date		
5	8/1/23		
Description View of recent grading work upgradient and associated with Outfall #17A.		<div> <div> DIRECTION 167 deg(T) 35.43639°N 089.46882°W ACCURACY 11 m DATUM WGS84 </div>

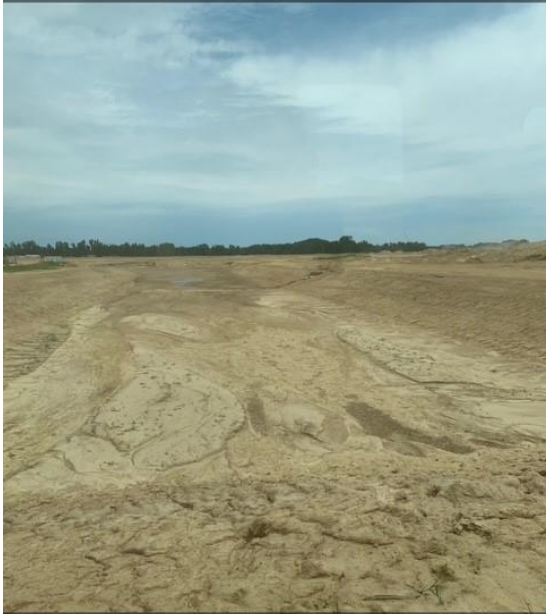
- **Sediment Basin S07B** (*Photo 6*)-Sediment Basin S07B was recently installed/graded. No internal components of the basin such as the porous and non-porous baffles nor the forebay were observed installed. The principal riser pipe and skimmer were not installed, only a rip rap check dam at the discharge point of the basin. Sediment Basin S07B discharges to Outfall #7. No discharge observed during inspection. Area north of S07BA graded for parking lot construction, but storm drain inlets have not yet been installed. All internal components of the basin should be installed per submitted EPSC plans.

<div> 2023-08-01 10:29:36-05:00 </div> </div>	
Photo No.	Date		
6	8/1/23		
Description View looking north at the southern edge of Sediment Basin S07B. Basin was recently installed/graded. No porous or non-porous baffles were observed installed. Principal riser pipe and skimmer were not installed, only a rip rap check dam at the discharge point of the basin. Sediment Basin S07B discharges to Outfall #7. No discharge observed during inspection. Sediment Basin S07A (to the east of this location) was under construction.		<div> <div> DIRECTION 16 deg(T) 35.42625°N 089.43742°W ACCURACY 8 m DATUM WGS84 </div>

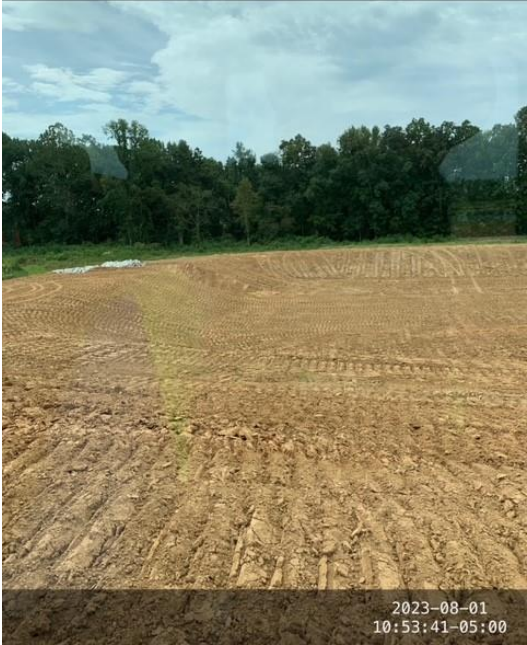
- **Sediment Basin S12A** (*Photo 7*)-Sediment Basin S12A was recently installed/graded. No internal components of the basin such as the porous and non-porous baffles nor forebay were observed installed. The principal riser pipe and skimmer were not installed, only a rip rap check dam at the discharge point of the basin. Sediment Basin S12A discharges to Outfall #7. No discharge observed during inspection. All internal components of the basin should be installed per submitted EPSC plans.

Project:		Site Location:	Permit No.:
Blue Oval City – Ford Motor Company		Stanton, Haywood County	TN0082368
Photo No.	Date		
7	8/1/23		
Description View looking at downgradient end of Sediment Basin S12A. Basin was recently installed/graded. No porous or non-porous baffles were observed installed. Principal riser pipe and skimmer were not installed, only a rip rap check dam at the discharge point of the basin. Sediment Basin S12A discharges to Outfall #7. No discharge observed during inspection.		<div style="display: flex; justify-content: space-between; font-size: 0.8em;"> DIRECTION 173 deg(T) 35.42844°N 089.44497°W ACCURACY 9 m DATUM WGS84 </div>

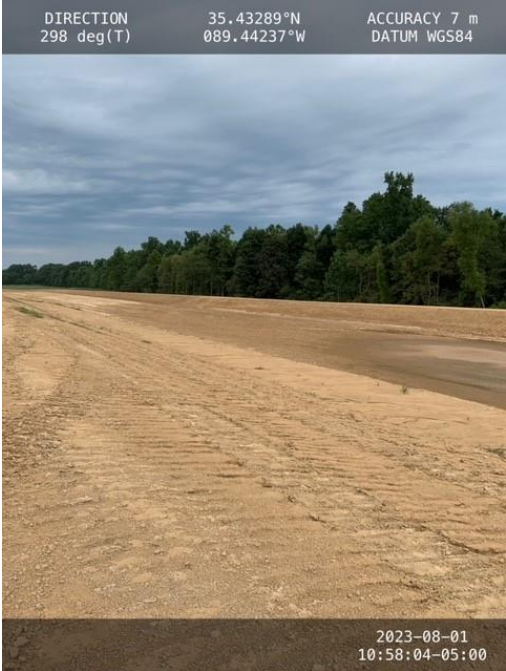
- **Sediment Basin S11A** (*Photos 8, 9 and 11*)-Sediment Basin S11A was recently installed/graded. No internal components of the basin such as the porous and non-porous baffles nor forebay were observed installed. The principal riser pipe and skimmer were not installed, only a rip rap check dam at the discharge point of the basin (*Photo 9*). Sediment Basin S11A discharges to Outfall #6. No discharge observed during inspection. Area surrounding the discharge point (*Photo 11*) was not stabilized, but appeared to be actively under construction. All internal components of the basin should be installed per submitted EPSC plans.

<div style="text-align: right; font-size: 0.7em;"> 2023-08-01 10:53:41-05:00 </div>	
Photo No.	Date		
8	8/1/23		
Description View of upgradient end of Sediment Basin S11A. Basin was recently installed/graded. No porous or non-porous baffles were observed installed. Principal riser pipe and skimmer were not installed, only a rip rap check dam at the discharge point of the basin (see photo 11). Sediment Basin S11A discharges to Outfall #6. No discharge observed during inspection.		<div style="display: flex; justify-content: space-between; font-size: 0.8em;"> DIRECTION 298 deg(T) 35.43289°N 089.44237°W ACCURACY 7 m DATUM WGS84 </div>

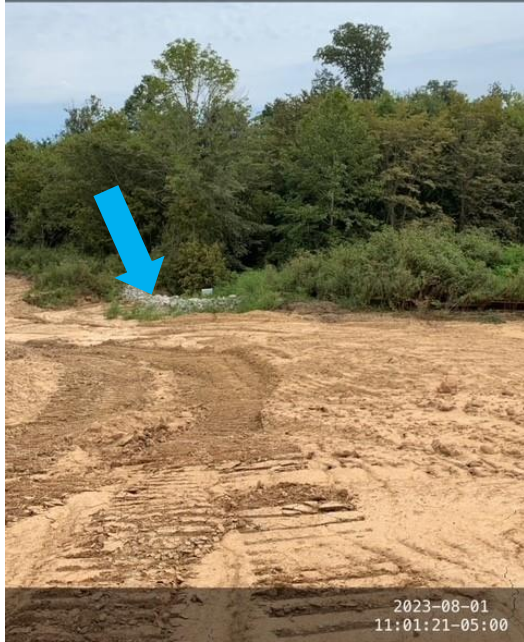
Project:		Site Location:	Permit No.:
Blue Oval City – Ford Motor Company		Stanton, Haywood County	TN0082368
Photo No.	Date		
9	8/1/23		
Description View of the discharge point of Sediment Basin S11A. Basin was recently installed/graded. No porous or non-porous baffles were observed installed. Principal riser pipe and skimmer were not installed, only a rip rap check dam at the discharge point of the basin. Sediment Basin S11A discharges to Outfall #6. No discharge observed during inspection.		<div style="background-color: #444; color: white; padding: 2px; font-size: 0.8em;"> DIRECTION 35.43288°N ACCURACY 5 m 38 deg(T) 089.44236°W DATUM WGS84 </div>   <div style="text-align: right; font-size: 0.7em;"> 2023-08-01 10:58:08-05:00 </div>	
Photo No.	Date		
10	8/1/23		
Description View of area of site associated with Outfall #6 (yellow arrow-see photo 12), the discharge point of Sediment Basin S11A (blue arrow-see photo 11) and Sediment Basin S06A (green arrow). Rip rap check dam at Outfall #6 (see photo 12) and in upgradient locations within channel to be replaced with box culvert.		<div style="background-color: #444; color: white; padding: 2px; font-size: 0.8em;"> DIRECTION 35.43289°N ACCURACY 9 m 76 deg(T) 089.44199°W DATUM WGS84 </div>   <div style="text-align: right; font-size: 0.7em;"> 2023-08-01 11:00:09-05:00 </div>

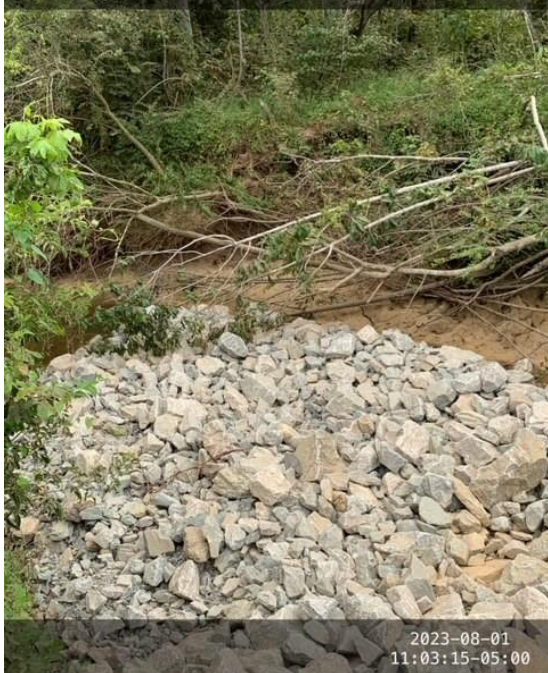
- **Outfall #6** (*Photos 10-12*)-Sediment Basin S11A and Sediment Basin S06A discharge to Outfall #6. This outfall also received drainage from the area south/upgradient (*Photo 13*), including drainage from Outfall #7. The area downgradient/north of the point shown in photo 10 should remain unaltered. The area upgradient/south of the point shown in photo 10 will be mitigated and replaced with a box culvert. Stockpiles of sediment observed on either side of the mitigated stream channel (*Photo 13*), which will be used as fill once the box culvert is installed. Check dams were installed within the channel and silt fence along the toe of the slopes. No discharge observed during inspection.

<div>2023-08-0111:01:21-05:00</div>	
11	8/1/23		
Description View of discharge point of Sediment Basin S11A at Outfall #6 (blue arrow). Area surrounding the discharge point was not stabilized, but appeared to be actively under construction.

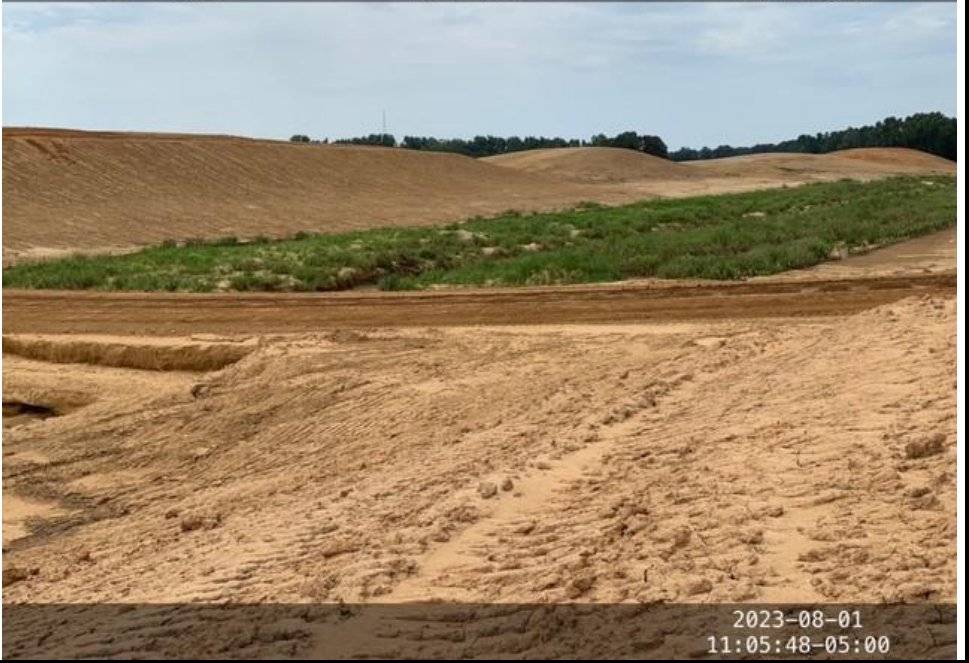
<div>2023-08-0111:03:15-05:00</div>	
12	8/1/23		
Description View of Outfall #6 within the channel. The area downgradient/north of this point is a stream channel to remain unaltered. The area upgradient/south of this point is being mitigated and will be replaced with a box culvert.

<div>2023-08-01 11:05:48-05:00</div>	
Description The area shown in this photo, upgradient/south of the point shown in photo 10, will be mitigated and replaced with a box culvert. Stockpiles of sediment observed on either side of the mitigated stream channel (photo 13), which will be used as fill once the box culvert is installed. Check dams were installed within the channel and silt fence along the toe of the slopes.			
Photo No.	Date	<div> <div>DIRECTION</div> <div>210 deg(T)</div> <div>35.41258°N</div> <div>089.40860°W</div> <div>ACCURACY 9 m</div> <div>DATUM WGS84</div> </div>	
14	8/1/23

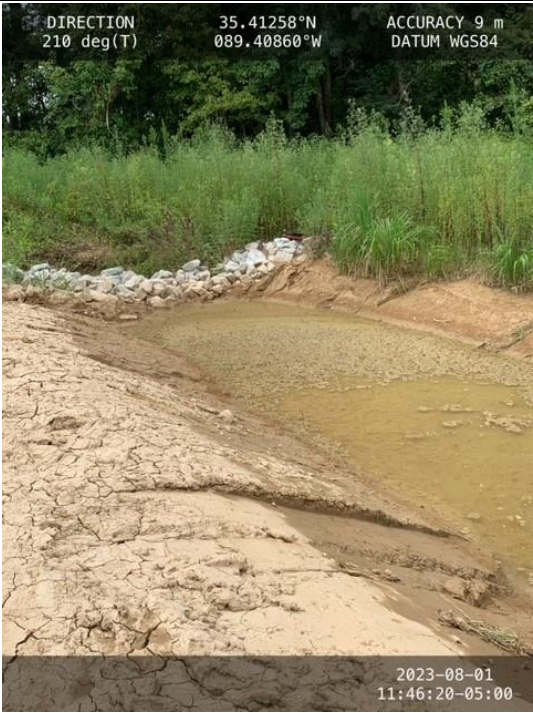
- **Outfall #9** (*Photo 14*)-The drainage swale upgradient of Outfall #9 was reported to be recently cleaned out (sediment removed) and check dams installed. No discharge observed during inspection.

Description The drainage swale associated with Outfall #9 had been recently cleaned out and check dams installed. This photo is example of check dam. No discharge at Outfall #9 was observed at the time of the inspection.

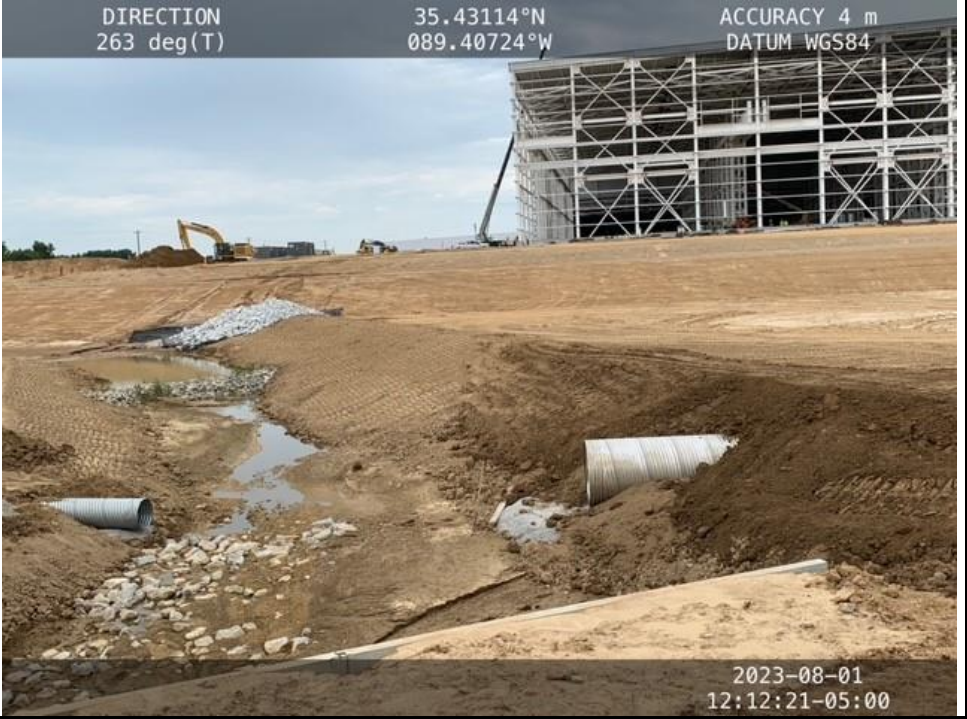
Description View of location between Sediment Basin S01B (photo 16) and Sediment Basin S01A (photo 18), which discharges to Outfall #1. Check dams observed.		<div>2023-08-01 12:12:21-05:00</div>	
Photo No.	Date	<div> <div>DIRECTION 313 deg(T)</div> <div>35.43115°N 089.40724°W</div> <div>ACCURACY 5 m DATUM WGS84</div> </div>	
18	8/1/23

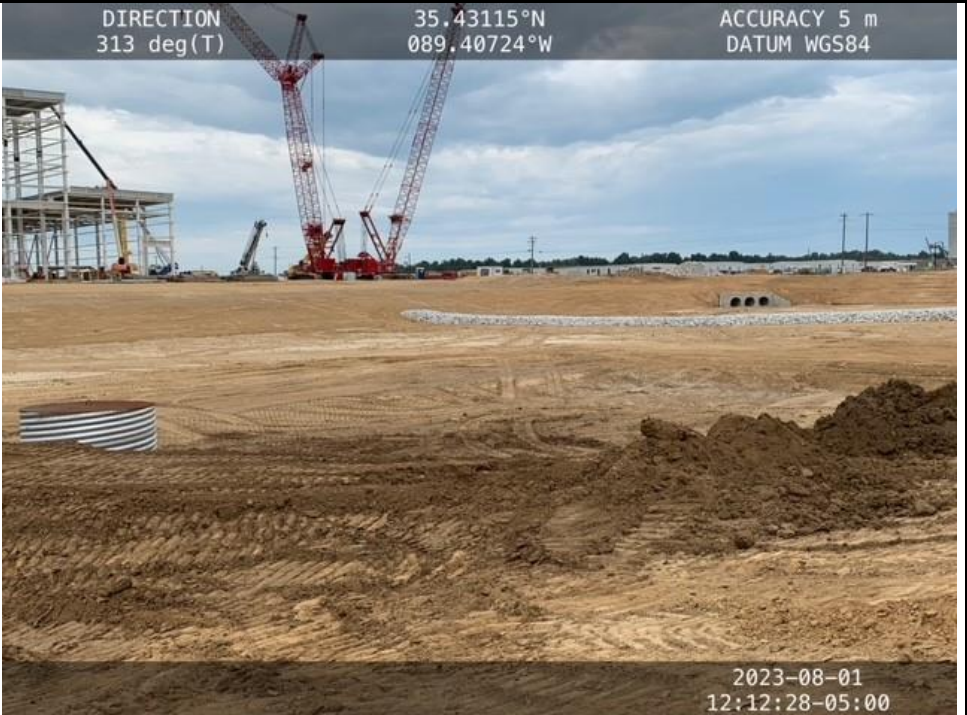
- **Sediment Basin S01A** (*Photo 16*) **and S01B** (*Photo 18*)- Sediment Basin S01B discharges to Outfall #1. Portion of S01B vegetated. Principal pipe installed in S01B, but skimmer was not installed yet. Baffles, forebay and skimmer not observed installed within S01B. Sediment Basin S01A discharges to Outfall #1. Rip rap berm installed within S01A, but baffles not observed installed. No skimmer device installed within S01A. Drainage channel between Sediment Basin S01B and Sediment Basin S01A (*Photo 17*), which discharges to Outfall #1 was not stabilized, but had check dams installed. All internal components of the basins should be installed per submitted EPSC plans.

Description View of Sediment Basin S01A, which discharges to Outfall #1. Rip rap berm installed, but baffles not observed installed. No skimmer device installed.		<div>2023-08-01 12:12:28-05:00</div>
