Date: April 13, 2020

RE: Hydrologic Determination Report  
Tony Nguyen Chicken Barns  
Greenfield, Weakley County, Tennessee

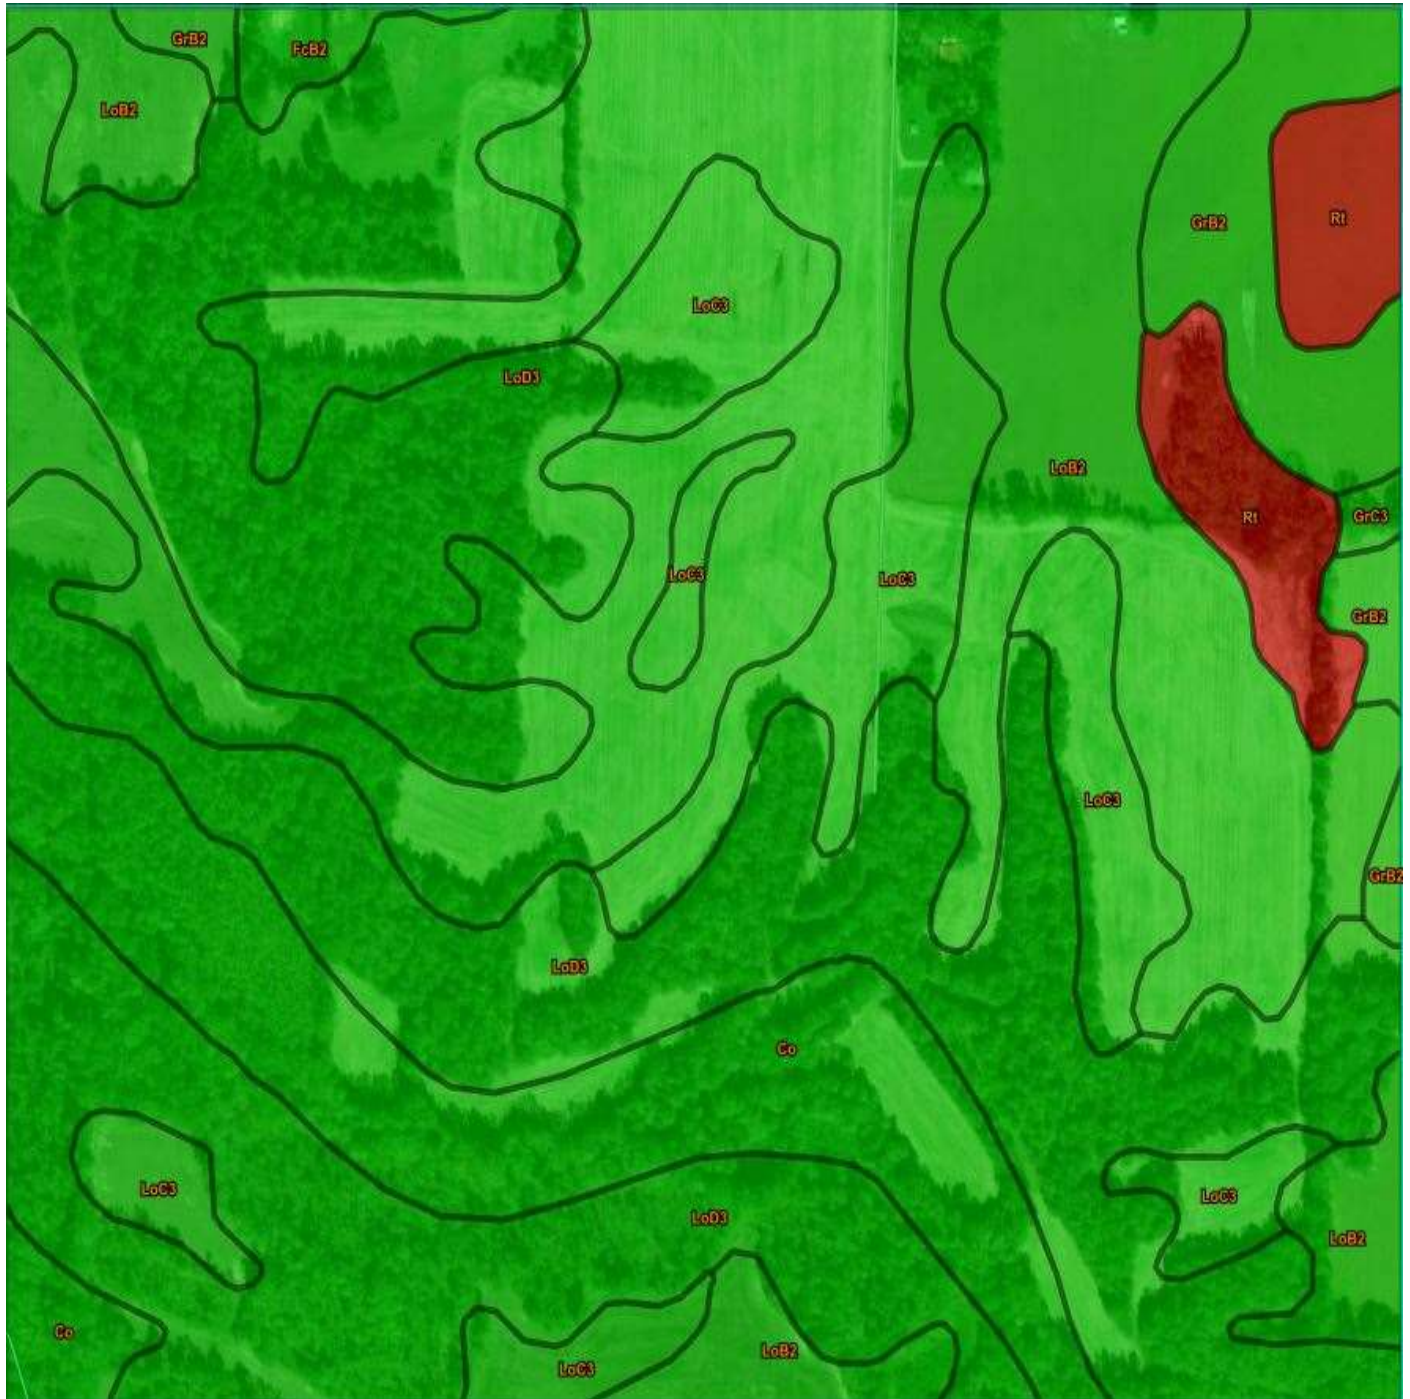
## SOIL MAP

This map shows the hydric soils rating for the determination area. The area highlighted in red better shows the outline of the wetland area that is feeding into Site 3 of this determination. The highlighted area is Ruten Silt Loam, 0% to 2% slopes.

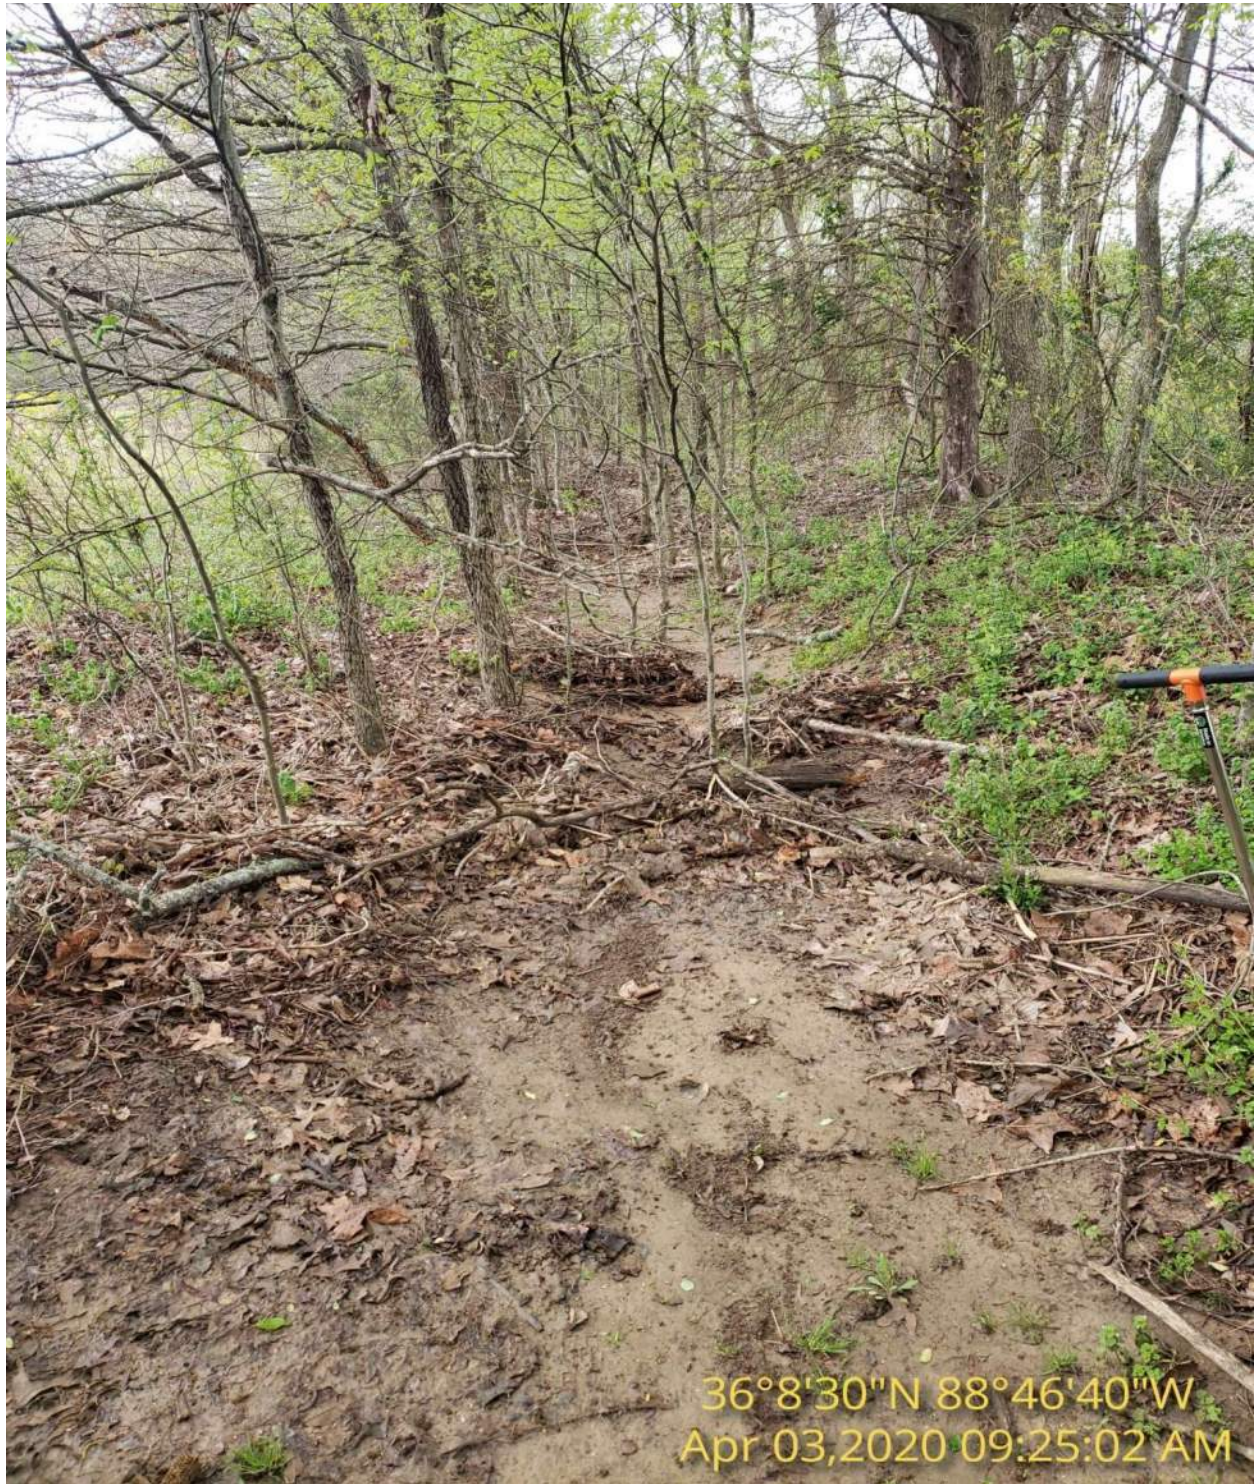
**PHOTO 1:** View of the channel looking west at the beginning.

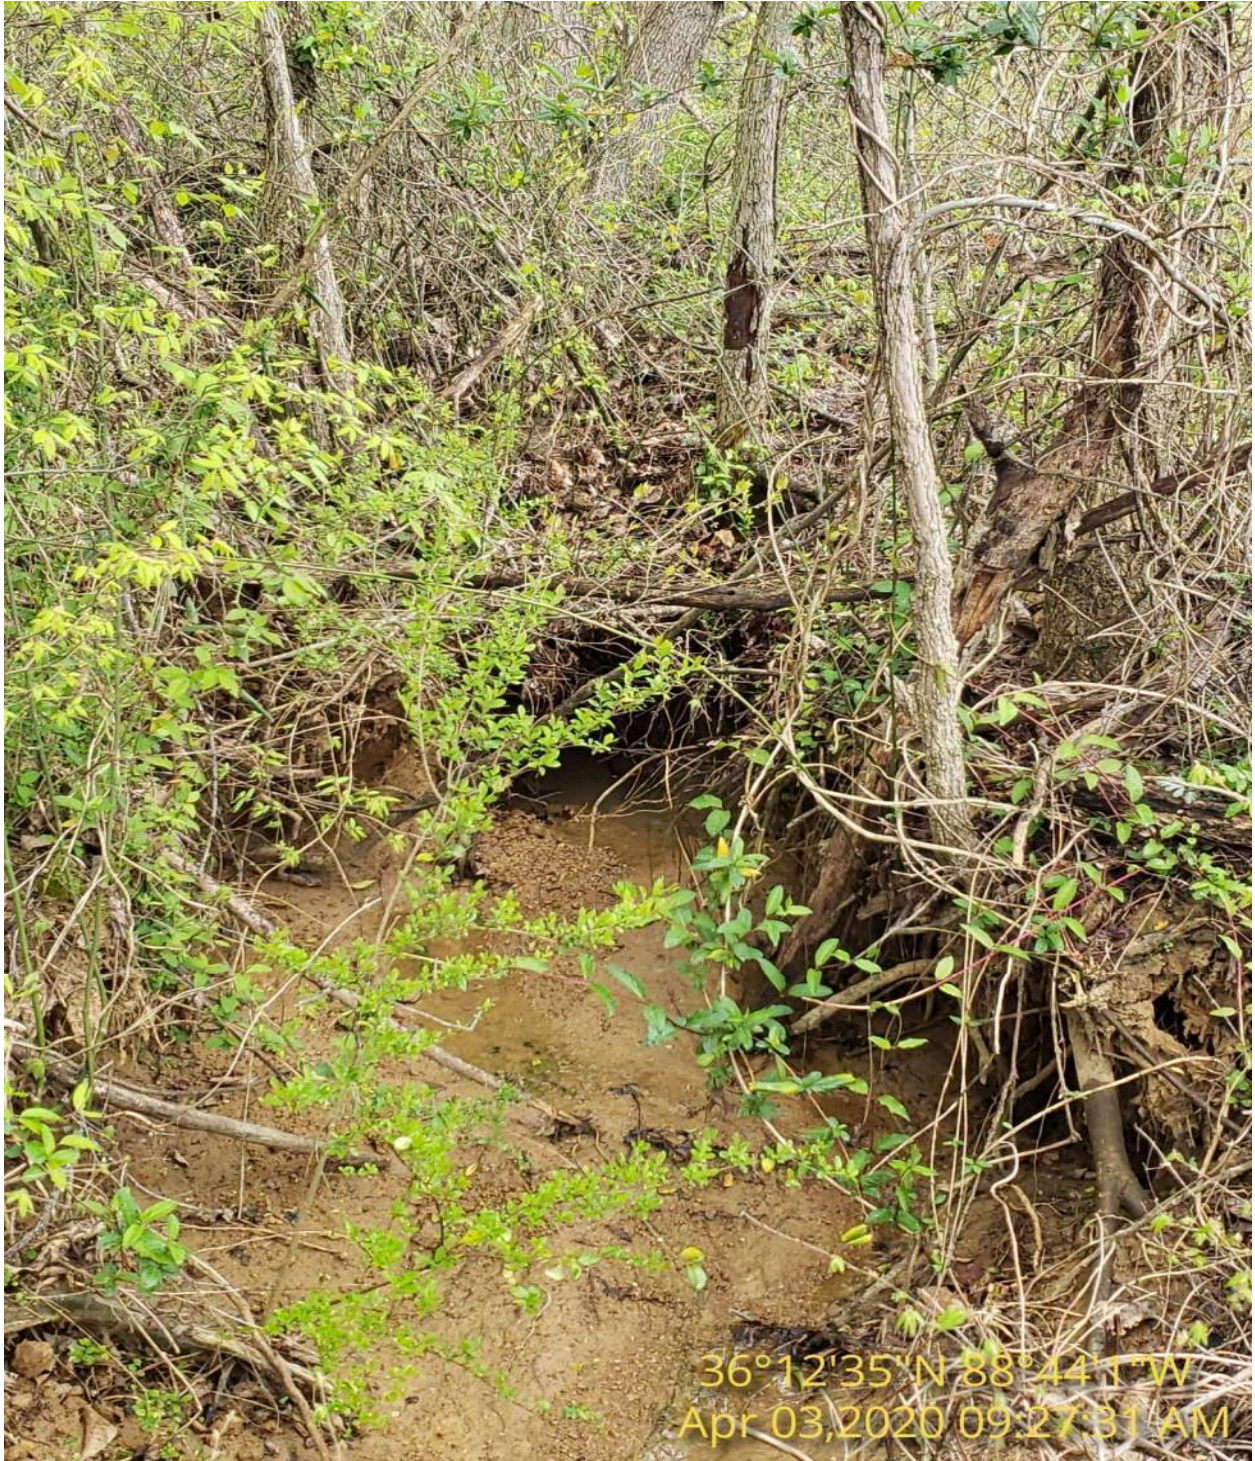
**PHOTO 2:** View of the channel looking east, showing a large grade control.

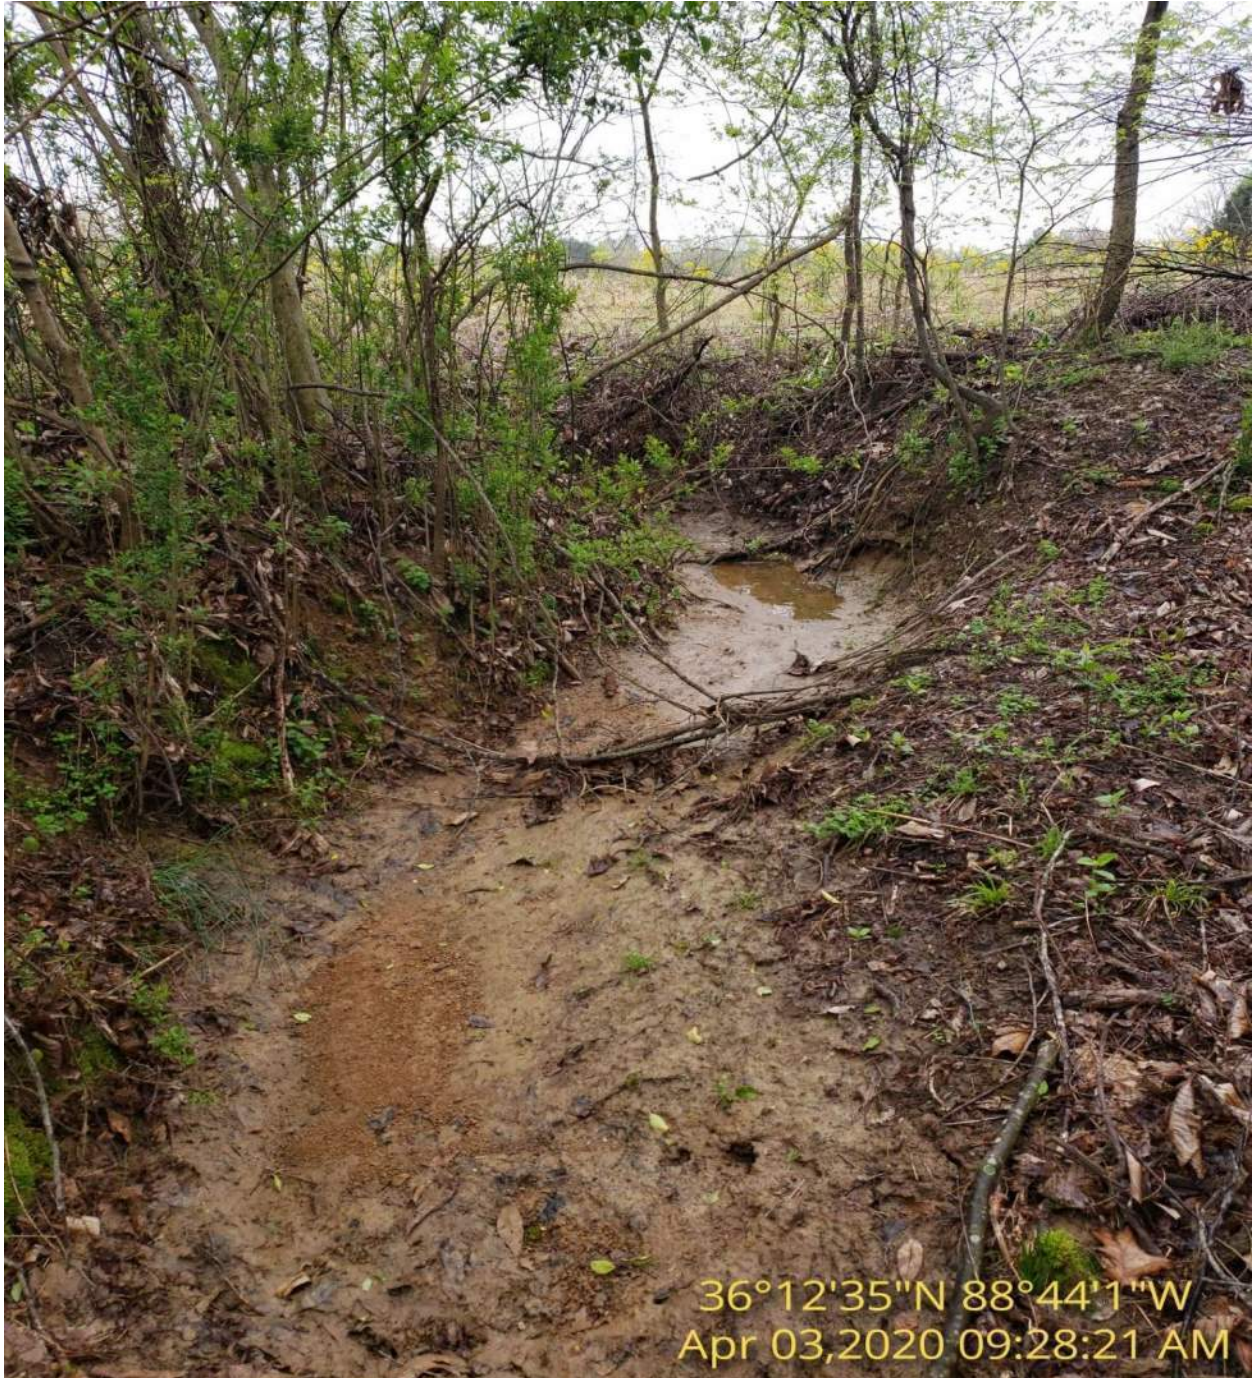
**PHOTO 3:** View of the channel looking north in a curve of the stream. Bed and Bank becoming more defined.

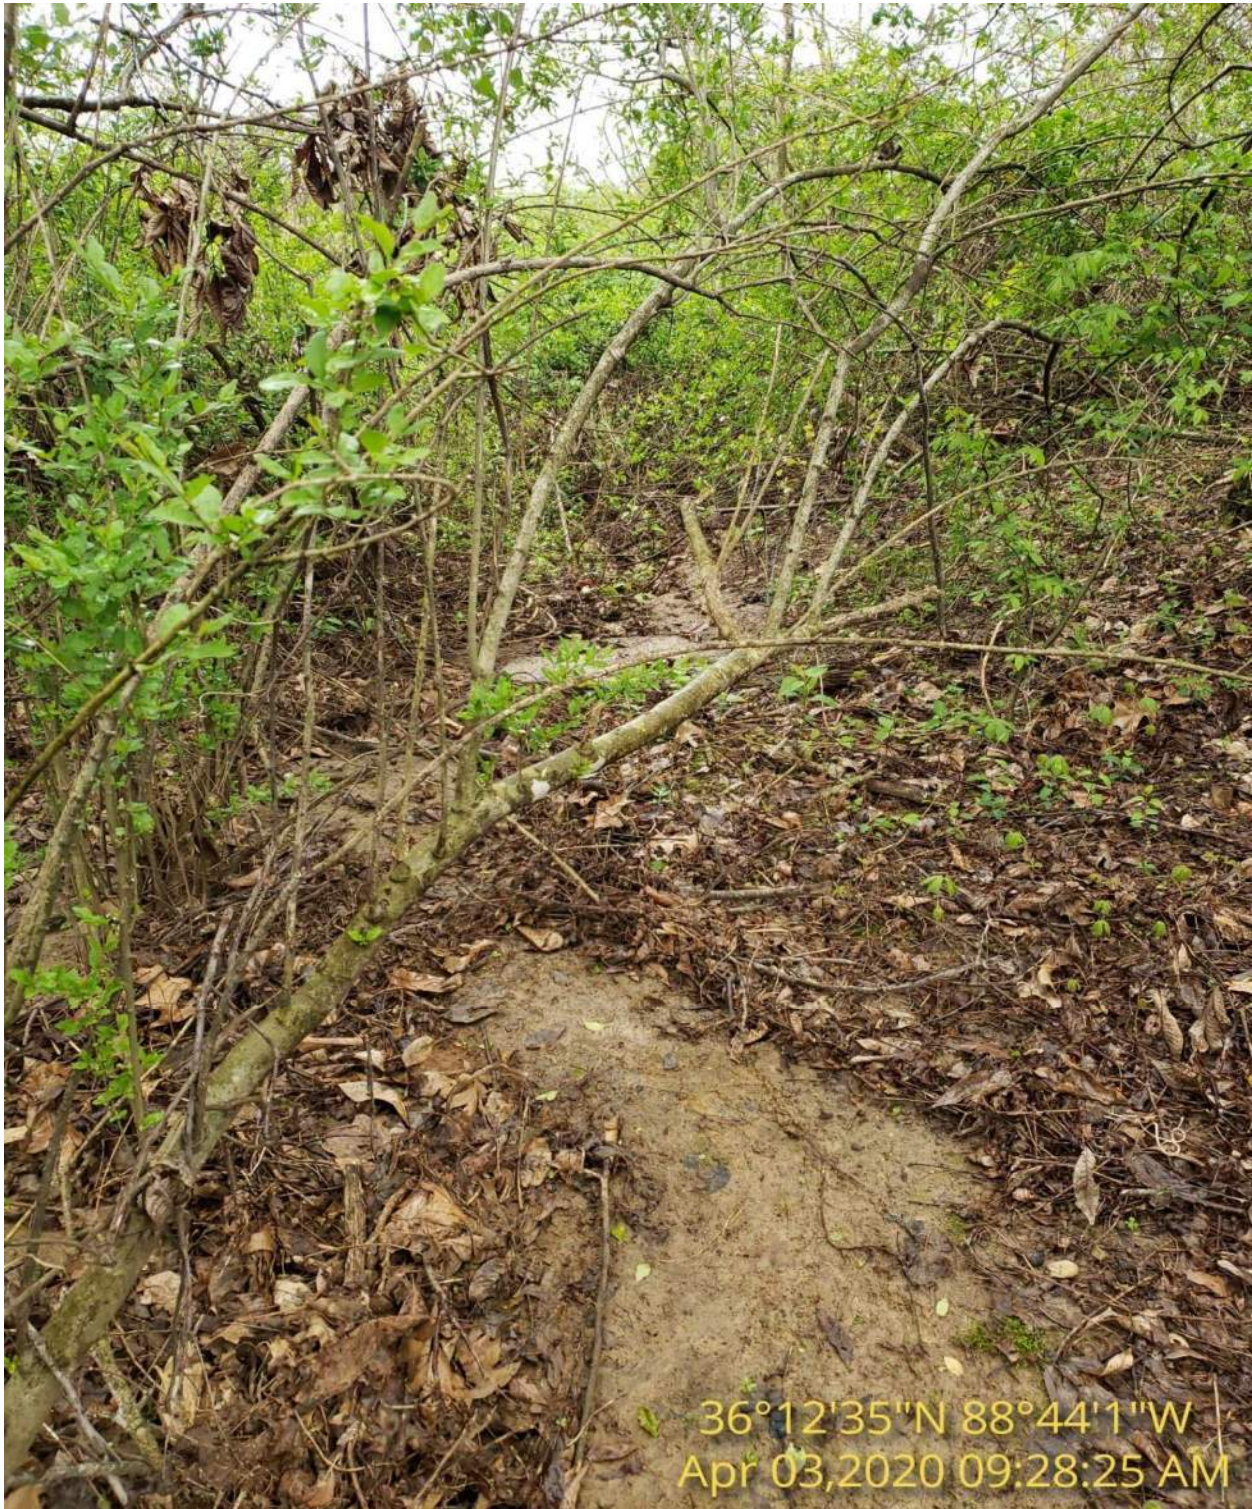
**PHOTO 4:** View of the wet weather conveyance this stream intersects facing east.

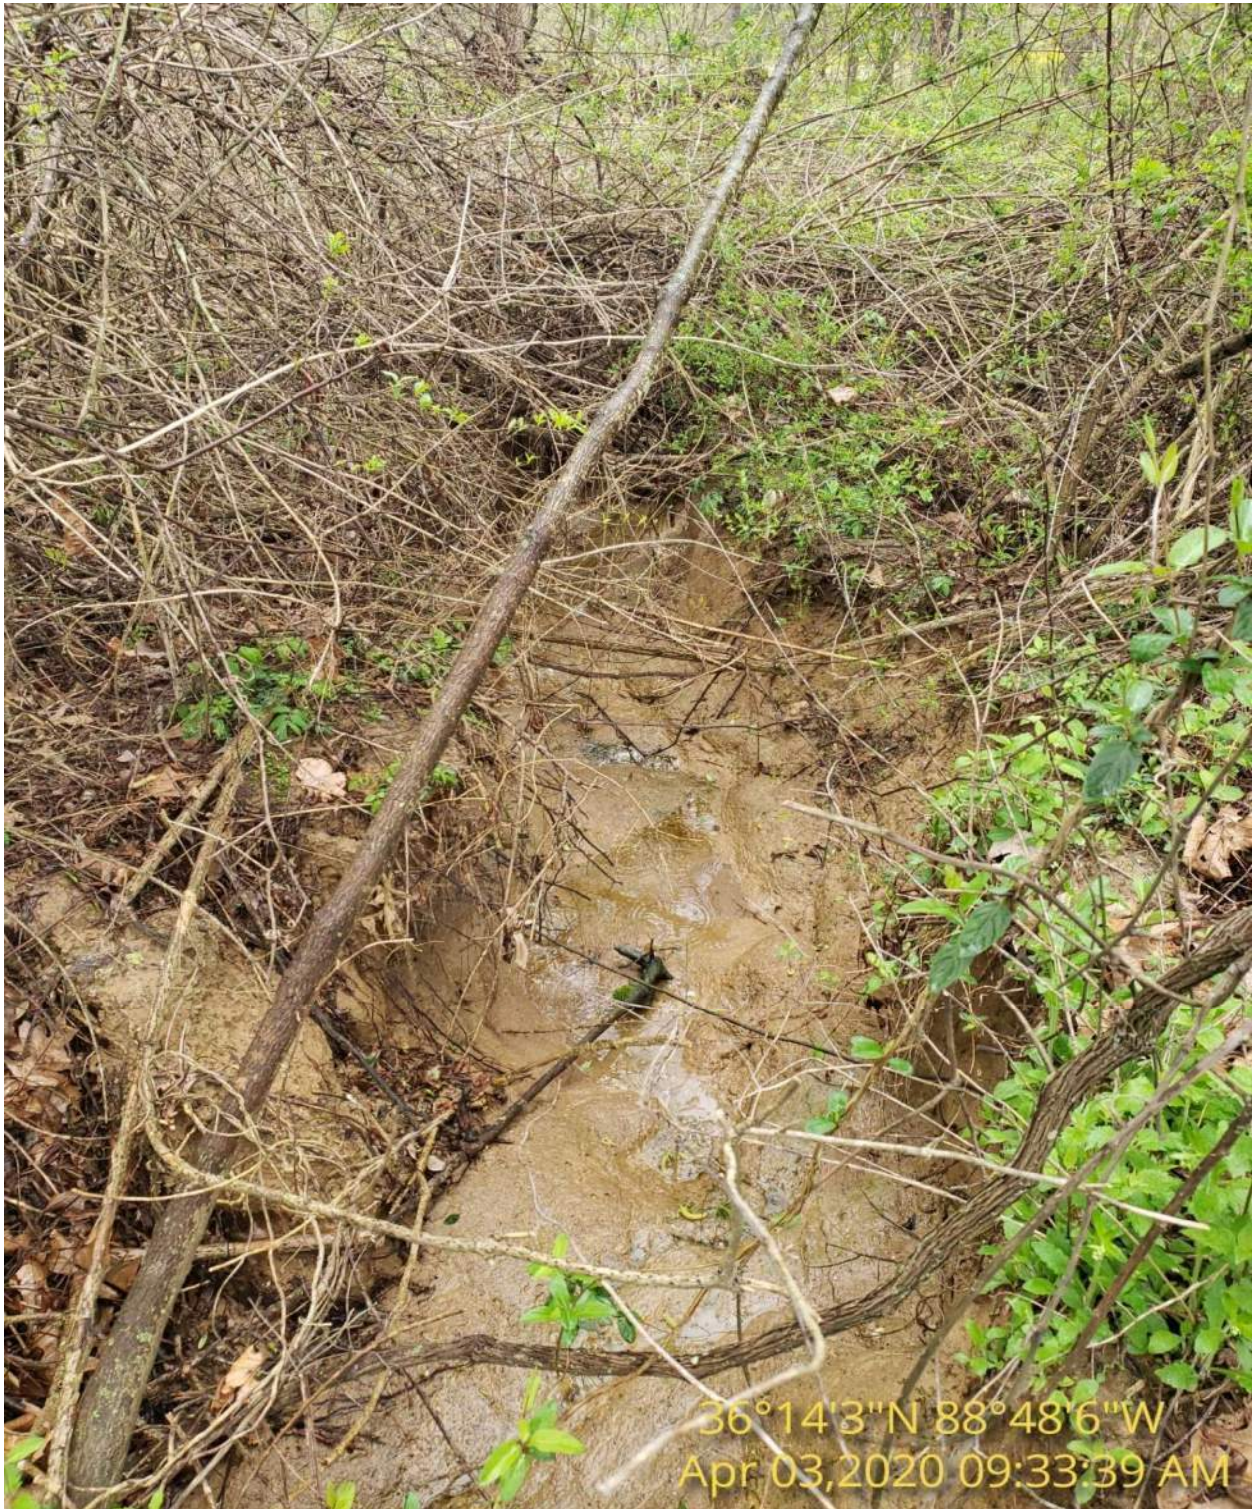
**PHOTO 5**: View of channel near intersection of wet weather conveyance looking west.

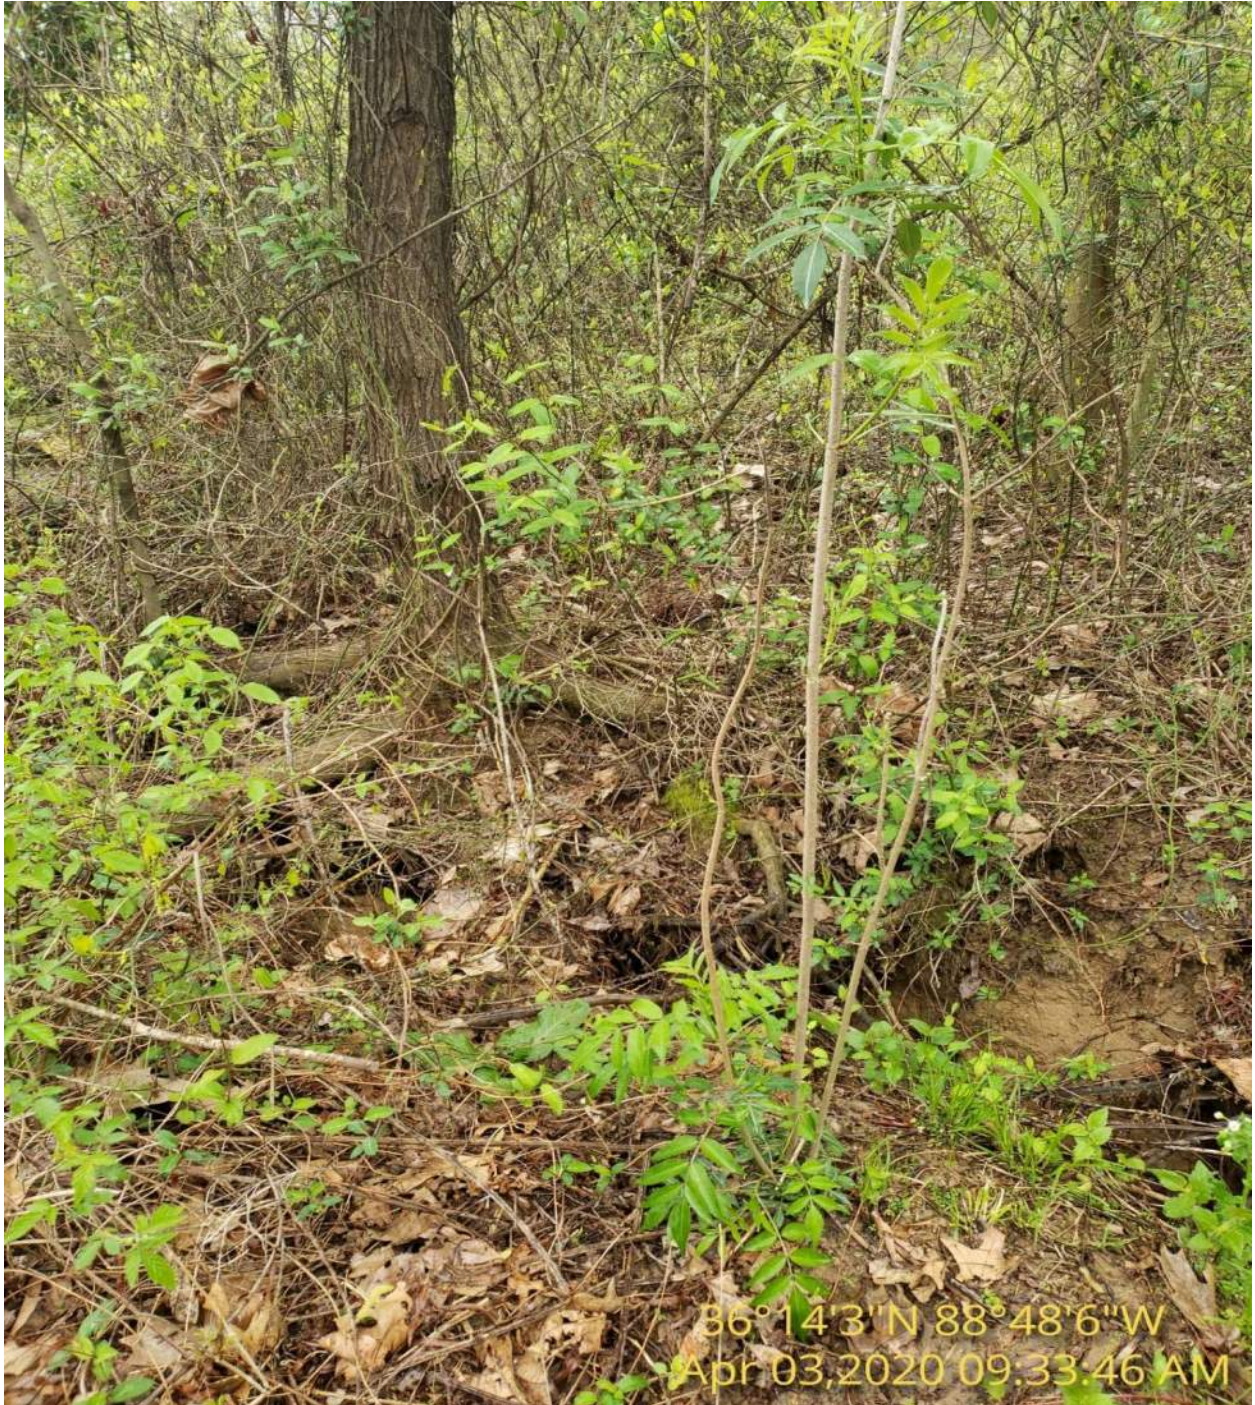
**PHOTO 6:** View of a large grade control as we continue west.

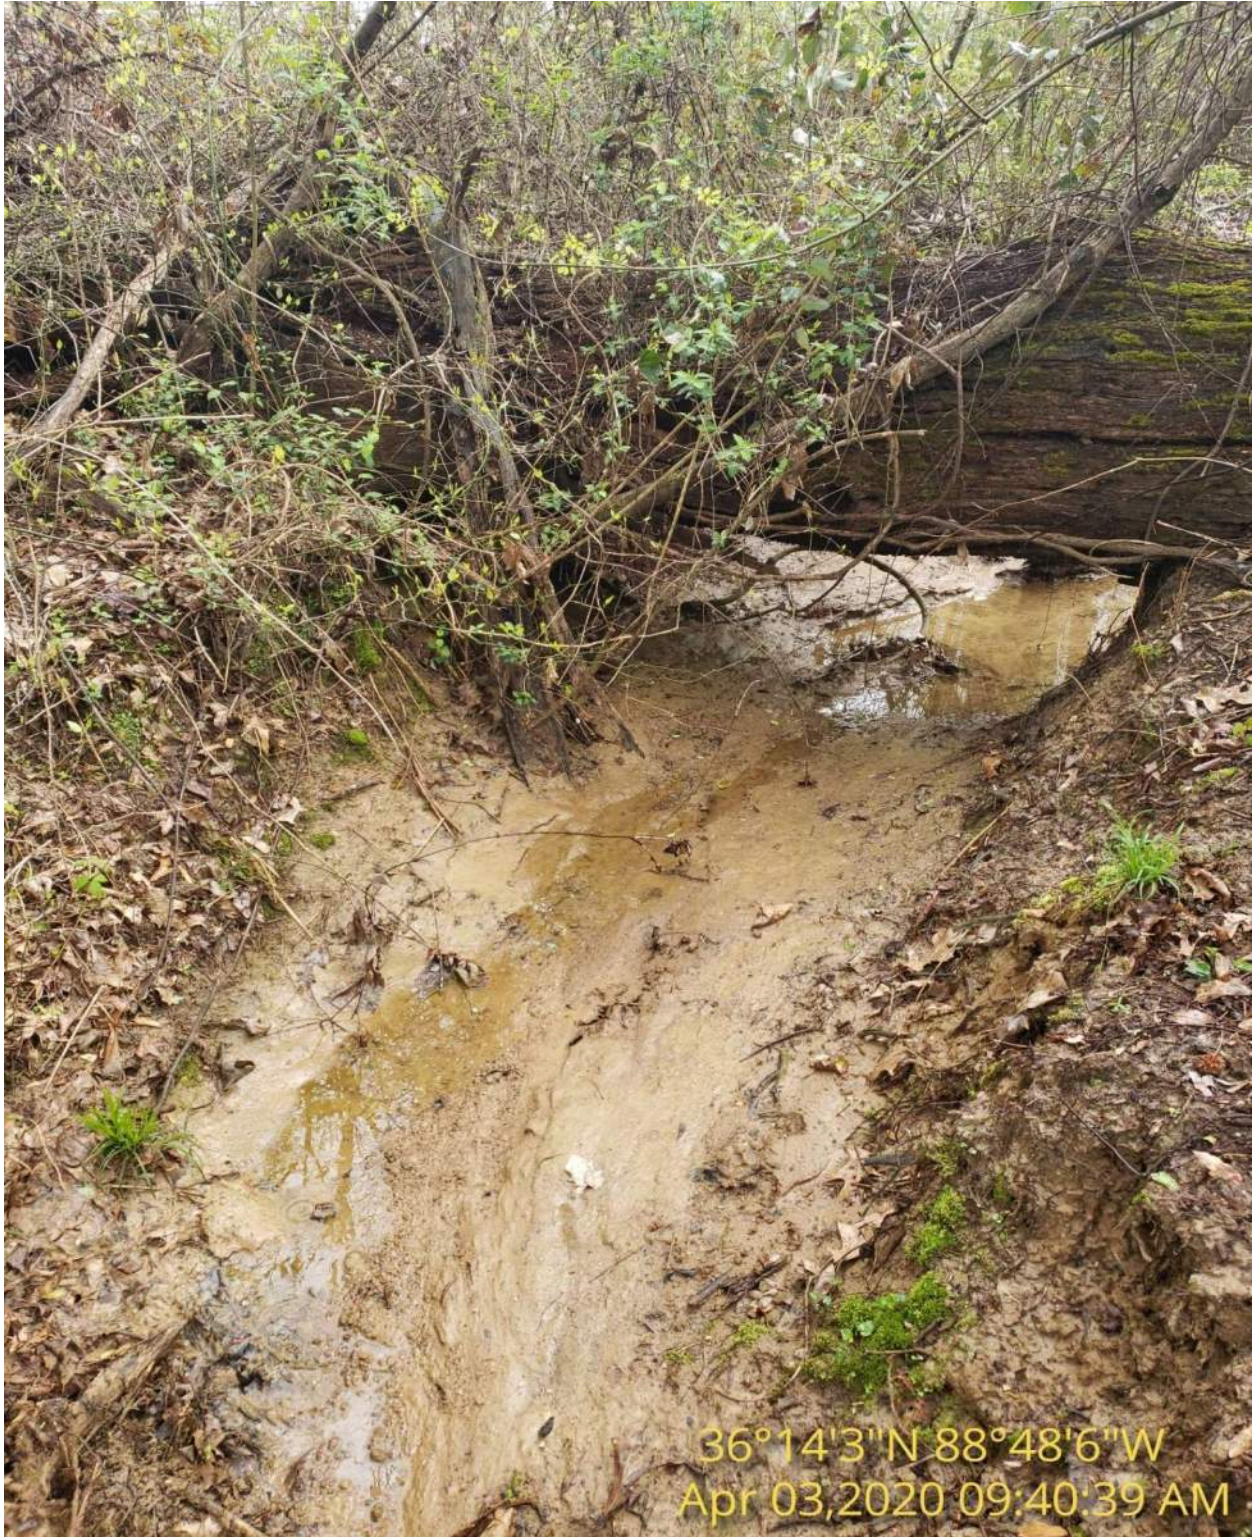
**PHOTO 7**: View of the channel looking west. Clear thalweg.

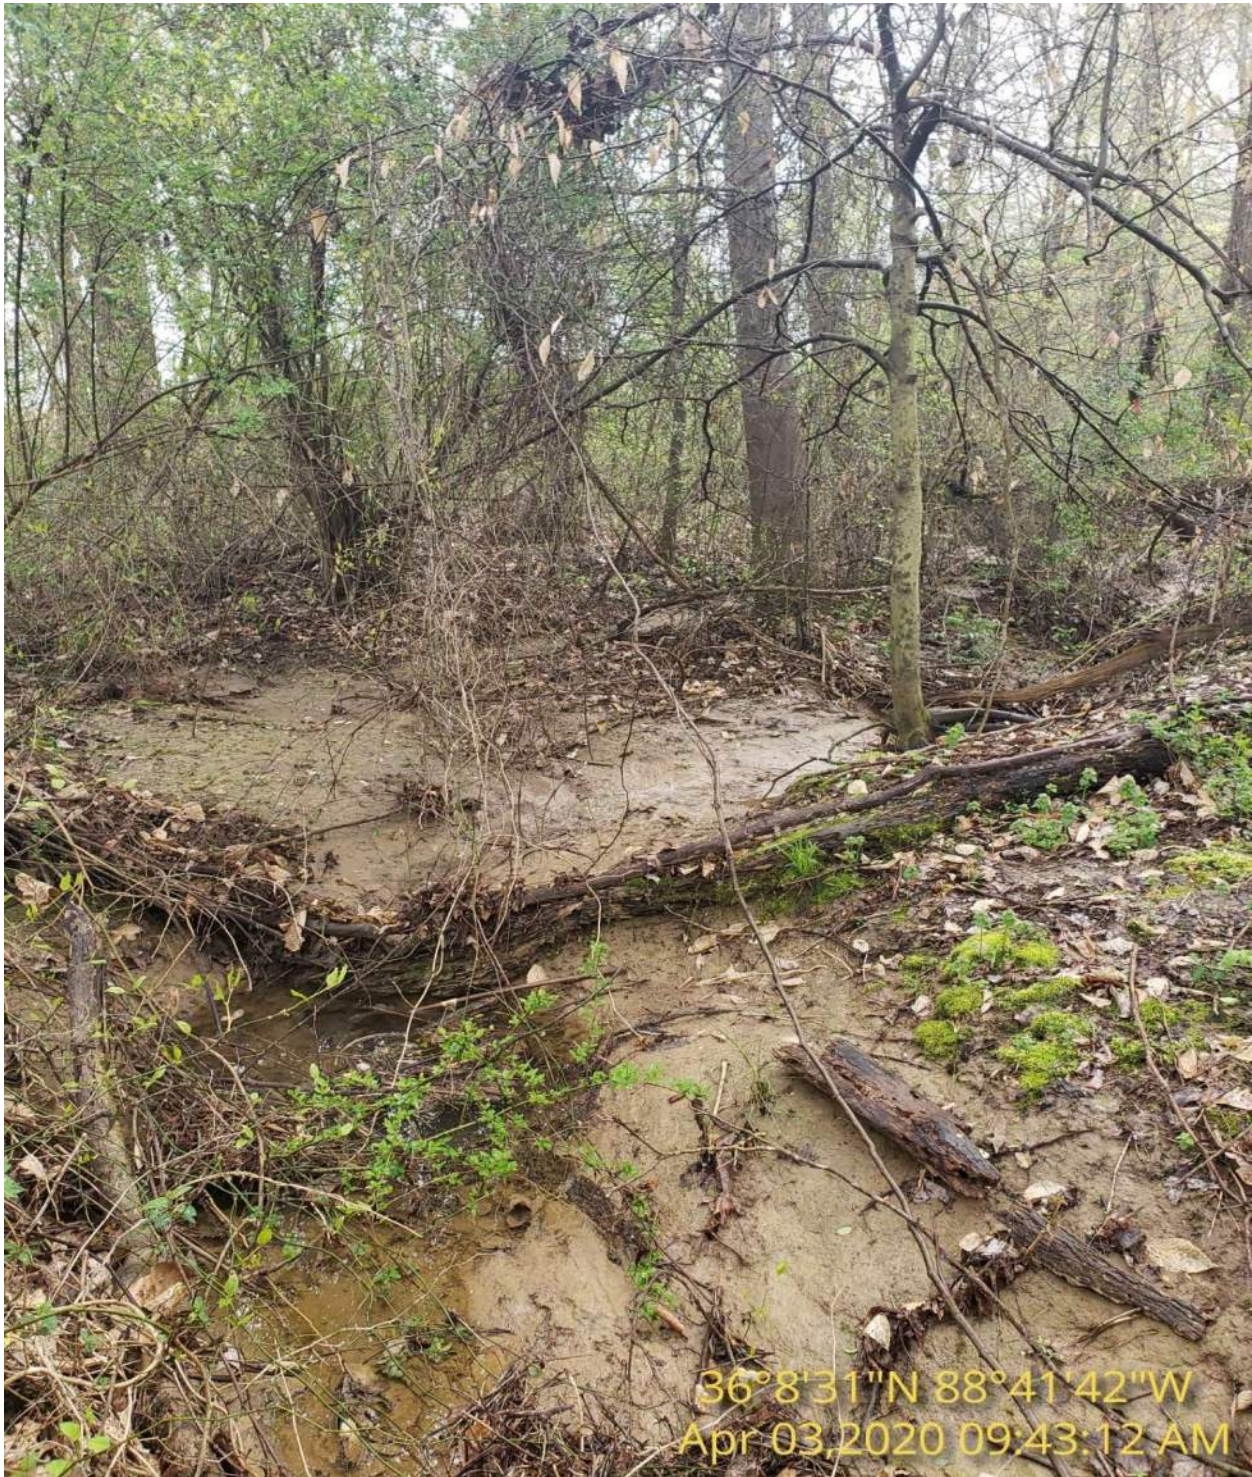
**PHOTO 8**: View of the channel looking east showing one section of a braid in the channel.

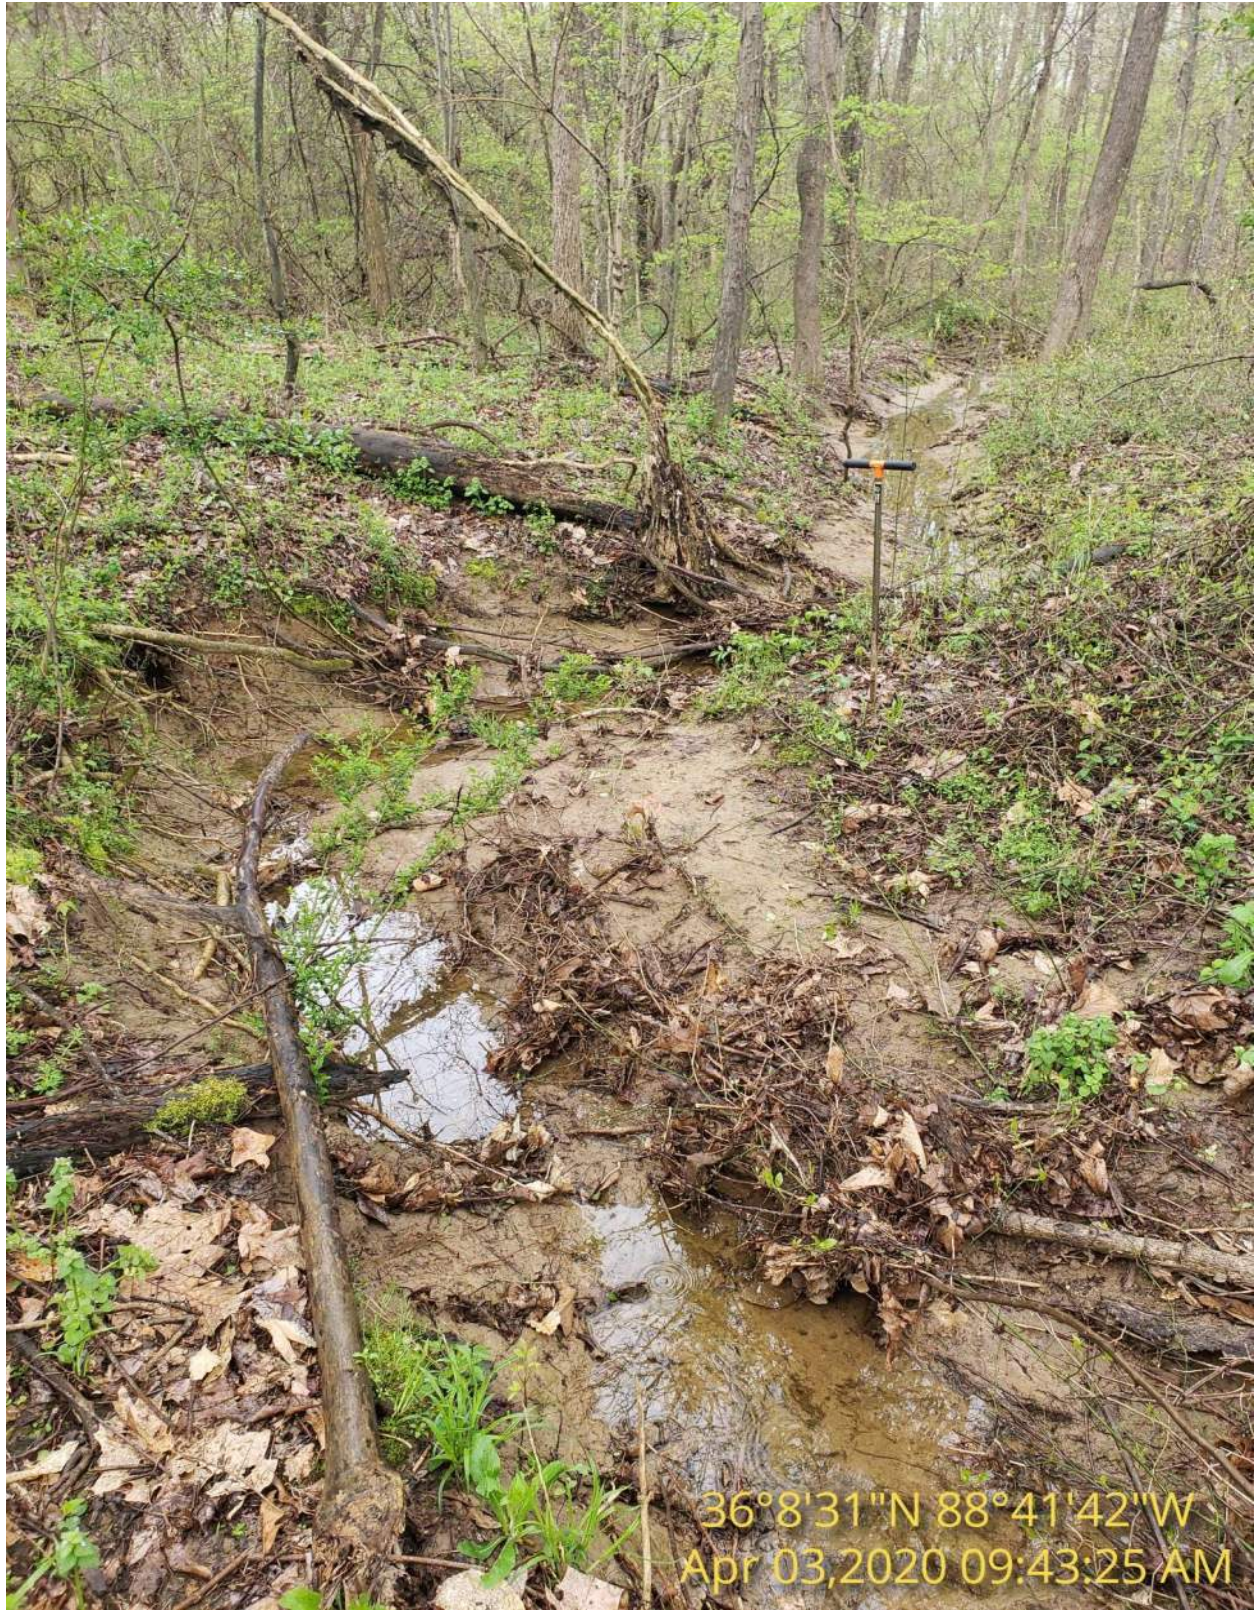
**PHOTO 9:** View of the channel looking west, showing some wrack lines.

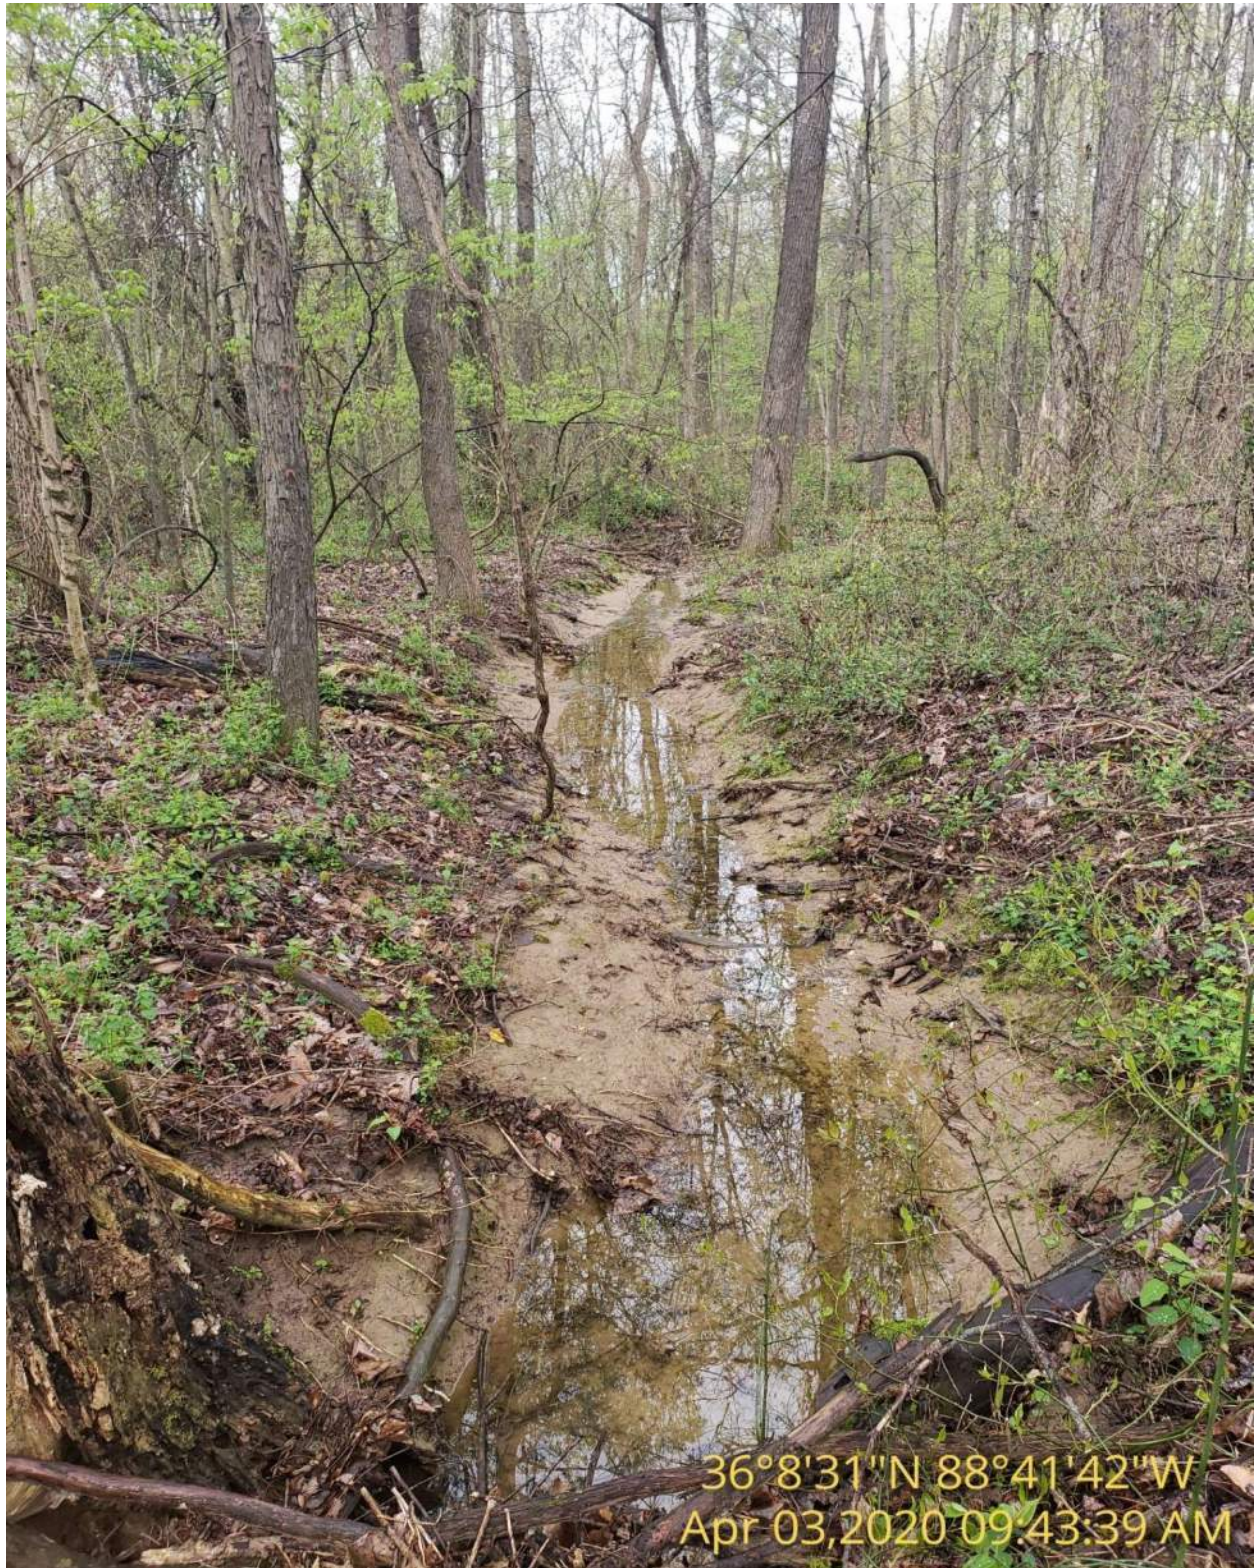
**PHOTO 10**: View of the channel looking west.

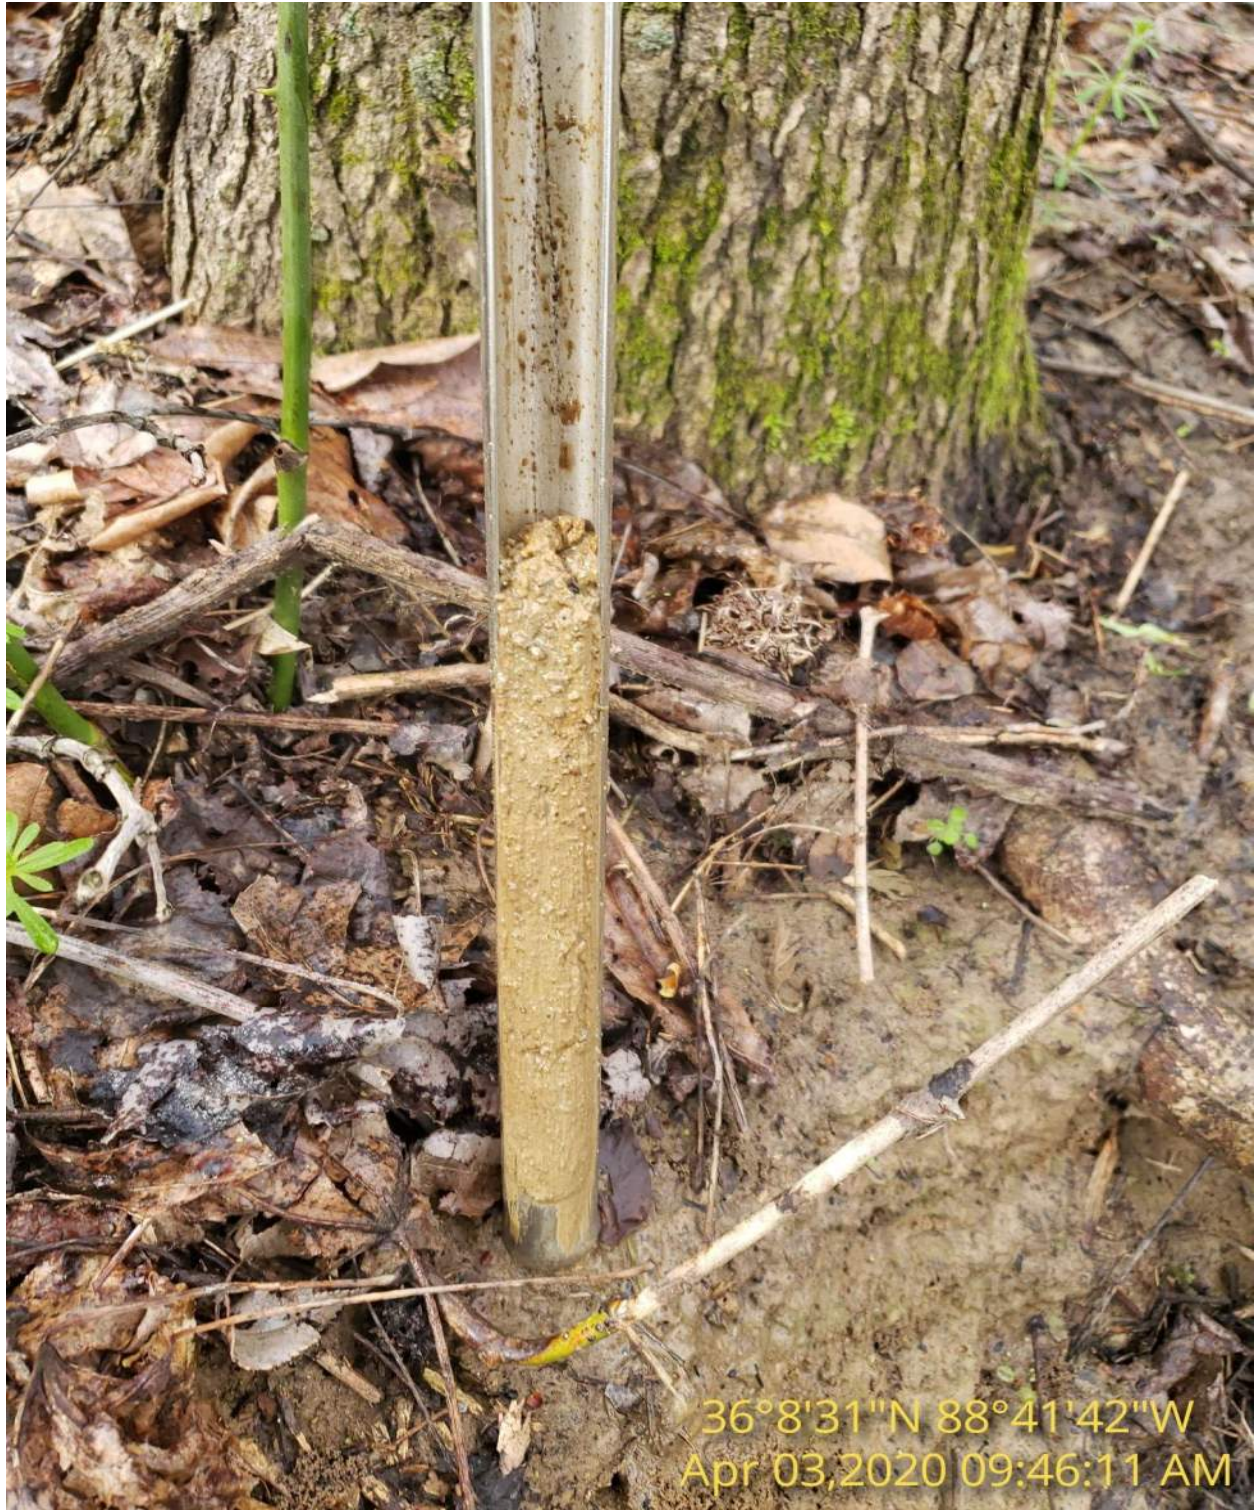
**PHOTO 11**: Soil Probe. Upland soils observed.
