Date: April 13, 2020

RE: Hydrologic Determination Report  
Tony Nguyen Chicken Barns  
Greenfield, Weakley County, Tennessee

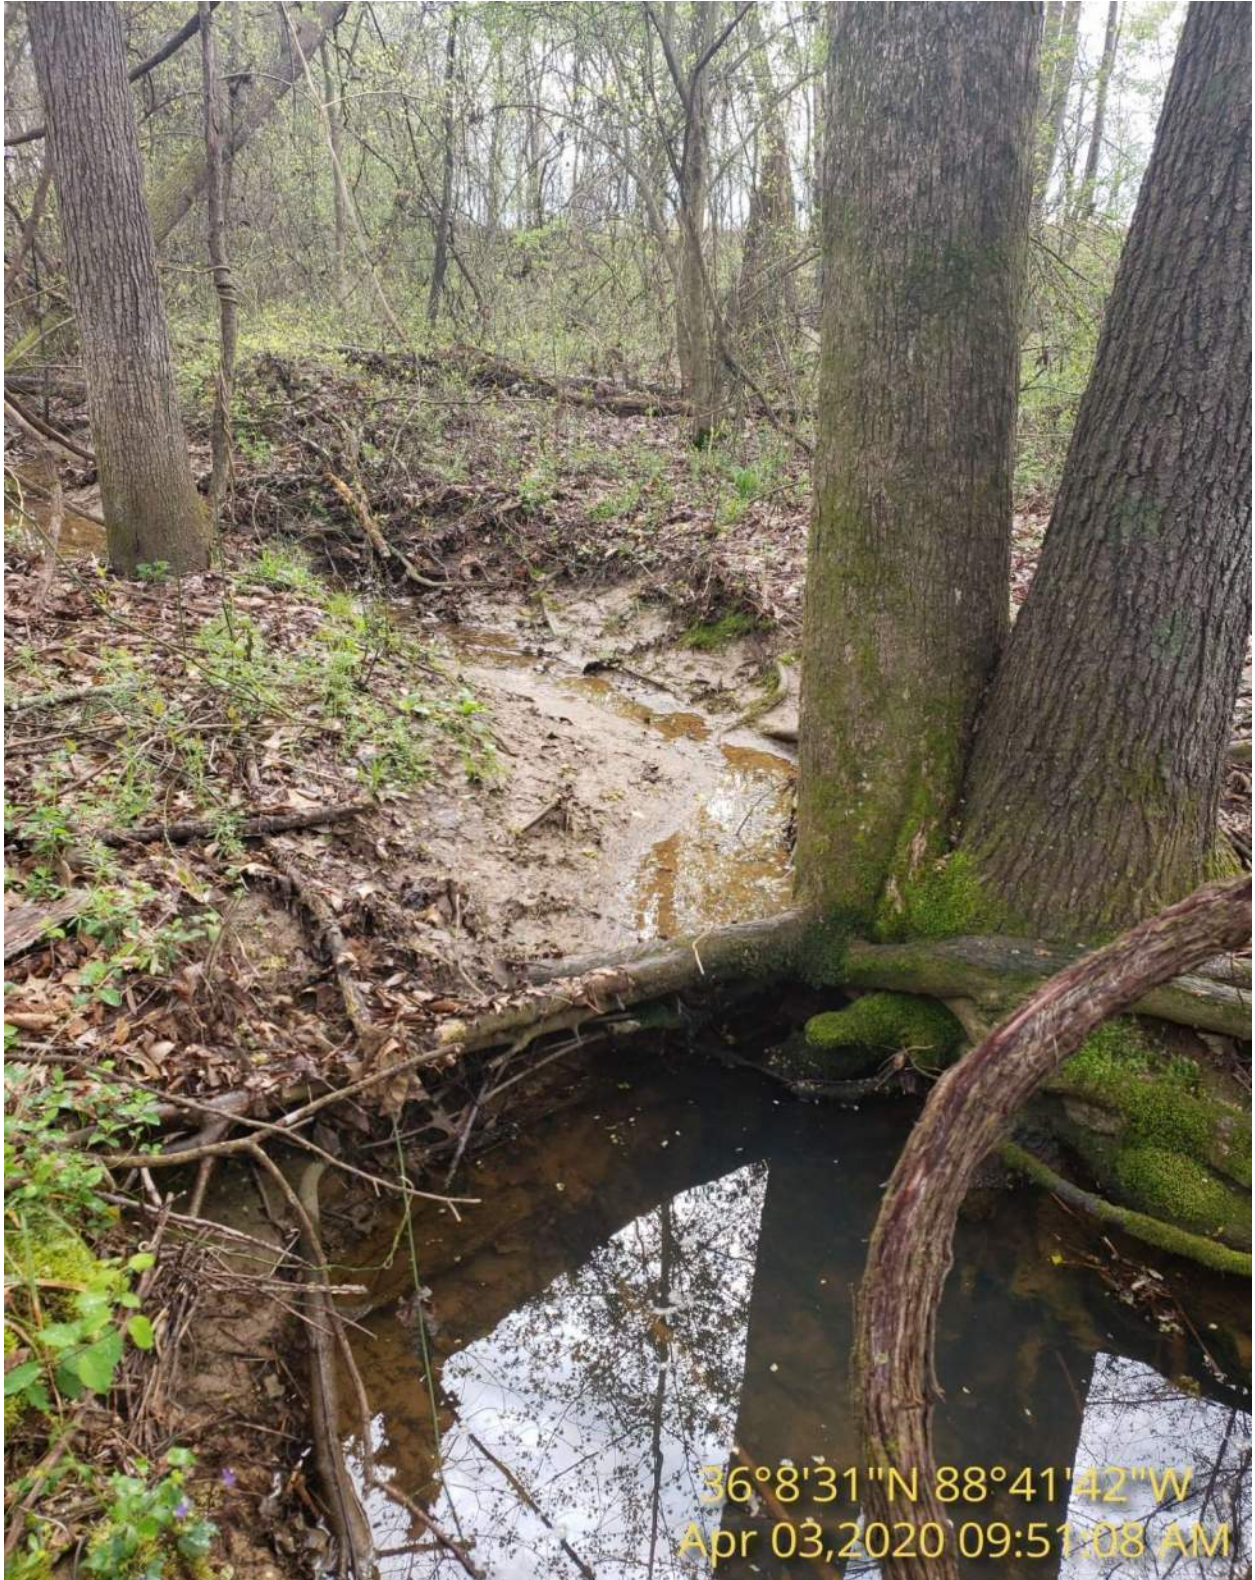
**PHOTO 12:** View of a large grade control and a deep pool of water.

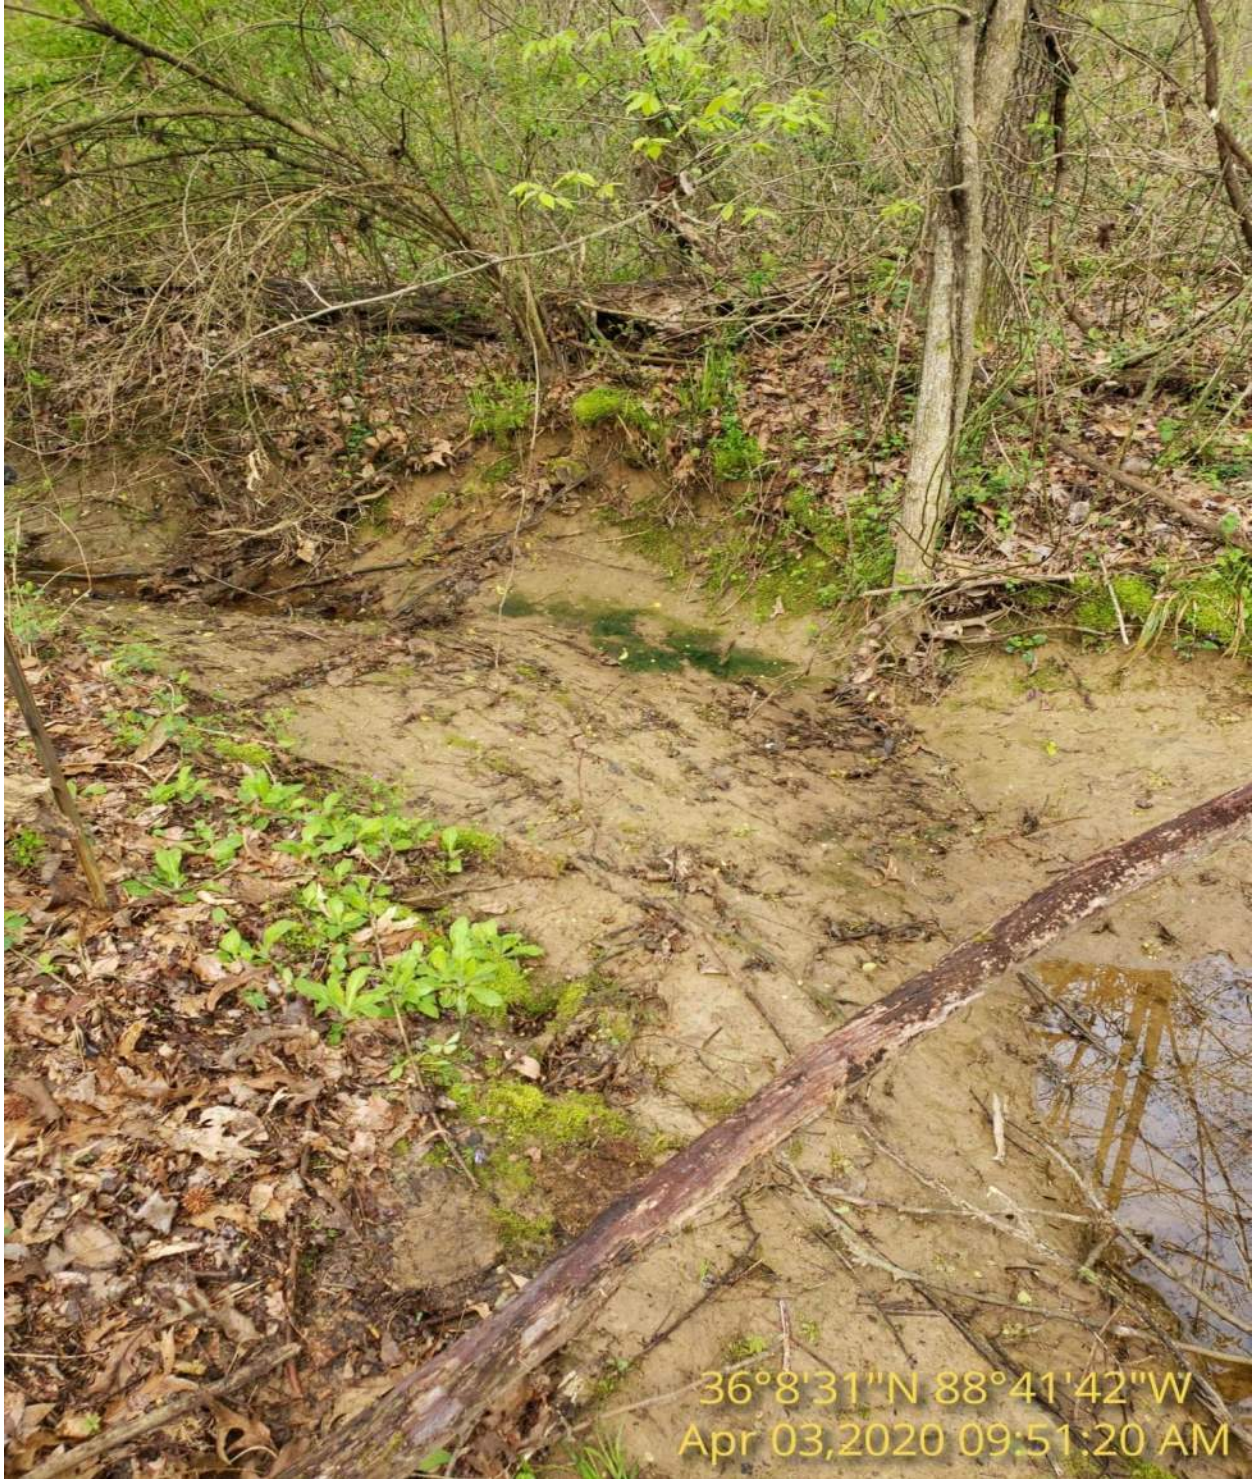
**PHOTO 13:** View of the channel showing a riffle area after the large grade control and pool from the photo above.

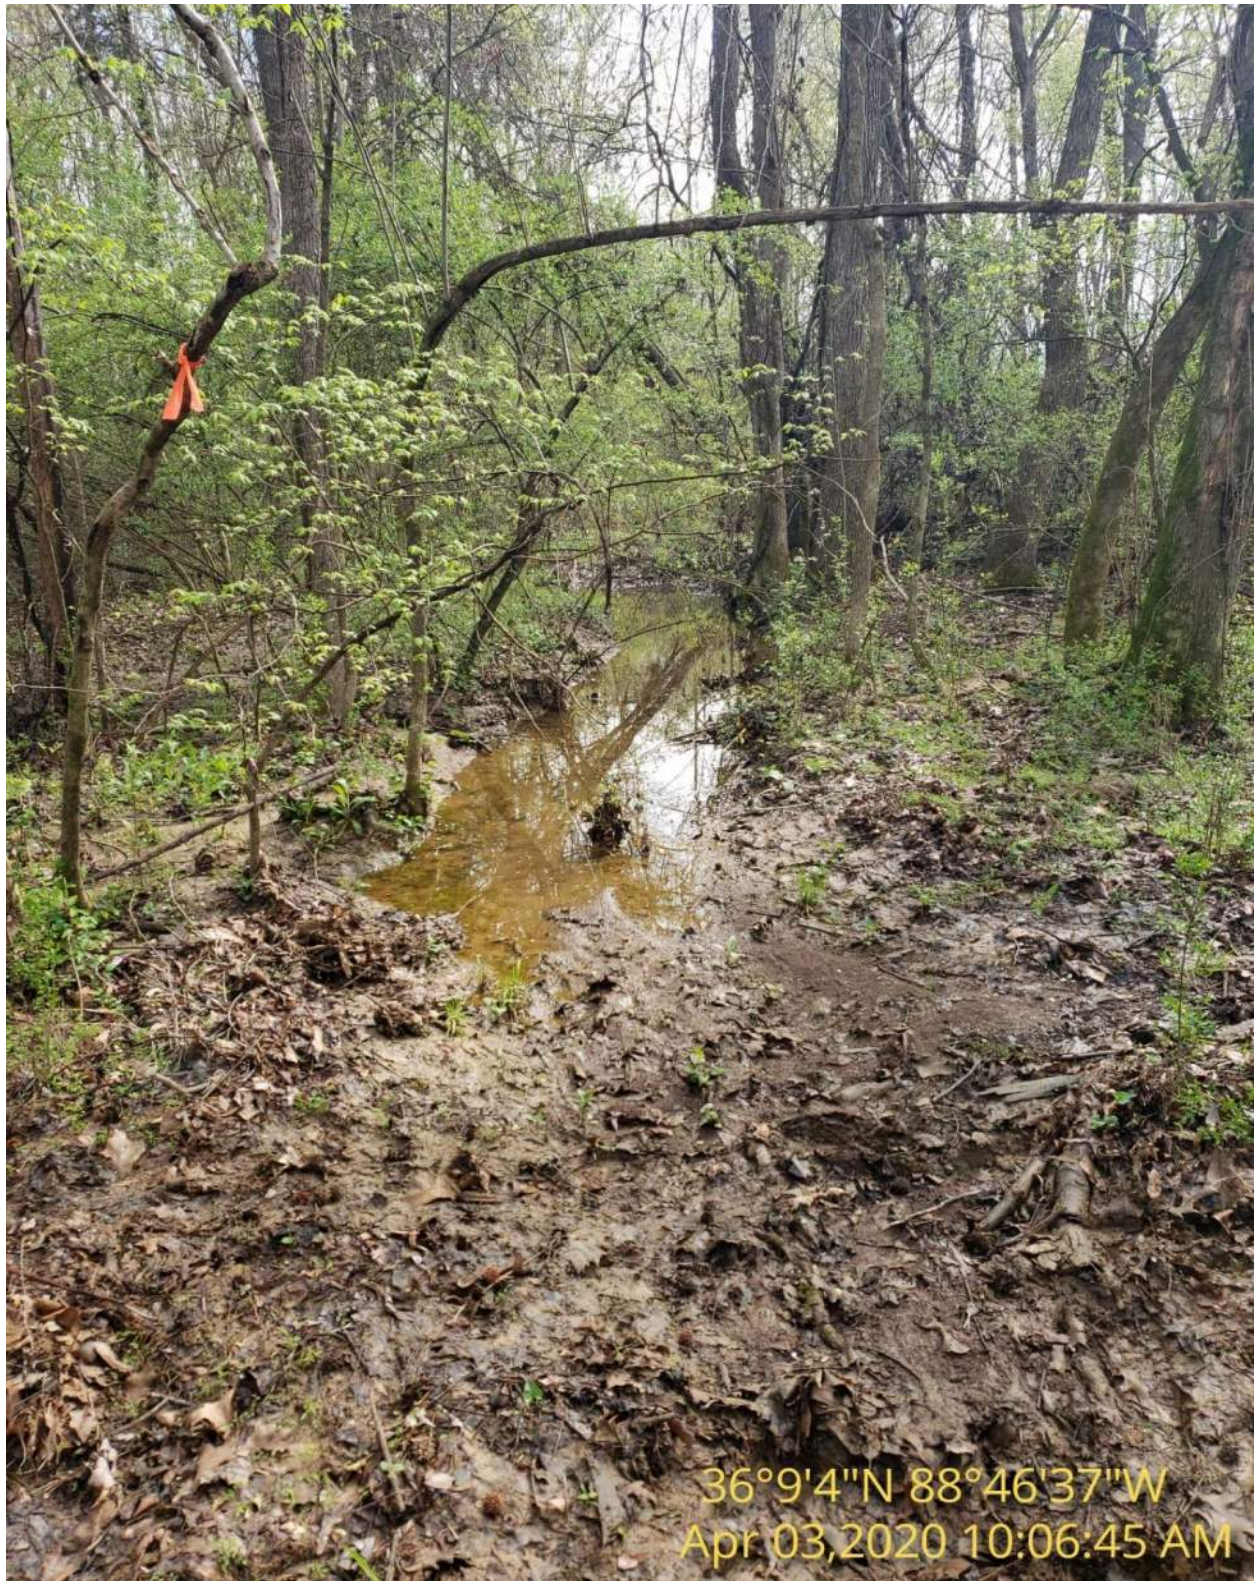
**PHOTO 14:** View of the channel at the end of this determination. At this end point the stream breaks up into a braided section.

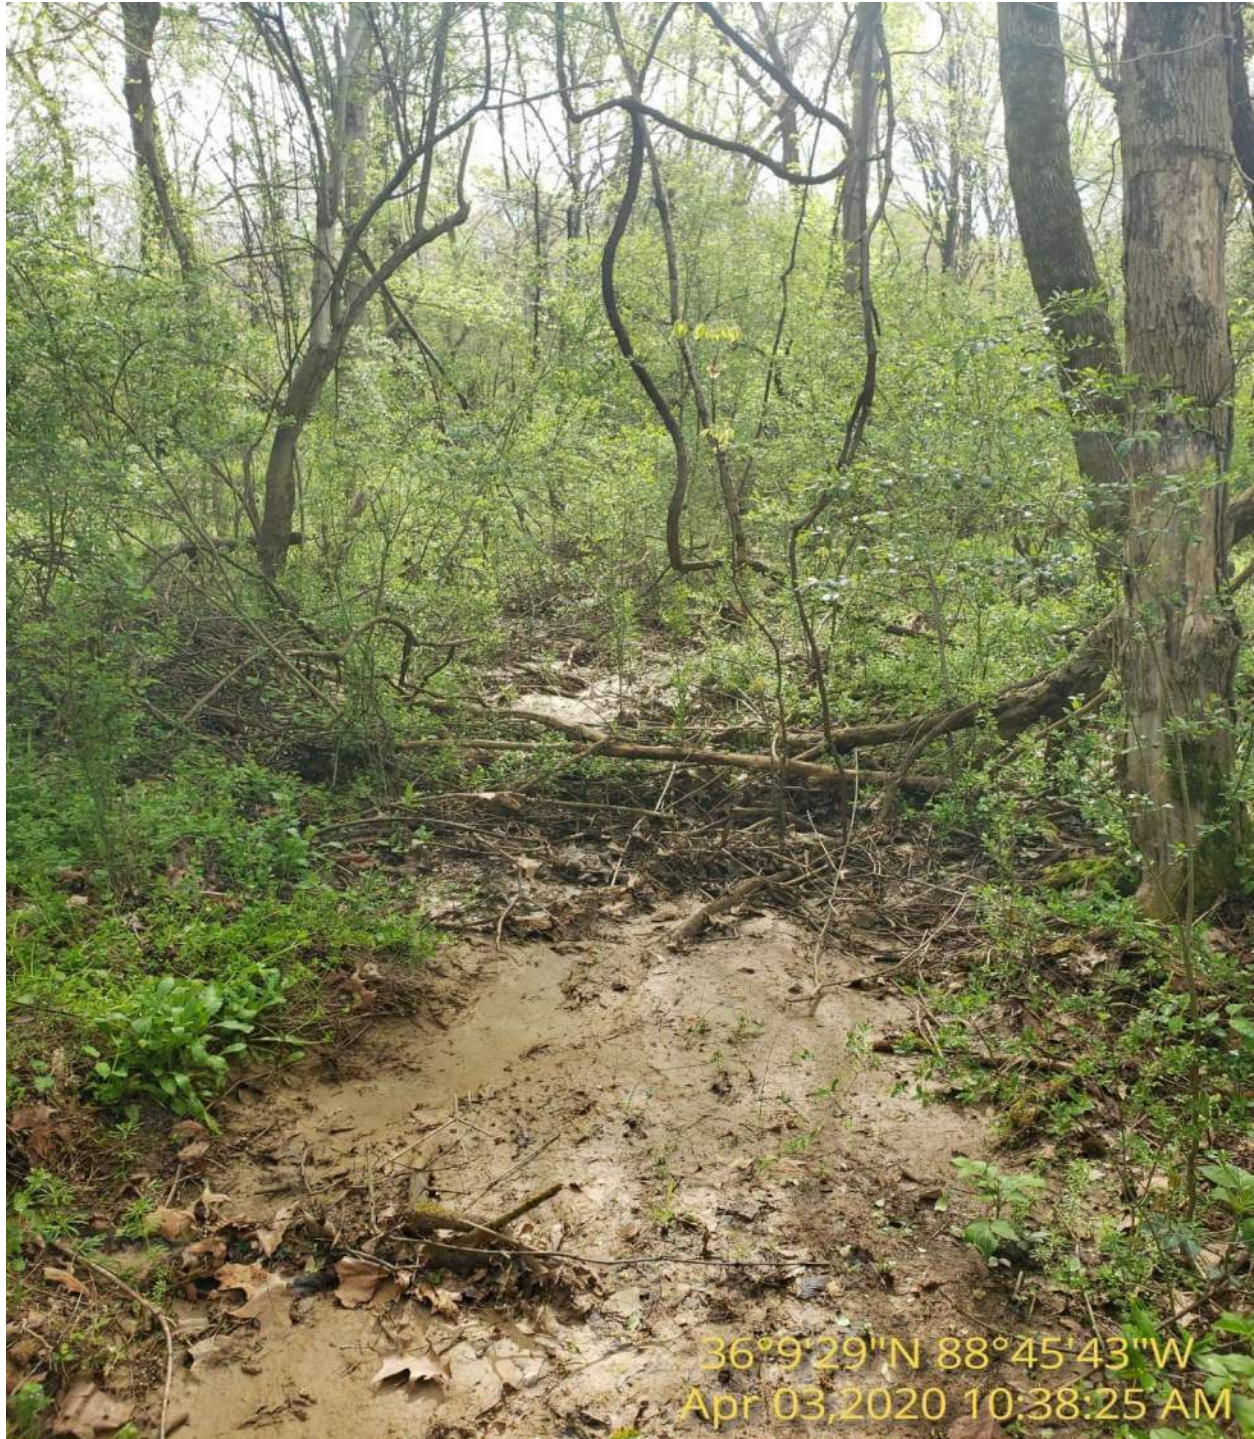
**PHOTO 1**: View of the channel looking south at the beginning. Wet Weather Conveyance.

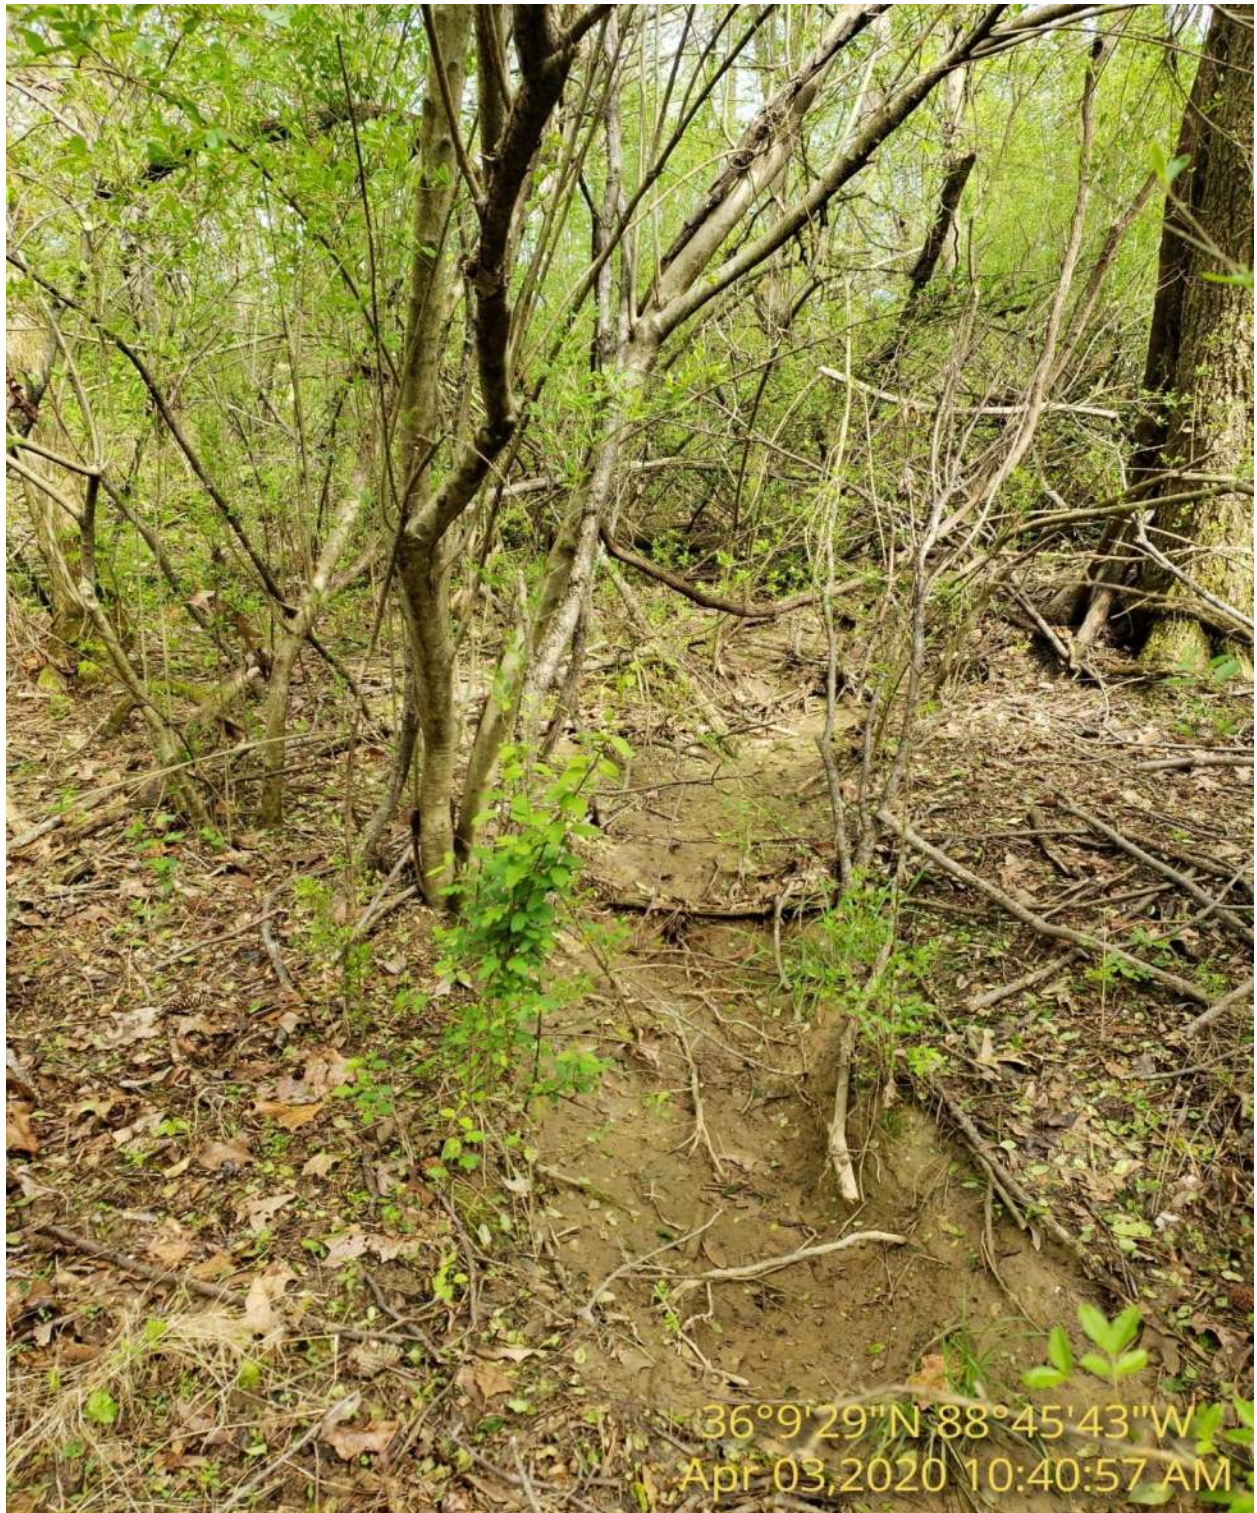
**PHOTO 2**: View of the channel looking south. Wet Weather Conveyance.

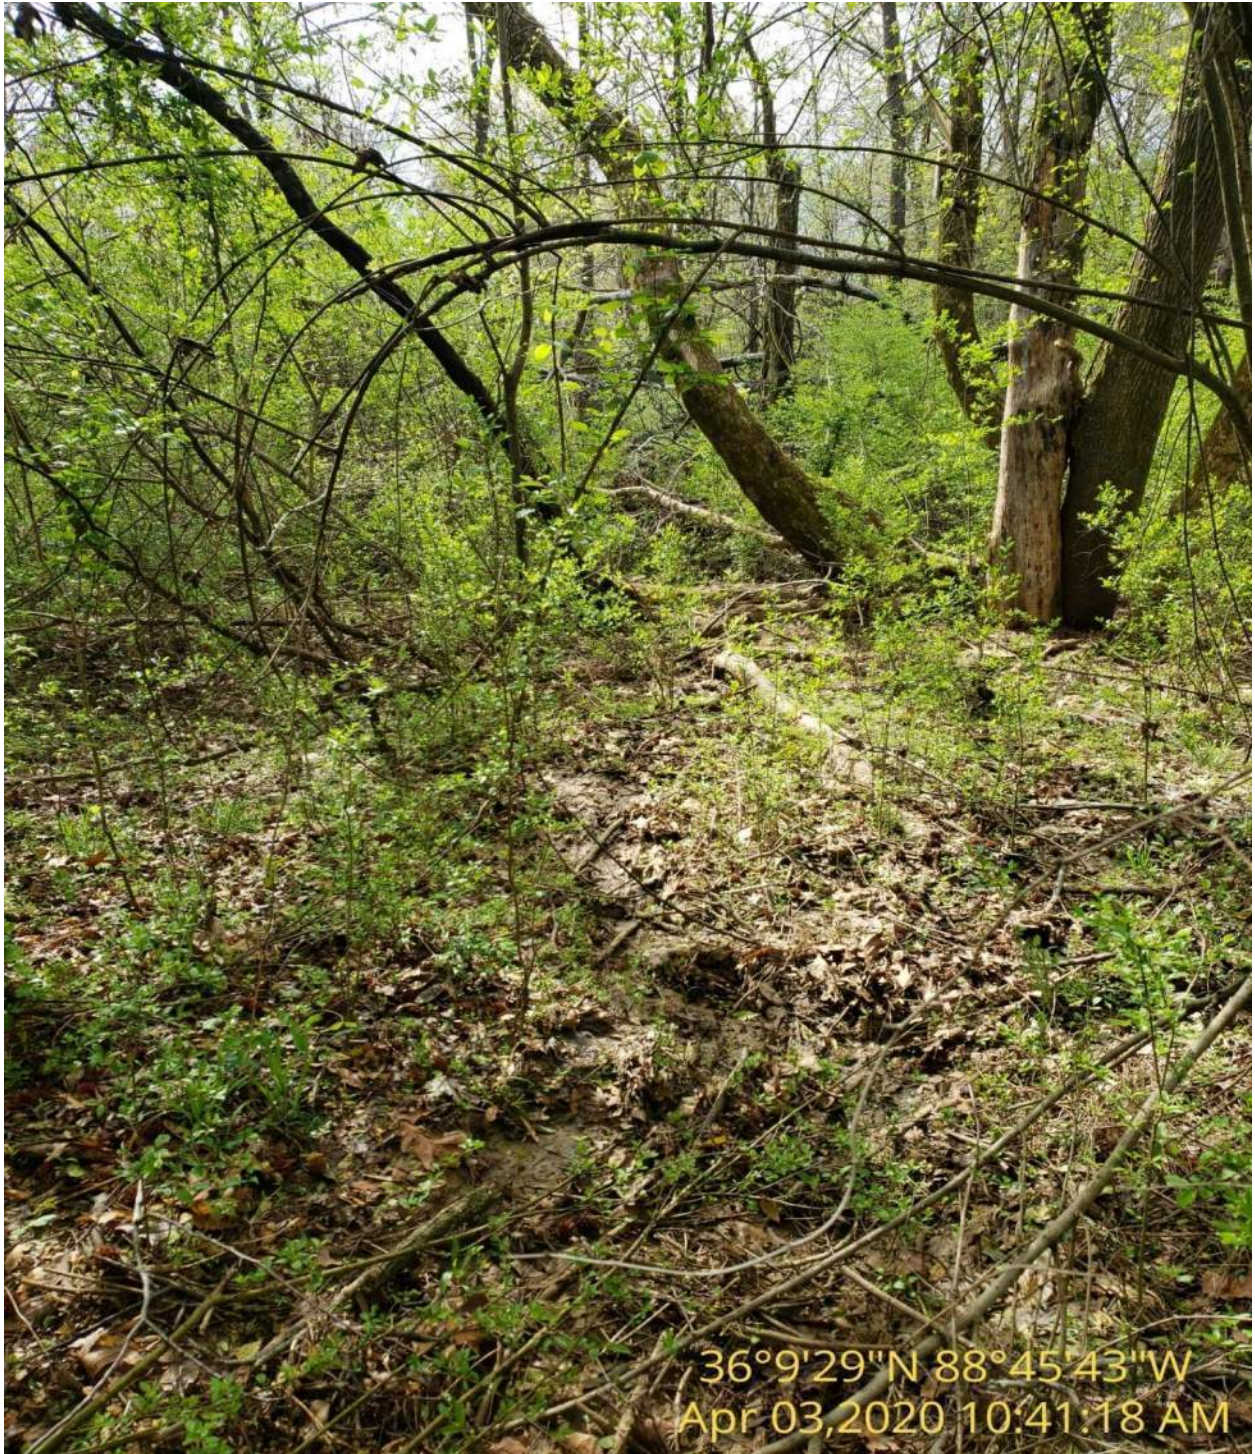
**PHOTO 3**: View of the channel looking north. Wet Weather Conveyance.

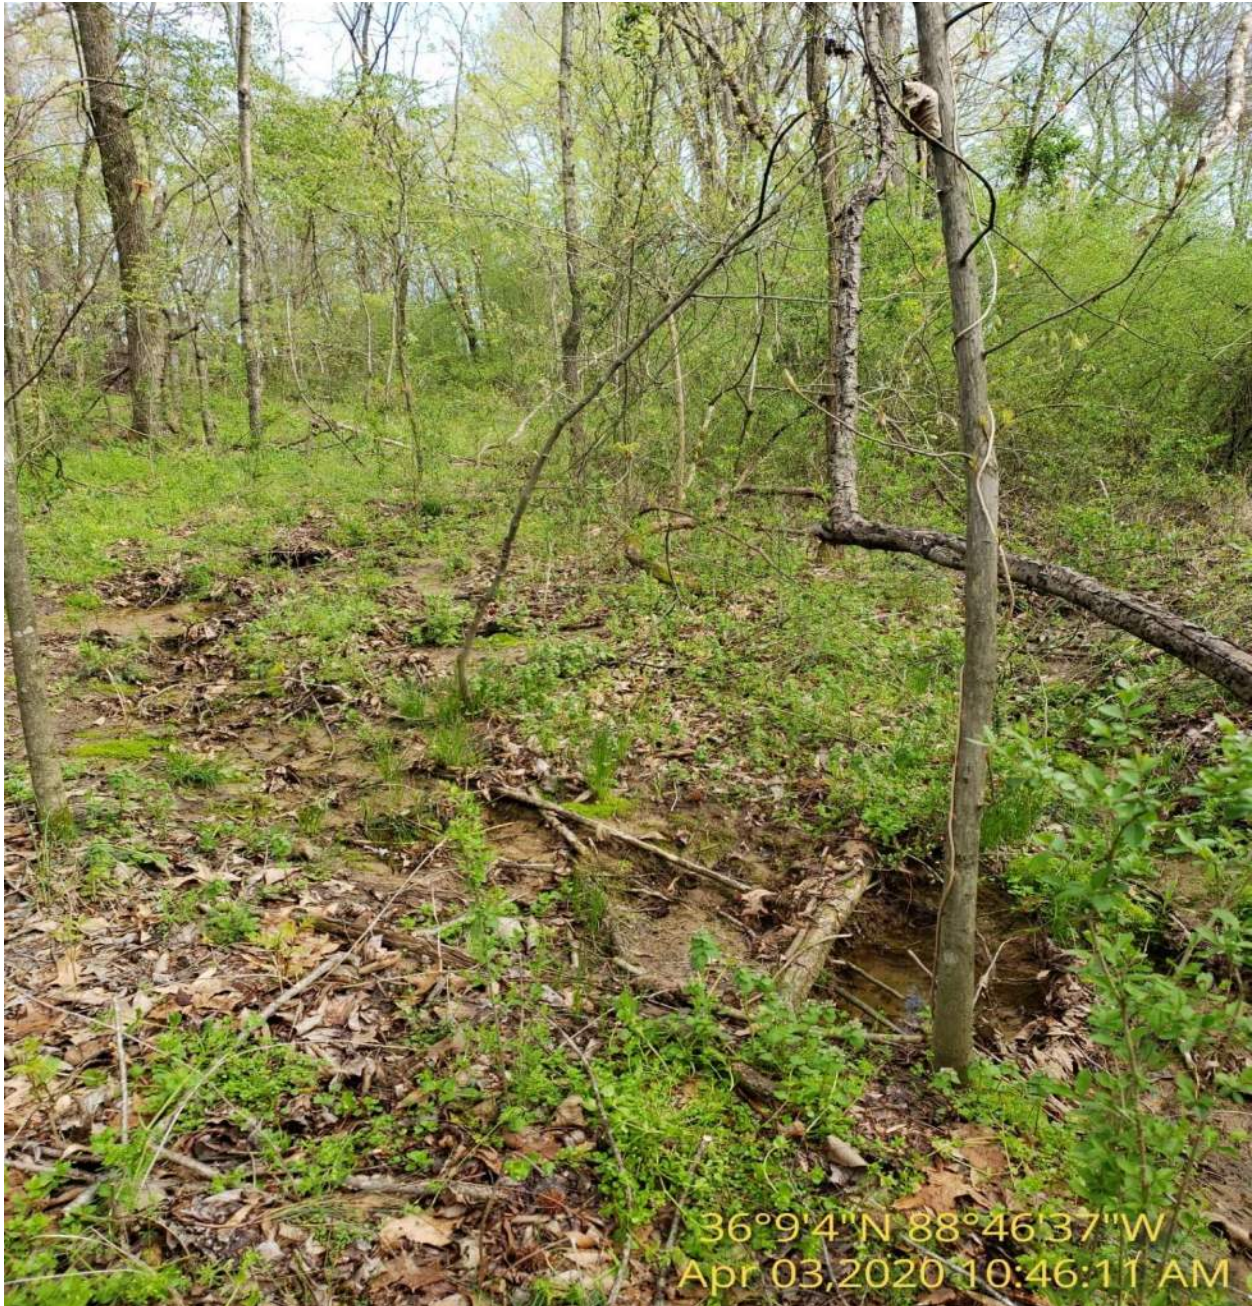
**PHOTO 4:** View of the channel at the start of the stream at the small grade control in the photo at coordinates LAT: 36.153923, -88.749980.

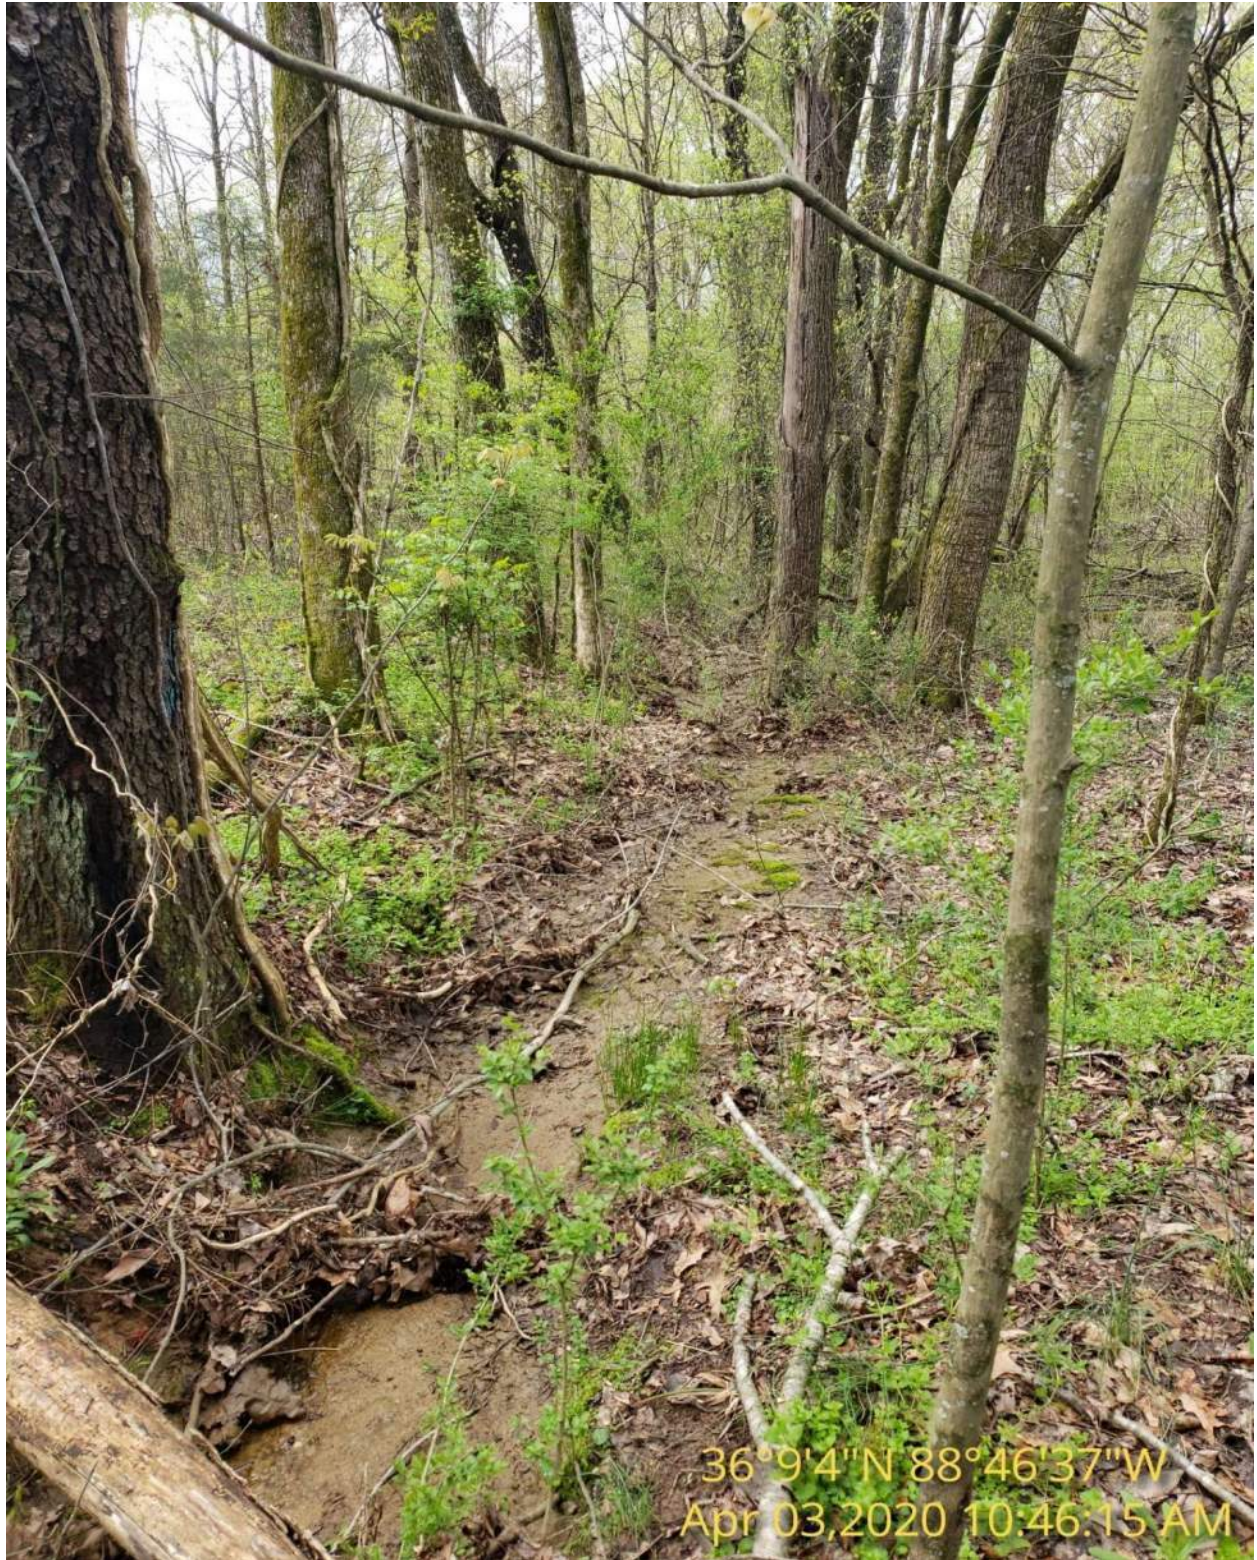
**PHOTO 5**: View of the channel looking south from the start of the stream. Stream.

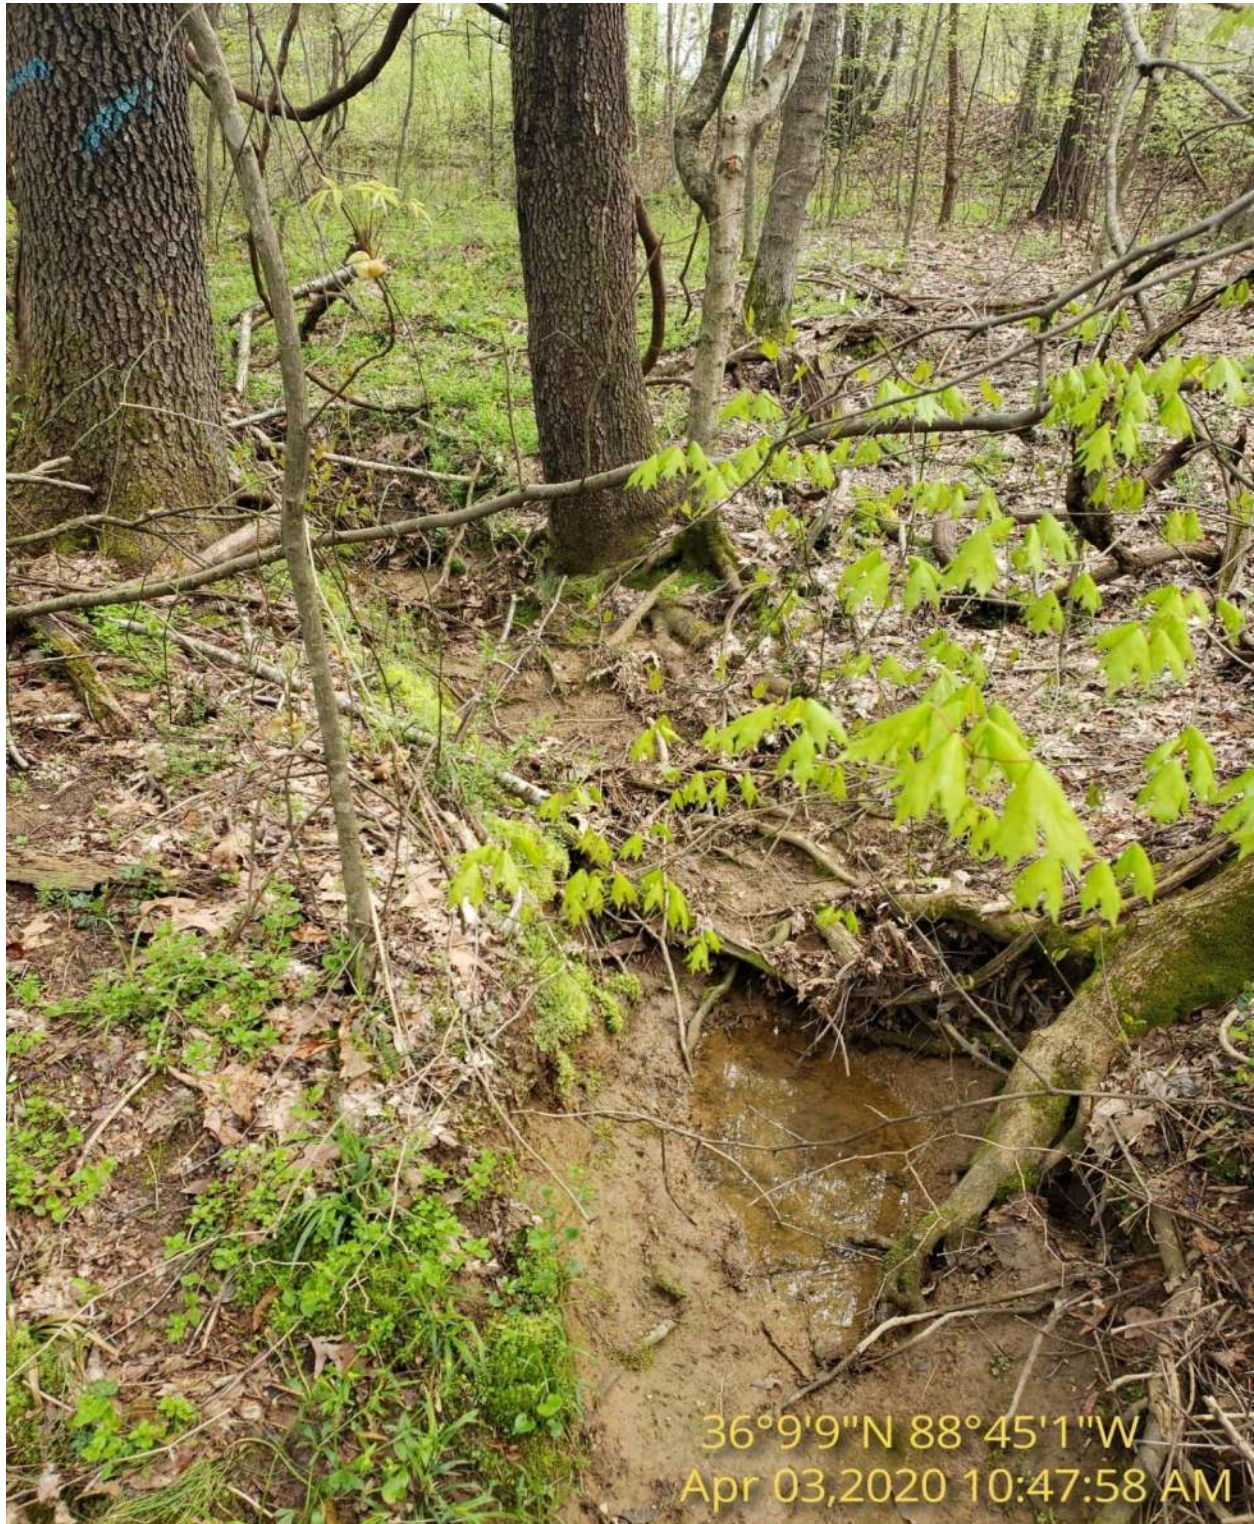
**PHOTO 6**: View of the channel looking north at a small grade control and pool. Stream.

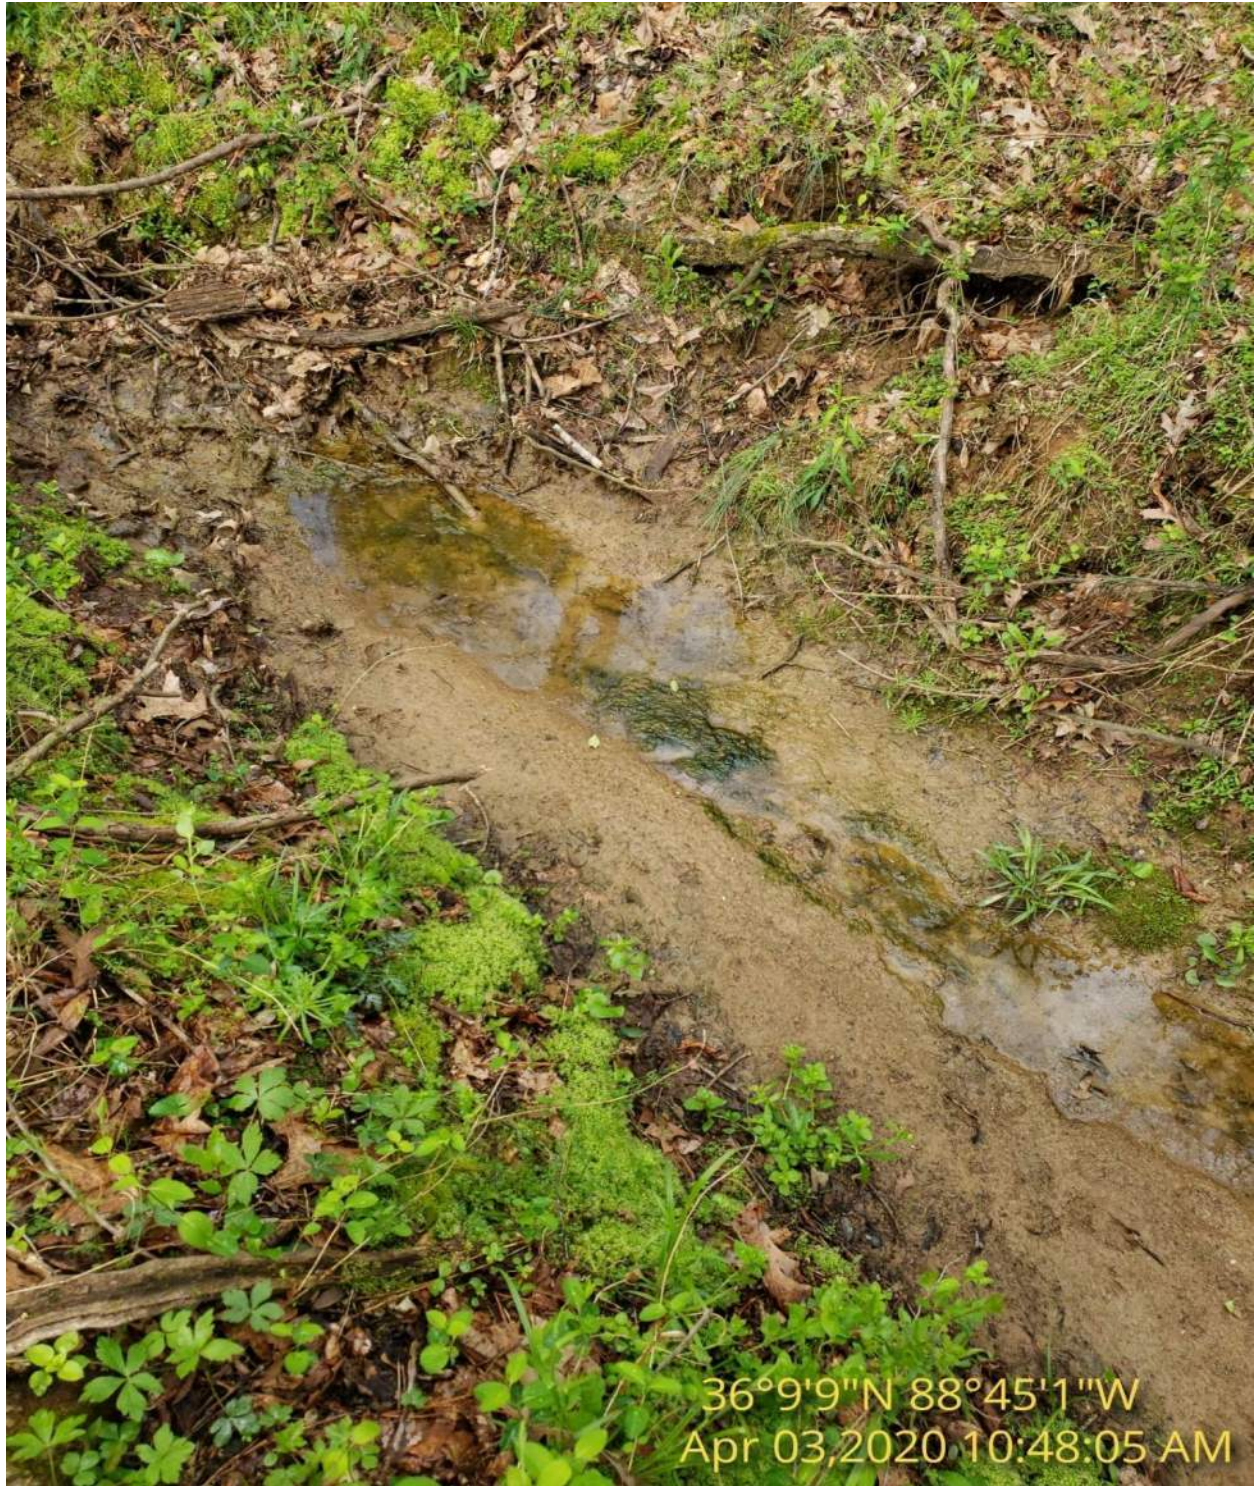
**PHOTO 7:** View of the channel looking south showing algae. Stream.

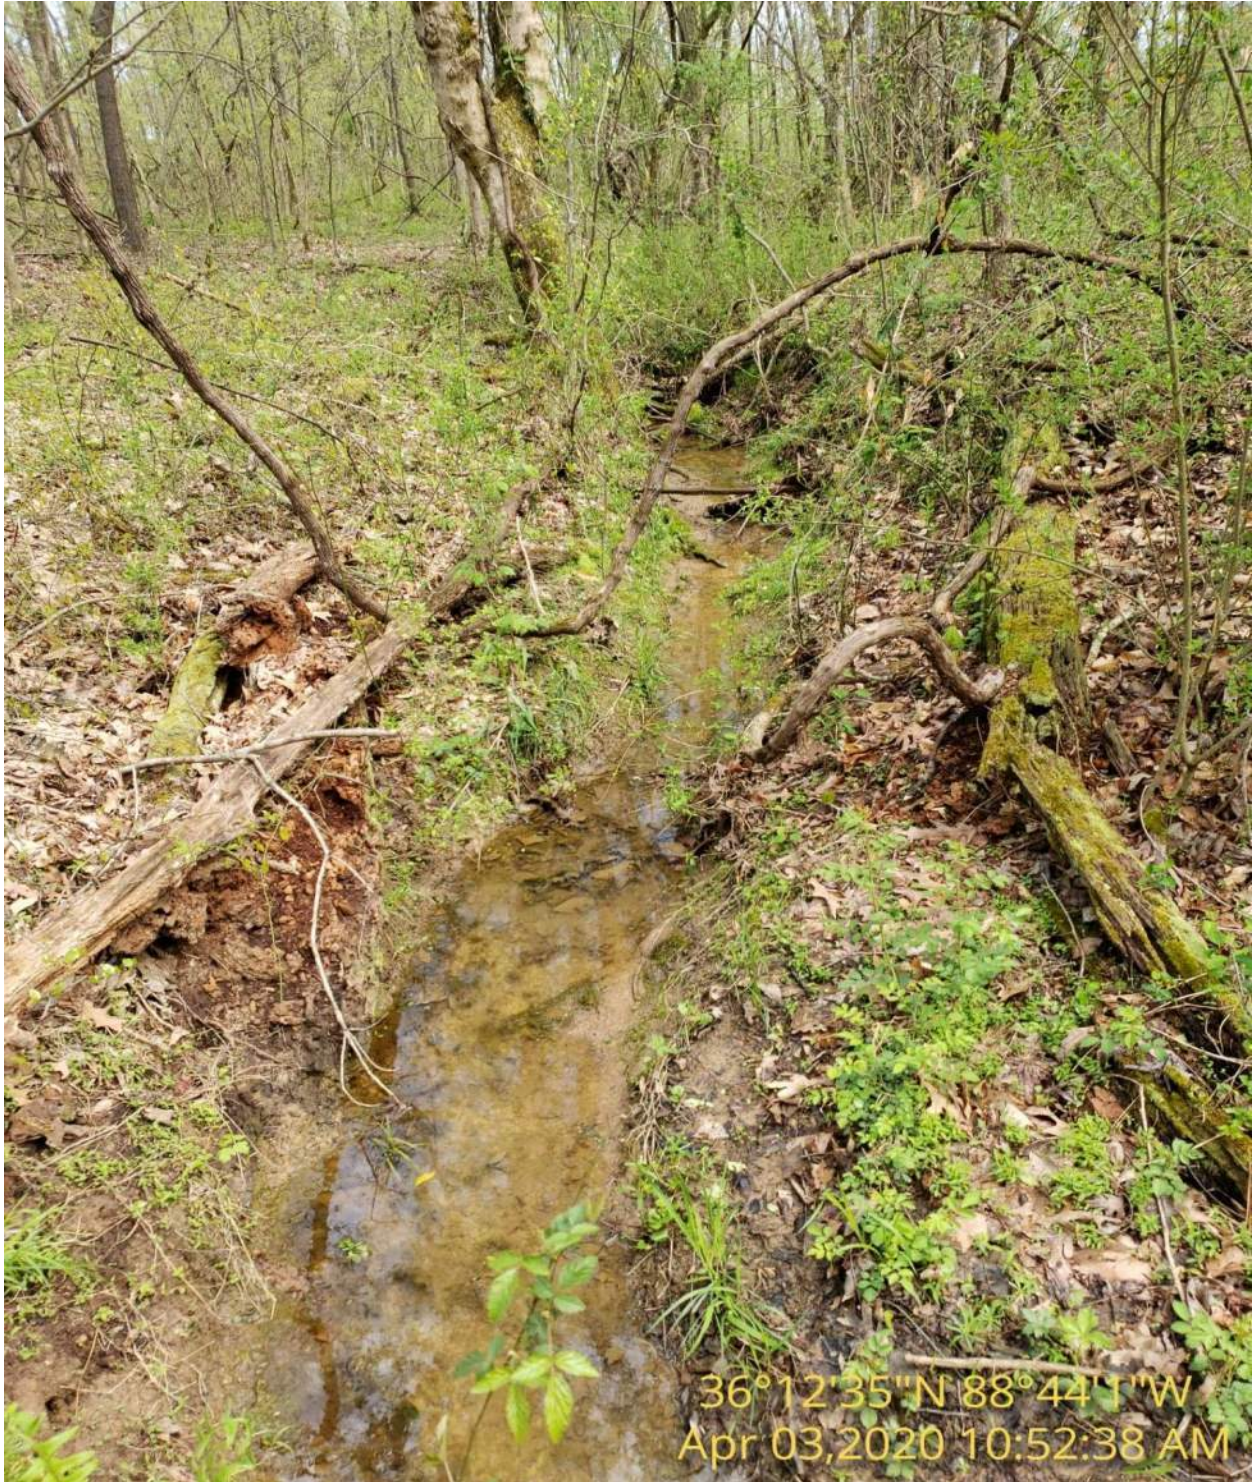
**PHOTO 8:** View of the channel looking south. Bed and bank becoming clearer and water in the thalweg. Stream.

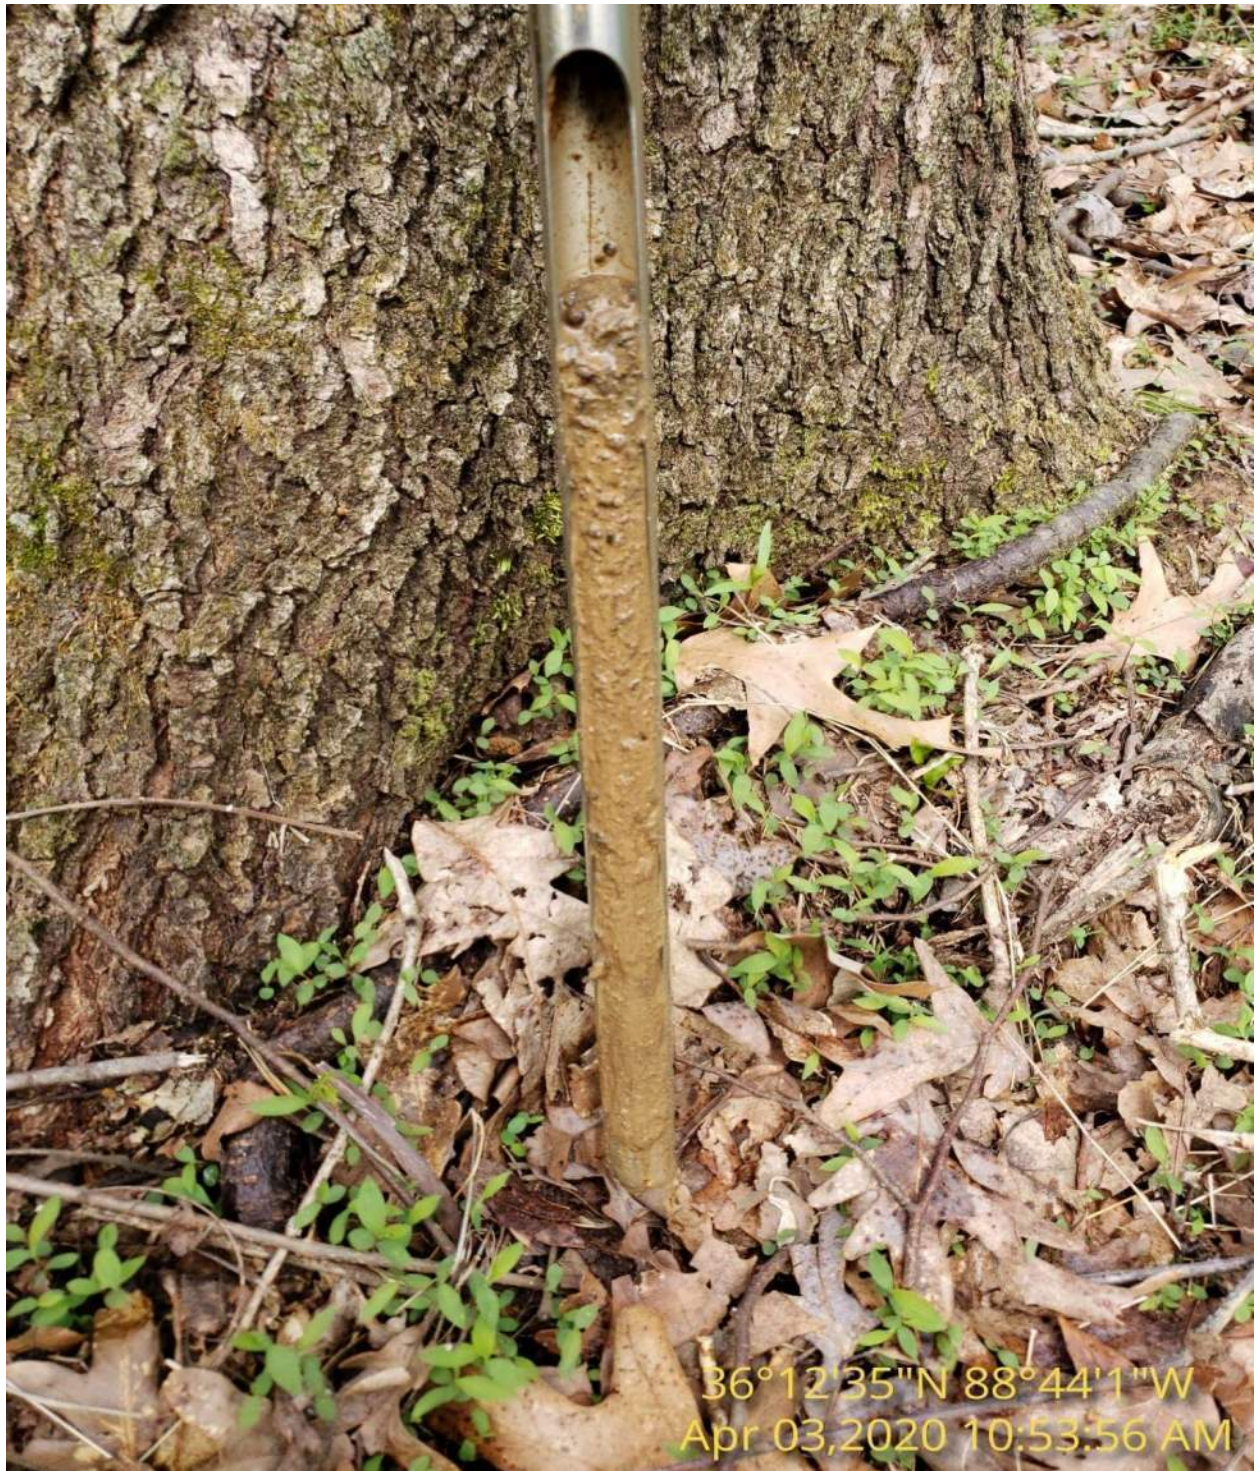
**PHOTO 9:** Soil Probe. Upland soils observed.
