Date: April 13, 2020

RE: Hydrologic Determination Report  
Tony Nguyen Chicken Barns  
Greenfield, Weakley County, Tennessee

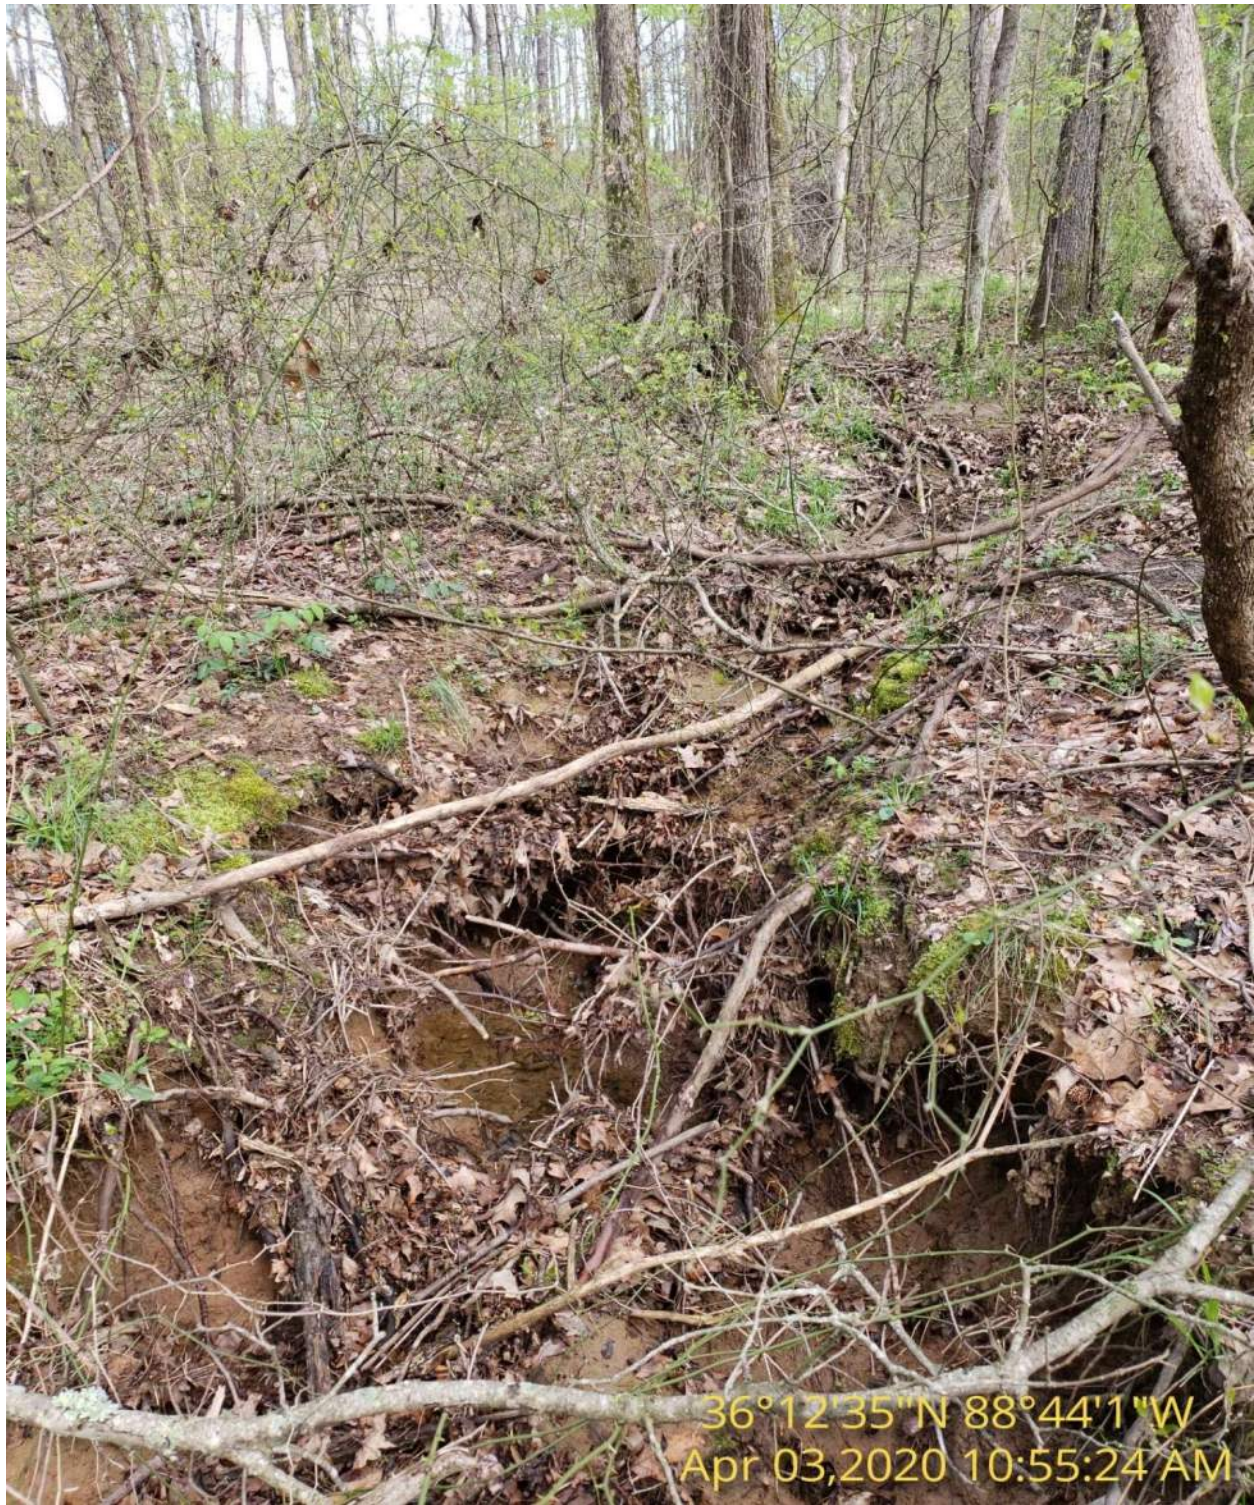
**PHOTO 10:** View of channel looking north at a large headcut. Stream.

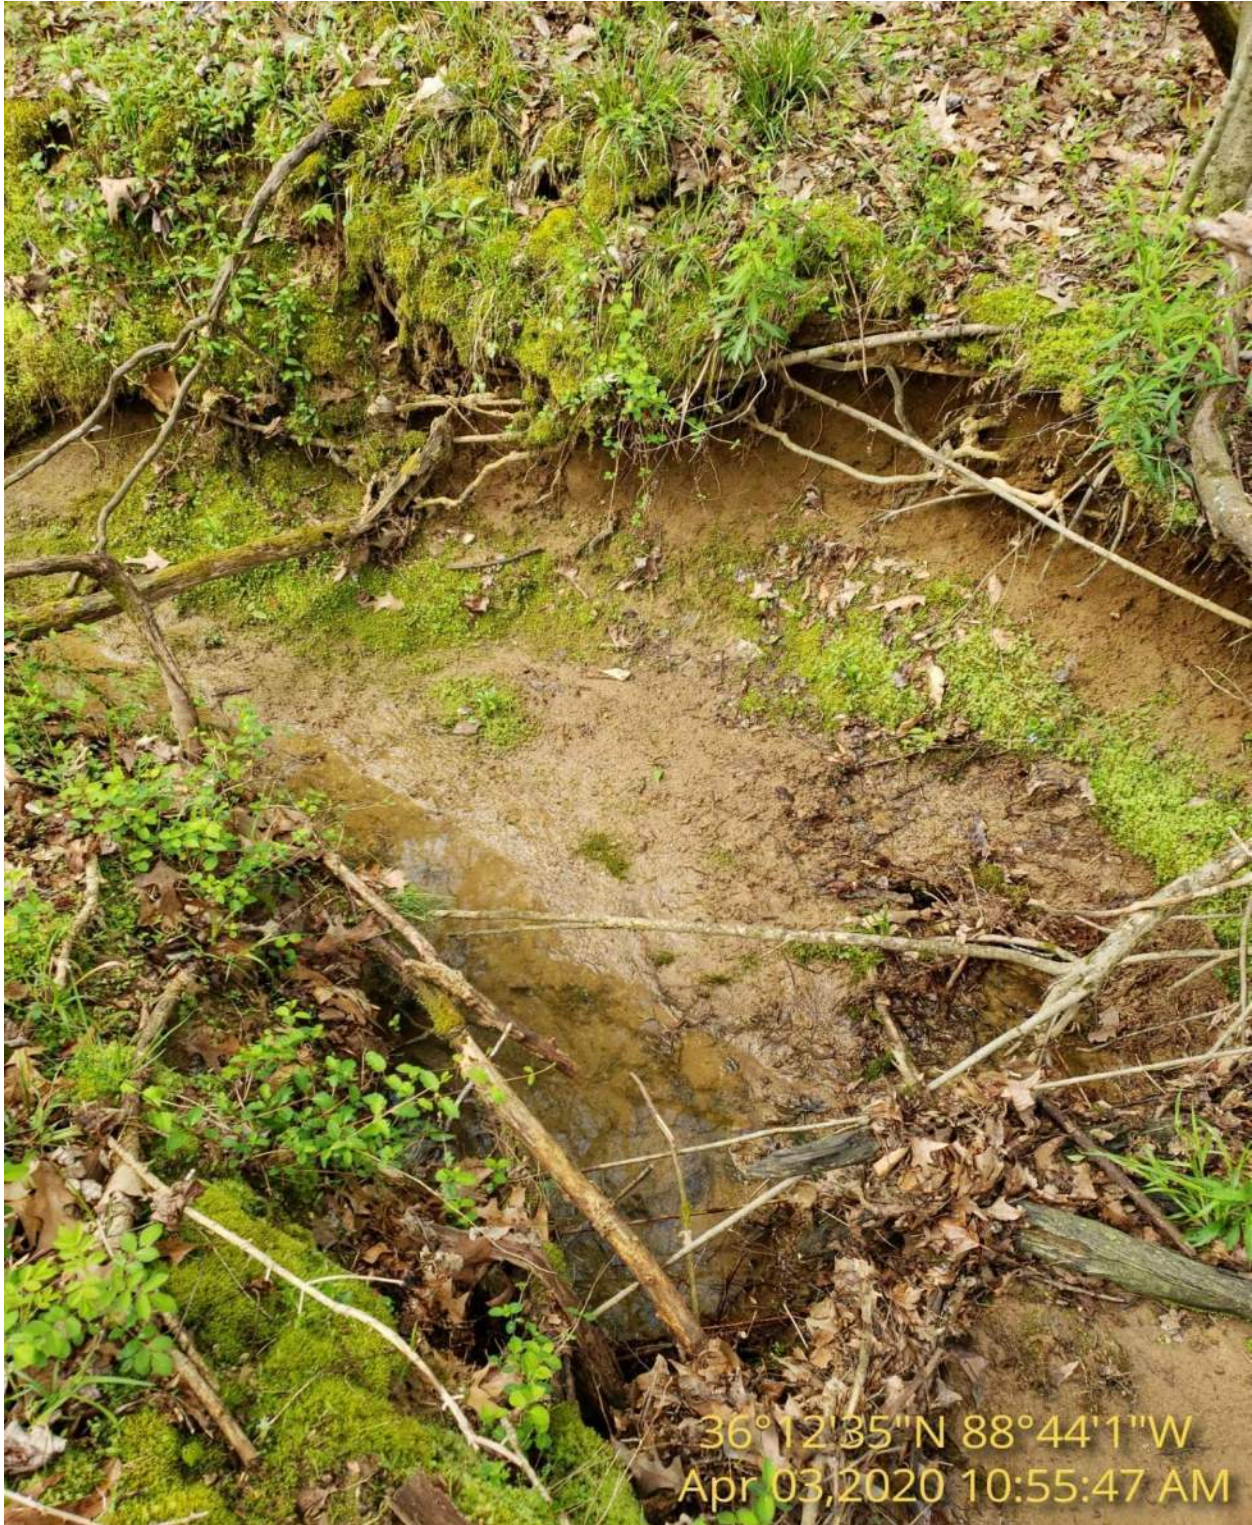
**PHOTO 11:** View of a small grade control as we continue south. Stream.

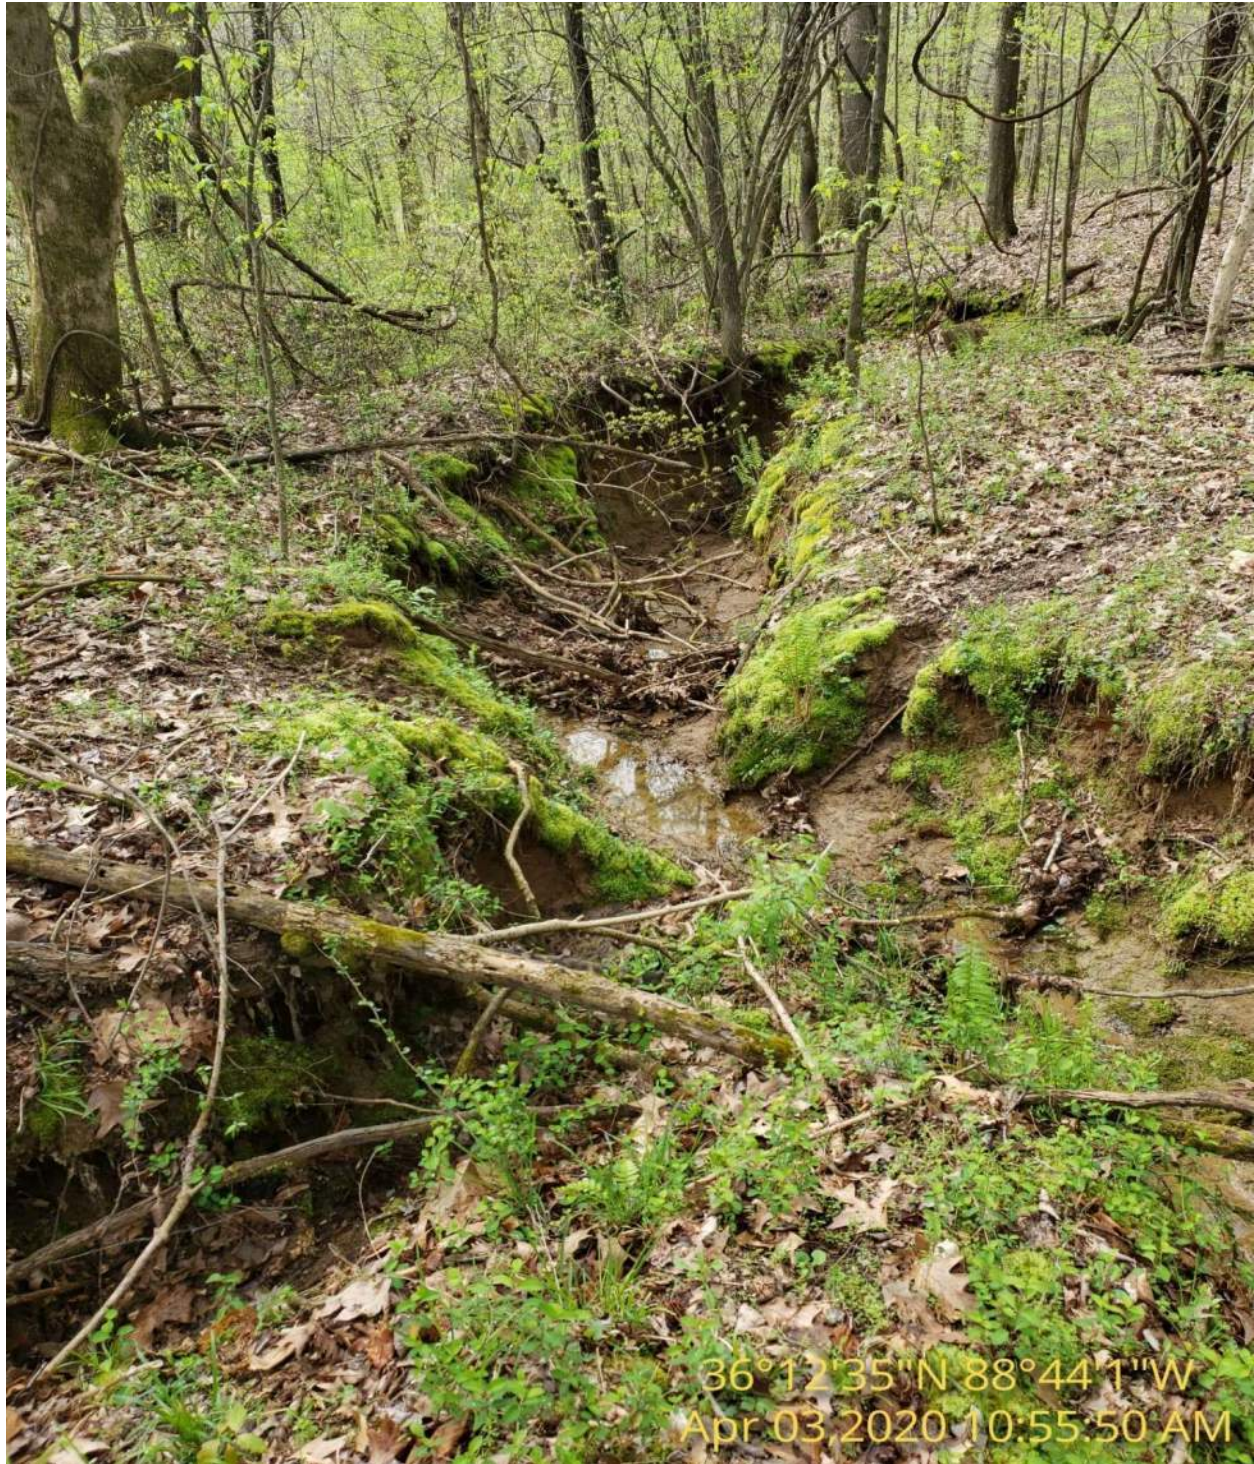
**PHOTO 12:** View of the channel looking south showing deep bank. Stream.

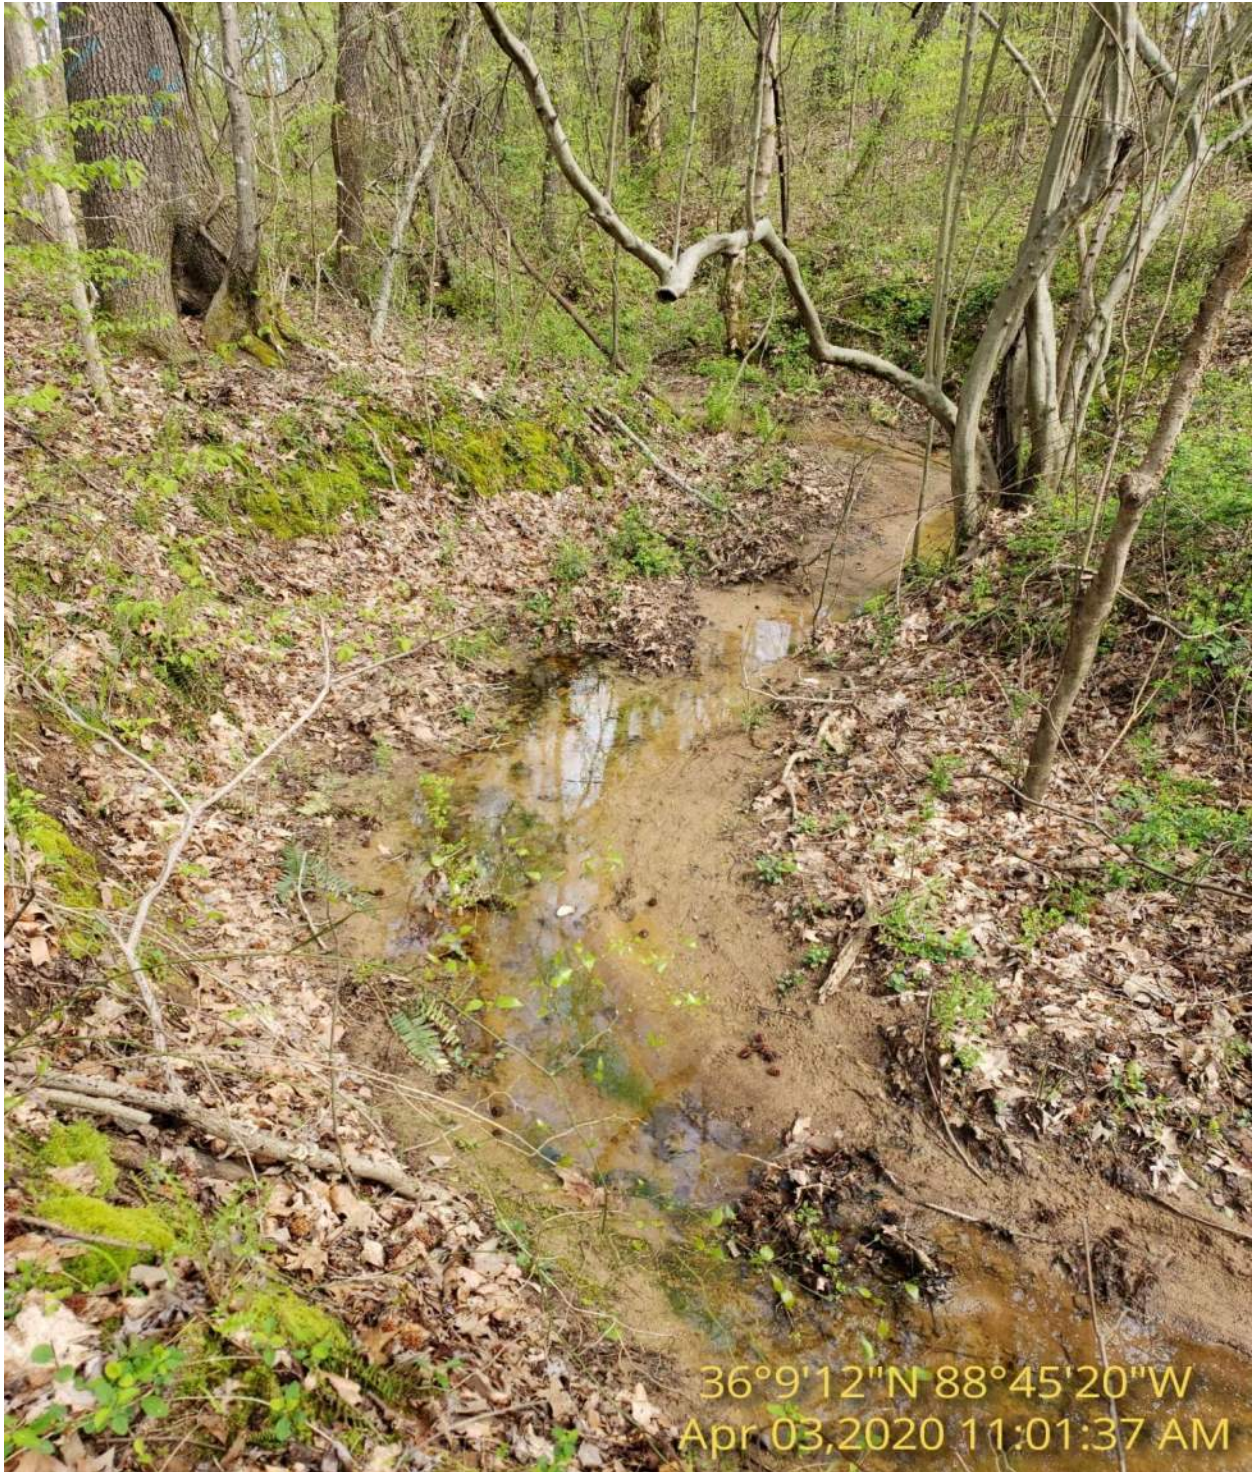
**PHOTO 13:** View of the channel looking north at the end of this determination. Stream.

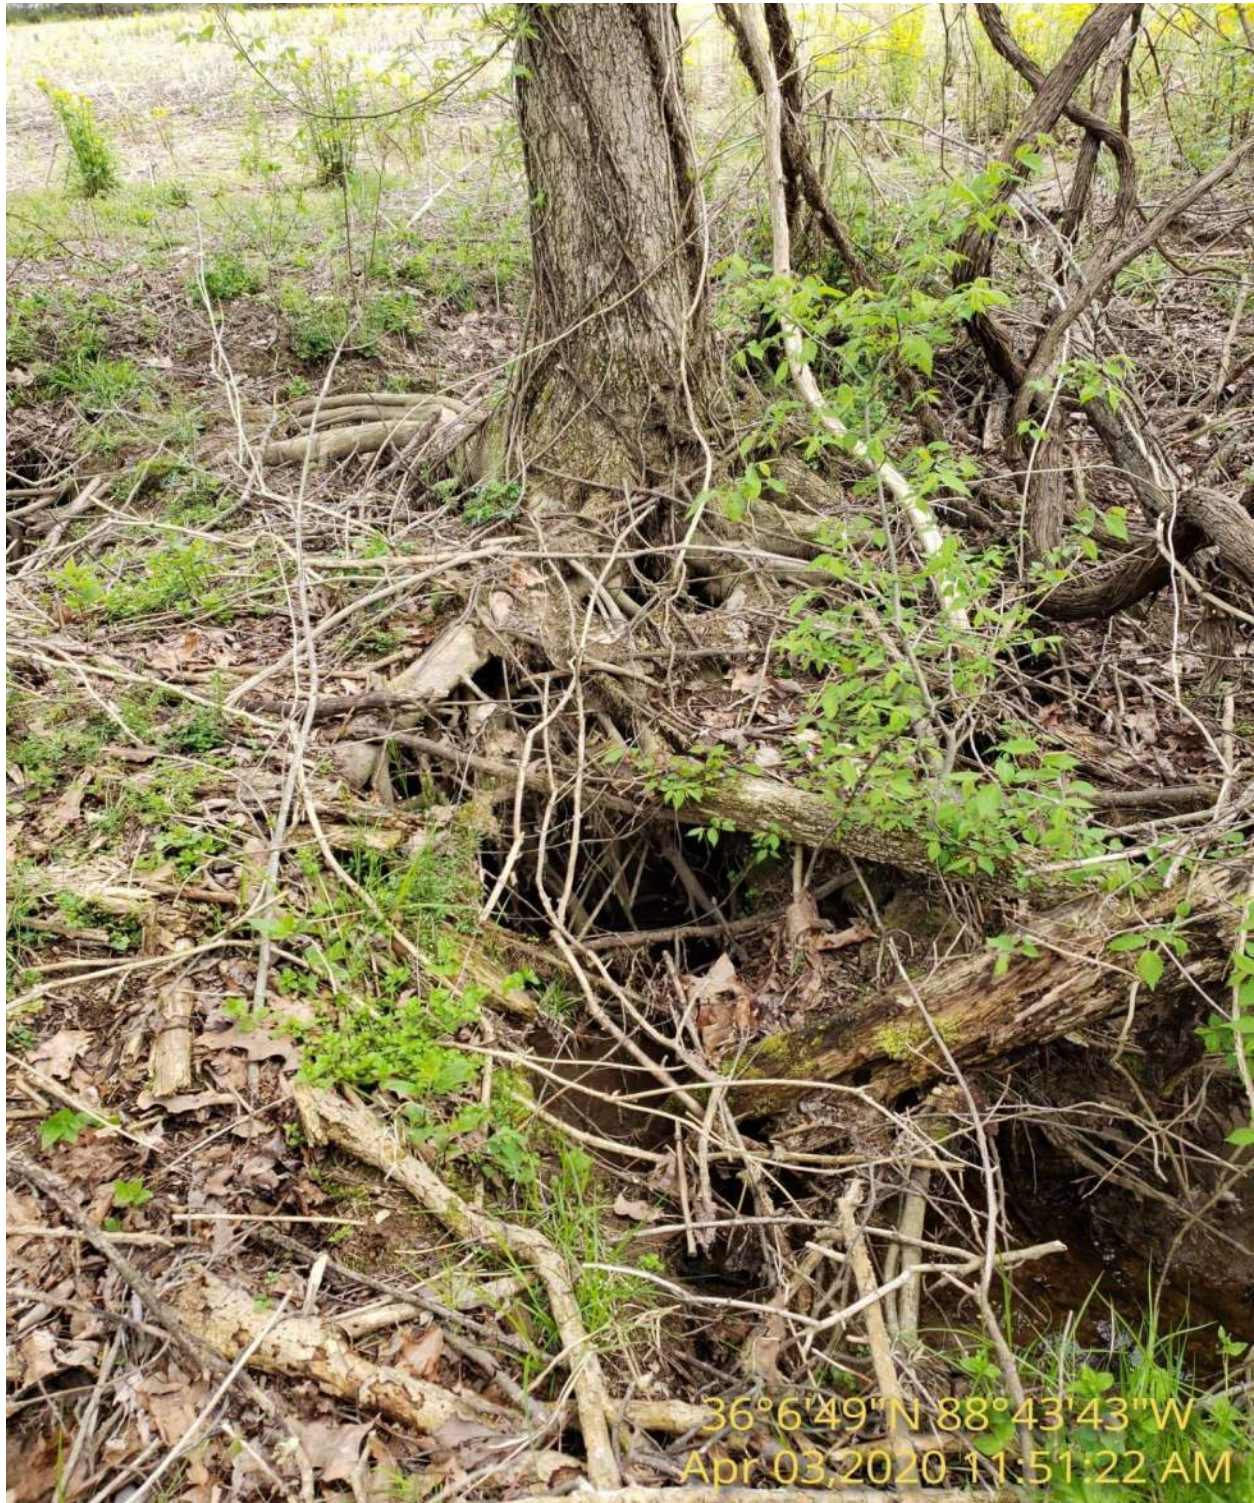
**PHOTO 1:** View of the channel at the beginning of this site looking north. Very large grade control shown.

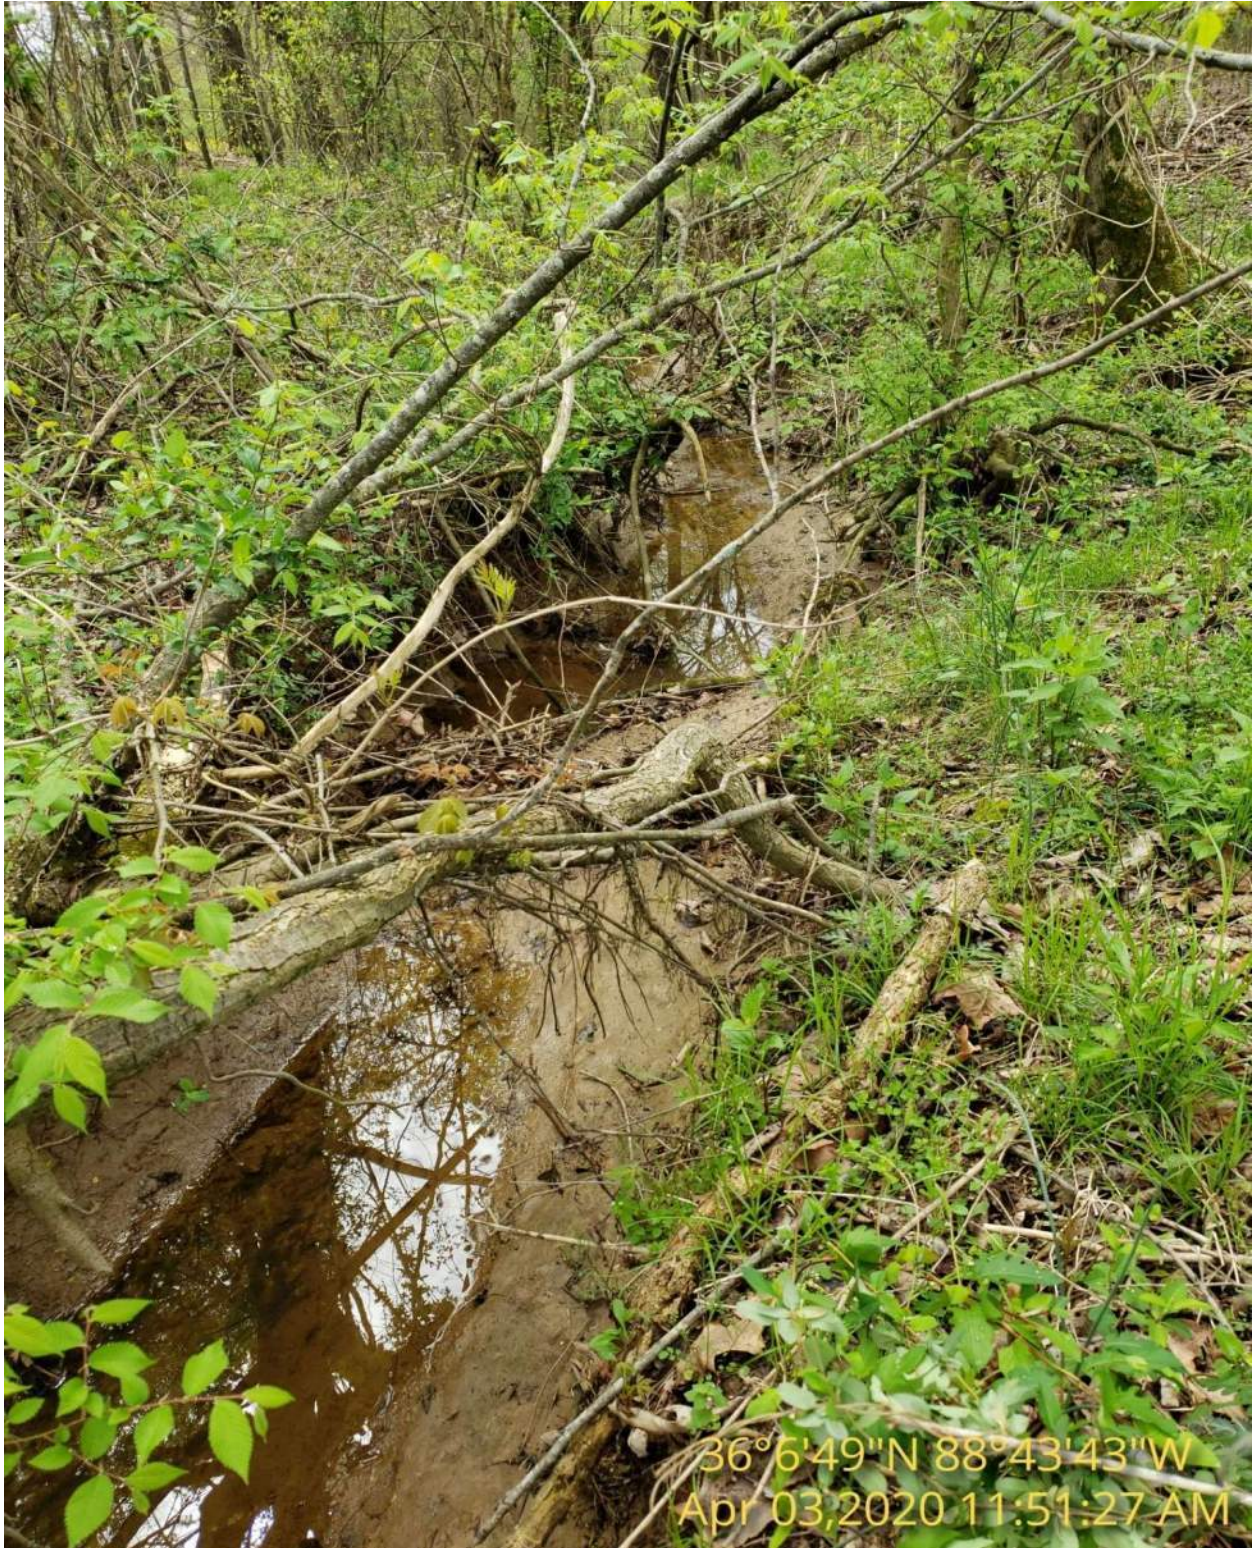
**PHOTO 2:** View of the channel looking south from the large grade control above.

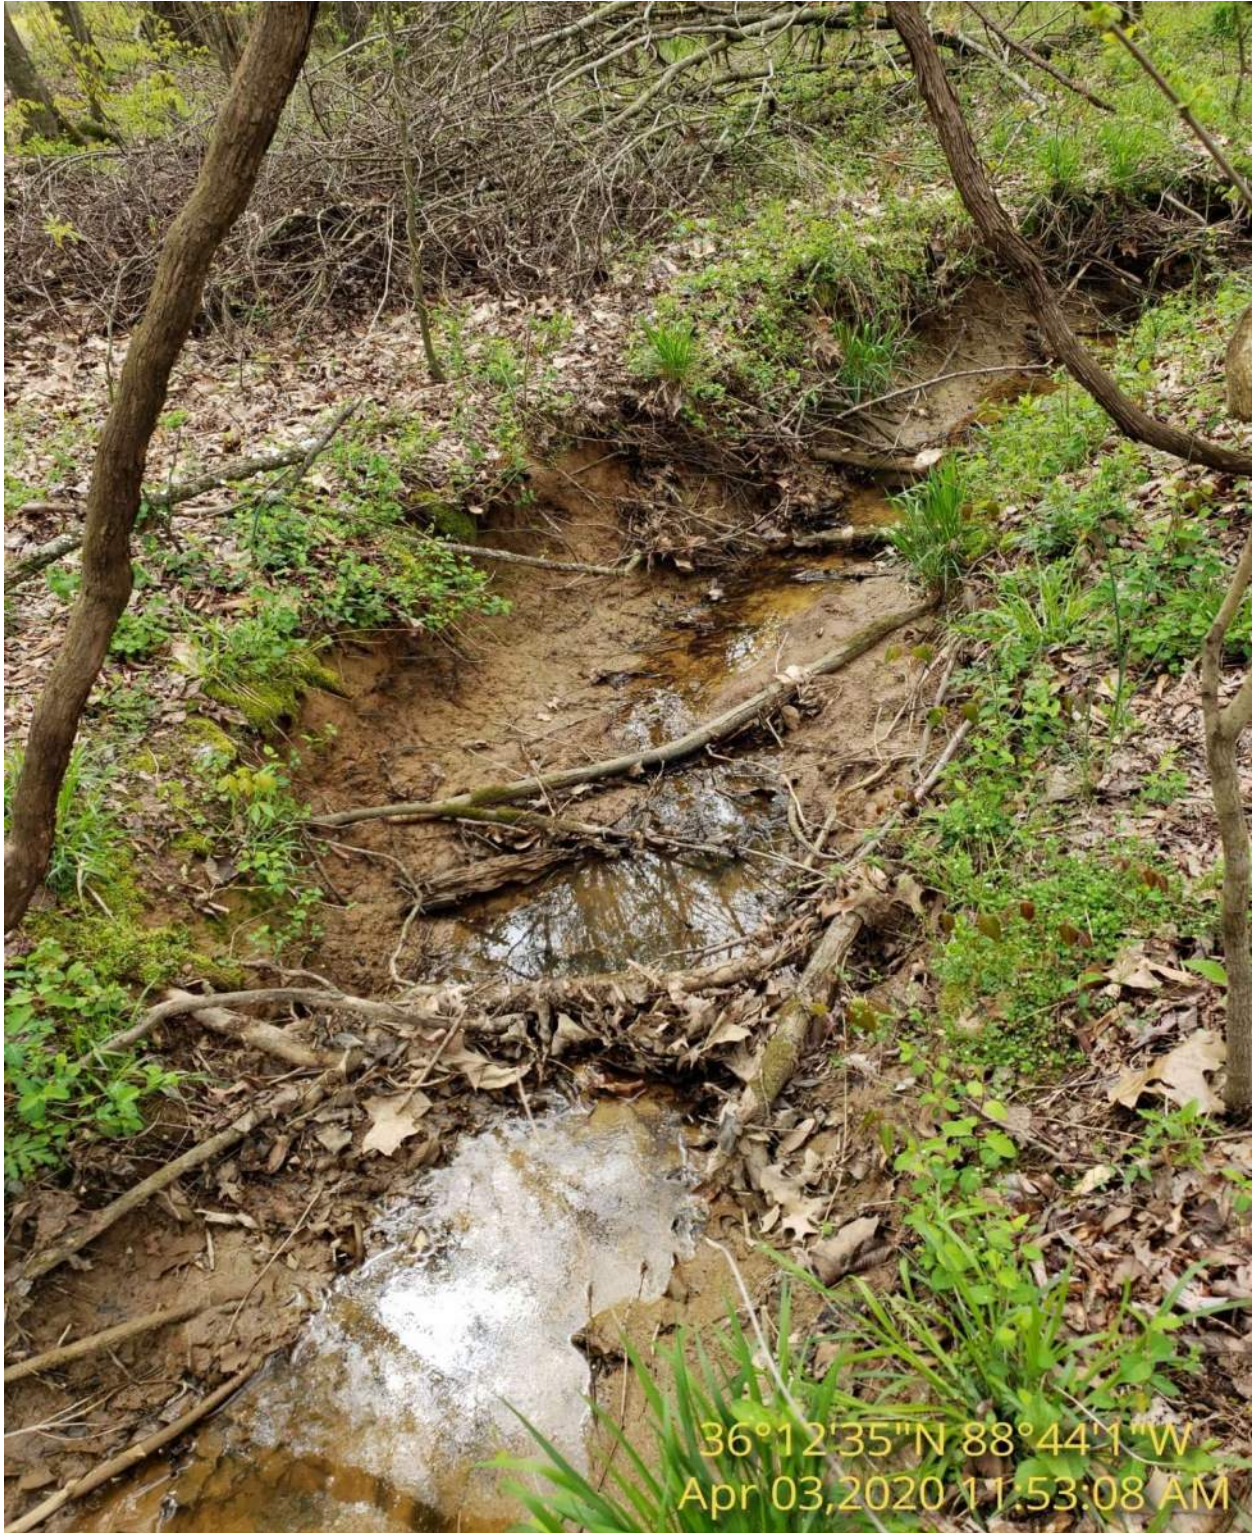
**PHOTO 3:** View of the channel looking south.

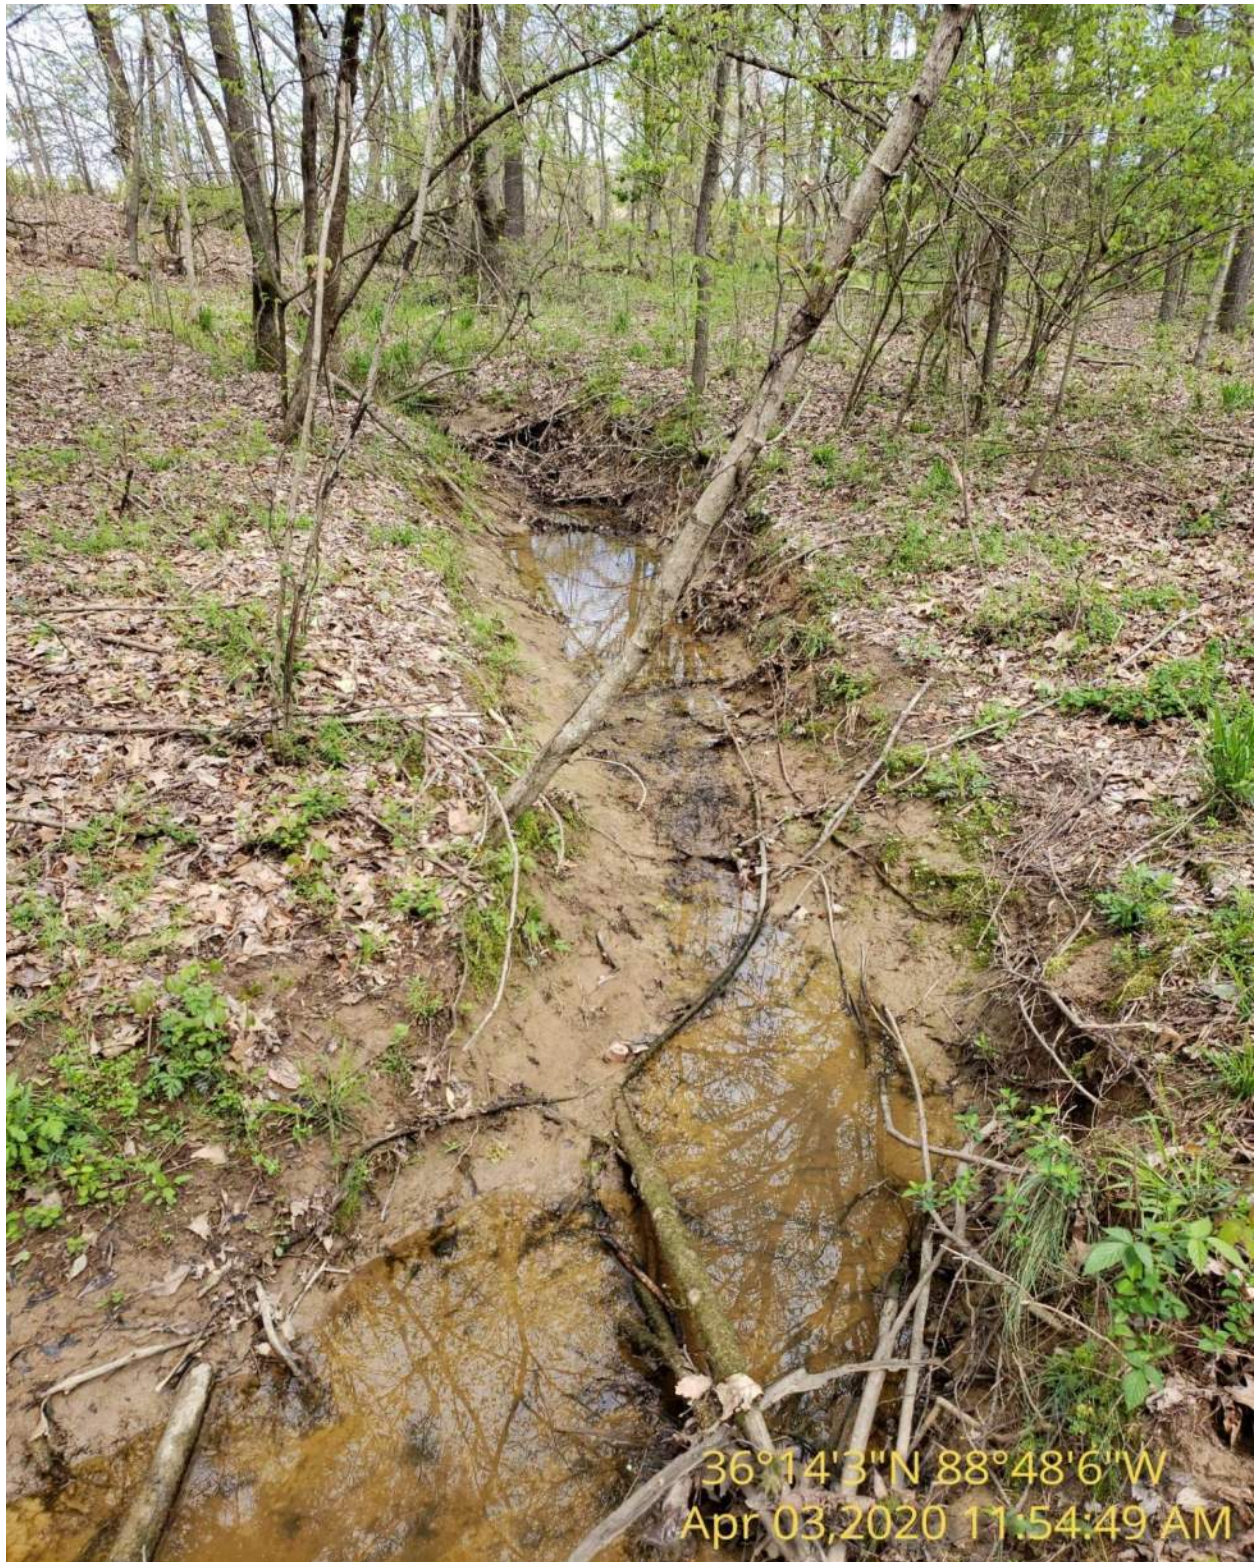
**PHOTO 4:** View of the channel as we continue south looking north, water was flowing very slowly.

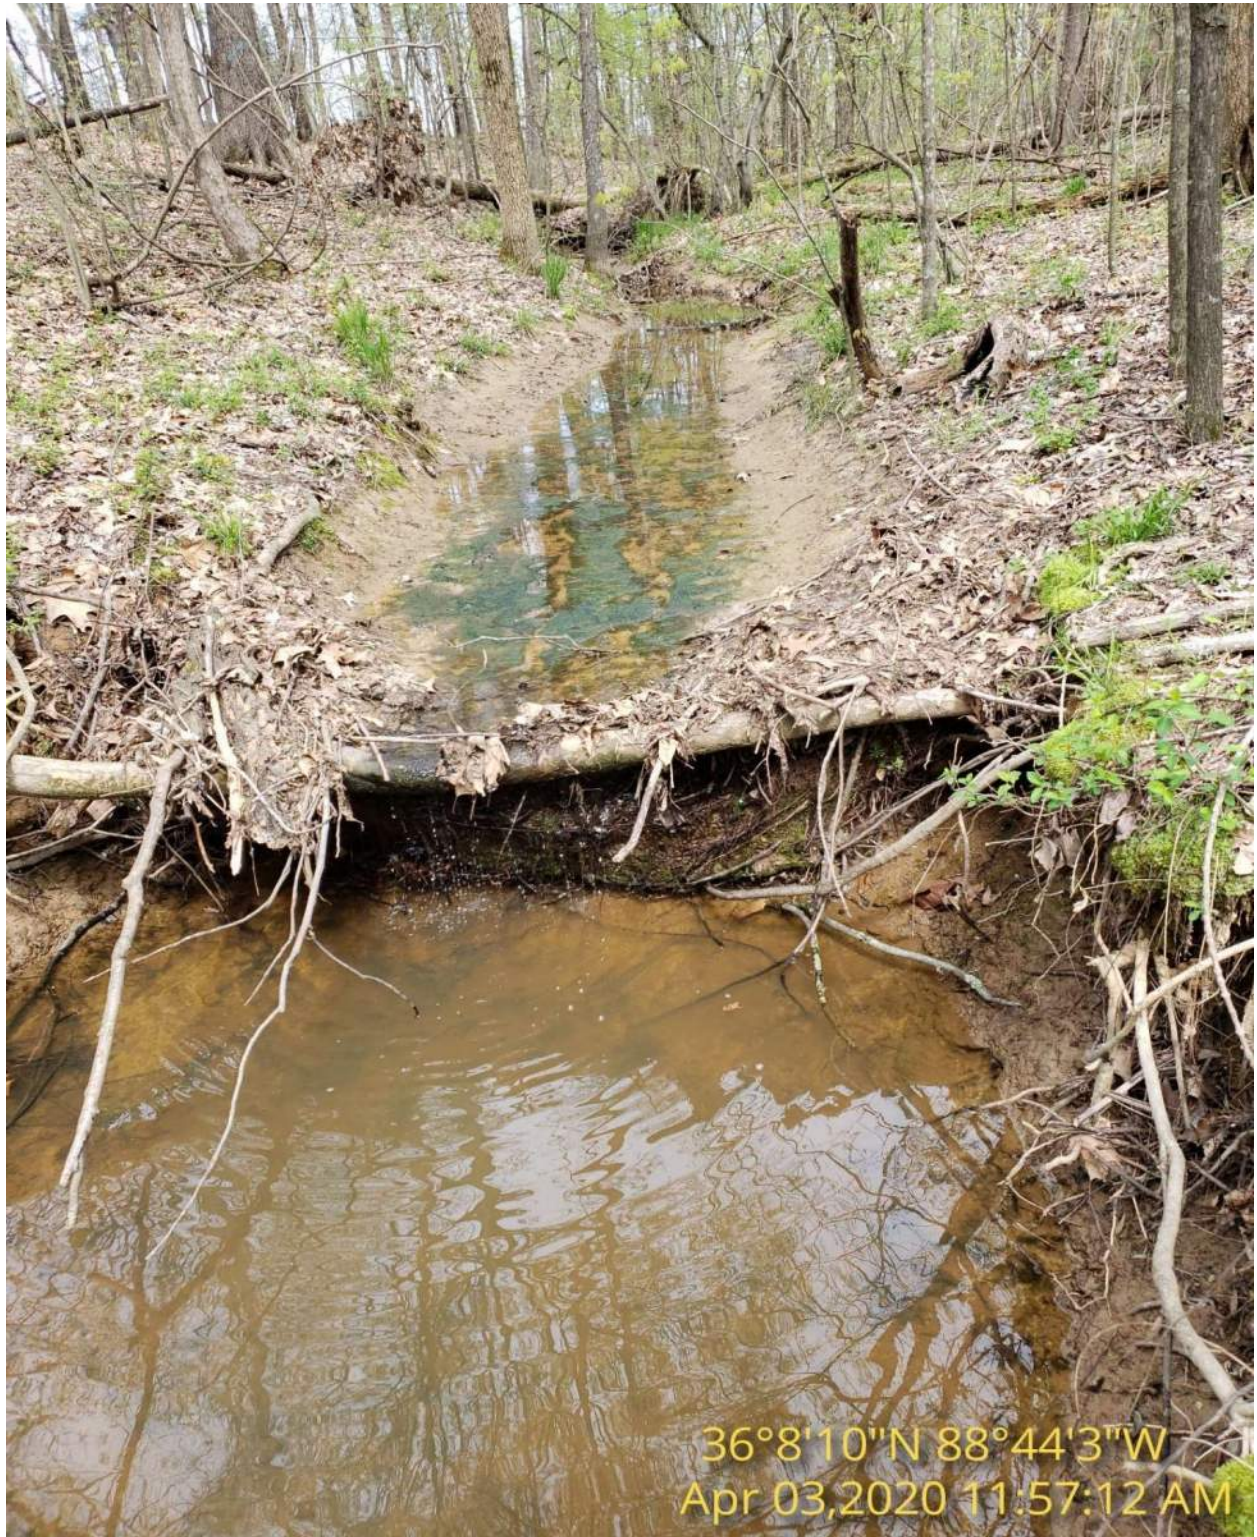
**PHOTO 5:** View of the channel looking north at a large grade control and a deep pool.

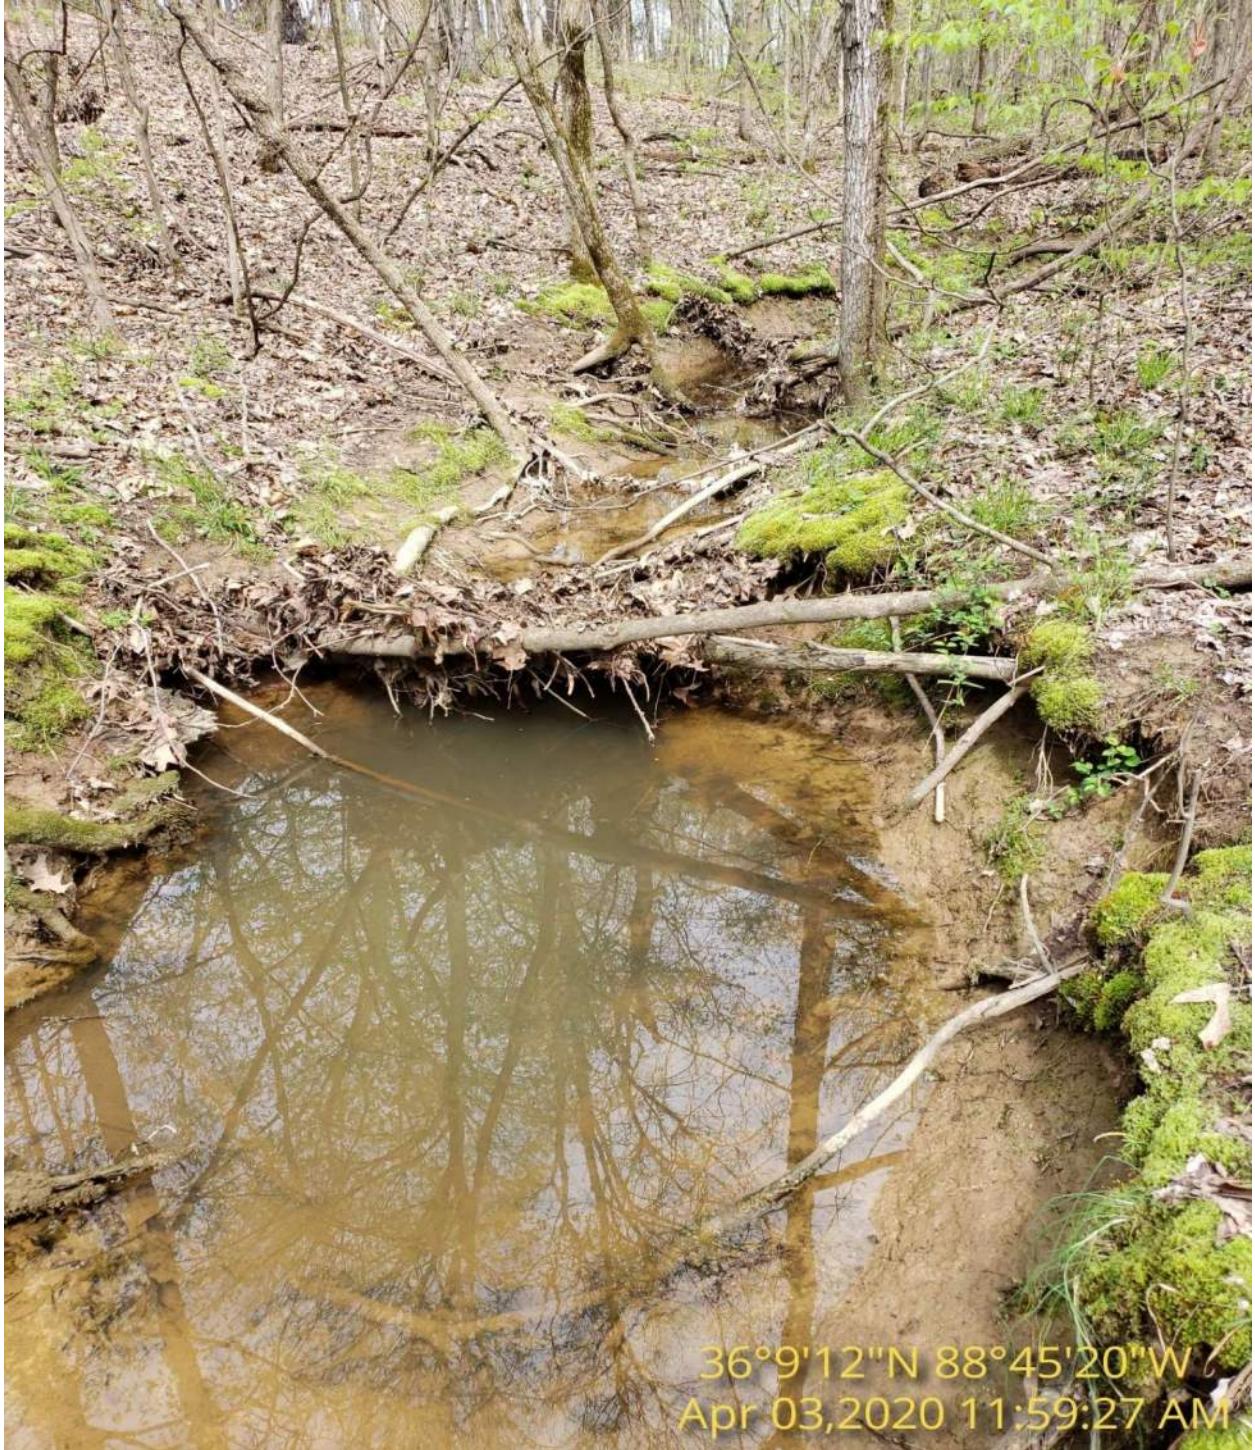
**PHOTO 6:** View of the channel as we continue south looking north at a large grade control and a deep pool.

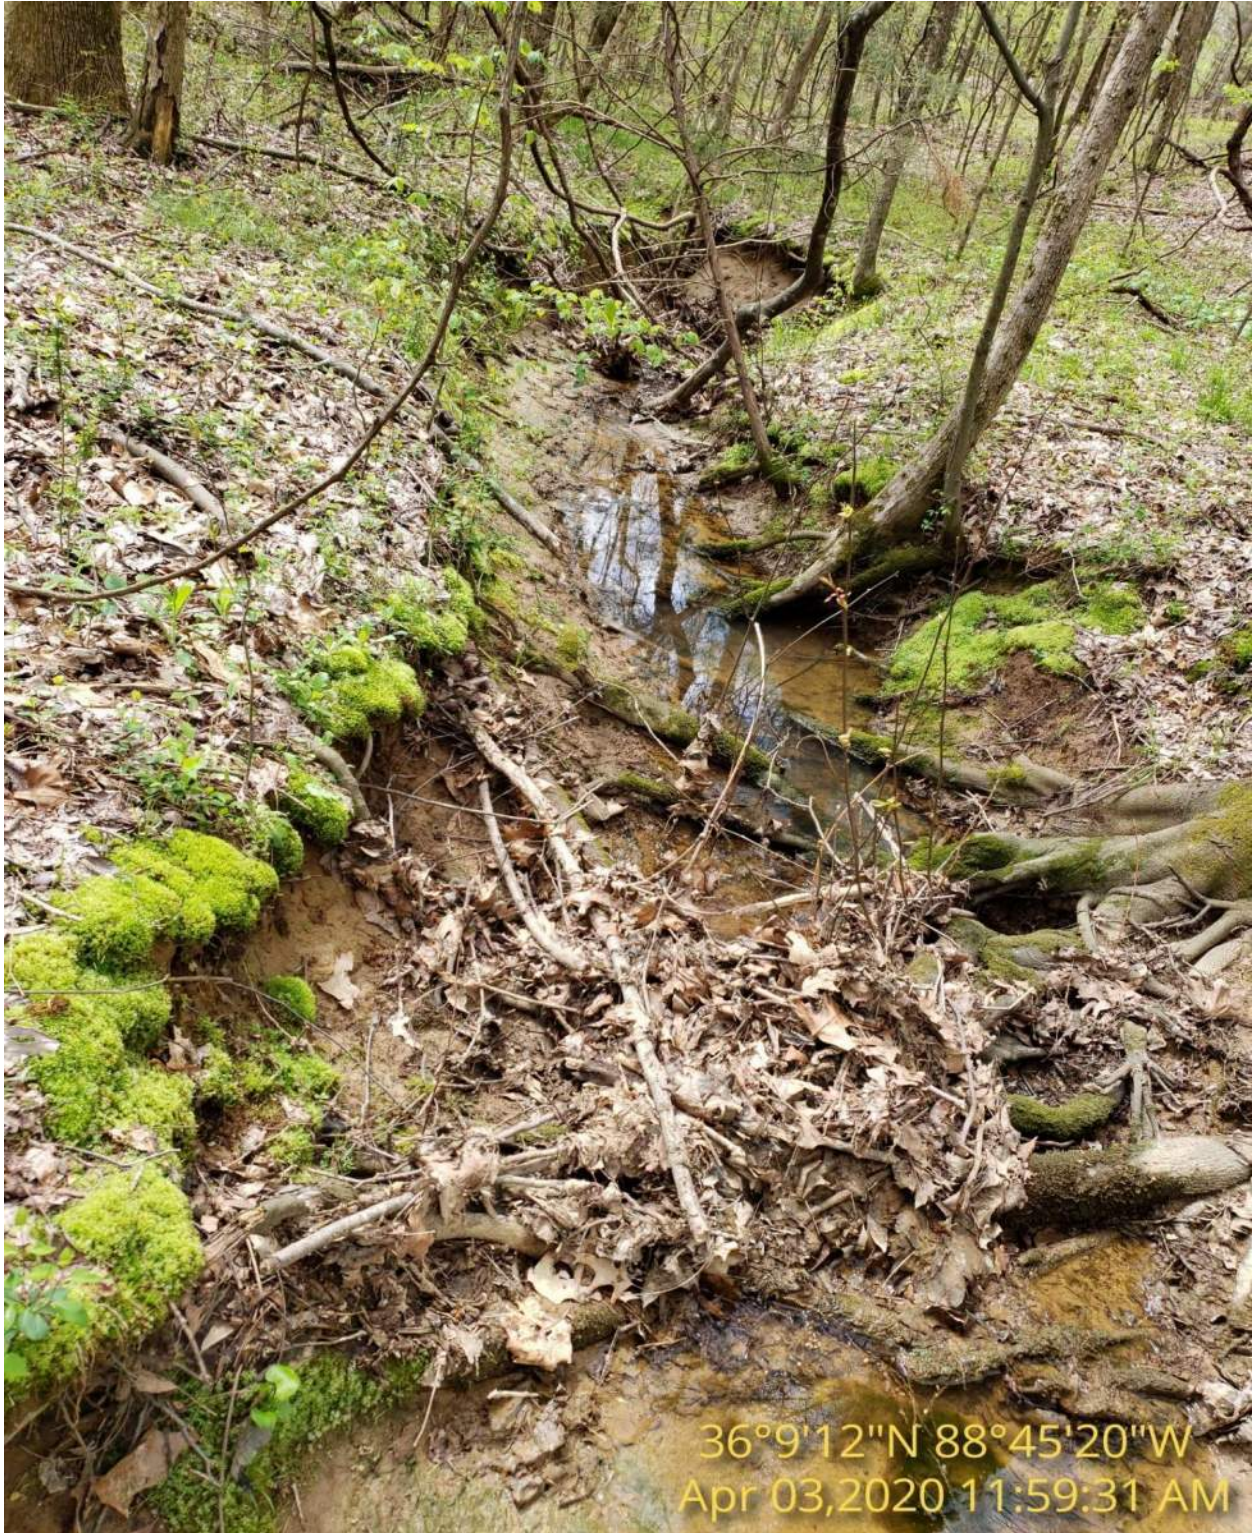
**PHOTO 7:** View of the channel looking south showing small grade controls.

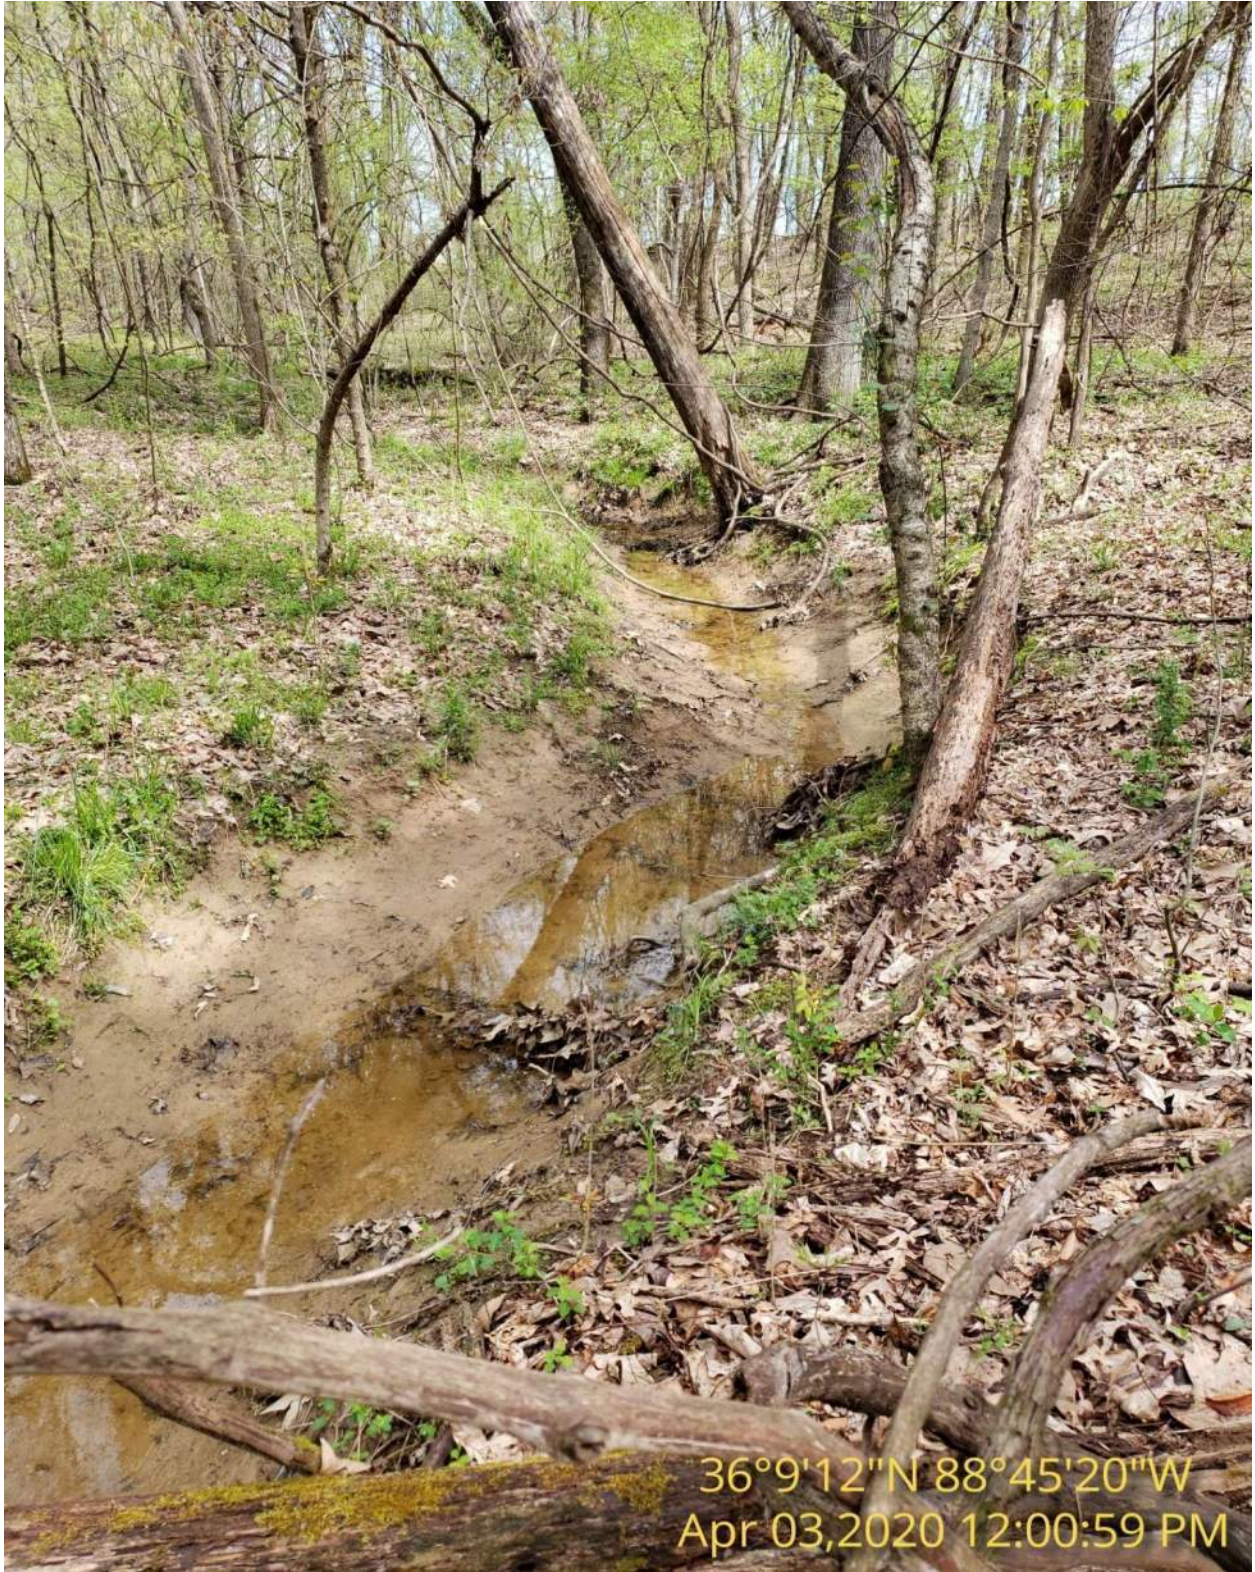
**PHOTO 8:** View of channel as we continue south looking north.
