Date: April 13, 2020

RE: Hydrologic Determination Report  
Tony Nguyen Chicken Barns  
Greenfield, Weakley County, Tennessee

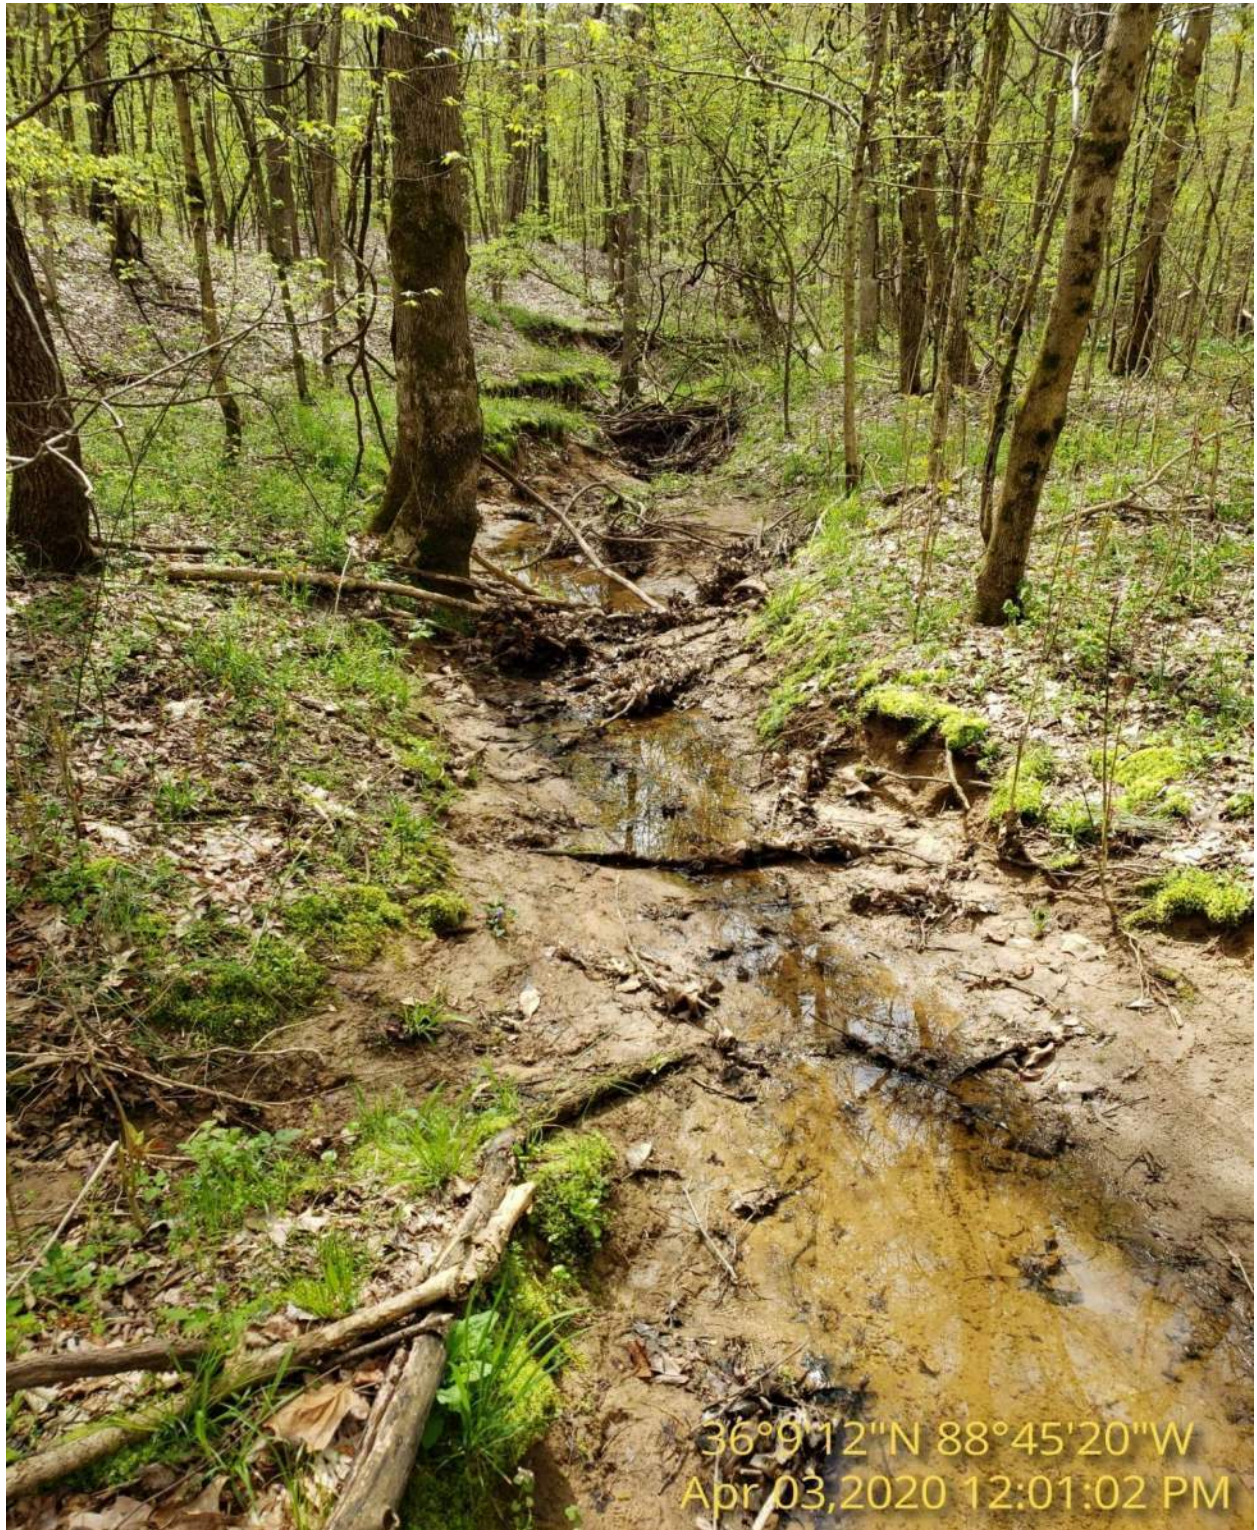
**PHOTO 9:** View of the channel looking south.

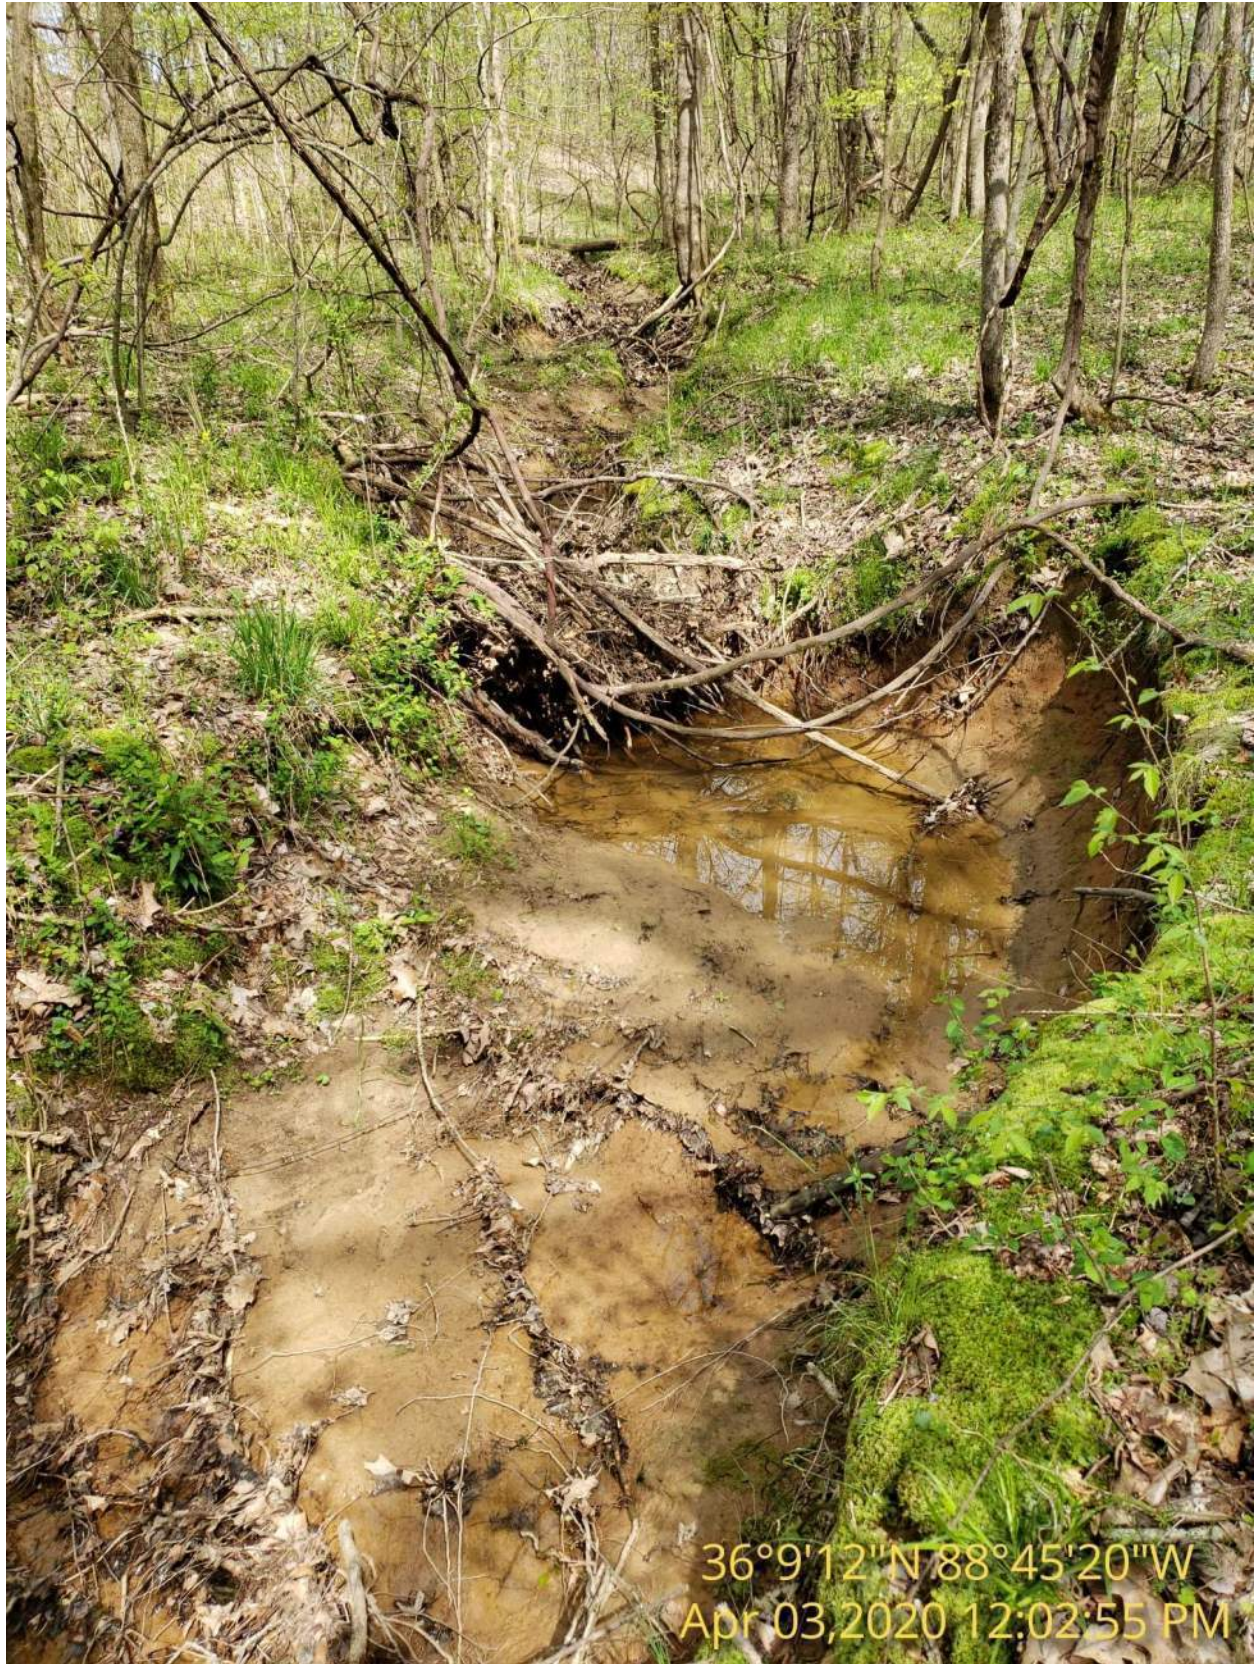
**PHOTO 10:** View of the channel looking north at the end of this determination.

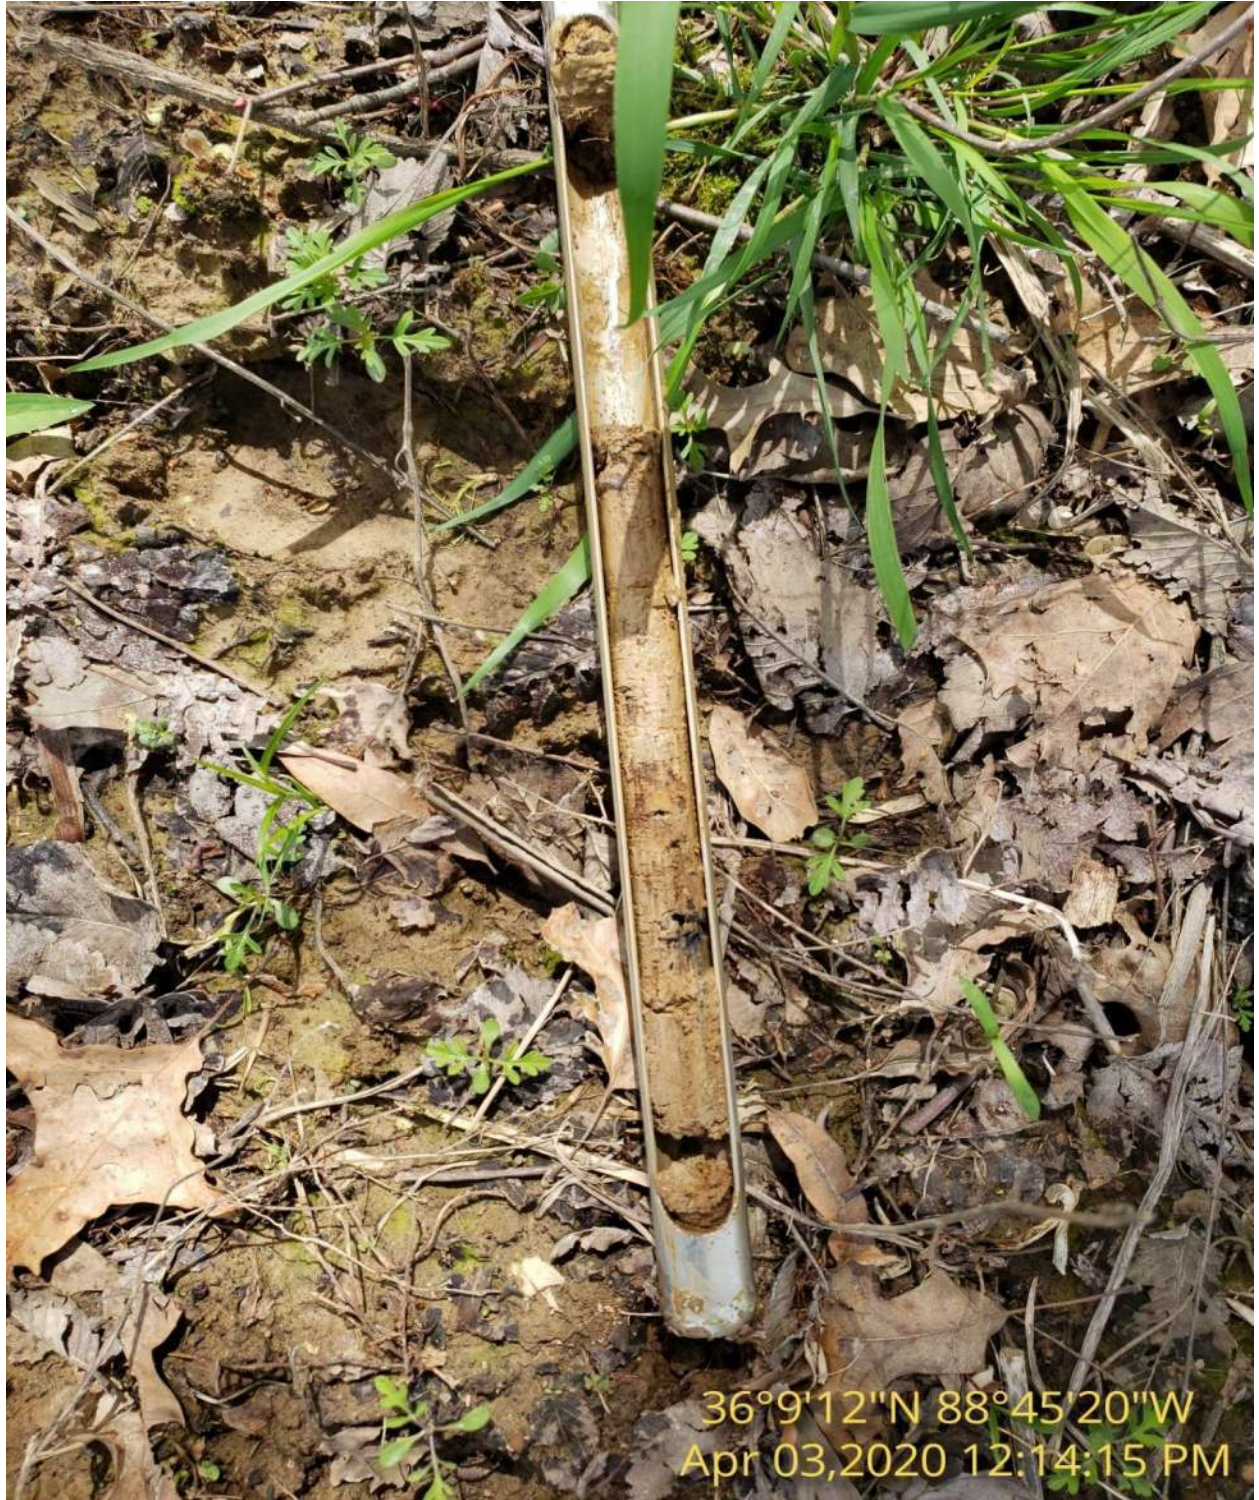
**PHOTO 11:** Soil Probe. Upland Soils observed.
