# **KINGSTON FOSSIL PLANT NPDES DIKE INSPECTION REPORT**

**PERMIT NUMBER TN0080870**

**Reporting Period October 1, 2015 - December 31, 2016**

**2016 Annual (Intermediate) Inspection of CCR Facilities  
Kingston Fossil (KIF) Plant  
Kingston, Roane County, Tennessee**

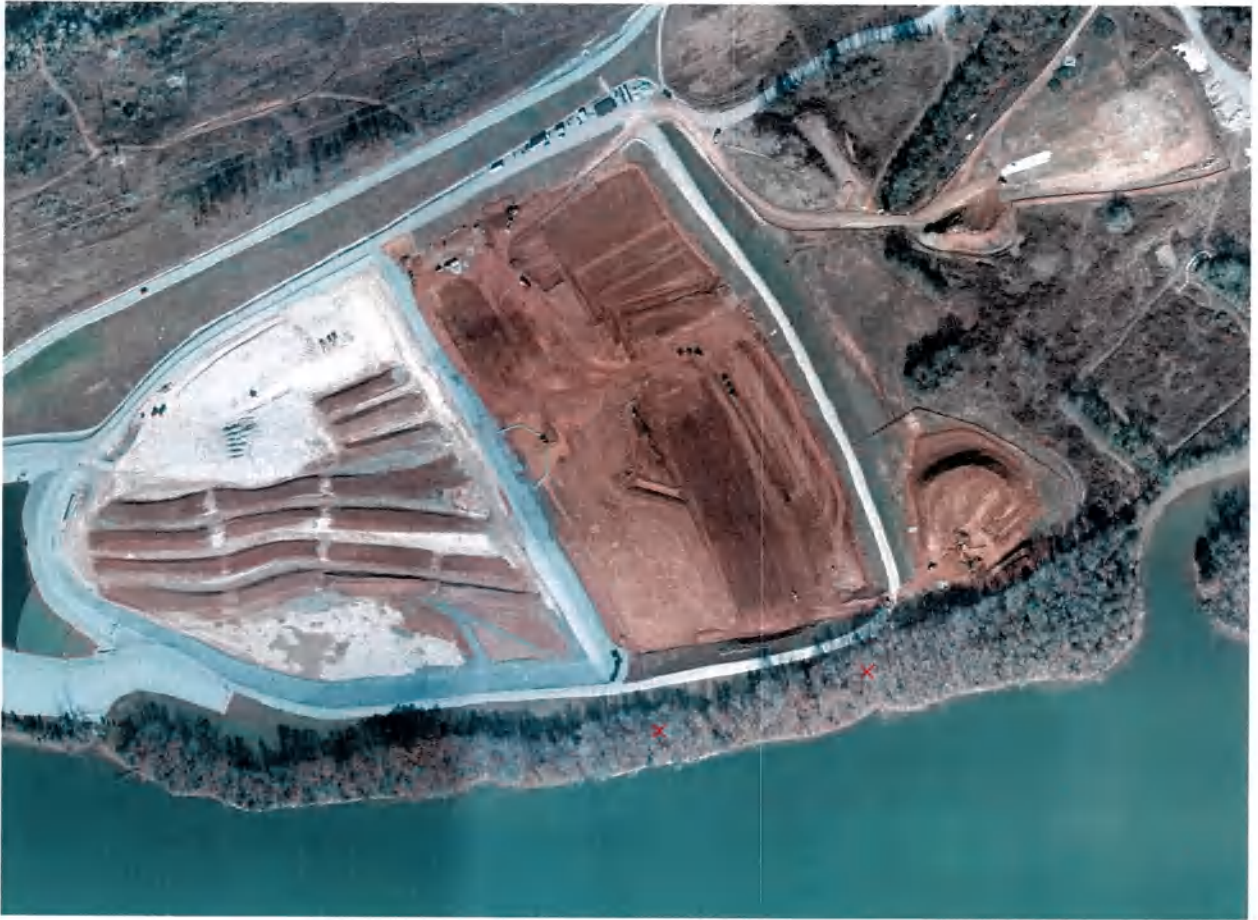
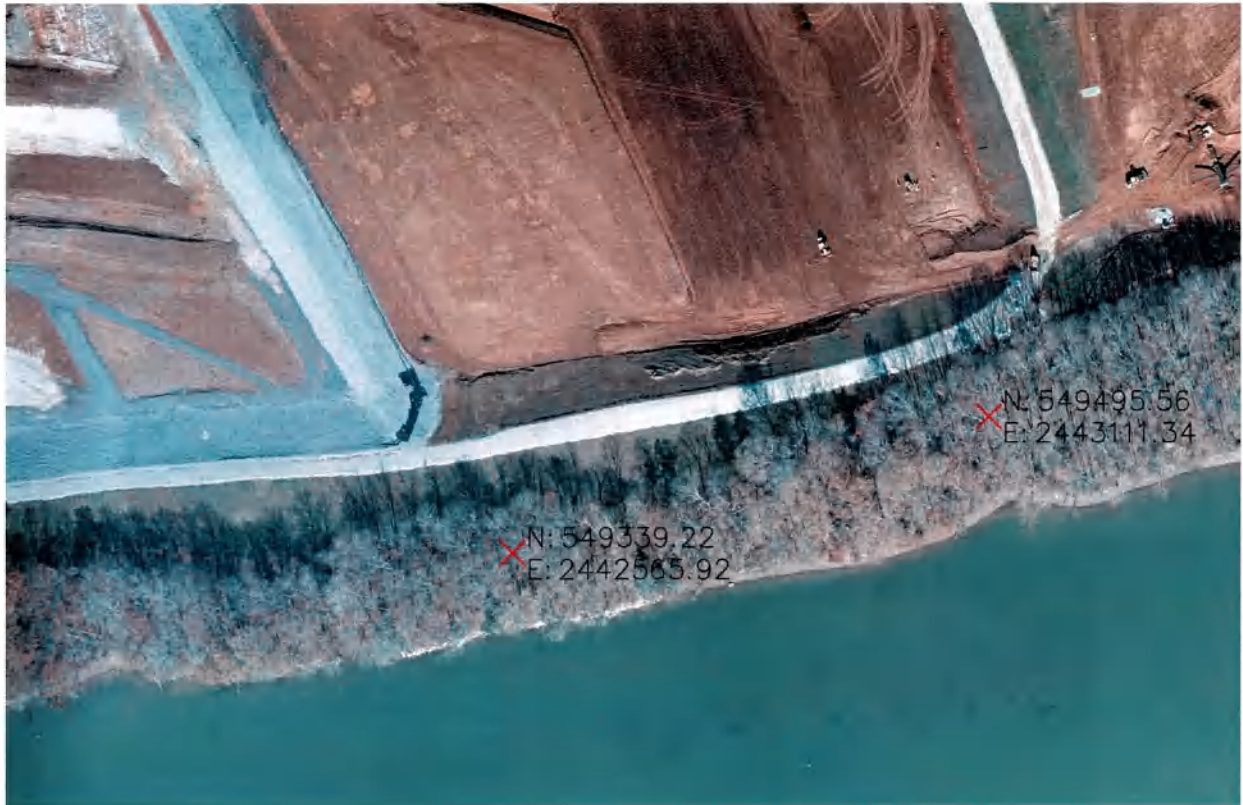
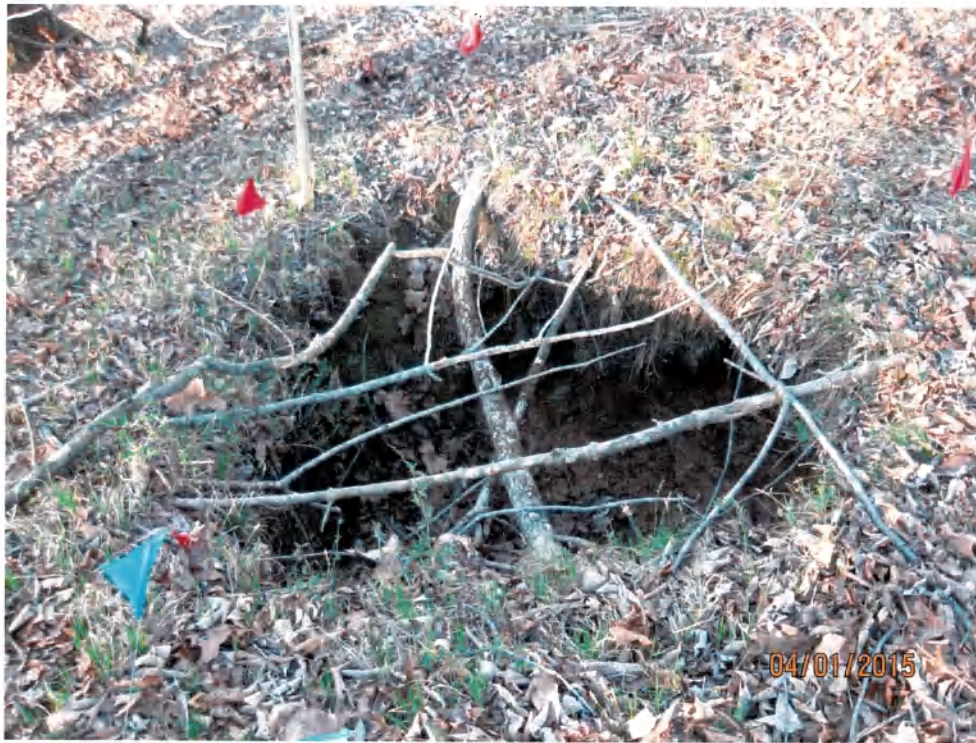
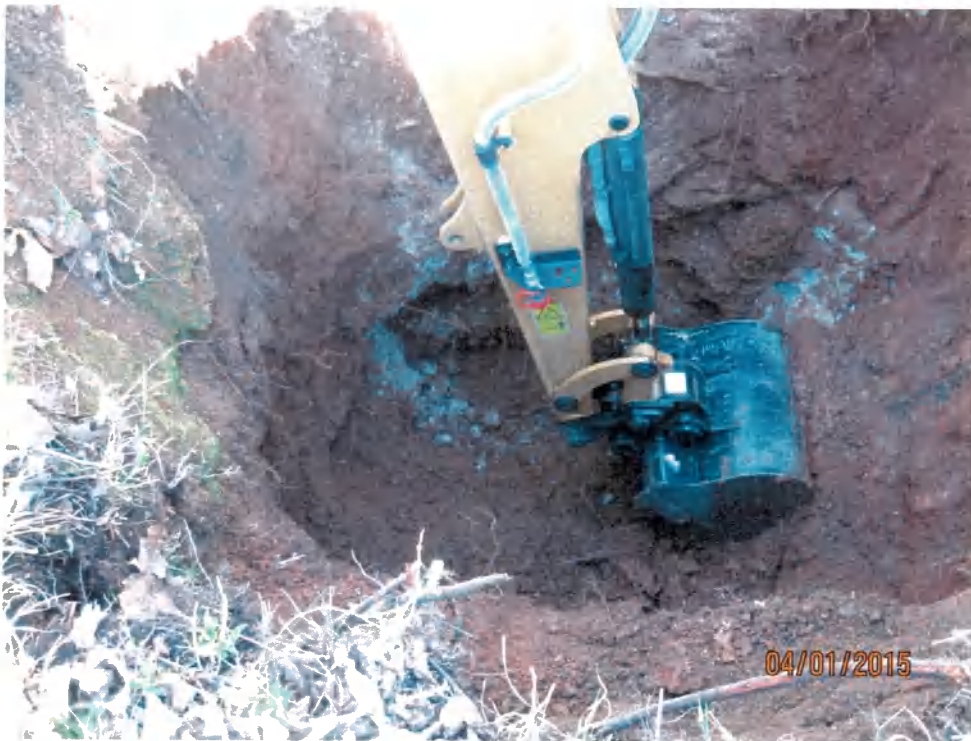
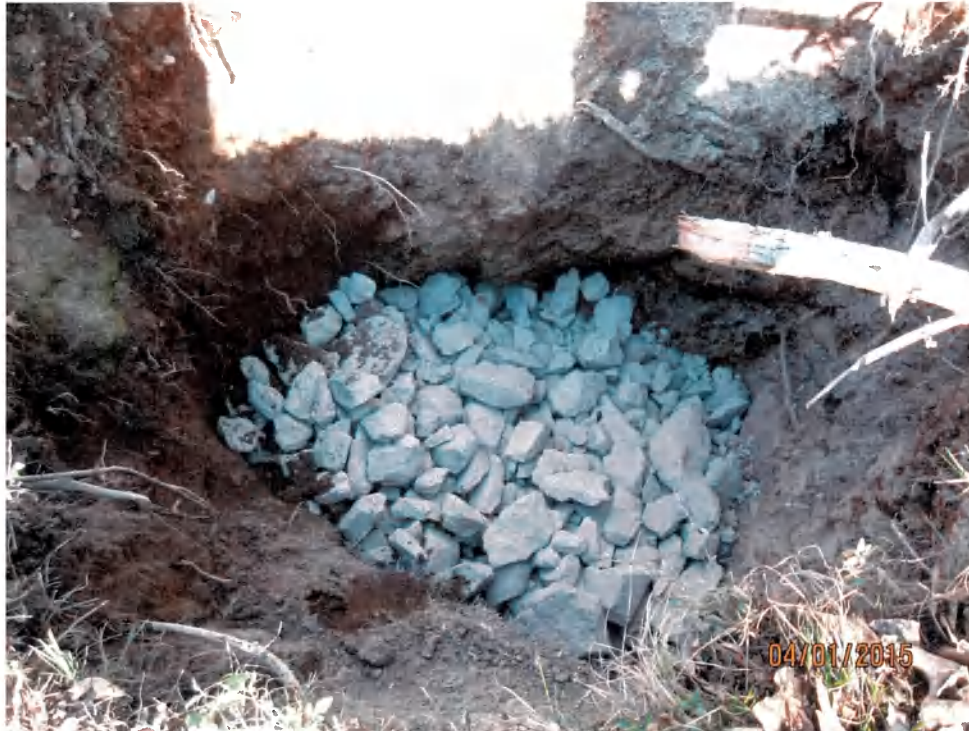
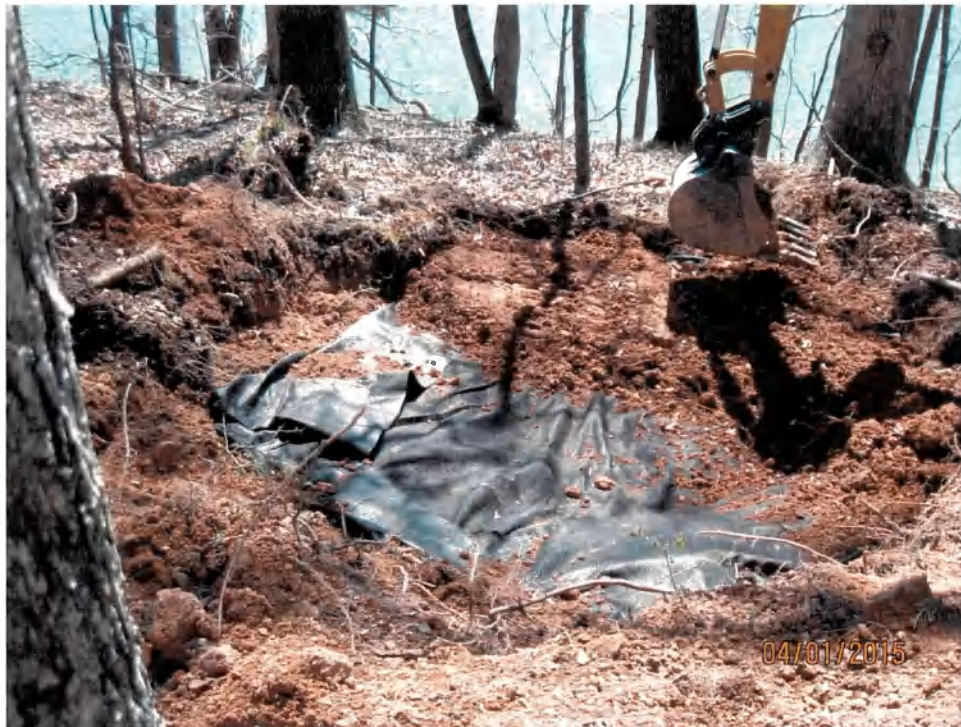
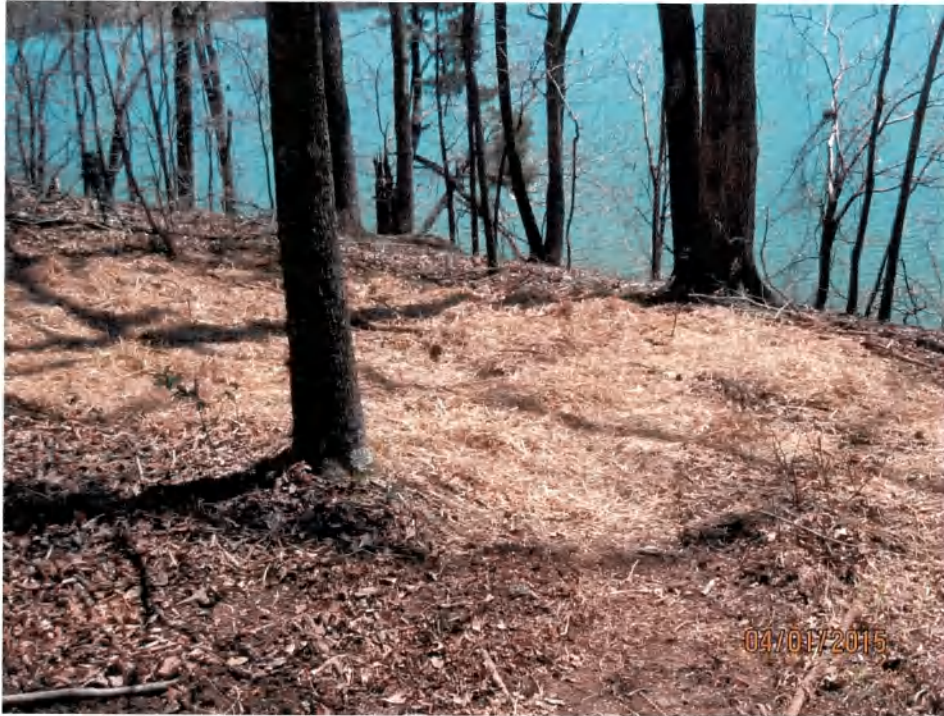
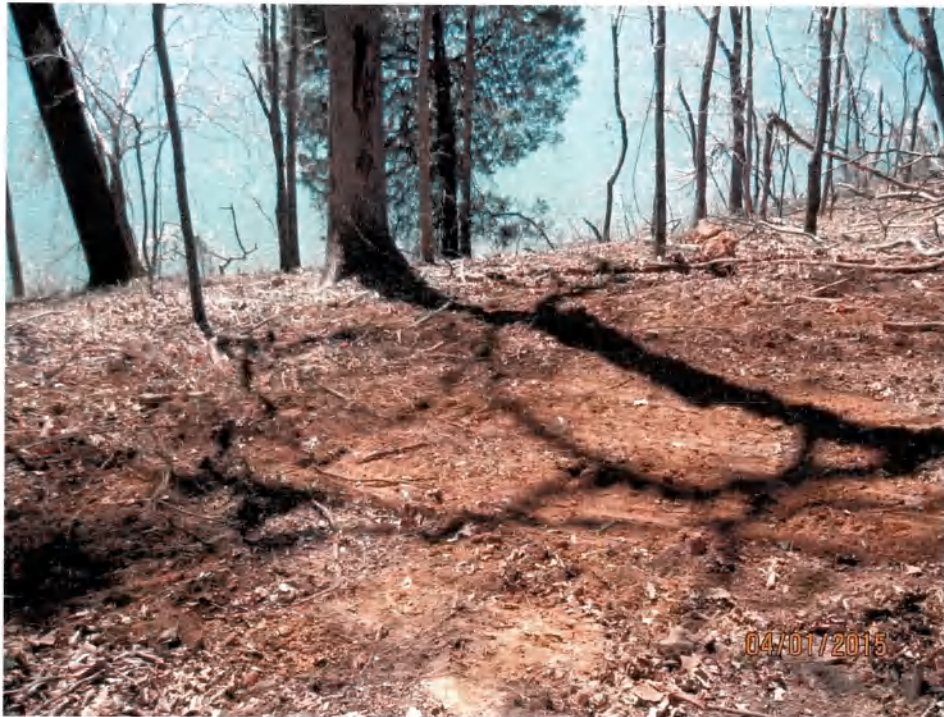
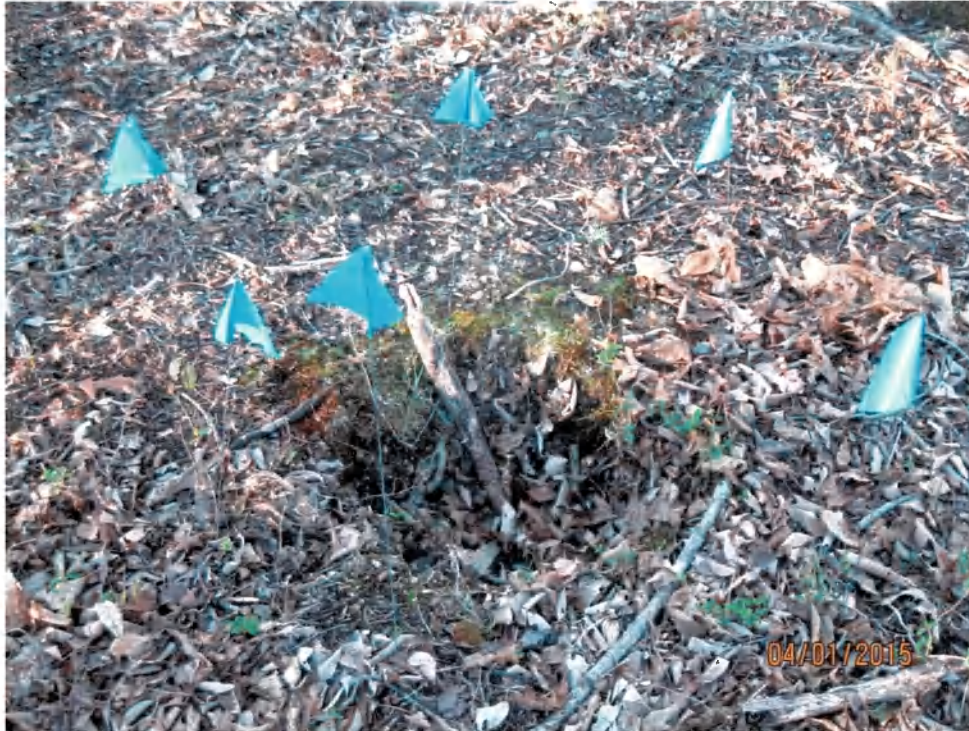
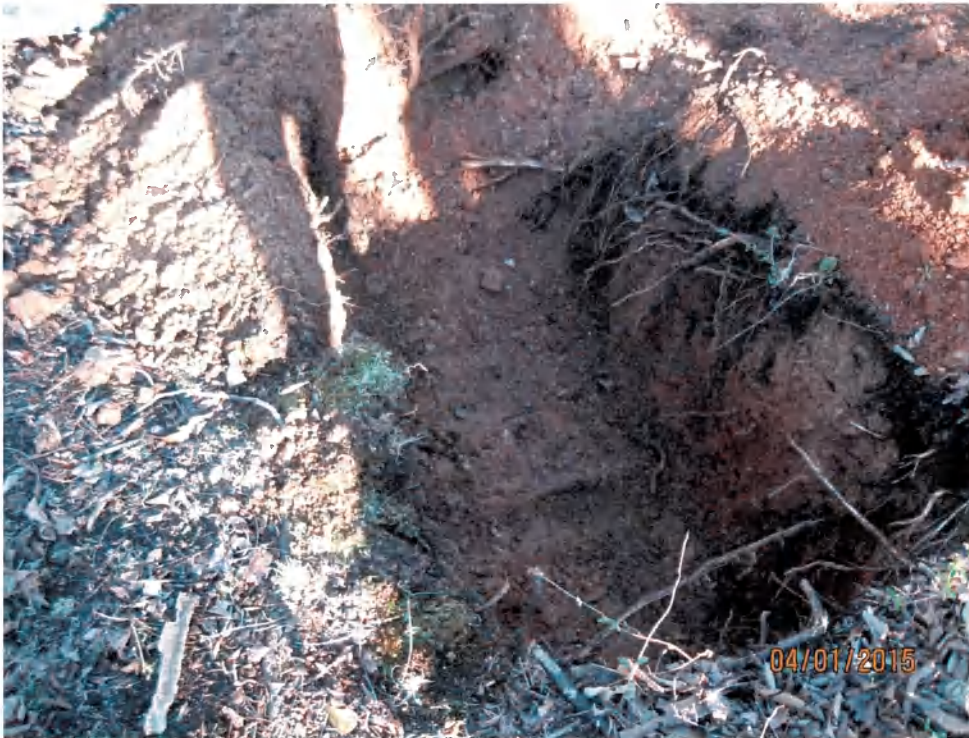
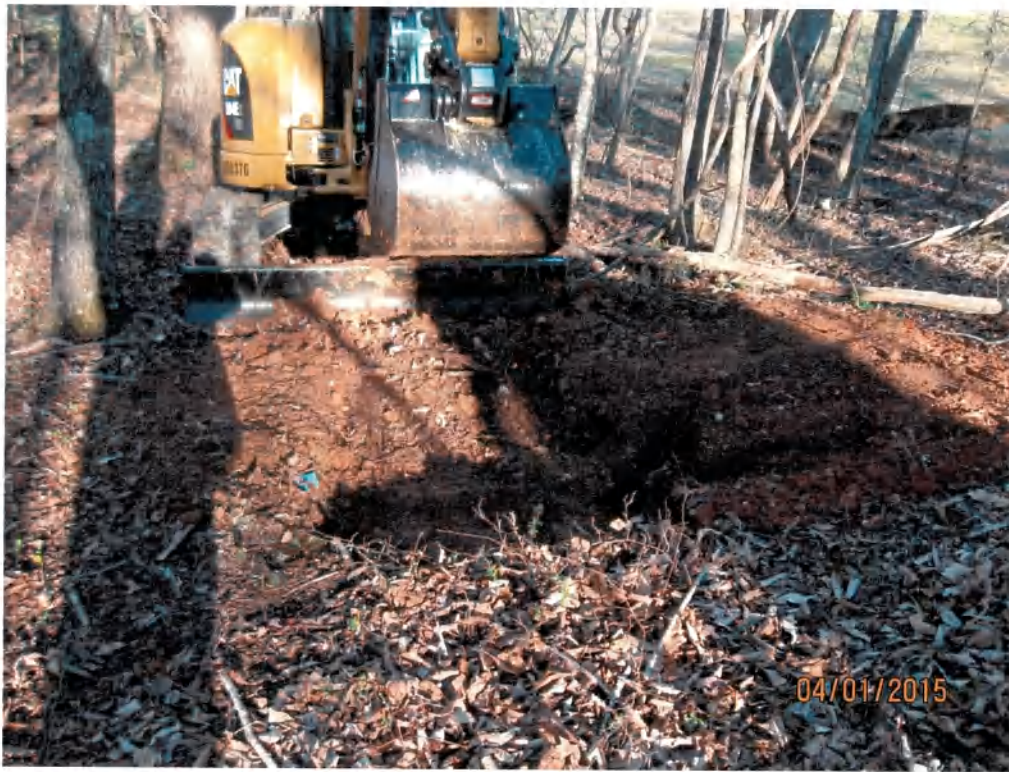
## **Attachment A**

On 4/01/15 the TVA team and Trans Ash contractors performed mitigation work on the depression areas in the woods along south side of GDA. TVA and TDEC teams were out on site 3/30/15 and 3/31/15 and inspected the depression areas. TVA received approval to proceed with the repairs. Upon starting repair work Trans Ash had two operators and a site supervisor on site to perform the work and a small excavator and a skid steer.

The first area was approximately 2x2x2 ft in size and Trans Ash excavated it out to approximately 3x5x4 ft. This depression was a rotted out tree stump. The bottom of the depression was probed and confirmed to have a solid bottom. Trans Ash started the backfill process of putting clay back in hole in 10 in lifts and compacting it with an excavator bucket to original grade.

The second depression was approximately 3x3x3 ft and was excavated to approx. 4x3x4.5 ft. This depression also appeared to be a stump hole. The bottom of the depression was probed and confirmed to have a solid bottom. Trans Ash preceded to backfill with clay in 8/10 in lifts and compacted with excavator bucket back to original grade .

The third area was the larger depression area, it was approximately 6x7x4 ft. While excavating this area, Trans Ash chased a rock down to approximately 11 ft deep and 8ft wide and 8ft long and found solid bottom where rock choked off. Trans Ash started their backfill procedure by placing approximately 5ft of riprap in 1ft lifts and compacted with excavator bucket. Then 3 ft of number 2 stone was then placed in approximately 10 in lifts and compacted with excavator and 2ft of crush and run stone was placed in 8/10 inch lifts and compacted with excavator. A layer of non-woven geo textile fabric was placed in a 10x10x10 ft area and clay was placed on top of the fabric in 8/10 in lifts and compacted with an excavator and brought to original grade.

There were three more depression areas found during the remediation. Each area was approximately 1x1x1 ft and once excavated Trans Ash it was determined that these areas were all rotted stumps and we probed all for solid sides and bottoms and repaired these by placing clay back into holes and compacting in 8/10 inch lifts and bringing to original grade.

All remediated areas were seeded and covered with straw. This completed the remediation work.

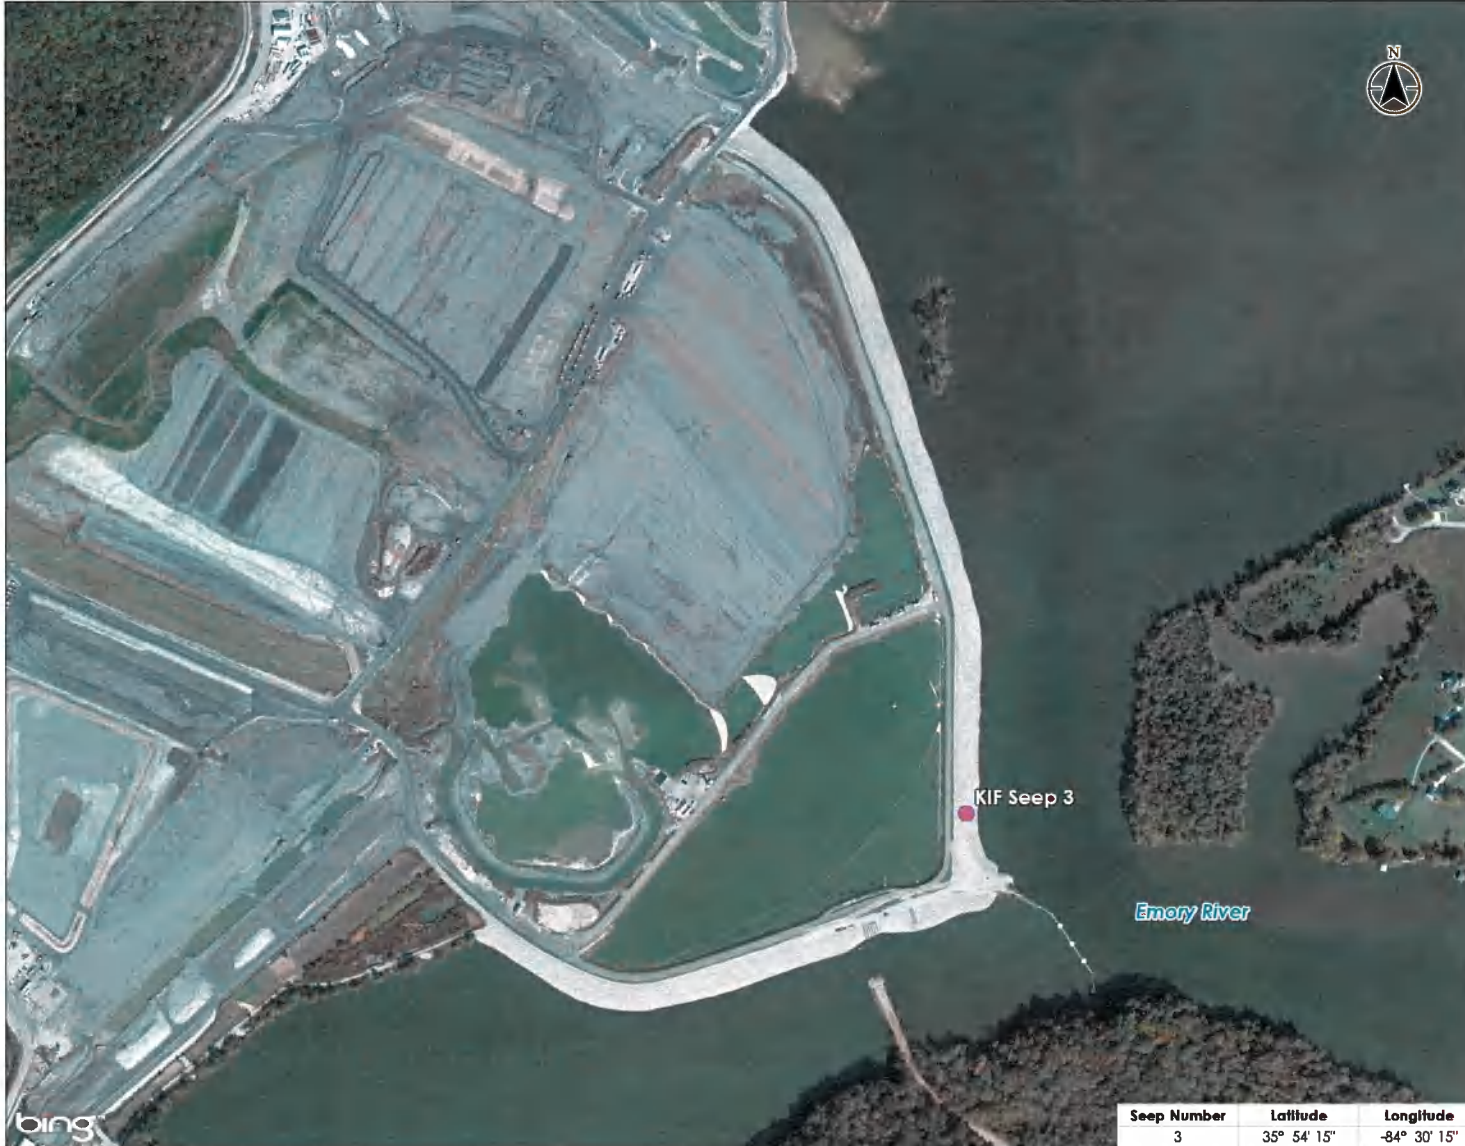
Figure No.  
**2**

As reported in the 2011 dike inspection report, five drainage trenches were installed on the southeast exterior side of the Stormwater Pond to maintain a low groundwater elevation near the toe of the dike. See Attachment C Seep Layout.

**Kingston Fossil Plant Seepage Layout  
Area North of Fossil Plant**
