Subject:        NOTICE OF VIOLATION  
                 Carothers Crossing Phase 7 Section 1 Road Crossing (NR1804.315)  
                 La Vergne, Tennessee

# Photographic Log

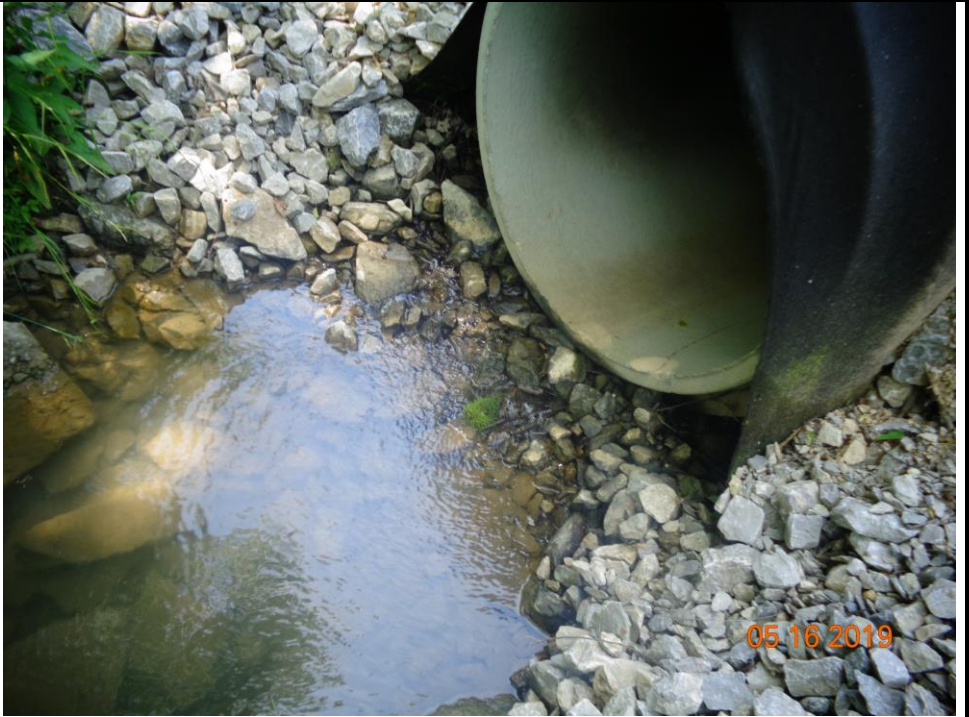
<b>Photo No.</b> 2	<b>Date</b> 5/16/2019

- Current stream crossing is not designed to TDEC standards for temporary stream crossings and is causing impoundment of the stream.

<b>Description</b> Culvert not installed correctly, water flowing under pipe.

1. Within 10 days, submit a Corrective Action Plan (CAP) describing how you propose to return the stream to its original condition and/or information on installing a road crossing that meets the terms and conditions of the general permit.

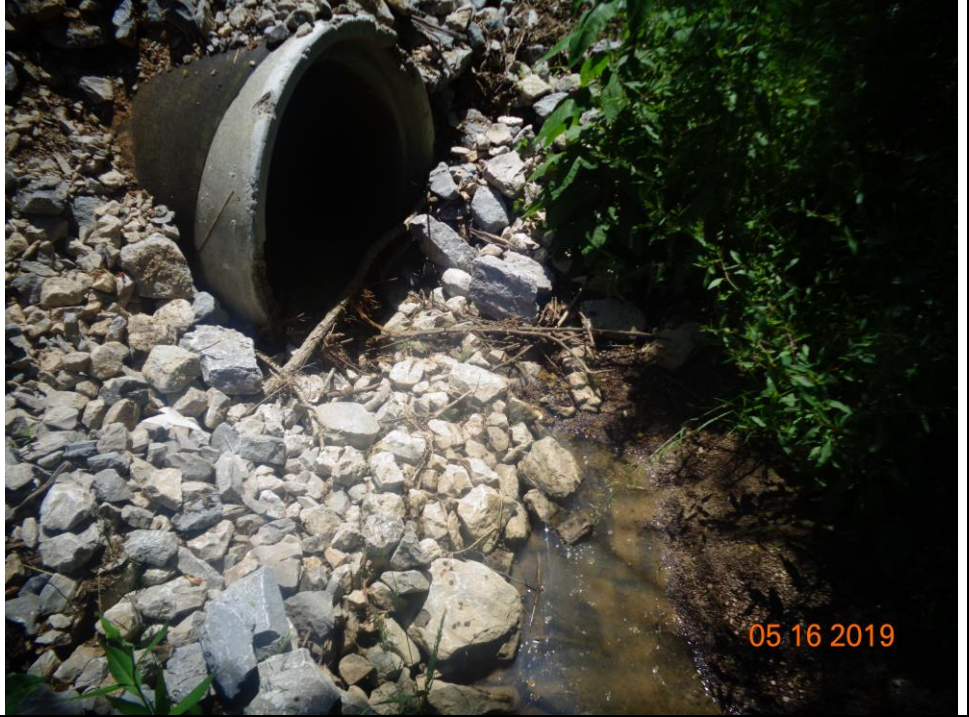
<b>Client or Facility Name:</b> Carothers Crossing Ph. 7 Section 1 Road Crossing		<b>Site Location:</b> 35.984244, -86.613608	<b>Project No.:</b> NR1804.315
<b>Photo No.</b> 3	<b>Date</b> 5/16/2019

<b>Description</b>  Culvert not installed properly, rip/rap impounding stream.
