RE: Hydrologic Determination Report for Gleason Clay Company Mine # 10,
TN0045527

There are three areas identified inside the proposed permit boundary addition for Gleason Clay Company's Mine # 10 (TN0045527) that have been assessed. The area to be permitted is farm land under cultivation for row crops that is divided by a woodland area. The features assessed have moderate alteration of the natural channel morphology. The features are designated here as WWC01, WWC02, and WWC03.

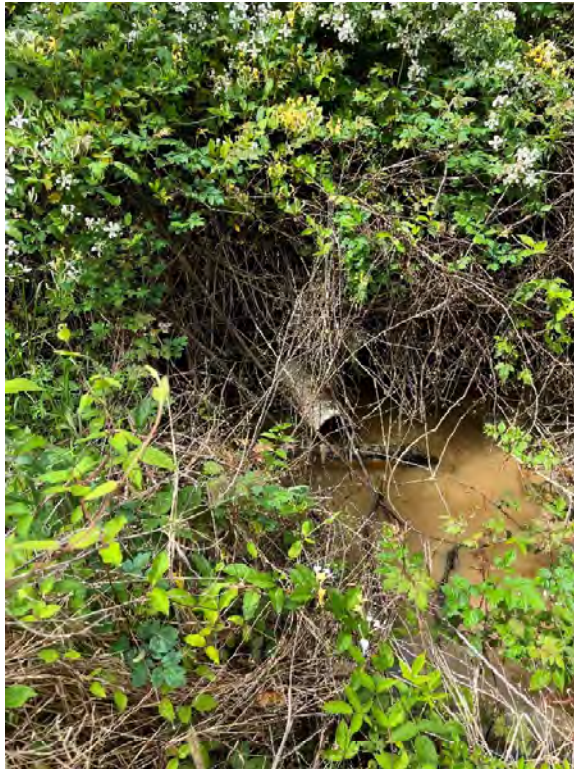
Picture 1

Date of Photo: 04/30/24. Photo looking southwest to the beginning of WWC01 (36.20975, -88.71603).

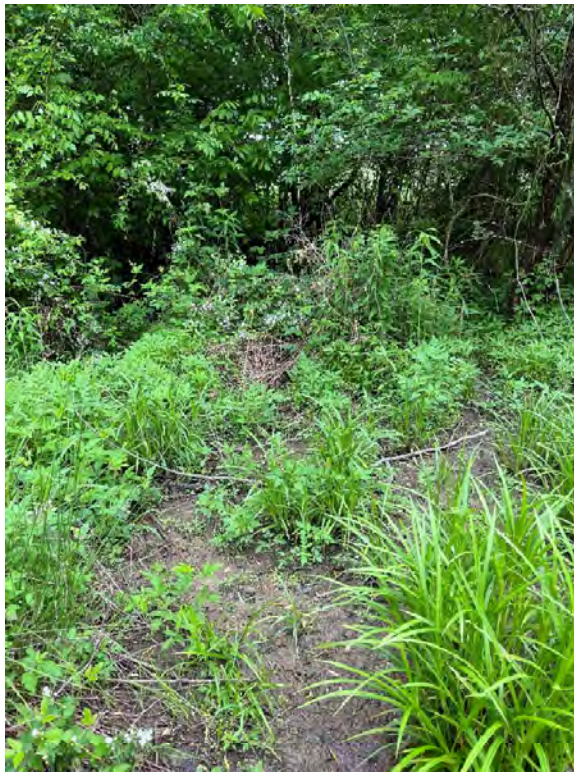
Picture 2

Date of Photo: 04/30/24. Photo looking north near the beginning of WWC01 (36.20981, -88.71600).

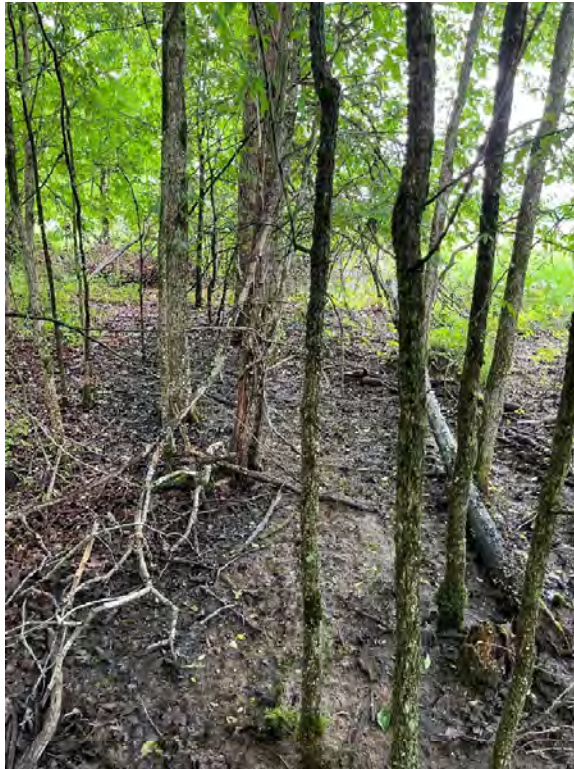
Picture 3

Date of Photo: 04/30/24. Photo of WWC01 looking north inside the wood line seen in picture 2 (36.20986, -88.71592).

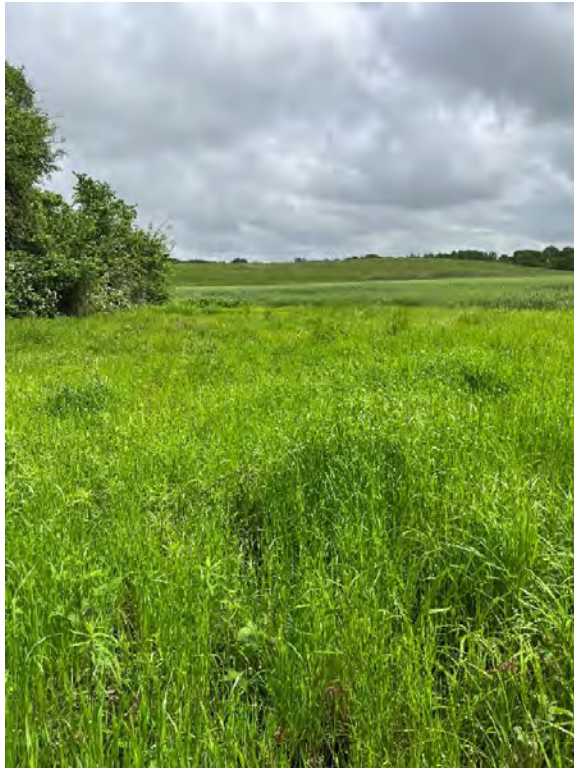
Picture 4

Date of Photo: 04/30/24. Photo of WWC01 looking north. North of picture 3 (36.21006, -88.71572).

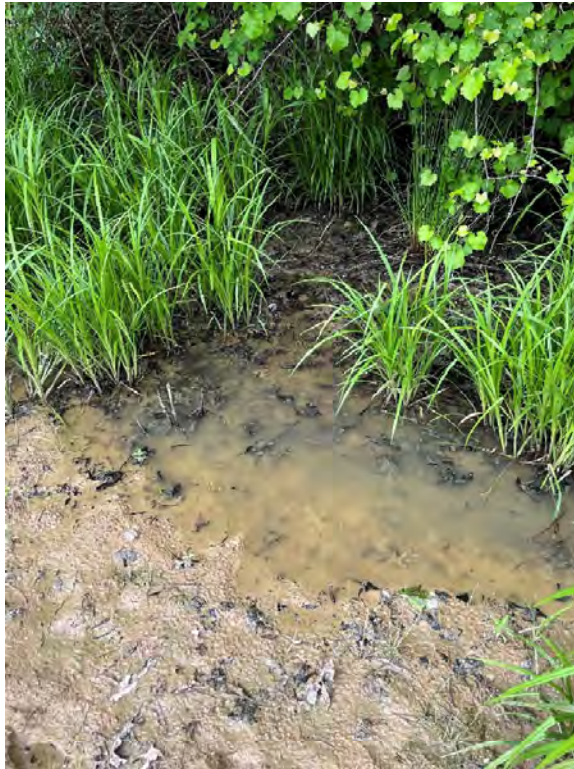
Picture 5

Date of Photo: 04/30/24. Photo of WWC01 along tree line looking west (36.21051, -88.71556).

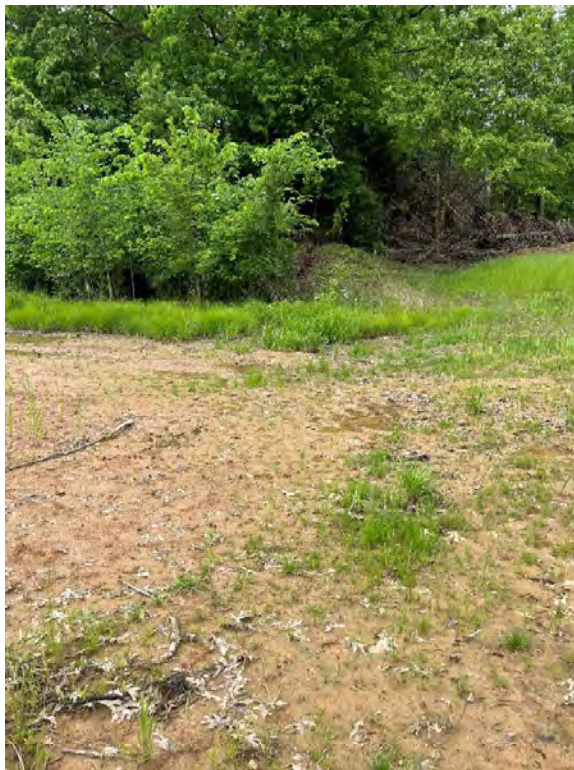
Picture 6

Date of Photo: 04/30/24. Photo of WWC01 looking southwest in the direction of photo 5 (36.21086, -88.71555).

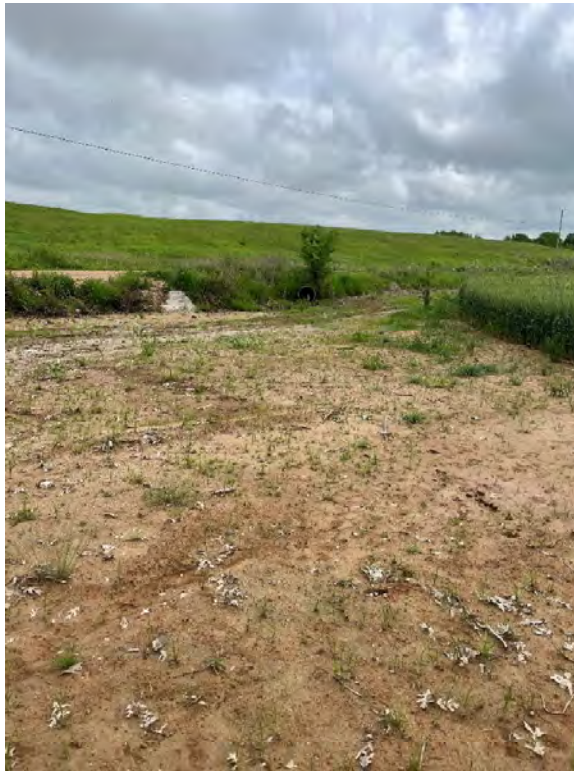
Picture 7

Date of Photo: 04/30/24. Photo of WWC01 looking northeast to culvert crossing under old Will Young Road (36.21081, -88.71564).

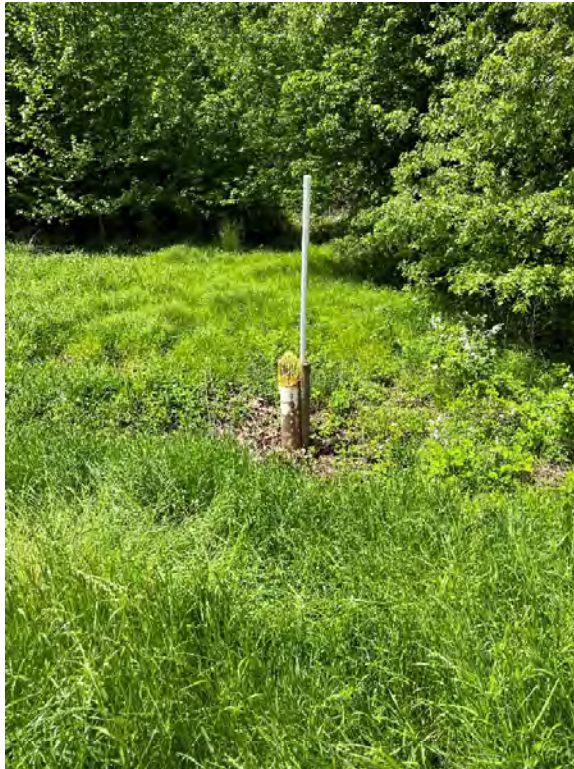
Picture 8

Date of Photo: 04/30/24. Beginning of WWC02 looking west at perforated pipe drain on west side of constructed levee (36.21081, -88.71564).

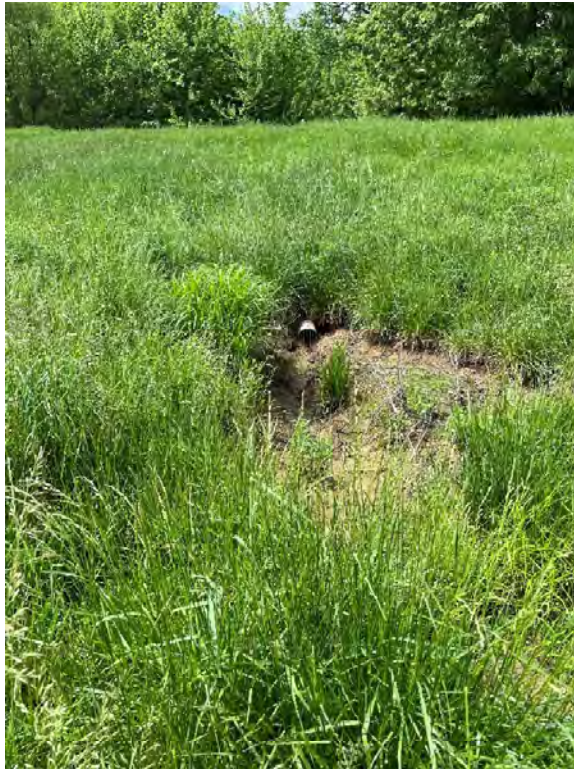
Picture 9

Date of Photo: 04/30/24. WWC02 looking west at perforated pipe drain outlet through levee (36.21081, -88.71564).

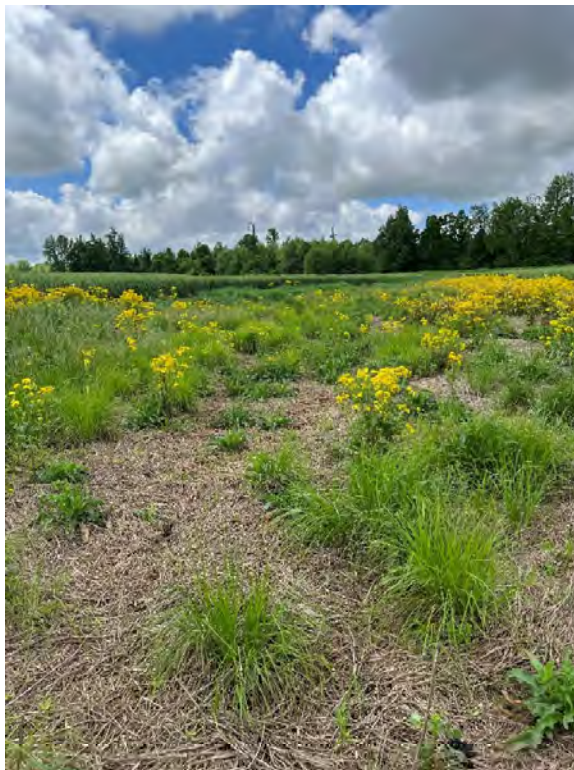
Picture 10

Date of Photo: 04/30/24. WWC02 looking southwest (36.20961, -88.71369).

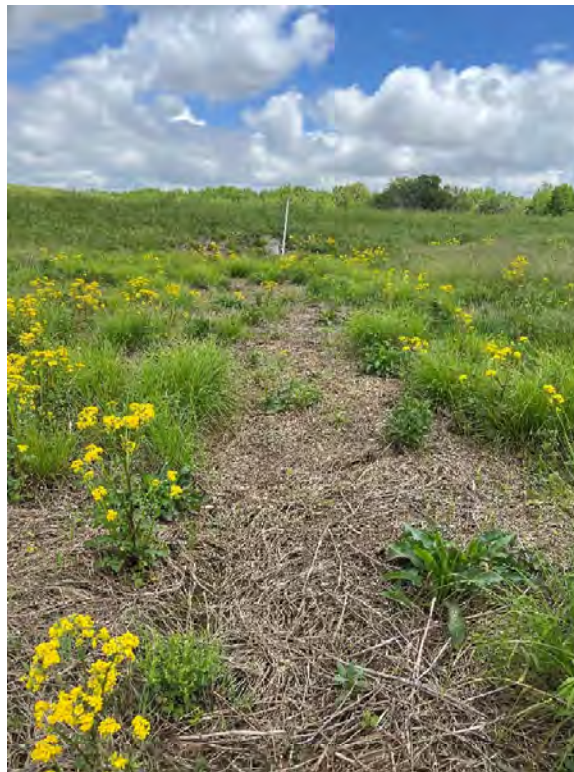
Picture 11

Date of Photo: 04/30/24. WWC02 from the same location as picture 10, looking northeast at second levee (36.20961, -88.71369).

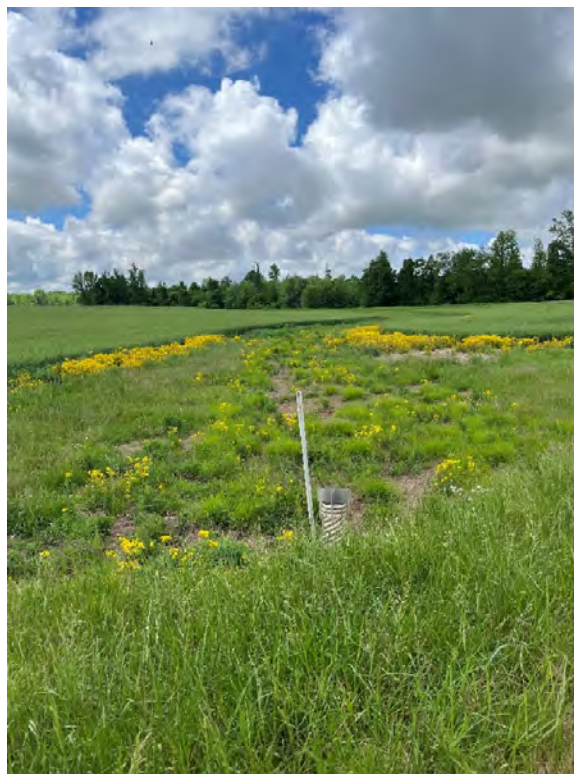
Picture 12

Date of Photo: 04/30/24. WWC02 from the top of the levee looking southwest towards location of picture 11 (36.20987, -88.71346).

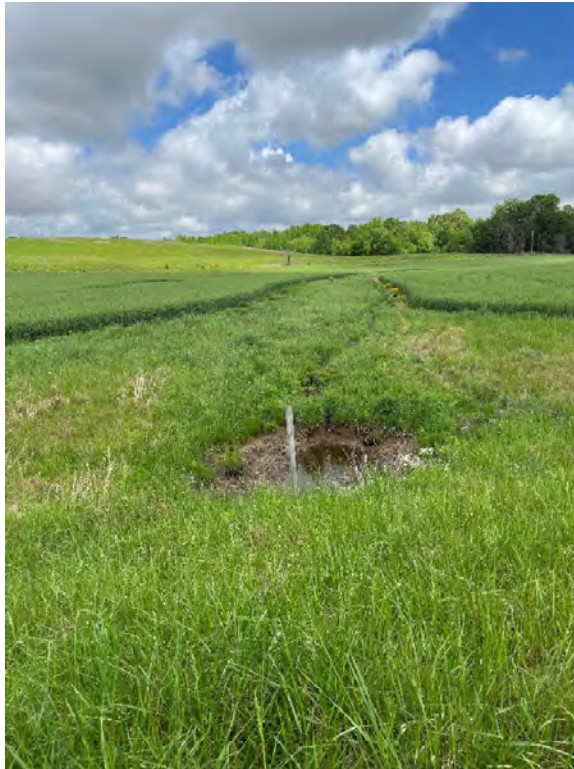
Picture 13

Date of Photo: 04/30/24. WWC02 from the top of the levee looking northeast. Taken in same location as picture 12 (36.20987, -88.71346).

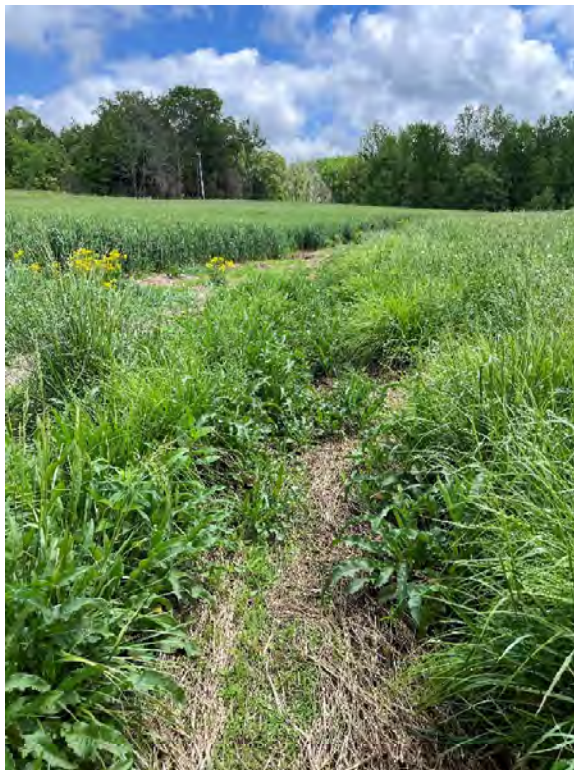
Picture 14

Date of Photo: 04/30/24. WWC02 looking east (36.21090, -88.71242).

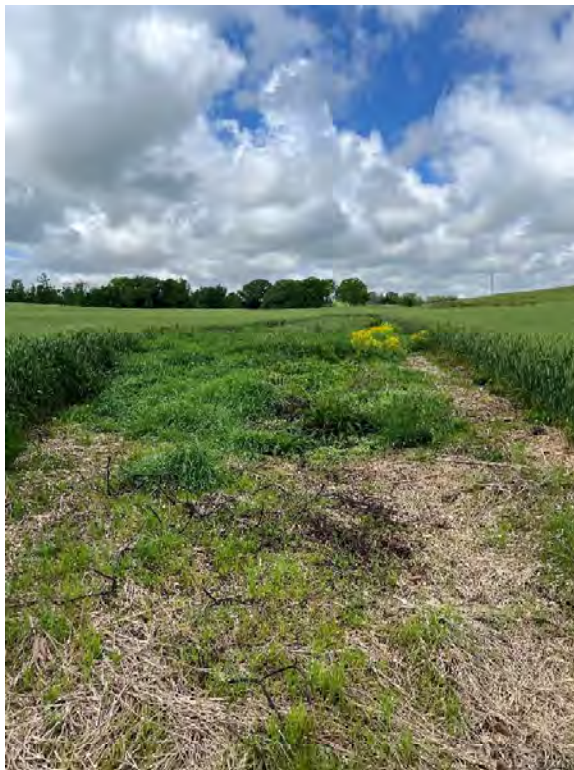
Picture 15

Date of Photo: 04/30/24. WWC02 looking west (36.21093, -88.71124).

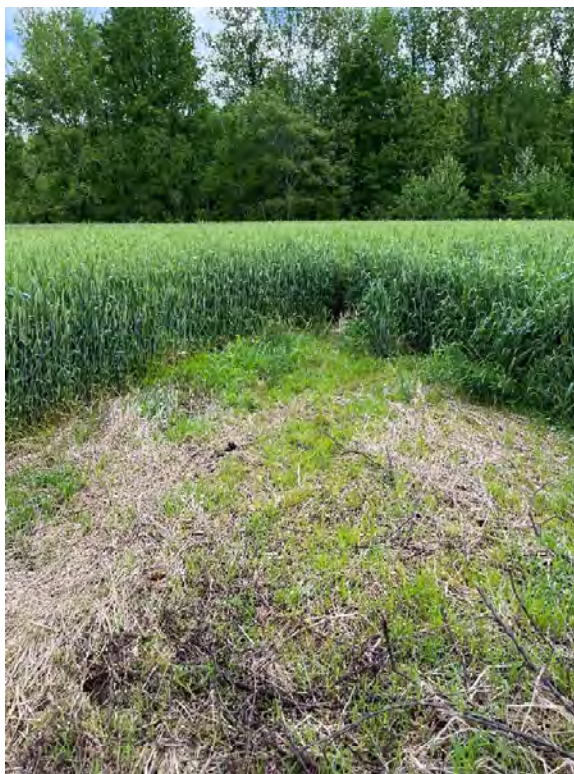
Picture 16

Date of Photo: 04/30/24. WWC02 looking east to the end of this WWC. Same location as picture 15 (36.21093, -88.71124).

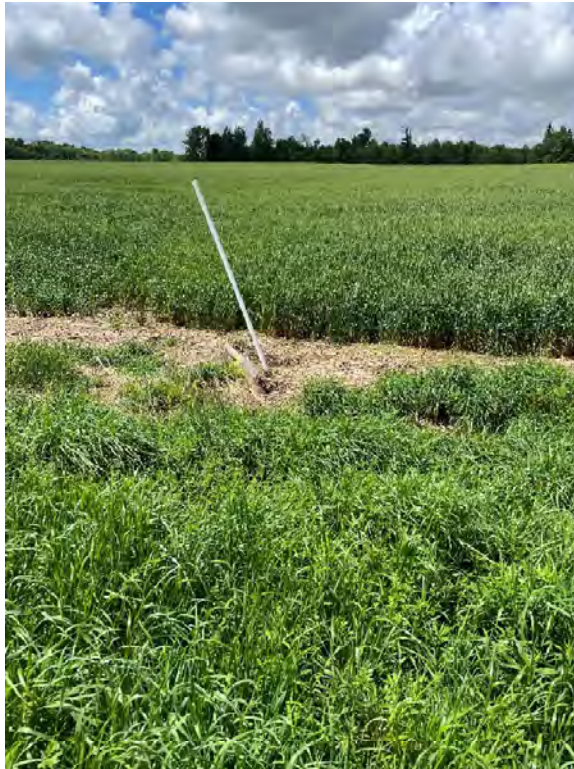
Picture 17

Date of Photo: 04/30/24. Beginning of WWC03 looking west at perforated pipe drain on west side of constructed levee (36.20895, -88.71173).

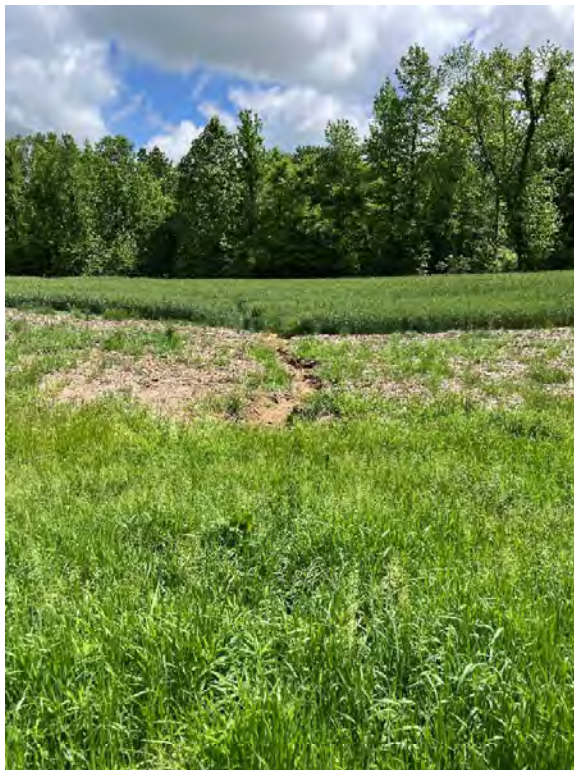
Picture 18

Date of Photo: 04/30/24. WWC03 looking east from top of levee. Taken in the same location as picture 17 (36.20895, -88.71173).

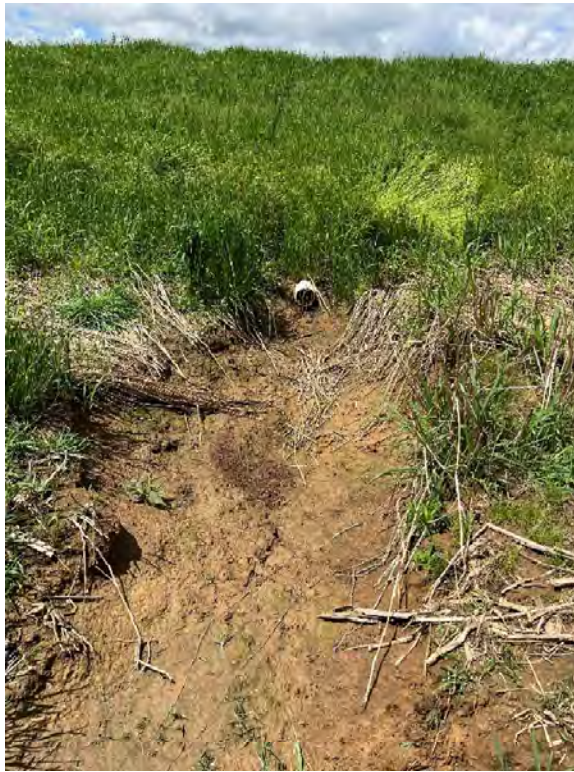
Picture 19

Date of Photo: 04/30/24. WWC03 looking west toward picture 18 location to drain pipe outlet through levee (36.20897, -88.71156).

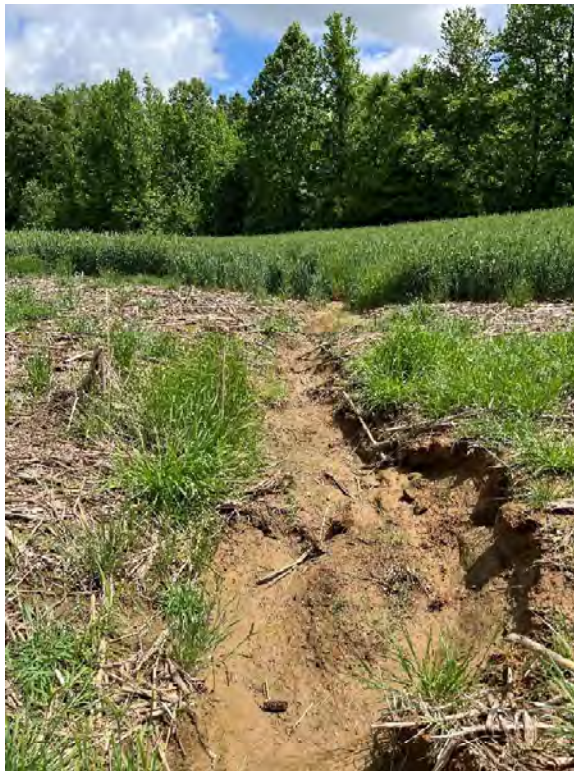
Picture 20

Date of Photo: 04/30/24. WWC03 looking east. Picture taken in same location as picture 19 (36.20897, -88.71156).

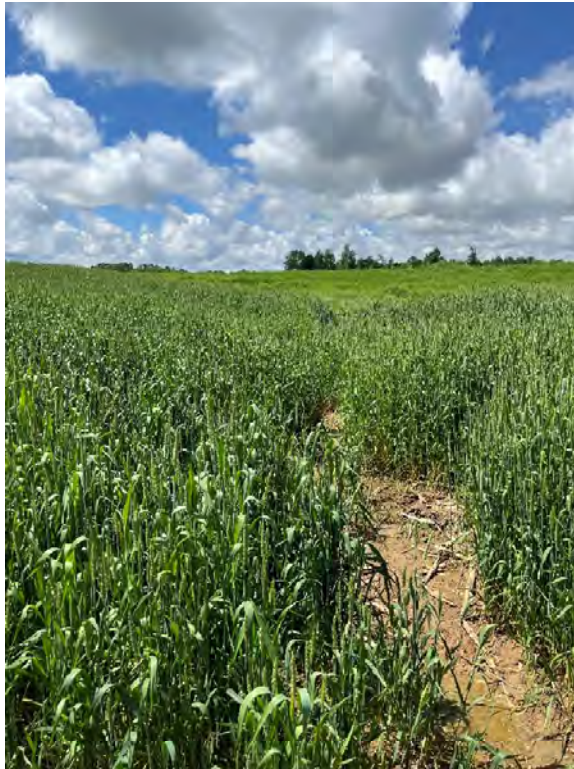
Picture 21

Date of Photo: 04/30/24. WWC03 looking west.
(36.20910, -88.71124).

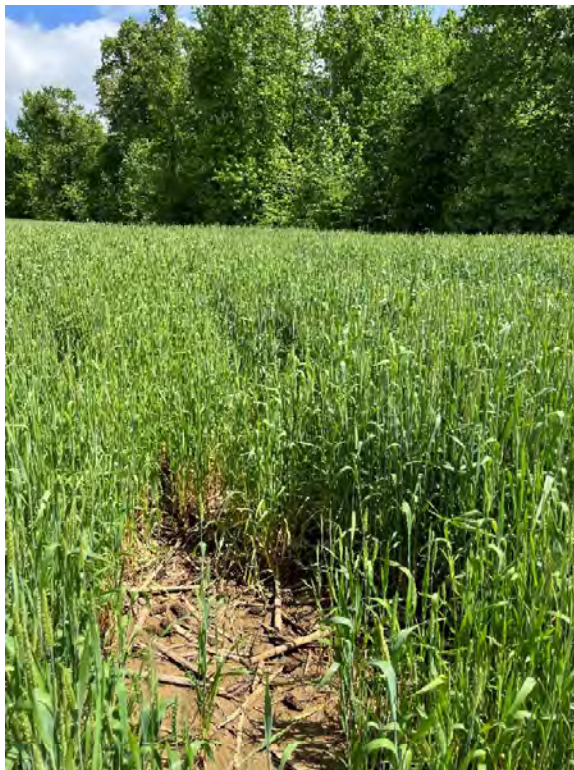
Picture 22

Date of Photo: 04/30/24. WWC03 looking east. Same location as picture 21.
(36.20910, -88.71124).
