### **JURISDICTIONAL WATERS REPORT**

3 Nicholas Drive Dayton, Rhea County, Tennessee Asa Project No. 24-0063

Reference: Jurisdictional Waters Assessment Report

Asa Project No. 24-0063

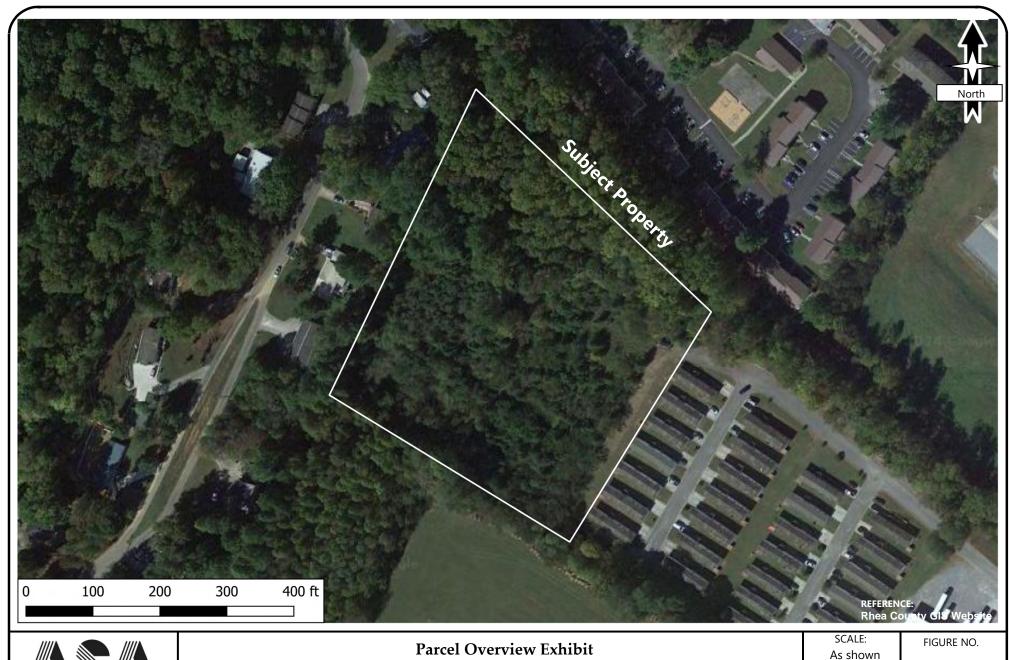
1

The subject property is a wooded undeveloped property located at 3 Nicholas Drive in Dayton, Rhea County, Tennessee. It is identified as Rhea County Parcel 072083\_06901 and consists of approximately 4.28 acres. The figures presented in Appendix I outline the approximate boundaries of the subject property. To support planning for future development, Asa was requested to conduct a jurisdictional waters assessment.

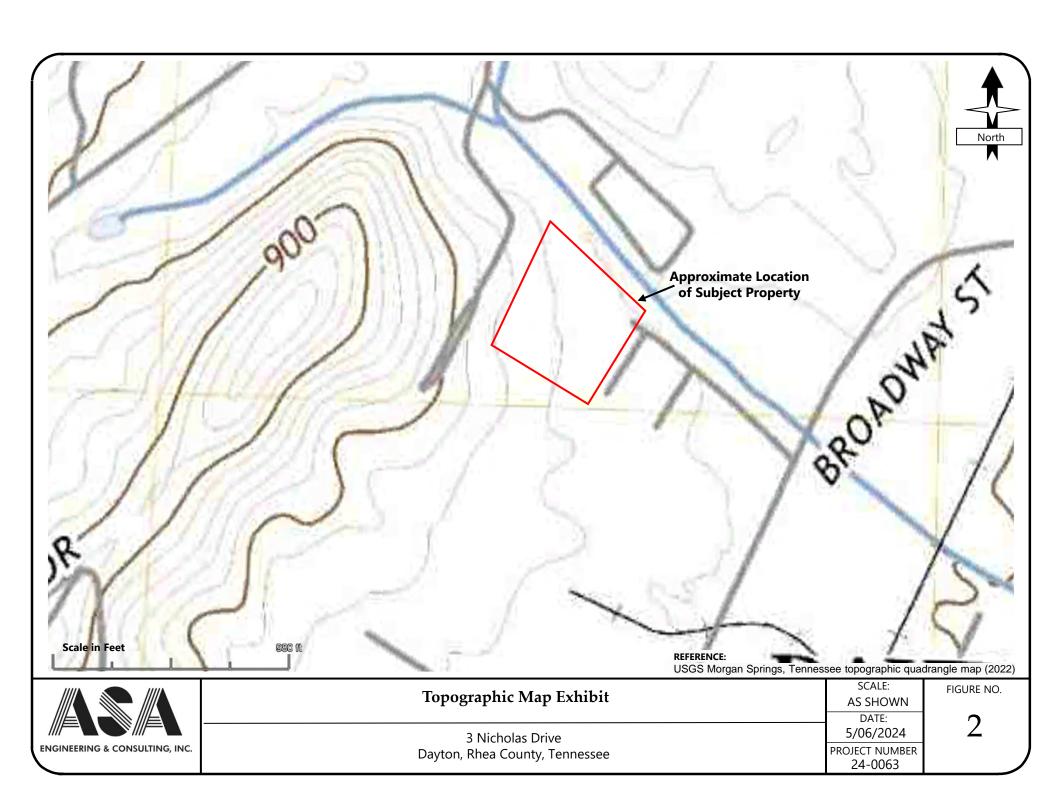
As a reviewed the referenced topographic quadrangle map to examine the topography and drainage of the subject property and vicinity. According to the topographic map, the property slopes down to the southeast from topographic high points along the northwestern boundary. No streams are depicted within the subject property. Figure 2 in Appendix I includes an excerpt of the topographic map that includes the subject property.

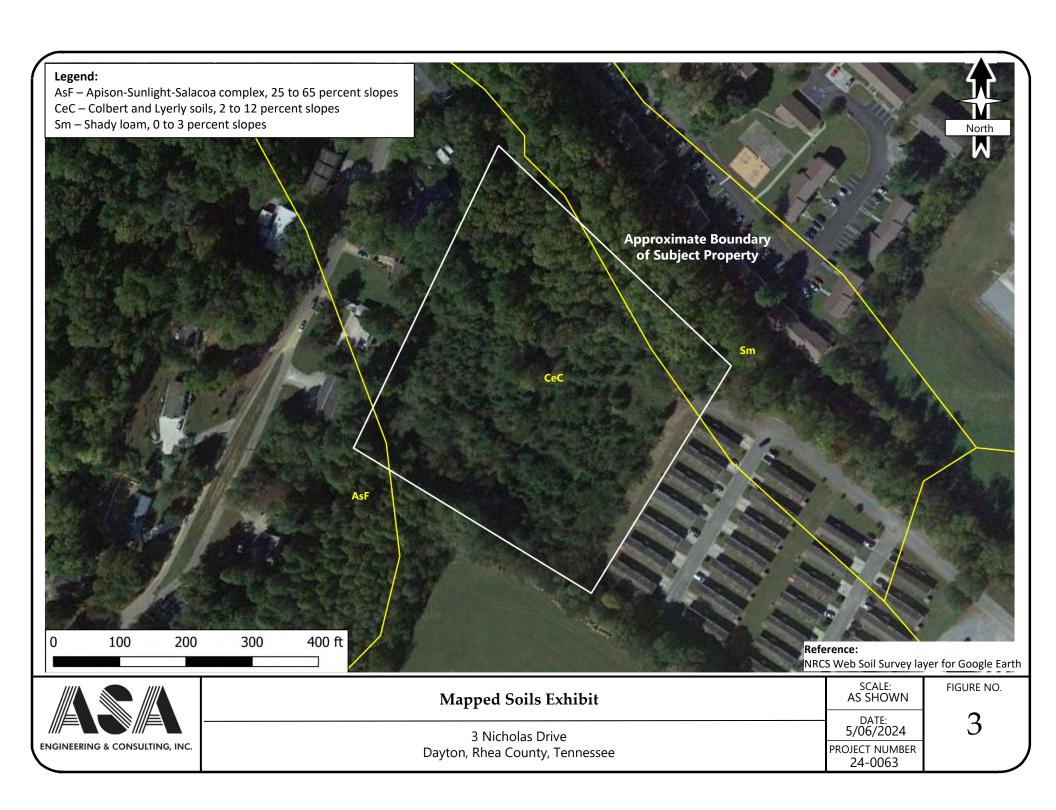
The soil survey information reviewed depicts the property are being underlain by three different major soil mapping units, including: Apison-Sunlight-Salacoa complex (25 to 65 percent (%) slopes), Colbert and Lyerly soils (2 to 12% slopes), and Shady loam (0 to 3% slopes). Of these, the Colbert and Lyerly soils and the Shady loam are both characterized as soil mapping units that can contain hydric inclusions in Rhea County, Tennessee. Figure 3 in Appendix I includes an overview of the soil map that includes the subject property.

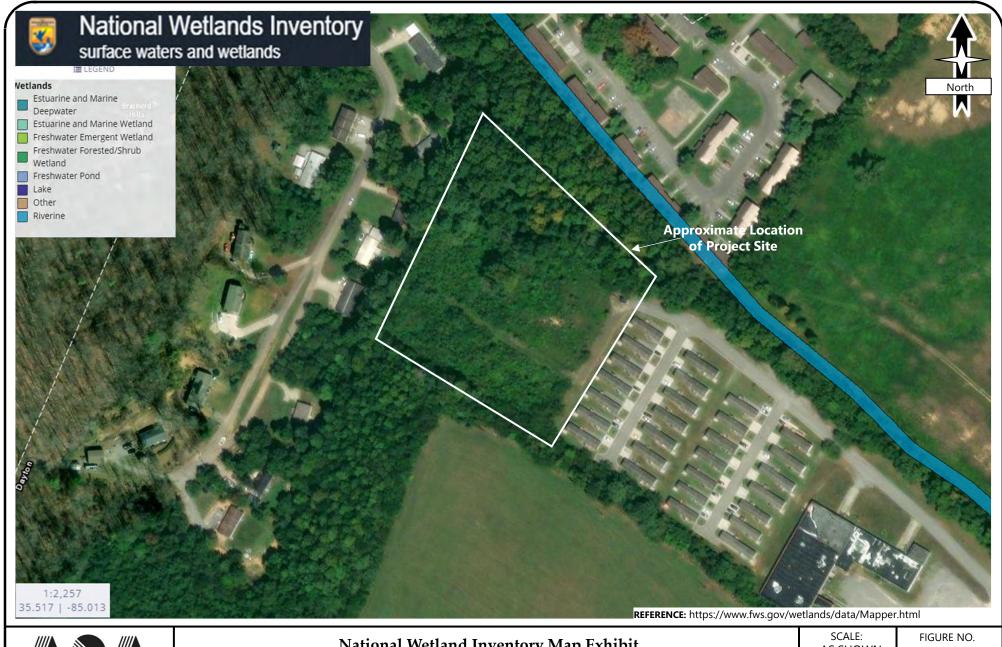
National Wetland Inventory Map Exhibit

No surface water or wetland features were depicted on the NWI map. Figure 4 in Appendix I depicts the NWI map that includes the subject property and vicinity.

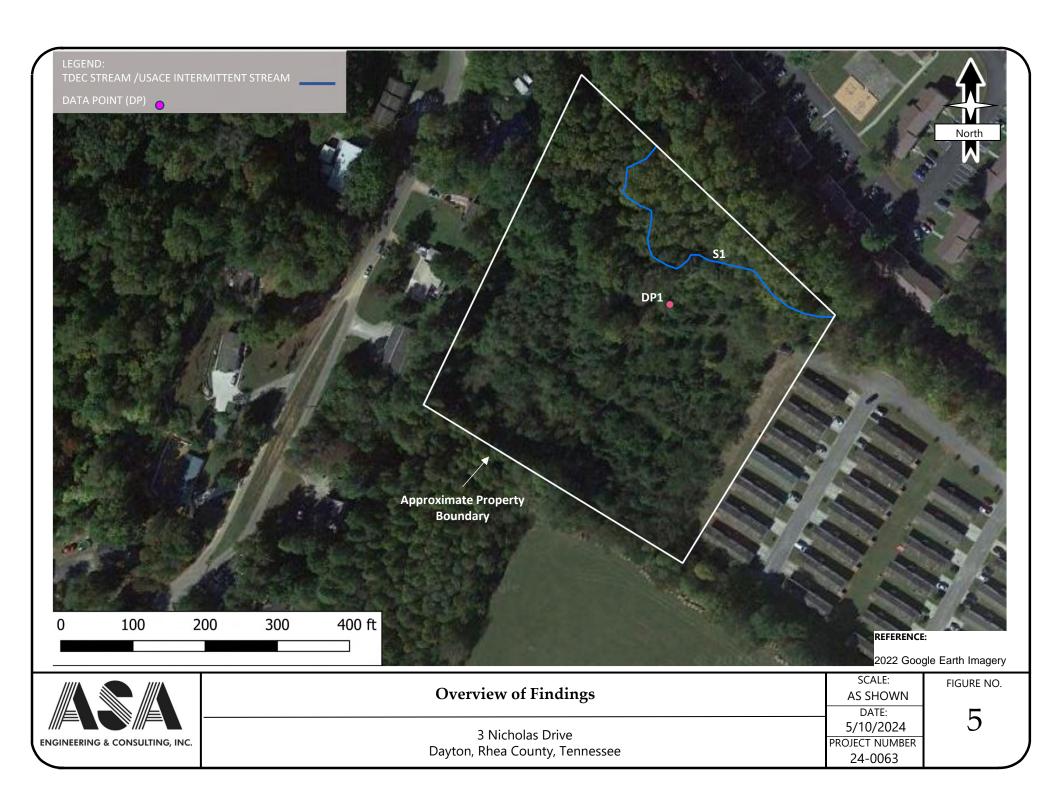
Asa conducted site visits on May 8 and 22, 2024 to evaluate the soils, vegetation, and hydrologic indicators within the subject property. The results are summarized below, and the features identified correspond to the areas depicted on Figure 5 in Appendix I. According to the Community Collaborative Rain, Hail, and Snow Network (CoCoRaHS), the significant rainfall amounts, i.e., greater than 0.10 inch, recorded from the nearest data station (Station TN-BL-18) within seven days prior to each of the site visits included the following: .12 inch on May 1st, 0.14 inch on May 3<sup>rd</sup>, 0.64 inch on May 4<sup>th</sup>, 0.41 inch on May 5<sup>th</sup>, 0.81 inch on May 7<sup>th</sup>, 0.42 inch on May 15<sup>th</sup>, and 2.8 inches on May 19th. Our site visit conducted on May 22, 2024 was in an effort to observe presence of flow more than 48 hours after a significant rain event.

No surface water features were evident in the 2022 aerial photograph reviewed. The background image of Figure 5 is the 2022 Google Earth aerial photograph.

One drainage feature was identified during the assessment. We evaluated the feature in accordance with the referenced TDEC HD methodology, and the feature was determined to have a Secondary Indicator score of 20.5, meeting the definition of a TDEC Stream. This stream (S1) would be considered an unnamed tributary to Little Richland Creek. Stream 1 (S1) entered the property's northeast boundary and exited the property at the northeastern corner. The stream flowed approximately 493 feet across the northern portion of the property. In our opinion, S1 would be considered an intermittent stream by the USACE.

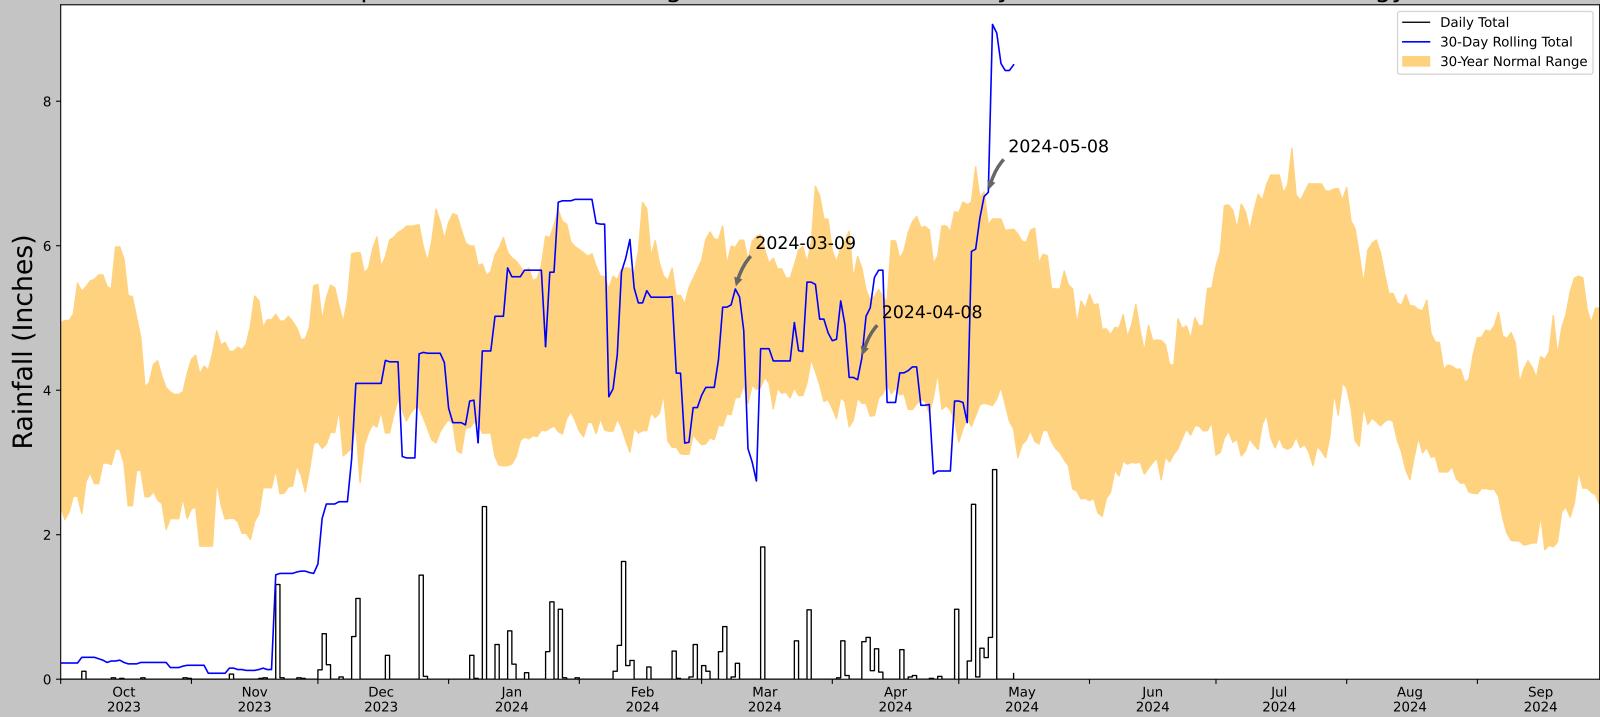
# Antecedent Precipitation vs Normal Range based on NOAA's Daily Global Historical Climatology Network

Coordinates	35.517019, -85.009173
Observation Date	2024-05-08
Elevation (ft)	719.976
Drought Index (PDSI)	Mild drought (2024-04)
WebWIMP H <sub>2</sub> O Balance	Wet Season

30 Days Ending	30 <sup>th</sup> %ile (in)	70 <sup>th</sup> %ile (in)	Observed (in)	Wetness Condition	Condition Value	Month Weight	Product
2024-05-08	3.806299	6.288583	6.740158	Wet	3	3	9
2024-04-08	3.820079	5.692126	4.444882	Normal	2	2	4
2024-03-09	3.898819	5.976772	5.401575	Normal	2	1	2
Result							Wetter than Normal - 15

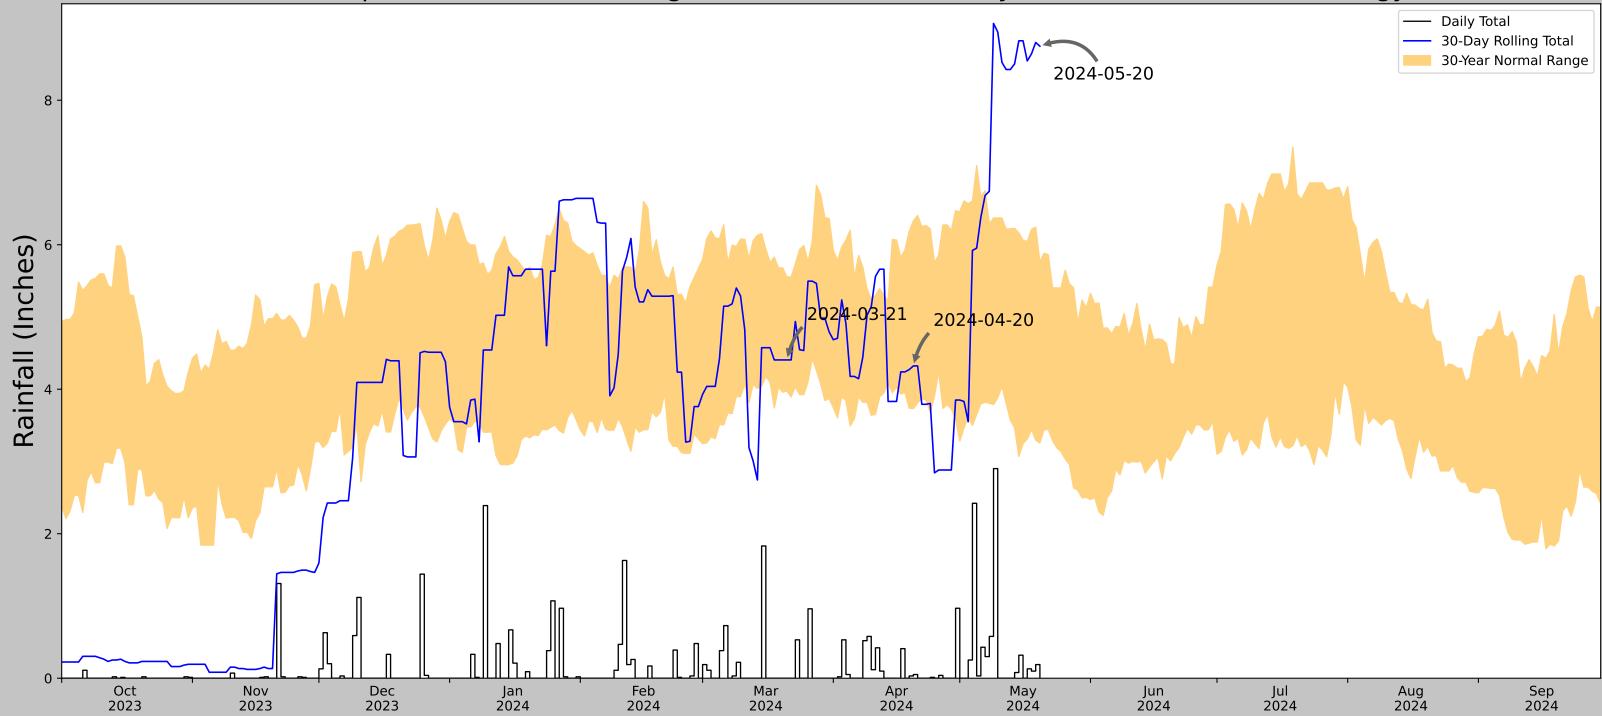
# Antecedent Precipitation vs Normal Range based on NOAA's Daily Global Historical Climatology Network

Coordinates	35.517019, -85.009173
Observation Date	2024-05-20
Elevation (ft)	719.976
Drought Index (PDSI)	Mild drought (2024-04)
WebWIMP H <sub>2</sub> O Balance	Wet Season

30 Days Ending	30 <sup>th</sup> %ile (in)	70 <sup>th</sup> %ile (in)	Observed (in)	Wetness Condition	Condition Value	Month Weight	Product
2024-05-20	3.254725	5.76063	8.748032	Wet	3	3	9
2024-04-20	3.732284	6.330709	4.322835	Normal	2	2	4
2024-03-21	3.975984	5.553543	4.405512	Normal	2	1	2
Result							Wetter than Normal - 15
