Subject: Jurisdictional Waters Delineation
TCAT Harriman Site Development
Rockwood, Roane County, Tennessee
CEC Project 333-801

**BARBER MCMURRY ARCHITECTS
TCAT HARRIMAN SITE DEVELOPMENT
ROCKWOOD, ROANE COUNTY, TENNESSEE**

Photo Summary: October 17, 2023

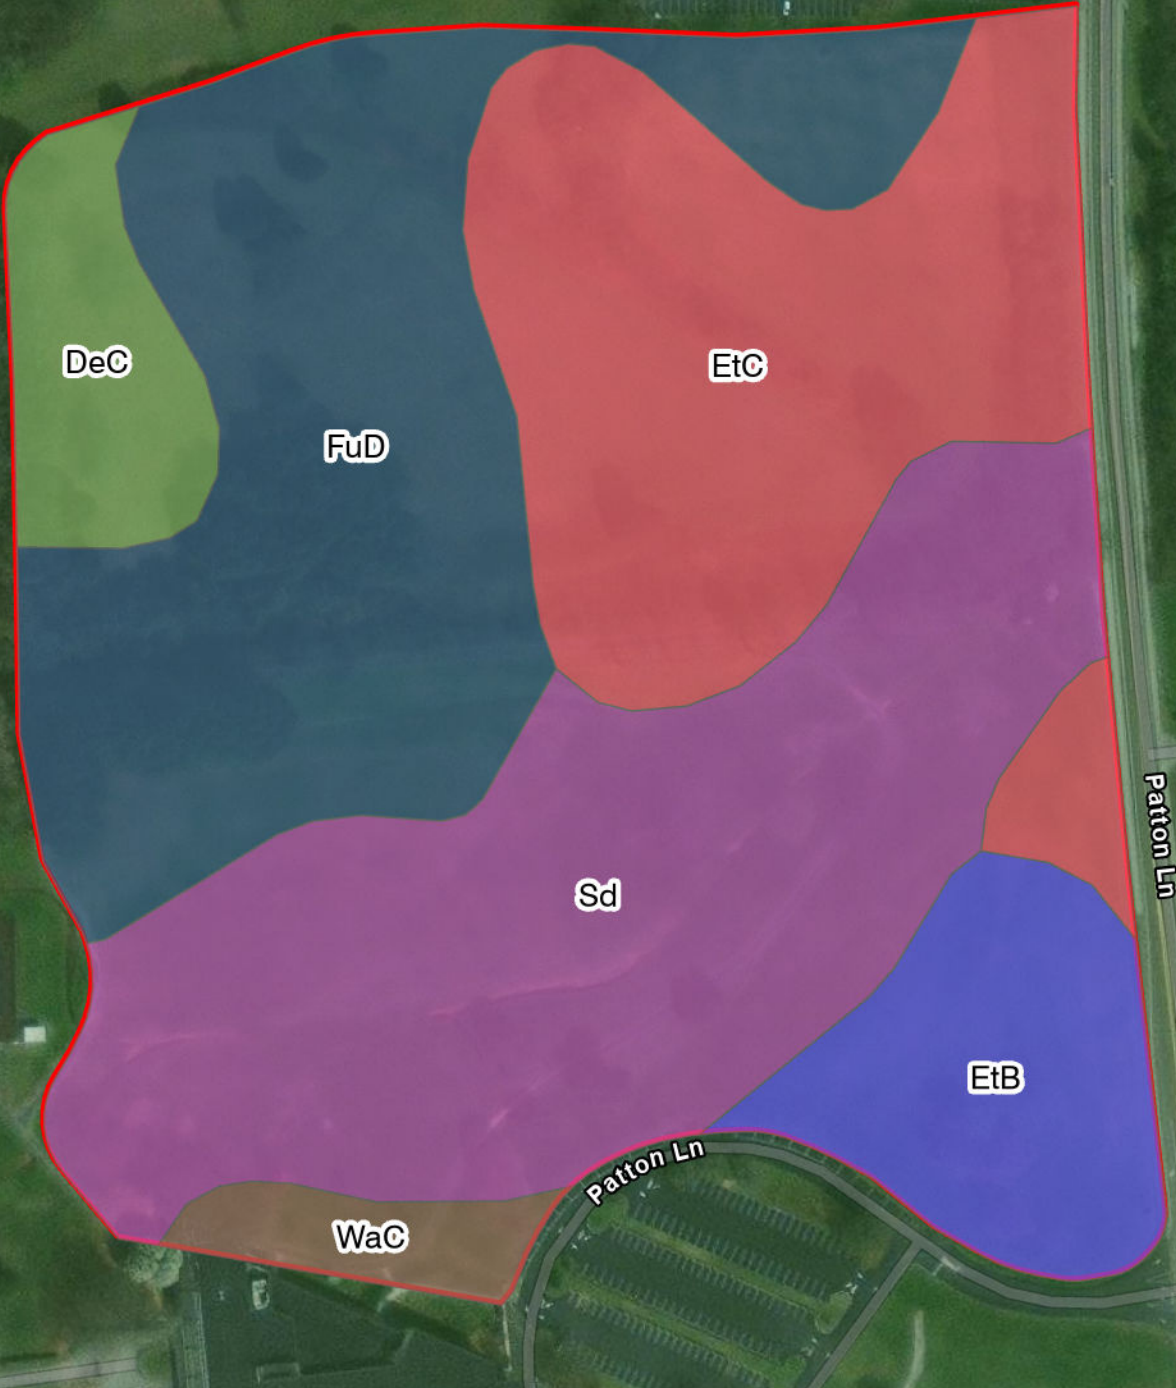
DRAWN BY:	CGK	CHECKED BY:	DRS	APPROVED BY:	GSB	FIGURE NO:	2
DATE:	6/20/2024	SCALE:	1"=200'	PROJECT NO:	333-801

A photographic summary (Attachment 1) depicting conditions observed during the site visit are attached. Figure 2 is an aerial map depicting the hydrologic features identified and delineated by CEC during the field survey, as described below. A summary table of hydrologic features can be found in Table 3.

In summary, CEC identified approximately 1,753 linear feet (l.f.) of wet weather conveyance/upland drainage features and 117 linear feet (l.f.) of wet weather conveyance/ephemeral features within the limits of investigation.

EXISTING AQUATIC RESOURCES MAP

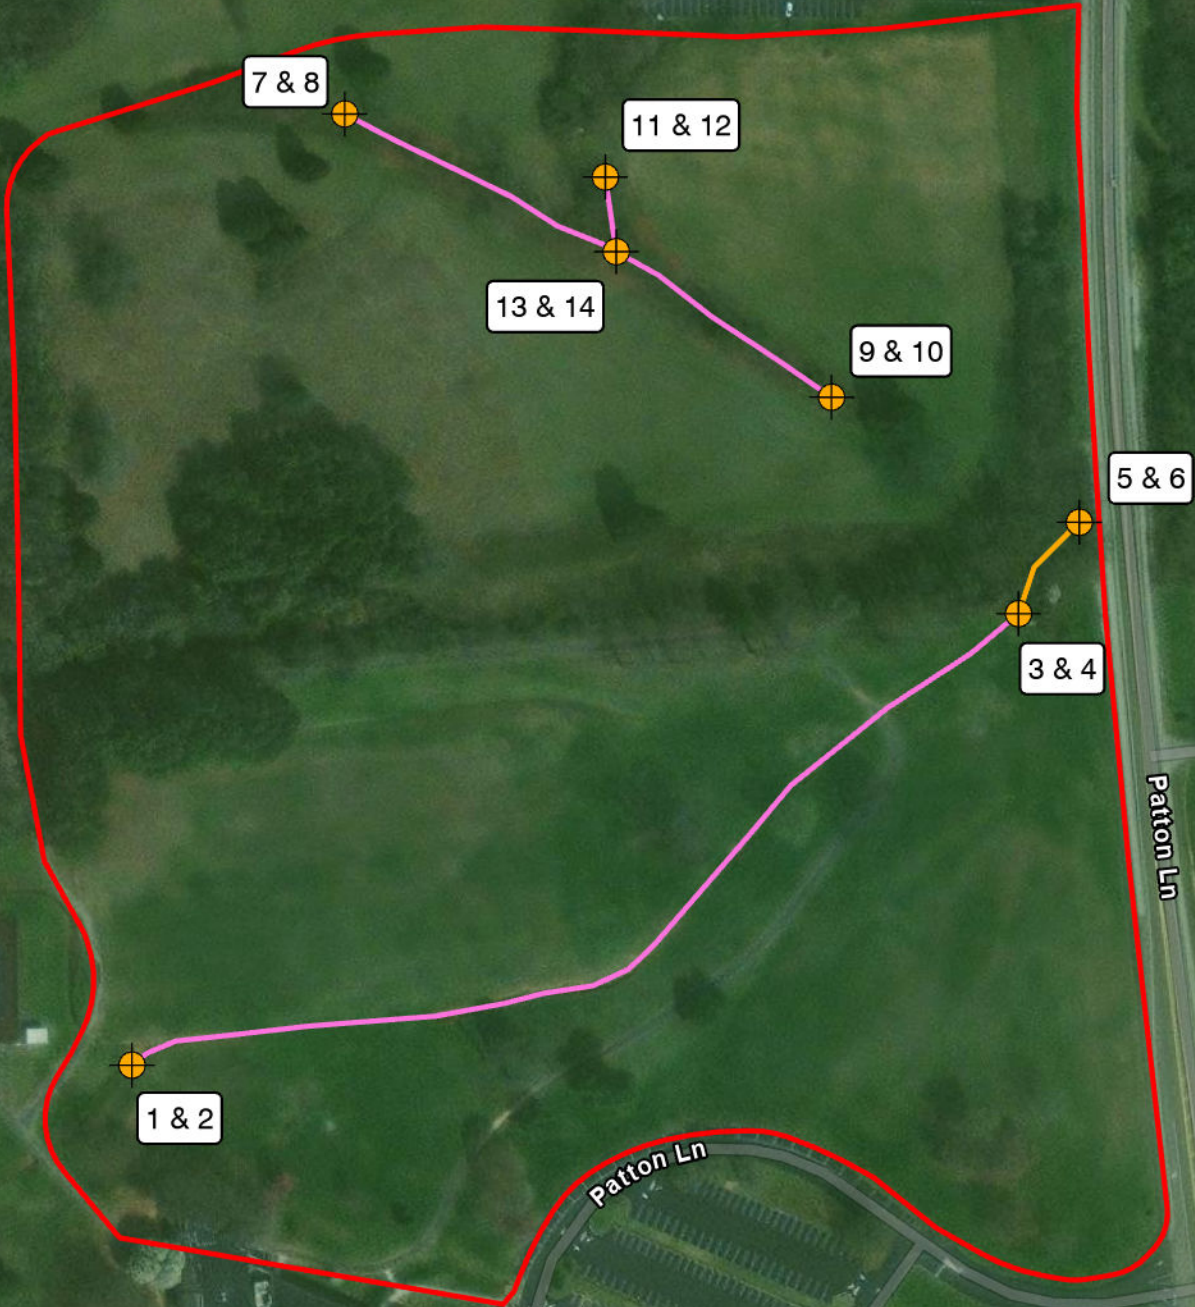
DRAWN BY:	CGK	CHECKED BY:	DRS	APPROVED BY:	GSB	FIGURE NO:	5
DATE:	6/20/2024	SCALE:	1"=200'	PROJECT NO:	333-801

PHOTO LOCATION MAP

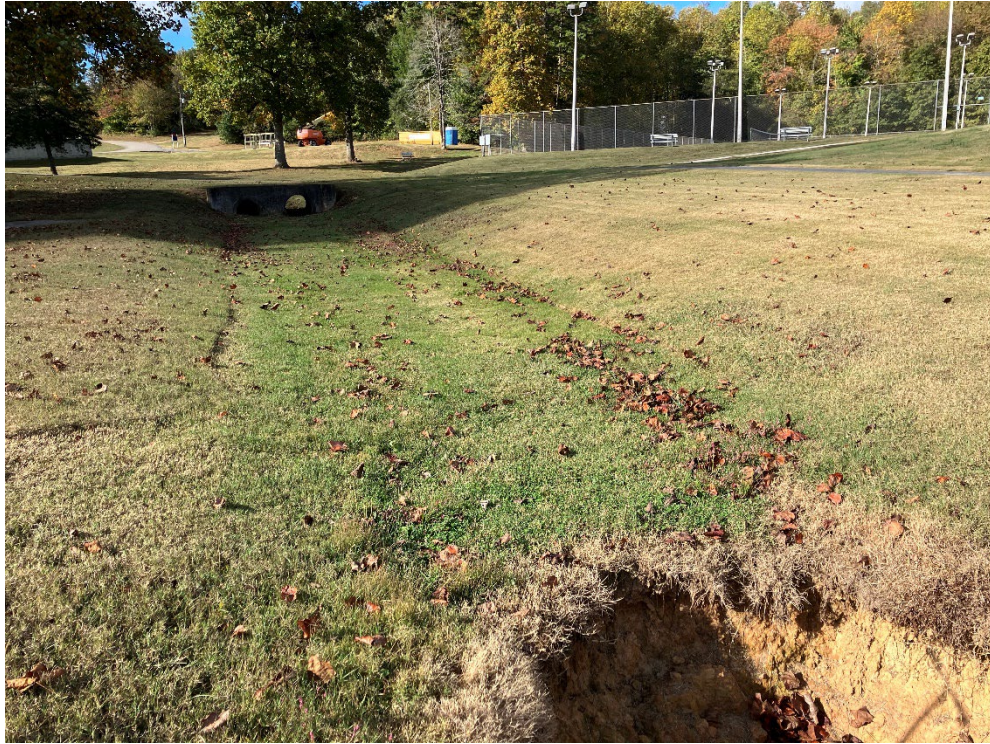
WWC-1/UDF-1 is a grassy swale with areas of headcutting and a more defined bed and bank beginning at coordinates 35.8824776, -84.6210053 and flows for approximately 1,085 linear feet (l.f.) before ending into a more defined channel at a headcut at coordinates 35.8837337, -84.6178658. WWC-1/UDF-1 lacked water and geomorphic features like depositional bars and recent alluvial deposits. WWC-1/UDF-1 received a secondary indicator score of 12.5, indicating this feature is a wet weather conveyance/upland drainage feature.

Photo 1: View at start of WWC-1/UDF-1 facing upstream located at 35.8824776, -84.6210053.

Areas of grassy swale, and other areas of headcutting with a cut down profile. Feature runs through mowed field of fescue.

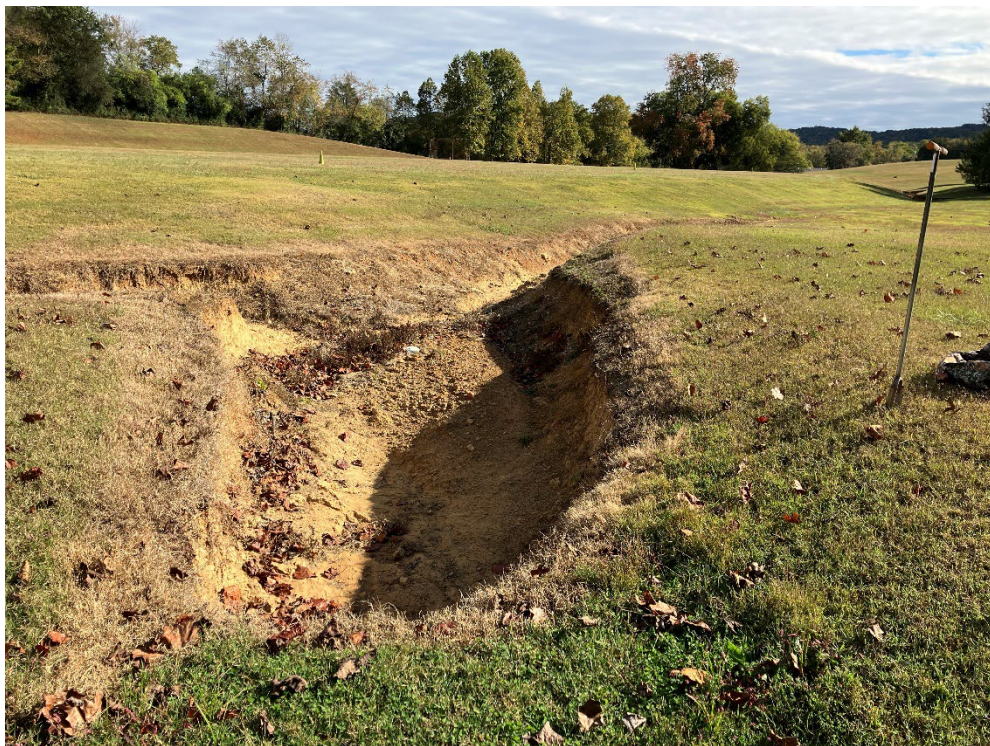
Photo 2: View at start of WWC-1/UDF-1 facing downstream located at 35.8824776, -84.6210053.

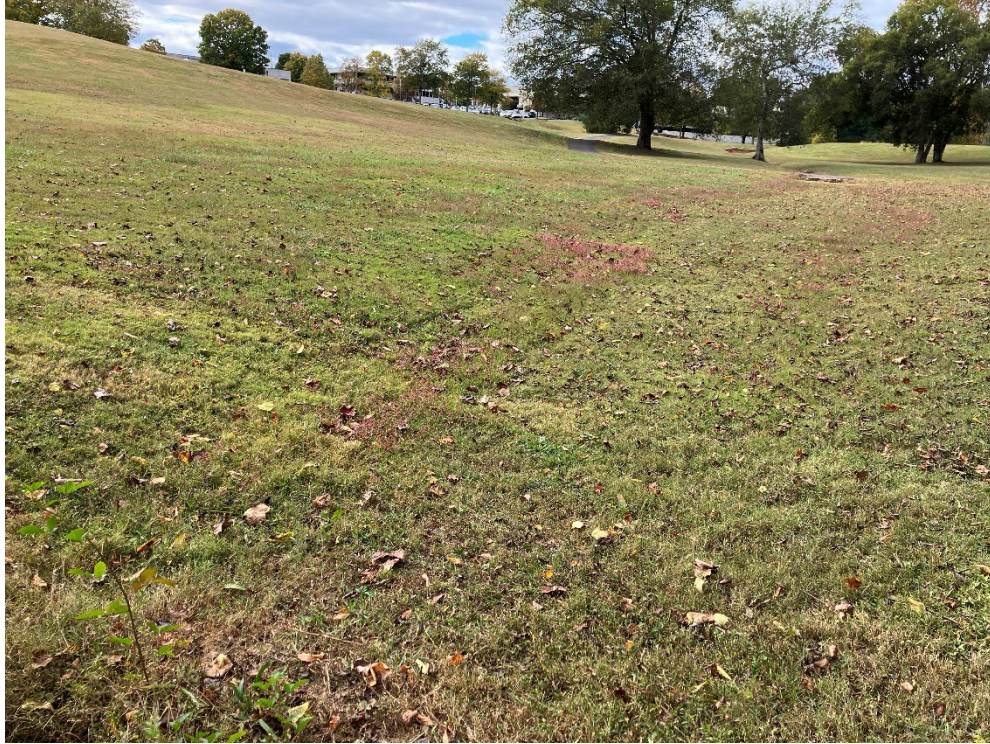
Photo 3: View at end of WWC-1/UDF-1, start of WWC-2/EPH-1 facing upstream located at 35.8837337, -84.6178658.

Starts at large headcut in wooded area. Weak hydrology and Biology.

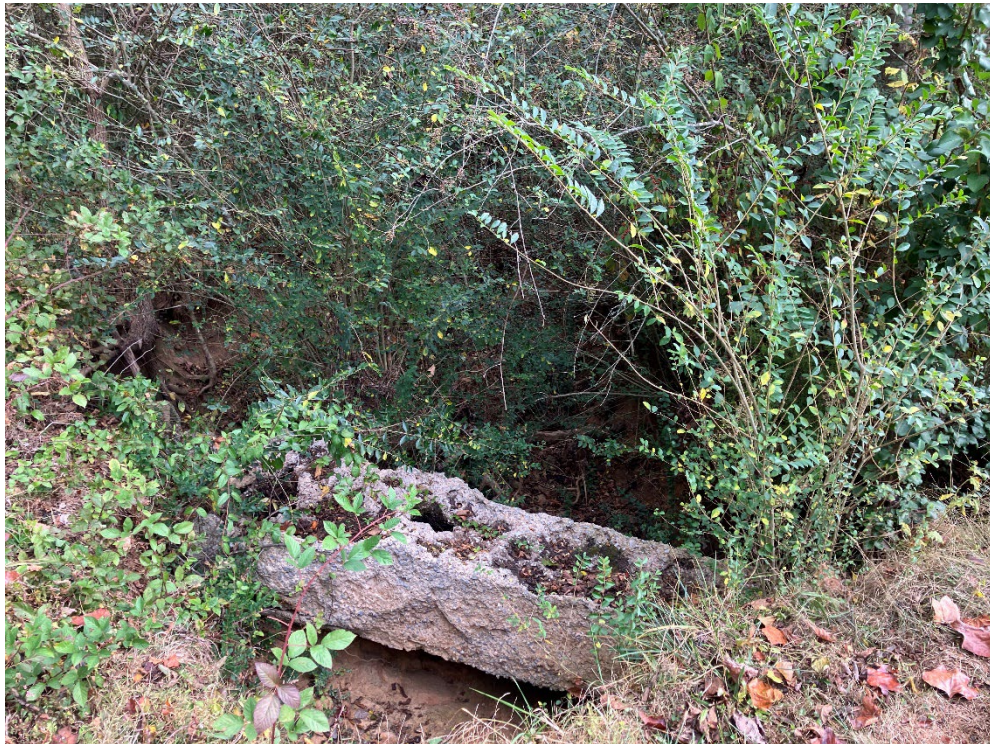
WWC-2/EPH-1 is a channel beginning at a headcut at coordinates 35.8837337, -84.6178658 and flows for approximately 117 linear feet (l.f.) before ending at a concrete culvert at coordinates 35.8839929, -84.6176475. WWC-2/EPH-1 lacked water and geomorphic features, had no riffle pool sequences, and little to no deposition. WWC-2/EPH-1 received a secondary indicator score of 14.75, indicating this feature is a wet weather conveyance.

Photo 4: View at end of WWC-1/UDF-1, start of WWC-2/EPH-1 facing downstream located at 35.8837337, -846178658.

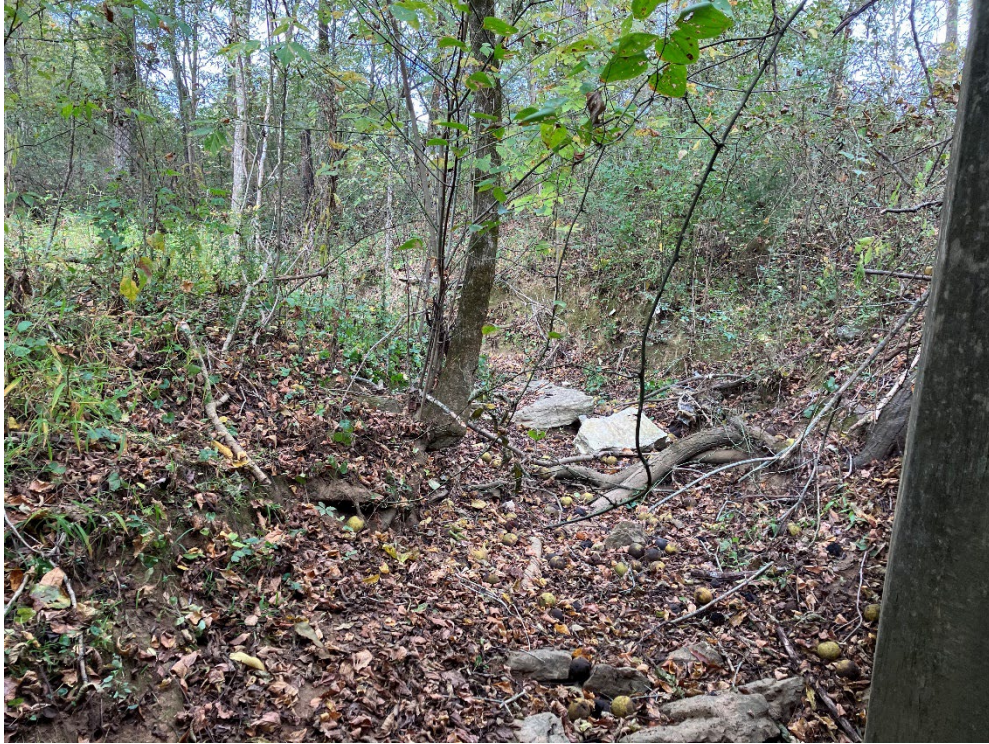
Photo 5: View at end of WWC-2/EPH-1 facing upstream located at 35.8839929, -84.6176475.

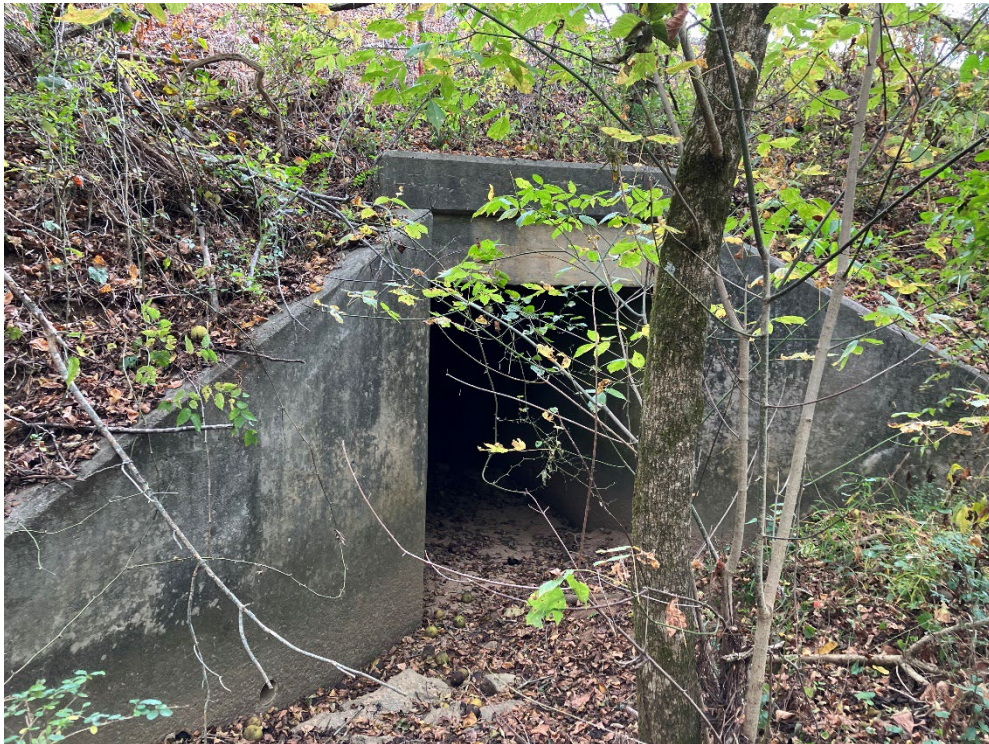
Photo 6: View at end of WWC-2/EPH-1 facing downstream located at 35.8839929, -84.6176475.

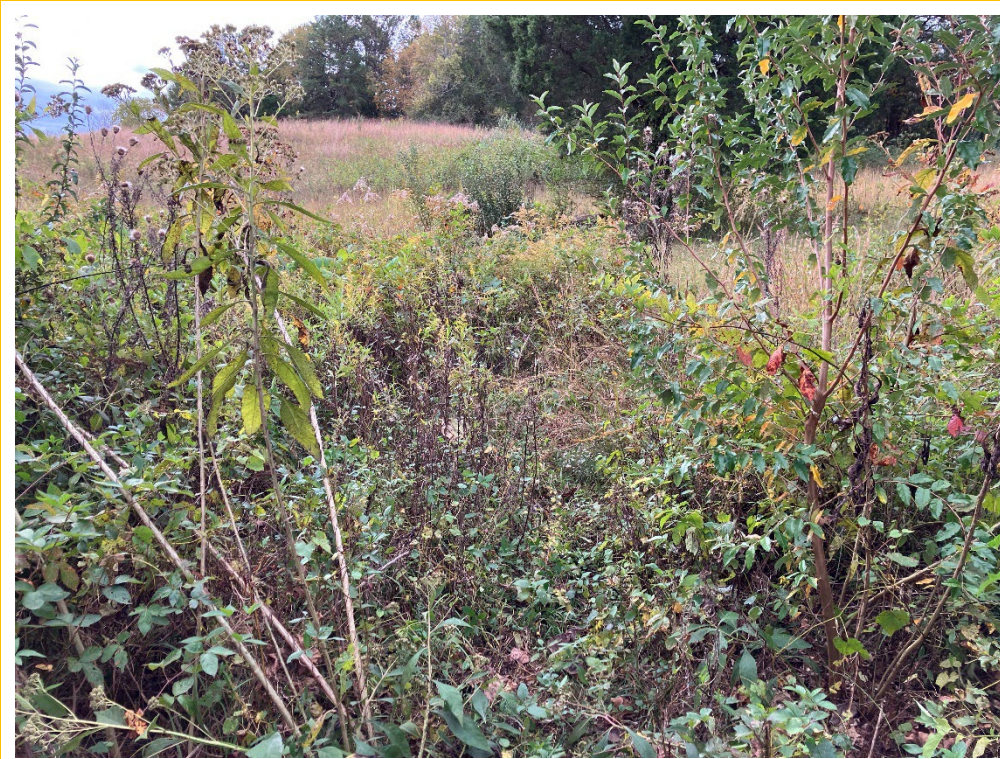
WWC-3/UDF-2 is a channel beginning at coordinates 35.8851907, -84.6202101 and extends for approximately 589 linear feet (l.f.) before ending at coordinates 35.8843607, -84.6185125. WWC-3/UDF-2 lacked water and geomorphic features like depositional bars and had a weak bed and bank. WWC-3/UDF-2 received a secondary indicator score of 1.25, indicating this feature is a wet weather conveyance.

Photo 7: View at start of WWC-3/UDF-2 facing upstream located at 35.8851907, -84.6202101.

wooded low point with minimal evidence of flow, no bed and bank.

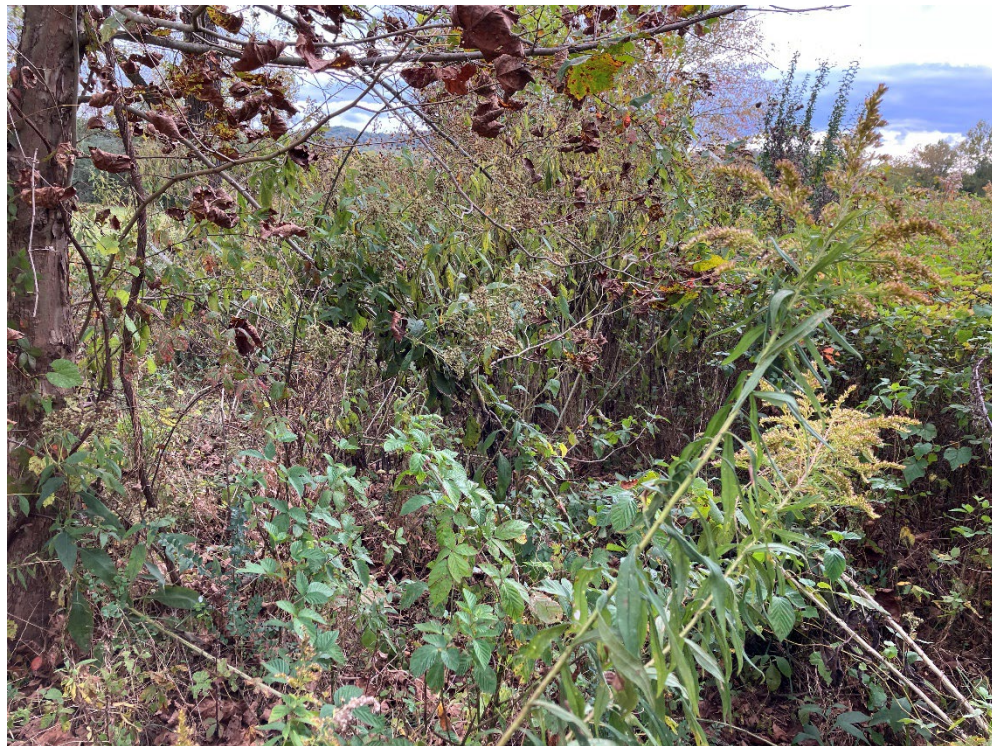
Photo 8: View at start of WWC-3/UDF-2 facing downstream located at 35.8851907, -84.6202101.

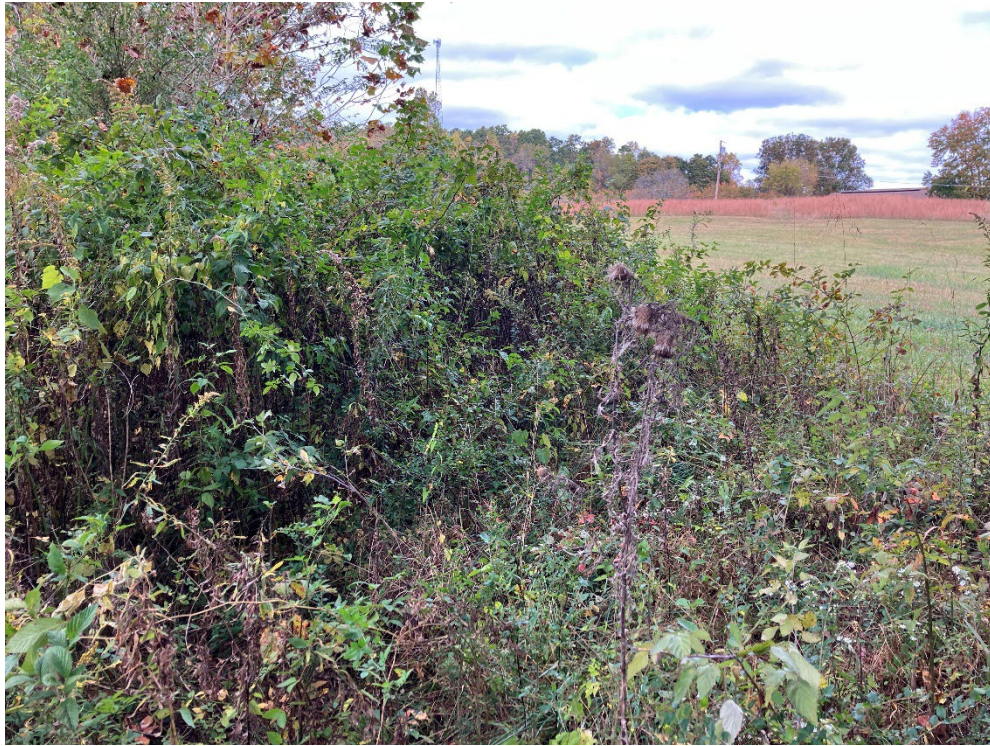
Photo 9: View at end of WWC-3/UDF-2 facing upstream located at 35.8843607, -84.6185125.

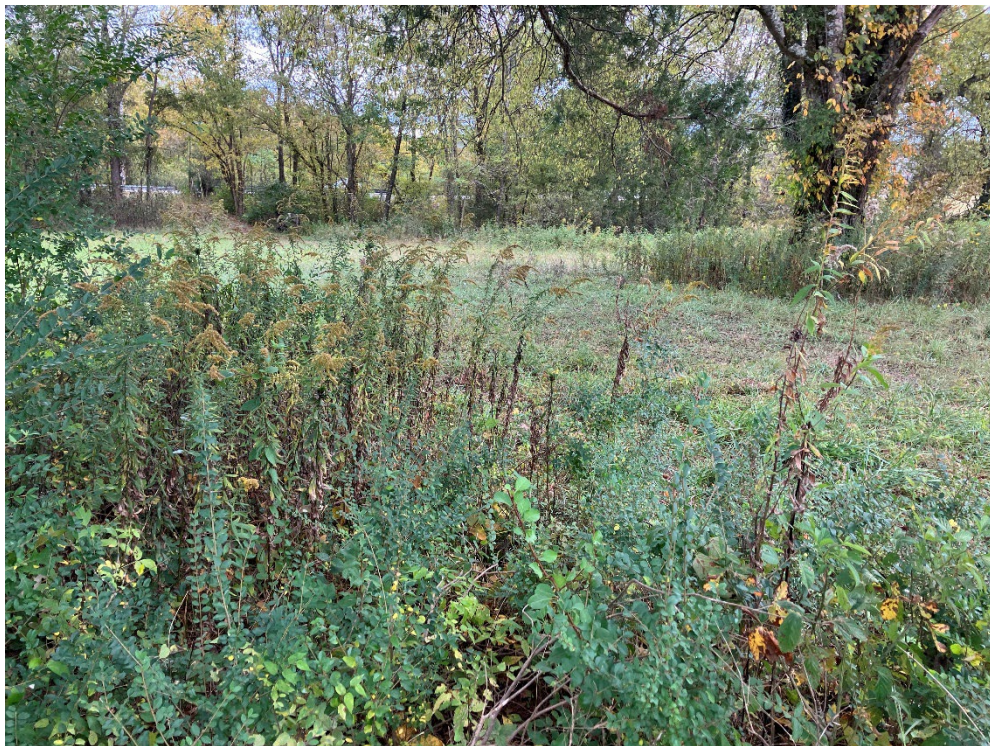
Photo 10: View at end of WWC-3/UDF-2 facing downstream located at 35.8843607, -84.6185125.

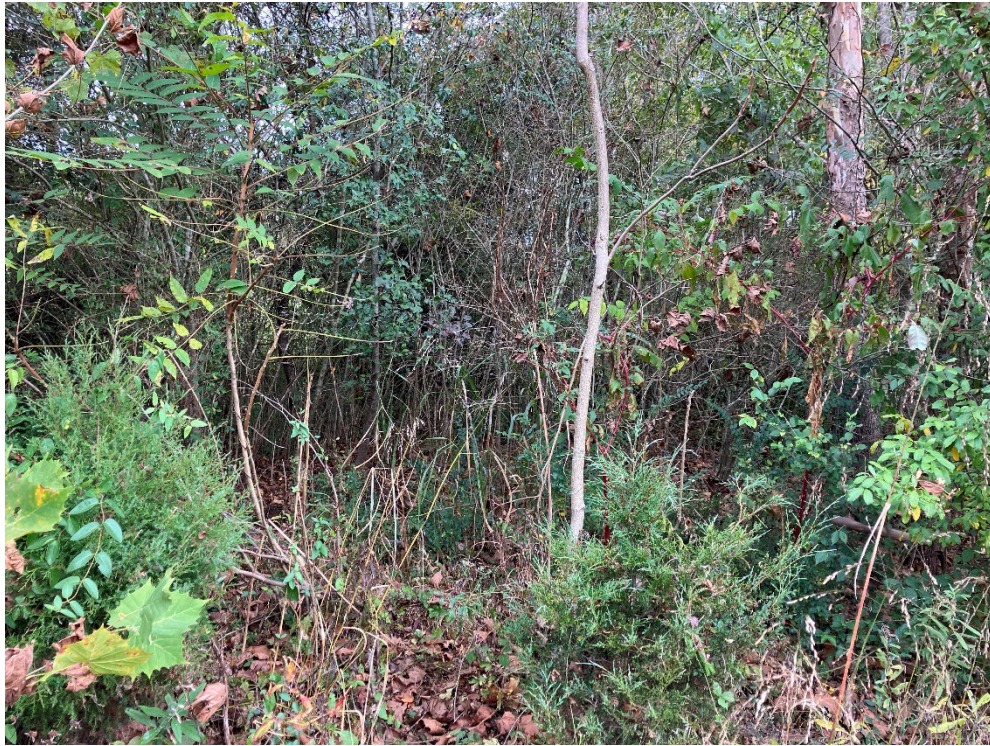
WWC-4/UDF-3 is a channel beginning at coordinates 35.8849998, -84.6192969 and flows for approximately 79 linear feet (l.f.) before ending at coordinates 35.8847859, -84.6192625. WWC-4/UDF-3 lacked water and geomorphic features like depositional bars and a bed and bank. WWC-4/UDF-3 received a secondary indicator score of 1.50, indicating this feature is a wet weather conveyance.

Photo 11: View at start of WWC-4/UDF-3 facing upstream located at 35.8849998, -84.6192969.

wooded low area with weak flow path, no bed and bank.

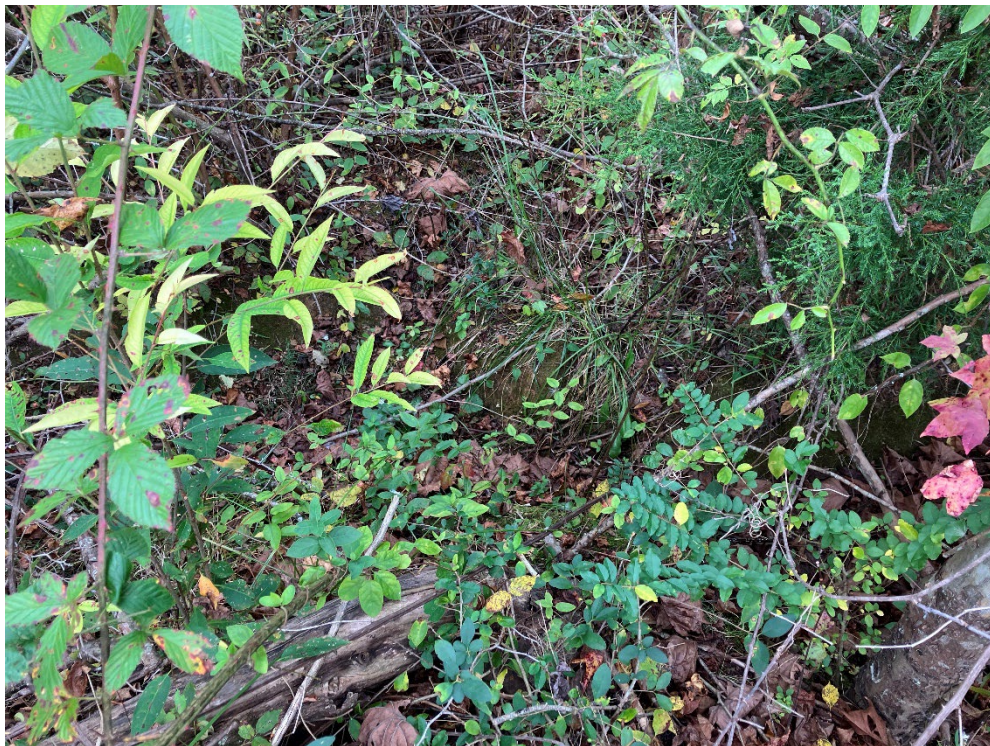
Photo 12: View at start of WWC-4/UDF-3 facing downstream located at 35.8849998, -84.6192969.

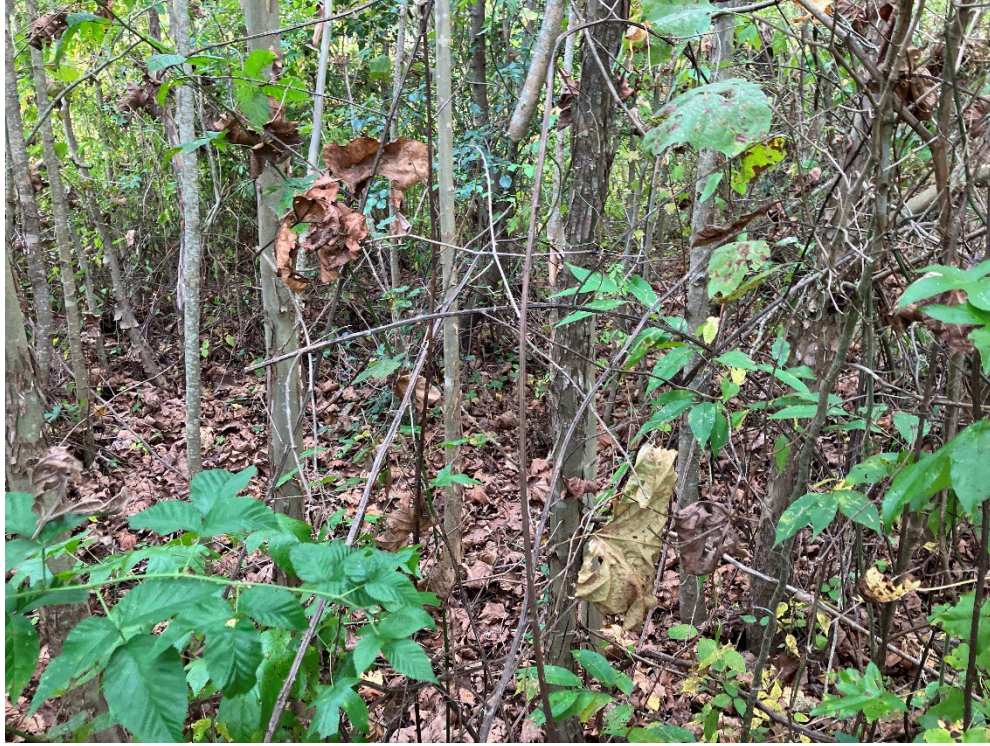
Photo 13: View at end of WWC-4/UDF-3 facing upstream located at 35.8847859, -84.6192625.

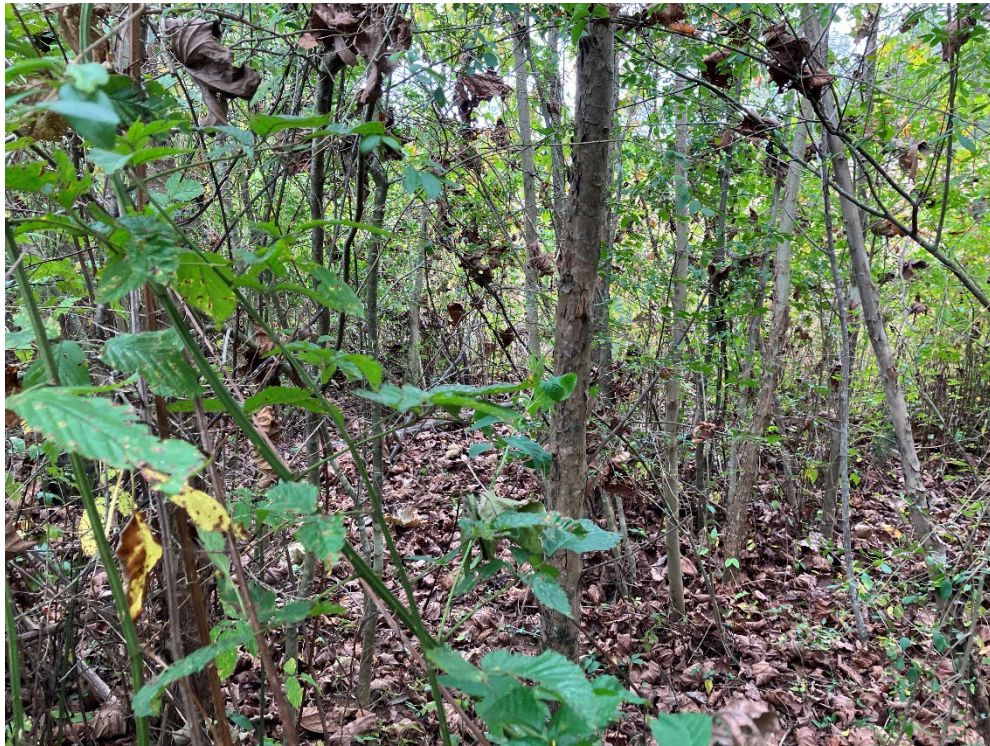
Photo 14: View at end of WWC-4/UDF-3 facing downstream located at 35.8847859, -84.6192625.
