STATE OF TENNESSEE  
DEPARTMENT OF ENVIRONMENT AND CONSERVATION  
KNOXVILLE ENVIRONMENTAL FIELD OFFICE  
DIVISION OF MINERAL & GEOLOGIC RESOURCES – MINING SECTION  
3711 MIDDLEBROOK PIKE  
KNOXVILLE, TENNESSEE 37921-6538  
PHONE (865) 594-6035 STATEWIDE 1-888-891-8332 FAX (865) 594-6105

## Mining Facility Inspection Report

**NPDES permit number:** TN0062910

**Inspection type:** Follow-up

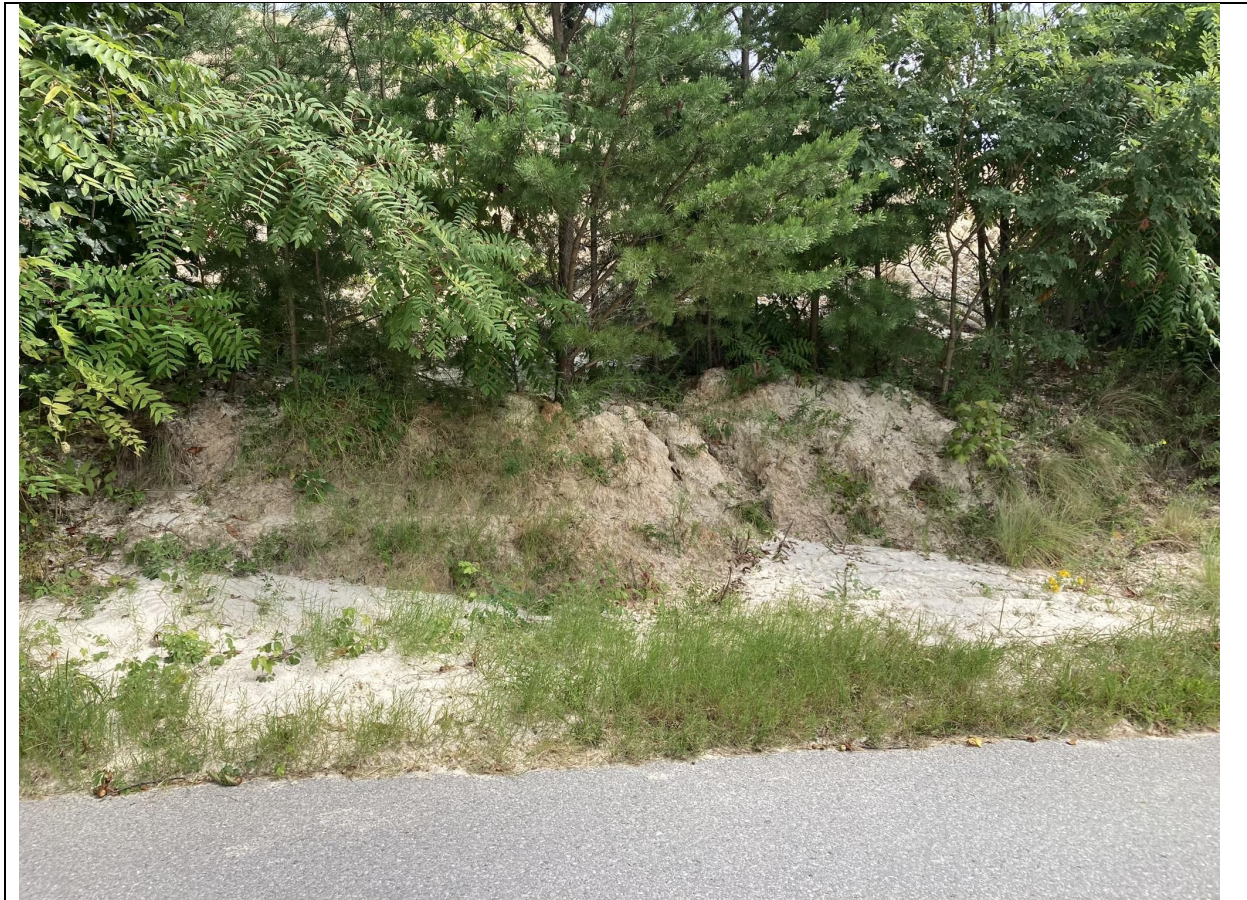
36.12881, -85.34411 2023/09/12 12:12:45 87°

Item 1: Sand stockpile overtopping perimeter berm on Sand Springs Church Rd.

Drive by inspection to assess loss of material off site at entrances. Substantial deposits were seen at both the front and side entrances to the site. An area where stockpiled material was overtopping a perimeter berm was noticed, as well. The permittee will be asked to provide solutions to minimize loss of material in the future.

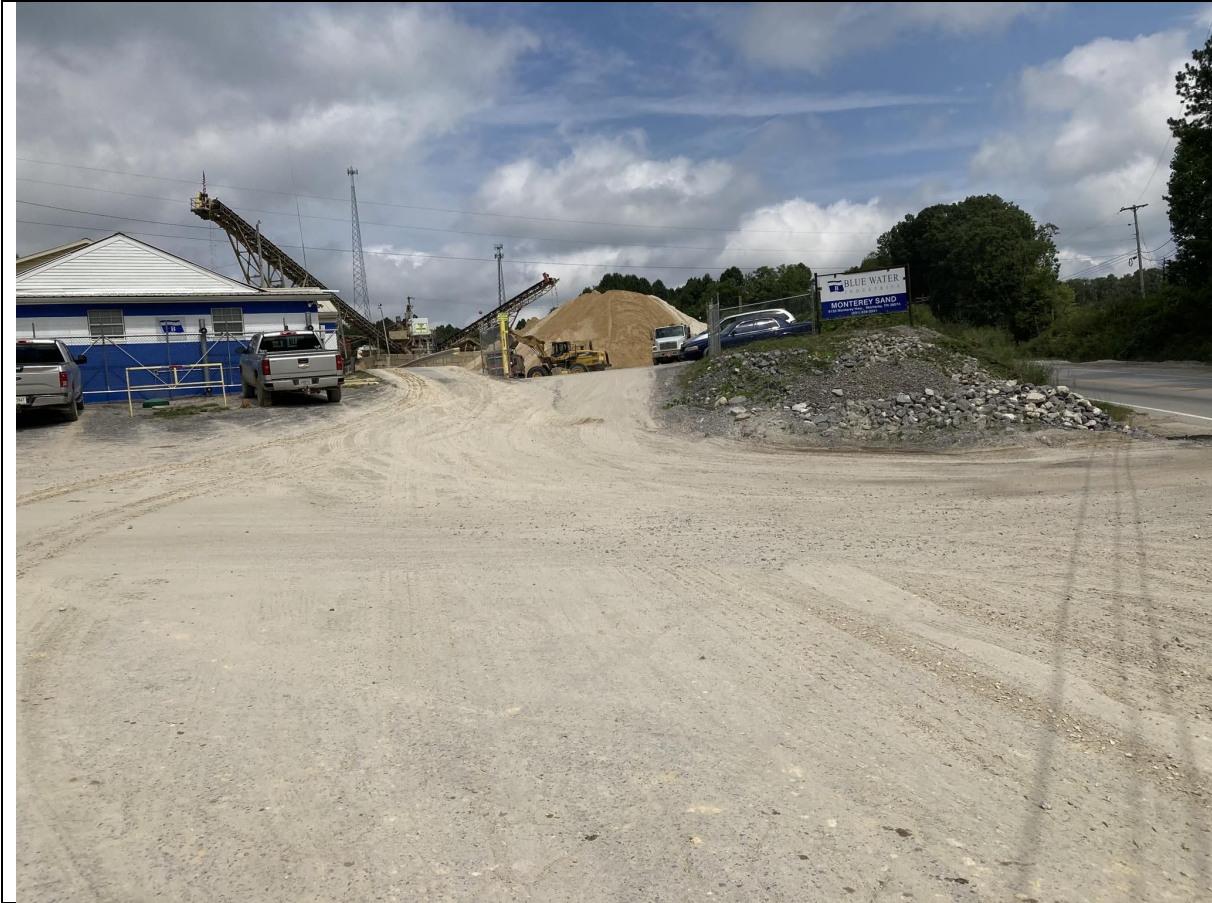
36.12639, -85.34356 2023/09/12 12:13:43 65°

Item 2: Main site entrance. Sand is covering driveway with no prevention to keep from entering roadway.

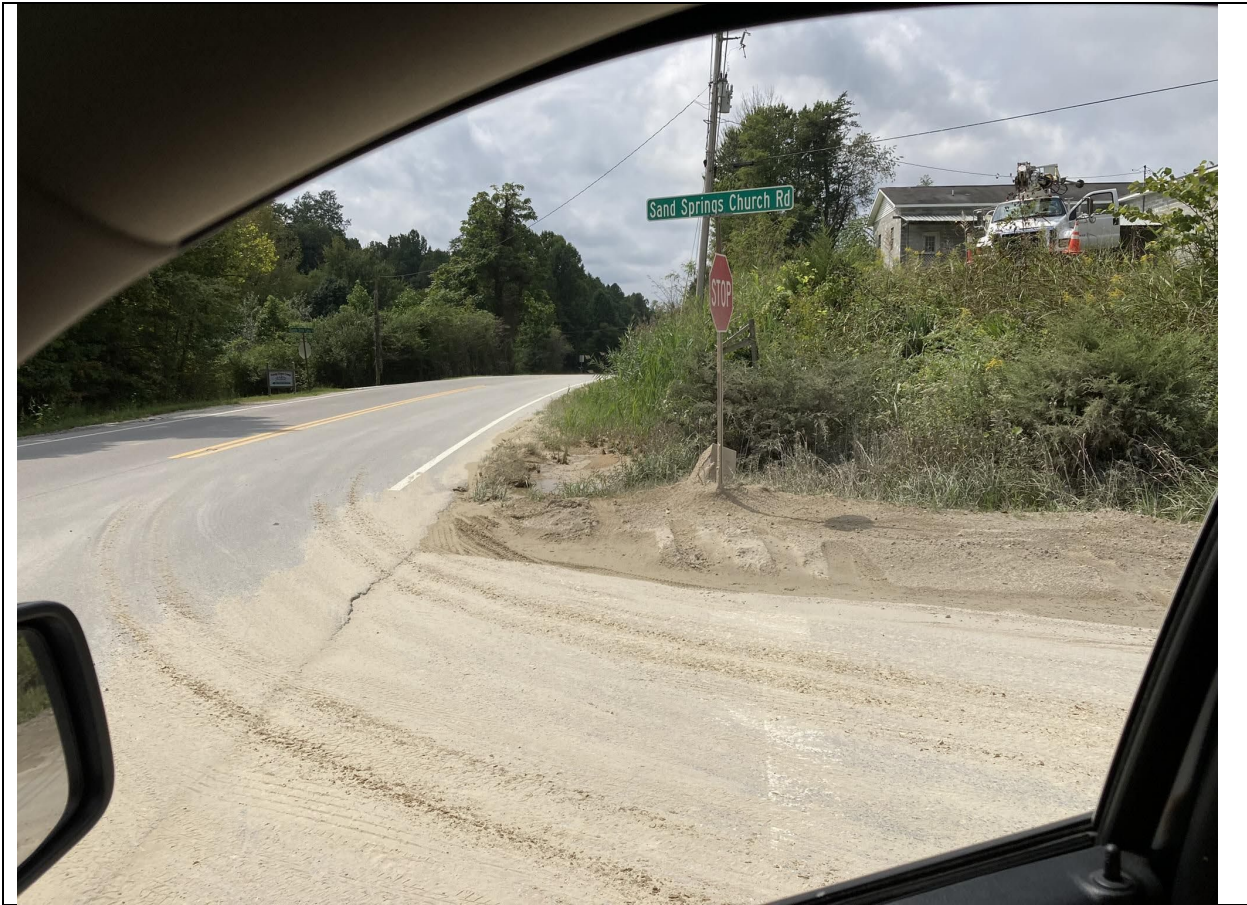
36.12636, -85.34351 2023/09/12 12:14:15 263°

Item 3: Sand deposits at Sand Springs Church Rd directly across from site entrance.

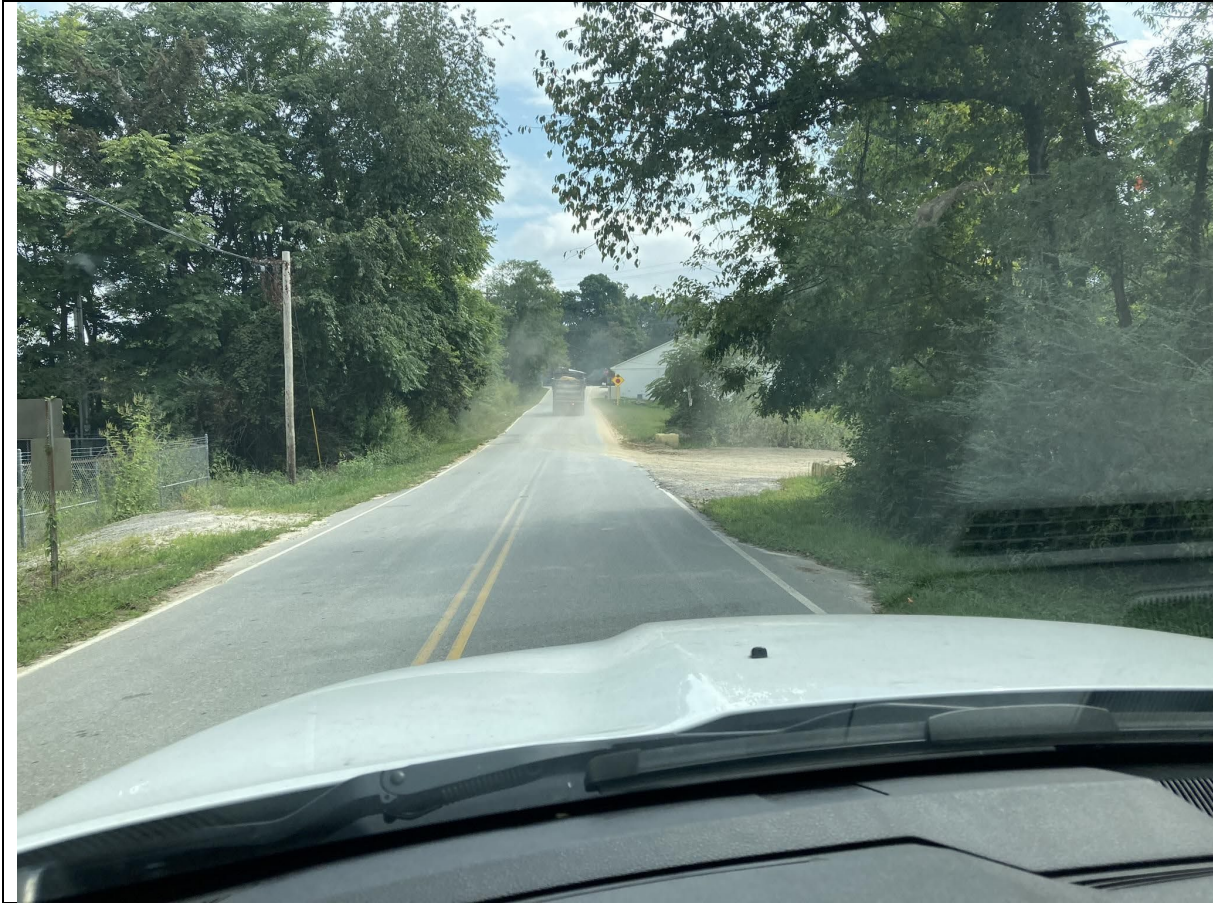
36.13143, -85.34237 2023/09/12 12:16:03 139°

Item 4: Sand leaving site at side entrance on Sand Springs Church Rd.

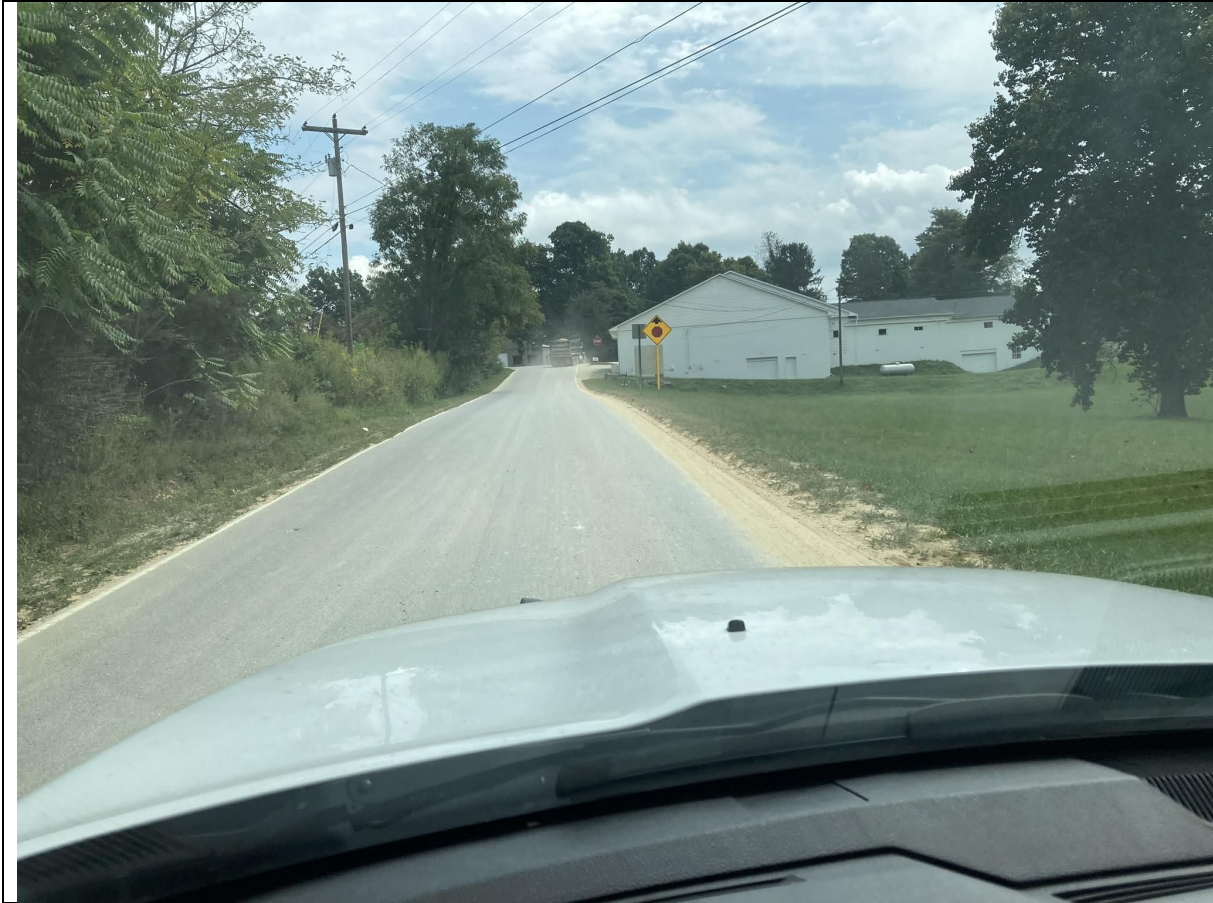
36.1312, -85.34181 2023/09/12 12:16:16 137°

Item 5: Sand deposits along extent of Sand Springs Church Rd.
