Subject: **Notice of Violation**  
APSU Health Professions Building  
341 8th Street  
Clarksville, 37040 Montgomery  
County, Tennessee Permit ID: TNR246917

**Compliance Inspection for General NPDES Permit for Stormwater Discharges from Construction Activities (CGP)**

<b>Site/Project Name:</b> APSU Health Professions Building		<b>NPDES Tracking Number:</b> TNR246917
<b>Street Address or Location:</b> 341 8th Street		<b>Date Coverage was Issued:</b> 15-AUG-23
<b>Site Description:</b> South of Marion Street, spanning from 8th Street to Ford Street.		<b>Start Date:</b> 16-AUG-23
<b>County(ies):</b> Montgomery		<b>Estimated End Date:</b> 01-SEP-25
<b>EFO:</b> Nashville	<b>MS4 Jurisdiction:</b> TNS088285	<b>Latitude (dd.ddd):</b> 36.53457
		<b>Longitude (-dd.ddd):</b> -87.350083
		<b>Acres Disturbed:</b> 2.99
		<b>Total Acres:</b>

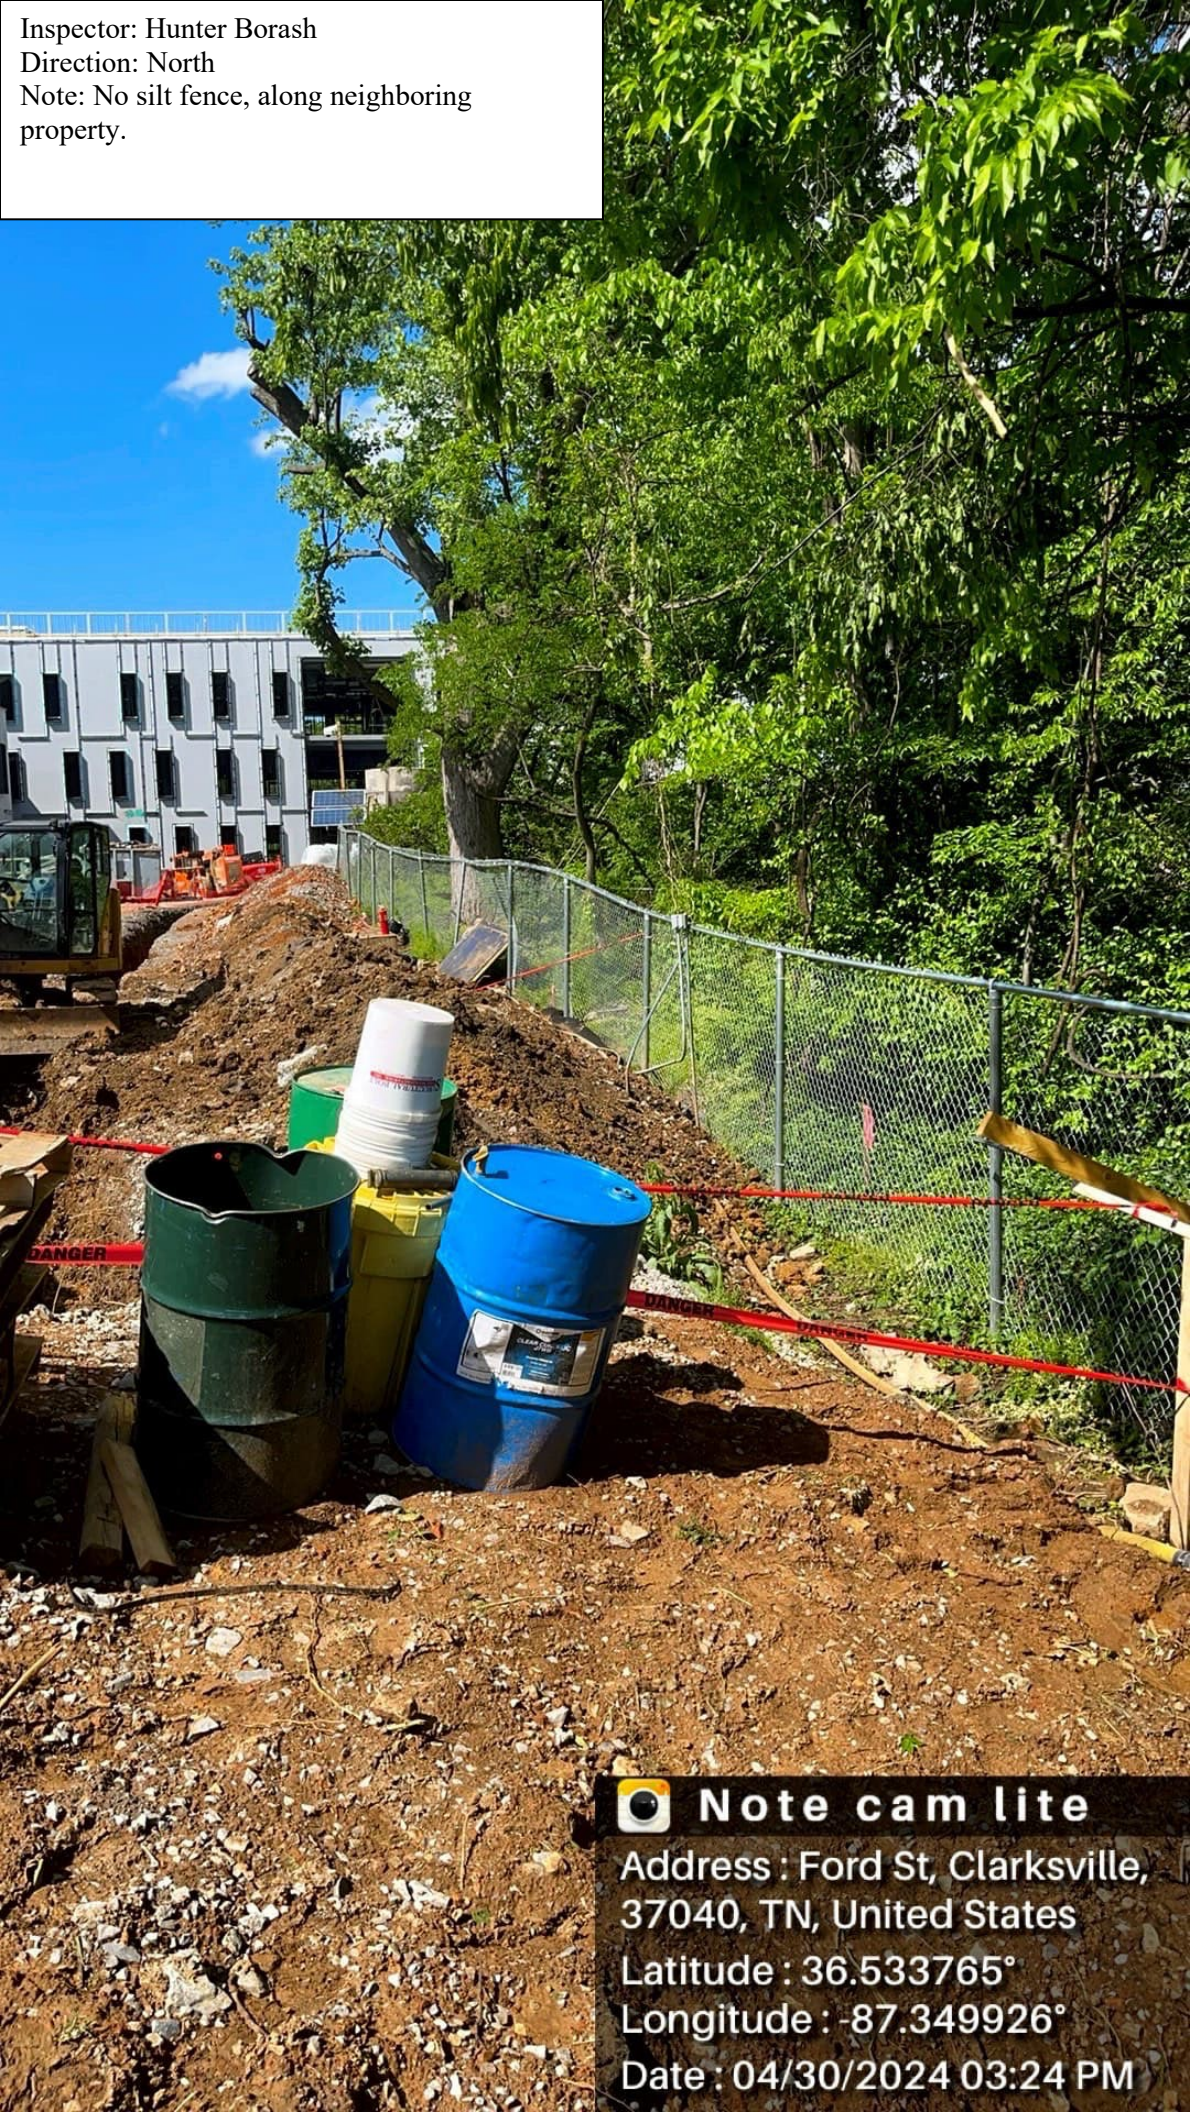
Inspector: Hunter Borash  
Direction: North  
Note: No silt fence, along neighboring property.

- 1.) Install effective silt fence for the site as per the EPSC plans
- 2.) Conduct EPSC maintenance for all outfalls and inlet protection measures
- 3.) Install SWPPP Box
- 4.) Provide pictures of the measures implemented

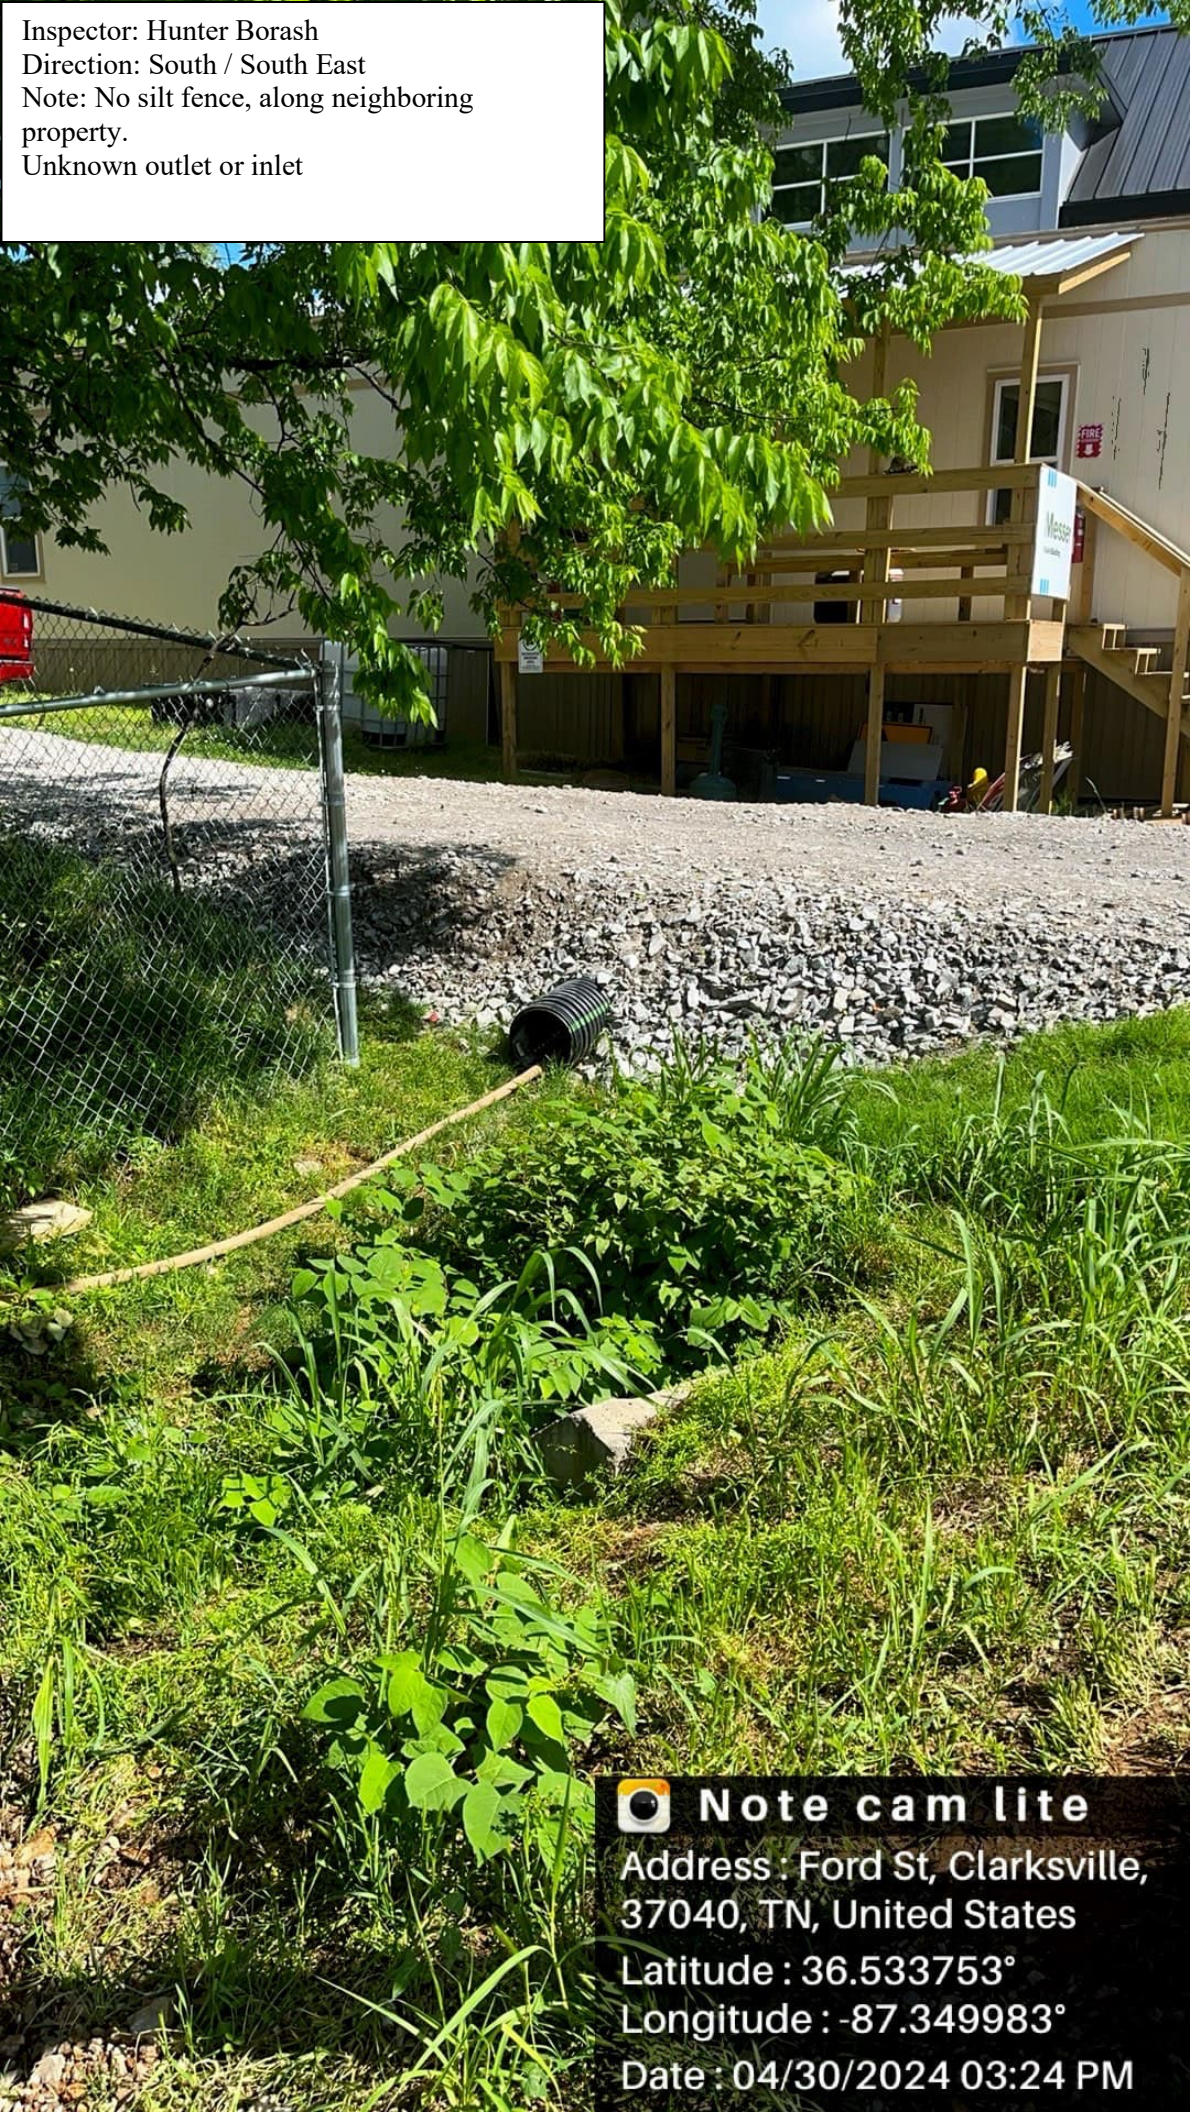
Inspector: Hunter Borash  
Direction: South / South East  
Note: No silt fence, along neighboring property.  
Unknown outlet or inlet

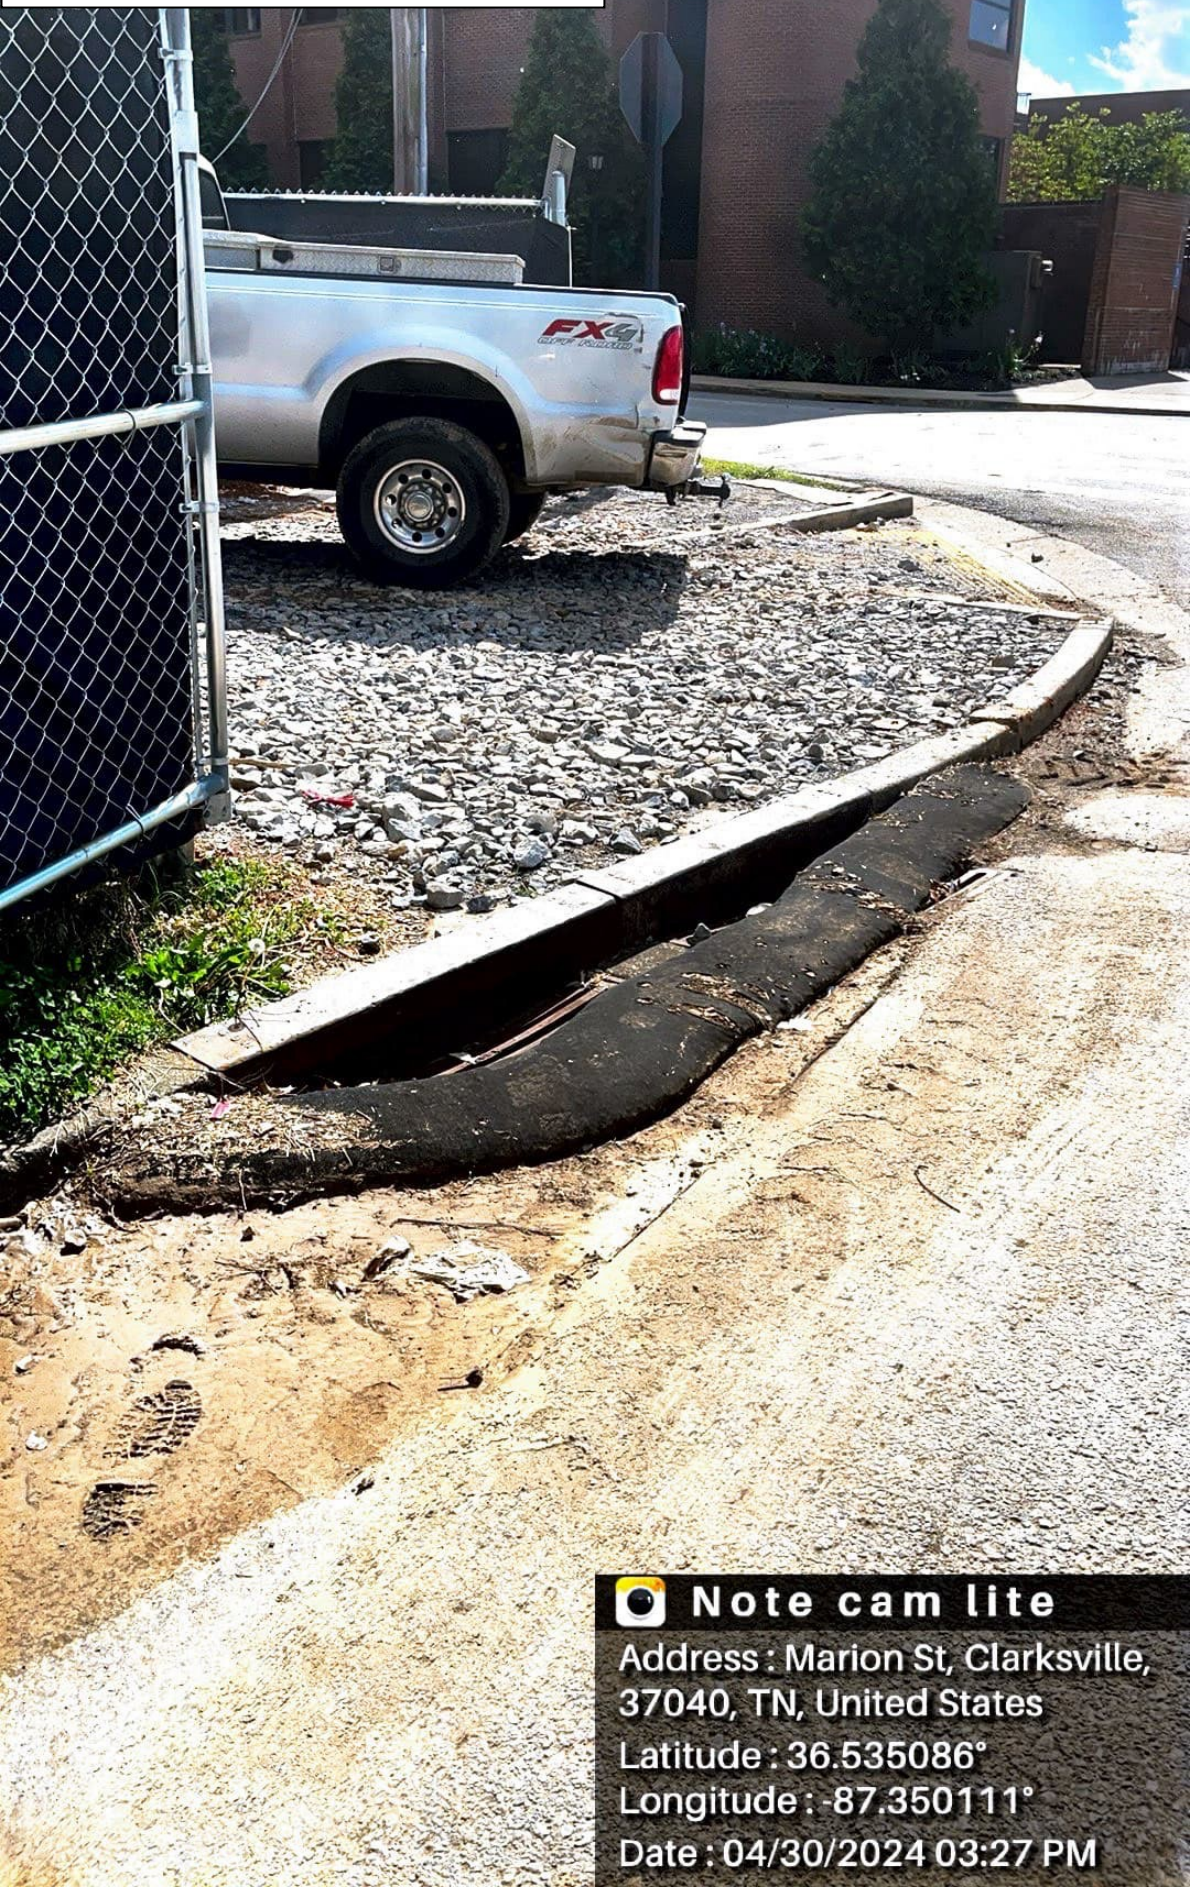
Inspector: Hunter Borash  
Direction: West / South West  
Note: Unmarked 3<sup>rd</sup> Construction Entrance  
along 8<sup>th</sup> Street and Marion Street.  
Small amount of sediment buildup

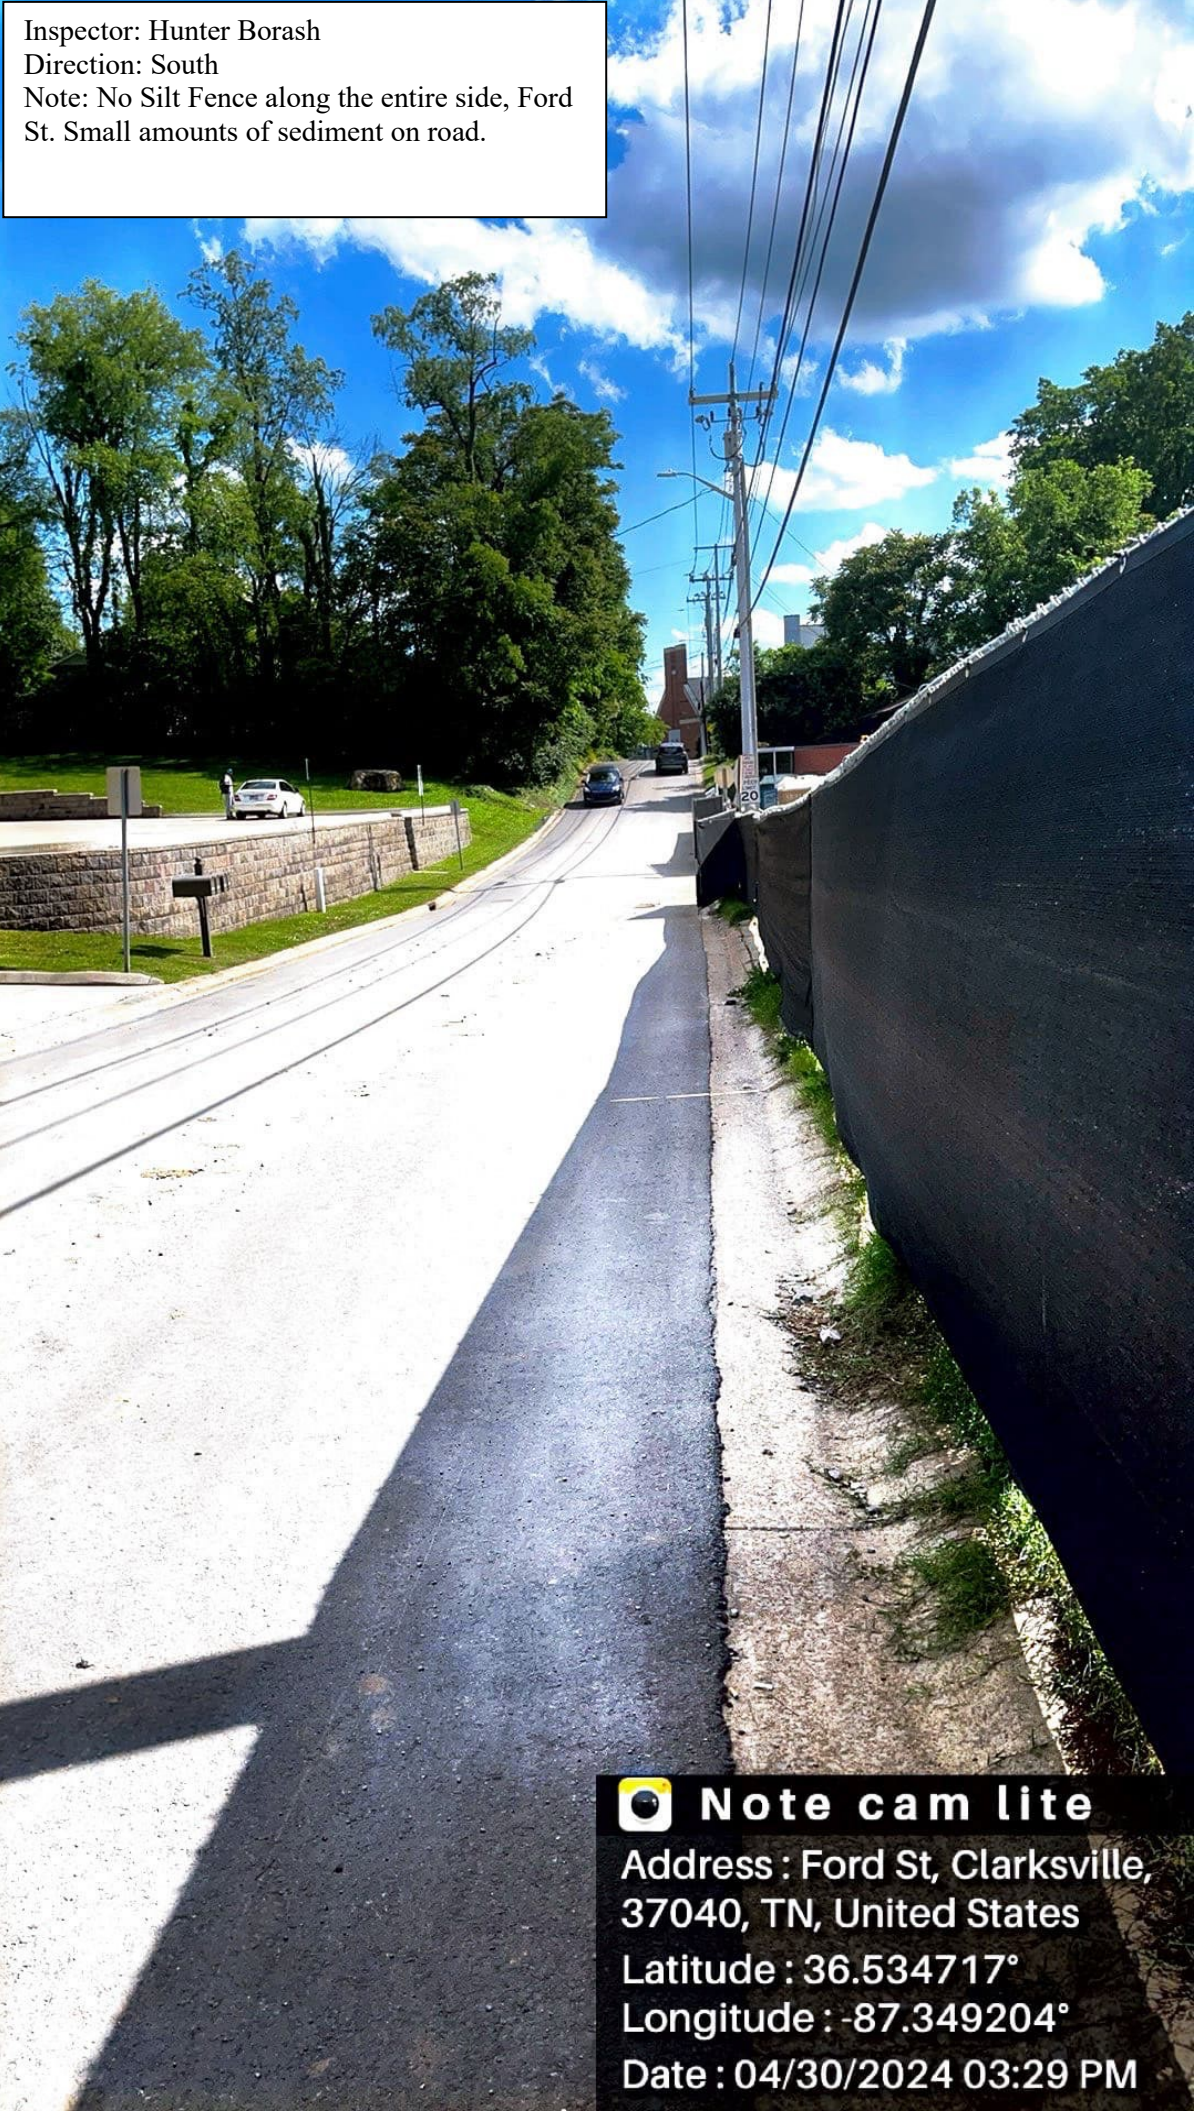
Inspector: Hunter Borash  
Direction: South  
Note: No Silt Fence along the entire side, Ford St. Small amounts of sediment on road.

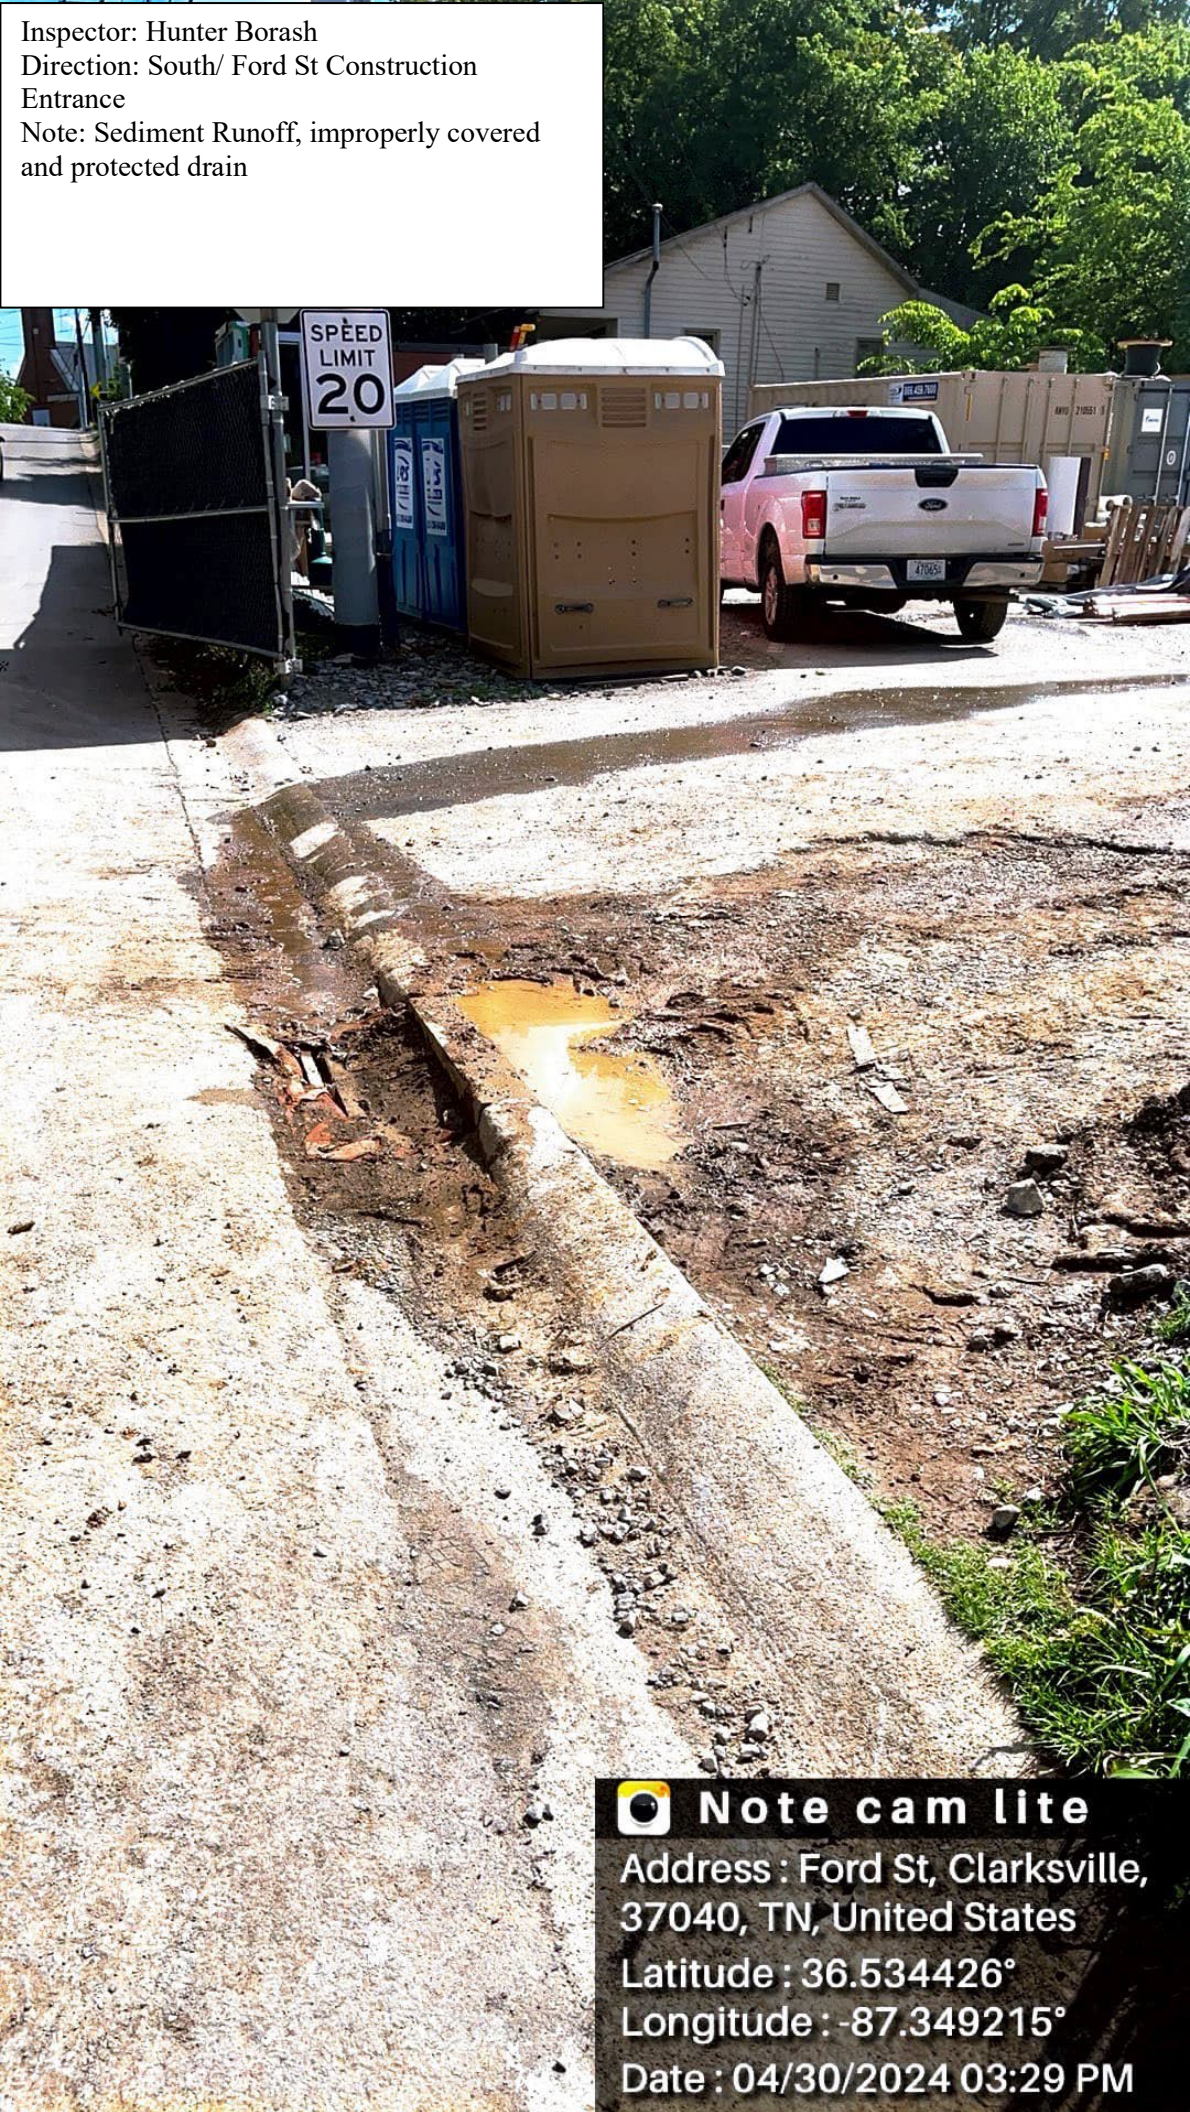
Inspector: Hunter Borash  
Direction: South/ Ford St Construction  
Entrance  
Note: Sediment Runoff, improperly covered  
and protected drain
