**Re: Inspection Findings Letter
J&E Finishers – SOPC00002
1570 Briar Patch Lake Road Paris, Henry County, TN**

Compliance Inspection for Concentrated Animal Feeding Operation (CAFO)

PHOTOLOG

Subject: 3-16-17 J&E Finishers Inspection Pictures

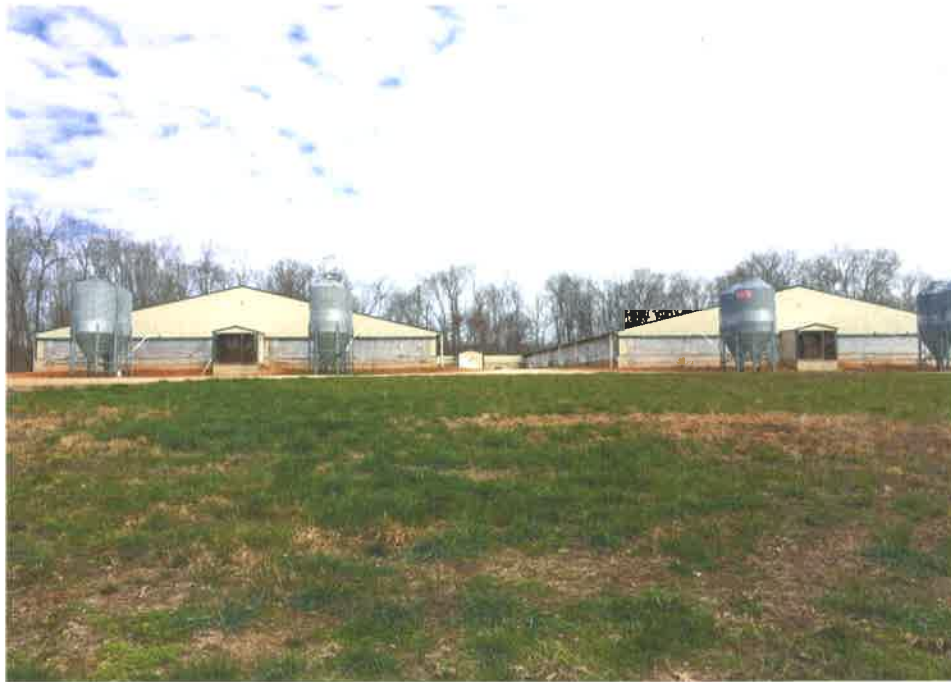
Picture 1

Date of Photo: 3/16/2017. Photo taken by: Kevin Smith. Location/Site Name: J&E Finishers / SOPC00002. TDWR personnel Present: Kevin Smith. Remarks: Picture is of the deep pit barns located at the J&E Finisher facility. Picture was taken standing on the south side of facility facing north.

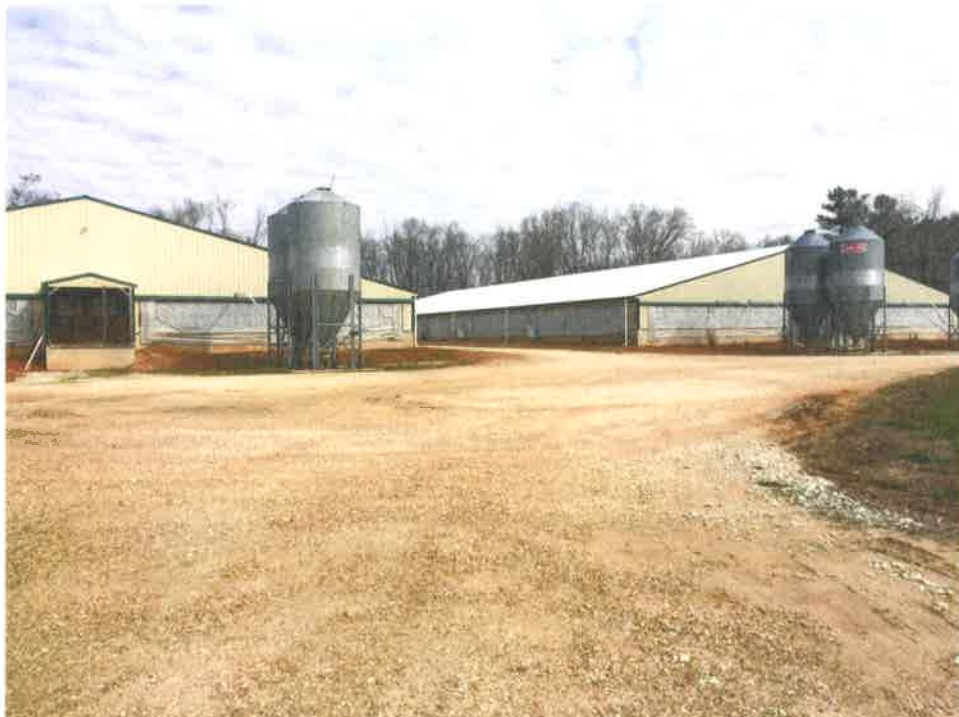
Picture 2

Date of Photo: 3/16/2017. Photo taken by: Kevin Smith. Location/Site Name: J&E Finishers / SOPC00002. TDWR personnel Present: Kevin Smith. Remarks: Picture is of the deep pit barns located at the J&E Finisher facility. Picture was taken standing on the southwest side of facility facing northeast.

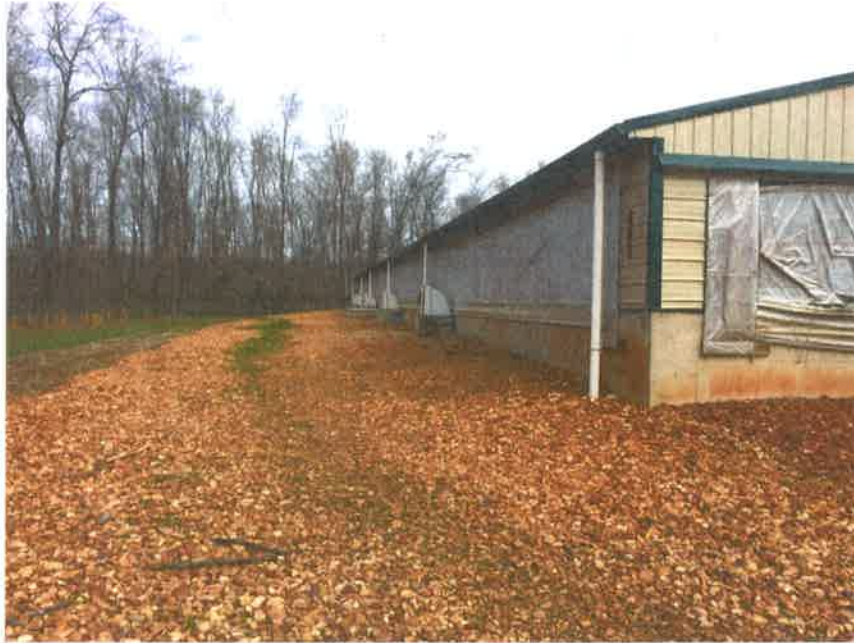
Picture 3

Date of Photo: 3/16/2017. Photo taken by: Kevin Smith. Location/Site Name: J&E Finishers / SOPC00002. TDWR personnel Present: Kevin Smith. Remarks: Picture is of western side of the western most pit barn. There are gutters installed on the barns to direct rainfall run-off away from barns. Also note rock which has been placed to stabilize area and also allow for vehicular travel around the pit barn. Picture was taken on southwest side of western most pit barn facing north.

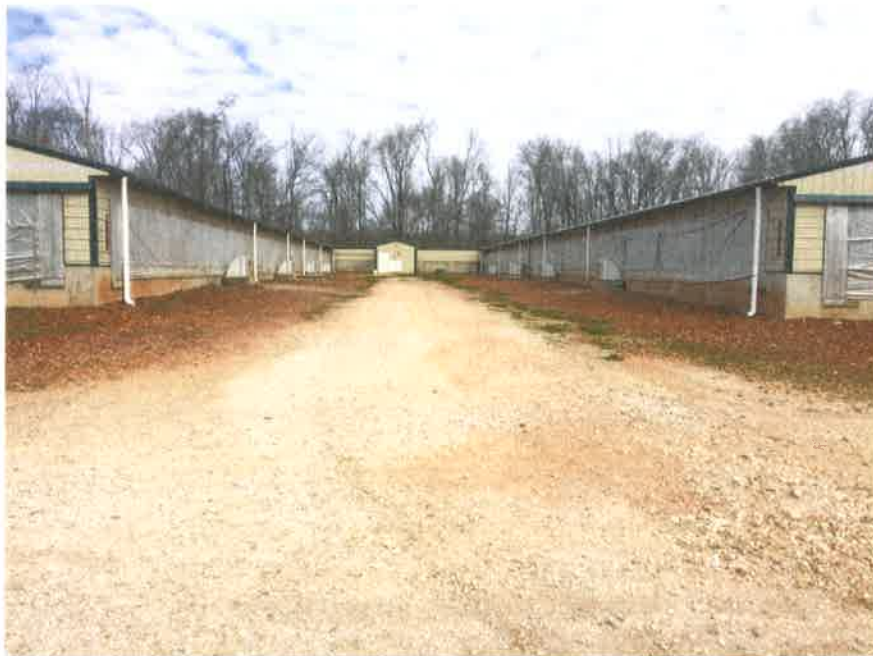
Picture 4

Date of Photo: 3/16/2017. Photo taken by: Kevin Smith. Location/Site Name: J&E Finishers / SOPC00002. TDWR personnel Present: Kevin Smith. Remarks: Picture is of area located between the two pit barns. There are gutters installed on the pit barns to direct rainfall run-off away from the pit barns. Also note rock has been placed to stabilize area between barns and also allow for vehicular traffic. Picture was taken on south side of pit barns facing north.

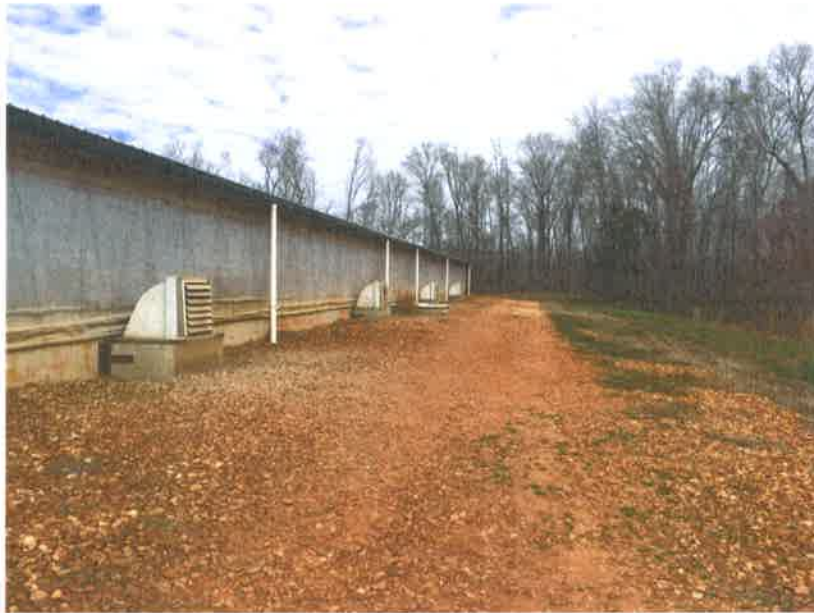
Picture 5

Date of Photo: 3/16/2017. Photo taken by: Kevin Smith. Location/Site Name: J&E Finishers / SOPC00002. TDWR personnel Present: Kevin Smith. Remarks: Picture is of eastern side of the eastern most pit barn. There are gutters installed on the barns to direct rainfall run-off away from barns. Also note rock which has been placed to stabilize area and also allow for vehicular travel around the pit barn. Picture was taken on southeast side of eastern most pit barn facing north.

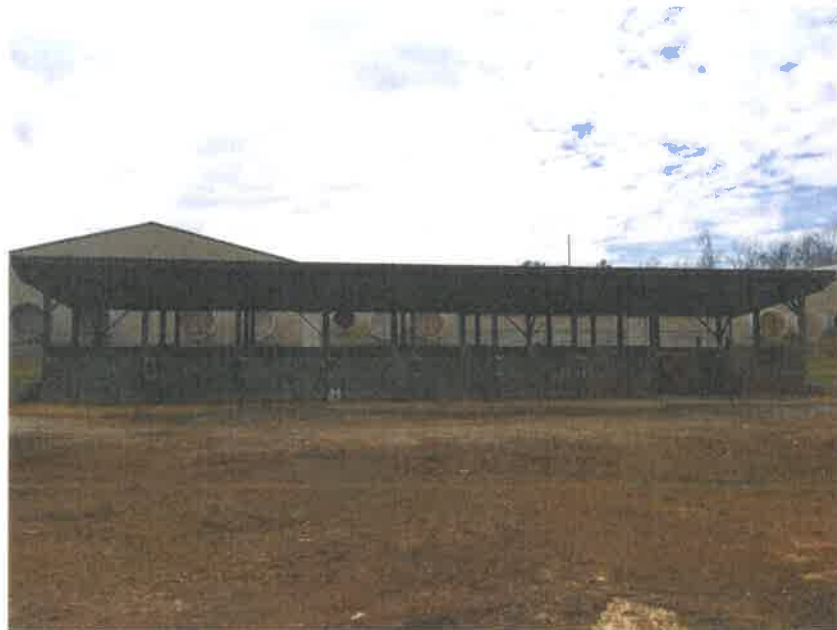
Picture 6

Date of Photo: 3/16/2017. Photo taken by: Kevin Smith. Location/Site Name: J&E Finishers / SOPC00002. TDWR personnel Present: Kevin Smith. Remarks: Picture is of the covered 7 bay compost shed located on the northern side of the facility. There is also an additional larger bay to store sawdust material, on the western side of compost shed, which is used as carbon source for the compost. There are wooden doors to close up each bay of the compost shed. There was no leachate observed coming from any of the compost bays on the day of inspection. Picture was taken on north side of compost shed facing south.

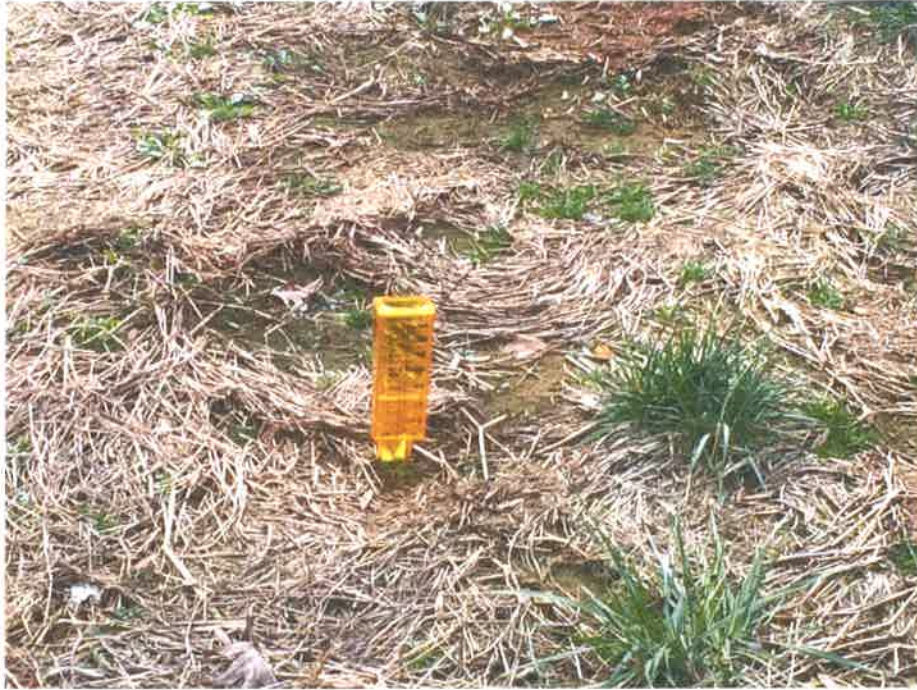
Picture 7

Date of Photo: 3/16/2017. Photo taken by: Kevin Smith. Location/Site Name: J&E Finishers / SOPC00002. TDWR personnel Present: Kevin Smith. Remarks: Picture is of rain gauge at the facility. The rain gauge was installed on the northern side of the facility on the day of inspection.
