Memo

TO: JFO File: Mike Sumners Dairy / TN0080667

Subject: 1-23-2020 Inspection Findings Mike Sumners Dairy

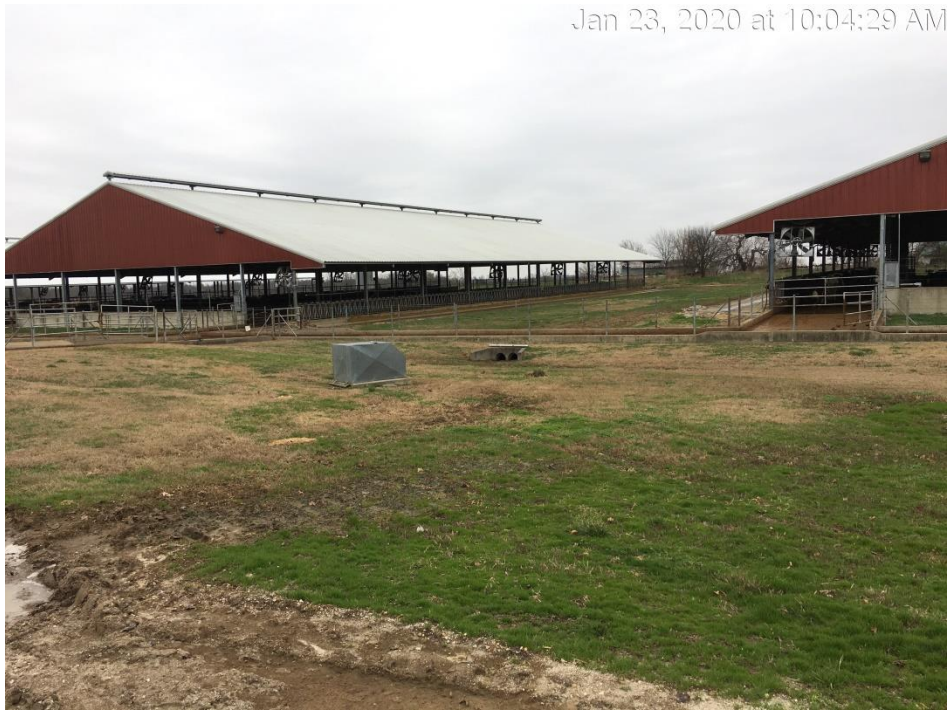
Picture 1

Date of Photo: 1/23/2020. Photo taken by: Kevin Smith. Location/Site Name: Mike Sumners Dairy/TN0080667. TDWR personnel Present: Kevin Smith and Conner Franklin, TDEC-DWR-JFO. Remarks: Picture is of loafing barns. Notice concrete flush pad. Concrete pad goes to primary lagoon. Picture was taken on west side of milking parlor facing east/northeast.

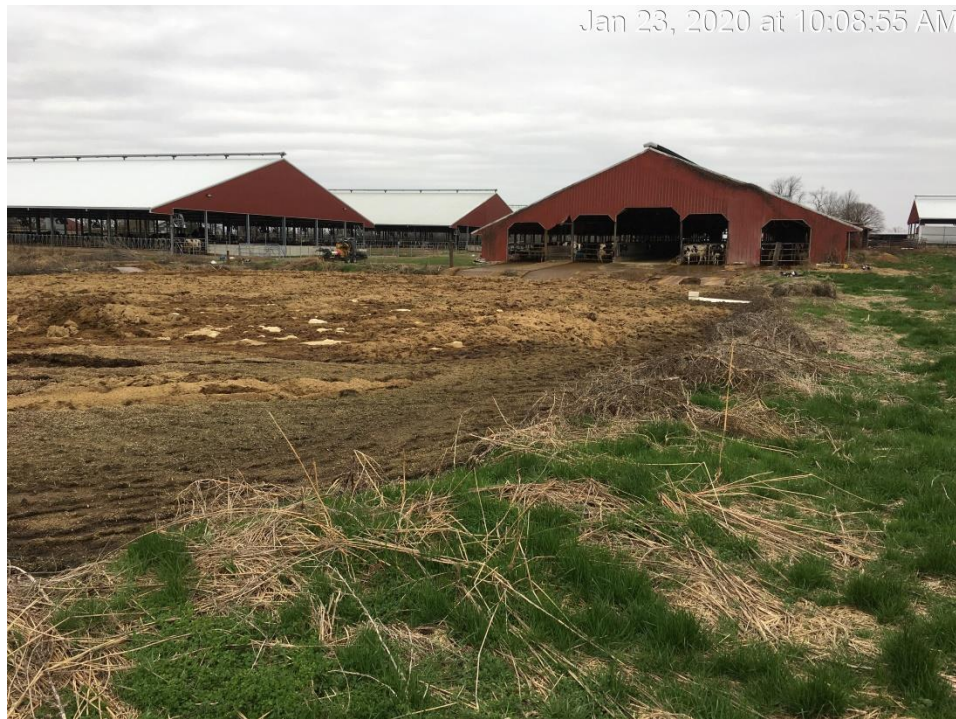
Picture 2

Date of Photo: 1/23/2020. Photo taken by: Kevin Smith. Location/Site Name: Mike Sumners Dairy/TN0080667. TDWR personnel Present: Kevin Smith and Conner Franklin, TDEC-DWR-JFO. Remarks: Picture was taken on the northwest side of the primary lagoon facing southeast.

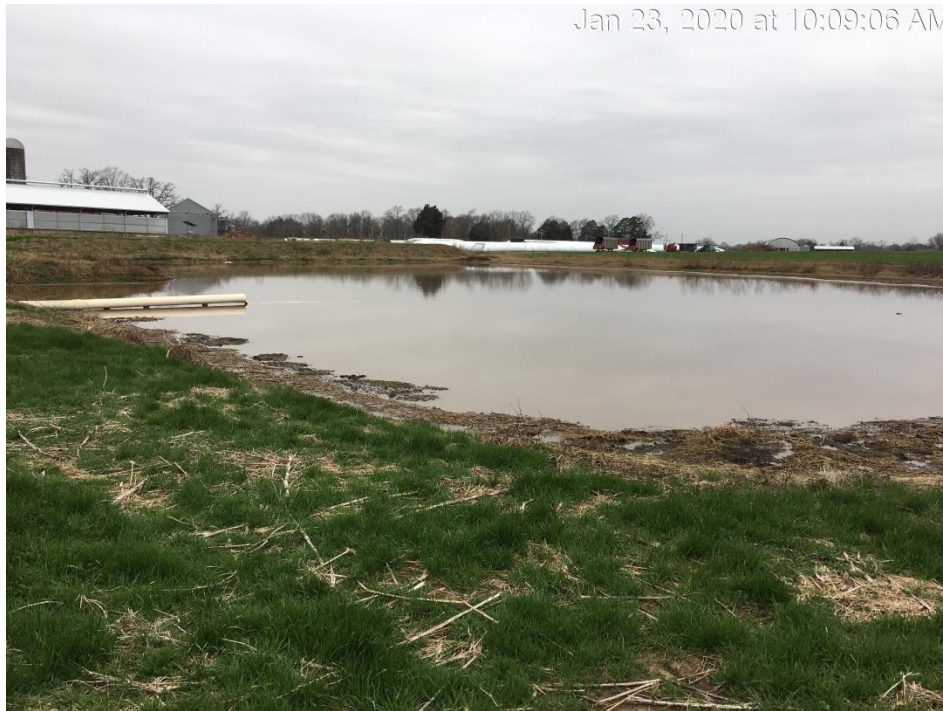
Picture 3

Date of Photo: 1/23/2020. Photo taken by: Kevin Smith. Location/Site Name: Mike Sumners Dairy/TN0080667. TDWR personnel Present: Kevin Smith and Conner Franklin, TDEC-DWR-JFO. Remarks: Picture is of secondary lagoon. Picture was taken on the northeast side of the secondary lagoon facing southwest.

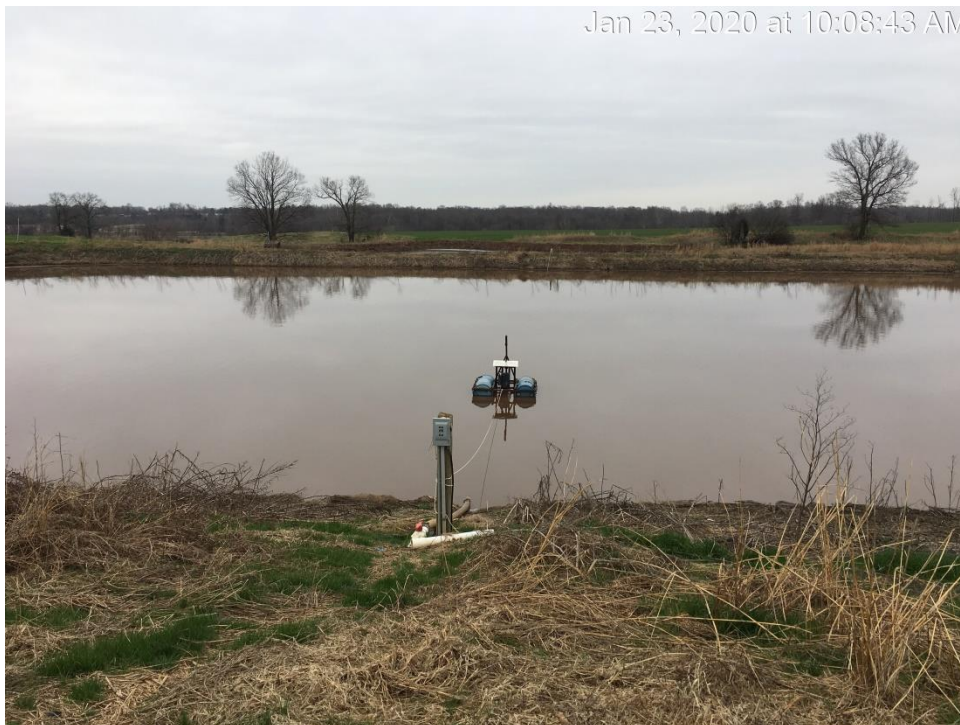
Picture 4

Date of Photo: 1/23/2020. Photo taken by: Kevin Smith. Location/Site Name: Mike Sumners Dairy/TN0080667. TDWR personnel Present: Kevin Smith and Conner Franklin, TDEC-DWR-JFO. Remarks: Picture is of the lower wastewater lagoon. Wastewater is recycled from the lower wastewater lagoon to flush travel lanes. Picture was taken on the southern side of the lower wastewater lagoon facing north.

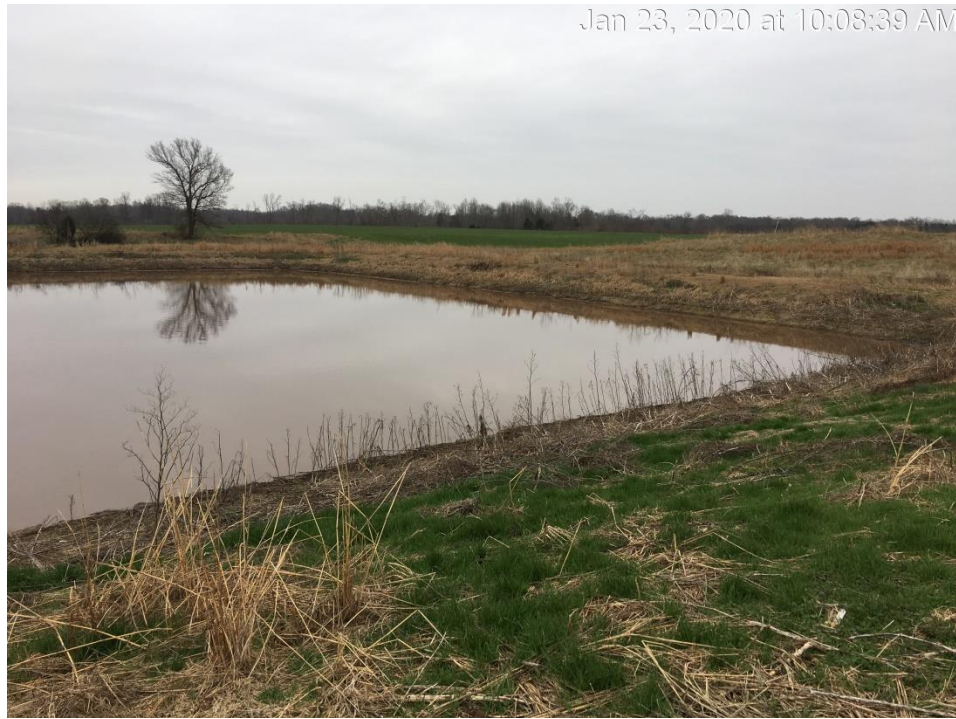
Picture 5

Date of Photo: 1/23/2020. Photo taken by: Kevin Smith. Location/Site Name: Mike Sumners Dairy/TN0080667. TDWR personnel Present: Kevin Smith and Conner Franklin, TDEC-DWR-JFO. Remarks: Picture is of the lower wastewater lagoon. Picture was taken standing on the south side of the lagoon facing northeast.

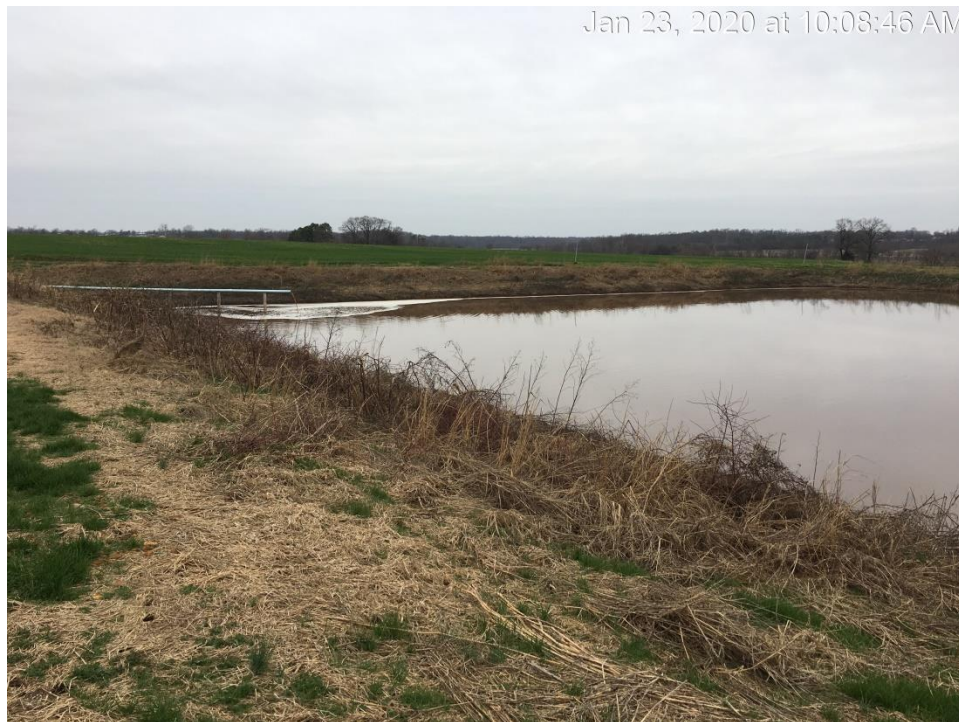
Picture 6

Date of Photo: 1/23/2020. Photo taken by: Kevin Smith. Location/Site Name: Mike Sumners Dairy/TN0080667. TDWR personnel Present: Kevin Smith and Conner Franklin, TDEC-DWR-JFO. Remarks: Picture is of the lower wastewater lagoon. Picture was taken standing on the south side of the lagoon facing northwest.

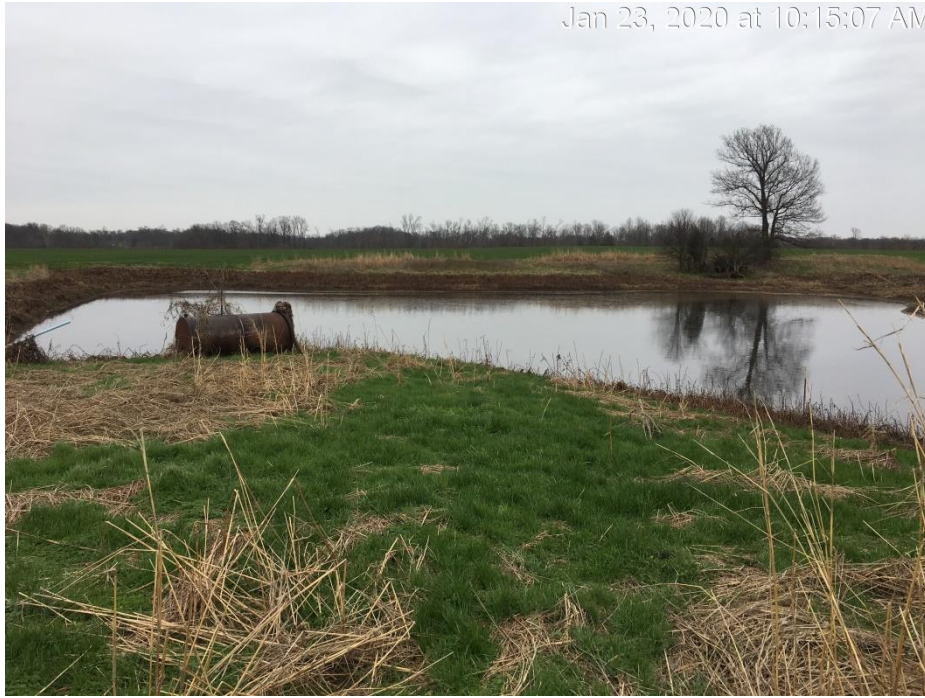
Picture 7

Date of Photo: 1/23/2020. Photo taken by: Kevin Smith. Location/Site Name: Mike Sumners Dairy/TN0080667. TDWR personnel Present: Kevin Smith and Conner Franklin, TDEC-DWR-JFO. Remarks: Picture is of man-made pond just north of the wastewater lagoons. Picture was taken on the southwest side of the man-made pond facing northeast. At the time of our visit this man made pond was capturing stormwater run-off from production areas that did not appear to be just clean stormwater.

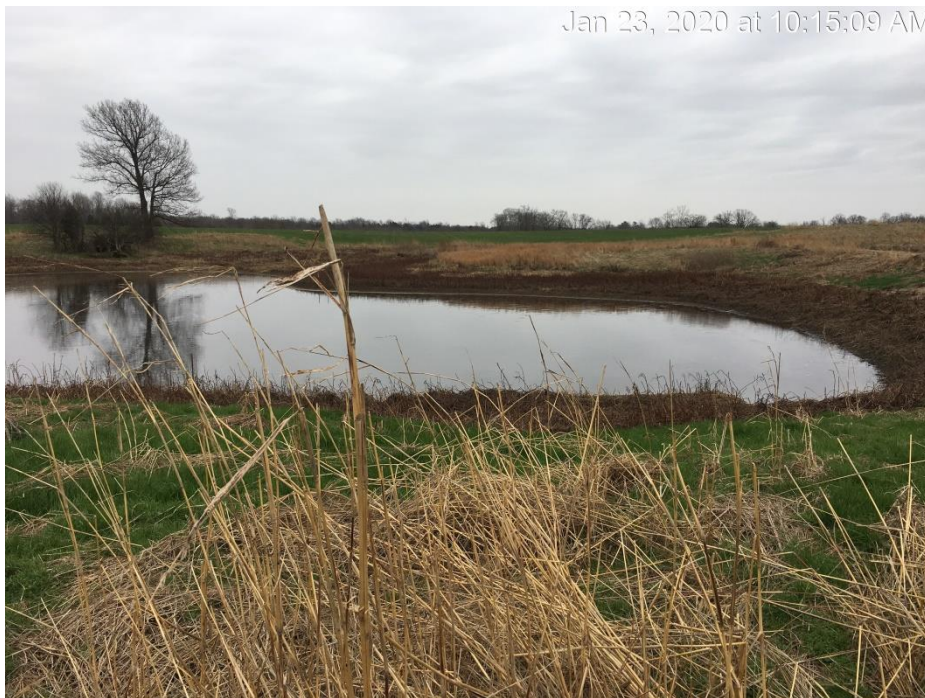
Picture 8

Date of Photo: 1/23/2020. Photo taken by: Kevin Smith. Location/Site Name: Mike Sumners Dairy/TN0080667. TDWR personnel Present: Kevin Smith and Conner Franklin, TDEC-DWR-JFO. Remarks: Picture was taken standing in the same location as Picture 7 only now I am facing east.

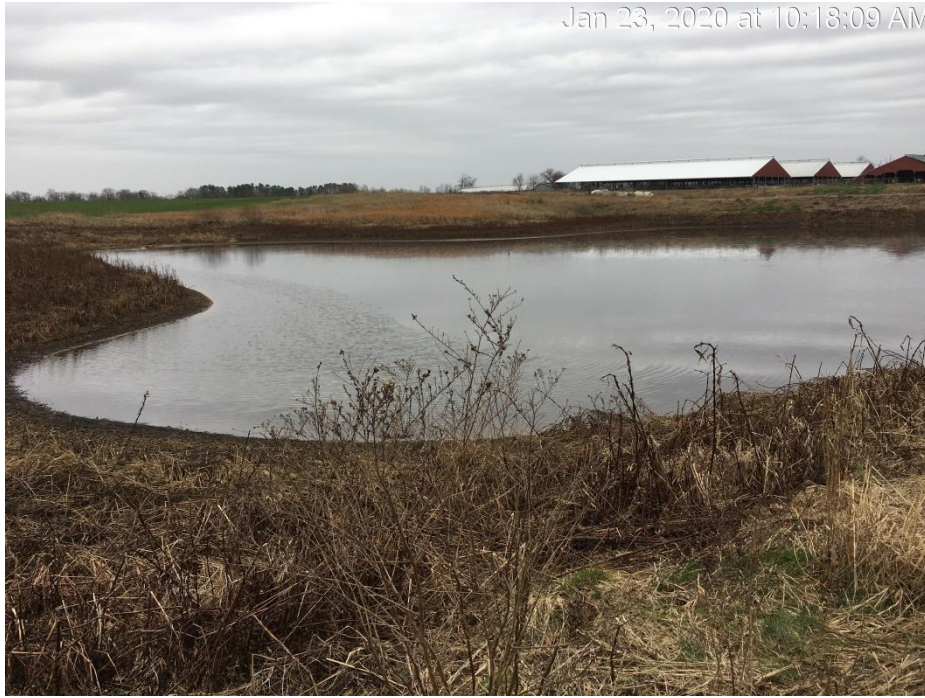
Picture 9

Date of Photo: 1/23/2020. Photo taken by: Kevin Smith. Location/Site Name: Mike Sumners Dairy/TN0080667. TDWR personnel Present: Kevin Smith and Conner Franklin, TDEC-DWR-JFO. Remarks: Picture was taken on the northwest side of the man-made pond, which is located just north of the wastewater lagoons, facing southeast.

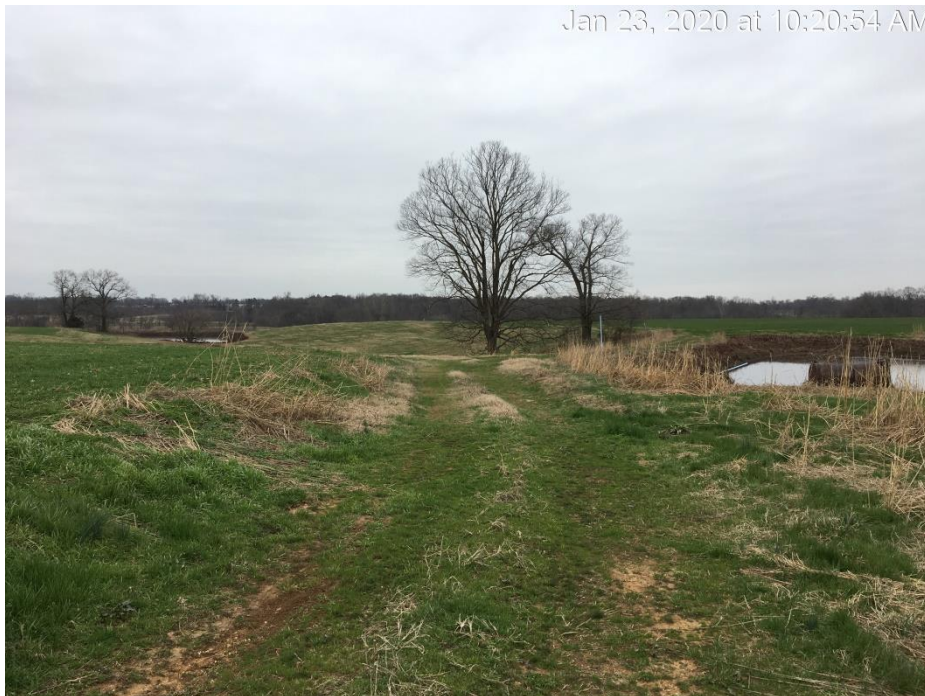
Picture 10

Date of Photo: 1/23/2020. Photo taken by: Kevin Smith. Location/Site Name: Mike Sumners Dairy/TN0080667. TDWR personnel Present: Kevin Smith and Conner Franklin, TDEC-DWR-JFO. Remarks: Picture was taken on the northwest side of lower wastewater lagoon facing north. There are two more additional ponds below the wastewater lagoons.

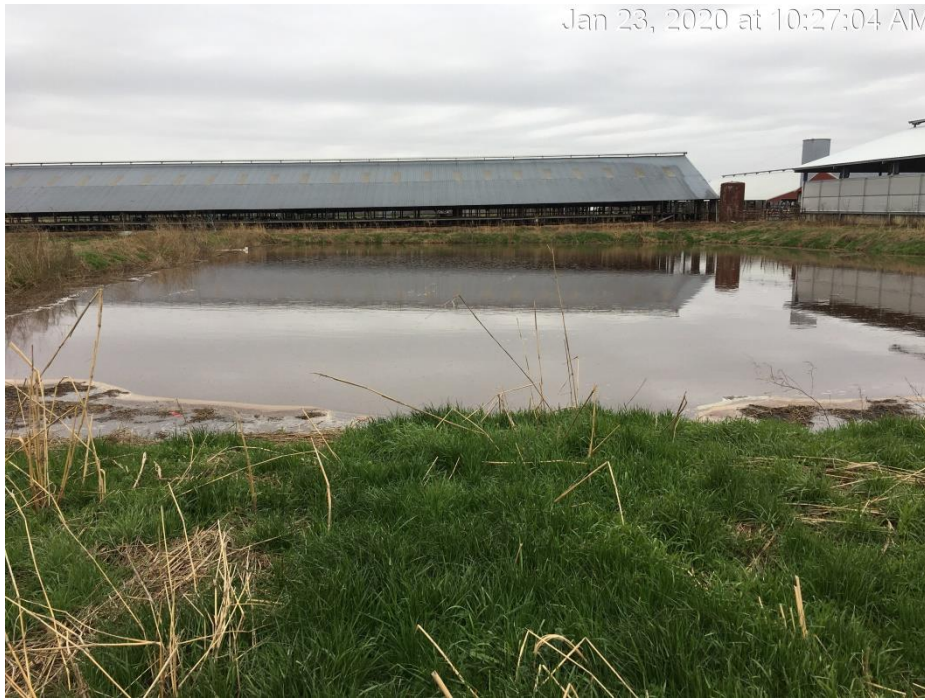
Picture 11

Date of Photo: 1/23/2020. Photo taken by: Kevin Smith. Location/Site Name: Mike Sumners Dairy/TN0080667. TDWR personnel Present: Kevin Smith and Conner Franklin, TDEC-DWR-JFO. Remarks: Picture is of the southernmost wastewater lagoon. This wastewater lagoon does not appear to be accounted for in the CNMP for the facility. Picture was taken standing on the west side of the lagoon facing east.

I conducted an inspection of Mr. Mike Sumners Dairy facility on January 23, 2020. Mr. Conner Franklin was also present during the inspection. The NPDES permit for Mr. Mike Sumners Dairy has expired. Mr. Sumners has requested to apply for coverage under the new state operating permit when it becomes available. Since Mr. Sumners, is going to apply for coverage under the new state operating permit when it becomes available records required to be kept under the Individual NPDES permit were not reviewed during this inspection. This inspection consisted of a walk around of the facility to see if any water quality issues were present. There were no water quality issues observed on the day we visited the facility. There is one wastewater lagoon that is being used that does not appear to be in the CNMP for the facility. This is the same wastewater lagoon that was noted as not being in the CNMP during the 2016 inspection. It had been raining and I noticed stormwater that is directed around the wastewater lagoons flowing into another man made pond just north of the last wastewater lagoon. The stormwater did not appear to be just clean stormwater. The stormwater appeared to be coming off of a silage storage area and areas around the barns/wastewater lagoons. This structure is also not shown in CNMP. Mr. Sumners will be required to provide an updated CNMP when he applies for coverage under the new state operating permit when it is finalized.

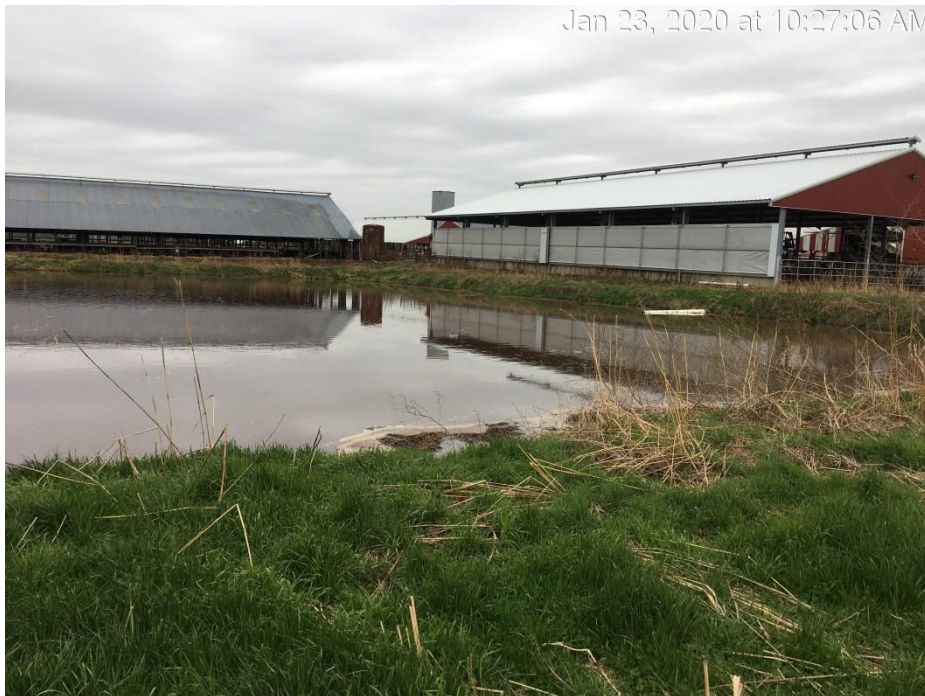
Picture 12

Date of Photo: 1/23/2020. Photo taken by: Kevin Smith. Location/Site Name: Mike Sumners Dairy/TN0080667. TDWR personnel Present: Kevin Smith and Conner Franklin, TDEC-DWR-JFO. Remarks: Picture was taken standing in the same location as Picture 11 only now I am facing southeast.

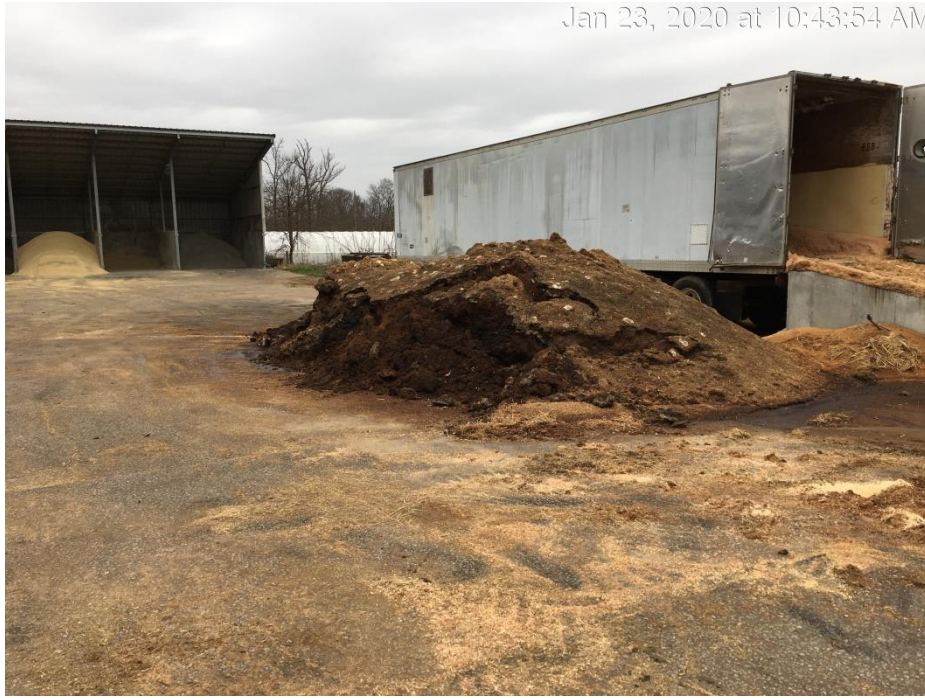
Picture 13

Date of Photo: 1/23/2020. Photo taken by: Kevin Smith. Location/Site Name: Mike Sumners Dairy/TN0080667. TDWR personnel Present: Kevin Smith and Conner Franklin, TDEC-DWR-JFO. Remarks: Picture is of compost area. Compost area is located across the road from the rest of the operation.
