RE: Compliance Evaluation Inspection (CEI)

Baxter Sewer Treatment Plant (STP); NPDES Permit: TN0021121

Baxter, Putnam County, Tennessee

Baxter Sewer Treatment Plant (STP) and Collection system, Putnam County, TN0021121

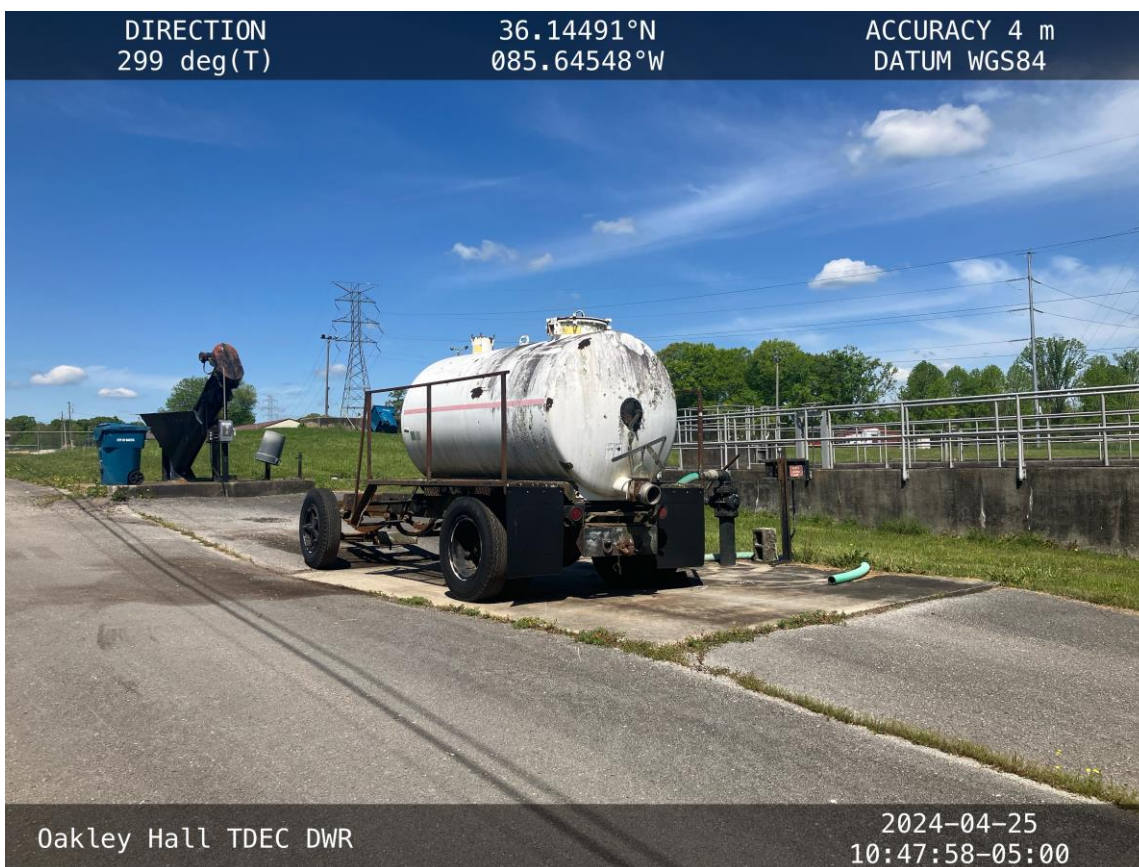
Baxter should consider the purchase of a new waste hauling truck along with upgrades to the off-loading plumbing that fills the truck. The current arrangement does not allow for over the road travel. This would open more areas for beneficial use. Photo By: Oakley Hall, April 25, 2024

- Consider the purchase of a bio-solids hauling truck and installing the associated plumbing to load the vehicle. This will assist with over the road hauling to different sites that may be needed in the future.
- Continue repairs of the city's sewer collection system.
- Work to prevent violations of the effluent ammonia nitrogen limit(s).

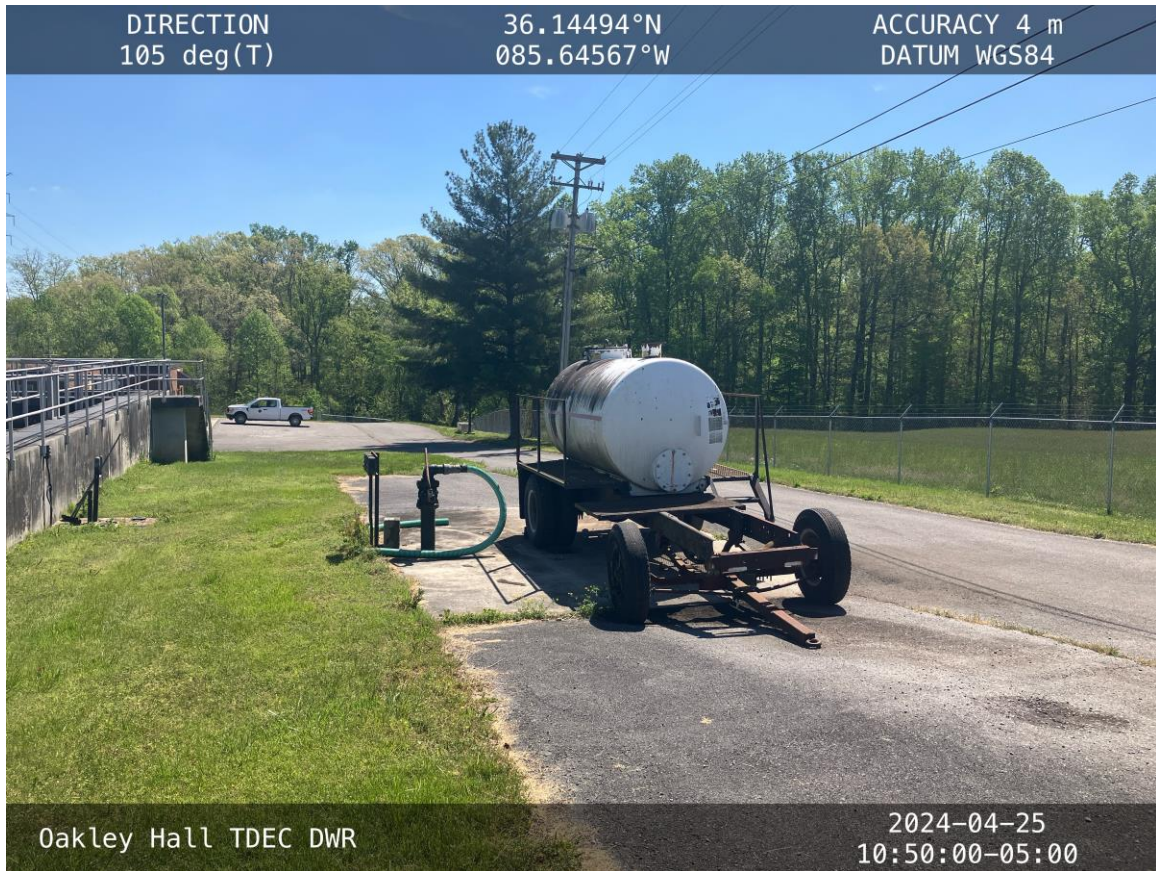
The grounds were clean and well maintained. A tractor is used to pull this liquid biosolids trailer across the surface of an adjacent field. Mechanical problems have recently occurred with the trailer and have been corrected. Photo By: Oakley Hall, April 25, 2024

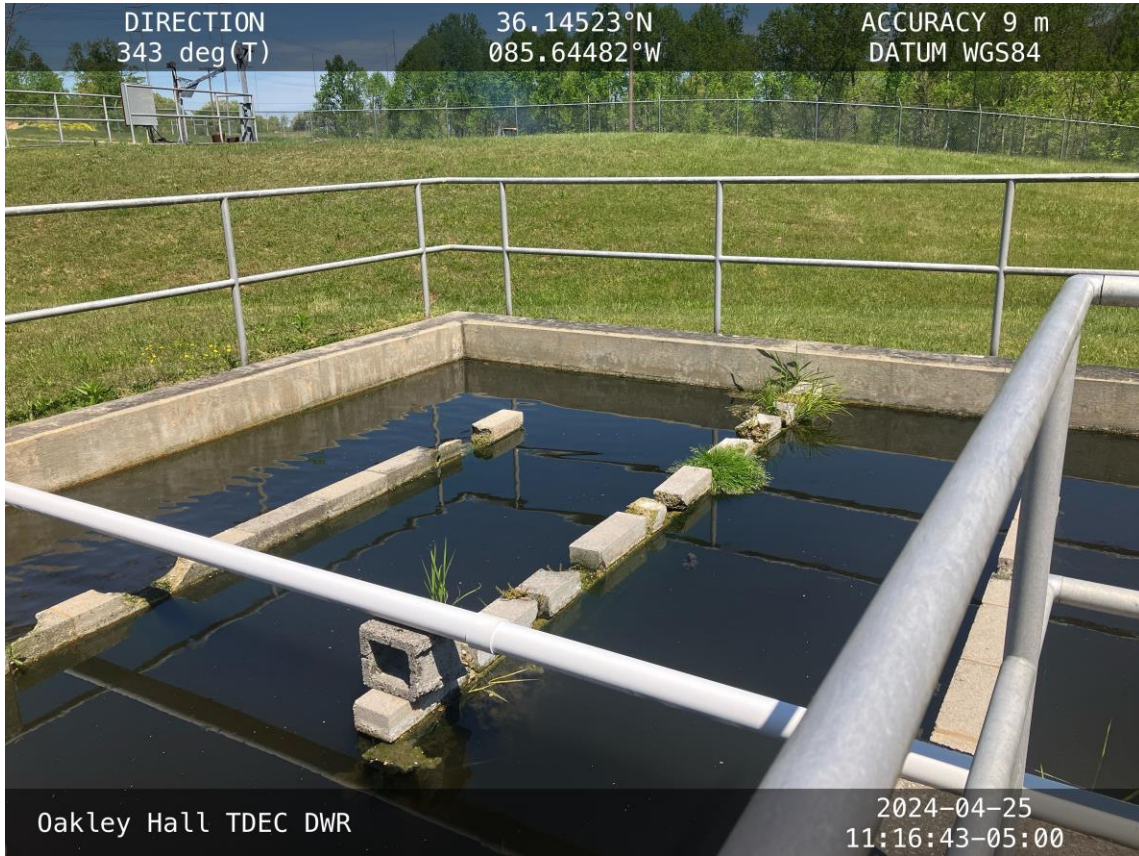
The Chlorine Contact Chamber is pictured. The chamber needs some block work improvements, to reduce short circuiting across the surface.
Photo By: Oakley Hall, April 25, 2024

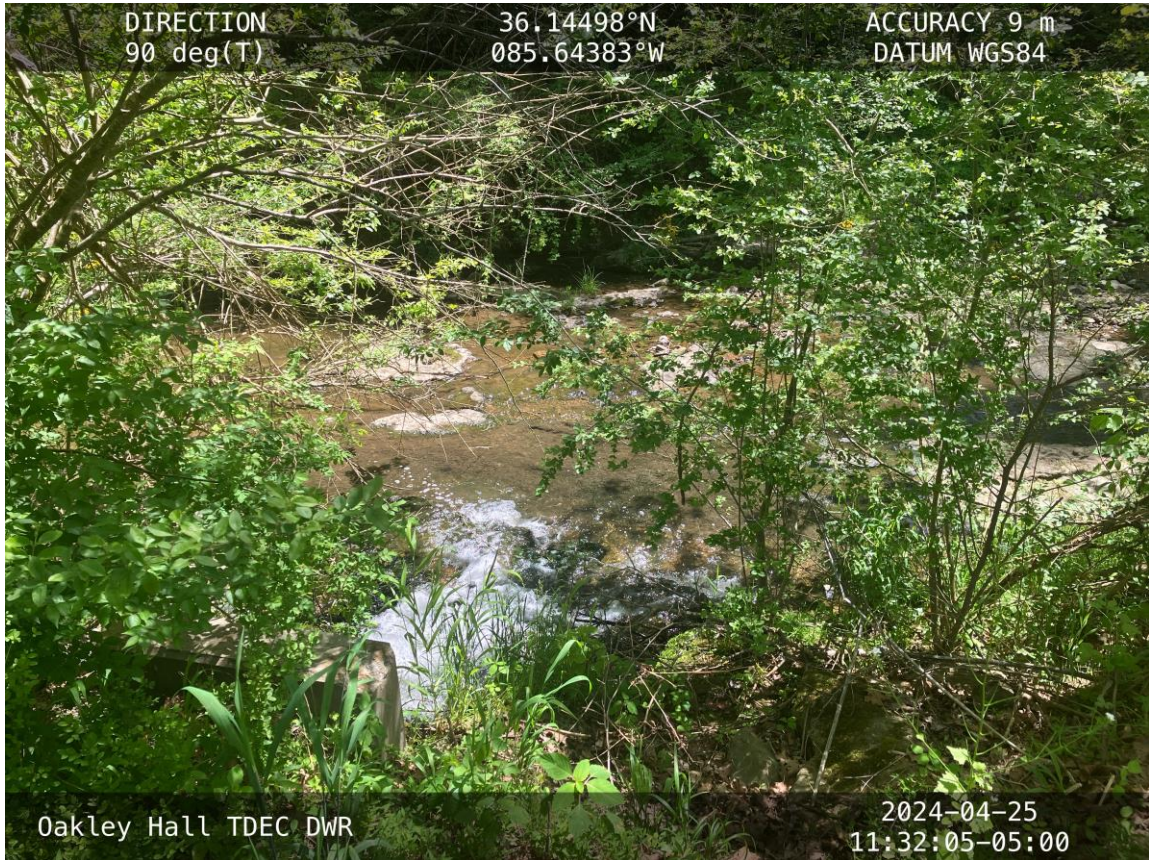
The effluent discharge at the stream was clear. Some algae growth was observed below the discharge pipe. The stream was at low flow conditions.
Photo By: Oakley Hall, April 25, 2024

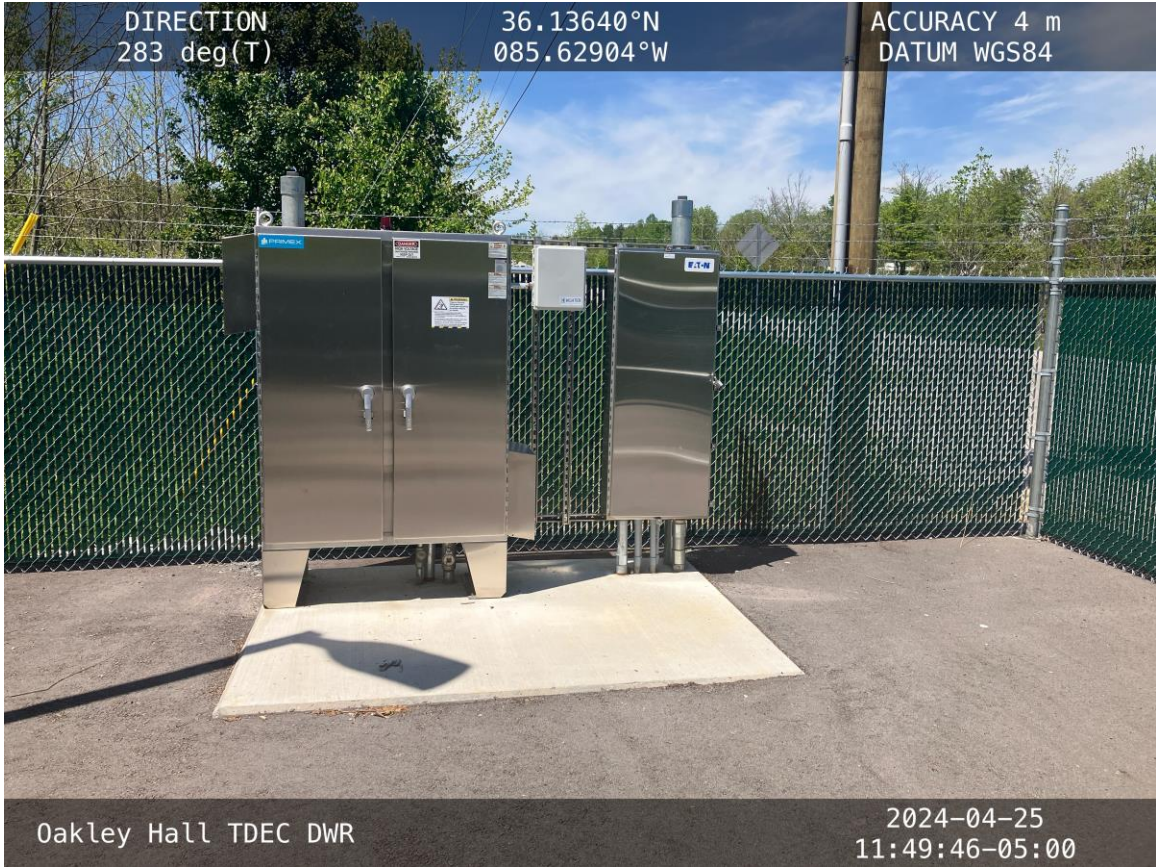
Two new lift stations were visited during the inspection. This one is located adjacent to I-40, on the south side. Note the green slats woven in the chain-link fence.

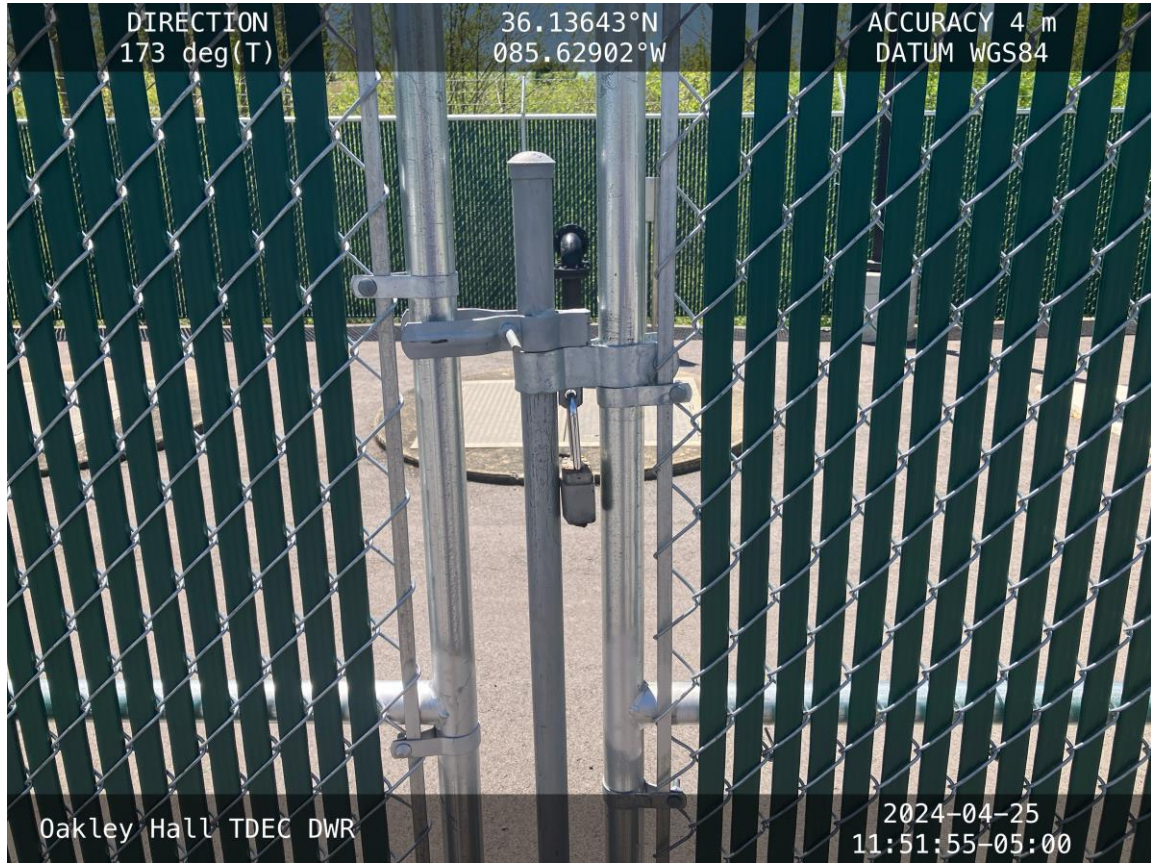
Security at the two pump stations was discussed. A chain should be added at this gate to reduce the possibility of unauthorized entry. Photo By: Oakley Hall, April 25, 2024

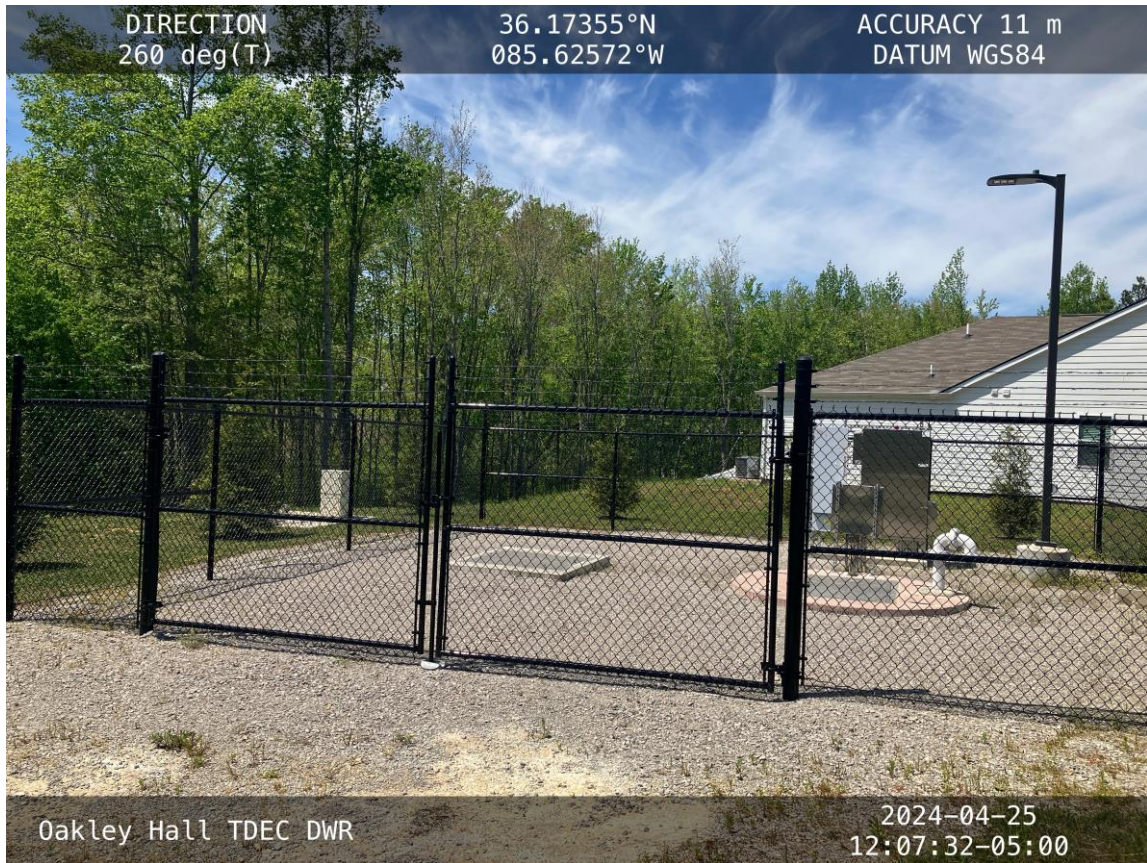
Security at the two pump stations was discussed. A chain should be added at this gate in order to reduce the possibility of unauthorized entry. The pump station was clean and is lit at night.
