Re: Compliance Evaluation Inspection
 Bartlett Sewage Treatment Plant (STP) #1
 NPDES Permit No. TN0066800
 Shelby County

Compliance Inspection for Individual NPDES Permit

Facility Name: Bartlett STP #1	NPDES Tracking Number : TN0066800
Permit Effective Date: February 1, 2018	Permit Expiration Date: September 30, 2022
Date and Time of Inspection: 5/5/2022	Inspector Name: Eddy Bouzeid

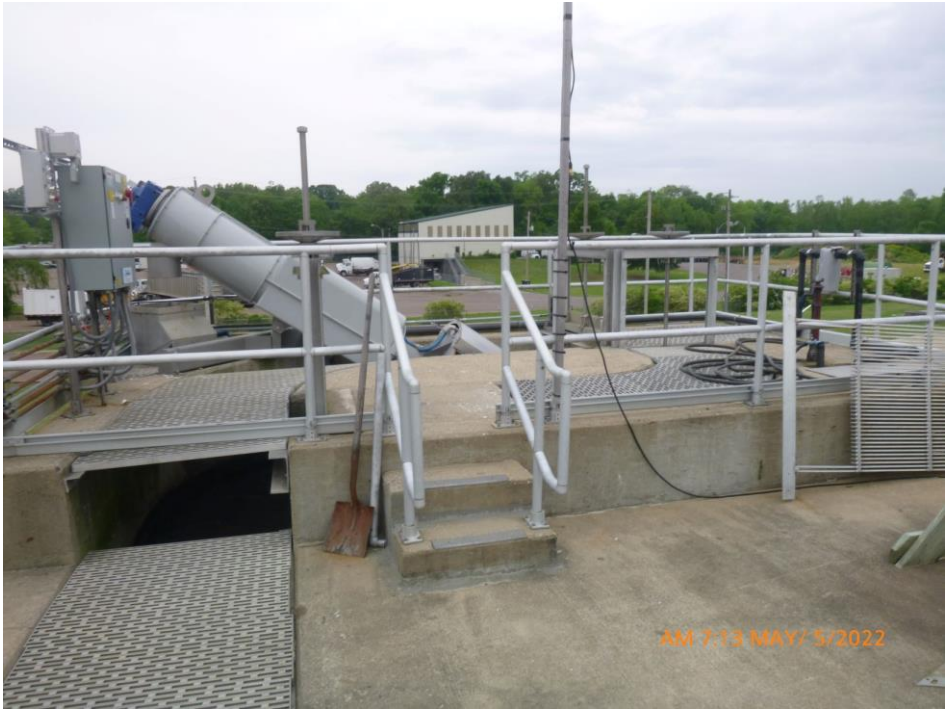
Facility Name: Bartlett STP #1		Site Location: Bartlett, Shelby County	Tracking No.: TN0066800
Photo No. 1	Date 5-5-2022

Description View of the bar screen at the headwork.

The Bartlett STP consists of two main lift stations at the head of the plant, followed by a headwork building that houses the bar screen (photo 1). From the headwork, the wastewater is pumped to two oxidation ditches for intensive aeration (photo 2). From the oxidation ditches the treated wastewater is clarified via two secondary clarifiers (photo 3), then disinfected using ultraviolet (UV) lights (photo 5) before being discharged to the Loosahatchie River.

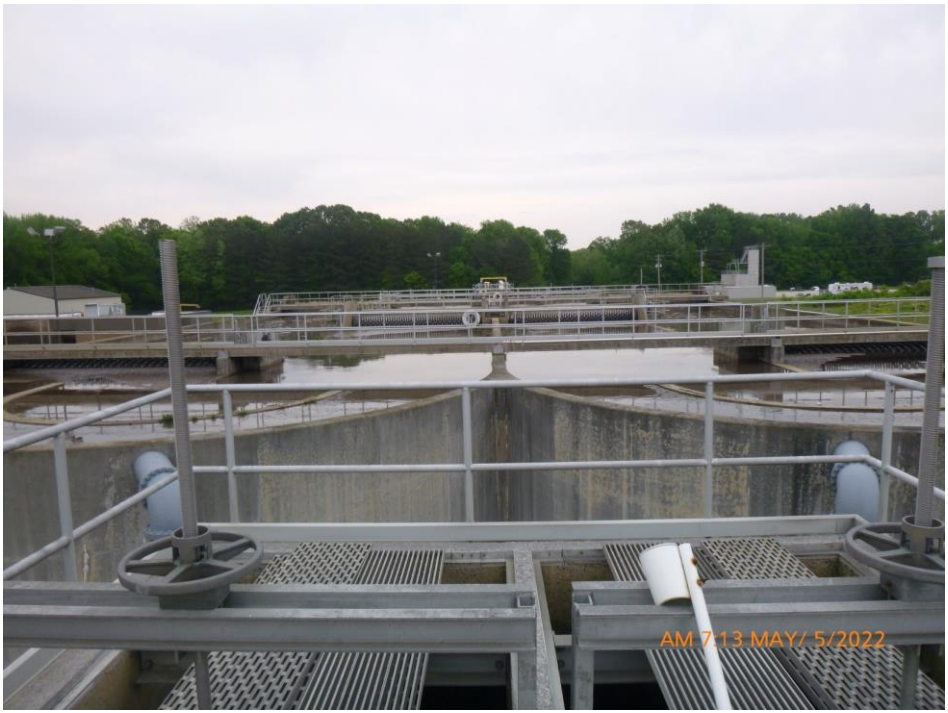
Photo No. 2	Date 5-5-2022

Description View of the oxidation ditches.

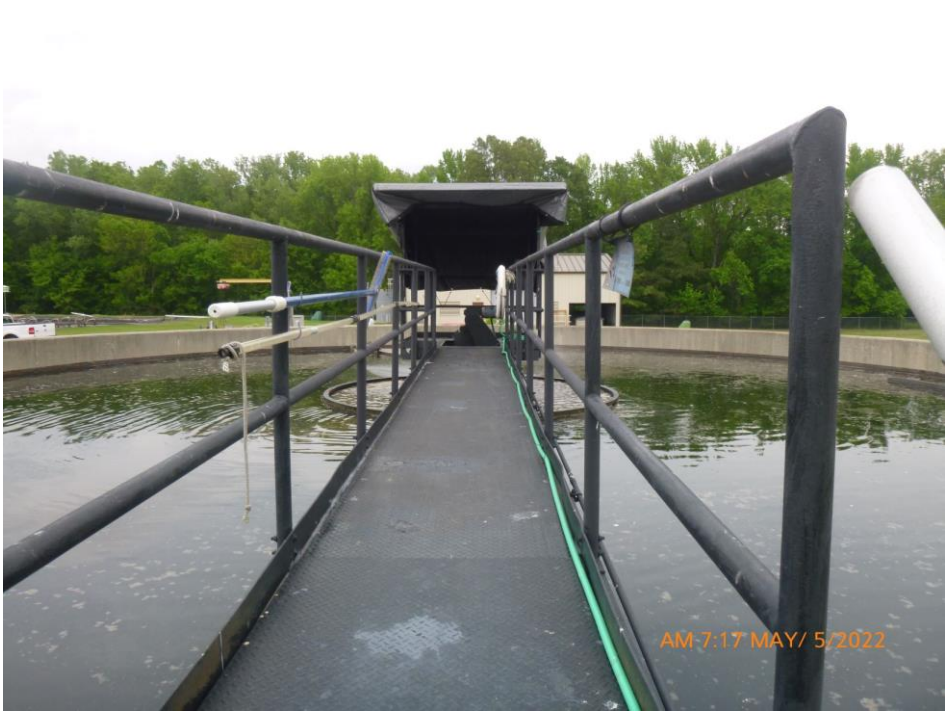
<p>AM 7:17 MAY/ 5/2022</p>	
3	5-5-2022		
Description	View of one of the secondary clarifiers.		
Photo No.	Date

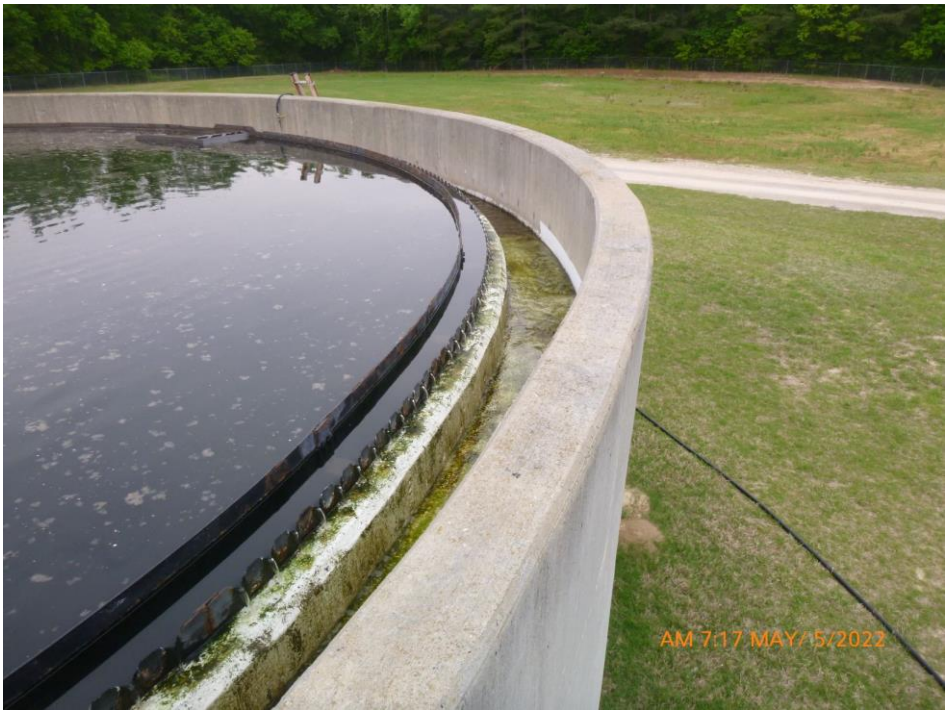
<p>AM 7:17 MAY/ 5/2022</p>	
4	5-5-2022		
Description	Close-up view of the clarifier overflow weir. The weir is cleaned once a week.

The overflow weirs from the clarifiers were clean at the time of the inspection (photo 4). According to Mr. Gamblin, the weirs are cleaned once a week to prevent algae and solids accumulation.

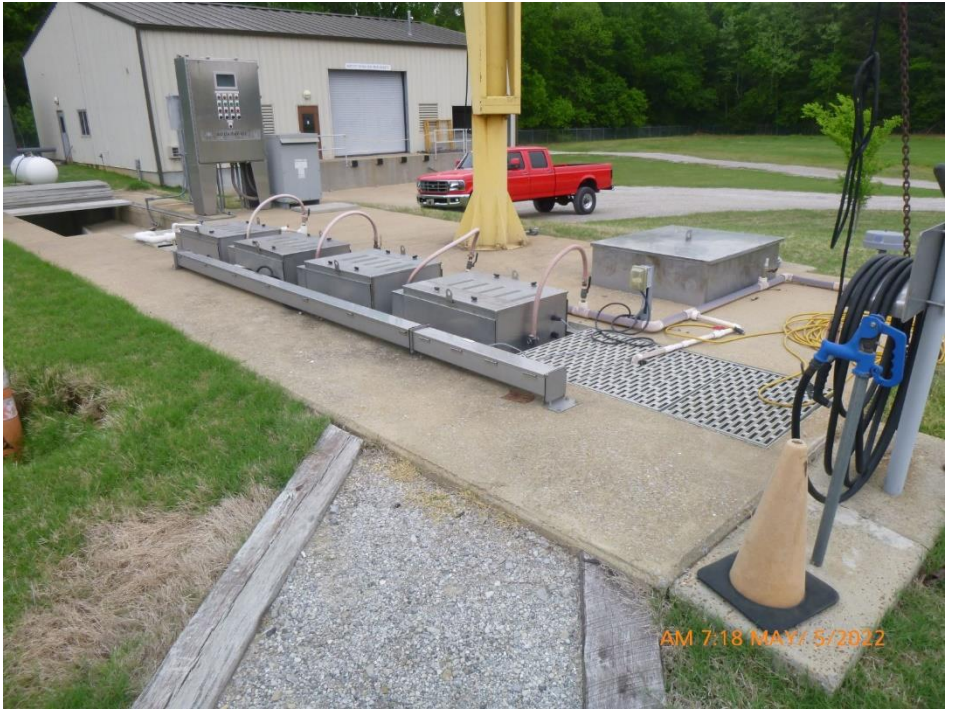
Facility Name: Bartlett STP #1		Site Location: Bartlett, Shelby County	Tracking No.: TN0066800
Photo No. 5	Date 5-5-2022

A photograph showing several rectangular Ultraviolet light units arranged in a row on a concrete pad. In the background, there is a grey building, a red pickup truck, and a yellow crane. A blue hose reel and a traffic cone are in the foreground. A timestamp in the bottom right corner reads "AM 7:18 MAY/ 5/2022".	
Description View of the Ultraviolet lights.			
Photo No. 6	Date 5-5-2022

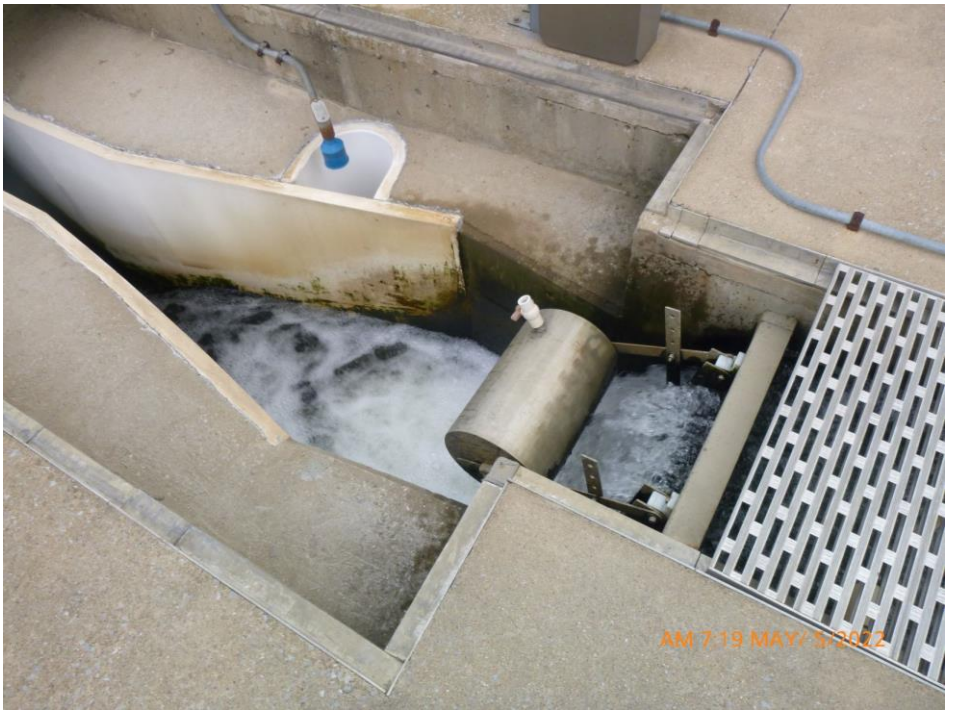
A photograph of a concrete effluent channel. A white pipe with a blue cap is visible on the left. A metal grate is on the right. A cylindrical metal tank is partially submerged in the water. The water appears clear. A timestamp in the bottom right corner reads "AM 7:19 MAY/ 5/2022".	
Description View of the effluent leaving the plant to the Loosahatchie River. The effluent was clear at the time of the inspection.

The effluent from the STP was clear at the time of the inspection (photo 6). The sign at the Loosahatchie River could not be inspected during the inspection due to falling trees and debris from a recent storm which restricted access to the Outfall. Mr. Gamblin informed Mr. Bouzeid that he would send photos of the sign and Outfall once the road to the River becomes accessible.

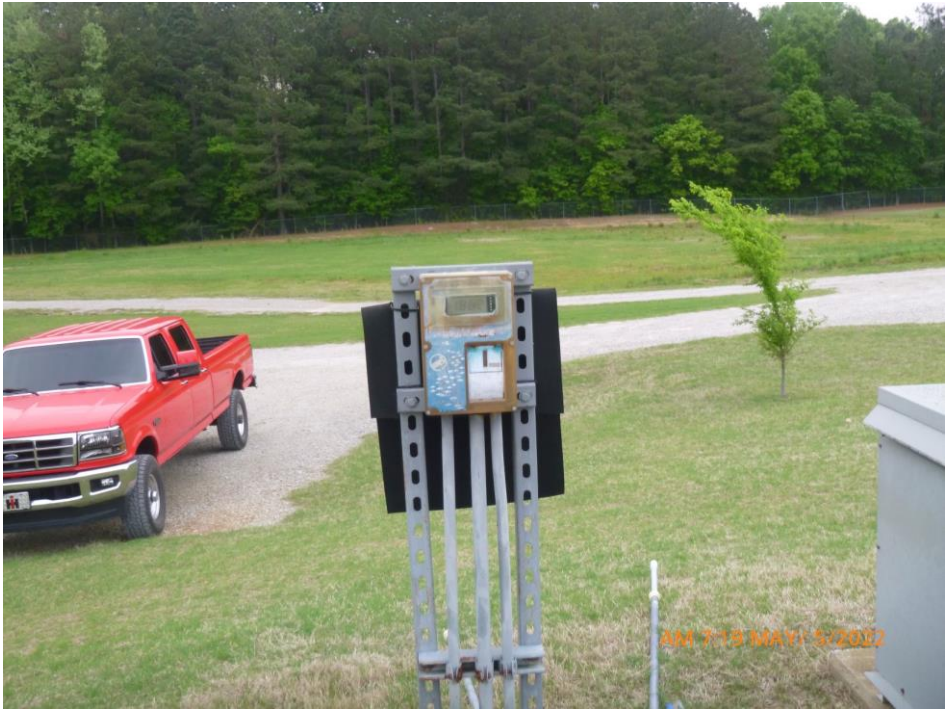
Facility Name: Bartlett STP #1		Site Location: Bartlett, Shelby County	Tracking No.: TN0066800
Photo No. 7	Date 5-5-2022

Description View of the effluent flow meter. The meter appeared to be operating properly at the time of the inspection. The meter was last calibrated by an independent contractor on October 11, 2021.			
Photo No. 8	Date 5-5-2022

The treatment system has a digital flow meter for the influent and the effluent (photos 7 & 8). The flow meters were operating during the time of the inspection. The devices are calibrated annually by LabtronX from Nashville, an independent contractor. The certifications by LabtronX were available at the plant. The devices were last calibrated on October 11, 2021.

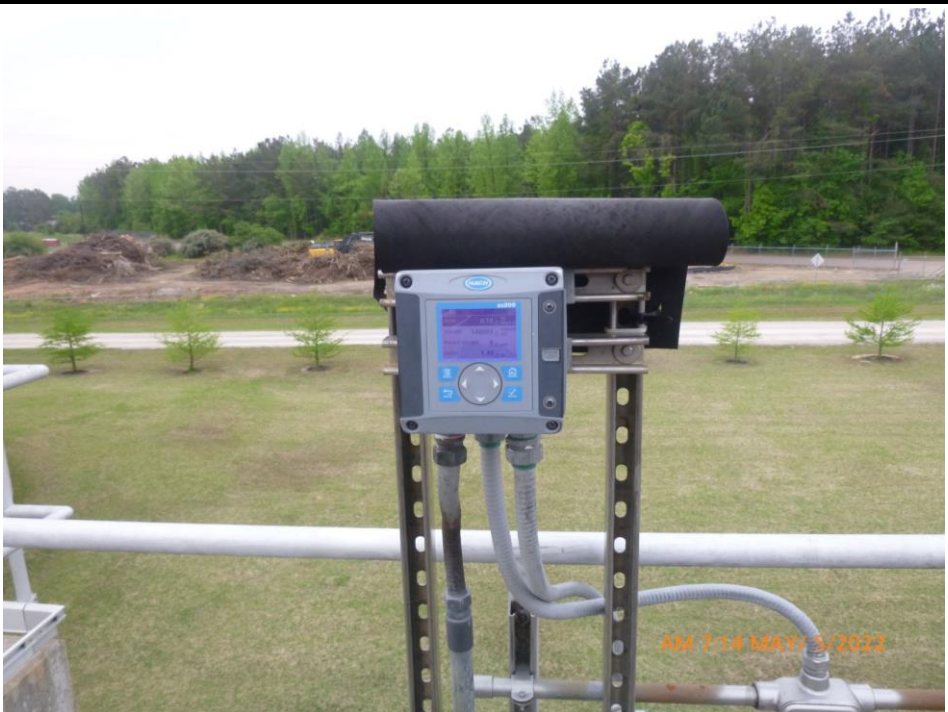
Description View of the influent flow meter. The meter appeared to be operating properly at the time of the inspection. The meter was last calibrated by an independent contractor on October 11, 2021.

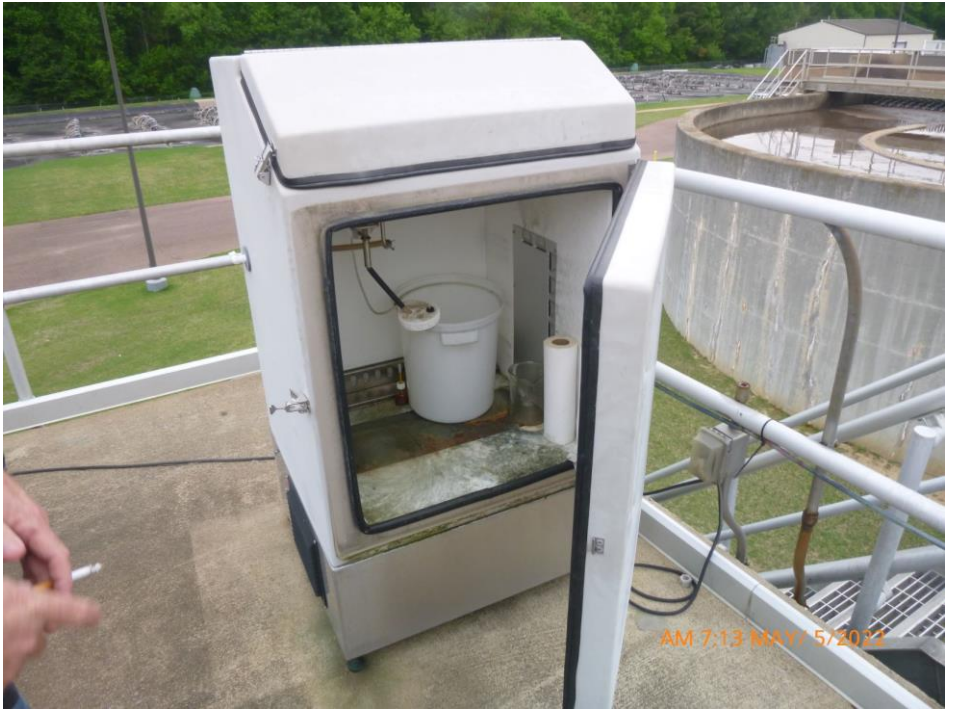
9	5-5-2022		
Description	View of the influent composite sampler. The 24-hour composite jug is replaced daily. The temperature in the control bottle was below 6 degrees Celsius.		
Photo No.	Date

The Bartlett STP has automatic flow proportional samplers for the influent and effluent as required by the permit (photos 9 and 10). At the time of the inspection, both samplers appeared to be operating properly. The samplers were equipped with temperature control bottles and thermometers. The readings on the thermometers in both samplers were below 6 degrees Celsius as required by the permit.

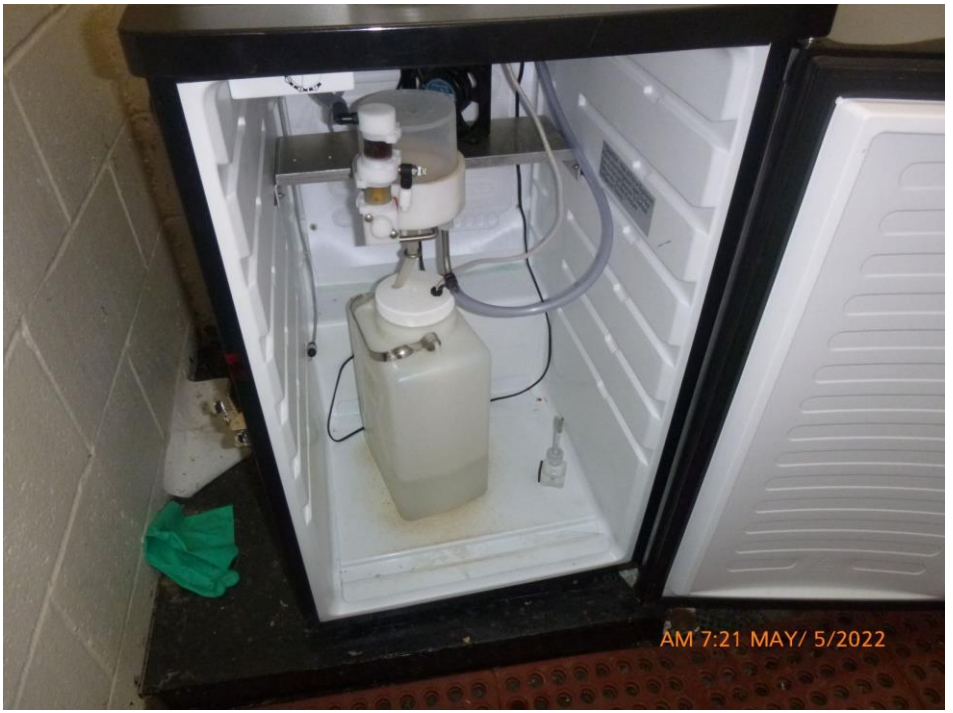
10	5-5-2022		
Description	View of the effluent composite sampler. The 24-hour composite jug is replaced daily. The temperature in the control bottle was below 6 degrees Celsius.

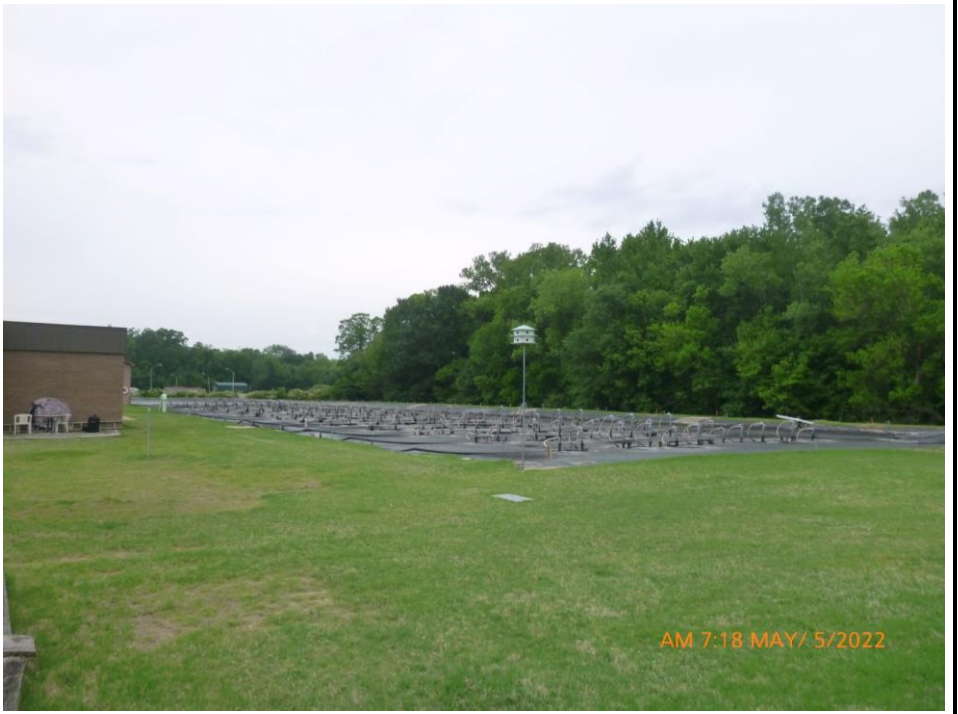
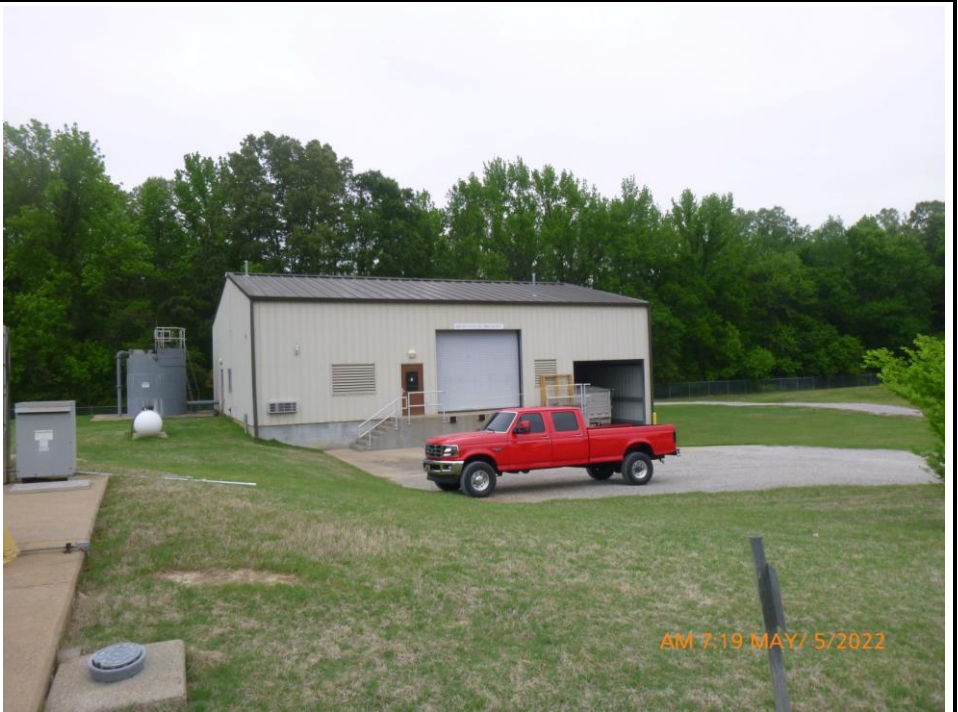
<p>AM 7:18 MAY/ 5/2022</p>	
11	5-5-2022		
Description

<p>AM 7:19 MAY/ 5/2022</p>	
The waste sludge from the plant is pumped into a storage lagoon for slow aerobic digestion.			
Description

At the time of the inspection, the wasted sludge from the STP was being pumped into a storage lagoon for slow aerobic digestion (photo 11). The digested sludge from the aerobic lagoon is dewatered by the addition of polymers and the use of filter press (photo 12). The sludge cake is hauled to Republic Service Landfill in North Shelby County.

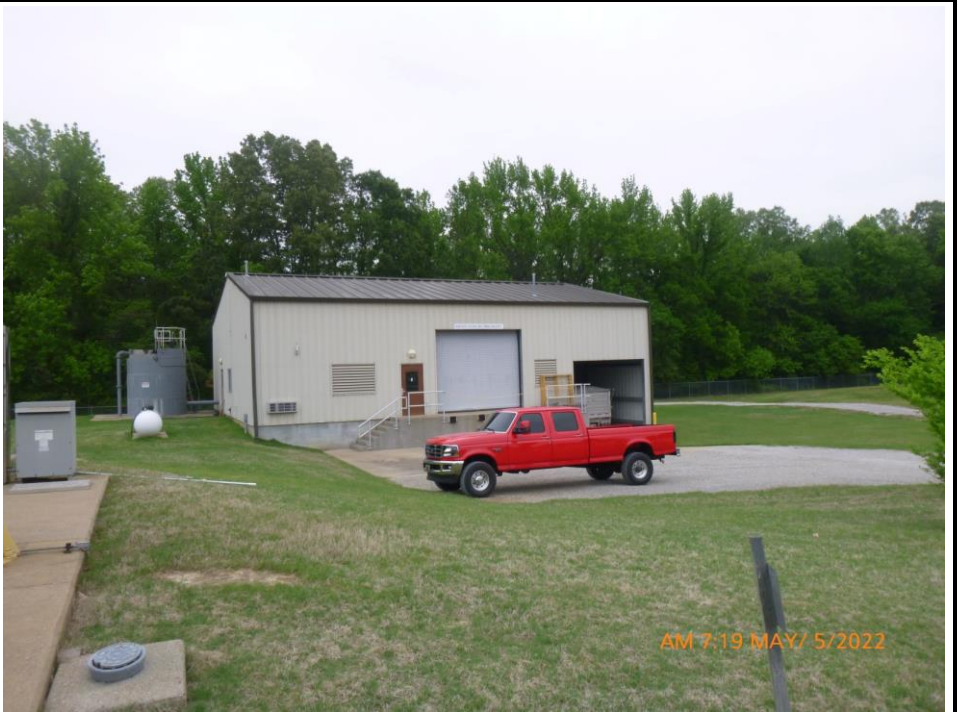
<p>AM 7:19 MAY/ 5/2022</p>	
View of the filter press building. The digested sludge from the aerobic lagoon is dewatered by the addition of polymers and the use of filter press. The sludge cake is hauled to Republic Service Landfill in North Shelby County.
