**Second Year Wetland and Stream Mitigation
Monitoring Report
For
Bledsoe County Correctional Complex**

**Second Year Wetland and Stream Mitigation Monitoring Report
Bledsoe County Correctional Complex
Pikeville, Bledsoe County, Tennessee
(DOA File/Permit 200502425)
(TDEC §401 Water Quality Certification 09.009)**

Mitigation Site Name: Bledsoe County Correctional Complex (BCCX), Pikeville, TN

DOA Permit Number: 200502425

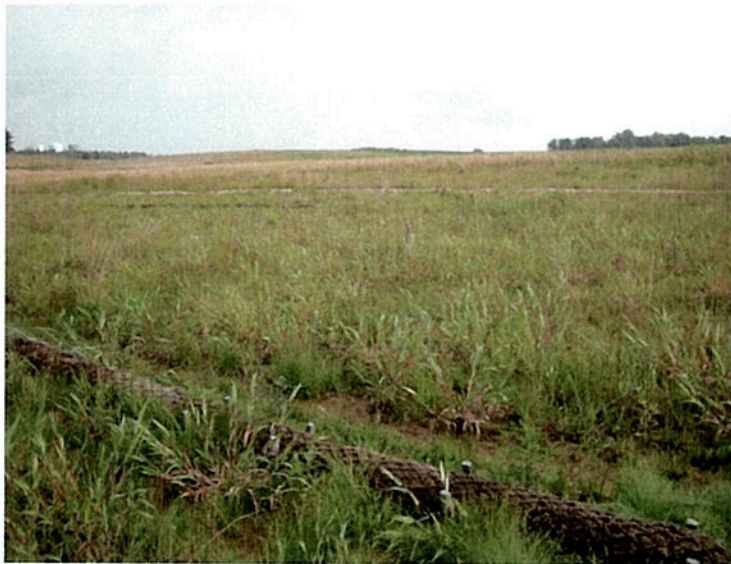
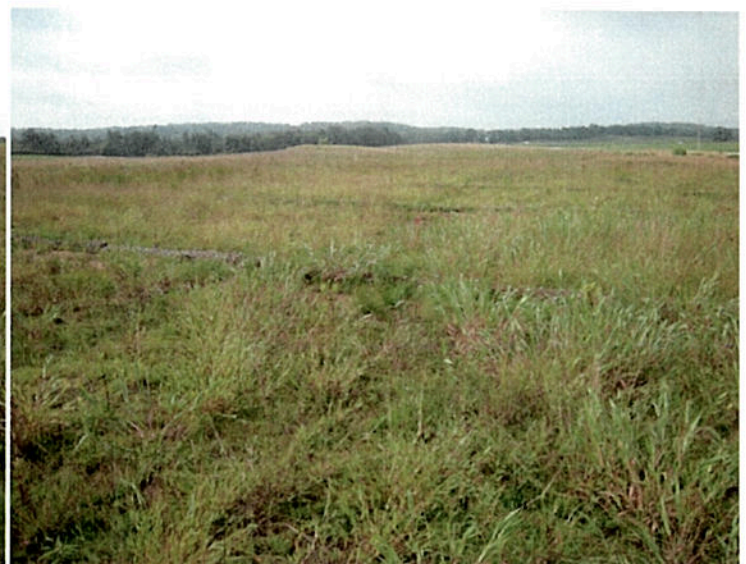
Photo 1.

Creation Area, Photo Reference Point C2: North

Dominant Vegetation: buttonbush (Obl), broom rosette grass (Facw), tapered rosette grass (Fac), slender spikerush (Facw)

Comments: Soils within the creation area are low in organics and in some places are underlain by a shallow fragipan. As a result, bare soils and other non-vegetated substrates currently occupy, on average, about 25% of the surface area.

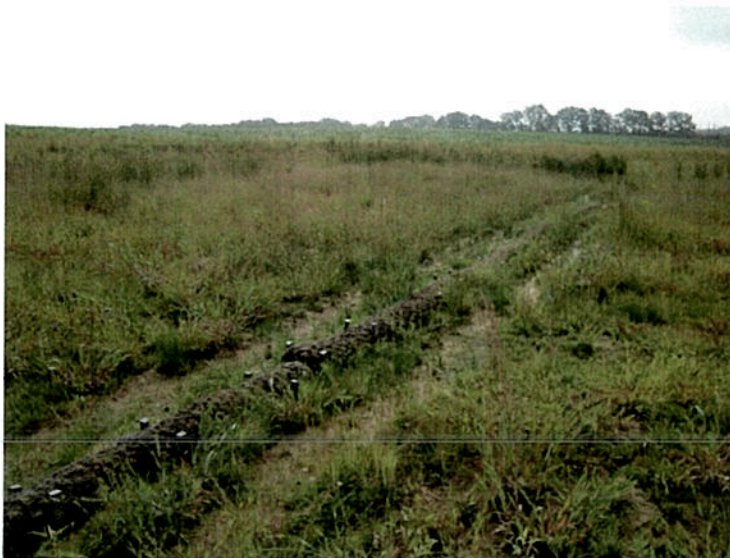
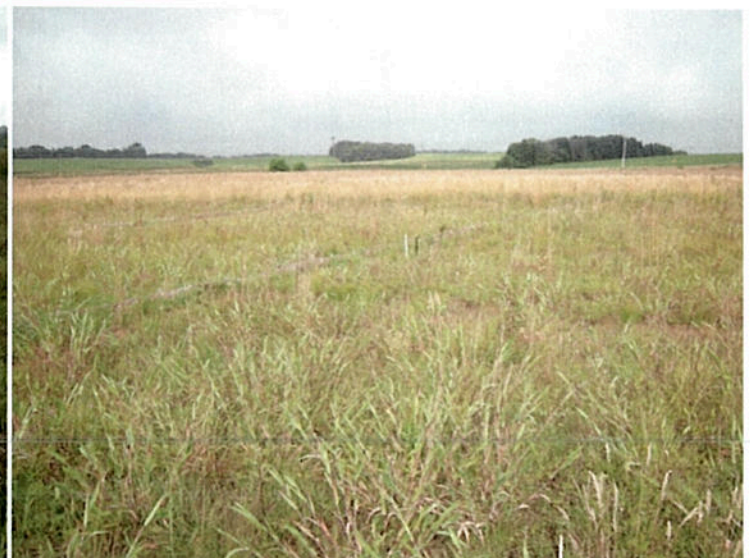
Photo 3.

Creation Area, Photo Reference Point C2: East

Dominant Vegetation: buttonbush (Obl), broom rosette grass (Facw), tapered rosette grass (Fac), greater poverty rush (TBC), sweetgum (Fac)

Comments: More evenly distributed rainfall has been beneficial for establishment of naturally invading herbs. Planted woody species have also benefitted.

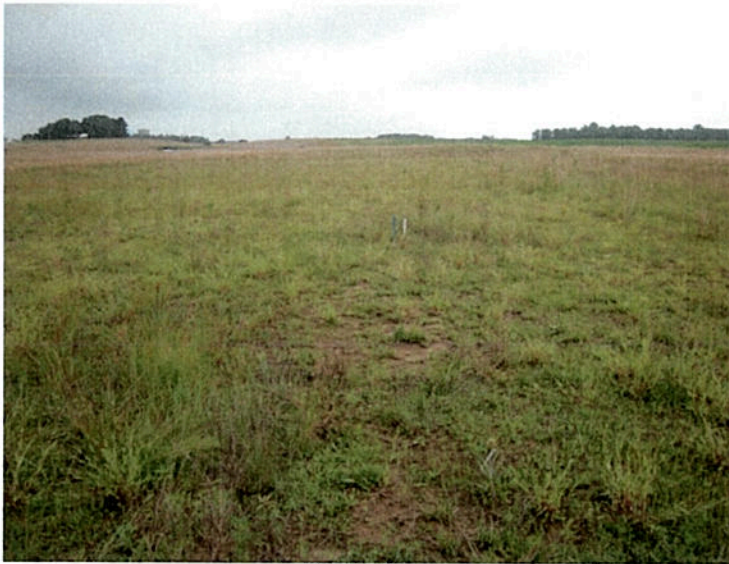
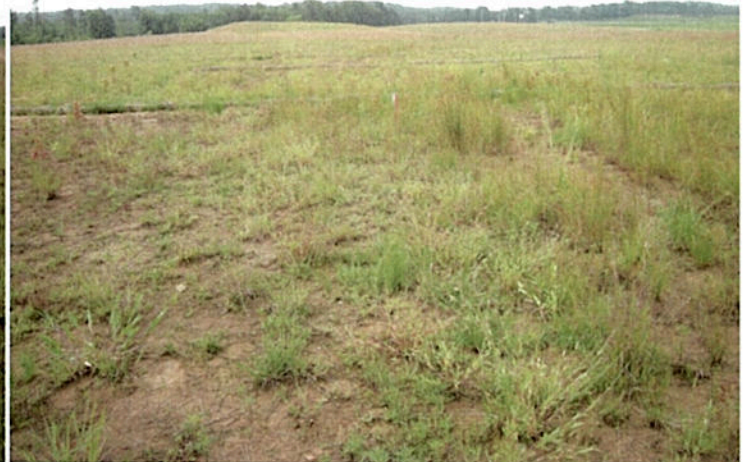
Photo 5.

Creation Area, Photo Reference Point C4: North

Dominant Vegetation: buttonbush (Obl), tapered rosette grass (Fac), greater poverty rush (TBD), dark-green bulrush (Obl), soft rush (Facw)

Comments: Though soils are shallow, they are building in depth behind the coir log dams. Even after the dams deteriorate, the remaining soils should be stabilized by plant roots. A series of dams can be seen in this view.

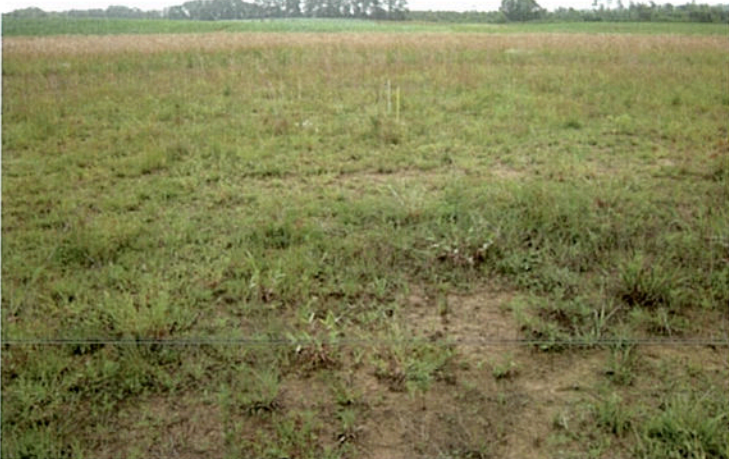
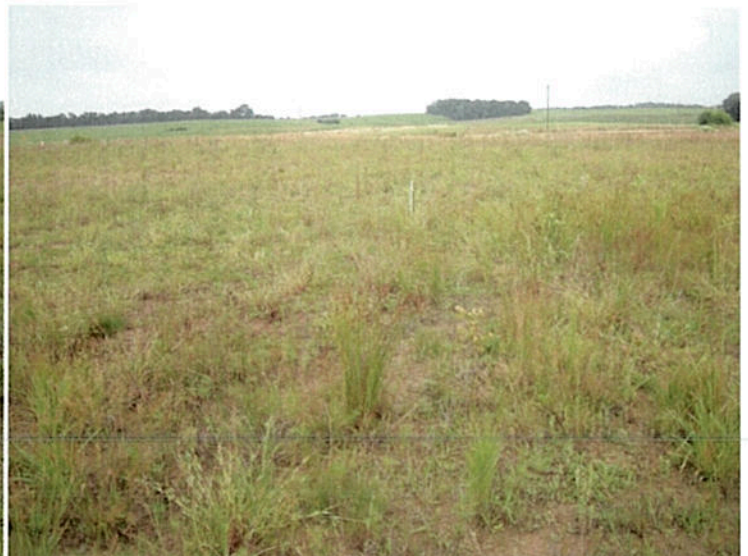
Photo 7.

Creation Area, Photo Reference Point C4: East

Comments: Evidence of surface hydrology includes saturated soils, and soil cracking, especially in areas of silt accumulation.

Dominant Vegetation: greater poverty rush (TBD), tapered rosette grass (Fac), soft rush (Facw), dark-green bulrush (Obl), sweetgum (Fac), buttonbush (Obl)

Comments: Crayfish burrows were noted in this location as well as several other places scattered throughout the mitigation site.

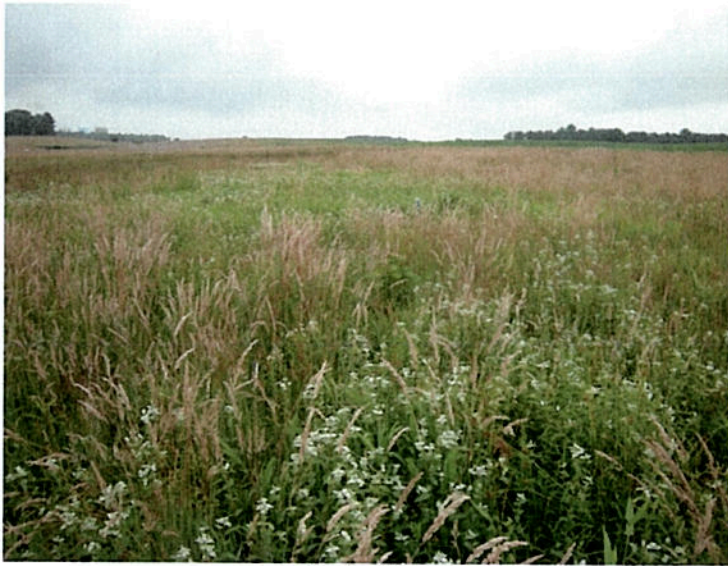
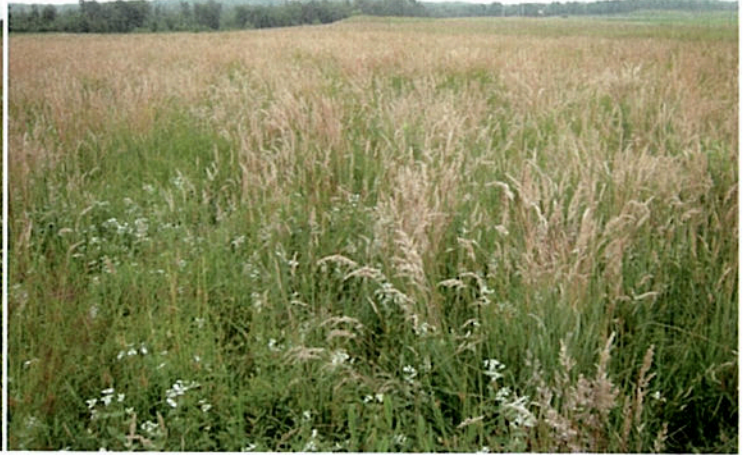
Photo 9.

Enhancement Area, Photo Reference Point E1: North

Comments: Dense stands of native and introduced grasses were found throughout each of the enhancement areas.

Dominant Vegetation: redtop panic grass (Facw), velvet grass (Fac), broom panic grass (Facw), deer-tongue grass (Fac), clustered mountain-mint (Facw)

Comments: Enhancement areas were mown in the late fall to facilitate the winter planting of woody vegetation. They now contain over 330 planted tree seedlings per acre but the long-term survival of the seedlings may prove difficult because of root competition from the sod-forming grasses.

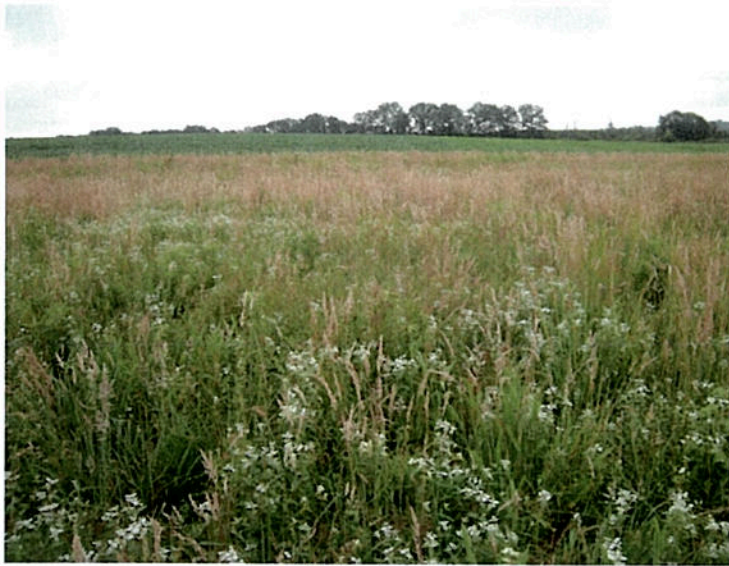
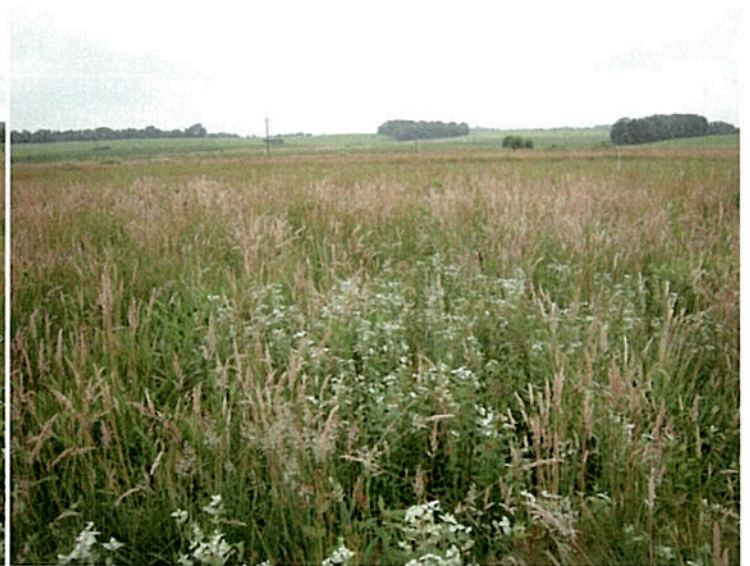
Photo 11.

Enhancement Area, Photo Reference Point E1: East

Dominant Vegetation: redtop panic grass (Facw), velvet grass (Fac), clustered mountain-mint (Facw), helmet flower (Fac), dark-green bulrush (Obl), Maryland meadowbeauty (Obl)

Comments: This is a favored hunting area for northern harriers (marsh hawks).

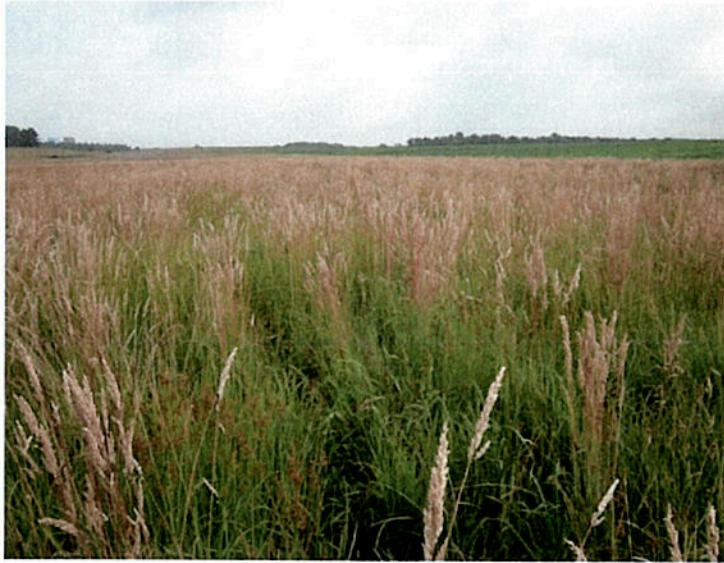
Photo 13.

Enhancement Area, Photo Reference Point E3: North

Dominant Vegetation: redtop panic grass (Facw), velvet grass (Fac), soft rush (Facw), helmet flower (Fac), greater poverty rush (TBD)

Comments: Non-native velvet grass (*Holcus lanatus*) seems to have benefitted from being mown and is now one of the dominant species in enhancement areas. It is easily identified in this photo by its light tan seed heads. It was probably sown in as a pasture grass years ago during farming operations.

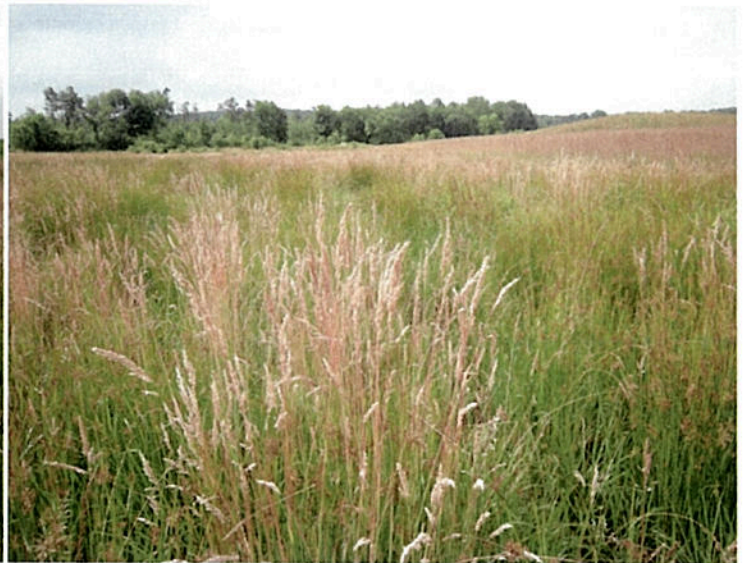
Photo 14.

Enhancement Area, Photo Reference Point E3: South

Dominant Vegetation: redtop panic grass (Facw), velvet grass (Fac), soft rush (Facw), helmet flower (Fac), greater poverty rush (TBD), pointed broom sedge (Facw)

Comments: Velvet grass tends to thrive in damp or wet soils with low fertility but will be outcompeted by native wetland vegetation once disturbance ceases.

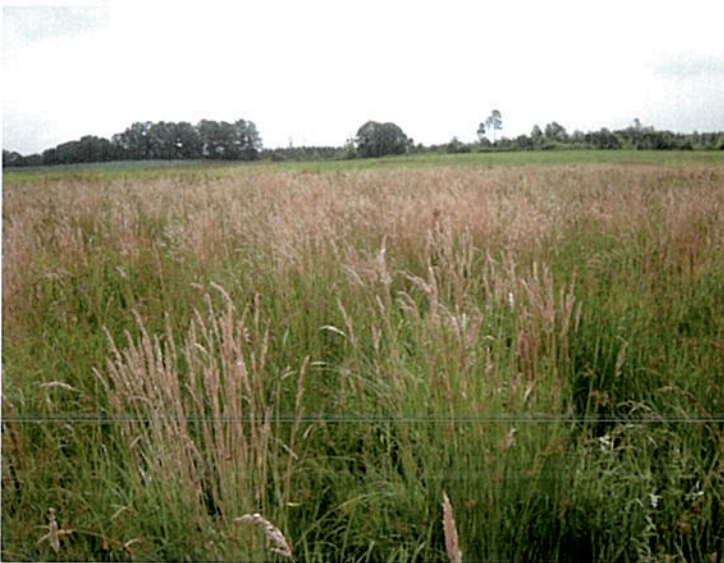
Photo 15.

Enhancement Area, Photo Reference Point E3: East

Dominant Vegetation: redtop panic grass (Facw), velvet grass (Fac), soft rush (Facw), blunt broom sedge (Facw), wool-grass (Obl)

Comments: The tall, dense vegetation on the middle and southern portions of the enhancement area provide favored habitat for white-tail deer. Despite the wetness, numerous "deer beds" were observed.

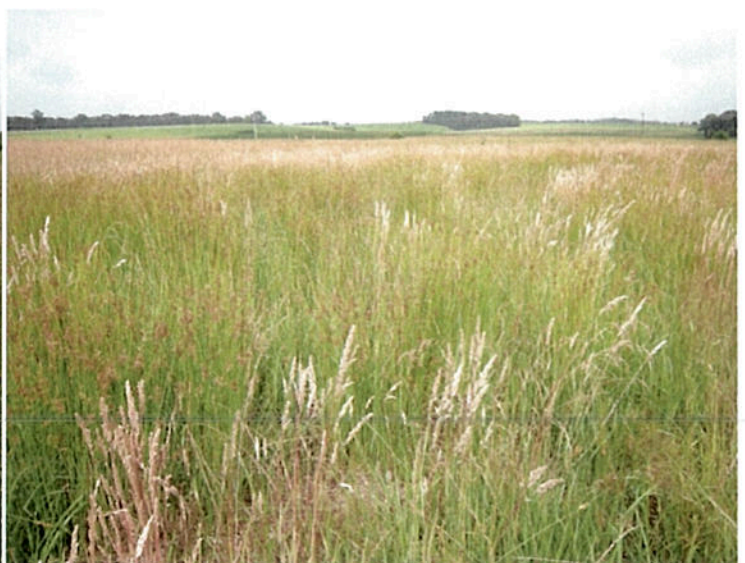
Photo 16.

Enhancement Area, Photo Reference Point E3: West

Dominant Vegetation: redtop panic grass (Facw), soft rush (Facw), velvet grass (Fac), sweetgum (Fac), boneset (Facw)

Comments: Small inundated depressions, hidden by the dense herb layer, are also occasionally used by foraging snapping turtles. These turtles likely reside in an abandoned farm pond lying near the southeastern boundary of the mitigation area.

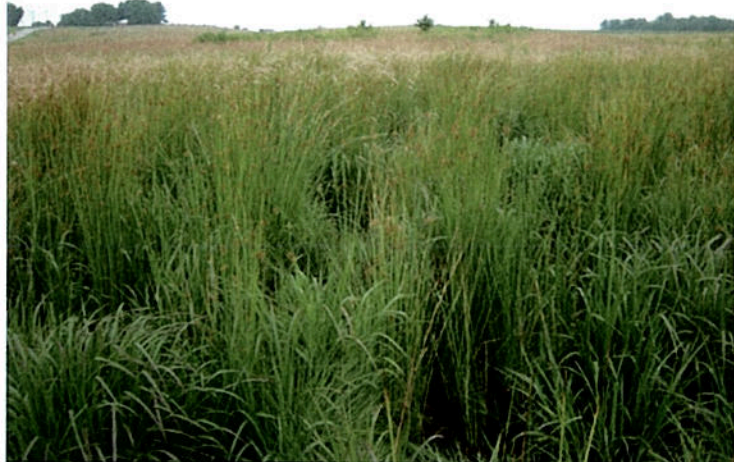
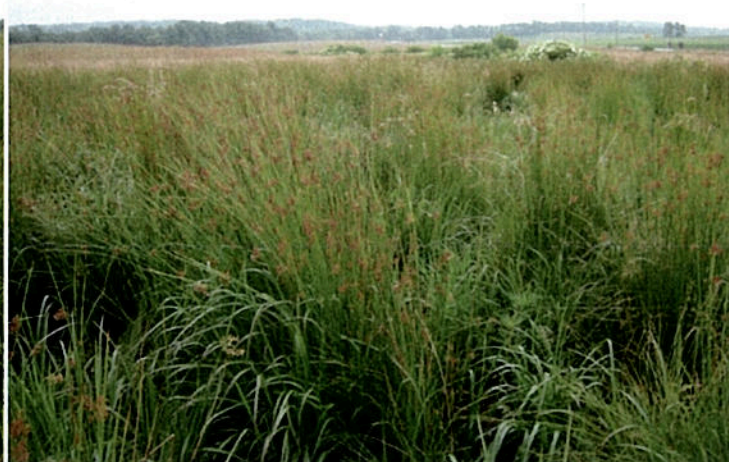
Photo 17.

Enhancement Area, Photo Reference Point E5: North

Dominant Vegetation: redtop panic grass (Facw), soft rush (Facw), sallow sedge (Obl), prickly bog sedge (Facw), rice cut grass (Obl), slender spikerush (Facw), buttonbush (Obl)

Comments: Some limited areas of standing water were observed between the tussocks of panic grass.

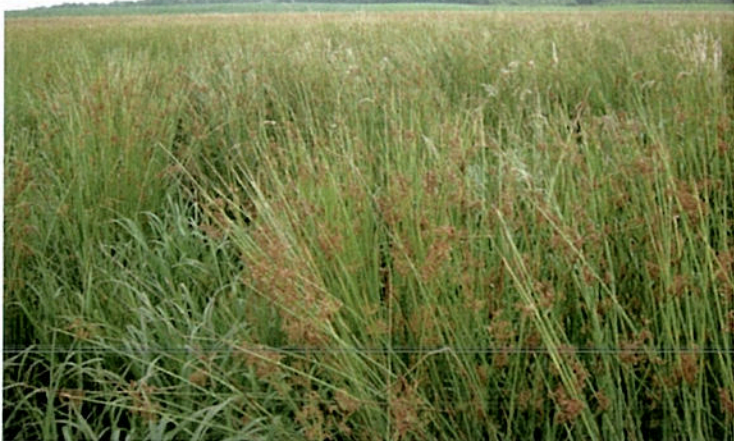
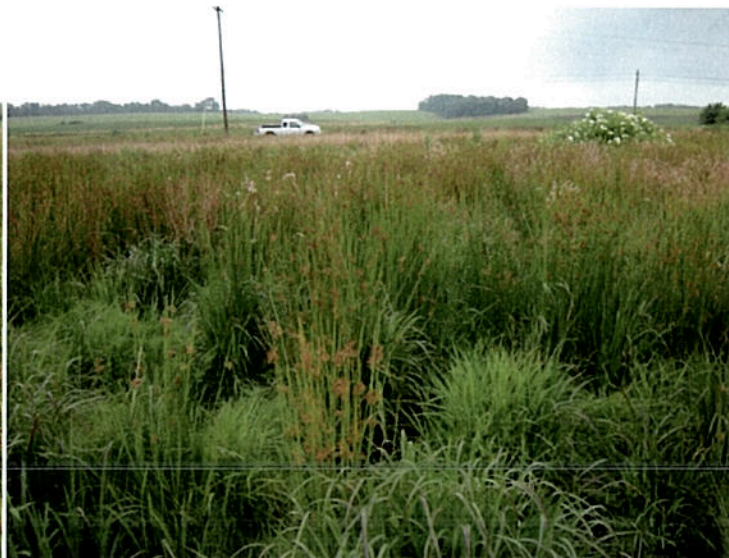
Photo 19.

Enhancement Area, Photo Reference Point E5: East

Dominant Vegetation: redtop panic grass (Facw), soft rush (Facw), sallow sedge (Obl), prickly bog sedge (Facw), rice cut grass (Obl), slender spikerush (Facw), buttonbush (Obl)

Comments: This is the approximate location where brown bog sedge (*Carex buxbaumii*) was discovered. It is listed as "endangered" by TDEC and is known from five or fewer locations in the state.

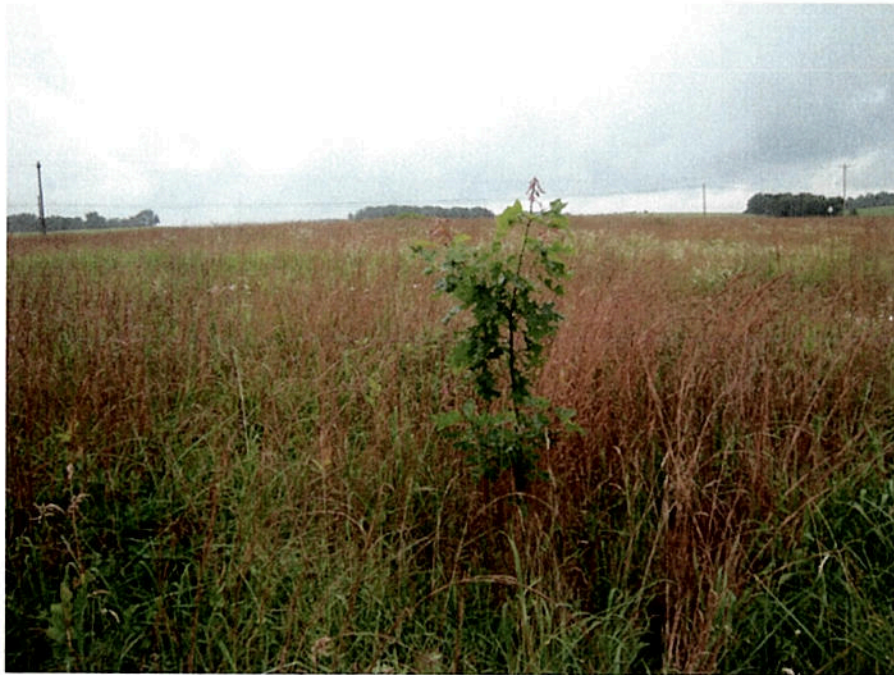
Photo 21. **Upland Buffer Zones:** Twenty-five ft-wide buffers, external to riparian buffers, were planted with upland oak species in order to provide extra protection to the restored streams. Areas were first mown to make planting easier. Current oak survivorship averages about 205 stems/ac.

Upland buffer zones lying adjacent to the stream and wetland mitigation have no specific performance requirements associated with them. They currently support, on average, 227 planted stems/ac, but survival is sporadic. Drought conditions that occurred the summer after planting killed off a significant number of red and white oaks. These are being supplemented in some areas by natural seed rain coming from adjoining forested areas. Red maple, Virginia pine, and black cherry, for example are now contributing 35 stems/ac. Multiflora rose is also beginning to appear in sizable numbers. Because it is an invasive, alien species, consideration might be given to chemical control.

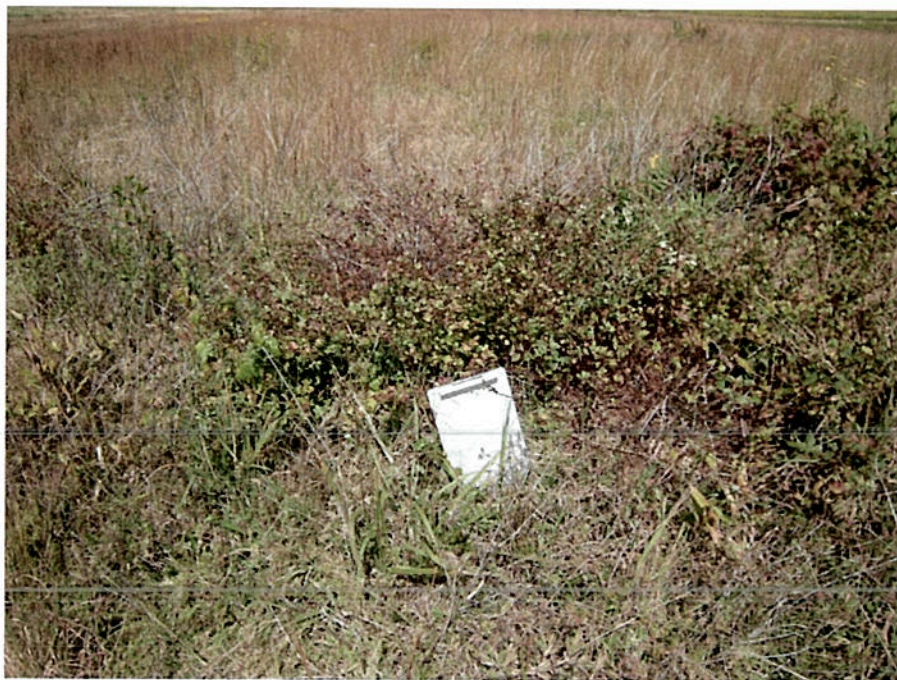
Photo 22. **Gooseberry Transplant Area:** Rare granite gooseberry shrubs, rescued from the prison construction site, and transplanted to the mitigation area in 2009, have survived and appear to be thriving. This year, 24 individual shrubs covering approximately 2,725 ft² were inventoried. This is a 37% increase in coverage since the 2011 monitoring effort.

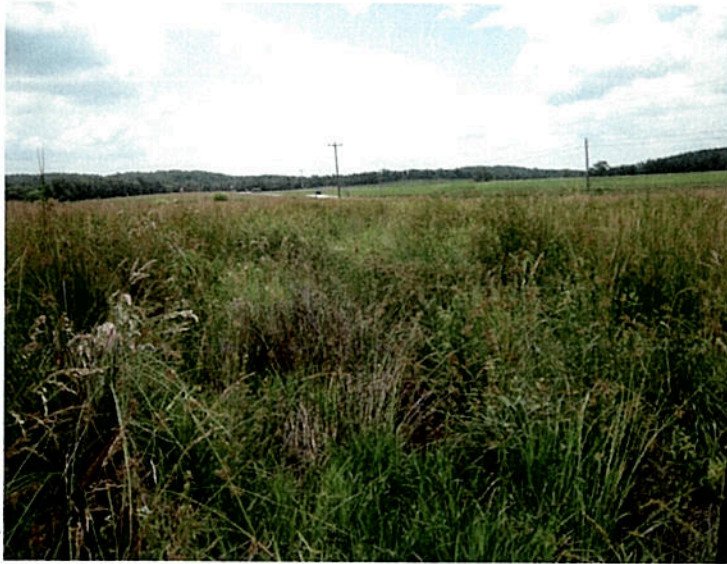
Photo 23.

Stream 1 Enhancement Area, Photo Reference Point 1:

Dominant Vegetation: redtop panic grass (Facw), soft rush (Facw), wool-grass (Obl), Maryland meadowbeauty (Obl)

Comments: At its upper end, Stream 1 bisects a portion of one of the site's wetland enhancement areas. Because of extreme wetness, planted woody vegetation is somewhat scattered.

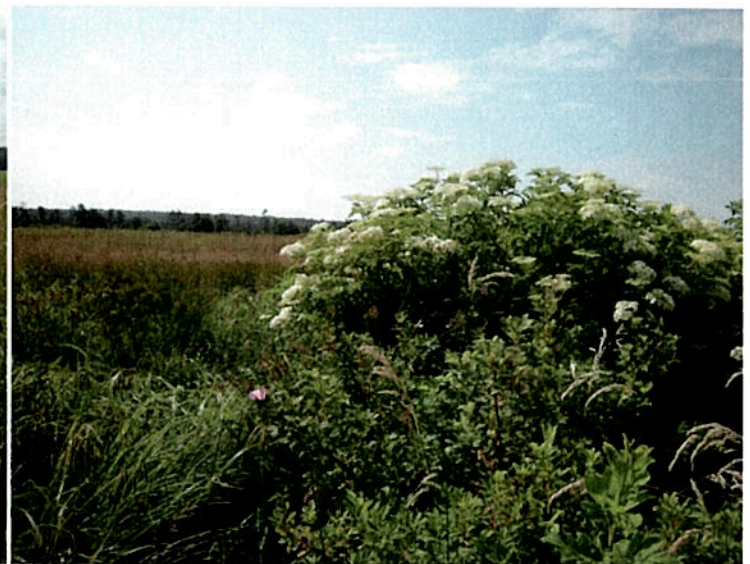
Photo 24.

Stream 1 Enhancement Area, Photo Reference Point 2:

Dominant Vegetation: redtop panic grass (Facw), soft rush (Facw), elderberry (Fac), swamp rose (Obl)

Comments: One of the site's elderberries is visible here. It has expanded greatly in size since it was originally planted in December 2010. The dense riparian vegetation hides the channel from view.

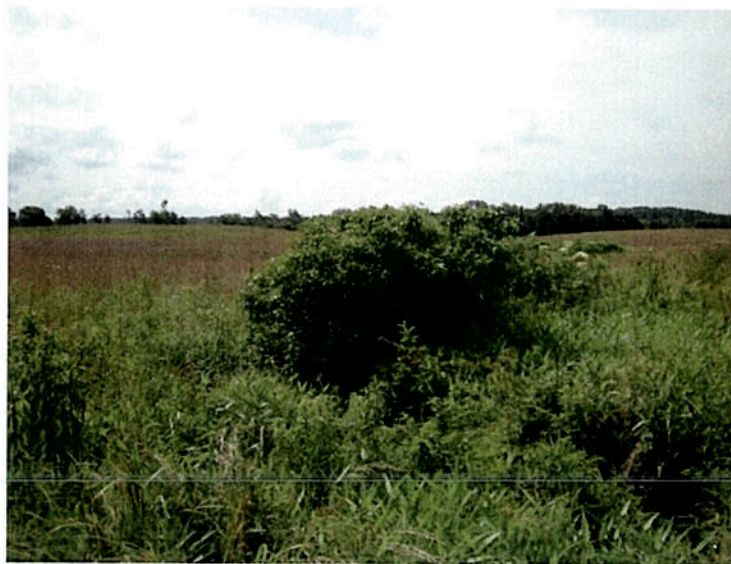
Photo 25.

Stream 1 Enhancement Area, Photo Reference Point 3:

Dominant Vegetation: deer tongue grass (Fac), late-flowering thoroughwort (Fac), silky dogwood (Facw)

Comments: As was often the case, this site contains both planted and naturally-occurring silky dogwood. Distinguishing between the two was not always possible in some areas.

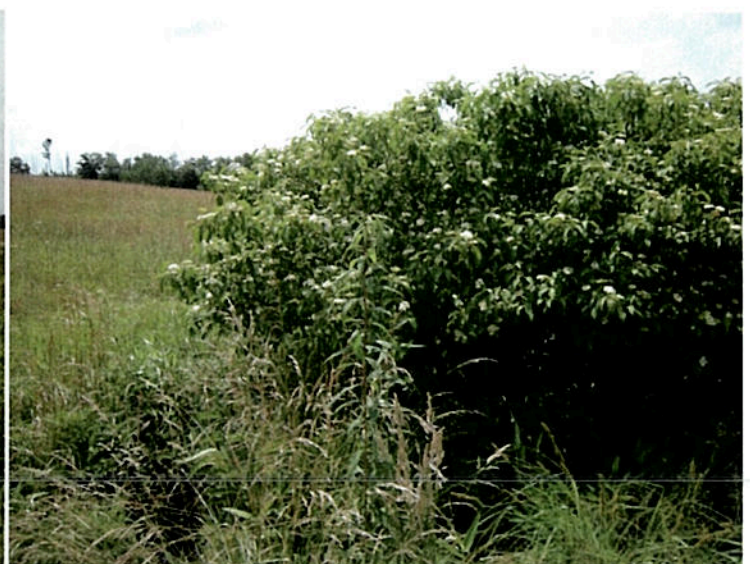
Photo 26.

Stream 1 Enhancement Area, Photo Reference Point 4:

Dominant Vegetation: silky dogwood (Facw), deer tongue grass (Fac), velvet grass (Fac)

Comments: Also, because of the colonial nature of many of the planted shrubs, it was very difficult to determine whether performance standards were being met given the high number of live stems present. Counting individual stems was impractical so counts were based on average number of live sprouts per 10 ft of plant length. Silky dogwoods, for example, were found to contain an average of 35 sprouts per 10 ft of shrub length.

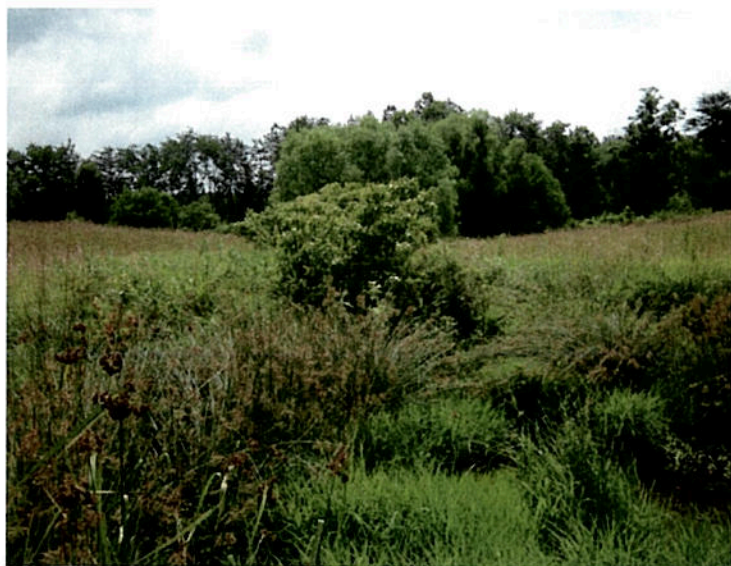
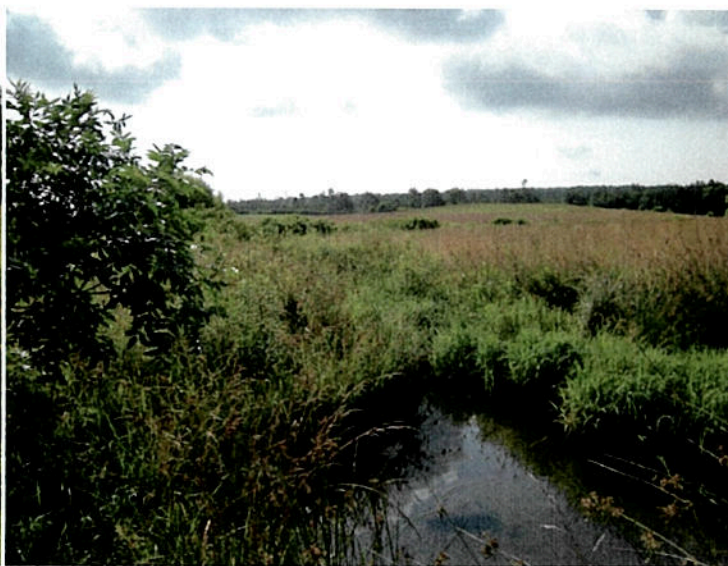
Photo 28.

Stream 1 Enhancement Area, Photo Reference Point 5:

Dominant Vegetation: rice cut grass (Obl), soft rush (Facw), winged sumac (Facu)

Comments: Stream Segment 2 is also well-stabilized and supports a high density of herbs as well as planted and naturally invasive woody species. The plunge pool in the foreground lies just downstream of two culverts which pass beneath SR 301. It gives a much exaggerated impression of the size of the waterway.

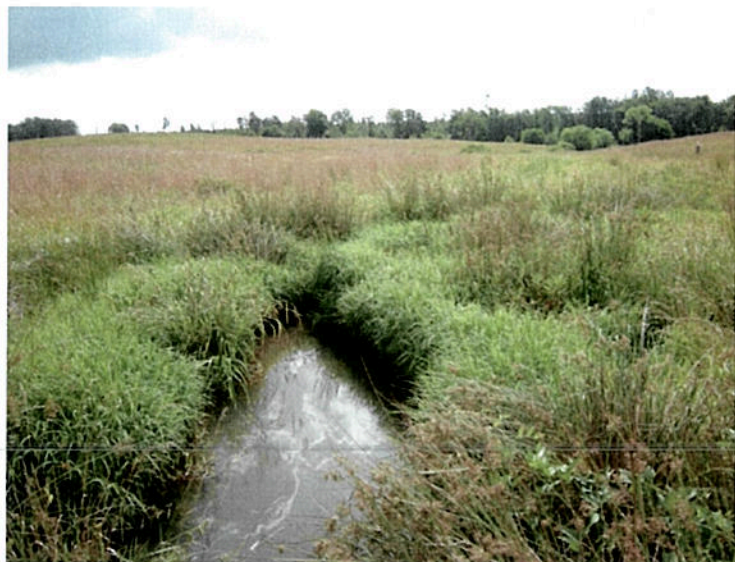
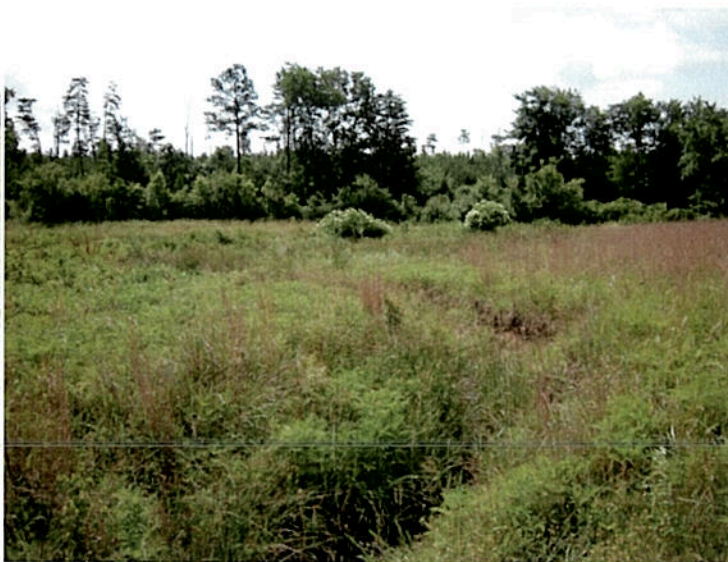
Photo 30.

Stream 1 Enhancement Area 3 , Photo Reference Point 1:

Comments: By contrast, Stream Segment 3 had the lowest density at 64 stems/100 ft of stream. Again, the plunge pool gives a false impression about the size of the waterway. Fish, frogs, and snapping turtles were observed at this location.

Comments: Stream 4 was relegated to scattered pools at the time of the survey. It contained the highest average stem density at over 8,400 woody stems/100 ft of stream length. Most common by far were planted elderberry and the naturally-occurring and highly-colonial swamp rose.

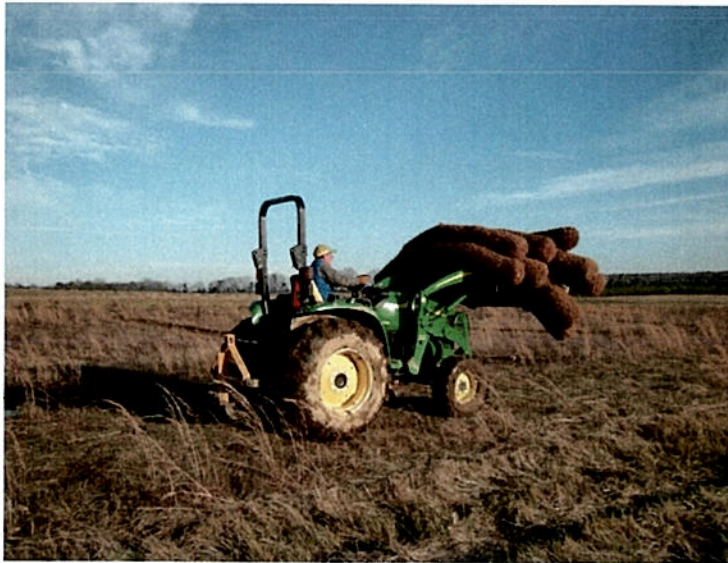
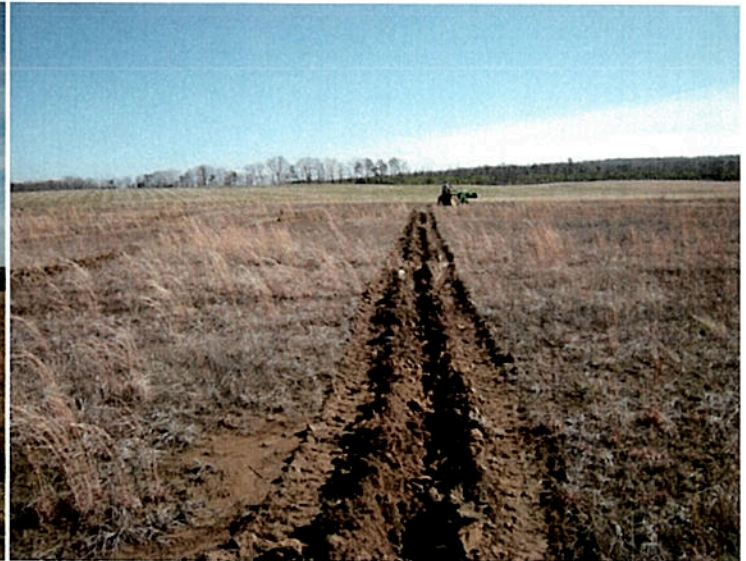
Photo 31.

Comments: Failure to meet performance standards for planted woody vegetation within the creation area was documented in the first annual monitoring report. The most critical cause of the failure was site degradation due to erosion of the thin soils. In order to reduce erosion and trap eroding soils, 23 coir log dams totaling more than 2,500 linear feet were installed perpendicular to the site drainage. Installation took place in early January 2013.

Comments: Each of the coir log dams was placed into a six inch deep trench to prevent them from being undercut by surface flow. Trenching was done with a single-blade plow.

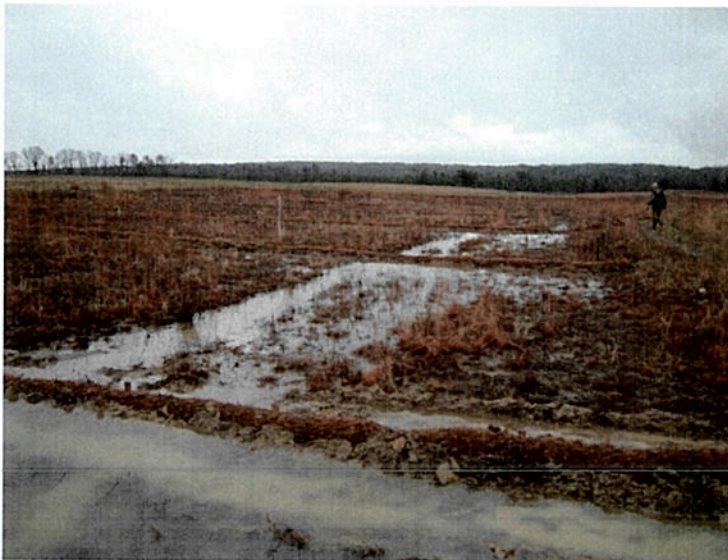
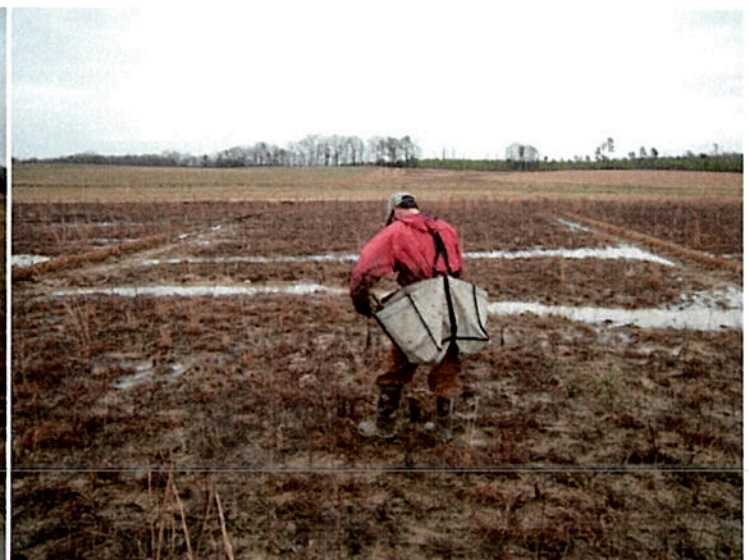
Photo 33.

Comments: Also on the day following dam installation the mitigation property was replanted with 5,650 wetland-adapted tree and shrub seedlings.

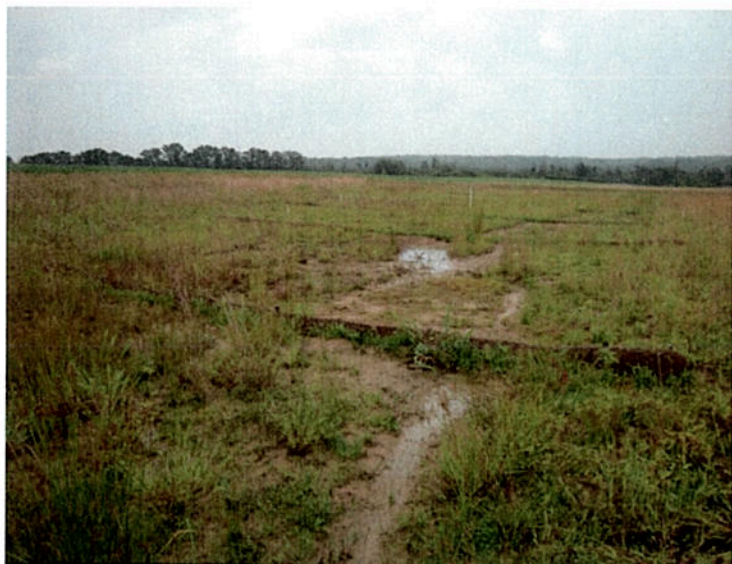
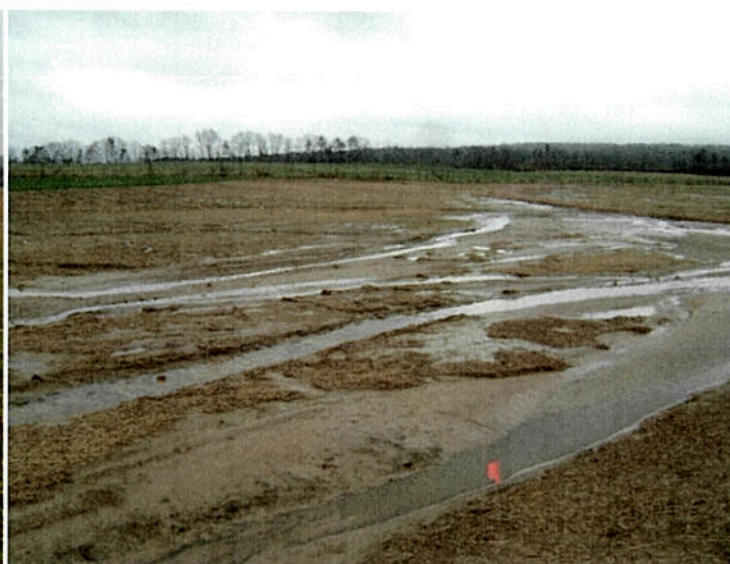
Photo 35.

Comments: This contrasting view of approximately the same location (taken in mid-March 2011) shows the improvements that time and site maintenance have made.

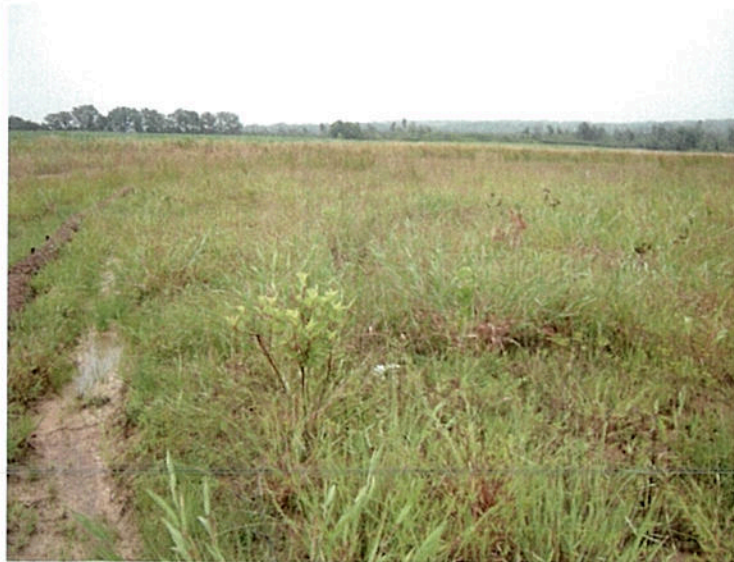
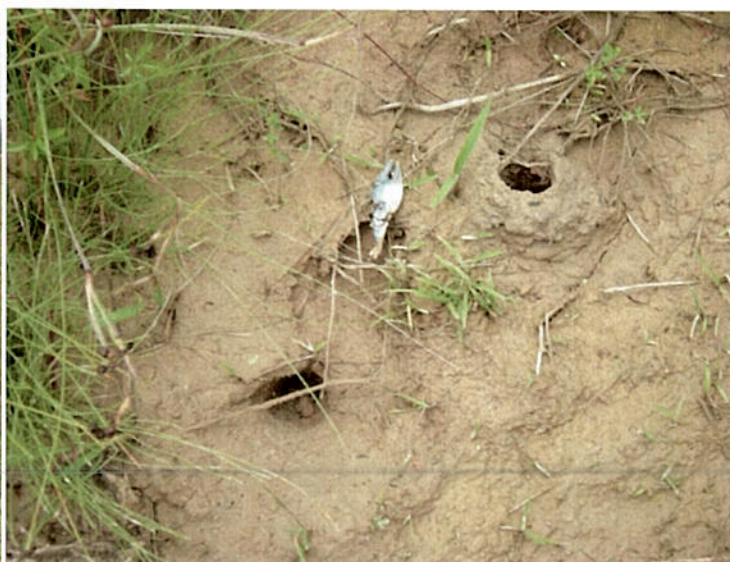
Photo 37.

Comments: Somewhat surprisingly, burrowing crayfish have already begun to colonize the creation area.

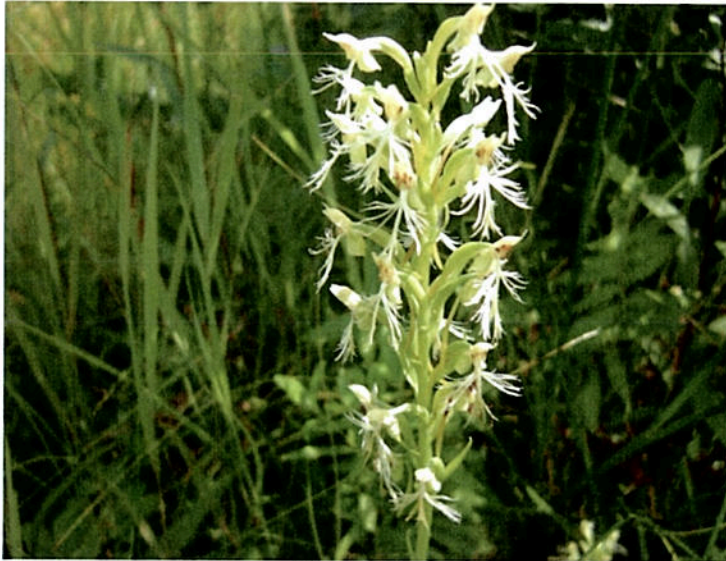
Photo 39.

Photo Supplement, Wetland Enhancement:

Comments: The wetland enhancement area was found to contain 47 distinct species. Among them were a number of green fringed orchids. While not rare, its known range in Tennessee is limited to only 18 counties.

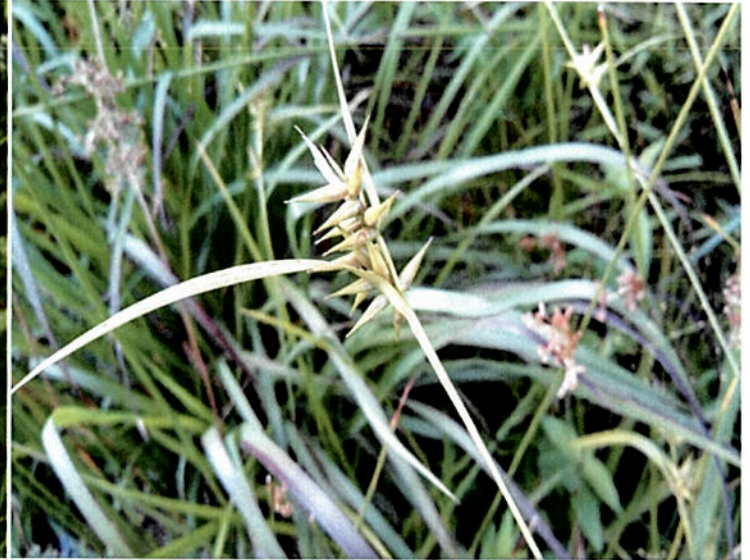
Photo 40.

Photo Supplement, Wetland Enhancement:

Comments: The wetland enhancement area also supports two small populations of very rare sedges which are listed as "endangered" in the state. One is the brown bog sedge (see Photo 20) and the other, pictured above, is the southern long sedge. Its range in Tennessee is confined to only 2 counties.

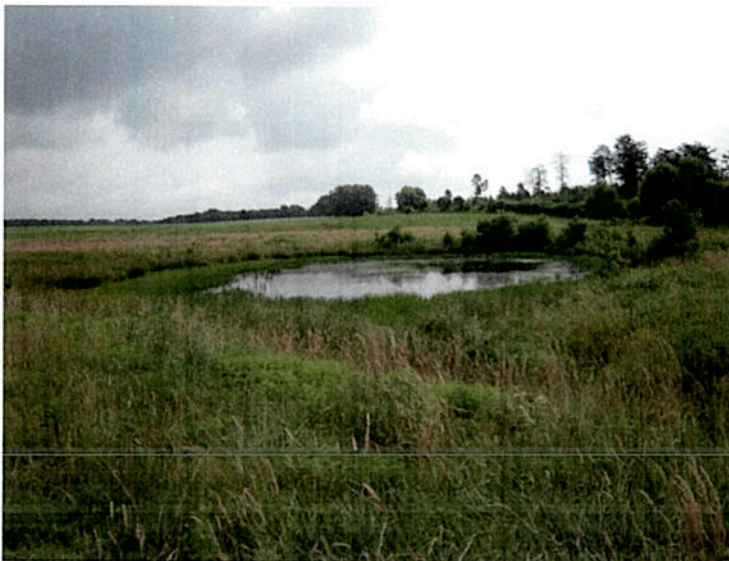
Photo 41.

Photo Supplement, Wetland Enhancement:

Comments: Besides supporting a number of interesting plant species, the enhancement area provides needed habitat for a variety of wetland-dependent animal species, particularly waterfowl. This remnant farm pond and emergent wetland have attracted blue-wing teal, mallard ducks, wood ducks, great blue herons, green herons, and, Canada geese. Sandhill cranes have also been observed using open lands adjacent to the pond.

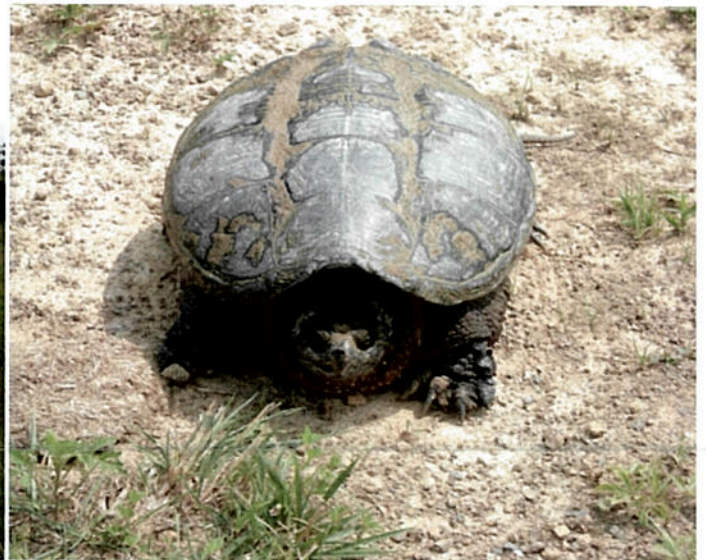
Photo 42.

Photo Supplement, Wetland Enhancement:

Comments: Several snapping turtles were seen in the pond and in stream enhancements. One individual was even observed foraging in the wetland enhancement area approximately 100 yards from the nearest source of open water.
