**Application for Aquatic Resource Alteration Permit (ARAP) & State §401 Water Quality Certification**

Site or Project Name: <b>Carothers Crossing Phase 5B</b>		Nearest City, Town or Major Landmark: <b>Cane Ridge Park</b>	
Street Address or Location (include zip): <b>7211 Carothers Road, Nolensville, TN 37135</b>			
County(ies): <b>Davidson</b>		MS4 Jurisdiction: <b>Nashville</b>	Latitude (dd.dddd): <b>35.9834</b>
			Longitude (dd.dddd): <b>-86.6086</b>
Resources Proposed for Alteration: <input checked="" type="checkbox"/> Stream / River <input type="checkbox"/> Wetland <input type="checkbox"/> Reservoir			
Name of Water Resource (for more information, access <a href="http://tdeconline.tn.gov/dwr">http://tdeconline.tn.gov/dwr</a> ): <b>Unnamed Drain to East Branch Hurricane Creek</b>			
Brief Project Description (a more detailed description is required under Section 8): <div style="text-align: right;">Installation of a minor road crossing on Badric Drive (35.9834, -86.6086).</div>

**Carothers Crossing Phase 5B - Proposed Road Crossing - Badric Drive**

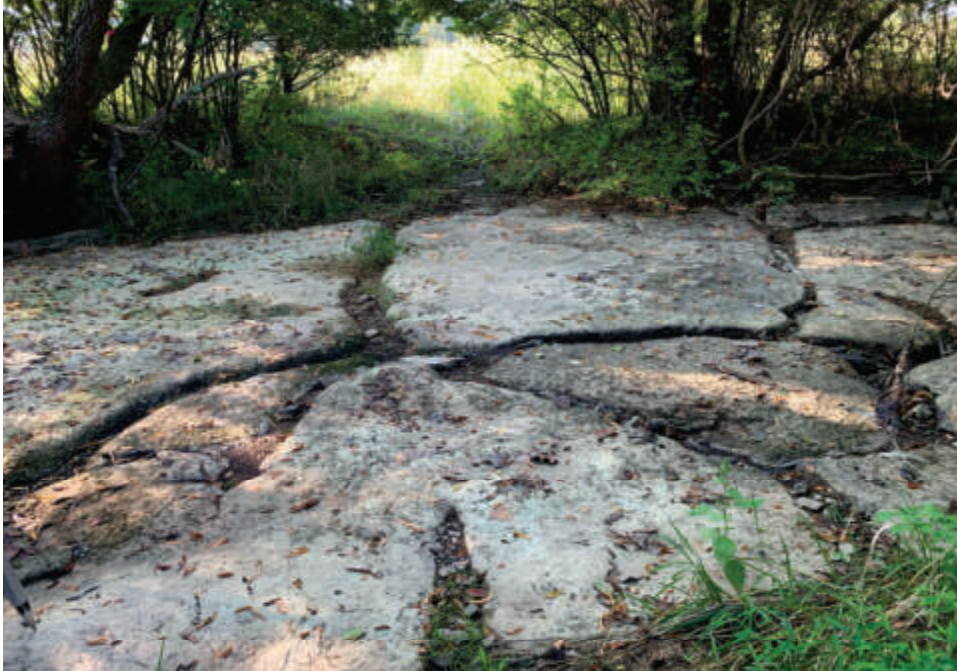
**1. Facing Right Bank (Southerly)**

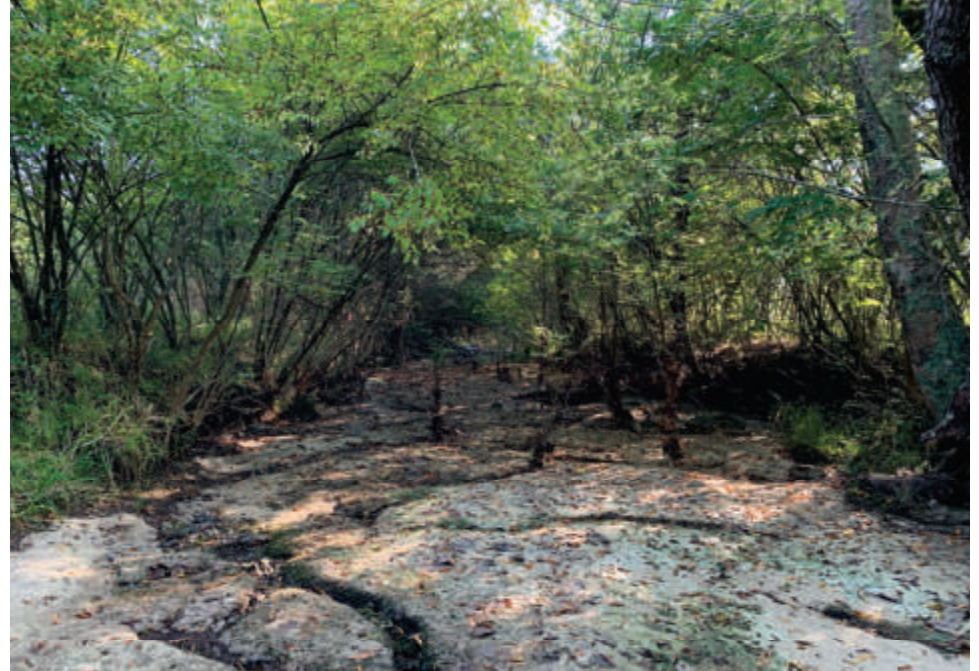
**2. Facing Downstream (Easterly)**

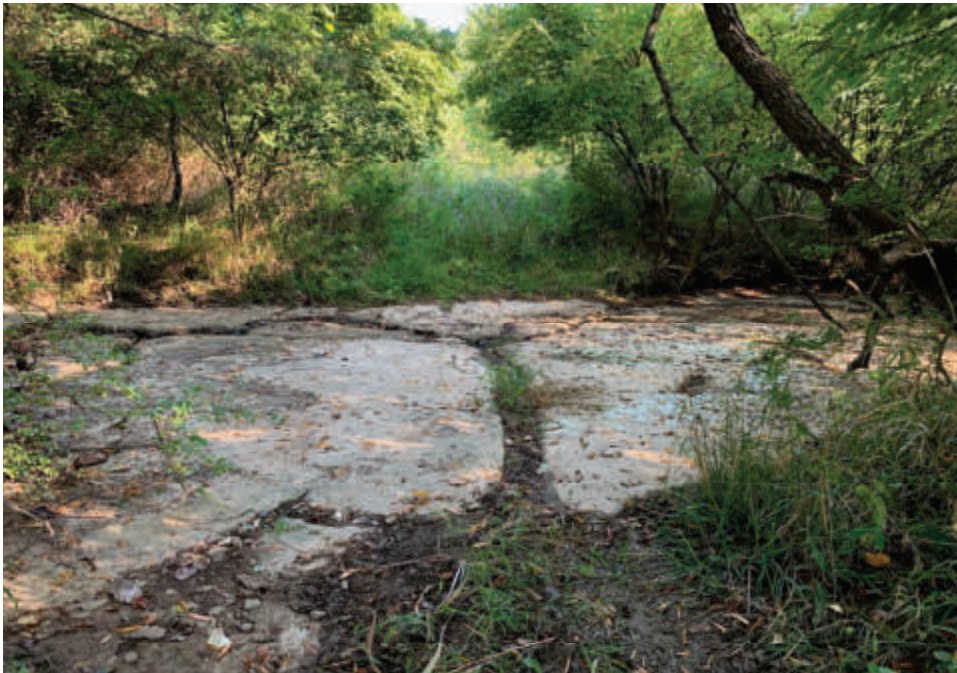
**3. Facing Left Bank (Northerly)**

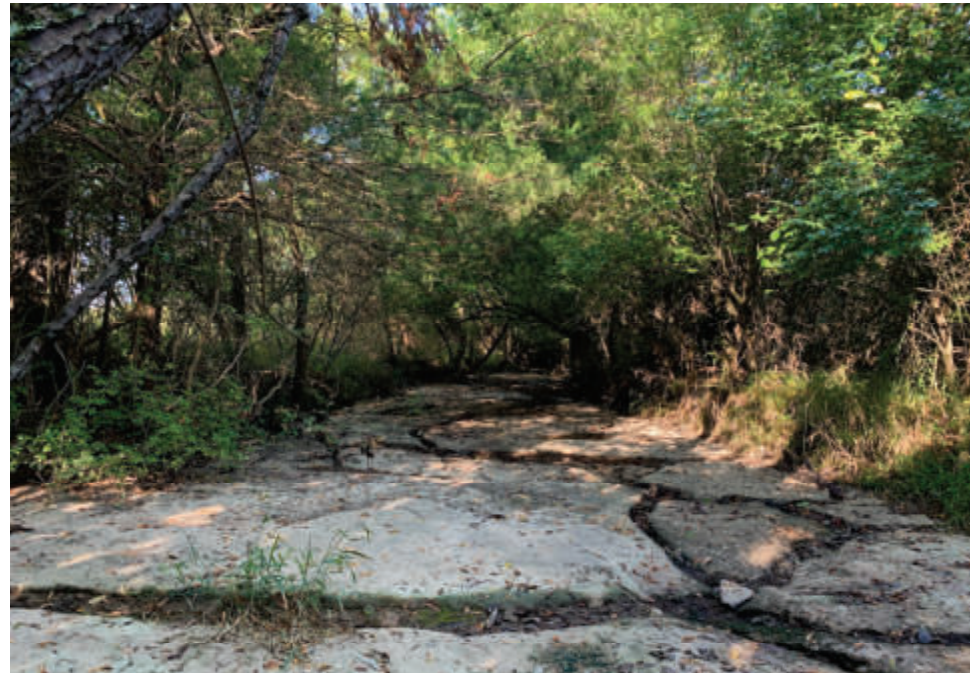
**4. Facing Upstream (Westerly)**

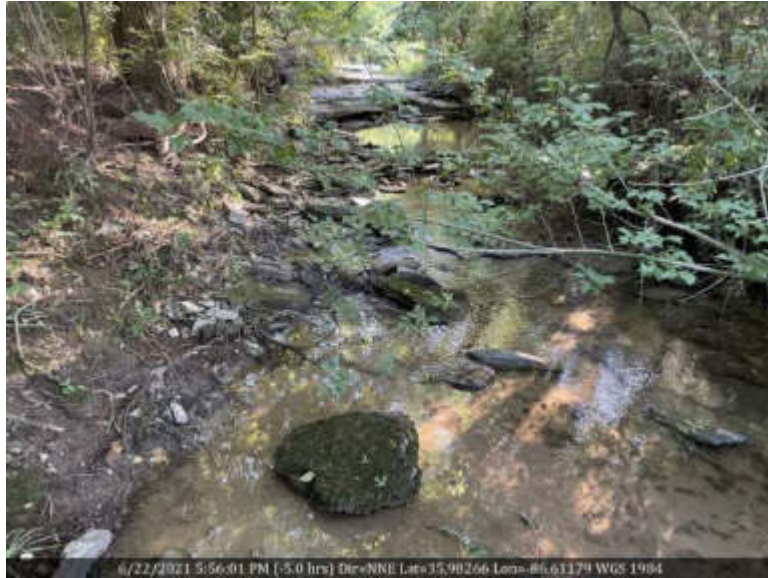
1 View of D-1 entering site, facing upstream/west.

D-1 is a well defined, obvious stream with bedrock and cobble substrates and multiple connections to subsurface seepage. BDY observed fish and multiple populations of wood- and stone-case building caddisfly larvae in D-1.

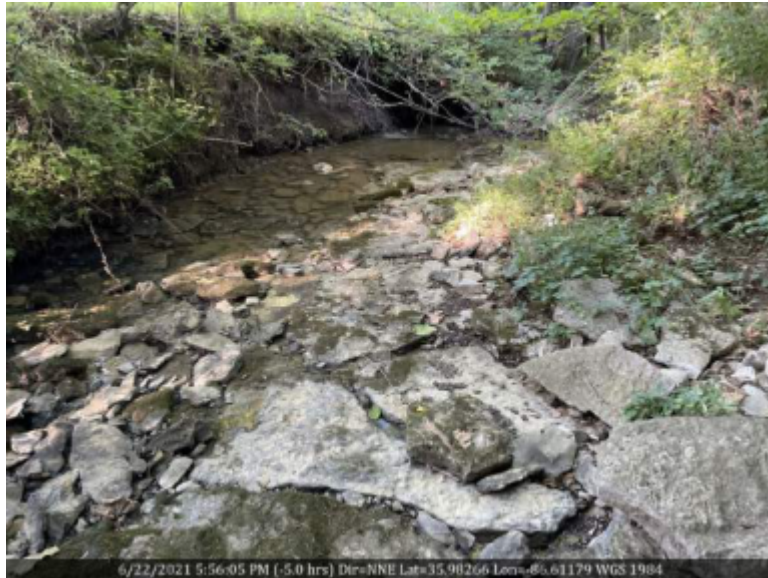
2 View of D-1 entering site, facing downstream/east.

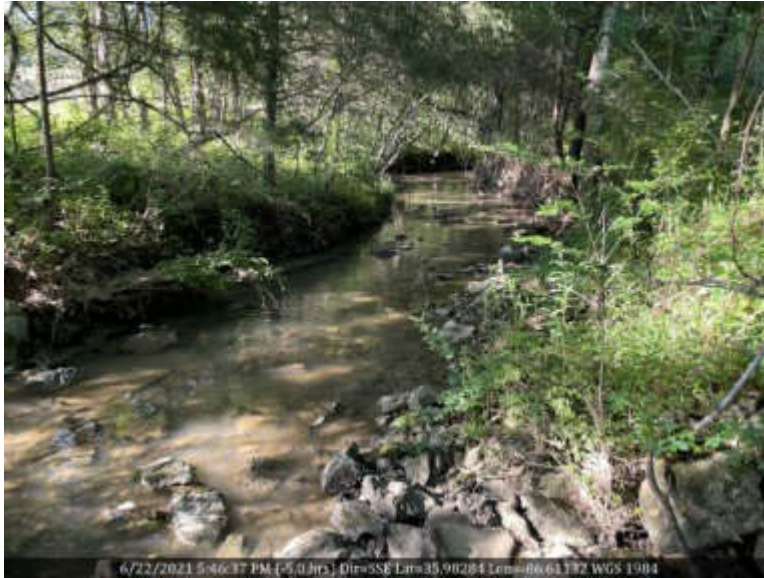
3 View of D-1 upper reach, facing downstream/northeast.

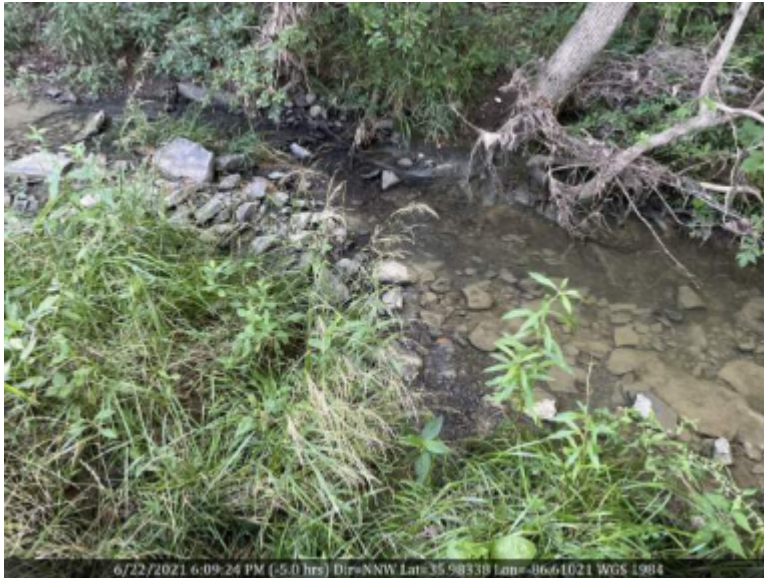
4 View of D-1 mid-reach with D-2 confluence in image foreground (downstream/east to image right).

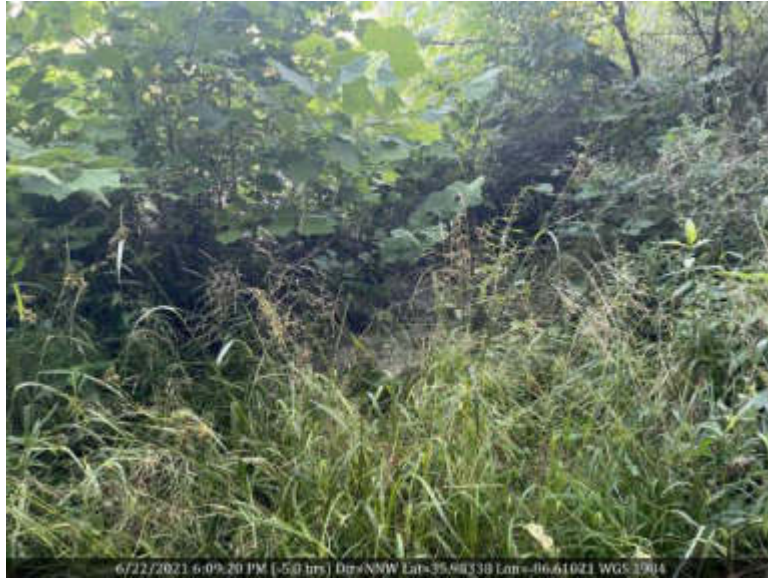
5 View of heavily vegetated D-2 at D-1 confluence, facing upslope/south.

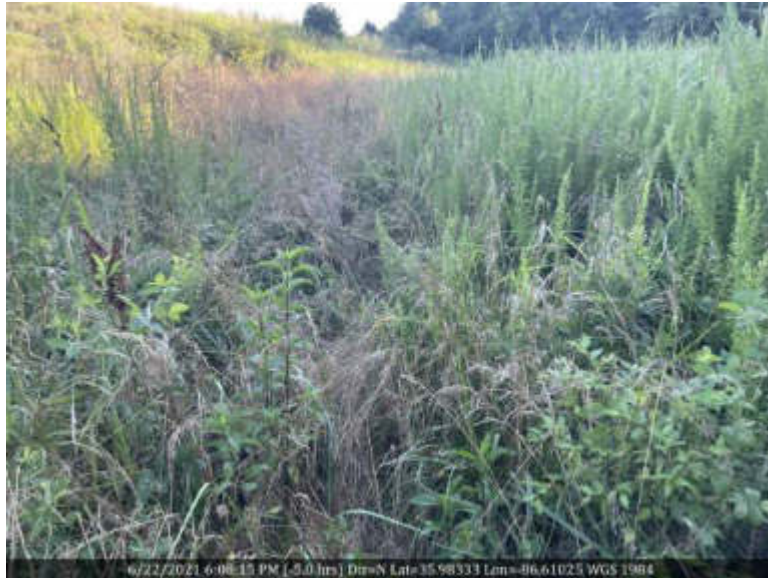
6 View of heavily vegetated D-2 lower reach, facing upslope/southwest.

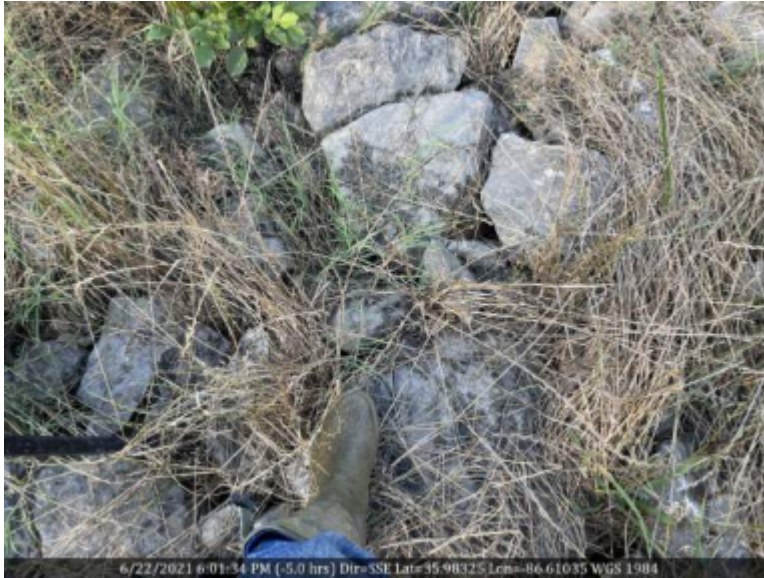
9 View of D-2 mid-reach substrate, facing down.

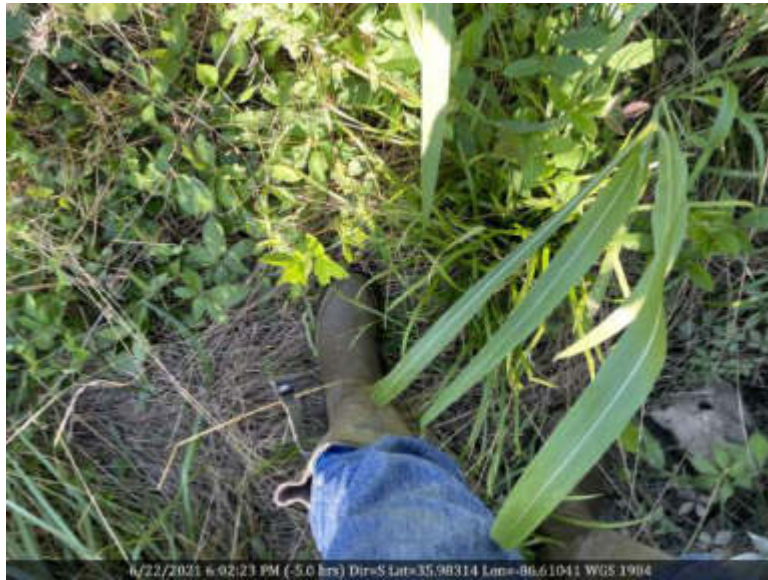
13 View of substrate and vegetation in D-1 below culvert outlet, facing down.

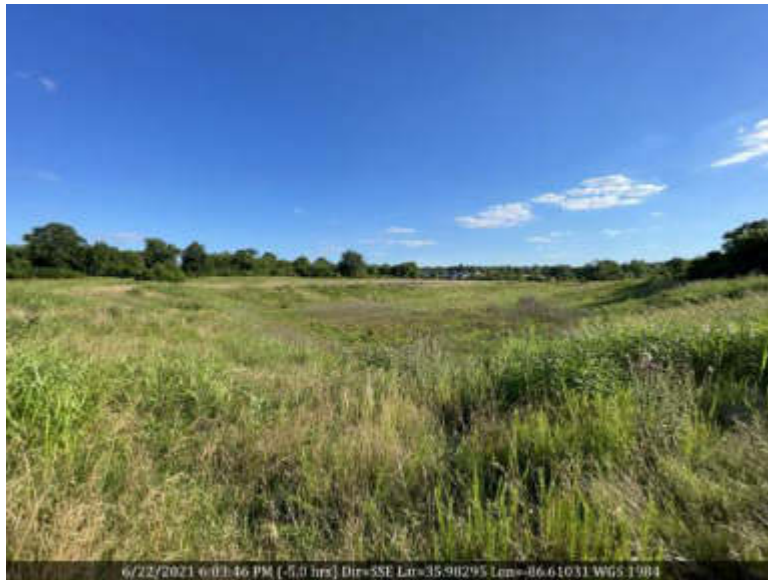
14 Overview of large detention pond, facing southwest.

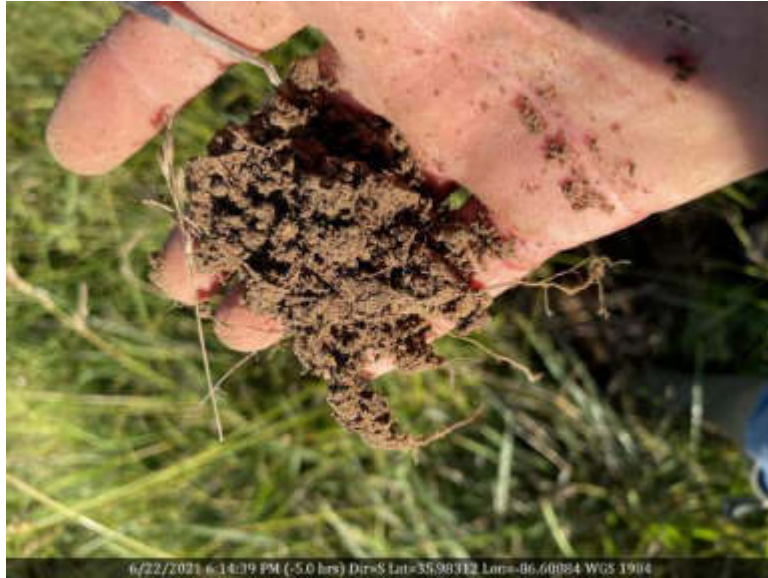
17 View of upland soils within floodplain area south of D-1, facing down.

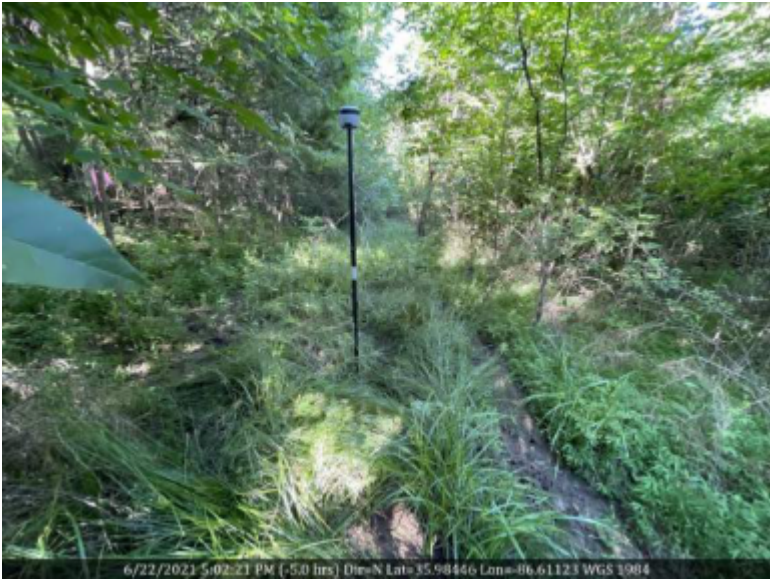
20 Overview of WTL-B and sample pit, facing east.

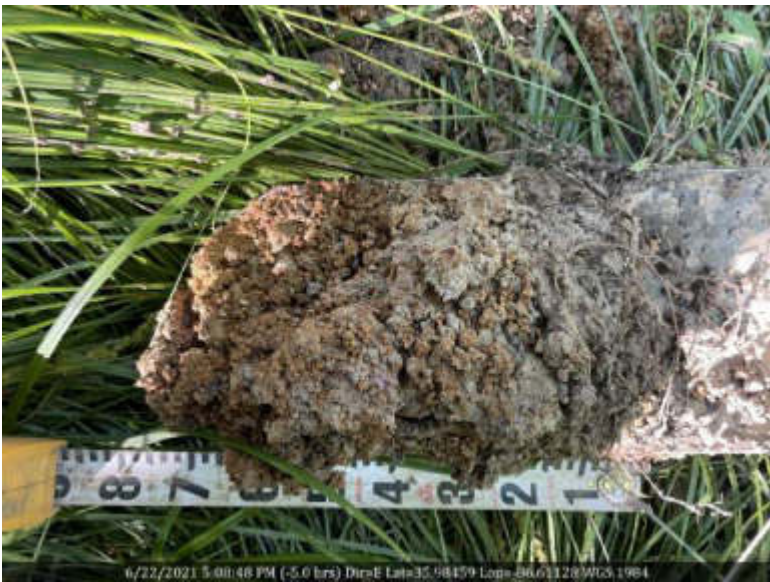
21 View of soil profile at WTL-B sample pit, facing down.

Depth (Inches)	Matrix		Redox Features				Texture	Remarks
	Color (moist)	%	Color (moist)	%	Type*	Loc**		
0-6	2.5Y 5/1	85	5YR 4/6	15	C	PL/M	silty clay	
6-10	5YR 4/6	90	2.5Y 4/1	10	D	M	silty clay	
10-12+	5YR 4/6	100					clay

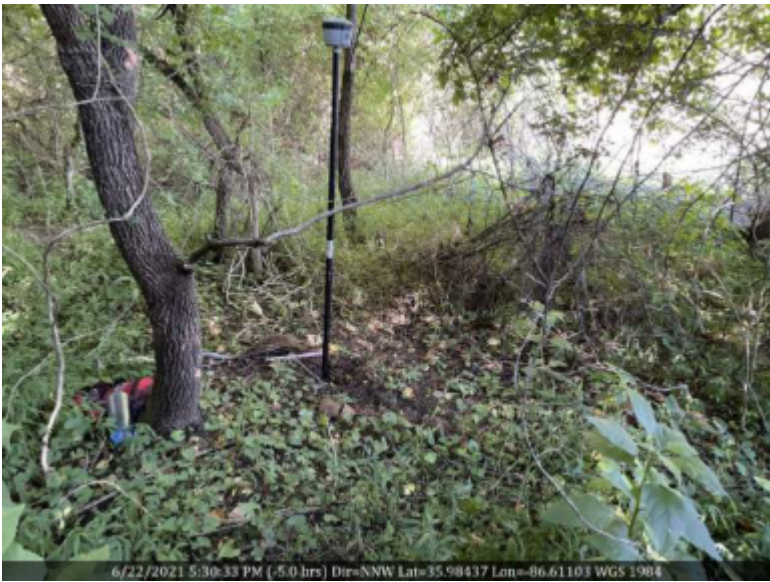
22 View of UPL-B sample pit location, facing southwest.

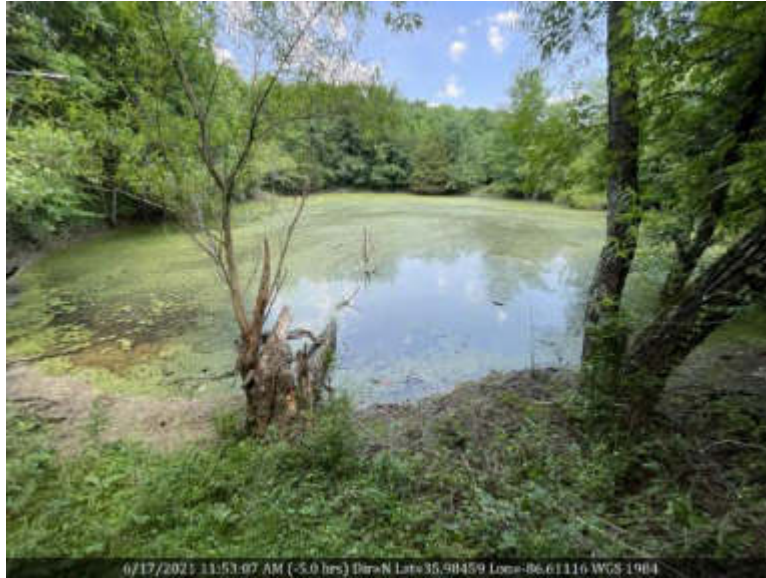
25 View of ISOPND-A, facing north/upslope.

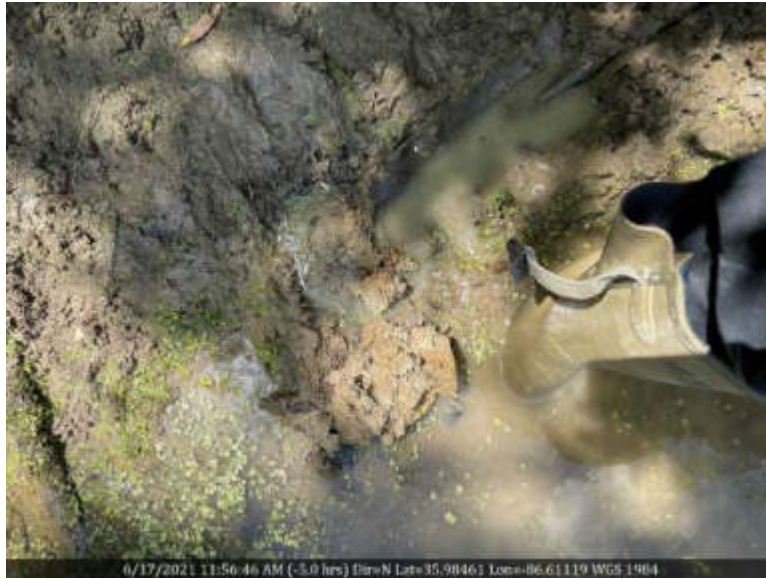
26 View of clay liner in ISOPND-A.

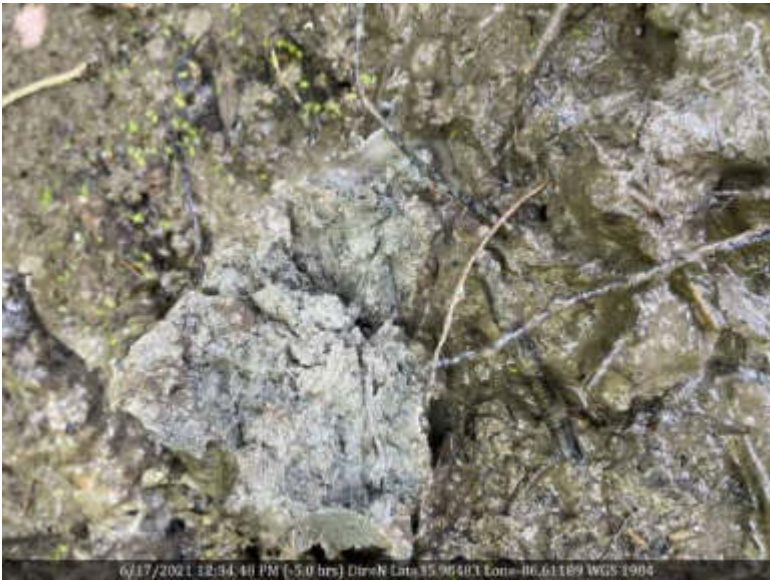
33 View of clay liner from upper portion of ISOPND-B, facing down.

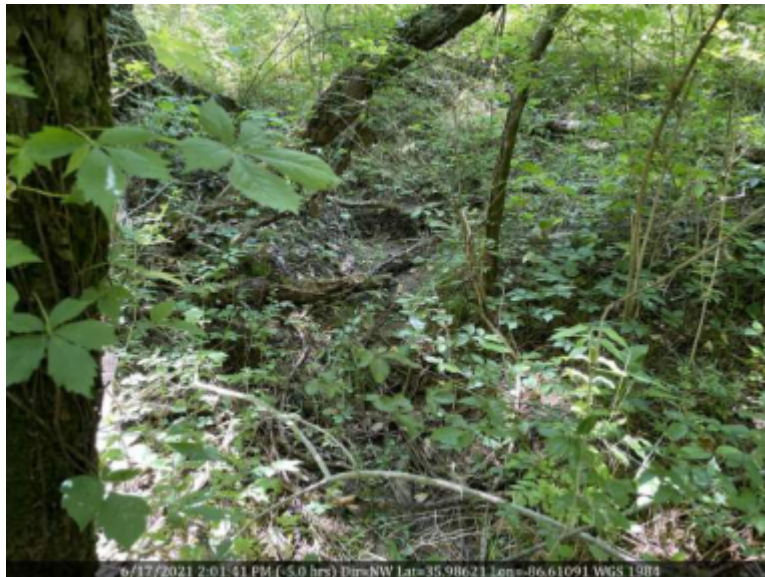
36 View of D-3 at origin, facing upslope/west.

Short, erosional, soil-substrate channel that loses definition at slope break. No evidence of seepage inputs, sorting, or macrobenthos observed. Erosion from historic ag practices.

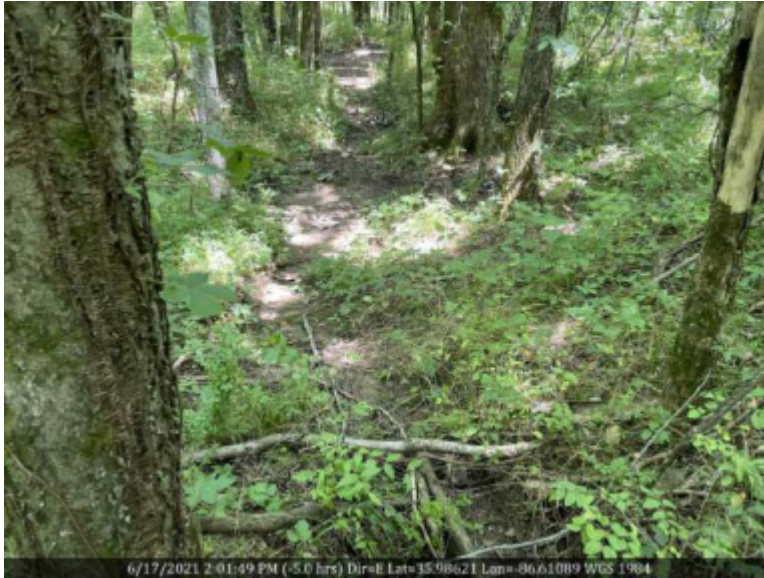
37 View of D-3 below origin, facing downslope/east.

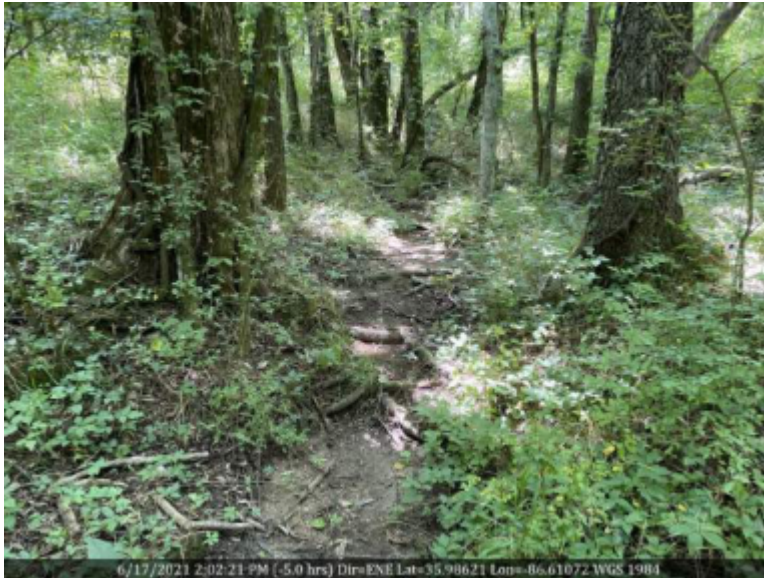
38 View of lower portion of D-3, facing upslope/west.

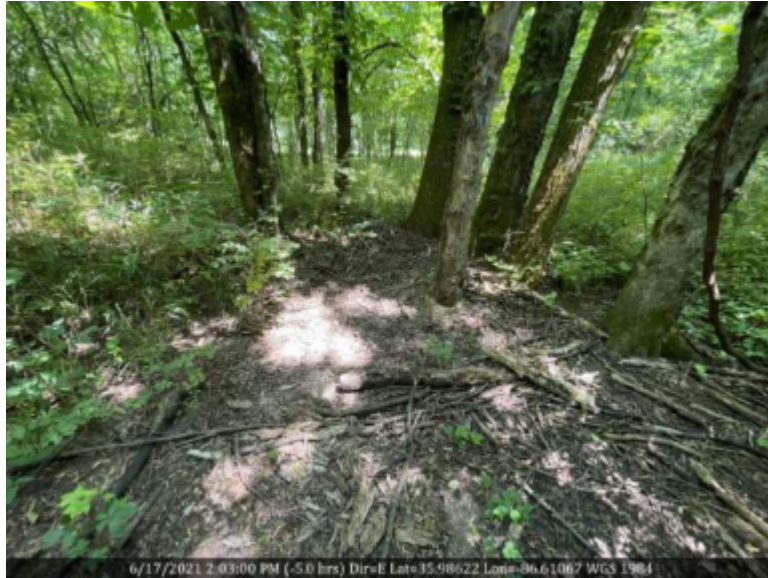
39 View of D-3 end of definition point, facing downslope/east.

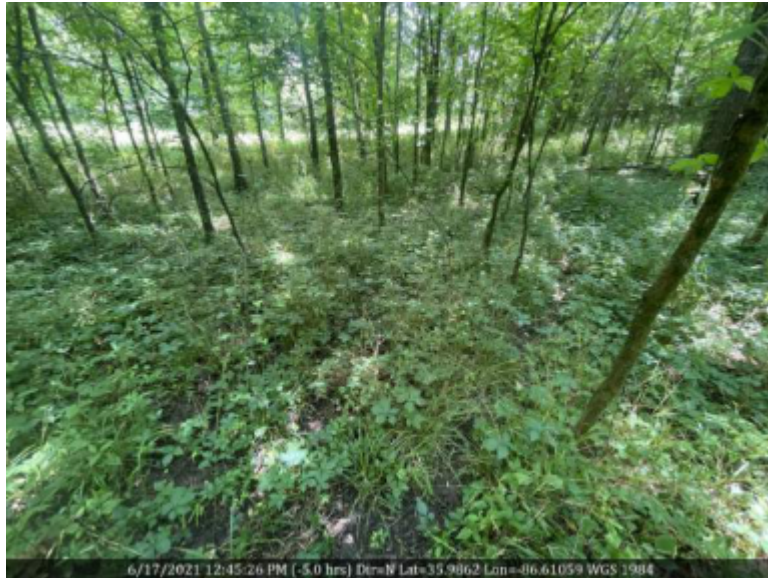
40 Overview of upper, western portion of WTL-A, facing downslope/east.

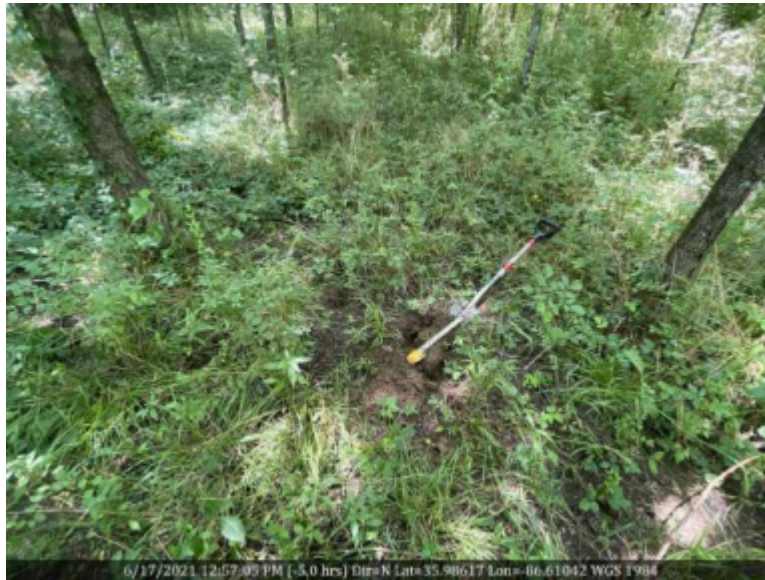
41 View of WTL-A sample pit area, facing west.

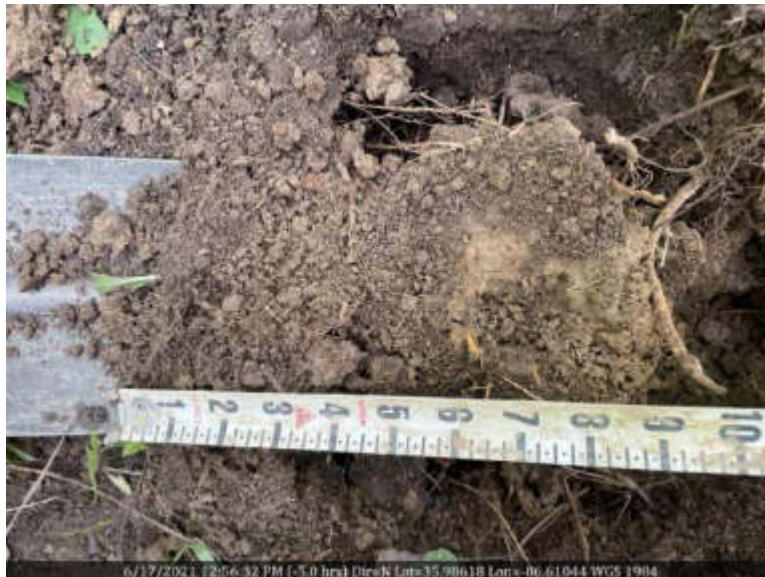
42 View of WTL-A soil profile, facing down.

Depth (Inches)	Matrix		Redox Features				Texture	Remarks
	Color (moist)	%	Color (moist)	%	Type*	Loc**		
0-2	10YR 3/2	95	7.5YR 4/4	5	C	PL/M	silt loam	
2-8	10YR 4/2		7.5YR 4/6	8	C	M	silt loam	Mn Masses
8-11	10YR 5/4		7.5YR 4/6	5	C	M	silty clay loam

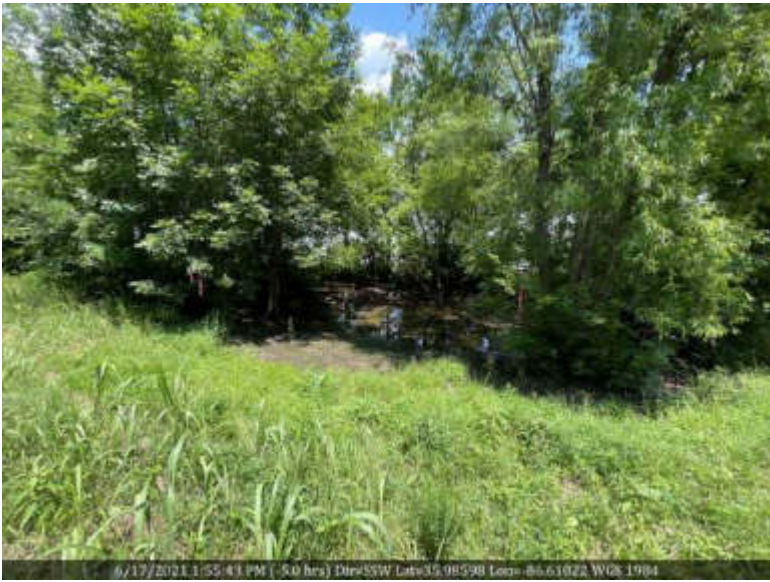
43 Overview of WTL-A eastern portion with former farm pond, facing east/downslope.

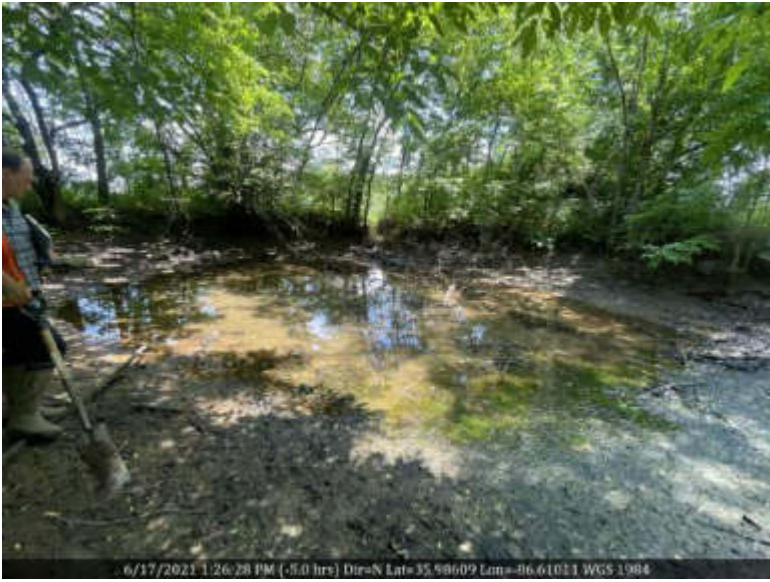
44 View of ponded portion of WTL-A, facing east.

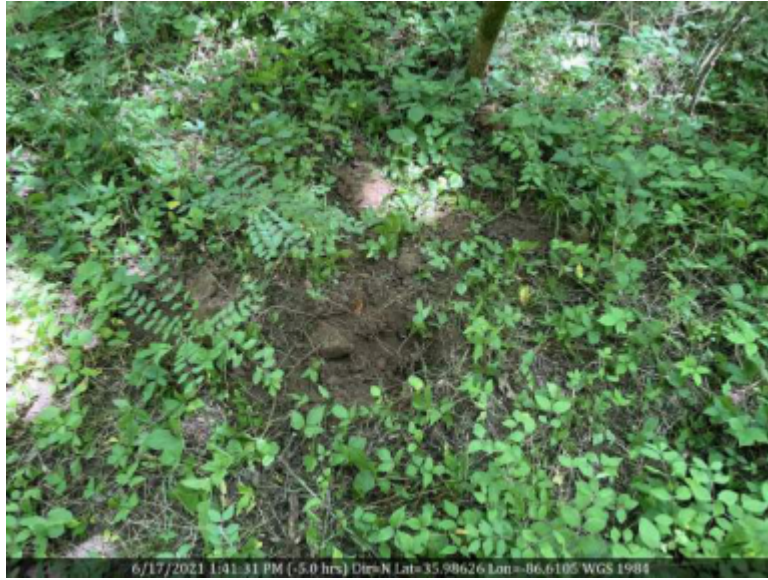
47 View of Upland-A sample pit vegetation, facing down.

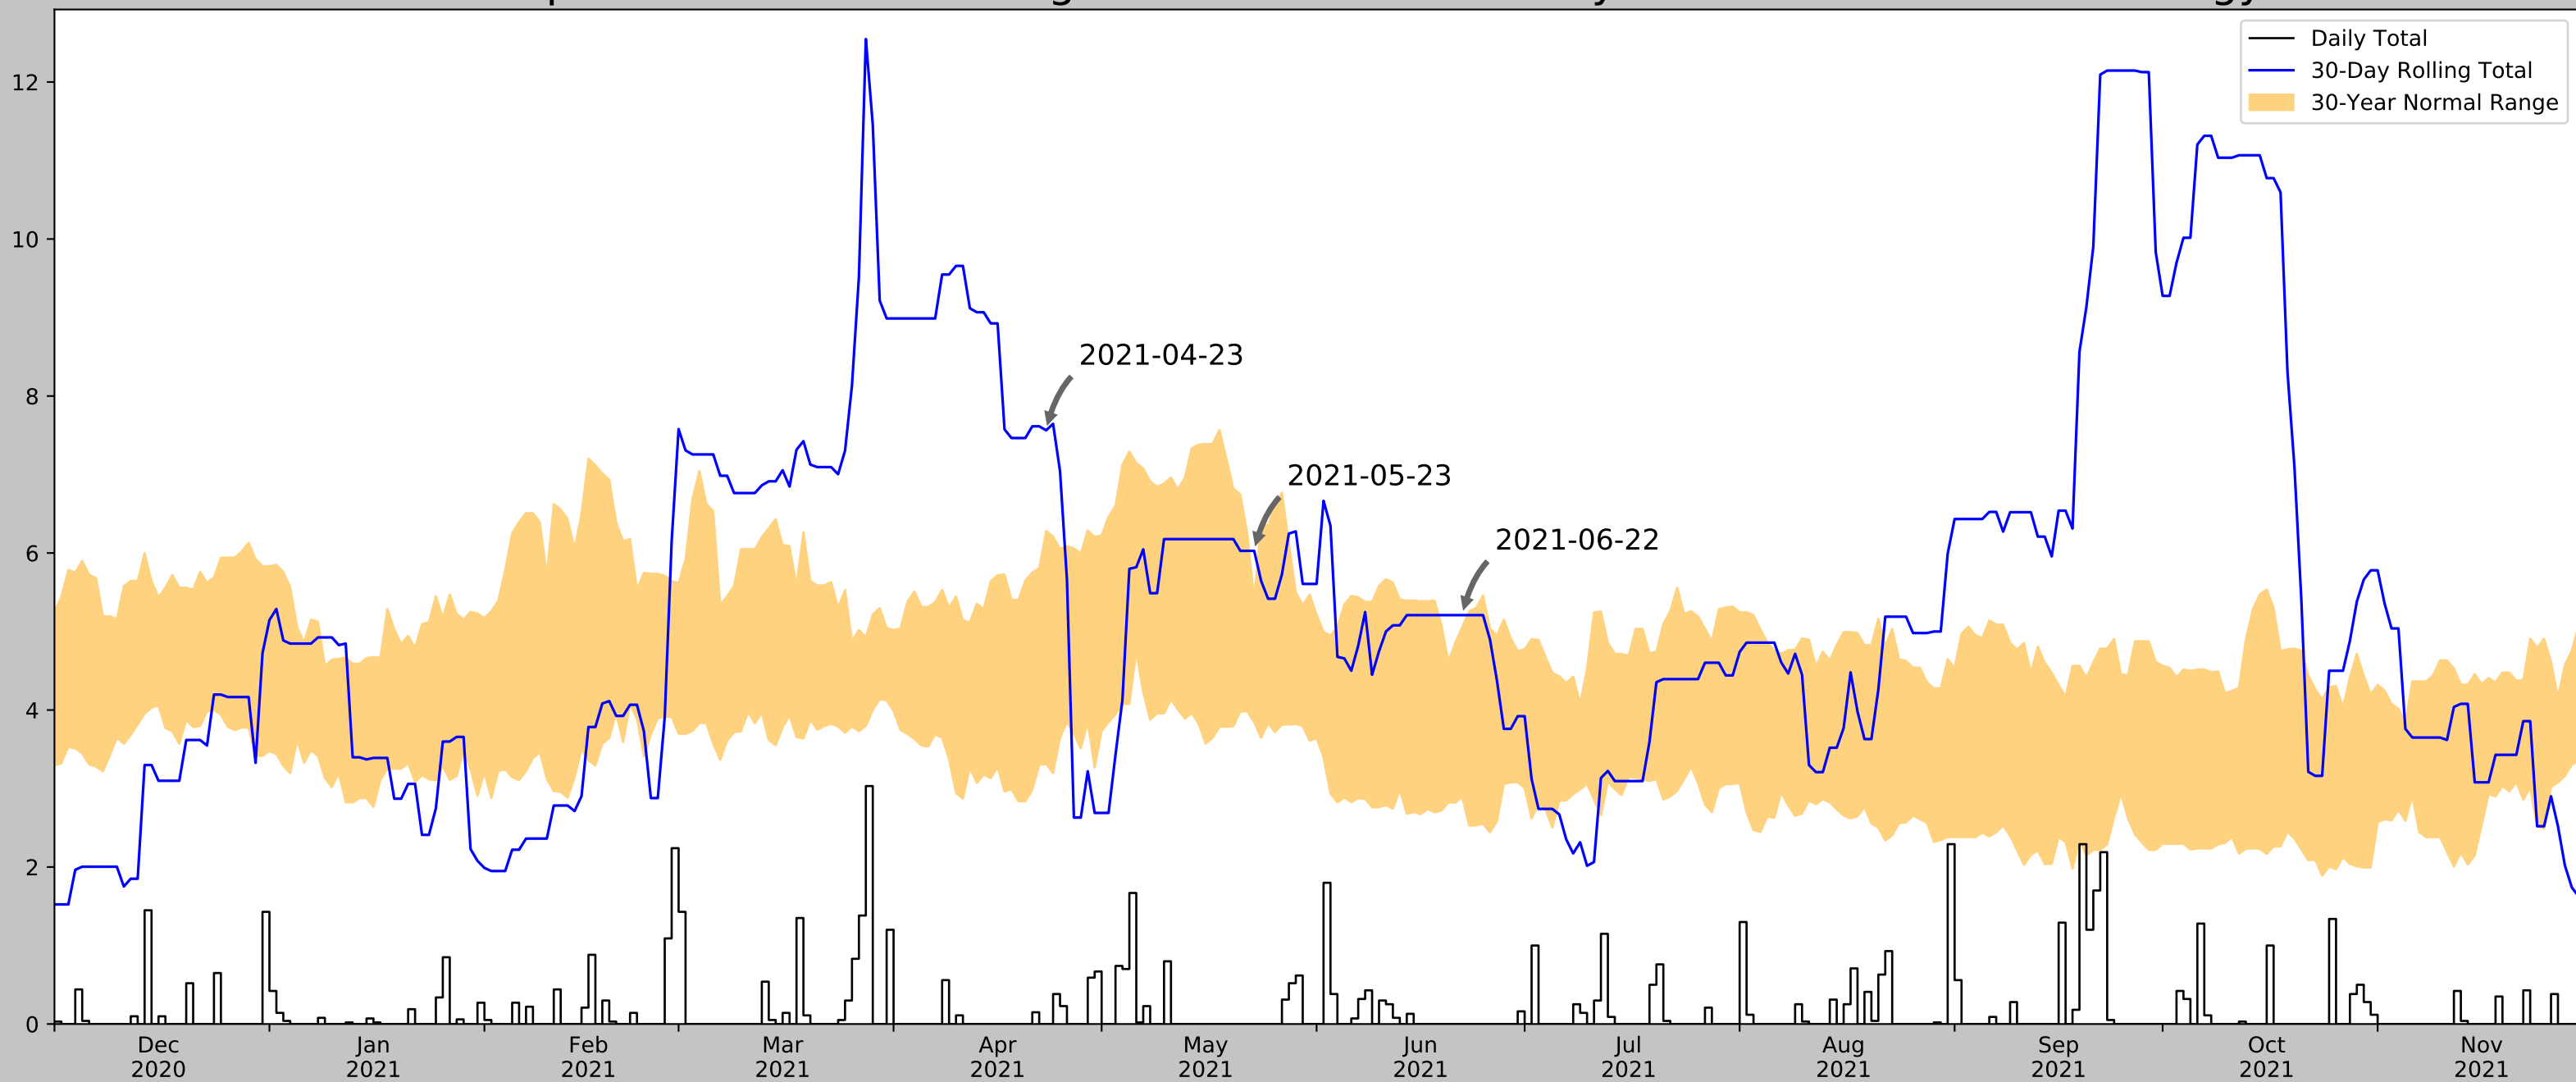
# Antecedent Precipitation vs Normal Range based on NOAA's Daily Global Historical Climatology Network

Coordinates	35.983137, -86.61043
Observation Date	2021-06-22
Elevation (ft)	638.84
Drought Index (PDSI)	Moderate wetness
WebWIMP H <sub>2</sub> O Balance	Dry Season
