Re: Notice of Violation - Compliance Evaluation Inspection
 Pine Grove Mobile Home Park
 State Operating Permit Tracking Number: SOP-11012
 Munford, Tipton County, Tennessee

Compliance Inspection for State Operating Permits

Facility Name: Pine Grove Mobile Home Park	Tracking Number: SOP-11012
Permit Effective Date: September 1, 2016	Permit Expiration Date: August 31, 2021
Date of Inspection: February 25, 2020 Time of Inspection: 12:30 p.m.	Inspector(s) Name: Steve Owens

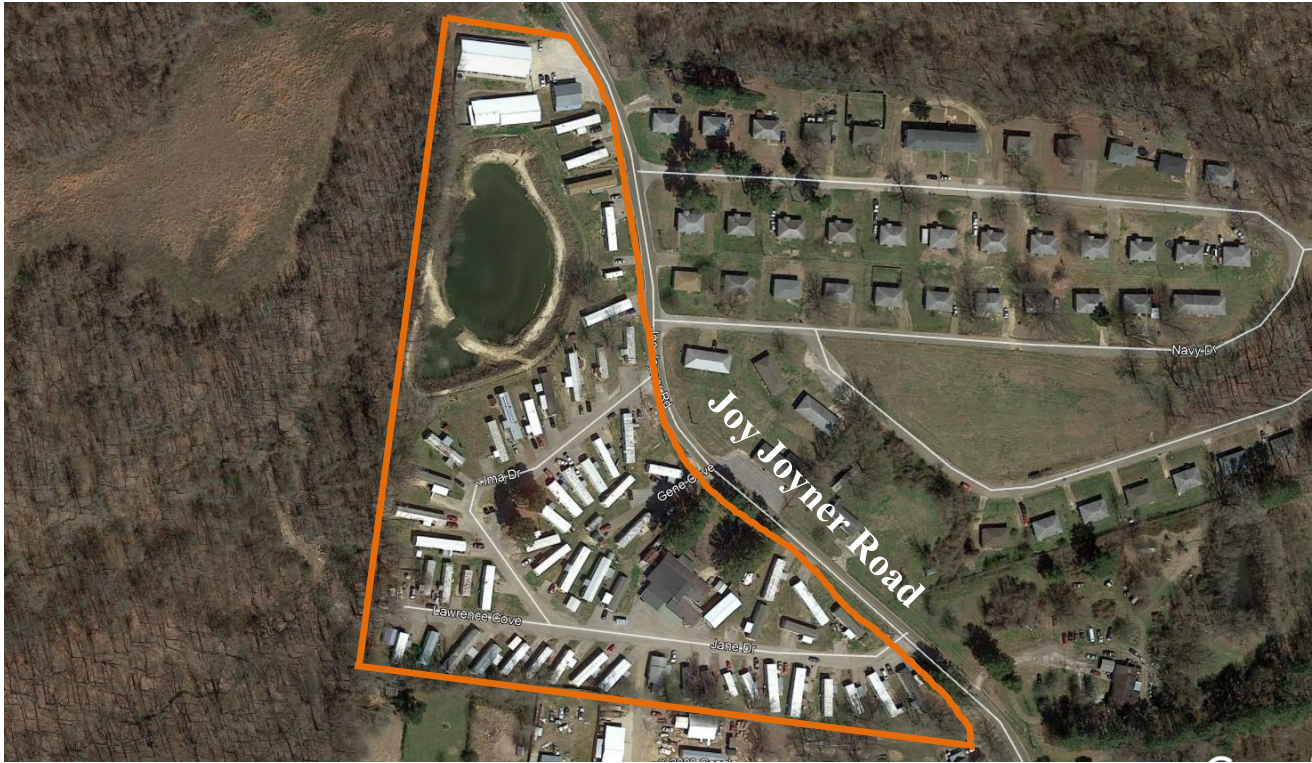
Photo 1. Aerial photo of the Pine Grove Mobile Home Park and wastewater treatment lagoon. The approximate property line is shown with an orange line.

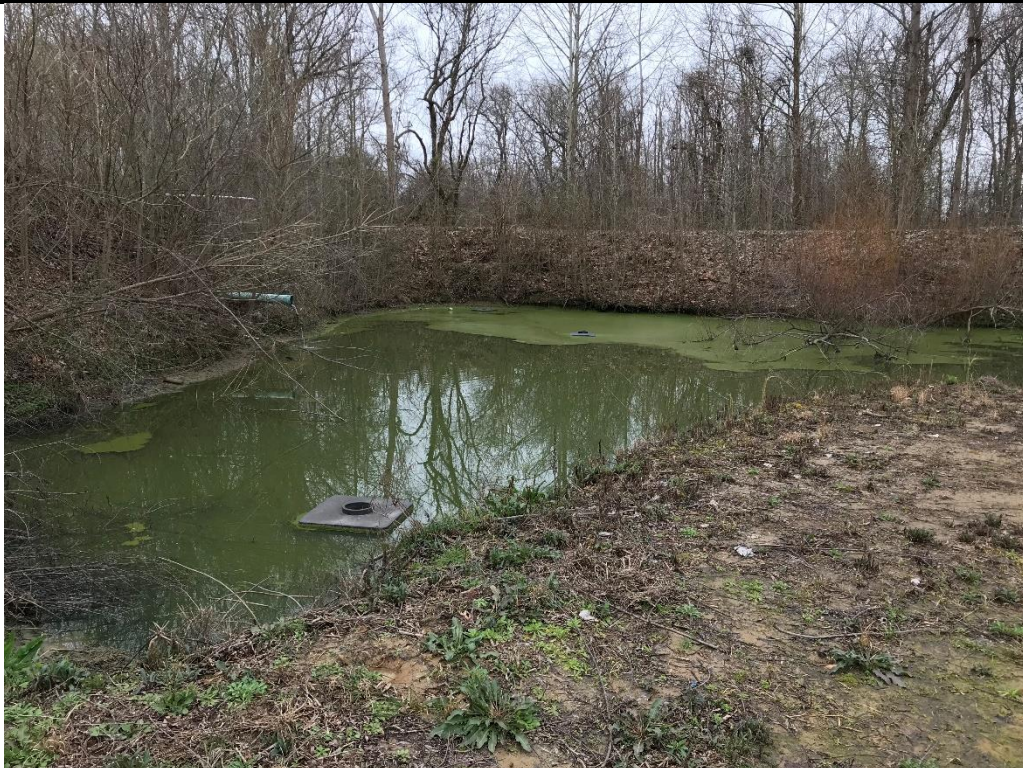
Photo 2. View of the southern portion of the wastewater treatment lagoon. The aerator serving the southern portion of the lagoon was inoperable during the inspection.

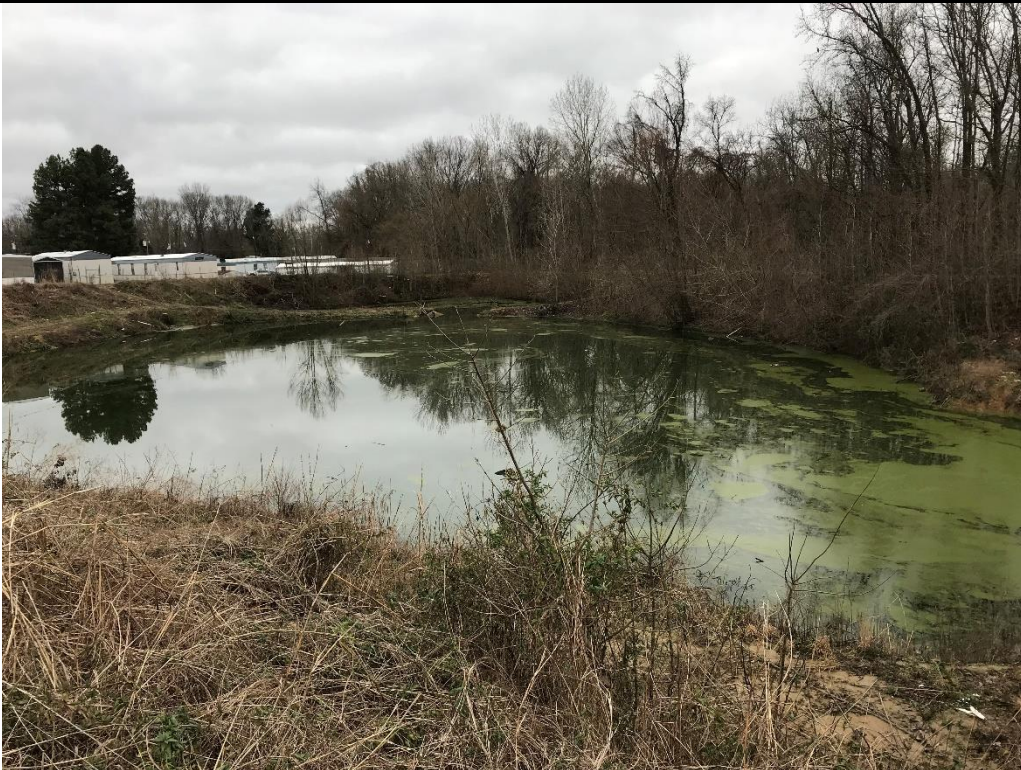
Photo 3. View of the northern portion of the wastewater treatment lagoon. The aerator serving the northern portion of the lagoon was inoperable during the inspection.

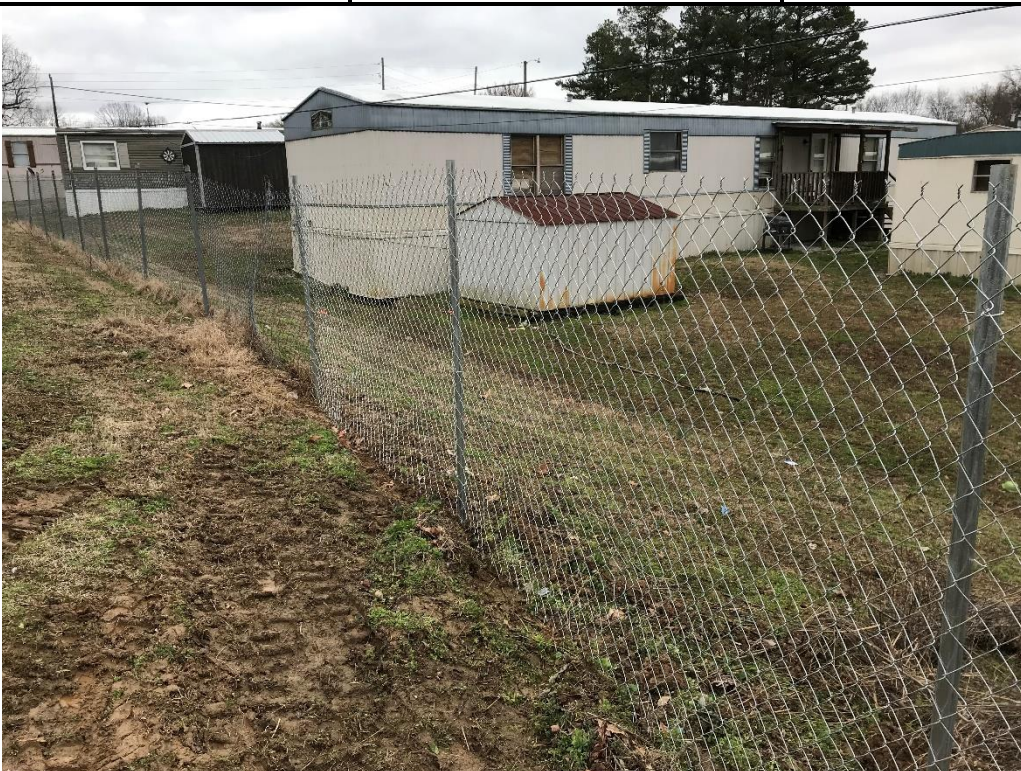
A chain link fence over 4 ft. high encompasses the wastewater lagoon. Mr. Arnold has replaced the section of fencing that was observed during the previous inspection as being less than 4 ft. high (Photo 4). There is a berm that surrounds the top of the lagoon which prevents rainwater from entering (Photo 5).

Photo 4. The portion of fencing that was less than 4 ft. high observed during the previous inspection had been replaced with appropriate fencing.

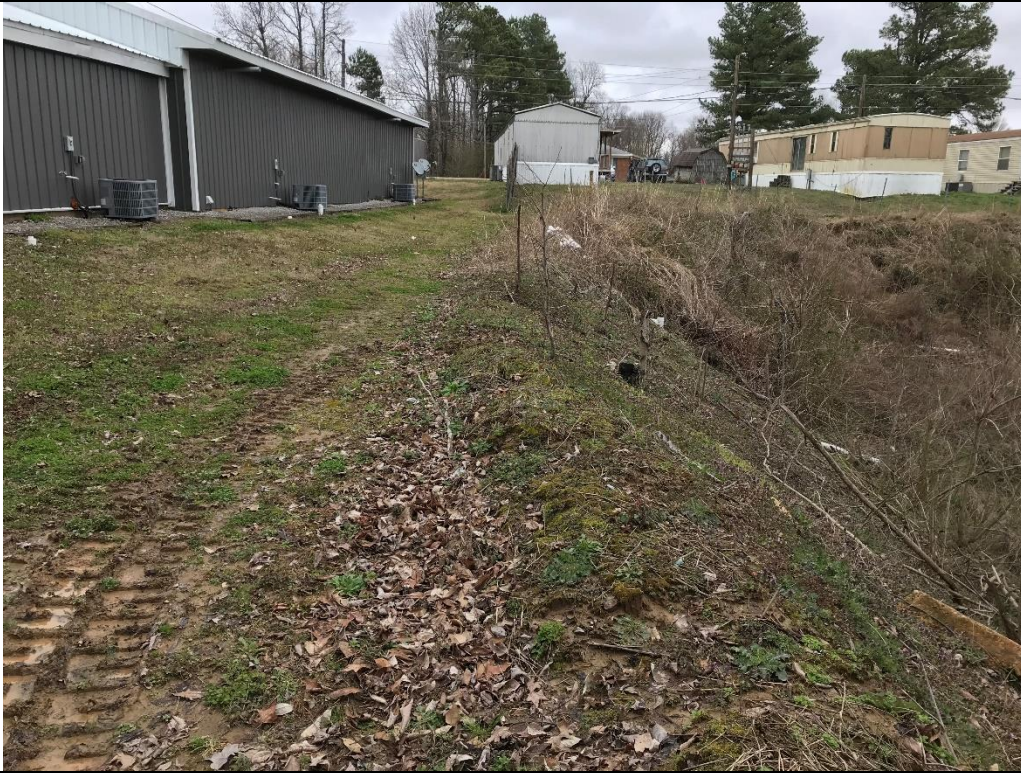
Photo 5. There is a berm that surrounds the top of the lagoon which prevents rainwater from entering.

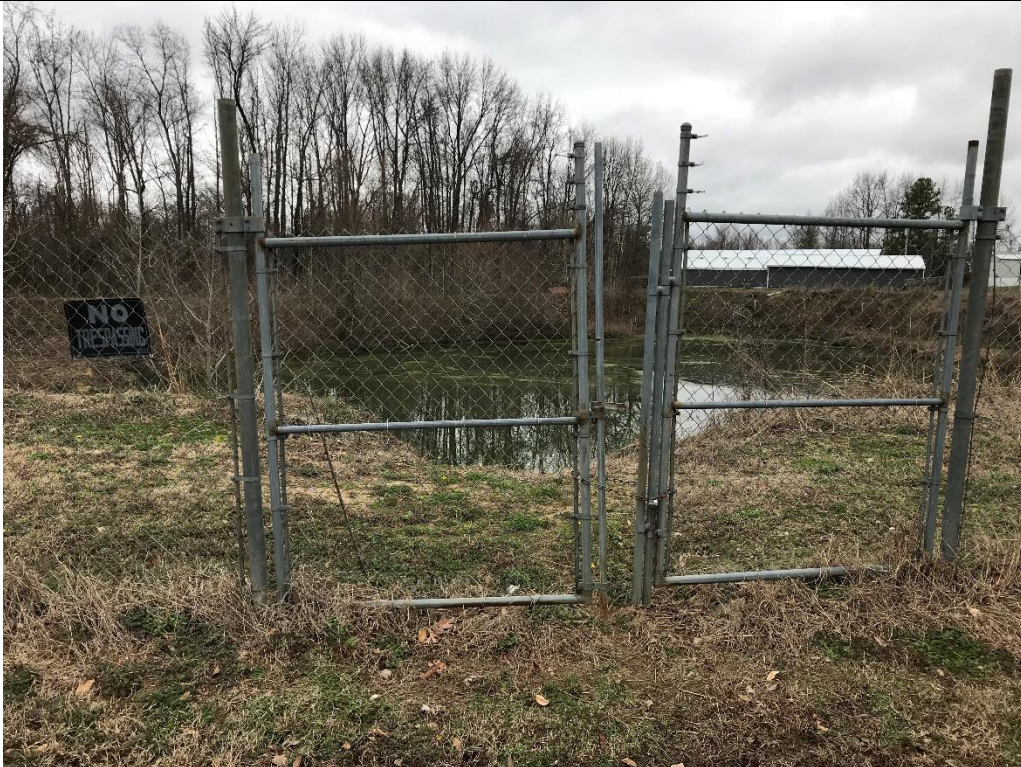
There is also a secured gate at the entrance of the lagoon to prevent or impede unauthorized entry. The gate and fence that surrounds the lagoon lacks the appropriate signage as required by the permit (Photos 6 and 7). The information shown below should be placed at the entrance and on signs posted at regular intervals (maximum 150 ft. intervals) around the perimeter of the wastewater treatment lagoon. The minimum sign size should be two feet by two feet (2 ft. x 2 ft.) with letters not less than two inches (2 in.) high. Each sign shall be made of durable material and have a white background with black letters, see Part III, B. Placement of Signs (pg. 12), of the permit for additional information.

Photo 6. Secured gate and "No Trespassing" sign at the entrance of the wastewater treatment lagoon. The appropriate sign was not posted at the entrance of the wastewater treatment lagoon.

- Place the appropriate signs at regular intervals (at least every 150 ft.) around the perimeter of the lagoon as required by the permit. See Part III, Section B of the permit for additional information and required language.

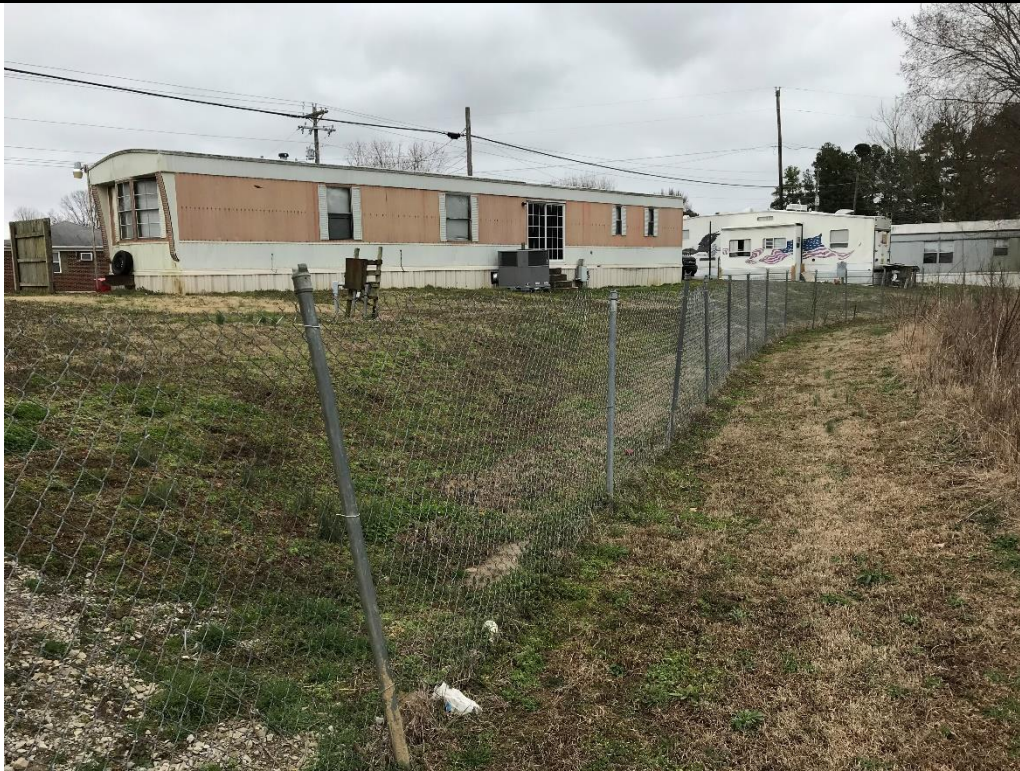
Photo 7. Representative example of the chain link fence surrounding the perimeter of the wastewater treatment lagoon. The appropriate signs were not posted at regular intervals (at least every 150 ft.) around the perimeter of the wastewater treatment lagoon.

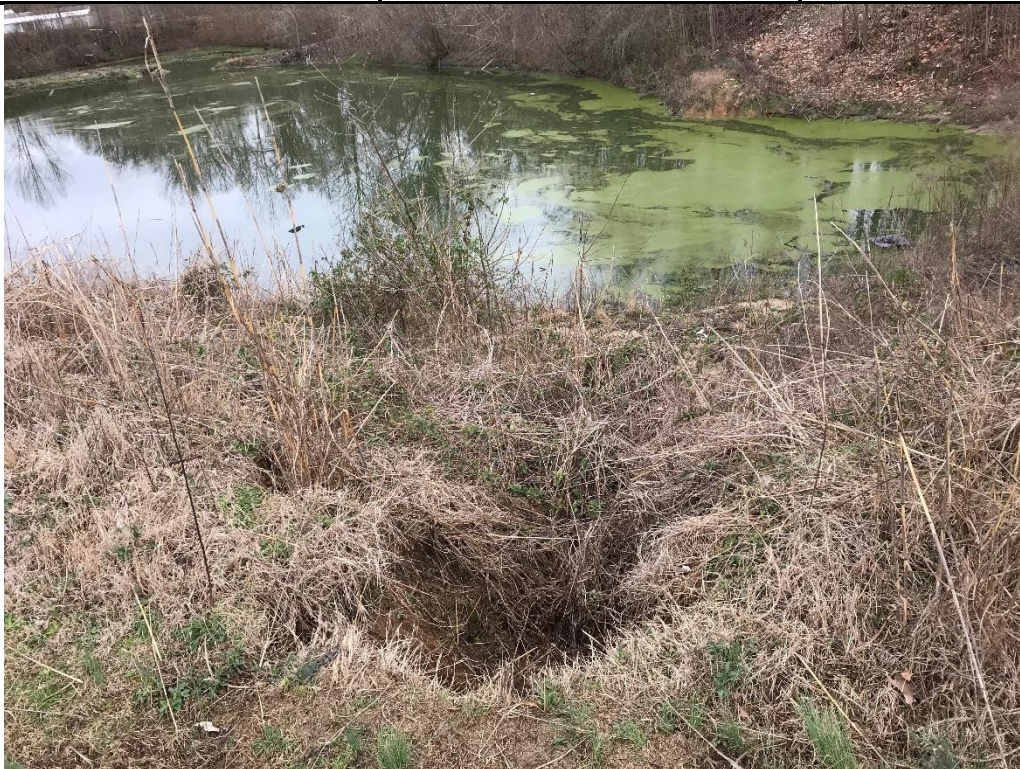
An area of erosion on the northern portion of the bank of the wastewater treatment lagoon was observed during the inspection (Photo 8). Mr. Arnold was also made aware that the eroded area would need to be repaired during the inspection.

Photo 8. View of an eroded area on the northern portion of the wastewater treatment lagoon.
