Re: Compliance Evaluation Inspection
 Memphis-Chapel Hill S.D. STP
 NPDES Permit No. TN0026361
 Shelby County

Compliance Evaluation Inspection for Individual NPDES Permit

Facility Name: Memphis-Chapel Hill S. D. STP	NPDES Tracking Number: TN0026361
Permit Effective Date: August 1, 2022	Permit Expiration Date: July 31, 2027
Date of Inspection: 3/13/2024	Inspector Name: Brittany Gibson

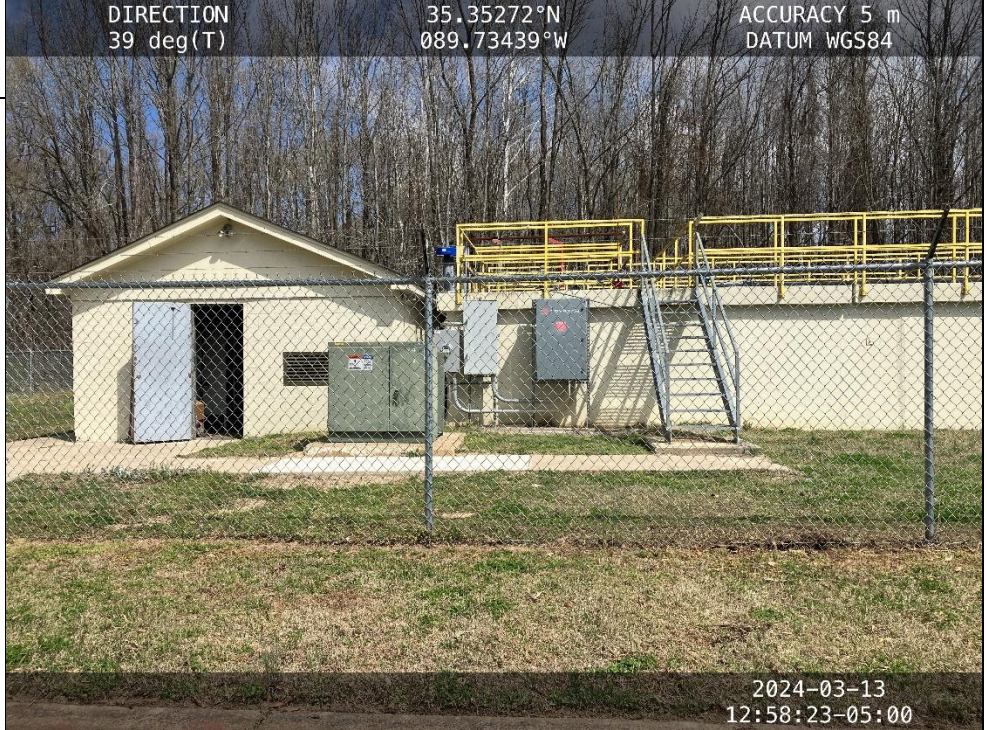
The Memphis-Chapel Hill S.D. STP consists of a compact package sewage treatment plant (photo 1) followed by two aeration basins (photo 2) and a clarifier (photo 3). The effluent from the clarifier is then treated via a series of trickling filters (photo 4). The effluent from the trickling filters is disinfected (photo 5) and then de-chlorinated (photo 6) prior to final discharge into Crooked Creek. Chlorine tablets are utilized for disinfection and Sulfur Dioxide tablets are used for de-chlorination. According to Mr. Crawford, the facility anticipates the installation of an Ultraviolet (UV) light system that will be used to disinfect the effluent prior to discharge. This system upgrade will take place once pending federal funds have been disbursed.

Facility Name: Memphis-Chapel Hill S.D. STP		Site Location: 9856 Bette Lu Drive Millington, TN 38053	Tracking No.: TN0026361
Photo No. 1	Date 3-13-2024	DIRECTION 39 deg(T) 35.35272°N 089.73439°W ACCURACY 5 m DATUM WGS84	
Description View of the compact package STP.		2024-03-13 12:58:23-05:00

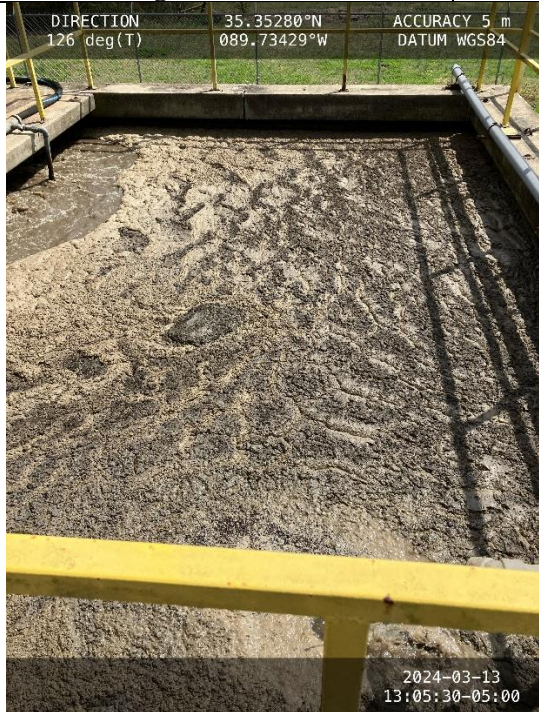
Facility Name: Memphis-Chapel Hill S.D. STP		Site Location: 9856 Bette Lu Drive Millington, TN 38053	Tracking No.: TN0026361
Photo No. 2	Date 3-13-2024	DIRECTION 126 deg(T) 35.35280°N 089.73429°W ACCURACY 5 m DATUM WGS84	
Description View of one of the aeration basins.		2024-03-13 13:05:30-05:00

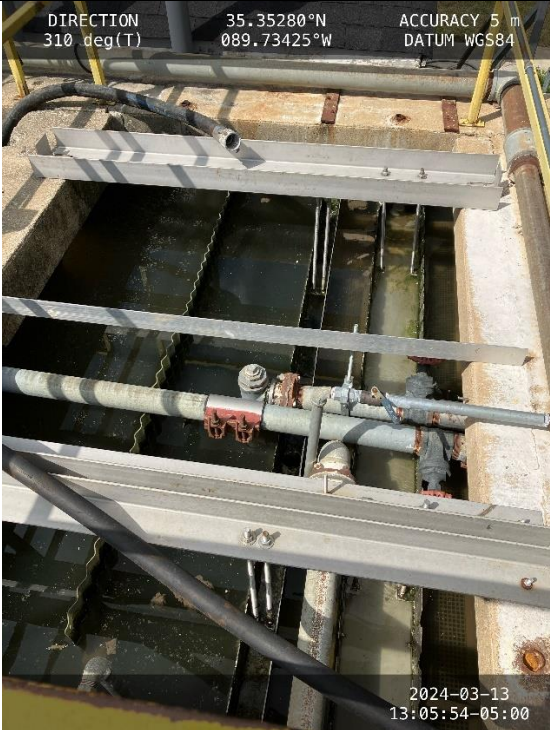
Facility Name: Memphis-Chapel Hill S.D. STP		Site Location: 9856 Bette Lu Drive Millington, TN	Tracking No.: TN0026361
Photo No. 3	Date 3-13-2024

Description View of the clarifier.

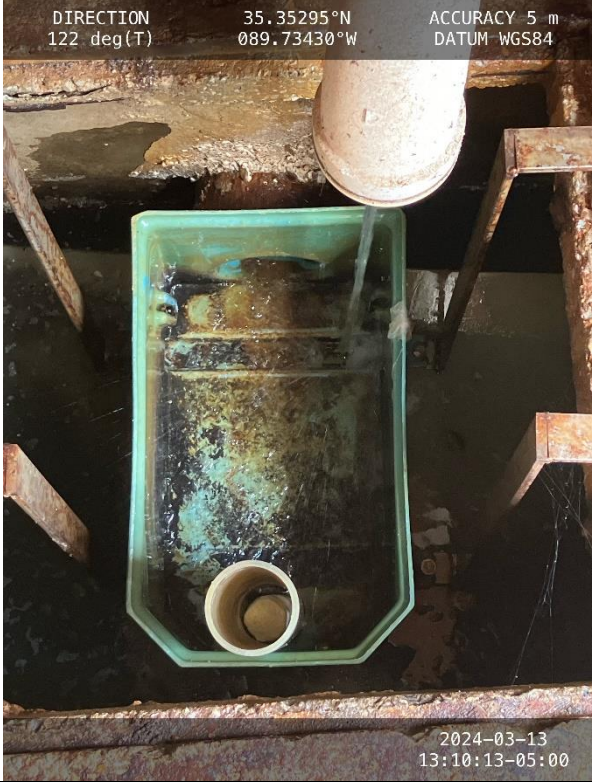
Facility Name: Memphis-Chapel Hill S.D. STP		Site Location: 9856 Bette Lu Drive Millington, TN	Tracking No.: TN0026361
Photo No. 5	Date 3-13-2024	DIRECTION 35.35295°N ACCURACY 5 m 122 deg(T) 089.73430°W DATUM WGS84	
Description View of the disinfection basin. Chlorine tablets are used for disinfection.

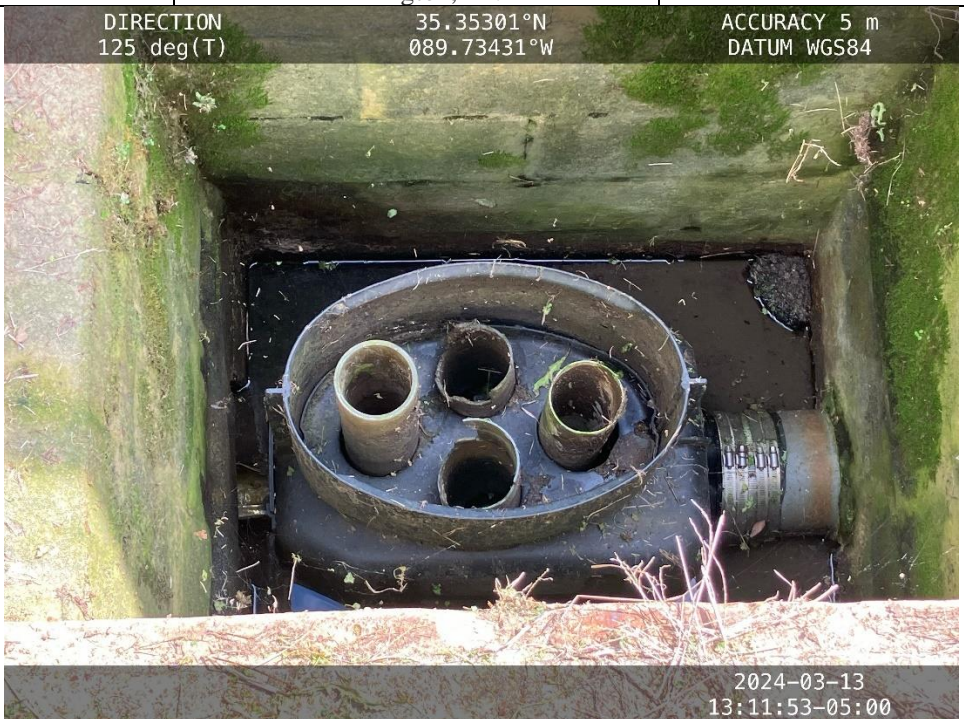
Facility Name: Memphis-Chapel Hill S.D. STP		Site Location: 9856 Bette Lu Drive Millington, TN	Tracking No.: TN0026361
Photo No. 6	Date 3-13-2024	DIRECTION 35.35301°N ACCURACY 5 m 125 deg(T) 089.73431°W DATUM WGS84	
Description View of the de-chlorination basin. Sulfur dioxide tablets are used to de-chlorinate the effluent.

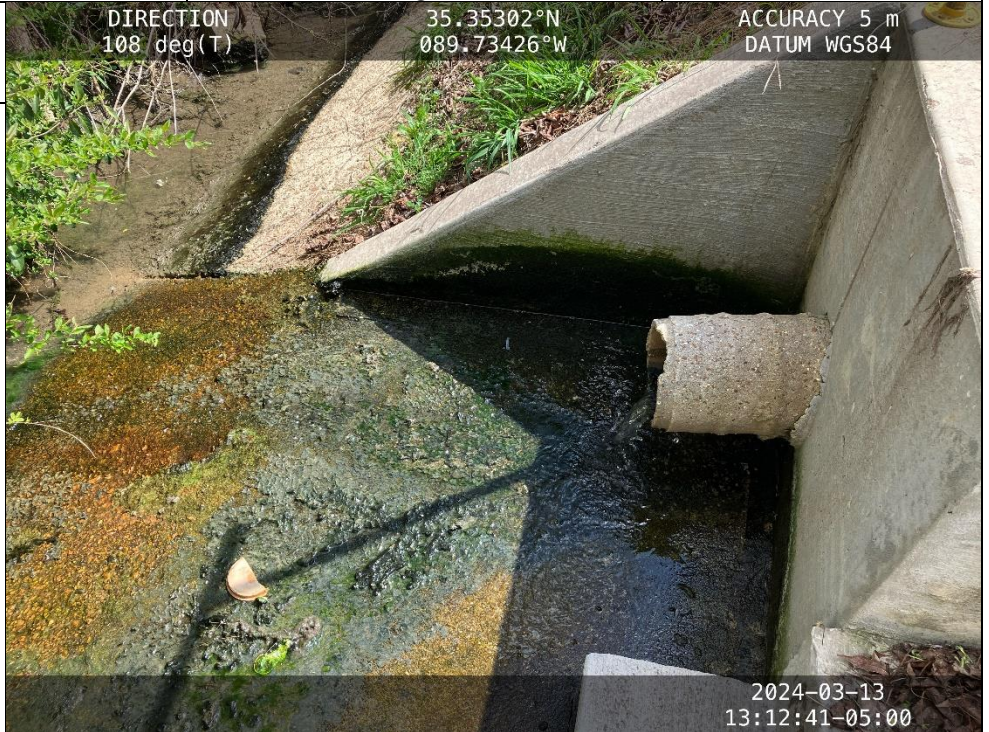
At the time of the inspection, there was a discharge from the STP, and the effluent was clear.

Facility Name: Memphis-Chapel Hill S.D. STP		Site Location: 9856 Bette Lu Drive Millington, TN		Tracking No.: TN0026361	
Photo No. 7	Date 3-13-2024	DIRECTION 108 deg(T)	35.35302°N 089.73426°W	ACCURACY 5 m DATUM WGS84	
Description View of the effluent discharge point. The effluent was clear at the time of the inspection. It is recommended that an additional sign be added in place here as at the effluent discharges into Crooked Creek.		2024-03-13 13:12:41-05:00

The outfall sign (photo 8) was affixed to the front of the fence enclosing the STP. The information on the sign was consistent with the requirements of the NPDES permit. However, it is recommended that an additional sign be added in place at the effluent discharge point (photo 7) going into Crooked Creek.

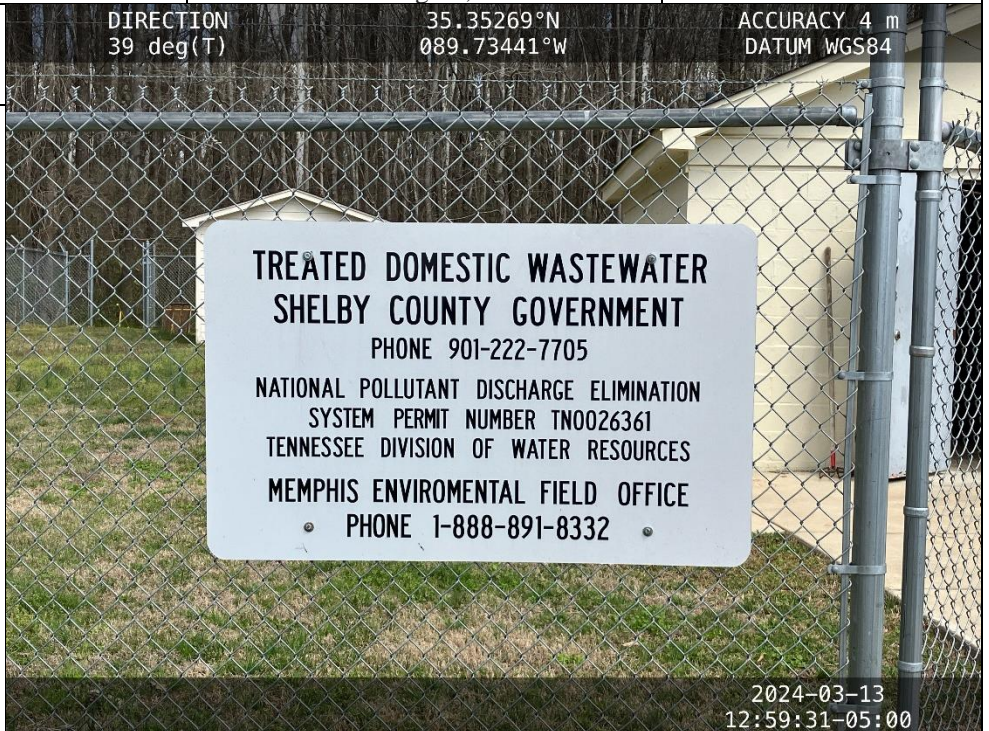
Facility Name: Memphis-Chapel Hill S.D. STP		Site Location: 9856 Bette Lu Drive Millington, TN		Tracking No.: TN0026361	
Photo No. 8	Date 3-13-2024	DIRECTION 39 deg(T)	35.35269°N 089.73441°W	ACCURACY 4 m DATUM WGS84	
Description View of the sign at the outfall. The information on the sign was consistent with the requirements of the NPDES permit.		2024-03-13 12:59:31-05:00

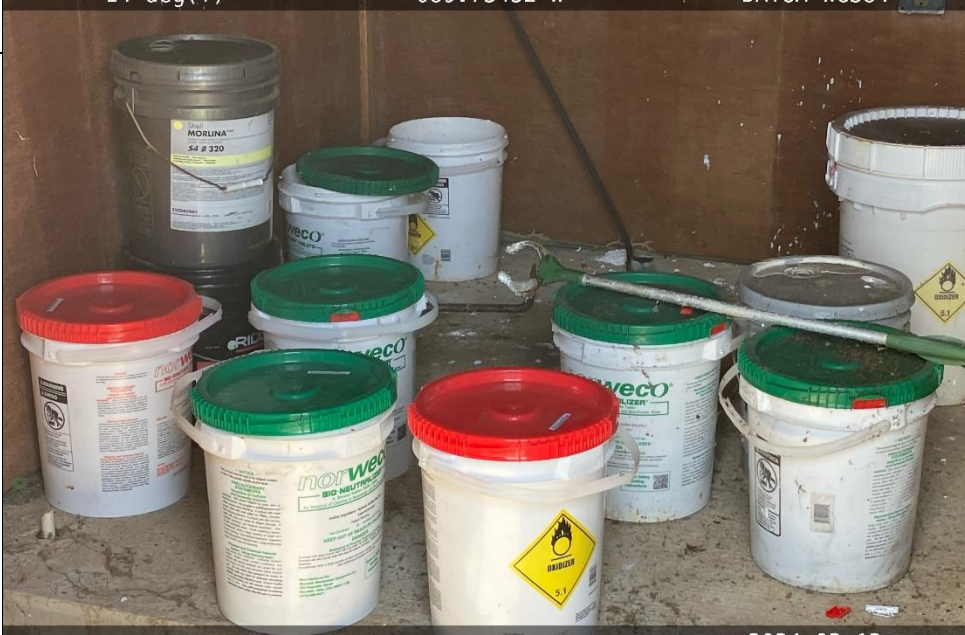
Facility Name: Memphis-Chapel Hill S.D. STP		Site Location: 9856 Bette Lu Drive Millington, TN		Tracking No.: TN0026361
Photo No. 9	Date 3-13-2024	DIRECTION 14 deg(T)	35.35295°N 089.73432°W	ACCURACY 5 m DATUM WGS84
<p>Description</p> <p>View of the stored treatment chemicals. It is recommended that the MSDS/SDS sheets for the chemicals housed in the storage shed on site be laminated and placed on the walls within the storage shed for easy access to pertinent safety information.</p>

It is also recommended that the MSDS/SDS sheets for the chemicals (photo 9) housed in the storage shed on site be laminated and placed on the walls within the storage shed for easy access to pertinent safety information.

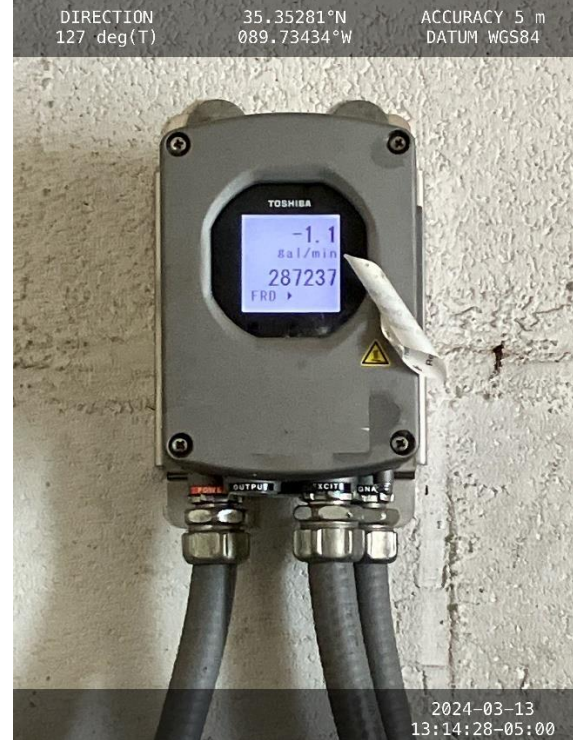
A digital flow meter is utilized at the plant to measure the effluent flow (photo 10). The meter measures the flow in Gallons Per Day (GPD). The flow is then converted to Million Gallons per Day (MGD) and recorded on the DMR.

Facility Name: Memphis-Chapel Hill S.D. STP		Site Location: 9856 Bette Lu Drive Millington, TN		Tracking No.: TN0026361
Photo No. 10	Date 3-13-2024	DIRECTION 127 deg(T)	35.35281°N 089.73434°W	ACCURACY 5 m DATUM WGS84
<p>Description</p> <p>View of the effluent digital flow meter.</p>
