RE: Third Year Wetland and Stream Monitoring Report
Bledsoe County Correctional Complex
Pikeville, Tennessee

**Third Year Wetland and Stream Mitigation Monitoring Report
Bledsoe County Correctional Complex
Pikeville, Bledsoe County, Tennessee
(DOA File/Permit 200502425)
(TDEC §401 Water Quality Certification 09.009)**

Project Overview

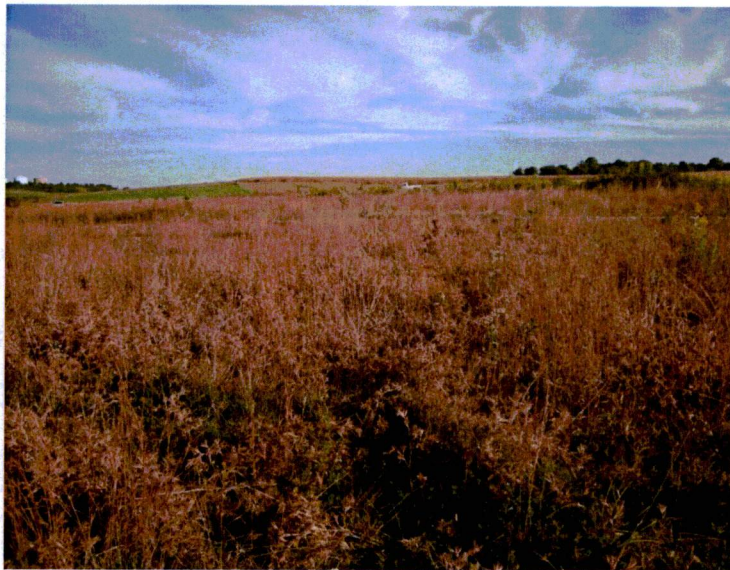
Photo 1.

Creation Area, Photo Reference Point C2: North

Comments: Corrective actions such as installing coir logs has helped a great deal to trap eroding soils and by doing so, provide a growth medium for planted and invasive vegetation.

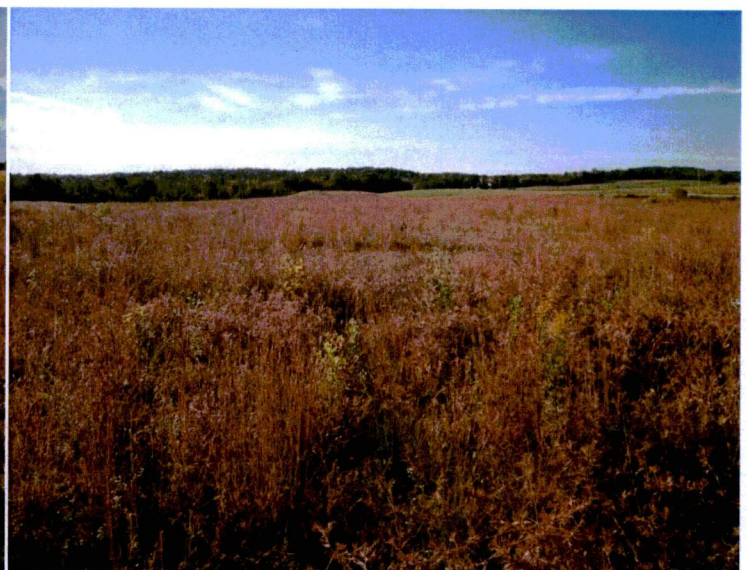
Photo 2.

Creation Area, Photo Reference Point C2: South

Comments: Because of this soil building, total herbaceous cover is now more than 87% in the creation area. This is a 33% increase since just last year.

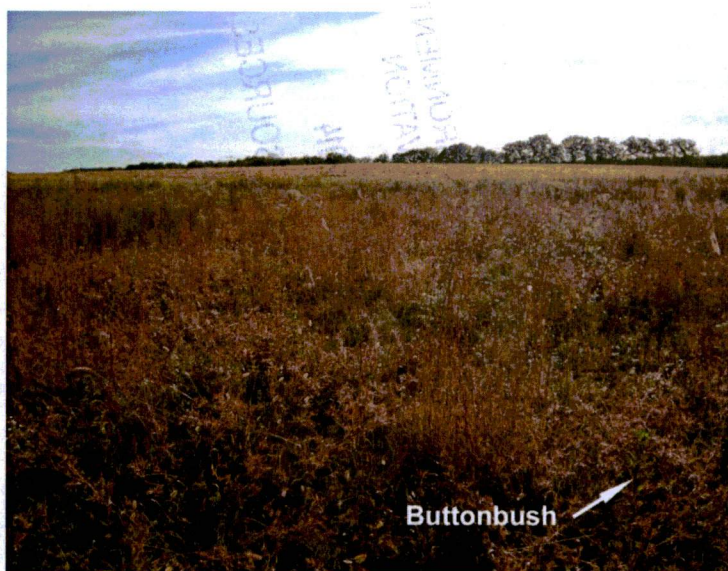
Photo 3.

Creation Area, Photo Reference Point C2: East

Comments: Soil accretion has helped to increase herb populations but planted woody species have struggled somewhat because of low soil fertility. Although they occur at an average rate of 340 stems/acre, many are still small in stature and sometimes difficult to find in the dense herbs.

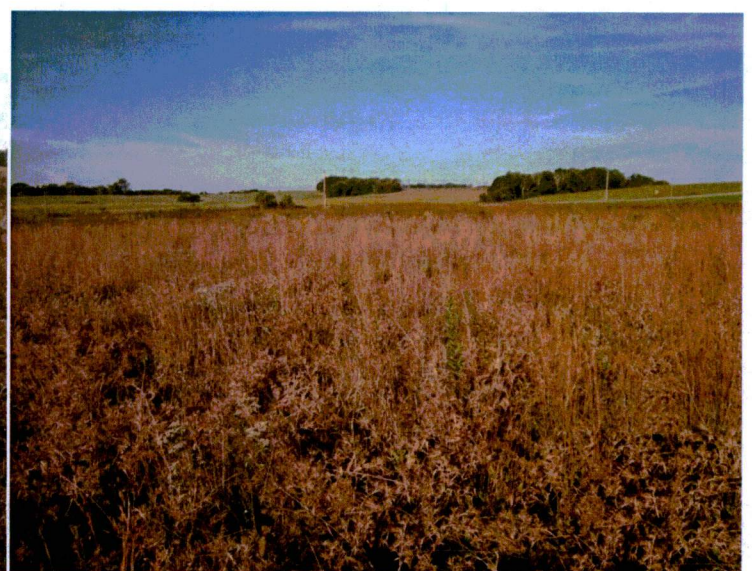
Photo 4.

Creation Area, Photo Reference Point C2: West

Comments: Sampling was delayed this year until early fall. Therefore, certain species that were dominant last year (when sampling was conducted in June) have been replaced by fall-flowering/fruited species, especially grasses. Broomsedge, a non-wetland grass was very prevalent in some areas.

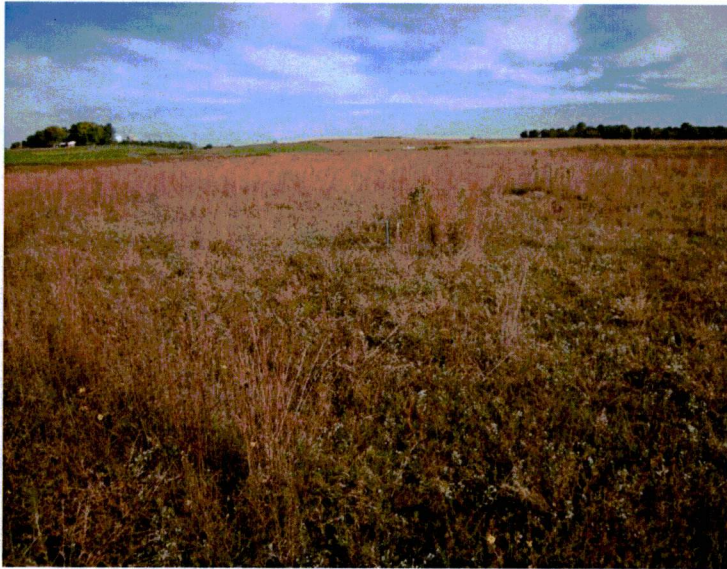
Photo 5.

Creation Area, Photo Reference Point C4: North

Comments: Stunted vegetation in this part of the site is primarily the result of low soil fertility, but seasonal ponding of concave surfaces also plays a role.

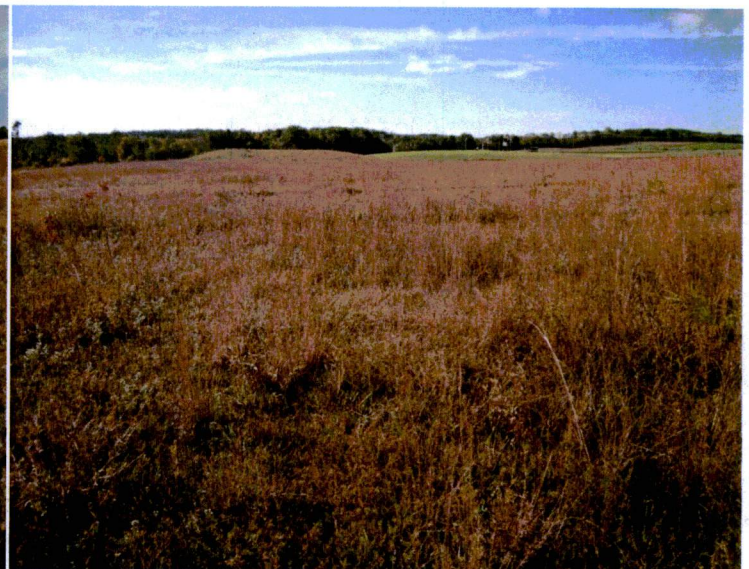
Photo 6.

Creation Area, Photo Reference Point C4: South

Comments: Parts of the creation area are wet in winter through early summer. By mid-summer and fall they dry significantly. Such locations typically contain a mixture of wetland and non-wetland species.

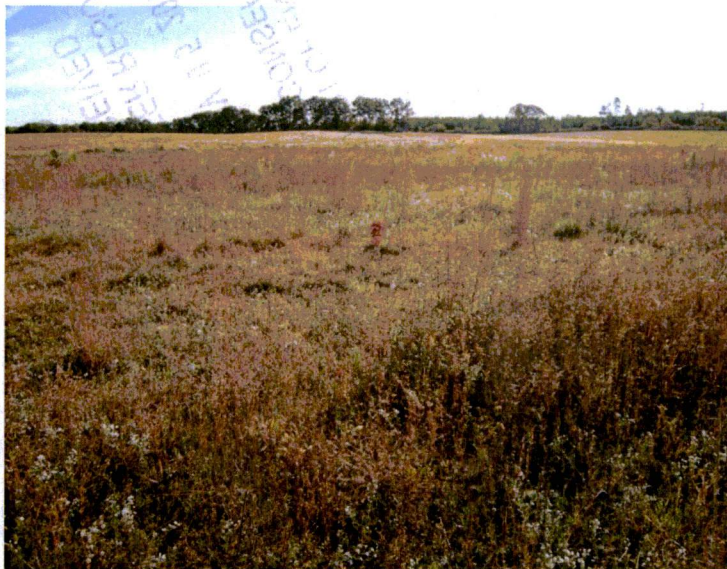
Photo 7.

Creation Area, Photo Reference Point C4: East

Comments: Despite dry fall conditions evidence of early-season surface ponding in this area included soil cracking, silt accumulation, and algal mats.

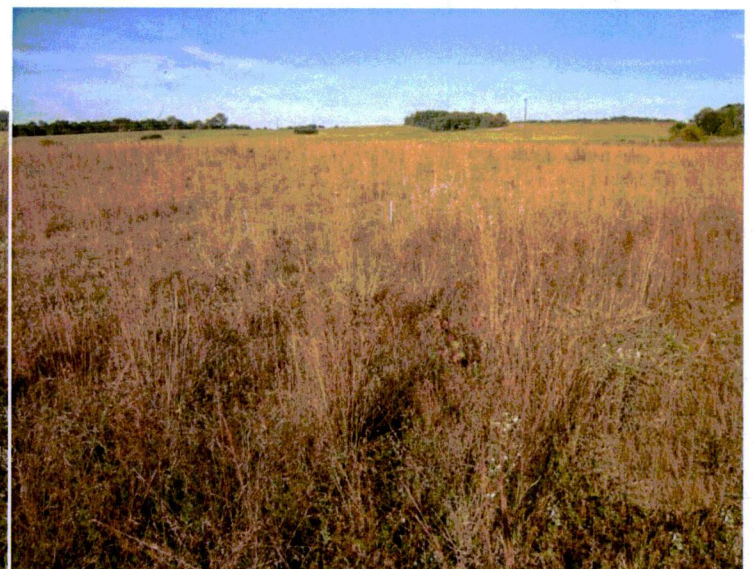
Photo 8.

Creation Area, Photo Reference Point C4: West

Comments: Crayfish burrows were noted here as well as in several other places scattered throughout the mitigation site.

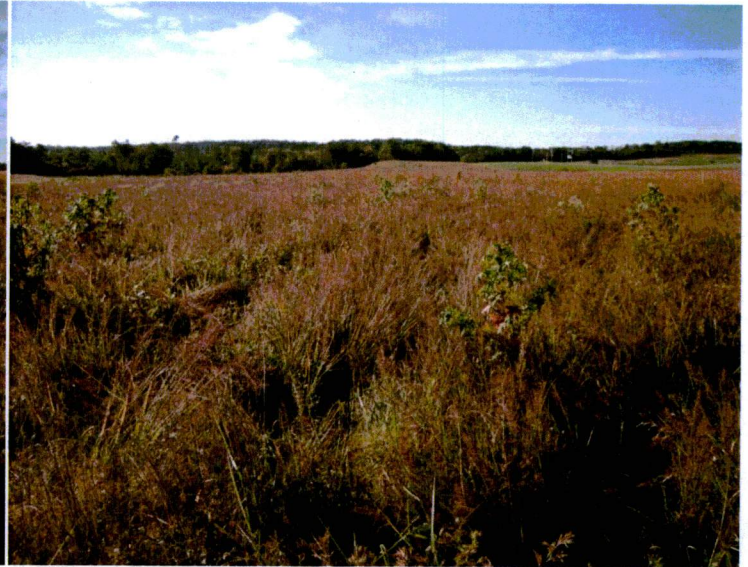
Photo 10.

Enhancement Area, Photo Reference Point E1: North

Comments: Dense stands of native and introduced grasses were found throughout each of the enhancement areas.

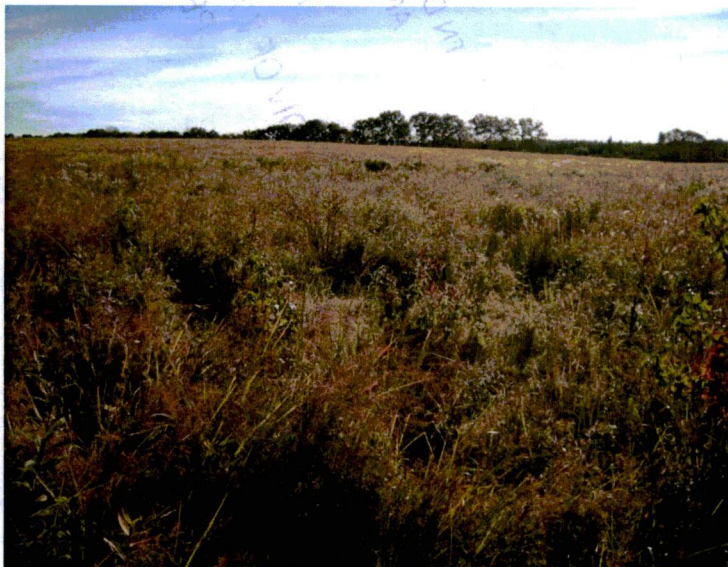
Photo 11.

Comments: Enhancement areas contain over 360 planted tree and shrub seedlings per acre but the establishment of the seedlings has proven difficult because of root competition from the sod-forming grasses. A number of sweetgum trees can be seen in this view.

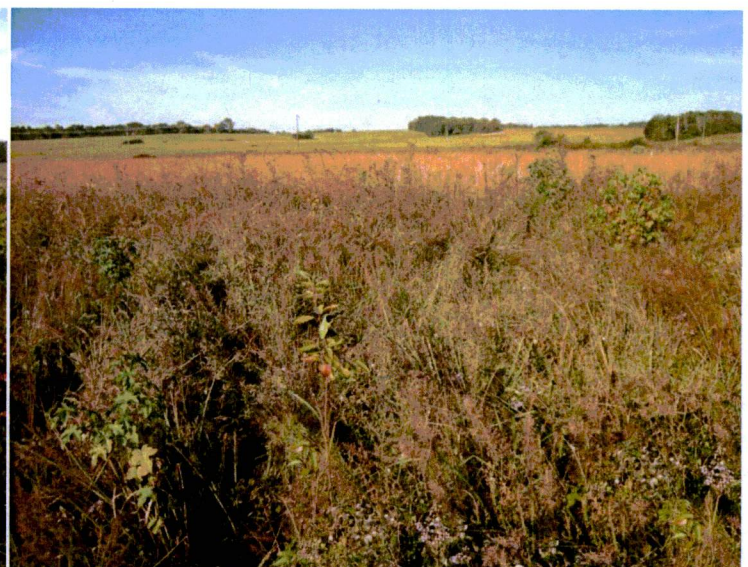
Photo 12.

Enhancement Area, Photo Reference Point E1: East

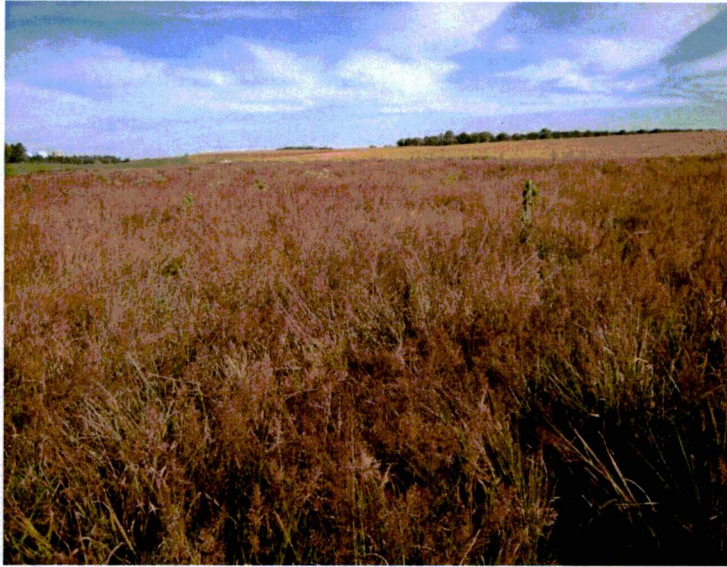
Photo 13.

Comments: This is a favored hunting area for northern harriers (marsh hawks).

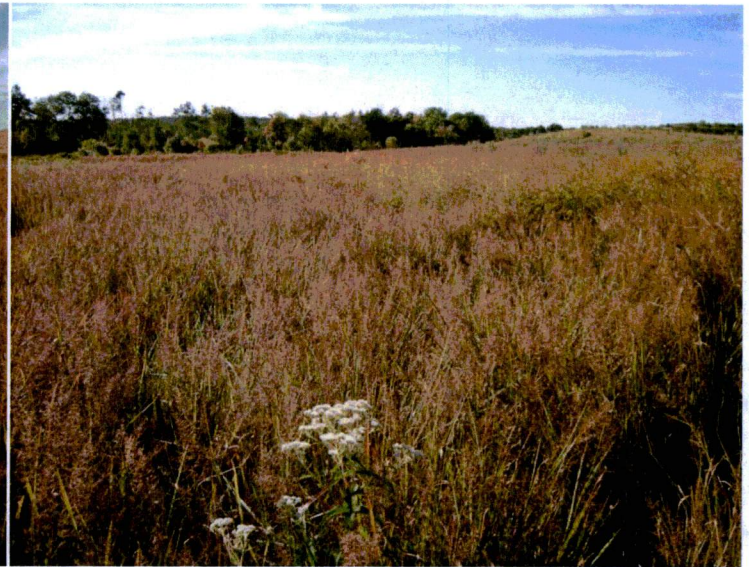
Photo 14.

Enhancement Area, Photo Reference Point E3: North

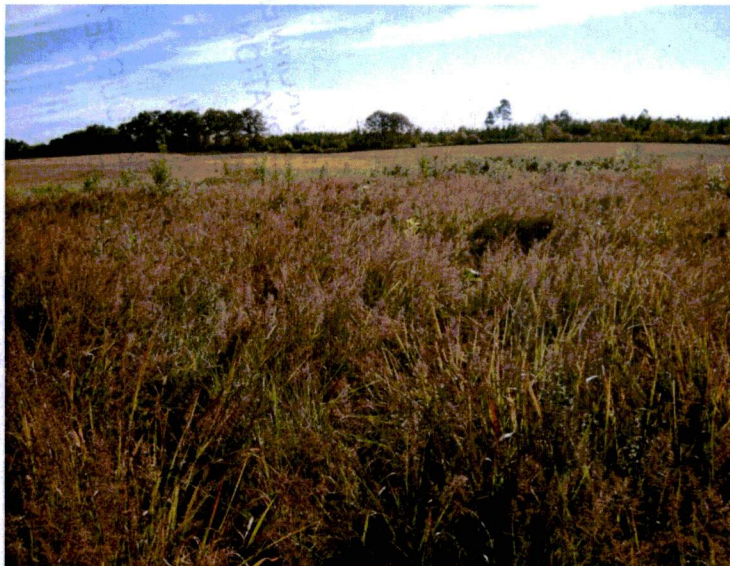
Photo 15.

Comments: Redtop panic grass tends to thrive in damp or wet soils with adequate sunlight. It will eventually be outcompeted by woody vegetation and more shade-tolerant herb-layer species.

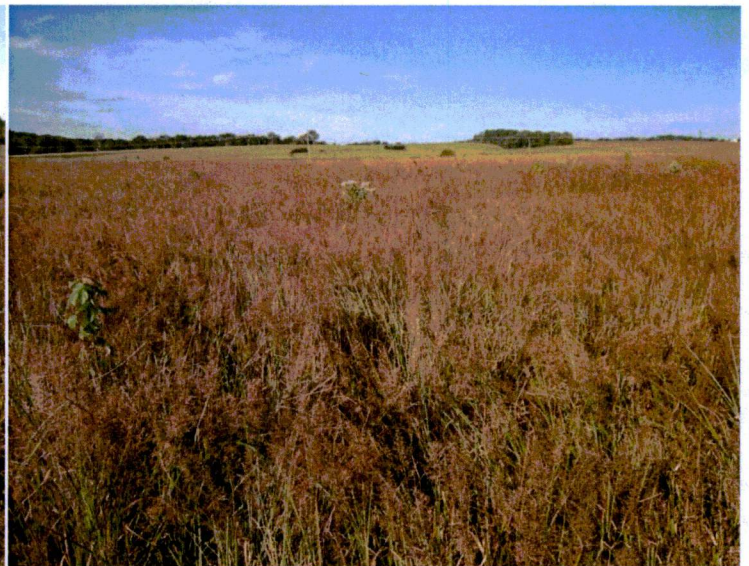
Photo 16.

Enhancement Area, Photo Reference Point E3: East

Comments: The tall, dense vegetation on the middle and southern portions of the enhancement area provide favored habitat for white-tail deer. Despite the wetness, numerous "deer beds" were observed.

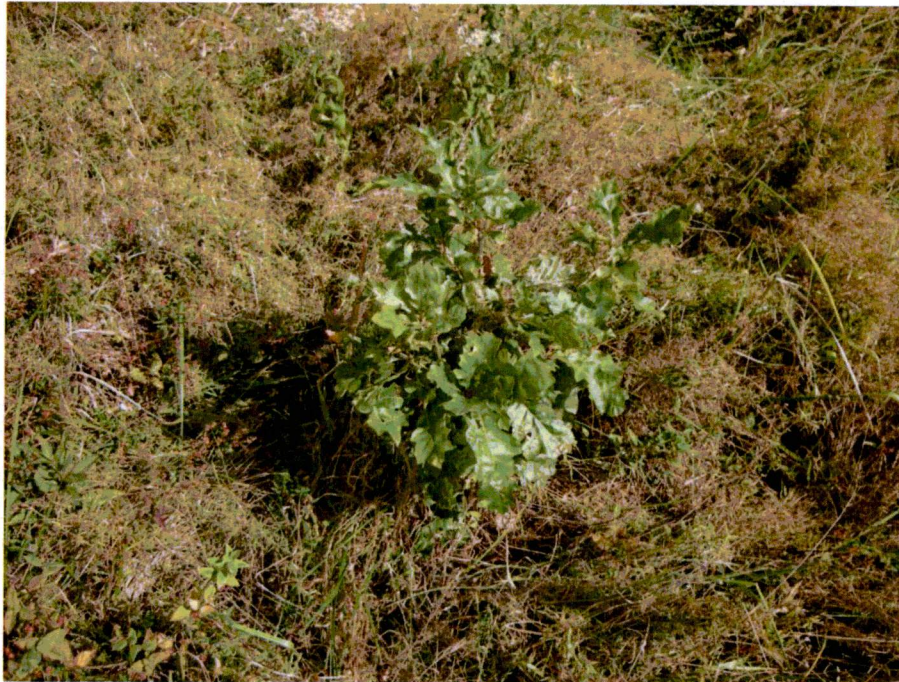
Photo 17. **Upland Buffer Zones:** Twenty-five ft-wide buffers, external to riparian buffers, were planted with upland oak species in order to provide extra protection to the restored streams. Areas were first mown to make planting easier. Current oak survivorship averages about 110 stems/acre. Naturally-invading woody species contribute just over an additional 110 stems/acre.

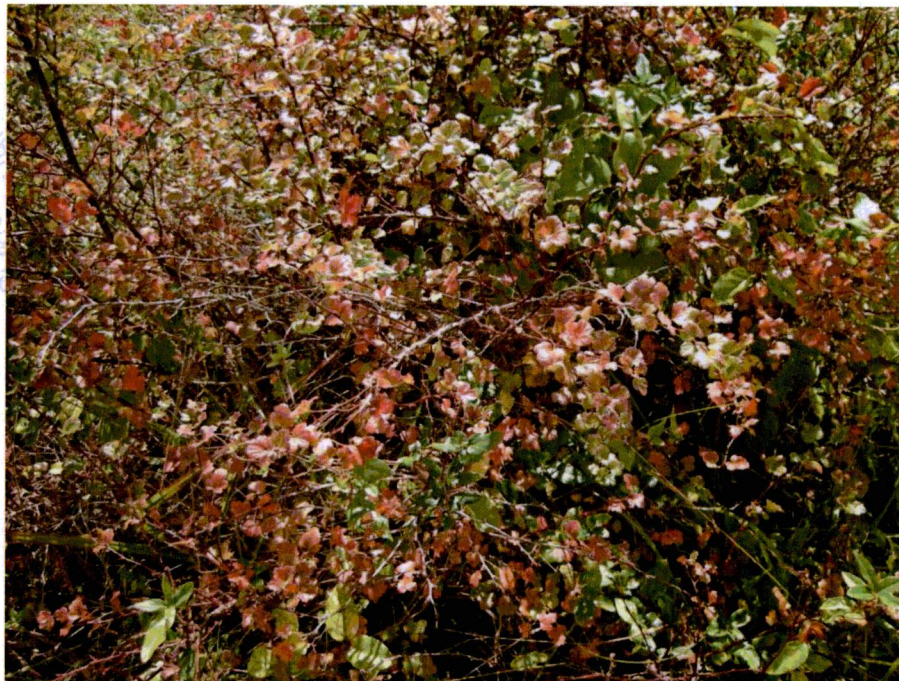
Photo 18. **Gooseberry Transplant Area:** Rare granite gooseberry shrubs, rescued from the prison construction site, and transplanted to the mitigation area in 2009, have survived and thus far appear to be doing relatively well. This year, however, we have noticed that invasive Japanese honeysuckle vines are beginning to strongly compete with some of the shrubs. Because they have become so entwined, there is little that can be done to release the gooseberries from the vines that threaten to overtake them. We will continue to monitor the situation. (In the photo above the gooseberries have red leaves and the Japanese honeysuckles have bright green leaves).

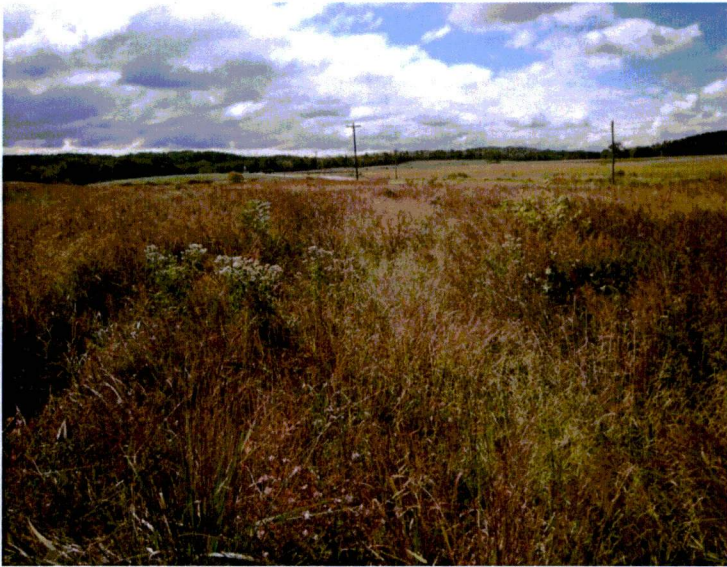
Photo 19.

Stream 1 Enhancement Area, Photo Reference Point 1:

Comments: At its upper end, Stream 1 bisects a portion of one of the site's wetland enhancement areas. Because of extreme wetness, planted woody vegetation is somewhat scattered.

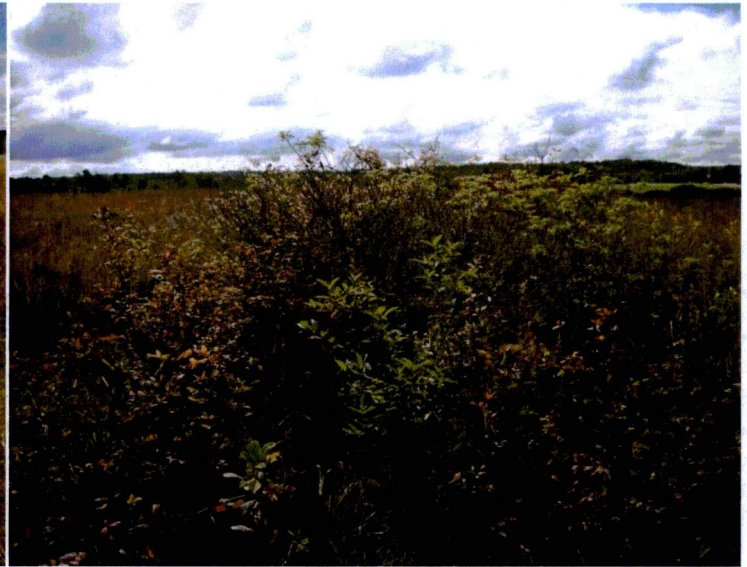
Photo 20.

Stream 1 Enhancement Area, Photo Reference Point 2:

Comments: One of the site's elderberries is visible here. It has expanded greatly in size since it was originally planted in December 2010. The dense riparian vegetation hides the channel from view.

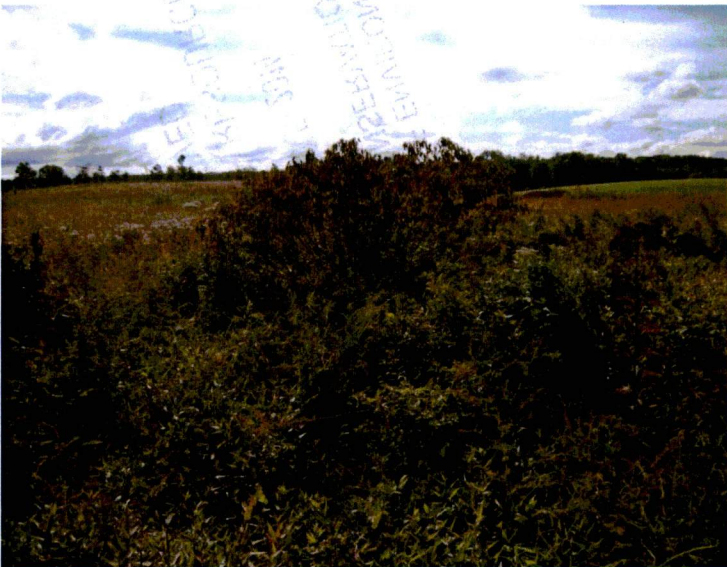
Photo 21.

Stream 1 Enhancement Area, Photo Reference Point 3:

Comments: As was often the case, this site contains both planted and naturally-occurring silky dogwood. Distinguishing between the two was not always possible in some areas.

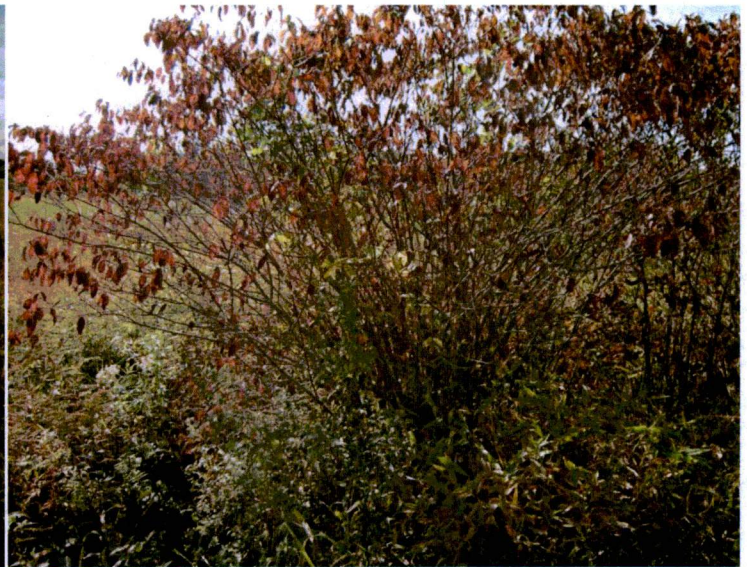
Photo 22.

Stream 1 Enhancement Area, Photo Reference Point 4:

Comments: Also, because of the colonial nature of many of the planted shrubs, it was very difficult to determine whether performance standards were being met given the high number of live stems present. Counting individual stems was impractical so counts were based on average number of live sprouts per 10 ft of plant length. Silky dogwoods, for example, were found to contain an average of 35 sprouts per 10 ft of shrub length.

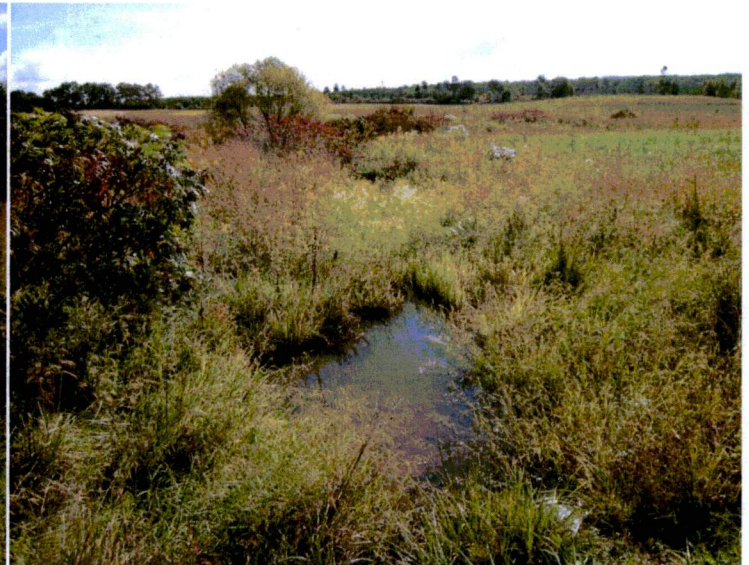
Photo 24.

Dominant Vegetation: winged sumac (Facu), black willow (Obl), rice cut grass (Obl), soft rush (Facw)

Comments: Stream Segment 2 is also well-stabilized and supports a high density of herbs as well as planted and naturally invasive woody species. The plunge pool in the foreground lies just downstream of two culverts which pass beneath SR 301. It gives a much exaggerated impression of the size of the waterway.

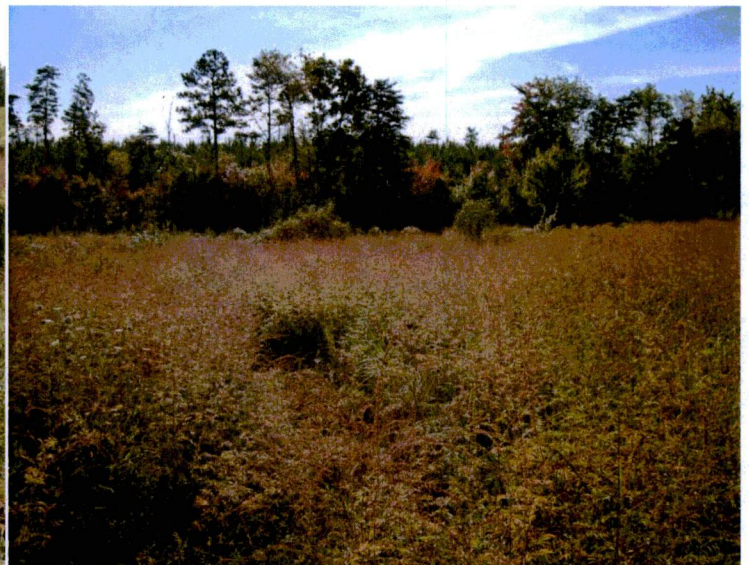
Photo 26.

Stream 1 Enhancement Area 3 , Photo Reference Point 1:

Comments: By contrast, Stream Segment 3 had the lowest density at 73 stems/100 ft of stream. Again, the plunge pool gives a false impression about the size of the waterway. Fish, frogs, and snapping turtles were observed at this location.

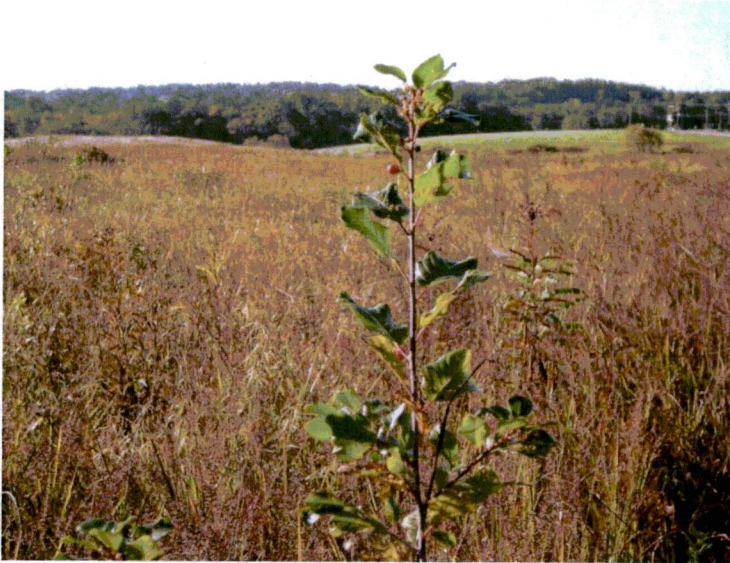
Photo 27.

Photo Supplement, Wetland Enhancement Area Maintenance:

Comments: During one of the planting efforts, one of the nursery suppliers improperly included glossy false buckthorn among the wetland plants provided. Unfortunately this species has proven to be a noxious weed in other parts of the US. Although only a few dozen were planted, they pose a major threat to the success of the mitigation. They should be identified during next growing season (2015) and treated with herbicide before they spread.

Because of the occurrence of invasive glossy false buckthorn shrubs in several of the stream mitigation zones we strongly recommend that a regimen of herbicide applications begin in the spring of 2015. The buckthorn is capable of rapidly colonizing open, moist or wet areas and supplanting desirable native vegetation. Since current population size is estimated at only a few dozen plants, control should be readily achievable, but it is likely that several treatments will be required. Two other invasive woody species have also been identified on the mitigation site. These include autumn-olive and multiflora rose. Although both have the ability to spread rapidly, they are not considered wetland species and would be most problematic in uplands and buffer zones adjacent to the mitigation areas. Because of this they would not be primary targets for control, but spraying with herbicide should be given consideration.

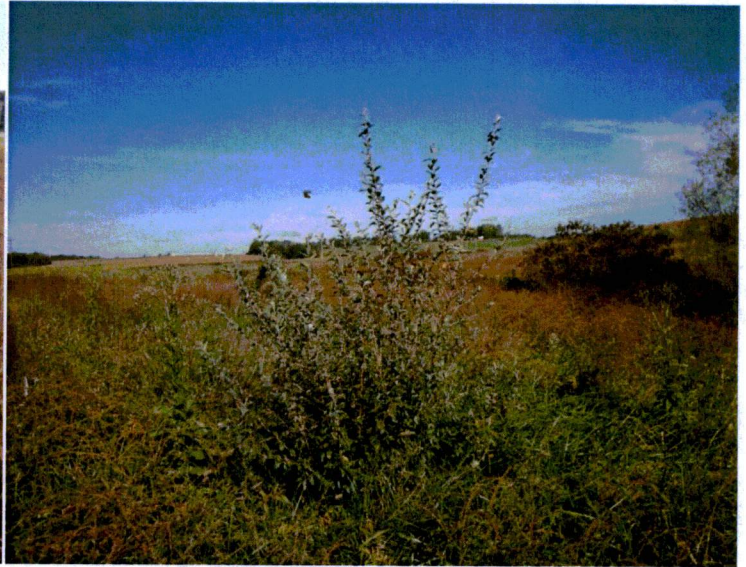
Photo 28.

Photo Supplement, Upland Buffer Zone Area Maintenance:

Comments: Another problem species is autumn-olive. While not an invader of wetlands, a small number of individuals were found adjacent to wetlands within upland oak buffer zones. These could be treated with herbicide in conjunction with false buckthorn. A routine maintenance program started next spring will circumvent the need for a more extensive herbicide spraying regimen in the future.

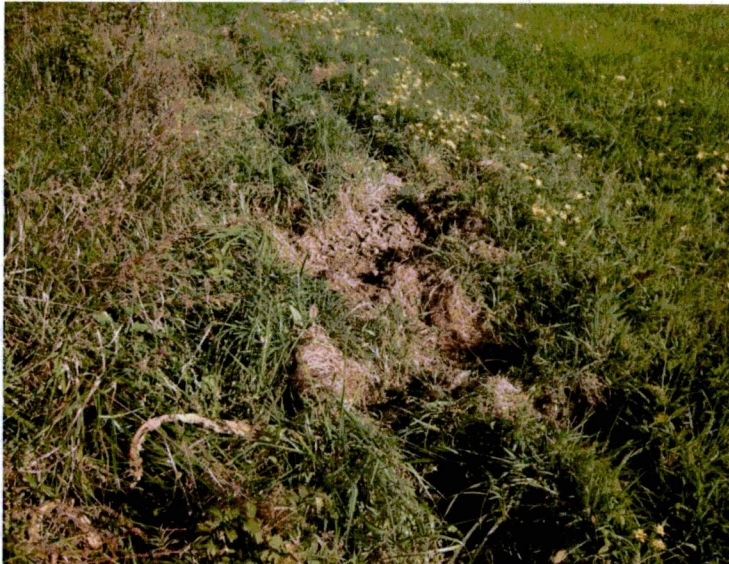
Photo 29.

Photo Supplement, Wetland Enhancement Area:

Comments: Another potential threat to the mitigation area is rooting by wild hogs. This photo was taken at the edge of a field lying just to the east of the wetland enhancement area. Some disturbance has been observed in the enhancement zone but so far it has been minimal.

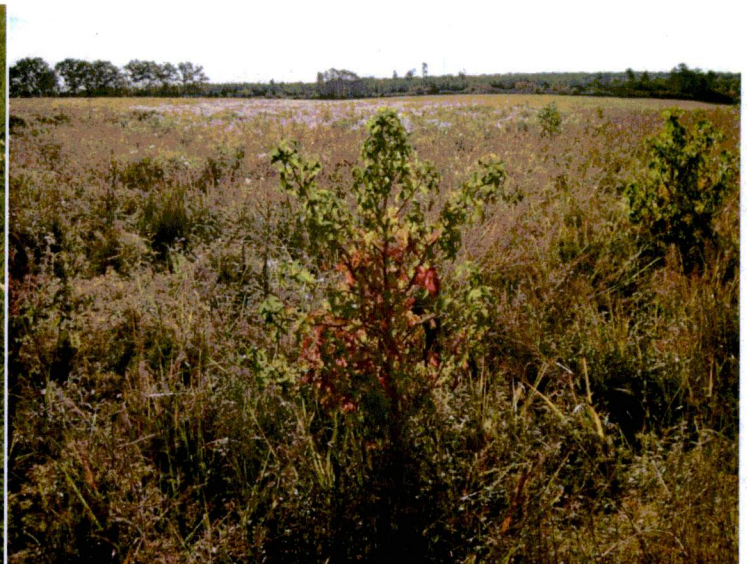
Photo 30.

Photo Supplement, Wetland Enhancement Area:

Comments: Because of better soil fertility within the enhancement area, those planted trees that have managed to outcompete the dense layer of herbs, are now approaching 4 ft tall.

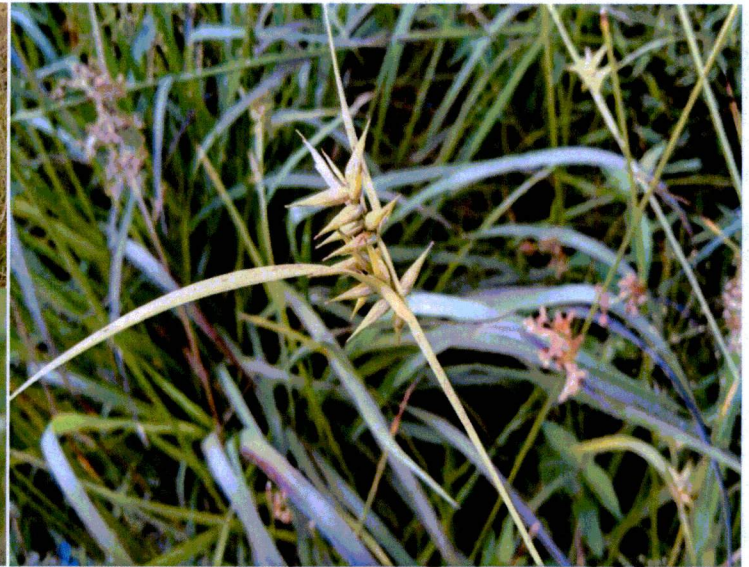
Photo 32.

Comments: The BCCX wetland mitigation property is noteworthy since it contains four species of plants that are very rare in TN. This means that long-term protection of the site is important for the people of the state. The rarest is the grass-like brown bog sedge. It is listed by TDEC as "endangered" and there are fewer than five known occurrences statewide.
