**Application for Aquatic Resource Alteration Permit (ARAP) & State §401 Water Quality Certification**

Site or Project Name: <b>Carothers Crossing Phase 5B</b>		Nearest City, Town or Major Landmark: <b>Cane Ridge Park</b>	
Street Address or Location (include zip): <b>7211 Carothers Road, Nolensville, TN 37135</b>			
County(ies): <b>Davidson</b>		MS4 Jurisdiction: <b>Nashville</b>	Latitude (dd.dddd): <b>35.9834</b>
			Longitude (dd.dddd): <b>-86.6086</b>
Resources Proposed for Alteration: <input checked="" type="checkbox"/> Stream / River <input type="checkbox"/> Wetland <input type="checkbox"/> Reservoir			
Name of Water Resource (for more information, access <a href="http://tdeconline.tn.gov/dwr">http://tdeconline.tn.gov/dwr</a> ): <b>Unnamed Drain to East Branch Hurricane Creek</b>			
Brief Project Description (a more detailed description is required under Section 8): <div style="text-align: right;">Installation of a minor road crossing on Badric Drive (35.9834, -86.6086).</div>

# **Carothers Crossing Phase 5B - Proposed Road Crossing - Badric Drive**

**CAROTHERS CROSSING - PHASE 5B  
 PROPOSED CROSSING  
 PICTURE LOCATION EXHIBIT  
 SCALE: 1" = 30'**

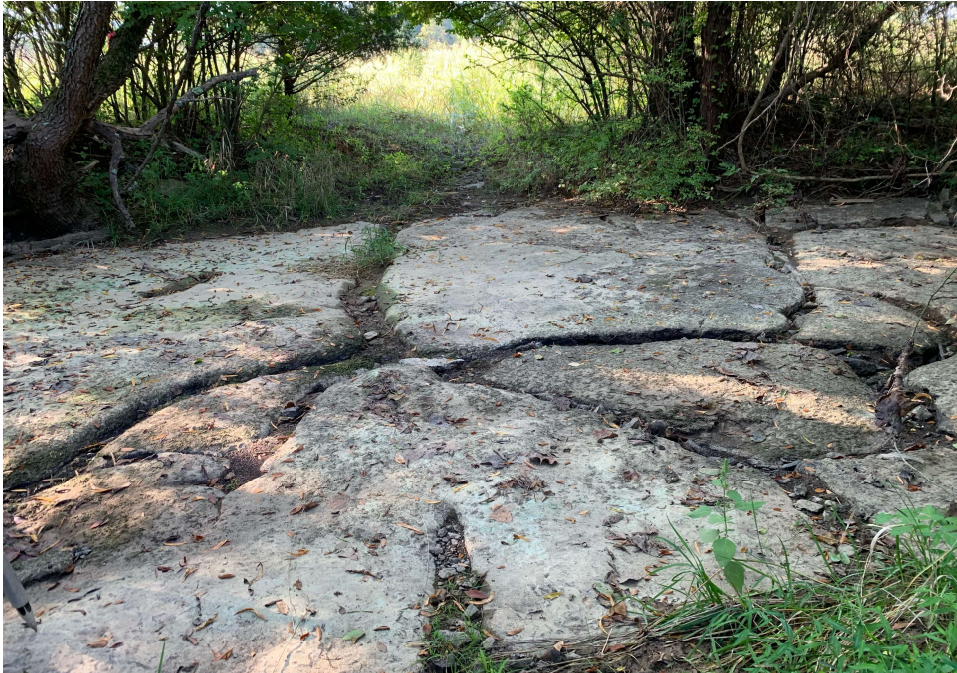
**1. Facing Right Bank (Southerly) [35.9835°, -86.6086°]**

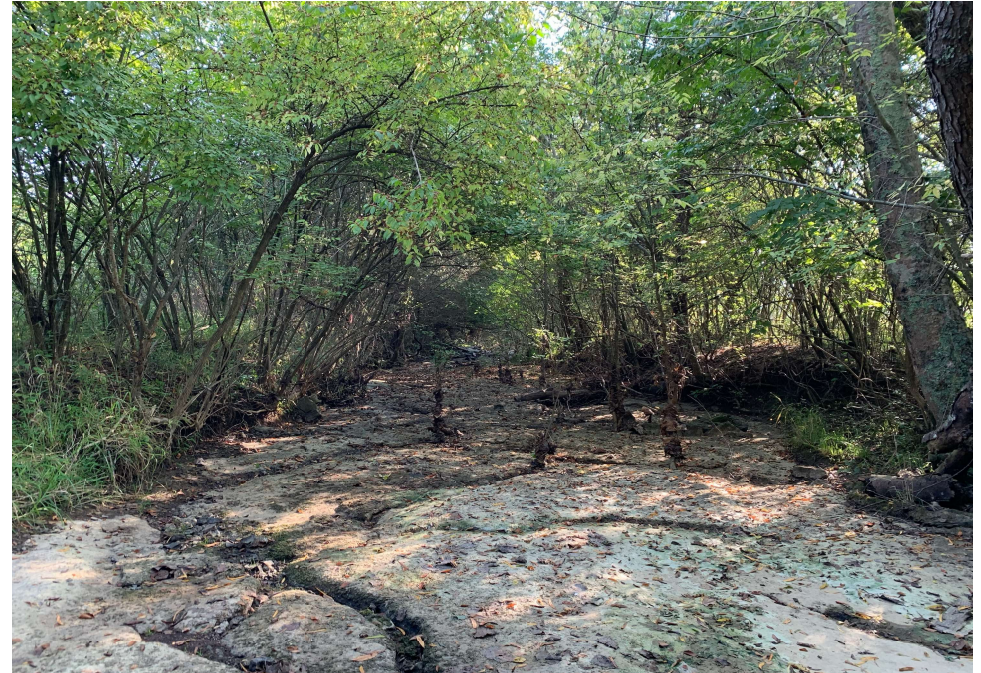
**2. Facing Downstream (Easterly) [35.9834°, -86.6087°]**

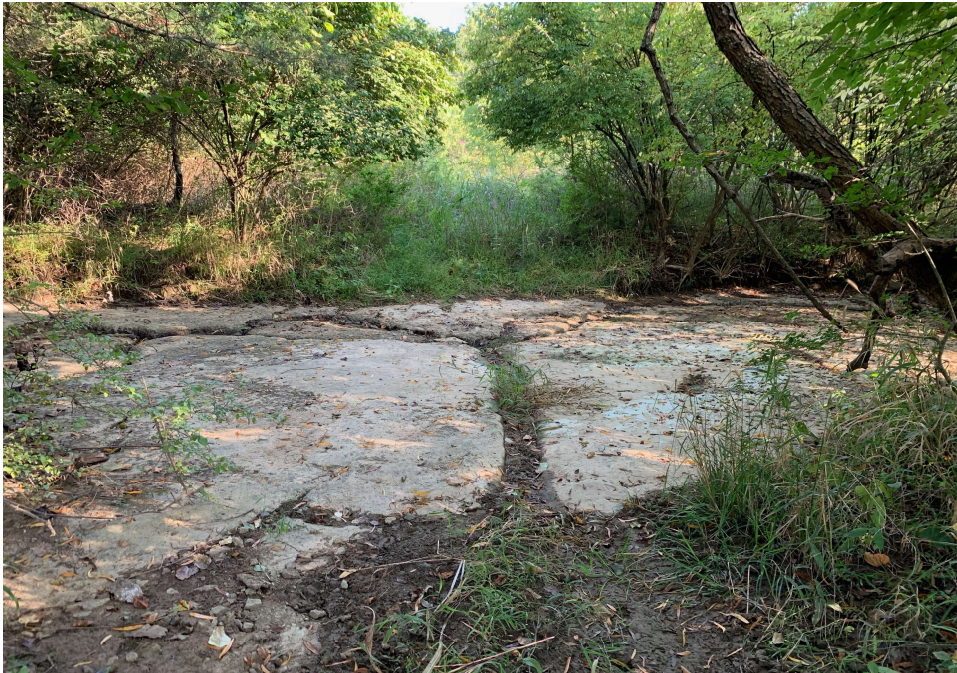
**3. Facing Left Bank (Northerly) [35.9834°, -86.6086°]**

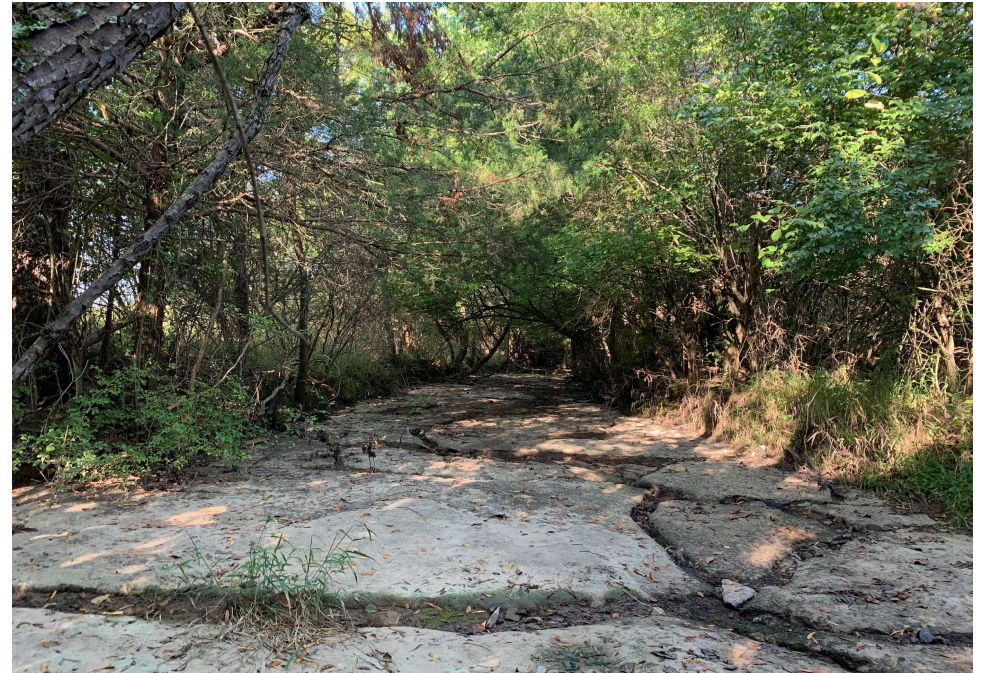
**4. Facing Upstream (Westerly) [35.9835°, -86.6085°]**

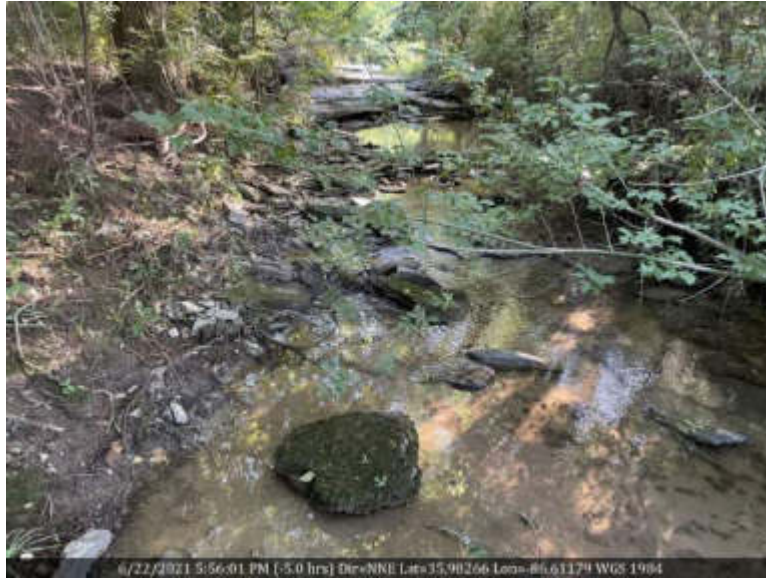
1 View of D-1 entering site, facing upstream/west.

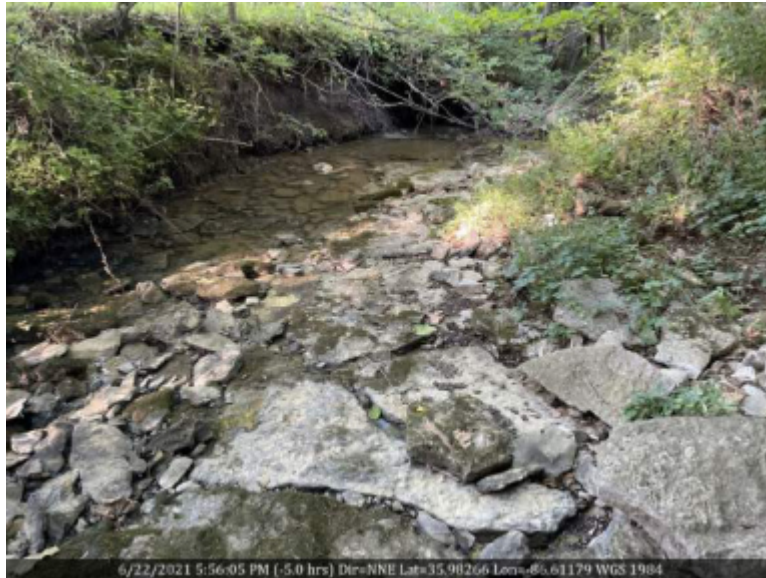
2 View of D-1 entering site, facing downstream/east.

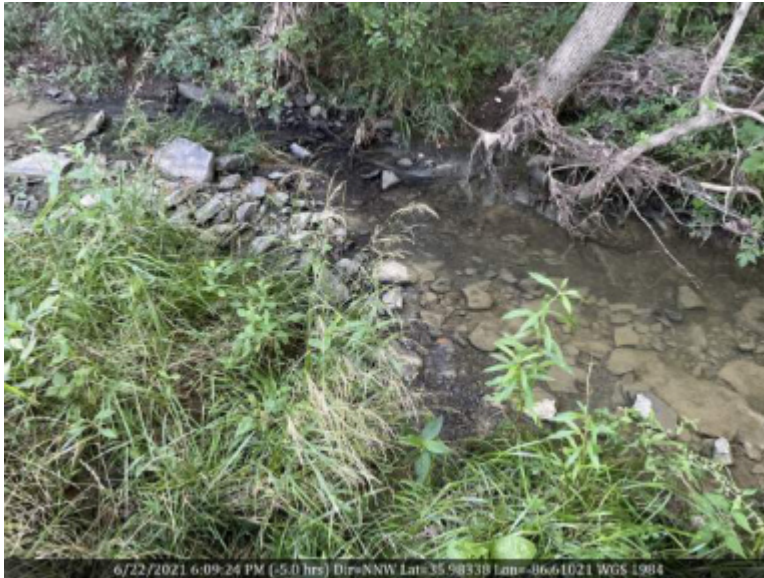
4 View of D-1 mid-reach with D-2 confluence in image foreground (downstream/east to image right).

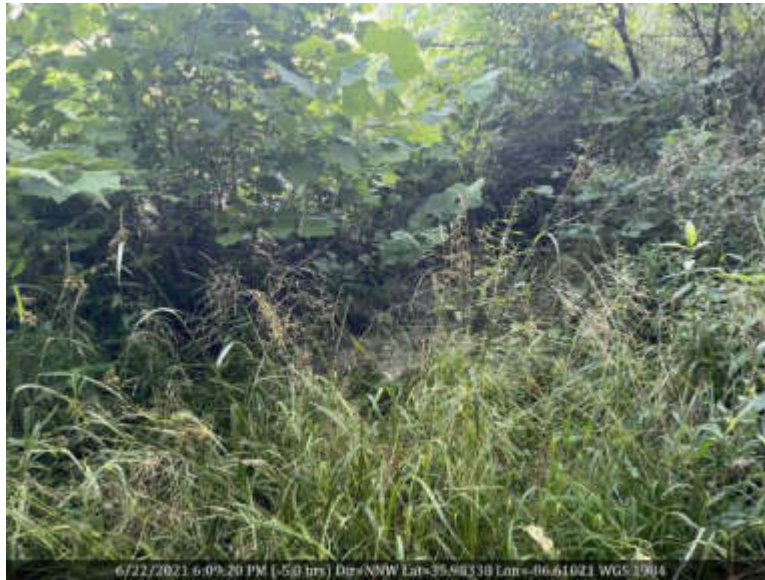
5 View of heavily vegetated D-2 at D-1 confluence, facing upslope/south.

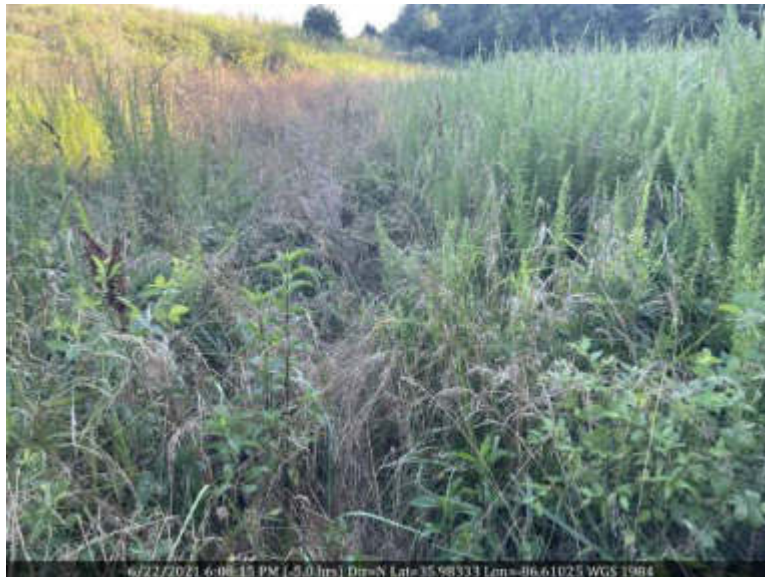
6 View of heavily vegetated D-2 lower reach, facing upslope/southwest.

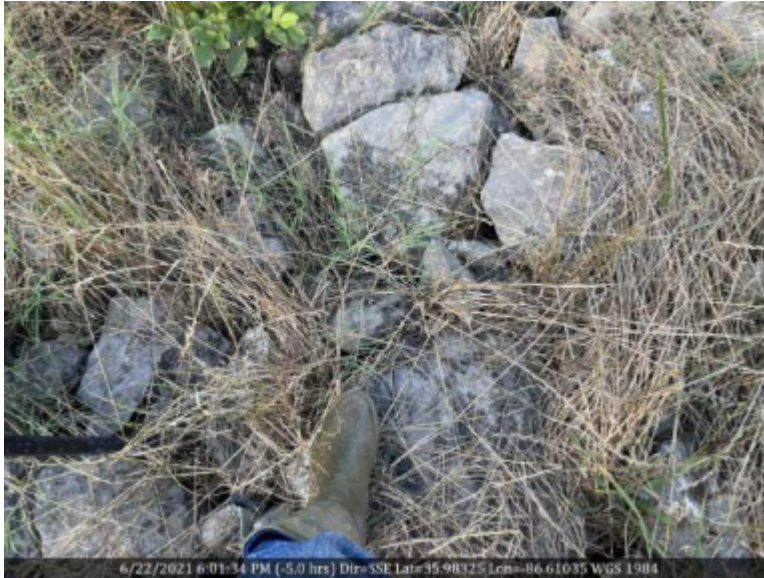
9 View of D-2 mid-reach substrate, facing down.

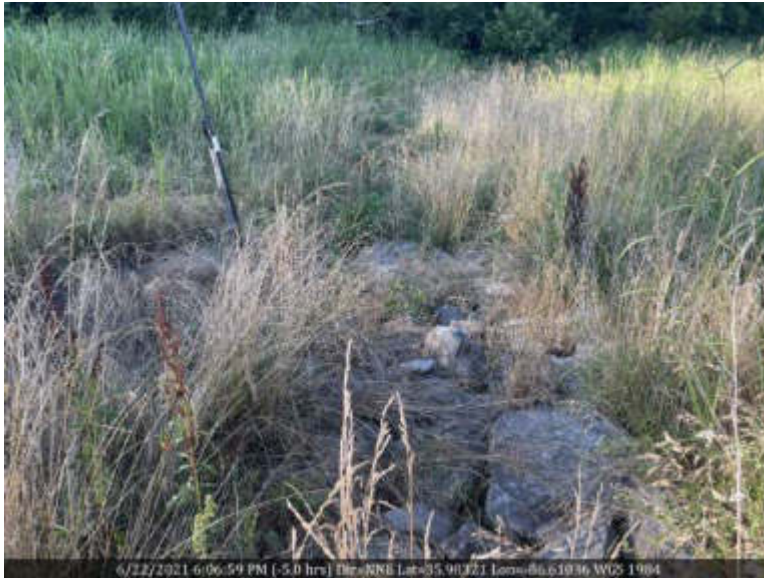
10 View of D-2 upper reach with rip rap substrate, below detention pond outlet, facing downslope/northeast.

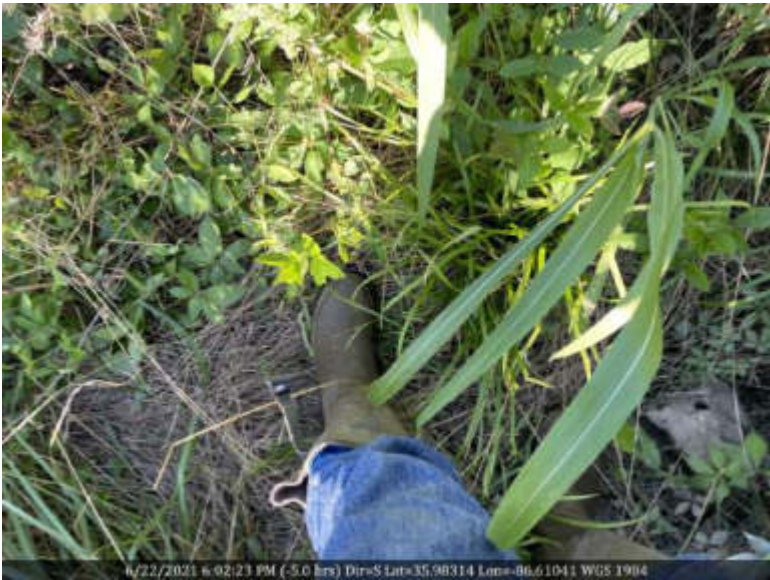
13 View of substrate and vegetation in D-1 below culvert outlet, facing down.

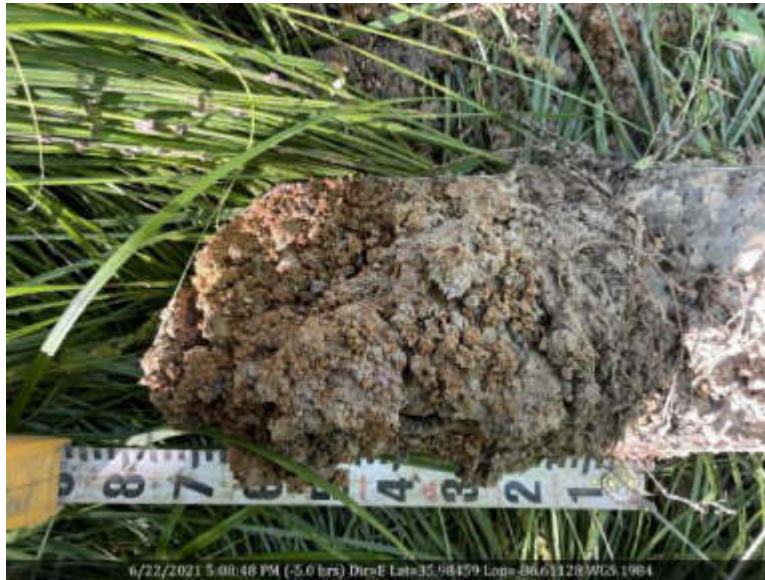
21 View of soil profile at WTL-B sample pit, facing down.

Depth (Inches)	Matrix		Redox Features				Texture	Remarks
	Color (moist)	%	Color (moist)	%	Type*	Loc**		
0-6	2.5Y 5/1	85	5YR 4/6	15	C	PL/M	silty clay	
6-10	5YR 4/6	90	2.5Y 4/1	10	D	M	silty clay	
10-12+	5YR 4/6	100					clay

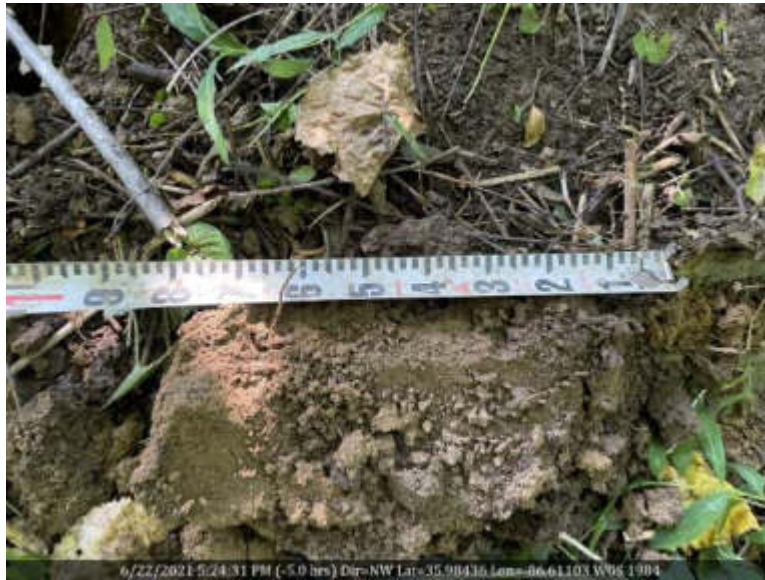
23 View of soil profile at UPL-B.

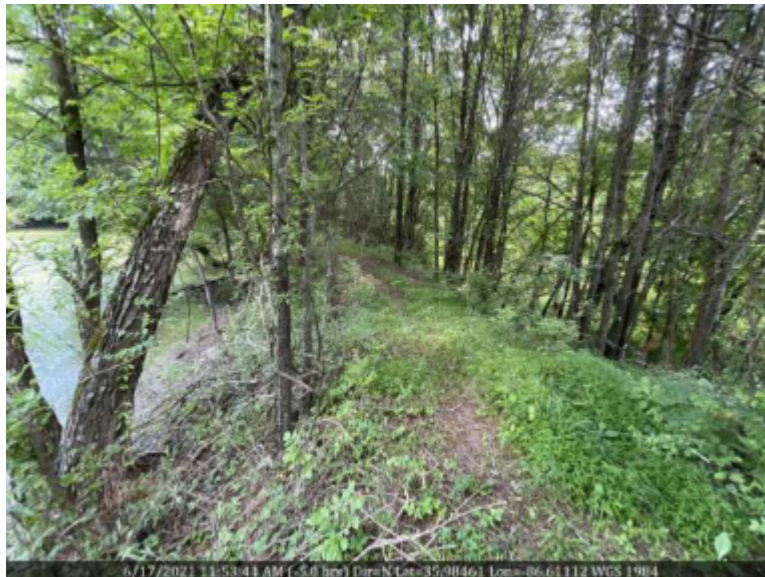
24 View of steep, artificial pond embankment separating Pond ISOPND-A from WTL-B, facing northeast/downslope to image right.

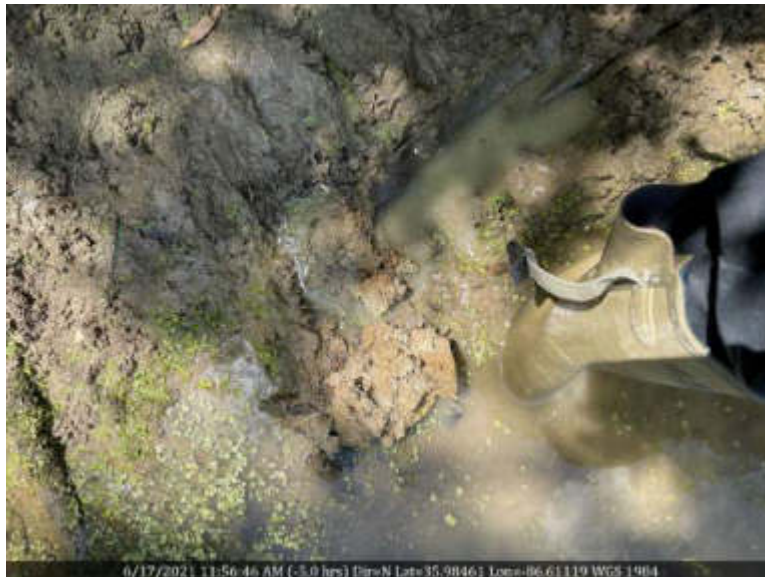
26 View of clay liner in ISOPND-A.

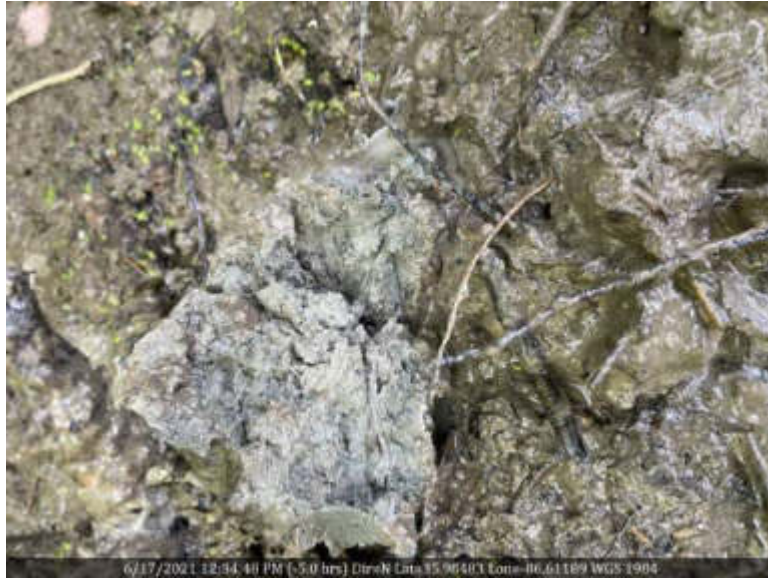
33 View of clay liner from upper portion of ISOPND-B, facing down.

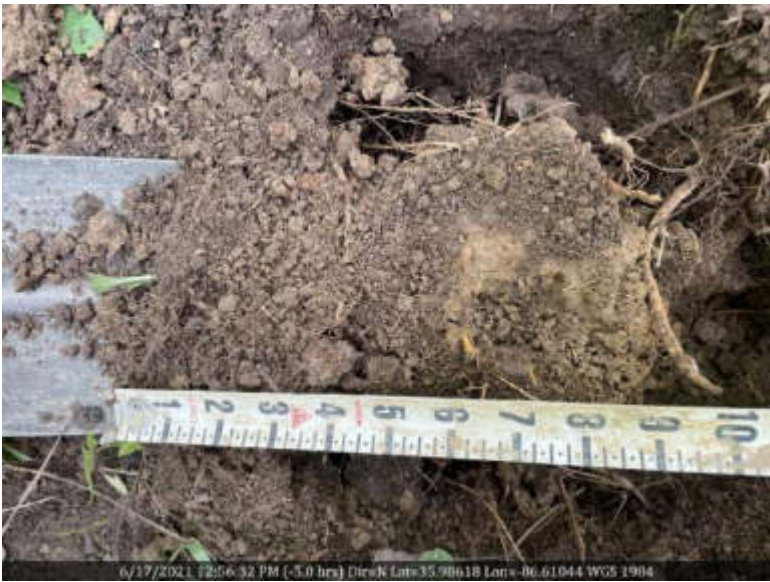
42 View of WTL-A soil profile, facing down.

Depth (Inches)	Matrix		Redox Features				Texture	Remarks
	Color (moist)	%	Color (moist)	%	Type*	Loc**		
0-2	10YR 3/2	95	7.5YR 4/4	5	C	PL/M	silt loam	
2-8	10YR 4/2		7.5YR 4/6	8	C	M	silt loam	Mn Masses
8-11	10YR 5/4		7.5YR 4/6	5	C	M	silty clay loam

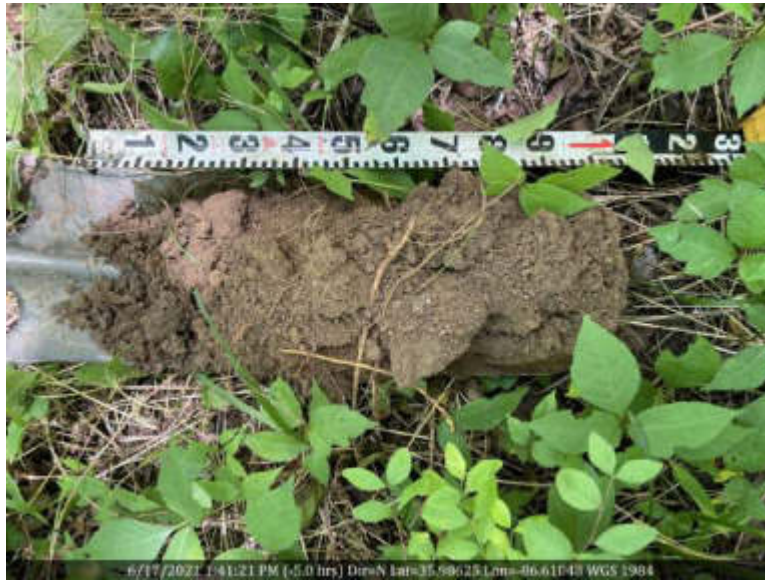
45 View of soil profile at Upland A sample pit.

Depth (Inches)	Matrix		Redox Features				Texture	Remarks
	Color (moist)	%	Color (moist)	%	Type*	Loc**		
0-12	10YR 3/4	100					silt-loam
