Notice of Intent (NOI) for General NPDES Permit for Stormwater Discharges from Construction Activities (TNR100000)

Site or Project Name: Black Creek Phase 14-Access Road
NPDES Tracking Number: TNR
Street Address or Location: Upper River Gorge Drive
Construction Start Date: 9/30/2021
Estimated End Date: 12/31/2021
Site Description: Land Disturbance
Latitude (dd.dddd): 34.9994
Longitude (-dd.dddd): -85.4261
County(ies): Hamilton MS4 (if applicable): City of Chattanooga Acres Disturbed: 6
Check box if a SWPPP is attached: [X] Check box if a site location map is attached: [X] Total Acres: 8
Streams [] Wetlands [X]
Has a jurisdictional determination been made by the USACE or EPA identifying waters of the United States?: Yes [X] No []
Note: if yes, attach the jurisdictional determination
If an Aquatic Resource Alteration Permit (ARAP) has been obtained for this site, what is the permit number? NR(S) N/A
Receiving waters: Pope Creek, Wauhatchie Branch, Unnamed Tributary to Black Creek

Appendix D:
Figures

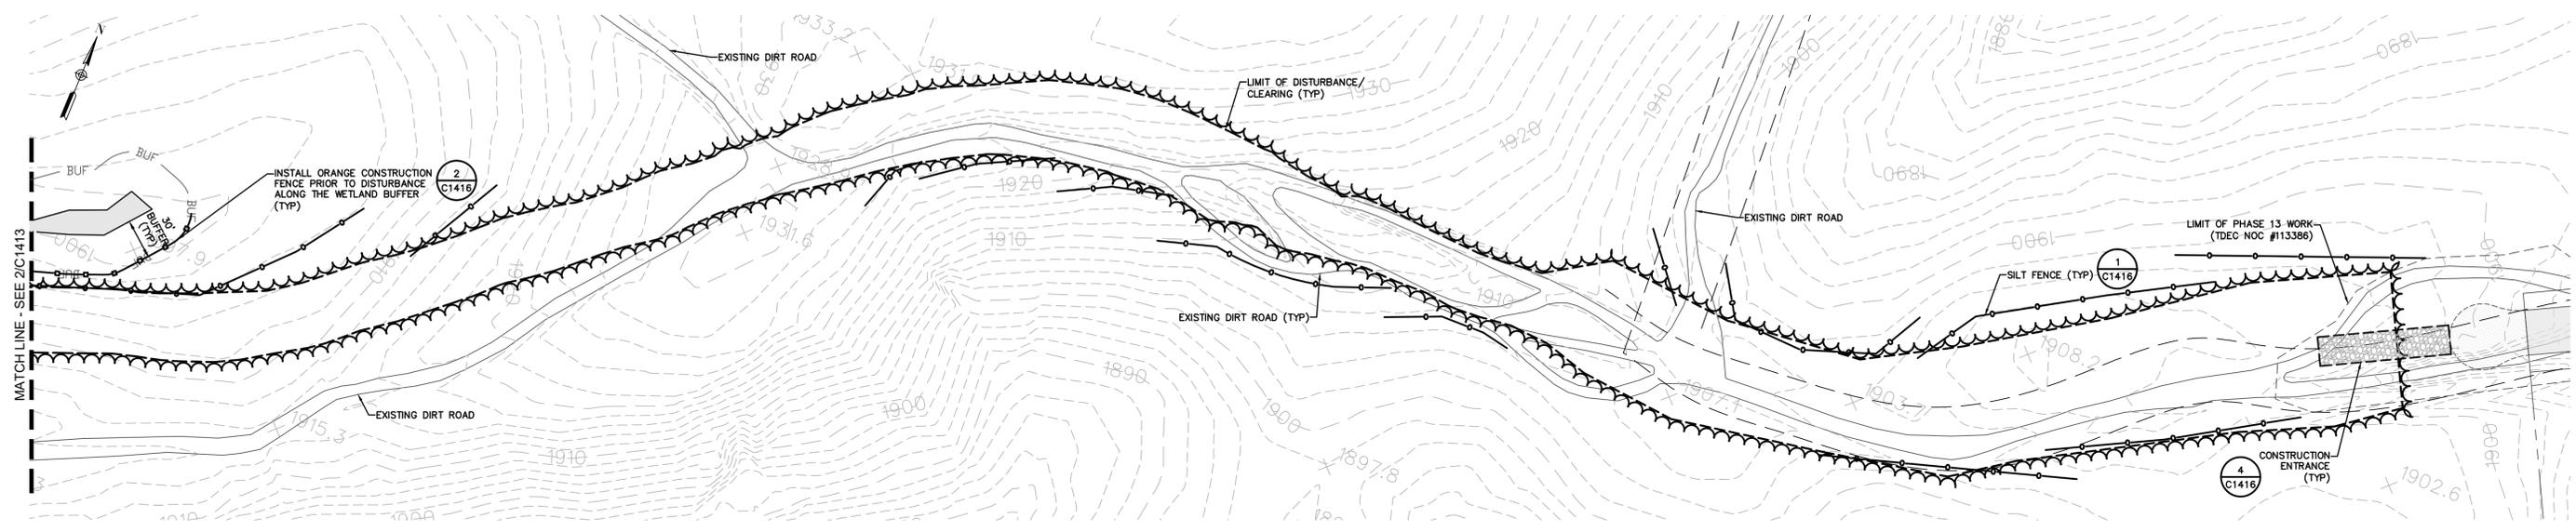
1 EXISTING CONDITIONS AND INITIAL EROSION & SEDIMENT CONTROL PLAN
SCALE: 1"=60'

- INITIAL CONSTRUCTION SEQUENCING NOTES:**
1. PRIOR TO COMMENCING ANY CLEARING, GRUBBING, EARTHWORK ACTIVITIES, ETC. AT THE SITE, THE CONTRACTOR SHALL FLAG THE WORK LIMITS AND SHALL INSTALL TEMPORARY EROSION AND SEDIMENT CONTROL MEASURES (I.E. SILT FENCES, TREE PROTECTION/BARRIER FENCES, STABILIZED CONSTRUCTION ENTRANCES, STORM DRAIN SEDIMENT FILTERS, DRAINAGE DITCH SEDIMENT FILTERS, ETC.) INDICATED ON THE INITIAL EROSION AND SEDIMENT CONTROL PLANS. TEMPORARY EROSION AND SEDIMENT CONTROL MEASURES MUST BE CONSTRUCTED, STABILIZED, AND FUNCTIONAL BEFORE SITE DISTURBANCE BEGINS WITHIN THEIR TRIBUTARY AREAS.

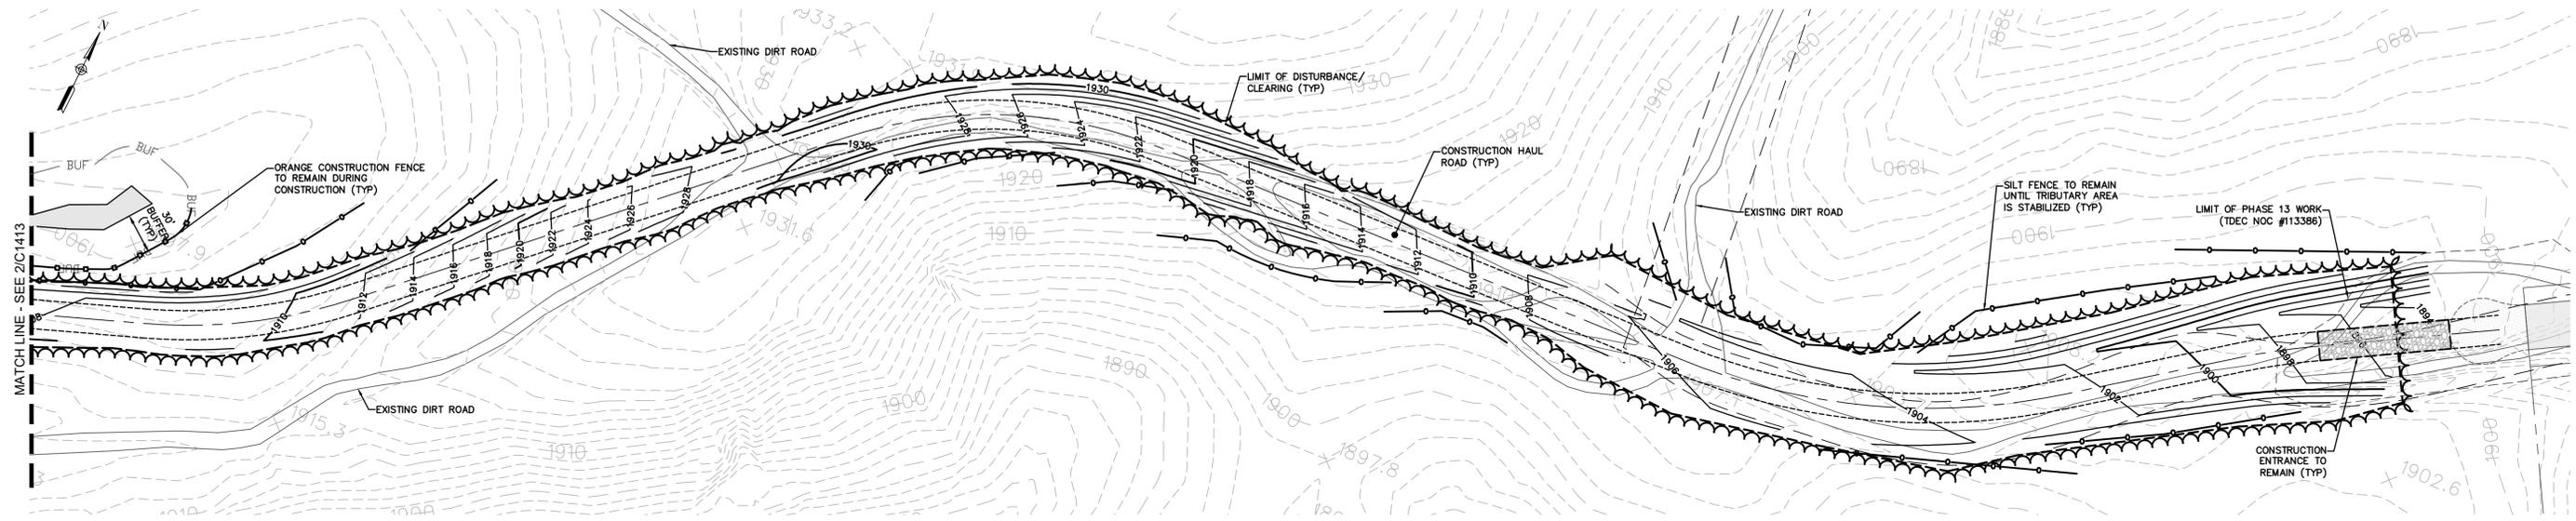
1 GRADING AND INTERMEDIATE EROSION & SEDIMENT CONTROL PLAN
SCALE: 1"=60'

INTERMEDIATE CONSTRUCTION SEQUENCING NOTES:
1. DISTURBED, TEMPORARILY STABILIZED OR GRADED SLOPES WHICH HAVE ACHIEVED FINAL GRADE AND REQUIRE NO FURTHER DISTURBANCE CAN RECEIVE FINAL STABILIZATION MEASURES SUCH AS TOPSOIL, BLANKETS, MATTING, SEED AND MULCH.

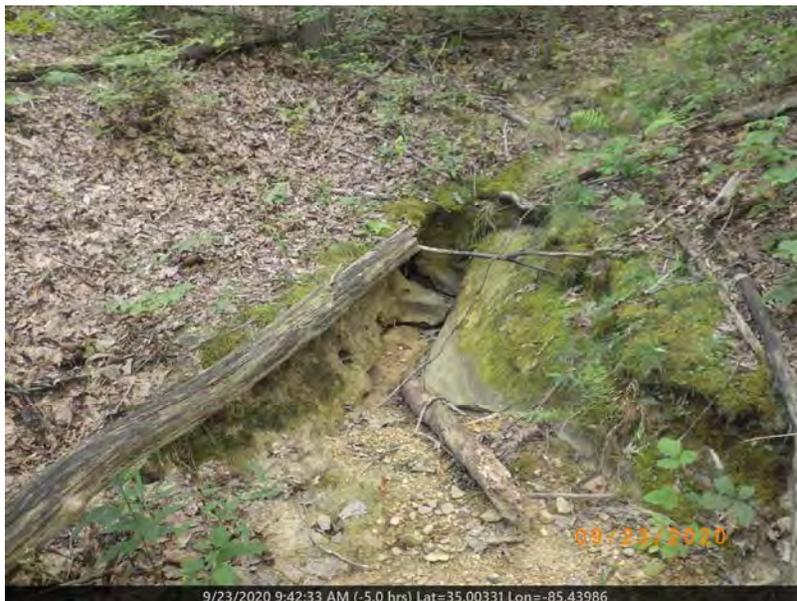
1. View of D-1 facing northeast/upstream showing headcut at beginning of assessed reach.

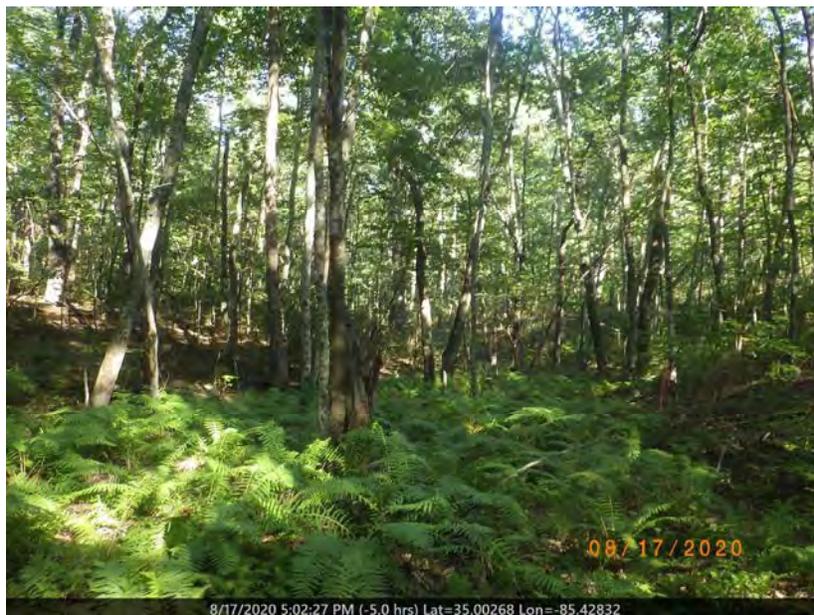
33. View of Wetland-1 from approximate center of wetland facing east/downgradient showing prevalence of *Osmundastrum cinnamomeum*.

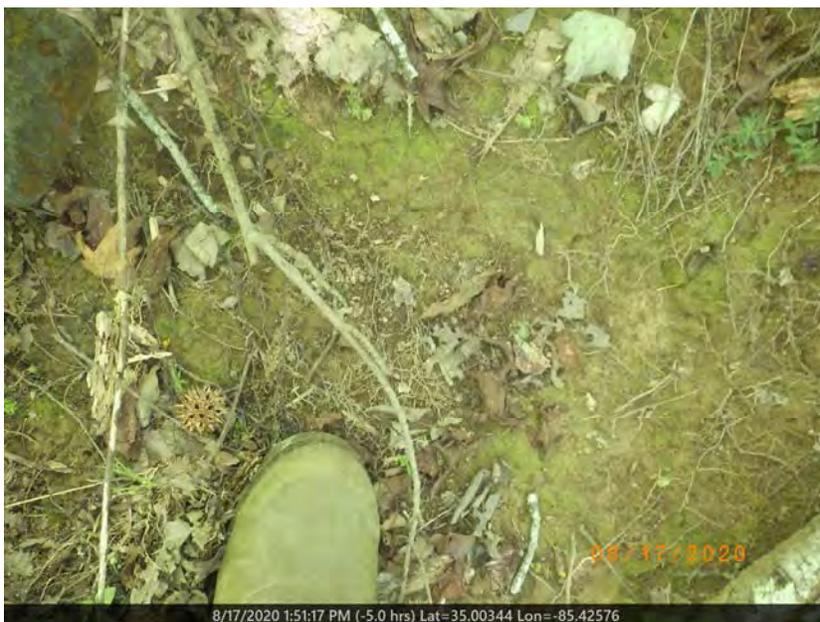
68. View of D-3-M facing down showing fibrous roots in thalweg.

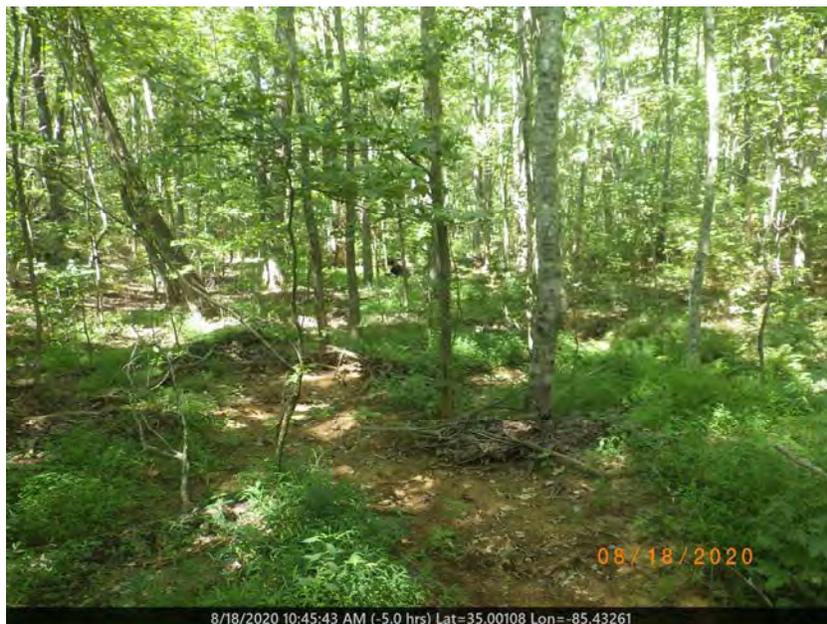
92. View of Wetland-13 facing west/downgradient showing drainage patterns and prevalence of *Microstegium vimineum*.

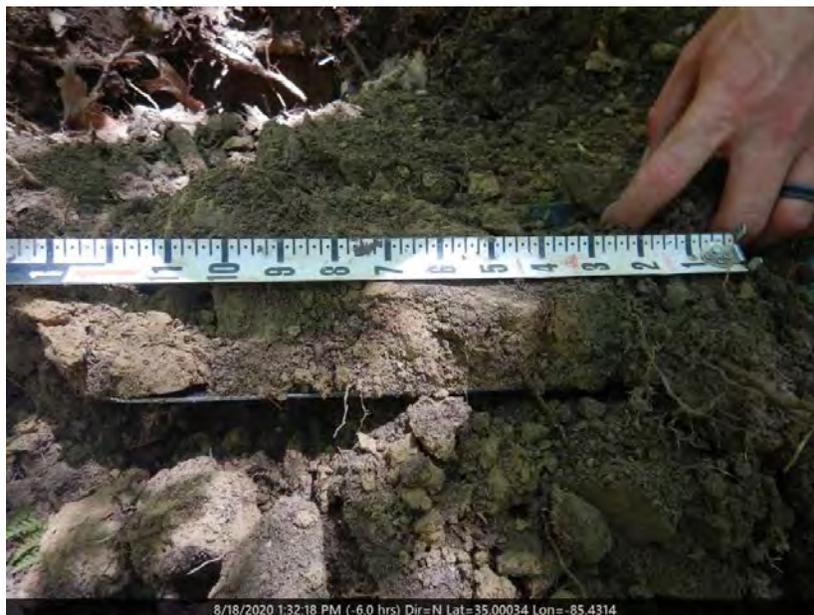
101. View of soils in Upland-12 sample pit showing light brown/grey matrix.

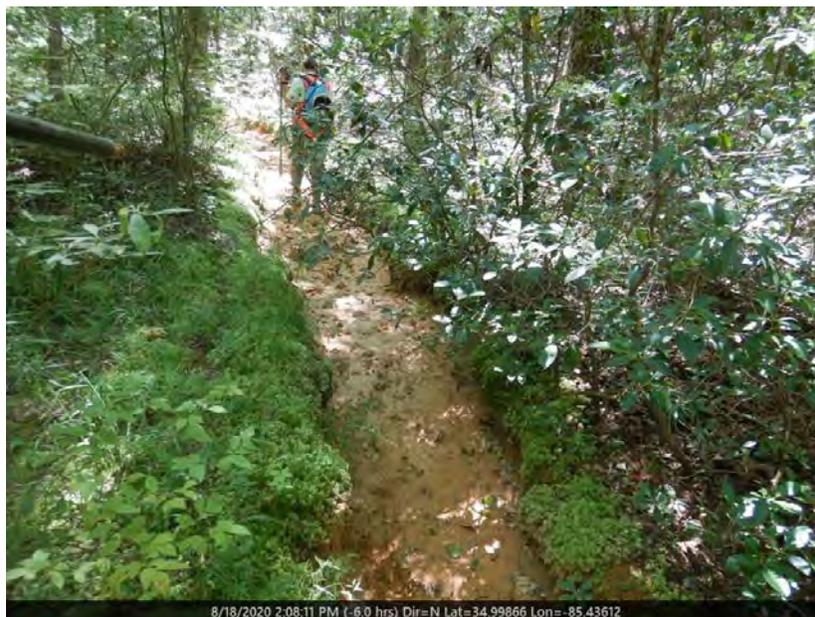
117. View of D-6 facing SSW/downstream showing fine sediment accumulated in channel.

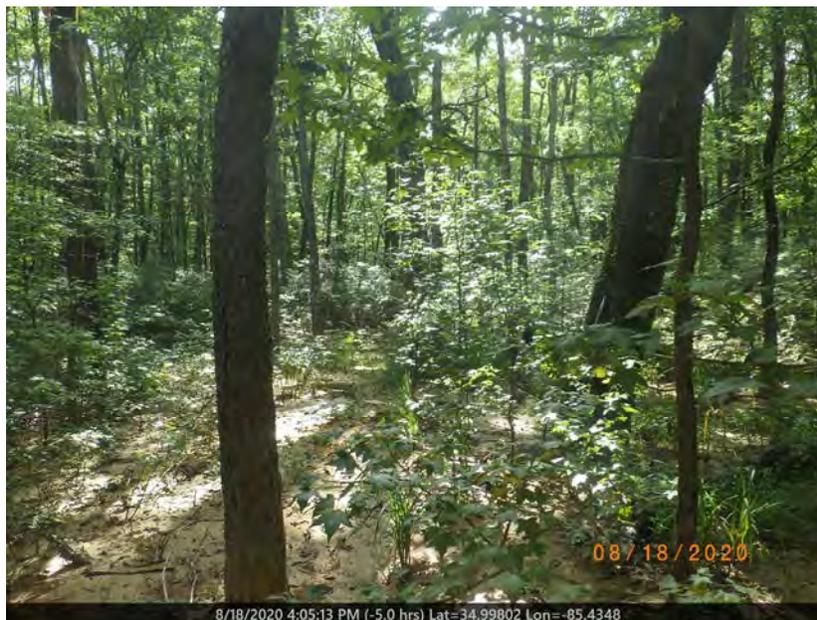
132. View of Wetland-10 facing southwest/downgradient showing understory vegetation and accumulation of fine sediment in wetland area.

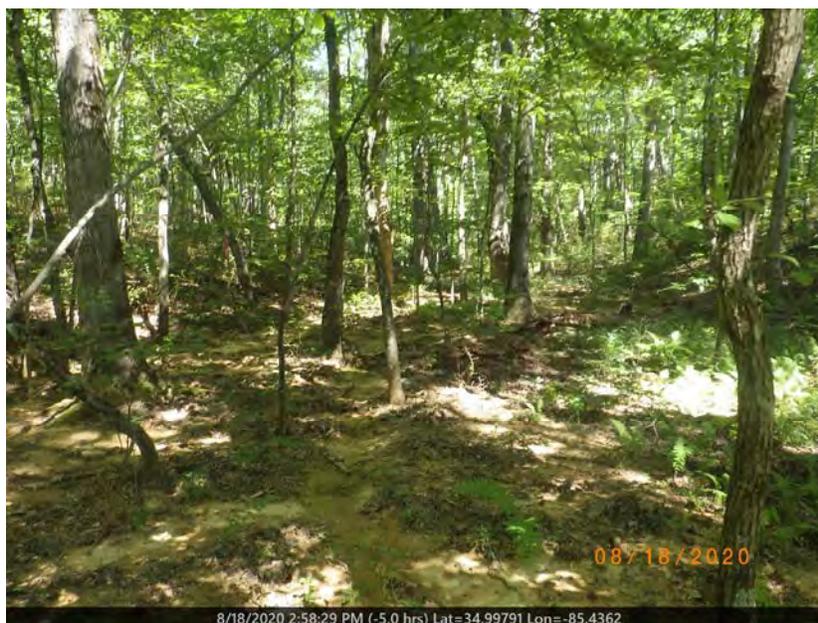
146. View of Wetland-9 facing east/upgradient showing drainage patterns.

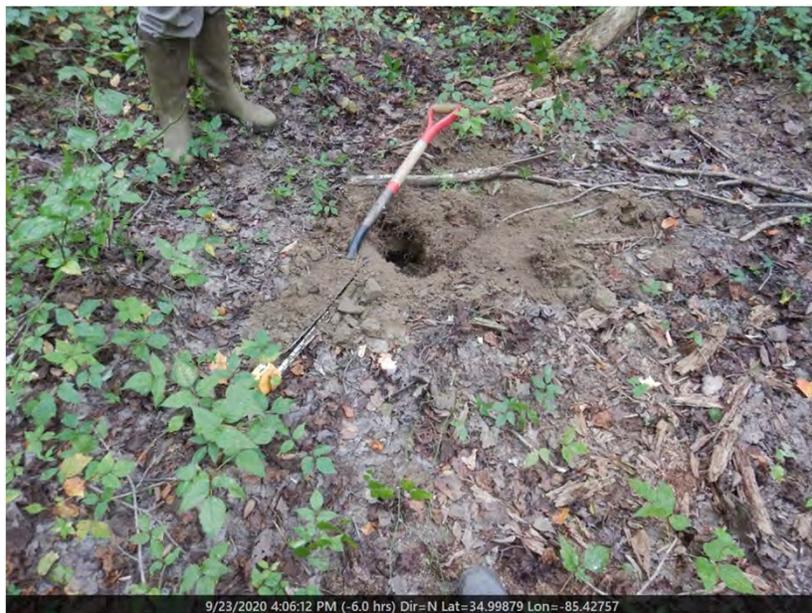
153. View of Wetland-5 sample pit area facing southeast showing leaf staining and herbaceous stratum dominated by *Toxicodendron radicans*.

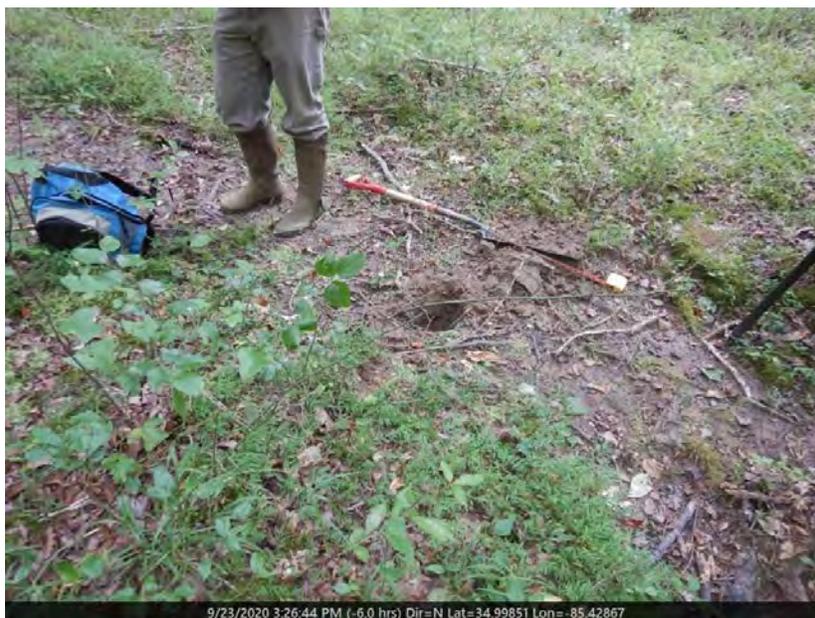
162. View of Wetland-6 sample pit area facing south showing herbaceous vegetation.

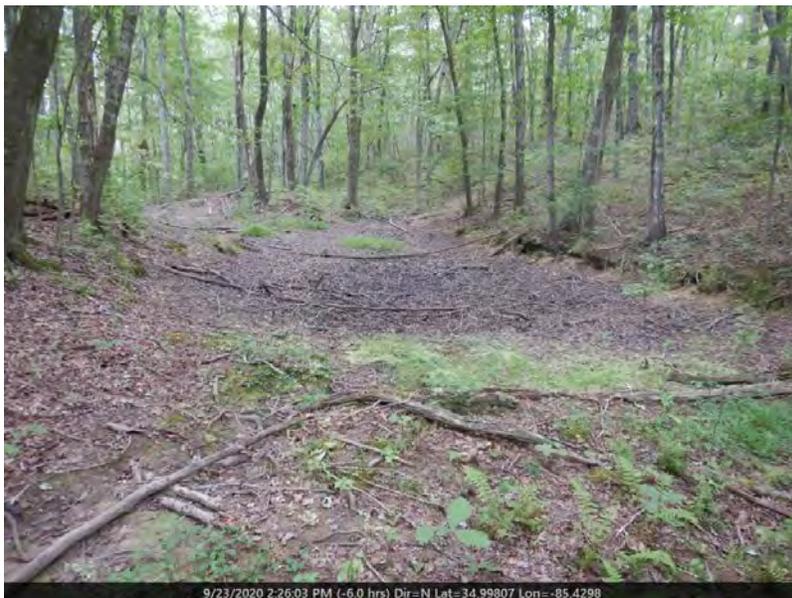
169. View of Pond-2 facing west/downgradient showing artificial berm (rear-ground) and leaf staining in dry pond.

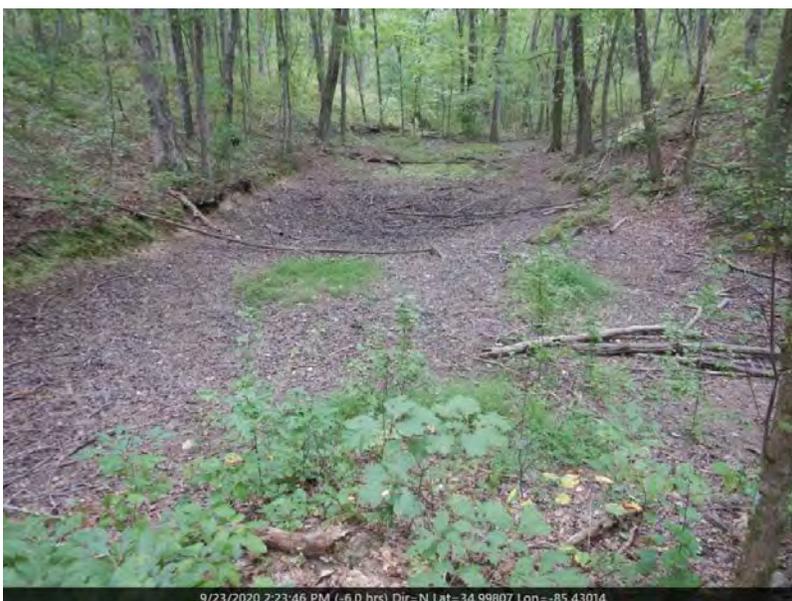
170. View of Pond-2 facing east/upgradient showing sparse vegetation in dry pond.

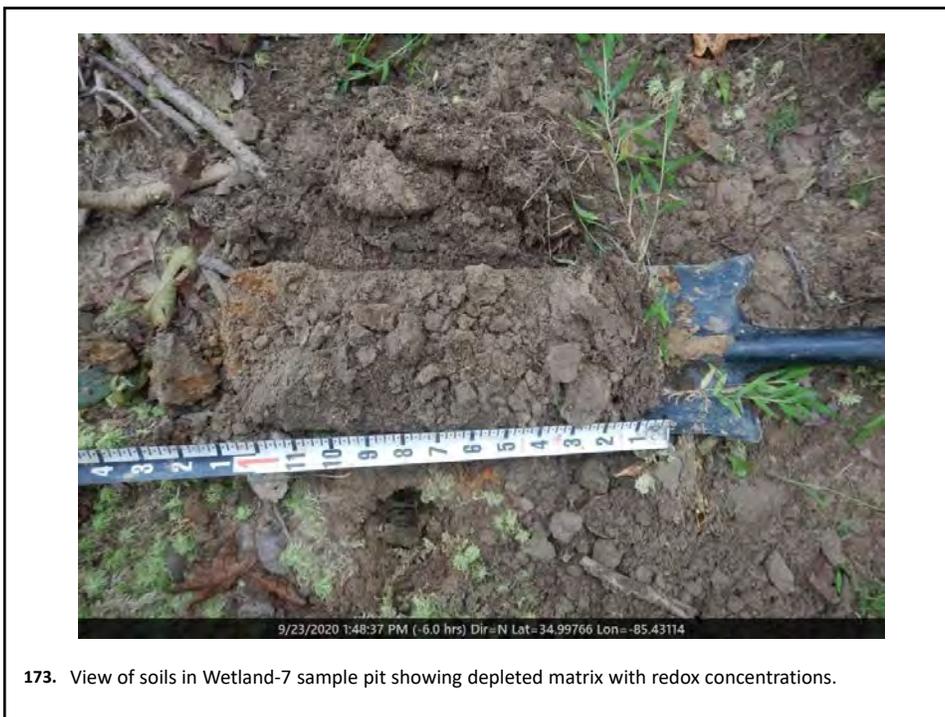
173. View of soils in Wetland-7 sample pit showing depleted matrix with redox concentrations.

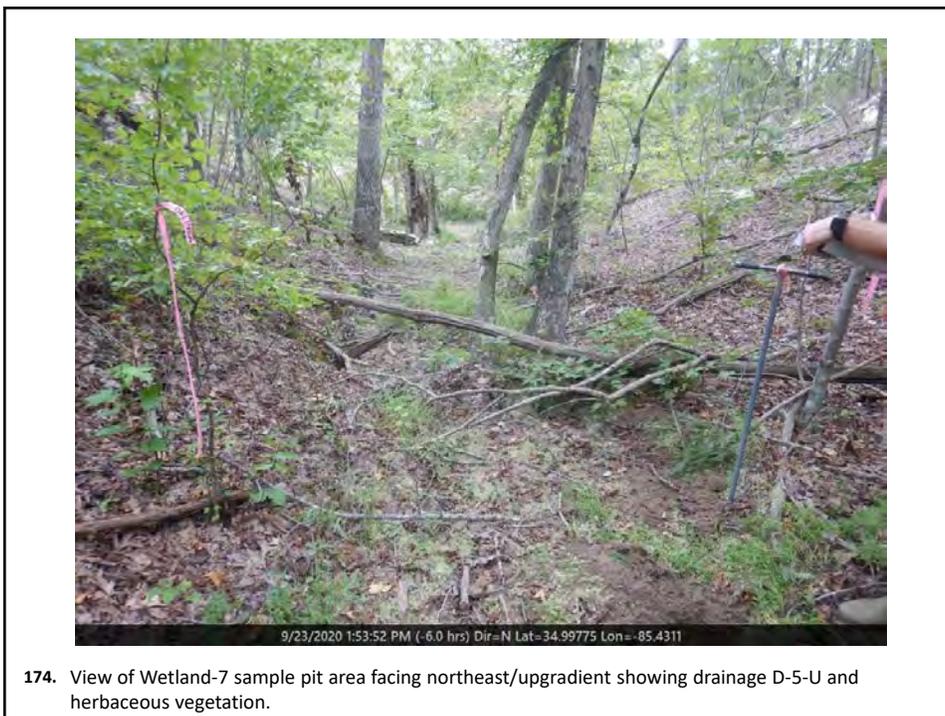
174. View of Wetland-7 sample pit area facing northeast/upgradient showing drainage D-5-U and herbaceous vegetation.

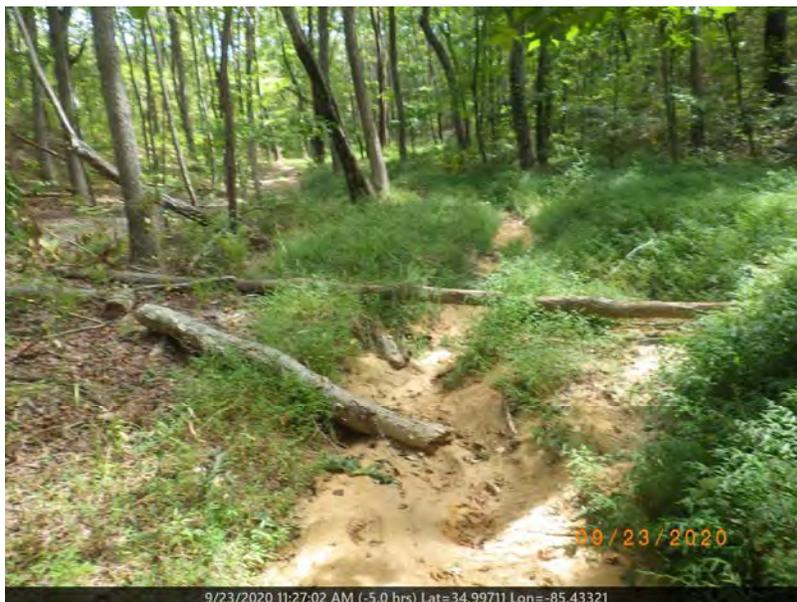
198. View of Wetland-8 facing west/upgradient showing dominance of *Microstegium vimineum* in drainage area with fresh sediment deposits.

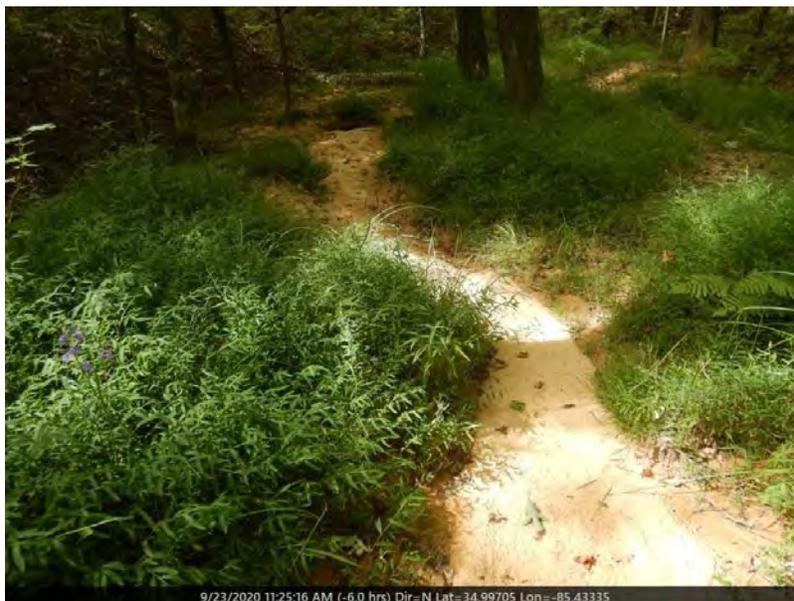
199. View of Wetland-8 facing west/downgradient showing fine sediment accumulating in wetland area adjacent to drainage D-5-L.
