Re: Compliance Evaluation Inspection
Munford Sewer Department Lagoon
NPDES Permit No. TN0062499
Tipton County

Compliance Inspection for Individual NPDES Permit

Facility Name: Munford Sewer Department Lagoon	NPDES Tracking Number: TN0062499
Permit Effective Date: December 1, 2011	Permit Expiration Date: September 30, 2015
Date and Time of Inspection: 3/11/2015	Inspector Name: Eddy Bouzeid

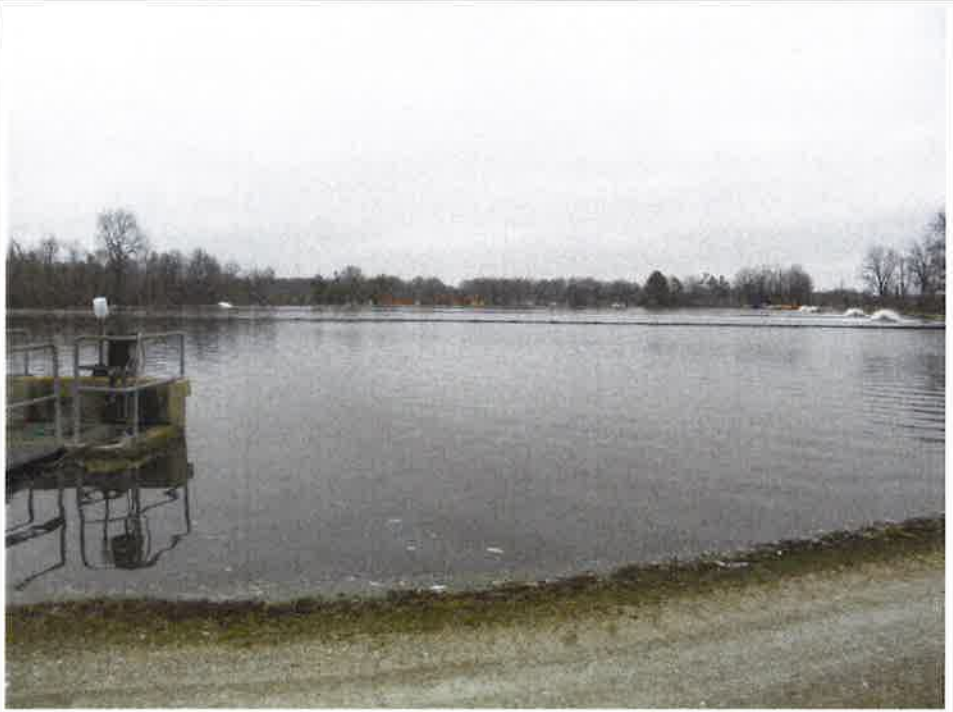
Client or Facility Name: Munford Sewer Department Lagoon		Site Location: Munford, Tipton County	Tracking No.: TN0062499
Photo No. 1	Date 3-11-2015

The Munford treatment system consists of a multi-cellular aerated lagoon. A total of 14 floating brush aerators are installed at the plant. Nine aerators are designated for the complete mix cell, two aerators are designated for each of the two partial mix cells, and one aerator is for the polishing cell. All aerators were operating properly at the time of the inspection except for one. One aerator in the partial mix cells was down awaiting repair work. There was no duckweed in the lagoon cells (photo 1). From the polishing cell, the effluent is chlorinated using sodium hypochlorite, than pumped approximately 13 miles to the Mississippi River.

Description The aerated lagoon is shown in this photo. No duckweed was observed.

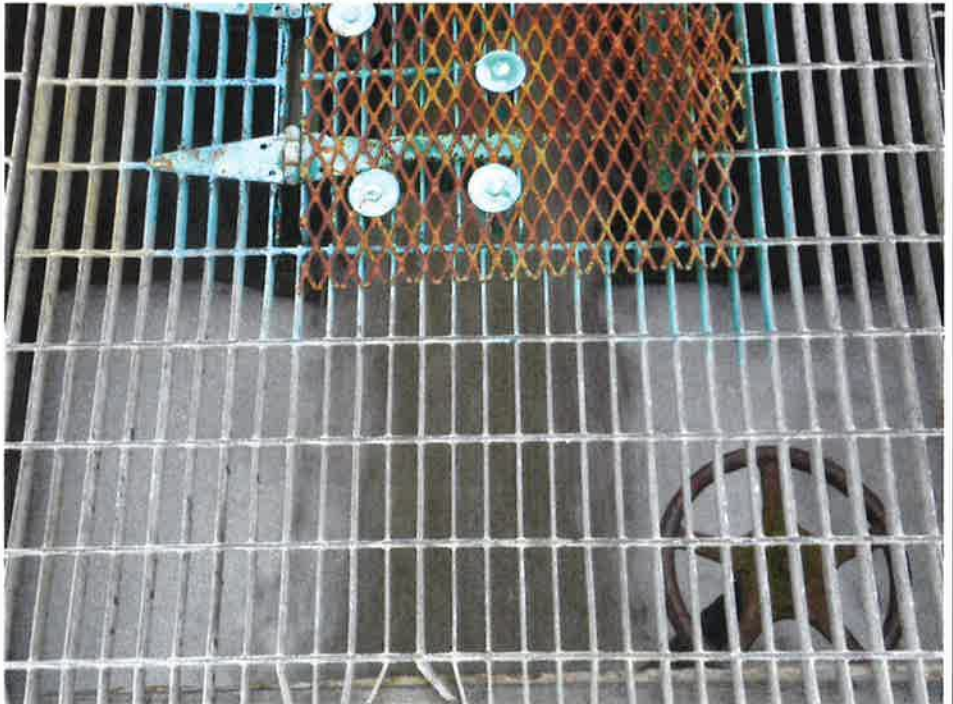
Photo No. 2	Date 3-11-2015

There was a discharge at the time of the inspection. The effluent in the discharge pipe from the lagoon was slightly green (photo 2) and the odor at the plant was minimal.

Description Effluent from the aerated lagoon was slightly green in color.

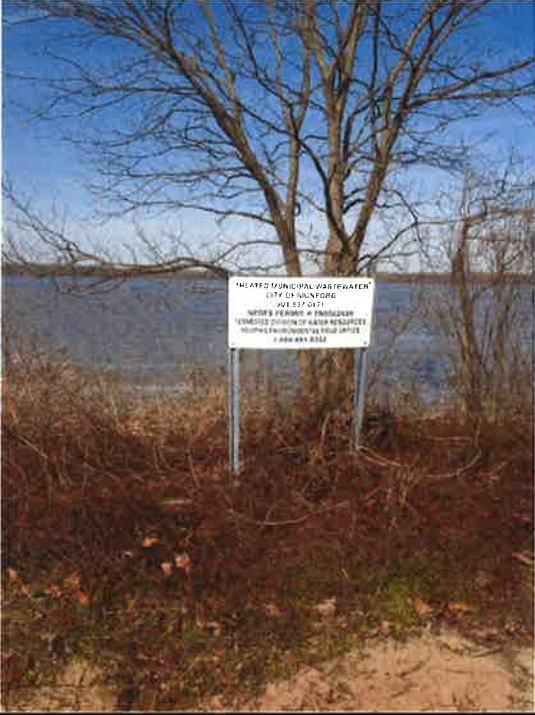
The elevated water in the Mississippi River, as well as the access fields to the outfall being under water, prohibited the inspection of the NPDES sign as well as the discharge pipe into the Mississippi River. Mr. Walker provided Mr. Bouzeid with a photo of the sign (photo 3) taken in December 2014.

3	3-11-2015		
Description			
Sign at the outfall provided by Mr. Walker

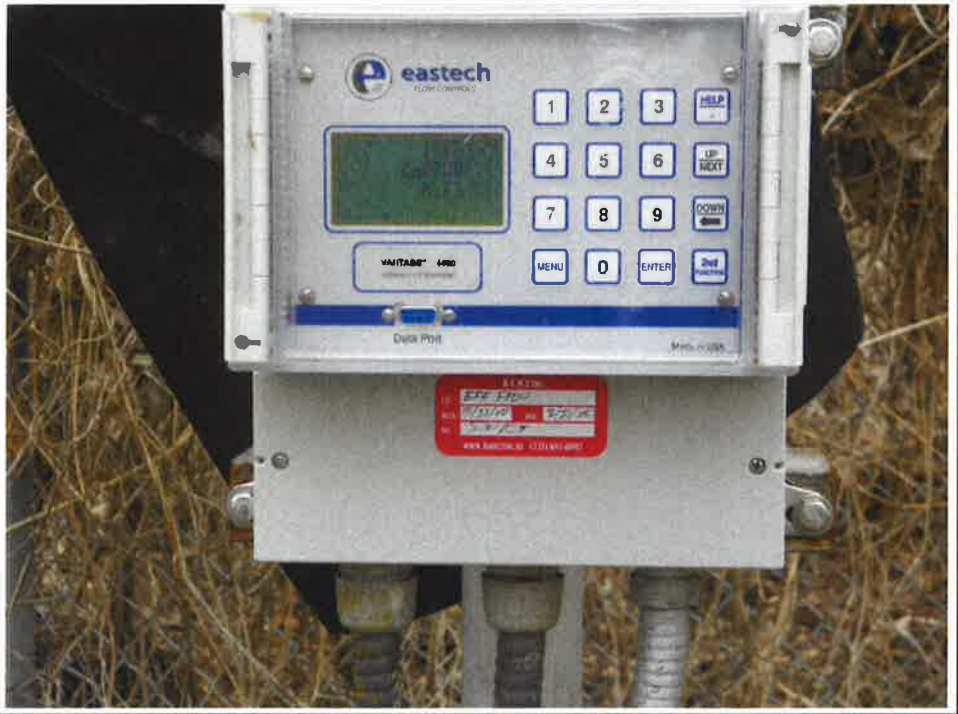
- The effluent digital flow meter was not functioning properly at the time of the inspection. The device was fairly new and it appeared that the recent inclement weather had caused the device to malfunction. Mr. Walker informed Mr. Bouzeid that the device was still under warranty and that the manufacturer would be sending a technician to repair/recalibrate the unit. Mr. Walker was advised to ensure that the flow meter is operating properly in the near future.

The lagoon has digital flow measurement devices for the influent and effluent. The influent digital flow meter was functioning at the time of the inspection. The device is calibrated annually by an independent contractor. A certificate of calibration was available at the facility. The effluent digital flow meter is fairly new. The device was installed in March 2014 (photo 5). However, the effluent device was not functioning properly at the time of the inspection. According to Mr. Walker, the recent inclement weather had apparently caused the device to malfunction. Mr. Walker stated that the device was still under warranty and that the manufacturer would be sending a technician to repair/recalibrate the meter. At the time of the inspection, Mr. Walker was utilizing the time run by the two discharge pumps to calculate the effluent flow.

Description Digital flow meter for the effluent.

- On or before April 17, 2015, submit documentation that the effluent digital flow meter has been repaired.
- On or before April 17, 2015, provide a written response confirming how the pH meter will be calibrated and how required monitoring of nutrients will be conducted to ensure compliance with the permit.
