Re: Spill Report

Cheese & Water Spill - 09.09.2020

Bongards South

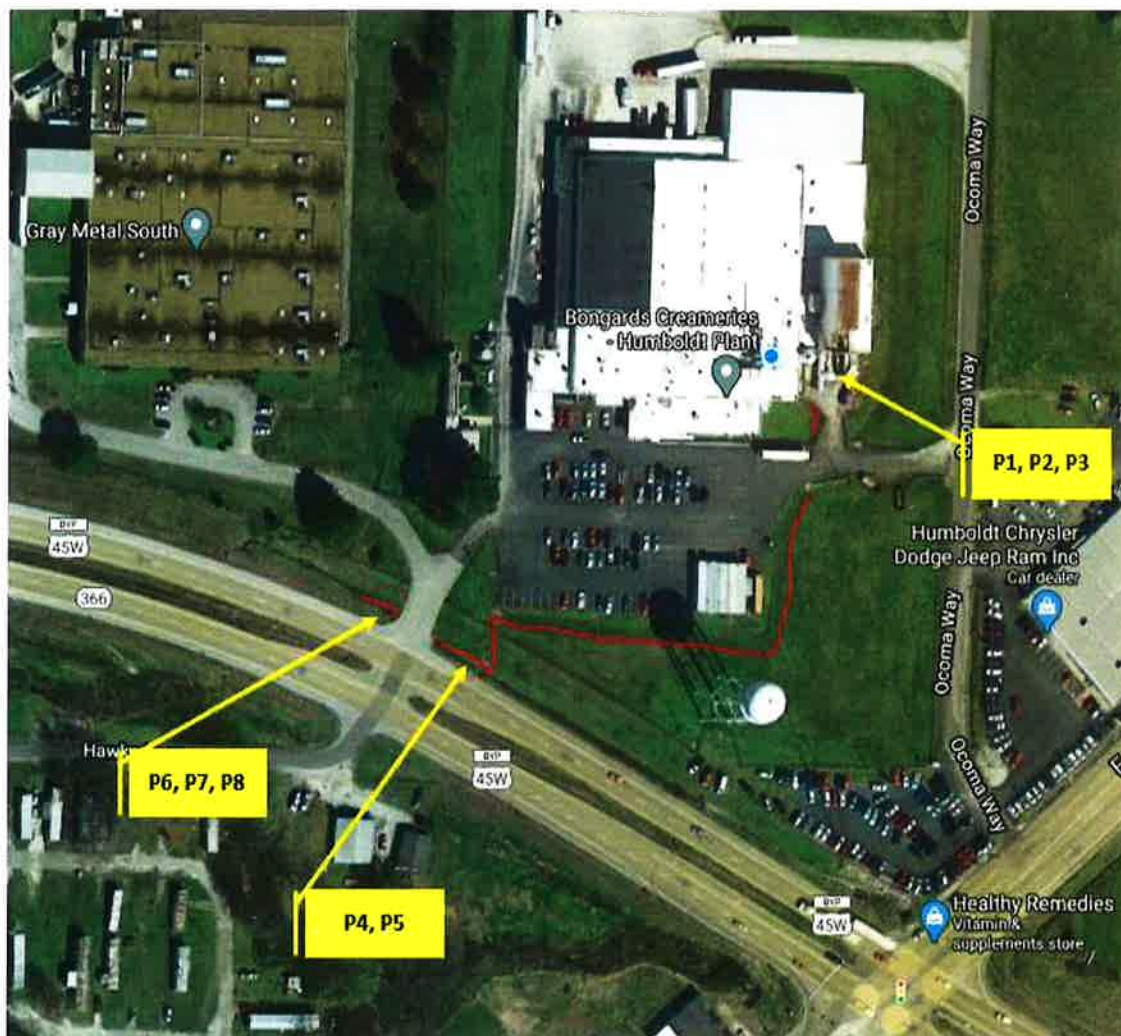
Spill Area (red line)

Clean-up: Temporary check dams were created with bags of floor dry to contain the flow in Outfall #002. A third party vacuum truck was contacted to clean-up and dispose the cheese and water captured by the check dams (See Photo P4, P5). The cheese and water solution traveled less than 100 feet past the property line and was contained by low spots in the roadside ditch. The low spots allowed all the cheese and water to be captured (See Photo P6, P7, P8).

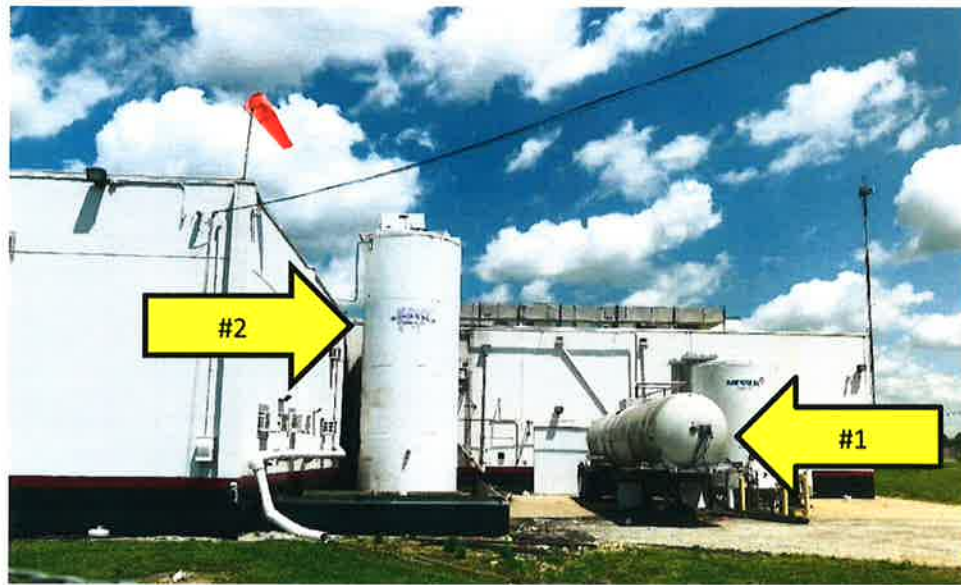
Photo P1

The Incident: Bongards Creameries South, LLC (aka "Bongards") had a tanker spotted on the property to hold liquids from the sanitation process of the cheese production lines (See Photo P1). This tanker is pumped out and disposed by Terra Renewal, a waste recycling company. On 09/04/2020, a driver from Terra Renewal left the bottom "bleed off valve" partially open after emptying the tanker (See Photo P2). Late in the evening of 09/08/2020, Bongards' sanitation placed liquids (cheese and water) into the tanker as part of the normal production line(s) "clean-up process". Early afternoon on 09/09/2020, Bongards maintenance employee noticed liquid on the concrete under the tanker. Upon review, it was observed that the bottom "bleed off valve" was partially open. The maintenance employee closed the valve and called his supervisor. Bongards estimates the amount released for the tanker to be less than 100 gallons. The cheese and water had entered Bongards Stormwater Outfall #002. The cheese and water had mixed with HVAC condensate drainage in the outfall and left the "property line."

- 1 – Tanker for holding sanitation solution for recycling off site.
- 2 – EQ Tank

Corrective measure(s): Bongards removed the tanker on 09/17/2020. The Equalization Tank (aka: EQ Tank) in the wastewater treatment system will be used as a replacement for the tanker. The EQ Tank is a 12,000 gal tank with level controls and secondary containment around it.

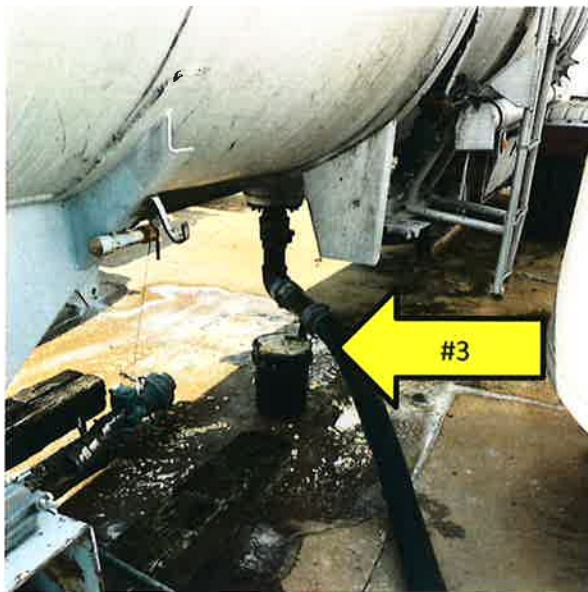
Photo P2

- 3 – Bleed off valve that was left open. (It is shown partially submerged in the bucket)
