AREA 6 MITIGATION SITE  
2022 MITIGATION MONITORING REPORT  
WAYPOINT# 2022-04  
DECEMBER 2022

**Alden Resources LLC**  
**USACE# LRN-2018-00397**  
**Nationwide Permit 49**  
**&**  
**ARAP# NR19MS.001**  
**Aquatic Resource Alteration Permit**

**Area 6 Project**  
**2022 Mitigation Monitoring Report**  
**Waypoint# 2022-04**

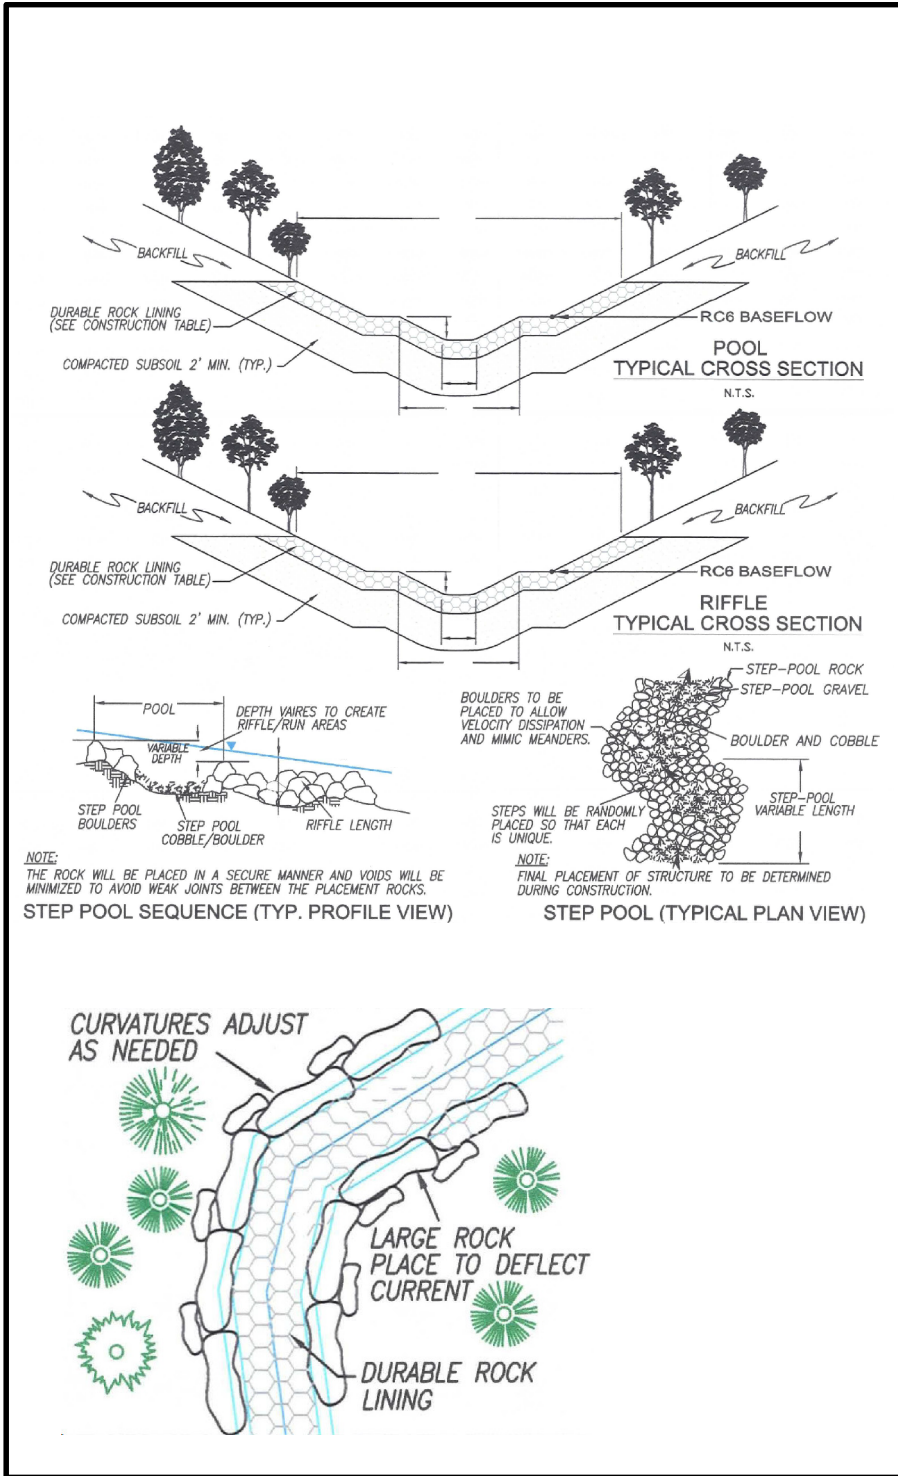
FIGURE 4. STREAM 4 REVISED PLANVIEW

**Intermittent Stream 4 (S4) Planview and Restoration Details**

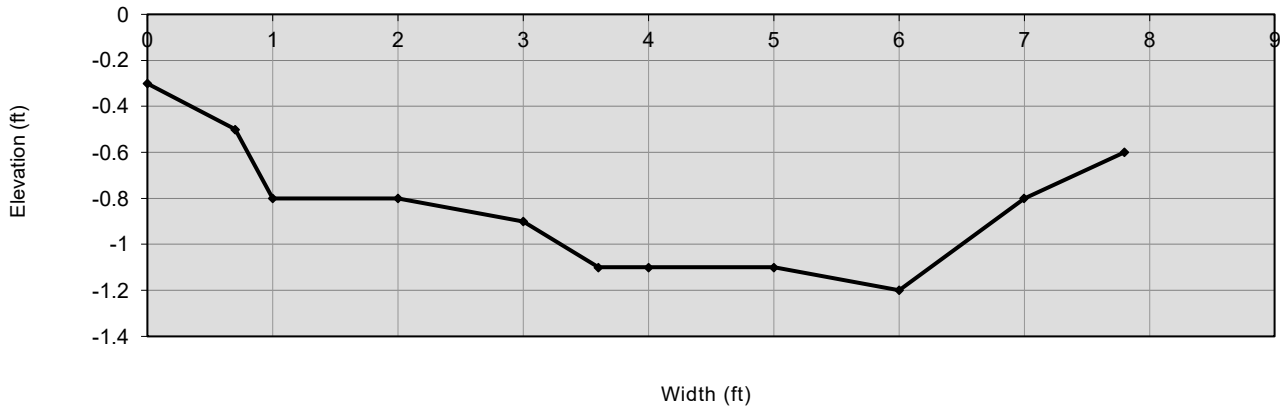
Stream 4, Riffle 0+49

## Restored Channel Cross Sections Stream 4

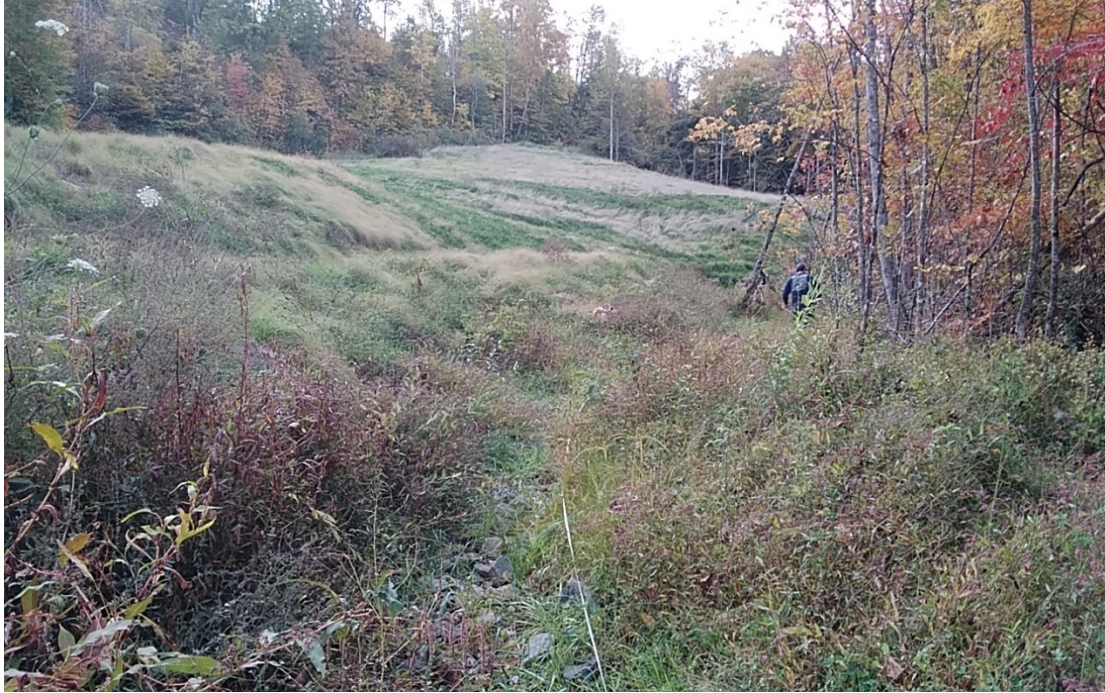
Date: 10/13/22	Feature: Stream 4, Lower
	Latitude / Longitude: 36.486, -84.023
	Direction Facing: South, Upstream

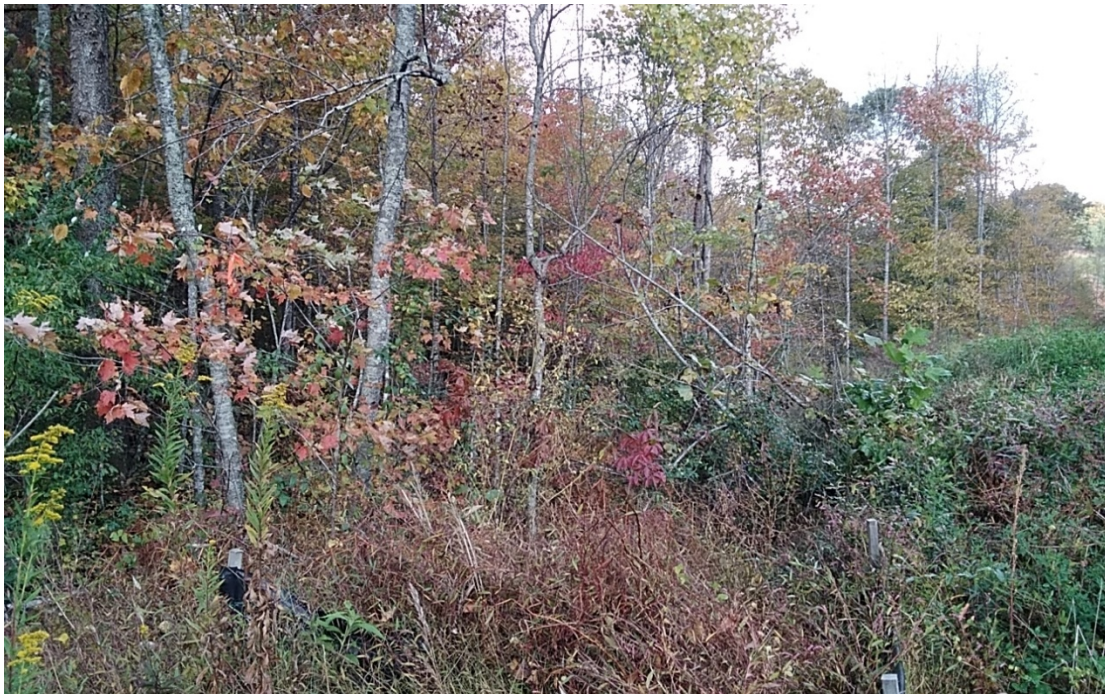
Date: 10/13/22	Feature: Below Stream 4, Not Impacted
	Latitude / Longitude: 36.486, -84.023
	Direction Facing: North, Downstream

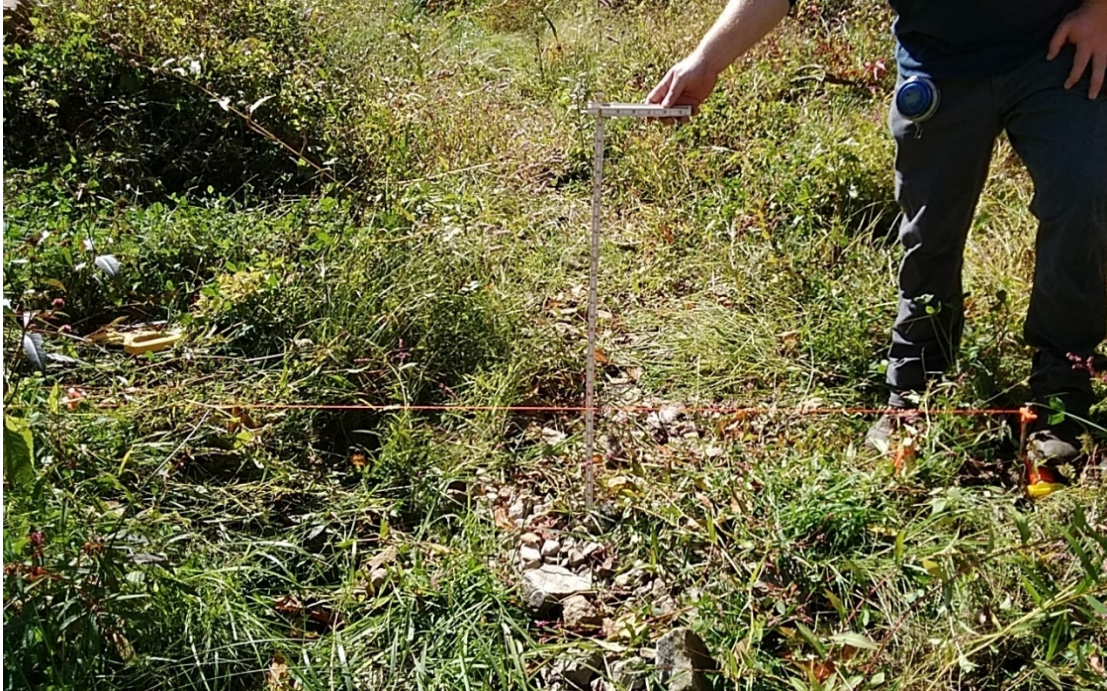
Date: 10/13/22	Feature: Stream 4, Riffle Cross Section, 0+49
	Latitude / Longitude: 36.486, -84.023
	Direction Facing: South, Upstream

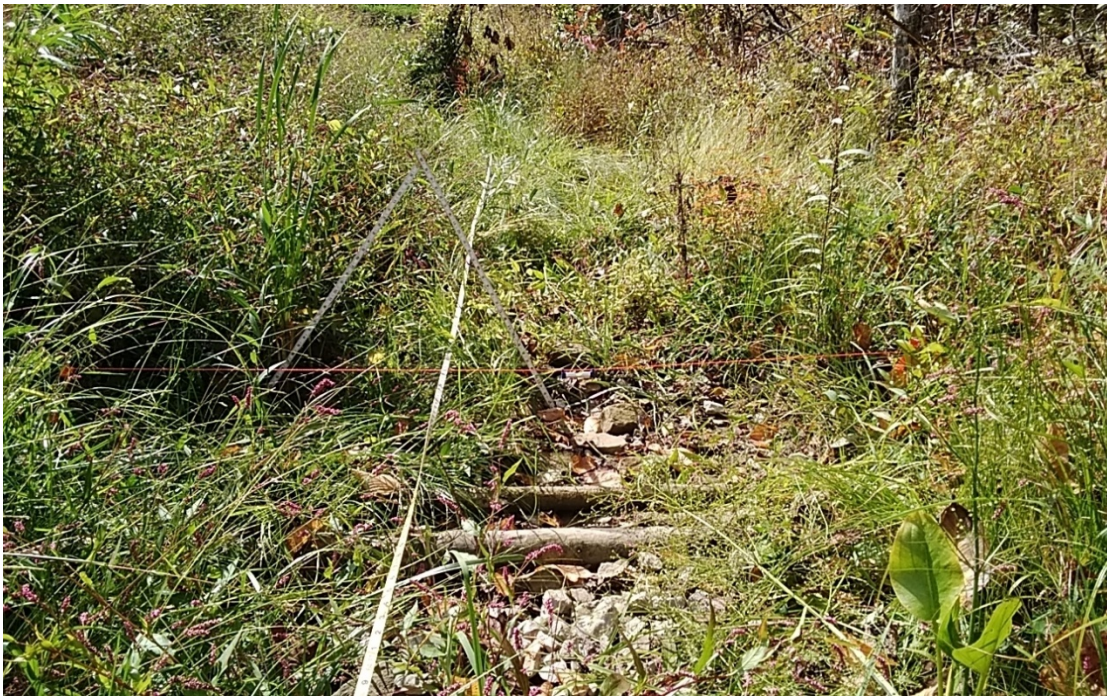
Date: 10/13/22	Feature: Stream 4, Pool Cross Section, 0+67
	Latitude / Longitude: 36.486, -84.023
	Direction Facing: South, Upstream

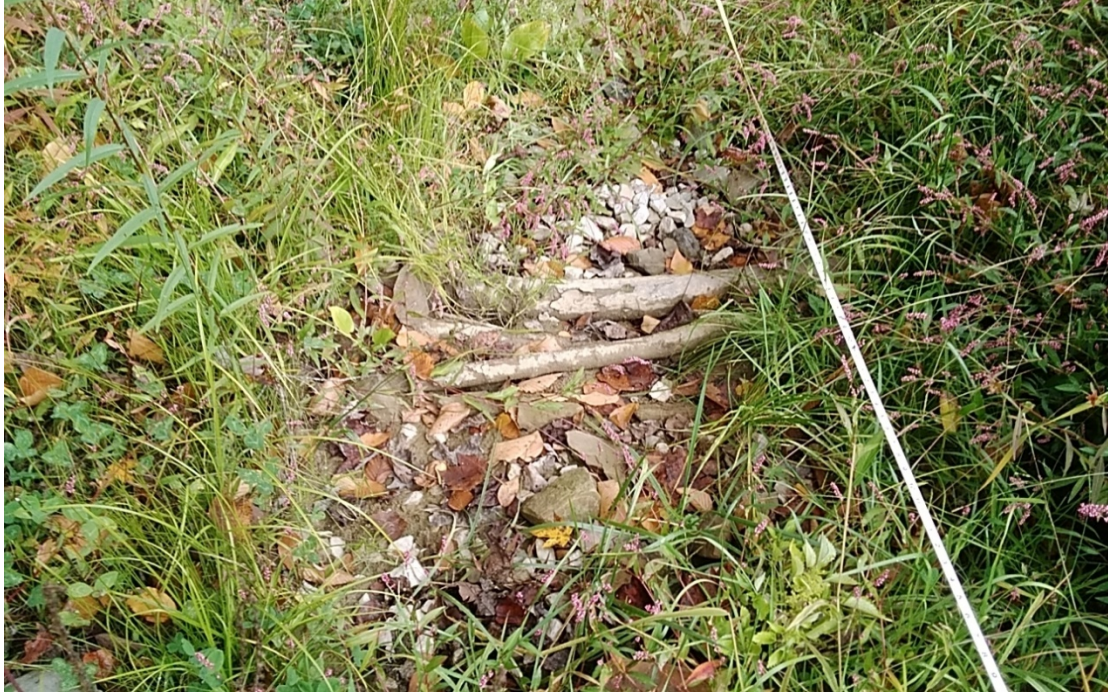
Date: 10/13/22	Feature: Stream 4, Typical Structures
	Latitude / Longitude: 36.486, -84.023
	Direction Facing: South, Upstream

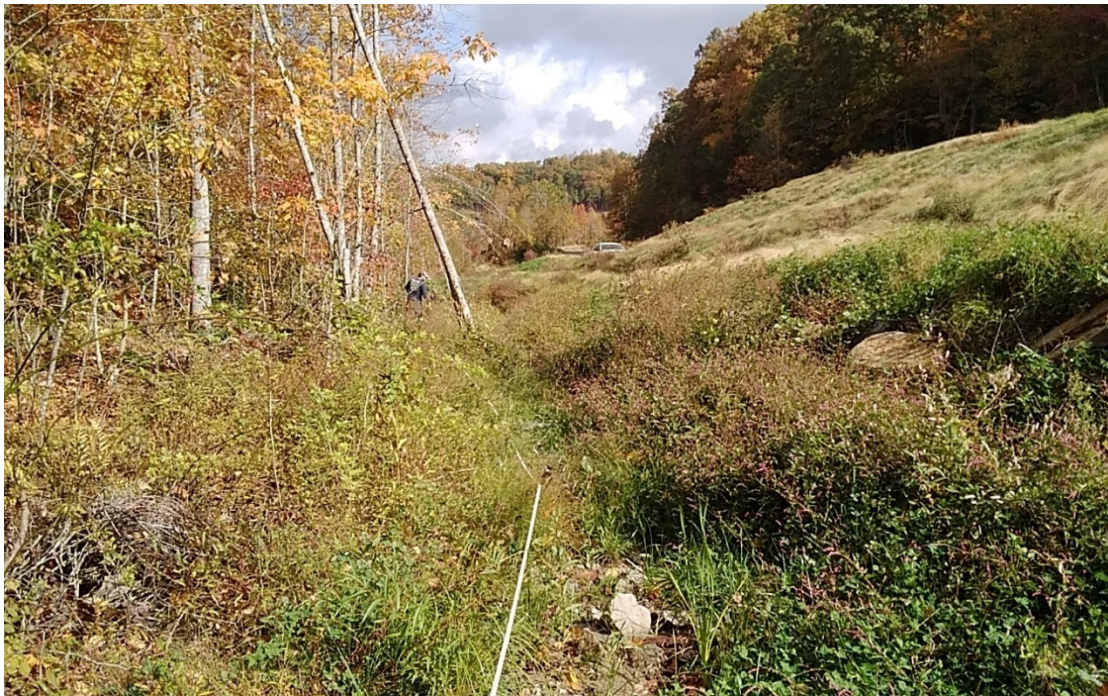
Date: 10/13/22	Feature: Stream 4, Upper
	Latitude / Longitude: 36.486, -84.023
	Direction Facing: North, Downstream
