RE: Fifth Year Wetland and Stream Monitoring Report
Bledsoe County Correctional Complex
Pikeville, Tennessee

Bledsoe County Correctional Complex

FIFTH YEAR WETLAND AND STREAM MITIGATION MONITORING REPORT

Mitigation Site Name: Bledsoe County Correctional Complex (BCCX), Pikeville, Tennessee

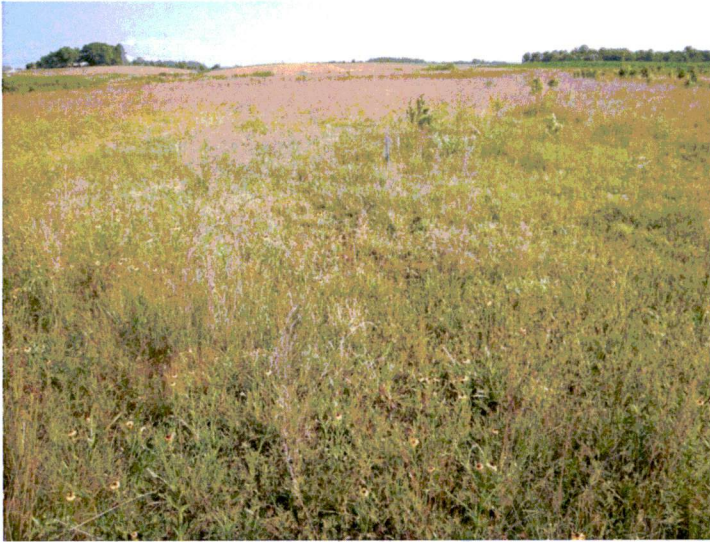
Photo 5.

Creation Area, Photo Reference Point C4: North

Dominant Vegetation: red maple (Fac), buttonbush (Obl), false indigobush (Facw), tapered rosette grass (Fac), greater poverty rush (Facw)

Comments: Stunted vegetation in this part of the site is primarily the result of low soil fertility, but seasonal ponding of concave surfaces also plays a role.

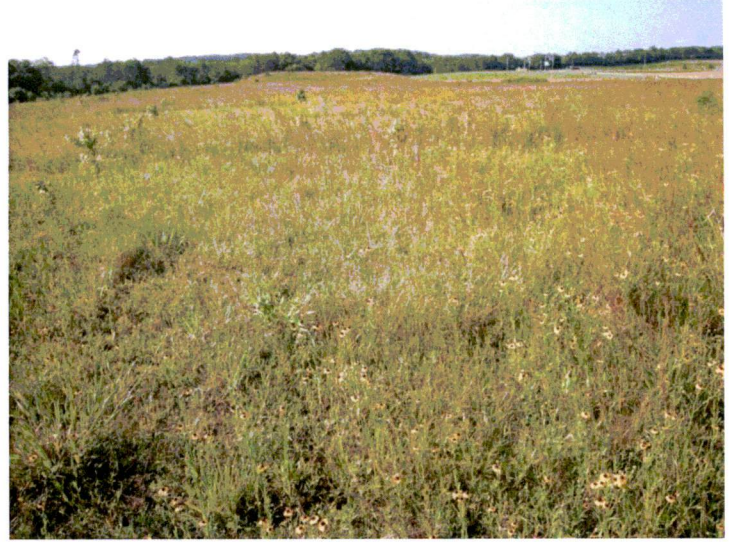
Photo 6.

Creation Area, Photo Reference Point C4: South

Dominant Vegetation: sweetgum (Fac), purplehead sneezeweed (Fac), tapered rosette grass (Fac), Georgia bulrush (Obl)

Comments: Parts of the Creation Area are wet in winter through early summer. By mid-summer and fall they dry significantly. Such locations typically contain a mixture of wetland and non-wetland species.

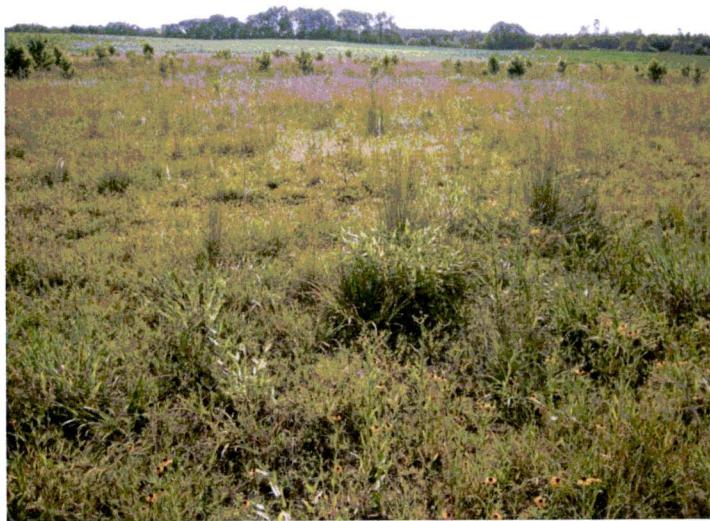
Photo 7.

Creation Area, Photo Reference Point C4: East

Dominant Vegetation: sweetgum (Fac), buttonbush (Obl), soft rush (Facw), tapered rosette grass (Fac), common cinquefoil (Facu), deer-tongue grass (Fac)

Comments: A shallow, relatively impervious fragipan restricts rooting in this area. It also traps water at the surface. After heavy rains this area can become ponded. Cyanobacteria (*Nostoc* sp.) deposits are common on the soil surface.

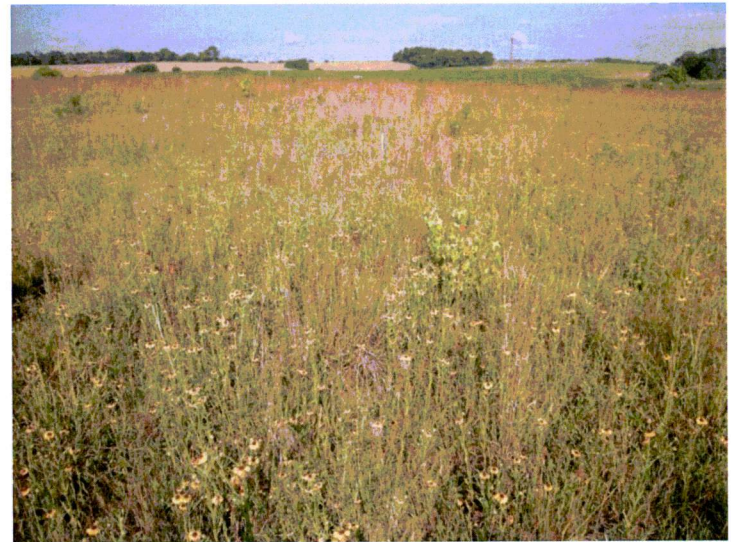
Photo 8.

Creation Area, Photo Reference Point C4: West

Comments: This area is a favorite hunting ground of marsh hawks. Both male and female hawks have been observed preying on small rodents and songbirds.

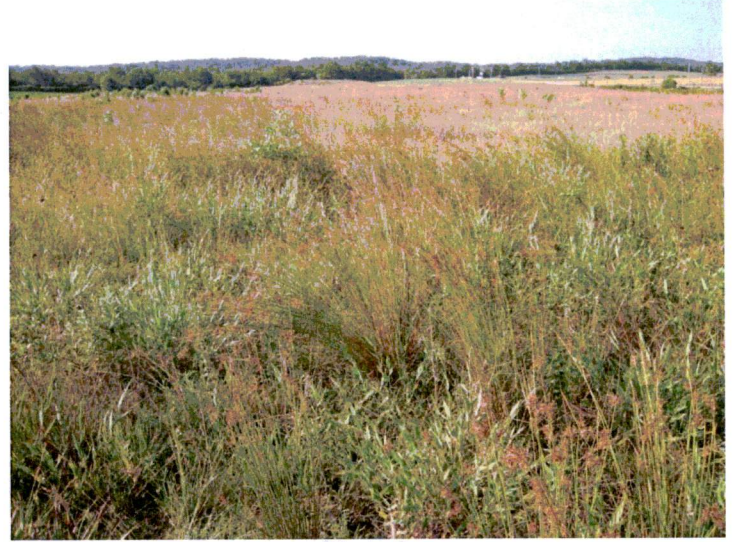
Photo 2.

Creation Area, Photo Reference Point C2: North

Dominant Vegetation: buttonbush (Obl), sweetgum (Fac), broom rosette grass (Facw), soft rush (Facw), greater poverty rush (Facw), Georgia bulrush (Obl)

Comments: Wetland vegetation, in particular, has benefitted from these corrective actions. This year more than 67% of all species in the Creation Area are considered wetland indicators.

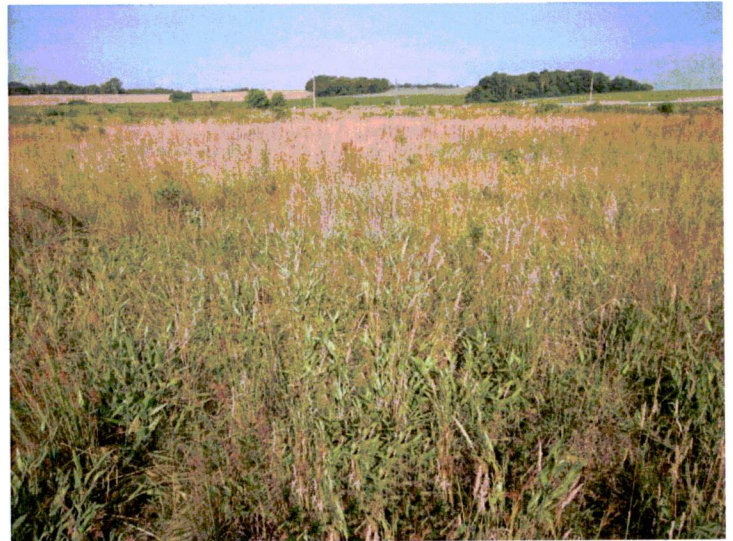
Photo 4.

Creation Area, Photo Reference Point C2: East

Dominant Vegetation: buttonbush (Obl), sweetgum (Fac), broom rosette grass (Facw), greater poverty rush (Facw), purplehead sneezeweed (Fac)

Comments: The 520-stem/acre average density of woody plants represents a nearly 27% increase since last year. This increase has resulted partly from the influx of new seedlings coming from local seed sources as well as an increase in the size of the planted species, which makes them easier to find among the dense herbs.

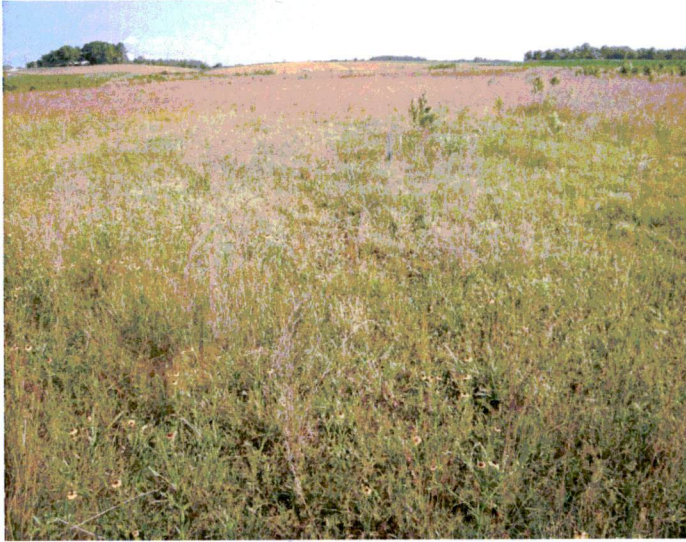
Photo 5.

Creation Area, Photo Reference Point C4: North

Dominant Vegetation: red maple (Fac), buttonbush (Obl), false indigobush (Facw), tapered rosette grass (Fac), greater poverty rush (Facw)

Comments: Stunted vegetation in this part of the site is primarily the result of low soil fertility, but seasonal ponding of concave surfaces also plays a role.

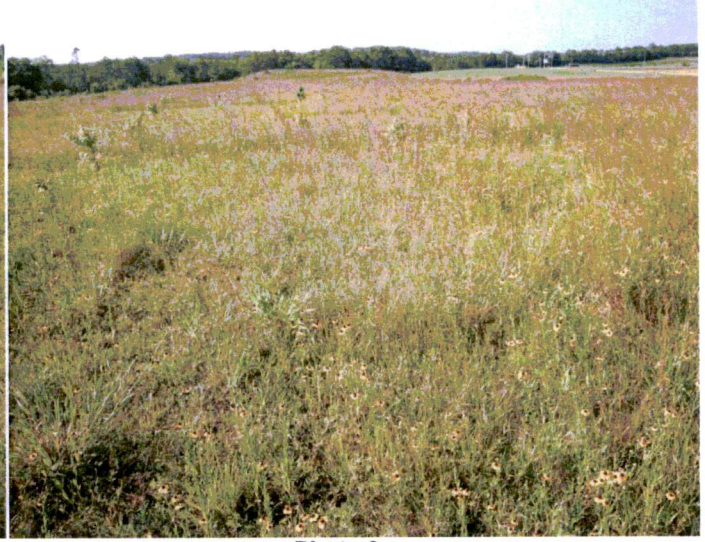
Photo 6.

Creation Area, Photo Reference Point C4: South

Dominant Vegetation: sweetgum (Fac), purplehead sneezeweed (Fac), tapered rosette grass (Fac), Georgia bulrush (Obl)

Comments: Parts of the Creation Area are wet in winter through early summer. By mid-summer and fall they dry significantly. Such locations typically contain a mixture of wetland and non-wetland species.

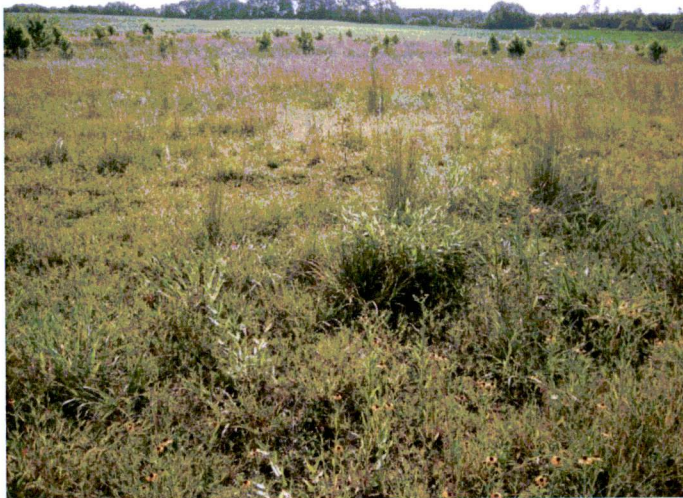
Photo 7.

Creation Area, Photo Reference Point C4: East

Dominant Vegetation: sweetgum (Fac), buttonbush (Obl), soft rush (Facw), tapered rosette grass (Fac), common cinquefoil (Facu), deer-tongue grass (Fac)

Comments: A shallow, relatively impervious fragipan restricts rooting in this area. It also traps water at the surface. After heavy rains this area can become ponded. Cyanobacteria (*Nostoc* sp.) deposits are common on the soil surface.

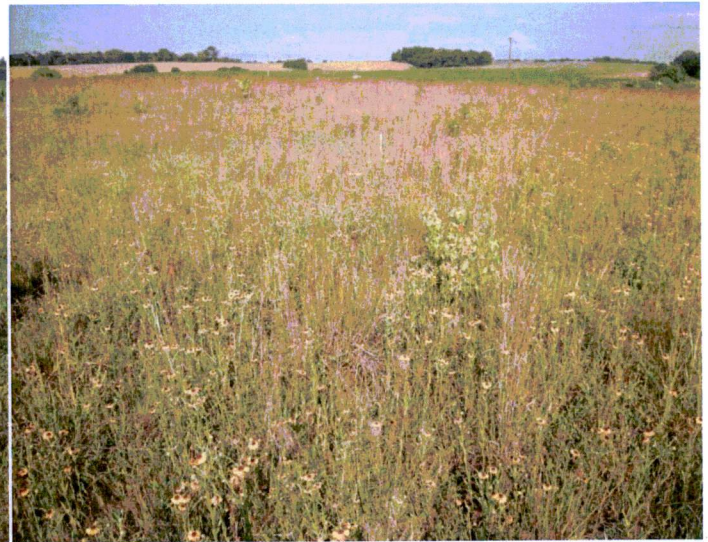
Photo 8.

Creation Area, Photo Reference Point C4: West

Comments: This area is a favorite hunting ground of marsh hawks. Both male and female hawks have been observed preying on small rodents and songbirds.

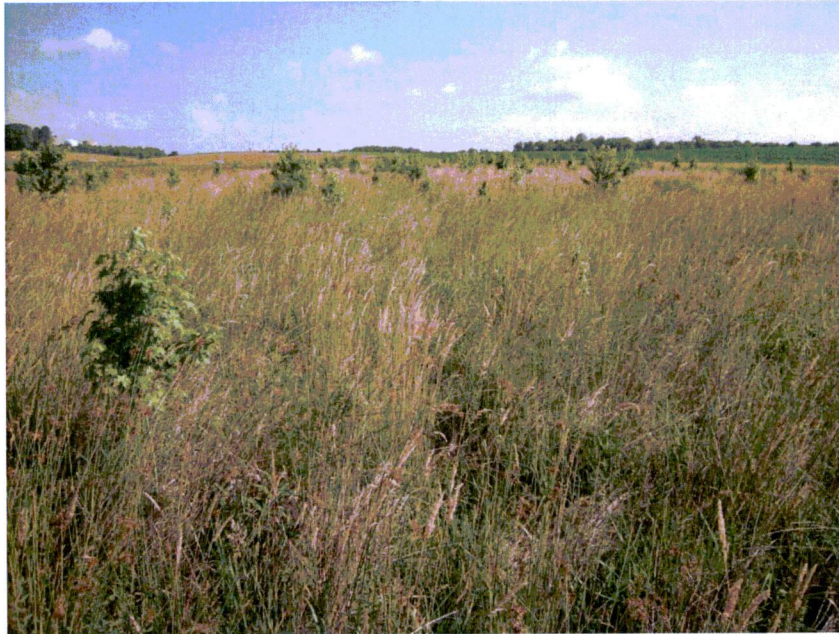
Photo 9.

Enhancement Areas: Former wetland fields and pastures were enhanced by planting tree and shrub seedlings at the rate of 435 trees/acre. The most dominant woody species include sweetgum and red maple, but blackgum and wetland oaks are also frequently observed. These Enhancement Areas, along with the rest of the mitigation site will be protected from future disturbance by placing them under a deed restriction or conservation easement. Because they have consistently met or exceeded performance standards in all phases (i.e., vegetation, soils, hydrology), TDEC and USACE are no longer requiring monitoring of these sites.

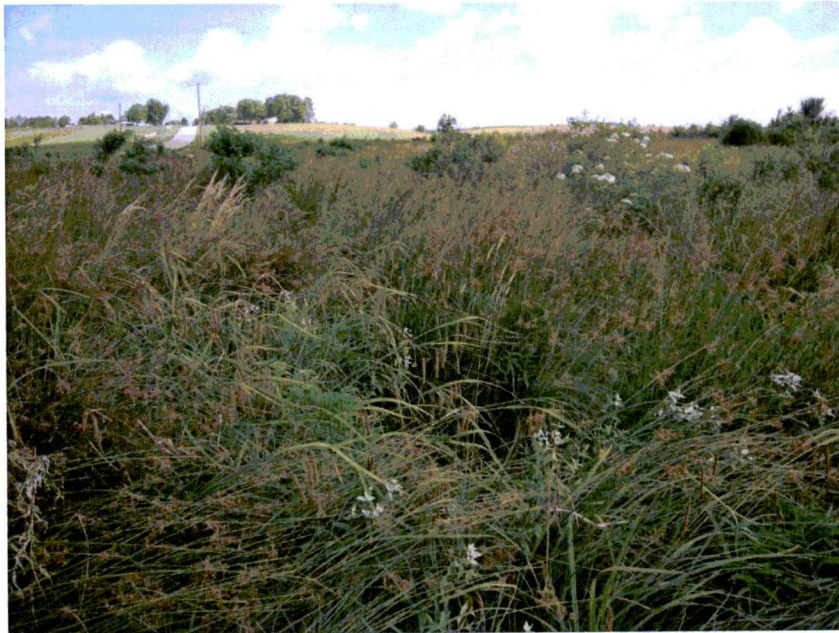
Photo 10.

Enhancement Areas: On the wettest parts of the Enhancement Areas, planted wetland shrubs such as buttonbush, elderberry, and false indigobush are more commonly encountered than trees. Dense stands of rushes and sedges are responsible for retarding the establishment of trees.

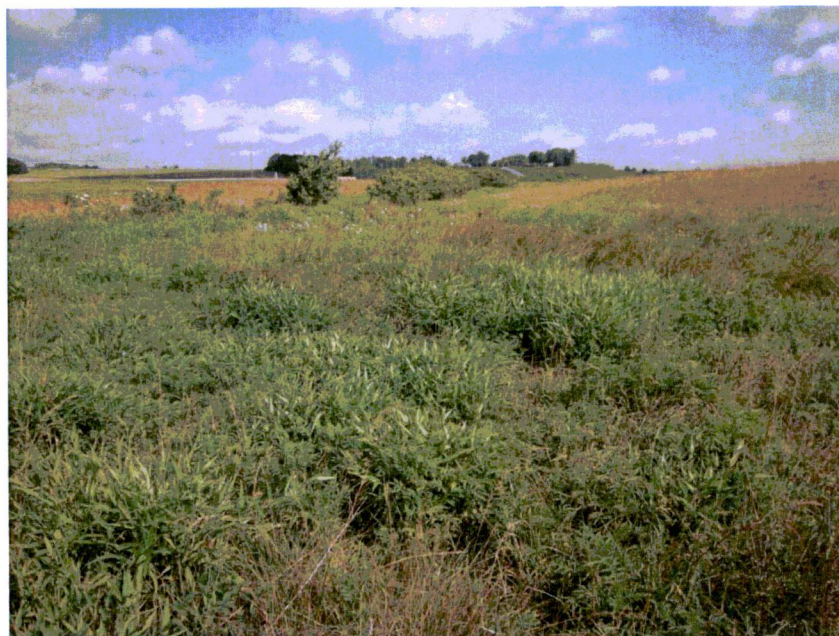
Photo 11.

Stream 1 Enhancement Area: Like the Wetland Enhancement Areas, Stream Enhancement Areas have been determined by TDEC and USACE to have attained an acceptable level of performance. Consequently, they are no longer being monitored for plant demographics or channel morphology. This view of Stream 1 shows the degree to which vegetation has become established. No signs of stream erosion have been detected, largely because of the dense cover.

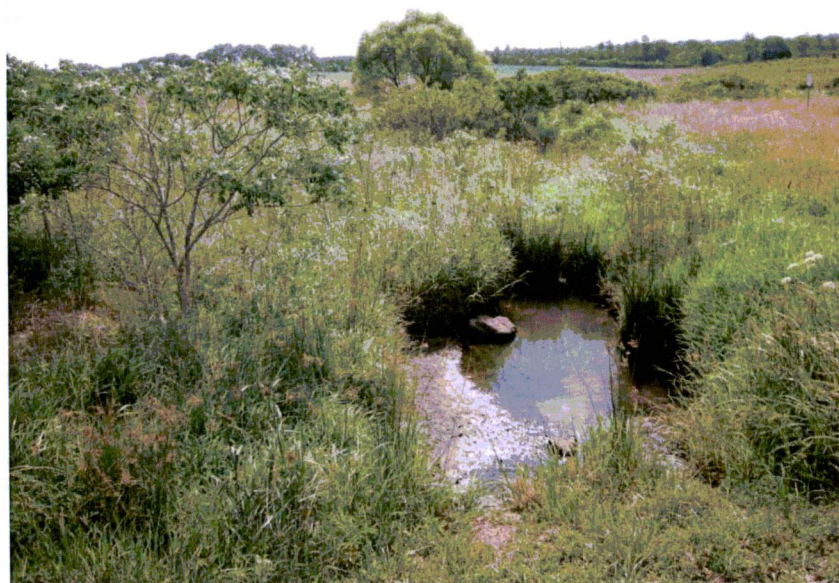
Photo 12.

Stream 2 Enhancement Area: The riparian zone around Stream 2 is also very stable. This view looking downstream demonstrates how quickly the vegetation has recovered after the cessation of agricultural activities. Typical woody plants include black willow, silky dogwood, and winged sumac, while dominant herbs are rice cut grass and soft rush.

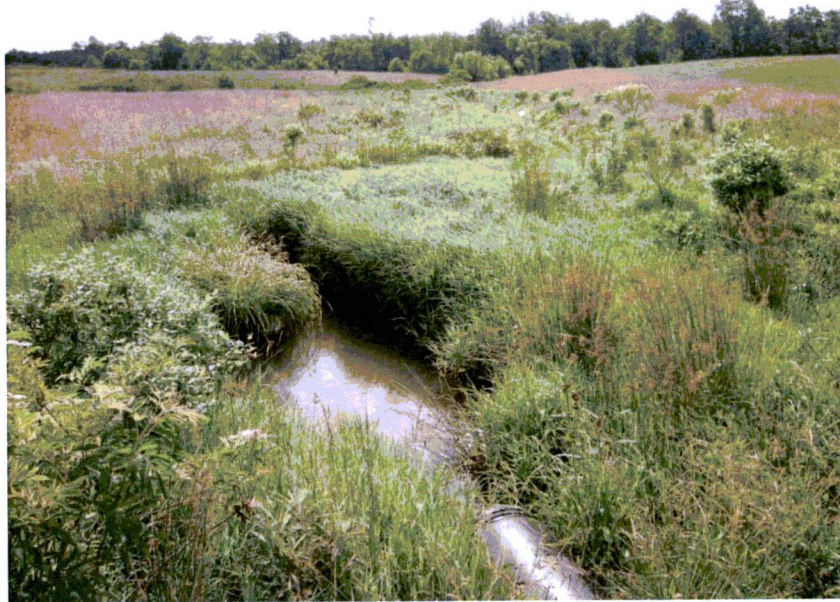
Photo 13.

Stream 3 Enhancement Area: Stream 3 is similar in composition to Stream 2, although the amount of woody plant development is somewhat less. Again, the dominant herbs are rice cut grass and soft rush, while the shrub layer is composed largely of buttonbush, silky dogwood, and elderberry.

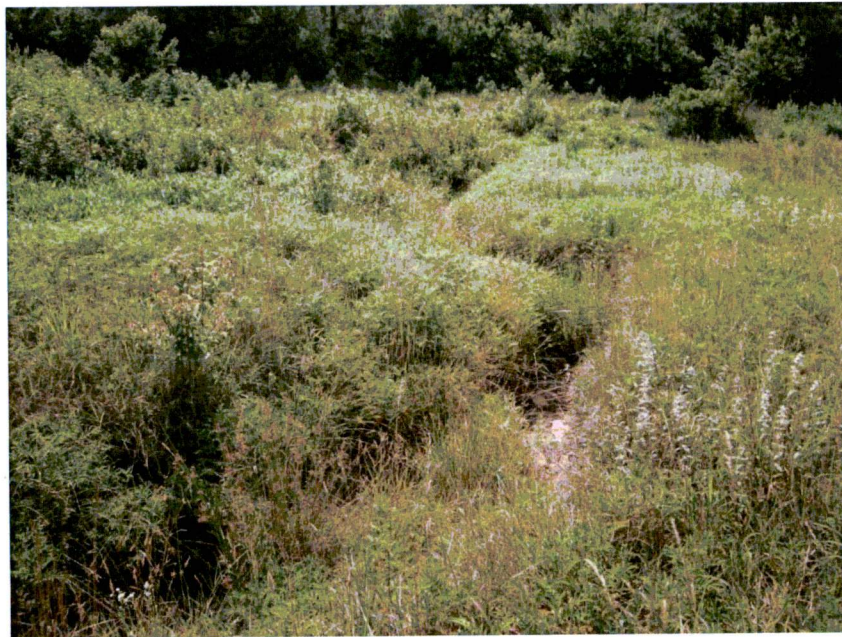
Photo 14.

Stream 4 Enhancement Area: Stream 4 is positioned at the extreme southeastern corner of the mitigation site and lies below the discharge point of a farm pond. Embankments are completely vegetated with a mixture of herbs such as deer-tongue grass, harvest-lice, and clustered mountain mint. The shrub layer is very strongly dominated by swamp rose, which last year occurred at the rate of over 350 stems/100 feet of stream length.

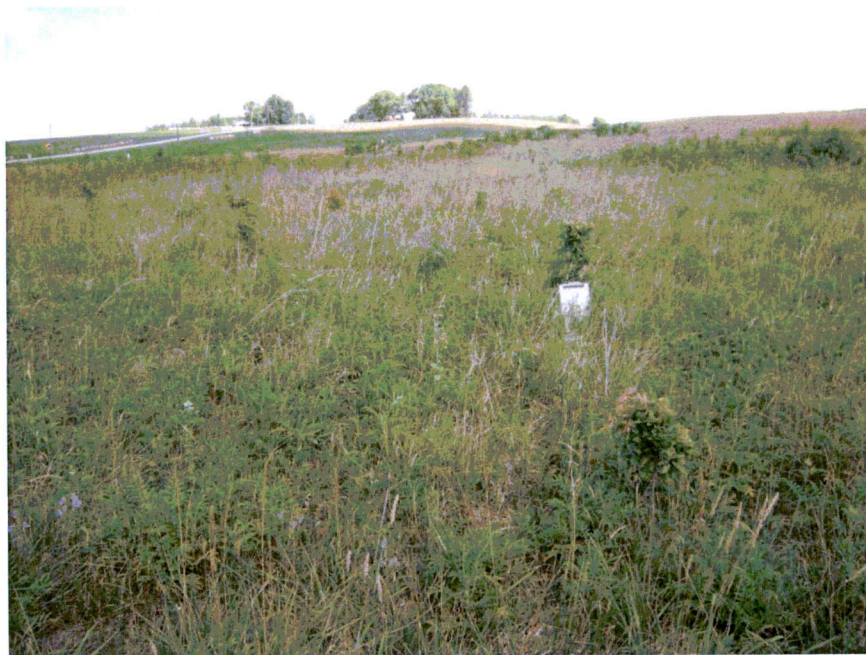
Photo 15.

Upland Buffers: The site's mitigation plan called for the establishment of 25-foot-wide upland buffers around all mitigated streams and wetlands. These areas were then planted with a mixture of oaks. Competition from residual pasture grasses and heavy deer browsing has slowed growth, but stem densities of oaks combined with naturally invading hardwoods has consistently exceeded 225 stems/acre.

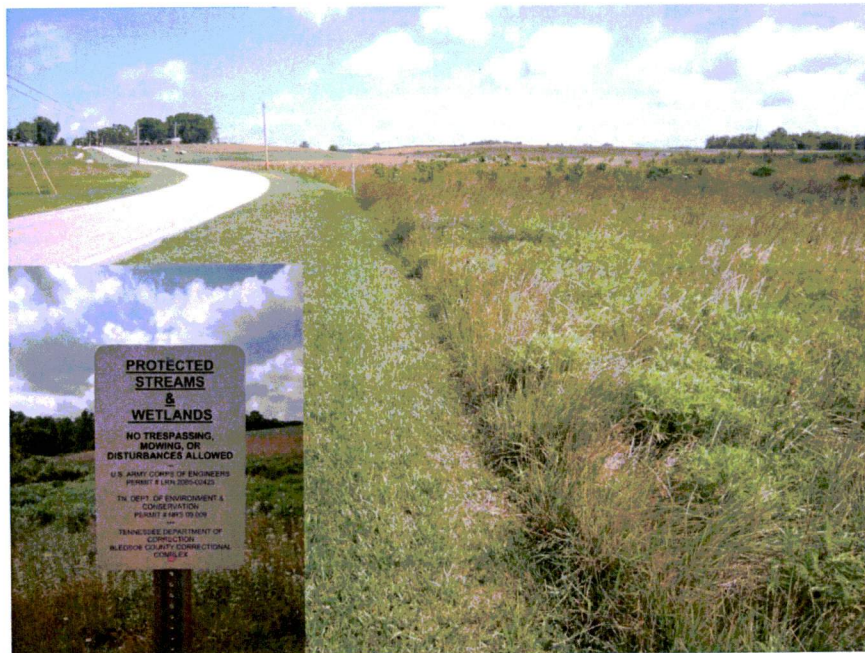
Photo 16.

Upland Buffers: In order to compensate for the failure to establish enough woody plants (and also the proper species ratios) in some areas, TDEC requested that the buffer zones around the west side of Stream 1, the south side of Stream 2, and both sides of Stream 3 be expanded from 25 to 50 feet. Also because of mowing incursions into the buffer zones, TDEC asked that signs be erected to prevent mowing in this area permanently. This view is looking north along SR 301 at an upland buffer lying adjacent to Stream 1 and Enhancement Area U.

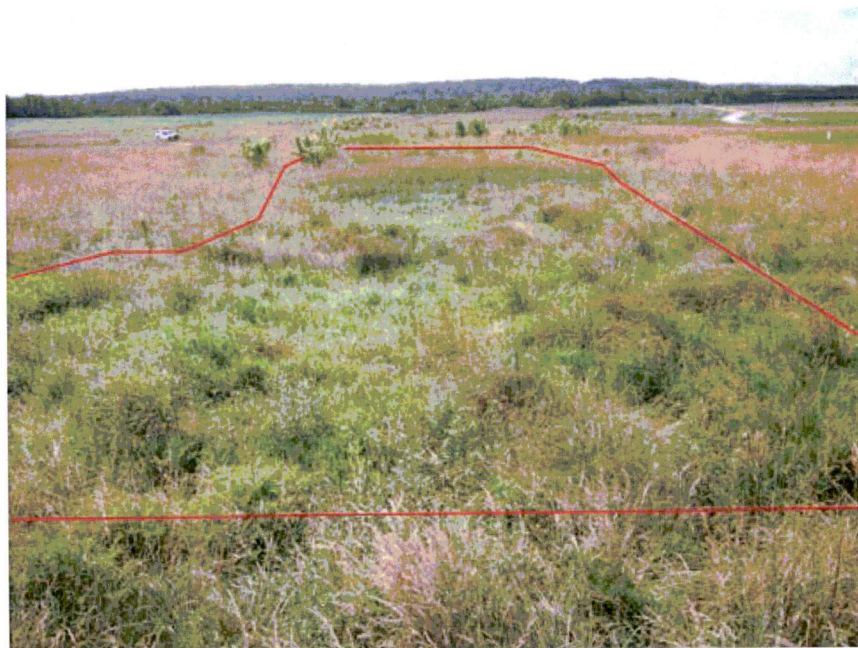
Photo 18.

Wetland Addition: As another way to compensate for the failure to establish enough woody vegetation in some locales, TDEC requested that a seepage wetland lying immediately to the north of the mitigation property also be incorporated into the mitigation effort and protected in perpetuity from future disturbance. This view of the wetland addition is looking southward. Its approximate boundaries are outlined in red. Total wetland area is approximately 0.6 acre.

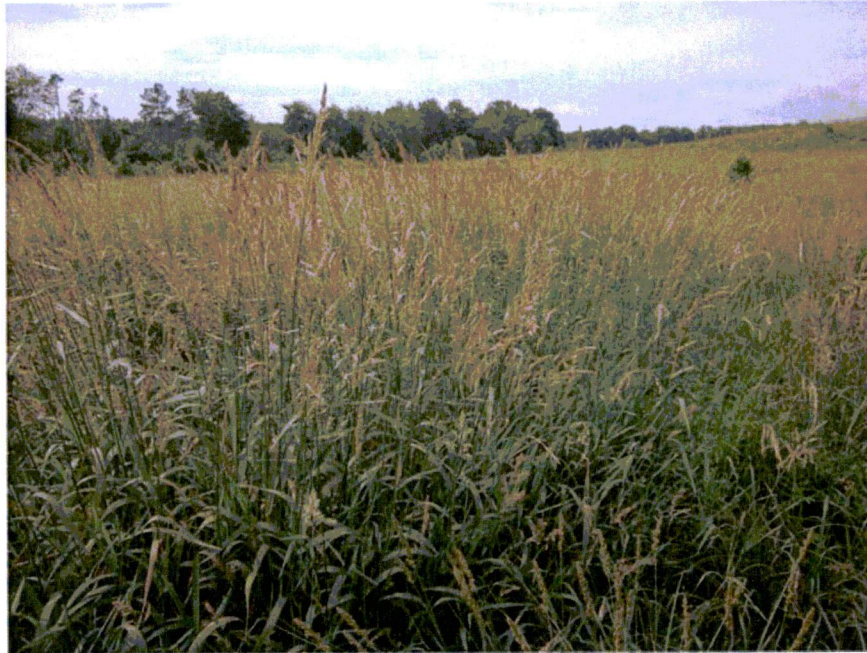
Photo 19.

Reed Canary Grass Control: Non-native strains of reed canary grass are aggressive invaders of open wetland areas. If left unchecked, they could jeopardize the success of wetland mitigation efforts. As of 2015, nine small populations of reed canary grass had been identified. With the consent of TDOC, EnSafe began an herbicide spraying regimen designed to bring reed canary grass under control and prevent its future spread.

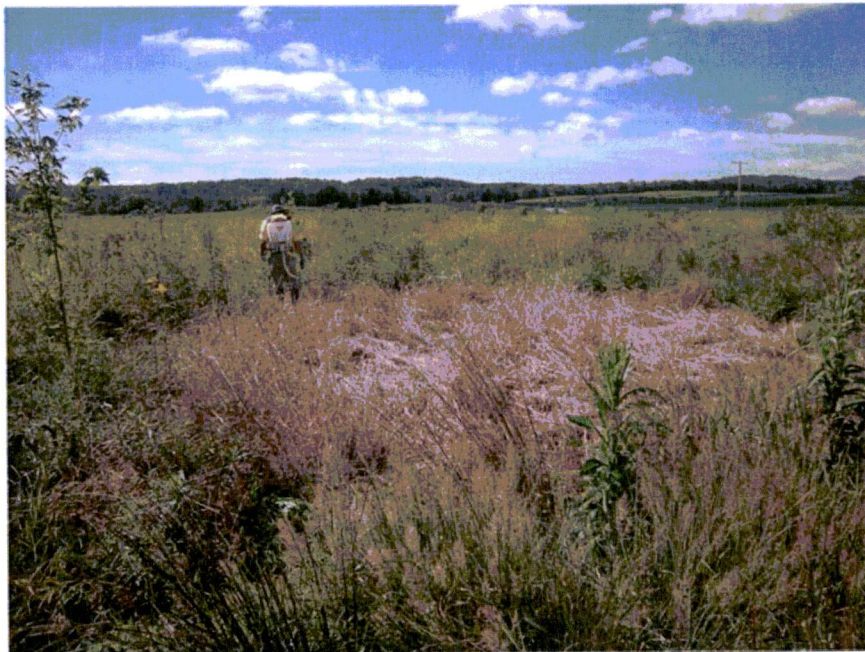
Photo 20.

Reed Canary Grass Control: This small patch was treated with herbicide in the early summer 2016. Follow-up monitoring showed that some plants continued to survive, so they were treated again in late August. Experience has shown that after reed canary grass is eliminated, native wetland herbs quickly become reestablished. Complete elimination, however, almost always requires repeated herbicide applications.

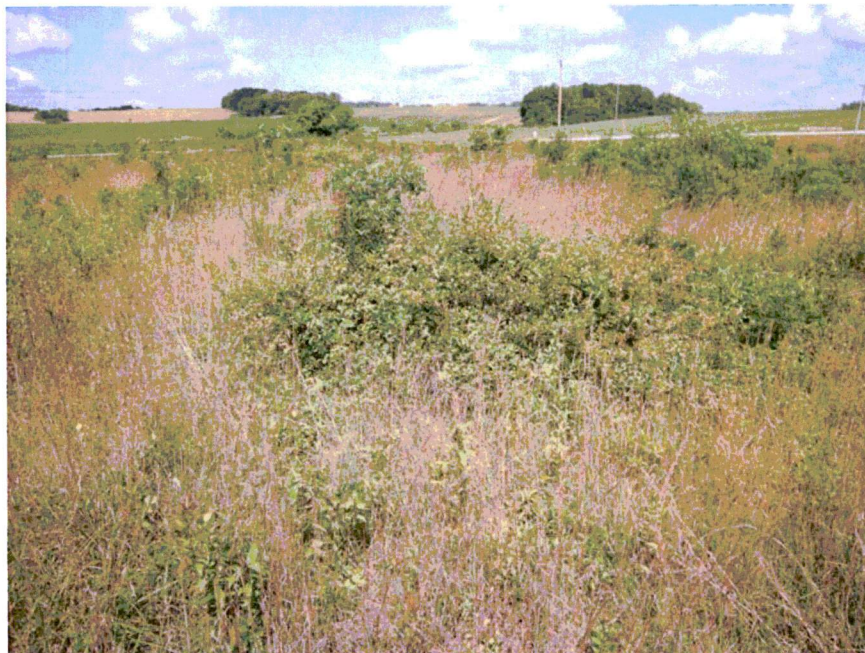
Photo 21.

Gooseberry Transplant Area: Rare granite gooseberry shrubs, rescued from the prison construction site and transplanted to the Mitigation Area in 2009, have survived and thus far appear to be doing relatively well. Although Japanese honeysuckle vines and native blackberries are strongly competing with some of the shrubs, they continue to expand. This year we documented a robust 59% increase in areal coverage since the last monitoring period (4,128 ft² to 6,555 ft²).
