RE: Fourth Year Wetland and Stream Monitoring Report  
Bledsoe County Correctional Complex  
Pikeville, Tennessee

## Bledsoe County Correctional Complex

# FOURTH YEAR WETLAND AND STREAM MITIGATION MONITORING REPORT

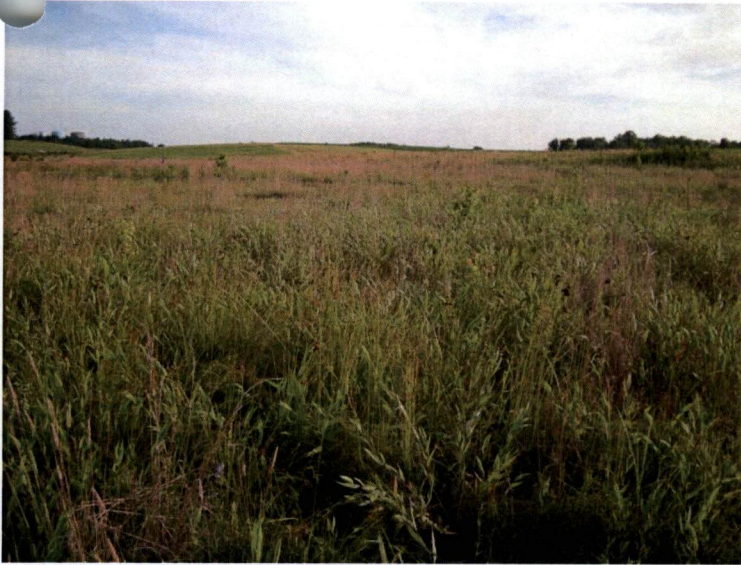
Photo 1.

Creation Area, Photo Reference Point C2: North

**Dominant Vegetation:** sweetgum (Fac), red maple (Fac), broom rosette grass (Facw), broomsedge (Facu), common cinquefoil (Facu), yellow-fruited sedge (Facw)

**Comments:** Corrective actions such as installing coir logs has helped a great deal to trap eroding soils and by doing so, provide a growth medium for planted and invasive vegetation.

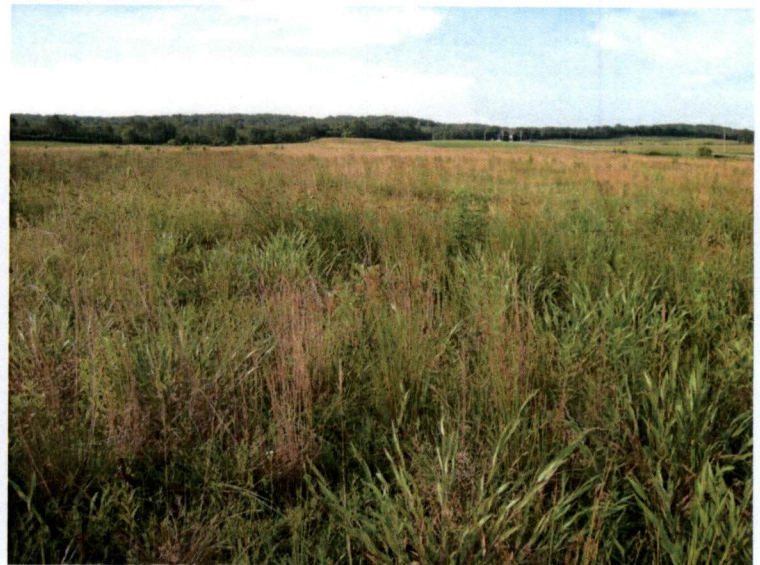
Photo 2.

Creation Area, Photo Reference Point C2: South

**Dominant Vegetation:** buttonbush (Obl), cypress witch grass (Fac), broom rosette grass (Facw), soft rush (Facw), greater poverty rush (Facw), late goldenrod (Facw)

**Comments:** Wetland vegetation, in particular, has benefitted from these actions. This year, 63.15% of all species in the creation area are considered wetland indicators.

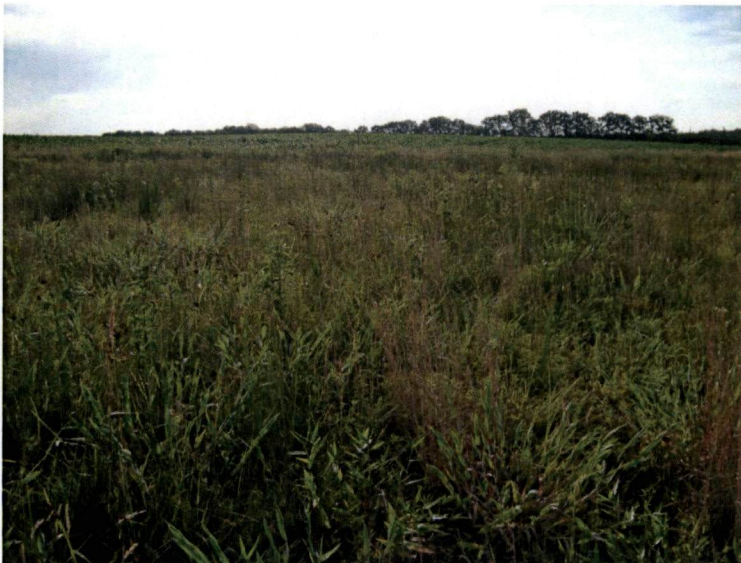
Photo 3.

Creation Area, Photo Reference Point C2: East

**Dominant Vegetation:** buttonbush (Obl), broom rosette grass (Facw), soft rush (Facw), broomsedge (Facu), Georgia bulrush (Facw) tapered rosette grass (Fac)

**Comments:** Soil accretion, especially on the northern half of the creation area, has helped to increase herb populations, but planted woody species have struggled somewhat because of low soil fertility. Although they occur at an average rate of 410 stems/acre, many are still small in stature and sometimes difficult to find in the dense herbs.

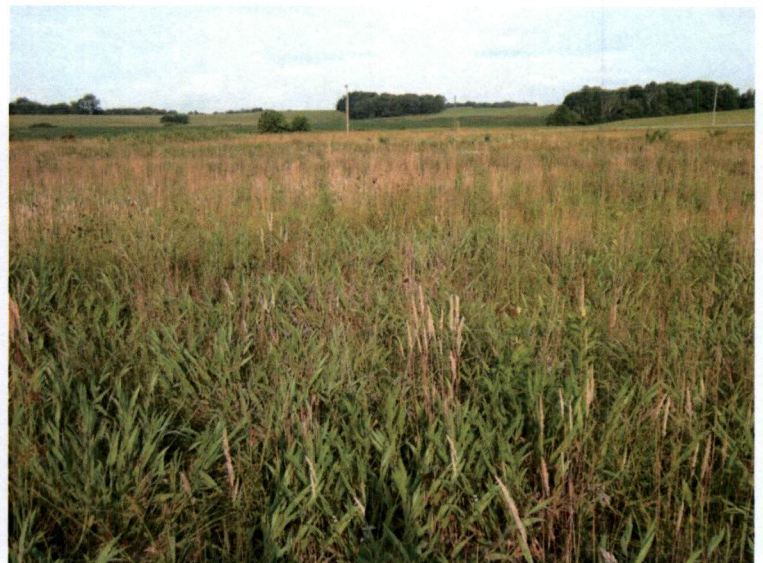
Photo 4.

Creation Area, Photo Reference Point C2: West

**Dominant Vegetation:** buttonbush (Obl), sweetgum (Fac), broom rosette grass (Facw), broomsedge (Facu), wrinkle-leaf goldenrod (Fac), taper-tip rush (Obl), tapered rosette grass (Fac)

**Comments:** Five species of rosette grasses (*Dichanthelium*) have been among the most successful natural invaders of the site. Together they account for almost 20% of total cover in the creation area.

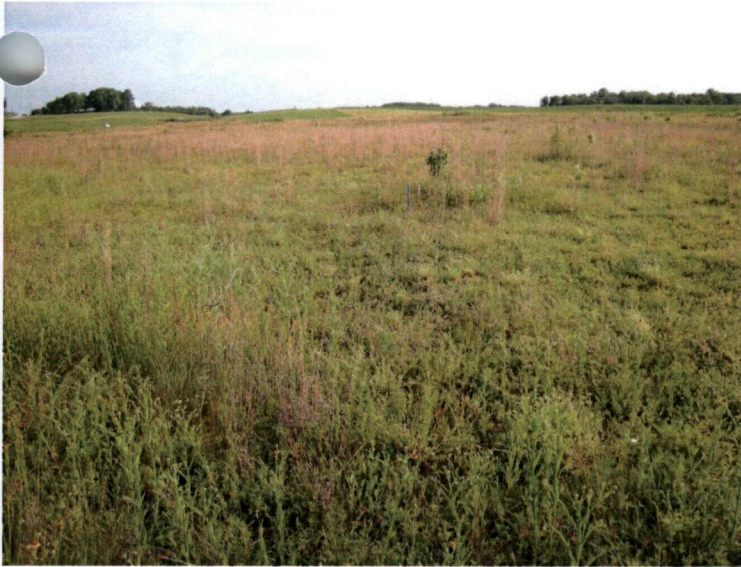
Photo 5.

Creation Area, Photo Reference Point C4: North

**Dominant Vegetation:** red maple (Fac), Japanese-clover (Facu), bearded beggar-ticks (Facw), downy American-aster (Fac), tapered rosette grass (Fac)

**Comments:** Stunted vegetation in this part of the site is primarily the result of low soil fertility, but seasonal ponding of concave surfaces also plays a role.

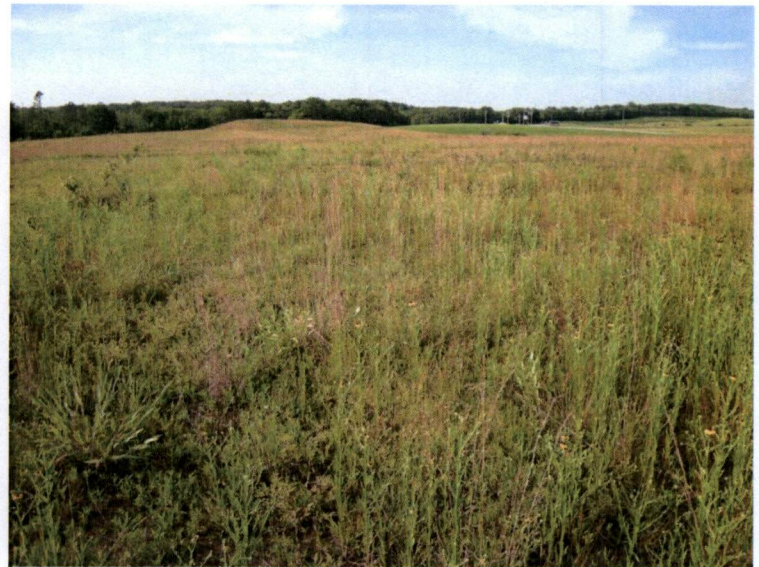
Photo 6.

Creation Area, Photo Reference Point C4: South

**Dominant Vegetation:** sweetgum (Fac), purplehead sneezeweed (Fac), broomsedge (Facu), Japanese-clover (Facu), tapered rosette grass (Fac)

**Comments:** Parts of the creation area are wet in winter through early summer. By mid-summer and fall they dry significantly. Such locations typically contain a mixture of wetland and non-wetland species.

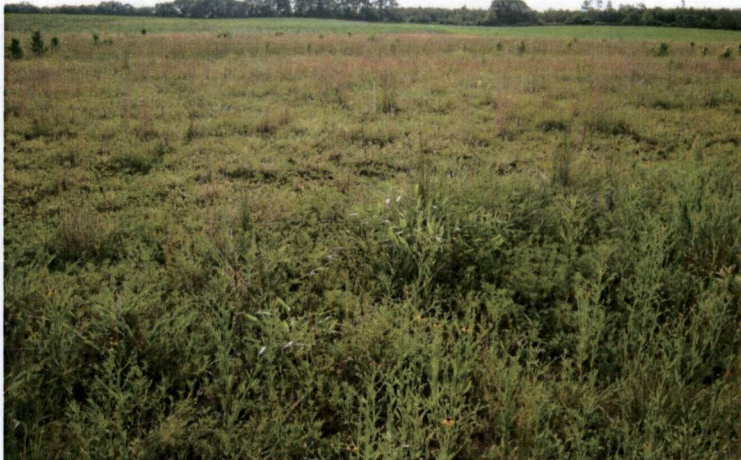
Photo 7.

Creation Area, Photo Reference Point C4: East

**Dominant Vegetation:** sweetgum (Fac), Japanese-clover (Facu), bearded beggar-ticks (Facw), downy American-aster (Fac), purple-head sneezeweed (Fac), tapered rosette grass (Fac)

**Comments:** A shallow, relatively impervious fragipan restricts rooting in this area. It also traps water at the surface. After heavy rains this area can become ponded. Algal deposits are common on the soil surface.

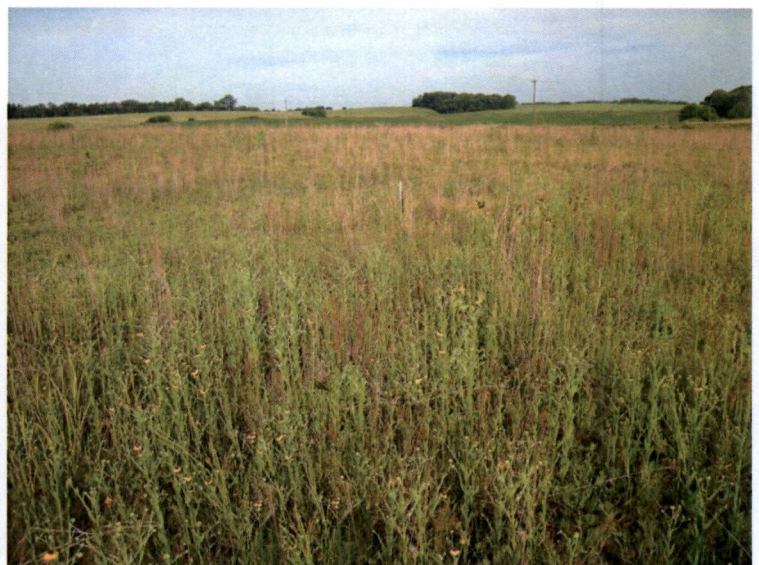
Photo 8.

Creation Area, Photo Reference Point C4: West

**Dominant Vegetation:** sweetgum (Fac), broomsedge (Facu), bearded beggar-ticks (Facw), purple-head sneezeweed (Fac), cypress witch grass (Fac), Georgia bulrush (Obl)

**Comments:** Crayfish burrows were noted here as well as in several other places scattered throughout the mitigation site.

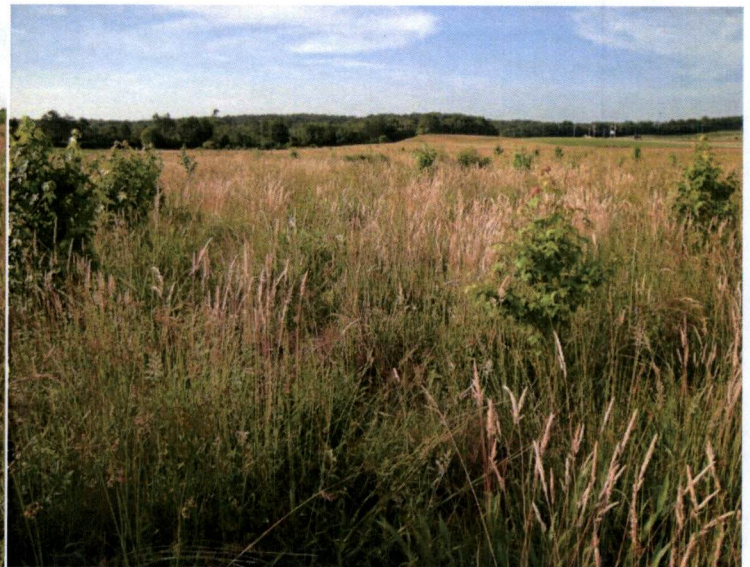
Photo 10.

**Enhancement Area, Photo Reference Point E1: North**

**Dominant Vegetation:** sweetgum (Fac), false indigobush (Facw), velvet grass (Fac), soft rush (Facw)

**Comments:** Enhancement areas contain over 490 tree and shrub seedlings per acre but the establishment of the seedlings has proven difficult because of root competition from the sod-forming grasses. A number of planted sweetgum trees can be seen in this view.

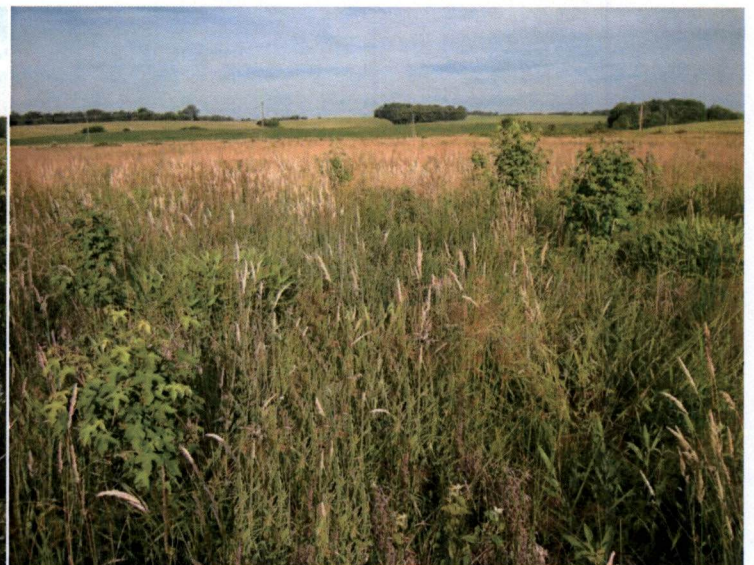
Photo 12.

**Enhancement Area, Photo Reference Point E1: East**

**Dominant Vegetation:** sweetgum (Fac), velvet grass (Fac), soft rush (Facw), deer-tongue grass (Fac)

**Comments:** Although sweetgums are prominent in this photo, red maples are more numerous occurring at the average rate of 157 stems/acre. Because of their shorter stature they are not as visible among the dense herbs.

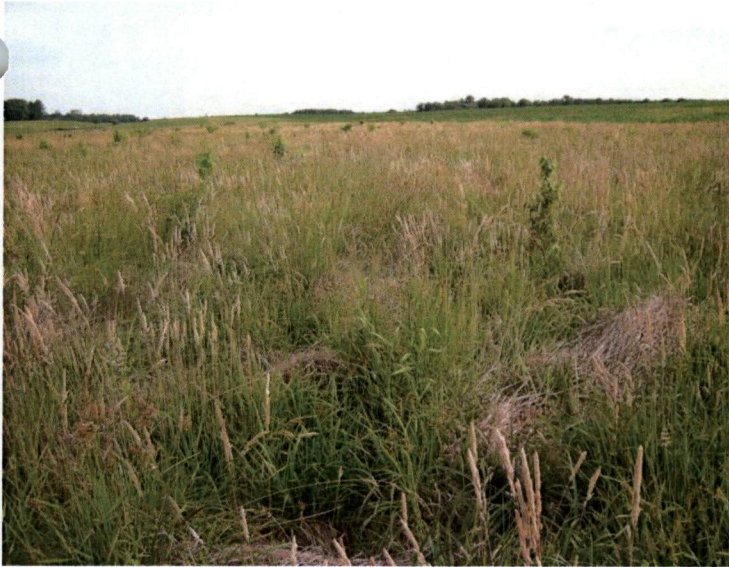
Photo 13.

Enhancement Area, Photo Reference Point E3: North

**Dominant Vegetation:** red maple (Fac), false indigobush (Facw), velvet grass (Fac), redtop panic grass (Facw), cypress witch grass

**Comments:** Redtop panic grass is a native wetland species that produces seed in the fall. While very dominant in enhancement areas, it has not yet begun to colonize adjoining created wetlands.

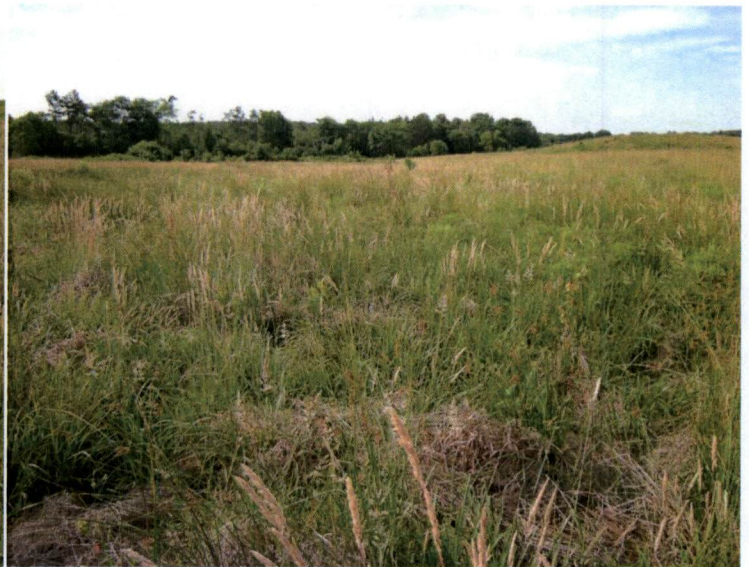
Photo 14.

Enhancement Area, Photo Reference Point E3: South

**Dominant Vegetation:** red maple (Fac), buttonbush (Obl), redtop panic grass (Facw), soft rush (Facw), wool-grass (Facw), velvet grass (Fac)

**Comments:** Redtop panic grass tends to thrive in damp or wet soils with adequate sunlight. It will eventually be outcompeted by woody vegetation and more shade-tolerant herb-layer species.

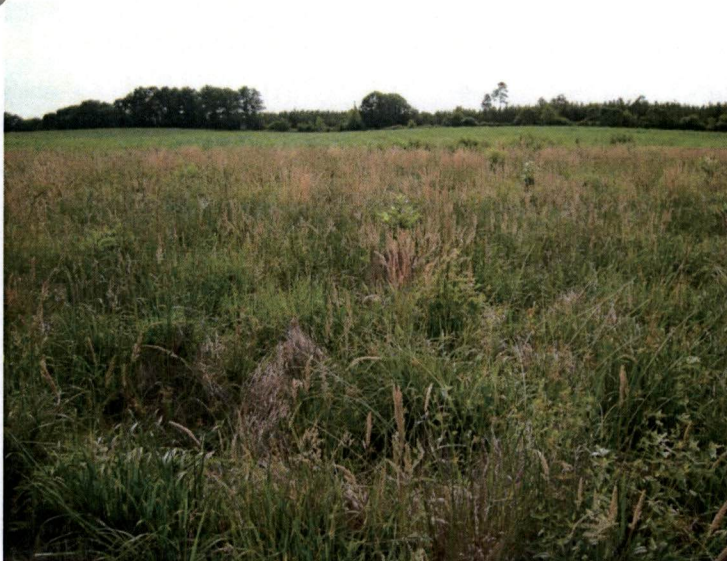
Photo 15.

Enhancement Area, Photo Reference Point E3: East

**Dominant Vegetation:** red maple (Fac), buttonbush (Obl), redtop panic grass (Facw), clustered mountain-mint (Facw), cypress witch grass, rice cut grass (Obl), squarrose sedge (Facw)

**Comments:** The tall, dense vegetation on the middle and southern portions of the enhancement area provide favored habitat for white-tail deer. Despite the wetness, numerous "deer beds" were observed.

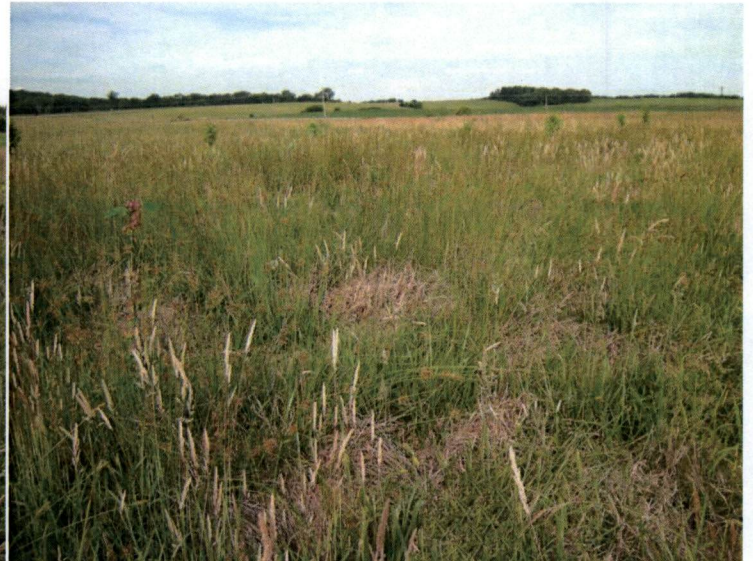
Photo 16.

Enhancement Area, Photo Reference Point E3: West

**Dominant Vegetation:** red maple (Fac), sweetgum (Fac), redtop panic grass (Facw), soft rush (Facw), velvet grass

**Comments:** Small inundated depressions, hidden by the dense herb layer, are also occasionally used by foraging snapping turtles. These turtles likely reside in an abandoned farm pond lying near the southeastern boundary of the mitigation area.

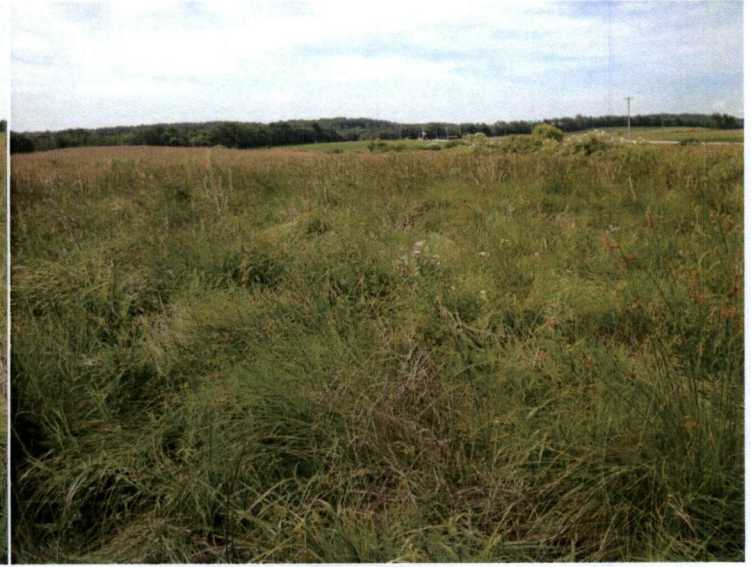
Photo 18.

Enhancement Area, Photo Reference Point E5: North

**Dominant Vegetation:** prickly bog sedge (Facw), redbtop panic grass (Facw), soft rush (Facw), sallow sedge (Obl), clustered mountain-mint (Facw)

**Comments:** Because of this wetness, planted trees have failed to become established to any great extent. Shrubs such as buttonbush and false indigobush, however, are doing well in some places.

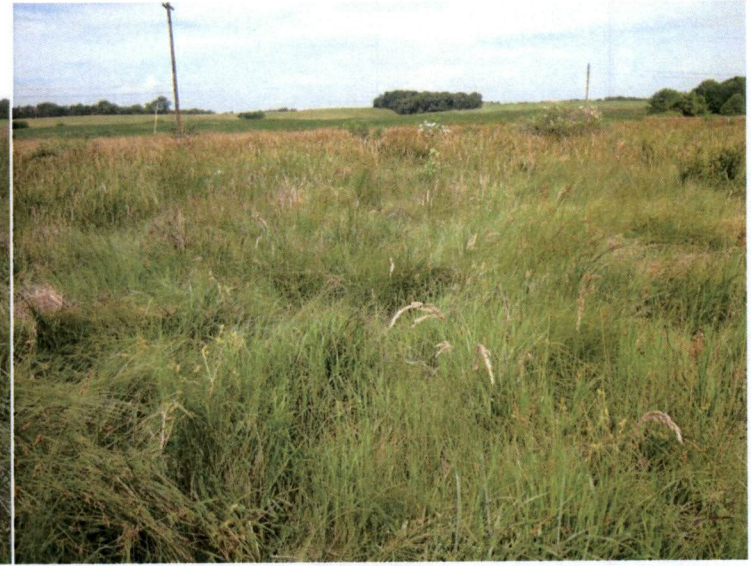
Photo 20.

Enhancement Area, Photo Reference Point E5: East

**Dominant Vegetation:** buttonbush (Obl), false indigobush (Facw), prickly bog sedge (Facw), soft rush (Facw), redbtop panic grass (Facw)

**Comments:** This general area supports an occurrence of the state-endangered brown bog sedge (see photo 35).

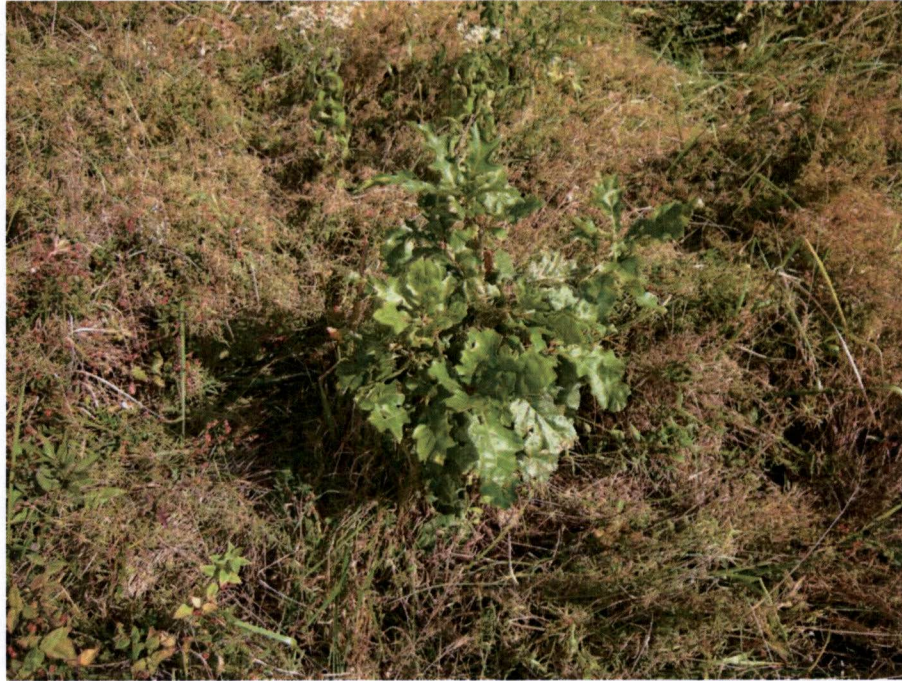
**Photo 21.** **Upland Buffer Zones:** Twenty-five ft-wide buffers, external to riparian buffers, were planted with upland oak species in order to provide extra protection to the restored streams. Current oak survivorship averages about 145 stems/acre. Other planted and naturally-invading woody species contribute an additional 80 stems/acre.

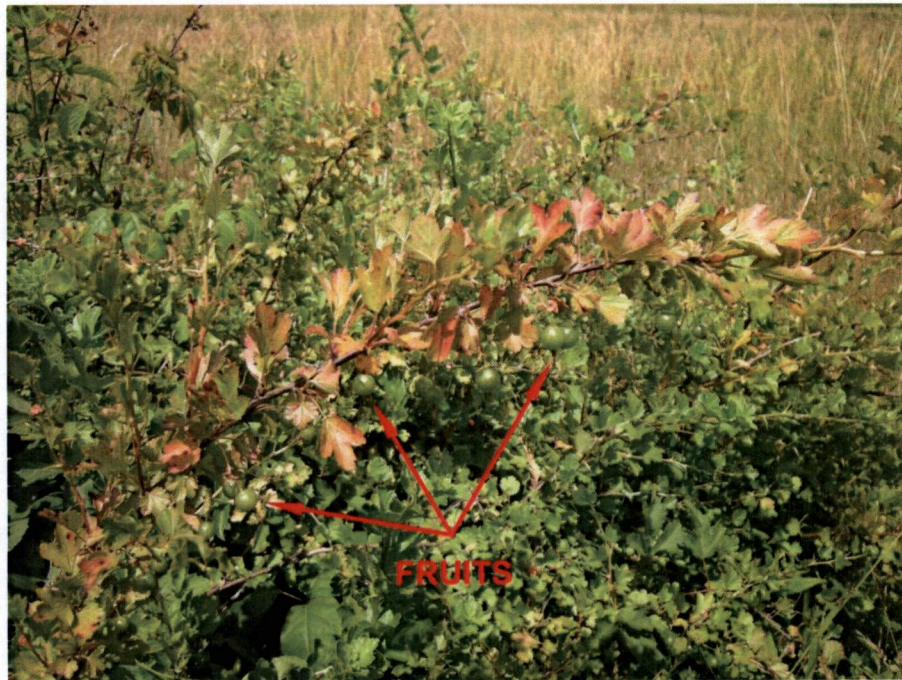
**Photo 22.** **Gooseberry Transplant Area:** Rare granite gooseberry shrubs, rescued from the prison construction site, and transplanted to the mitigation area in 2009, have survived and thus far appear to be doing relatively well. Although Japanese honeysuckle vines and native blackberries are strongly competing with some of the shrubs, they continue to expand. This year we documented a 38% increase in areal coverage since the last monitoring period. We are also encouraged by the fact that many of the plants are producing fruit. Hopefully this will add new plants to the population.

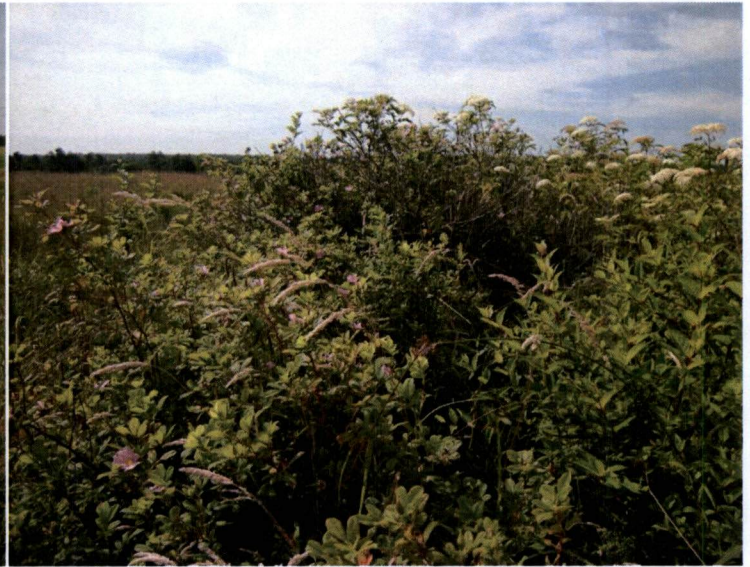
Photo 24.

**Stream 1 Enhancement Area, Photo Reference Point 1:**

**Dominant Vegetation:** elderberry (Fac), redbtop panic grass (Facw), soft rush (Facw), swamp rose (Obl)

**Comments:** One of the site's elderberries is visible here. It has expanded greatly in size since it was originally planted in December 2010. The dense riparian vegetation hides the channel from view.

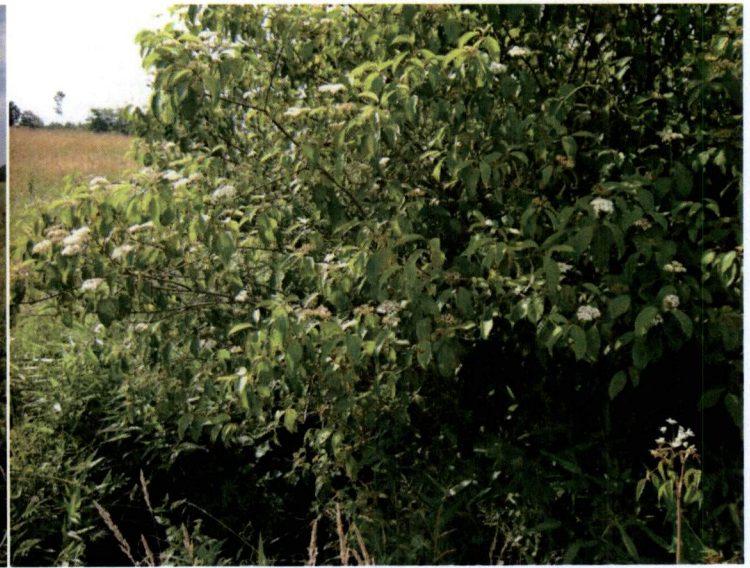
Photo 26.

**Stream 1 Enhancement Area, Photo Reference Point 3:**

**Dominant Vegetation:** silky dogwood (Facw), deer-tongue grass (Fac)

**Comments:** Also, because of the colonial nature of many of the planted shrubs, it was very difficult to determine whether performance standards were being met given the high number of live stems present. Counting individual stems was impractical so counts were based on average number of live sprouts per 10 ft of plant length. Silky dogwoods, for example, were found to contain an average of 35 sprouts per 10 ft of shrub length.

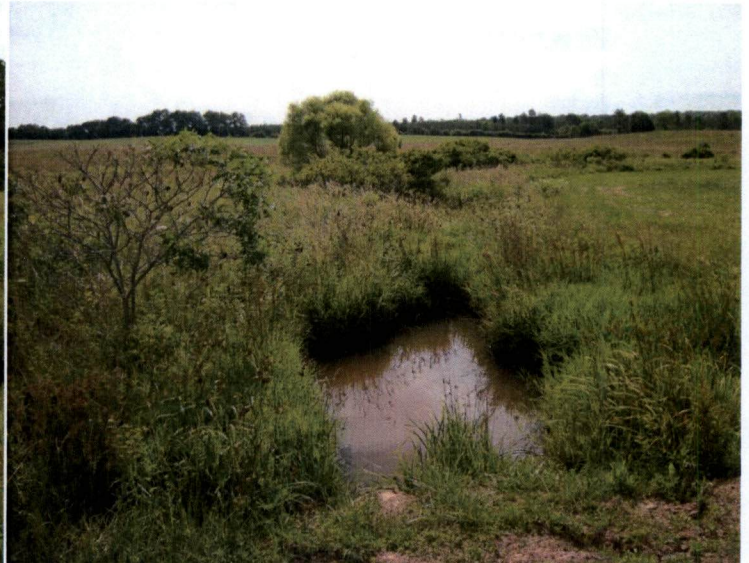
Photo 28.

**Comments:** Stream Segment 2 is also well-stabilized and supports a high density of herbs as well as planted and naturally invasive woody species. The plunge pool in the foreground lies just downstream of two culverts which pass beneath SR 301. It gives a much exaggerated impression of the size of the waterway.

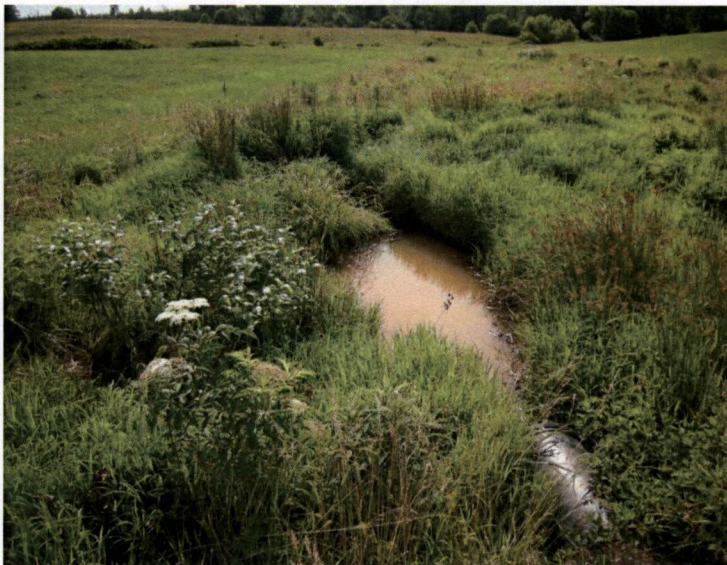
Photo 29.

**Dominant Vegetation:** winged sumac (Facu), black willow (Obl), rice cut grass (Obl), soft rush (Facw)

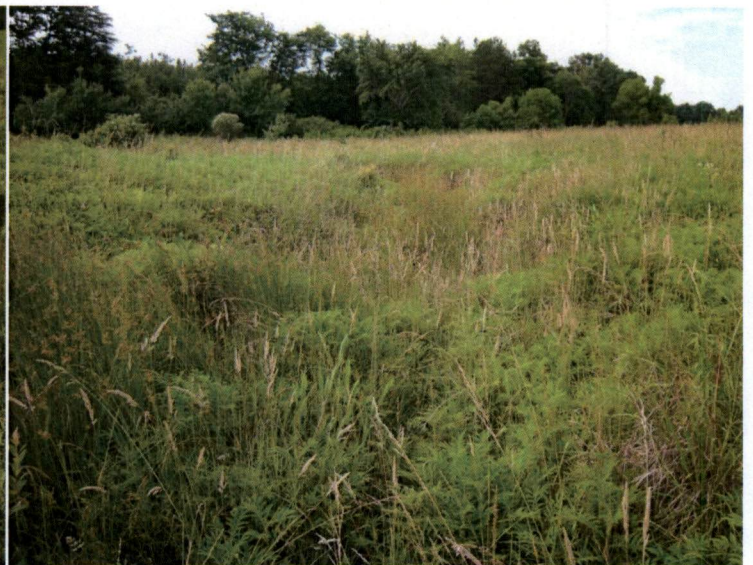
Photo 30.

**Comments:** By contrast, Stream Segment 3 had the lowest density at 60 stems/100 ft of stream. Unfortunately, some of this was caused by accidental mowing in the riparian zone. This can be seen in the left of the photo. Coordination with prison officials will be necessary to prevent this from recurring.

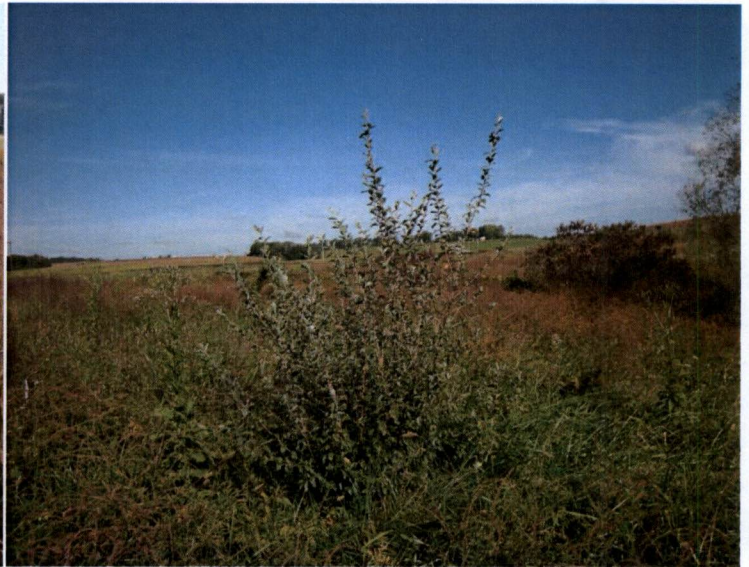
Photo 32.

**Photo Supplement, Wetland Enhancement Area Maintenance:**

**Comments:** Other problem species include autumn-olive (shown here) and multiflora rose. While not invaders of wetlands, they are beginning to encroach into stream enhancement areas. These were treated with herbicide in conjunction with false buckthorn. A routine maintenance program will circumvent the need for a more extensive herbicide spraying regimen in the future.

Because of the occurrence of invasive glossy false buckthorn shrubs in several of the stream mitigation zones we strongly recommend that a regimen of herbicide applications begin in the spring of 2016. The buckthorn is capable of rapidly colonizing open, moist or wet areas and supplanting desirable native vegetation. Since current population size is estimated at only a few dozen plants, control should be readily achievable, but it is likely that several treatments will be required. Two other invasive woody species (autumn-olive and multiflora rose) and one invasive grass species (reed canary grass) have also been identified on the mitigation site. Although these two shrubs have the ability to spread rapidly, they are not considered wetland species and would be most problematic in uplands and buffer zones adjacent to the mitigation areas. Because of this they would not be primary targets for control, but controlling them with herbicide applications should be given consideration. Reed canary grass is extremely tolerant of wetland conditions; it can quickly spread into wetlands and crowd out the native species.

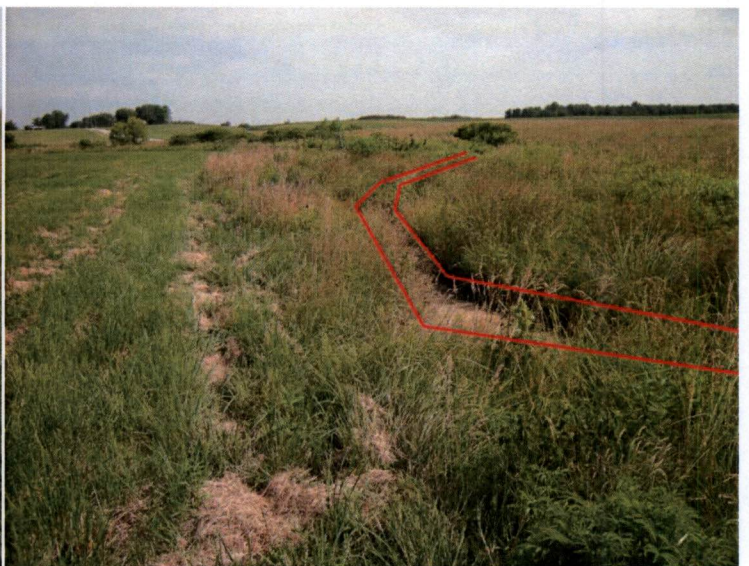
Photo 34.

**Photo Supplement, Wetland Enhancement Area Maintenance:**

**Comments:** Site mowing has encroached well into protected stream enhancement zones. Unknown numbers of planted trees and shrubs have been impacted. These zones extend 25 ft on either side of the creek channel (channel shown in red). Consideration should be given to curtailing all mowing adjacent to the mitigation site. At minimum we recommend the placement of signs along the border of the protected areas to prevent this from occurring again.

Mr. Lee also noted that several areas did not meet performance criteria due in part to heavy competition from sod-forming grasses and forbs had reduced tree seedling survival. He also noted that mowing incursions into stream buffers along the west side of Stream 1, the south side of Stream 2, and both sides of Stream 3 had further reduced stocking densities. It was also noted that in the remaining stream buffer areas density met performance criteria but not the requirement that no single tree species exceed 20% of the total density. Mr. Lee provided the following recommendations/conditions to help bring the site into compliance with the performance criteria:

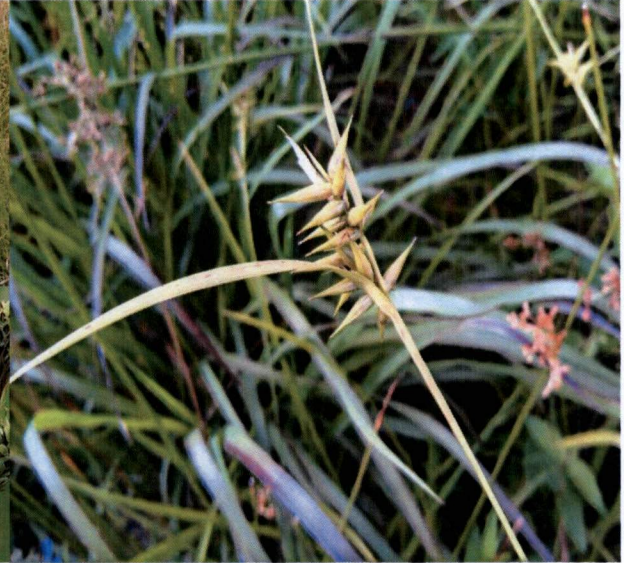
Photo 36.

**Photo Supplement, Rare Plants:**

**Comments:** Also "endangered" is the southern long sedge. Other than Bledsoe County, it has been documented from only one other TN county (Lincoln).

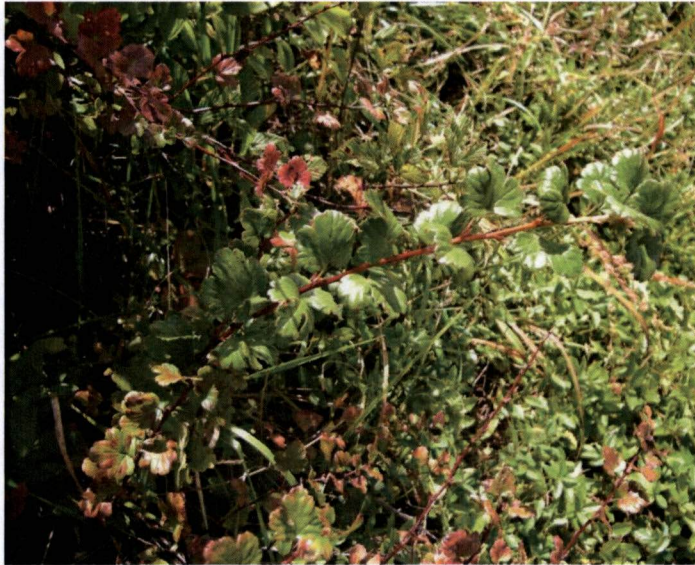
Photo 37.

**Photo Supplement, Rare Plants:**

**Comments:** The granite gooseberry is listed as "threatened". While relatively common in the immediately vicinity of BCCX, there are five or fewer other known populations in the state. Approximately 20 shrubs were "rescued" from destruction during construction of the BCCX expansion and transplanted to the wetland mitigation area. (See comments under Photo 22.)

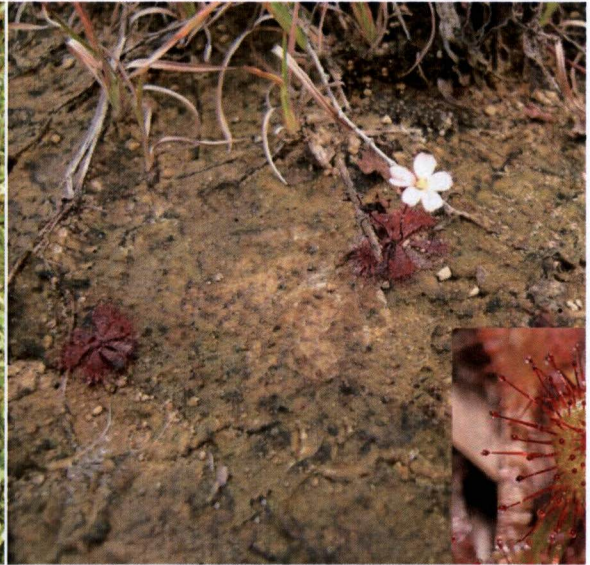
Photo 38.

**Photo Supplement, Rare Plants:**

**Comments:** The latest addition to the rare plant list is the tiny dwarf sundew; a state "threatened" species. Sundews inhabit nitrogen poor soils and supplement their nutrient intake by capturing insect prey. This is done by trapping insects with sticky hairs that coat the leaf surface (see insert) and then dissolving the prey with specialized enzymes. The nutrients from the insect are then absorbed through the leaves.

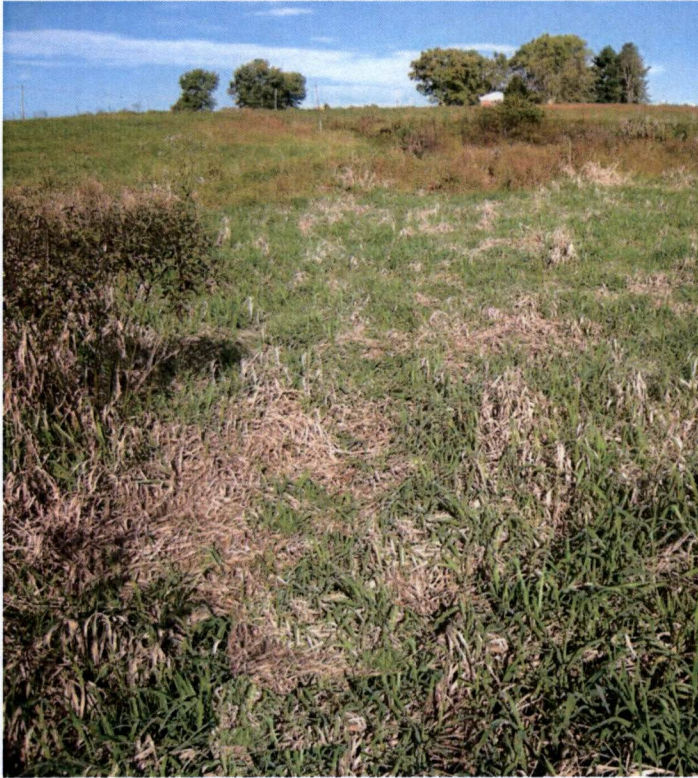
Photo 39

**Photo Supplement, Wetland Enhancement Area Maintenance:**

**Comments:** Reed canary grass in Wetland T at BCCX mitigation area on October 5, 2015 prior to herbicide treatment. View to north.

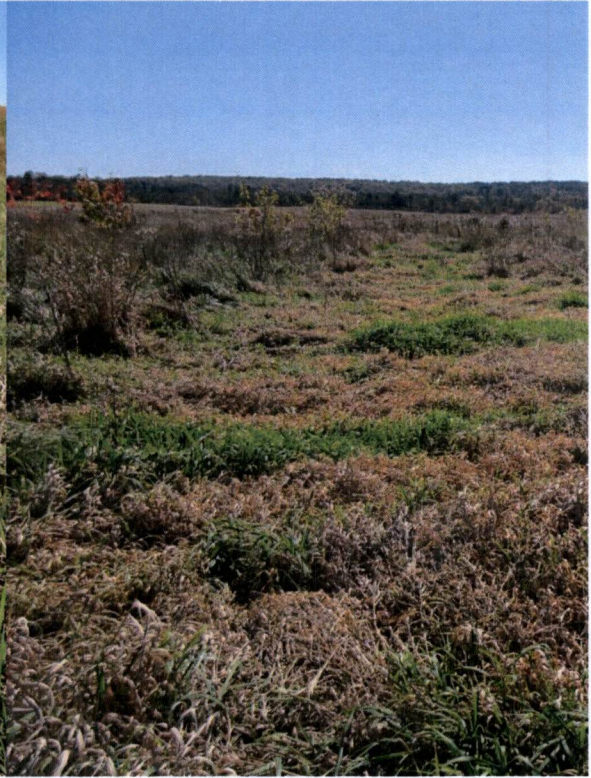
Photo 40

**Photo Supplement, Wetland Enhancement Area Maintenance:**

**Comments:** Reed canary grass in Wetland T at BCCX mitigation area on October 19, 2015 approximately two weeks after herbicide treatment. View to south.

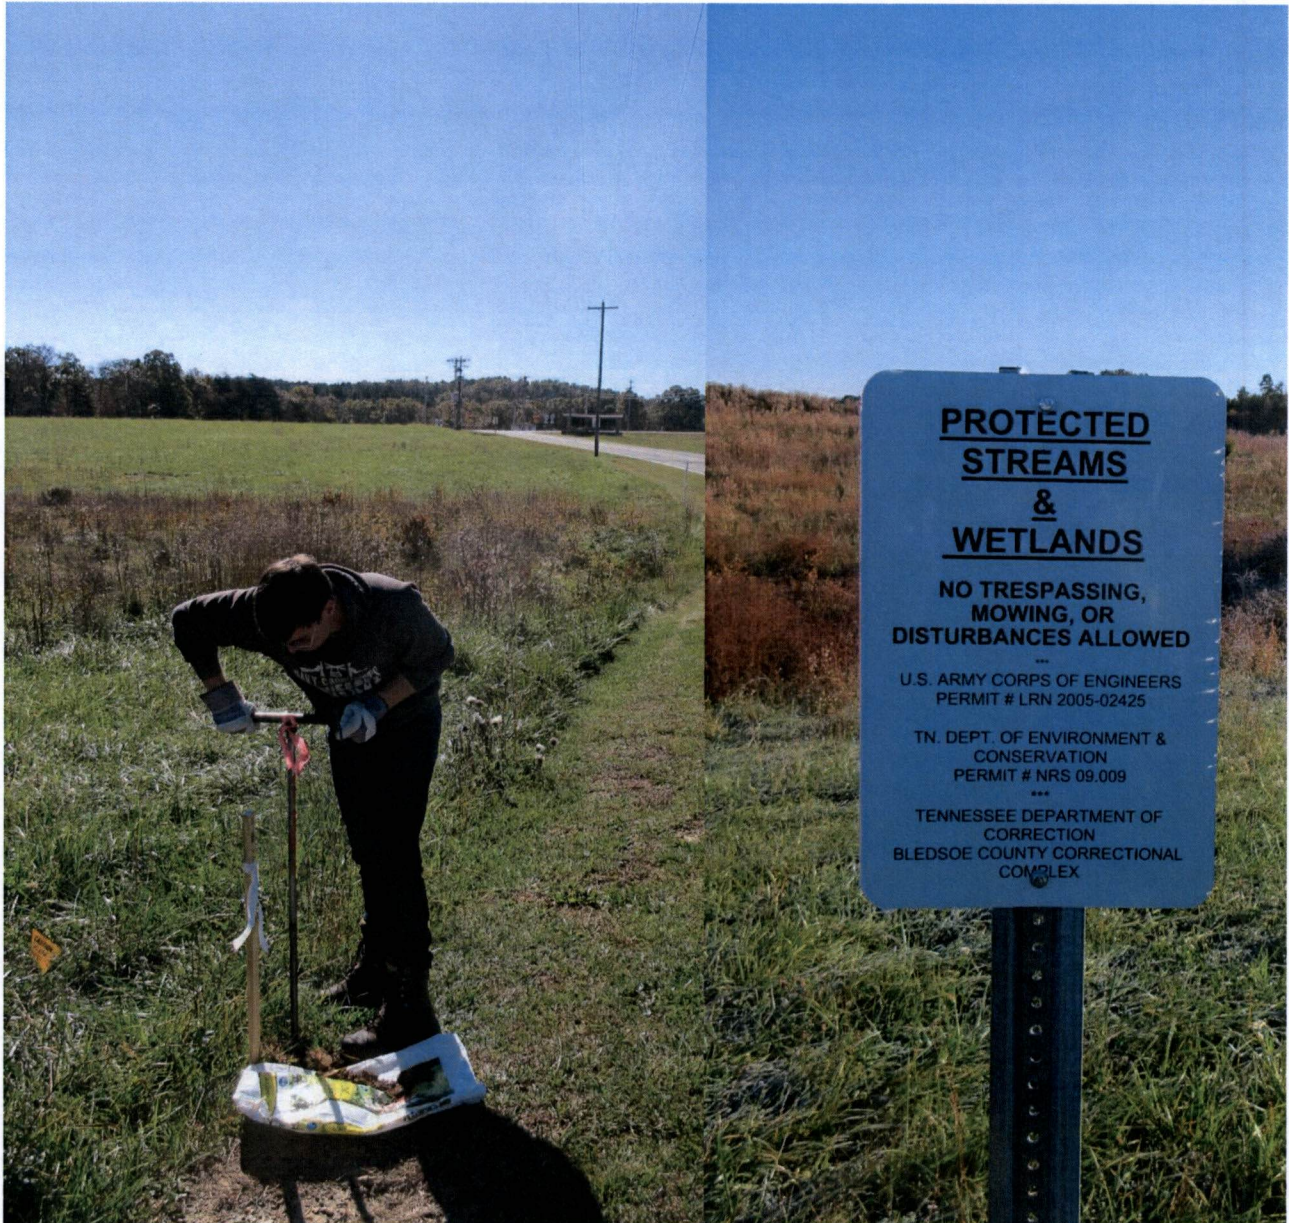
Photo 41

**Photo Supplement, Wetland Enhancement Area Maintenance:**

**Comments:** Sign marking protective zone around BCCX mitigation area. Stream 1 riparian zone in background.
