CORRECTIVE ACTION PLAN
FOR
SANITARY SEWER OVERFLOWS
OCCURRING
IN THE
WEST END DRAINAGE AREA
COOKEVILLE, TENNESSEE
MARCH 2017

BARRY K. TURNER, P.E.
CITY OF COOKEVILLE
DEPARTMENT OF WATER QUALITY CONTROL
1860 SOUTH JEFFERSON AVE
COOKEVILLE, TN 38506
(931) 520-5258

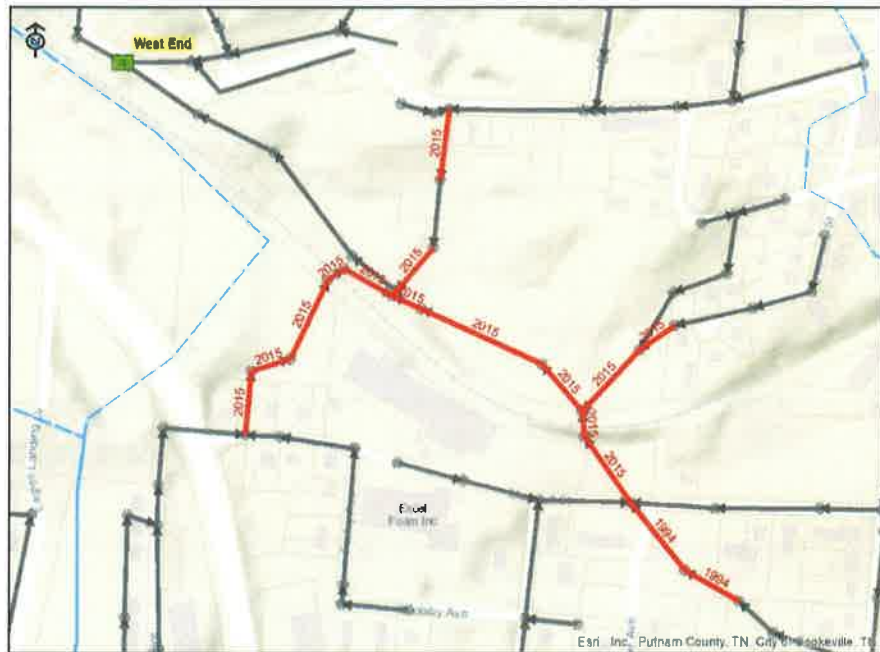
Figure 5, Lines with CIPP installed

In 1994, there was a total of 434' of sewer in this basin that was lined using cured-in-place pipe (CIPP). In a 2015 rehabilitation project, an additional 2,499' of sewer in this basin had CIPP installed. In the latter project, there were very few laterals, but they all were replaced, whereas in the first project they were not.

These sections are shown in Figure 5. The cost for these projects was approximately \$89,000.

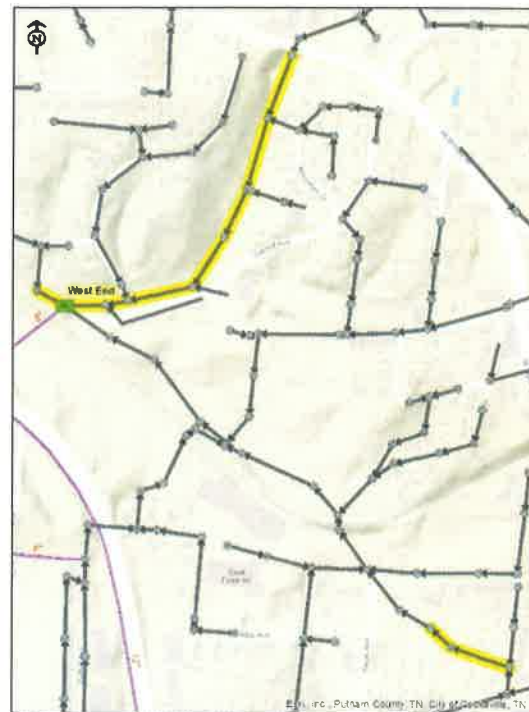
Figure 7. Lines to CCTV

All of the sections in this basin that we have televised have been concrete pipe. Also, all of the sections that we have installed CIPP in, and the ones we are installing CIPP in this year are concrete. To better assess the condition of the drainage basin, some of the clay pipe needs to be televised. The section west of the pump station and at least four of the sections northeast of the pump station toward Highway 70 will be televised. The section west of the station was chosen because the first 40' is shown as ductile iron; the transition to clay pipe should be looked at to see how it was made, and to see if it is still water-tight. Also this section did have a dry weather blockage. In addition, the two sections of concrete pipe upstream of the 1994 lining need to be televised. These lines will be used as indicators of the condition of other sections. By December 31, 2018, the seven

sections mentioned will be televised. These sections are shown on Figure 7. This will be approximately 1,650 linear feet at approximately \$2.50 per foot, for a total cost of \$3,600.
