## Mining Facility Inspection Report

**ARAP Permit Number:** NR19MS.001

**Inspection type:** ARAP Compliance Inspection - Mining

### INSPECTION RESULTS: In Compliance

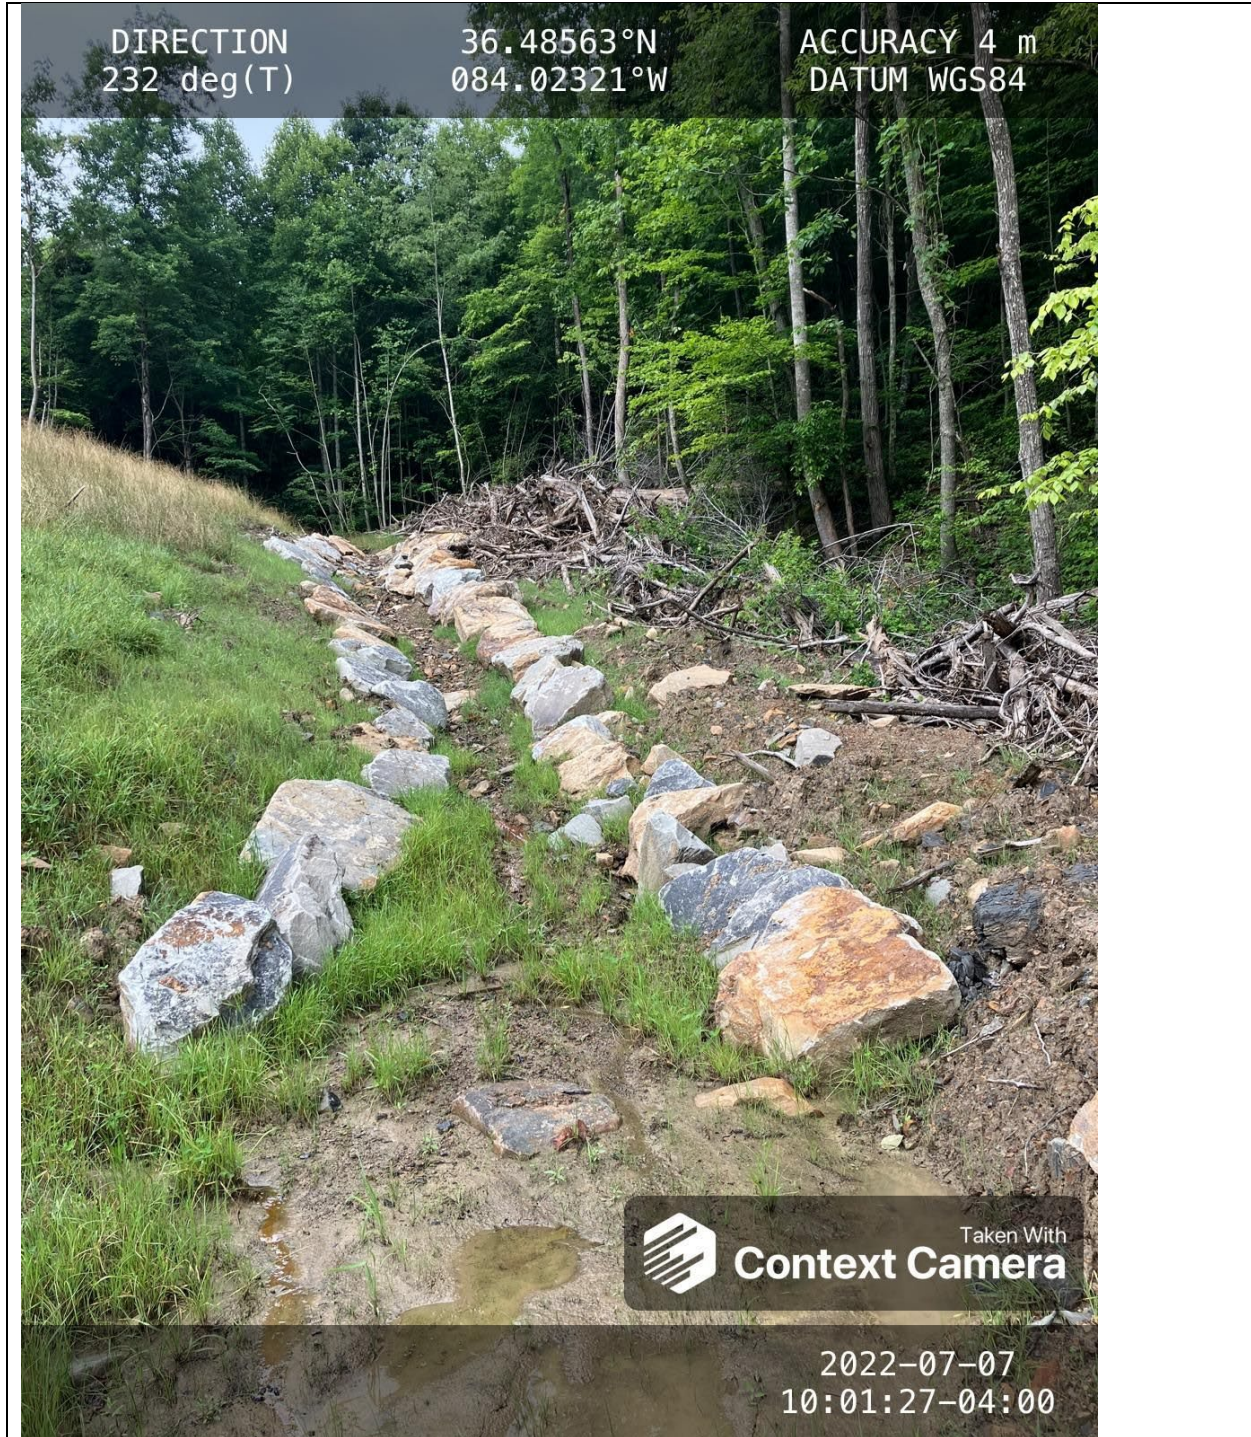
36.48563 -84.02321 232.0361370716511 2022/07/07 10:01:27

Item 2: Photo of diversion ditch above Stream 4 routing stormwater to a treatment basin, per SMCRA permit, and not into Stream 4.

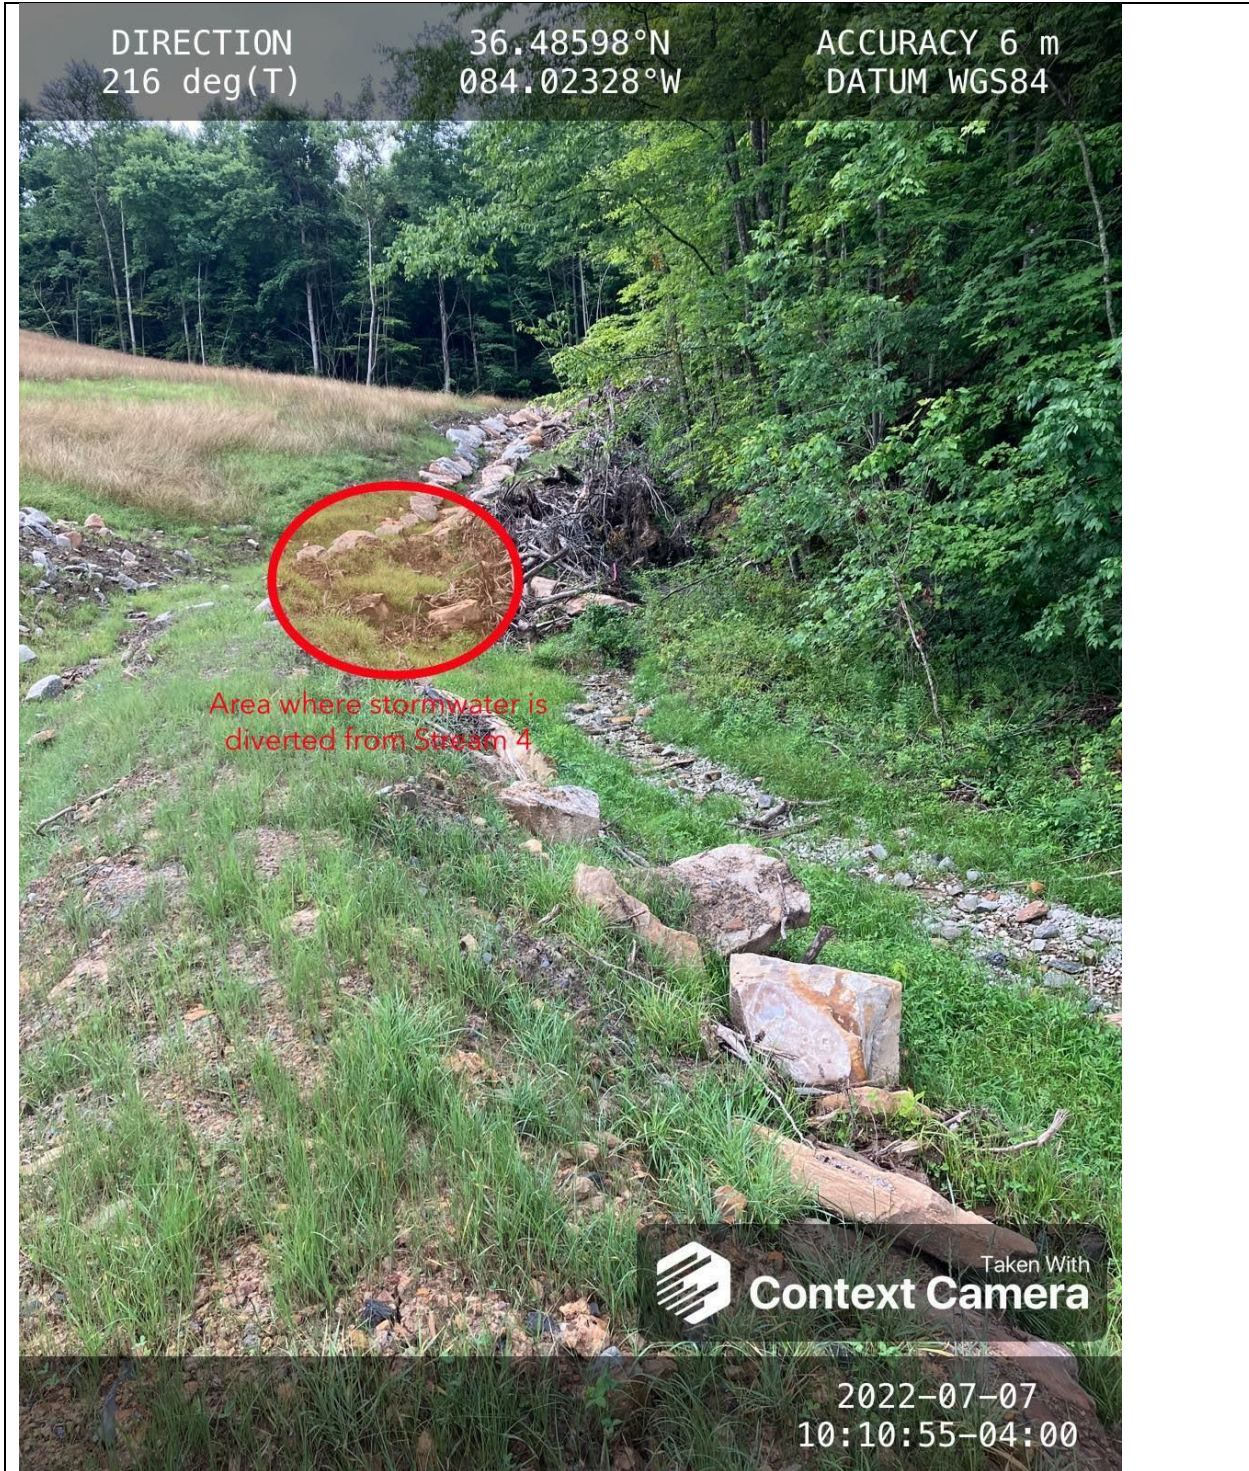
36.48599 -84.02327 216.46086533787067 2022/07/07 10:10:55

Item 3: Photo showing diversion of stormwater from Stream 4

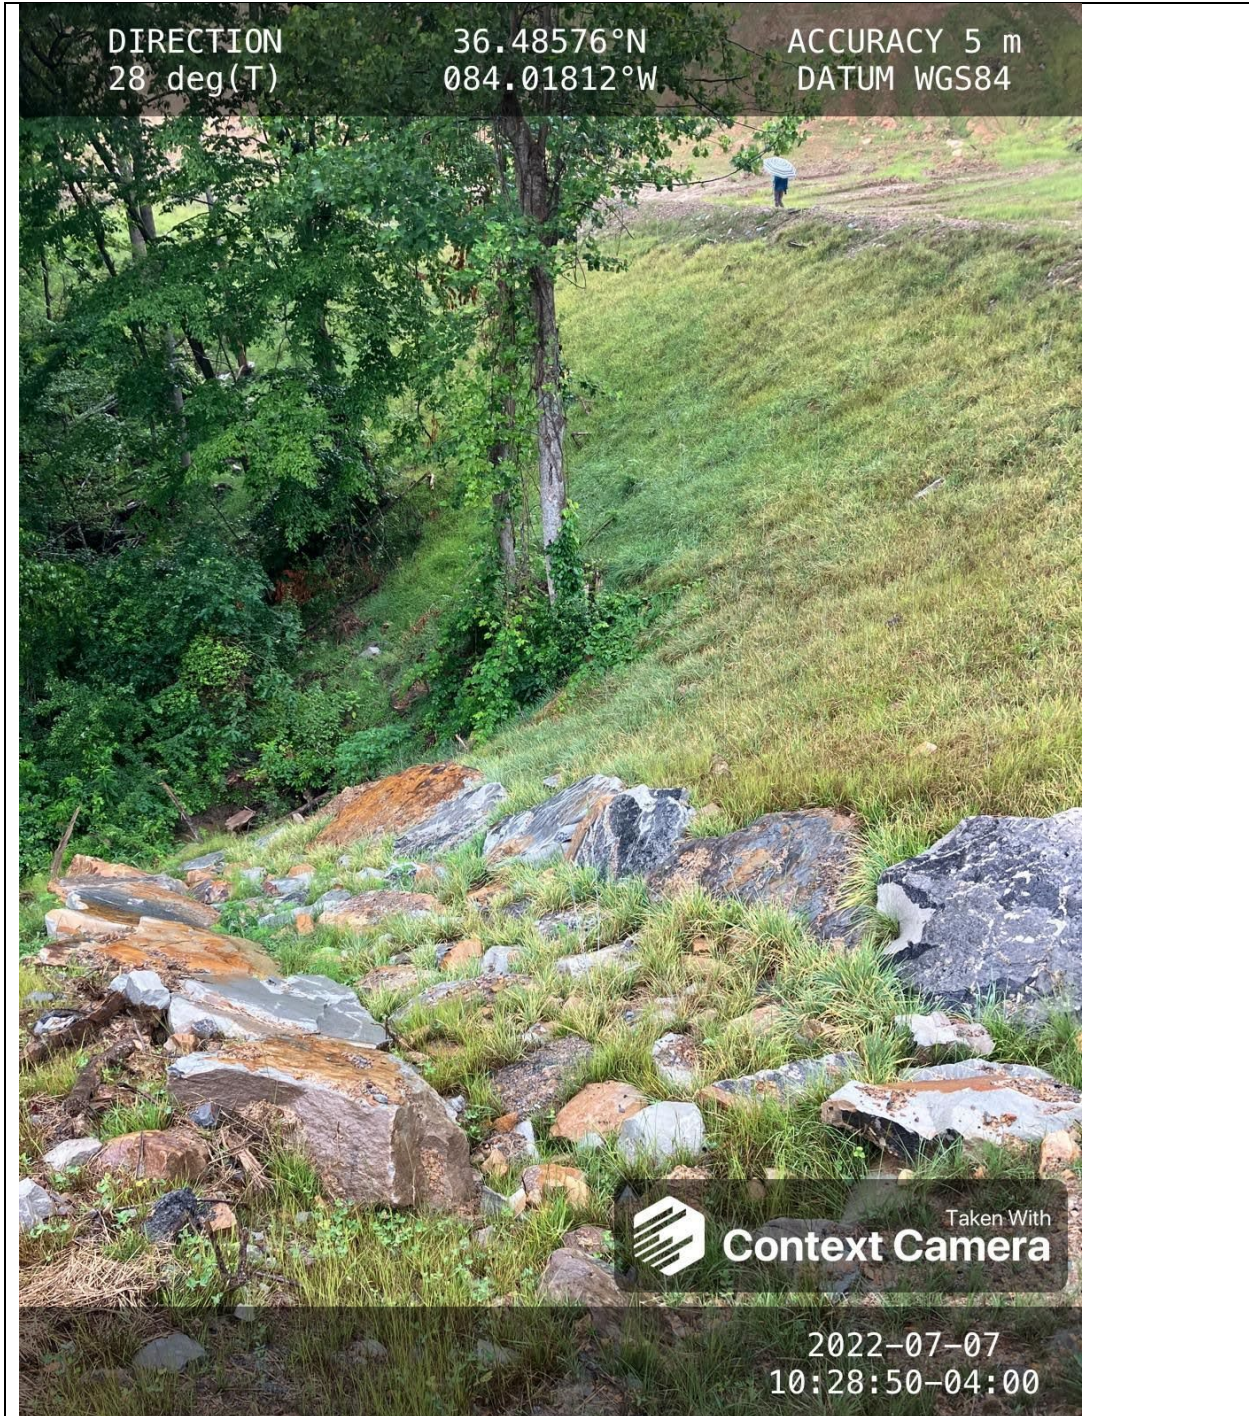
36.48576 -84.01812 27.792490477054237 2022/07/07 10:28:50

Item 4: Rock lined channel for Stream 2. Stormwater from the watershed for Stream 2 is being diverted into a treatment pond, per SMCRA requirements.
