Re: Compliance Evaluation Inspection
Collierville-Shelton Road STP
NPDES Permit No. TN0057461
Shelby County

Compliance Evaluation Inspection for Individual NPDES Permit

Facility Name: Collierville-Shelton Road STP	NPDES Tracking Number: TN0057461
Permit Effective Date: April 1, 2019	Permit Expiration Date: December 31, 2023
Date and Time of Inspection: December 12, 2023	Inspector Name: Brittany Gibson

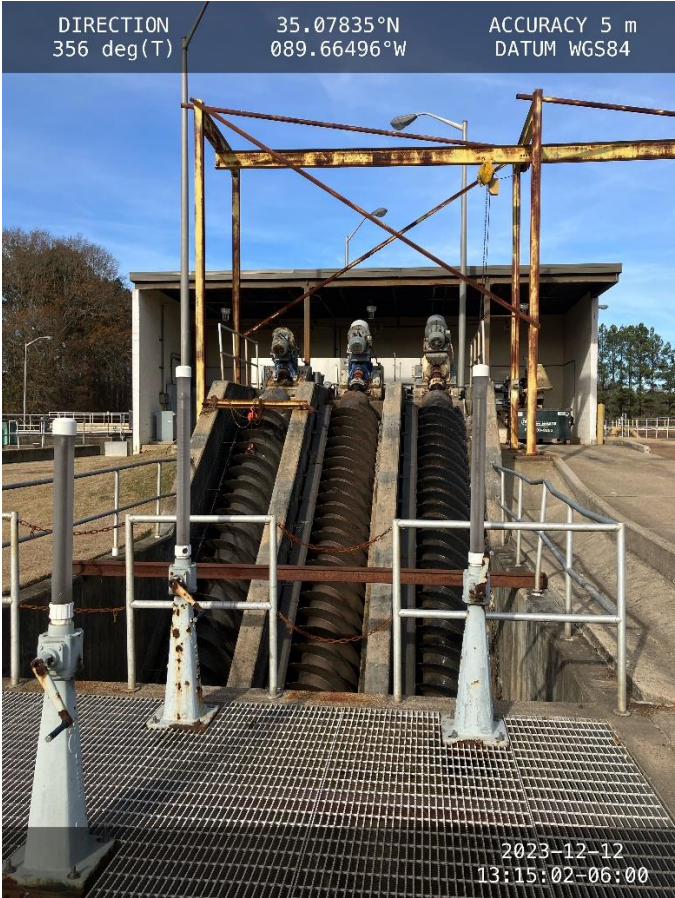
Facility Name: Collierville-Shelton Road STP		Site Location: Shelby County	Tracking No.: TN0057461
Photo No. 1	Date 12-12-2023	DIRECTION 356 deg(T) 35.07835°N 089.66496°W ACCURACY 5 m DATUM WGS84	
Description View of the three screw pumps at the headworks.

The Collierville-Shelton Road STP consists of centrifugal influent pumps, three screw pumps at the head of the plant (photo 1), followed by a bar screen (photo 2) and two grit chambers (photo 3). From the headworks, the wastewater is pumped to two oxidation ditches (photo 4) for intensive aeration. From the oxidation ditches, the wastewater is clarified using two clarifiers (photo 5), then disinfected using ultraviolet lights (UV) (photo 6) before being discharged to the Wolf River. Ultraviolet lights are the primary effluent disinfection process; however, a bleach disinfection process is available as a backup. UV light replacement units were stored on site. Wastewater can enter the plant through two ways. It can either flow into the plant by gravity or via screw pump mechanism.

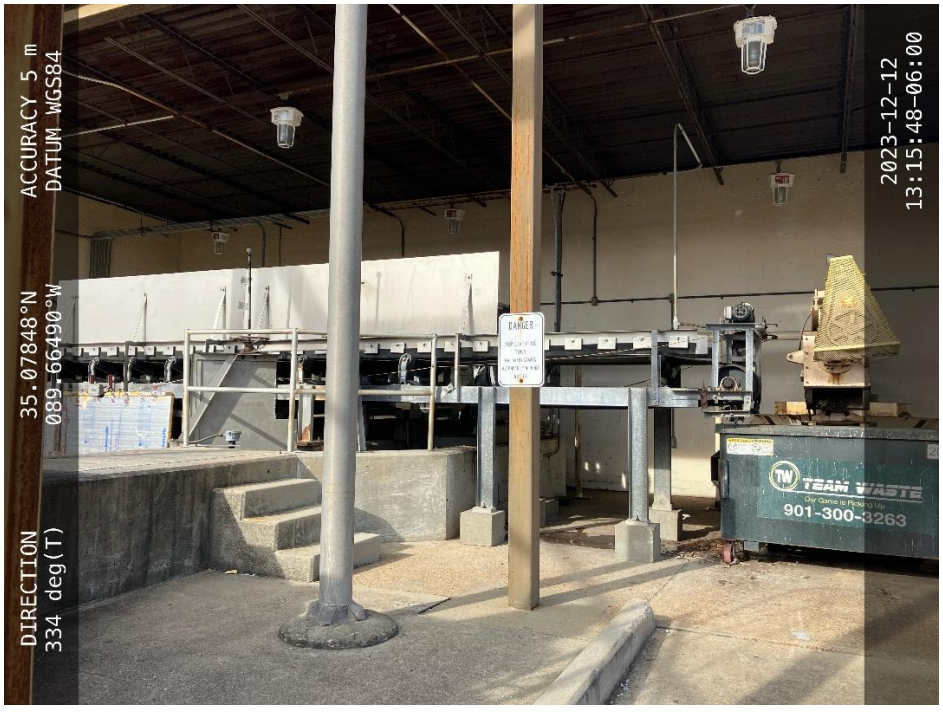
Photo No. 2	Date 12-12-2023	DIRECTION 334 deg(T) 35.07848°N 089.66490°W ACCURACY 5 m DATUM WGS84	
Description View of the bar screen.

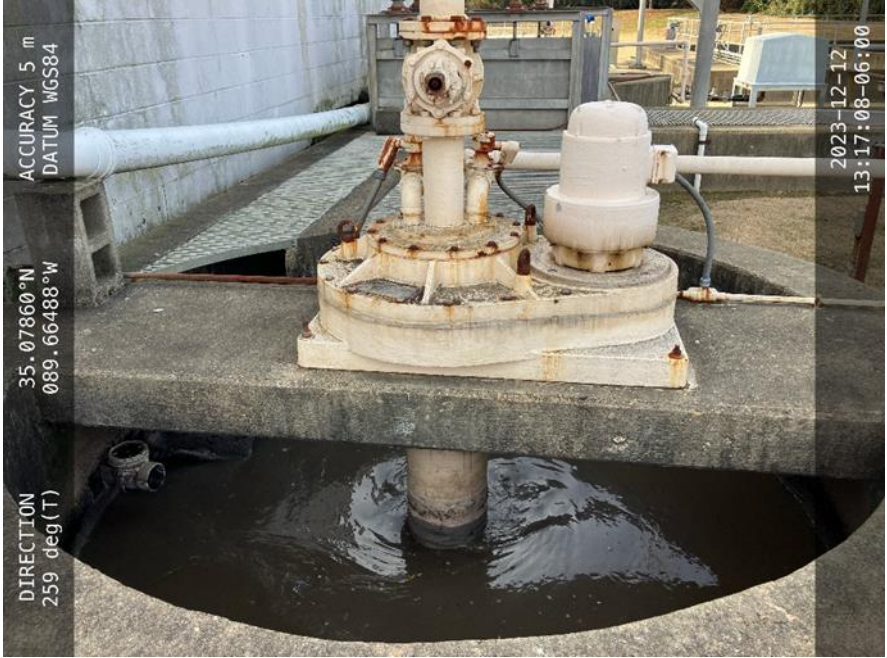
Facility Name: Collierville-Shelton Road STP		Site Location: Shelby County	Tracking No.: TN0057461
Photo No. 3	Date 12-12-2023

Description View of one of the grit chambers.

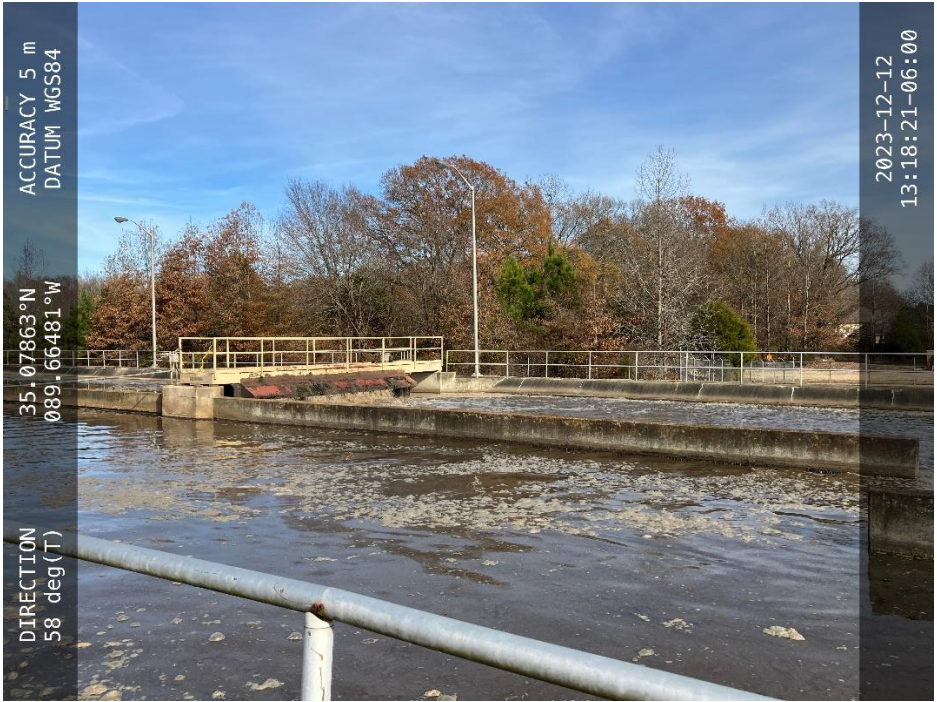
Photo No. 4	Date 12-12-2023

Description View of the one of the oxidation ditches.

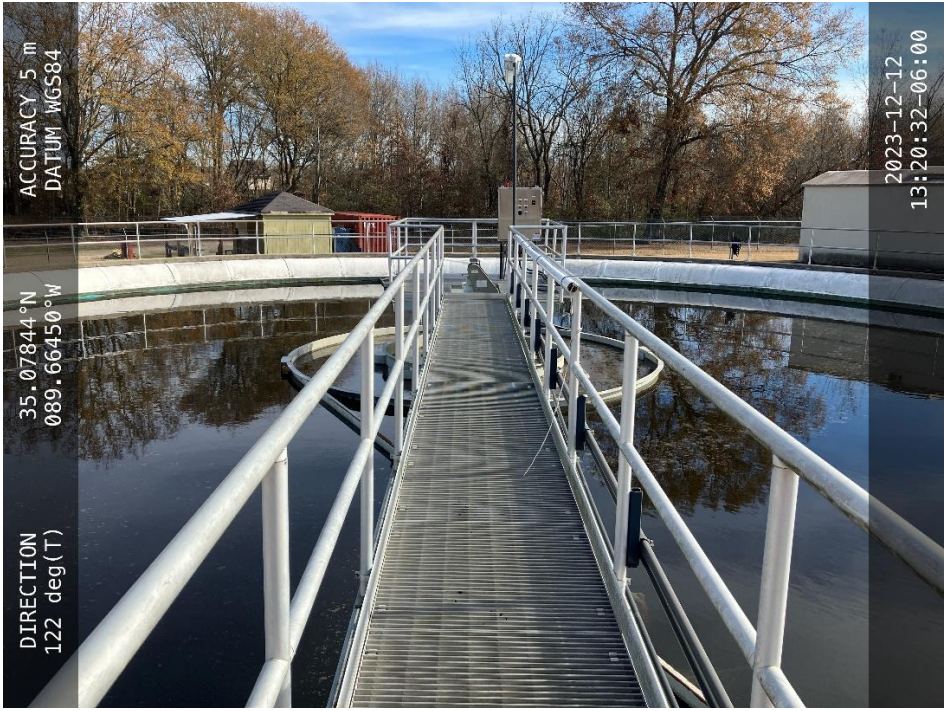
Facility Name: Collierville-Shelton Road STP		Site Location: Shelby County	Tracking No.: TN0057461
Photo No. 5	Date 12-12-2023

Description View of one of the clarifiers.

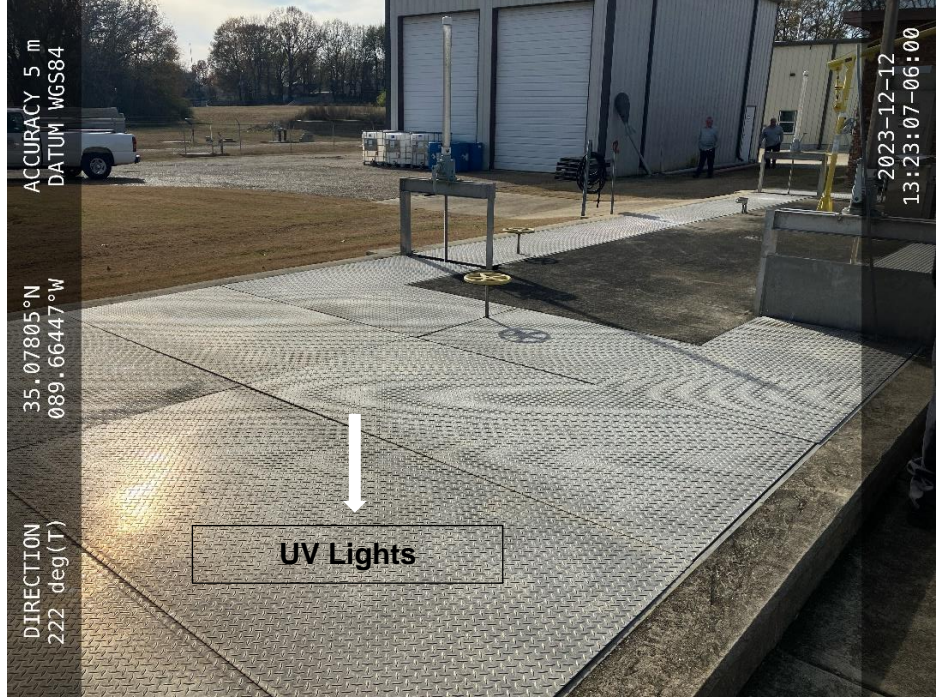
Photo No. 6	Date 12-12-2023

Description View of the covered Ultraviolet lights.

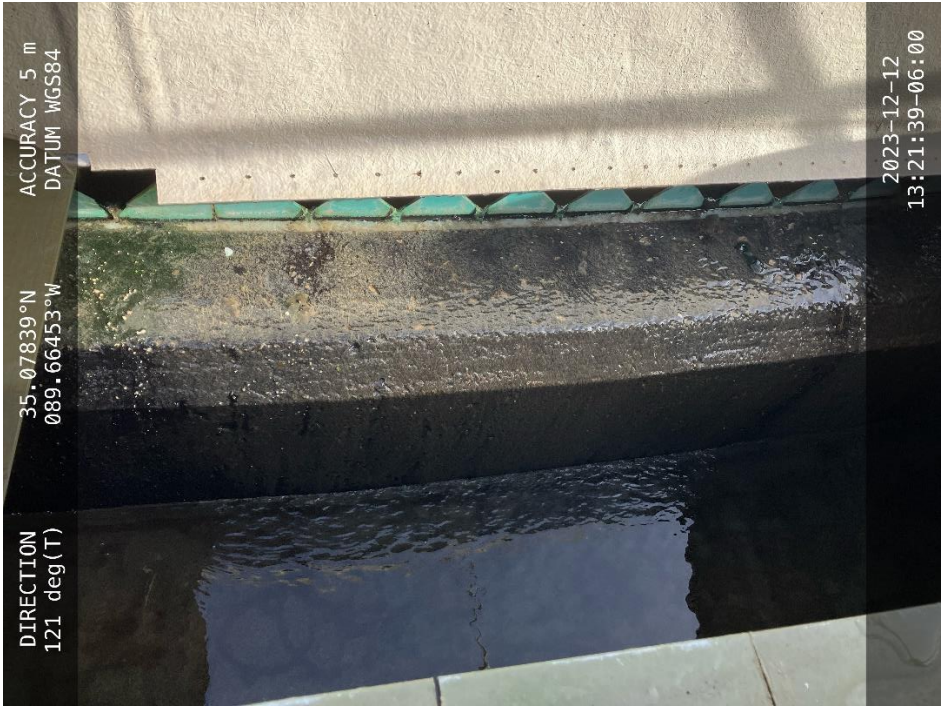
Facility Name: Collierville-Shelton Road STP		Site Location: Shelby County	Tracking No.: TN0057461
Photo No. 7	Date 12-12-2023

All overflow weirs in the clarifiers are covered to control algae growth (photo 7). According to Mr. Davis, they are cleaned once a month or as needed to prevent algae and solids growth.

<p>Description View of the covered overflow weirs in one of the clarifiers. One lid was open to assess the weirs. There was some algae present.</p>

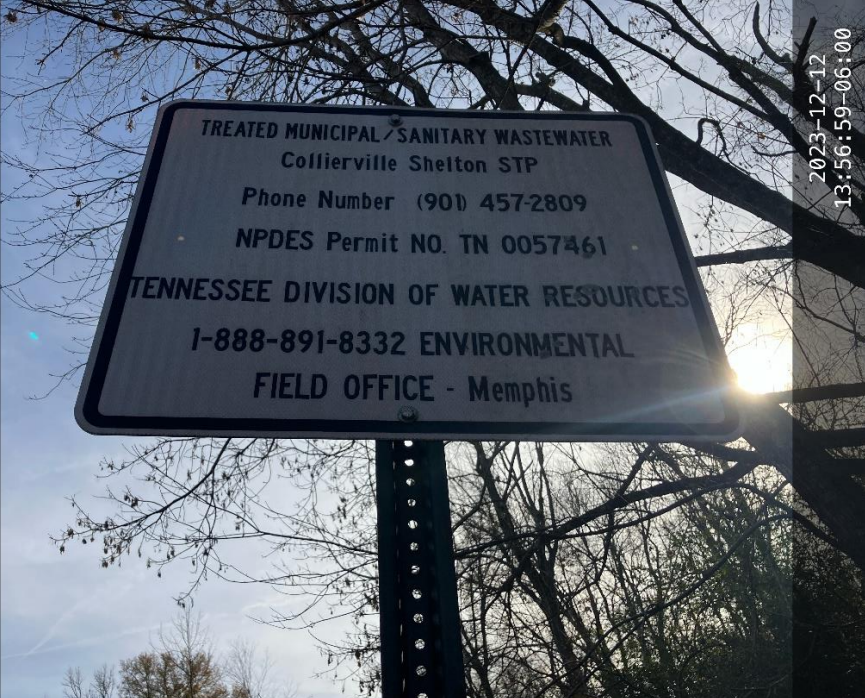
<div style="writing-mode: vertical-rl; transform: rotate(180deg);"> 2023-12-12 13:56:59-06:00 </div> </div>	
Description View of the sign at the outfall by the Wolf River. The information on the sign was consistent with the permit requirements.

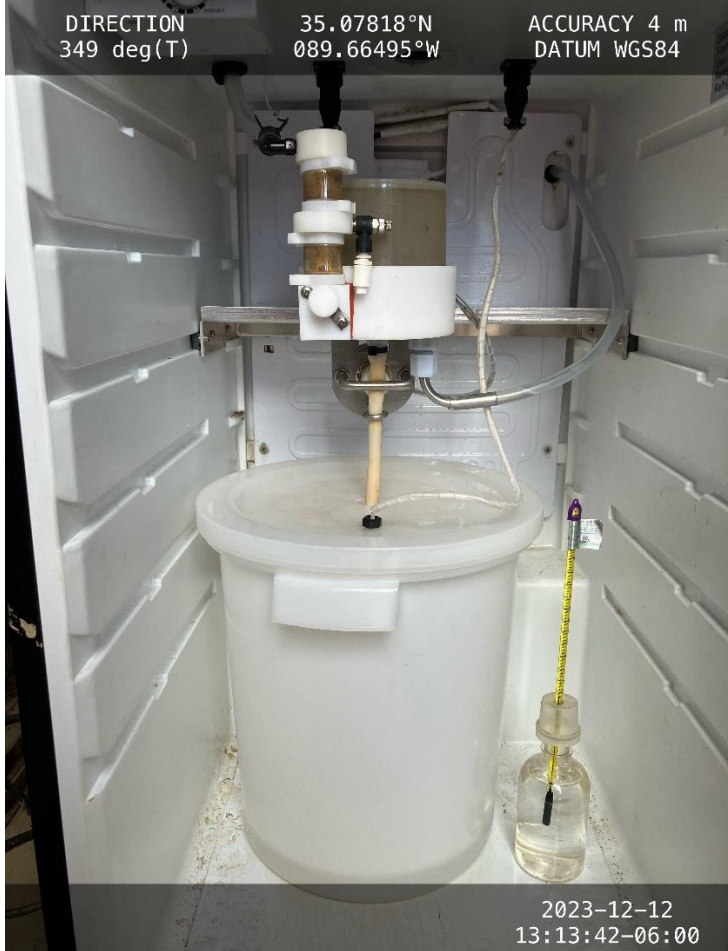
The Collierville-Shelton Road STP has automatic, flow-proportional samplers for the influent (photo 10) and effluent (photo 12), and they appear to be maintained properly. They are activated and paced by a flow meter placed in the flume. The automatic samplers can provide adequate refrigeration during the sampling period. Each automatic sampler is equipped with a temperature control bottle and a thermometer. The readings on the thermometers were below 6°C as required by the permit. The composite sampler tubing for both the influent and effluent were clear of any residuals. According to Mr. Davis the composite sampler tubing is replaced the first week of every month.

Photo No. 10	Date 12-12-2023	<div style="display: flex; justify-content: space-between;"> <div style="writing-mode: vertical-rl; transform: rotate(180deg);"> DIRECTION 349 deg(T) </div> <div style="writing-mode: vertical-rl; transform: rotate(180deg);"> 35.07818°N 089.66495°W </div> <div style="writing-mode: vertical-rl; transform: rotate(180deg);"> ACCURACY 4 m DATUM WGS84 </div> </div>	
Description View of the influent composite sampler.

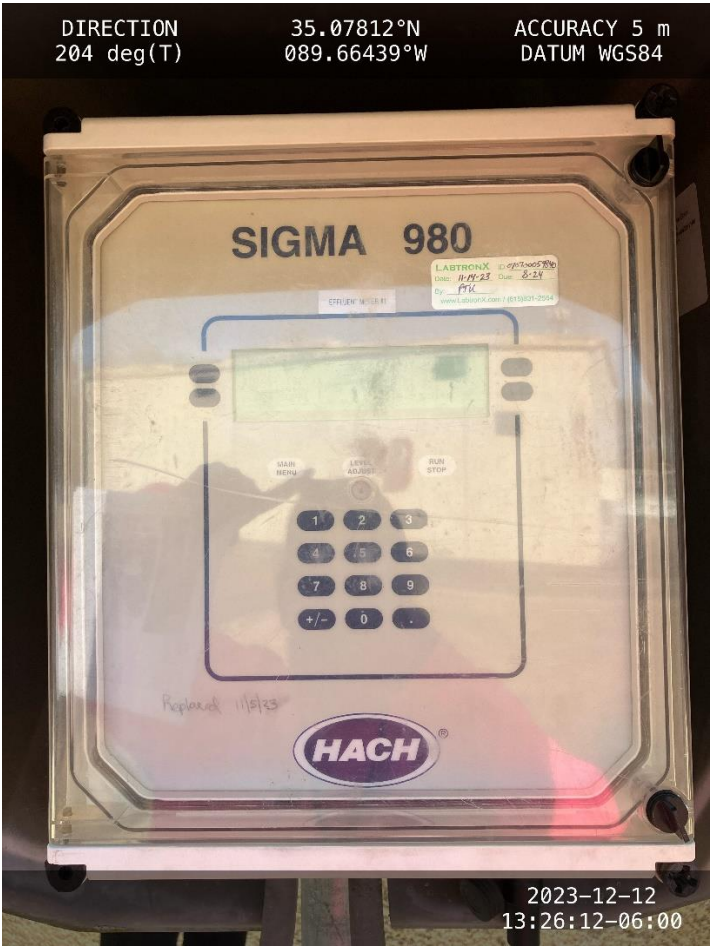
Digital flow meters are installed at the influent and effluent flumes. The flow meters were operating during the time of the inspection. A review of the certification records of the flow meters indicated that the devices were being calibrated annually by Labtronix located in Nashville, TN. The influent flow meter was calibrated in September 2023 and the effluent flow meter (photo 11) was calibrated in November 2023. The facility keeps the calibration records on site. The current calibration year is kept in the main office while subsequent years are stored in the lab.

Facility Name: Collierville-Shelton Road STP		Site Location: Shelby County	Tracking No.: TN0057461
Photo No. 11	Date 12-12-2023	DIRECTION 35.07812°N 204 deg(T) ACCURACY 5 m 089.66439°W DATUM WGS84	
Description View of the effluent digital flow meter.

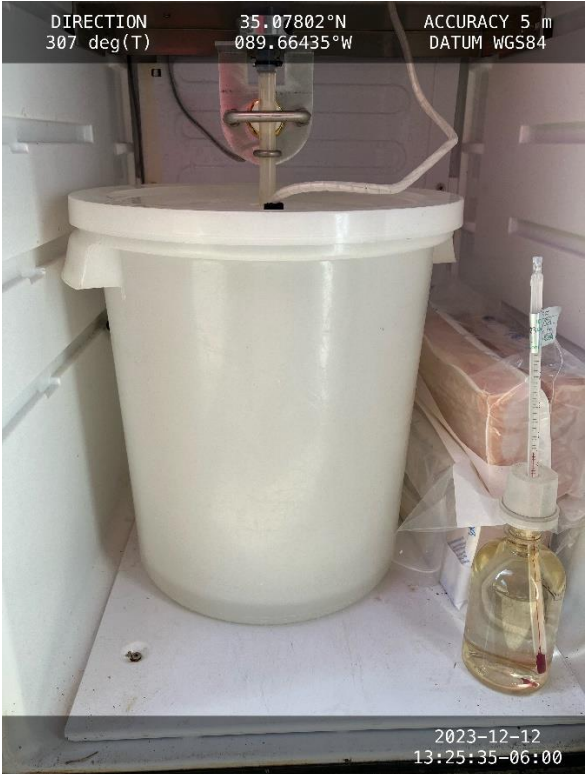
Photo No. 12	Date 12-12-2023	DIRECTION 35.07802°N 307 deg(T) ACCURACY 5 m 089.66435°W DATUM WGS84	
Description View of the effluent composite sampler.

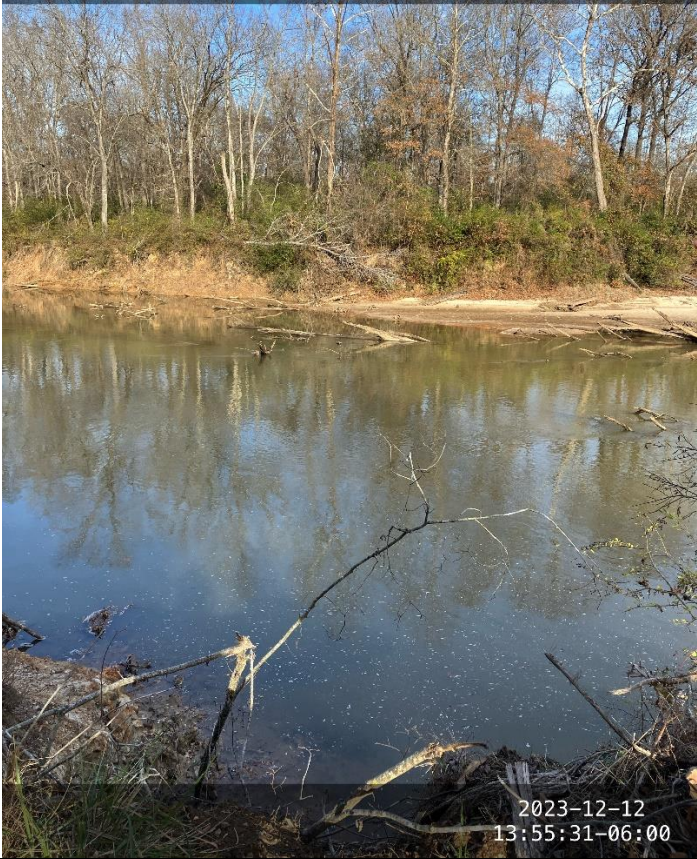
Facility Name: Collierville-Shelton Road STP		Site Location: Shelby County	Tracking No.: TN0057461
Photo No. 13	Date 12-12-2023	DIRECTION 35.07539°N ACCURACY 1.59 km 41 deg(T) 089.67178°W DATUM WGS84	
Description View of the outfall bank that discharges into the Wolf River.

At the time of the inspection, the effluent from the STP to the Wolf River was clear (photo 8). The odor at the plant was minimal, and the sign was in place at the point of discharge at the Wolf River (photo 9). All the information on the sign was consistent with the requirements in the NPDES permit. The STP is currently involved in a soil erosion mitigation plan. This plan will help to rebuild the banks along the Wolf River that have washed away due to erosion near the outfall (photo 13).

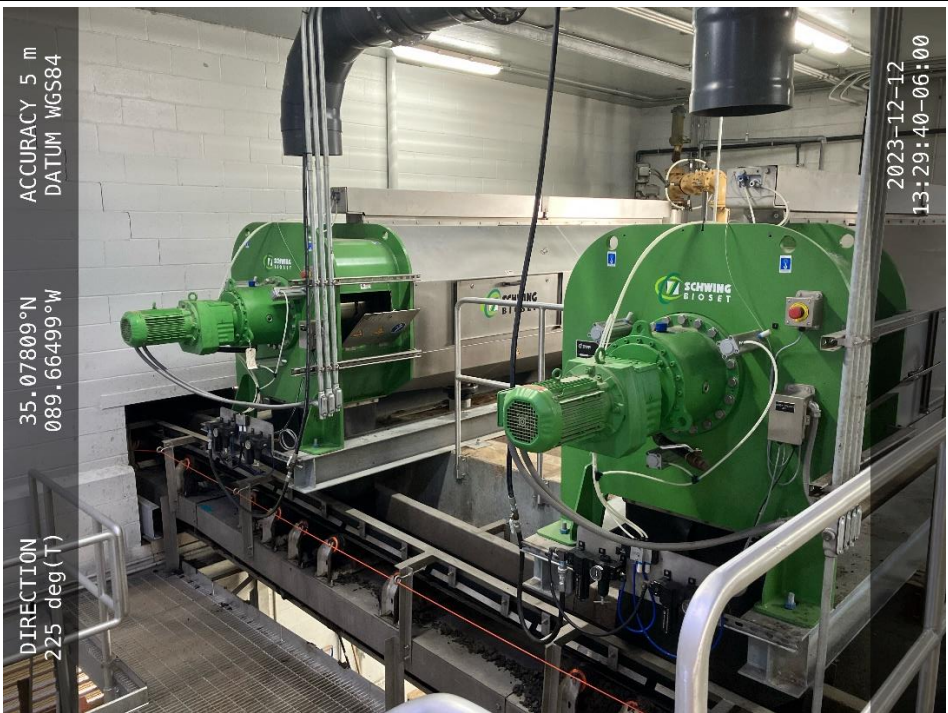
The wasted sludge is pumped into a gravity thickener then dewatered by the addition of polymers and the use of a screw press (photo 14). The sludge cake is transported to Quad County Landfill in Mississippi. A scrubber system has been installed to control the odor from the filter press building. Additional chemicals are stored in the filter press building which is secured by a lock and key. However, it is recommended that the facility invests in secondary containment for their stored chemicals in the event of a spill.

Photo No. 14	Date 12-12-2023	DIRECTION 35.07809°N ACCURACY 5 m 225 deg(T) 089.66499°W DATUM WGS84	
Description View of the filter press building for dewatering the sludge.

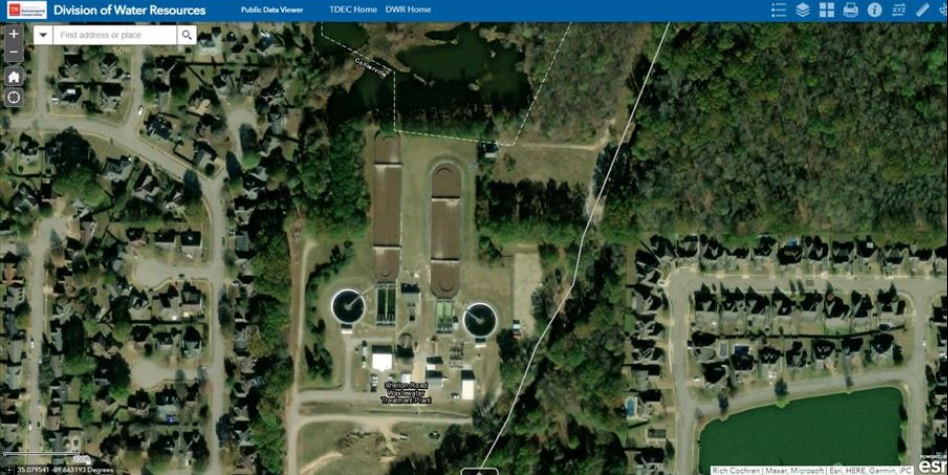
Facility Name: Collierville-Shelton Road STP		Site Location: Shelby County	Tracking No.: TN0057461
Photo No. 15	Date 12-12-2023

Description Aerial view of the Shelton Road STP.
