STATE OF TENNESSEE
DEPARTMENT OF ENVIRONMENT AND CONSERVATION
DIVISION OF WATER RESOURCES

Re: Compliance Sampling Inspection
Lakeland Sewage Treatment Plant
NPDES Permit No. TN0078255
Shelby County

**Compliance Sampling Inspection for NPDES
Permits**

Facility Name: Lakeland STP	NPDES Permit Number: TN0078255
Permit Effective Date: October 1, 2022	Permit Expiration Date: September 30, 2027
Date and Time of Inspection: 12/13/2023	Inspector Name: Brittany Gibson

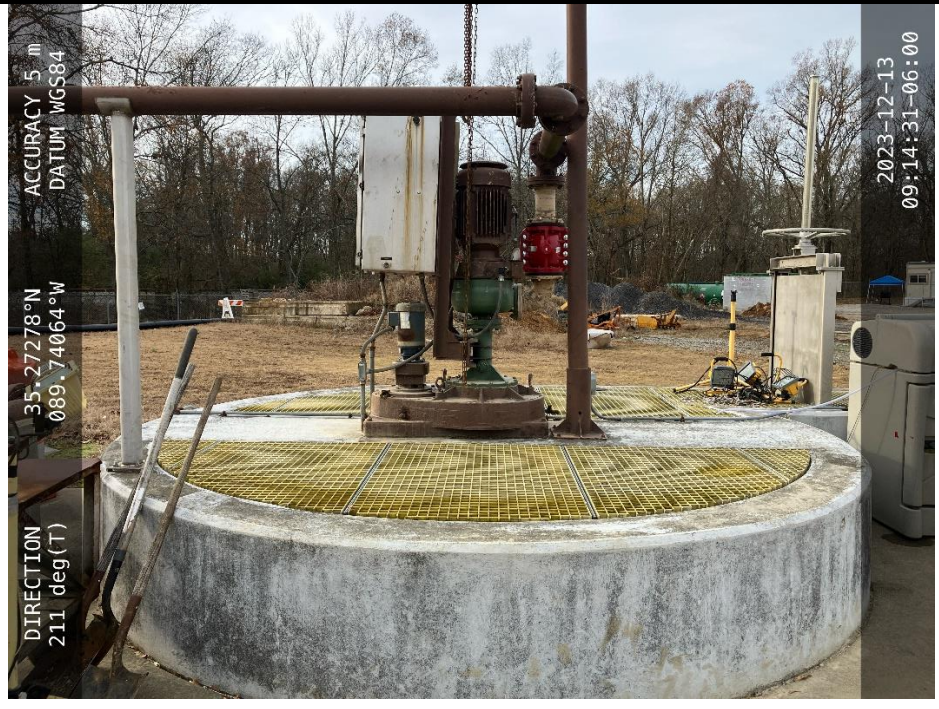
Photo No.	Date
3	12-13-2023

Description
View of the grit chamber. The grit chamber flows into the Sequence Batch Reactor (SBR).

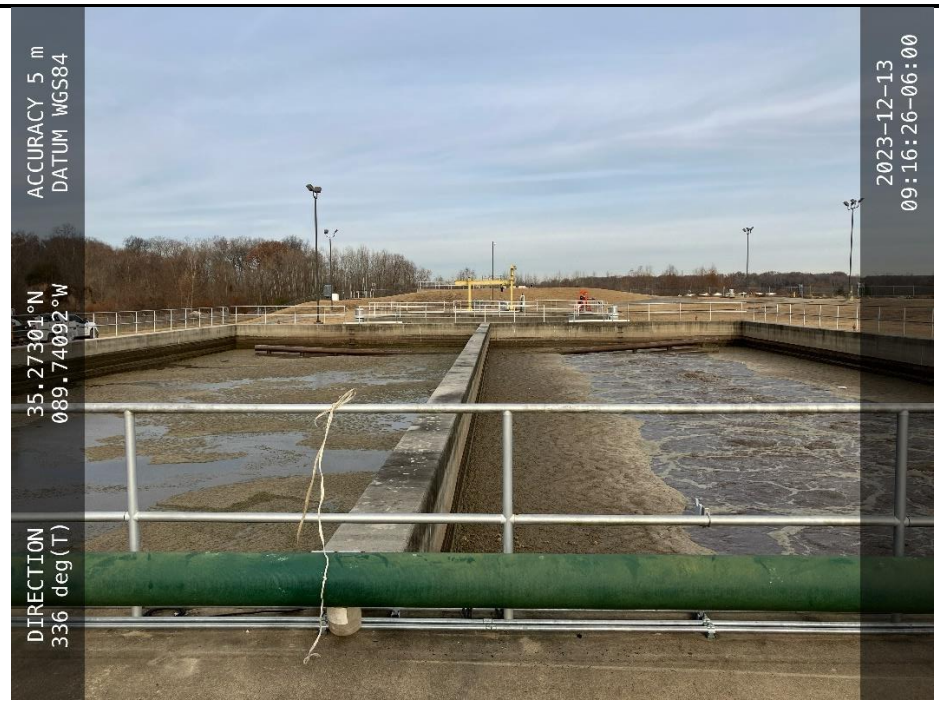
Photo No.	Date
4	12-13-2023

Description
View of the aeration basins. The aeration basins are cleaned every two (2) months.

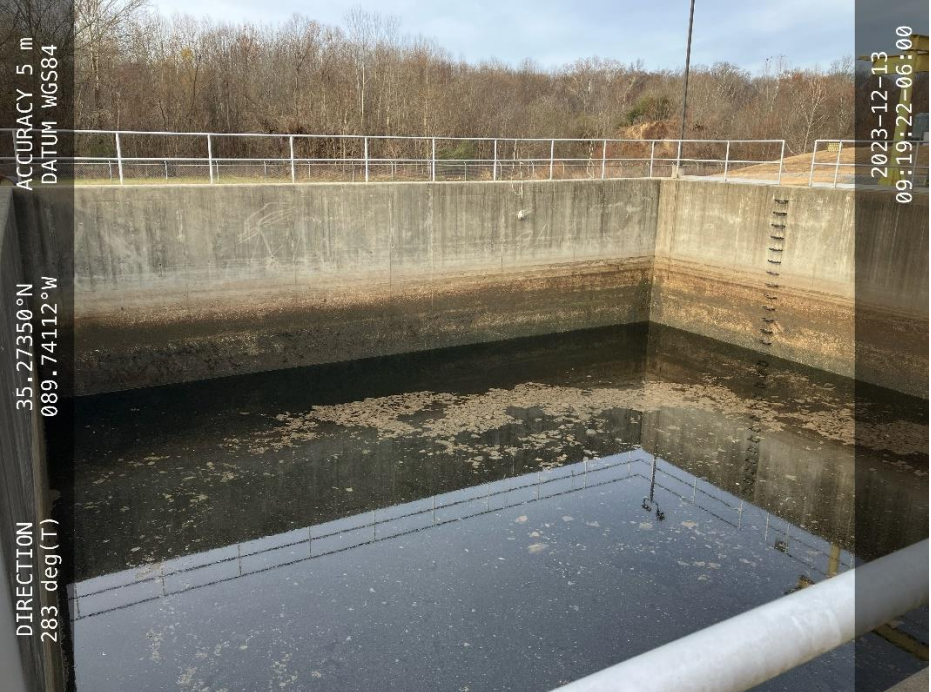
Photo No. 5	Date 12-13-2023

Description View of the equalization (EQ) basin.

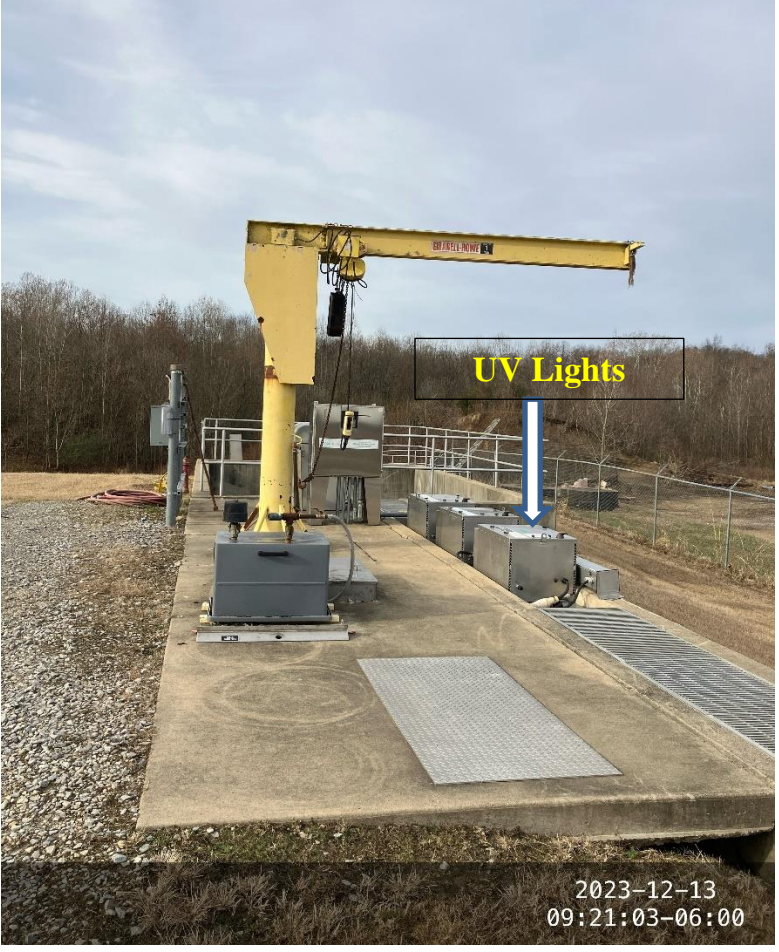
Photo No. 6	Date 12-13-2023

Description View of ultraviolet (UV) lights used for disinfecting the effluent. The <i>E.coli</i> grab sample was collected at this station post UV disinfection.

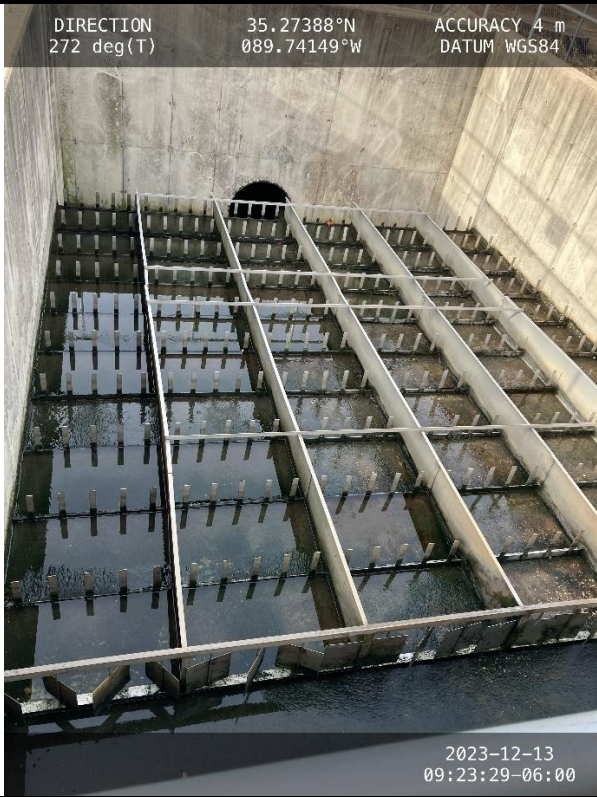
Photo No. 7	Date 12-13-2023	<div style="display: flex; justify-content: space-between; font-size: small;"> DIRECTION 272 deg(T) 35.27388°N 089.74149°W ACCURACY 4 m DATUM WGS84 </div>

<div style="text-align: right; font-size: x-small;"> 2023-12-13 09:23:29-06:00 </div>
Description View of the cascade system.

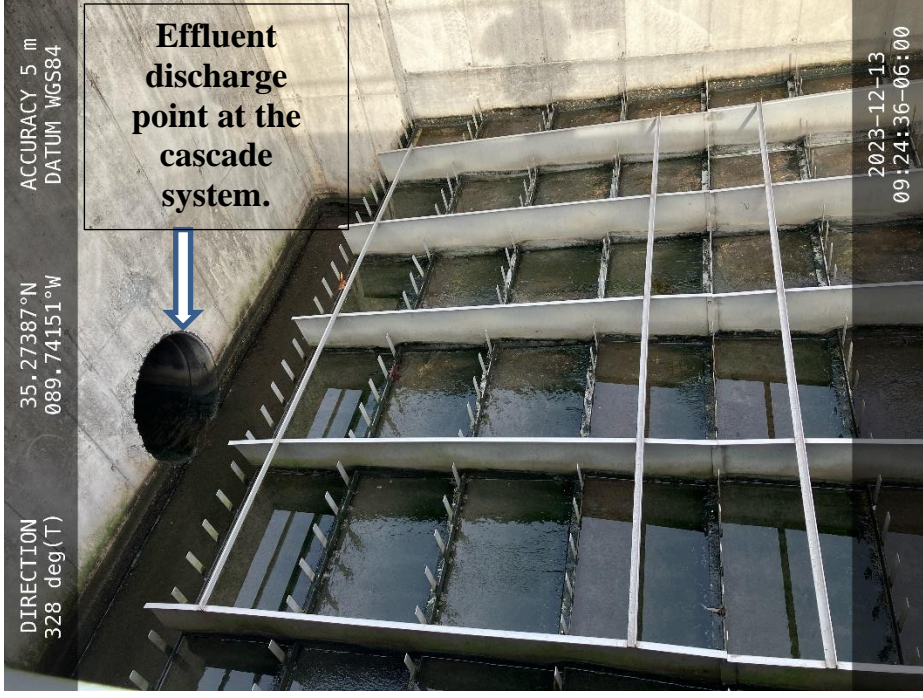
At the time of the inspection, there was a discharge from the STP (photo 8), which eventually flows into the Loosahatchie River. The discharge was clear and odor free. The inspection of Outfall 001 at mile 24.1 of the Loosahatchie River (photo 15) occurred on December 11, 2023. Mr. Smalley drove Ms. Gibson to the outfall in a side-by-side ATV. The information on the outfall discharge sign was consistent with the permit requirements (photo 14).

Photo No. 8	Date 12-13-2023	<div style="display: flex; justify-content: space-between; font-size: small;"> DIRECTION 328 deg(T) 35.27387°N 089.74151°W ACCURACY 5 m DATUM WGS84 </div> <div style="text-align: center; margin-bottom: 10px;"> <p>Effluent discharge point at the cascade system.</p>

<div style="text-align: right; font-size: x-small;"> 2023-12-13 09:24:36-06:00 </div>
Description View of the effluent from the STP prior to discharging off-site and into the Loosahatchie River. At the time of this photo, the cascade system was not actively discharging. It is on a timed system and had already discharged for the day. The effluent was clear at the time of the inspection.

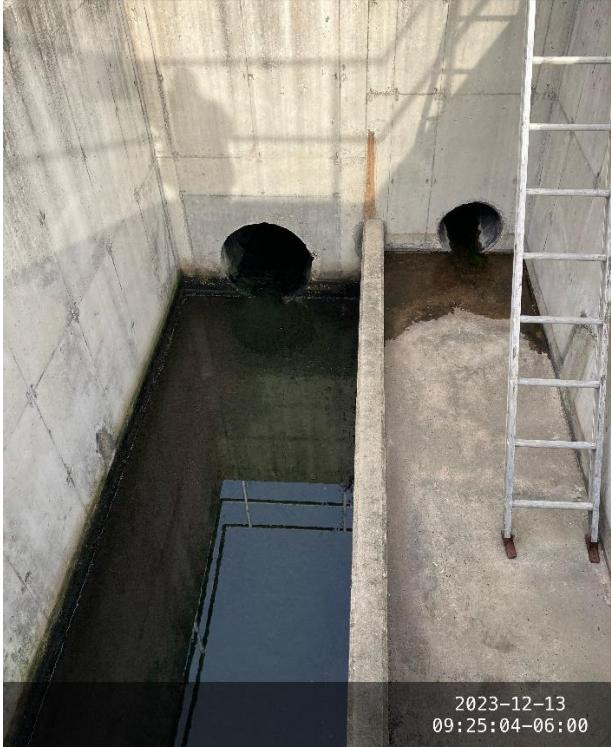
Facility Name: Lakeland STP		Site Location: Shelby County	Permit No.: TN0078255
Photo No. 9	Date 12-13-2023	DIRECTION 313 deg(T) 35.27386°N ACCURACY 5 m 089.74167°W DATUM WGS84	
Description View of the grab sample pit. This is where the grab effluent samples were collected.

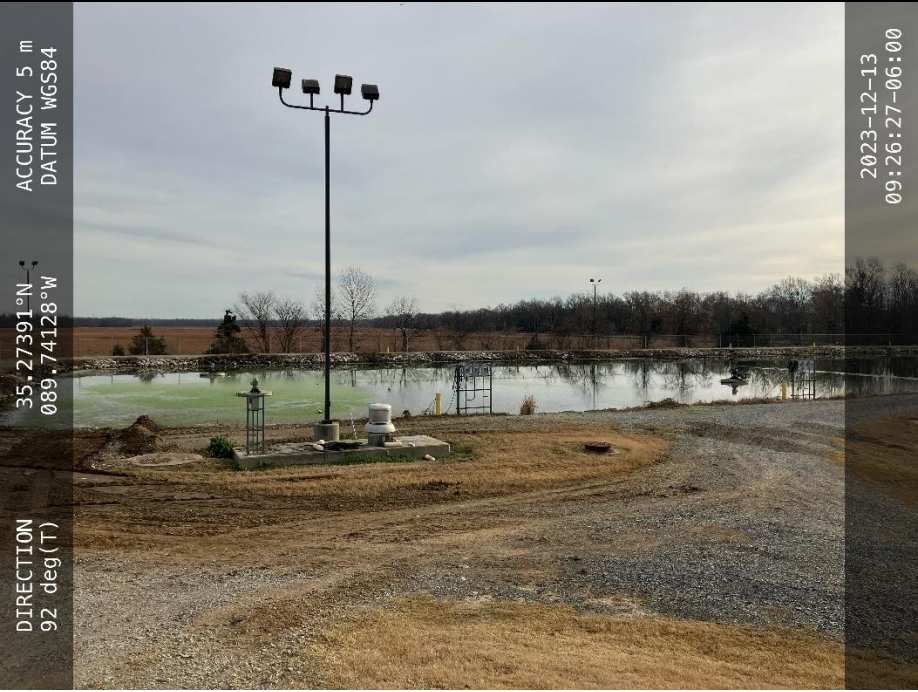
Lakeland uses an aerated lagoon as an aerobic digester and for sludge wasting (photo 10). The sludge is then thickened (photo 11) and dewatered by the addition of polymers and the use of a filter press (photo 12).

Photo No. 10	Date 12-13-2023	DIRECTION 92 deg(T) 35.27391°N ACCURACY 5 m 089.74128°W DATUM WGS84	
Description View of the aerobic digester used for sludge wasting.

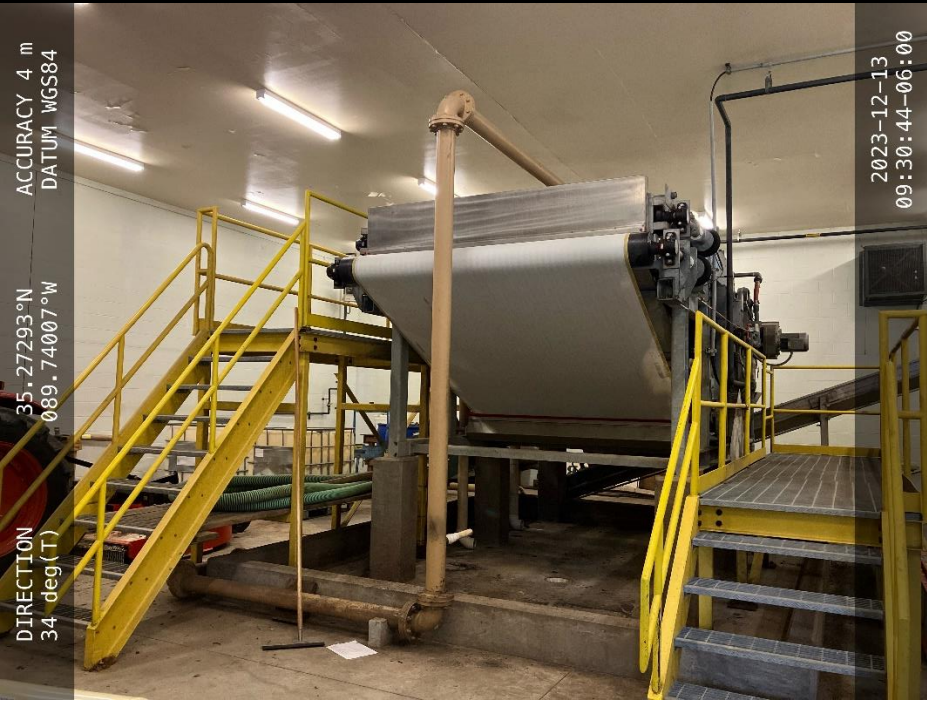
Photo No. 12	Date 12-12-2023

ACCURACY 4 m DATUM WGS84 35.27293°N 089.74007°W DIRECTION 34 deg (T)	2023-12-13 09:30:44-06:00
Description View of the filter press used for dewatering the sludge.

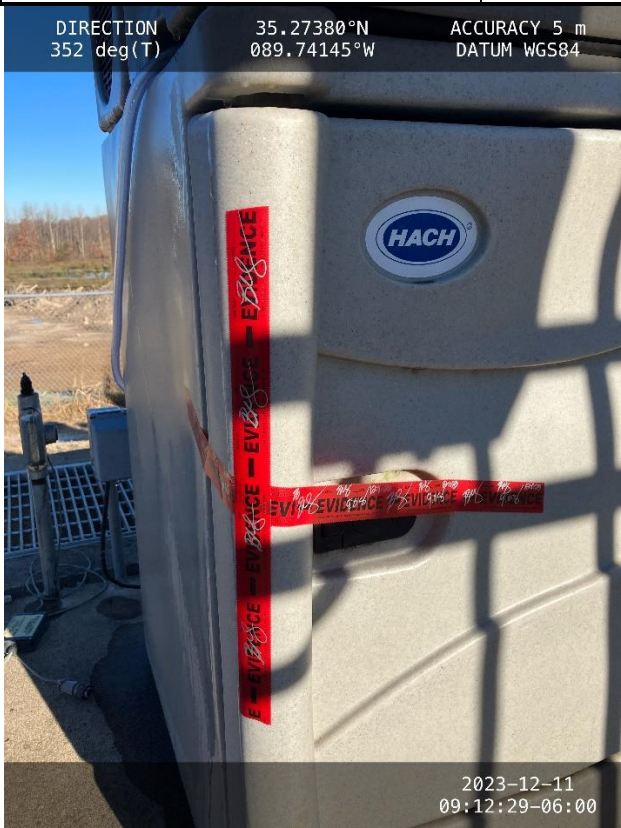
Photo No. 13	Date 12-11-2023	<div style="display: flex; justify-content: space-between; font-size: small;"> DIRECTION 352 deg (T) 35.27380°N 089.74145°W ACCURACY 5 m DATUM WGS84 </div>

Ms. Gibson went to the Lakeland STP on December 11, 2023, to custody seal the effluent composite sampler (photo 13) to ensure the integrity of the sample was maintained. Ms. Gibson also visited the outfall on this day and took pictures of the outfall sign and the discharge point into the Loosahatchie River. The Lakeland STP's outfall is only accessible via a side-by-side ATV. On December 12, 2023, Ms. Gibson collected grab and composite effluent samples while on site. These samples were collected at the pit (photo 9) adjacent to the cascade system, the UV light station (*E.coli* sample), and the effluent composite sampler. The custody seal was still intact the day of the sampling event. The intake tubing was clean and the temperature in the sampler was maintained below 6°C. The effluent samples were packed in a cooler with ice and shipped via FedEx to the Tennessee Department of Health Laboratory Services (TDHLS) in Nashville for analysis. The composite samples were tested for Total Suspended Solids (TSS), Total Nitrogen (N), Total Phosphorus (P), and Carbonaceous Biochemical Oxygen Demand (CBOD). Settable Solids was collected as a grab sample per the permit and was also shipped to the TDHLS. Another grab effluent sample for *E. coli* was collected and delivered to Waypoint Analytical Laboratory (WAL) in Memphis for analysis. On December 14, 2023, the DWR received the *E. coli* test result from WAL. On January 8, 2024, the DWR received the test results from the TDHLS. *These results did not include the Total Ammonia Nitrogen (NH₃) analysis results. This was due to a Chain-Of-Custody (COC) error; Ms. Gibson did not check the "Nitrogen, Ammonia" box on the COC form.* The analytical results met the values set forth in the NPDES permit for the Lakeland STP. The results are illustrated in Table 1.

<div style="text-align: right; font-size: x-small;"> 2023-12-11 09:12:29-06:00 </div>
Description		
View of the effluent composite sampler. It was custody sealed by Ms. Gibson on 12/11/23. The custody seal was still intact the day of the sampling event. The intake tubing was clean and the temperature in the sampler was maintained below 6°C.

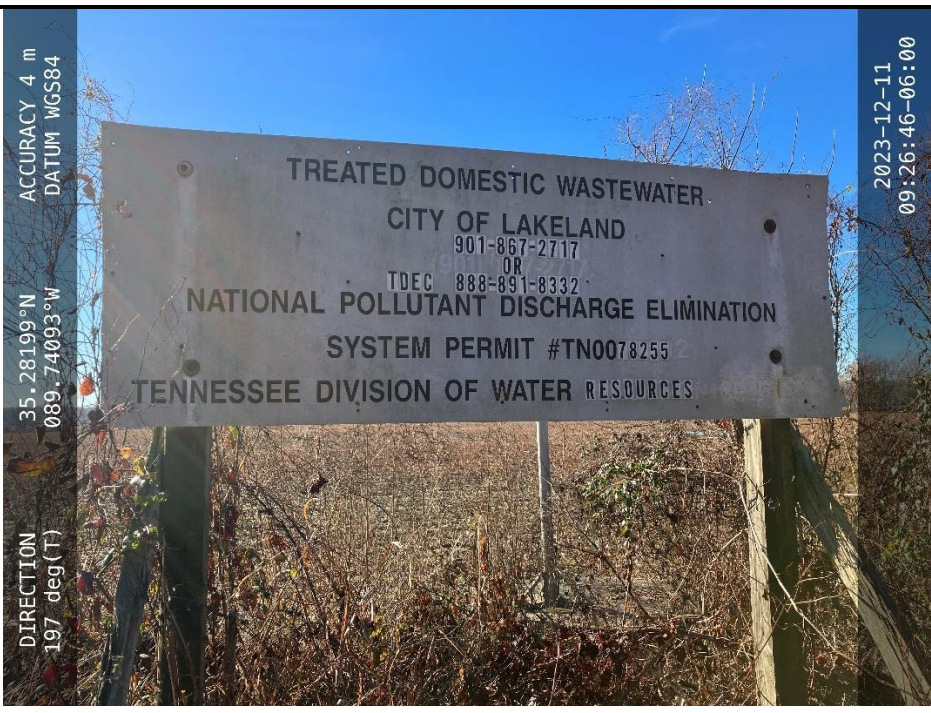
Photo No. 14	Date 12-11-2023	<div style="display: flex; justify-content: space-between; font-size: x-small;"> ACCURACY 4 m DATUM WGS84 35.28199°N 089.74093°W DIRECTION 197 deg (T) </div>

<div style="text-align: right; font-size: x-small;"> 2023-12-11 09:26:46-06:00 </div>
Description		
View of outfall sign at the Loosahatchie River bank. The information on the sign was consistent with the permit requirements.

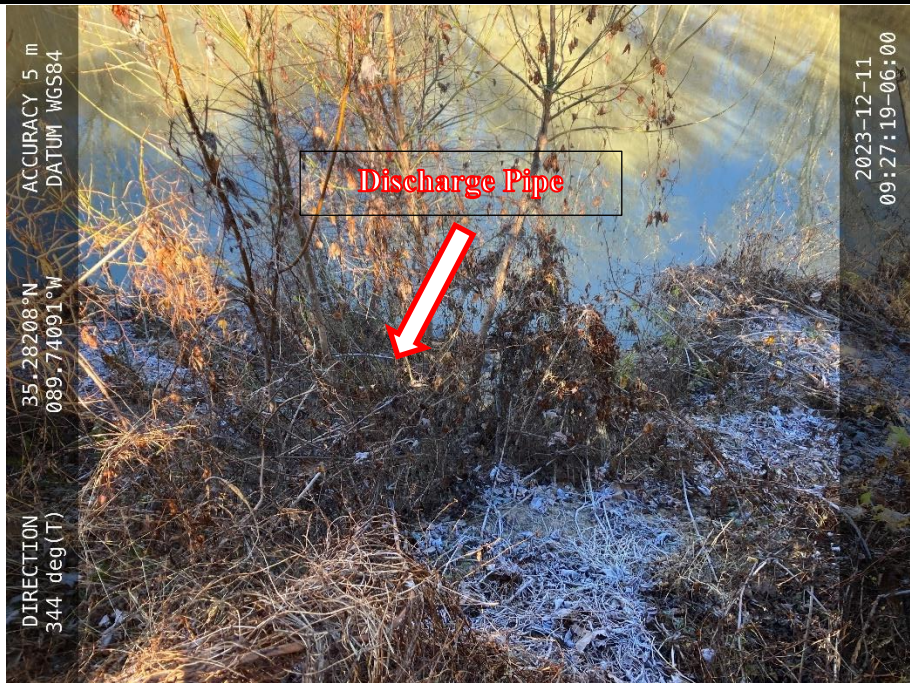
Photo No. 15	Date 12-11-2023	<div style="display: flex; justify-content: space-between;"> <div style="writing-mode: vertical-rl; transform: rotate(180deg); font-size: small;"> ACCURACY 5 m DATUM WGS84 35.28208°N 089.74091°W DIRECTION 344 deg(T) </div>

<div style="writing-mode: vertical-rl; font-size: small;"> 2023-12-11 09:27:19-06:00 </div> </div>
Description View of outfall discharge point along the Loosahatchie River.

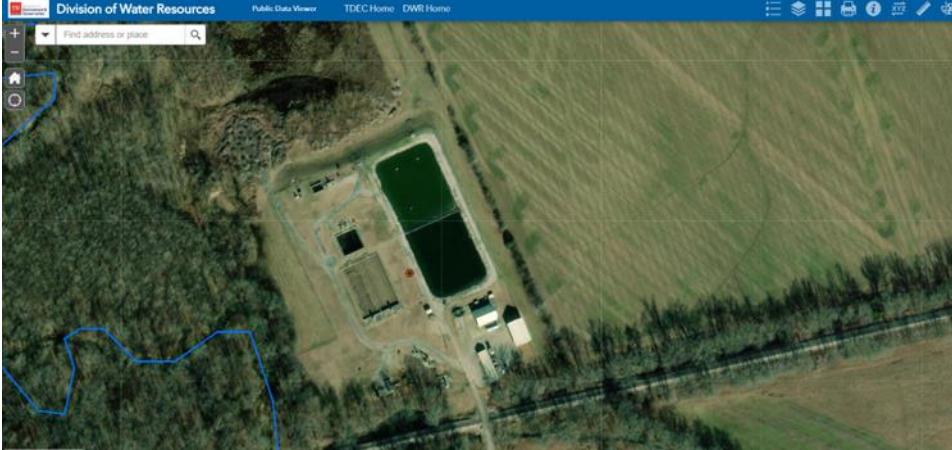
Photo No. 16	Date 12-13-2023

Description Aerial view of the Lakeland STP (Scotts Creek Wastewater Treatment Plant).
