# Application for Aquatic Resource Alteration Permit (ARAP) & State §401 Water Quality Permit Supporting Information

## Nashville Zoo Dam/Weir Removals Davidson County, Tennessee

## NASHVILLE ZOO DAMWEIR REMOVALS PROJECT

### NASHVILLE ZOO AT GRASSMERE NASHVILLE, TENNESSEE

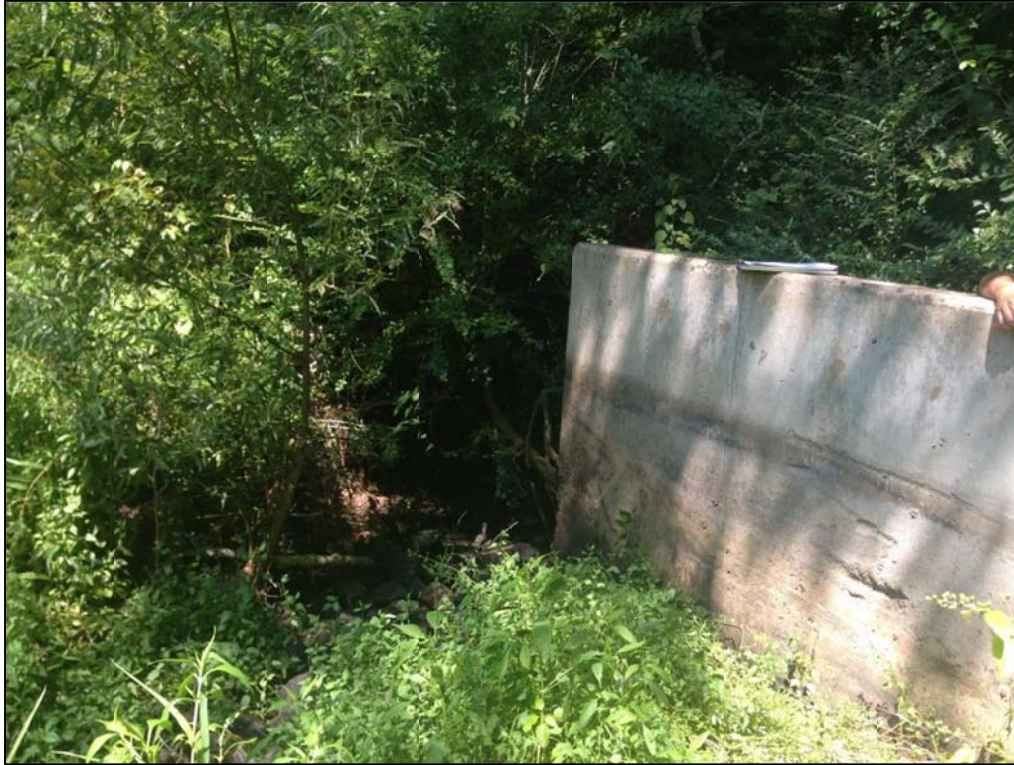
Photo 1. View looking at left side of pond dam where the stream has cut around the structure.

The structures to be removed were built in 1989 to create ponded conditions for site aesthetics. The first structure is a concrete dam that is 8" thick, 4'-5' tall, and approximately 40' wide. It has a low spillway and within this spillway a v-notch weir for low flows. This structure formerly tied into an earthen berm and was built to contain a pond. A breach between the dam and the berm occurred during historic flooding in May 2010 and the pond has since drained. Currently the stream still flows around this breach. The fine sediment that had accumulated in the pond has developed into a wetland with a stable, small stream flowing through it. At the breached point, the bottom portion of the berm is eroded and the stream pipes through rock before coming out on bedrock approximately 20' downstream of the breach.

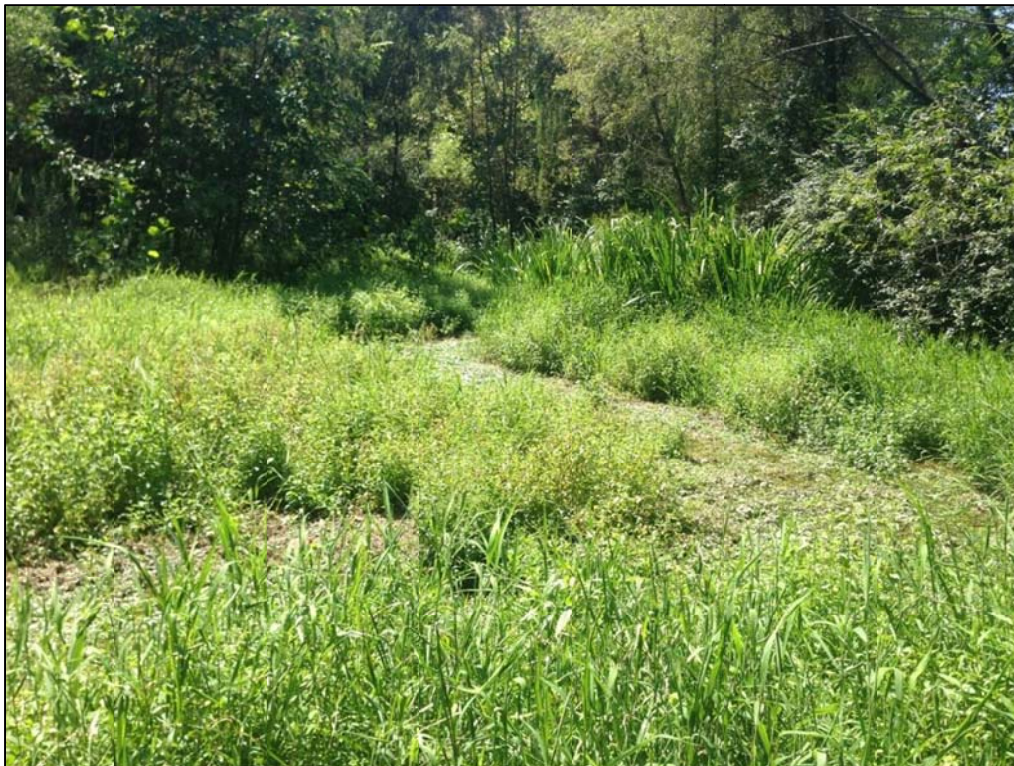
Photo 2. View looking upstream from pond dam to the former pond bed where there is an existing stable small stream and wetland.

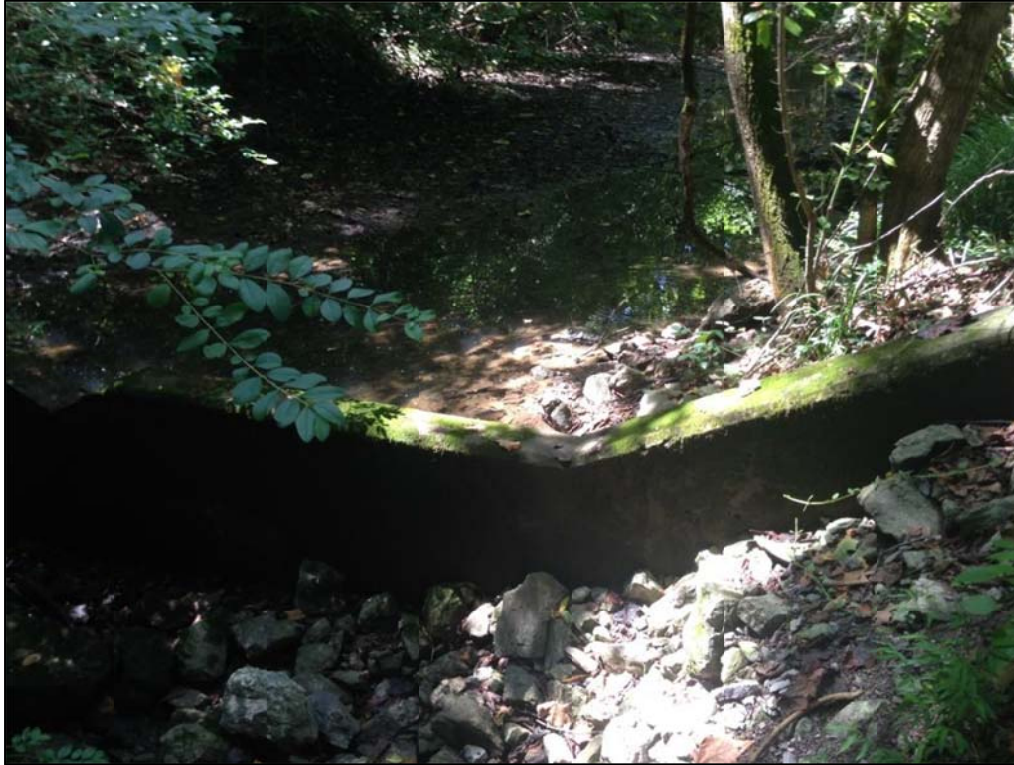
Photo 3. View looking at second (downstream) weir/dam structure where it interfaces with the left bank.

The second dam/weir is located approximately 380 linear feet downstream of the first structure. This structure is also an 8" thick concrete dam/weir, approximately 3' tall, and 30' wide. This structure formerly contained a linear impoundment. In this location, the left bank of the stream is contiguous with the road fill that slopes up to the zoo exit road. The stream has not breached the structure, but it does flow around the dam and through the coarse rock that makes up the road fill, bypassing the structure. Upstream of the dam there is a small amount of water ponded, that varies depending on flow. Beneath the standing water is a variable amount of fine sediment on top of bedrock. This sediment is less than one foot deep at the dam and then decreases in depth farther upstream of the dam. The influence of this structure can be seen almost all the way upstream to the first dam. While there is not extensive backwater, most of the channel is composed of fine sediment that overlays bedrock, which is the former natural stream bed. These dams have significantly altered the habitat of this stream. The plan, as outlined

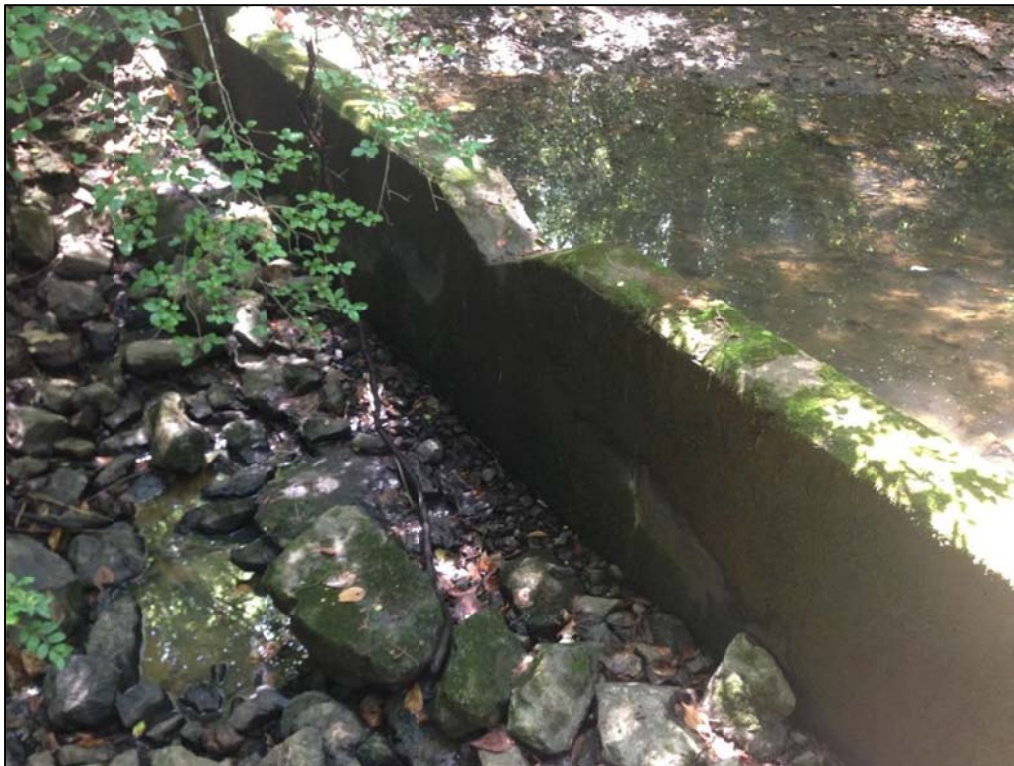
Photo 4. Another view looking upstream at the second structure and the v-notch weir. Notice the standing water upstream of the structure and that the flow is not going through the weir opening. Instead it is flowing through the rock on the left bank, which is depicted in Photo 3.

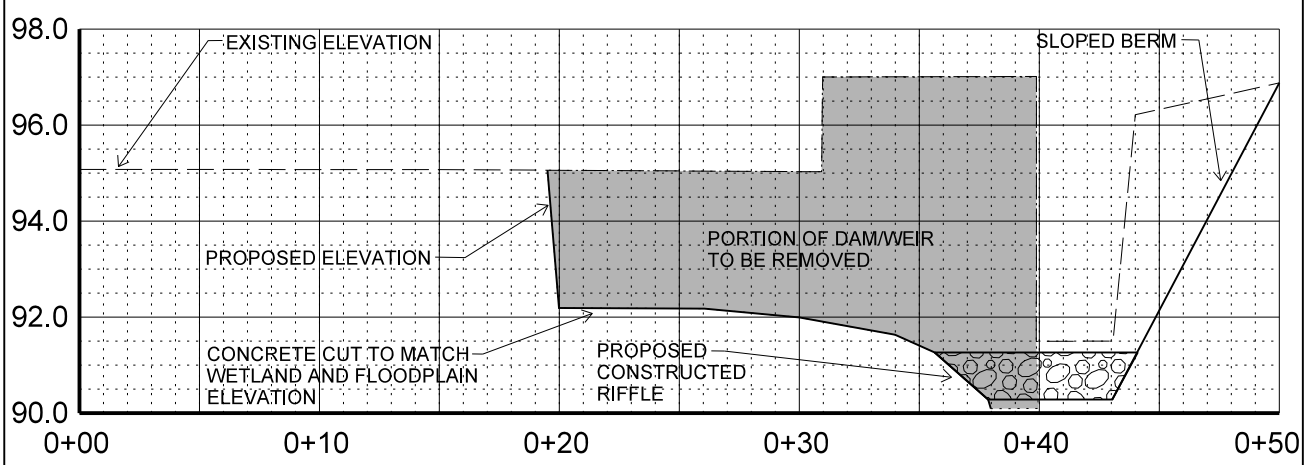
**EXISTING/PROPOSED DAM/WEIR CROSS-SECTION**

SEE EXISTING CONDITIONS ABOVE FOR CROSS-SECTION STATIONING

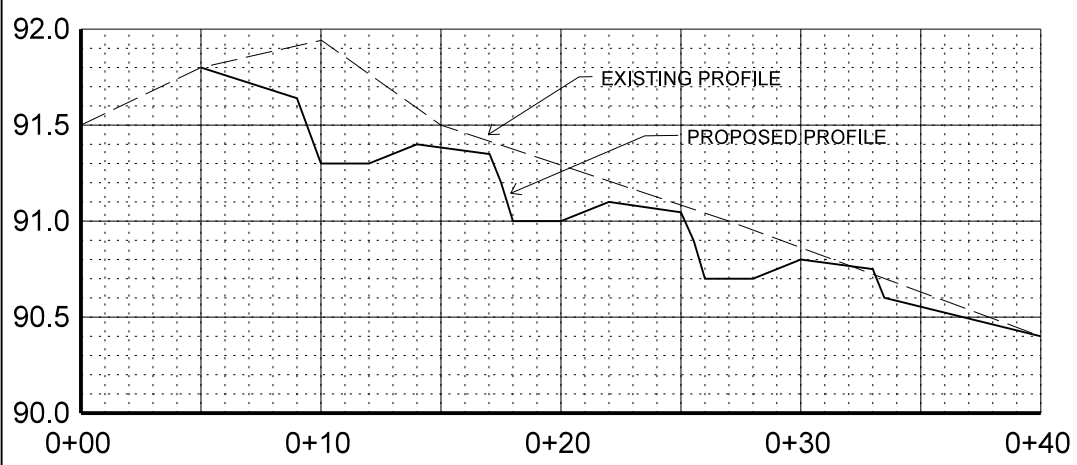
**EXISTING/PROPOSED LONGITUDINAL PROFILE**

SEE PROPOSED CONDITIONS ABOVE FOR PROFILE STATIONING
