Date: June 10, 2015
Project Name: Jasper Highlands Subdivision
Timber Ridge Access Road
ADES Job Number: 15147

Report of Jurisdictional Waters Determination

Jasper Mountain Subdivision
Timber Ridge Access Road
Off Timber Ridge Road
Marion County, Tennessee

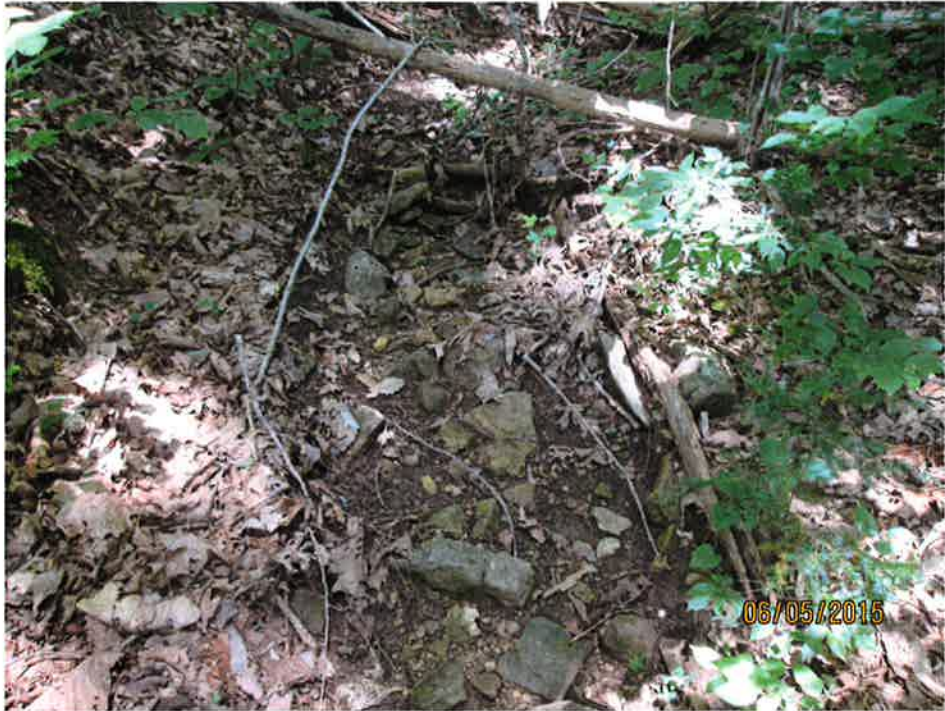
Photo 1:
Channel A
Upstream Portion of
Segment
Photo Taken 6/5/2015

The only alteration to the natural channel morphology in the evaluated reach is at the downstream end where a dirt road crosses the channel. No water was observed in the channel.

Beginning at the upper terminus of the proposed bypass road and traveling downhill, the proposed road will first cross Channel A. See Figures 1 and 2 for the location of the evaluated reach in Channel A. An existing dirt road crosses the channel at the downstream end of the evaluated reach. From this point, the channel extends uphill into a forested hillside dotted with small boulders. No water was present in the channel at the time of the observation. The channel cross section varied throughout the reach, but in general was approximately 2 feet wide and 2 – 4 inches deep. The steep gradient of the channel (greater than 20%) resulted in a step pool sequence. The absence of any primary indicators led to the use of secondary indicators to make a determination. With a total score of 12.25, it was determined that the evaluated reach of Channel A is a WWC.

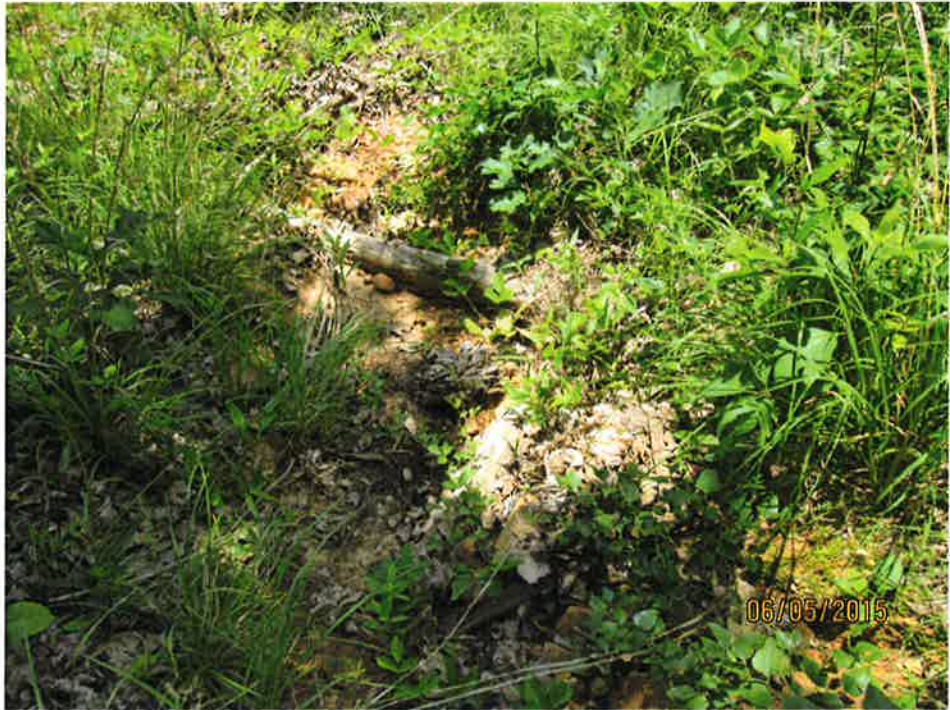
Photo 2:
Channel A
Downstream Portion of
Segment
Photo Taken 6/5/2015

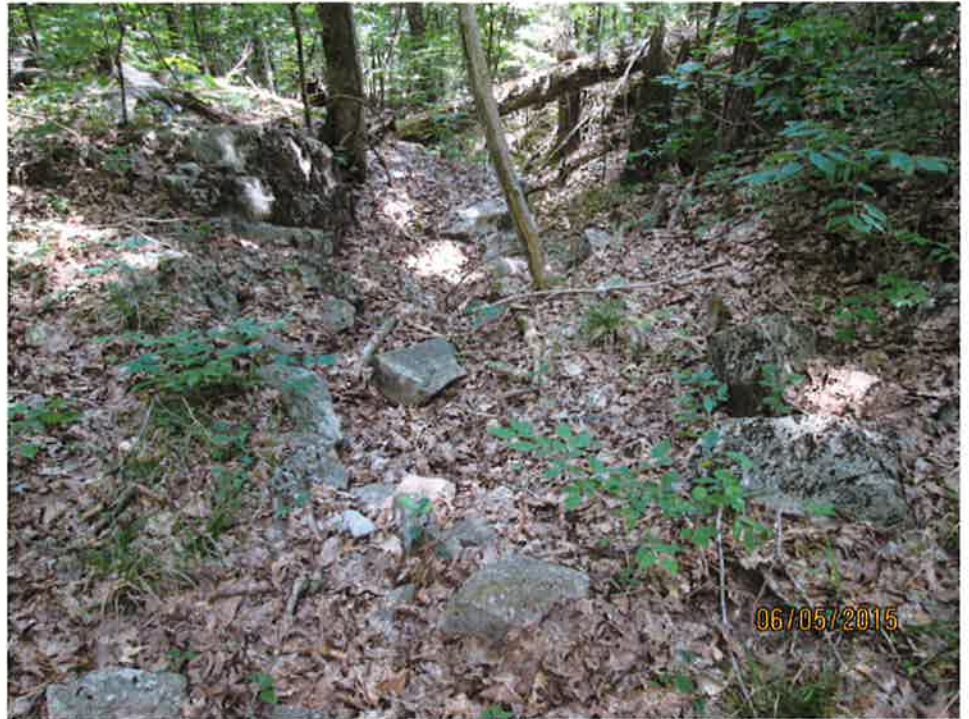
Photo 3:
Channel B
Downstream Portion of
Segment
Photo Taken 6/5/2015

Beginning at the upper terminus of the proposed bypass road and traveling downhill, the second drainage crossed by the proposed road is Channel B. See Figures 1 and 2 for the location of the evaluated reach in Channel B. An existing dirt road crosses the channel downstream of the evaluated reach, and an existing asphalt road crosses the channel upstream of the evaluated reach. A large cave opening was observed in the channel downstream of the upper road crossing and upstream of the evaluated reach. No water was present in the channel at the time of the observation, but it appeared that a significant amount of water would flow into the cave when the channel does convey water. The cave dropped vertically and the bottom could not be seen from the surface. The upper end of the evaluated reach begins slightly downhill from the cave opening. The channel runs down a forested hillside dotted with small boulders. The channel cross section varied throughout the reach, but in general was approximately 2 feet wide and 2 inches deep, and at times the channel structure was not well defined. The steep gradient of the channel (greater than 20%) resulted in a step pool sequence. The absence of any primary indicators led to the use of secondary indicators to make a determination. With a total score of 7, it was determined that the evaluated reach of Channel B is a WWC.

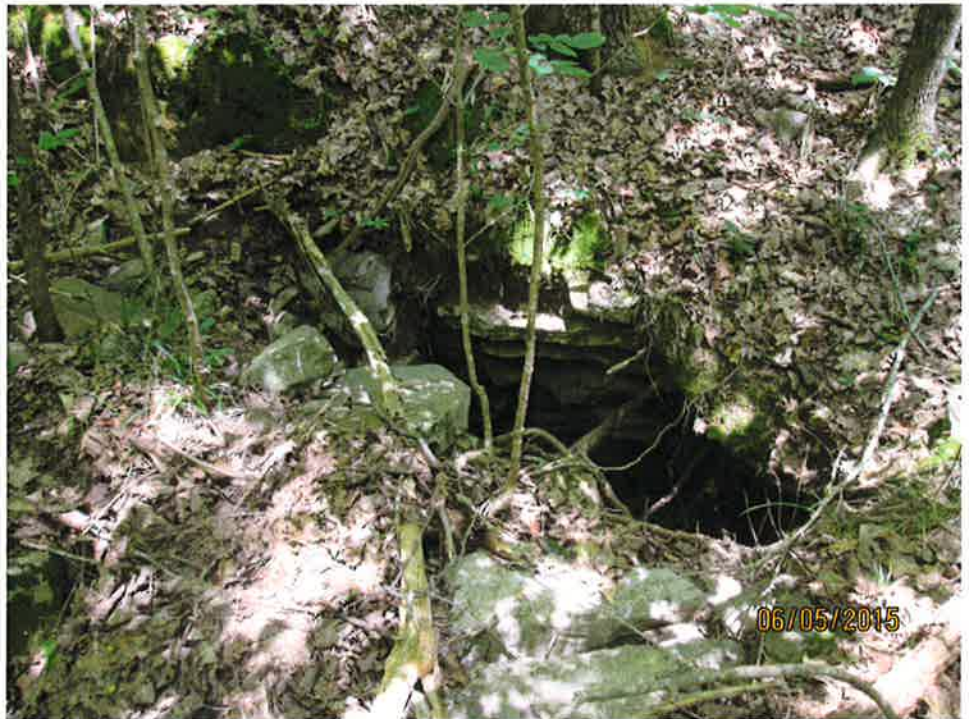
Photo 4:
Opening of Cave in
Channel B Upstream of
Evaluated Segment
Photo Taken 6/5/2015

No modifications have been made to the evaluated reach. Slightly upstream of the evaluated reach, a large opening in the channel leads to a cave which drops a significant distance vertically. No water was present during the evaluation, but it appeared that a significant amount of flow would enter into the cave rather than continuing downstream in the channel toward the evaluated reach.
