Subject: Compliance Evaluation Inspection (CEI)  
NPDES Permit No. TN0081809  
Gateway Global Logistics Center  
Rossville, Fayette County, Tennessee

## Photographic Log for Gateway Global Logistics Center

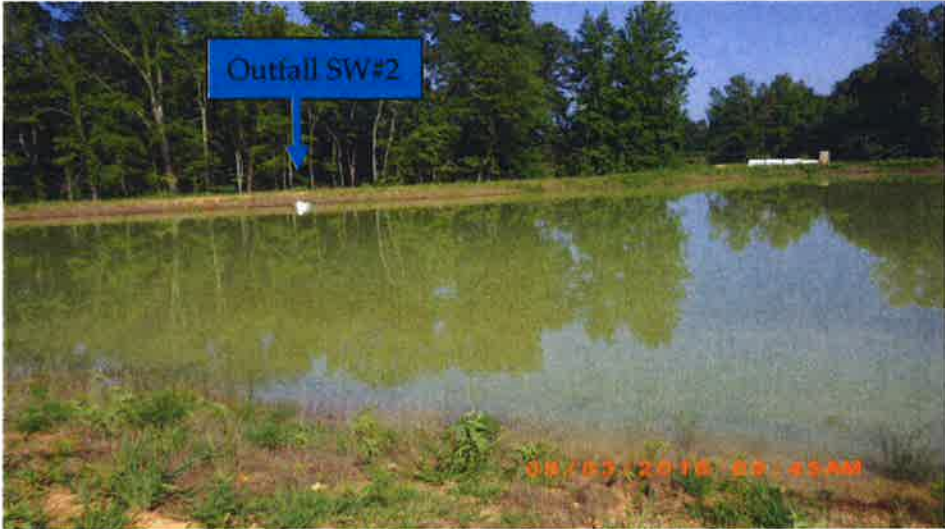
1	8-3-16		
<p><b>Description</b>                  Sediment basin #2 was installed and vegetated (view NW). According to Gateway Global Logistics Center (GGL) personnel, the basin had been flocculated 4 days prior to the inspection. However, an unexpected rain event prevented dewatering of the basin. Therefore, the basin should be flocculated again prior to dewatering. The basin was not discharging at the time of inspection. The receiving stream is located in the tree line west of the basin (see photo 4).</p>

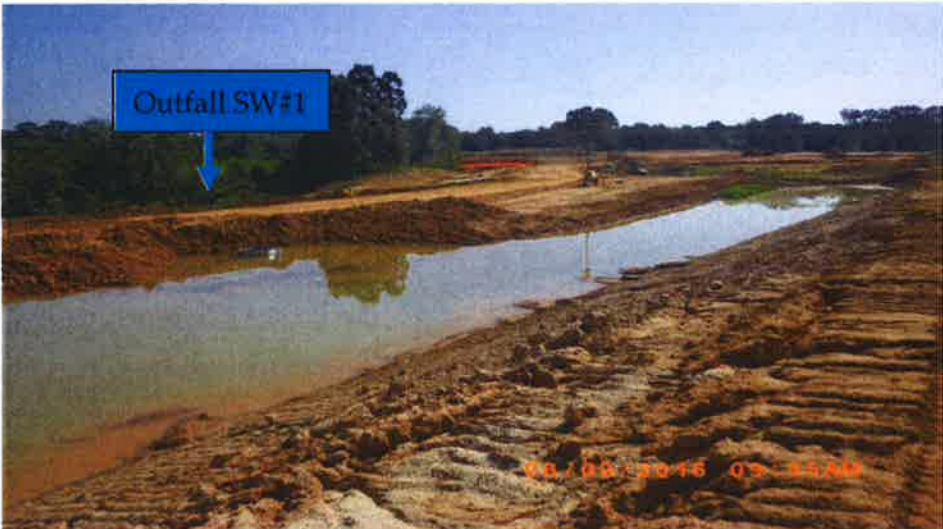
2	8-3-16		
<p><b>Description</b></p> <p>Sediment basin #1 was installed but has not been vegetated (view NE). According to GGL personnel, the basin had been flocculated 4 days prior to the inspection. However, an unexpected rain event prevented dewatering of the basin. Therefore, the basin should be flocculated again prior to dewatering. The basin was not discharging at the time of inspection. Rills and gullies were observed on the banks of the basin. Please remember to stabilize the banks of the basin as soon as possible, and within 14 days from when activity ceases. The receiving lake is located in the tree line north of the pond (see photo 6).</p>

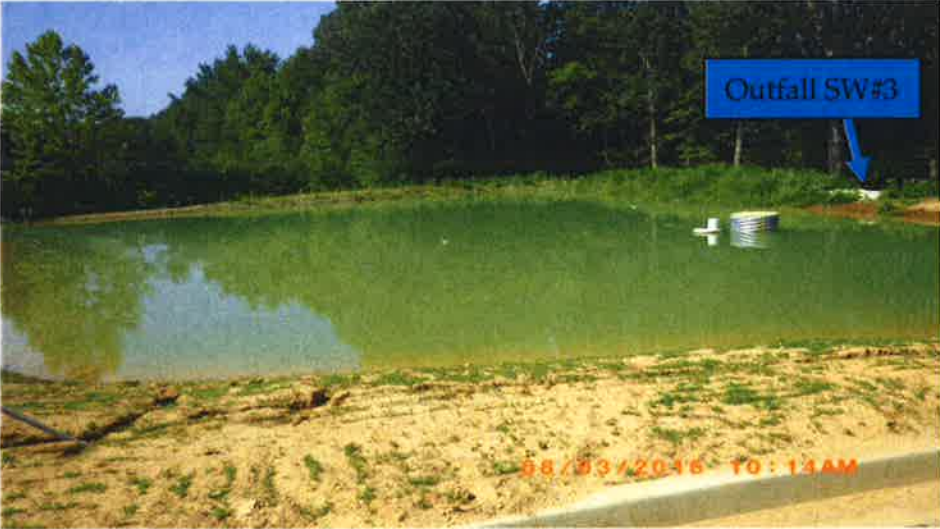
<b>Permittee Name:</b> Gateway Global Logistics Center		<b>Site Location:</b> 0.5 miles south of Knox Road, south of proposed N. Industrial Road	<b>Tracking No.:</b> TN0081809
<b>Photo No.</b> 3	<b>Date</b> 8-3-16

<p><b>Description</b> Sediment basin #3 was installed, and sparse vegetation was observed (view SW). According to GGL personnel, the basin had been flocculated 4 days prior to the inspection. However, an unexpected rain event prevented dewatering of the basin. Therefore, the basin should be flocculated again prior to dewatering. The basin was not discharging at the time of inspection. This basin was dewatered prior to flocculation due to an on-site emergency on July 10, 2016. The receiving stream is within the tree line west of the pond (see photo 5).</p>

On Sunday, July 10, 2016, GGL personnel notified DWR via telephone and text messages of an accidental drowning and the need to immediately dewater sediment basin #3, although the pond had not been flocculated. GGL personnel installed sediment control measures down-gradient of the basin to capture sediment-laden runoff. Mr. Yancey and Ms. Martin stated they walked the receiving stream two days following the emergency release and observed little to no sediment discharge in the stream. GGL personnel sent a follow up email to DWR summarizing the events of emergency release on July 13, 2016, thereby following the terms and conditions of the individual permit. During the inspection, DWR personnel reminded GGL personnel to include information about the dewatering in their July DMRs.

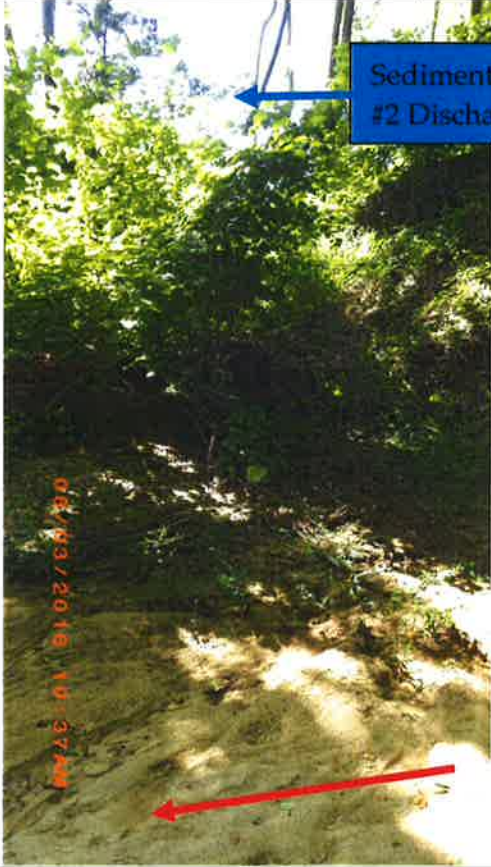
<b>Permittee Name:</b> Gateway Global Logistics Center		<b>Site Location:</b> 0.5 miles south of Knox Road, south of proposed N. Industrial Road	<b>Tracking No.:</b> TN0081809
<b>Photo No.</b> 4	<b>Date</b> 8-3-16

<p><b>Description</b> Outfall SW2, the outfall for sediment basin #2 (see photo 1), located down-gradient of Outfall SW#3 and up-gradient of In-stream Monitoring Point #2, was observed. The sandy substrate showed no evidence of sediment discharge into the receiving stream. Surface water was not observed in the stream at the time of inspection; the direction of stream flow, when it occurs, is indicated by the red arrow.</p>

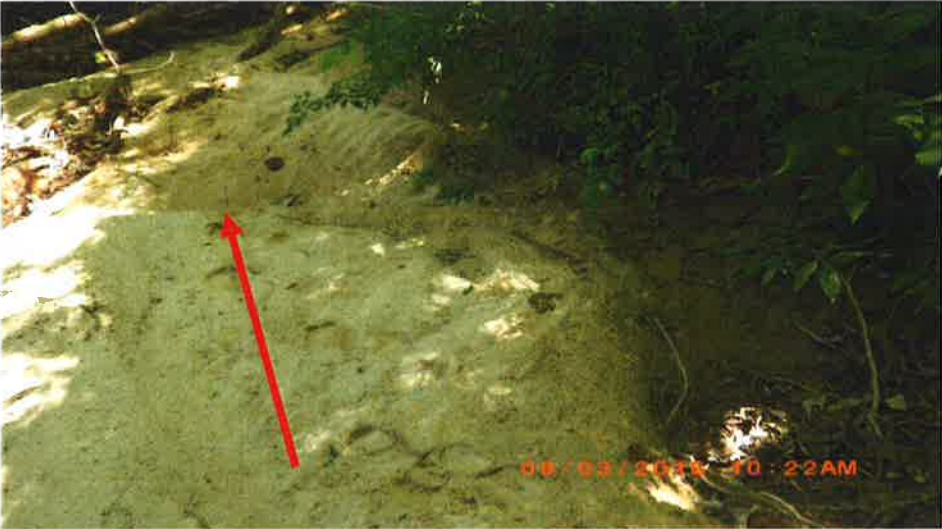
<b>Permittee Name:</b> Gateway Global Logistics Center		<b>Site Location:</b> 0.5 miles south of Knox Road, south of proposed N. Industrial Road	<b>Tracking No.:</b> TN0081809
<b>Photo No.</b> 5	<b>Date</b> 8-3-16	<div style="display: flex;"> <div style="flex: 1; padding-right: 10px;"> <p><b>Description</b> Outfall SW#3, the outfall for sediment basin #3 (see photo 3), located down-gradient of In-stream Monitoring Point #1 and up-gradient of Outfall SW#2, was observed. The sandy substrate showed no evidence of sediment discharge into the receiving stream, even though this basin was dewatered prior to flocculation due to an on-site emergency on July 10, 2016. Surface water was not observed in the stream at the time of inspection; the direction of stream flow, when it occurs, is indicated by the red arrow.</p> </div> <div style="flex: 2;">

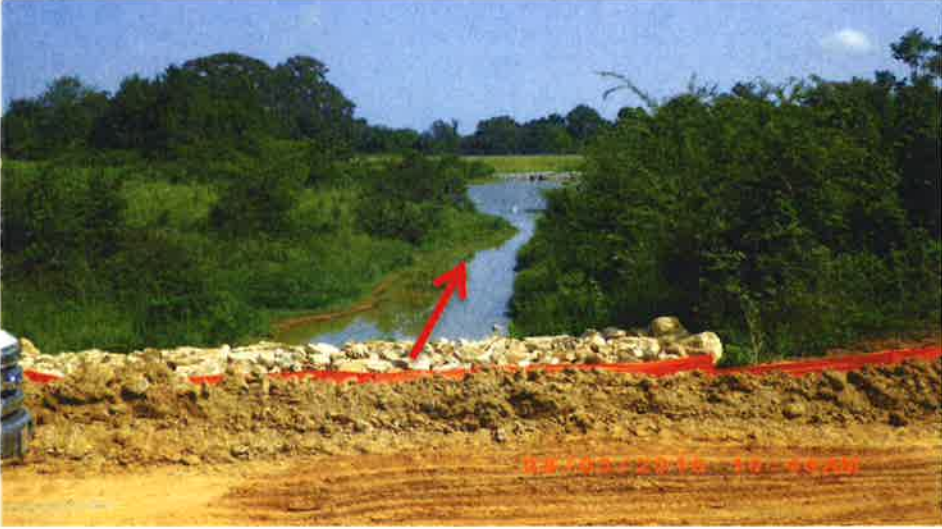
<b>Permittee Name:</b> Gateway Global Logistics Center		<b>Site Location:</b> 0.5 miles south of Knox Road, south of proposed N. Industrial Road	<b>Tracking No.:</b> TN0081809
<b>Photo No.</b> 6	<b>Date</b> 8-3-16

<b>Description</b> The receiving lake for Outfalls SW#1 and SW#4 was observed (view N; see photo 2). There was no flow into the lake at the time of inspection, and the water in the lake did not appear sediment-laden. Direction of flow into the lake is indicated by the red arrow.
