**Re: Inspection Findings Letter
Pigsville Farm / SOPC00102
756 Bill Lamb Road, Henry County, TN**

ICIS NPDES Facilities Inspection Report

Compliance Inspection for Concentrated Animal Feeding Operation (CAFO)

PHOTOLOG

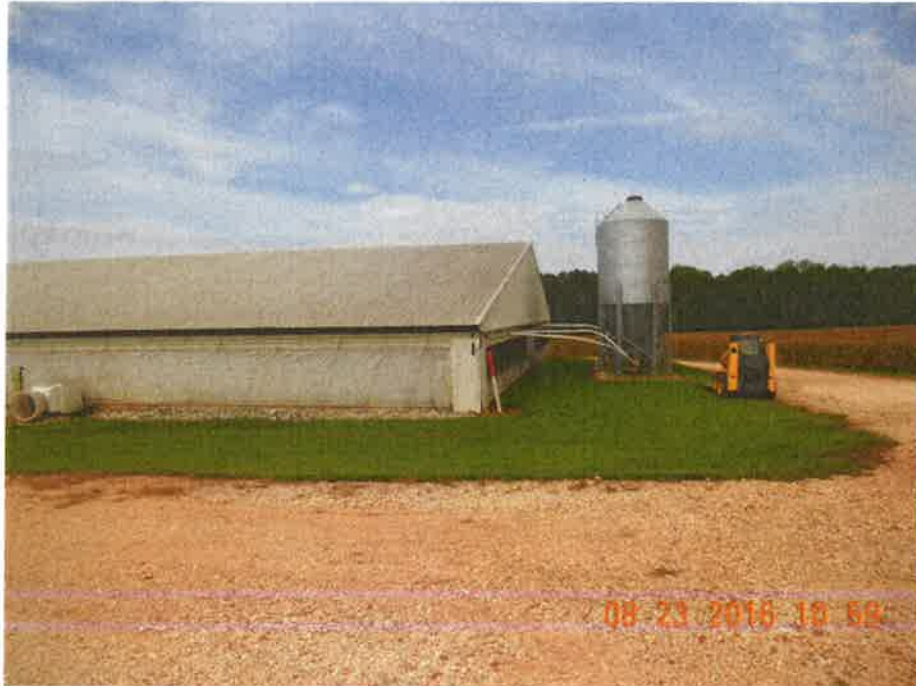
Picture 1

Date of Photo: 8/23/2016. Photo taken by: Kevin Smith. Location/Site Name: Pigsville Farm/SOPC00102. TDWR personnel Present: Kevin Smith. Remarks: Picture was taken standing on north side of hog barns facing west. There was good vegetation established around the hog barns.

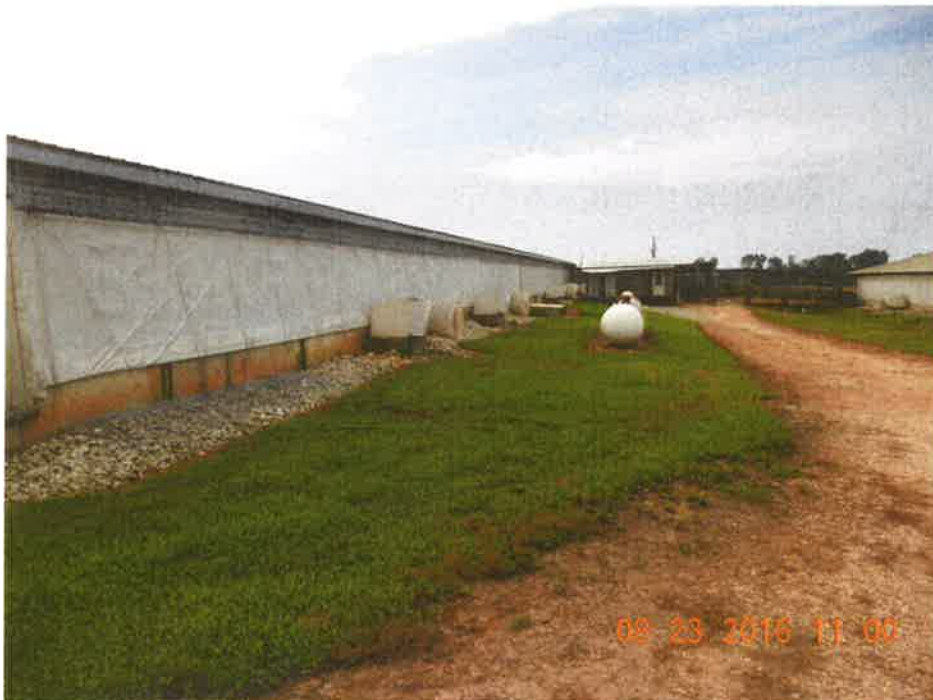
Picture 2

Date of Photo: 8/23/2016. Photo taken by: Kevin Smith. Location/Site Name: Pigsville Farm/SOPC00102. TDWR personnel Present: Kevin Smith. Remarks: Picture was taken standing on north side of hog barns facing south. Picture is of western side of the eastern most hog barn. Site is stabilized with either vegetation or rock. There is also rock along the roof drip line of the hog barns to prevent scouring.

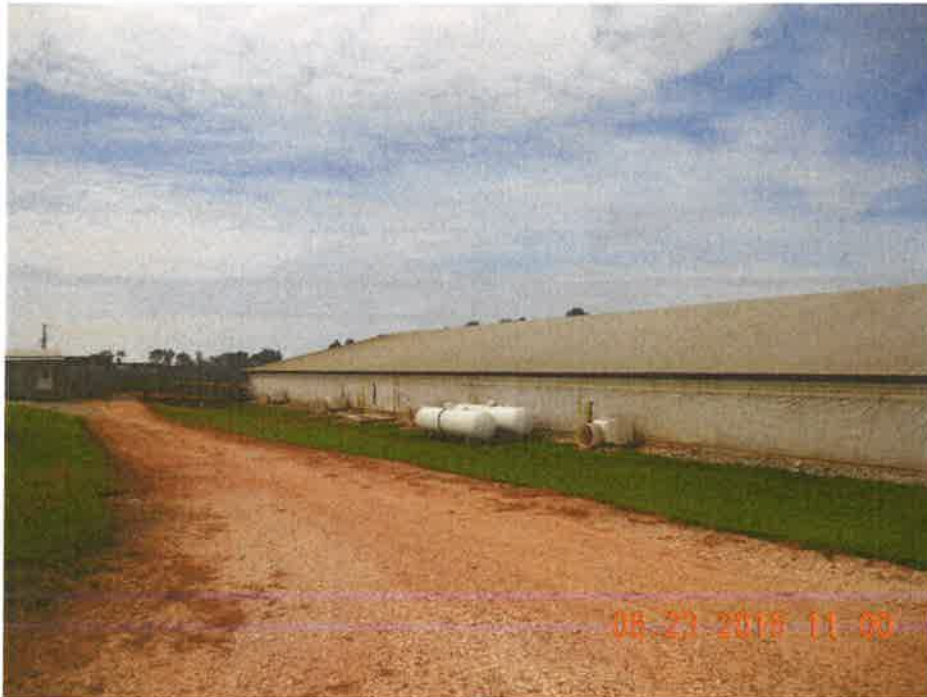
Picture 3

Date of Photo: 8/23/2016. Photo taken by: Kevin Smith. Location/Site Name: Pigsville Farm/SOPC00102. TDWR personnel Present: Kevin Smith. Remarks: Picture is of the eastern side of the westernmost hog barn. Picture was taken facing southwest. Site is stabilized with either vegetation or rock.

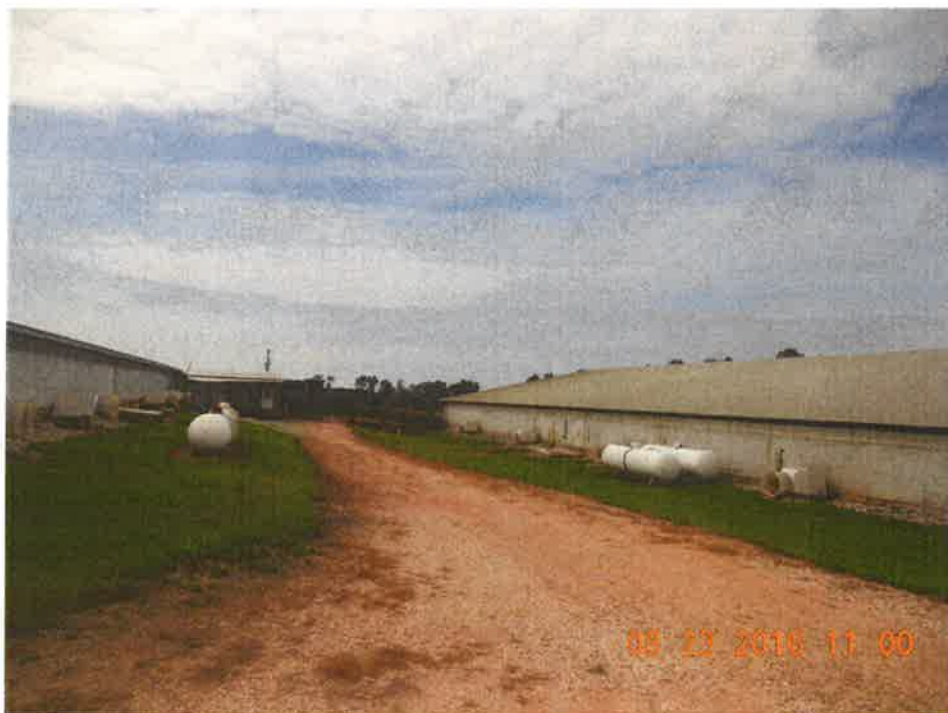
Picture 4

Date of Photo: 8/23/2016. Photo taken by: Kevin Smith. Location/Site Name: Pigsville Farm/SOPC00102. TDWR personnel Present: Kevin Smith. Remarks: Picture was taken on north side of hog barns facing south. Area between hog barns was stable with either vegetation or rock.

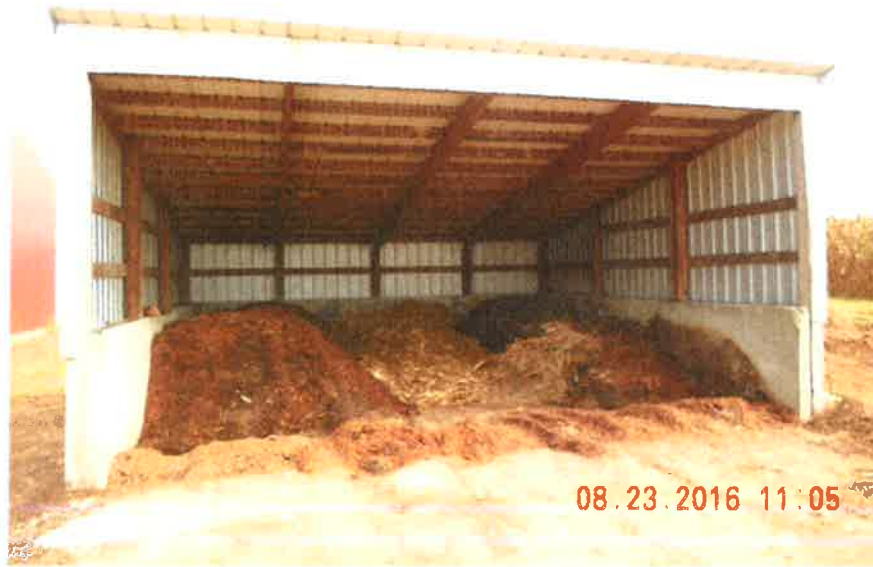
Picture 5

Mortalities are composted on-site in a covered compost shed, which has a concrete floor and concrete walls. The floor of the compost shed is sloped towards the back to prevent liquid from running out of the compost shed. You use sawdust and/or wood chips as your carbon source for your compost mixture. There were no uncovered hog remains observed on the day of inspection. There was also no leachate observed leaving the concrete pad of the compost shed on the day of inspection.

Facility compost mortalities in a covered shed with a concrete floor. Facility keeps records of compost temperature. No uncovered hog remains were observed on day of inspection. No leachate was observed running off of concrete pad of compost shed on day of inspection. Sawdust and wood chips are used as a carbon source.

Date of Photo: 8/23/2016. Photo taken by: Kevin Smith. Location/Site Name: Pigsville Farm/SOPC00102. TDWR personnel Present: Kevin Smith. Remarks: Picture was taken on south side of compost shed facing north. There were no uncovered hog remains observed on day of inspection. There was no leachate observed running off the concrete pad of the compost shed on day of inspection. Concrete floor of the compost shed is sloped where liquid will flow back towards back concrete wall of compost shed.

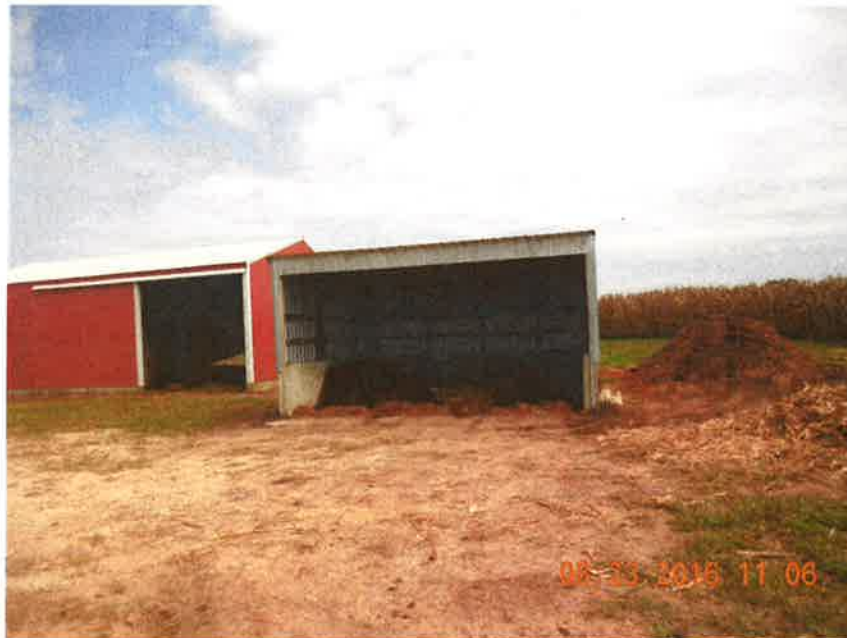
Picture 6

Date of Photo: 8/23/2016. Photo taken by: Kevin Smith. Location/Site Name: Pigsville Farm/SOPC00102. TDWR personnel Present: Kevin Smith. Remarks: Picture was taken on south side of compost shed facing north. There were no uncovered hog remains observed on day of inspection. There was no leachate observed running off the concrete pad of the compost shed on day of inspection. Producer uses sawdust and wood chips as a carbons source. Sawdust and wood chips were piled on east side of compost shed on day of inspection.

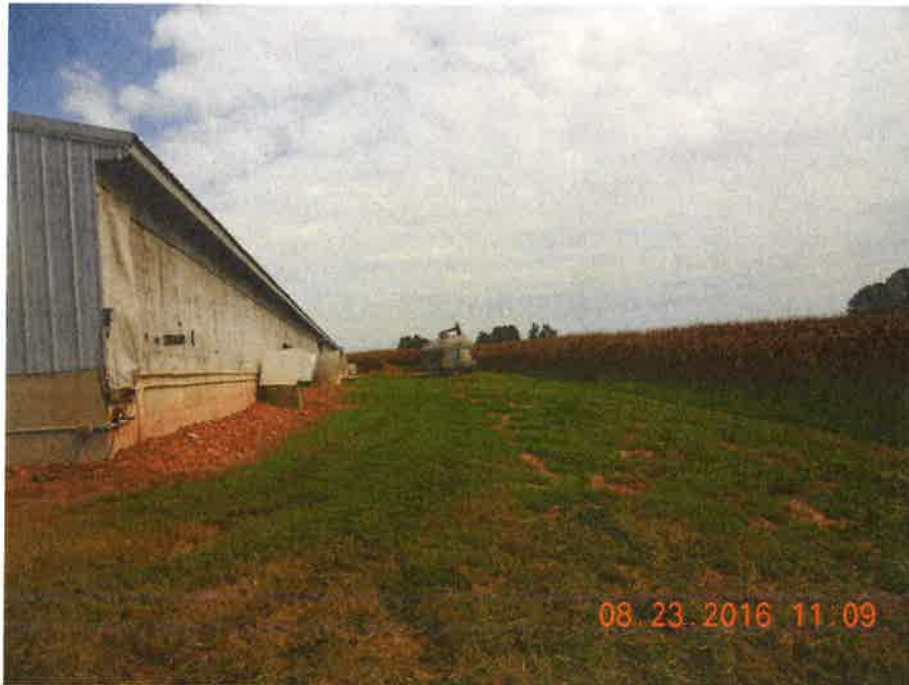
Picture 7

Date of Photo: 8/23/2016. Photo taken by: Kevin Smith. Location/Site Name: Pigsville Farm/SOPC00102. TDWR personnel Present: Kevin Smith. Remarks: Picture is of east side of the easternmost hog barn. Area is stabilized with vegetation. There was rock along roof drip line to prevent scouring. Picture was taken near southeast corner of easternmost hog barn facing north.

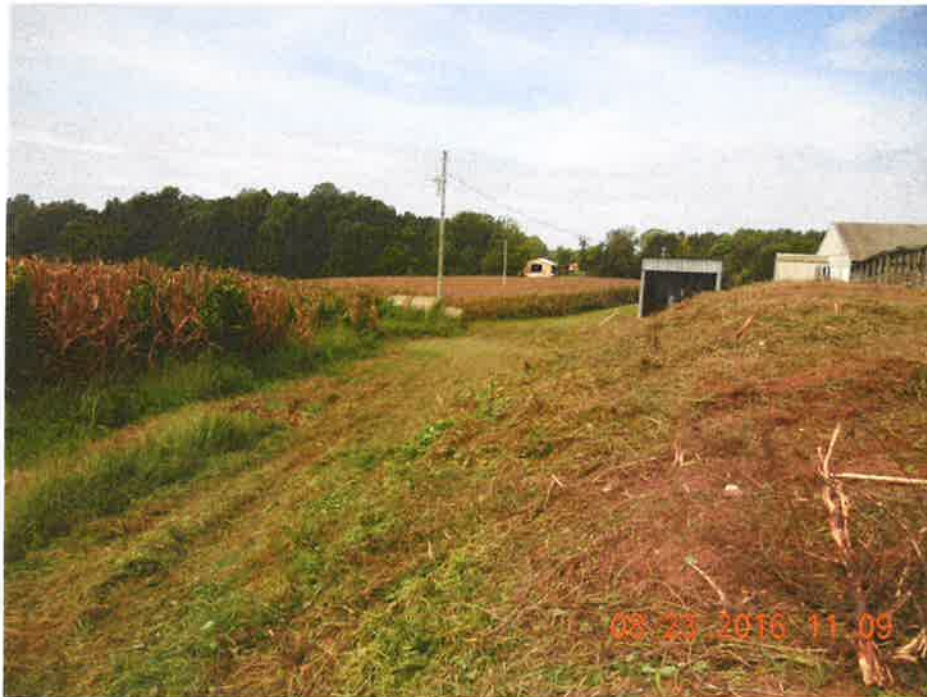
Picture 8

Date of Photo: 8/23/2016. Photo taken by: Kevin Smith. Location/Site Name: Pigsville Farm/SOPC00102. TDWR personnel Present: Kevin Smith. Remarks: Picture is of slope located south of the easternmost hog barn. Area was stabilized with vegetation. Picture was taken standing on south side of hog barn facing west.

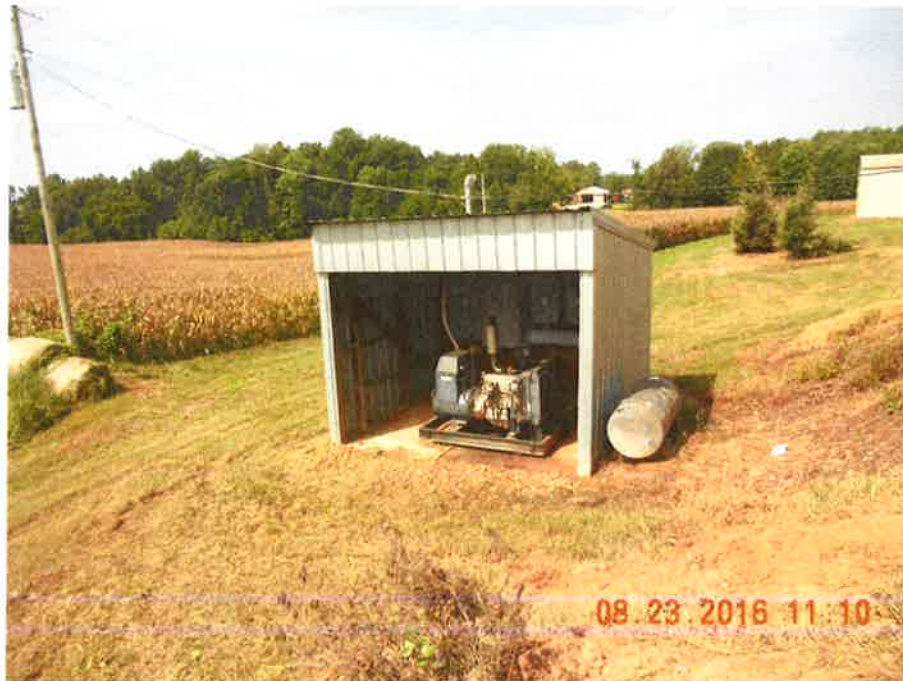
Picture 9

Date of Photo: 8/23/2016. Photo taken by: Kevin Smith. Location/Site Name: Pigsville Farm/SOPC00102. TDWR personnel Present: Kevin Smith. Remarks: Picture is of generator shed located on south side of hog barns.

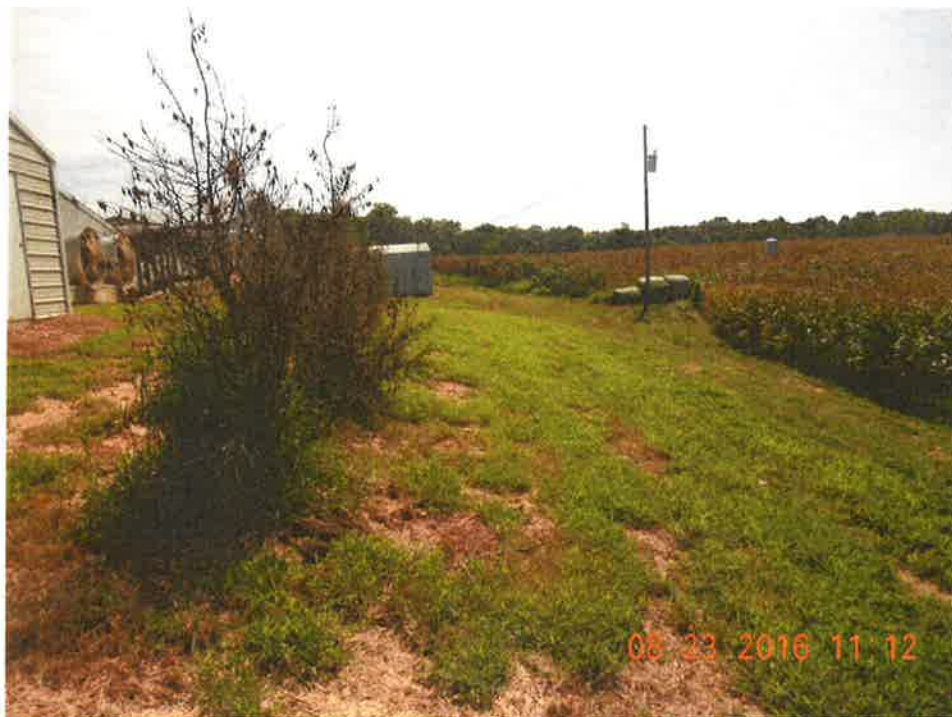
Picture 10

Date of Photo: 8/23/2016. Photo taken by: Kevin Smith. Location/Site Name: Pigsville Farm/SOPC00102. TDWR personnel Present: Kevin Smith. Remarks: Picture is of slope located south of the westernmost hog barn. Slope was stabilized with vegetation. Picture was taken standing on south side of westernmost hog barn facing east.

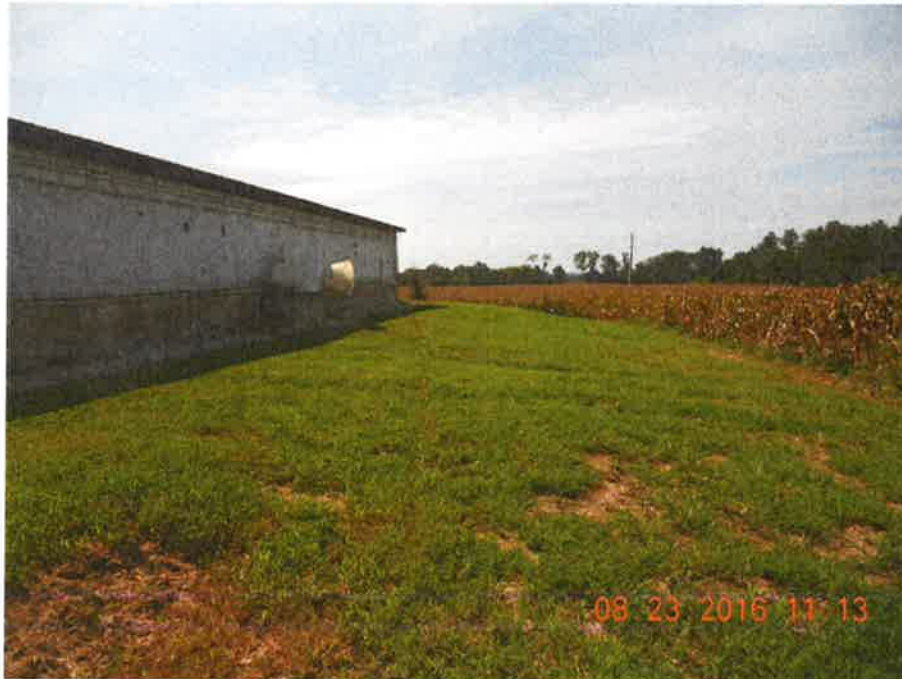
Picture 11

Date of Photo: 8/23/2016. Photo taken by: Kevin Smith. Location/Site Name: Pigsville Farm/SOPC00102. TDWR personnel Present: Kevin Smith. Remarks: Picture is of the west side of the westernmost hog barn. Area was well vegetated. Picture was taken on west side of westernmost hog barn facing south.

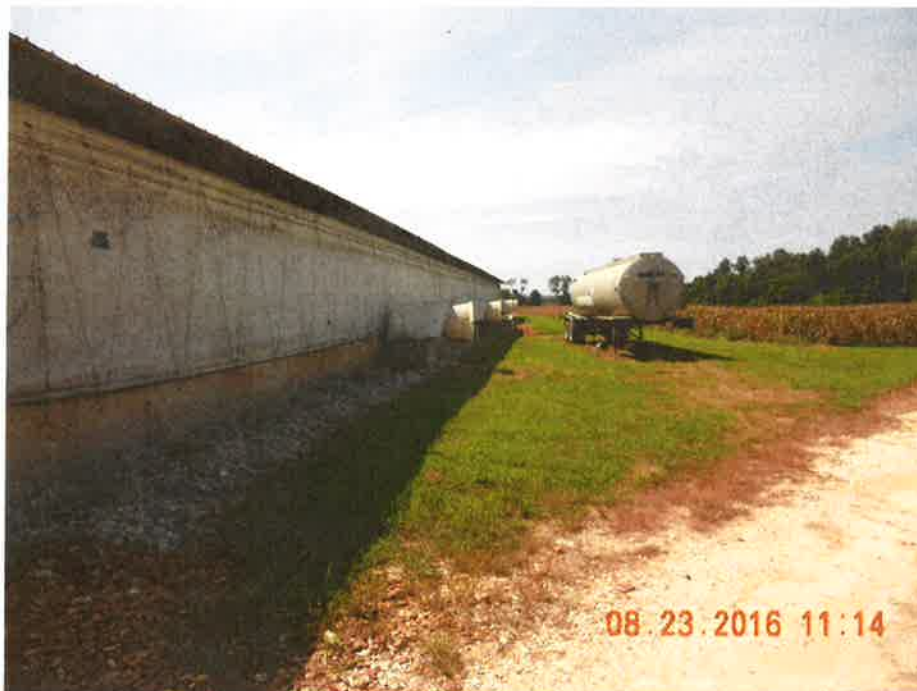
Picture 12

Date of Photo: 8/23/2016. Photo taken by: Kevin Smith. Location/Site Name: Pigsville Farm/SOPC00102. TDWR personnel Present: Kevin Smith. Remarks: Picture is of the west side of the westernmost hog barn. Area was well vegetated. There was rock along roof drip line to prevent scouring. Picture was taken on west side of westernmost hog barn facing south.

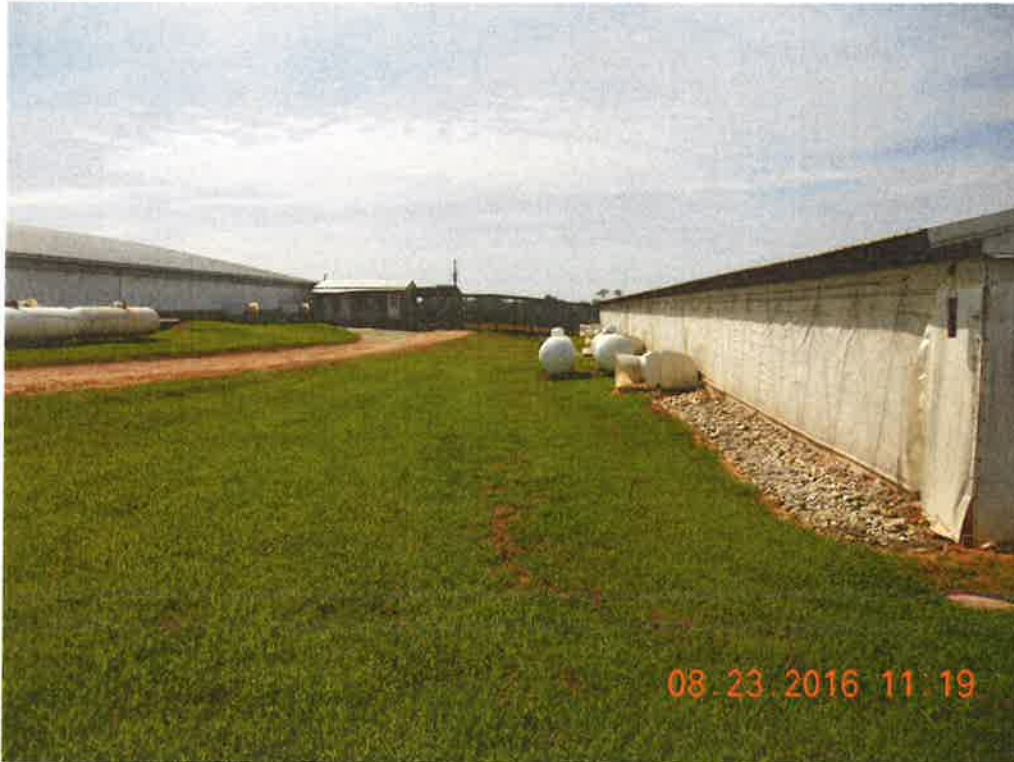
Picture 13

Date of Photo: 8/23/2016. Photo taken by: Kevin Smith. Location/Site Name: Pigsville Farm/SOPC00102. TDWR personnel Present: Kevin Smith. Remarks: Picture is of the eastern side of the westernmost hog barn. Site is stable with vegetation. There is also rock along the roof drip lines to prevent scouring. Picture was taken near the northeast corner of the western most hog barn facing south.
