RE:    ARAP Compliance Inspection  
      Blue Oval City  
      ARAP Tracking Number: NRS21.238

**TENNESSEE DEPARTMENT OF ENVIRONMENT AND CONSERVATION  
DIVISION OF WATER RESOURCES  
MEMPHIS ENVIRONMENTAL FIELD OFFICE  
AQUATIC RESOURCE ALTERATION PERMIT COMPLIANCE INSPECTION**

Location name: Blue Oval City

## Photographic Log

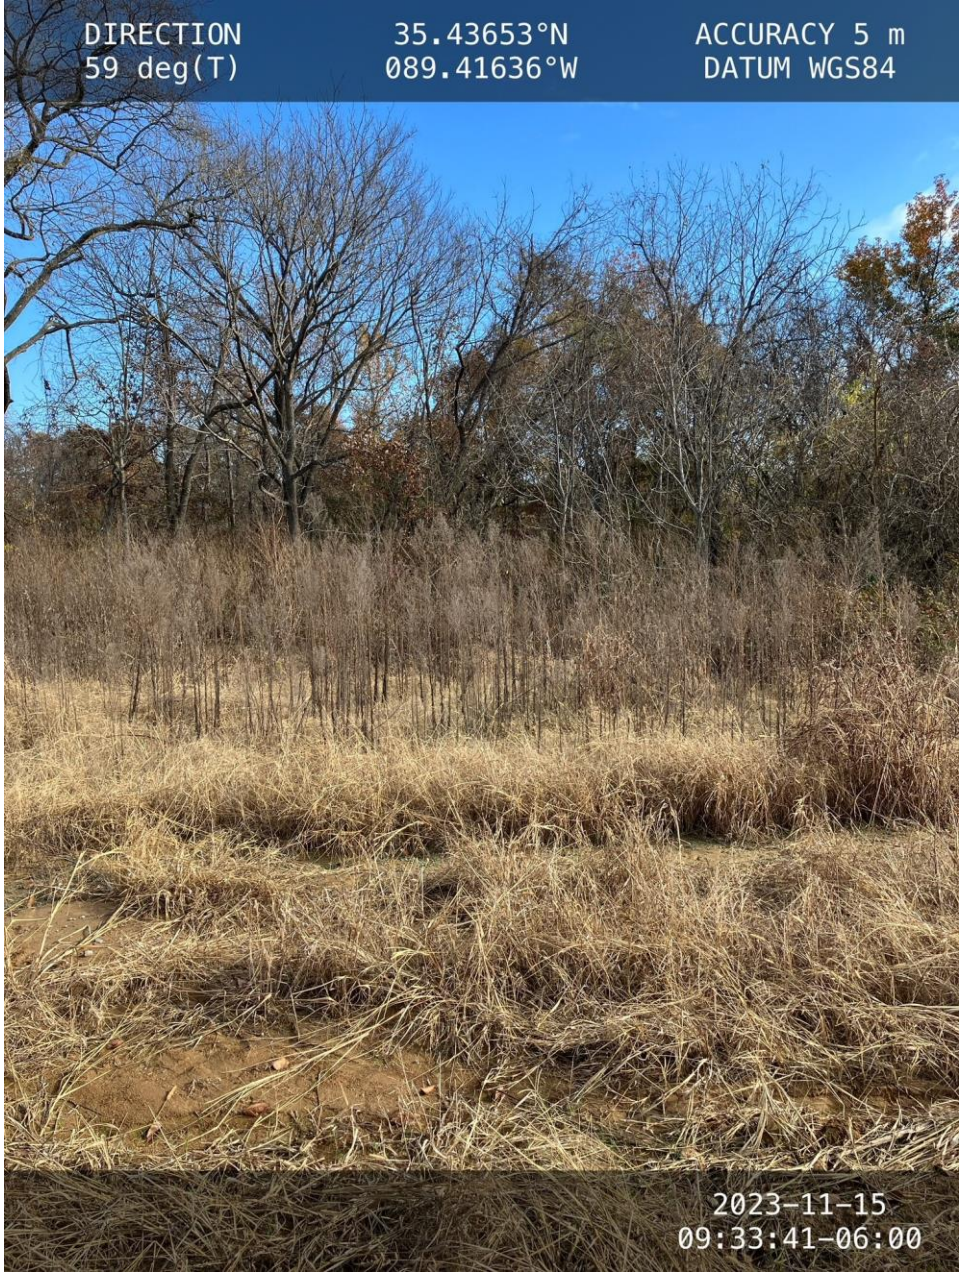
<b>Project:</b> Blue Oval City		<b>Site Location:</b> 2672 Keeling Road		<b>Permit No.:</b> NRS21.238	
<b>Photo No.</b> 01	<b>Date</b> 11/15/2023	<b>DIRECTION</b> 59 deg(T)	35.43653°N 089.41636°W	<b>ACCURACY 5 m</b> <b>DATUM WGS84</b>	
<p><b>Description</b> View of wetland 2, near the southwestern corner of the wetland. No alterations were observed within this wetland, which was to be left undisturbed as per ARAP NRS21.238. However, no signage was observed identifying this area as protected wetlands to which no disturbance is permitted.</p>

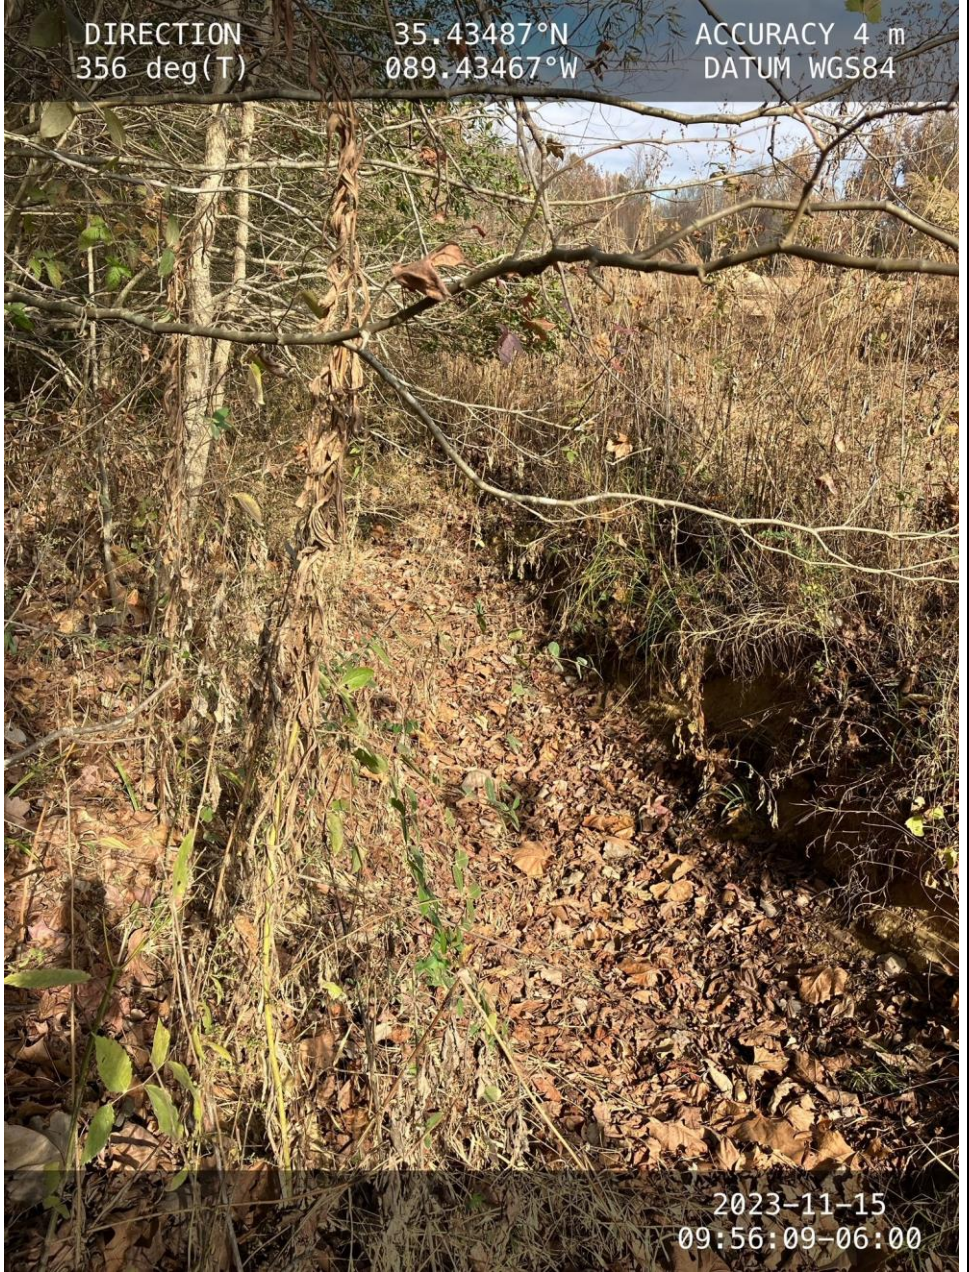
Project:		Site Location:	Permit No.:
Blue Oval City		2672 Keeling Road	NRS21.238
Photo No.	Date	DIRECTION 35.43487°N 356 deg(T) 089.43467°W ACCURACY 4 m DATUM WGS84	
02	11/15/2023

Description		2023-11-15 09:56:09-06:00	
View of the undisturbed segment of Stream 11, which was not proposed to be disturbed under NRS21.238. No disturbance was observed within this segment of the stream.

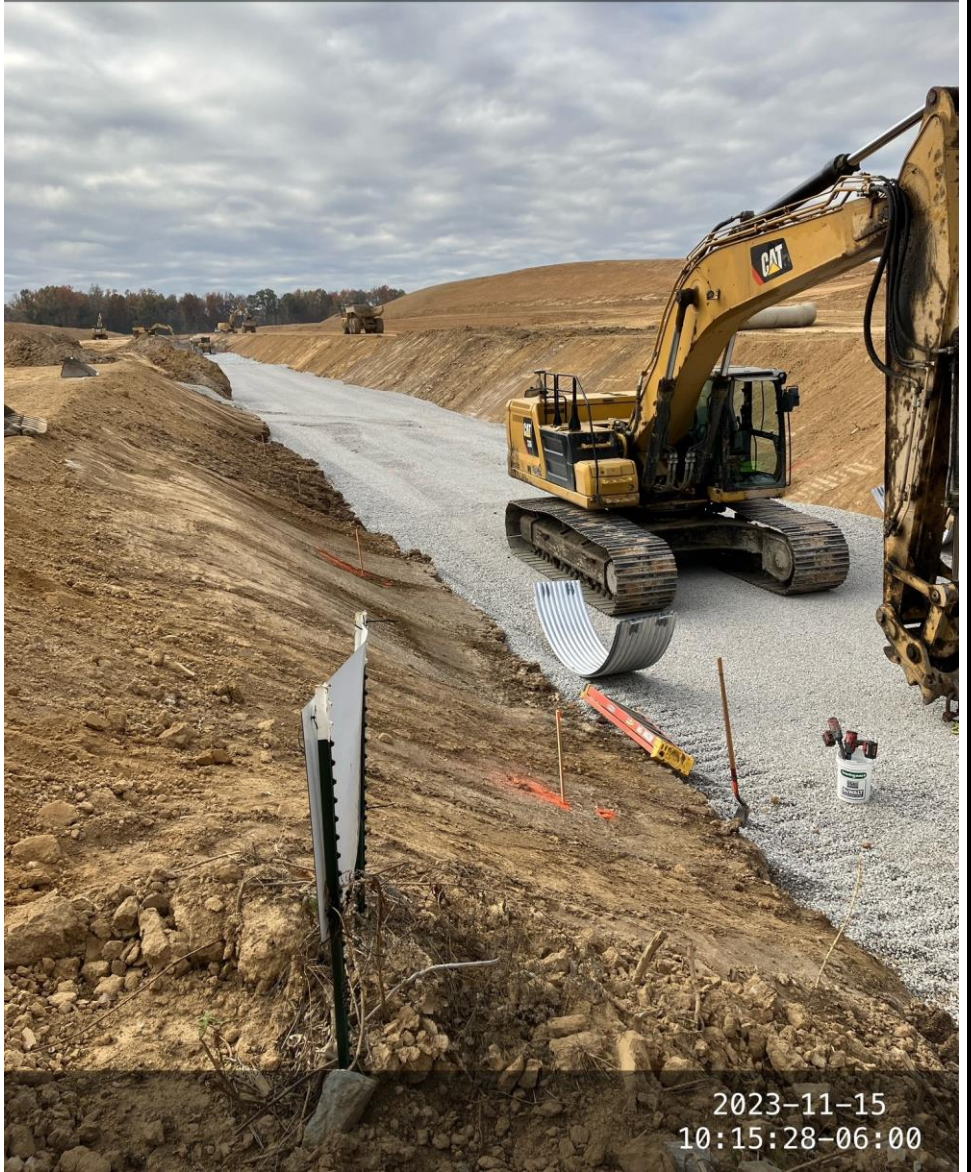
Project:		Site Location:	Permit No.:
Blue Oval City		2672 Keeling Road	NRS21.238
Photo No.	Date	DIRECTION	ACCURACY 5 m DATUM WGS84
03	11/15/2023	222 deg(T)	35.43296°N 089.44128°W
<b>Description</b> View of the northern end of the portion of Stream 1-A permitted to be encapsulated, looking southwest. No flow was observed within the work area.

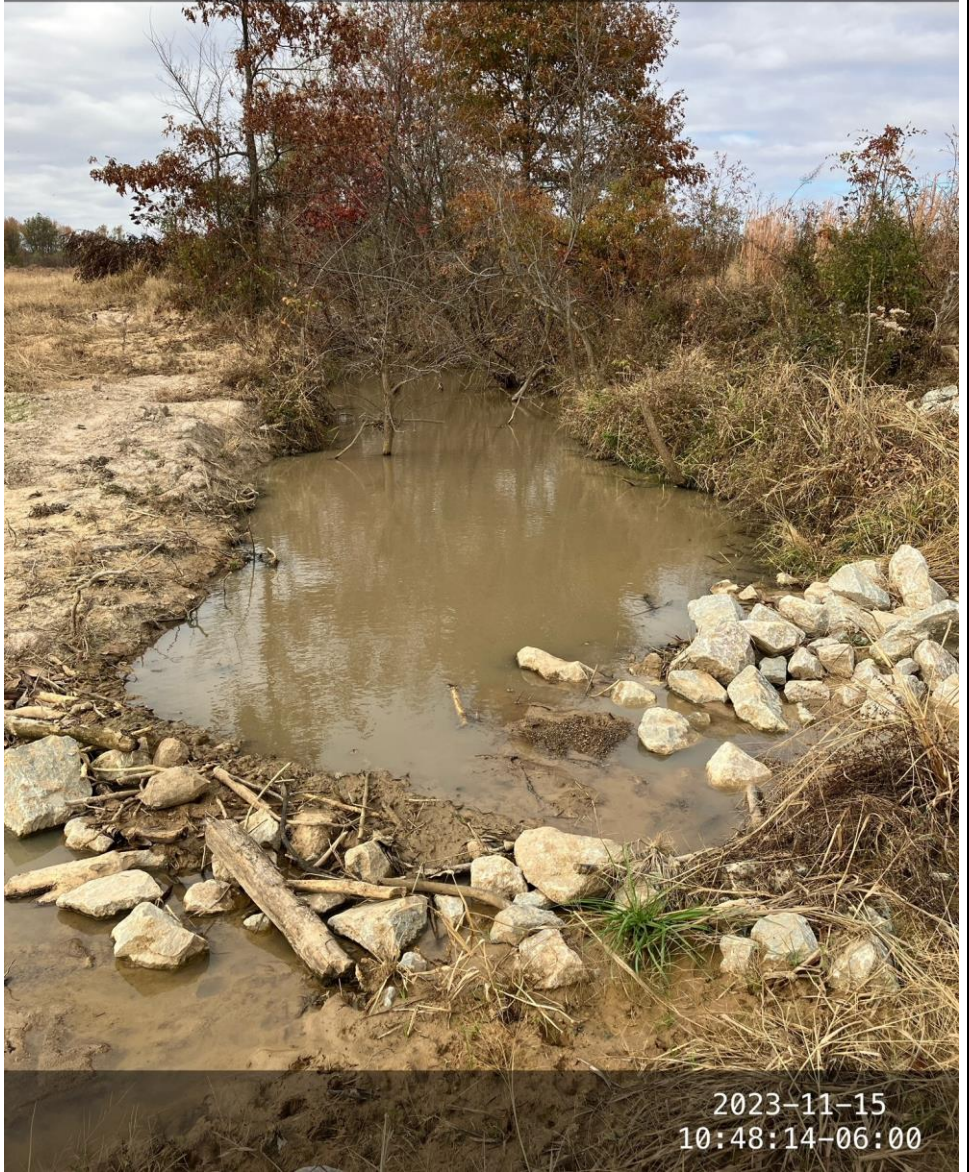
- No signage identifying Wetlands 5 and 2 as protected wetlands was observed onsite as required by ARAP NRS21.238.
- A portion of Stream 1-A had been realigned to flow south of the project area, which was not shown on the plans submitted to the Division. The plans the Division has on file show this segment of the stream being encapsulated. The Division has no record of a permit modification request or revised plans being submitted for this deviation. The original Stream 1-A channel that was permitted to be encapsulated, was filled.

<b>Project:</b> Blue Oval City		<b>Site Location:</b> 2672 Keeling Road	<b>Permit No.:</b> NRS21.238
<b>Photo No.</b> 04	<b>Date</b> 11/15/2023	<b>DIRECTION</b> 288 deg (T)	<b>35.42915°N</b> <b>089.44774°W</b> <b>ACCURACY 5 m</b> <b>DATUM WGS84</b>
<b>Description</b> View of Stream 1-A, near the southwestern terminus of the segment of Stream 1-A that was permitted to be encapsulated, looking west. The stream was not encapsulated in this area as shown on plans submitted as part of NRS21.238.

- On or before **June 11, 2024**, submit the following to the Division:
  - 1) A detailed plan utilizing data driven methods using aspects of natural channel design that documents elements of the channel such as watershed hydrology, channel hydraulics, sediment transport, lateral site constraints and morphological reference conditions within the ecoregion. The plan should include specific information regarding the linear footage of stream channel for Stream 1-A and Stream 9 that was initially authorized under NRS21.238, information regarding the amount of fill that occurred to either/both channels and specific information regarding the realignment/relocation, including but not limited to linear length.

- 2) A 12-point mitigation plan (following Section 5.2.2 of the Division’s Stream Mitigation Guidelines) that includes documenting the stream’s existing conditions (pre-impact), proposed condition and monitoring requirements. Replacement channels will need to be vegetated, have a natural channel bottom, and have channel stability, both laterally and vertically throughout the monitoring period. Please consult credible sources such as the Natural Resource Conservation Services National Engineering Handbook Stream Restoration Design or the TN Department of Transportation Design Division Drainage Manual, Chapter 11, Natural Stream Design or the Division’s Compensatory Mitigation website. The 12-point mitigation plan must use the TN SQT or other scientifically defensible and approve method to

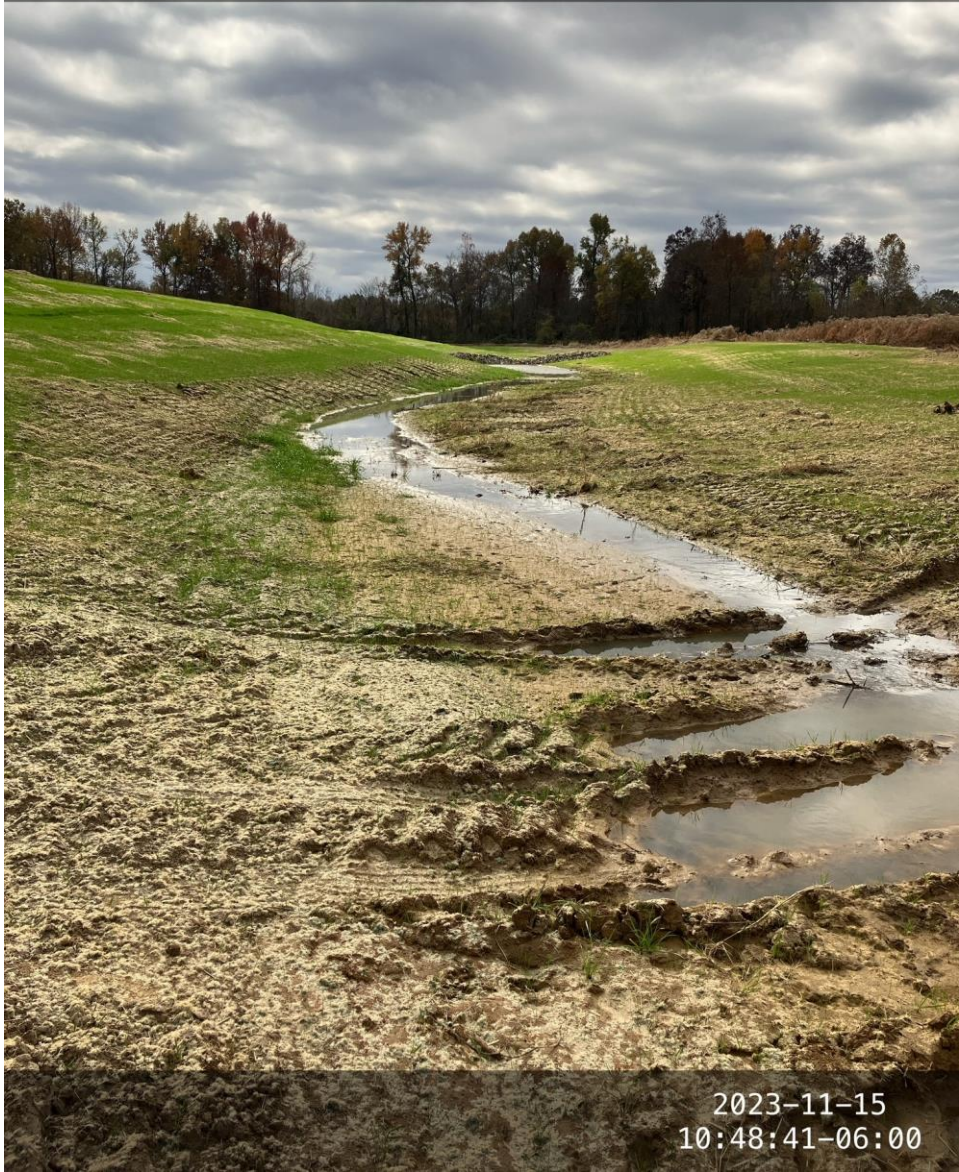
<b>Project:</b> Blue Oval City		<b>Site Location:</b> 2672 Keeling Road		<b>Permit No.:</b> NRS21.238	
<b>Photo No.</b> 05	<b>Date</b> 11/15/2023	DIRECTION 175 deg(T)	35.42915°N 089.44776°W	ACCURACY 5 m DATUM WGS84	
<p><b>Description</b> View of Stream 1-A in the same location as photo 04, looking south. The stream appears to have been realigned which was not included in the plans submitted under NRS21.238. The banks had been hydroseeded and grass was observed establishing. Several checks dams were installed across the channel.</p>

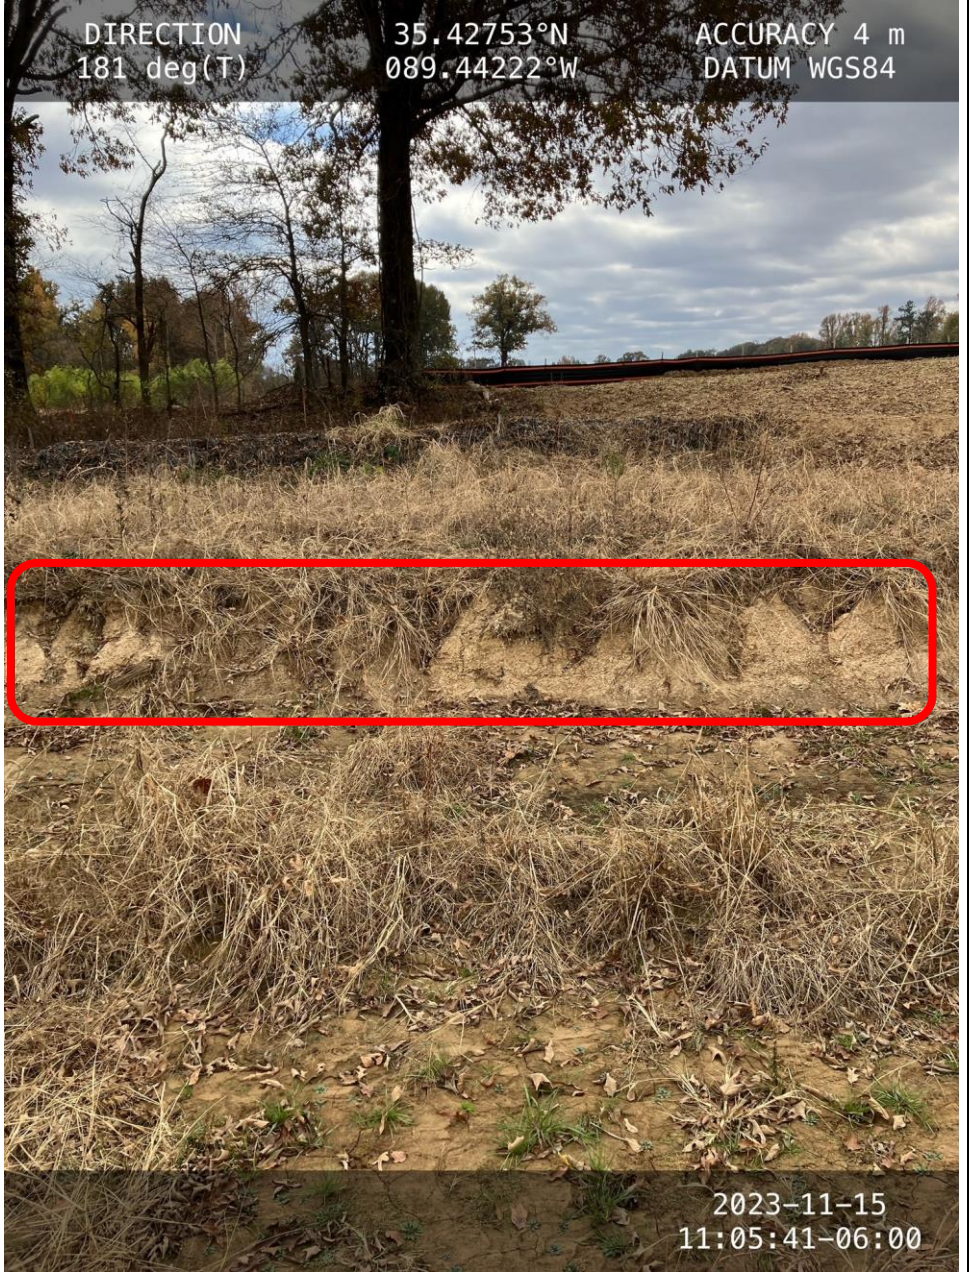
Project:		Site Location:	Permit No.:
Blue Oval City		2672 Keeling Road	NRS21.238
Photo No.	Date	DIRECTION 35.42753°N 181 deg(T) 089.44222°W ACCURACY 4 m DATUM WGS84	
06	11/15/2023

- Partially bare, unstable areas were observed throughout the channelized segment of Stream 2. Although vegetation was observed within the channel, it did not appear to be installed as the plans the Division has on file describe and therefore as required by ARAP NRS21.238. Additionally, the Division has no record of being contacted prior to diverting the stream flow into the new channel as required by ARAP NRS21.238.

<b>Description</b> View looking south, at the segment of Stream 2 that was channelized as part of the alterations permitted under NRS21.238. Erosional rills (circled) were observed along both banks of the channelized segment of the stream.			
		2023-11-15 11:05:41-06:00

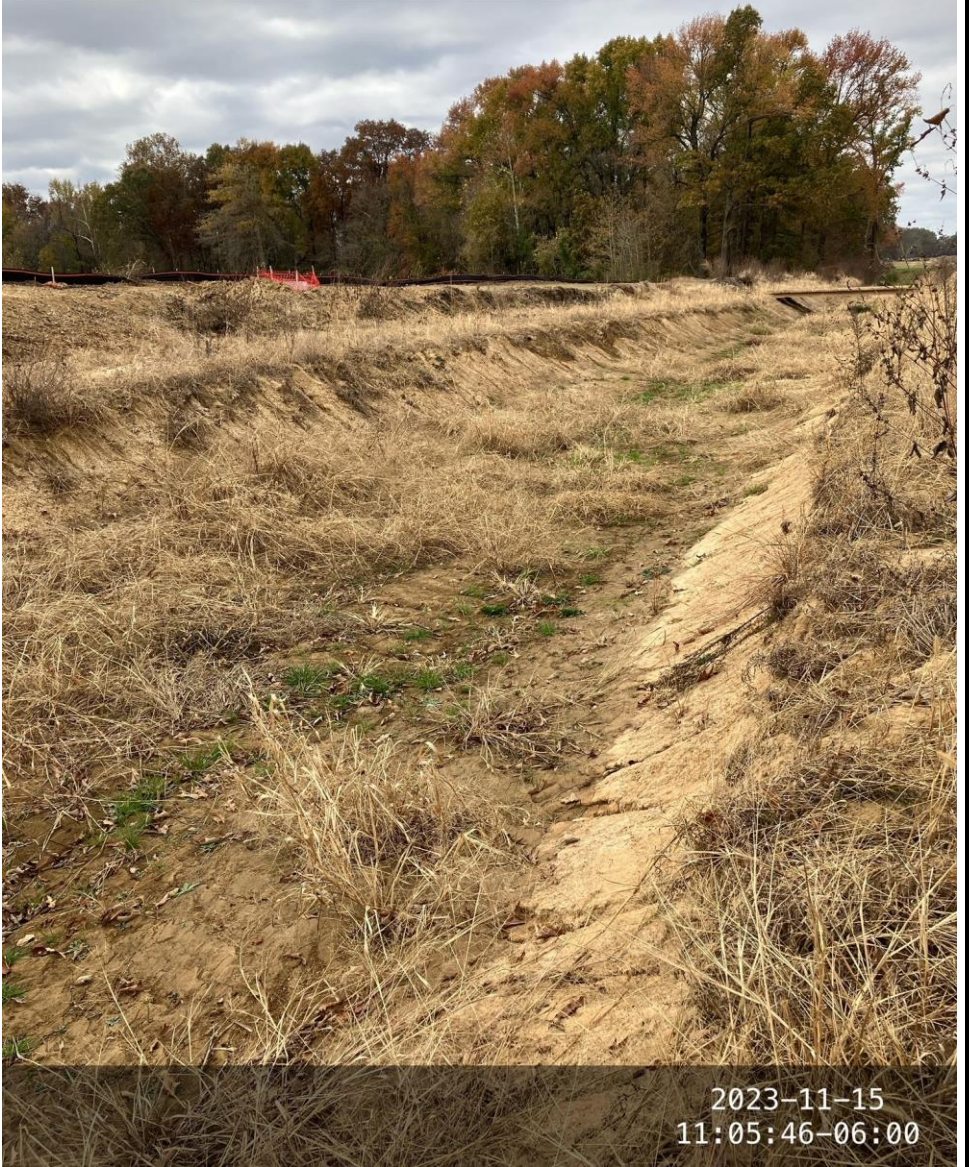
<b>Project:</b> Blue Oval City		<b>Site Location:</b> 2672 Keeling Road		<b>Permit No.:</b> NRS21.238	
<b>Photo No.</b> 07	<b>Date</b> 11/15/2023	DIRECTION 247 deg(T)	35.42752°N 089.44222°W	ACCURACY 4 m DATUM WGS84	
<p><b>Description</b> Another view of the channelized segment of Stream 2, looking west southwest. While some vegetation was observed within the stream, both banks of the stream appeared unstable and numerous erosional rills were observed.</p>

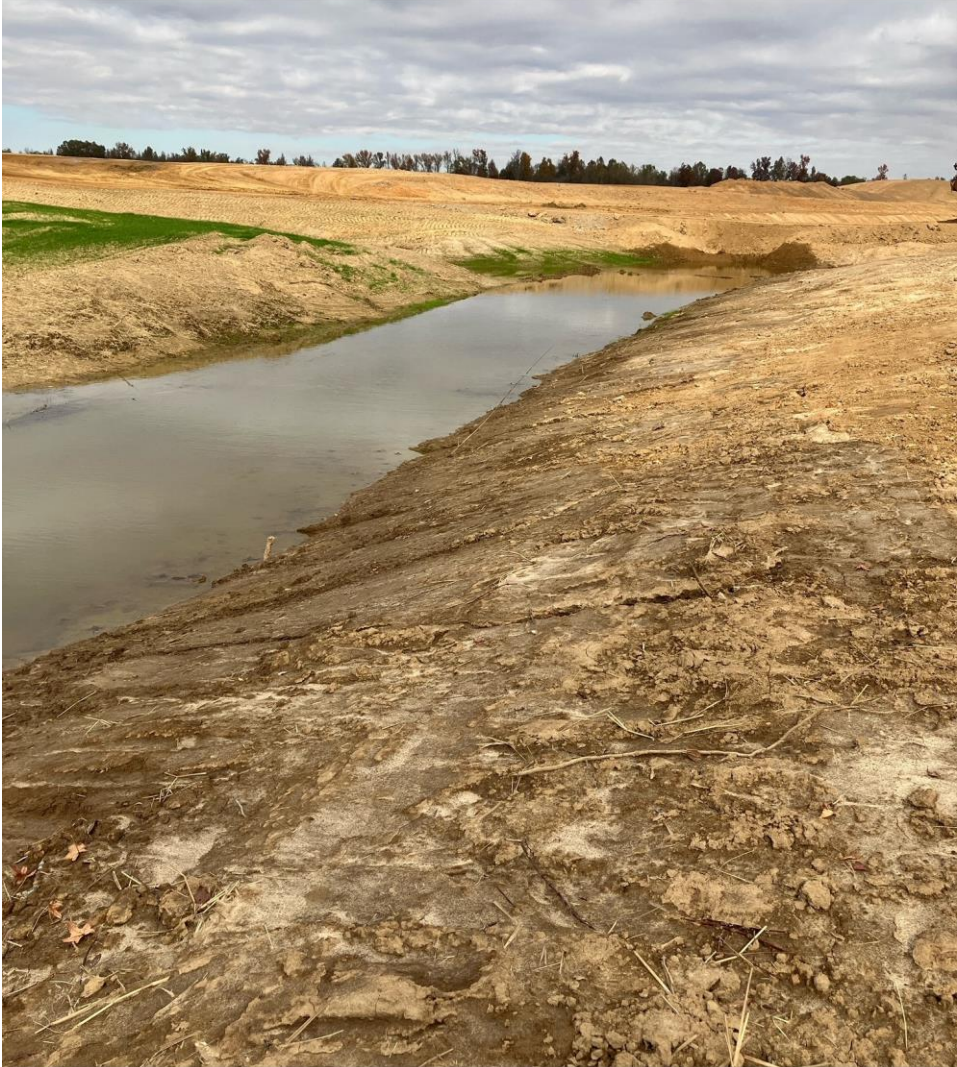
- Water was observed impounded upgradient of the segment of Stream 9 that will be encapsulated.

<b>Project:</b> Blue Oval City		<b>Site Location:</b> 2672 Keeling Road		<b>Permit No.:</b> NRS21.238	
<b>Photo No.</b> 08	<b>Date</b> 11/15/2023	DIRECTION 352 deg(T)	35.42764°N 089.44416°W	ACCURACY 5 m DATUM WGS84	
<p><b>Description</b> View of Stream 9, looking north, towards the segment of the stream permitted to be encapsulated under NRS21.238. Water was impounded on the upgradient end of the work area within the stream. Check dams and other in-flow treatments are not authorized to be placed within streams.</p>

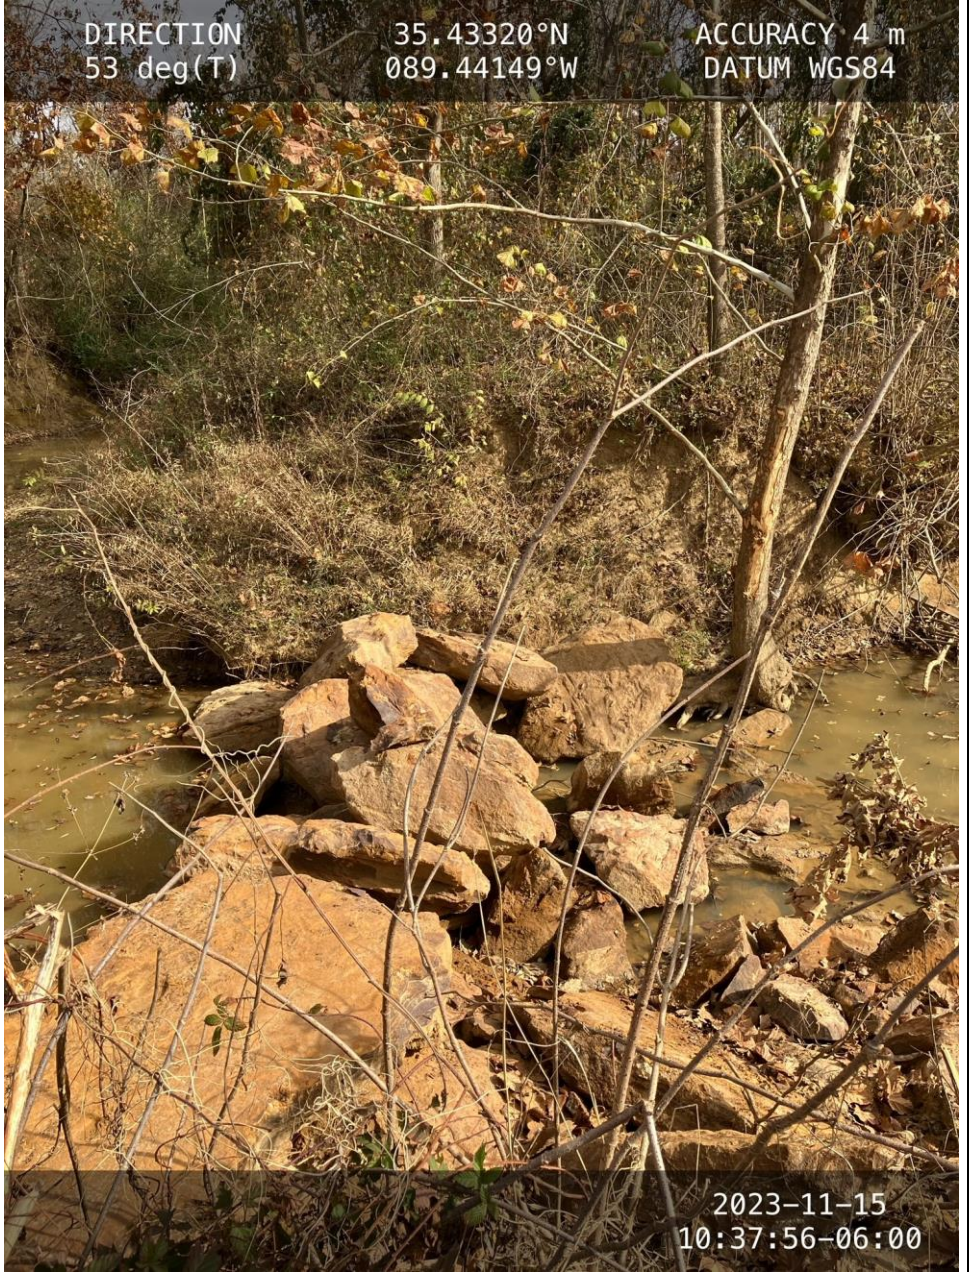
- A check dam was observed installed at the northern terminus of the channelized segment of Stream 1-B.

<b>Project:</b> Blue Oval City		<b>Site Location:</b> 2672 Keeling Road	<b>Permit No.:</b> NRS21.238
<b>Photo No.</b> 09	<b>Date</b> 11/15/2023	<b>DIRECTION</b> 53 deg(T)	<b>35.43320°N</b> <b>089.44149°W</b> <b>ACCURACY 4 m</b> <b>DATUM WGS84</b>
<b>Description</b> A view of the check dam installed in Stream 1-B at the northern terminus of the segment of the stream channelized under NRS21.238. Checkdams and other in-flow treatments are not authorized to be placed within streams.
