HYRDOLOGICAL ASSESSMENT REPORT

**10444 OOLTEWAH GEORGETWON ROAD
PARCEL # 070 036
OOLTEWAH, TENNESSEE**

Project No. 34-214107

June 18, 2021

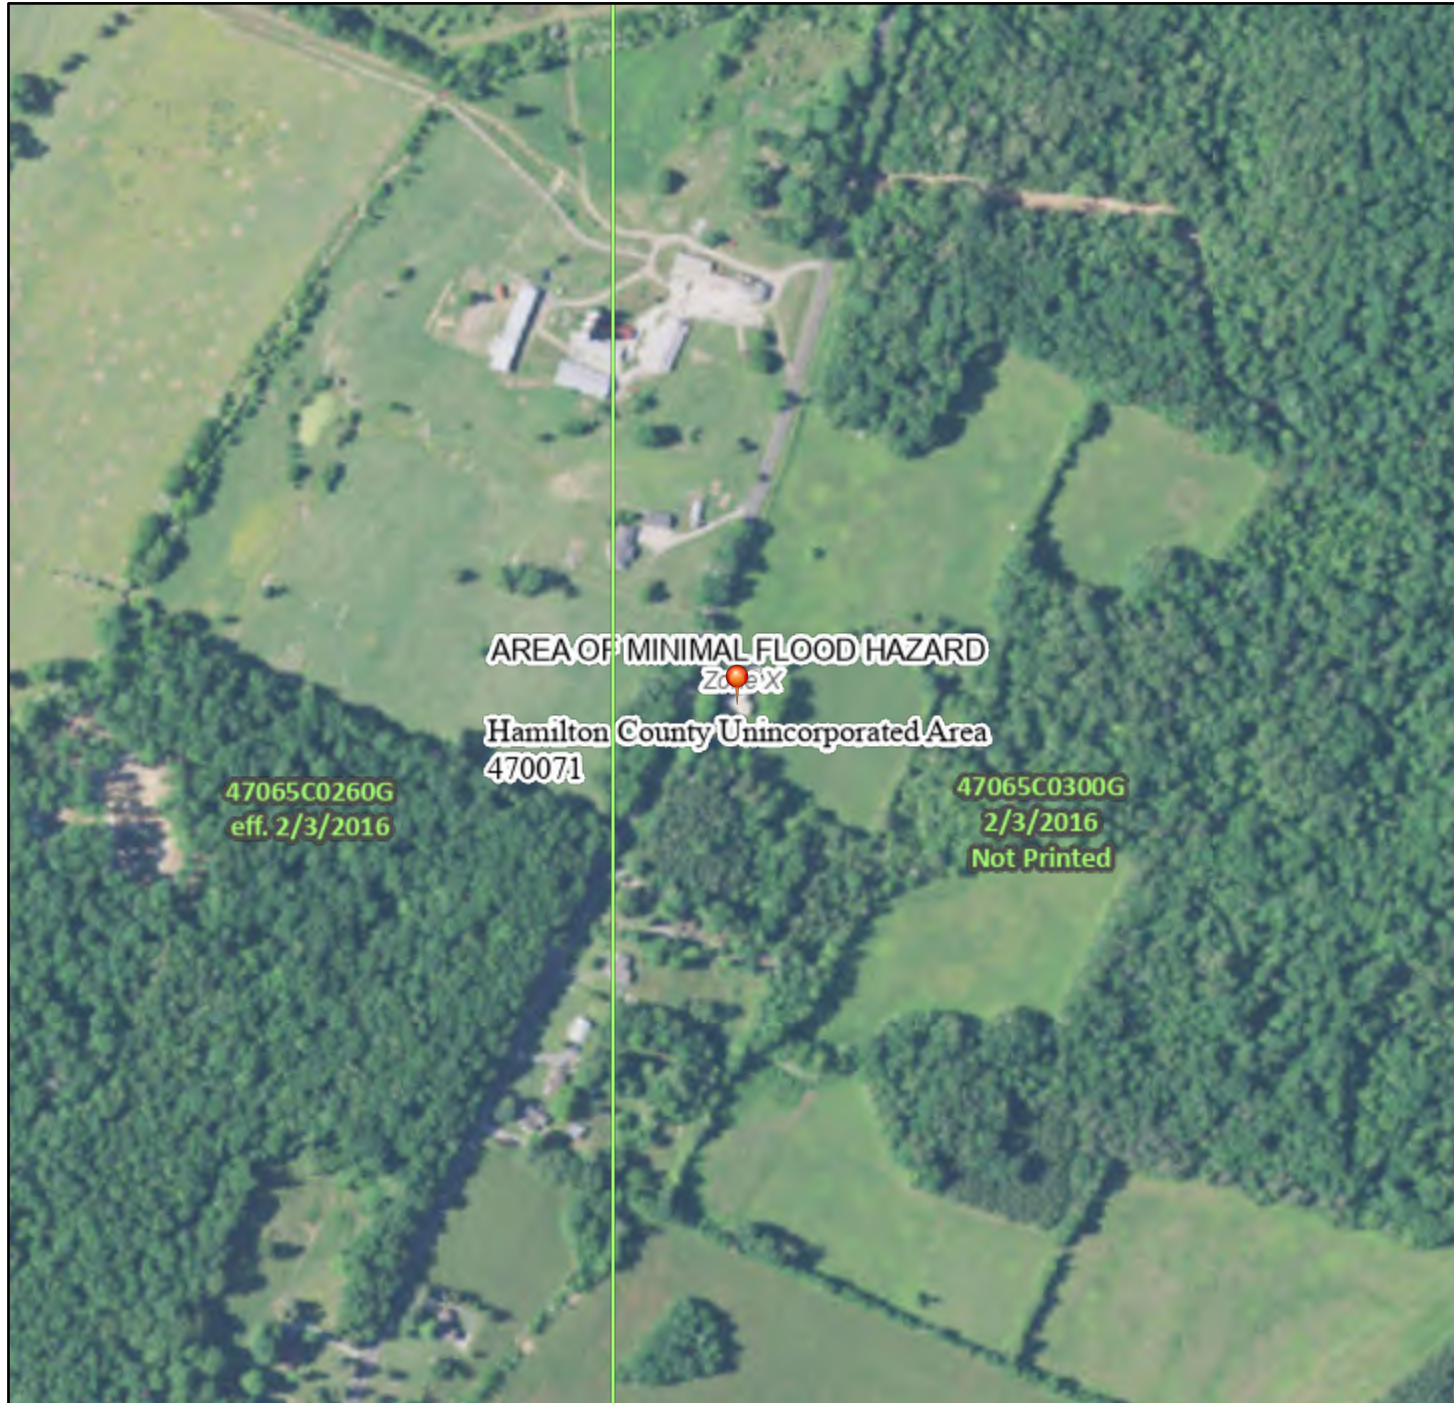
National Flood Hazard Layer FIRMette

The FEMA FIRM Map- According to FEMA Data, the Subject Property is located in Zone-X Area of Minimal Flood Hazard Panel: 47065C0300G effective date 2/3/2016. Zone X- Area of Minimal Flood Hazard are defined as areas determined to be outside the 1 % and 0.2% annual chance floodplain.

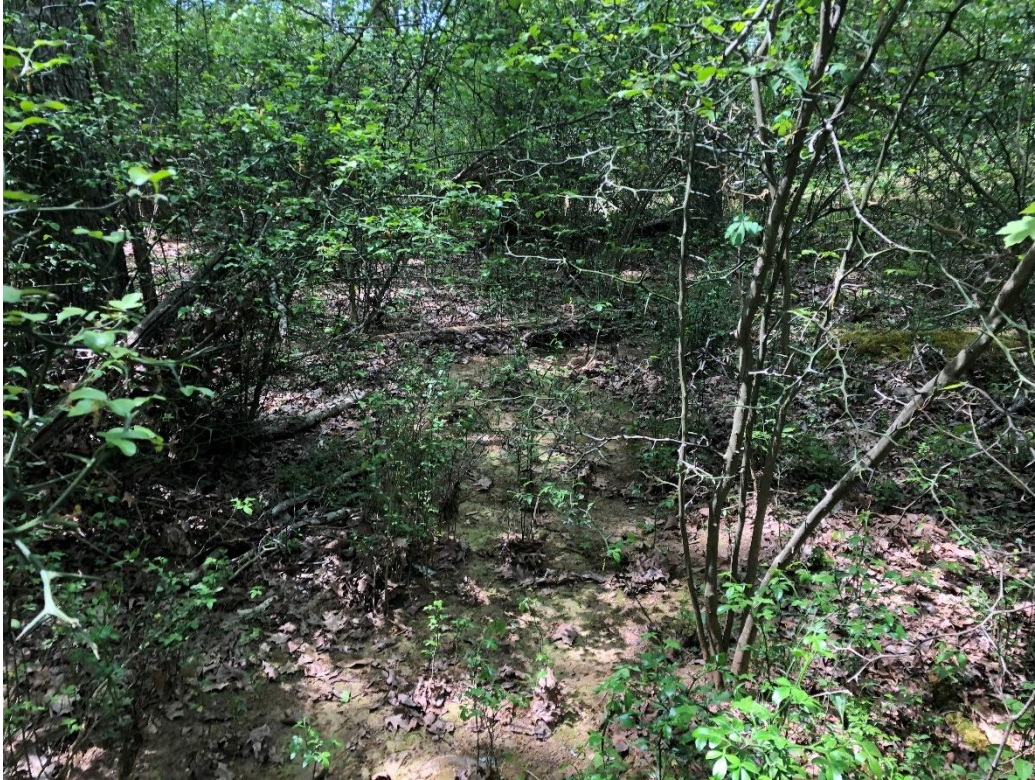
Wet Weather Conveyance-1 did not display a primary indicator for a stream at the time of the field assessment. The channels secondary indicators consisted mostly of weak geomorphology with a weakly pronounced bed and back found throughout the length of the feature. Other indicators of geomorphology consisted of weak amounts of sediment sorting along with weakly pronounced riffle-pool sequencing. Hydrology indicators were observed to be mostly absent to weak with no visible flow or pooling with the feature and 48 hours since a significant (i.e., greater than 0.1 inch) rain fall event. Weak amounts of wrack lining were located within the feature along with weak amounts of sediment on plants and debris within the channel. Biology indicators were mostly weak with the exception of moderate to strong amounts of fibrous roots and rooted plants located within the channel. The channel ultimately scored a 9 on the TDEC Hydrologic Determination Field Data Sheet (HDFD) and is considered a Stream.

Photograph 1: View of WWC-1 facing west-southwest and downstream in the northwestern portion of the Subject Property.
(35.227052, -84.997988)

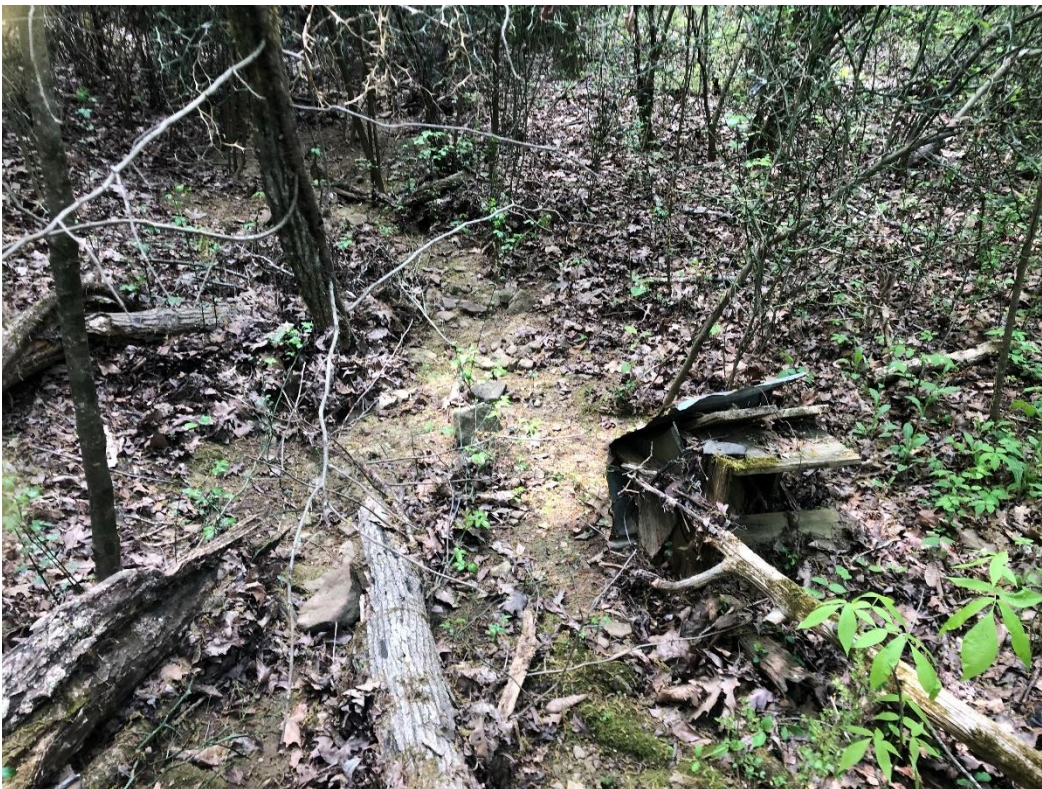
Photograph 2: View of WWC-1 facing west-southwest and downstream in the northwestern portion of the Subject Property.
(35.226995, -84.998263)

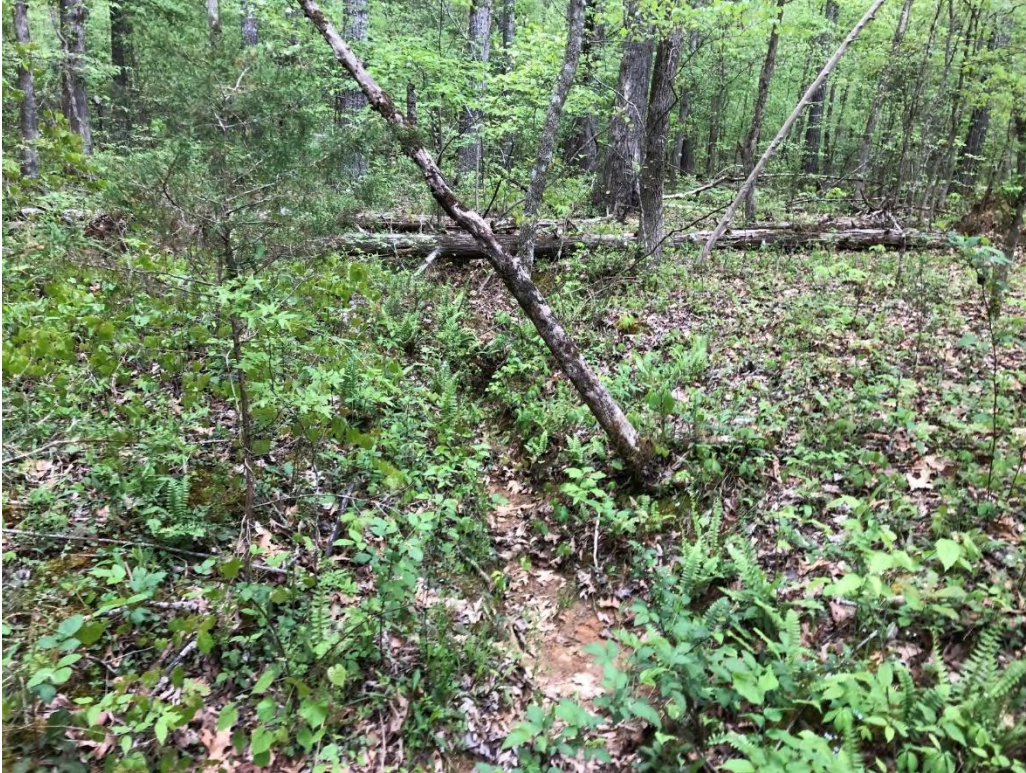
Wet Weather Conveyance-2 did not display a primary indicator for a stream at the time of the field assessment. The channels secondary indicators consisted mostly of weak to moderate geomorphology with a moderately pronounced bed and back found throughout the length of the feature. Other indicators of geomorphology consisted of weak to moderate sinuosity within the channel along with weakly pronounced riffle-pool sequencing. Hydrology indicators were observed to be mostly absent to weak with no visible flow or pooling with the feature and 48 hours since a significant (i.e., greater than 0.1 inch) rain fall event. Weak amounts of wrack lining were located within the feature along with weak amounts of sediment on plants and debris within the channel. Biology indicators were mostly weak with the exception of weak to moderate amounts of fibrous roots and rooted plants located within the channel. The channel ultimately

Photograph 3: View of WWC-2 facing west-southwest and downstream in the northeastern portion of the Subject Property.
(35224969, -84.995719)

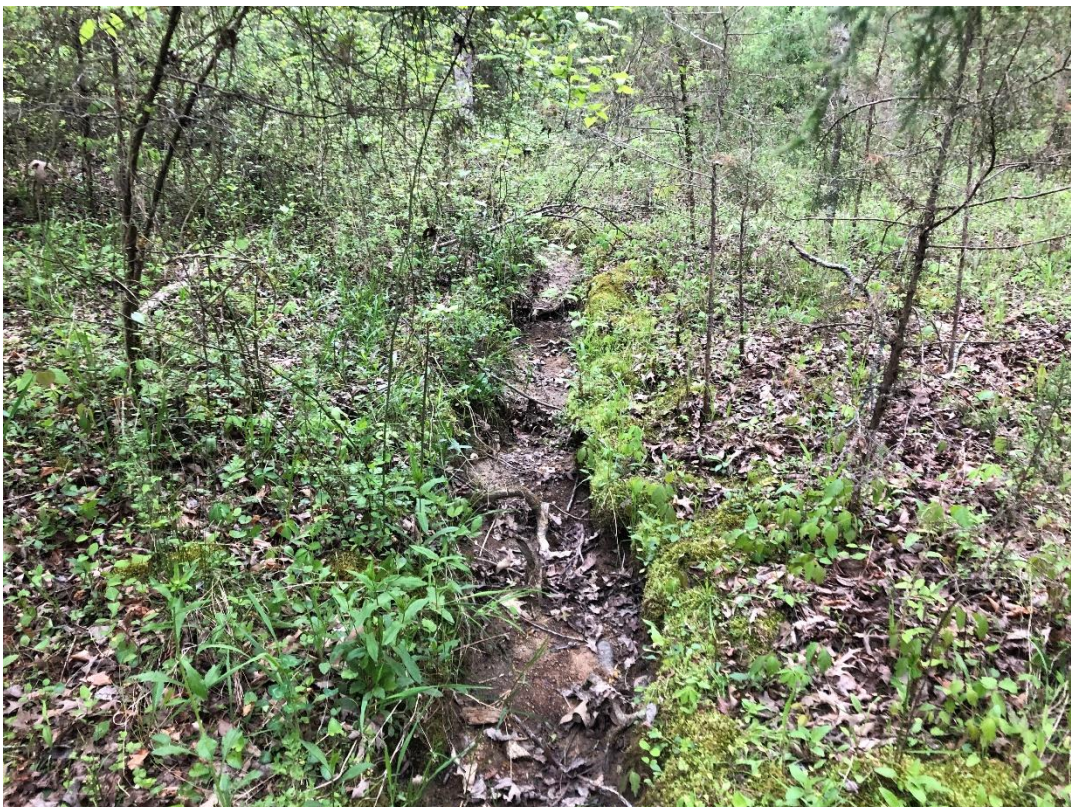
Photograph 4: View of WWC-1 facing northeast and upstream in the northeastern portion of the Subject Property.
(35.224669, -84.996750)

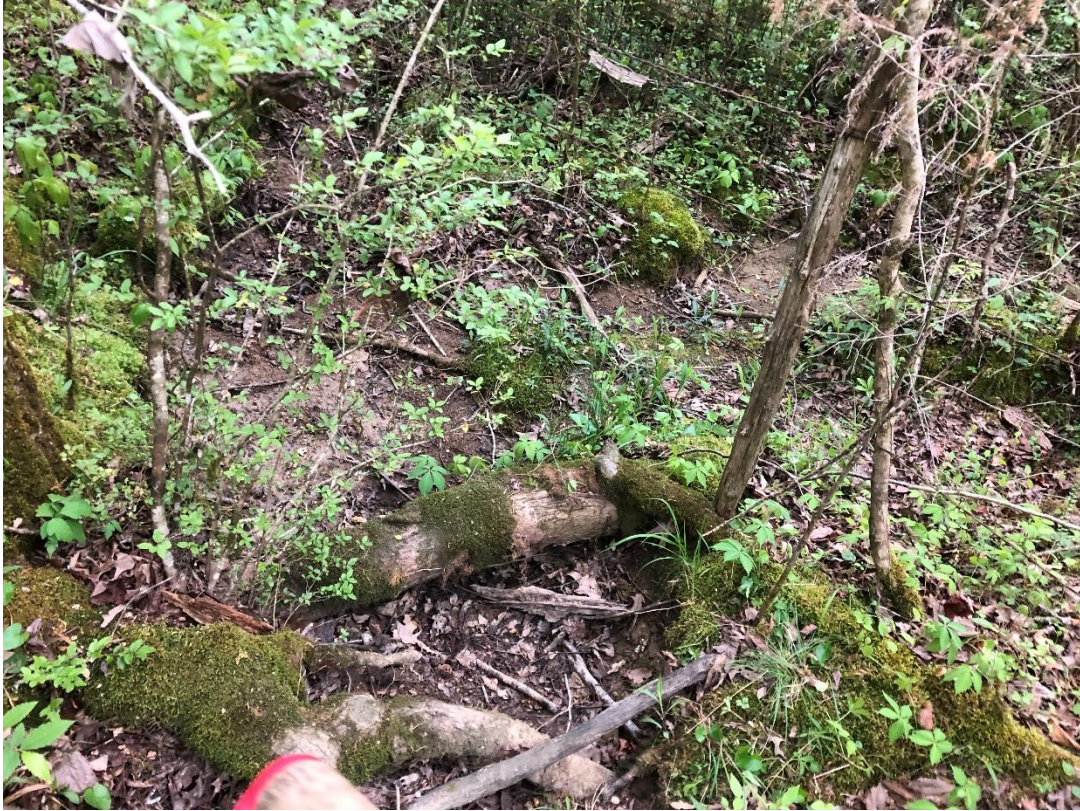
Wet Weather Conveyance-3 did not display a primary indicator for a stream at the time of the field assessment. The channels secondary indicators consisted mostly of weak geomorphology with a weakly pronounced bed and back found throughout the length of the feature. Other indicators of geomorphology consisted of weakly pronounced riffle-pool sequencing along with weak sorting of soil and sediment with the channel bed. Hydrology indicators were observed to be mostly absent to weak with no visible flow or pooling with the feature and 48 hours since a significant (i.e., greater than 0.1 inch) rain fall event. Weak amounts of wrack lining were located within the feature along with weak amounts of sediment on plants and debris within the channel. Biology indicators were mostly weak with the exception of weak to moderate amounts of fibrous roots and rooted plants located within the channel. The channel ultimately scored a 10.75 on the TDEC Hydrologic Determination Field Data Sheet (HDFD) and is considered a Stream.

Photograph 5: View of WWC-3 facing east and downstream in the northeastern portion of the Subject Property.
(35.224675, -84.996904)

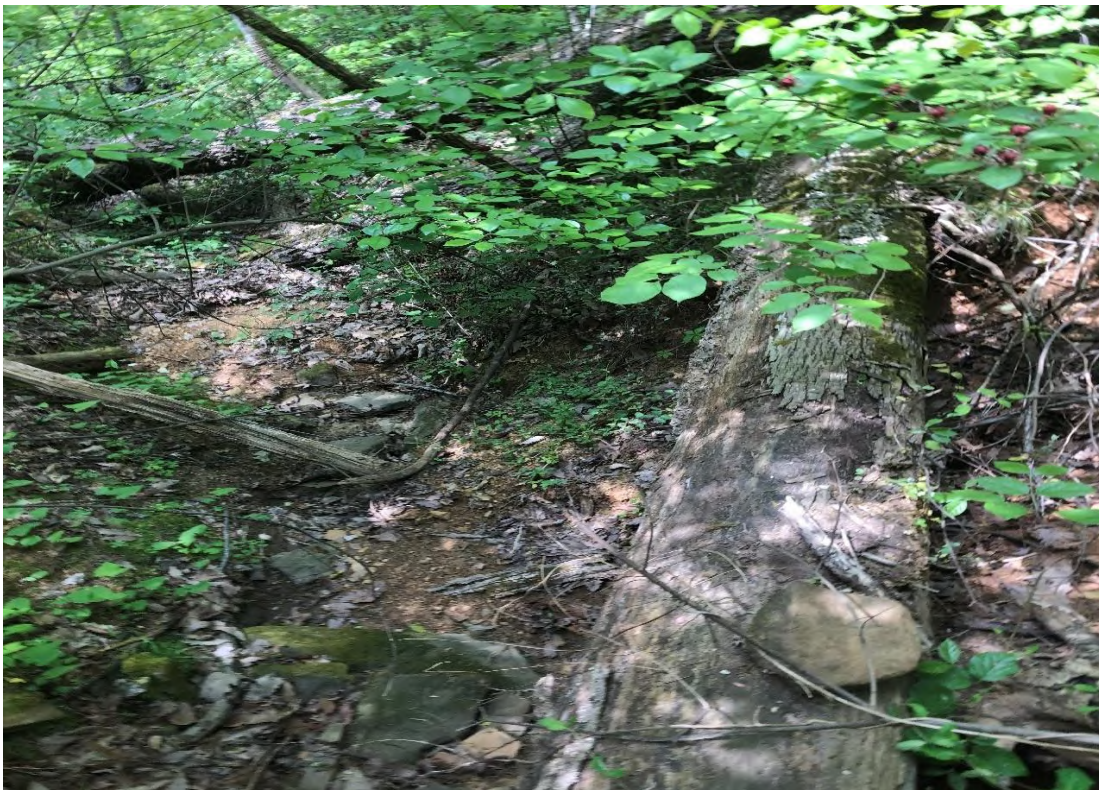
Wet Weather Conveyance-4 did not display a primary indicator for a stream at the time of the field assessment. The channels secondary indicators consisted mostly of weak to moderate geomorphology with a moderately pronounced bed and back found throughout the length of the feature. Other indicators of geomorphology consisted of weakly pronounced riffle-pool sequencing along with a strongly pronounced natural valley or drainageway along the channel margins. Hydrology indicators were observed to be mostly absent to weak with no visible flow or pooling with the feature and 48 hours since a significant (i.e., greater than 0.1 inch) rain fall event. Weak to moderate amounts of wrack lining were located within the feature along with weak amounts of sediment on plants and debris within the channel. Biology indicators were mostly weak with the exception of moderate amounts of fibrous roots located in the channel along with a weak to moderate amount of rooted plants additionally. The channel ultimately scored a 14.75 on the TDEC Hydrologic Determination Field Data Sheet (HDFD) and is considered a Stream.

Photograph 6: View of WWC-4 facing west-southwest and downstream in the eastern portion of the Subject Property.
(35.220194, -84.990964)

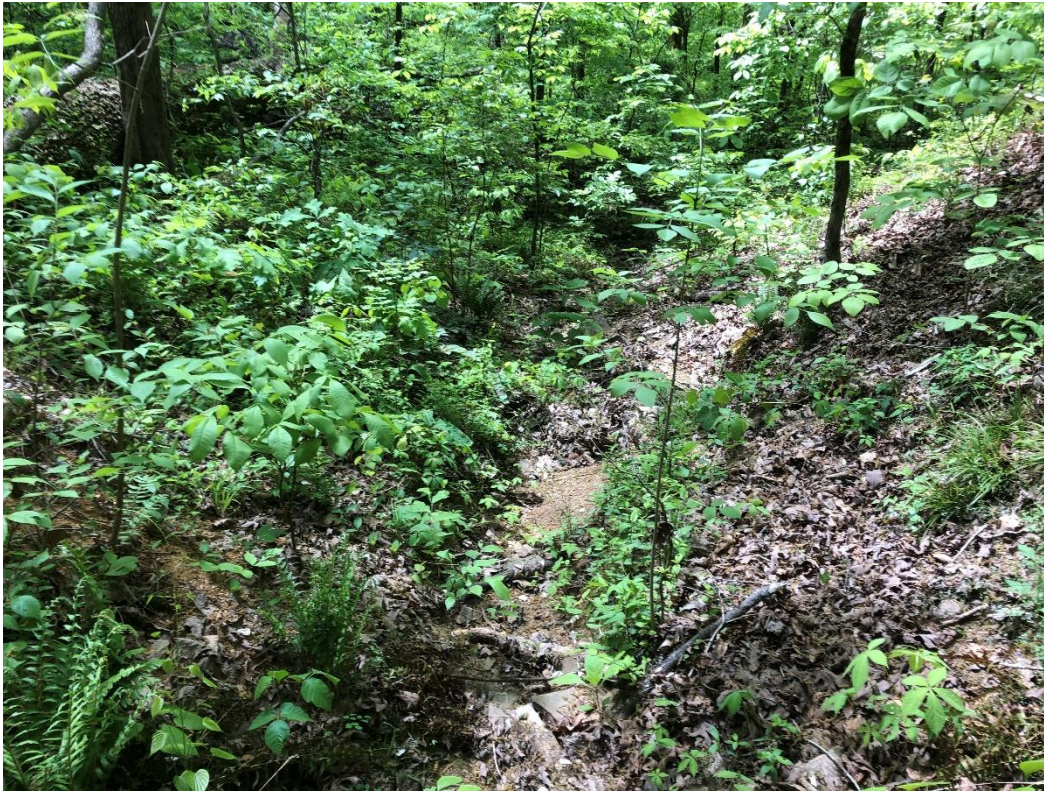
Photograph 7: View of WWC-4 facing west-southwest and downstream in the eastern portion of the Subject Property.
(35.220046, -84.991919)

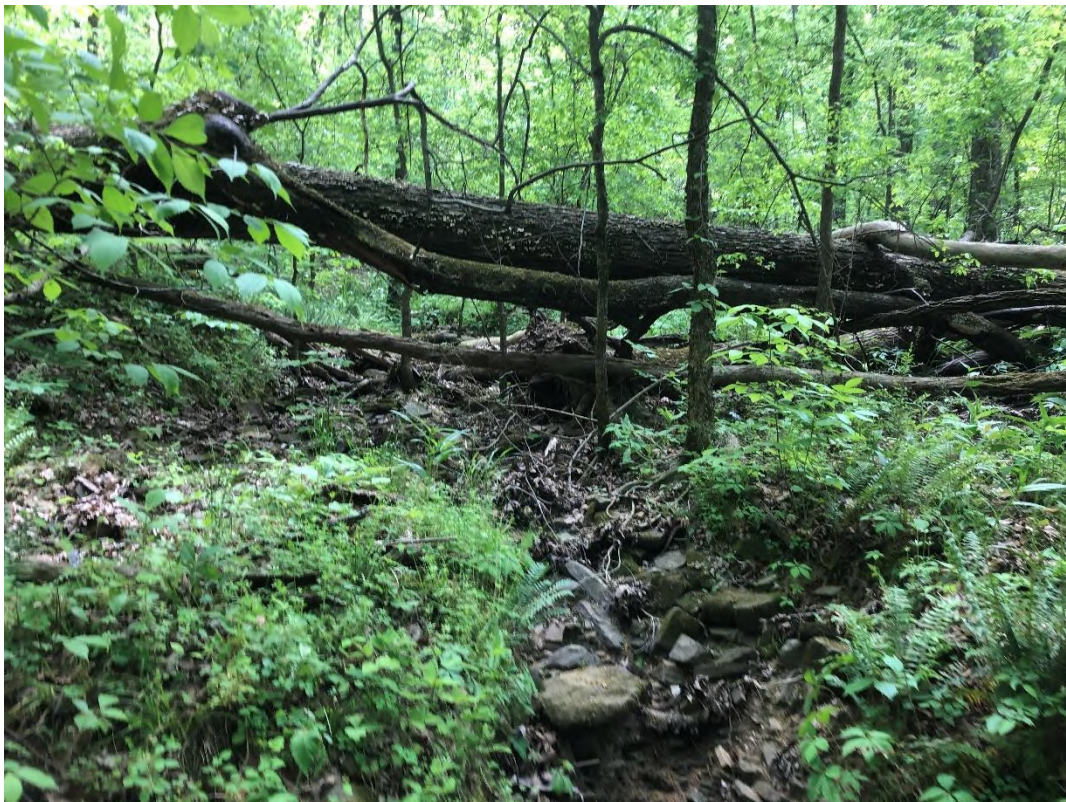
Photograph 8: View of WWC-4 facing east-northeast and upstream in the eastern portion of the Subject Property.
(35.220020, -84.991998)

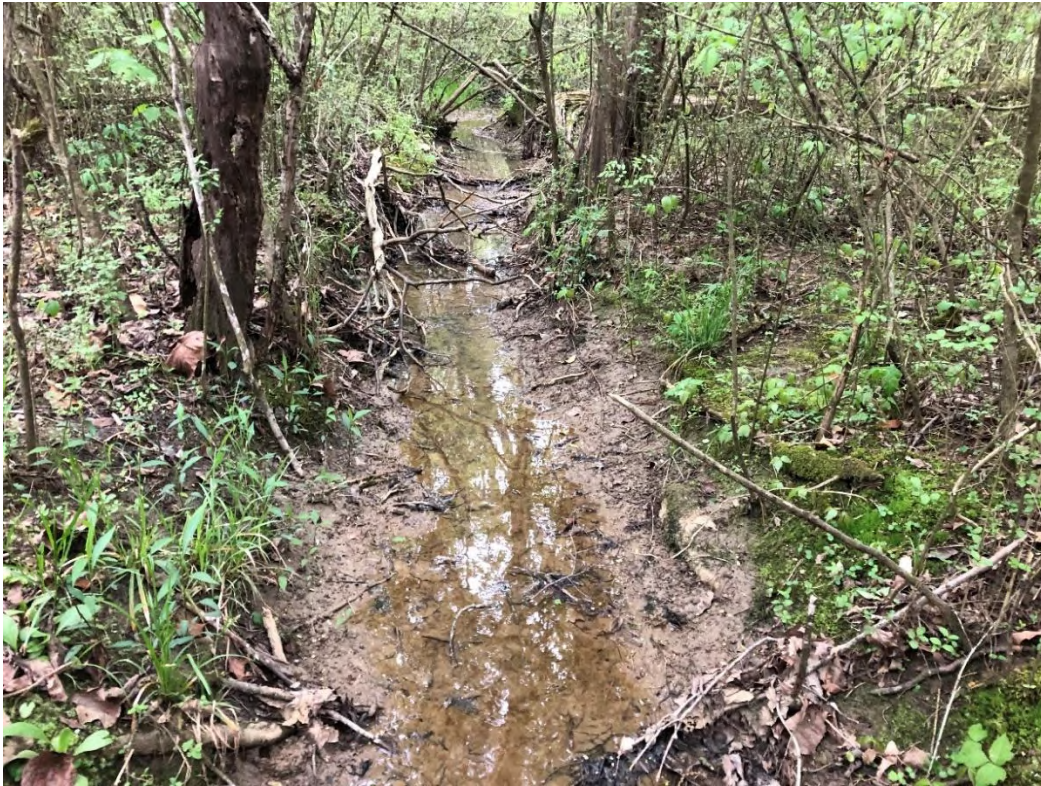
Stream-1 did not display any primary indicators for a stream at the time of the field assessment. The channels secondary indicators consisted mostly of moderate to strong geomorphology with a moderately to strongly pronounced bed and back found throughout the length of the feature. Other indicators of geomorphology consisted of moderately pronounced visible riffle-pool sequences and a moderate to strong natural valley or drainageway. Hydrology indicators were observed to be moderate to strong with visible flow found throughout the feature and 48 hours

Photograph 9: View of Stream-1 facing northeast and upstream in the southwestern portion of the Subject Property.
(35.223177, -84.998916)

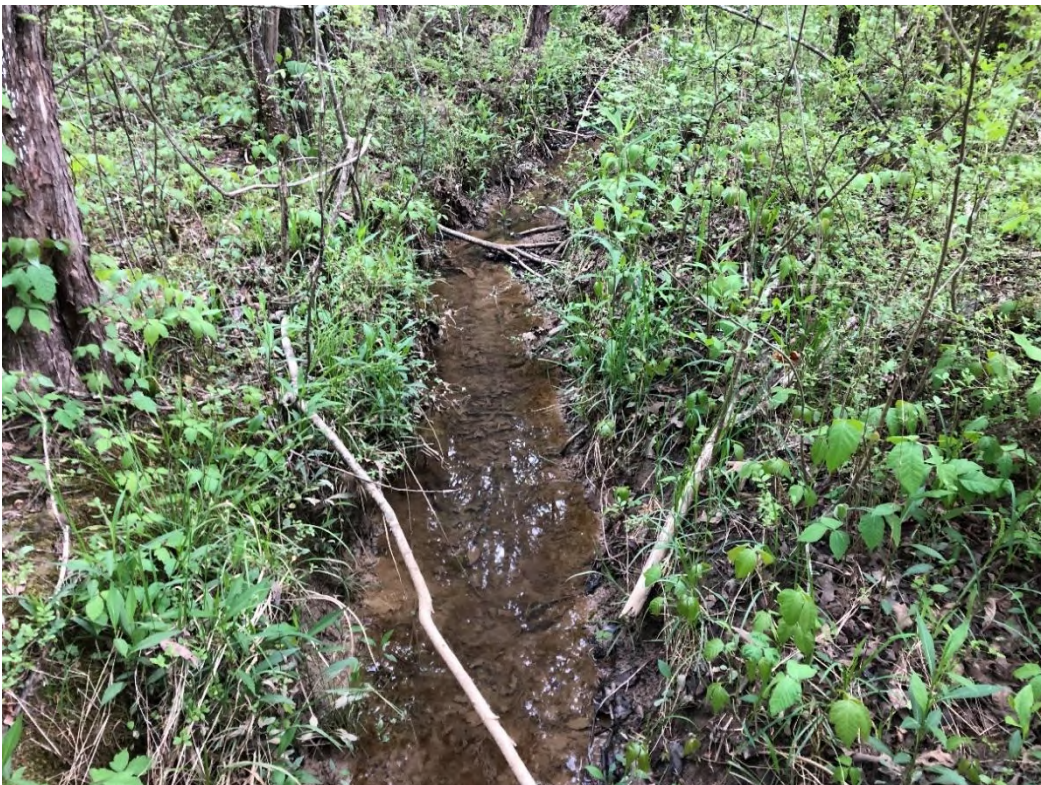
Photograph 10: View of Stream-1 facing north and upstream in the western portion of the Subject Property.
(35.223798, -84.998328)

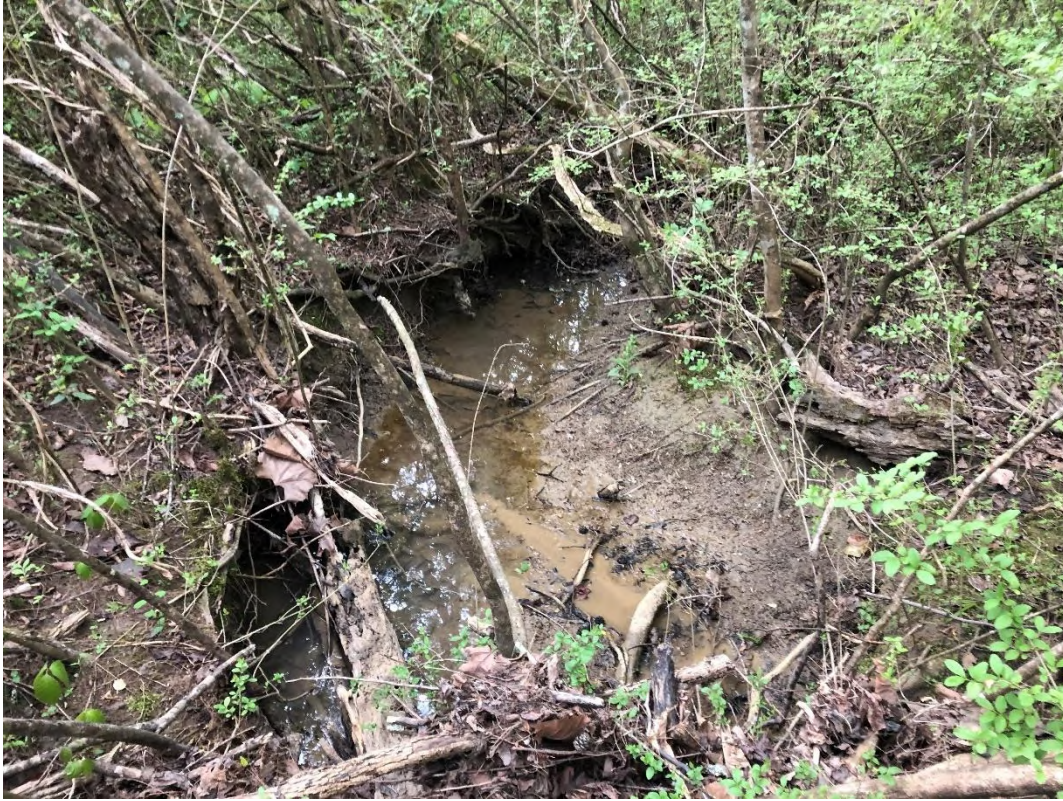
Photograph 11: View of Stream-1 facing north and upstream in the western portion of the Subject Property.
(35.224023, -84.998012)

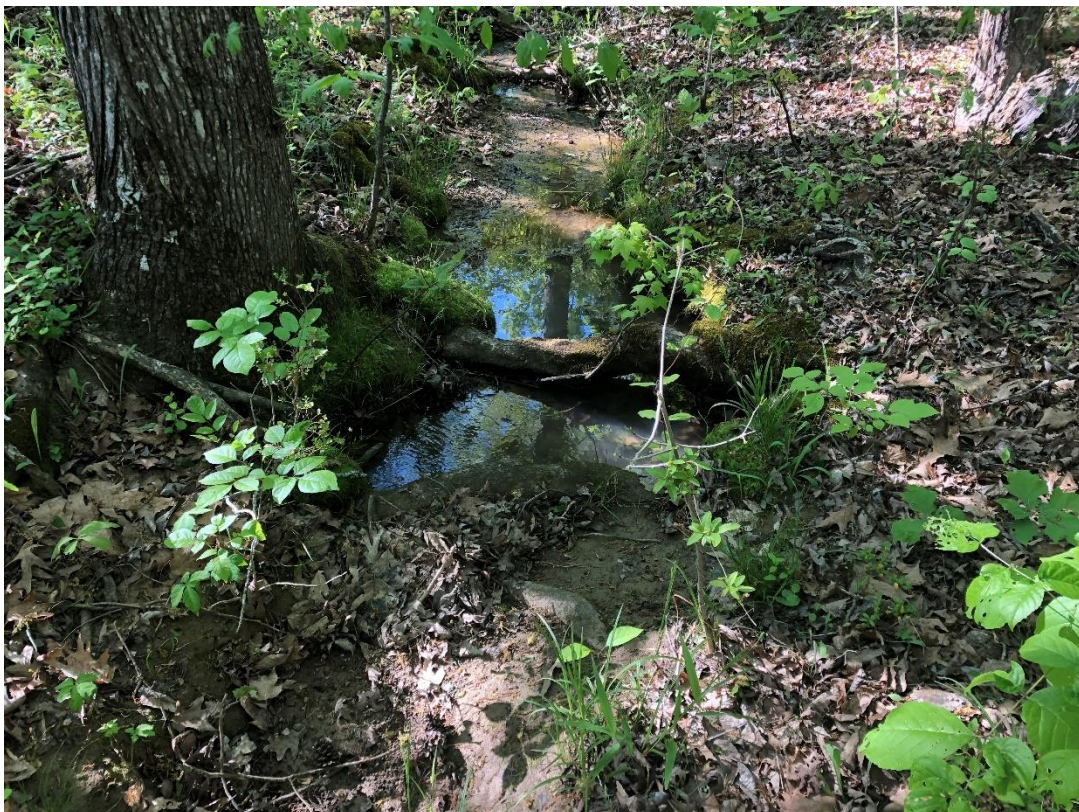
Stream-2 did display a primary indicator for a stream at the time of the field assessment with the presence of a naturally occurring groundwater table connection. The channels secondary indicators consisted mostly of moderate to strong geomorphology with a moderately to strongly pronounced bed and back found throughout the length of the feature. Other indicators of geomorphology consisted of moderately pronounced visible riffle-pool sequences and a moderate to strong natural valley or drainageway. Hydrology indicators were observed to be mostly moderate with visible flow within some sections of the feature and 48 hours since a significant (i.e., greater than 0.1 inch) rain fall event. Weak to moderate amounts of wrack lining were located within the feature along with moderate amounts of sediment on plants and debris within the channel. Biology indicators were mostly weak to moderate with a weak amounts filamentous algae and periphyton located within the feature along with a few species of caddis fly in the upper reaches of the channel. A weak to moderate amount wetland plants existed within the channel bed that consisted of Rush Grass (*Juncus effusus*). The channel ultimately scored a 29 on the TDEC Hydrologic Determination Field Data Sheet (HDFD) and is considered a Stream.

Photograph 12: View of Stream-2 facing west and downstream in the central portion of the Subject Property.
(35.220161, -84.994371)

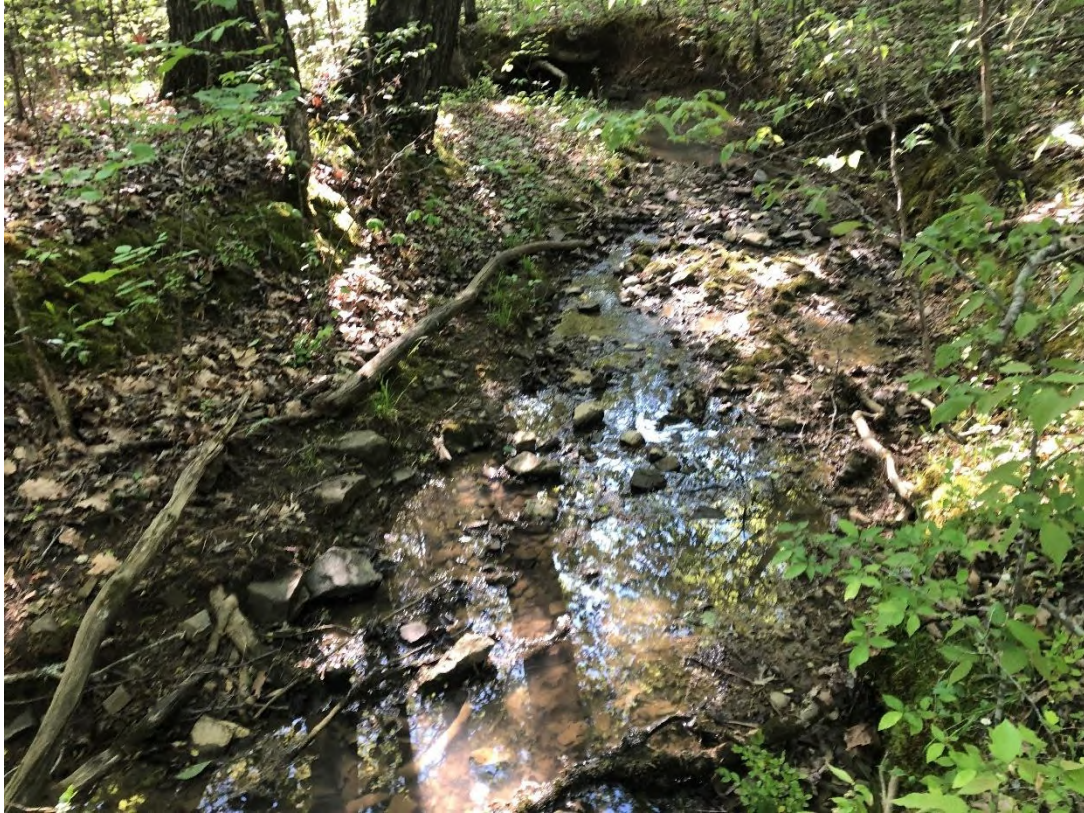
Photograph 13: View of Stream-2 facing west-northwest and downstream in the central portion of the Subject Property.
(35.222226, -84.994513)

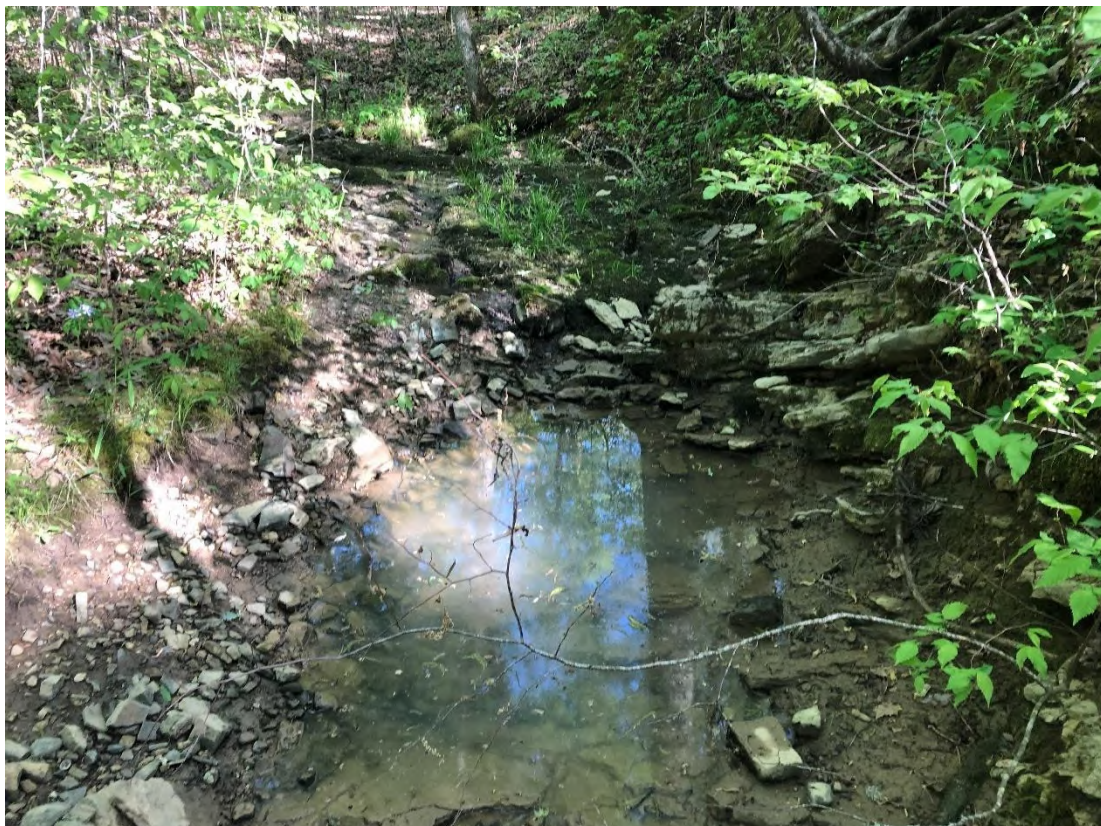
Photograph 14: View of Stream-2 facing west-northwest and downstream in the central portion of the Subject Property.
(35.222397, -84.995216)

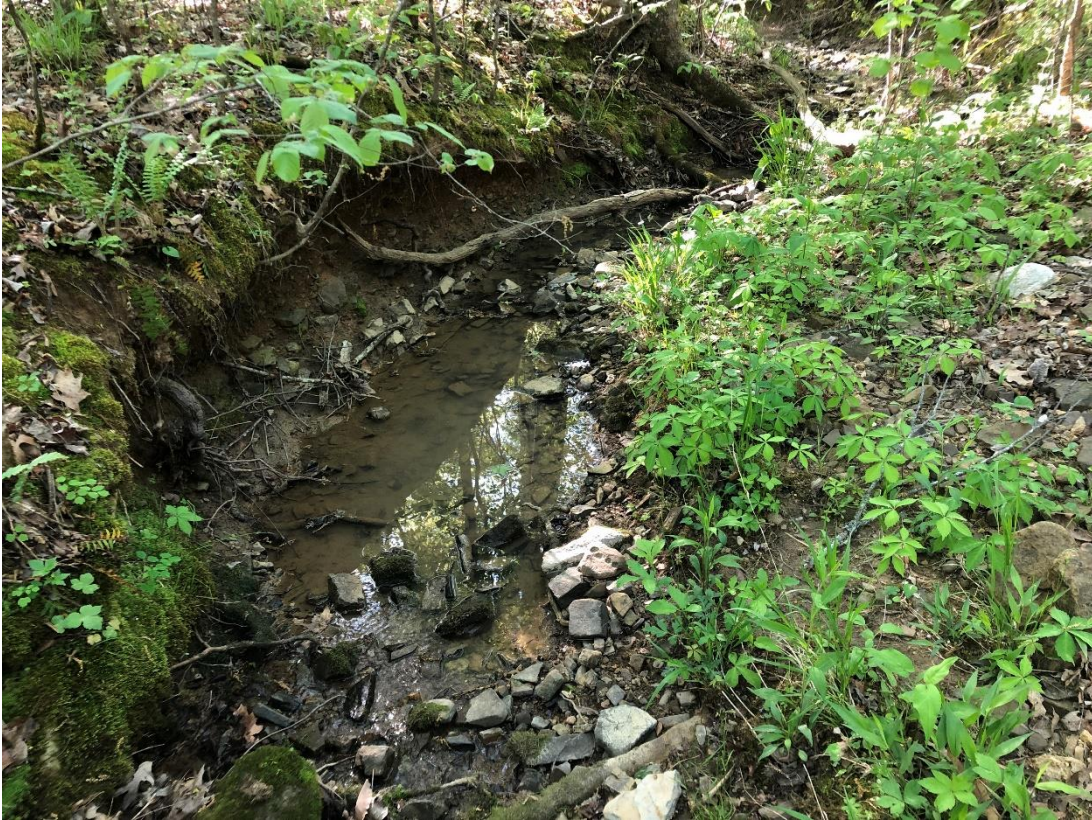
Stream-3 did not display a primary indicator for a stream at the time of the field assessment. The channels secondary indicators consisted mostly of moderate to strong geomorphology with a moderately to strongly pronounced bed and back found throughout the length of the feature. Other indicators of geomorphology consisted of weak to moderate amounts of depositional bar and benches along with a moderate to strong natural valley or drainageway. Hydrology indicators were observed to be mostly moderate with visible flow within some sections of the feature and 48 hours since a significant (i.e., greater than 0.1 inch) rain fall event. Weak to moderate amounts of wrack lining were located within the feature along with weak amounts of sediment on plants and debris within the channel. Biology indicators were mostly weak with a weak amounts visible iron oxidizing bacteria / fungus located within the channel along with a couple of caddis fly casings in the central portion of the channel. The channel ultimately scored a 24 on the TDEC Hydrologic Determination Field Data Sheet (HDFD) and is considered a Stream.

Photograph 15: View of Stream-3 facing northwest and upstream in the central portion of the Subject Property.
(35.222368, -84.994742)

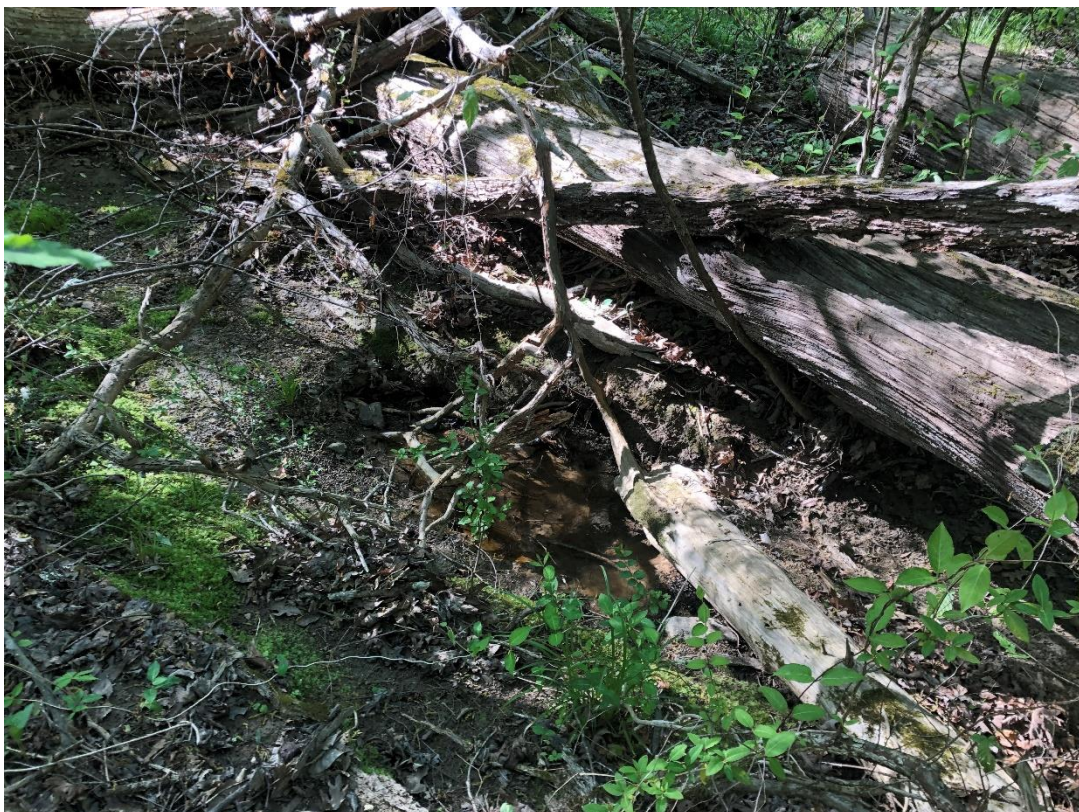
Photograph 16: View of Stream-3 facing west-southwest and downstream in the central portion of the Subject Property.
(35.222355, -84.994605)

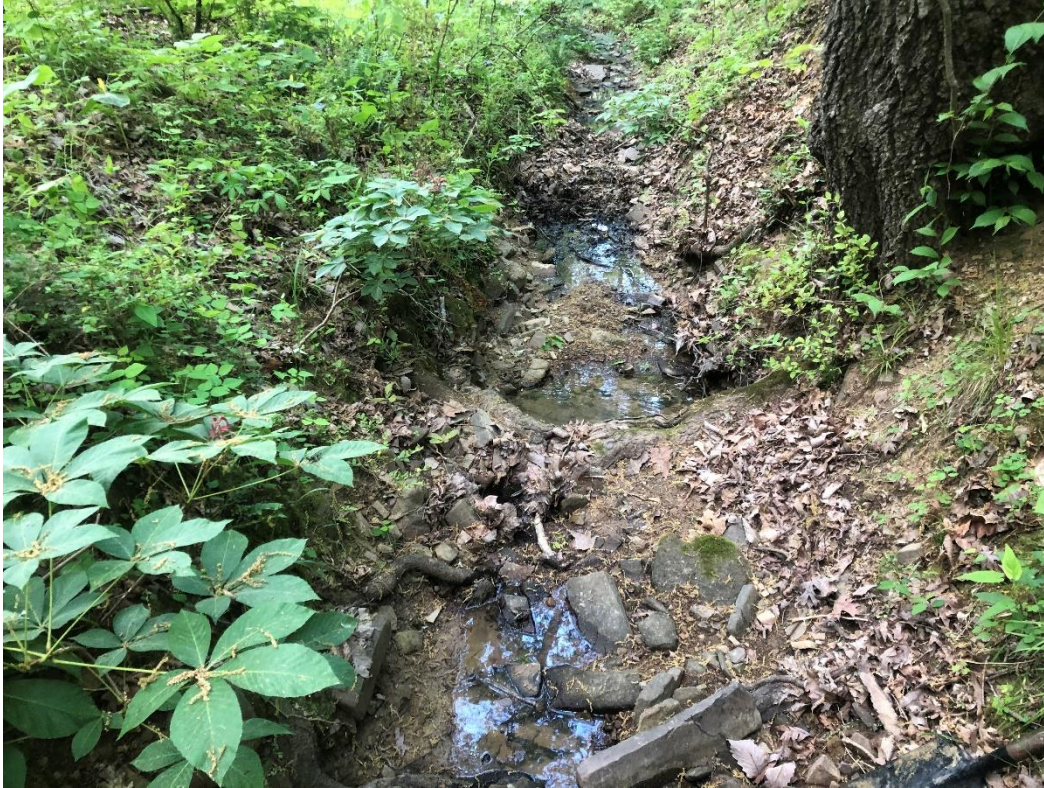
Stream-4 did display a primary indicator for a stream at the time of the field assessment with the presence of a naturally occurring groundwater table connection. The channels secondary indicators consisted mostly of moderate to strong geomorphology with a moderately to strongly pronounced bed and back found throughout the length of the feature. Other indicators of geomorphology consisted of moderately pronounced visible riffle-pool sequences and a strongly natural valley or drainageway. Hydrology indicators were observed to be mostly weak to moderate with visible flow within some sections of the feature and 48 hours since a significant (i.e., greater than 0.1 inch) rain fall event. Weak to moderate amounts of wrack lining were located within the feature along with moderate amounts of sediment on plants and debris within the channel. Biology indicators were mostly weak to moderate with weak amounts filamentous algae and periphyton located within the feature along with a few caddis fly casings in the upper reaches of the channel. A weak to moderate amount wetland plants existed within the channel bed that consisted of Stilt grass (*Microstegium vimineum*). The channel ultimately scored a 24 on the TDEC Hydrologic Determination Field Data Sheet (HDFD) and is considered a Stream.

Photograph 17: View of Stream-4 facing east and upstream in the eastern portion of the Subject Property.
(35.220062, -84.992210)

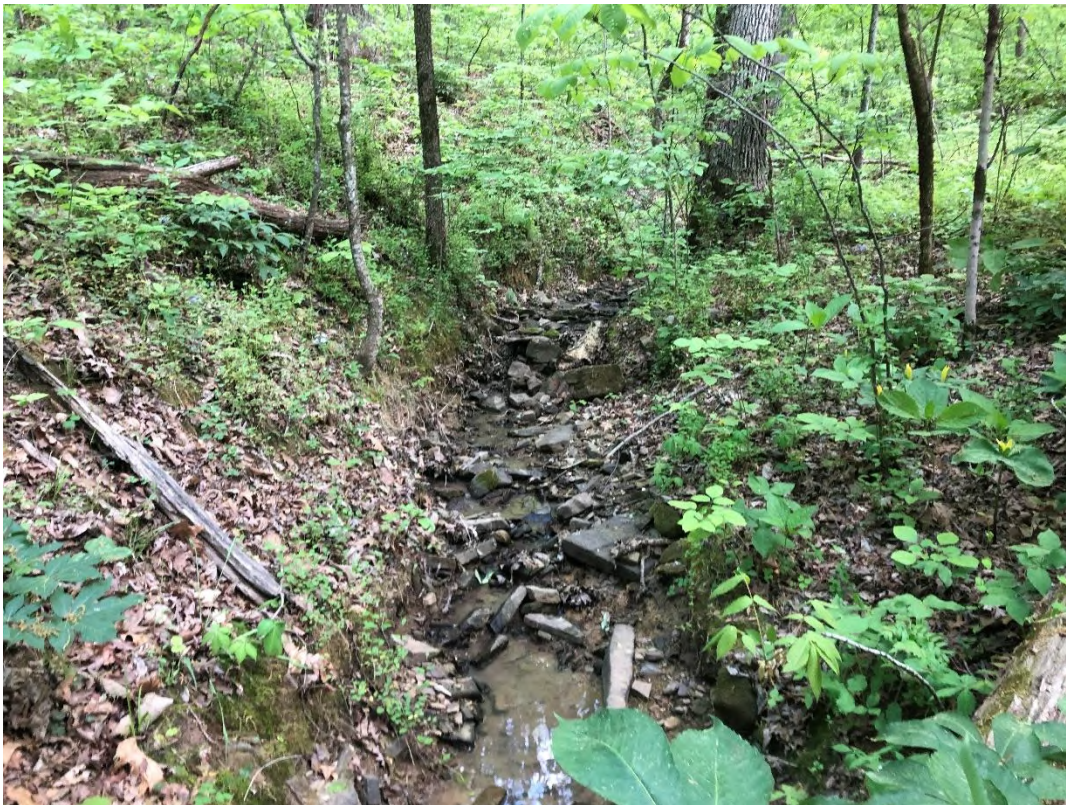
Photograph 18: View of Stream-4 facing east and upstream in the eastern portion of the Subject Property.
(35.219950, -84.992960)

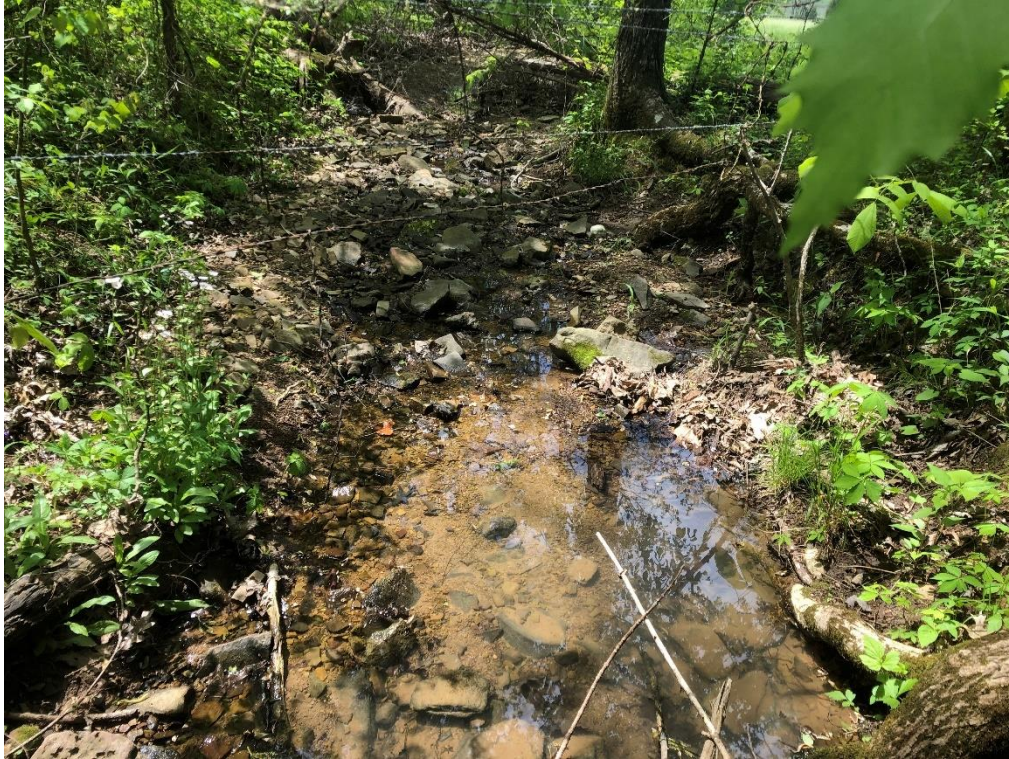
Photograph 19: View of Stream-4 facing west and downstream in the eastern portion of the Subject Property near the property boundary.
(35.219938, -84.993766)

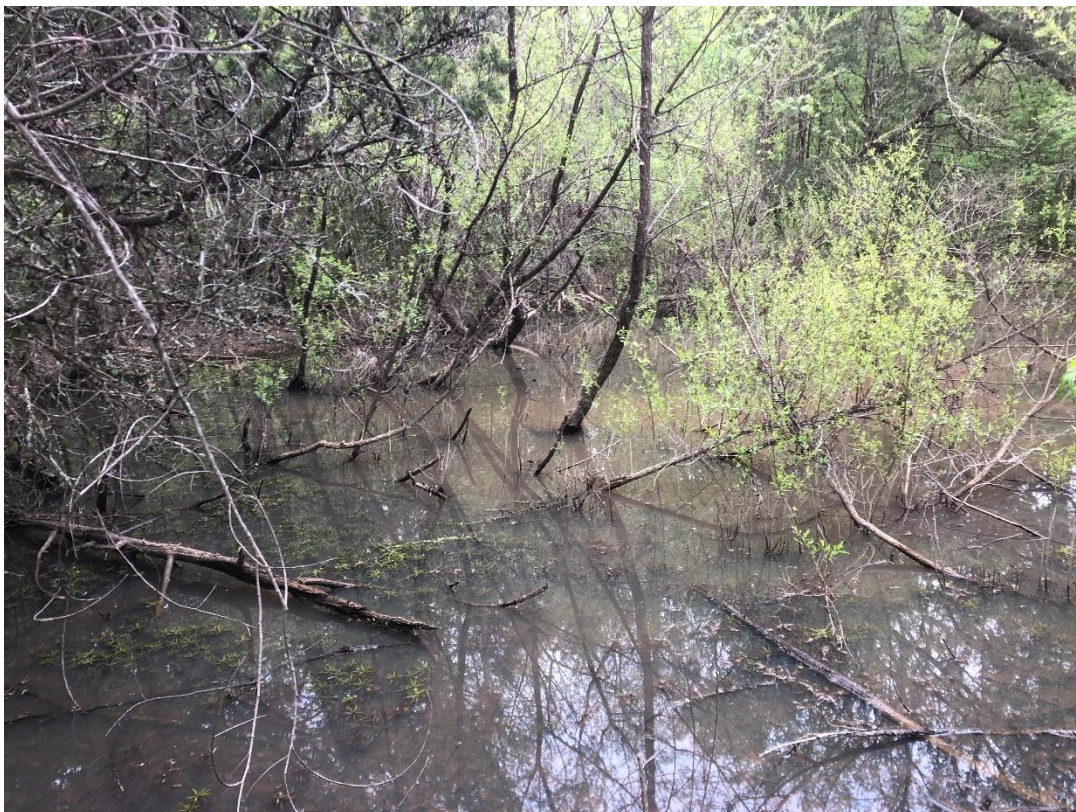
Pond-1 was located in the west-central portion of the Subject Property. This feature was assessed during the site reconnaissance and was found to meet the criteria of a freshwater pond. This feature was determined to meet the criteria of a freshwater pond per the Tennessee Department of Environment and Conservation (TDEC) guidance with a direct connection to downstream surface waters.

Photograph 20: View of Pond-1 facing north in the west-central portion of the Subject Property.
(35.224620, -84.997083)
