HYRDOLOGICAL ASSESSMENT REPORT

**10444 OOLTEWAH GEORGETWON ROAD
PARCEL # 070 036
OOLTEWAH, TENNESSEE**

Project No. 34-214107

June 18, 2021

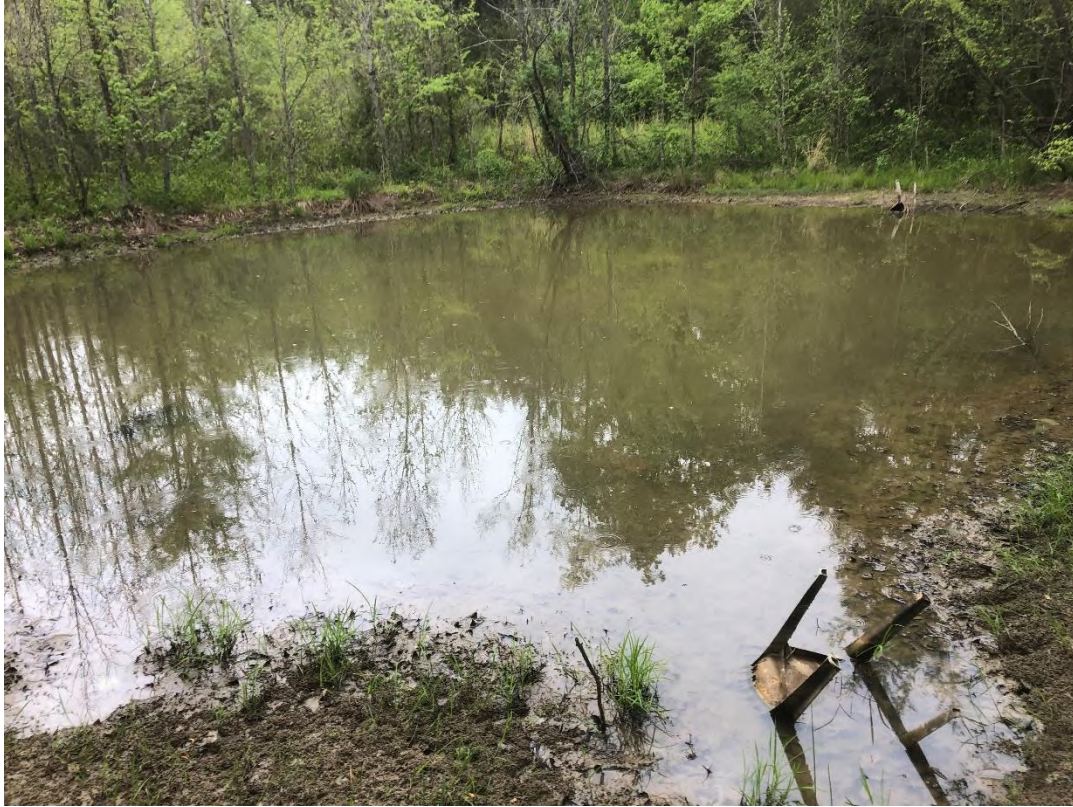
Pond-2 was located in the west-central portion of the Subject Property. This feature was assessed during the site reconnaissance and was found to meet the criteria of a freshwater pond. This feature was determined to meet the criteria of a freshwater pond per the Tennessee Department of Environment and Conservation (TDEC) guidance with a surface connection to downstream surface waters.

Photograph 21: View of Pond-2 facing west in the west-central portion of the Subject Property.
(35.224332, -84.997222)

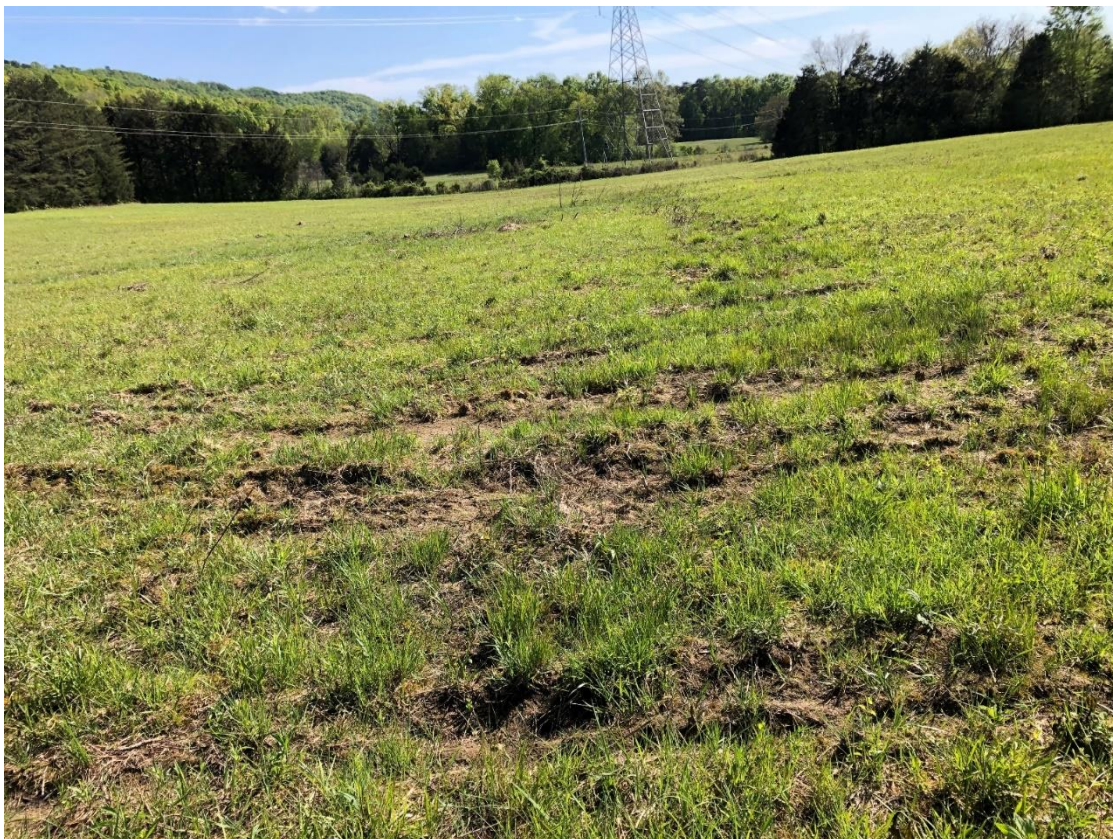
Wetland-1 was located in the east-central portion of the portion of the Subject Property. Data points were taken to define the boundary of Wetland-1. Wetland-1 included species of American Elm (*Ulmus americana*), Common Rush (*Juncus effusus*), and Sweet Gum (*Liquidambar styraciflua*) Hydrology, hydrophytic vegetation, and hydric soil indicators were observed in this area. Wetland-1 consisted of plant species with a Facultative and Facultative Wet Wetland Indicator status. Visual hydrology indicators consisted of algal matting and crusting, saturation within the soil profile, and drift deposits. The soil from the data points taken met the criteria for the F3 Depleted Matrix indicator needed to confirm hydric soil conditions along with the

Photograph 22: View of Wetland-1 facing south in the central portion of the Subject Property.
(35.221737, -84.995186)

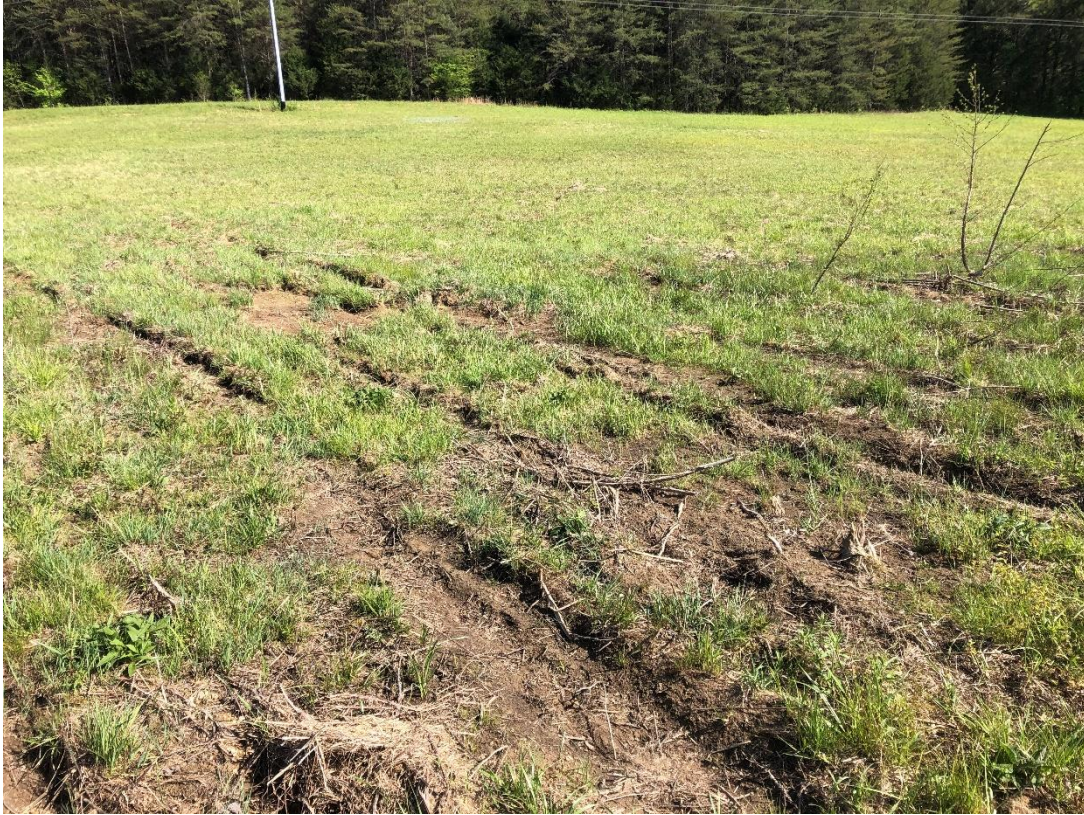
Photograph 23: View of Wetland-1 facing east in the central portion of the Subject Property.
(35.221492, -84.995337)

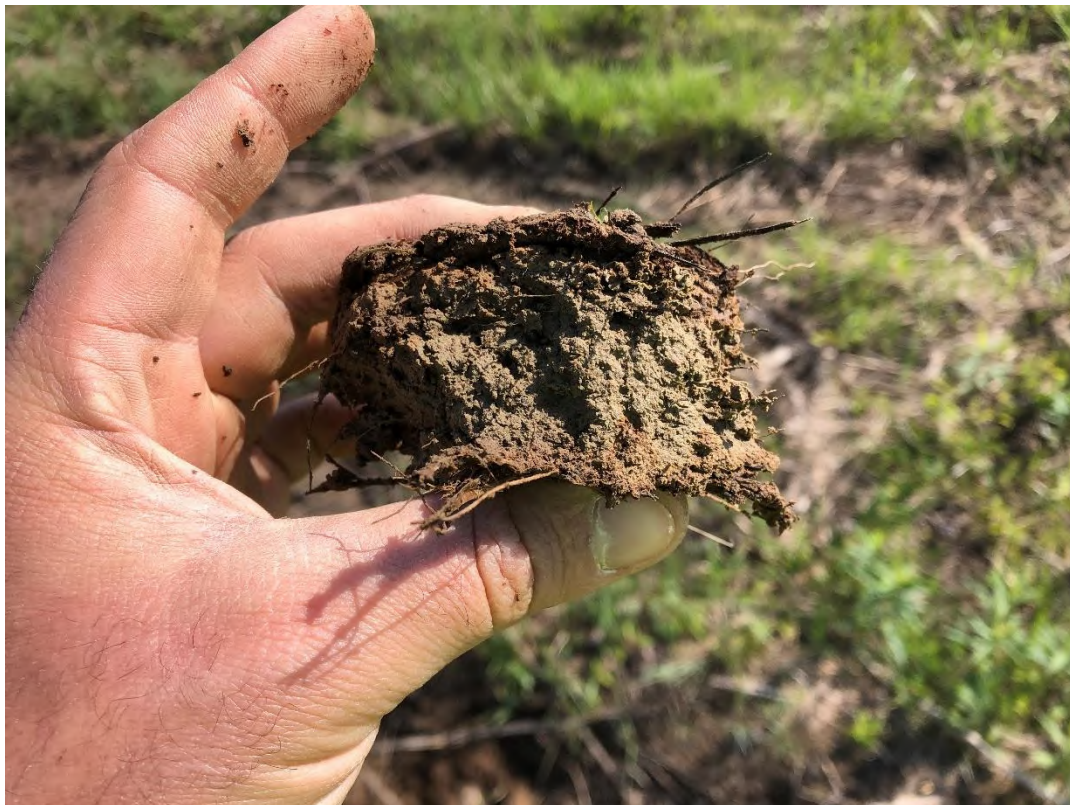
Photograph 24: View of soil located within Wetland-1.
(Data Point-3)

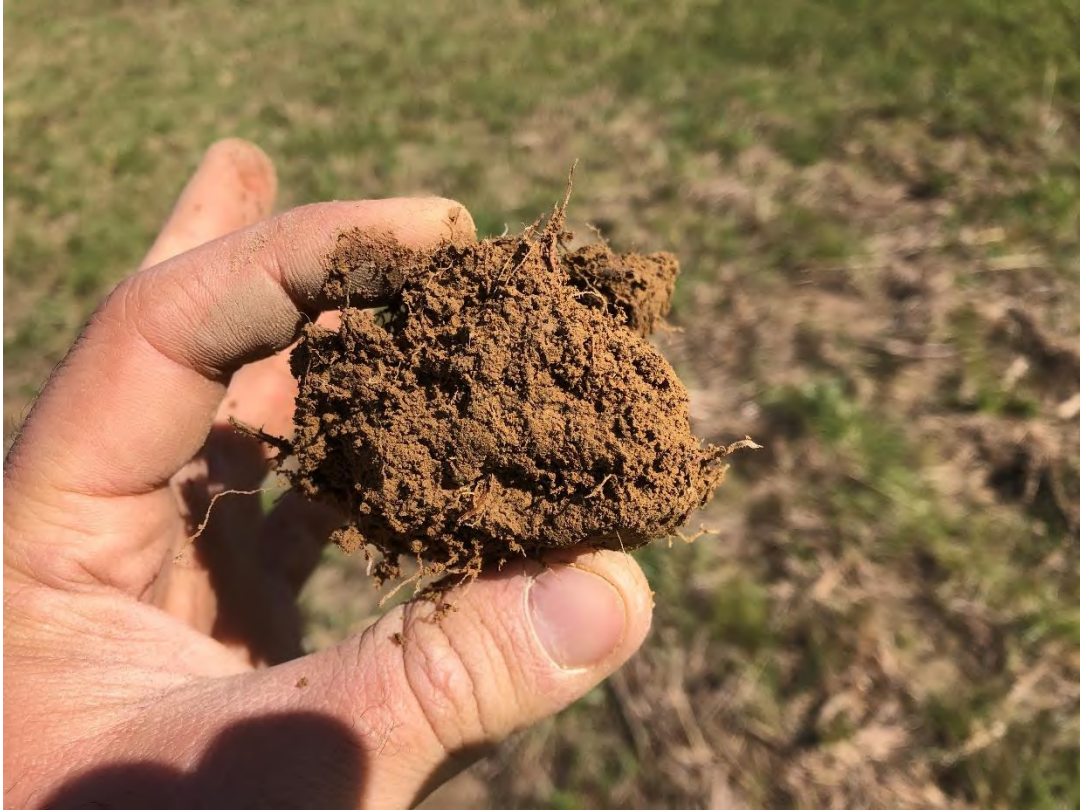
Photograph 25: View of soil located outside of Wetland-1.
(Data Point-2)

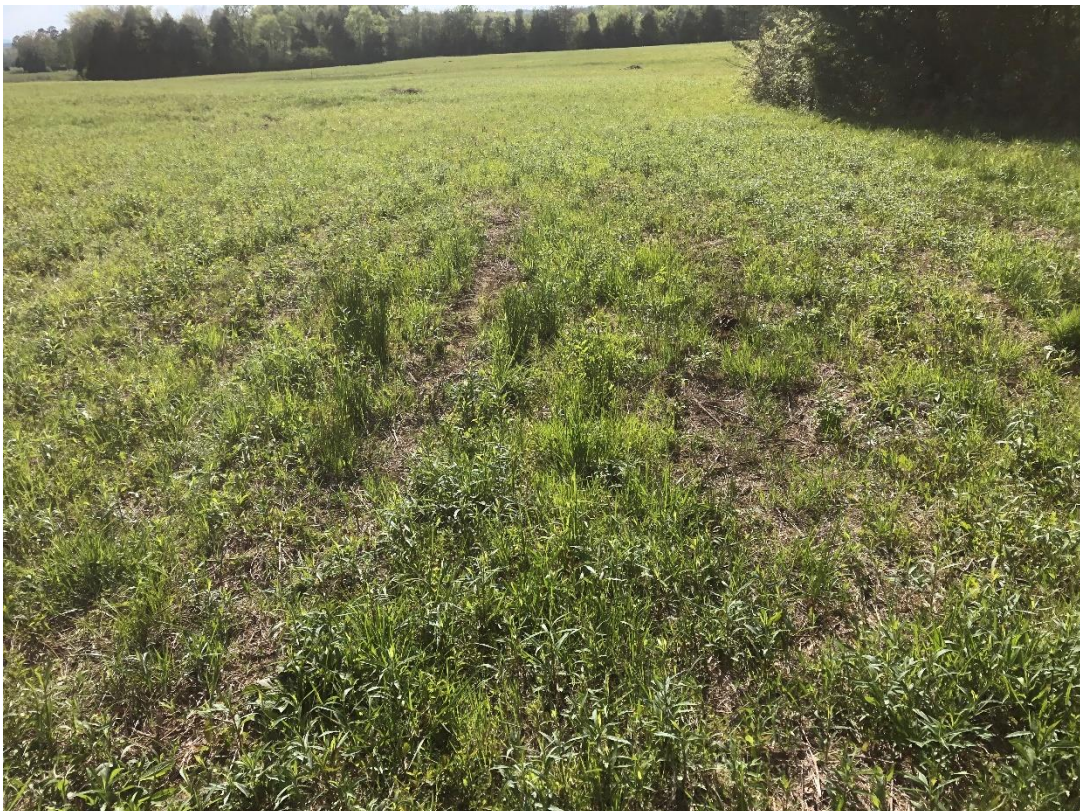
Wetland-2 was located in the east-central portion of the portion of the Subject Property. Data points were taken to define the boundary of Wetland-2. Wetland-2 included species of American Elm (*Ulmus americana*), Sweet Gum (*Liquidambar styraciflua*), and Common Rush (*Juncus effusus*). Hydrology, hydrophytic vegetation, and hydric soil indicators were observed in this area. Wetland-2 consisted of plant species with a Facultative and Facultative Wet Wetland Indicator status. Visual hydrology indicators consisted of saturation within the soil profile along with drift deposits, and oxidized rhizospheres on living roots. The soil from the data points taken met the criteria for the F3 Depleted Matrix indicator needed to confirm hydric soil conditions along with the necessary redox concentrations needed for hydric soils.

Photograph 26: View of Wetland-2 facing west in the central portion of the Subject Property.
(35.221891, -84.994071)

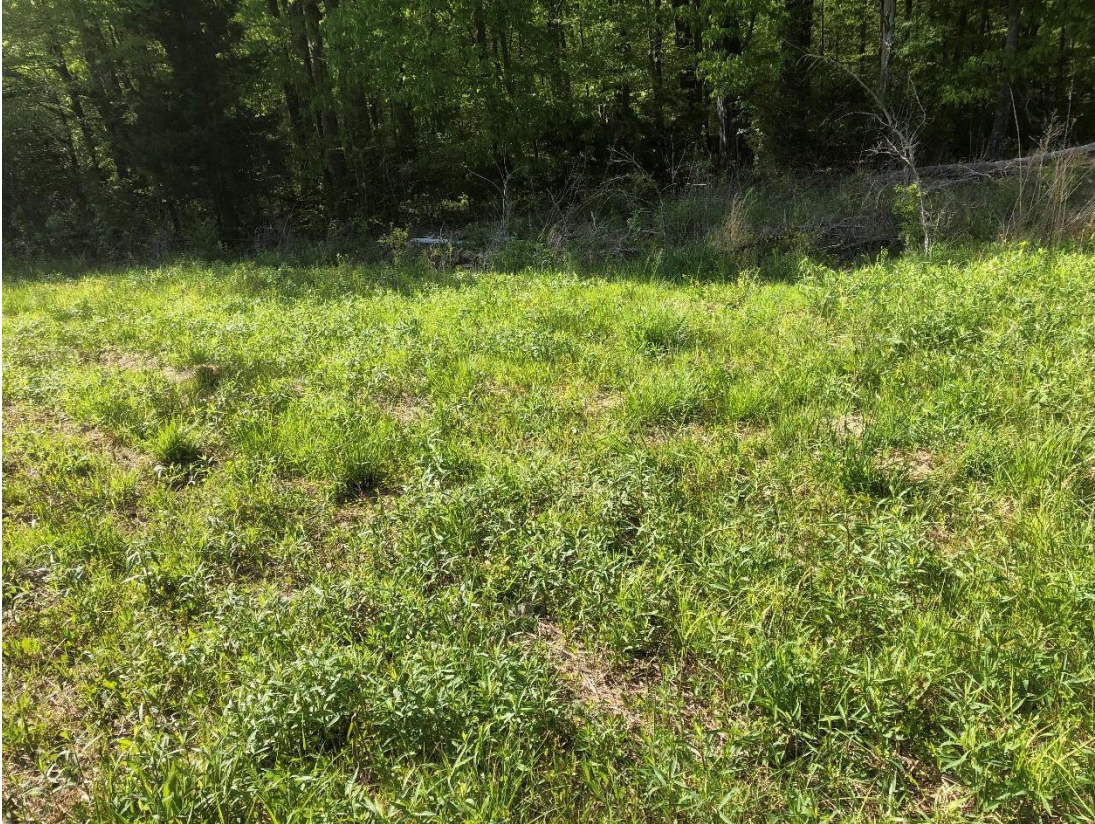
Photograph 27: View of Wetland-2 facing west-northwest in the central portion of the Subject Property.
(35.221898, -84.994084)

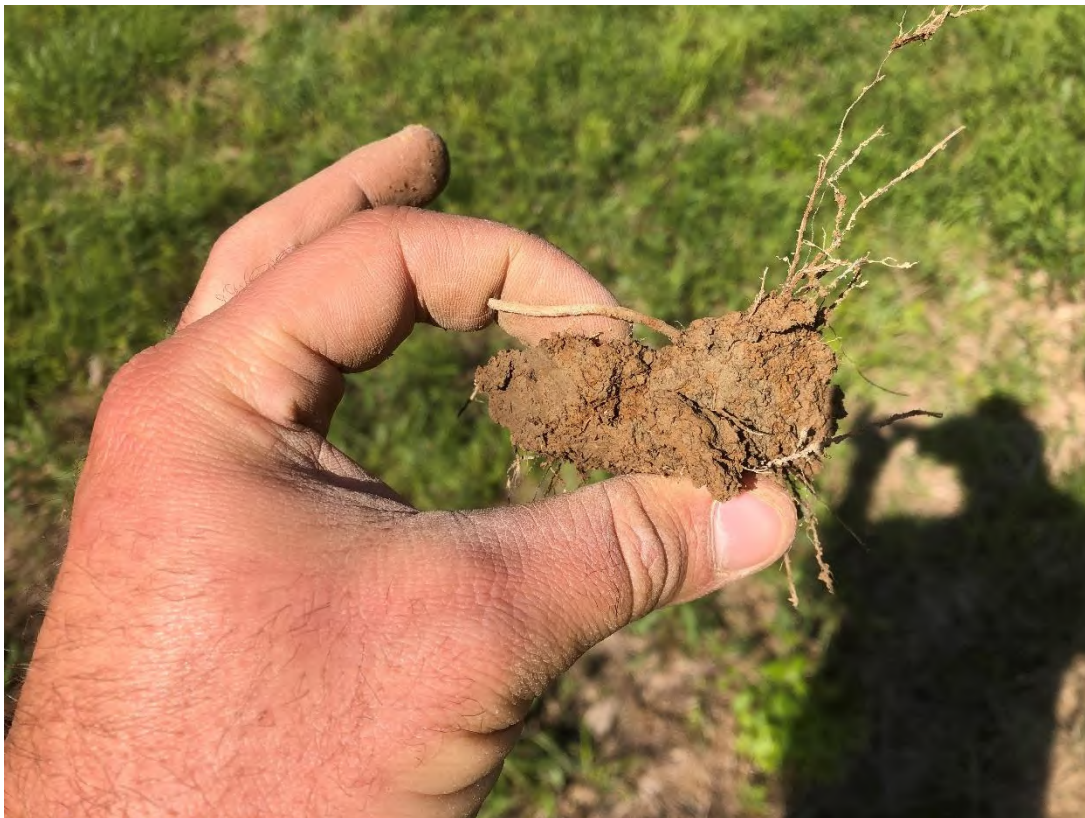
Photograph 28: View of soil located within Wetland-2.
(Data Point-8)

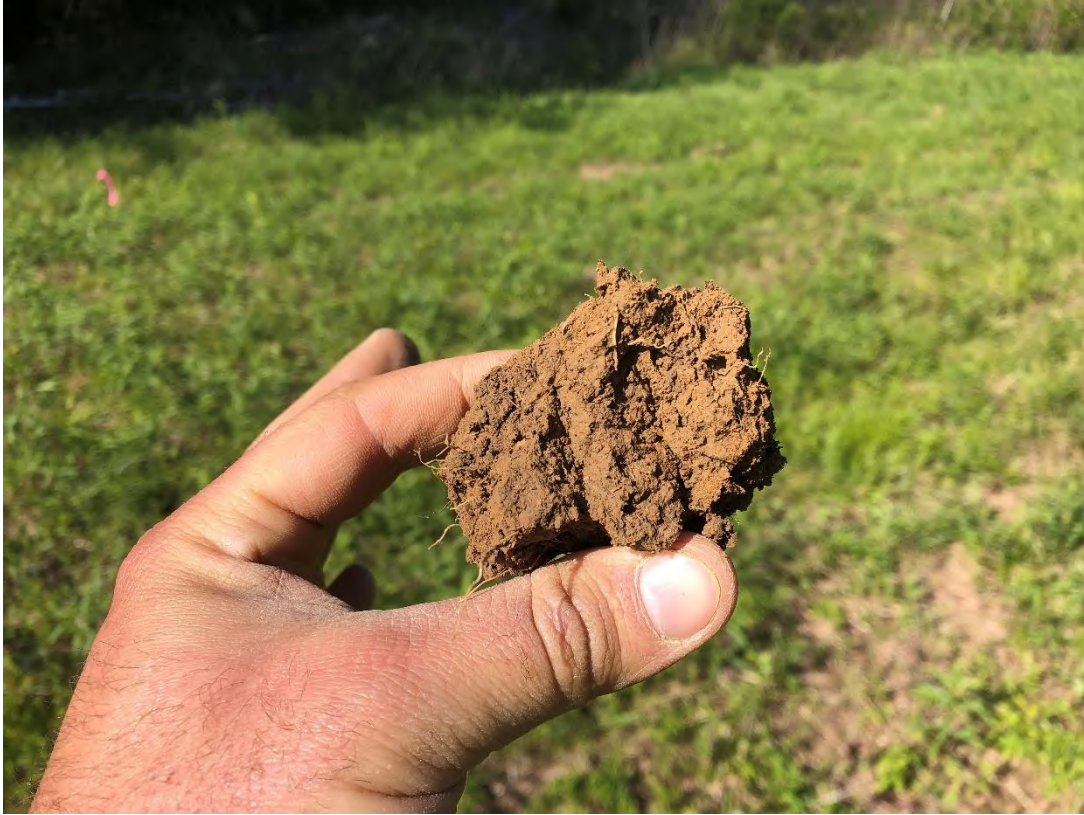
Photograph 29: View of soil located outside of Wetland-2.
(Data Point-9)

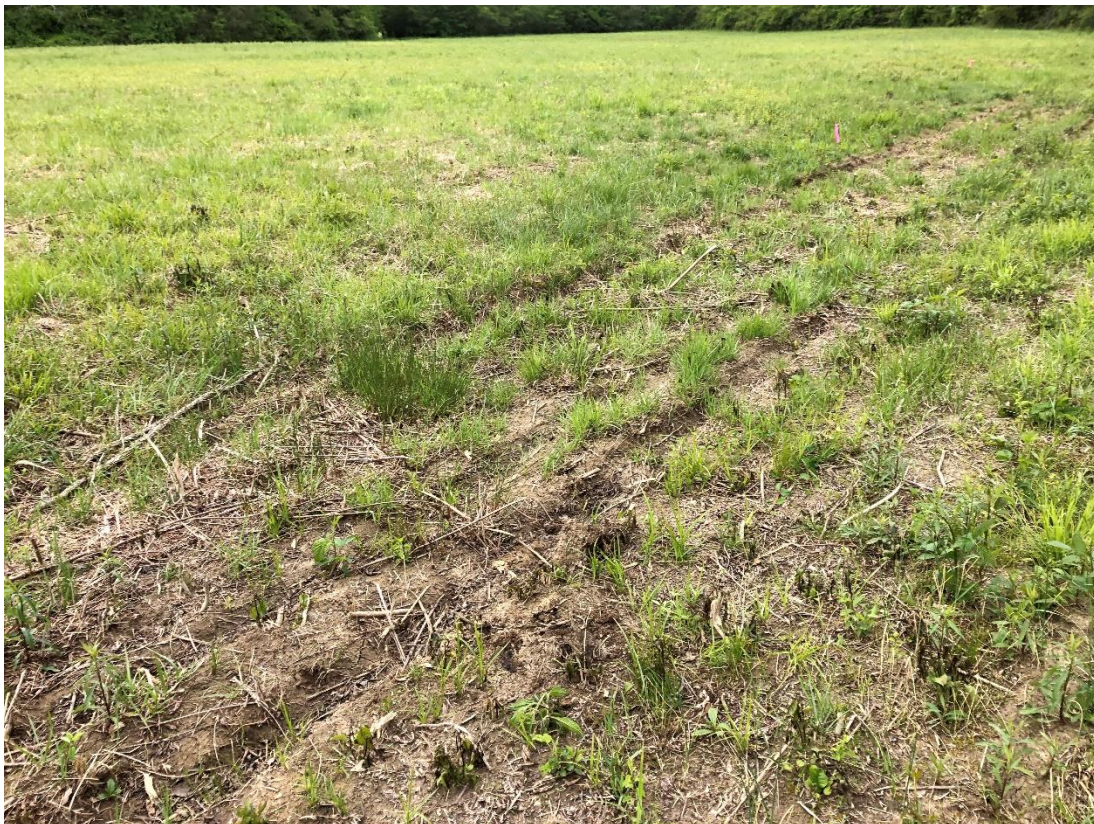
Wetland-3 was located in the western portion of the portion of the Subject Property. Data points were taken to define the boundary of Wetland-3. Wetland-3 included species of Common Rush (*Juncus effusus*) and American Elm (*Ulmus americana*). Hydrology, hydrophytic vegetation, and hydric soil indicators were observed in this area. Wetland-3 consisted of plant species with a Facultative and Facultative Wet Wetland Indicator status. Visual hydrology indicators consisted of saturation within the soil profile along with drift deposits, algal matting/ crusting, and oxidized rhizospheres on living roots. The soil from the data points taken met the criteria for the F3 Depleted Matrix indicator needed to confirm hydric soil conditions along with the necessary redox concentrations needed for hydric soils.

Photograph 30: View of Wetland-3 facing south in the west-central portion of the Subject Property.
(35.223957, -84.997561)

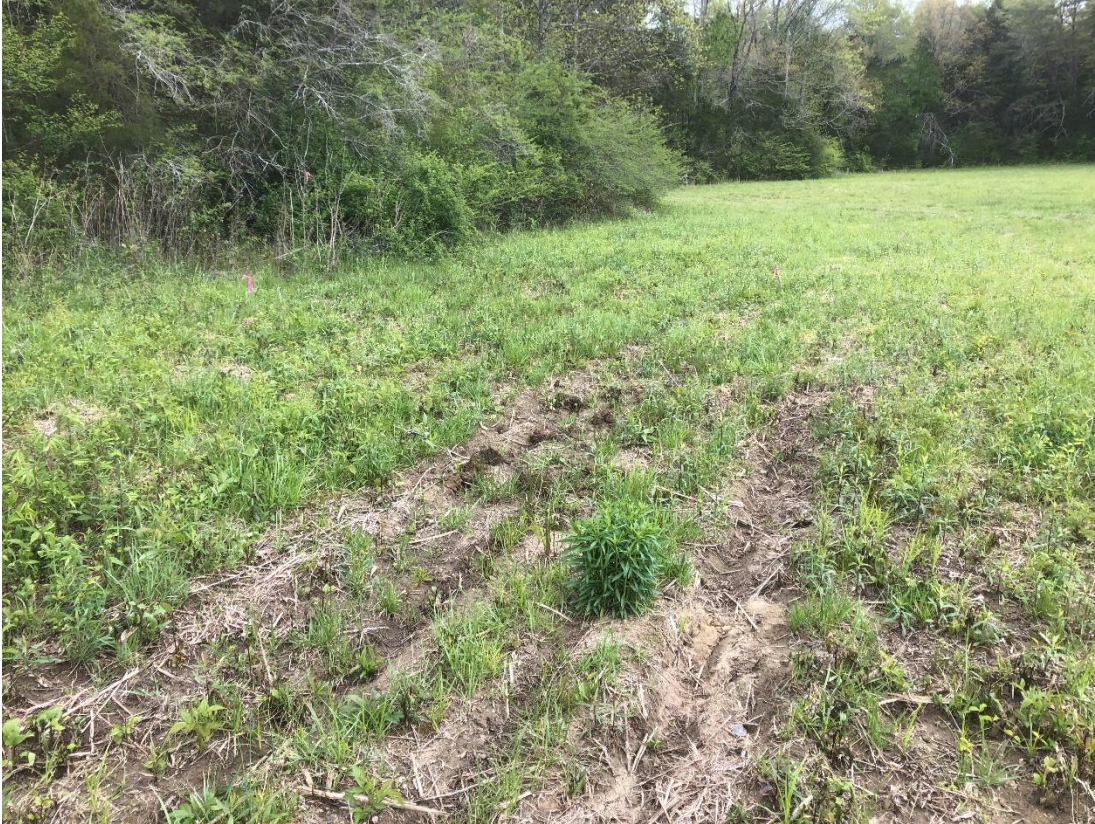
Photograph 31: View of Wetland-3 facing east in the west-central portion of the Subject Property.
(35.224003, -84.997447)

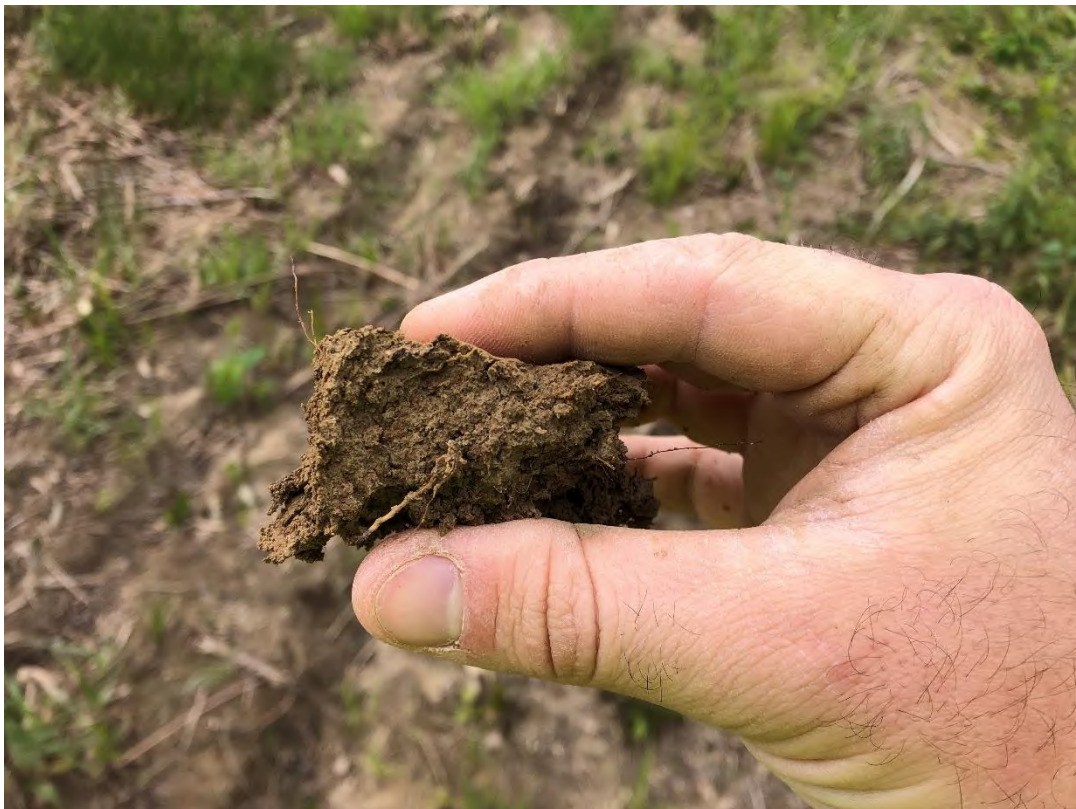
Photograph 32: View of soil located within Wetland-3.
(Data Point-12)

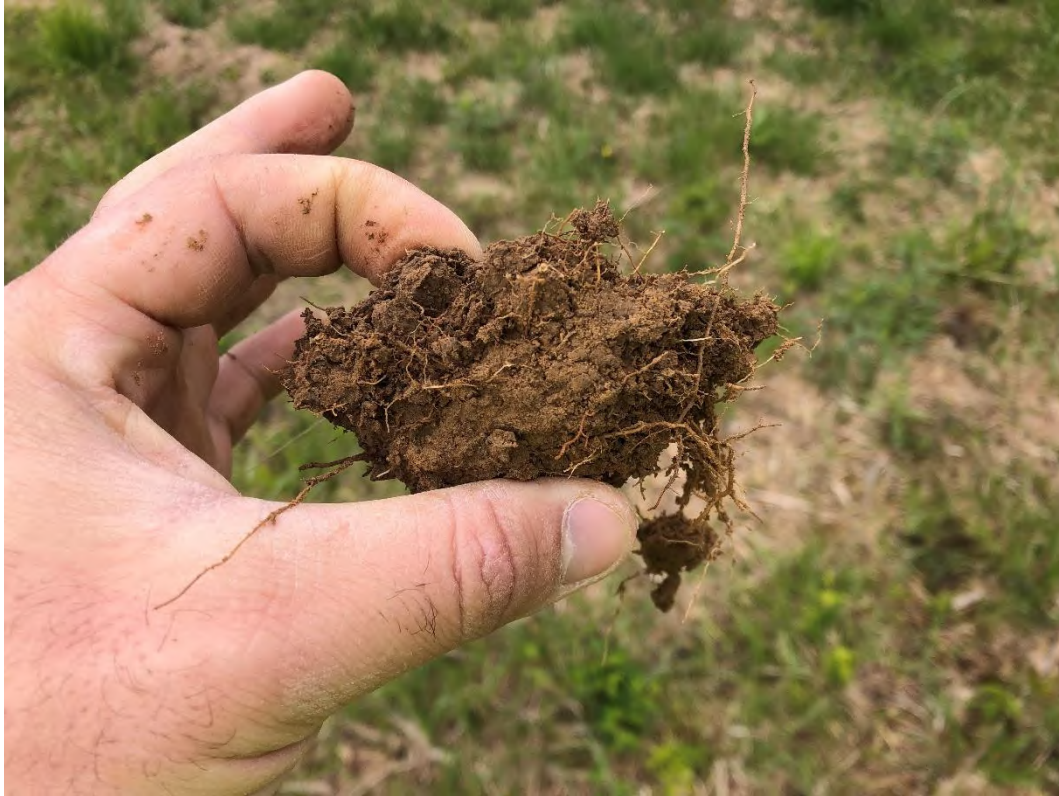
Photograph 33: View of soil located outside of Wetland-3.
(Data Point-13)

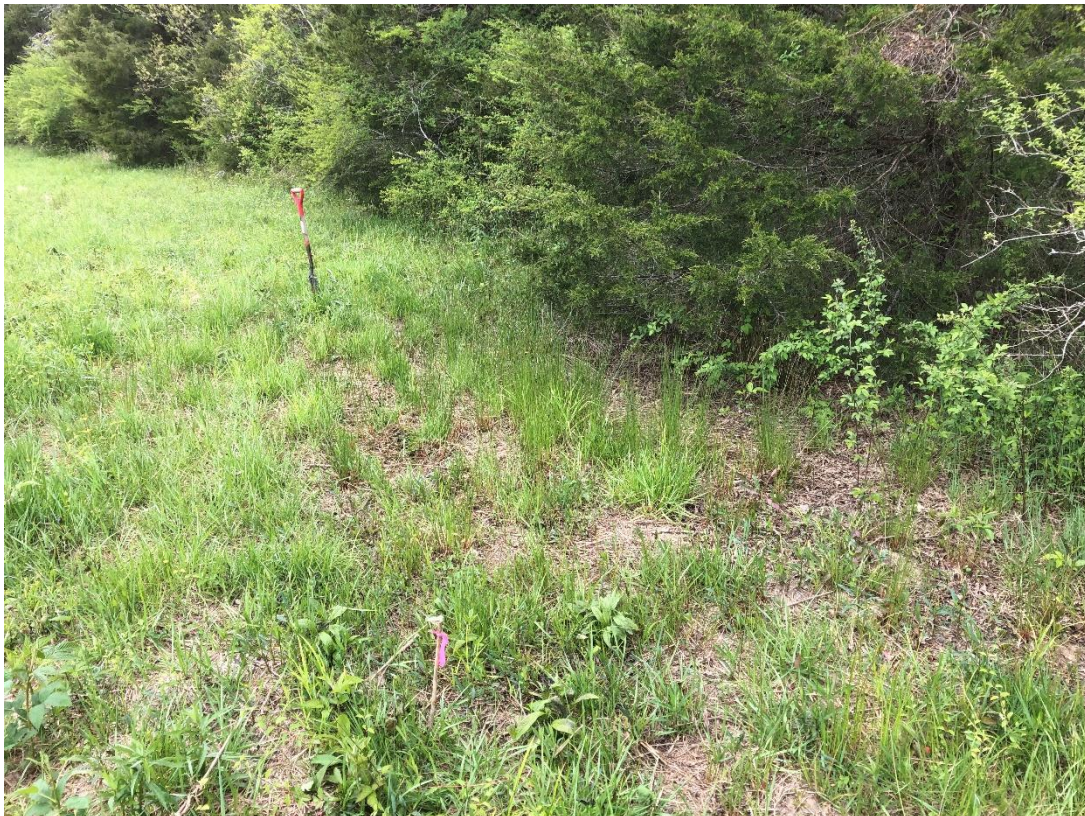
Wetland-4 was located in the western-central portion of the Subject Property. Data points were taken to define the boundary of Wetland-4. Wetland-4 included species of Common Rush (*Juncus effusus*), American Elm (*Ulmus americana*), and Red Maple (*Acer rubrum*). Hydrology, hydrophytic vegetation, and hydric soil indicators were observed in this area. Wetland-4 consisted of plant species with a Facultative and Facultative Wet Wetland Indicator status. Visual hydrology indicators consisted of drift deposits along with saturation within the soil profile, and oxidized rhizospheres on living roots. The soil from the data points taken met the criteria for the F3 Depleted Matrix indicator needed to confirm hydric soil conditions along with the necessary redox concentrations needed for hydric soils.

Photograph 34: View of Wetland-4 facing west-southwest in the west-central portion of the Subject Property.
(35.224037, -84.997578)

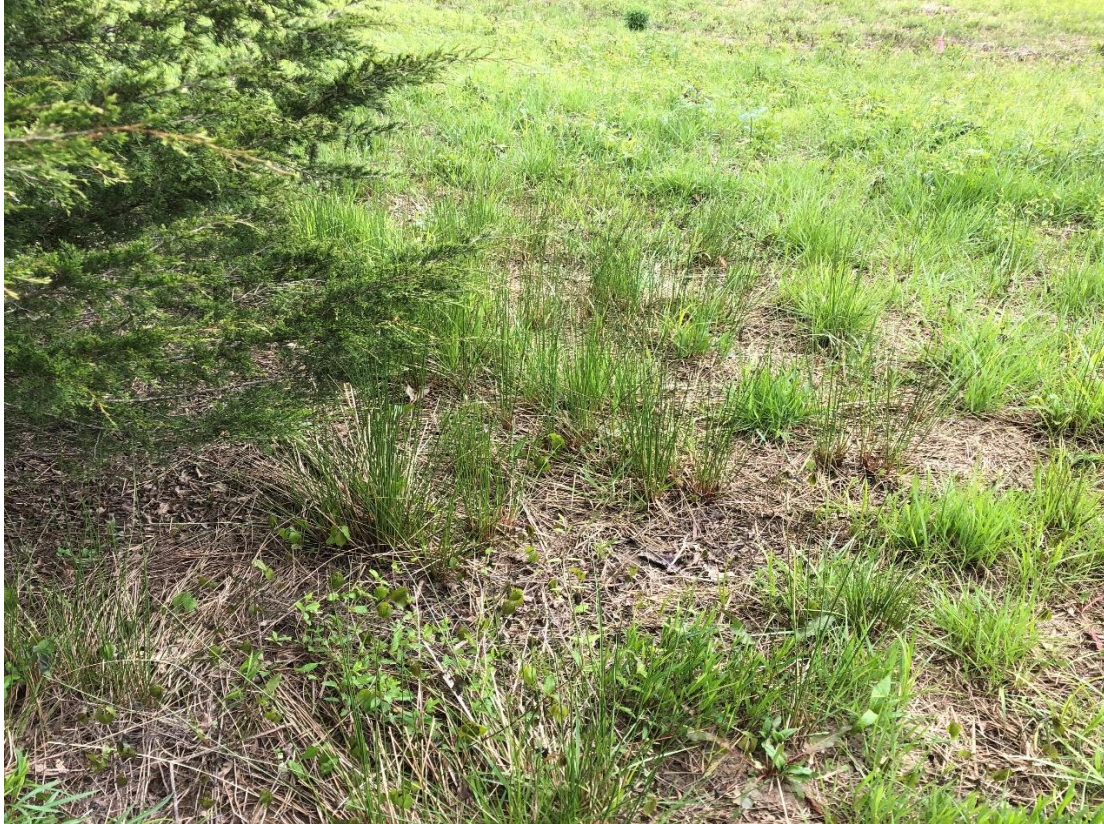
Photograph 35: View of Wetland-4 facing northeast in the west-central portion of the Subject Property.
(35.224027, -84.997637)

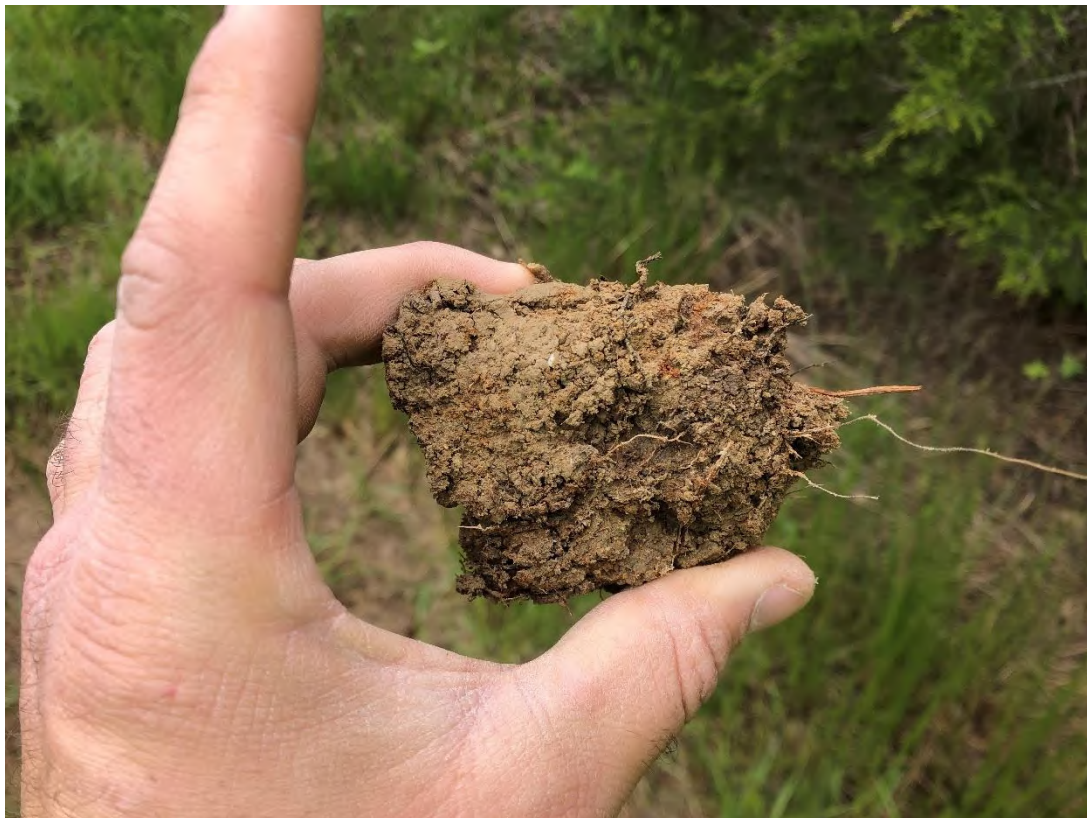
Photograph 36: View of soil located within Wetland-4.
(Data Point-16)

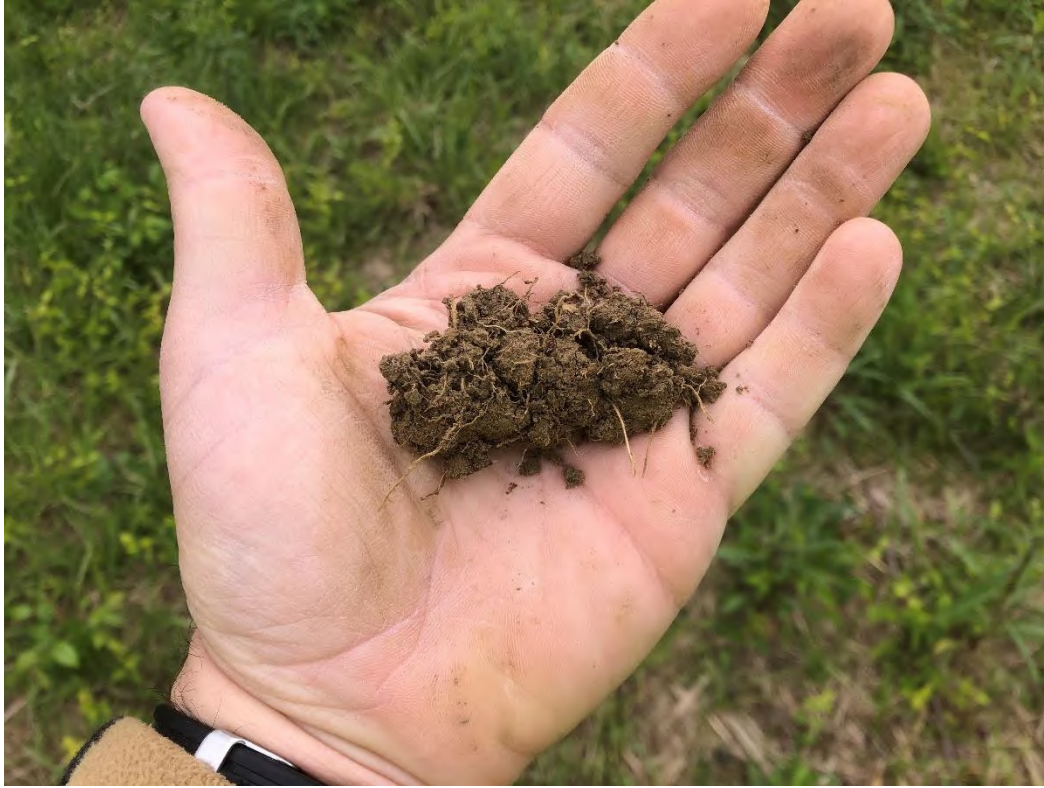
Photograph 37: View of soil located outside of Wetland-4.
(Data Point-17)
