STATE OF TENNESSEE
DEPARTMENT OF ENVIRONMENT AND CONSERVATION
KNOXVILLE ENVIRONMENTAL FIELD OFFICE
DIVISION OF MINERAL & GEOLOGIC RESOURCES – MINING SECTION
3711 MIDDLEBROOK PIKE
KNOXVILLE, TENNESSEE 37921-6538
PHONE (865) 594-6035 STATEWIDE 1-888-891-8332 FAX (865) 594-6105

Mining Facility Inspection Report

NPDES permit number: TN0070408

Inspection type: Follow-up

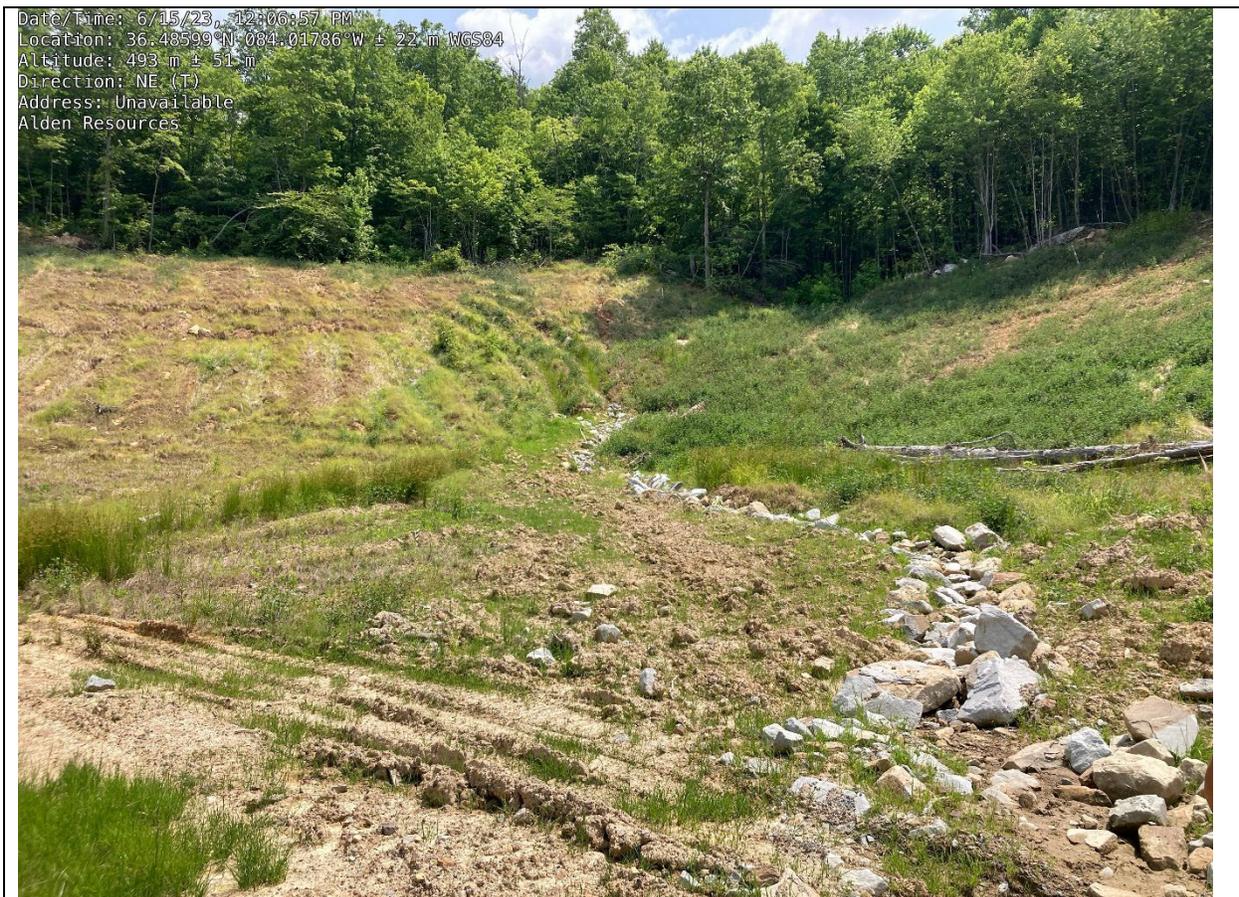
36.48599, -84.01786 2023/06/15 12:06:57 61°

Item 1: Photo of the new stream channel constructed in the backfill on the left side of the head of the hollow.

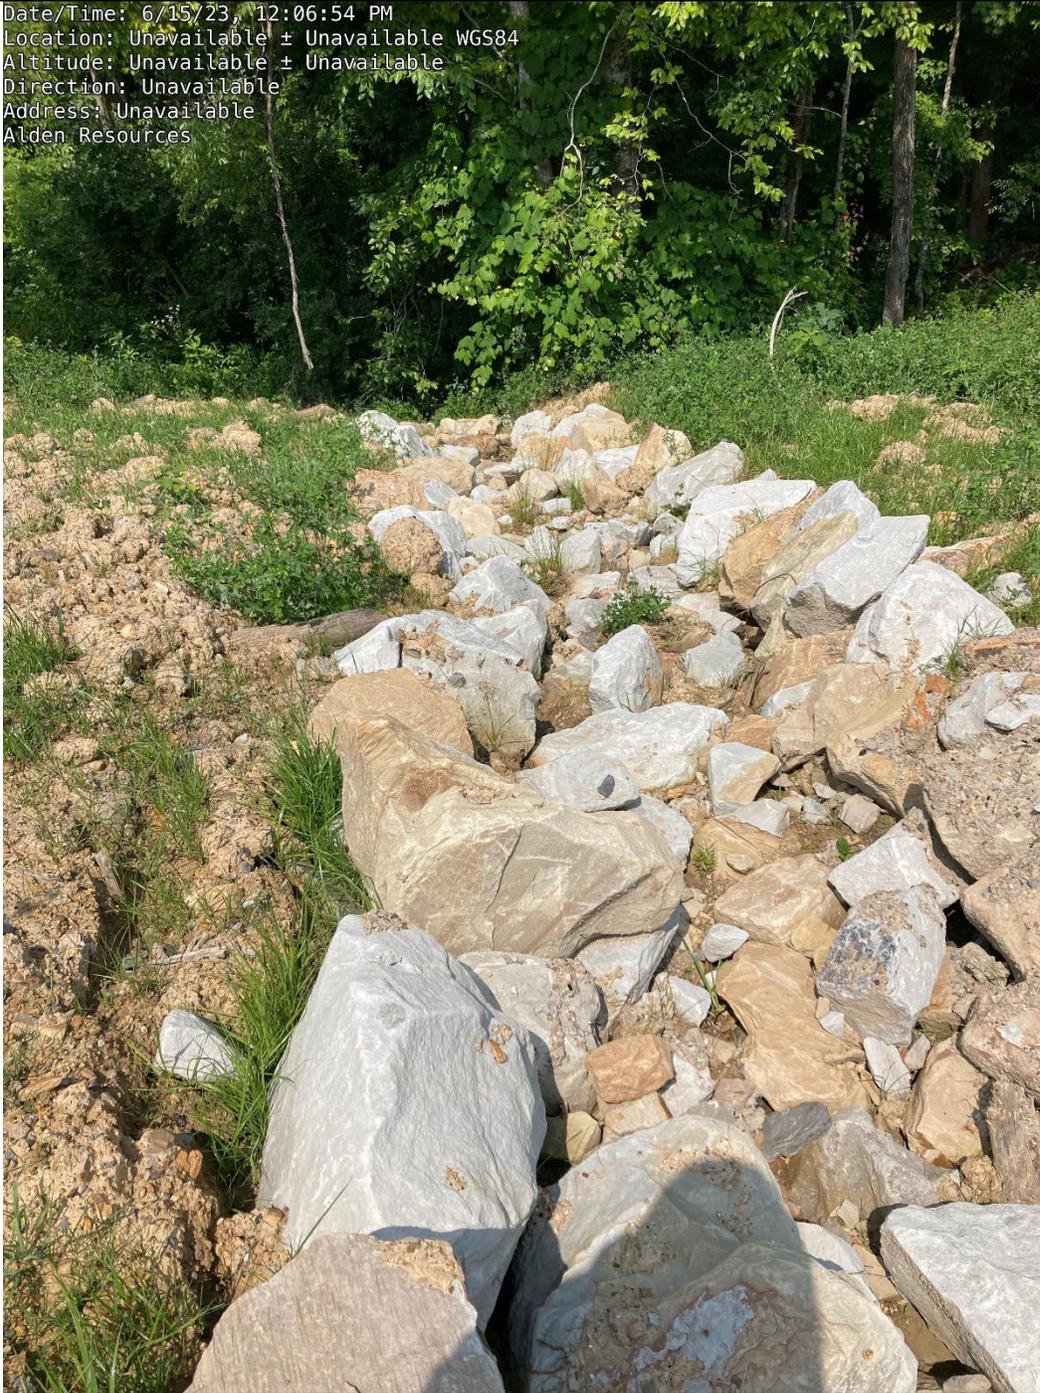
, 2023/06/15 12:06:54 °

Item 2: Photo of the channel in item 1 extending down to the existing stream.

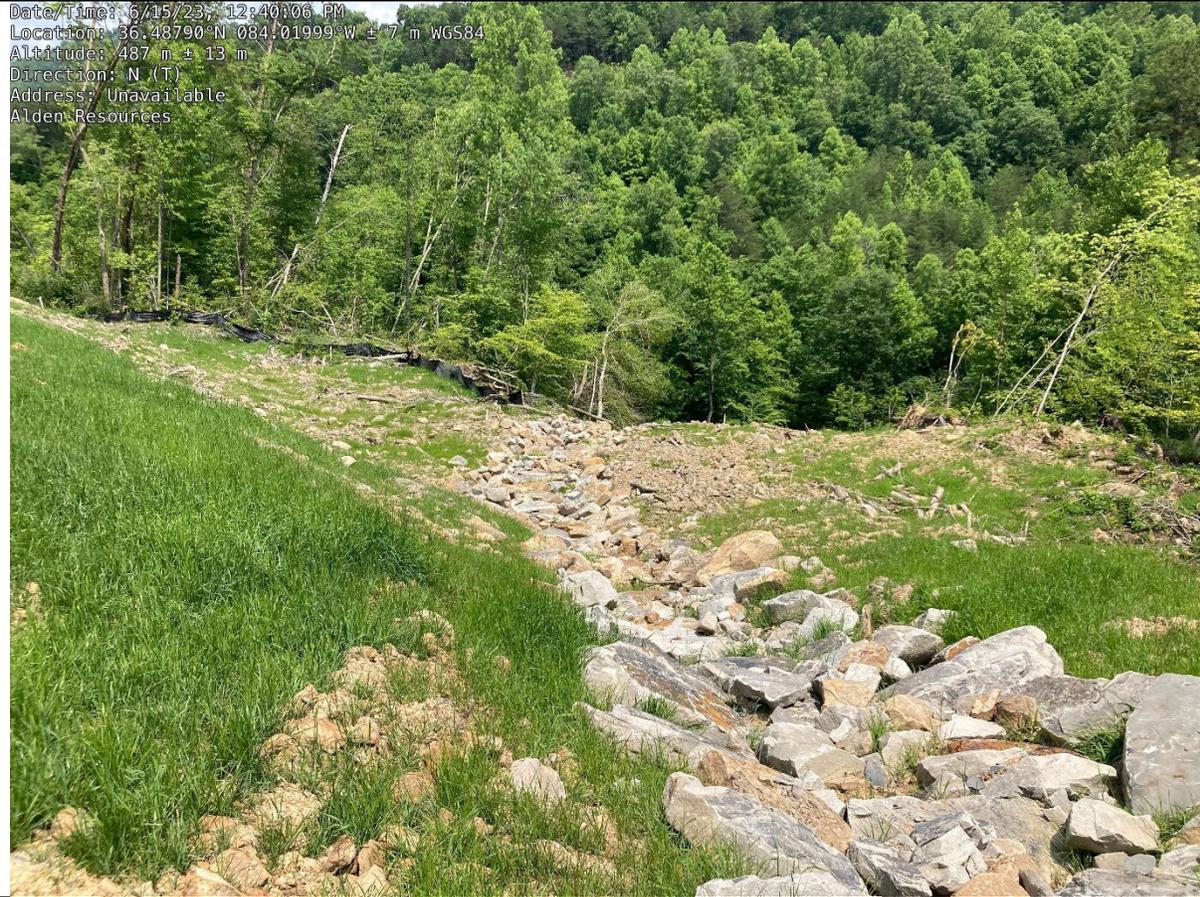
36.4879, -84.01999 2023/06/15 12:40:06 354°

Item 3: Photo of the regraded landslide and the ditch constructed down it. The hydroseeded grass is growing well.

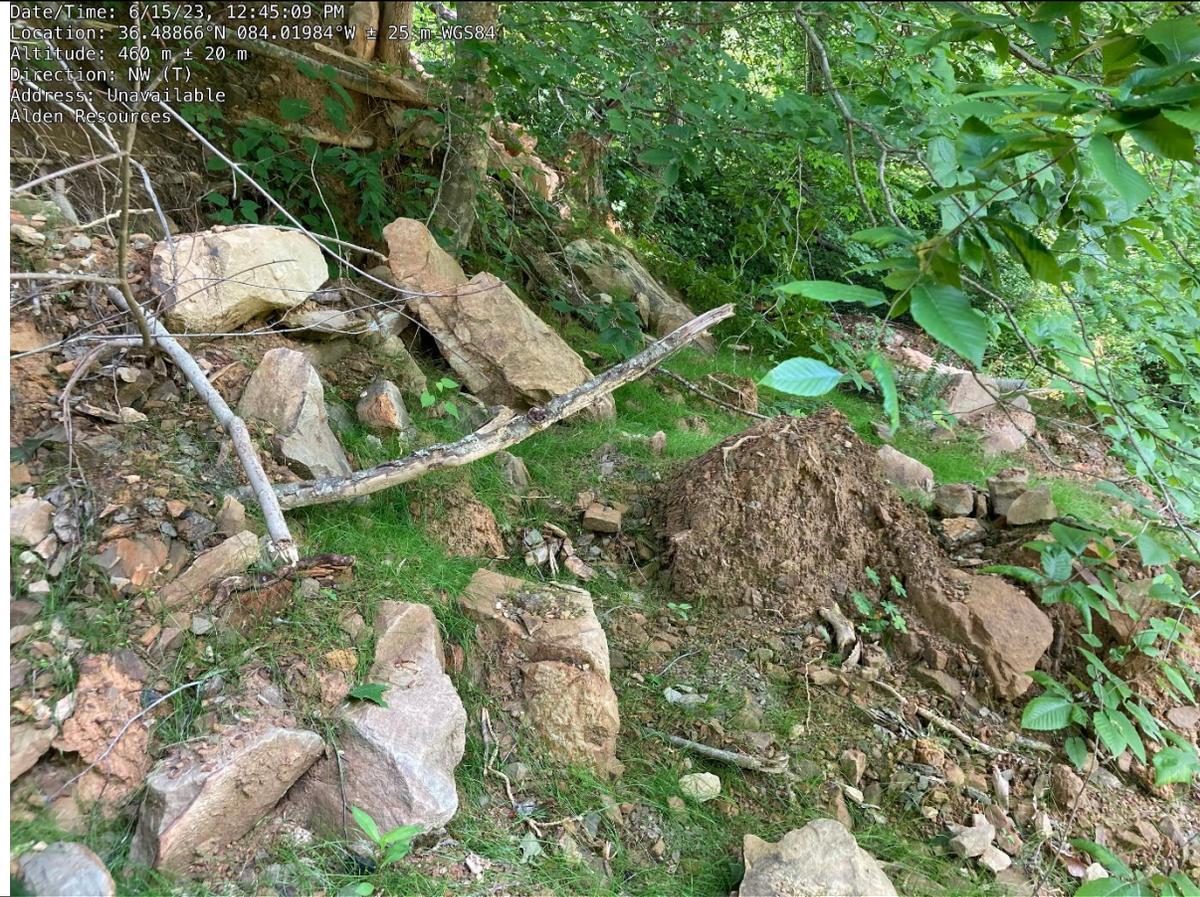
36.48866, -84.01984 2023/06/15 12:45:09 296°

Item 4: Photo of hand-seeded grass growing on the landslide towards the bottom of of the slide.

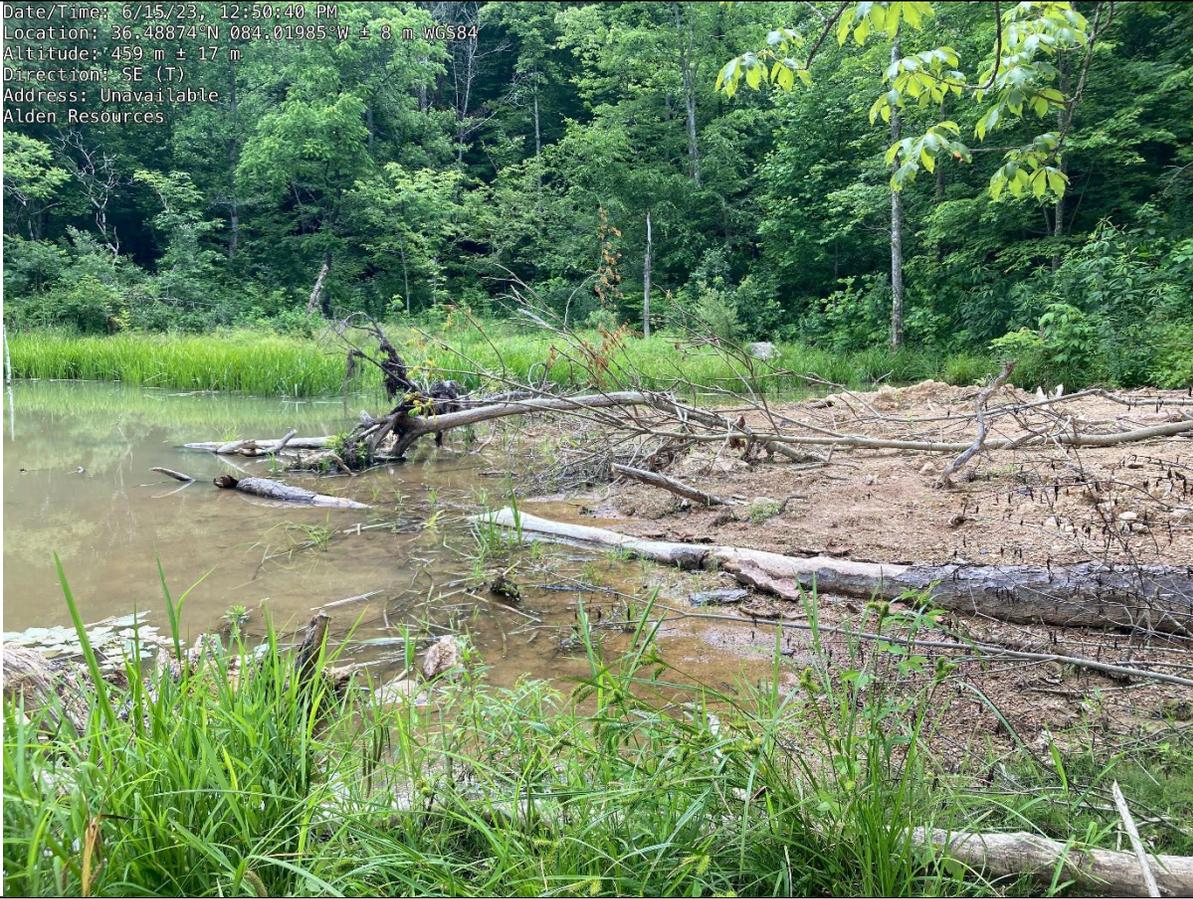
36.48874, -84.01985 2023/06/15 12:50:40 114°

Item 5: Photo of the toe of the landslide extending into the water feature. At the time of inspection there was no obvious signs of seed germination of the wetland mix.

A follow-up inspection was conducted after being notified by Mike Erp that Alden Resources, LLC seeded the toe of the landslide extending into the water feature on 6/2/2023. At the time of inspection the hydroseeded grass was several inches tall. Inspectors could not identify any sprouting or seeds from the wetland mix, but germination might have not occurred. The company also addressed the drainage issue on the pre-mining landslide as requested. The toe of the landslide extending into the water feature should be monitored and re-seeded with a cover such as annual rye if germination of the wetland mix does not occur.

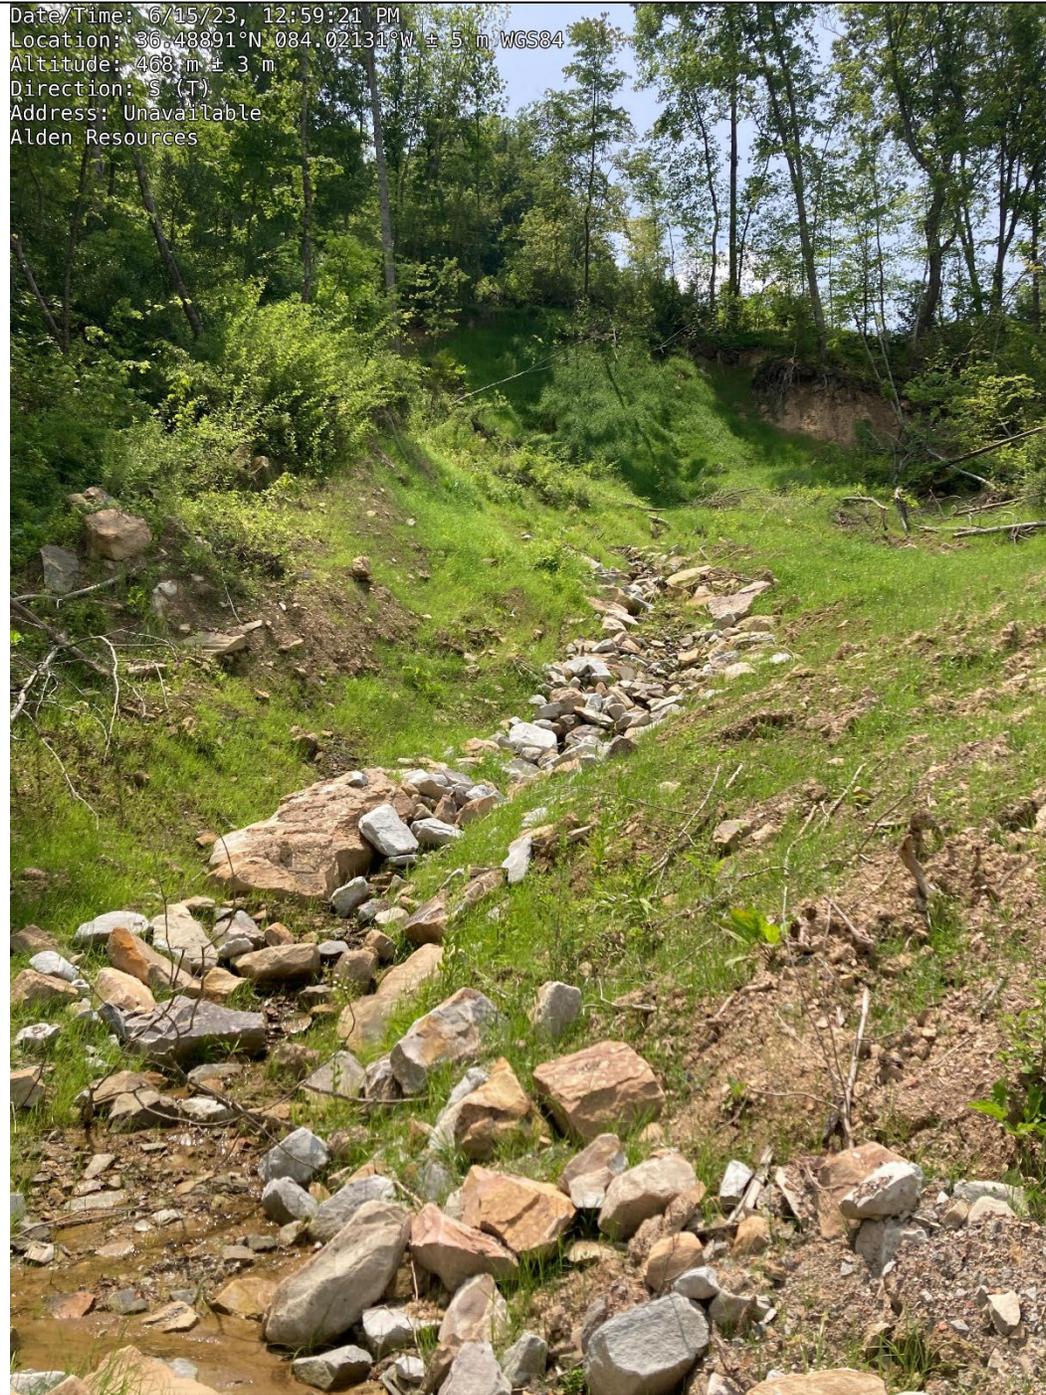
36.48891, -84.02131 2023/06/15 12:59:21 188°

Item 6: Photo of the new channel constructed through the pre-law landslide. The hydroseeded grass has germinated and is growing well.

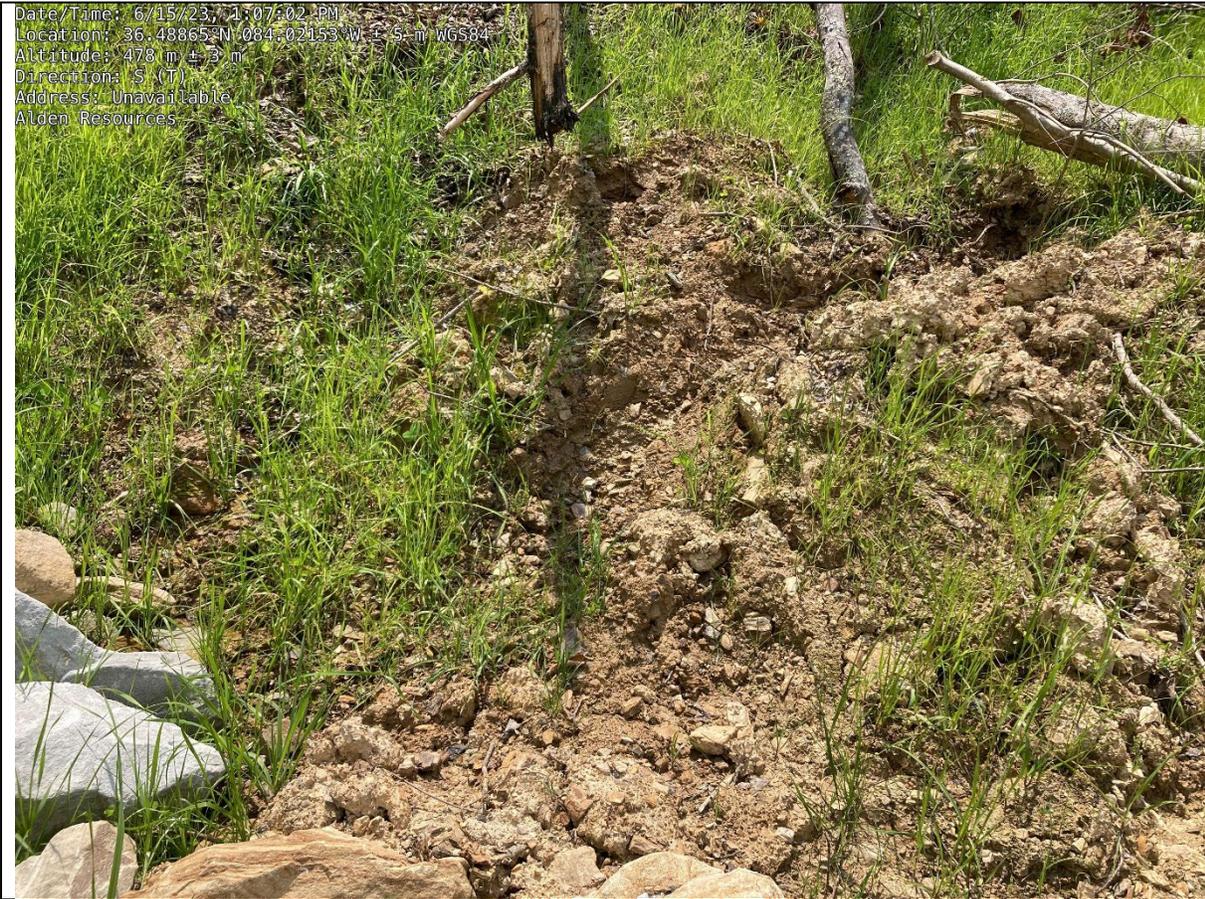
36.48865, -84.02153 2023/06/15 13:07:02 190°

Item 7: Photo of the drainage area in the pre-law slide that has been connected to the constructed channel as requested by TDEC.

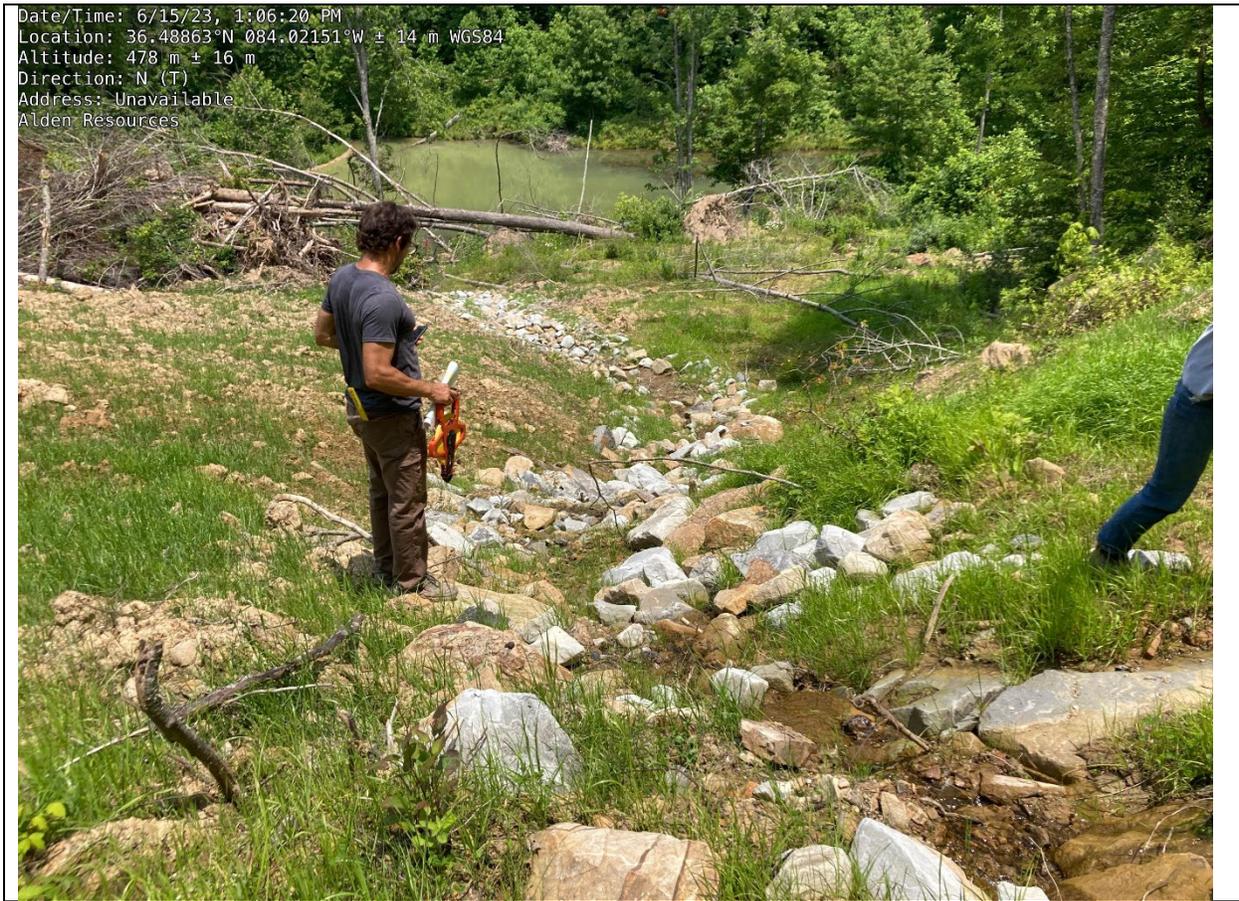
36.48863, -84.02151 2023/06/15 13:06:20 15°

Item 8: Additional photo of the constructed channel on the pre-law landslide.
